Learning from Earthquakes

The M_w 6.5 Offshore Northern California Earthquake of January 9, 2010

From January 14th to 16th, 2010, an EERI team investigated the effects of the Eureka, California, earthquake. The team comprised San Francisco structural engineer David Bonowitz, Lori Dengler of Humboldt State University, Bret Lizundia of Rutherford and Chekene Consulting Engineers, and Nick Sherrow-Groves of the University of California, Berkeley. This report was authored by Bonowitz, Dengler and Lizundia.

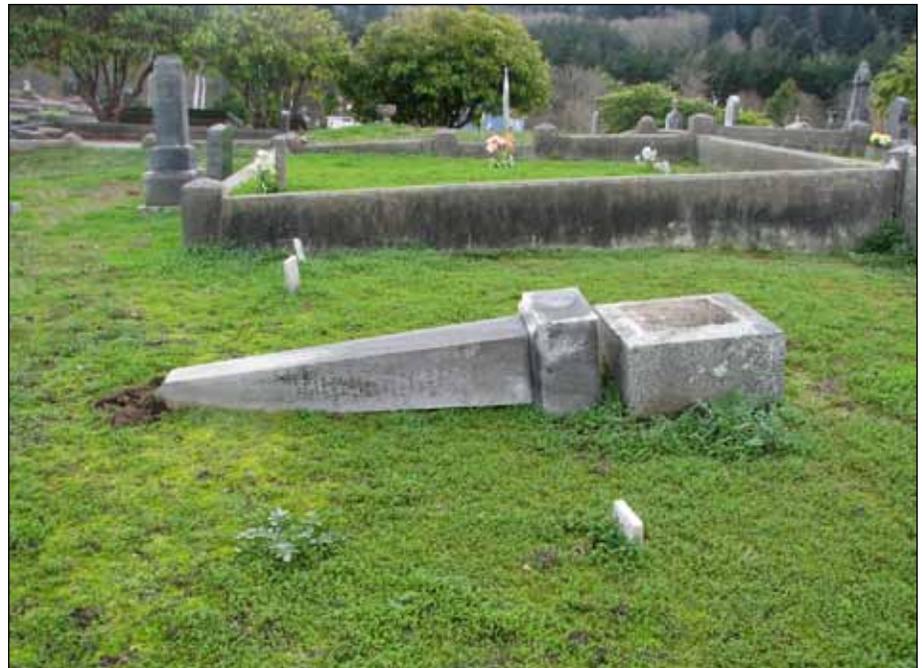
as far east as Reno, Nevada. About 20% of the vertical monuments at the Ferndale Cemetery were toppled or displaced, and preliminary analysis suggests an east-west alignment (Figure 4). Cemetery monuments in Eureka, Table Bluff and Loleta show similar, but smaller, amounts of displacements.

Figure 4. Toppled monument at the Ferndale Cemetery.

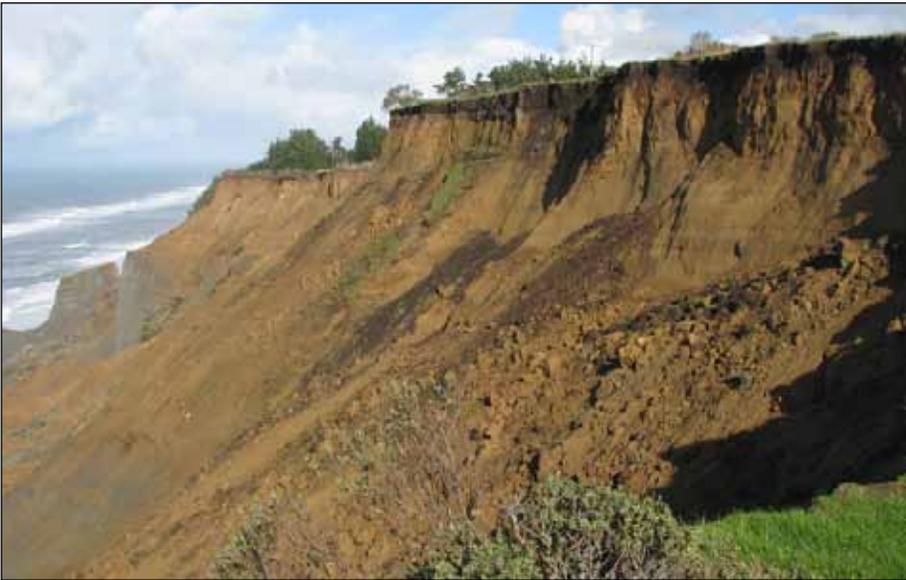
Landslides: Large bluff failures were observed south of the Eel River (Figure 6). A number of small slips were seen in the Humboldt Hill area and on the bluffs adjacent to Highway 101 south of Eureka. Several bank failures caused damage to the Mattole Road south of Ferndale.

Figure 6. ▲ Above: Bluff failures south of the Eel River Valley.
▼ Below: Bank failure on the Mattole Road.

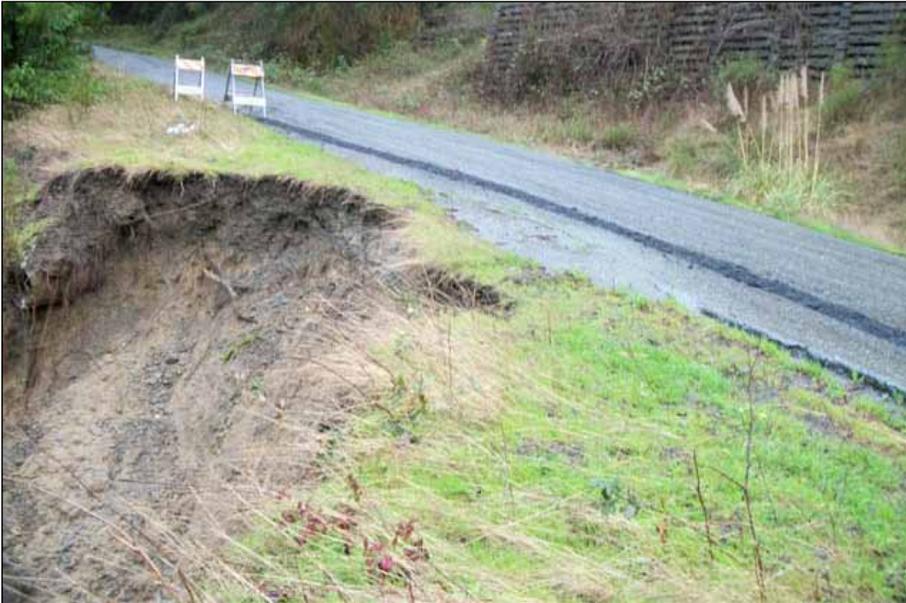
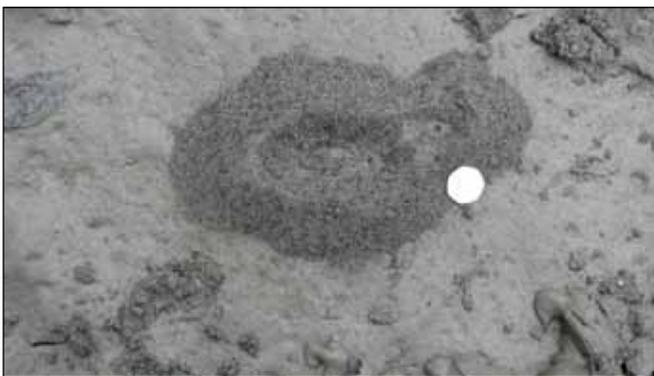
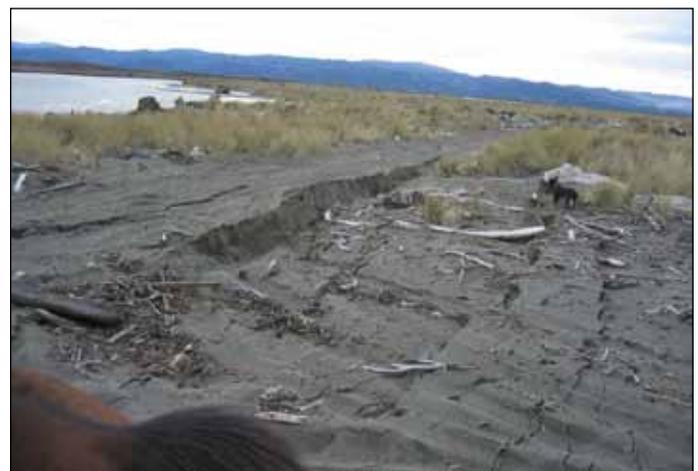
Liquefaction and spread failures: Liquefaction was observed on Centerville Beach and along the Eel River (Figure 7). The Centerville Beach features were subtle and had been overtopped by high tide washover. Small sand boils were better preserved on the banks of the Eel River and associated with spread failures ranging in length from less than one meter to 20 m. Spread failures were observed at King Salmon and along the banks of the Eel River. The most developed spread failures were located on the spit north of the mouth of the Eel River, where some features extended 10 m or more with offsets up to 40 cm. Heavy rainfall on January 12 likely erased surface features elsewhere.

Figure 7. ▲ Above: Sand boils along the Eel River, 25 centimeters in length. Right: Spread failures on spit north of Eel River mouth. ►

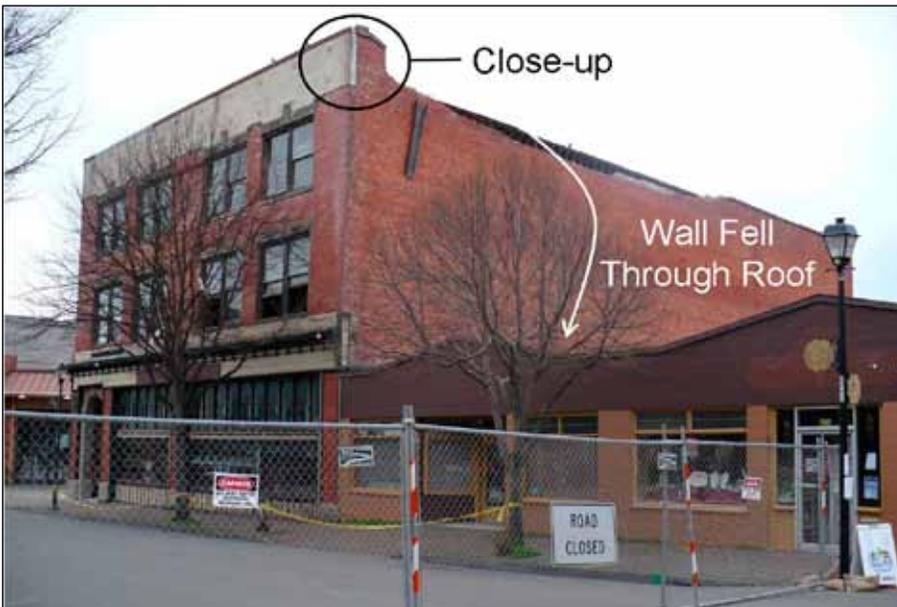
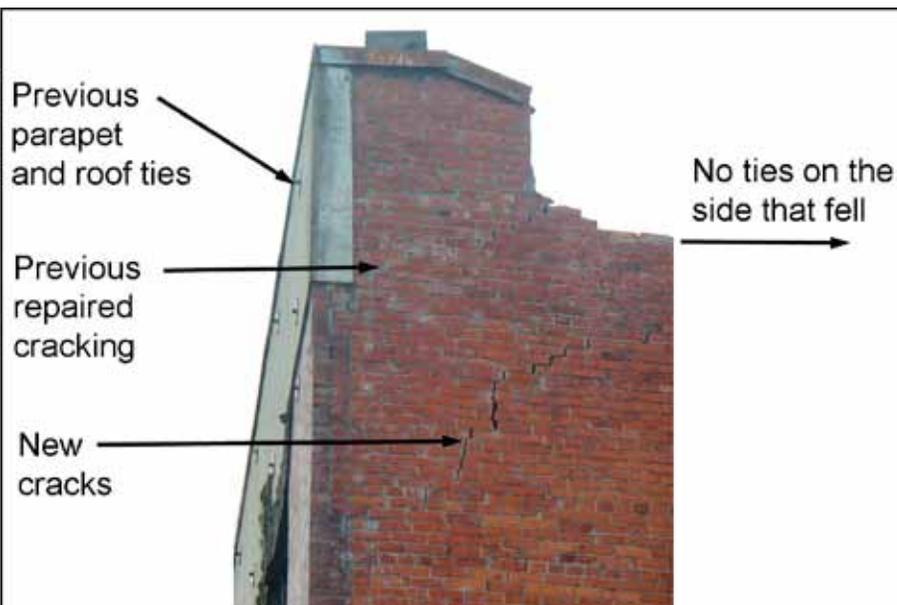
At the vacant, three-story Old Town Bar and Grill, a long length of the parapet and top of the east side wall fell and destroyed the wood roof of the adjacent single story building. No one was in the adjacent building at the time. In addition, the front (south) façade was leaning toward the street, leading the city to fence off most of the block. This URM had been damaged in a previous earthquake, and roof-to-wall and roof-to-parapet through-wall ties had been installed as a repair measure. No ties were installed on the side walls, including the wall that fell (Figure 8).

Figure 8. ▲ Top: Unreinforced masonry damage to the Old Town Bar and Grill, Eureka. ▼ Bottom: Close up of damage at southeast roof corner.

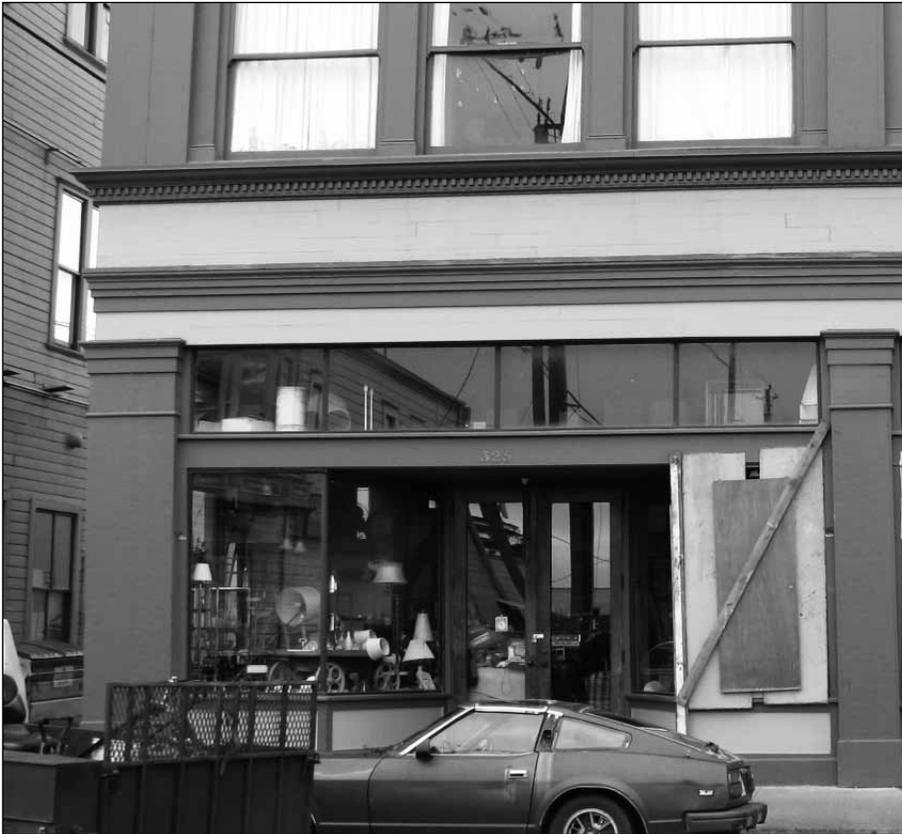
Large woodframe (commercial): Downtown Eureka has several multi-story woodframe buildings. A four-story Renaissance Revival building built in 1903 on E Street (Figures 9 and 10) has a front (west) façade that is largely glass, particularly in the ground story. Plumb bob measurements found ground story north-south permanent drift of 1.4% on this line, with only 0.6% along the rear (east) wall. Ground story north-south windows and interior partitions were also damaged.

Figure 9: Base of a portion of the front façade of 333 E Street with damaged glazing. Residual ground story interstory drift of 1.4% was to the left.

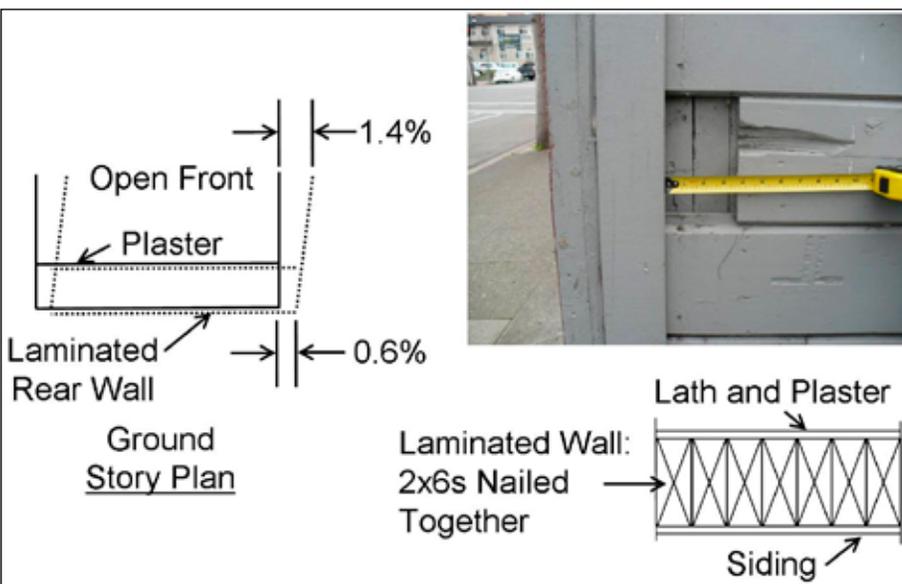
Figure 10. Plan view of ground story drift and detail of rear laminated wall construction at 333 E Street.

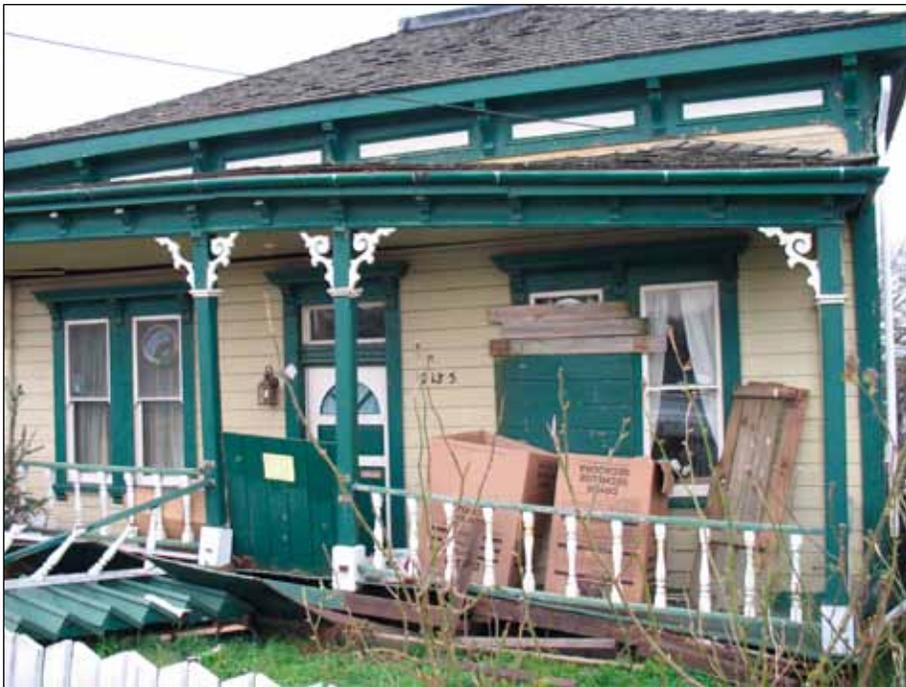
A collapsed cripple wall house in Eureka represented the most complete loss of any structure in this event (Figure 11). The collapse of unbraced cripple walls is not surprising; in 1992, several collapsed in Ferndale and Petrolia (EERI, 1992). The City of Eureka Building Department received 56 reports or inspection requests for foundation damage within a week of the earthquake, but only the collapsed house and one other were red-tagged. Six others were yellow-tagged, and ten had not yet been inspected but remained occupied. One house outside the city was reported “knocked off its foundation” (Greenon, 1/13/2010).

The collapsed house did have a taller cripple story than its neighbors, with eight steps to the porch instead of the more commonly observed three or five. Still, similarly tall cripple walls were observed in Ferndale, with no apparent damage.

Figure 11. The only structure to collapse in this event. Note the large number of front steps, indicating a cripple story taller than that of neighboring houses.

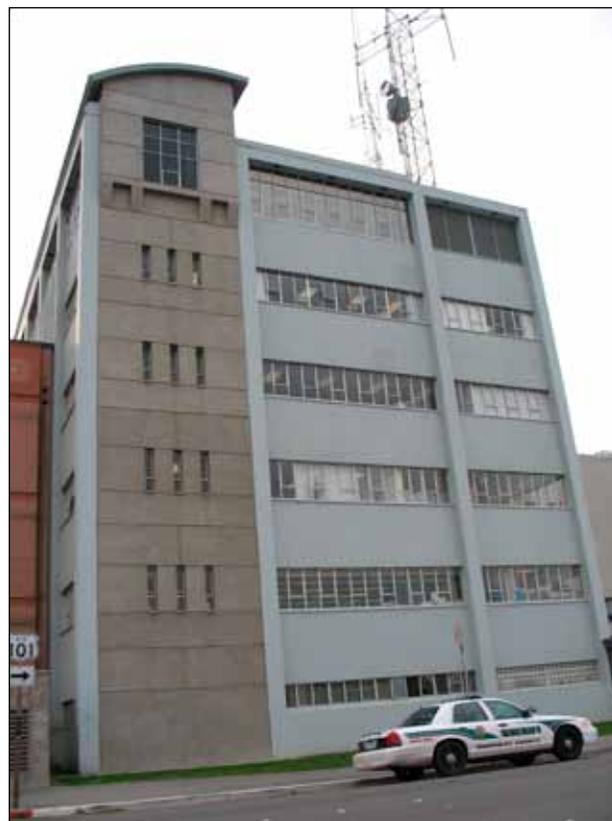
The six-story Humboldt County Courthouse is one of the largest facilities in the city (Figure 12). Built in the 1960s and retrofitted with concrete shear walls after the 1992 earthquake, the structure showed only insignificant cracking along a horizontal construction joint in an original stairwell, as well as partition damage around a door opening to that stairwell.

Figure 12. Humboldt County Courthouse, showing shear wall added in left bay as part of a seismic retrofit after the 1992 earthquake.

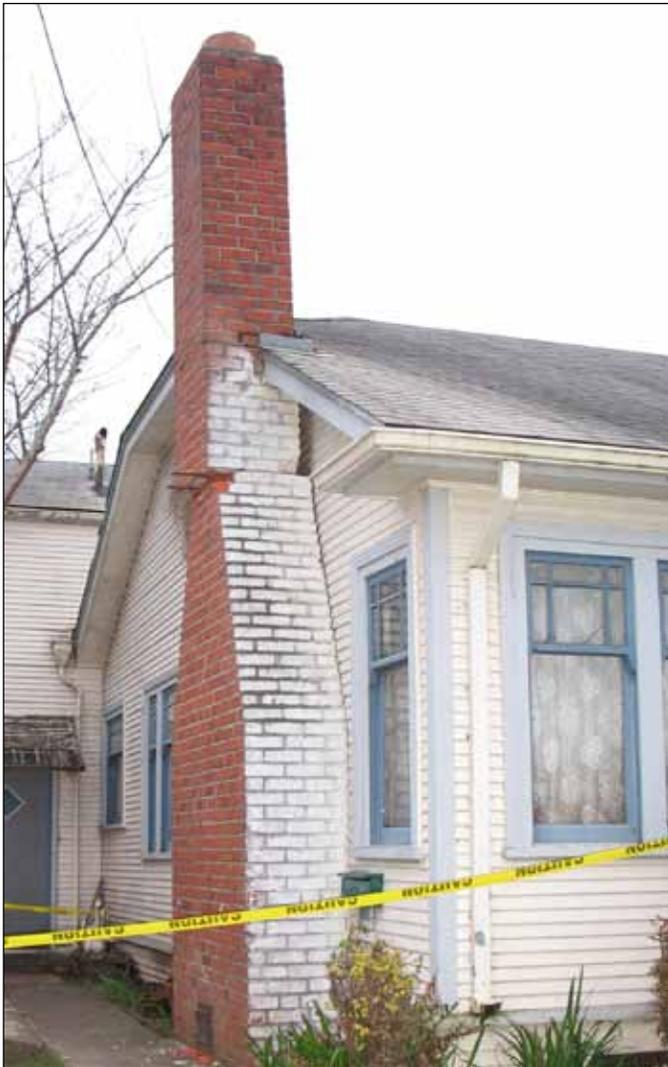
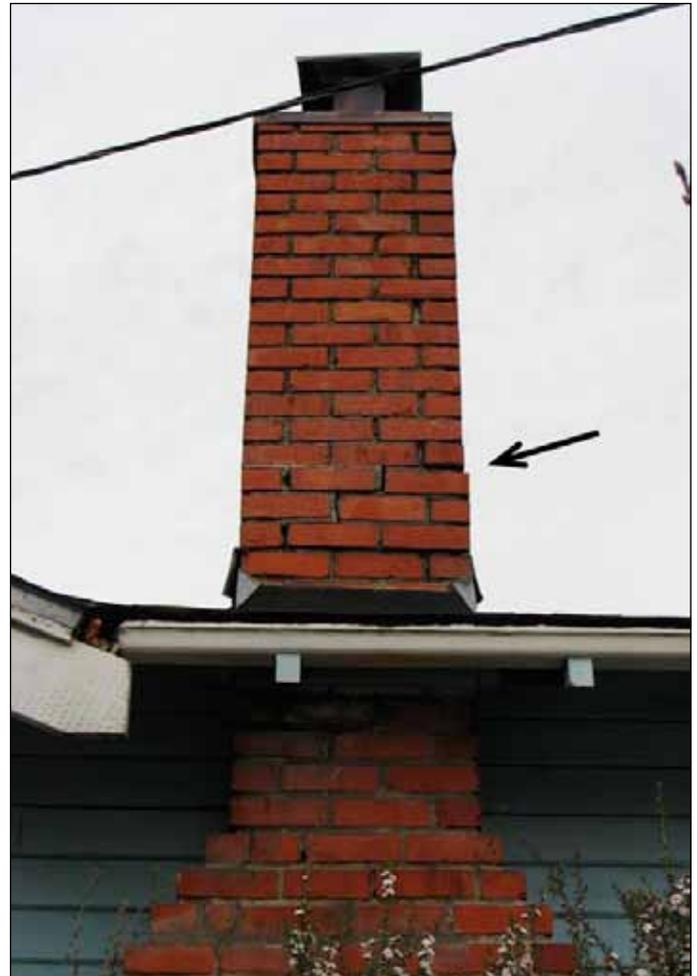
- Extensive damage to reinforced and unreinforced brick chimneys, including cracking, collapse, and shifting above the roof line.

Within a week of the earthquake, Eureka's building department had logged 197 reports or inquiries about chimney damage, 78 of which received yellow tags suggestive of a remaining risk. We found additional chimney damage that owners were unaware of (see Figure 13), so these figures likely undercount the actual damage. On January 22, the city posted on its web page an advisory about the possibility of unseen chimney damage.

Figure 13. Chimney damage in Eureka was both ◀ obvious and ▲ unnoticed.
