Learning from Earthquakes

The M_w 5.8 Virginia Earthquake of August 23, 2011

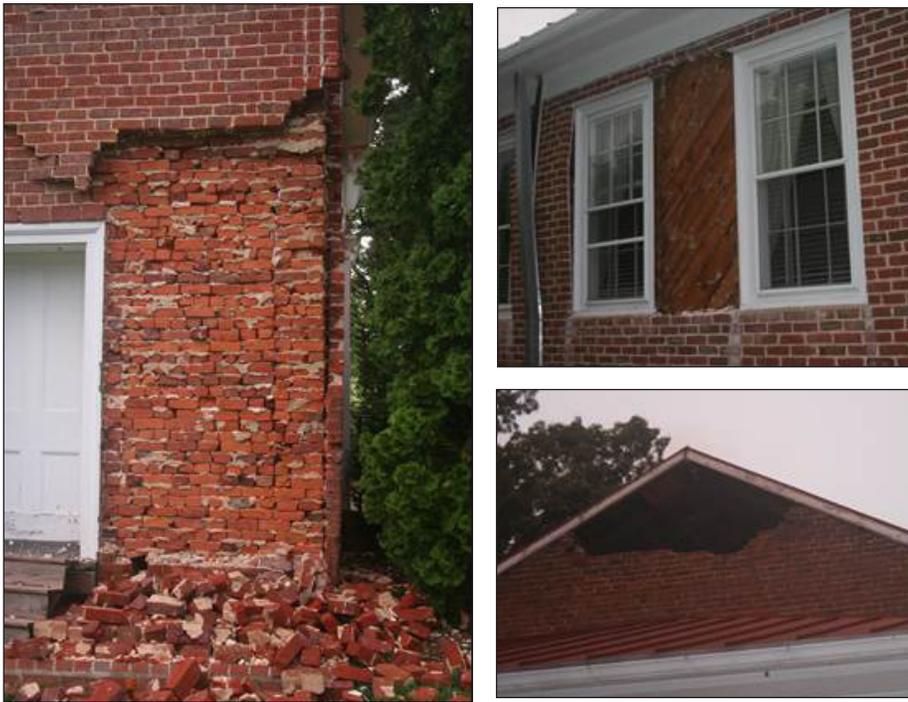
Figure 7. Damage to the historic Gilboa Christian Church.

had considerable architectural and some structural damage. As shown in Figure 7, the outer wythe of a brick wall collapsed where there was no apparent connection between the wythes of the wall. A portion of a gable wall collapsed that did not appear to be well anchored to the roof diaphragm. A section of brick veneer also failed where ties between the brick and backup wall consisted of 16d nails driven into straight sheathing and then encased in the brick mortar joint. Approximately 20% of the vertical standing tombstones in the Gilboa Church cemetery were thrown over.

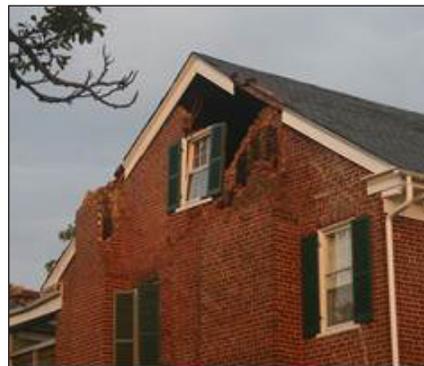
The Cuckoo House, a Federal style house in the small village of Cuckoo, near Mineral, was built in 1819 and was listed on the National Register of Historic Places in 1994. The unreinforced masonry building had considerable architectural and some structural damage, with partial collapse of some walls and both tall chimneys (Figure 8).

Figure 8. Partial collapse of a gable wall and two chimneys at the Cuckoo House outside Mineral.

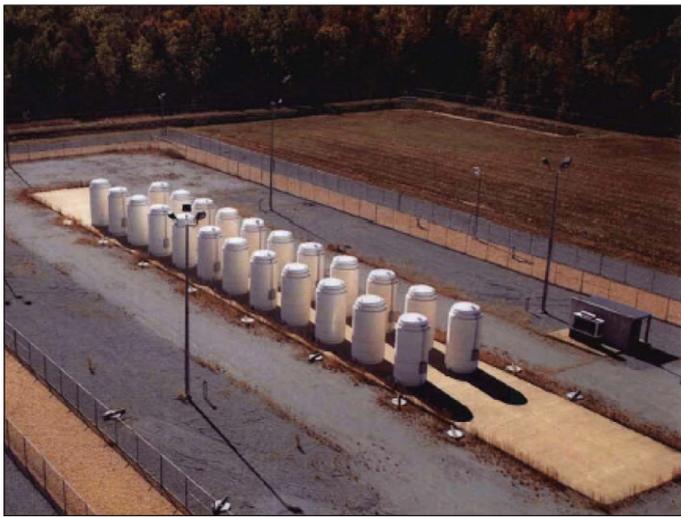
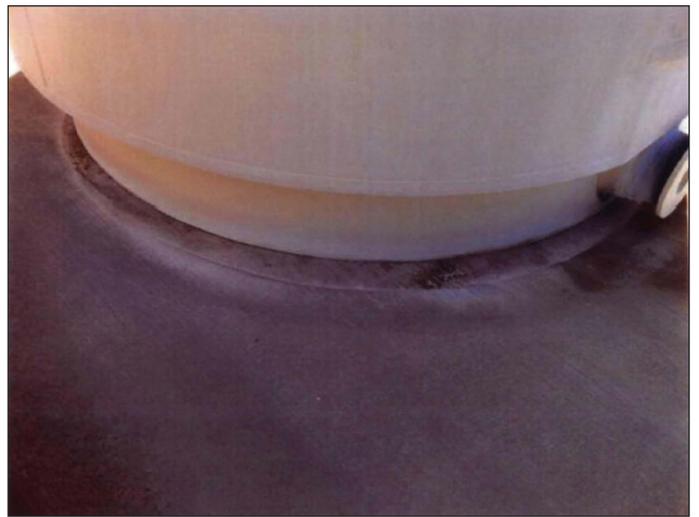
Figure 10. 117-ton steel casks for dry storage of spent fuel rods (photos: Dominion Power).

to the foundation, though they were not tied down; however, it was clear that 27 massive steel storage casks for spent fuel rods slid around on their concrete slab as much 4.5 inches (Figure 10).

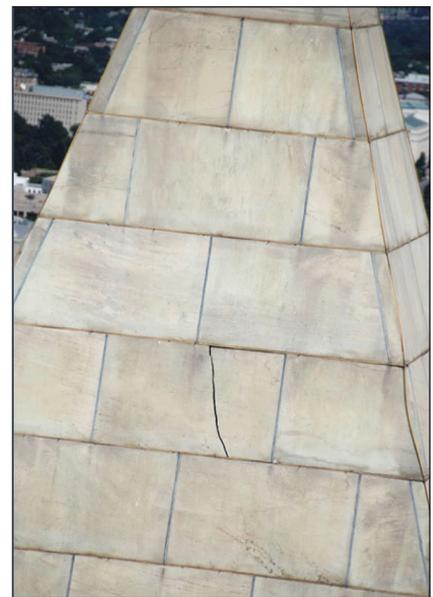
Figure 17. Crack in the Washington Monument (photo: National Park Service, 2011b).

The most significant damage was found in the pyramidion at the top of the structure, where a 4-foot long, 1-inch wide crack was observed (Figure 17). Engineers and inspectors were assisted in the damage assessment by a study of the Washington Monument that was completed in 1999 prior to a rehabilita-

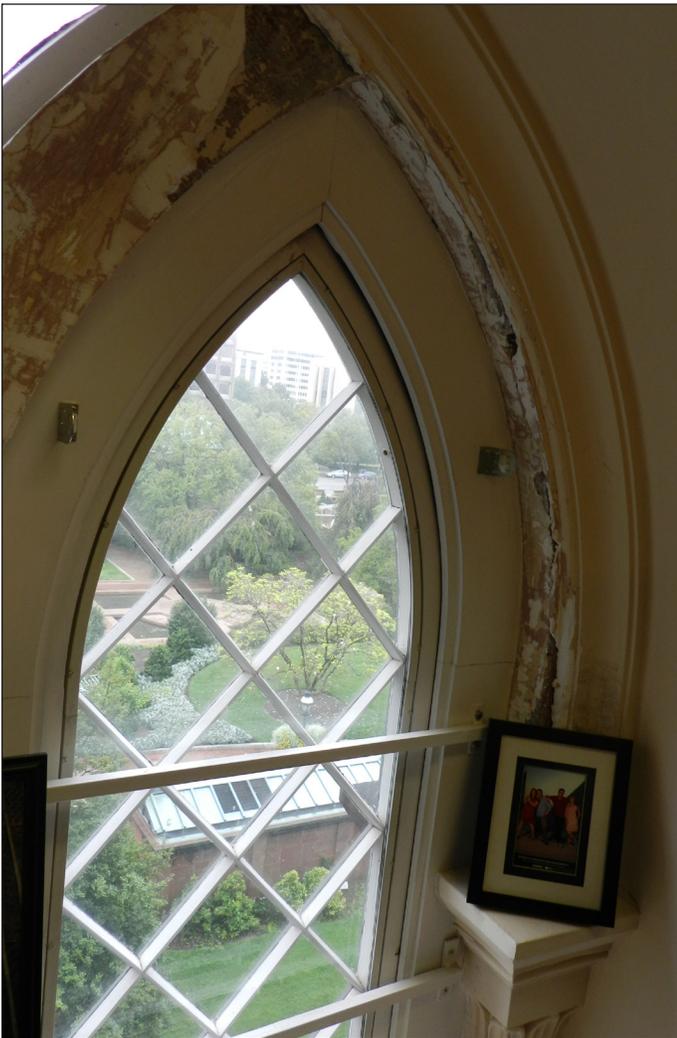
◀ **Figure 18.** Wall cracking around Castle windows; this window moved outward about one-fourth inch.)

the Castle. There was considerable shear cracking throughout the building, especially around windows and major corners (Figure 18). The large chimneys cracked to the point that they had to be wrapped in plywood and restrained (Figure 19).

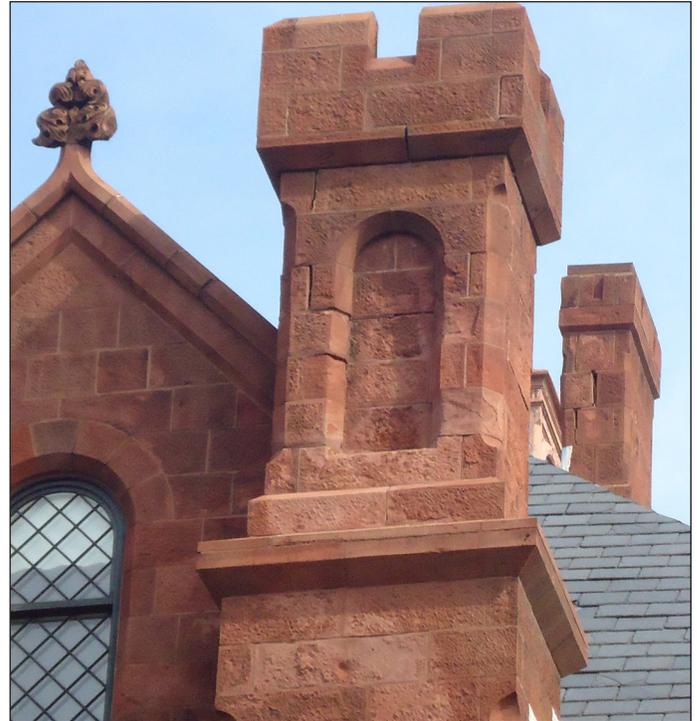
▲ **Figure 19.** Damaged chimneys of the Smithsonian Castle.

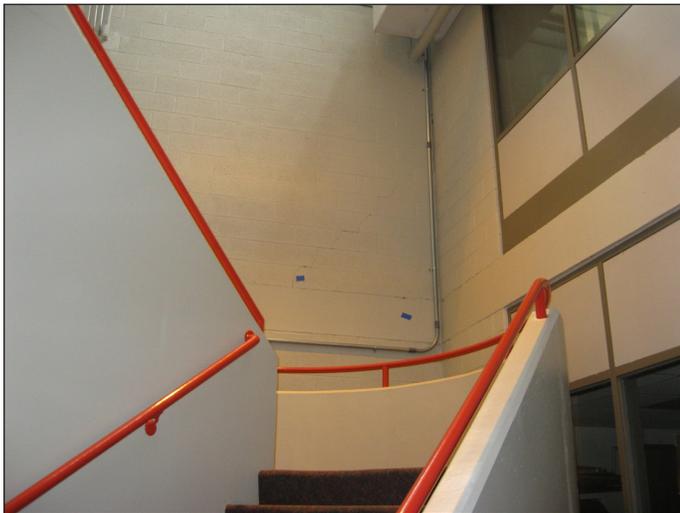
Figure 20. Concrete stairwell. Notice infilled wall crack (blue tape) at framing beam in warehouse wall across from stairs.

steel mezzanine construction once one got to each floor level (see Figures 20 and 21).

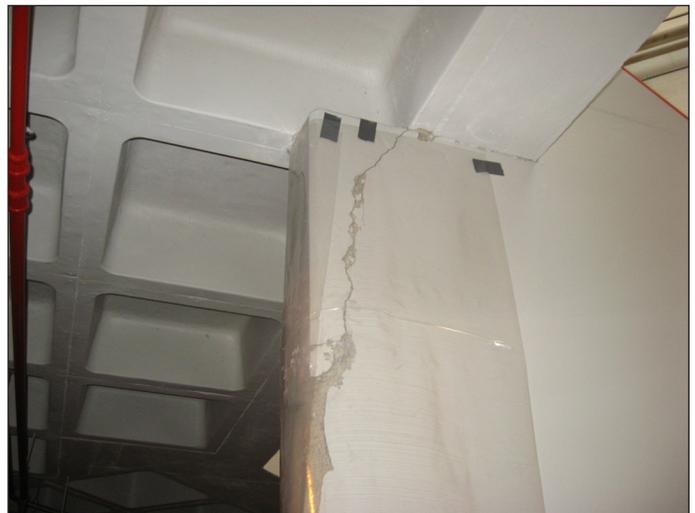
Figure 21. Stairwell concrete column failure at first mezzanine floor level.

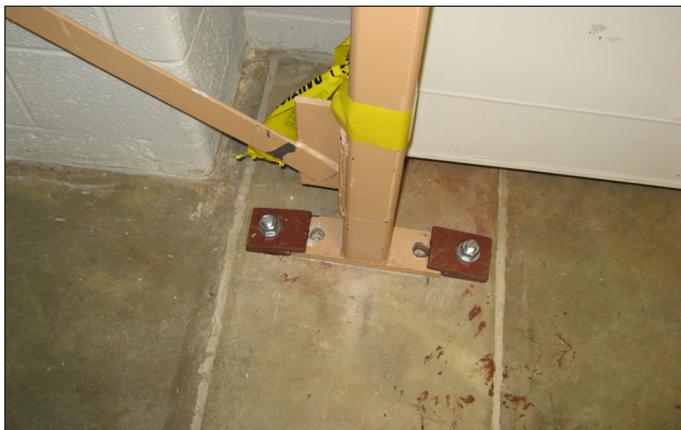
In the steel artifact storage area of one pod there was evidence of considerable seismic load (Figure 22). Two approximately 1-inch anchor bolts completely sheared and the tension cross brace yielded. Not only did that steel brace yield in tension, but one brace actually ruptured.

Figure 22. Base floor of artifact storage area showing sheared steel framing support anchorage and brace yielding (flaked off paint) at plate connection.

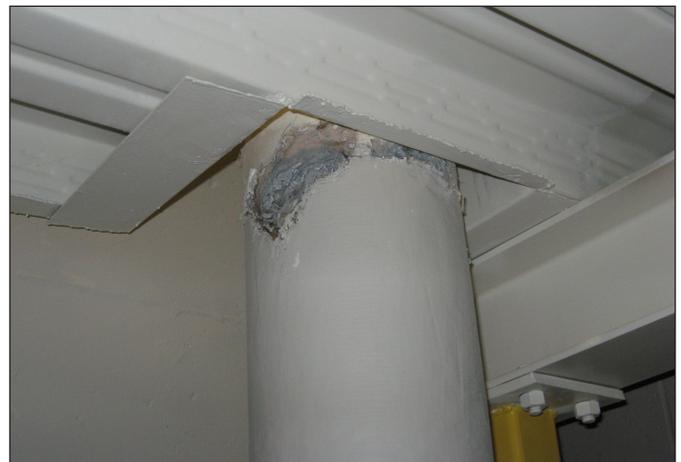
The building and the independent steel-framed storage structure moved differentially during the earthquake, as evidenced by damaged insulation seen in vertical pipes (Figure 23). The differential dis-

Figure 23. Battered insulation of vertical pipe through mezzanine floors.
