EERI Earthquake Reconnaissance Team Report:
M5.0 Cushing, Oklahoma, USA
Earthquake on November 7, 2016

February 2017

A product of the EERI Learning From Earthquakes Program

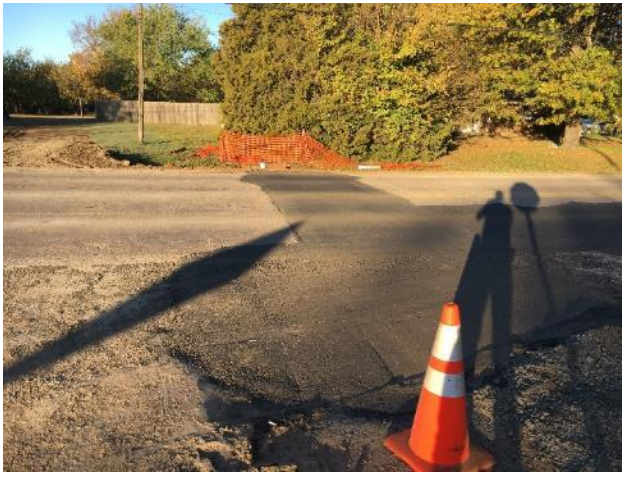
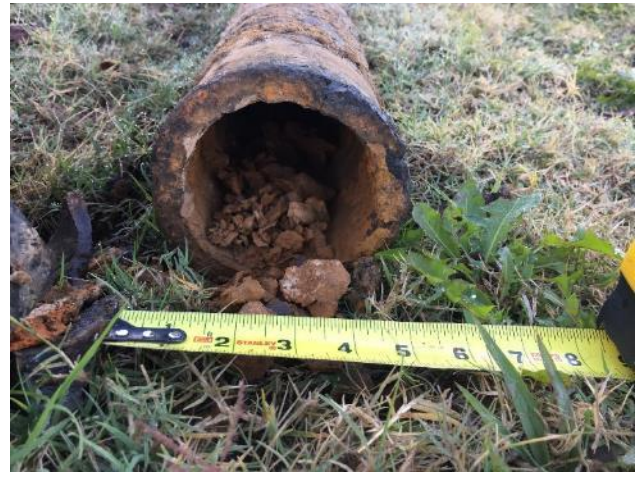
Water main breaks were reported at three locations near Cushing. The largest of these breaks included the fracture of a 4-inch diameter ductile iron pipe north of Cushing, at the intersection of North Oklahoma State Route 18 (North Little Avenue) and East Carson St. (Figure 10a). The Cushing Emergency Manager reported that Highway 18 was shut down from approximately noon on Monday, November 7, 2016 to 1:30 AM on Tuesday, November 8, 2016 for repairs. Approximately 35 to 50 ft. of existing ductile iron pipe was removed and replaced with PVC pipe under the roadway. The ductile iron pipe section removed from service was present near the roadway at the time of reconnaissance. There was significant mineral deposit and/or corrosion product build-up inside the iron pipe (Figure 10b), as well as several holes.

Figure 10. (a) Location of removal and replacement of existing ductile iron water line; and (b) cross section of removed pipe showing build-up of corrosion and sediment inside pipe (photos: E. Wilson).

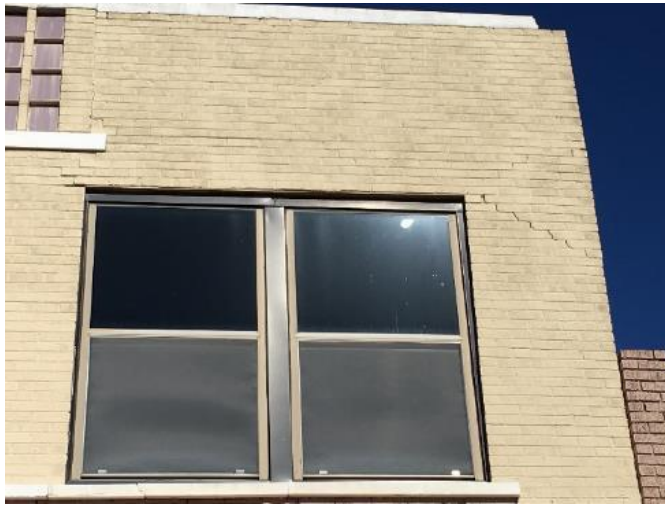
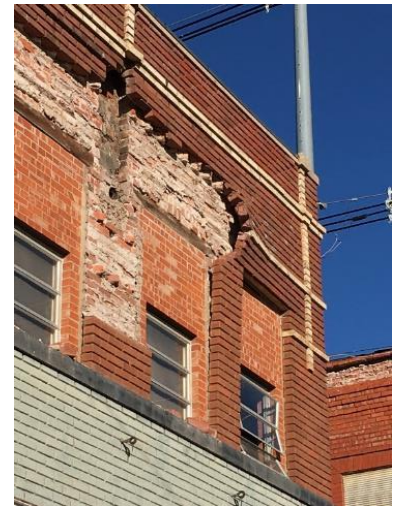
The November 6, 2016 Mw 5.0 earthquake generally resulted in Modified Mercalli Intensities of VI (Strong) in the CBD. At the recorded shaking levels, typical damage to URM structures in the CBD area included cracking of mortar joints and brick units near window and door openings (Figure 11a), slight bulging or bowing of outer wythes or multi-wythe walls lacking header brick units (Figure 11b), and fallen brick units from parapets and other projecting elements. More severe damage was isolated and included collapsed and fallen parapets, broken windows, and permanent lateral deformations. This damage resulted in unsafe conditions and the collapse of entire sections of exterior building walls in some buildings (Figure 12a, 12b & 12c).

Figure 11. (a) Cracking in brick units and mortar joints near window opening; and (b) Collapsed and bulging outer wythe of multi-wythe wall; note: no header units present to secure wythes (photos: E. Wilson).

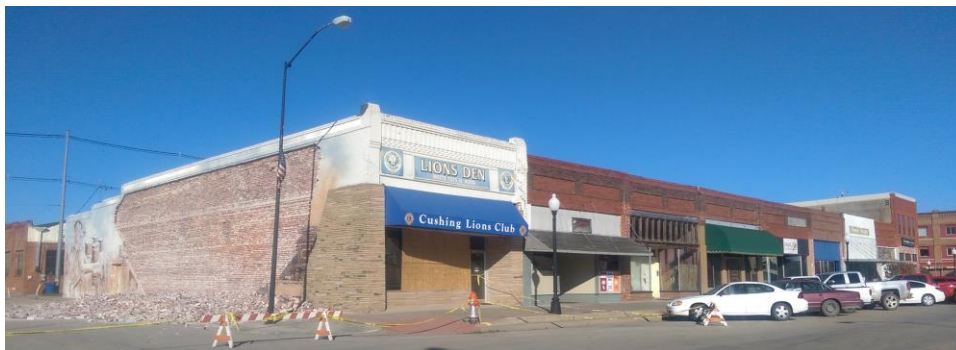
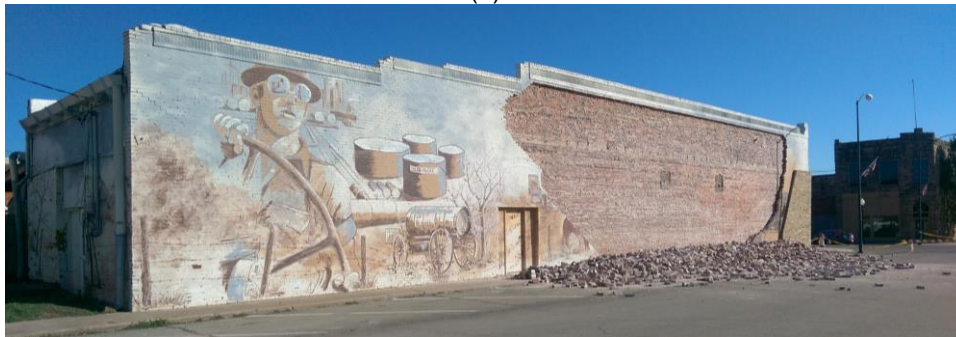
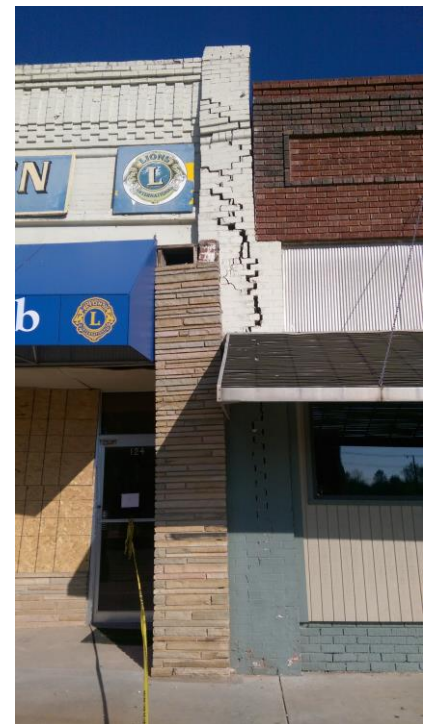
Figure 12. (a) Entire city block with common walls leaning progressively to the west (i.e. left); (b) Outer brick wythe buckled and collapsed onto sidewalk and street; (c) Permanent lateral displacement of the end building's common walls and roof diaphragm, creating a potentially unstable P-delta condition. The end building acted as a fuse that absorbed and dissipated a significant portion of the kinetic energy from the buildings on the entire city block due to a lack of continued confinement by buildings on the west end (photos: J. Taylor).

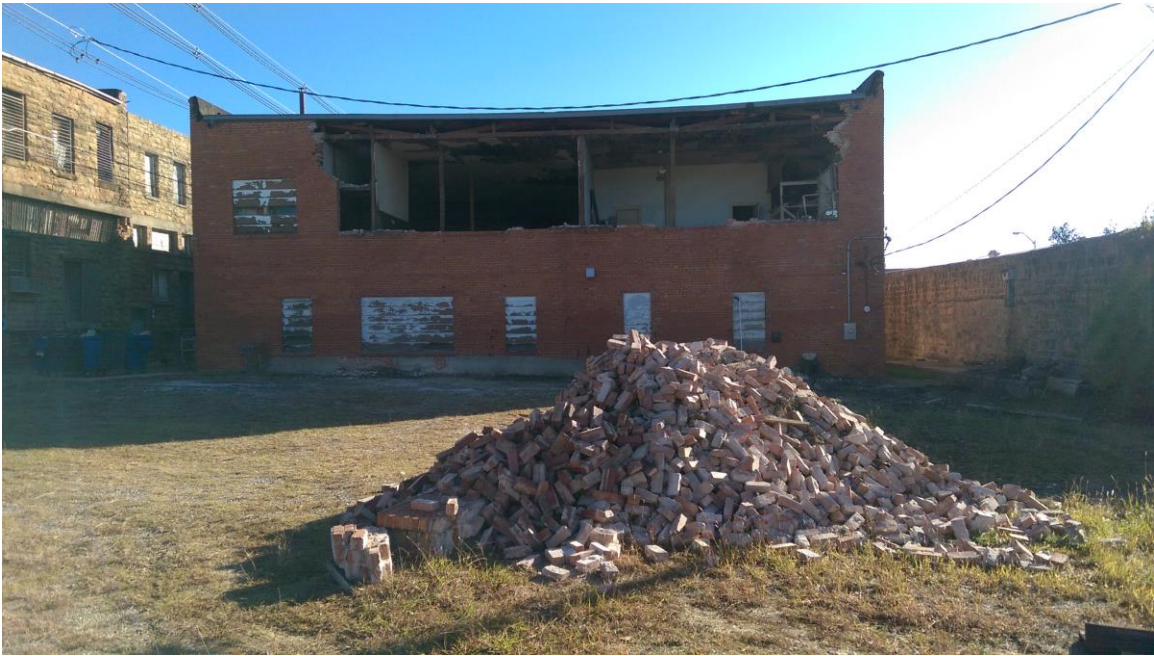
Out-of-plane failure of a non-load bearing wall, apparently due to the lack of an adequate diaphragm to top-of-wall connection, is shown in Figure 13.

Figure 13. Out-of-plane failure of a URM building wall (photos: J. Taylor).

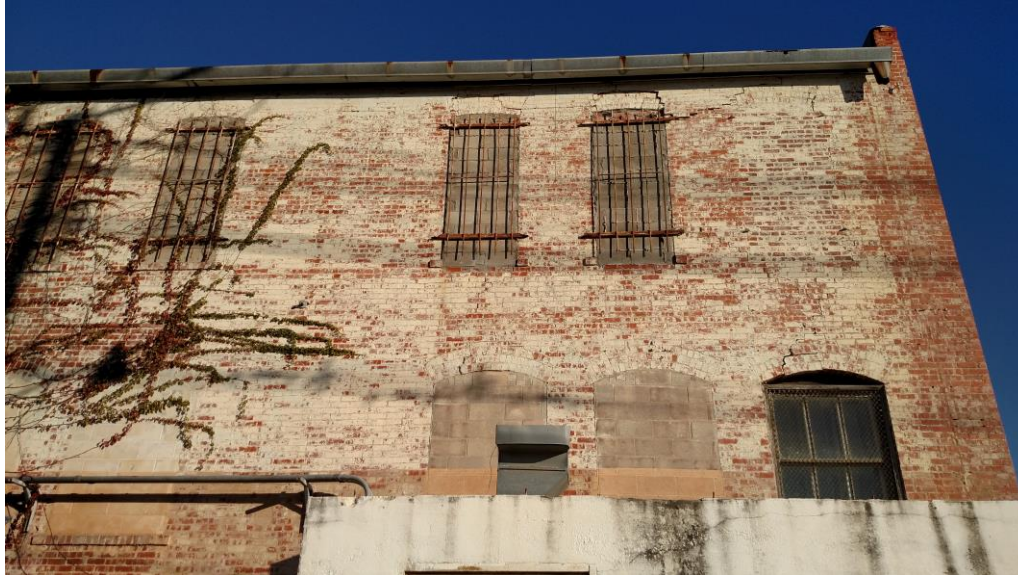
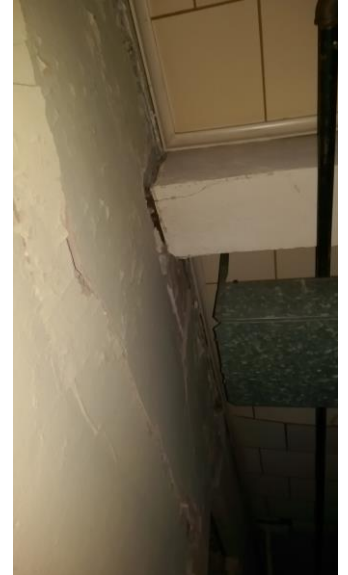
Several load-bearing URM walls out-of-plane sustained damage that created falling hazards and other potentially unstable conditions. Figure 14 shows the rear wall of a building at the southeast corner that experienced significant out-of-plane movement, cracking the masonry at the roof level and pulling a roof beam out of the supporting masonry pocket. In addition, the load-bearing rear wall is bowed significantly outward between the roof and grade.

Figure 14. (a) southeast building corner that experienced significant out-of-plane movement, cracking and displacing brick masonry at the roof level; and (b) roof beam pulled approximately 1-inch out of the supporting masonry pocket (photos: J. Taylor).

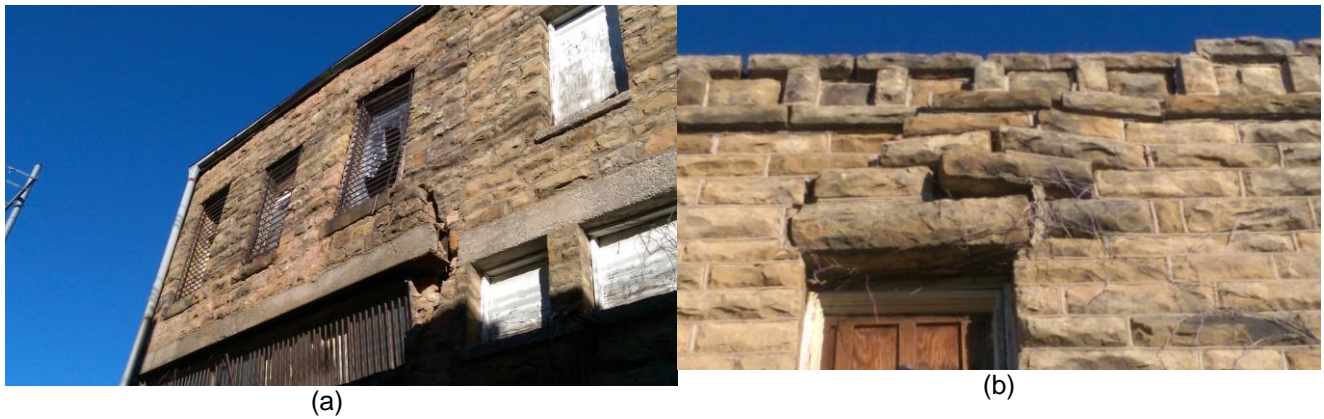
Out-of-plane cracking and displacement conditions were noted in many other locations resulting in significant falling hazards, as shown in Figure 15.

Figure 15. (a) severe out-of-plane displacement of a lintel beam resulting in a precarious falling hazard; and (b) cracked and displaced stone masonry above 2nd floor egress doorway (photos: J. Taylor).

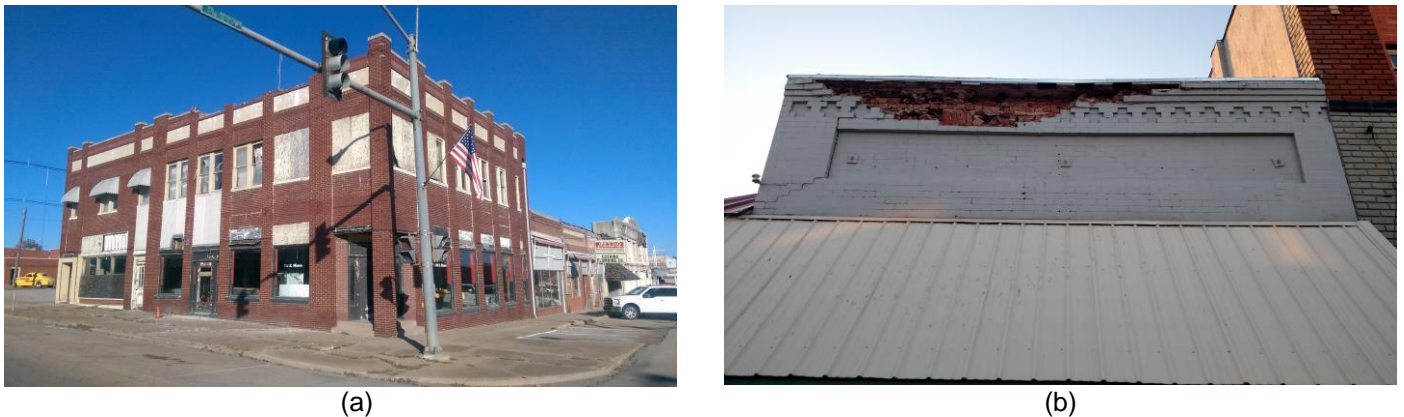
Several buildings also experienced out-of-plane failure of parapets projecting above the roof line, as shown in Figure 16. This condition is often caused by a combination of weakened mortar joints from weather exposure above the roof level combined with large flexible roof diaphragm displacements.

Figure 16. (a) Projecting parapet failure (debris already removed from sidewalk); and (b) Out-of-plane failure of parapet projecting above the roof line (photos: J. Taylor).

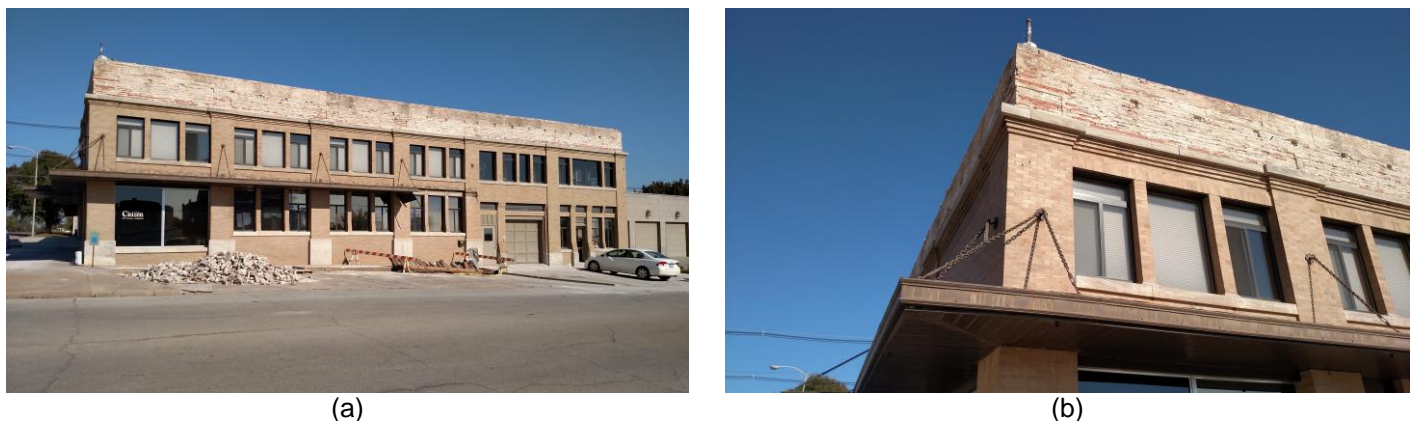
Several business owners in the downtown area began to clean up fallen debris the morning after the event and proactively remove architectural cornice elements. One such building houses the local newspaper, The Cushing Citizen, as shown in Figure 17.

Figure 17. (a) Cushing Citizen Newspaper building with remaining cornice rubble on pavement; and (b) Cornice with façade elements removed, revealing unreinforced masonry backup (photos: J. Taylor).

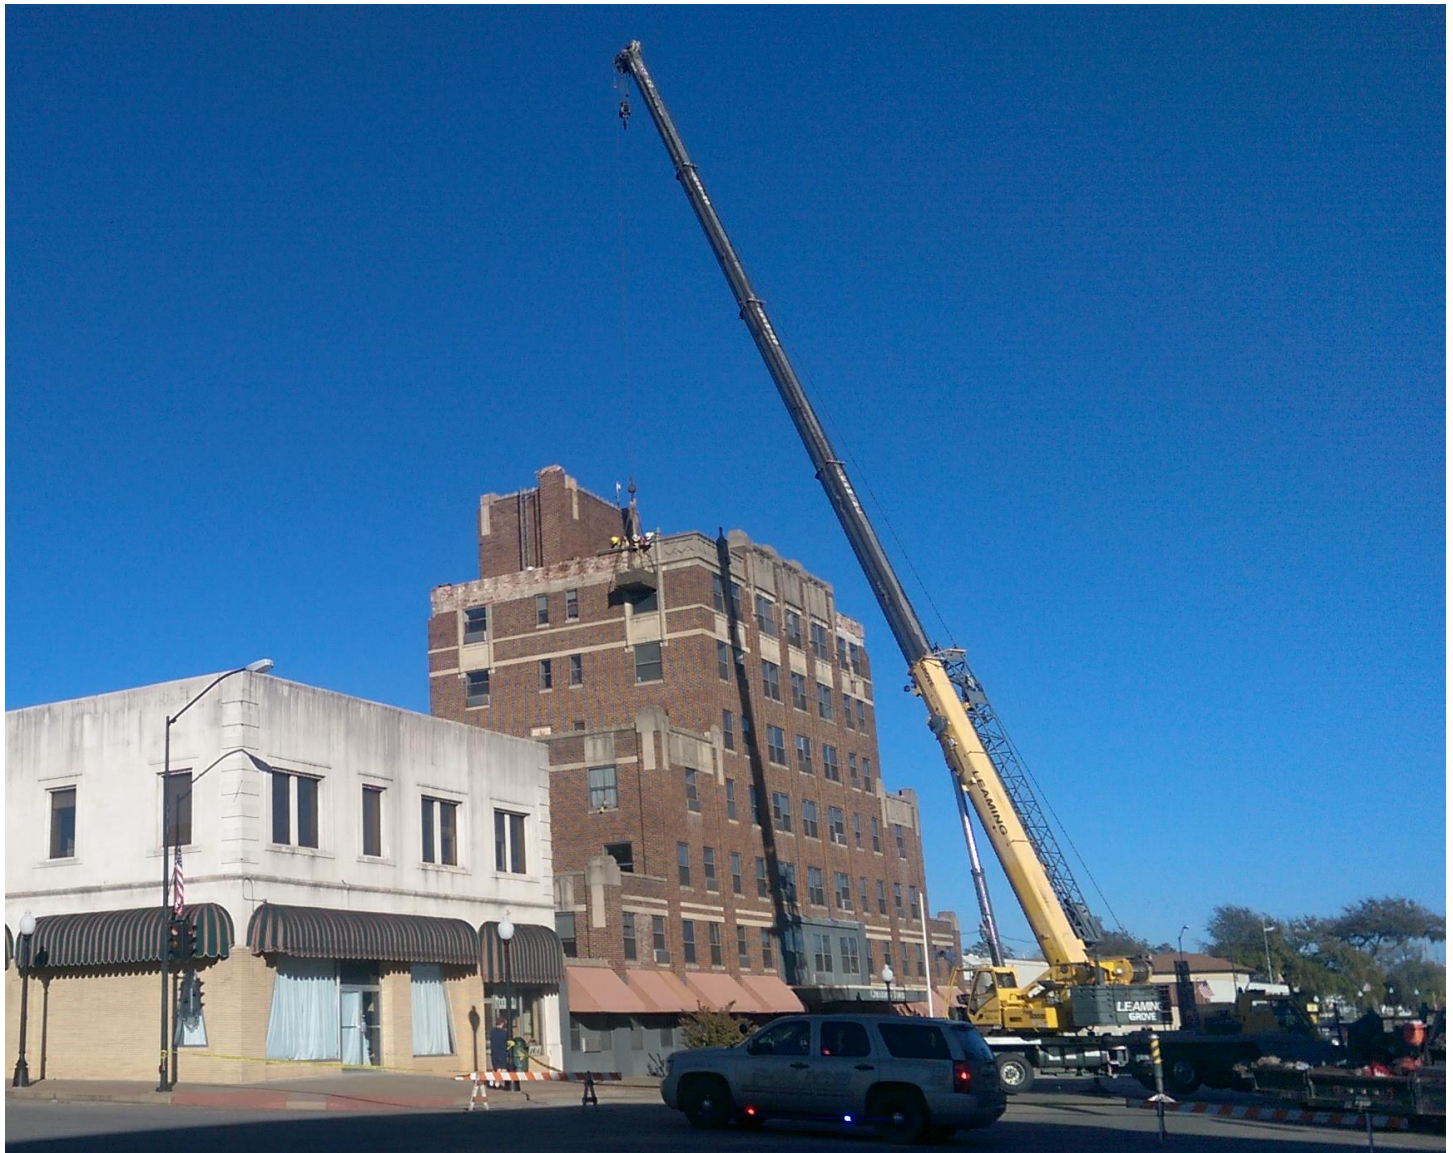
Cimarron Tower is a 7-story reinforced concrete frame structure clad with unreinforced clay brick and terra cotta infill masonry. A penthouse projects above the roof level, and 4-, 2-, and 1- story wings form a stair-step configuration down from the 7-story tower portion on the east and west sides. This building was constructed in the early 1900's, and appears to be the tallest structure in the City of Cushing. A drone survey was reported to have been performed with an infrared camera following the earthquake, which revealed masonry cracking at the roof and penthouse levels. At the time of the EERI Team's site visit, the terra cotta cornice on the parapet at the 7-story tower roof level was in the process of being removed by masons working with a crane basket (Figure 18). This was done in response to concerns regarding falling hazards posed by loose masonry units around the parapet level. While the building is not on the Historic Register, the removal of the terra cotta has a significant impact on the aesthetic appearance. An unknown number of water supply pipes for plumbing fixtures were reported to have broken open during the earthquake, causing water damage inside the building. However, due to safety concerns and work in progress on the building, the EERI Team did not enter the building to examine the interior condition.

Figure 18. Cimarron Tower, a reinforced concrete frame building with unreinforced masonry infill walls. Masons are removing terra cotta from the 7th-story roof parapet due to falling hazard concerns (photo: J. Taylor).

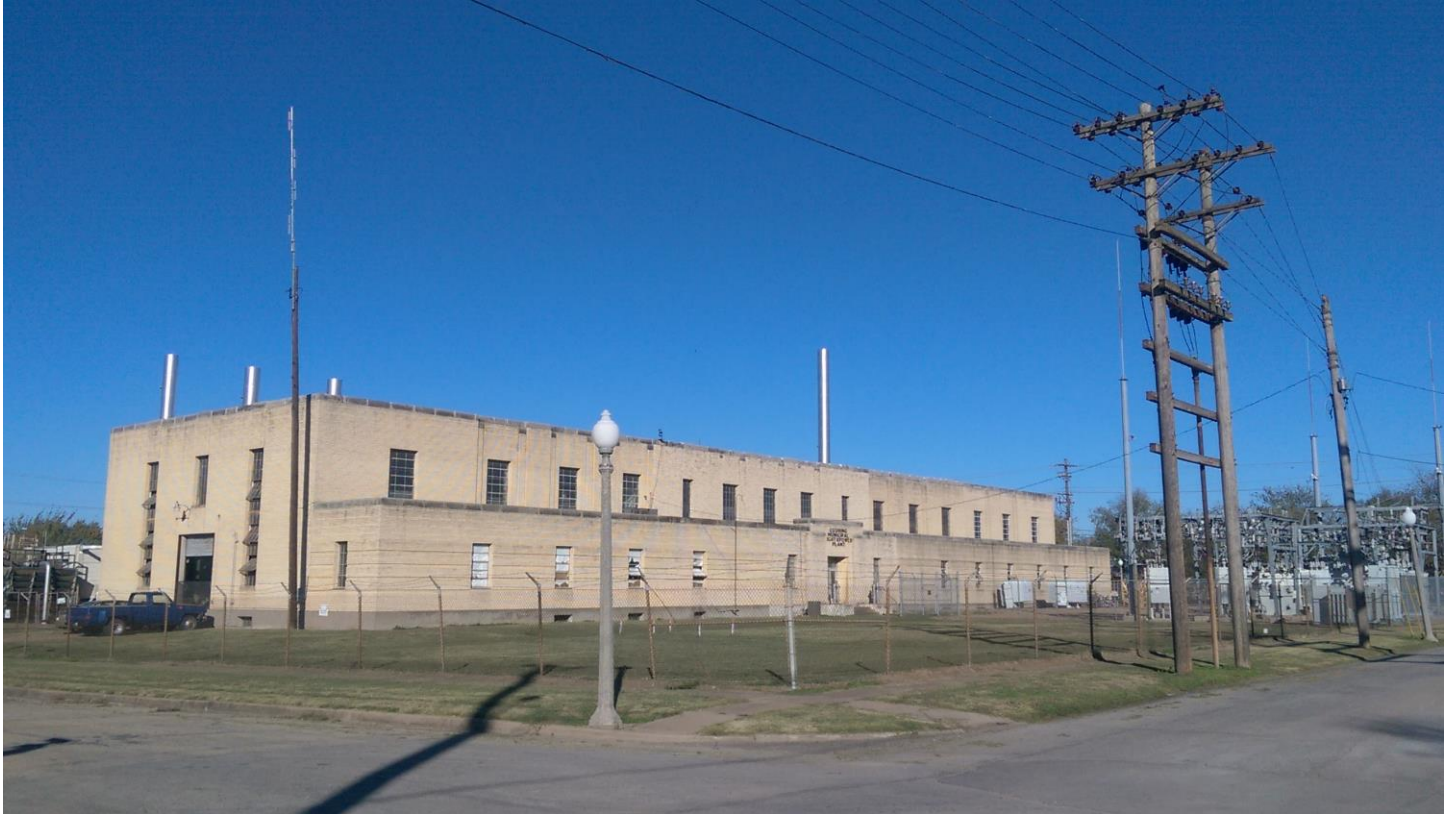
The Cushing Municipal Power Plant in Figure 19 is located to the west of the CBD, closer to the epicenter. It sustained only minor structural damage during the earthquake, primarily consisting of cracked masonry infill walls adjacent to steel frames supporting the high-bay roof and cracked floor slabs. Minor non-structural damage included fallen ceiling panels, a cracked interior masonry wall in the high-bay area, and displaced masonry coping stones. Minor equipment damage also occurred in a few limited locations, but no fuel leaks or other serious hazards occurred. A short-term power outage occurred immediately following the earthquake event, lasting approximately 30 minutes.

Figure 19. *The Cushing Municipal Power Plant, a steel frame building with unreinforced masonry infill walls, sustained minor damage during the earthquake (photo: J. Taylor).*

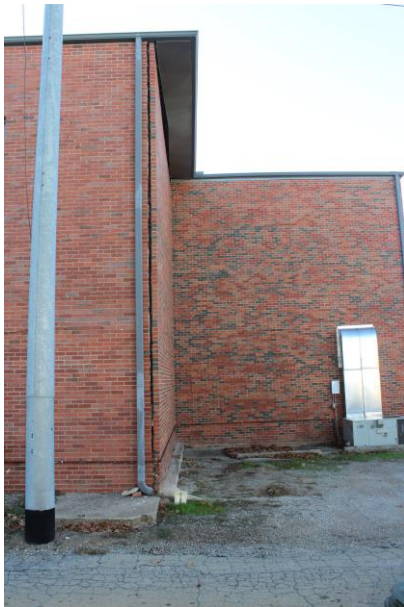
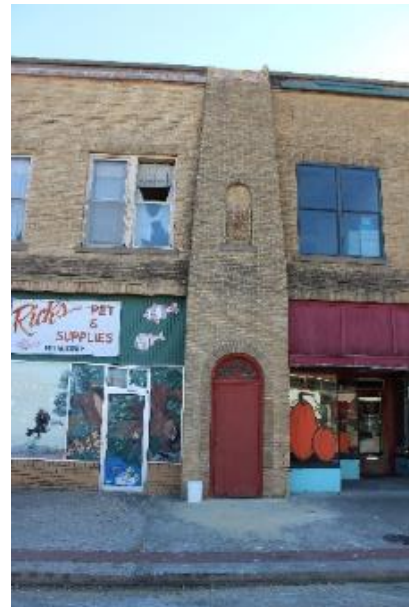
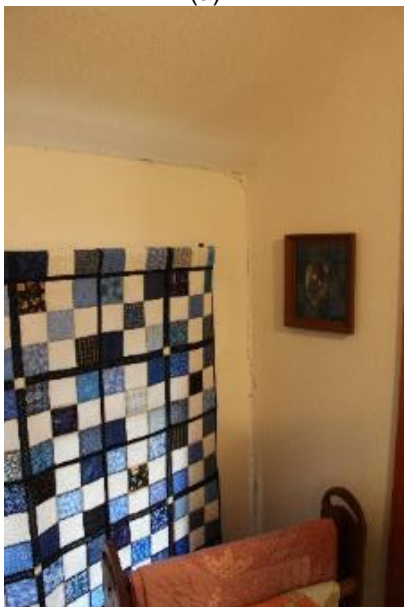
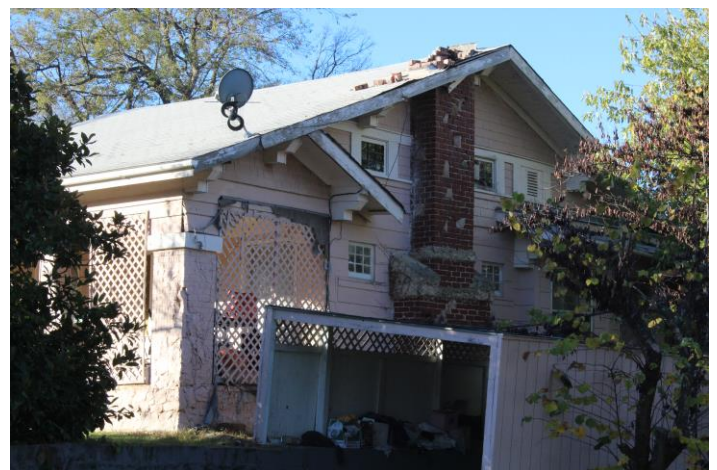
Damage to nonstructural components such as partition walls and facades can represent a significant portion of losses. These components are generally sensitive to story drift ratios. Many of the structures in the CBD experienced exterior façade damage. Figure 20a shows the brick façade of a former church that has separated from the CMU backing wall. There do not appear to be ties holding the brick back. Numerous businesses had damage similar to that shown in Figure 20b, in which brick and terra cotta tiles at the top of the façade fell onto the sidewalk, and a window was broken. A small number of structures in the CBD had cracks in floor tiles. Only the severely racked Lion's Den building (see section 8.2) had doors that would not open (reportedly). Typical finishes in light frame structures are damaged at very low story drift ratios ($< 0.2\%$), such as the gypsum board with cracks in the corners shown in Figure 20c. This type of damage to partition walls was typical to homes around the CBD. The earthquake damaged numerous chimneys of homes (Figure 20d).

Figure 20. (a) Separation of a brick façade from CMU backing; (b) Broken window, bricks and tiles fallen off façade near roof; (c) Cracks at corners of gypsum board sheathing in a house; (d) Chimney damage with precariously perched bricks over porch egress (photos: E. Jampole).

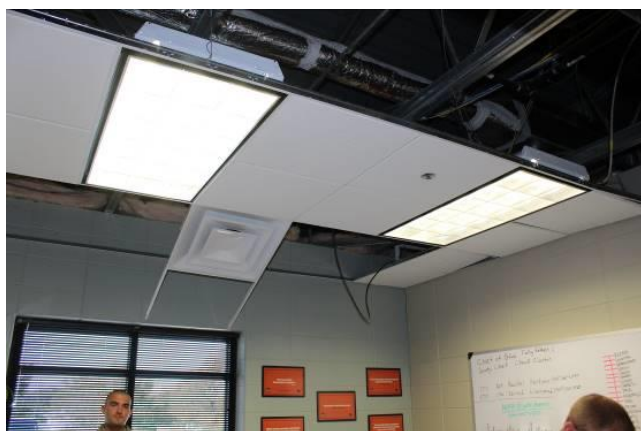
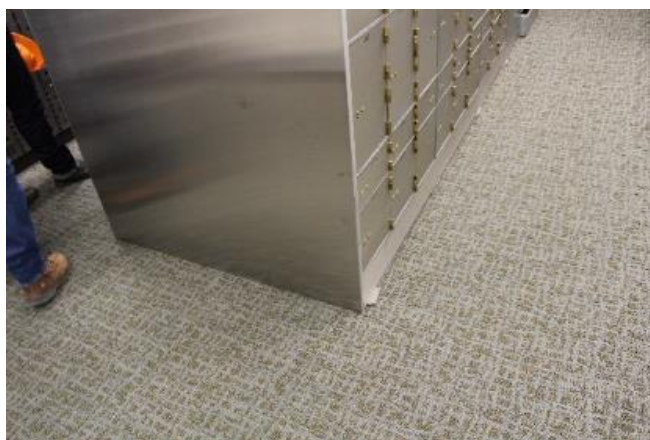
The Police and Fire Center, constructed in 2013, had many downed ceiling tiles and damage to steel grid support systems (Figure 21a), as well as a few reports of contents falling off bookshelves, which resulted in a short period of emergency service disruption. Numerous businesses had ceiling tiles fall out. A safety deposit box in the RCB Bank slid about one centimeter during the earthquake (Figure 21b). Widespread ceiling tile damage is not unexpected. FEMA (2012) reports median floor accelerations for three ceiling damage states as 0.3 g. for a few fallen panels, 0.65 g. for damage to some runners and fallen panels, and 1.28g for ceiling grids near collapse. Observed damage and likely floor accelerations both fall in the range of the first two damage states.

Figure 21. (a) Fallen ceiling tiles in Police and Fire Center and damage to steel grid; (b) Safety deposit box in RCB Bank shifted one centimeter – shim in the corner was originally covered (photos: E. Jampole).

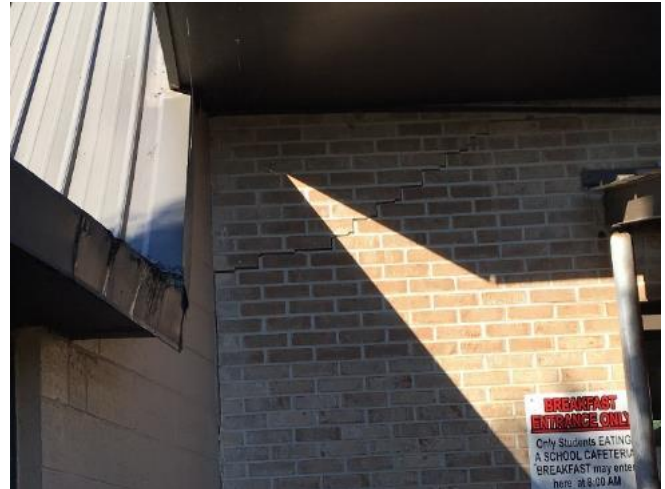
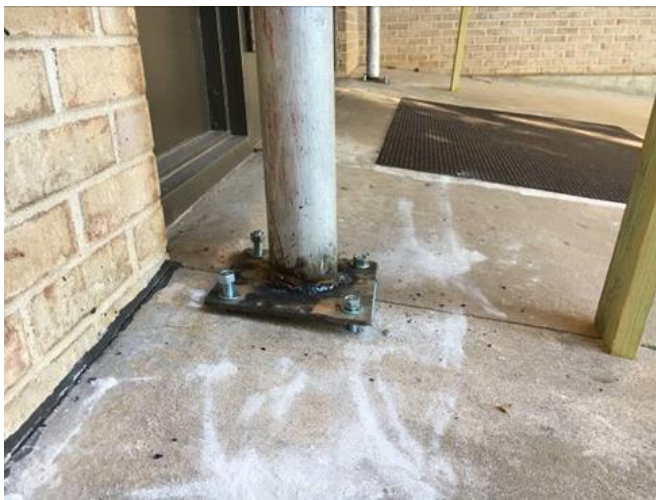
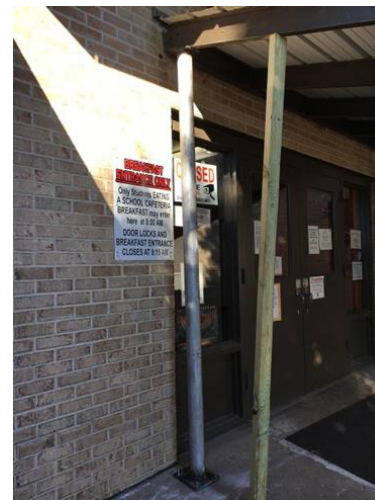
Minor structural damage to schools was only reported at Sunnyside Elementary (Figure 22a), one of eight schools in the Cushing Public School District. Sunnyside is less than 2 miles South/Southeast from the epicenter of the November 6, 2016 magnitude 5.0 earthquake. Damage to this school building included: cracks in mortar joints and brick units (near window openings in the brick veneer, Figure 22b), fallen ceiling tiles, and suspended grid. A steel-framed canopy structure is located outside the main entrance to the school building, and moderate damage was observed to this structure. The canopy structure apparently separated laterally from the brick veneer, and displaced vertically downward after the earthquake event; the steel support posts for the canopy roof also displaced laterally relative to the canopy beams. No attachment (i.e. weld or bolts) was observed between the cap plate on the post and the canopy beam, which allowed the relative displacement to occur, and resulted in an unstable condition. Nuts on anchors between the steel baseplate at the bottom of the posts and the concrete sidewalk were not fully tightened, allowing the baseplate to rotate relative to the sidewalk (Figure 22c). It is unlikely that the nuts were fully tightened prior to the earthquake. Installation of a single 2x4 nominal wood member as temporary shoring between the underside of the canopy beam and concrete sidewalk below was completed prior to the time of structural damage assessment (Figure 22d).

Figure 22. (a) Overall view of Sunnyside Elementary; (b) cracking in brick veneer near main entrance; (c) loose anchor nuts in canopy post base plate connection to concrete sidewalk; and (d) 2x4 stud post member installed as temporary shoring by school maintenance staff (photos: E. Wilson).

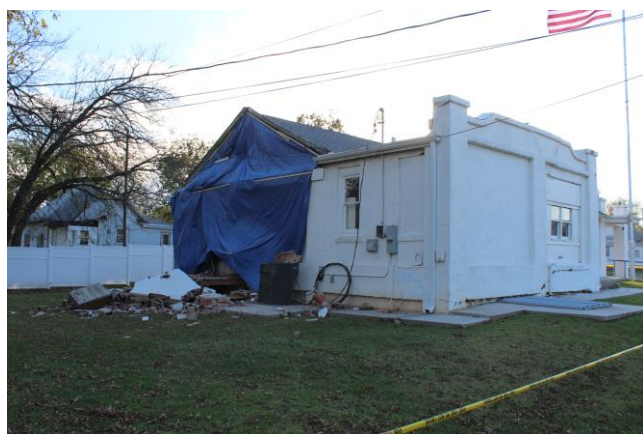
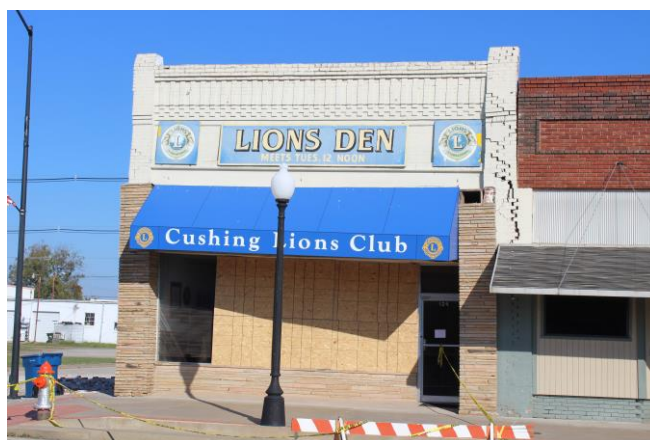
were obviously unsafe to occupy, as shown in Figure 24. While caution tape had selectively been placed around the exterior of both buildings, the reconnaissance team witnessed people entering the Lions Club building. The hazard posed by these and other buildings would be more clearly communicated with a comprehensive placard-based system.

Figure 24. Damaged buildings in Cushing did not have any building placards posted to inform building occupants of building safety hazards, despite serious structural damage and life-safety risk posed by both (a) the Lions Club building, and (b) the American Legion building (photos: E. Jampole).

During their fieldwork in Cushing, the EERI reconnaissance team noticed that building safety placards had not been clearly posted on any of the damaged buildings. EERI and the LFE reconnaissance team for Oklahoma strongly recommend the cities of Cushing and Pawnee, the County of Payne, and the State of Oklahoma develop a comprehensive plan for conducting building safety evaluations and posting building safety placards on buildings after earthquakes to inform building occupants of building safety hazards. Several URM buildings, such as the Lions Club building, located in the historic downtown, and the American Legion building, located southeast of the historic downtown,
