## RECONNAISSANCE REPORT OF THE JANUARY 1983

### MAMMOTH LAKES EARTHQUAKE SWARM

J. F. Meehan, Principal Structural Engineer  
Structural Safety Section, Office of the State Architect  
State of California

This report will be directed to observations made on January 10, 1983 at selected sites in the area.

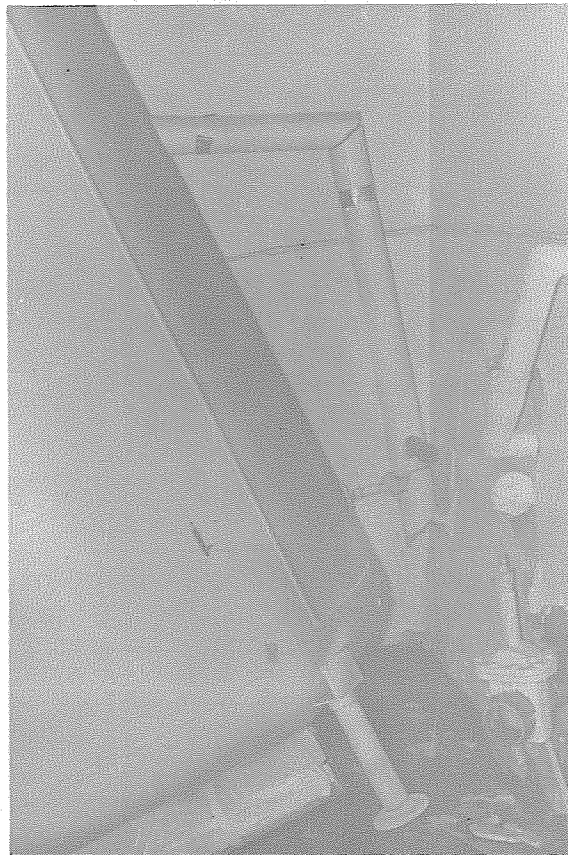
- Additional portions of the plaster on several walls and several ceiling tile fell to the floor.
- A water storage tank which was repaired following the 1980 earthquake again toppled. (See Photo 1)

Photo 1  
Toppled water tank.  
Former Mammoth Elementary School

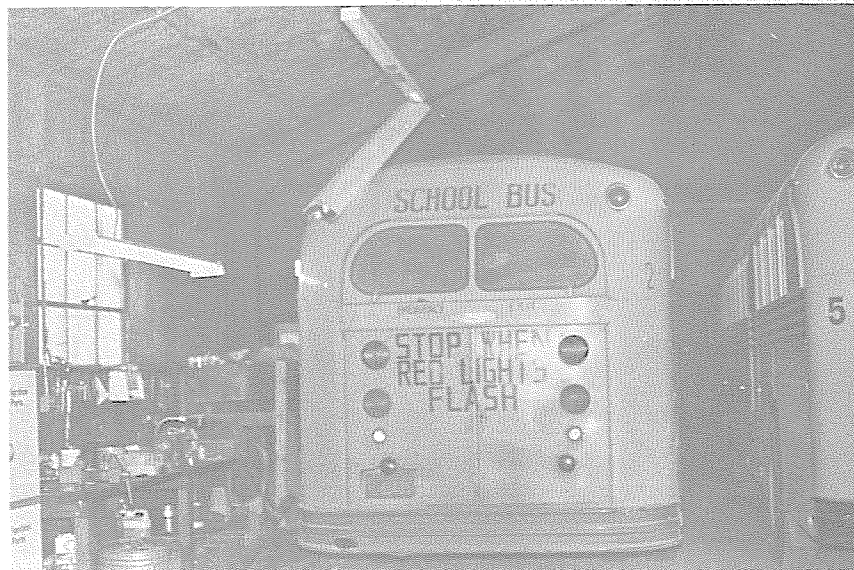
- The school bus garage, not approved by the Office of the State Architect, showed evidence of additional motion in the rod bracing, the bus exit doors became inoperable and several light fixtures fell (See Photo 2). A cantilevered vertical channel, which provided all of the lateral bracing for the end wall containing the bus exit door, was spliced about 3 feet above the floor. The welds on this splice were broken (See Photo 3 and 4).

Photo 2  
Displaced light fixture in bus garage.  
Former Mammoth Elementary School

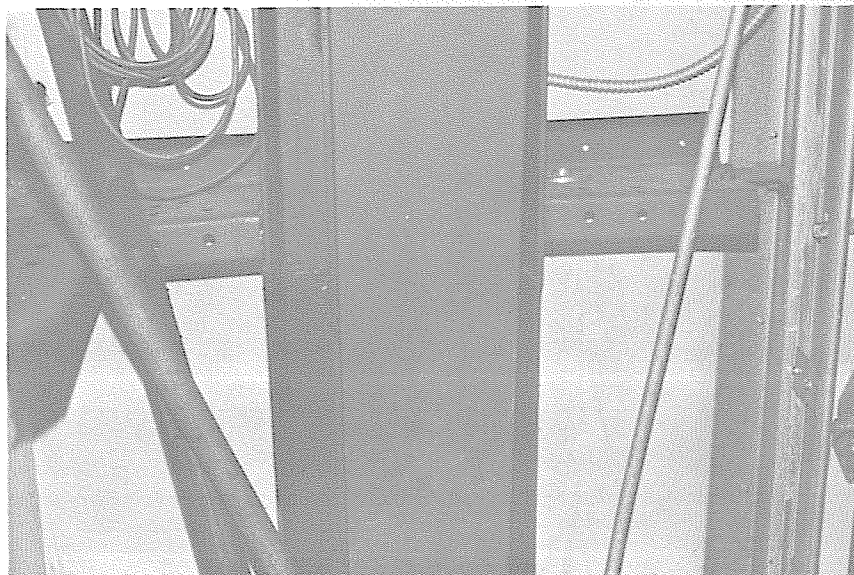
Photo 3  
Weld failure in bus garage.  
Former Mammoth Elementary School

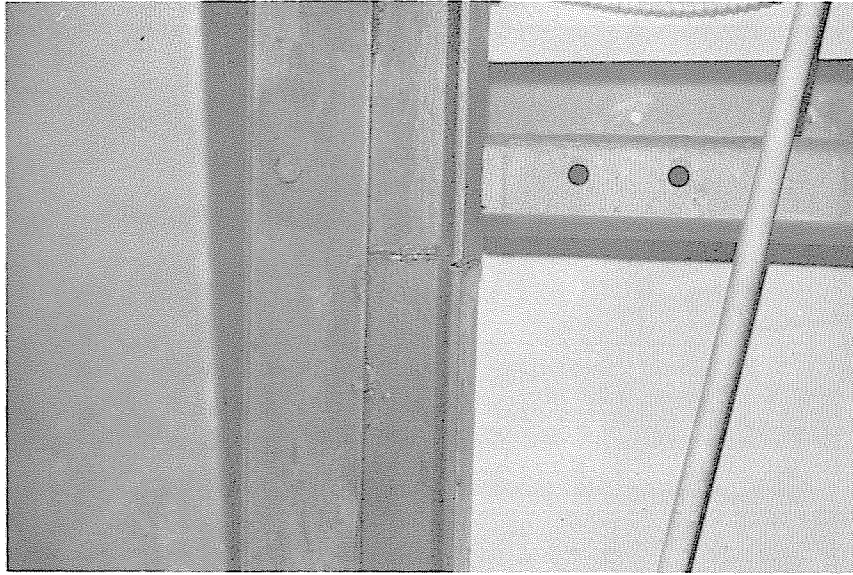
Photo 4  
Weld failure in bus garage  
Former Mammoth Elementary School

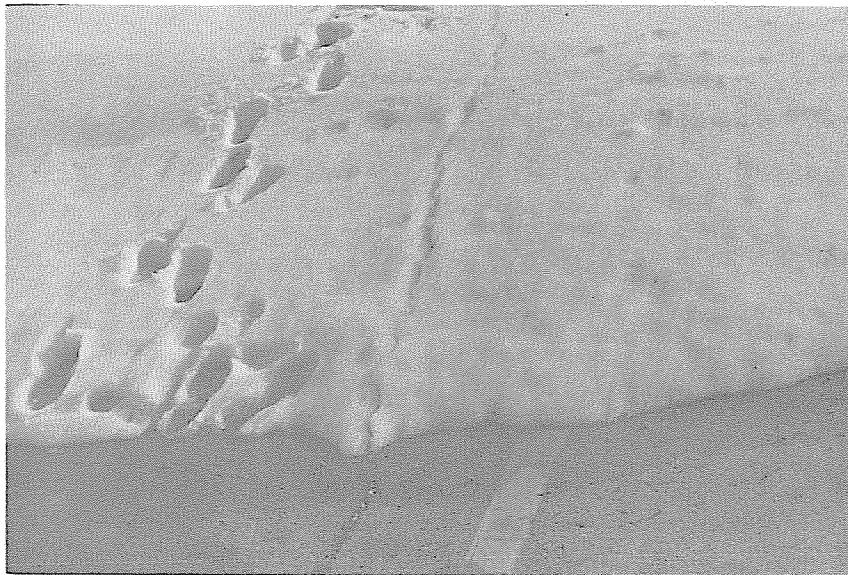
- An interesting observation was made concerning the cracks in the parking lot paving. That is, the recent earthquake movement of the parking lot segments was evidenced by a crack pattern transferred or projected up through the approximately 1½' of snow to the surface of the snow. The snow surface indicated the same pattern of cracking as that of the parking lot. This cracking in the snow strongly suggests that the length of the ground surface waves were rather short. (See Photo 5)

Photo 5  
Cracks in parking lot paving projected through snow  
Former Mammoth Elementary School

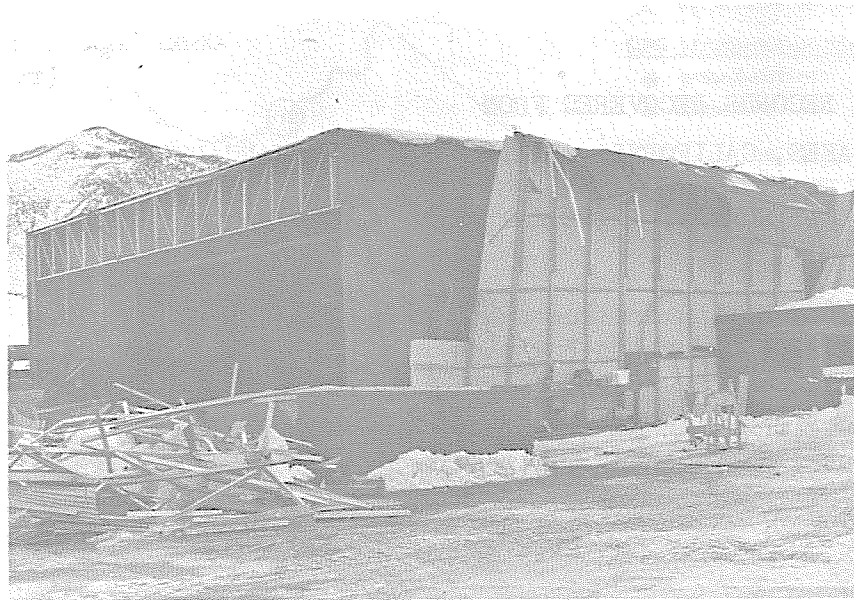
An airplane hanger collapsed during one of the shocks. It is reported that there was snow on the roof of the hanger. The hanger was constructed of aluminum trusses supported on aluminum columns. It is understood that two identical hangers were constructed. One hanger was sheathed with plywood on the interior of the walls and on bottom chord of the trusses. The interior sheathed hanger did not collapse. Photograph No. 6 shows the standing hanger and a portion of the collapsed hanger. A major portion of the collapsed hanger had been cleared away at the time of this visit. Photograph No. 7 shows the damaged airplane that had been in the collapsed hanger.

Photo 6  
Collapsed hanger at right.  
Mammoth Airport

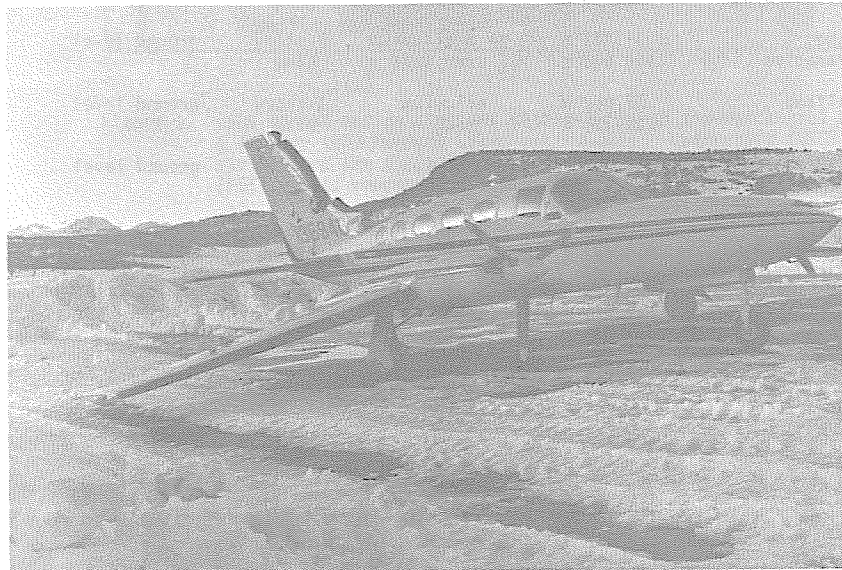
Photo 7  
Airplane damage from collapsed hanger.
