## Learning from Earthquakes

# Preliminary Observations on the Tecomán, Colima, Mexico, Earthquake of January 21, 2003

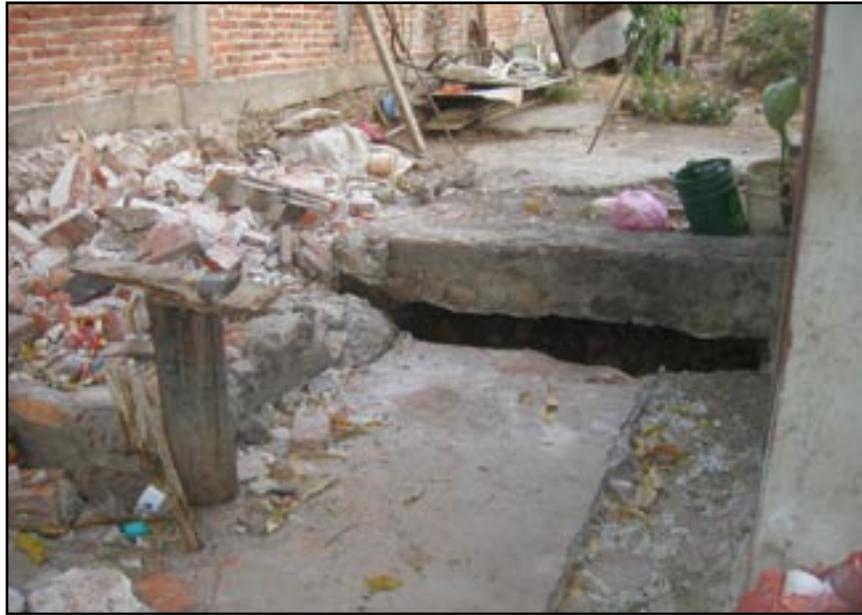
The San Isidro neighborhood is located near the Arroyo de Pereira, a small creek running north to south across Colima/Villa de Álvarez. Most of the damaged area overlies highly heterogeneous fill. Evidences of liquefaction were found in areas of high damage concentration. Significant ground settlement was observed at some locations, possibly due to collapse of poorly compacted fills (Figure 5). There were numerous reports of open-pit sand mining earlier in the 1900s at this location. Poor filling of these pits could explain localized zones of large surface settlement. Although construction quality in the San Isidro neighborhood is poor, other neighborhoods with similar construction did not suffer as much damage.

**Figure 5** - Large settlements in a house in the San Isidro neighborhood, possibly due to collapse of poorly consolidated fills.

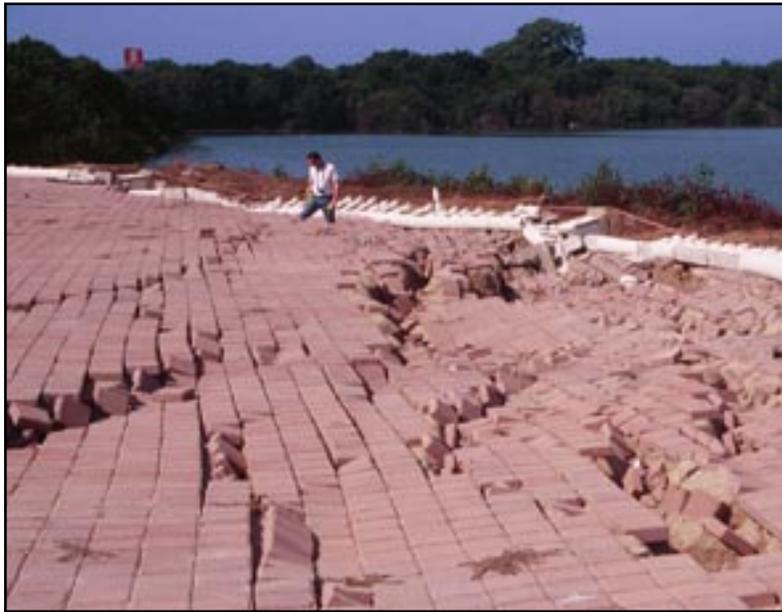
A majority of the waterfront liquefaction sites in Manzanillo were marked by lateral spreading of the ground toward the free face. The horizontal displacements varied between sites, but were often in the range of 1-3 m. Figure 6 shows lateral spread of a pedestrian promenade located off a major boulevard. The promenade surface consisted of paving blocks, whose positions after the earthquake clearly preserve the deformations caused by lateral spreading. Apparently, a 0.2-0.5 m thick crust of silty sand moved over an unknown thickness of liquefied ground. An overturned concrete railing is visible near the right portion of the photograph. The ground slope was about 3%, and maximum lateral spread displacements at the site were on the order of 2 m.

**Figure 6 -**  
*Liquefaction-induced lateral spread in Manzanillo (for scale, each paving block is 0.20 m square).*

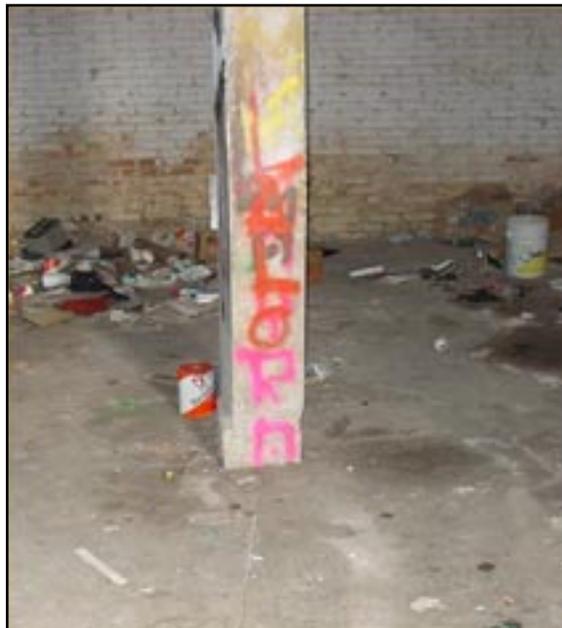
Figure 7 shows a concrete column supporting a modern three-story residential structure located in the Colima neighborhood damaged by liquefaction. It is typical construction practice in Colima to support columns and load-bearing walls on shallow foundations consisting of spread and wall footings. During the earthquake, the column experienced a loss of bearing capacity and dropped about 30 cm, causing significant structural damage to the building.

**Figure 7 -**  
*Bearing-capacity failure in Colima. The column dropped through the floor of the structure, ultimately settling about 0.3 m.*

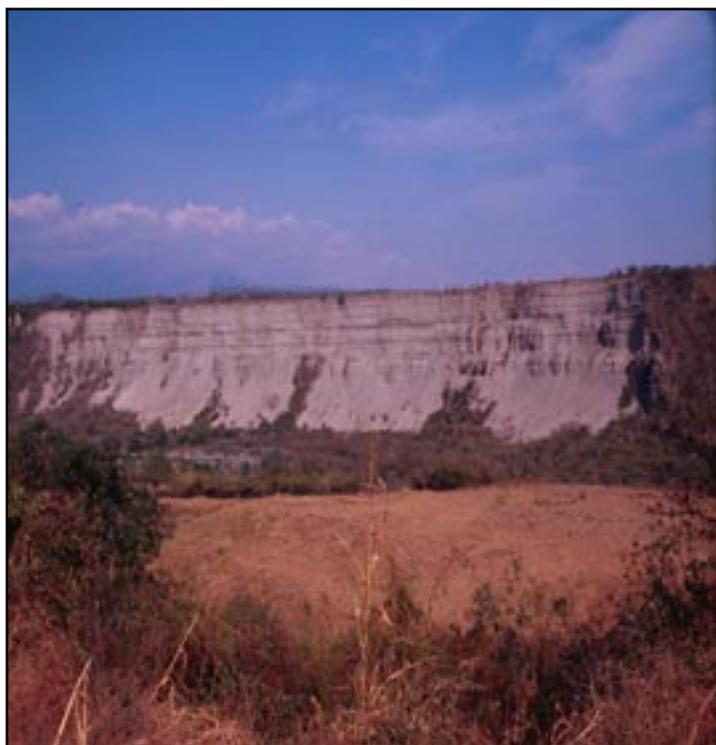
**Figure 8** - Stretch of cliff along Rio Armería northwest of Colima denuded by landslides during the earthquake. Before the earthquake, this stretch of slope was reportedly vegetated in a manner similar to the intact stretch of slope at the extreme right of the photograph.

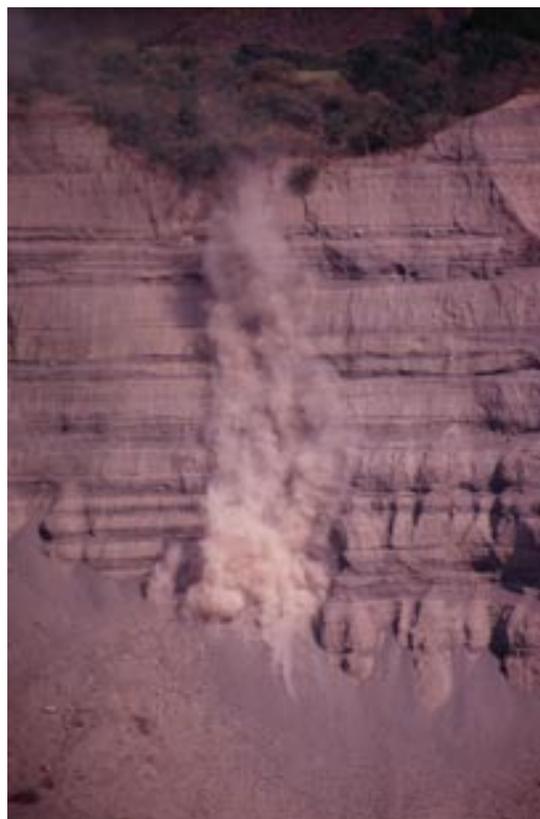
When this area was inspected on the ground on January 28 and again on January 31, the cliffs were so unstable that they were still producing several falls each minute (Figure 9). On January 31, in fact, 20 falls occurred in 15 minutes along a single section of cliff 1 km long, suggesting that approximately 2,000 falls were occurring there each day. These falls were typically small, ranging from a few cubic meters to perhaps 50 m<sup>3</sup> of

material each. The continuing instability of these cliffs, exacerbated by the ongoing removal of material by falls, indicates a possible continuing hazard to villages, dwellings, and other infrastructure in the areas located close to the cliffs.

**Figure 9** - One of the larger falls observed from the Rio Armería cliffs on the afternoon of January 28, 2003, which had an estimated volume of 20 m<sup>3</sup>.

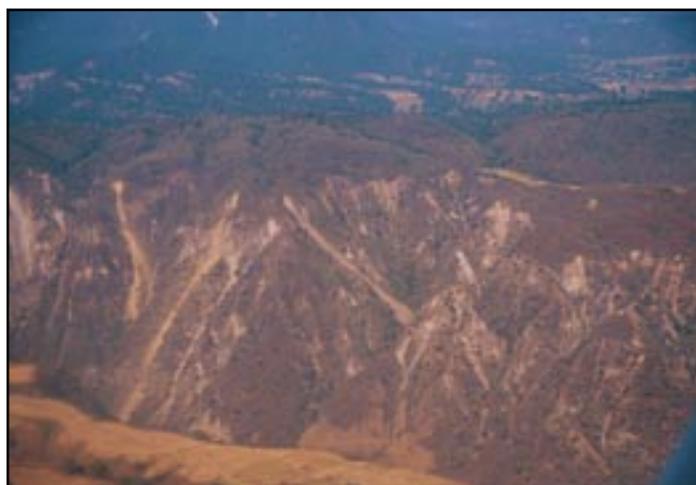
**Figure 10** - Landslides along one stretch of canyon wall in the Barranca de Atenquique, on the east flank of Nevado de Colima volcano.

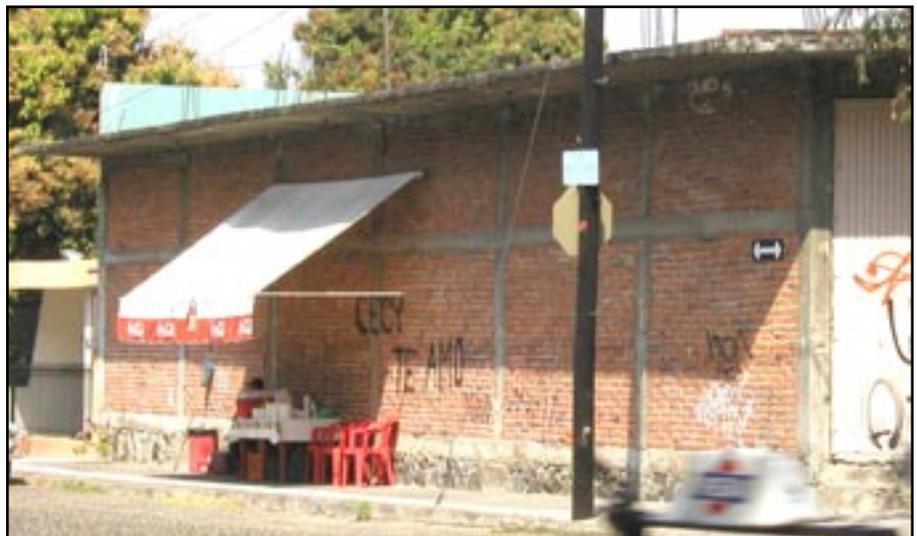
**Figure 11** - A typical confined masonry structure, which performed well in the Tecomán earthquake.

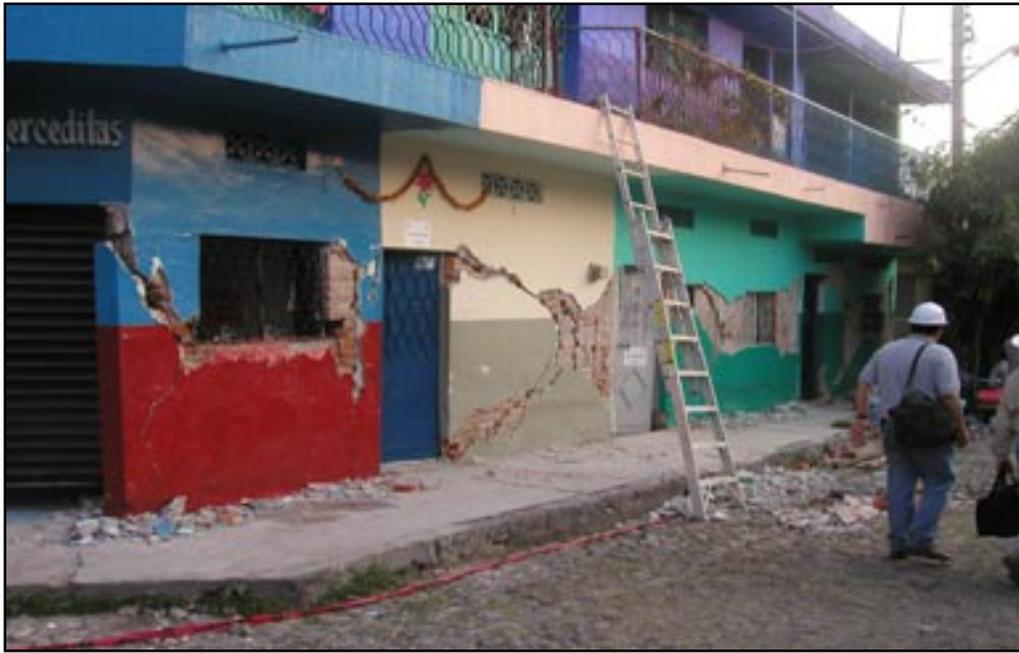
**Figure 12 - Typical damage to unreinforced masonry structures.**

bined with inadequate out-of-plane strength due to a lack of reinforcement; and in-plane shear failures occurred separately or in combination with out-of-plane failure. Increases in in-plane stiffness and strength due to stucco were lost as the stucco spalled off due to lack of mechanical anchorage. Due to the absence of reinforcement, combined in- and out-of-plane failure often led to collapse of walls and structures (Figure 12).

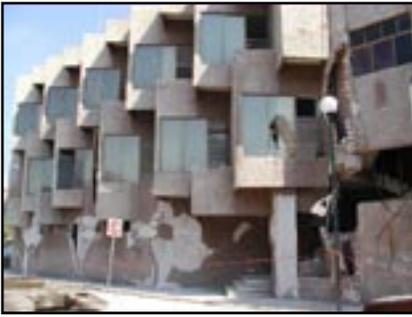
**Figure 13** - Example of lack of structural continuity of vertical and horizontal elements.

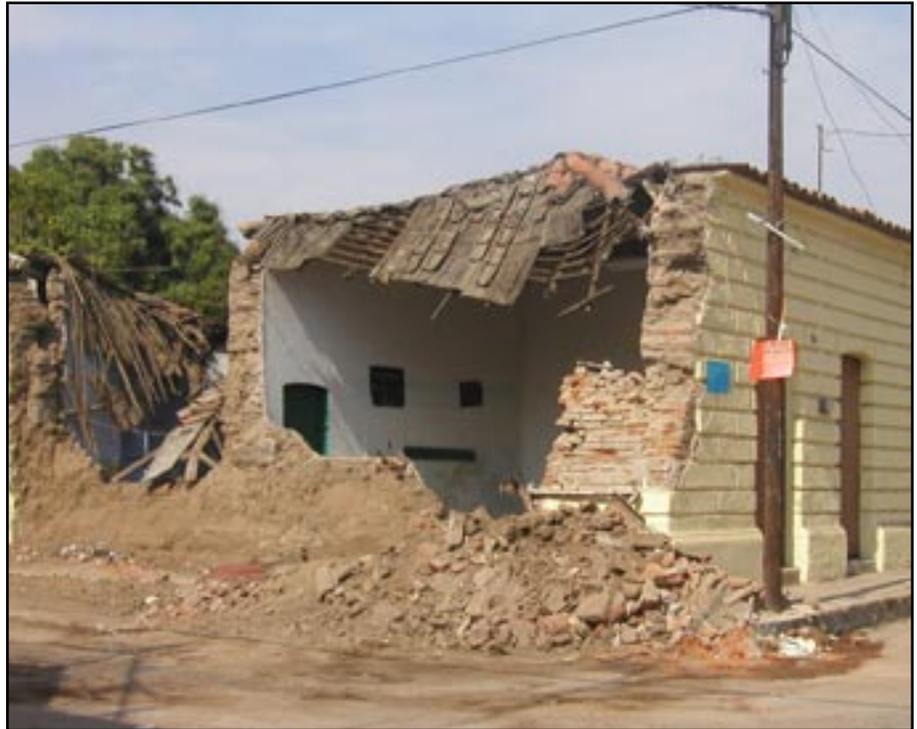
material, structural performance was clearly enhanced by aspects of building configuration: presence and symmetrical location of shear walls; absence of large openings in street level walls; and continuity of vertical and horizontal elements (figure 13). Location within a block was also important. Corner buildings appeared to suffer relatively heavy damage, due to a combination of the effects of openings in walls, and the plan eccentricity between the center of mass (generally located near the plan center of the building) and the center of rigidity (generally located near the interior corner of the building plan). This plan eccentricity led to heavy damage in the shear-resisting elements on the corner façade of the building, and sometimes to collapse of the exterior walls near the corner (Figure 14).

**Figure 14** - Typical damage to adobe structure at the corner of a block.

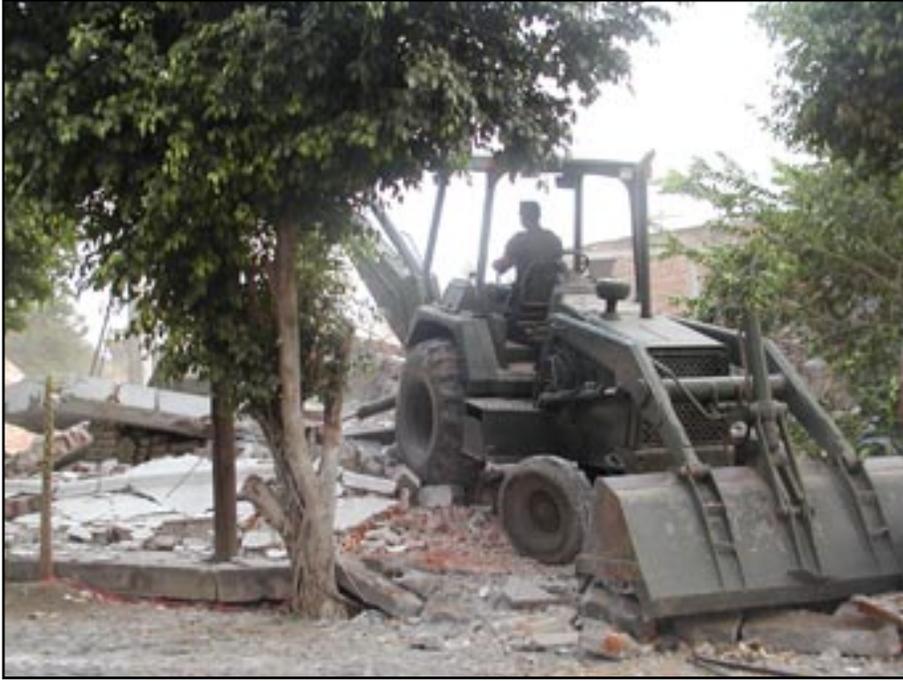
**Figure 17** - Demolition by the Mexican military of adobe structures categorized as totally damaged.

The Civil Protection System asked the Mexican military to begin the demolition of structures categorized as totally damaged and to remove the debris from streets. The team observed the demolition of damaged adobe structures in the Municipality of Villa de Álvarez, which borders the northwest section of the city of Colima (Figure 17). After the demolition in that area is complete,

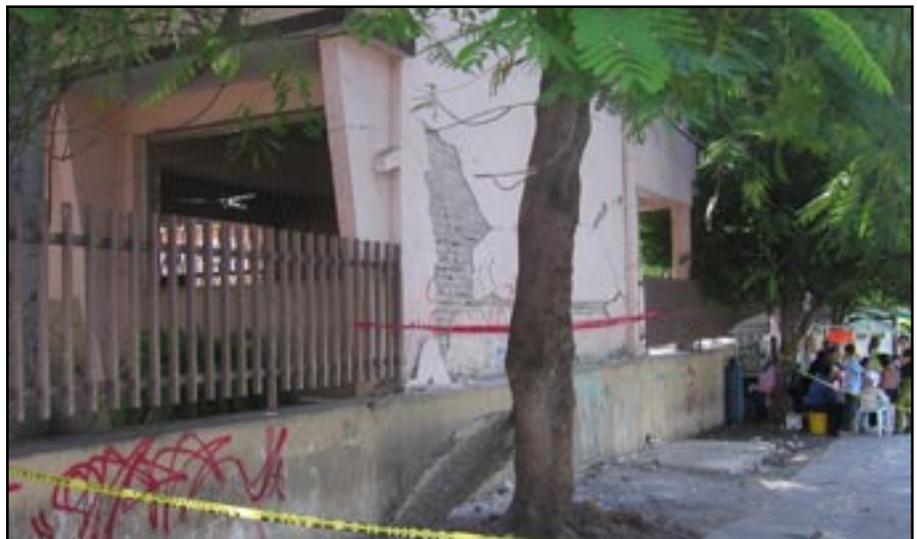
**Figure 18** - Damage to a school building.

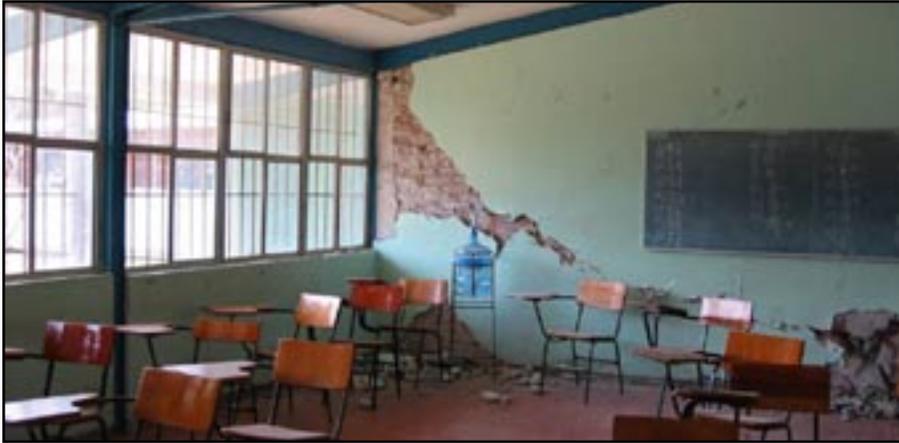
**Figure 19** - Inclined cracking in an infill wall of a school building in the village of Ixtlahuacan. The structure of the school is made of light gage steel members.
