**STBA Junior College Performance Report**  
EERI Earthquake Reconnaissance Trip  
Padang, Indonesia

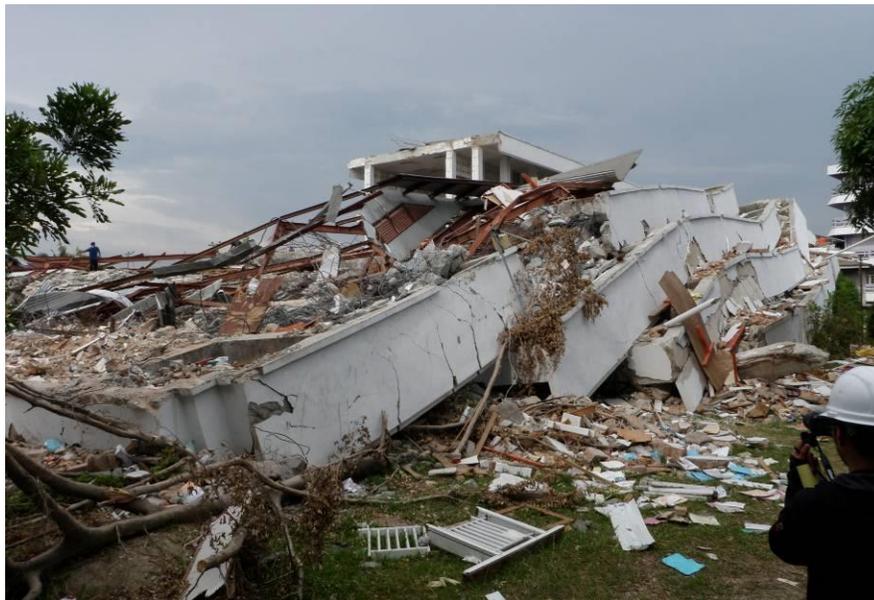
As a result of the earthquake, all four floors of the main building collapsed while it was occupied by 15 students and staff. Only two of those 15 survived. The following image shows the state of the main building after the earthquake.

**Image 1: The Main Building of the STBA Junior College**

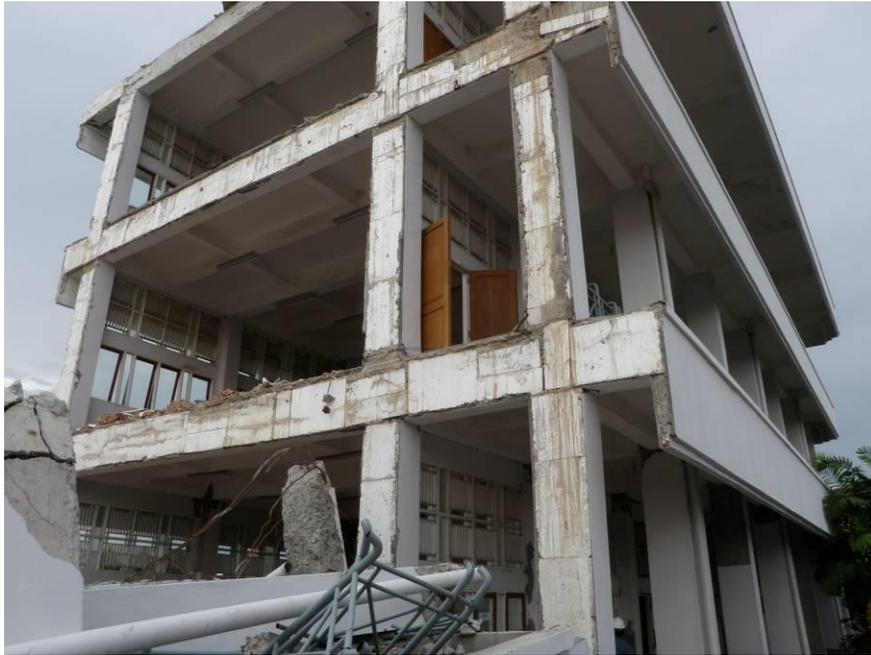
The unreinforced masonry infill walls crumbled in the other building, but its primary structural system suffered only moderate damage and remained intact.

**Image 2: Building #2 Suffered Moderate Damage in Columns and Infill Walls**

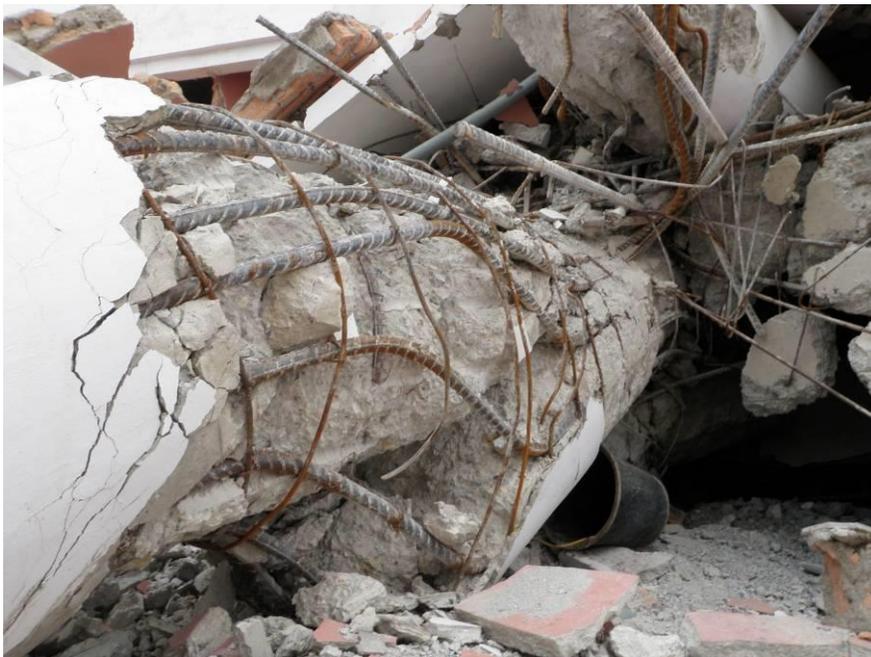
Inspection of the columns indicated that very small stirrups (generally 4-6 millimeters spaced at 6-12 inches) likely provided insufficient confinement to columns. As with other sites, all of the stirrups terminated with very short 90 degree hooks.

**Image 3: Column Confinement Generally Appeared to be Insufficient**

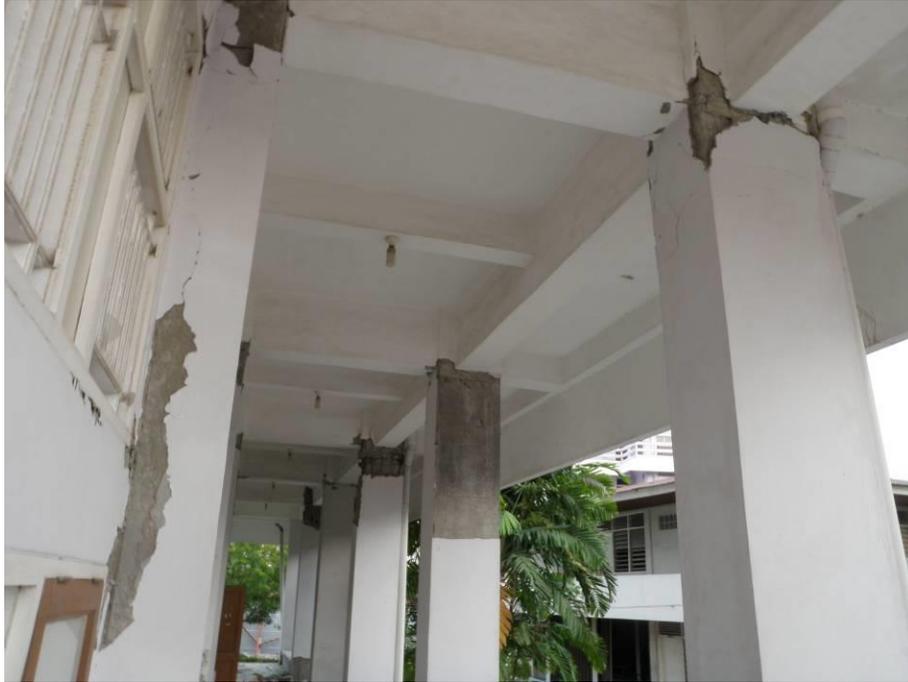
Bending failures were observed at the tops of the columns in both buildings with little damage to the beams, indicating a strong beam – weak column situation.

**Image 4: Strong Beam - Weak Column Situation in Building #2**

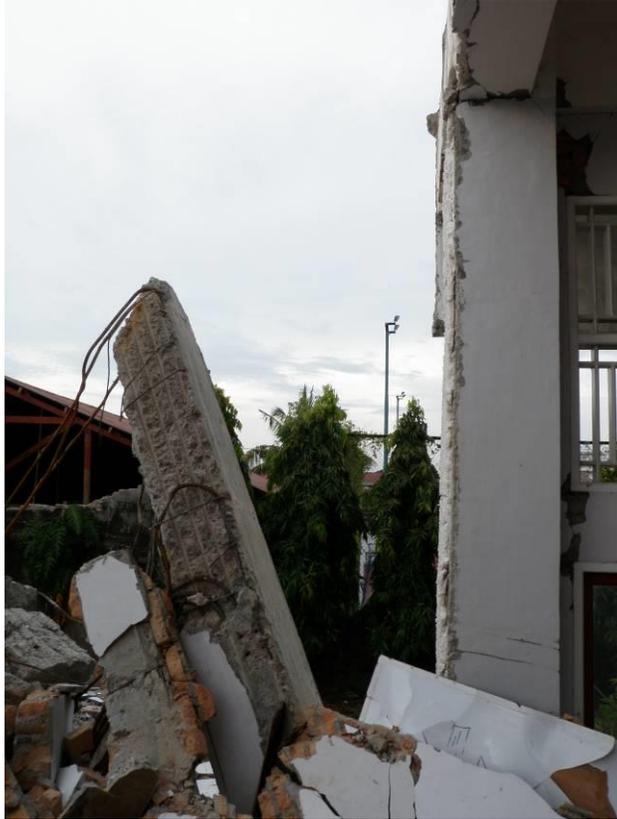
There was a seismic joint between the two buildings consisting of Styrofoam strips that were 1" thick, thereby suggesting that the joint would not have been capable of preventing pounding. The extent of the pounding issue could not be determined, but considering that pounding probably did occur suggests that additional torsion was imposed on the main building by Building #2.

**Image 5: The Styrofoam Seismic Joint was only 1" Thick**
