Tsunami Evacuation Study | Viña del Mar Zone 4

Laura Hernandez, Catherine Johnson, Chad Norvell, and Alvaro Rubinos
EERI Learning From Earthquakes Travel Study Program, Chile 2017

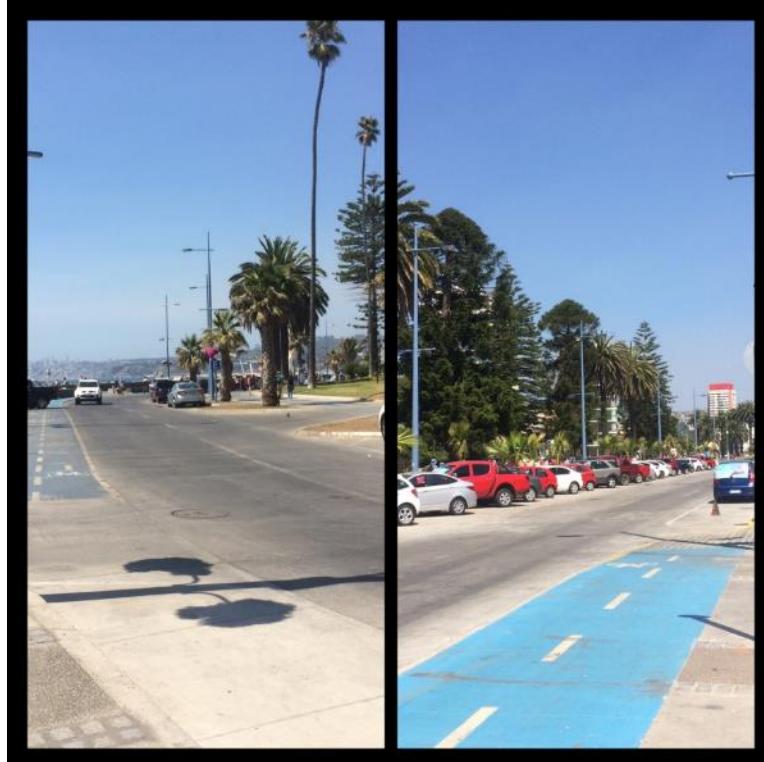
Starting at the beach there were no clear signs where to head, but using the escape route map the team was able to find 2 Norte, and started walking east. Team members couldn't see any hills from where they started except towards the north, along the beach, so without the map, the team likely would not have gone in the right direction to start with. The team was cautious about needing to walk so close to the river. It is important to note that after completing the evacuation route on 2 Norte, and looking more extensively at the map, the assembly point on the hill on other side of the river (to the south) seemed the closest place to go. The team originally did not choose this route because it was outside of the area marked Zone 4.

View at beginning of route, hill visible to the left but not straight ahead where route directed us to go

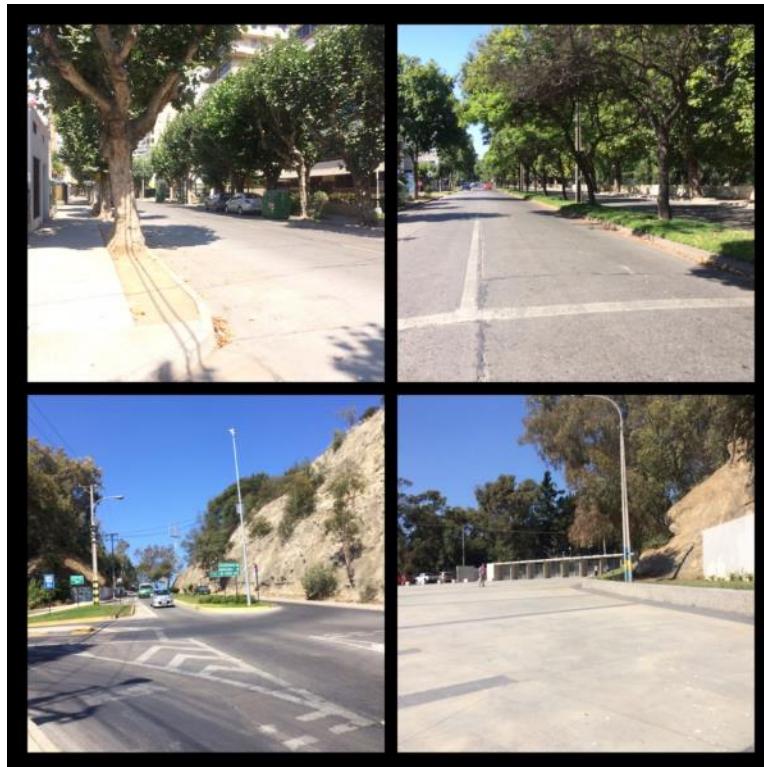
View of streets on route (in order of walking order), as well as the meeting point at the end

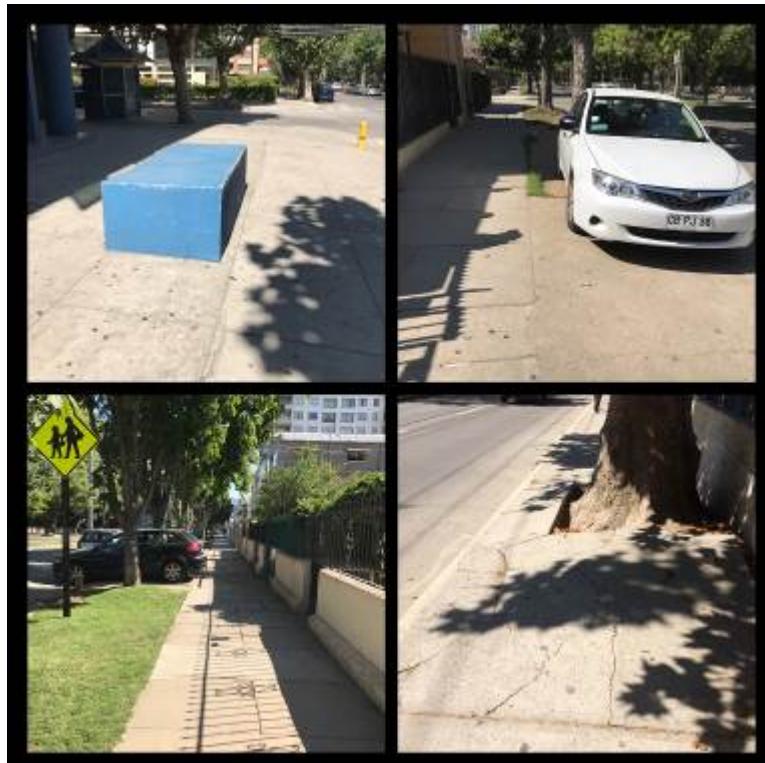
Obstacles on the paths along the way (especially Ave Los Castanos)

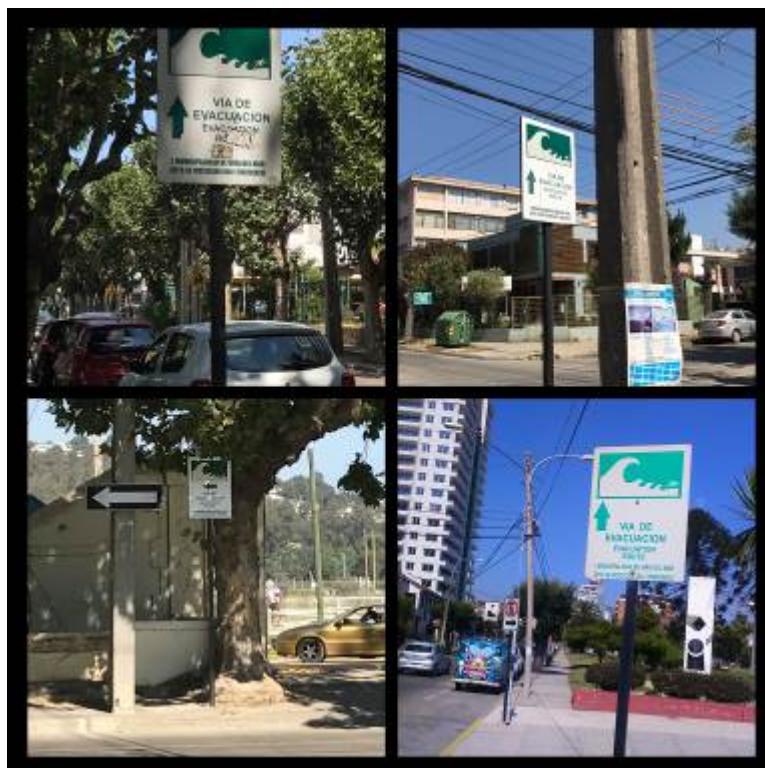
2 Norte was calm and relatively obstacle free most of the way. It appeared to be mostly residential, with many old trees, the only objects that could have been considered obstacles. For the first six blocks there was only one sign at the very beginning of the route. This was at 2 Norte and Libertad Ave. After this intersection, the signs were slightly more frequent. At 2 Norte and 5 Oriente it was unclear where to continue, because hills were seen to the north and south, but not straight ahead on the route and no sign was present. Upon reaching Ave Los Castanos, the team came upon a T-intersection, where it was completely unclear where to turn. The team did not see any signs walking on the right side of the road at all. There was a sign at the intersection with 4 Norte; however, a person would only see it turning onto Ave Los Castanos from 4 Norte. The left side of the road was unobstructed; however, the right side was very narrow, with many street signs, lights, and trees blocking the way. The team noticed street lights on this street in case of an evacuation at night (assuming power is still available). This entire way the route appeared relatively flat. It was only when the team turned right on Subida Sausalito that they steeply gained elevation. Again here there were no signs to direct a potential evacuee. Finally, because of the lack of signage team members only knew they were at Assembly Point 4 after consulting with the evacuation map and Google maps.

Signs present along the evacuation route
