Resilience Reconnaissance | Business Continuity and Economic Recovery

Quinn Peck, Sandra Hyde, Alexandria Julius, and Ana Maria Parra Bastidas
EERI Learning From Earthquakes Travel Study Program, Chile 2017

Case Study 1 | Colchagua Valley Winery

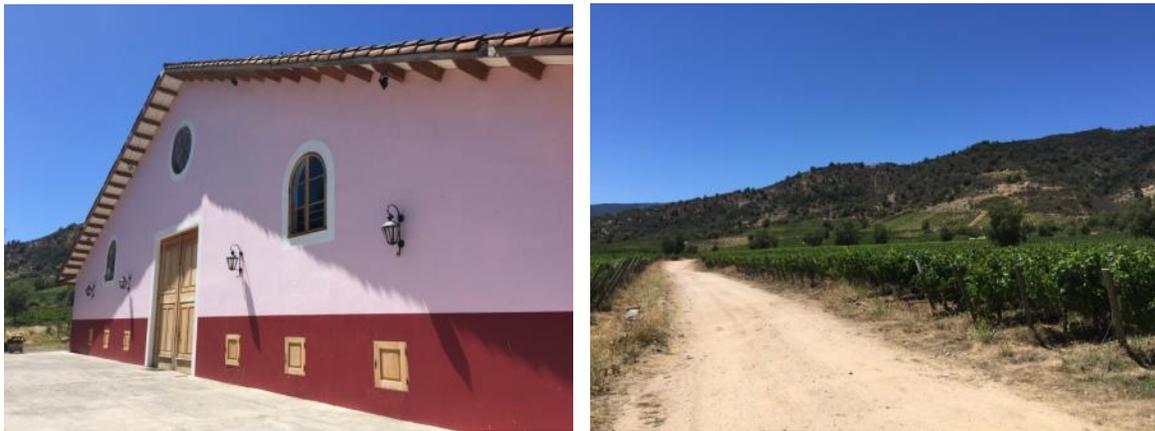
This internationally-owned boutique winery is situated in the Colchagua Valley (Figure 1). The winery has additional locations in Argentina, Spain and France. While this particular winery was largely spared, most wineries in the Colchagua Valley suffered serious economic losses as did those in the neighboring valleys.

Figure 1: Colchagua Valley Winery and associated vineyard

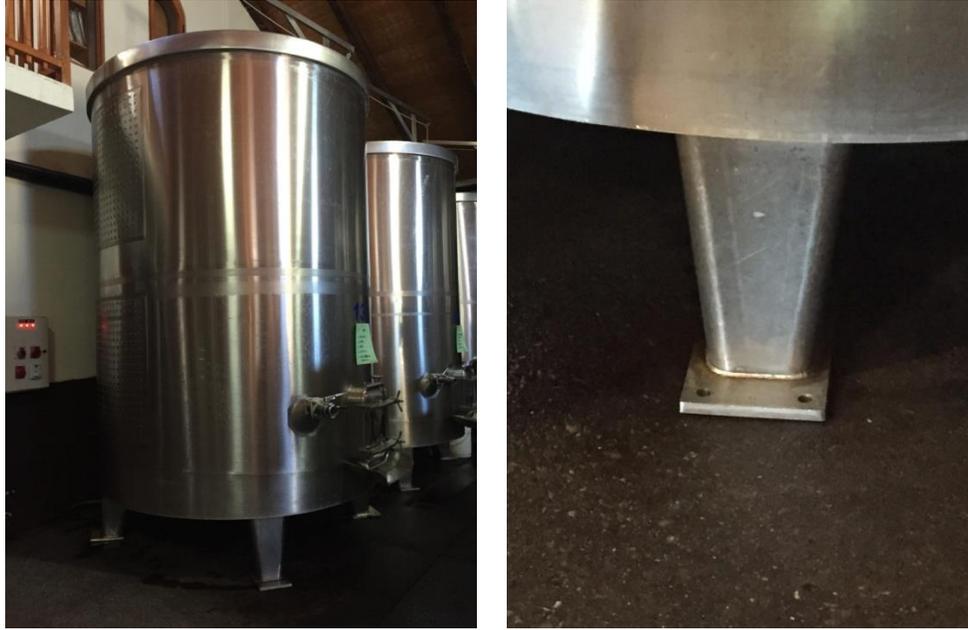
The most common failure seen throughout the region was local buckling of fermentation tanks, due to crippling of the support legs which precipitated stress concentrations in the tank walls. In this winery there was no significant damage to the structure nor equipment: the fermentation room houses approximately eight large stainless steel fermentation tanks aligned against the wall on three sides of the room. The tanks are supported on tapered steel tubes with thick stainless base plates (Figure 2). These particular tanks are not bolted down to the slab on grade, which is uncommon. During the earthquake the tanks rocked and “walked” up to 2 feet from their initial position, but did not impact each other despite relatively close spacing (approx. 1 to 2 feet). The slab slopes from the center of the room toward the wall for drainage, which may have helped prevent more movement of the tanks during the event.

Figure 2: Fermentation tank; unbolted tank foot

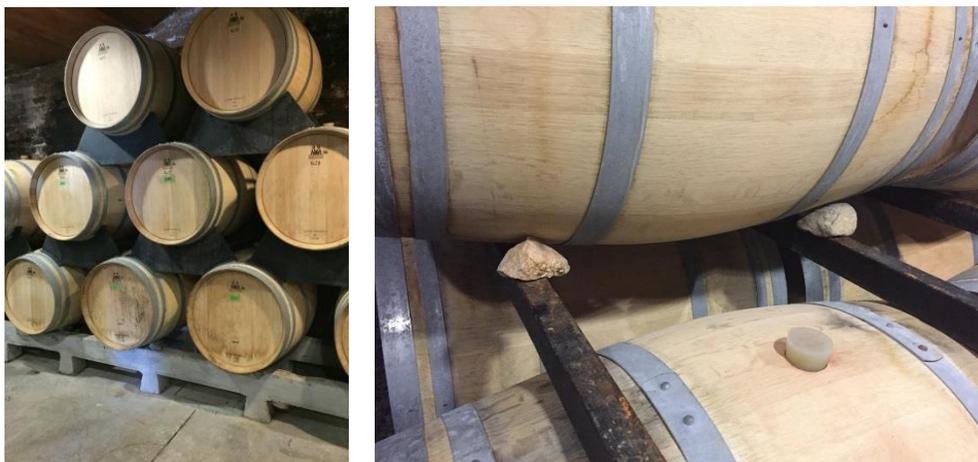
The winery's cold storage houses a large number of barrels for aging. The barrels are situated in stacks between 1 and 3 barrels high, and approximately 15-20 barrels long. The lower-most barrels sit on an approximately 4 inch by 6 inch concrete beam that is supported by 6 inch tall slightly tapered concrete feet between each barrel and on either end to elevate the barrels. A horizontal rectangular steel tube frame sat on top of the first row of barrels to receive the upper rows. Small rocks (some no larger than a golf ball) are placed in the angle formed by the circular barrel and the steel frame in an attempt to wedge the barrel to prevent rolling (Figure 3). The effectiveness of this is unknown, but appears to be unreliable, as some rocks could be removed with little effort and would likely fall out with any sustained shaking. In some cases, the rock wedge system has been upgraded to a folded steel plate support which appears significantly more robust. The rows of stacked barrels are not braced in the transverse direction in any way, relying only on their significant self-weight to prevent overturning.

Figure 3: Wine barrels in cold storage; rocks bracing barrel on frame

Given the lack of anchorage for the fermentation tanks and wine barrels, it appears that this winery was extremely lucky to avoid the significant damage seen elsewhere in the region. The winery sits on the side of a rock outcrop, so it is assumed that there was little to no amplification in shaking intensity from local site effects which may partially explain the lack of damage.

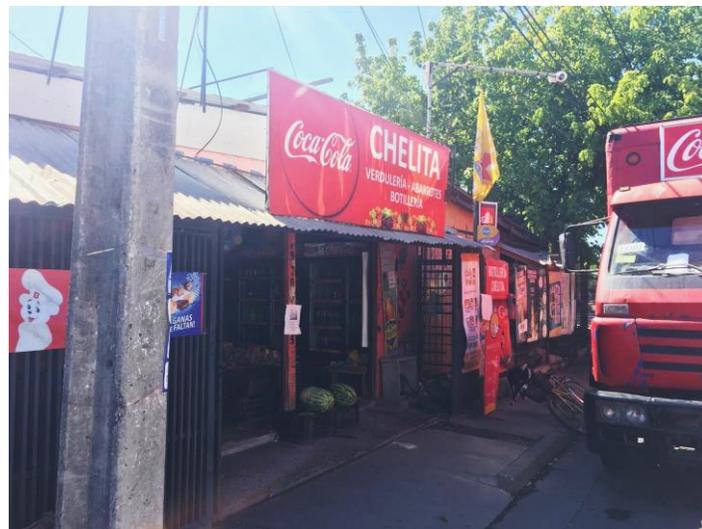
This small, local market is situated directly across the street from a large, eight-building social housing community with approximately 16 units per building in the outskirts of Santa Cruz. This community saw particularly significant damage during Maule 2010 earthquake, including some isolated structural collapses that claimed a number of lives. This market is run by two brothers, their mother and a cousin and was opened in 2006. The shopkeeper interviewed, one of the brothers, lived nearby during the earthquake. Once the shaking stopped, he and his mother rushed to the market to provide their neighbors with flashlights and candles so that they could survey the damage and search for missing people. This suggests that the physical structure of his business did not suffer any significant physical damage (Figure 4). In the aftermath of the earthquake, many temporary houses were built in the lot across from the market which provided a steady stream of clients into the store. This increase in business, which continued with the construction of the permanent social housing, prompted the family to hire their cousin for additional help. To date, he estimates that his clientele has increased by 50% since the earthquake.

Figure 4: Outside of local market
