NCREE REPORT

The February 6, 2016 M_L -6.6 Meinong, Taiwan Earthquake and Lessons Learned

**National Center for Research on Earthquake Engineering (NCREE)
Taiwan**

March 31, 2016

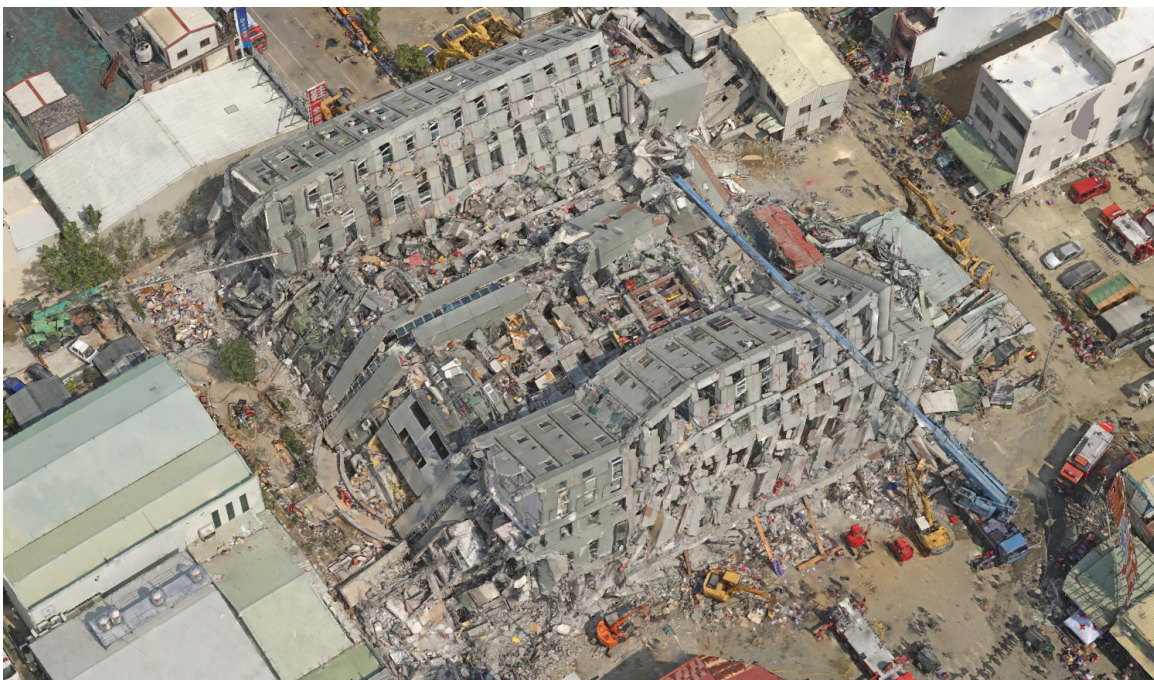
Figure 2.1 Aerial photographic view after the collapse of the Weiguan Jinlong Building in Yongkang District (provided by Ren-Zuo Wang)

The Weiguan Jinlong Building, unfortunately, collapsed during this earthquake (Figure 2.1), leading to 115 deaths and 96 injuries. Figure 2.2 survey

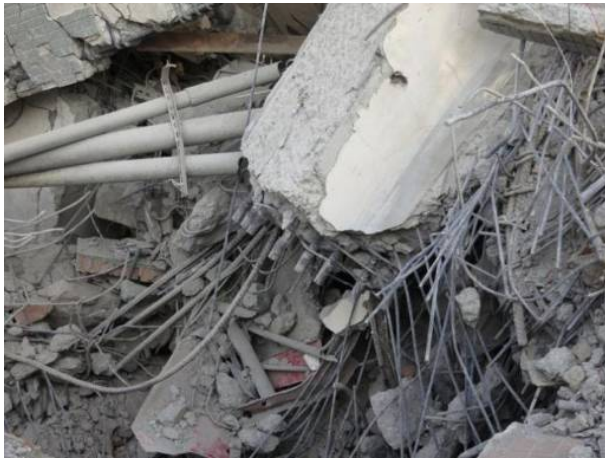
results showed that the main column reinforcement couplers were spliced in the same elevation. The reinforcements were detached from the coupler splices while the hook of column transverse reinforcements exhibited a non-seismic bending angle of only 90 degrees. The floor plan drawing currently available (Figure 2.3) showed that only a single bay was provided in the shorter structural axis, with very low structural redundancy. The building exterior facing Yongda Road had fewer walls. The rear side of the building, on the other hand, had more walls at the staircases and elevator lobbies. More damages were thus observed at the side of Yongda Road. The lower floors were allocated for commercial use and had less walls and probably less structural strength compared to the other floors. Most damages were tended to occur at these lower floors. During the earthquake, columns on one side of the building were mainly subjected to axial compressive forces, while columns on the other side were mainly subjected to axial tensile forces. The columns may be damaged if their strengths were unable to withstand the seismic forces. At the same time, rebar seismic detailing may be inadequate (transverse reinforcement may be too loose, the bends may have failed to be inserted into the concrete core, the main beam reinforcement may be improperly anchored to the column core, the coupler splices failed, or the main column reinforcements may be spliced in the same elevation) which resulted in lack of ductility and led to subsequent collapse during the earthquake. There were many factors that compromised the structure's ability to withstand earthquakes, leading to the collapse in the structurally weak layers of the building and horrendous casualties.

(a) Rebar coupler splices were located in the same elevation

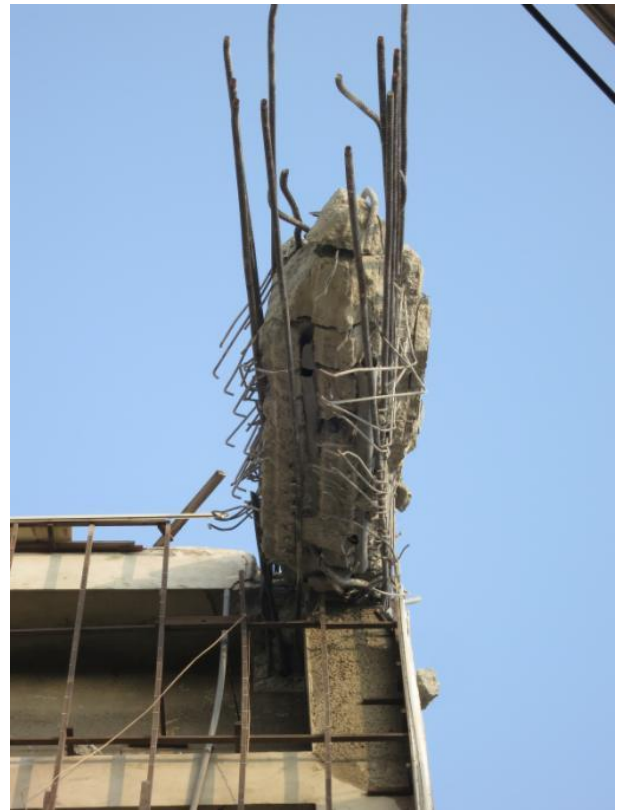
(b) 90 degrees hook of the column transverse reinforcement

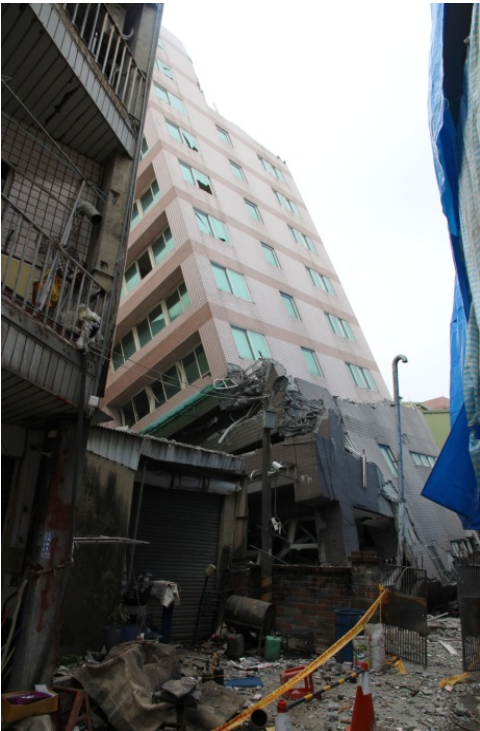
King's Town Bank is located at No. 586 Zhongshan Road, Sinhua District, Tainan. The building has 11 above ground floors and 1 basement floor. This building was constructed in about 1996 and was primarily a mixed-use commercial and residential building. The 2 bottom-most floors were allocated for the bank while floors 3 and above were undergoing renovations for a rental hotel. Hence, no one lived in the building at the time of the earthquake. When the earthquake occurred, no one was injured despite the building being tipped over. The bottom floors of the King's Town Bank building were allocated for commercial and had spacious interiors and higher ceilings. The bottom columns were thus subjected to extremely high axial stress, leading to axial damage of the columns near the driveway entrance and exits that resulted in the collapse of the building (as shown in Figure 2.4).

(a) Damages to the vertical elements at the bottom floors

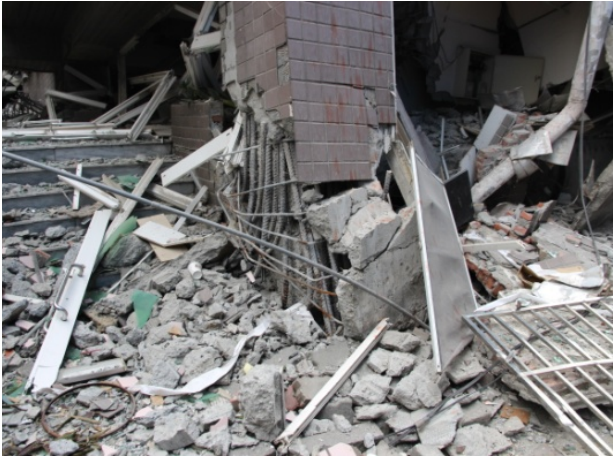
(b) Axial damages to the column at the 1st floor

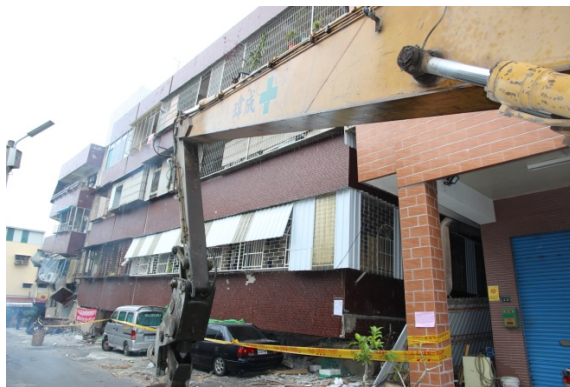
Dazhi Village Market is located at Lane 103, Changdong Street, Eastern District, Tainan City. The Market has 4 above ground floors and 1 basement floor, and is a mixed-use commercial and residential building. This building is a series of connected apartment buildings. Due to the presence of the market, the first floor had only a brick wall at the corner and hardly any partitioning walls throughout the entire level, creating a structurally weak bottom layer. During the earthquake, the columns were subjected to axial damages that led to collapse of the weak layer (Figure 2.5). Only a small area with the brick wall did not collapse. Fortunately, the market was not yet open to the public during the earthquake. No one was trapped when the bottom layer collapsed. Only 1 person living in the residences on the upper floors was injured.

(a) Collapse of the building

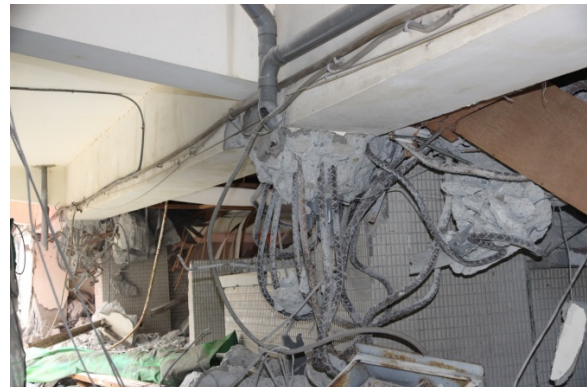
(b) Axial damage of the columns

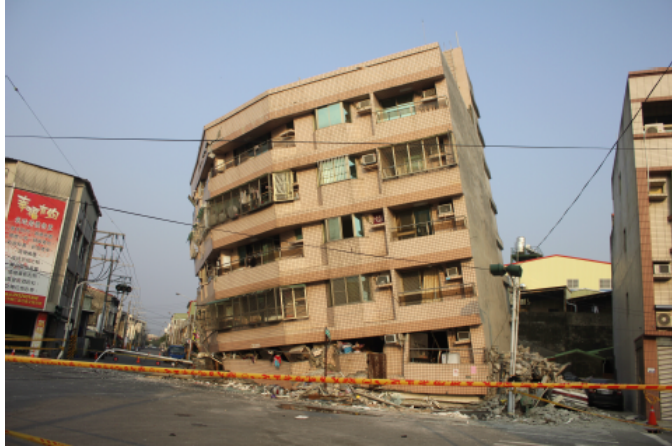
system led to torsion which, together with structurally weak bottom layers, caused the building to collapse (Figure 2.6). 1 person was injured in this building.

(a) Collapse of the building

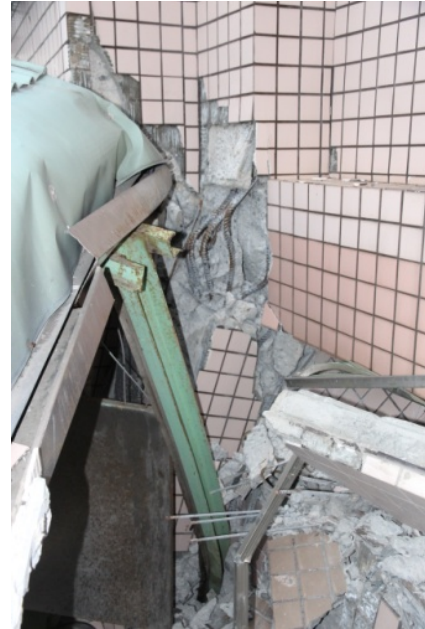
(b) Damaged connectors at the columns and beams

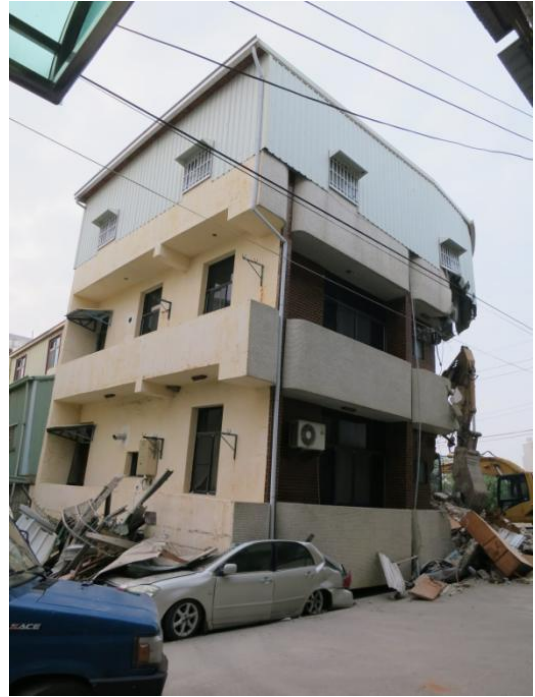
This apartment is located at Lane 101, Taizi Road, Rende District, Tainan City. The building has 3 above ground floors with an extra floor constructed using corrugated metal sheets atop the roof. The building was constructed in 1980. Since the building was constructed many years ago, the vertical elements failed to provide adequate anti-earthquake capabilities. Poor structural configuration also led to torsions in the structural system which led to the collapse of the structurally weak layer (Figure 2.7).

(b) The collapsed building

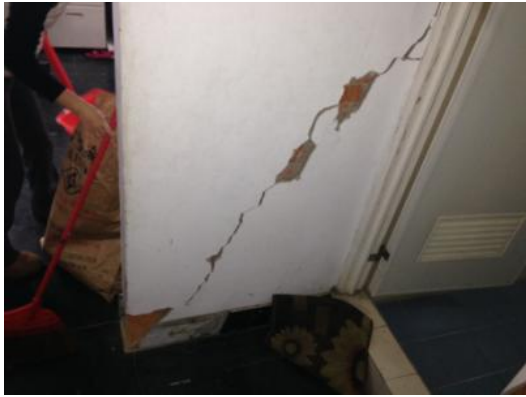
This building is located on Minzu Road, Yujing District, Tainan City, and is an ordinary house next to the street with 3 above ground floors. The building was constructed in 1989. Although this building did not collapse during the earthquake, there were obvious shearing damages of partitioning brick walls within the house (Figure 2.8).

(a) Shearing damages of the brick walls

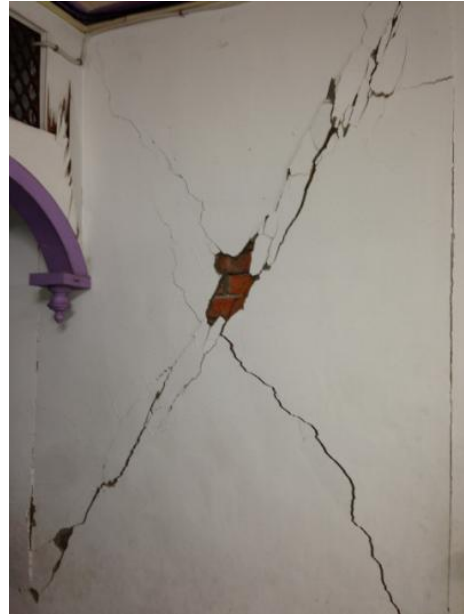
(b) X-shaped shearing cracks on the brick walls

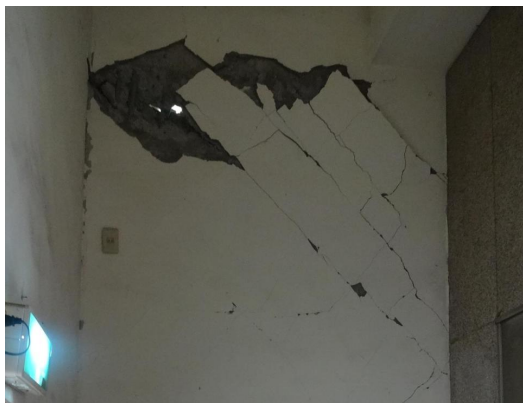
This building is located at Lane 141 of Dade Street, Southern District, Tainan City, and is a reinforced concrete building with 13 above ground floors. Post-earthquake survey found signs of shearing damages on non-structural walls of this building (Figure 2.9).

(a) Shearing damages of non-structural walls

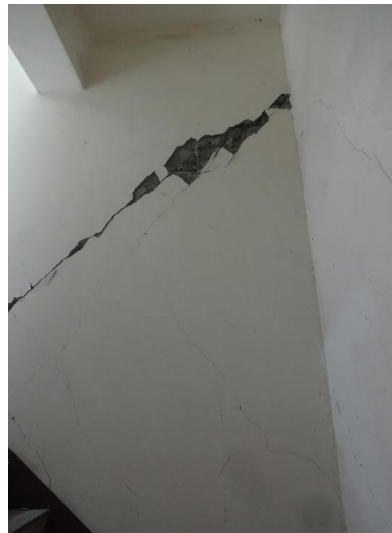
(b) Shearing damages of staircase walls

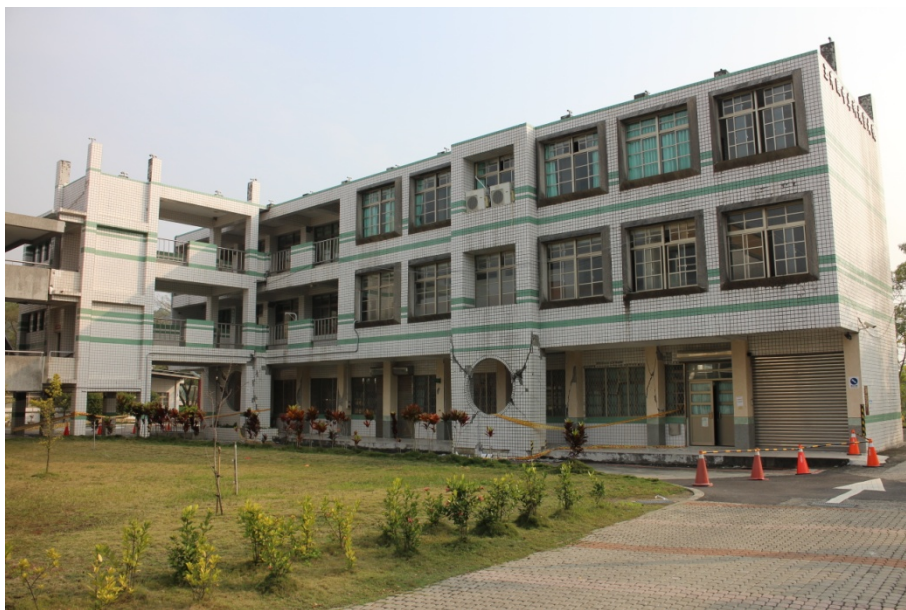
Figure 2.10 Diagonal cracks caused by shearing damages at the 1st floor window columns of the subject classrooms

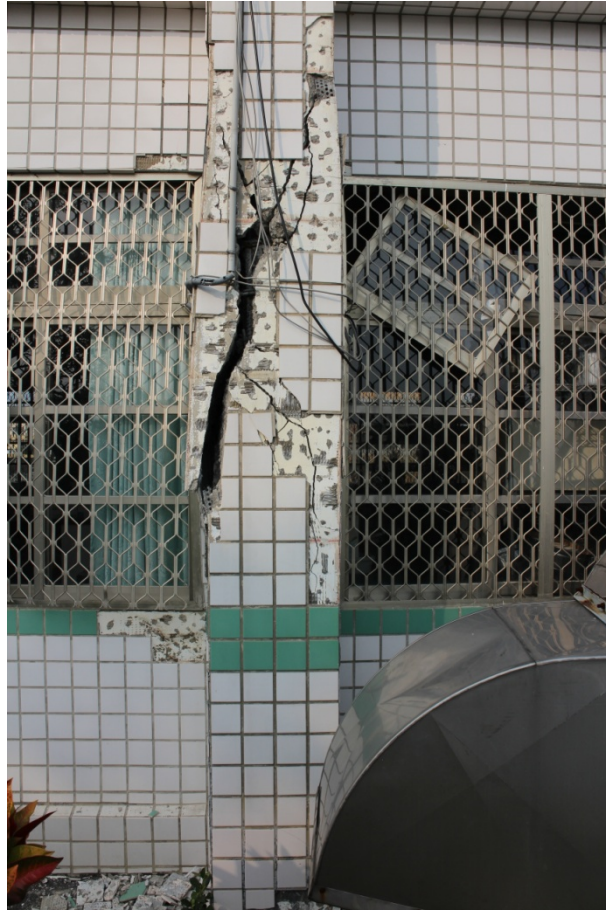
Figure 2.11 Severe shearing damages at the backside of the window columns

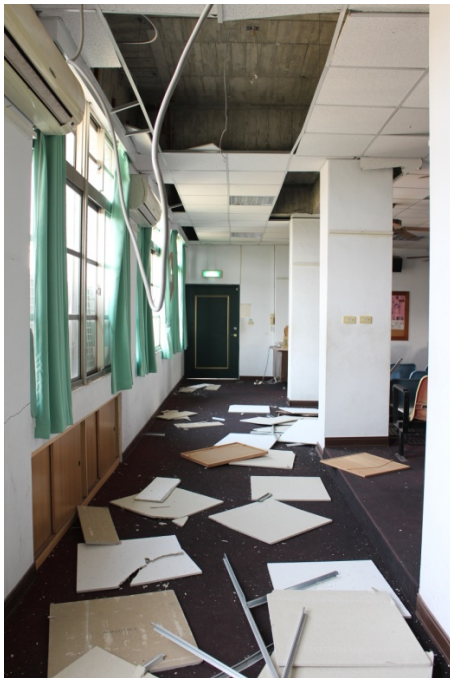
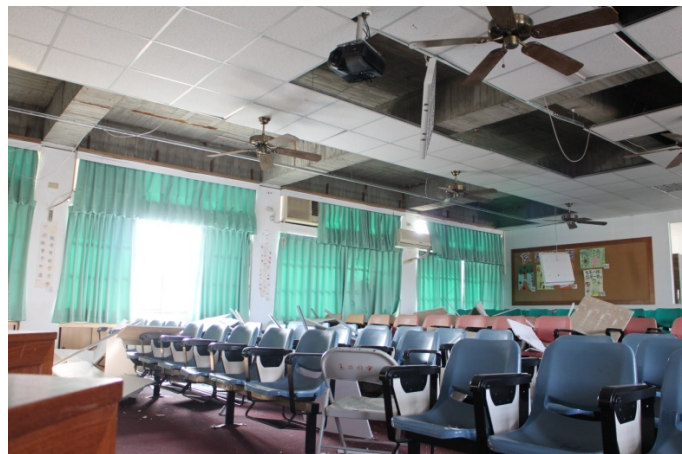
Figure 2.12 Subject Classroom building. Ceiling panels fallen from the light steel frame

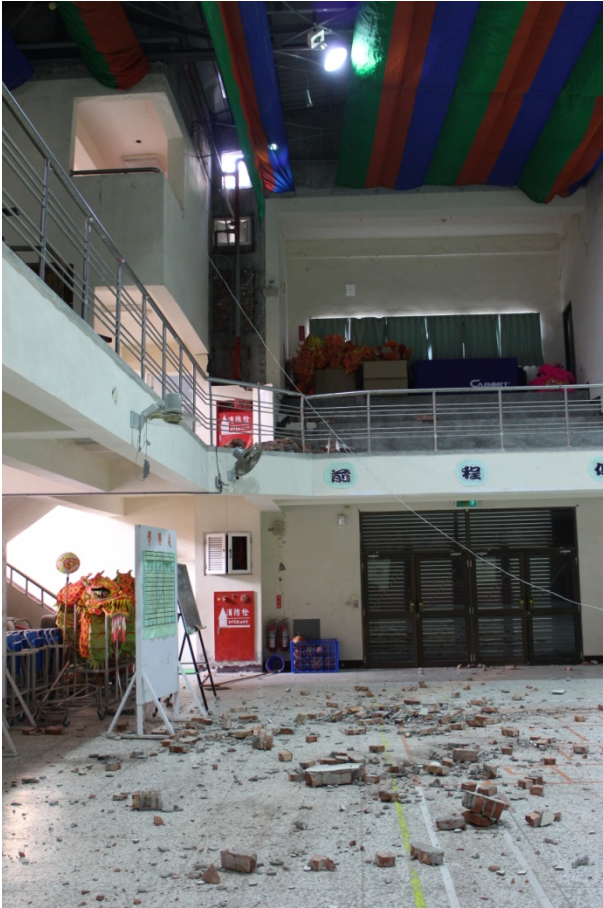
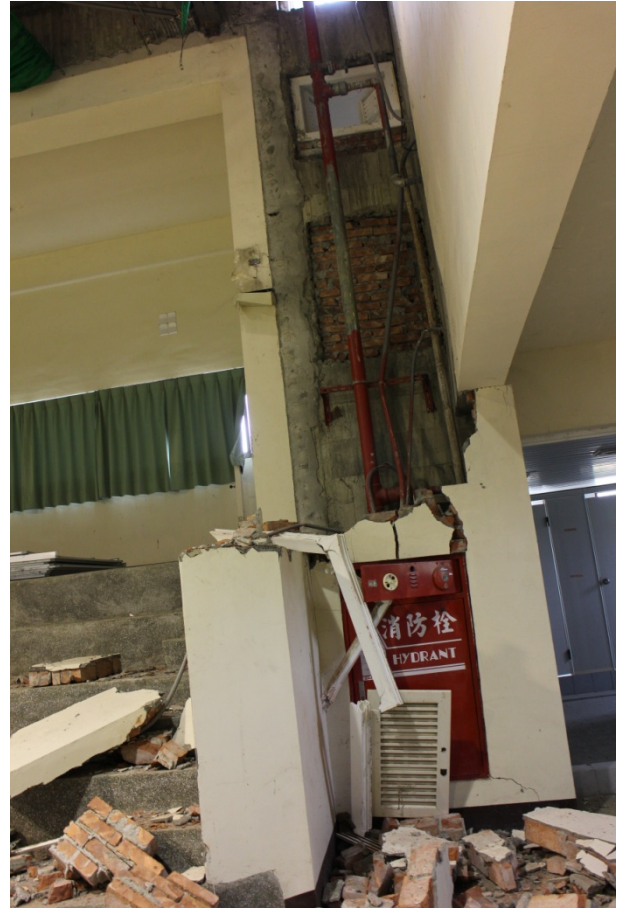
Figure 2.13 Activity Center. Large quantities of red bricks along the pipelines that had fallen off during the earthquake

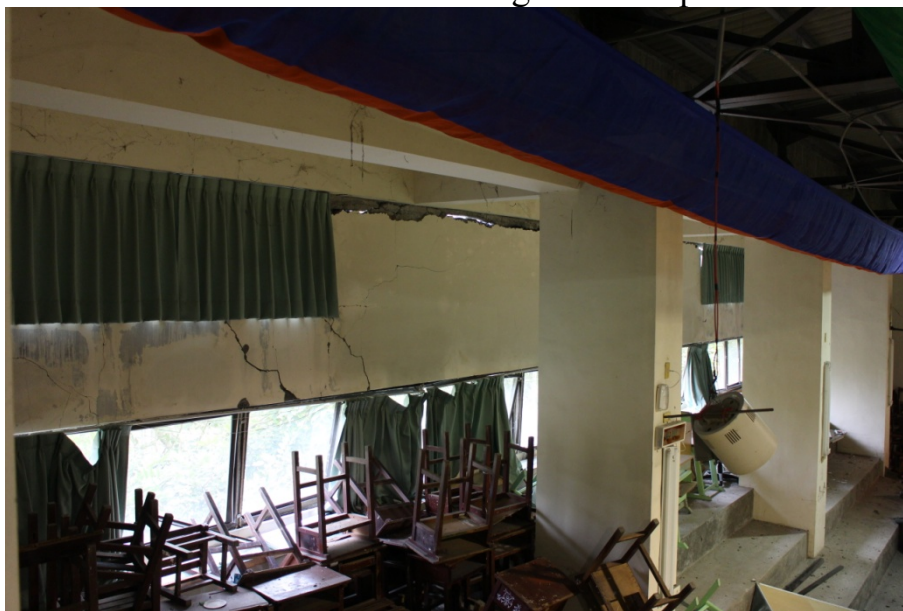
Figure 2.14 Activity Center. Cracks at the interface between the bottom of the beam and the brick wall at the bottom

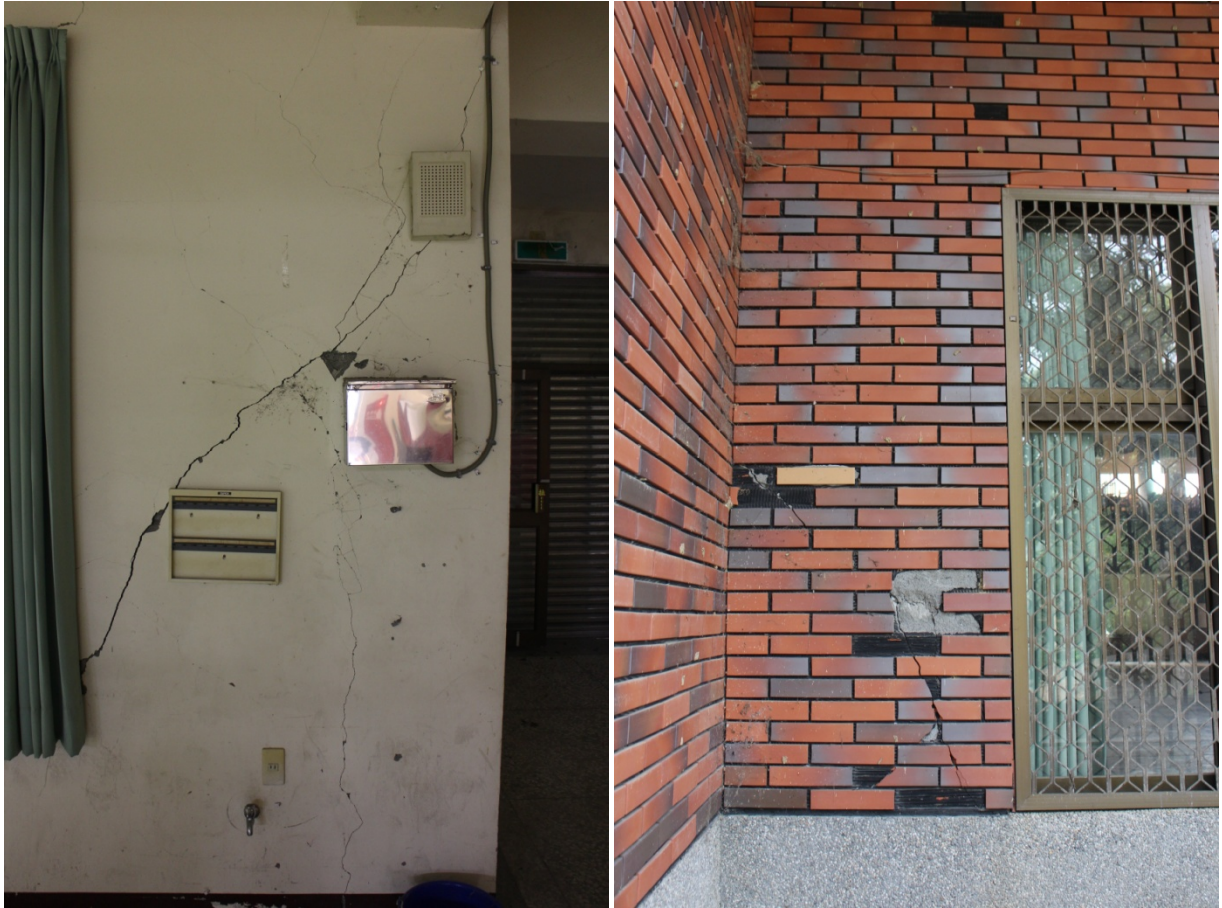
Figure 2.15 Activity Center. Diagonal cracks along the walls which were also observed at the other side

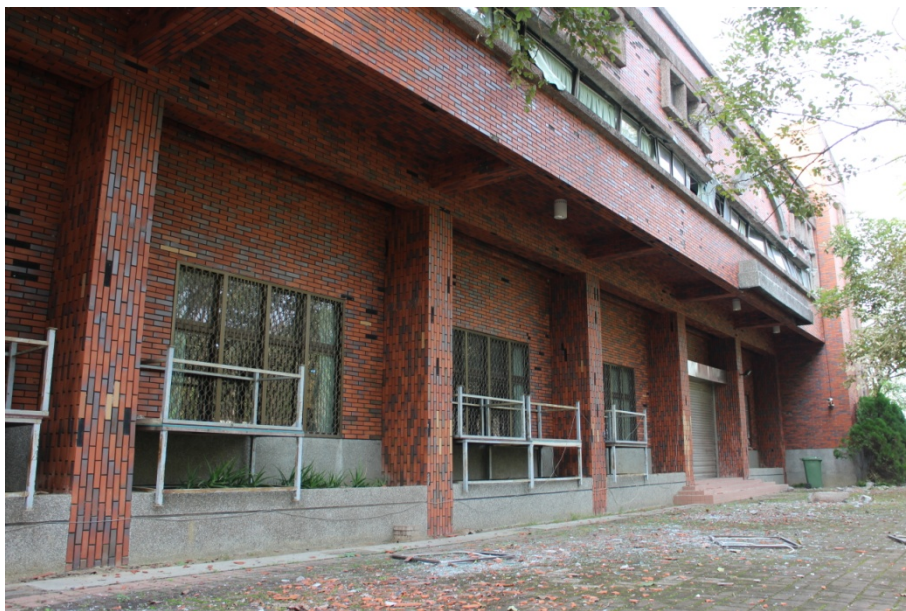
Figure 2.16 Activity Center. Tiles had fallen off the wall surface. A number of windows panels had been subjected to compression and fell onto the ground

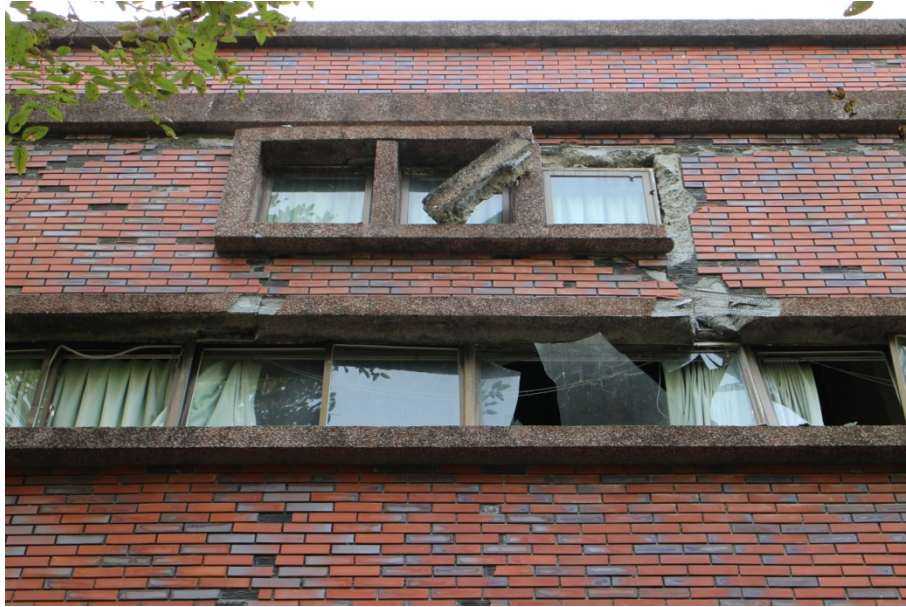
Figure 2.17 Activity Center. Concrete blocks forming the windows' outer frames hanging precariously as well as broken window panels.

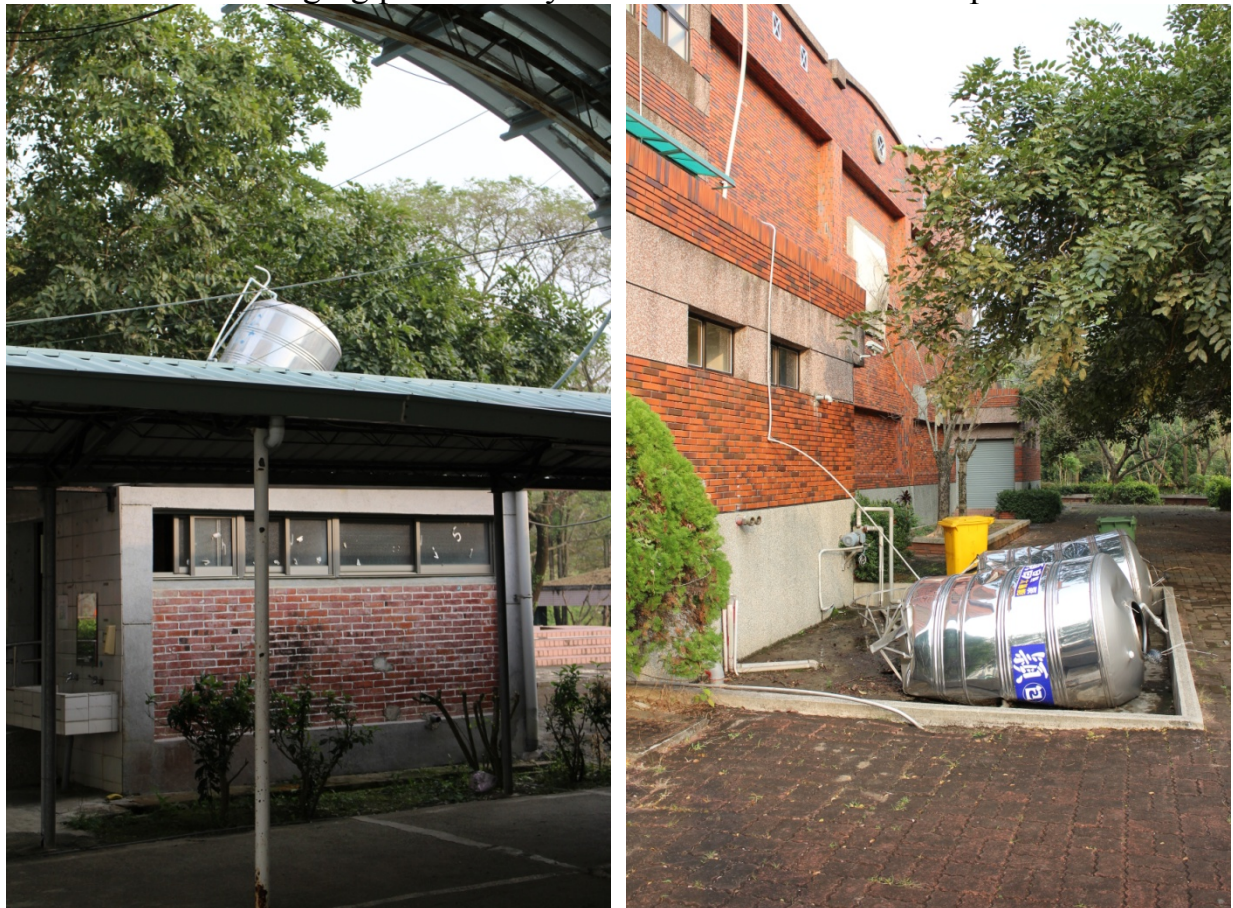
Figure 2.18 Failure of many stainless steel water tanks at Yujing Junior High School

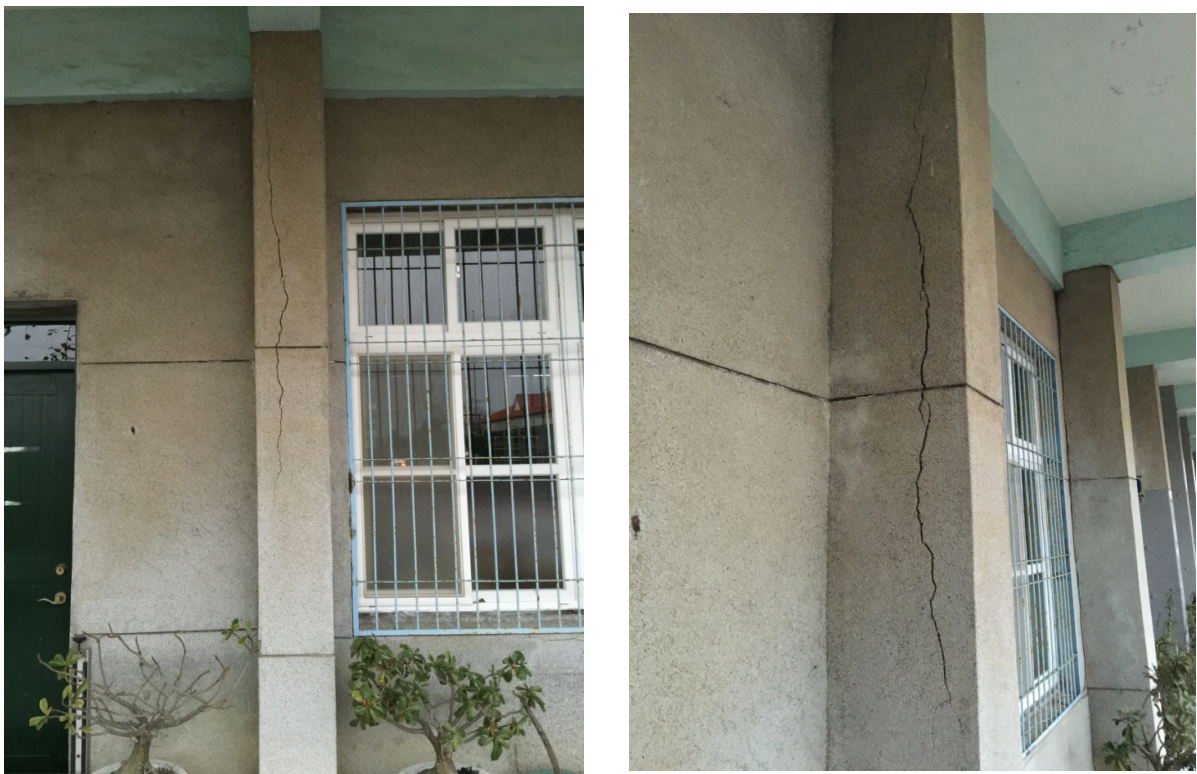
The West Block is a reinforced brick building with 1 above ground floor constructed in 1984. It has corridors running along one side devoid of any column structures. During this on-site inspection, it was found that this school building had earlier jacketed 3 classroom columns with steel plates for reinforcement purposes at an unspecified date. A vertical crack was found at one location of an unreinforced classroom (Figure 2.19) not likely caused by seismic forces. It was determined that the internal steel reinforcements may have become corroded and swollen, and the earthquake simply enlarged the cracks in the concrete.

Figure 2.19 West Block. Vertical cracks along the columns. It was suspected that the internal steel reinforcements have become corroded and swollen. The earthquake simply enlarged the cracks.

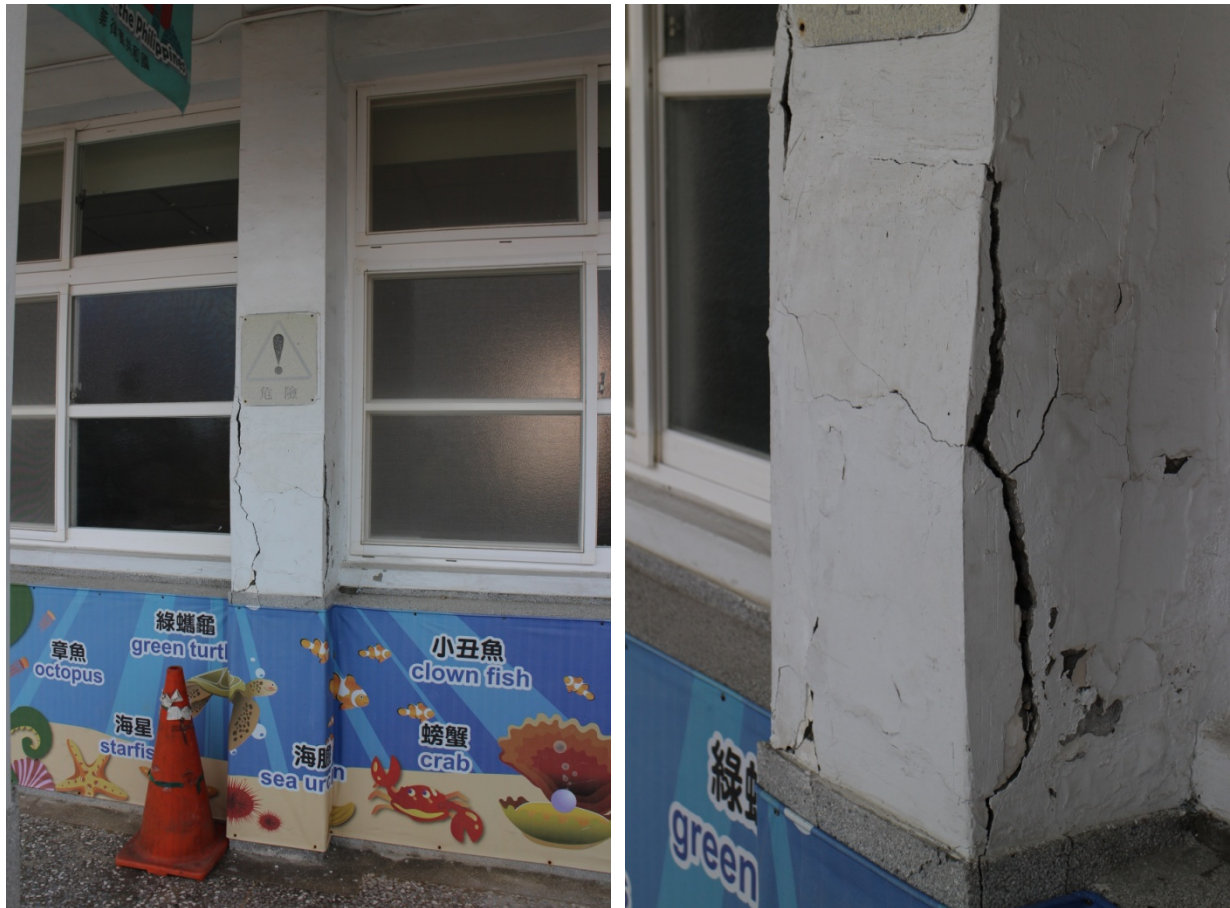
The West Block is a reinforced brick building with 1 above ground floor constructed in 1970 has corridors running along one side devoid of any column structures. On-site survey found cracks at 2 locations of classroom columns of the school building (Figure 2.20). It was determined that the cause of the cracks was probably because the school was located near the coast with an unobstructed area facing the sea. Long-term exposure to sea sprays may have corroded steel reinforcements within the column and led to swelling. This earthquake then caused the column to break apart. The concrete was then broken apart to reveal that the inside had become hollow. Additionally, concrete spalling was observed on 1 column along the side of the corridors, exposing the reinforcements within the concrete (Figure 2.21). Initial assessments determined that this was probably caused by the corrosion and swelling of the steel reinforcements that led to cracks in the concrete. This earthquake then caused parts of this concrete to fall off.

Figure 2.20 West Block. Vertical cracks on the building's columns probably caused by corrosion and swelling of the steel reinforcements contained within. This earthquake than caused the cracks to appear.

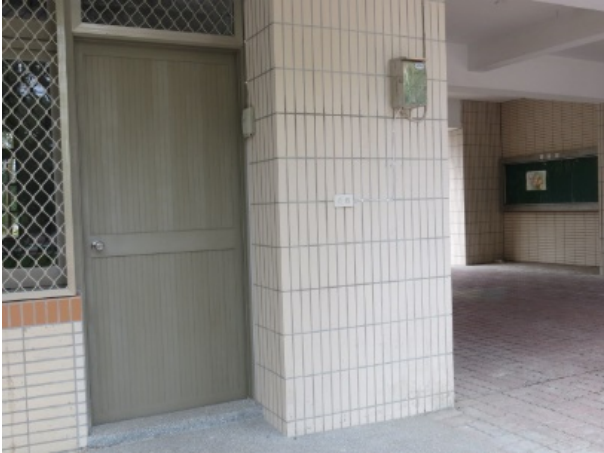
Figure 2.22 Yangming Building. No structural damage.

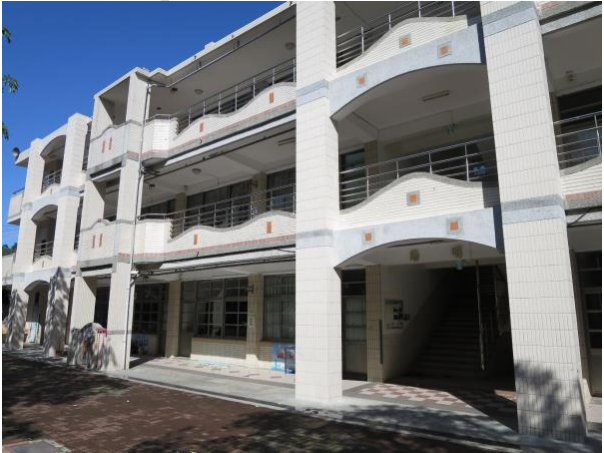
Figure 2.23 Boxue Building. No structural damage.

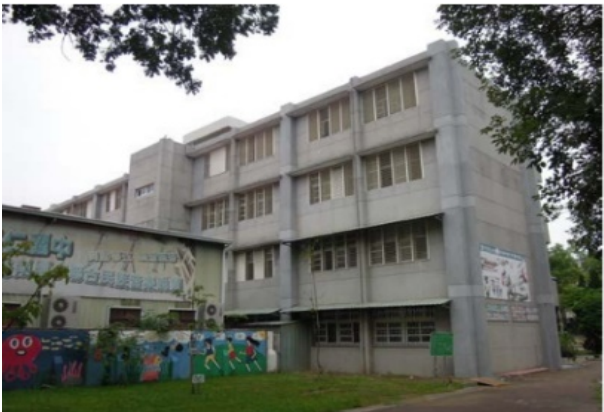
Figure 2.24 Lizhi Building. No structural damage.

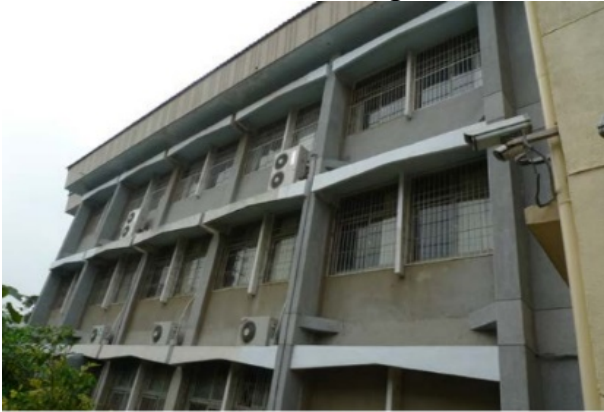
Figure 2.25 Chinese Music Classroom. No structural damage.

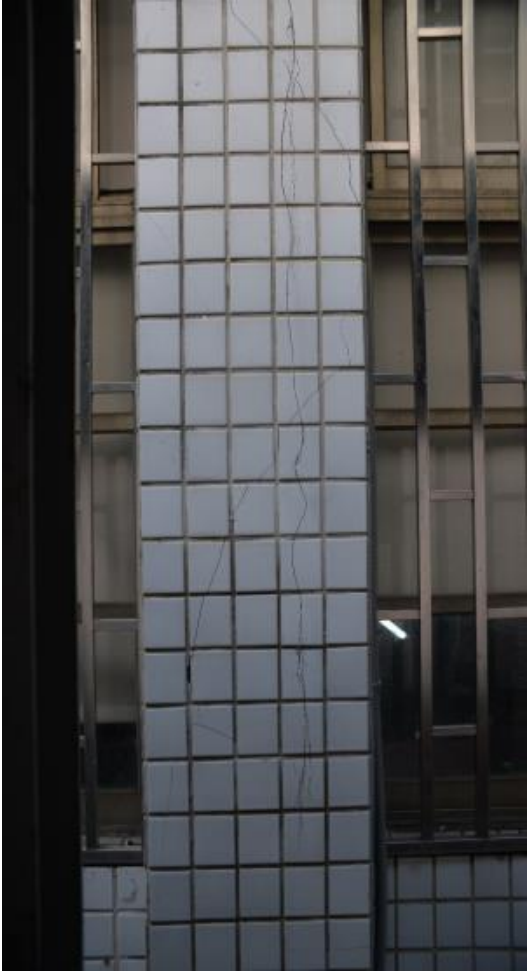
that lacked column structures outside the corridors. The building was constructed in 1987. This school building underwent comprehensive building assessment in 2009. Outcomes indicated that the building lacked earthquake resisting capability (Capacity-to-Demand Ratio, CDR = 0.706) and must undergo retrofit procedure. Retrofit design was completed in the same year and the school is currently waiting for the budget for retrofitting the school building.

This on-site investigation found shearing cracks in multiple columns at the first floor of this school building, of which one the columns exhibited shear failure (Figure 2.26 and Figure 2.27).

Figure 2.26 Guanghua Building.
Structural damage of the columns.

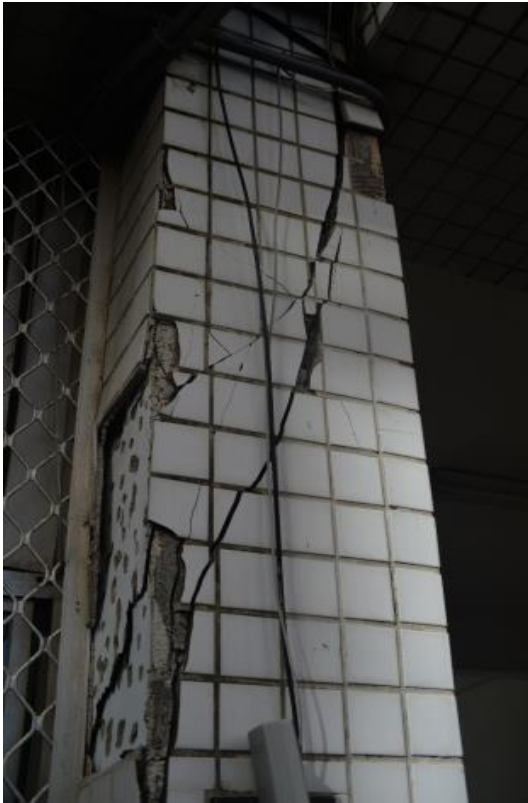
Figure 2.27 Guanghua Building.
Structural damage of the columns.

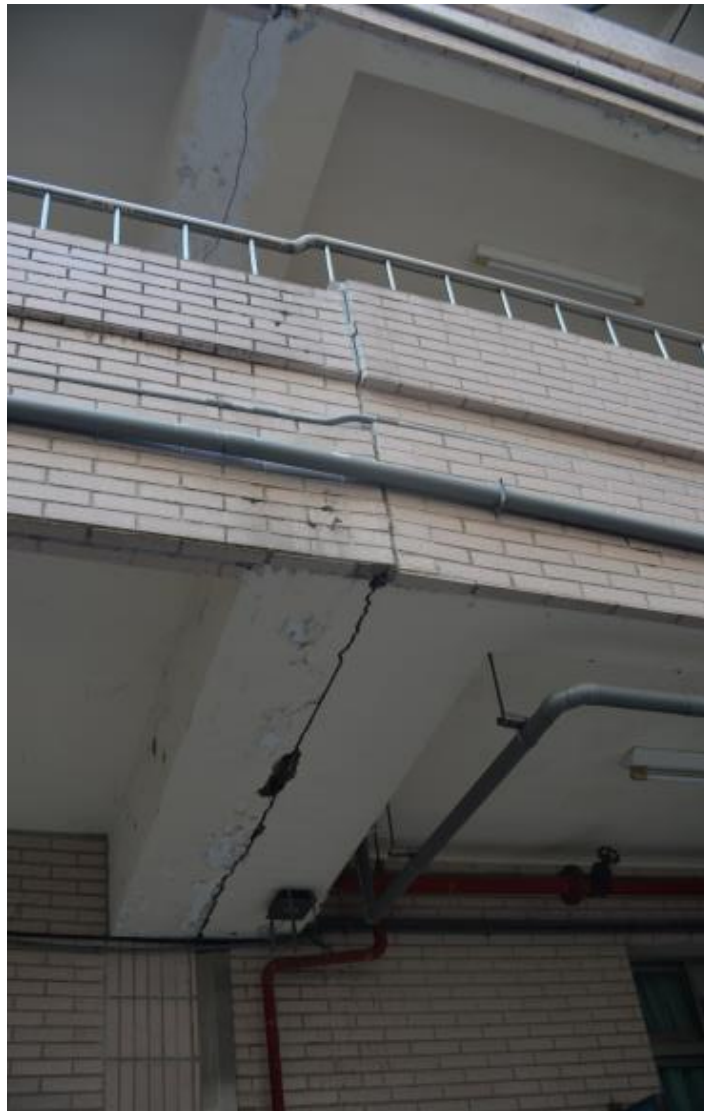
building underwent comprehensive assessments in 2014. Outcomes indicated that the building lacked earthquake resisting capability ($CDR = 0.969$) and must undergo retrofit procedure. Retrofit design was completed in the same year and the school is currently waiting for the budget for retrofitting the school building.

This on-site investigation found that this building underwent shearing damages in its walls as well as damages to its expansion joints caused by collisions with neighboring buildings during the earthquake (as shown in Figure 2.28).

Figure 2.28 Gezhi Building. Damages to the expansion joints

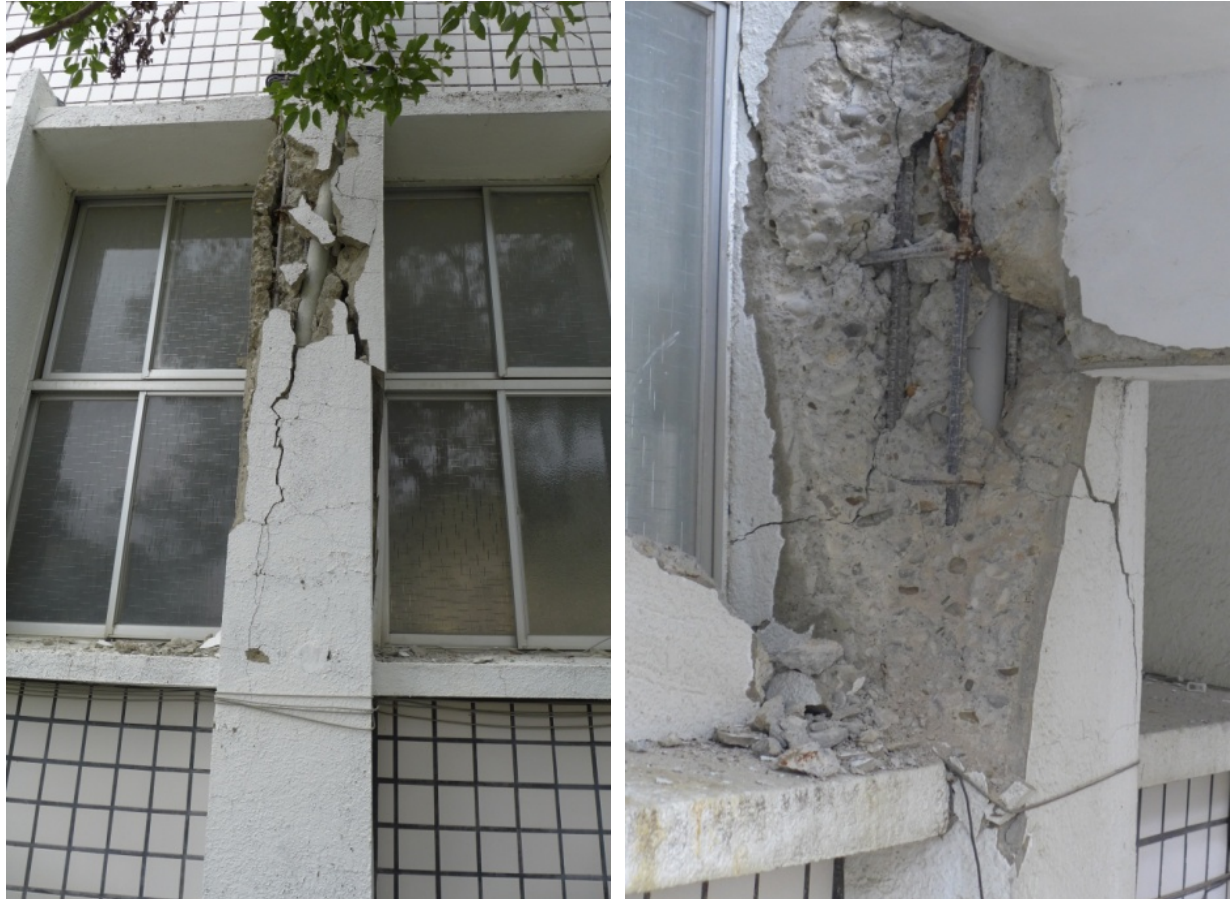
District, Tainan City, with coordinate of 120.4777° East and 23.0430° North. This building is a 3-story reinforced concrete building (Figure 2.29). The 1st floor is used for carrying out administrative tasks of the district office and lacked any partitioning walls. Only an infill brick wall was provided at the rear side of the building. Although the building did not collapse during this earthquake, there were significant shear failures observed on a large number of columns. The protective concrete cover spalled off from some of the columns, exposing the steel reinforcements as well as inlaid pipes contained within (Figure 2.30).

Figure 2.30 Windows have led to short column effects that led to shear failure to a large number of columns during the earthquake

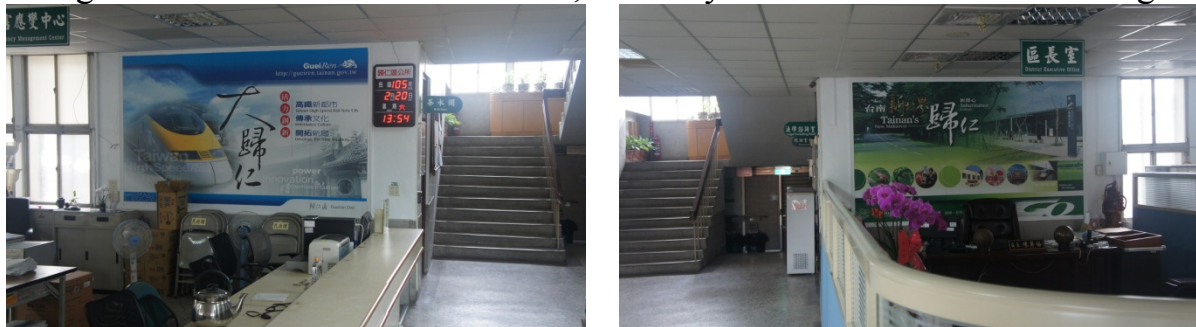
Figure 2.32 Shear walls built in the Gueiren District Office

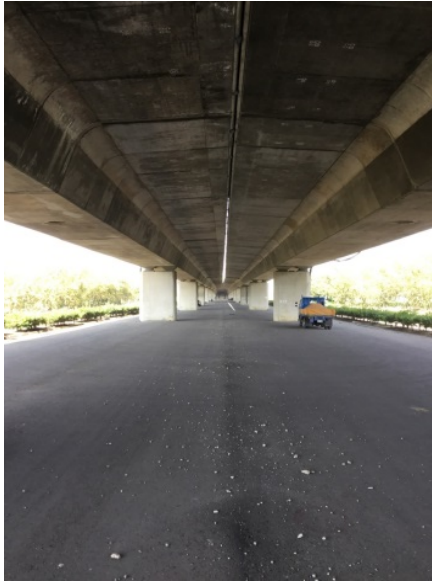
(a) Gaps caused by transverse displacement of 2-way bridges

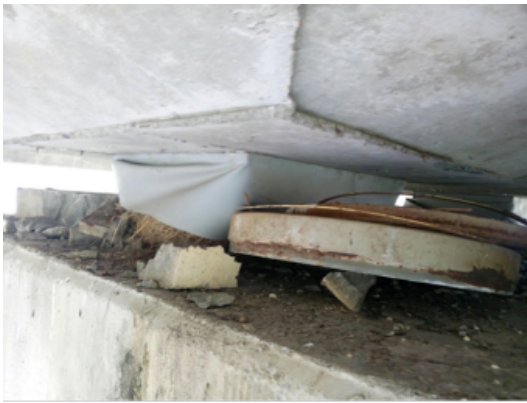
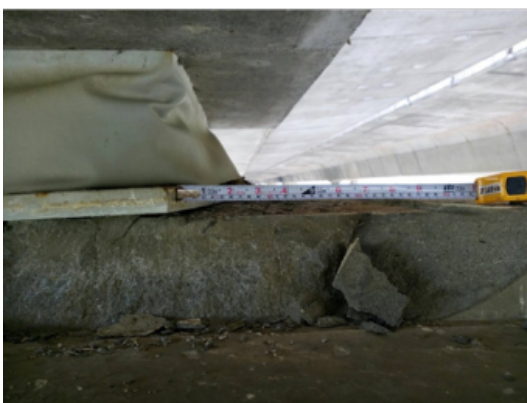
(c) Damages caused by excessive displacement of bridge bearings

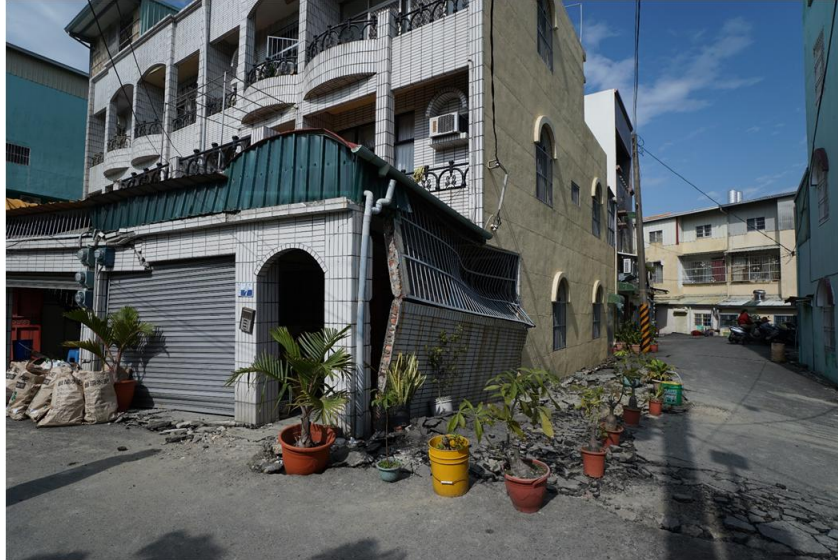
Soil liquefaction caused many houses in the area around Lane 50, Lane 50 Alley 10, and Lane 10 of Sanmin Street (an area about 60 m x 60 m in size) to sink or tip (Figure 4.1A). On-site measurements showed that sand eruption resulting from the liquefaction reached as high as 150 cm (Figure 4.1B). Sinking depths for the ground level floors in the building was about 47 cm compared to the street level (Figure 4.1C). Sand eruptions were also observed from drainage sewer manhole covers, utility poles, fire lanes, and drains around the building areas. For this area, damages were observed for the garage shed and fences built in front of the ground floor door as well as sinking and slight tipping of the main building. No other visible structural damage was seen. No other signs of disaster were observed outside this area, including buildings opposite the street of Lane 50 and Lane 10 of Sanmin District. After interviewing local residents and reviewing maps of Taiwan 100 years ago provided by Academia Sinica, it was found that this area was once a pond that was later filled to create land. Hence, only severe liquefaction was observed in this area but none in the vicinity.

(A) Sinking and tipping of buildings

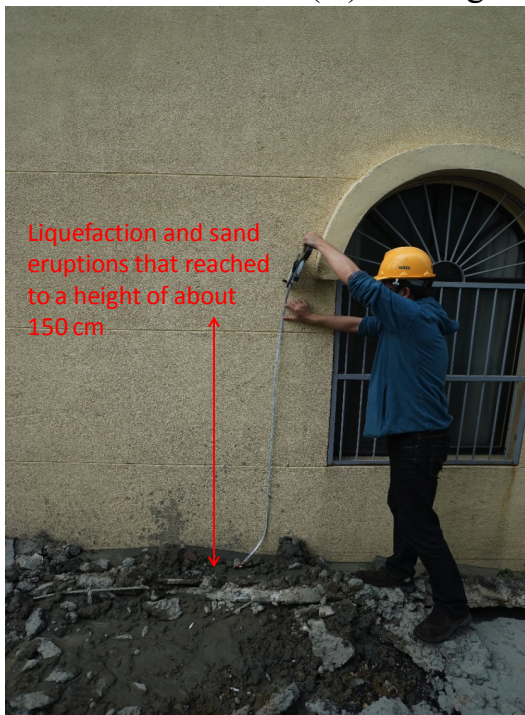
(B) Liquefaction and sand eruptions that reached to a height of about 150 cm

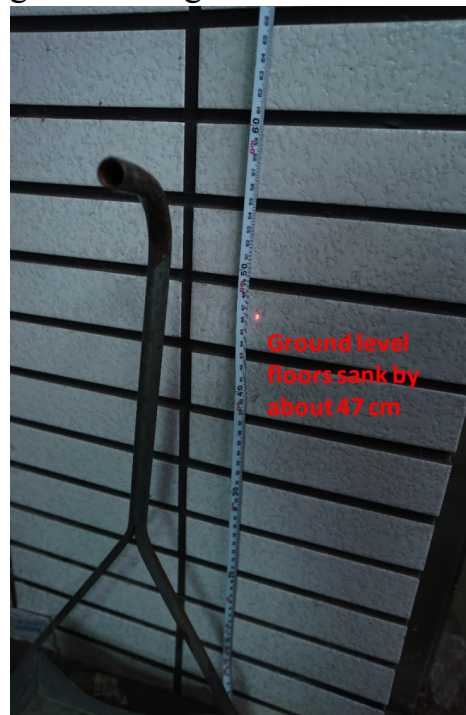
(C) Ground level floors sank by about 47 cm
