NCREE REPORT

The February 6, 2016 M_L -6.6 Meinong, Taiwan Earthquake and Lessons Learned

**National Center for Research on Earthquake Engineering (NCREE)
Taiwan**

March 31, 2016

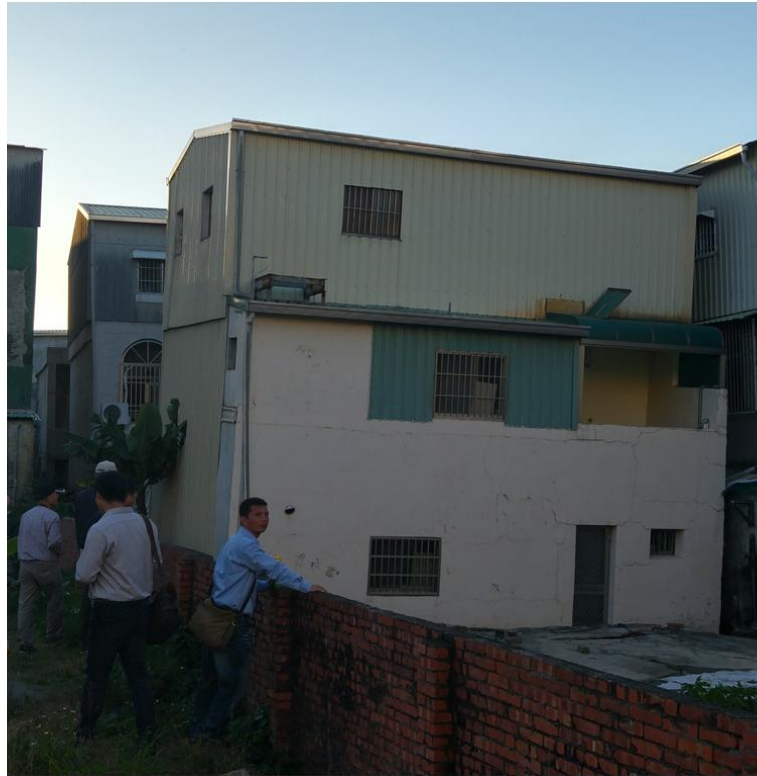
(A) Building at No. 24, Lane 161, Hui'an Street

Irrigation drainage line, the eastern side of Section 2 of Bei'an Road, and northern bank of Yanshui River. This area experienced severe liquefaction during the earthquake, especially in the area from Hui'an Street to Section 4 of Fu'an Road, with signs of eruptions from drains, manhole covers, and bottom of utility poles. Building tipping or sinking caused by soil liquefaction was most evident in Lane 161 of Hui'an Street. The building located at No. 24, Lane 161, Hui'an Street (Figure 4.2A) sank and tipped towards the rear by about 5 degrees as a result of soil liquefaction. The building located at No. 8, Lane 161, Hui'an Street sank by nearly half a story due to liquefaction (Figure 4.2B). On-site measurements showed that this forward tipping angle of the building reached 4 degrees (Figure 4.2C). It was determined that the local stratum may be relatively weak due to its proximity with Yanshui River. Century-old maps from Academia Sinica also revealed that the region around Xiding Village used to be a pond, and was thus severely affected during this earthquake.

Figure 4.2 Building tipping and sinking due to soil liquefaction at Lane 161, Hui'an Street, Annan District, Tainan City (provided by Shang-Yi Hsu)

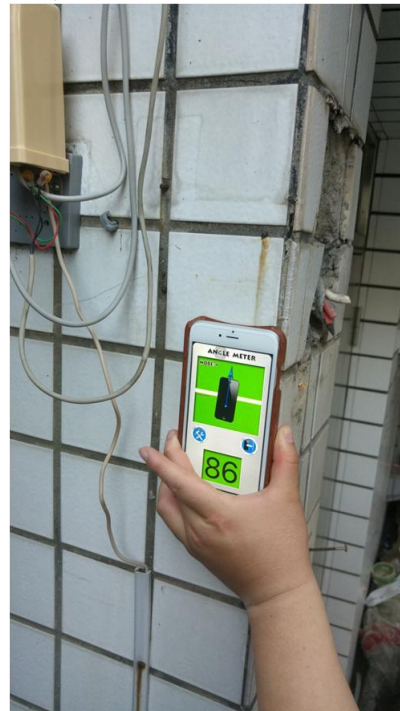
(C) Measuring the tipping angle in front of the house

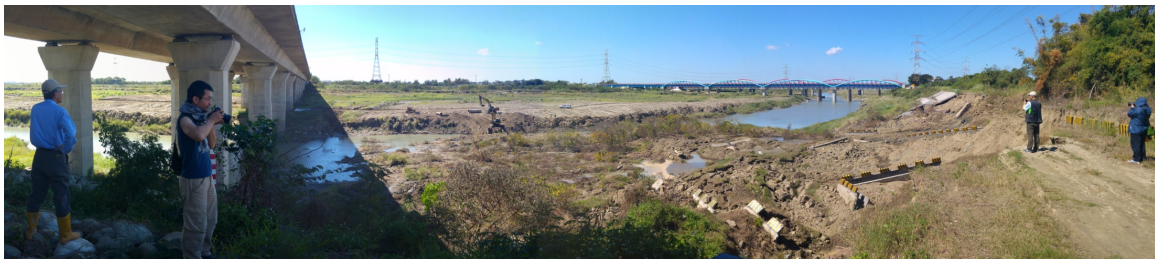
This earthquake caused large scale lateral spreading damages of Rixin embankments at Danei Bridge of Zengwun River in Tainan District (Figure 4.3) and right side levees at the Freeway No. 3 connection of Zengwun River Bridge (Figure 4.4). Cracking of concrete bank protection as well as warping and sinking of the levee road were also observed for the levees on the right bank of Erxi Bridge. Large amounts of sand due to soil liquefaction were also observed at locations where bank protection used to be at the lateral spreading spots of the Zengwun River levees. NCREE personnel also collected samples from these places (Figure 4.5) for subsequent laboratory testing.

Figure 4.4 Lateral spreading damages at the embankments of Zengwun River Bridge at Freeway No. 3 (provided by Shang-Yi Hsu)
