MAY 6, 2023

# FEBRUARY 6, 2023 TÜRKIYE EARTHQUAKES: REPORT ON GEOSCIENCE AND ENGINEERING IMPACTS

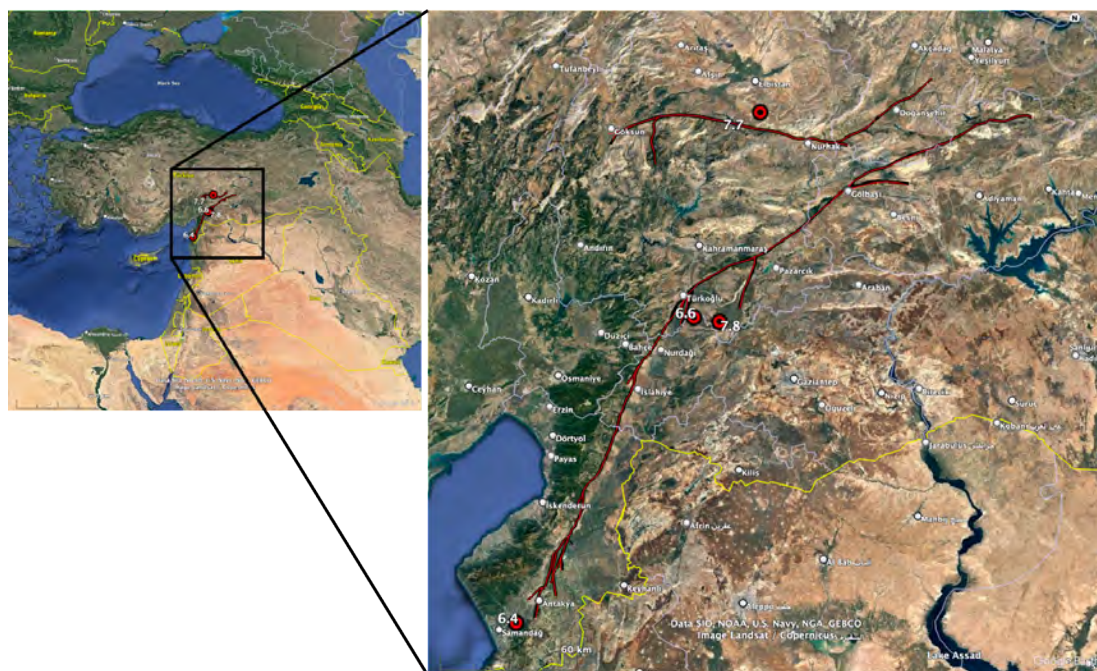
**Figure 1.1.** Map of Türkiye (Google Maps). The epicenter of the February 6, 2023, Kahramanmaraş (**M7.8**) and Elbistan (**M7.7**) earthquakes shown along with other aftershocks and surface fault rupture.

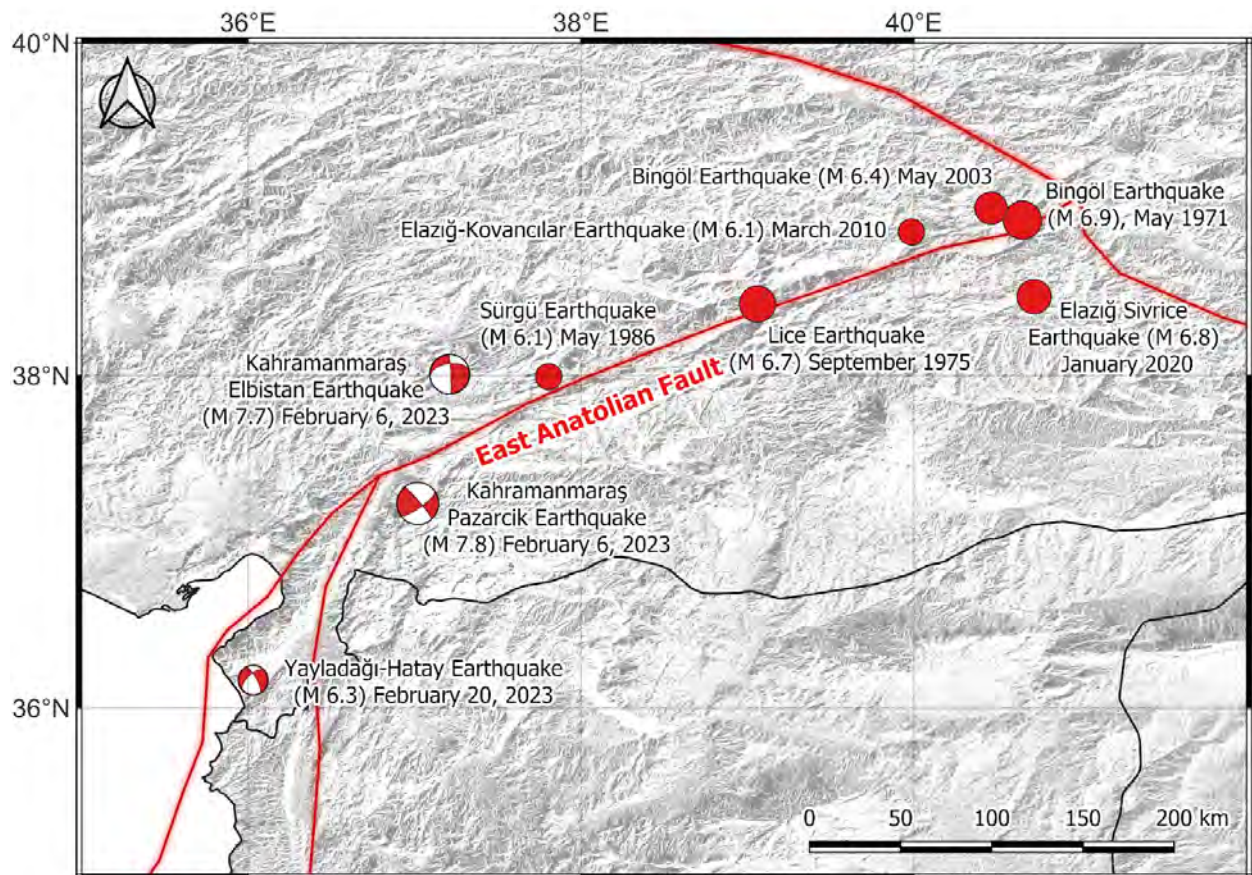
**Figure 1.2.** Locations of 2023 and historic earthquakes along the East Anatolian Fault

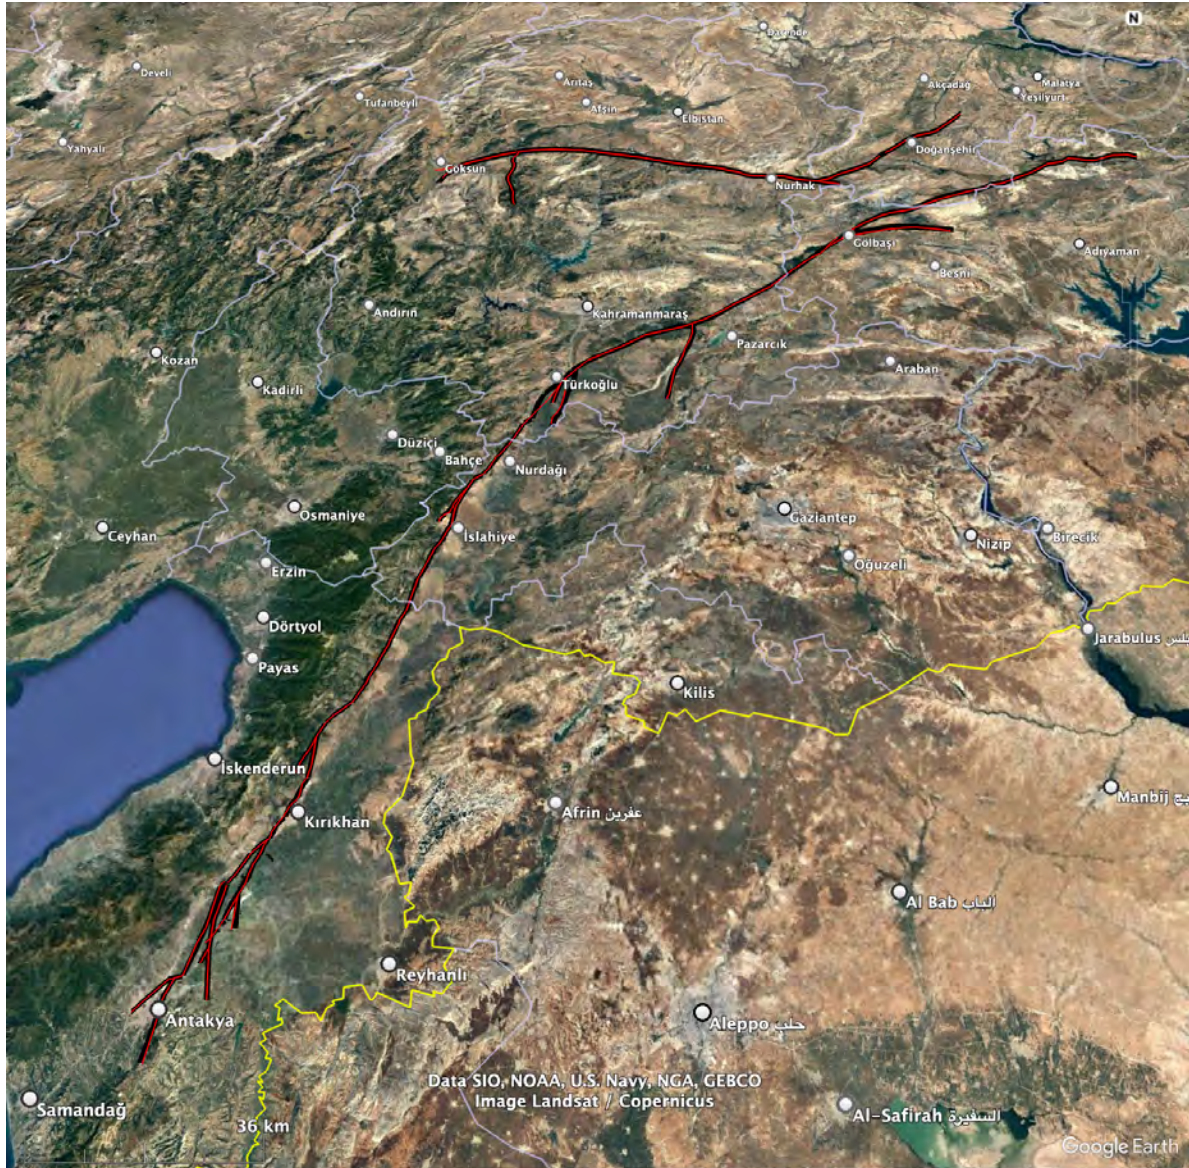
**Figure 1.3.** Map showing locations of towns described in the following text along with surface fault rupture from the earthquakes (Google Maps).

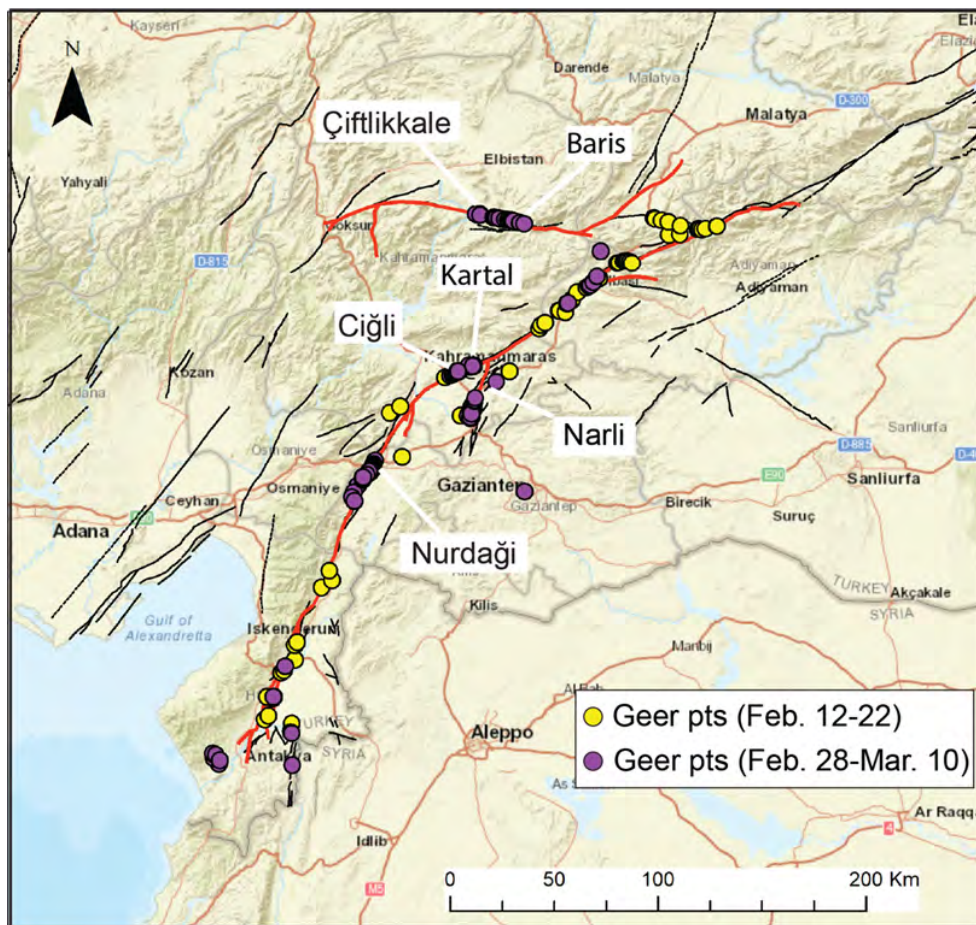
**Figure 2.1.** Fault Rupture Team observation points from the GEER field investigation. Red lines are the simplified rupture traces from the U.S. Geological Survey (Reitman et al., 2023). Thin black lines are previously mapped faults from the Active Fault Map of Turkey (Emre et al., 2013).

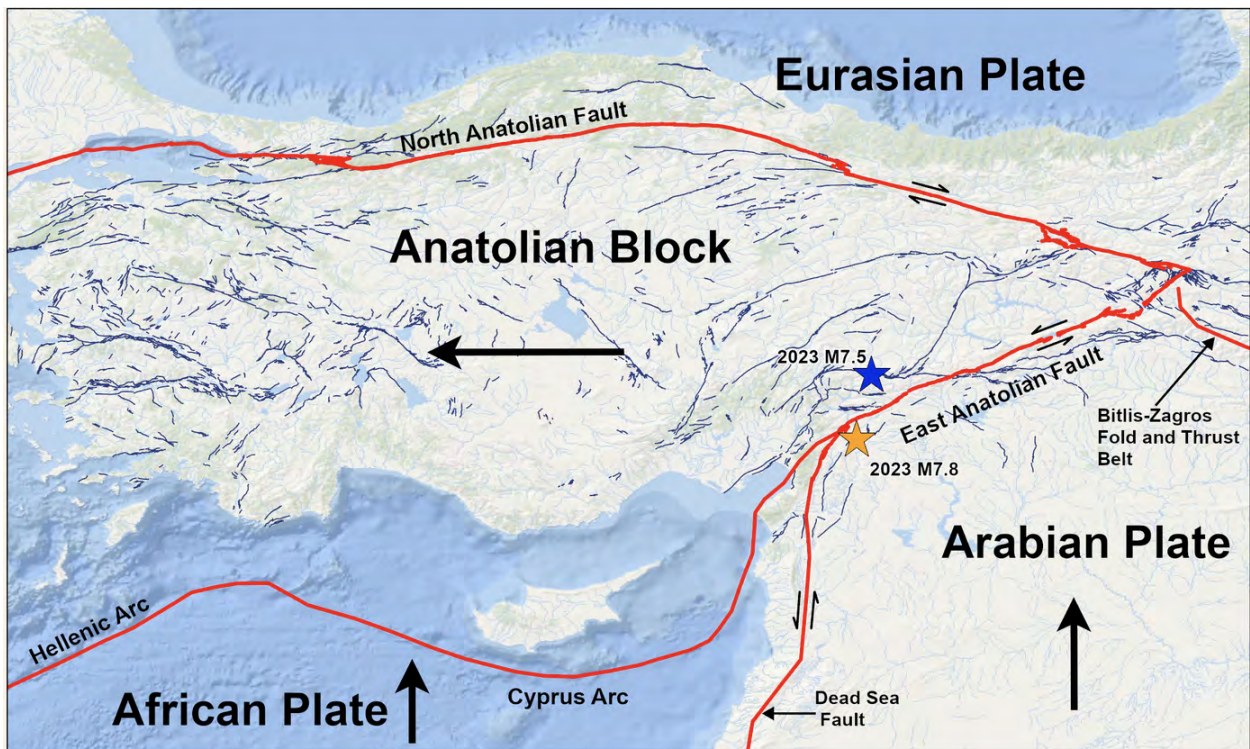
**Figure 2.2.** (USGS) Tectonic plate and fault map of the region ([link](#)). Red lines denote faults along the plate boundaries. Gray lines denote other faults.

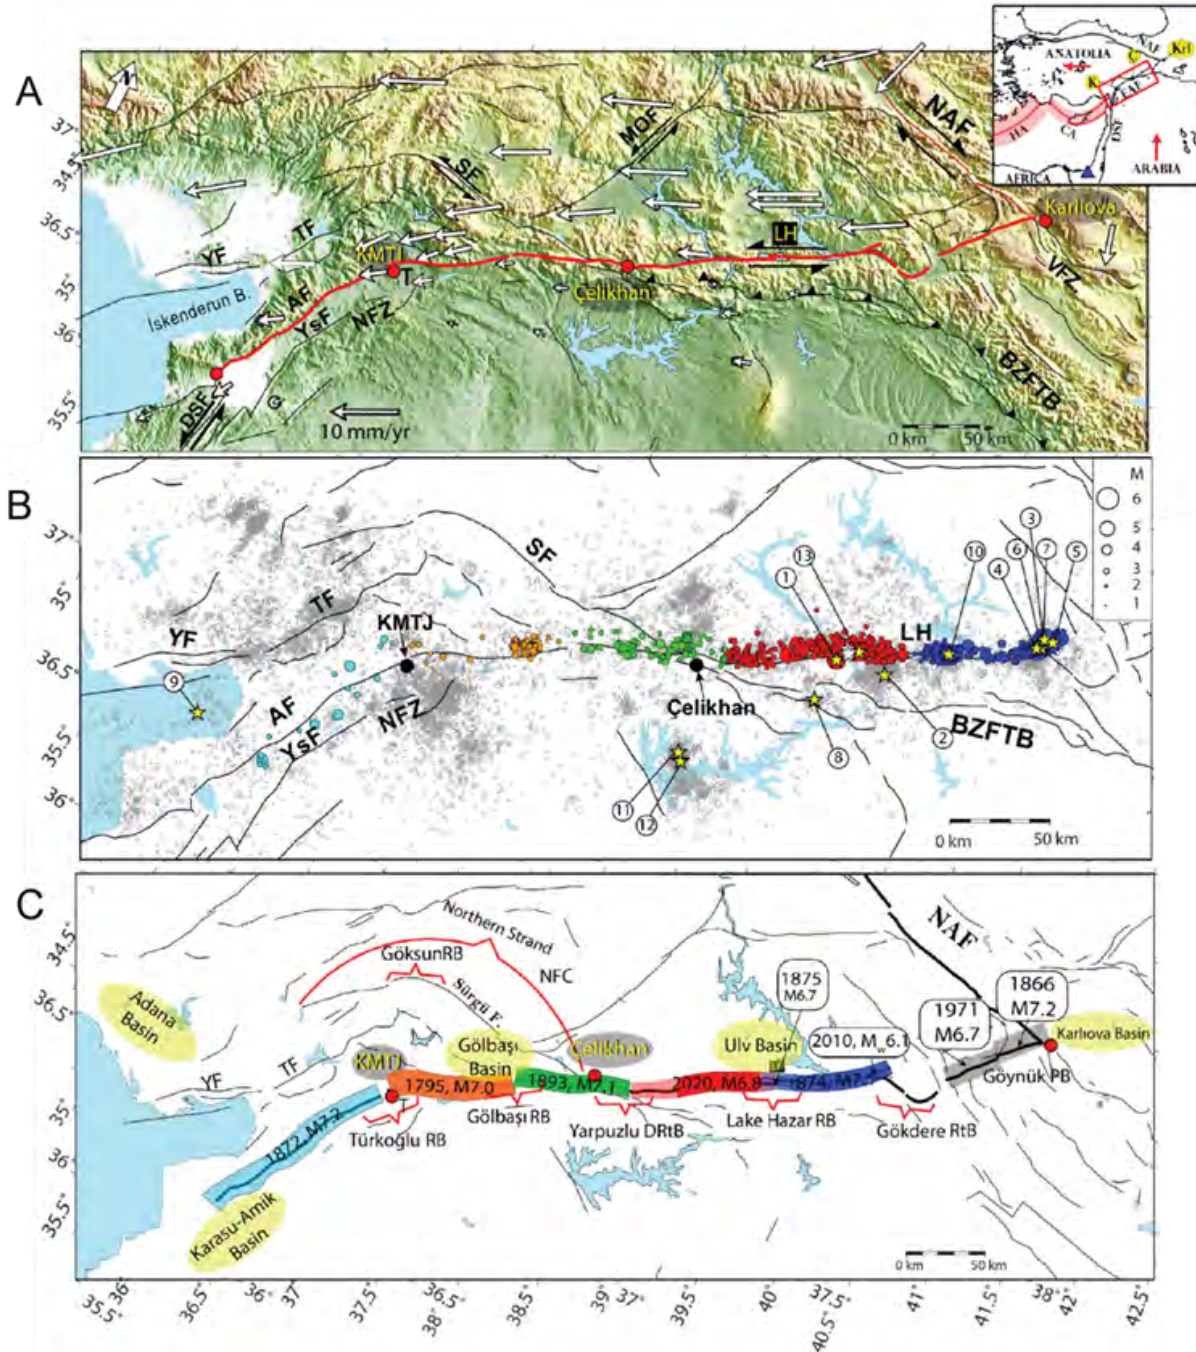
**Figure 2.3.** Maps of the East Anatolian fault from Guvercin et al. (2022) showing (A) Geodetically measured crustal velocities (white arrows) of Anatolia relative to a fixed Arabian plate, (B) seismicity from 2007-2019 colored by inferred segment, and (C) inferred extent of historical earthquakes.

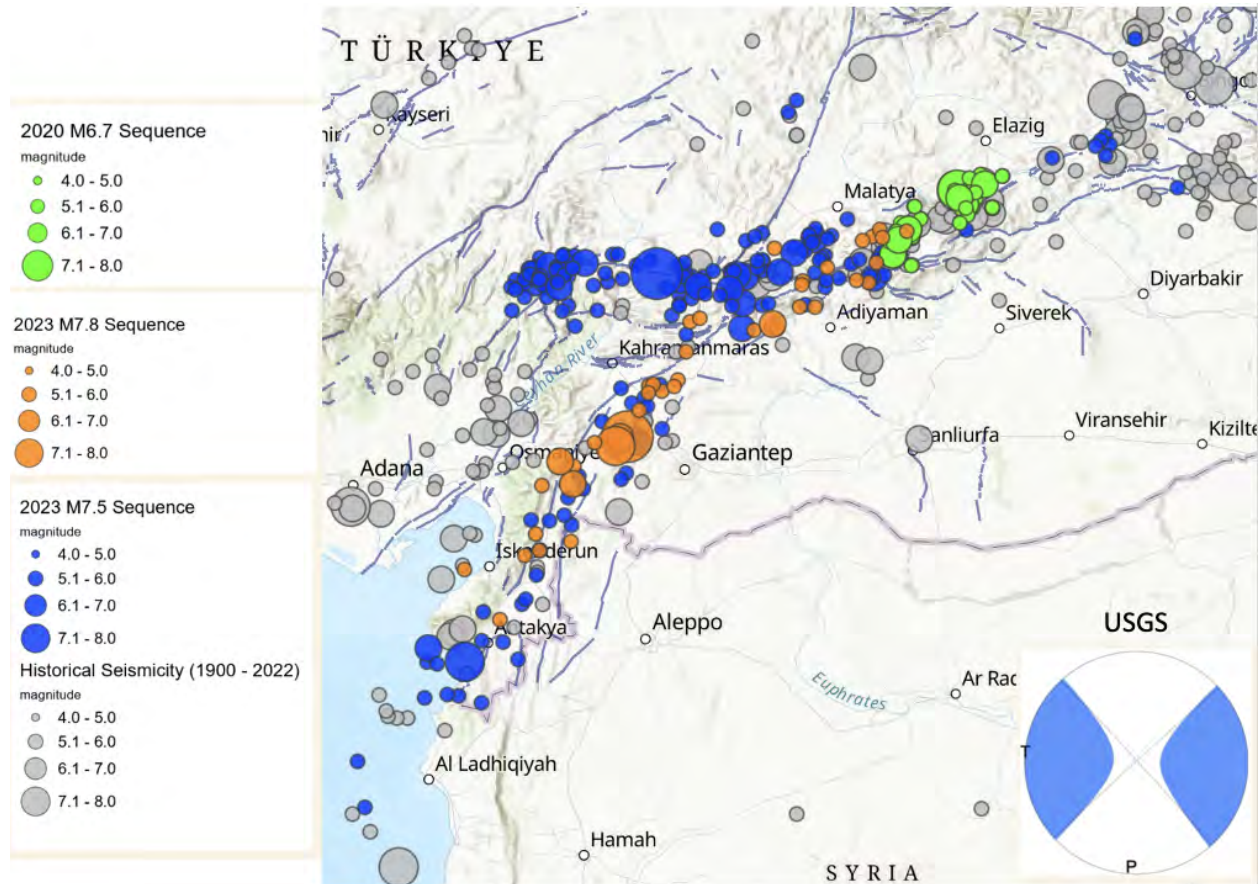
**Figure 2.4.** Locations and sizes of events in the sequence (USGS).

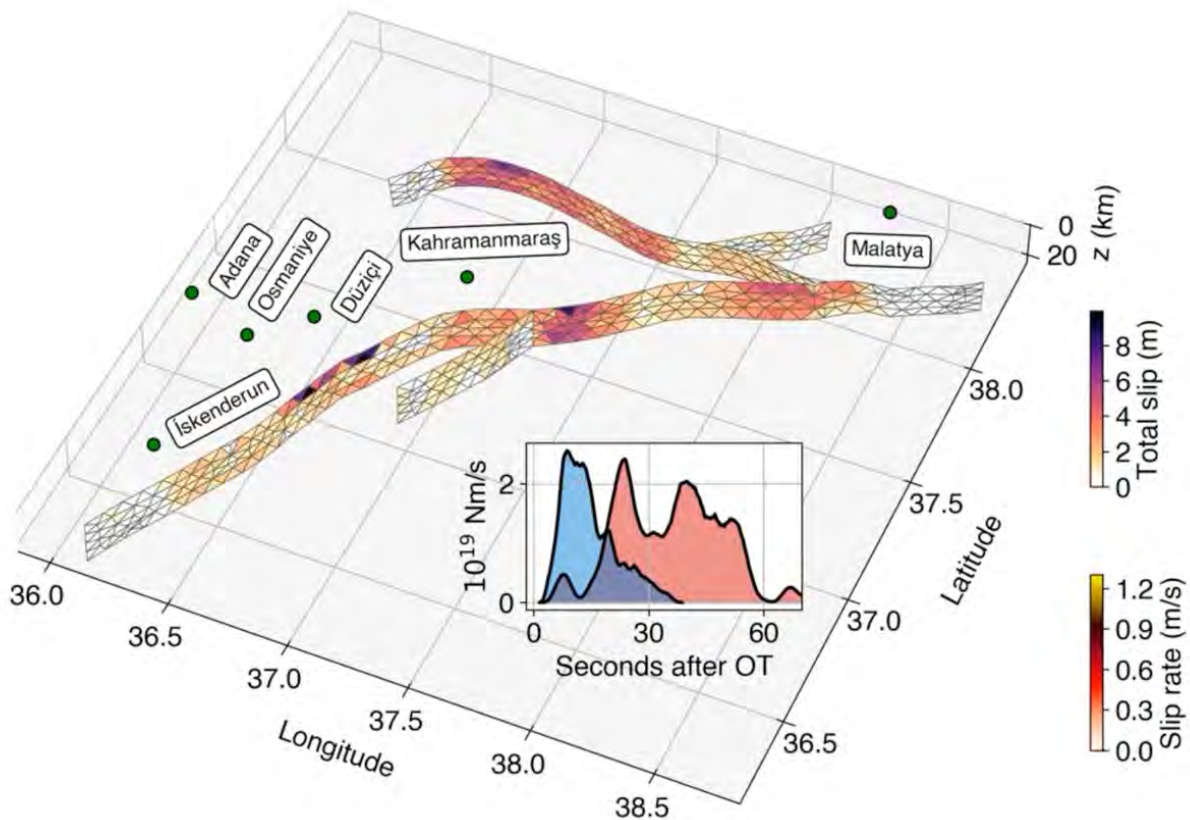
**Figure 2.5.** Preliminary finite fault model from Diego Melgar. Accessed from <https://twitter.com/i/status/1627723600282419200>

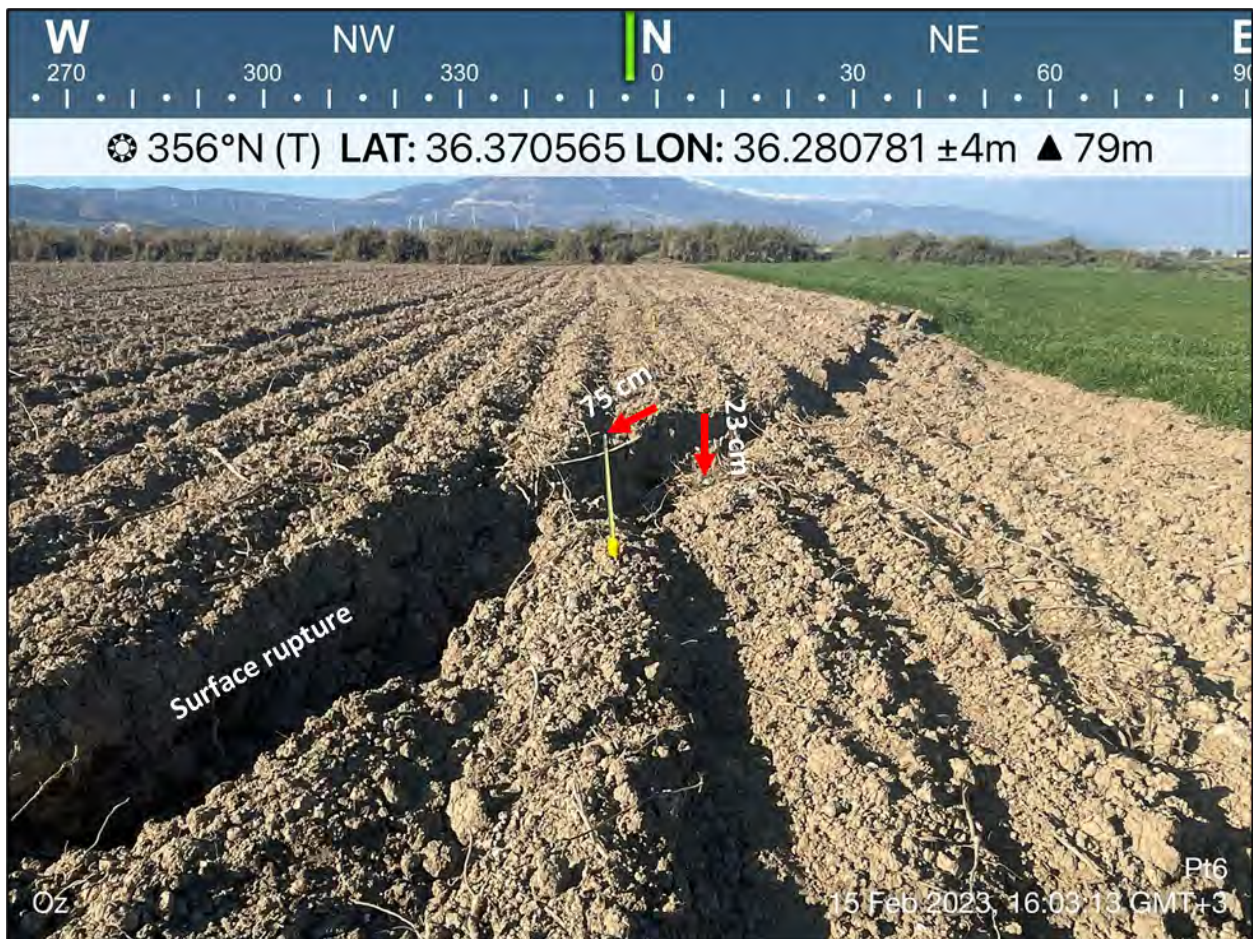
**Figure 2.6** February 6, 2023 M7.8 Kahramanmaraş earthquake surface rupture in the recently tilled field 300m north of Hatay Airport. Note the 75cm left lateral and 23cm vertical displacement at this location.

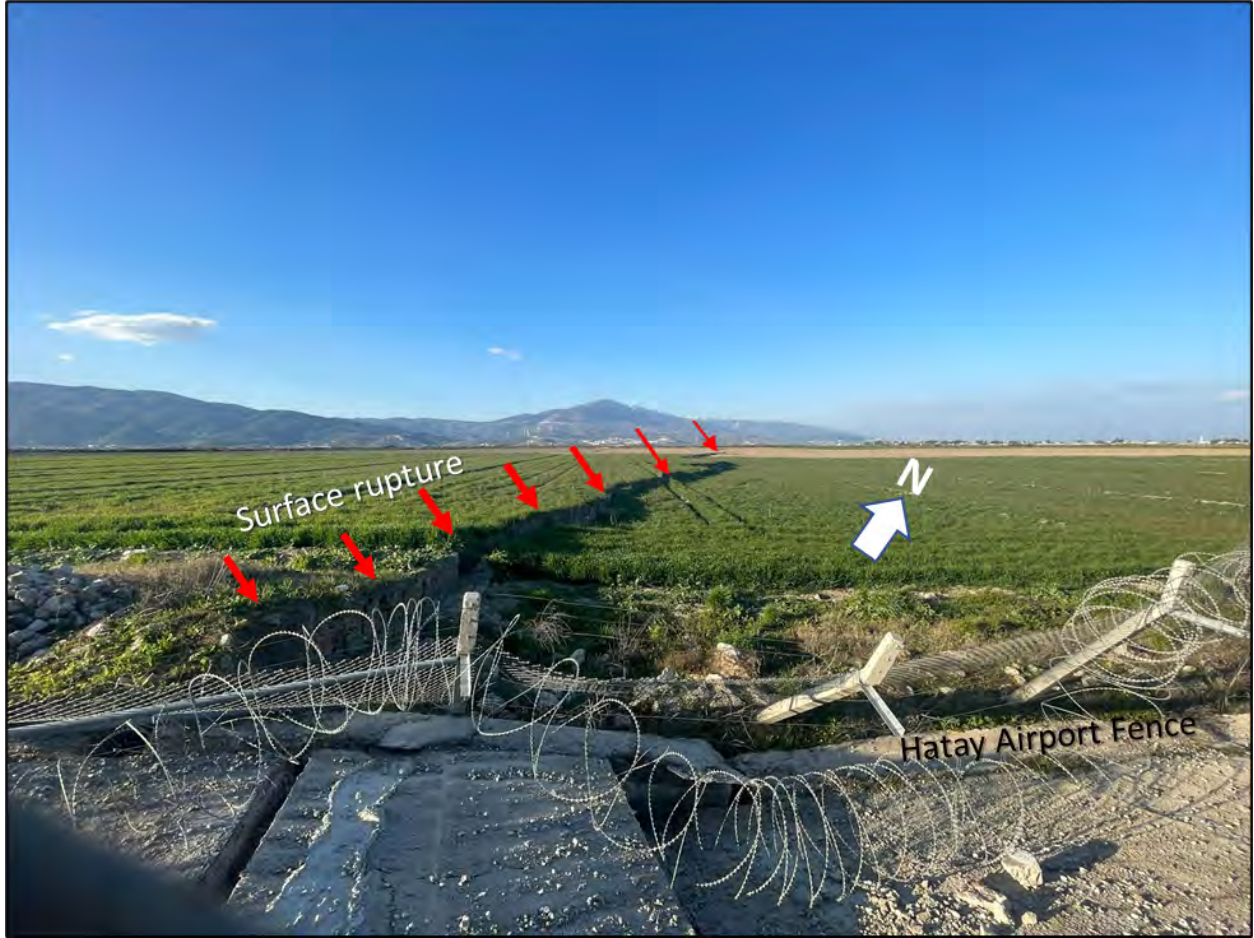
**Figure 2.7.** February 6, 2023 M7.8 Kahramanmaraş earthquake surface rupture at the Hatay Airport north fence. Note the left-stepping en-echelon left-lateral surface rupture with down-to-the-east vertical component. Lat/Long: 36.366992°N, 36.279822°E. Photo taken February 15, 2023.

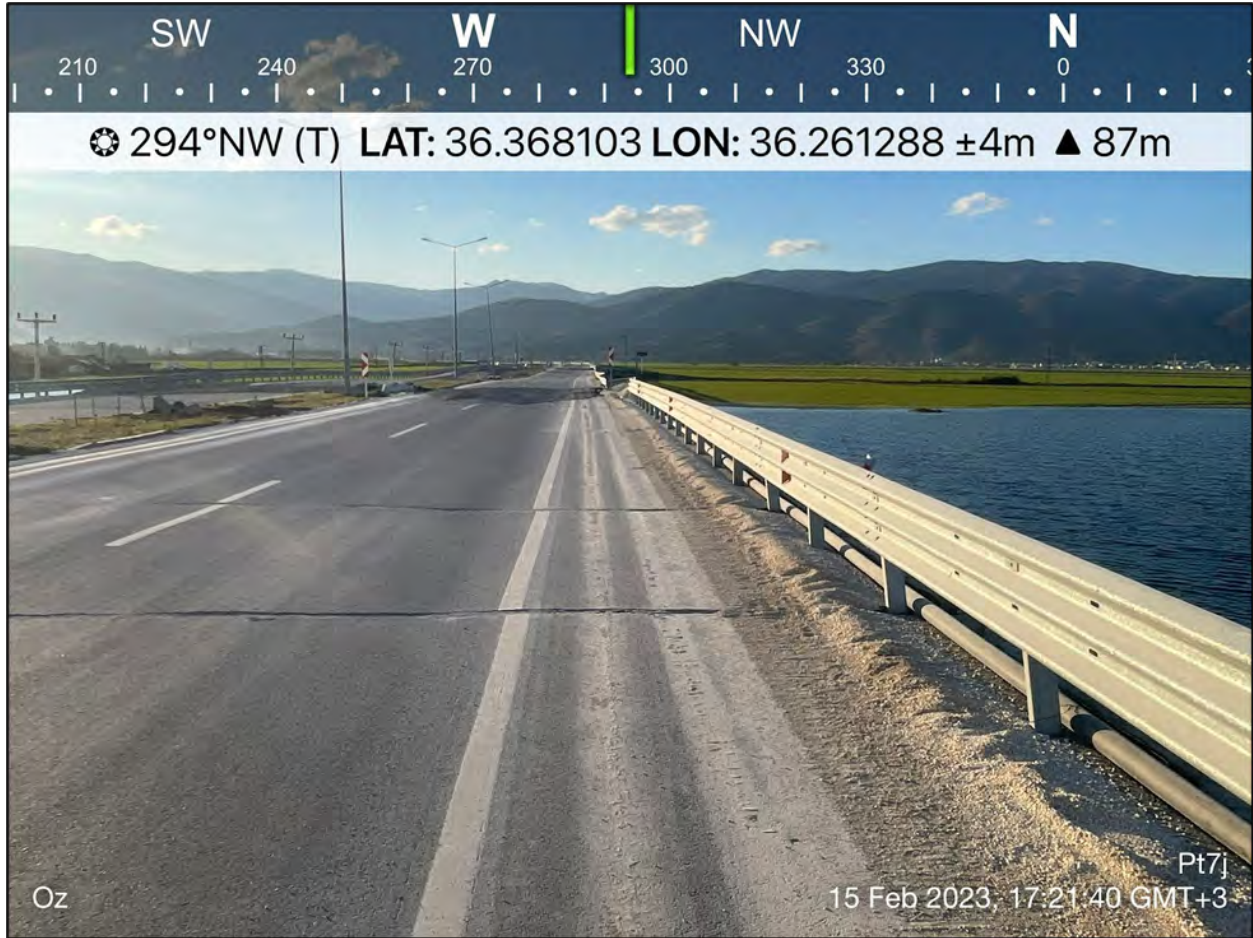
**Figure 2.8.** February 6, 2023 M7.8 Kahramanmaraş earthquake surface rupture expressed as an approximately 2.1-km-wide deformation zone with secondary fault rupture displacements on the order of centimeters and localized depression. Photo looking along the Hatay Airport access road.

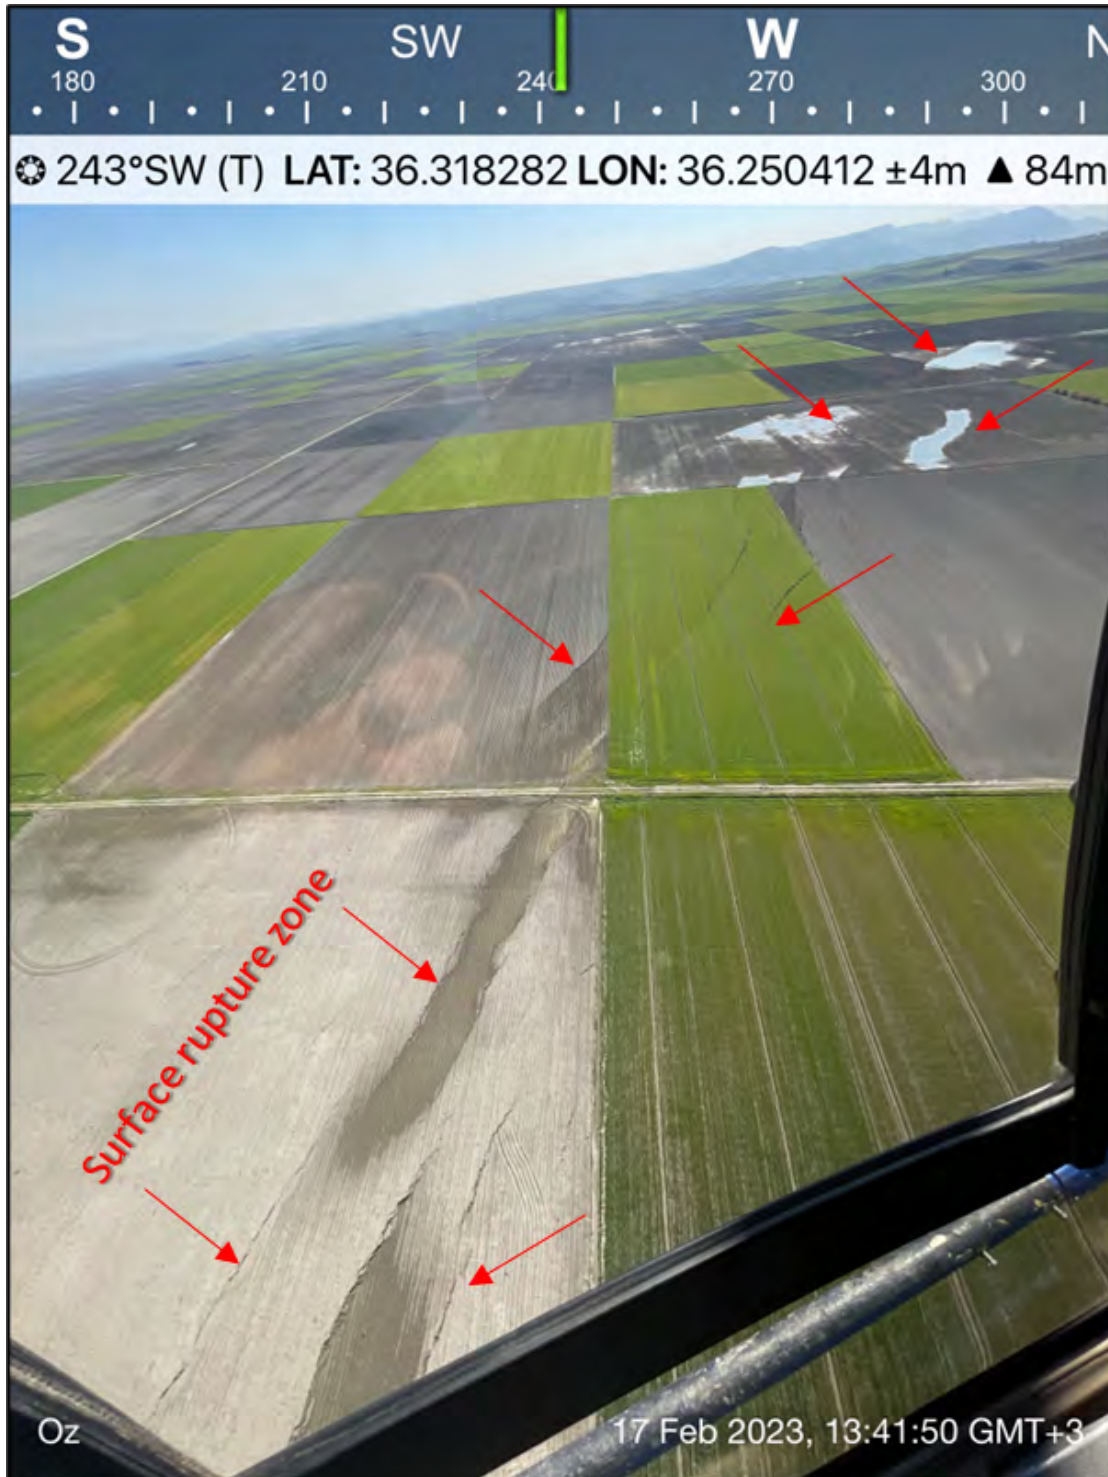
**Figure 2.9.** Aerial reconnaissance of the February 6, 2023 M7.8 Kahramanmaraş earthquake surface rupture south of the Hatay Airport.

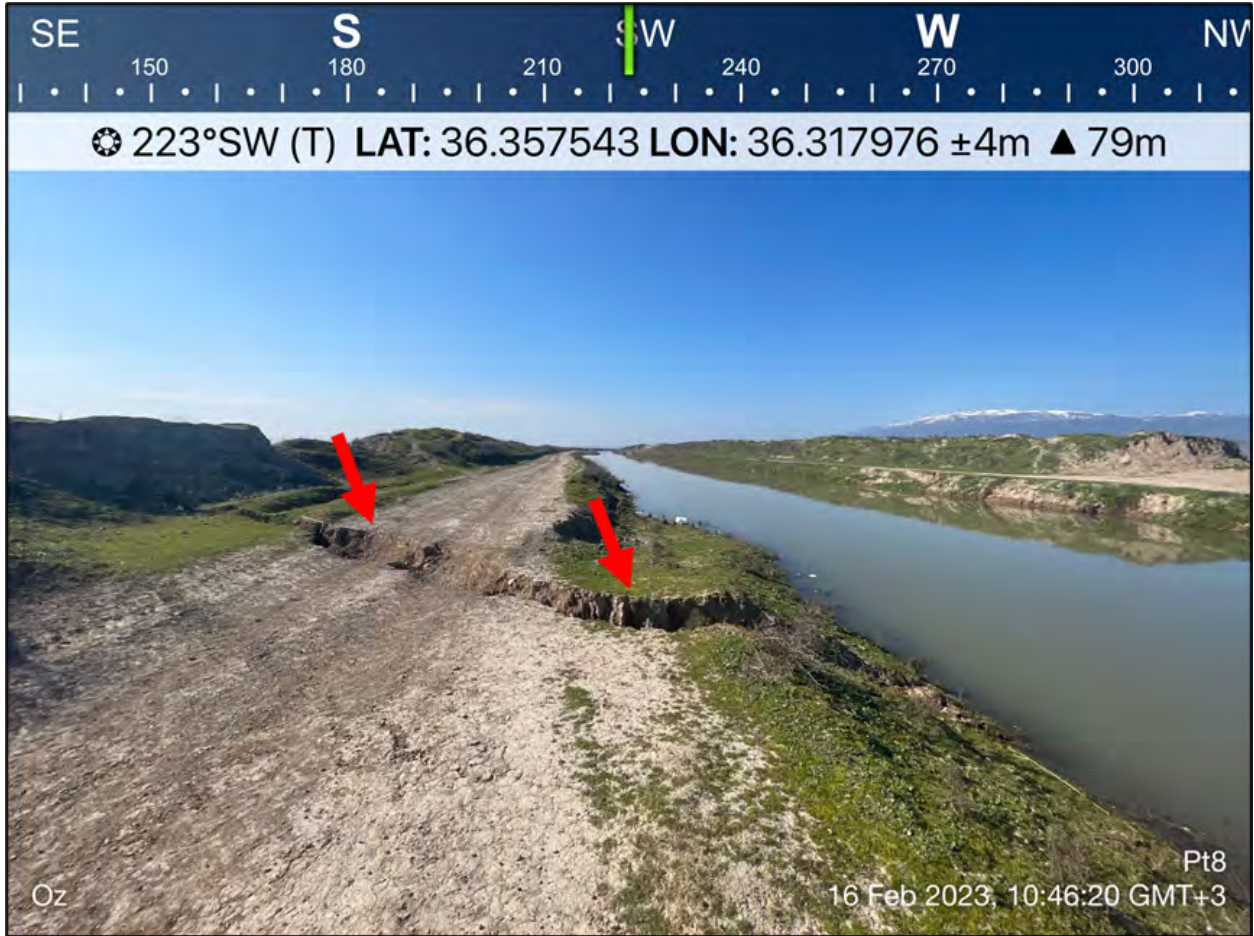
**Figure 2.10.** February 6, 2023 M7.8 Kahramanmaraş earthquake surface rupture crossing a levee south of the Hatay Airport.

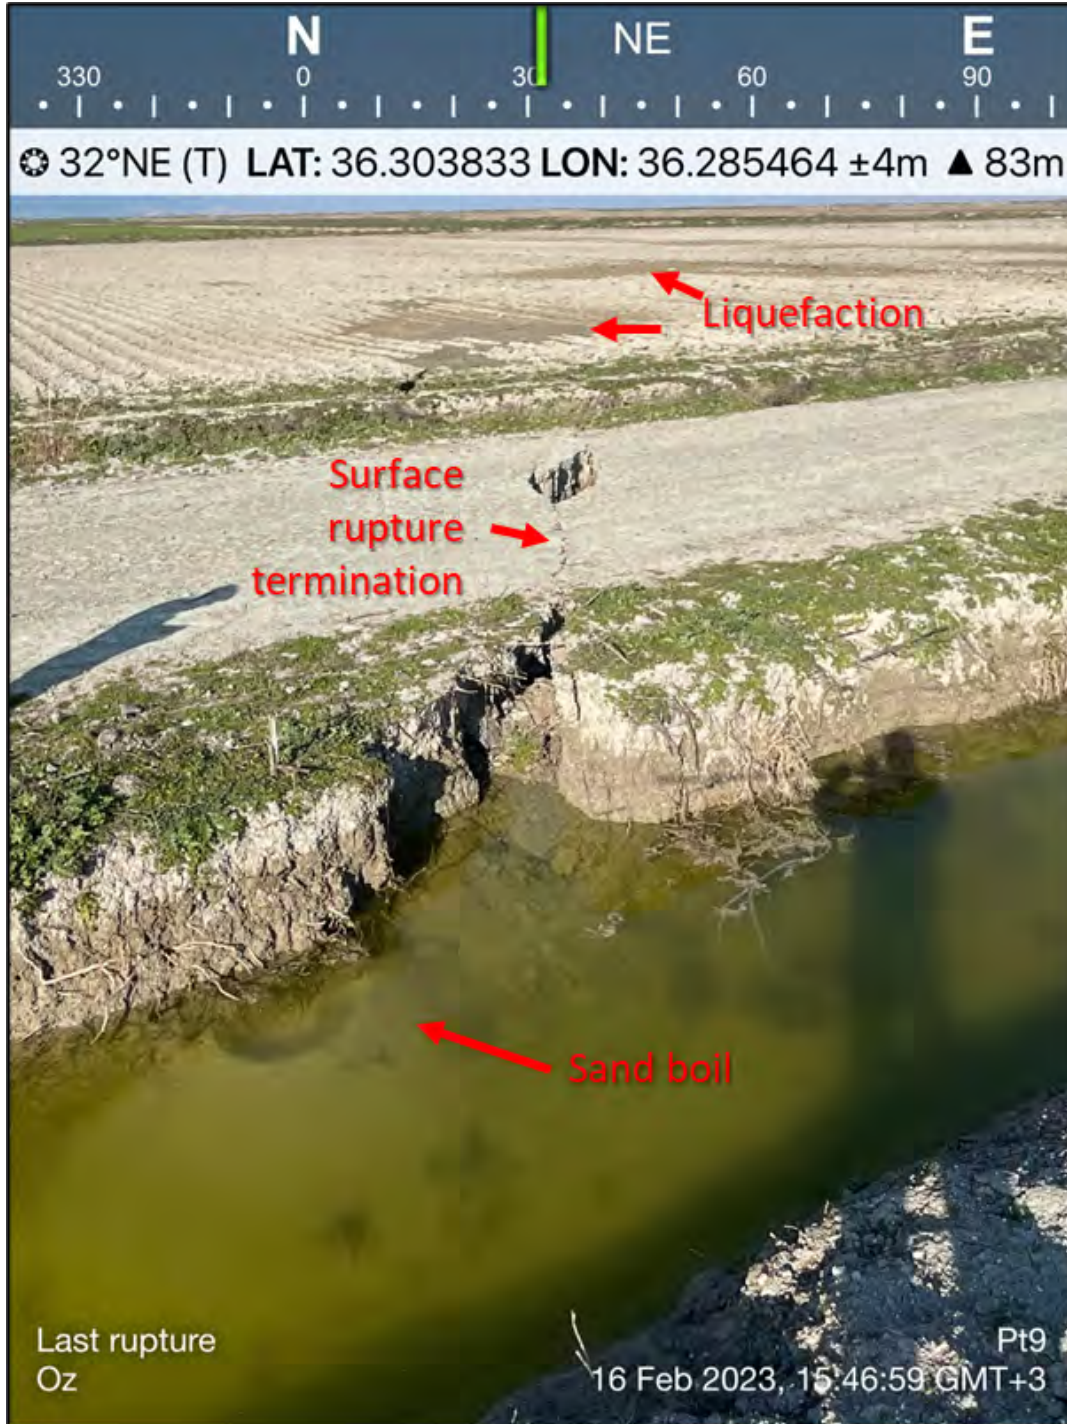
**Figure 2.11.** February 6, 2023 M7.8 Kahramanmaraş earthquake surface rupture dies out approximately 3.7km southeast of the Hatay Airport. At this location surface rupture is expressed as a crack with no discernable displacement but still displays en-echelon surface trace characteristics along with liquefaction features (sand boils).

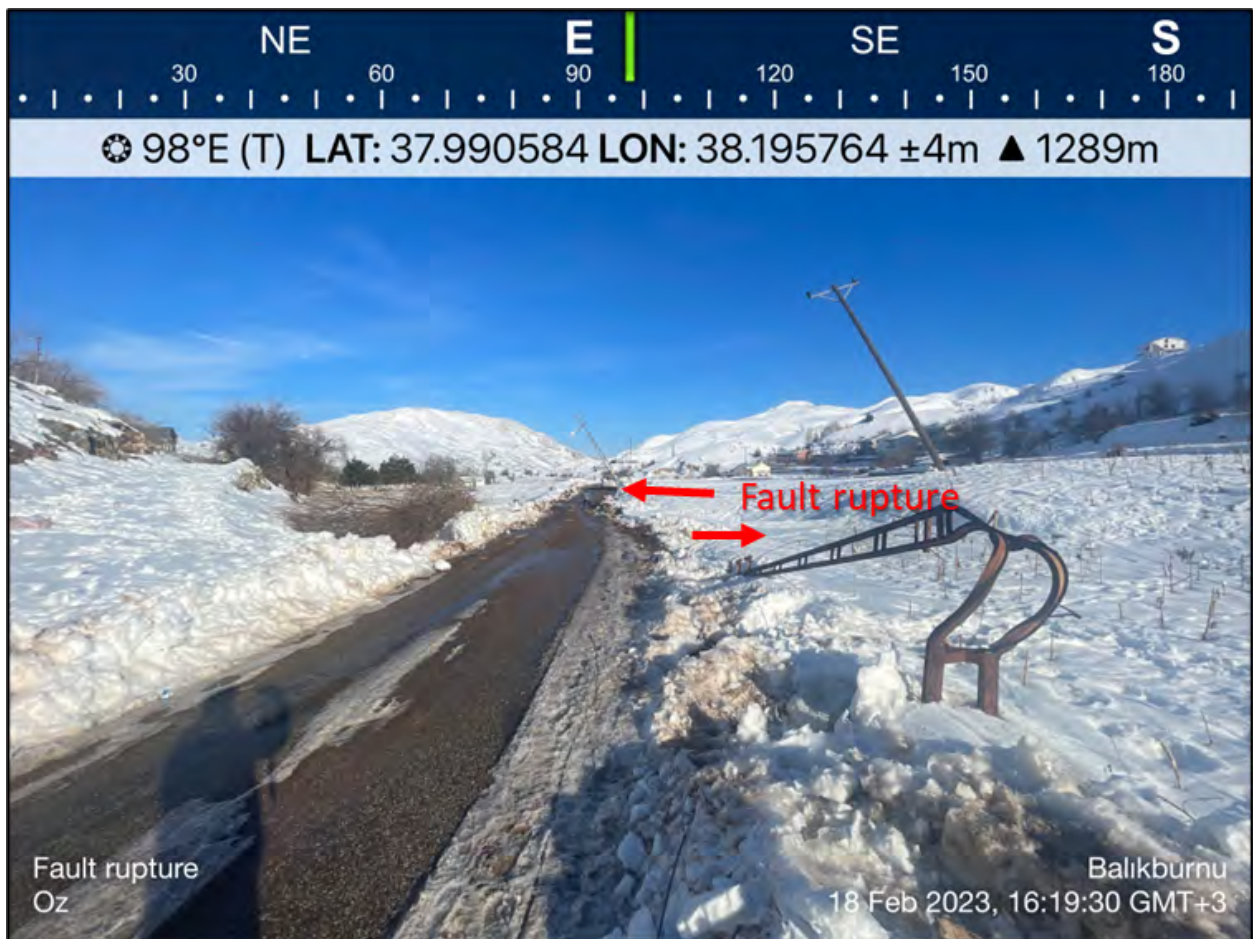
**Figure 2.12.** Left lateral offset of Çelikhan-Sürgü Road in Balıkburnu Village. Note that electric and telephone poles are bent and tilted only within the fault zone and its vicinity.

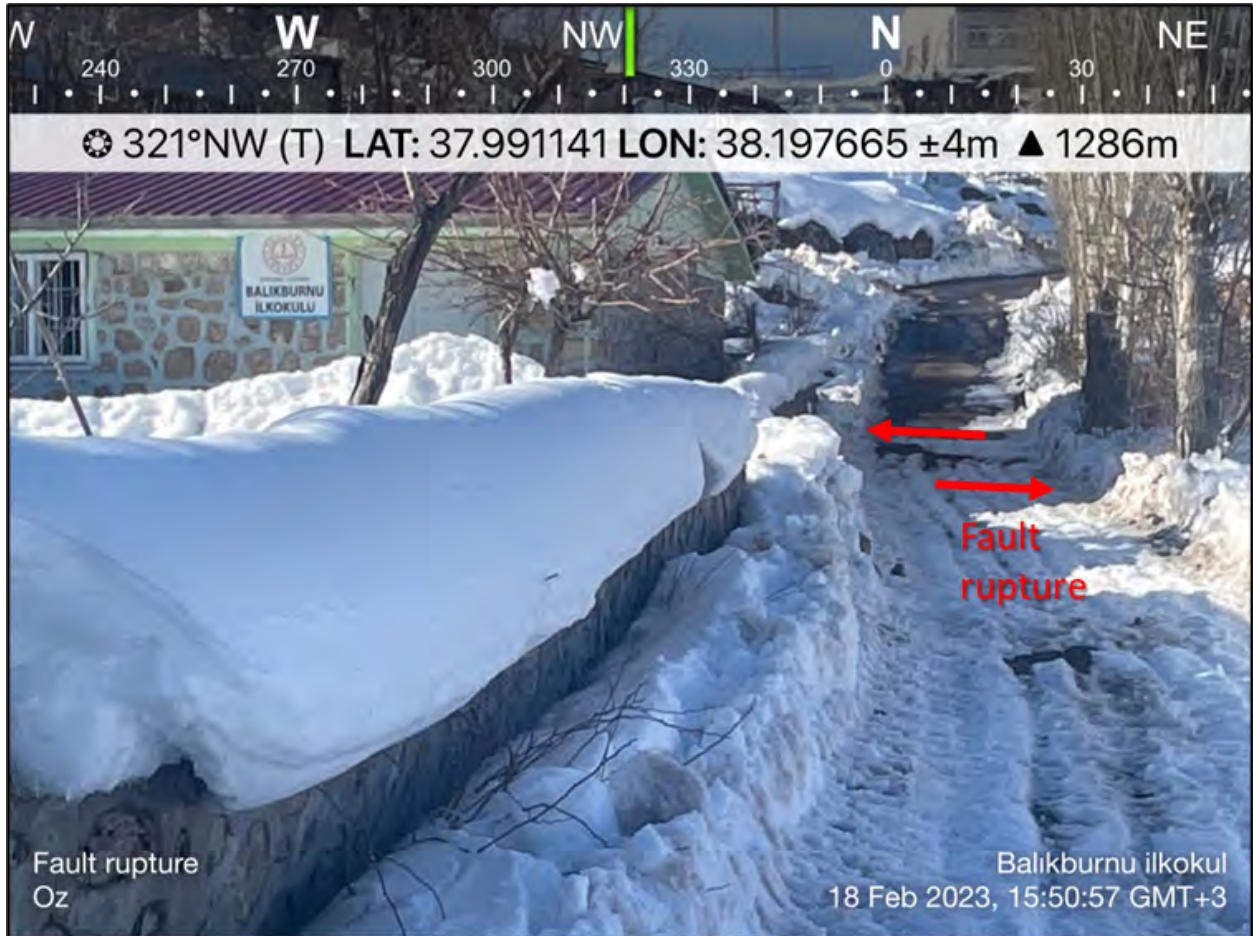
Figure 2.13. Approximately 1.4m left lateral offset stone wall of Balıkburnu Village Elementary School.

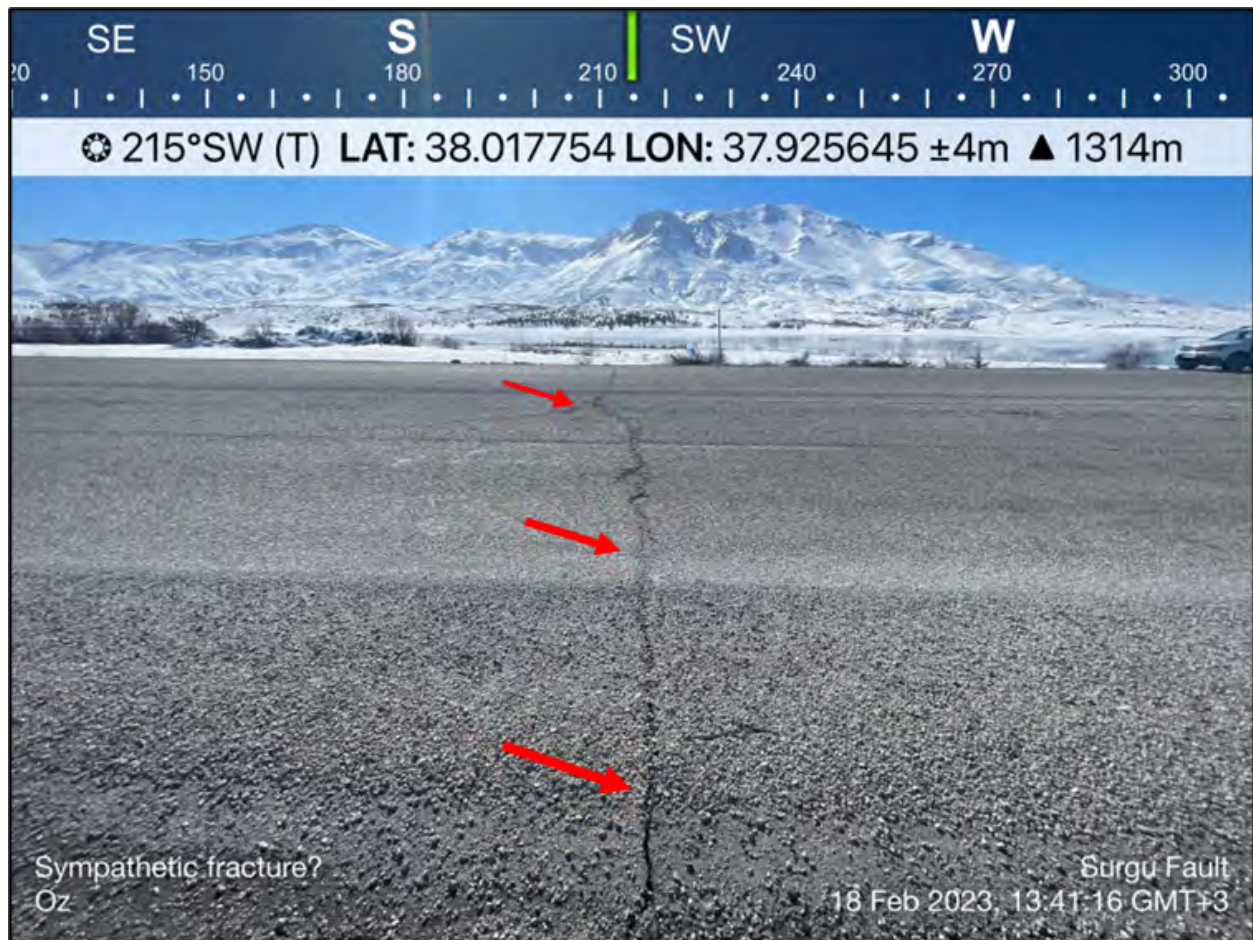
**Figure 2.14.** A sympathetic fracture on the road pavement was observed at the mapped surface trace location of the Sürgü fault; however, no displacement or continuation of the fracture exists.

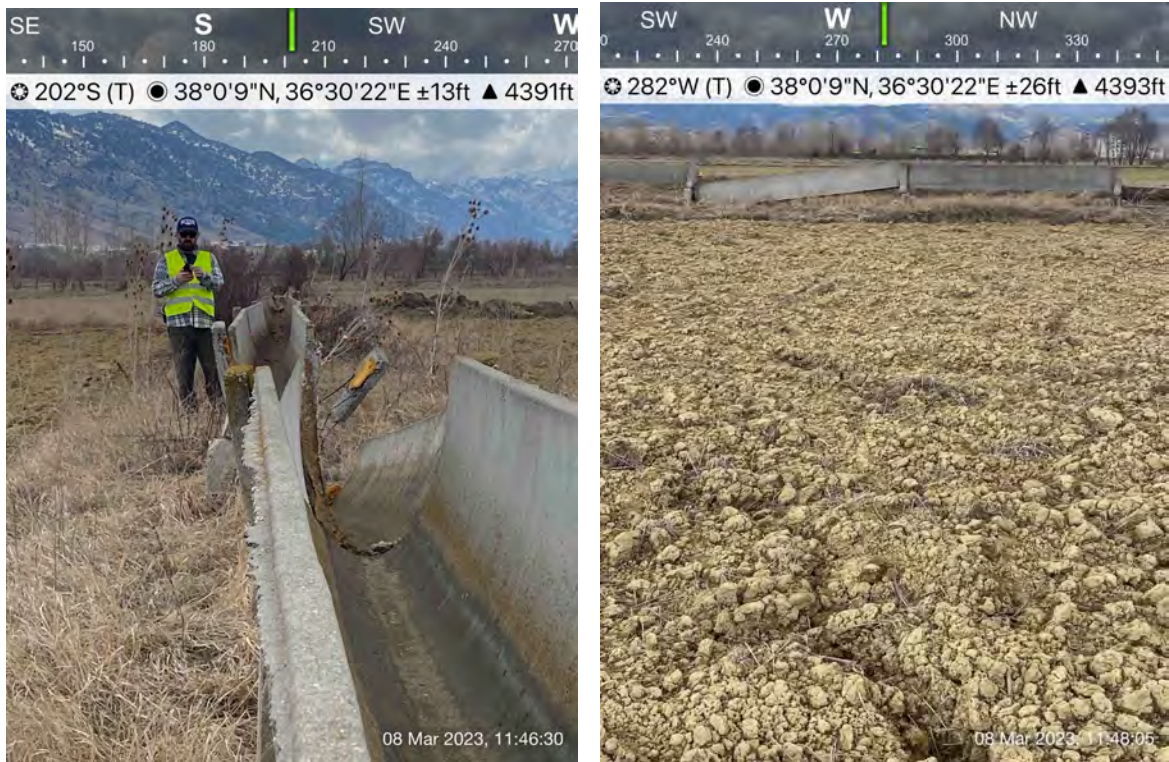
**Figure 2.15. (LEFT)** The westernmost point of the M7.7 Sürgü-Çardak earthquake south of the town of Goksun. The fault left-laterally offset an above ground aqueduct 15 cm near its termination. **Figure 2.16. (RIGHT)** Right stepping en-escalon fault shears appeared to “horsetail” at its westernmost extent.

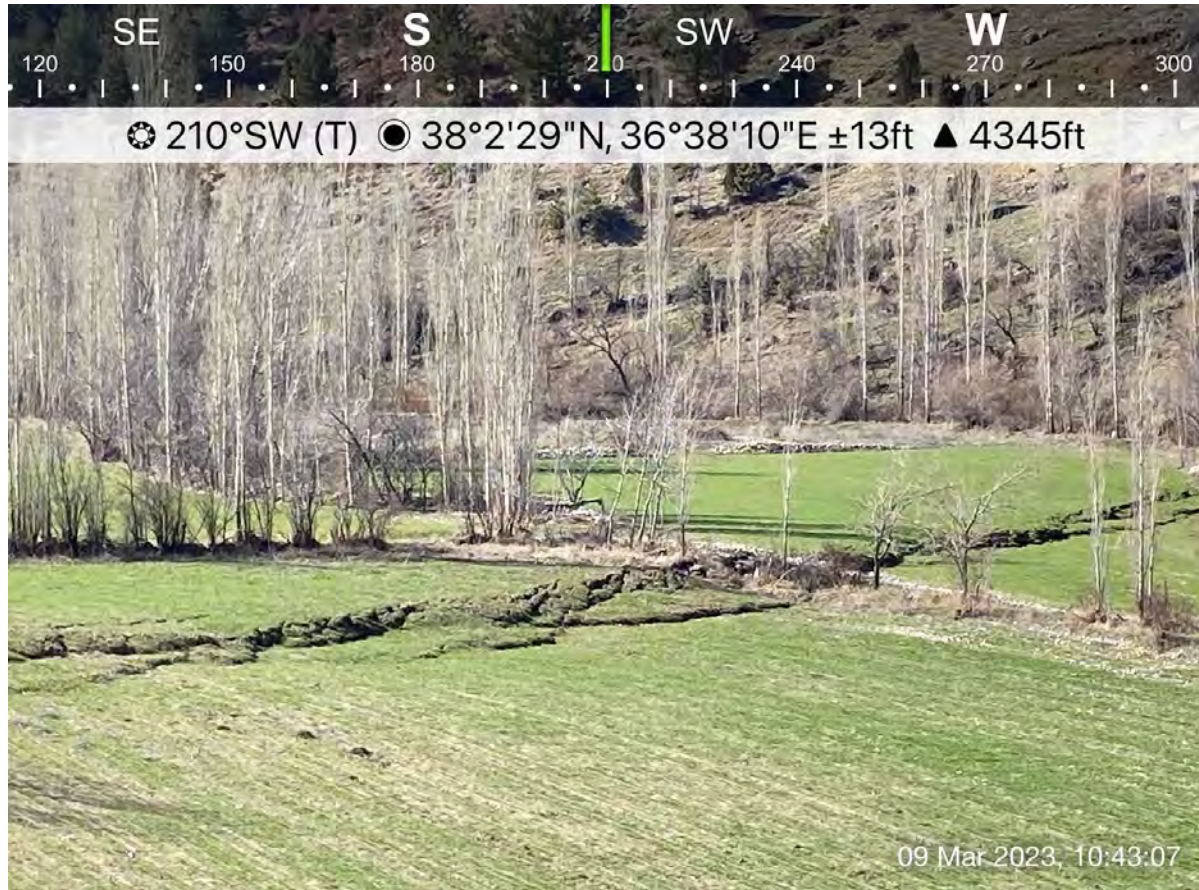
**Figure 2.18.** The Sürgü-Çardak fault displacement quickly increases to over 3 and 4 m within 13 km of the western termination.
