MAY 6, 2023

# FEBRUARY 6, 2023 TÜRKIYE EARTHQUAKES: REPORT ON GEOSCIENCE AND ENGINEERING IMPACTS

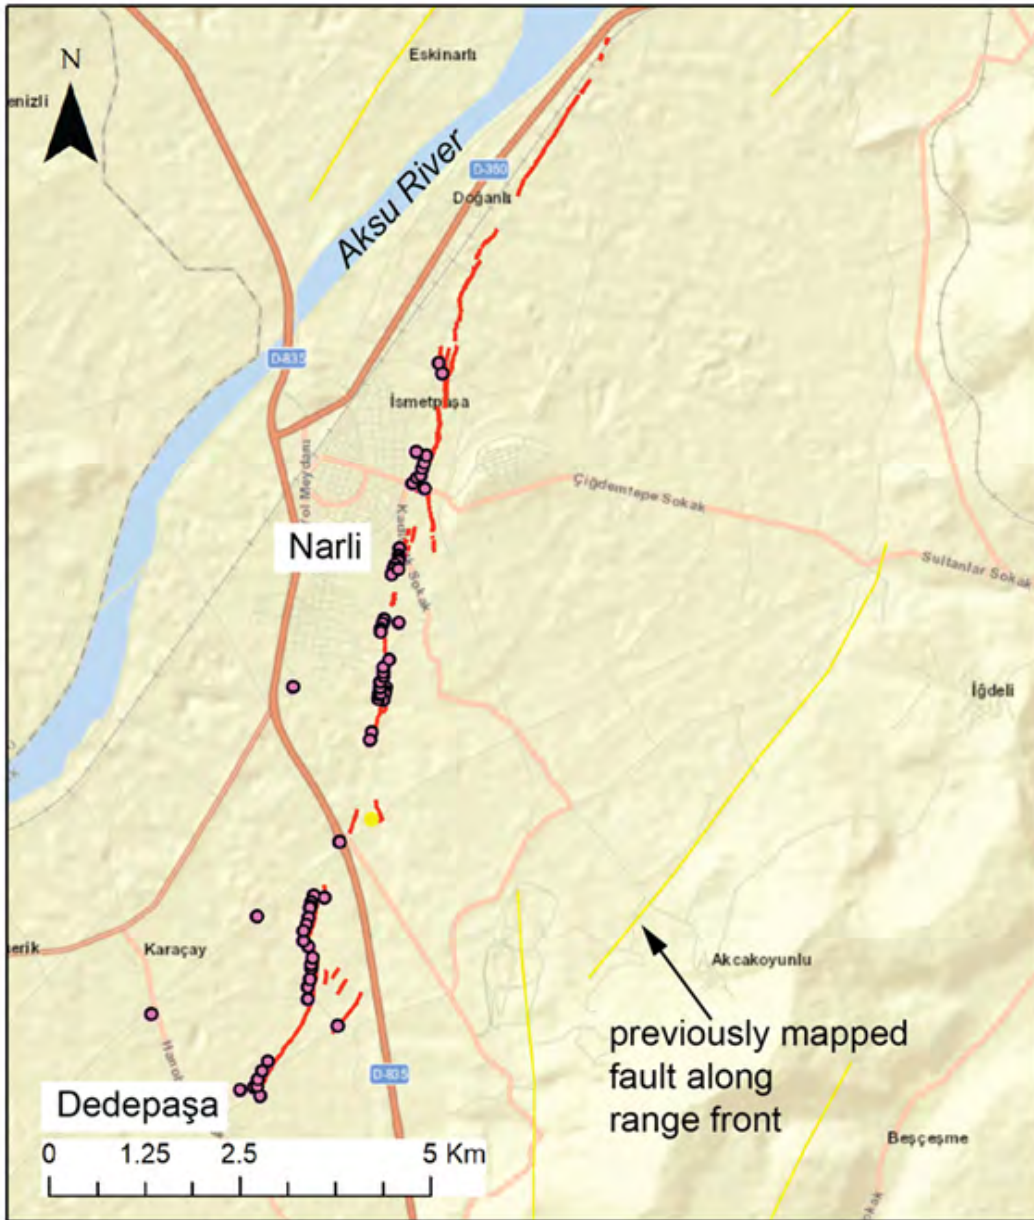
**Figure 2.19.** Map of geological observation points along the Narlı fault in the vicinity of Narlı. Red lines are rupture traces interpreted from post-event imagery (Reitman et al., 2023). Yellow lines are previously mapped faults from the Active Fault Map of Turkey (Emre et al., 2013).

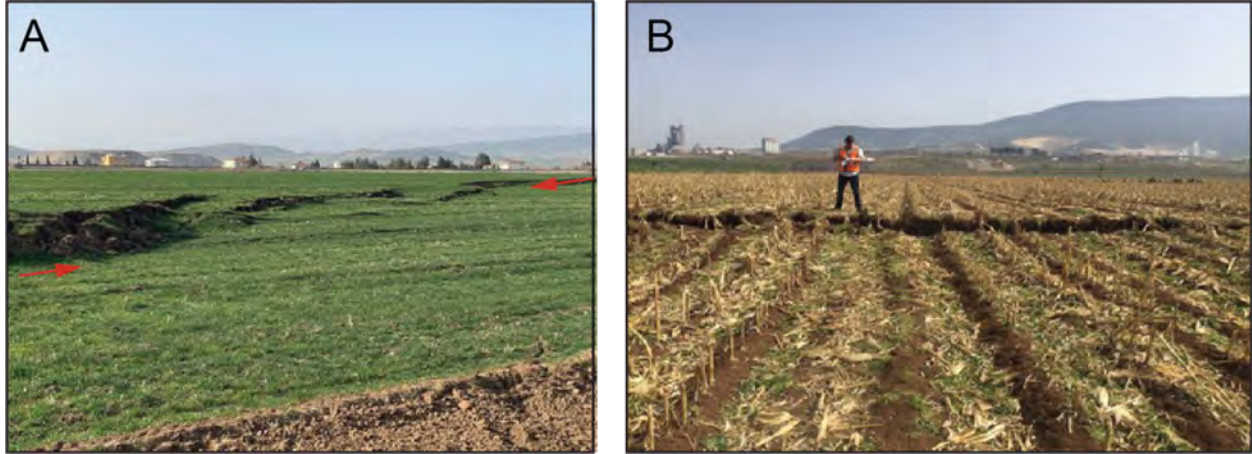
**Figure 2.20.** (A) Right-stepping en echelon rupture, typical geomorphic expression of the rupture across the Narlı plain. Lat/Long: 37.4025°N, 37.152778°E. Photo date: March 1, 2023. (B) Typical offset furrows in onion fields. Lat/Long: 37.343611°N, 37.136944°N. Photo date: February 28, 2023.

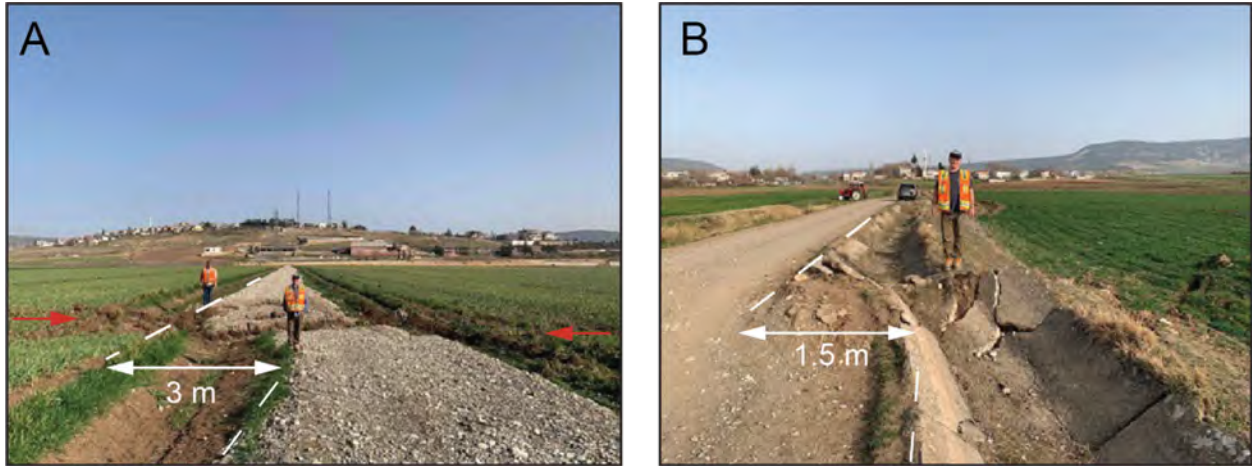
**Figure 2.21.** (A) Left-laterally offset farm road, 3 m lateral and 80 cm vertical. Lat/Long: 37.393917°N, 37.151171°E. Photo date: March 1, 2023. (B) Left-laterally offset road and drainage ditch, 1.5 m. Lat/Long: 37.378527°N, 37.146124°E. Photo date February 28, 2023.

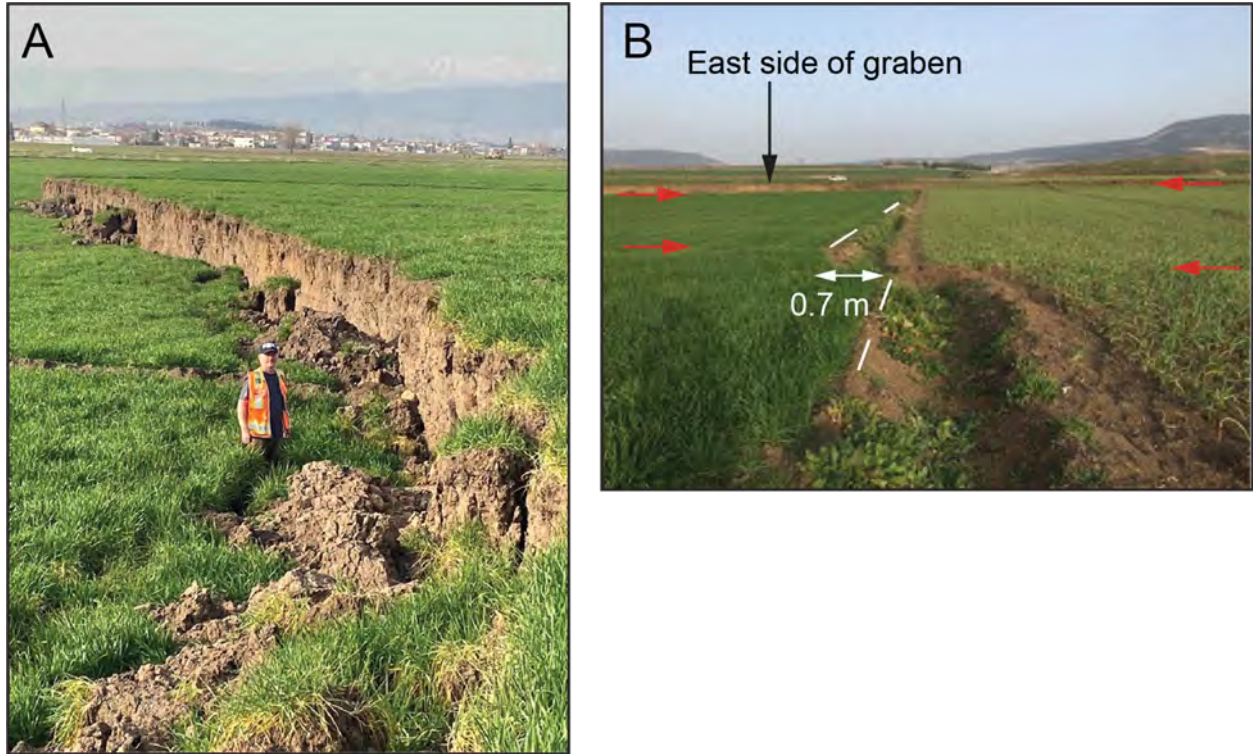
**Figure 2.22.** (A) Vertical Scarp (1.6 m) along the east side of a large graben. Left-lateral offsets of farm ditches perpendicular to the scarp are ~2 m. Fissures adjacent to scarp about 0.5 m deep. Lat/Long: 37.371944°N, 37.146389°E. (B) View to the east across graben showing 0.7 m left-lateral offset across the western bounding fault of the graben. Vertical scarp along east side of graben in (A) in the background. Lat/Long: 37.371944°N, 37.145556°E. Photographs taken February 28, 2023.

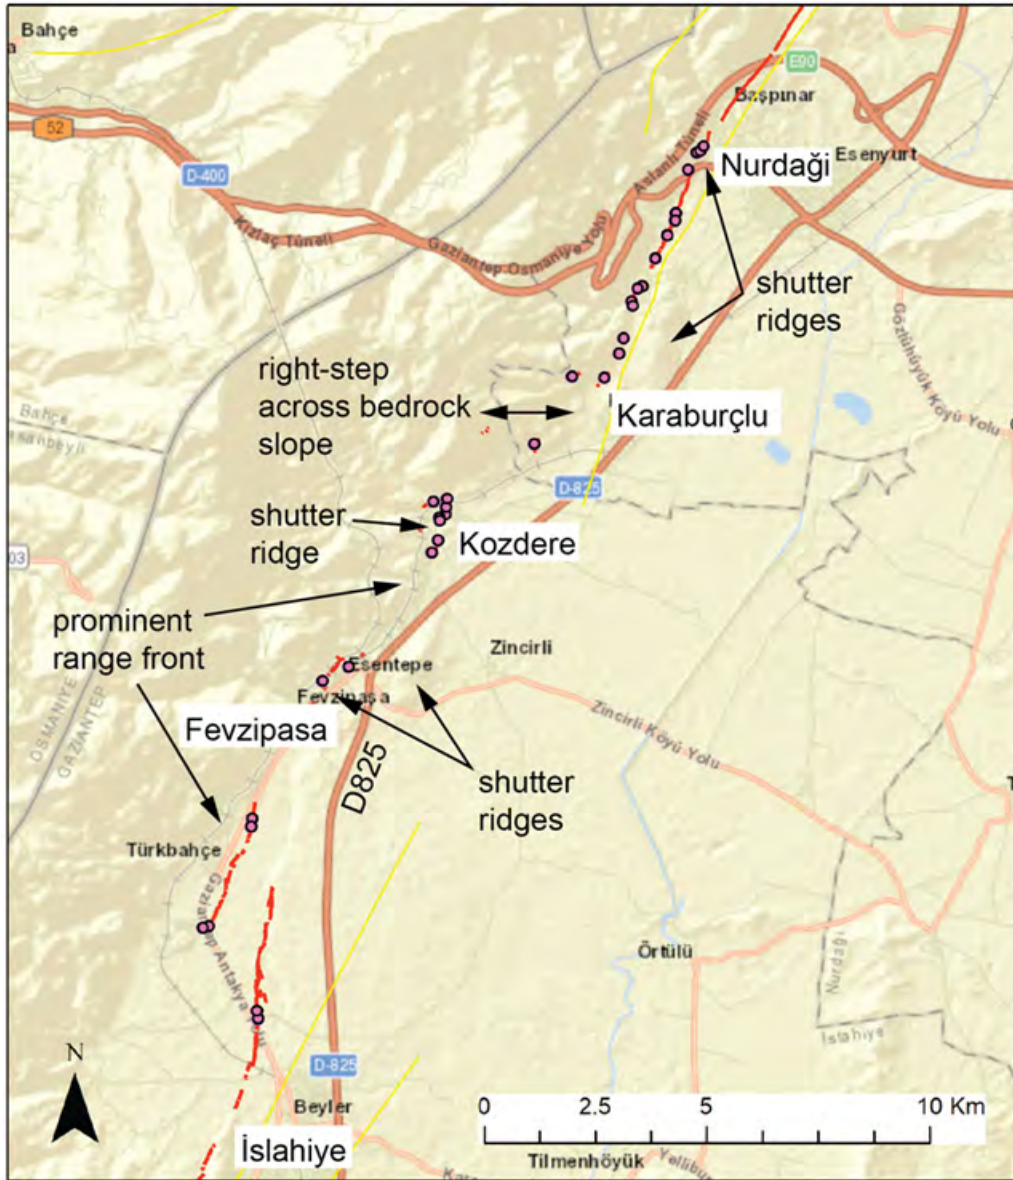
**Figure 2.23.** Map of geological observation points along the East Anatolian fault between the cities of İslahiye and Nurdağı. Red lines are rupture traces interpreted from post-event imagery (Reitman et al., 2023). Yellow lines are previously mapped faults from the Active Fault Map of Türkiye (Emre et al., 2013).

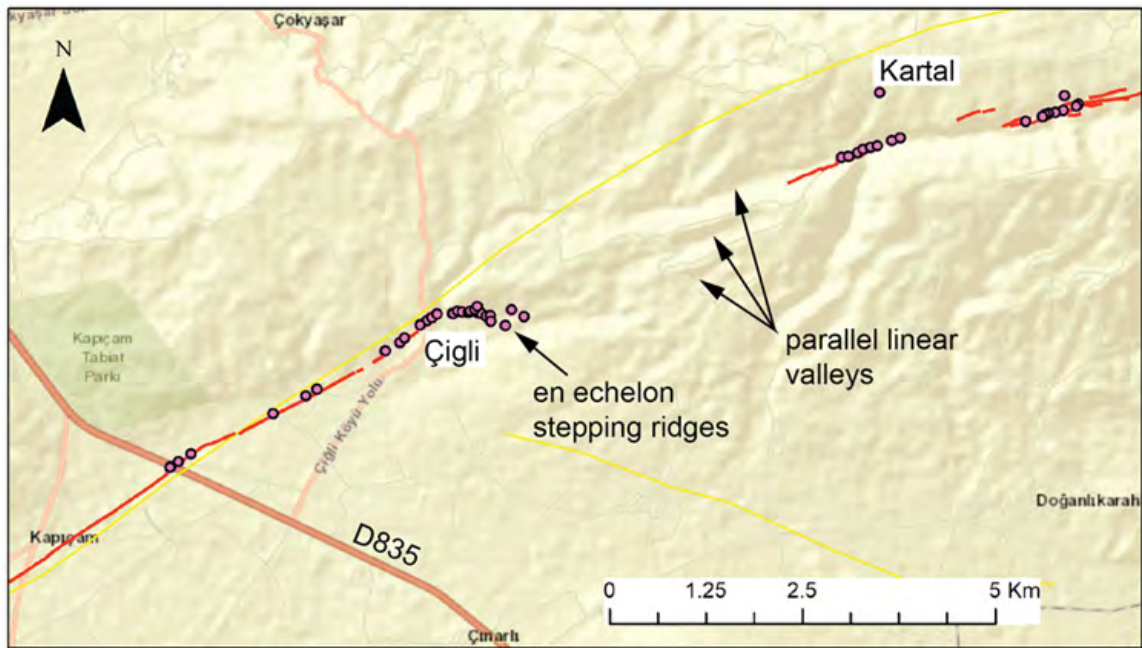
**Figure 2.24.** Map of geological observation points along the East Anatolian fault near the villages of Çiğli and Kartal. Red lines are rupture traces interpreted from post-event imagery (Reitman et al., 2023). Yellow lines are previously mapped faults from the Active Fault Map of Türkiye (Emre et al., 2013).

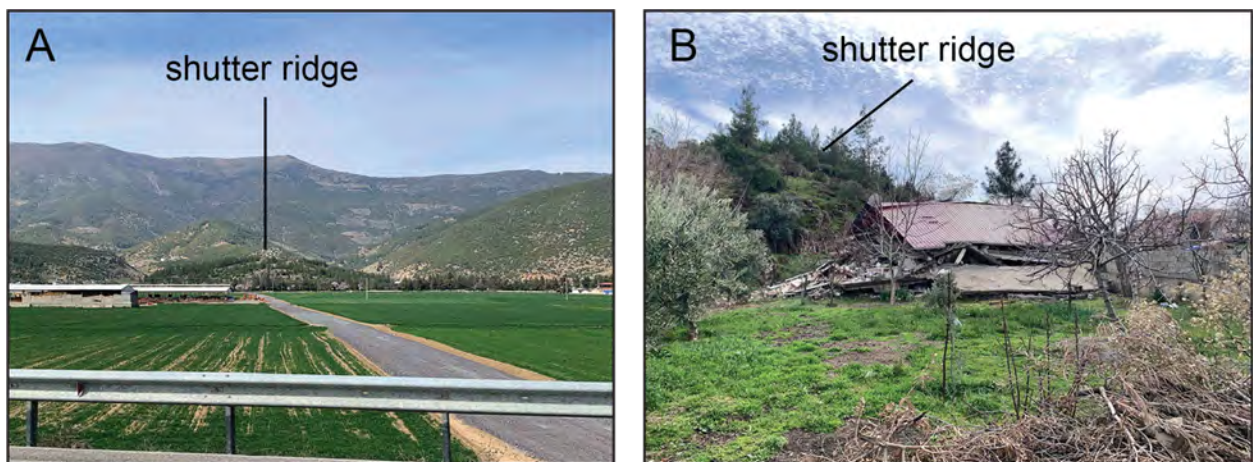
**Figure 2.25.** Classic rangefront morphology including shutter ridges and faceted spurs in the village of Kozdere. Rupture extends along the rangefront on the right and behind the shutter ridge in the center of the photograph. Lat/Long: 37.120278°N, 36.676111°E. (B) Collapsed house on the south side of the shutter ridge in (A). Lat/Long: 37.127222°N, 36.666667°E. Photographs taken March 5, 2023.

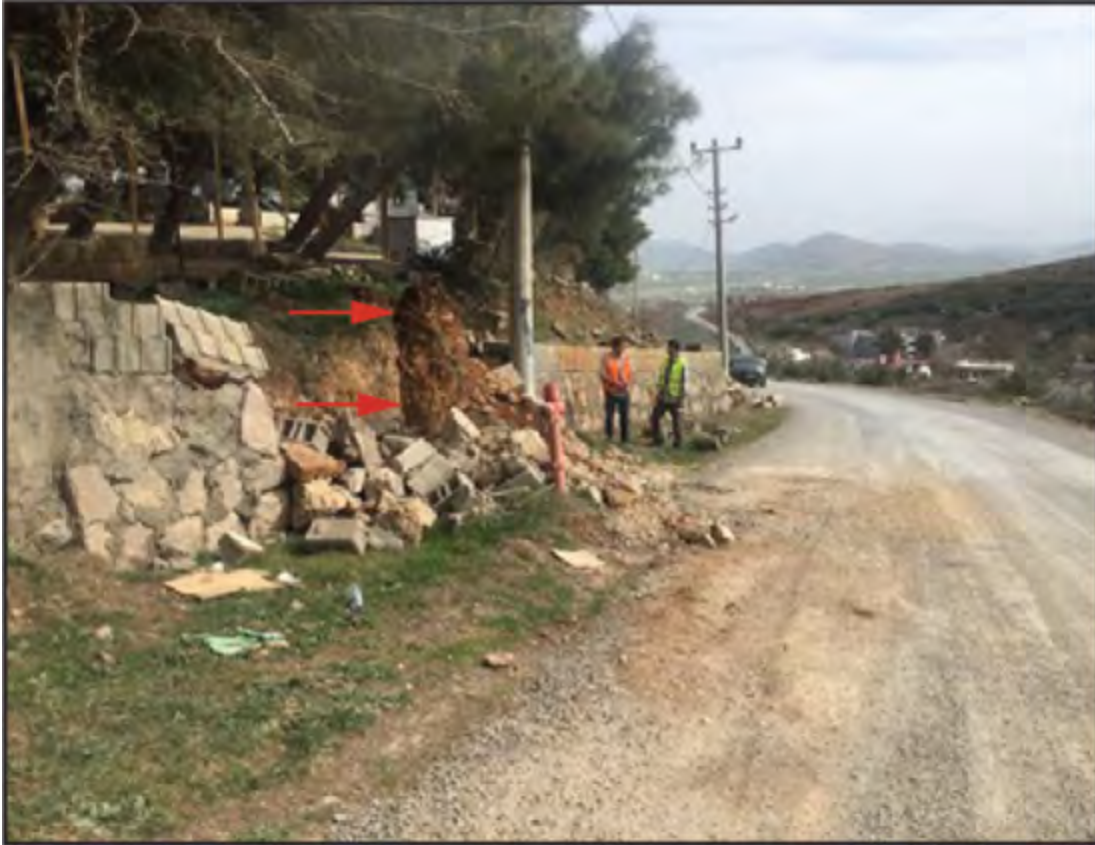
**Figure 2.26.** Distributed rupture along bedrock hillside south of Gökçedere. Lat/Long: 37.164314°N, 36.706504°E. Photograph date March 5, 2023.

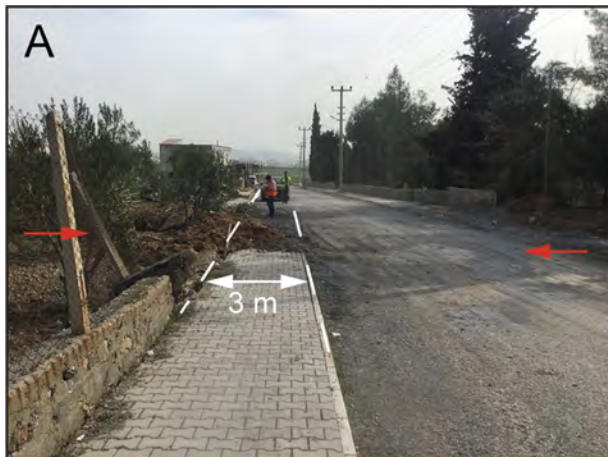
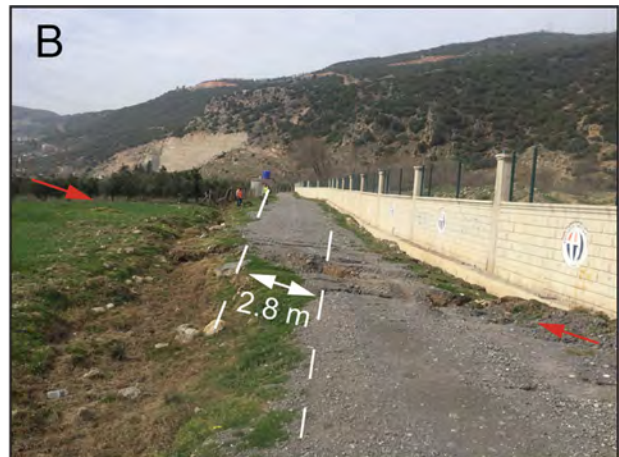
**Figure 2.27.** Photographs of offsets west of Nurdağı. (A) 3 m displacement of road and sidewalk. Lat/Log: 37.176332°N, 36.714138°E. (B) 2.8 m displacement of gravel road. Lat/Long: 37.172828°N, 36.712396°E.

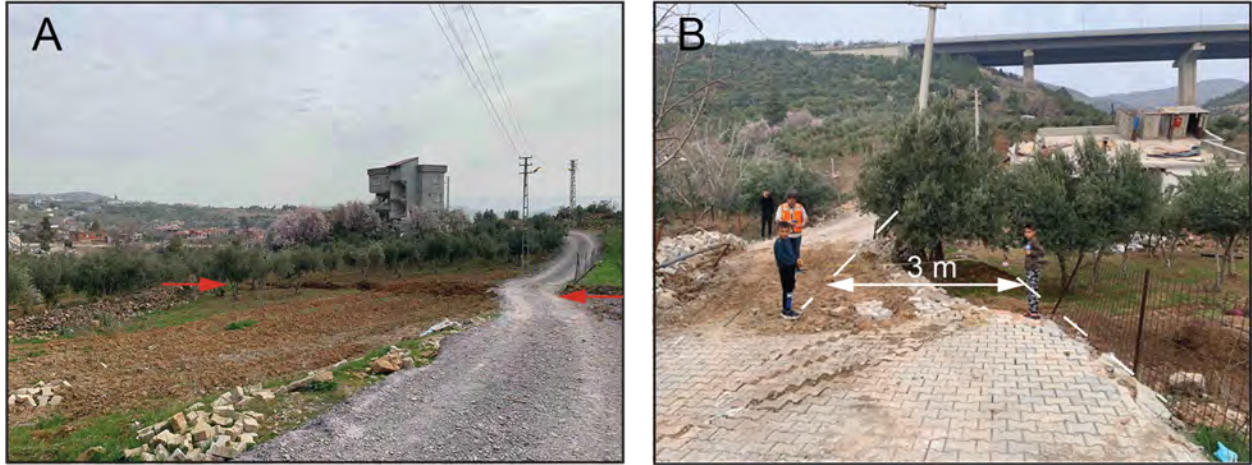
**Figure 2.28.** Photographs of the rupture west of the city of Nurdağı. (A) Rupture extending along western side of shutter ridge (east of range front). Left lateral offset of paver road and fence line, 2.8 m. Lat/Long: 37.186944°N, 36.719444°E. (B) Left-lateral offset of paver road, 3 m. Lat/Long: 37.186366°N, 36.719098°E. Photographs taken March 5, 2023.

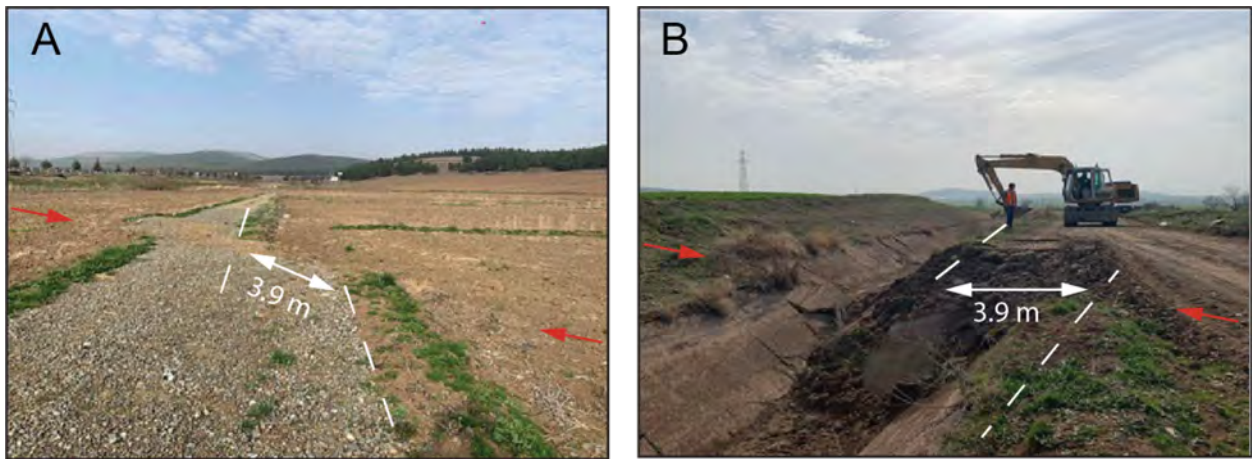
**Figure 2.29.** Photographs of rupture east of Highway D835 and west of the village of Çiğli. (A) Left-laterally offset gravel farm road, 3.9 m. Lat/Long: 37.480278°N, 37.043056°E. (B) Left-laterally offset drainage ditch, 3.9 m. Vertical displacement 60 cm up to the south. Backhoe present at the time of observation was beginning repairs. Lat/Long: 37.484722°N, 37.053889°E. Photographs taken March 2, 2023.

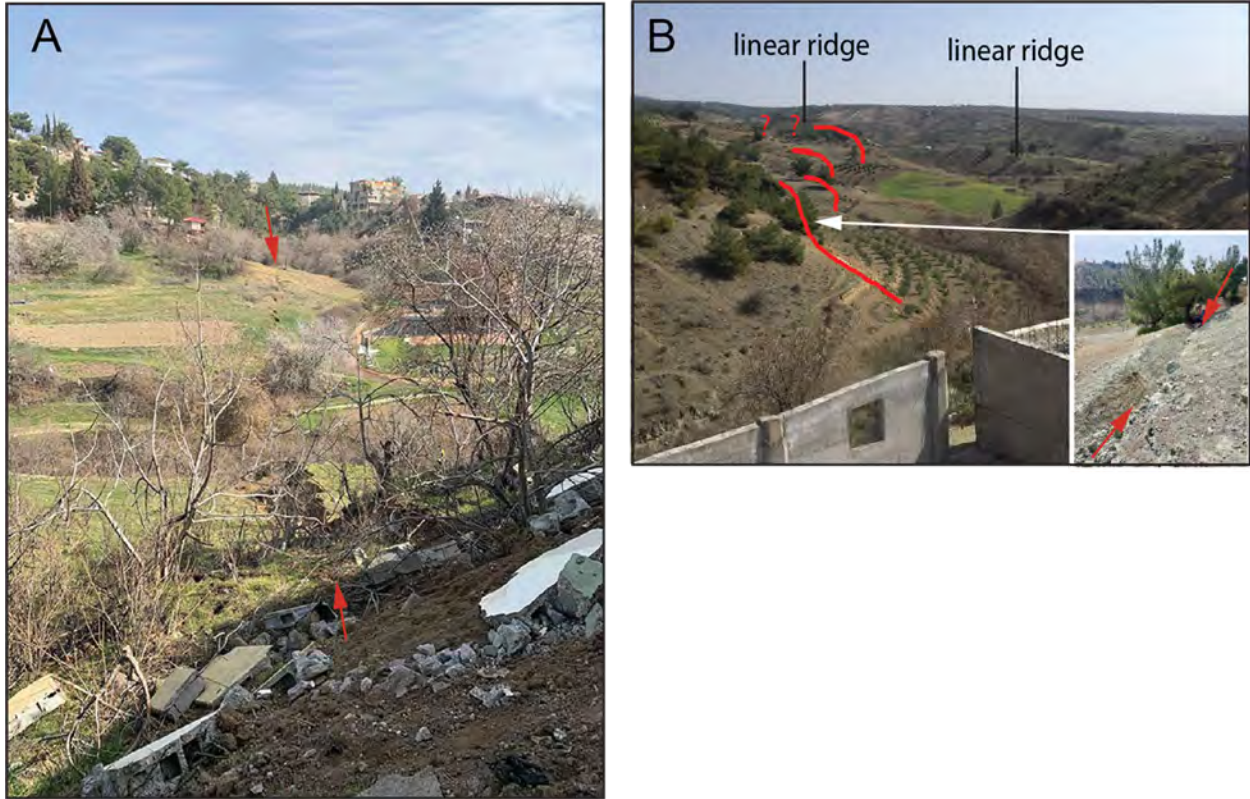
**Figure 2.30.** Photographs of the rupture in the village of Çiğli. (A) Uphill-facing fault scarp and moletrack within Çiğlivillage. Lat/Long: 37.491389°N, 37.069167°E. (B) Right-stepping scarps and ridges along the eastern side of Çiğlivillage. Lat/Long: 37.493889°N, 37.073333°E. Inset shows uphill-facing fault scarp and fault plane exposed across hillside. Lat/Long: 37.494167°N, 37.075556°E. Photographs taken March 2, 2023.

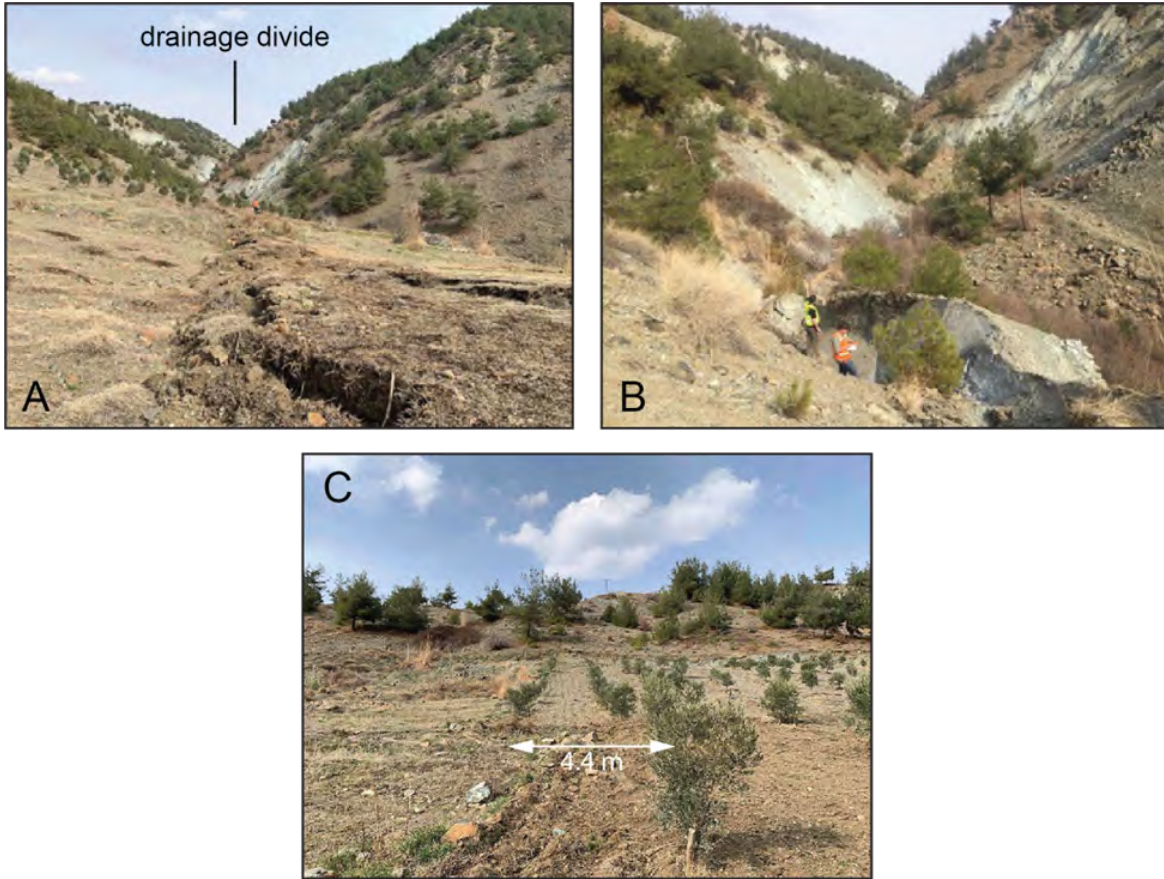
**Figure 2.31.** Photographs of rupture south of Kartal. (A) Moletrack rupture (4-m-wide, 1.5-m-high) projecting towards drainage divide. Lat/Long: 37.509167°N, 37.123056°E. (B) Uphill-facing fault scarp exposing fault plane (oriented 070, 58N). Lat/Long: 37.509722°N, 37.124167°E. (C) Left-laterally offset olive tree rows, 4.4 m. Lat/Long: 37.509167°N, 37.123611°E. Photographs taken March 2, 2023.

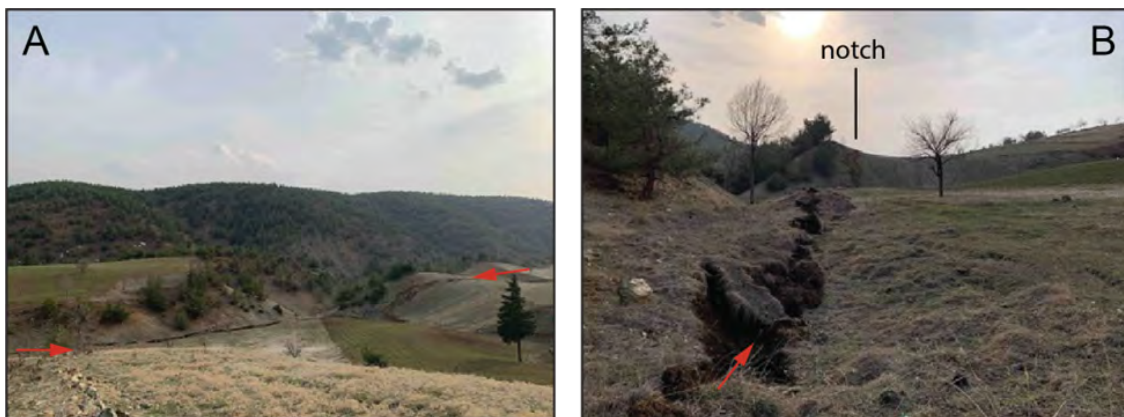
**Figure 2.32.** Photographs of rupture extending across fluvial terraces within the drainage divide of a long linear valley east of Kartal. (A) View to the south. Lat/Long: 37.514167°N, 37.146111°E. (B) View to the west. Moletrack rupture projects across topographic notch in the background. Lat/Long: 37.512778°N, 37.146389°E. Photographs taken March 2, 2023.

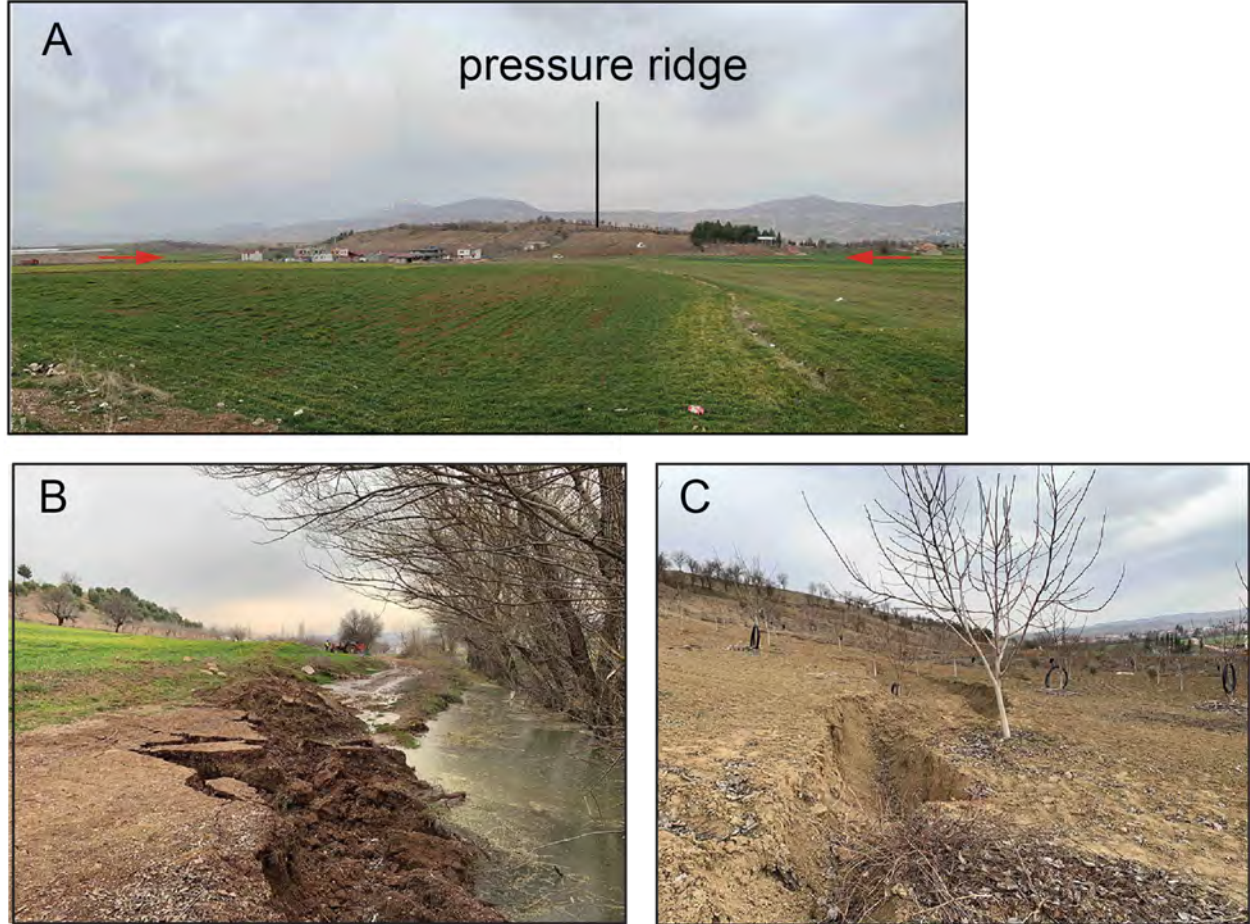
**Figure 2.33.** (A) Northeast trending pressure ridge in the middle of a large alluvial valley west of Balkar. Photo taken from Highway at Lat/Long: 37.725989°N, 37.559038°E. (B) Moletrack rupture projecting towards southeast side of pressure ridge associated with ponded water and up-to-northwest displacement of ~1 m. Lat/Long: 37.726389°N, 37.55°E. (C) Right-stepping fissures approximately 1.5 m deep and 10 m long extending along southeast side of pressure ridge. Tire tracks across rupture left-laterally offset 2.8 m. Lat/Long: 37.7275°N, 37.553333°E. Photographs taken March 3, 2023.

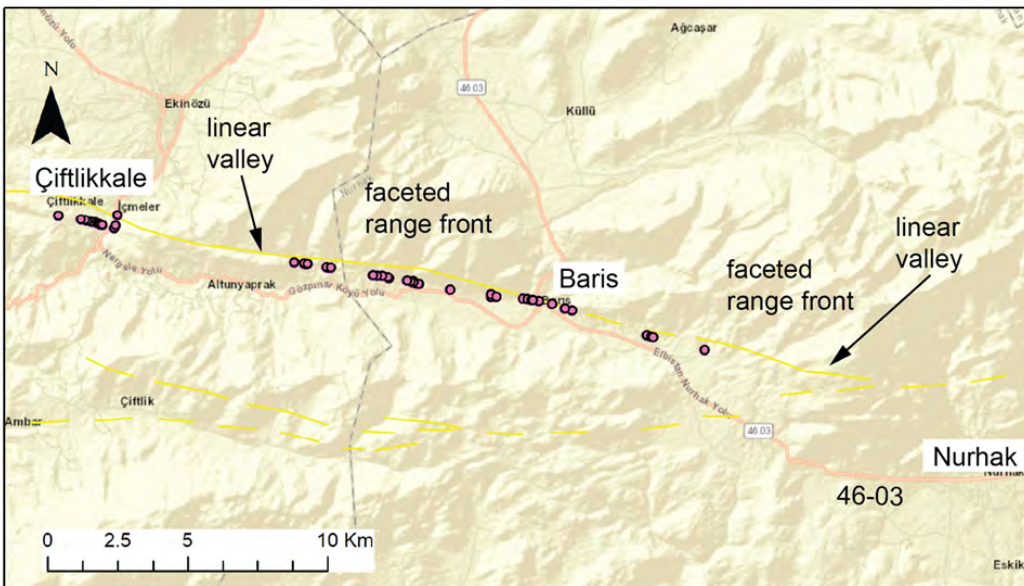
**Figure 2.34.** Map of geological observation points along the Çardak-Sürgü fault between Çiftlikkale and Nurhak. Yellow lines are previously mapped faults from the Active Fault Map of Turkey (Emre et al., 2013).

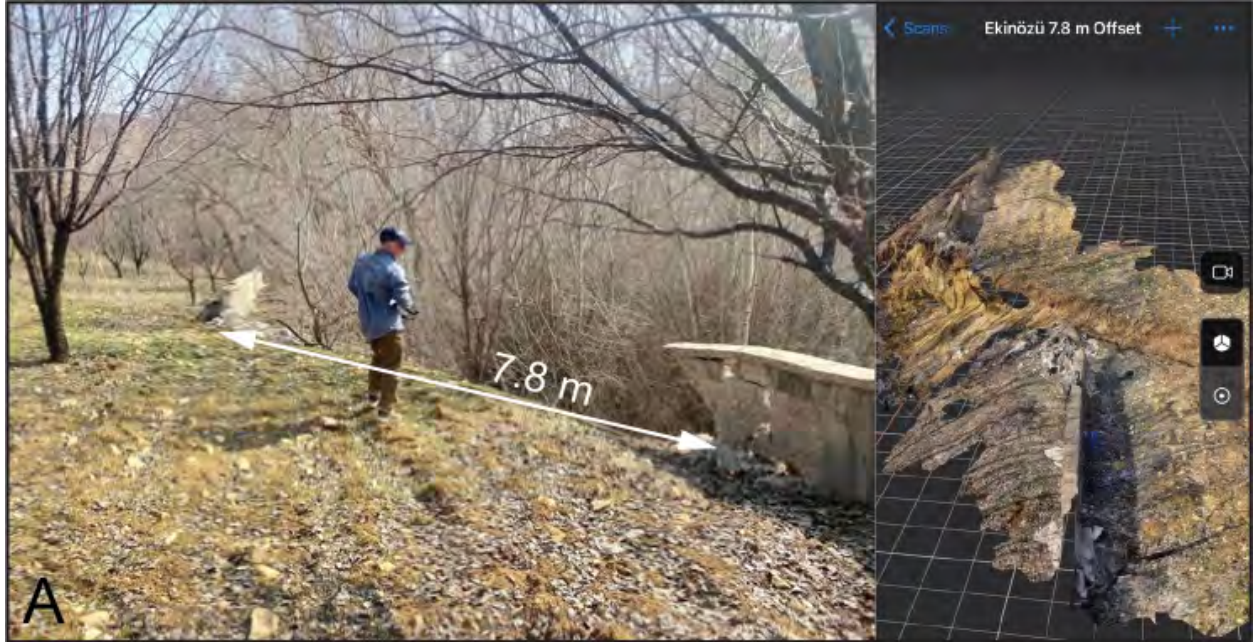
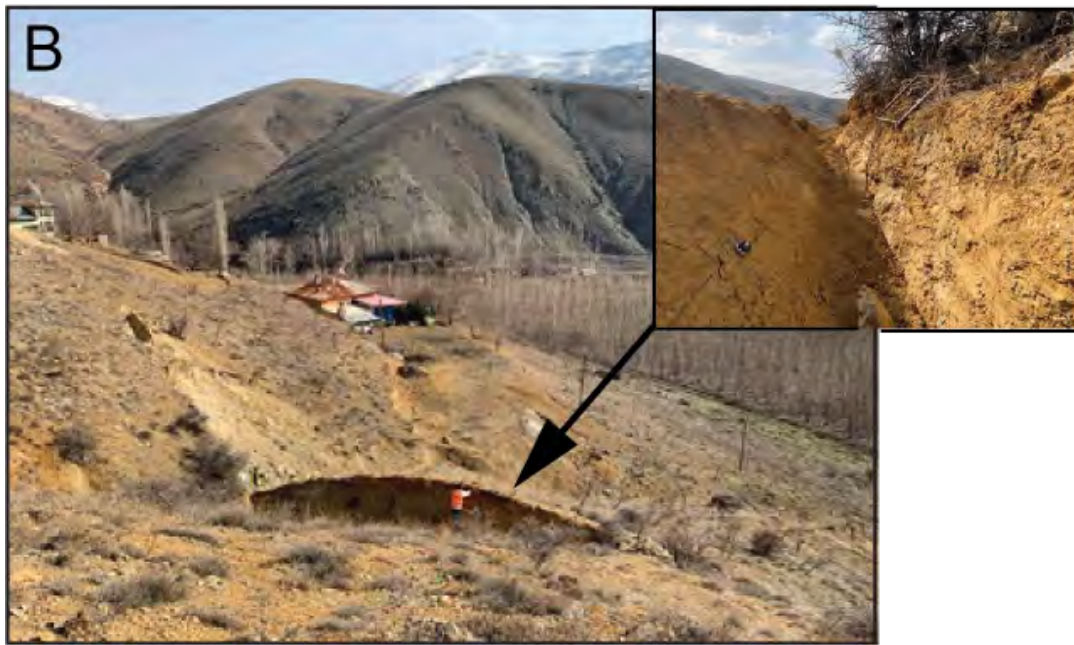
**Figure 2.35.** Photographs of rupture near the village of Çiftlikkale. (A) Left-laterally offset concrete wall along stream margin (7.8 m) and lidar scan of the feature. Lat/Long: 38.030556°N, 37.166111°E. (B) Uphill-facing scarp and fault plane extending along the south side of linear bedrock ridge. Lat/Long: 38.029722°N, 37.168611°E. Photographs taken March 3, 2023.

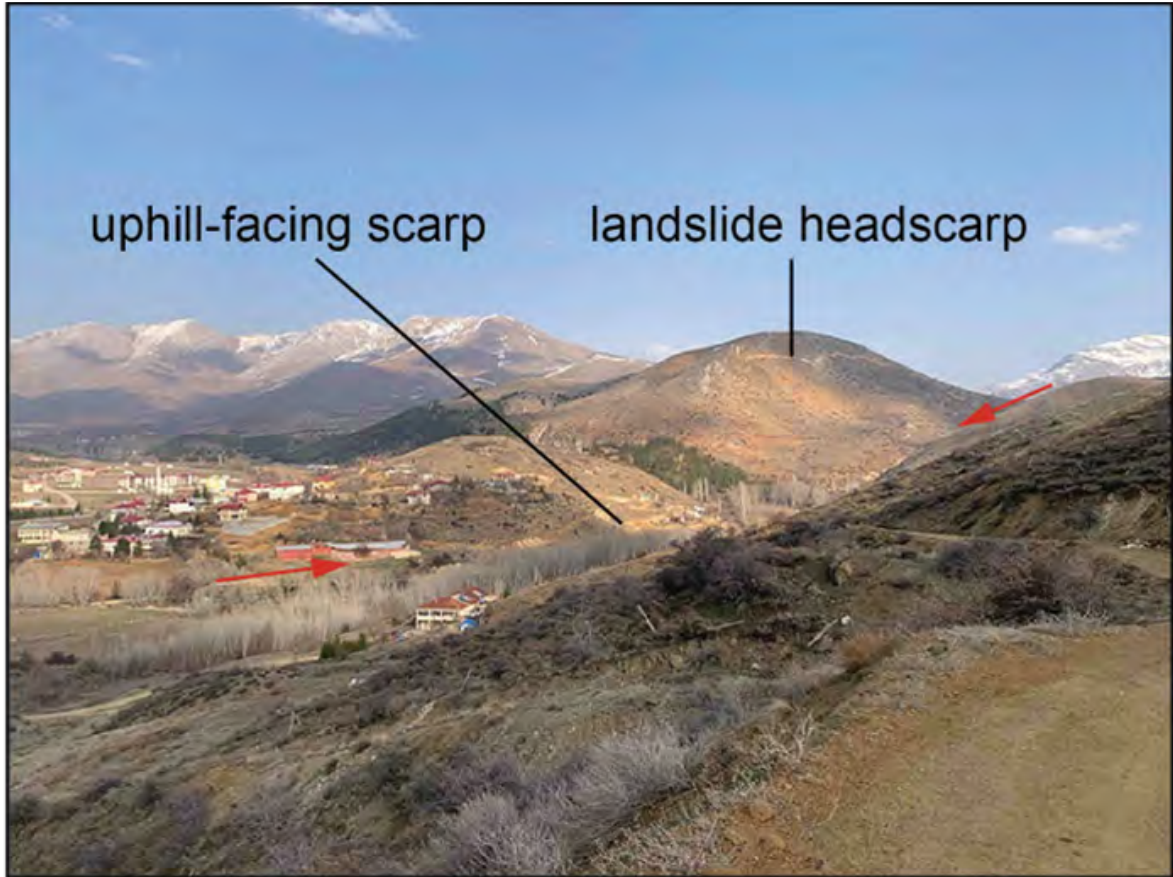
**Figure 2.36.** Photograph of rupture extending along linear valley south of Çiftlikkale. Uphill-facing bedrock scarp (fault plane) shown in Figure 2.35 is in the middle of photograph. A large landslide headscarp extends across the entire hillside east of town and slope movement is inferred to have occurred during the earthquake. Lat/Long: 38.029444°N, 37.161944°E. Photograph date March 3, 2023.

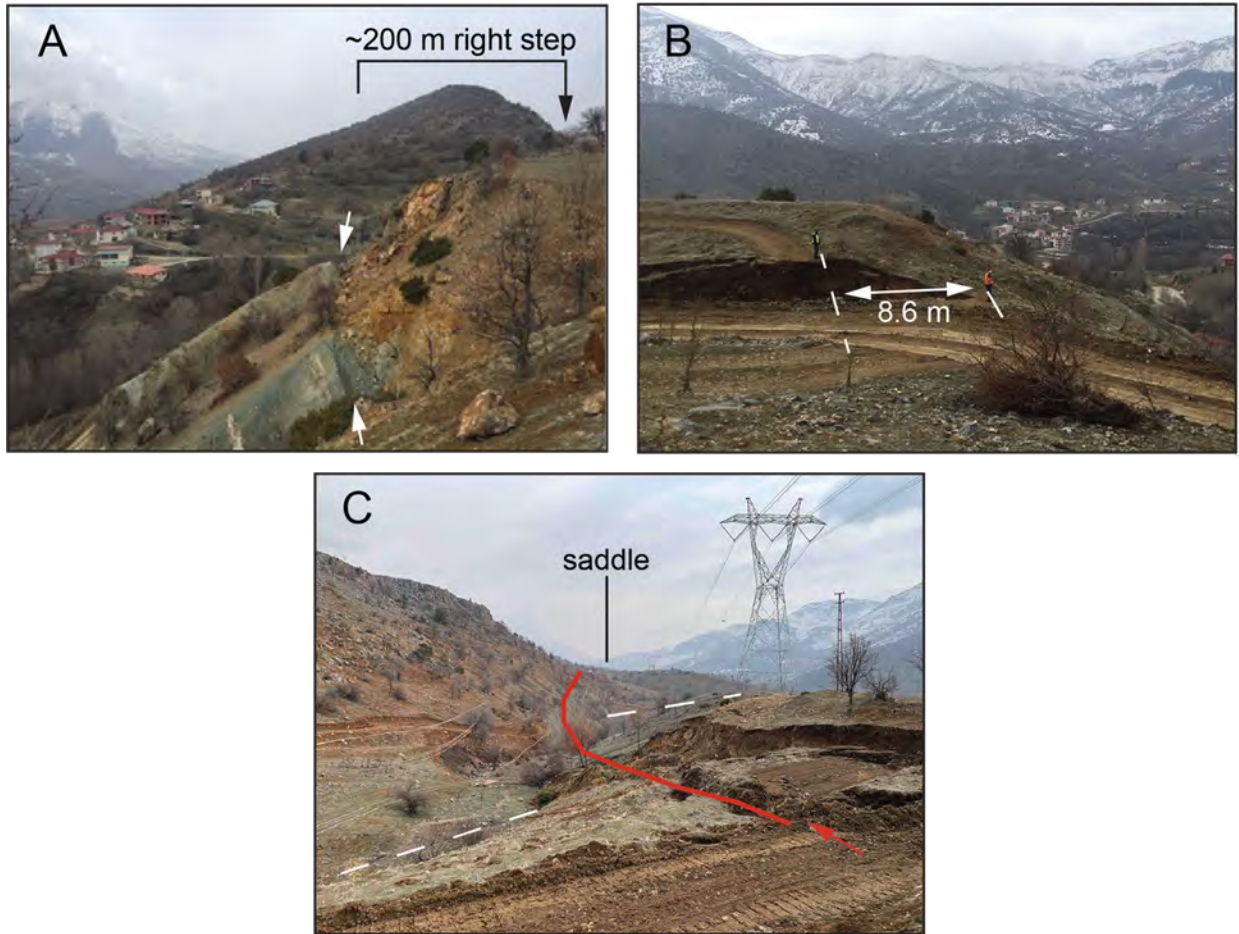
**Figure 2.37.** Photographs of the rupture extending across saddle and hillside near the village of Gözpınar. (A) Graben extending across saddle associated with 8.6 m left-lateral rupture of dirt road. Lat/Long: 38.02°N, 37.233333°E. (B) Uphill-facing scarp in bedrock. Large right-steps are common in the mountainous terrain in this area. Lat/Long: 38.020278°N, 37.233333°E. (C) Long-term offset of channel (thalweg approximated by white dashed line) and side-hill scarp that projects across saddle to the east. Lat/Long: 38.02°N, 37.234722°E. Photographs taken March 4, 2023.

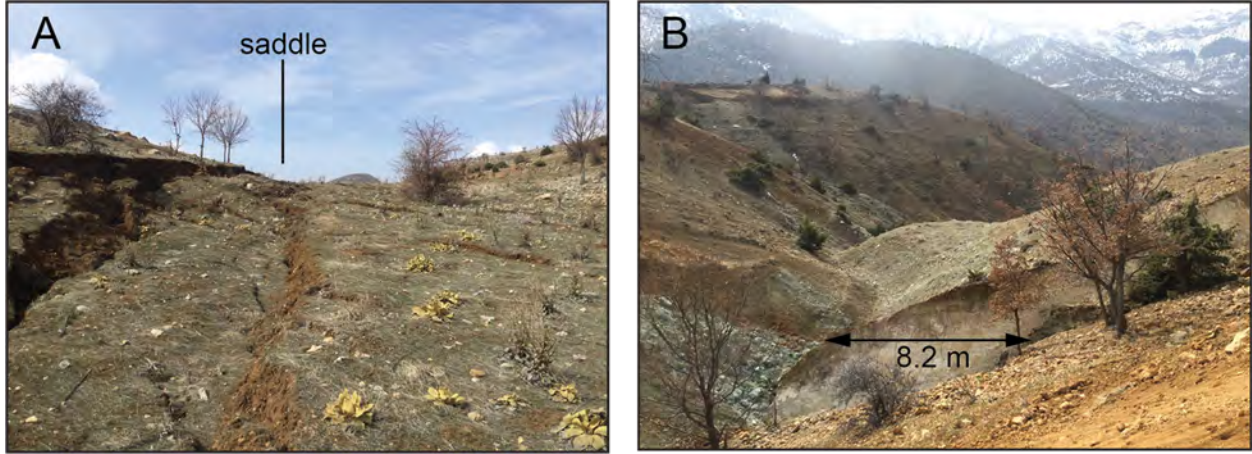
**Figure 2.38.** (A) Graben cutting across saddle (Lat/Long: 38.019130°N, 37.241423°E) and (B) bedrock scarp associated with 8.2 m of left-lateral displacement (Lat/Long: 38.019241°N, 37.240900°E) near the village of Gözpinar. Photographs taken on March 4, 2023.

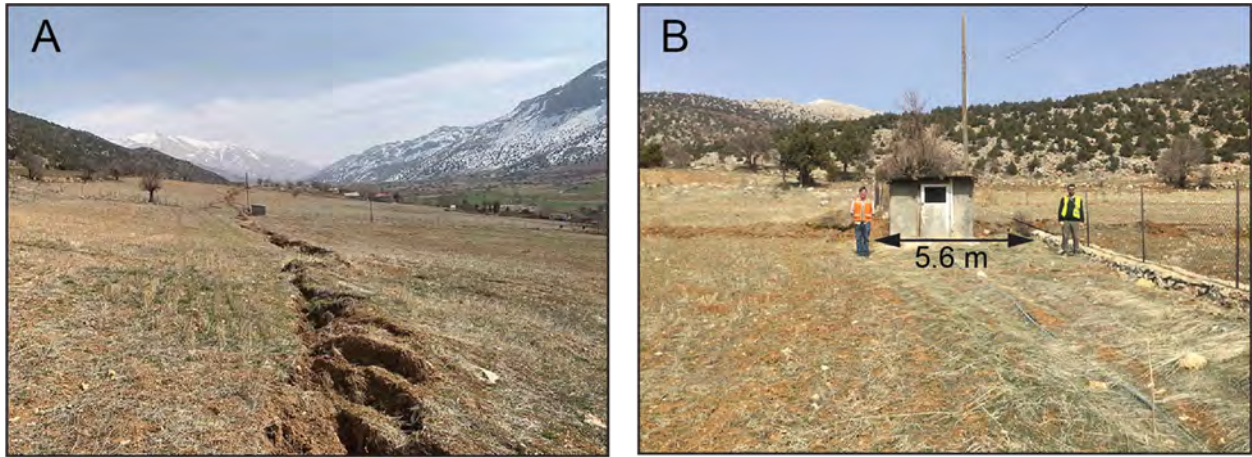
**Figure 2.39.** Photographs of the rupture extending across an alluvial fan west of Barış. (A) Right-stepping en echelon mole track scarp, zone of deformation relatively narrow ~5-m-wide. Lat/Long: 38.015556°N, 37.269444°E. (B) Left-laterally offset concrete wall and fence line, 5.6 m. Lat/Long: 38.014722°N, 37.270278°E. Photographs taken March 3, 2023.

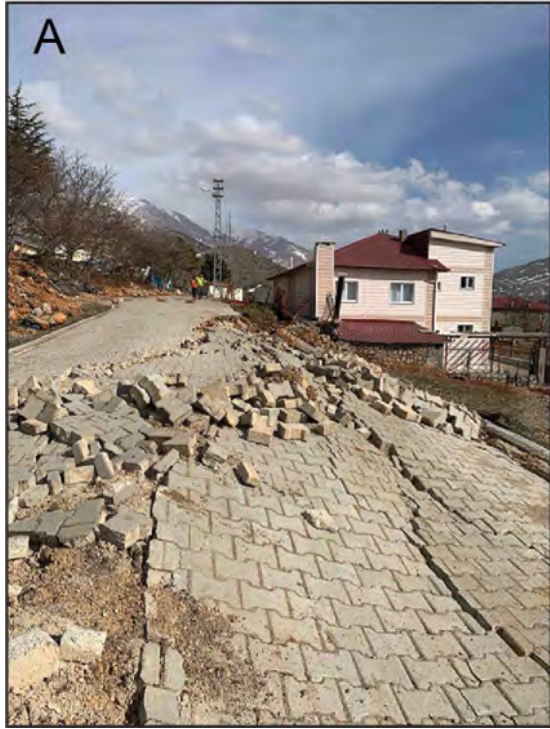
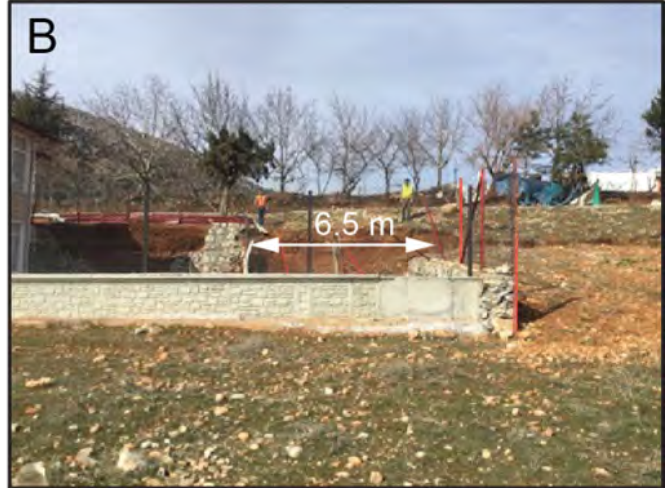
**Figure 2.40.** Photographs of rupture in the village of Barış. (A) Rupture extending along the north side of a house that was relatively undamaged. Lat/Long: 38.010833°N, 37.306944°E. (B) Left-laterally offset concrete wall (6.5 m) in the backyard of the house in (A). Lat/Long: 38.010556°N, 37.3075°E. Photographs taken March 4, 2023.

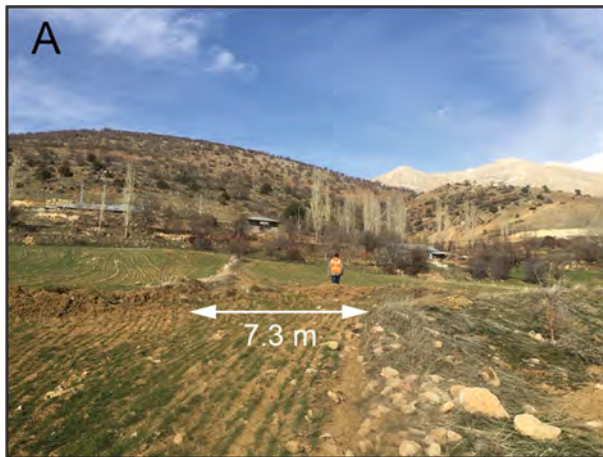
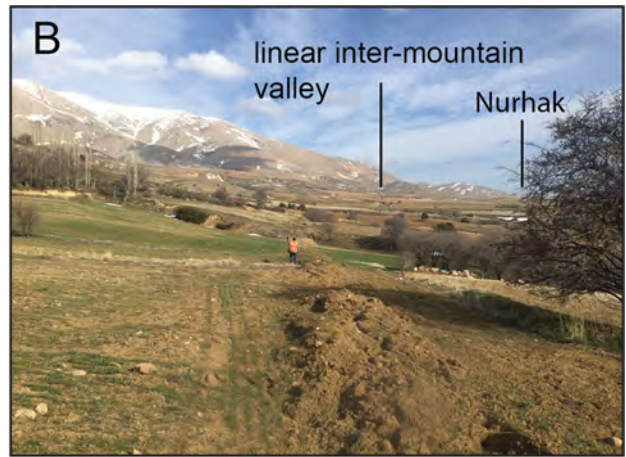
**Figure 2.41.** Photographs of the rupture approximately 3 km east of Barış. (A) 7.3 m left lateral displacement of rock wall along agricultural field margin. (B) View to the east from (A) showing the projection of the rupture into a linear bedrock valley. For both photographs, Lat/Long: 38.001971°N, 37.343925°E. Photographs taken March 4, 2023.

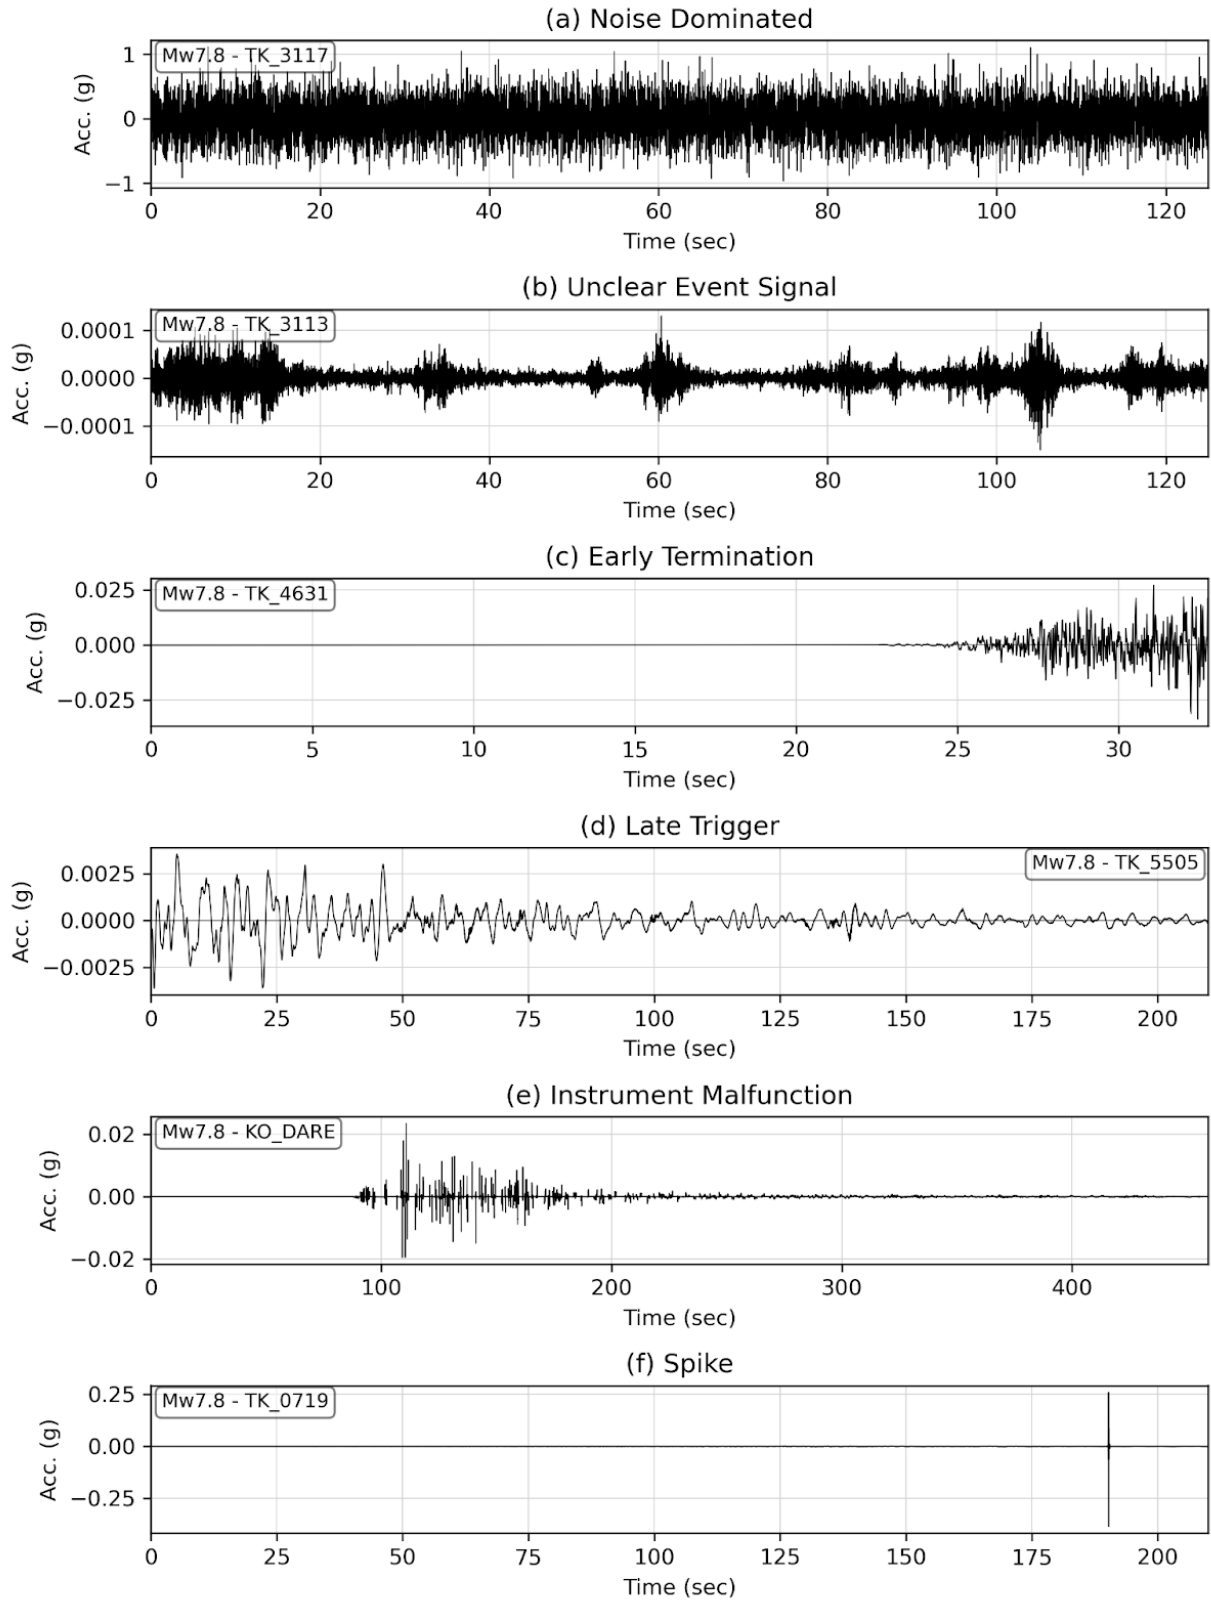
**Figure 3.1.** Example time-series for non-usable records: (a) noise-dominated, (b) unclear event signal, (c) early termination, (d) late trigger, (e) instrument malfunction, and (f) spike.
