MAY 6, 2023

# FEBRUARY 6, 2023 TÜRKIYE EARTHQUAKES: REPORT ON GEOSCIENCE AND ENGINEERING IMPACTS

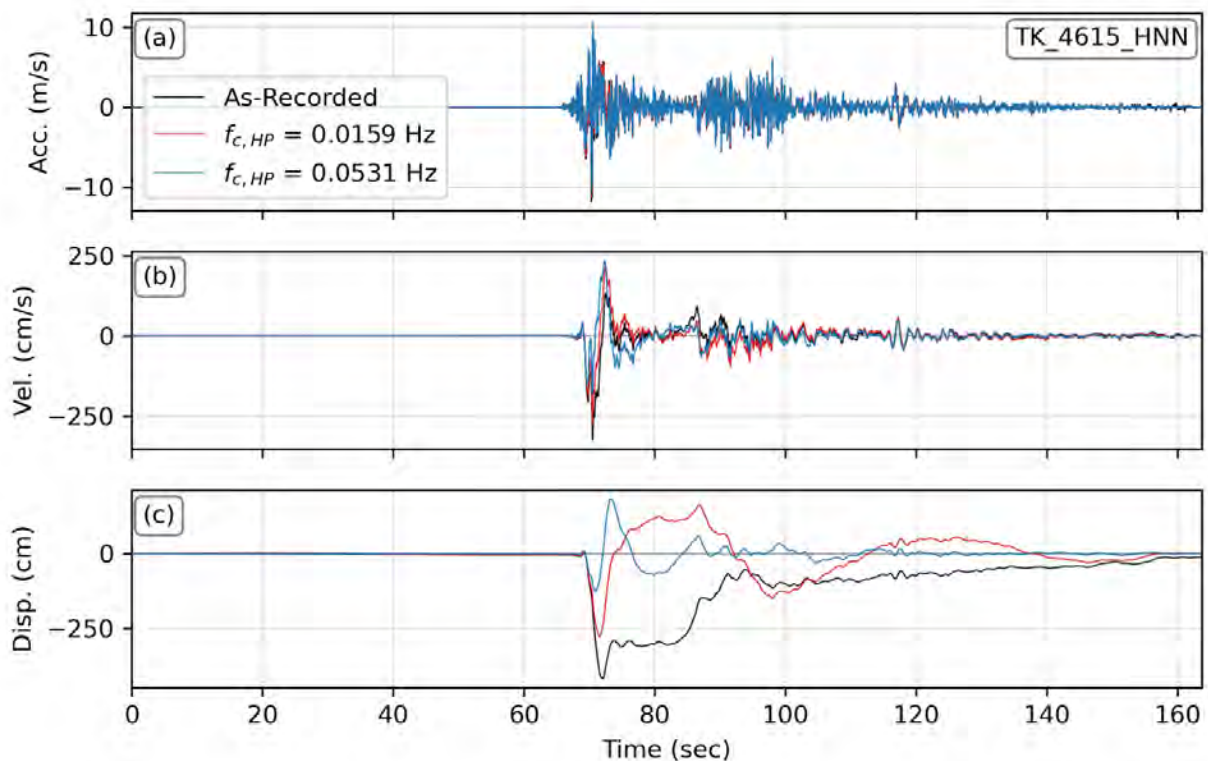
**Figure 3.4.** Example time-series plots illustrating sensitivity of high-pass corner selection during signal processing for north component of station TK 4615 corresponding to the **M7.8** mainshock: (a) acceleration, (b) velocity, and (c) displacement. Unprocessed shown by black curve,  $f_{c,HP} = 0.0159$  Hz shown in red, and  $f_{c,HP} = 0.0531$  Hz shown in blue.

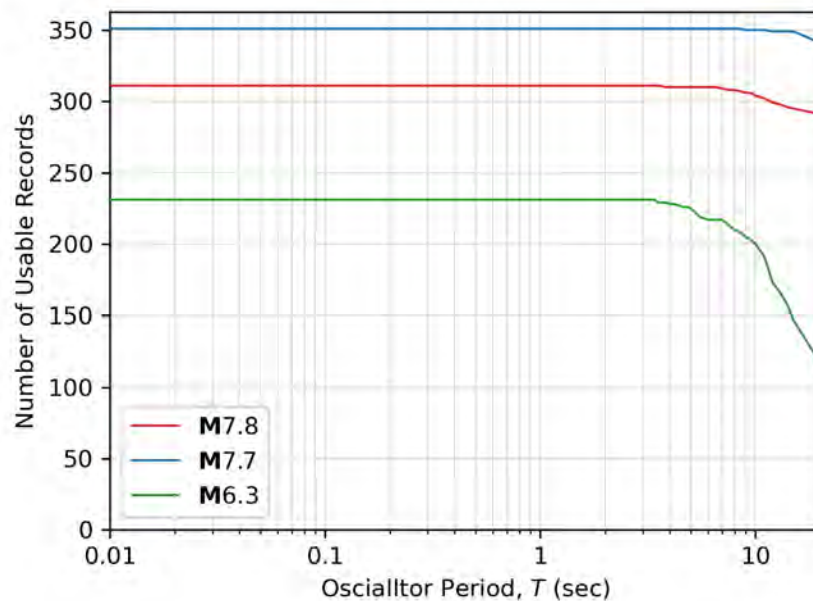
**Figure 3.5.** Number of usable records vs period for the **M7.8**, **M7.7**, and **M6.3** events. Longest usable period defined as  $1/(1.25f_{c,HP})$ , where  $f_{c,HP}$  is the maximum of the two horizontal components.

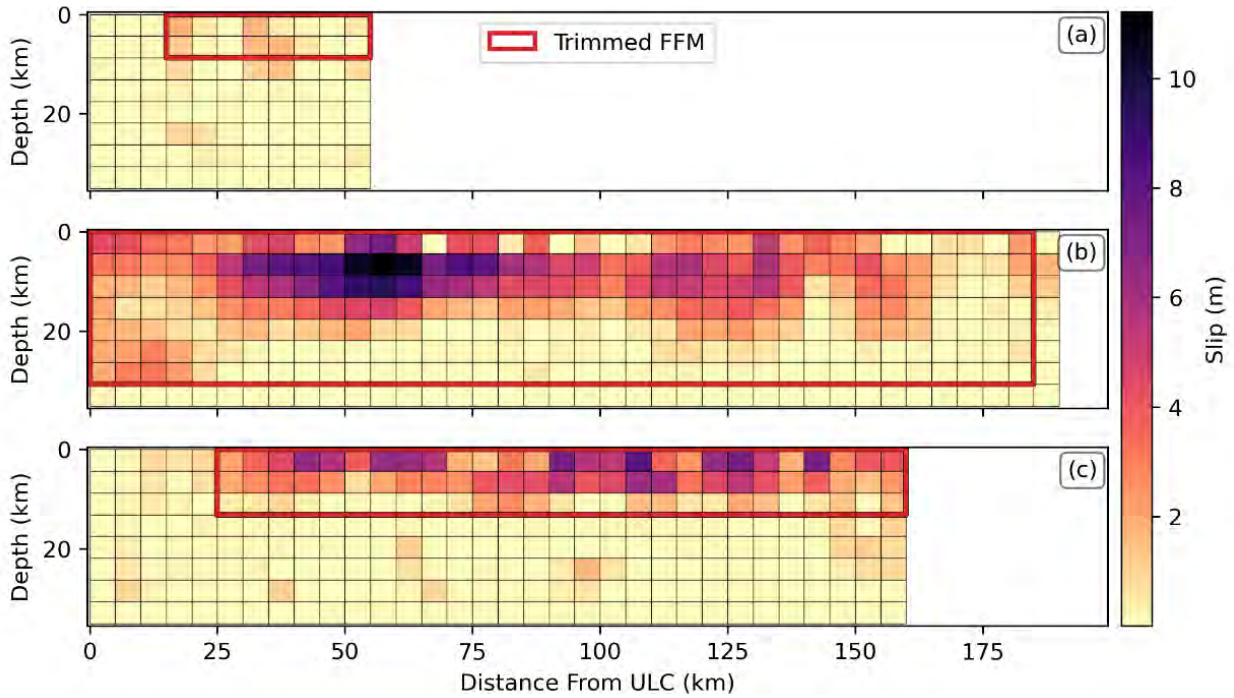
**Figure 3.8.** M7.8 finite fault model reported by USGS (2023); (a) segment 1, (b) segment 2, and (c) segment 3. Trimmed model corresponds to parts of the rupture surface with slip > 15% of the maximum slip (11.21 m).

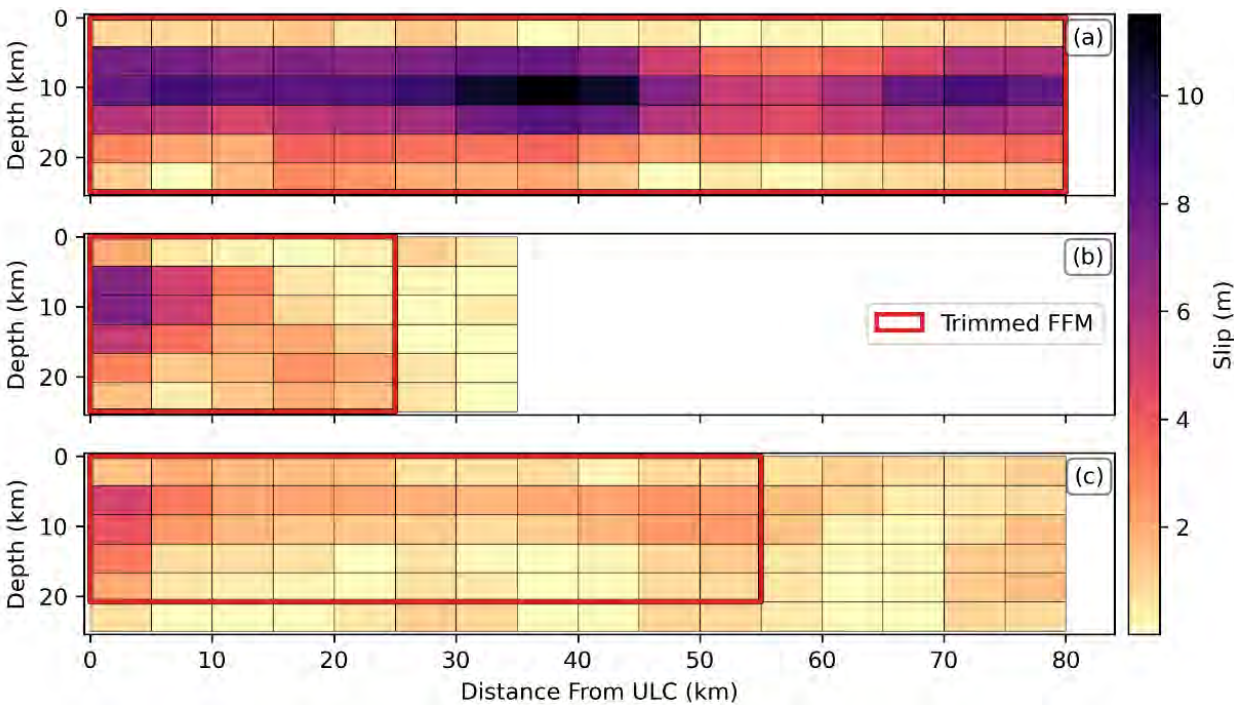
**Figure 3.9.** M7.7 finite fault model reported by USGS (2023); (a) segment 1, (b) segment 2, and (c) segment 3. Trimmed model corresponds to parts of the rupture surface with slip > 15% of the maximum slip (11.51 m).

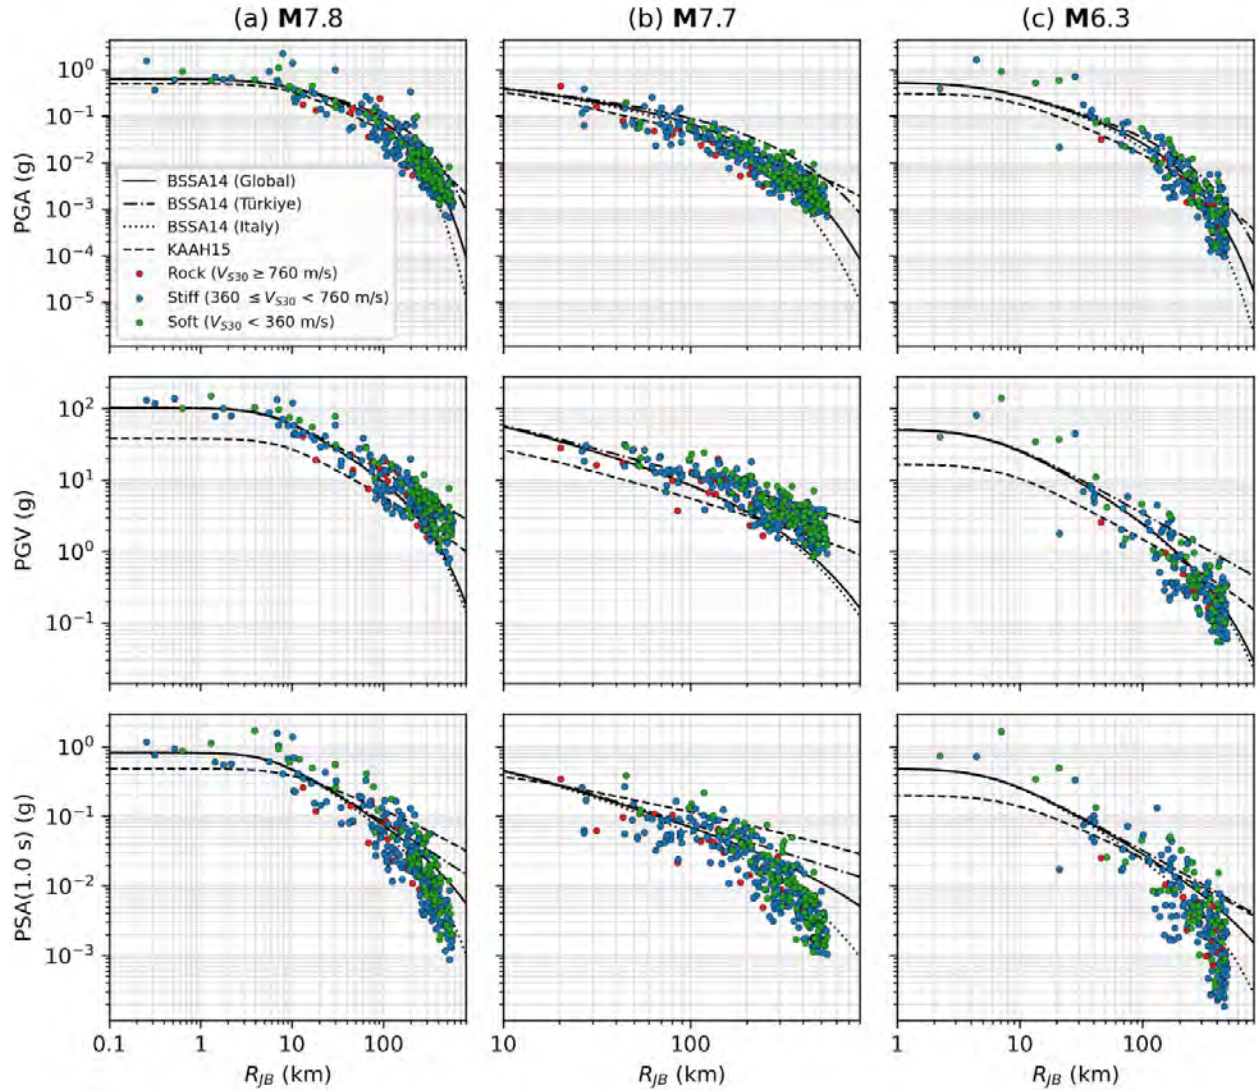
**Figure 3.11.** Observations vs distance colored by site condition (rock, stiff-soil, or soft-soil) for (a) **M7.8**, (b) **M7.7**, and (c) **M6.3** events. Predictions shown for global BSSA14, regional BSSA14, and KAAH15 GMMs for a  $V_{S30}$  of 360 m/s.

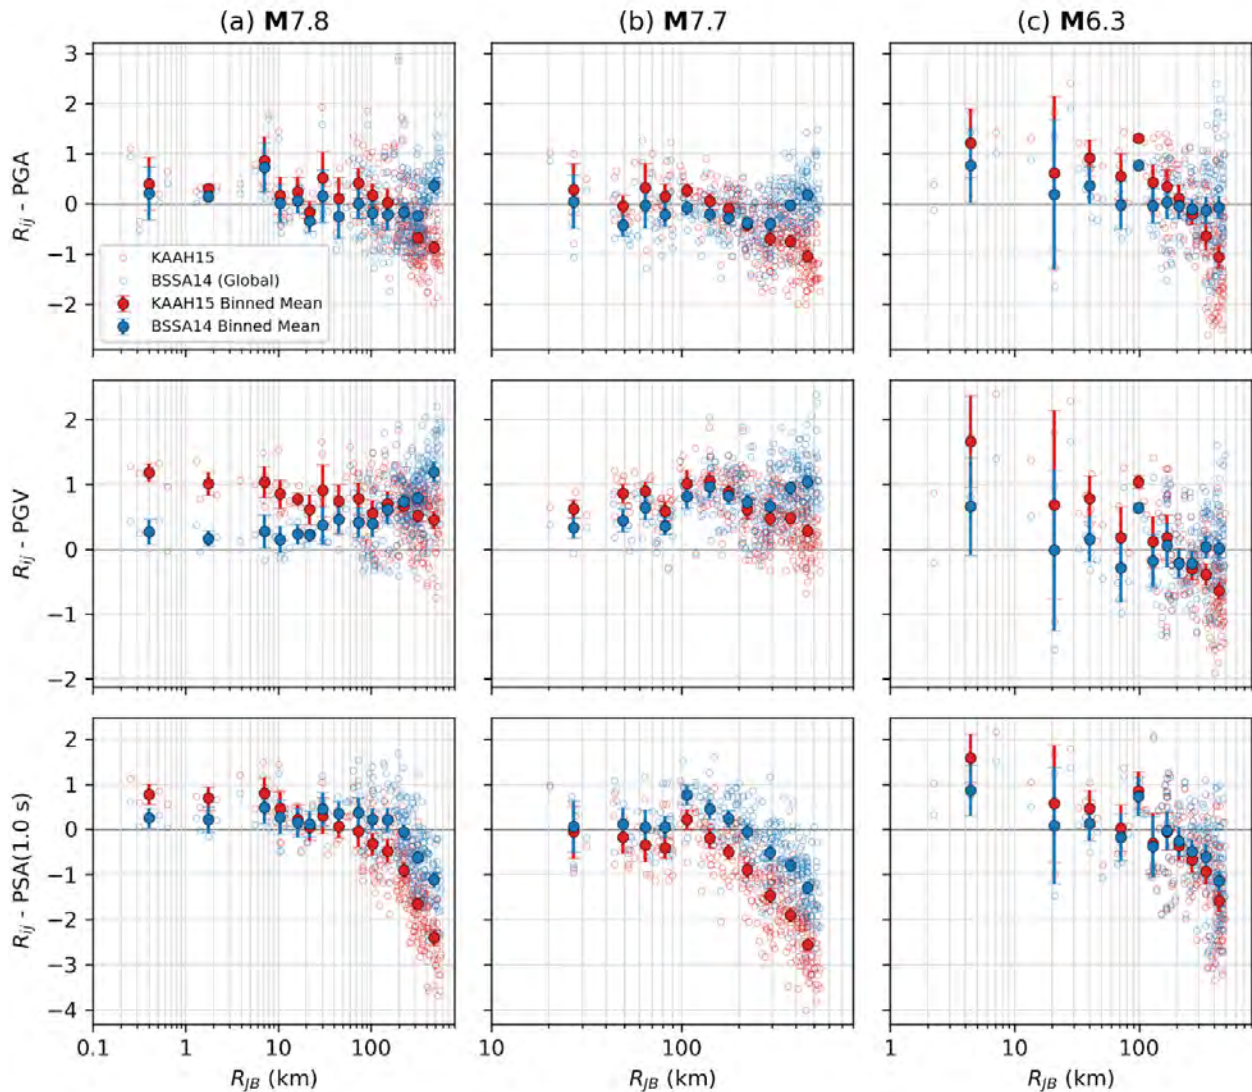
**Figure 3.12.** Total residuals vs distance for (a) **M7.8**, (b) **M7.7**, and (c) **M6.3** events. Residuals computed for PGA, PGV, and PSA(1.0 sec) for the global BSSA14 and KAAH15 GMMs.

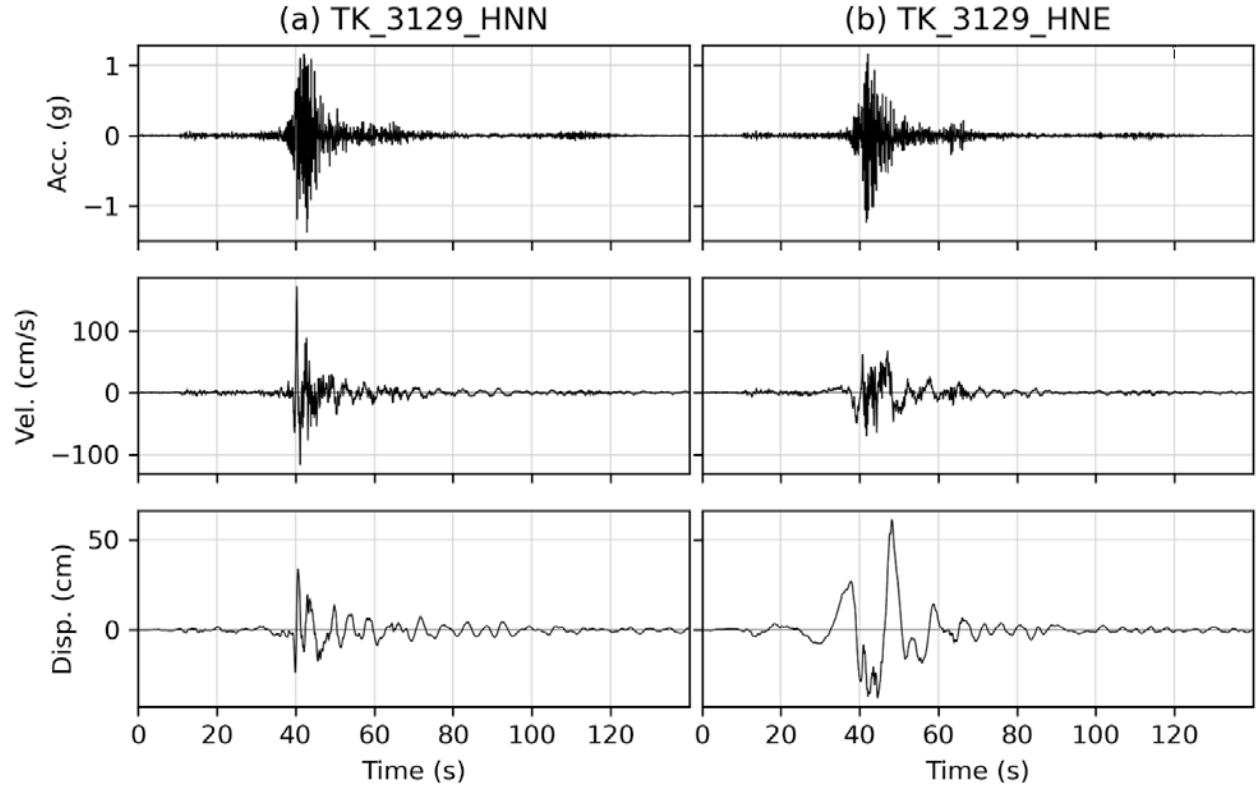
**Figure 3.14.** Plots of acceleration, velocity, and displacement for Hatay station (TK 3129); (a) north-south component; (b) east-west component.

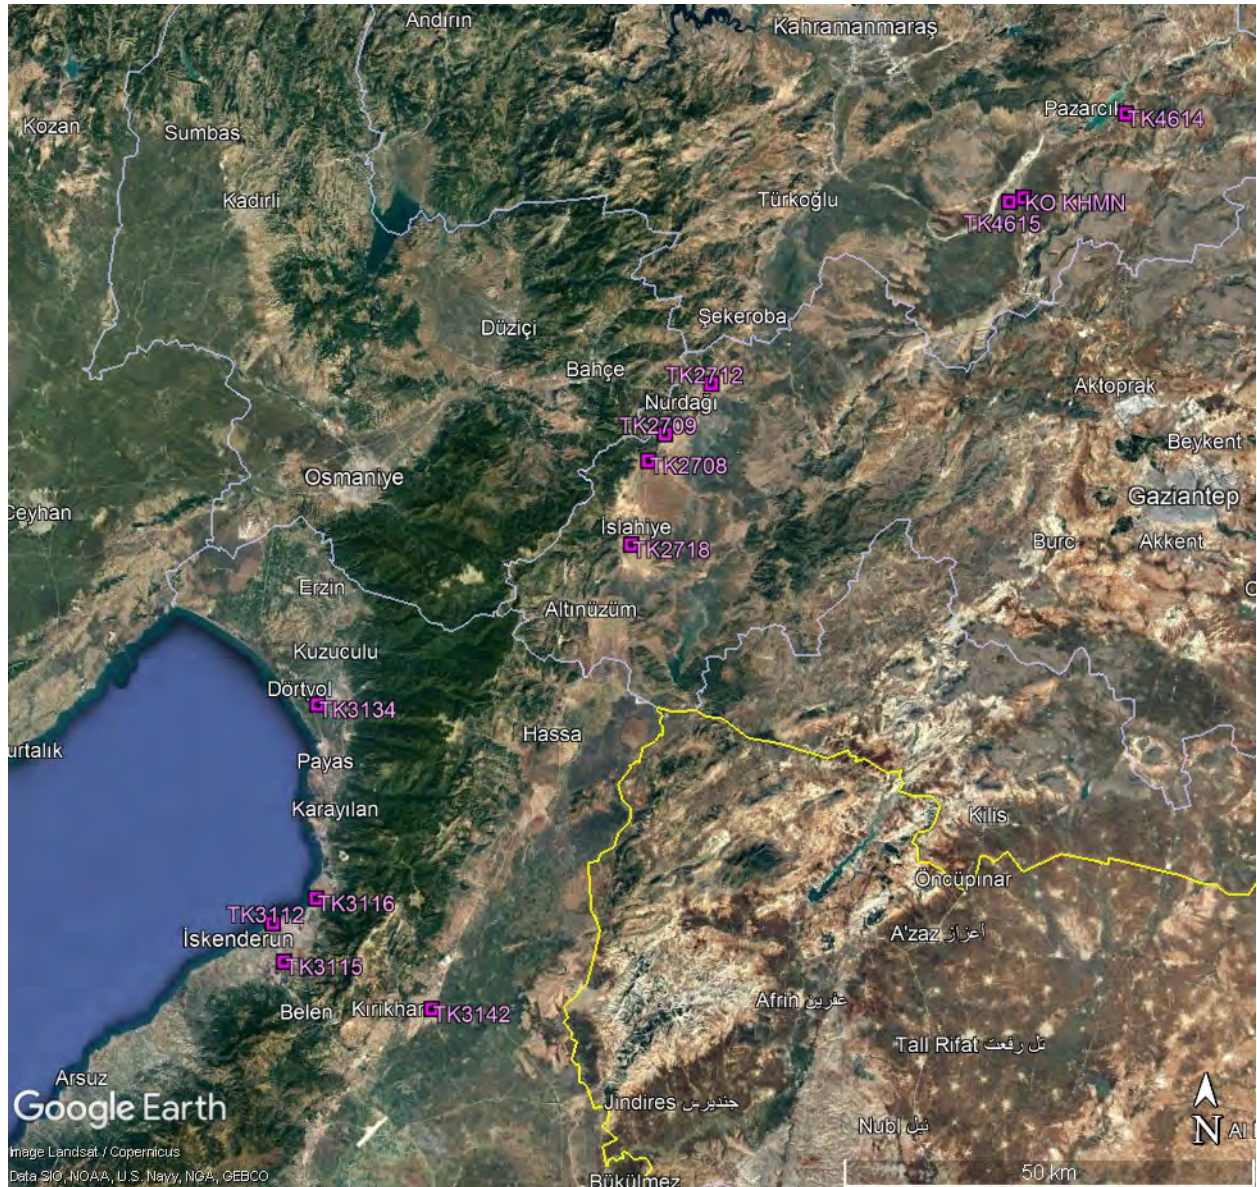
**Figure 3.21.** Map showing locations of ground motion stations visited by GEER Team 2.

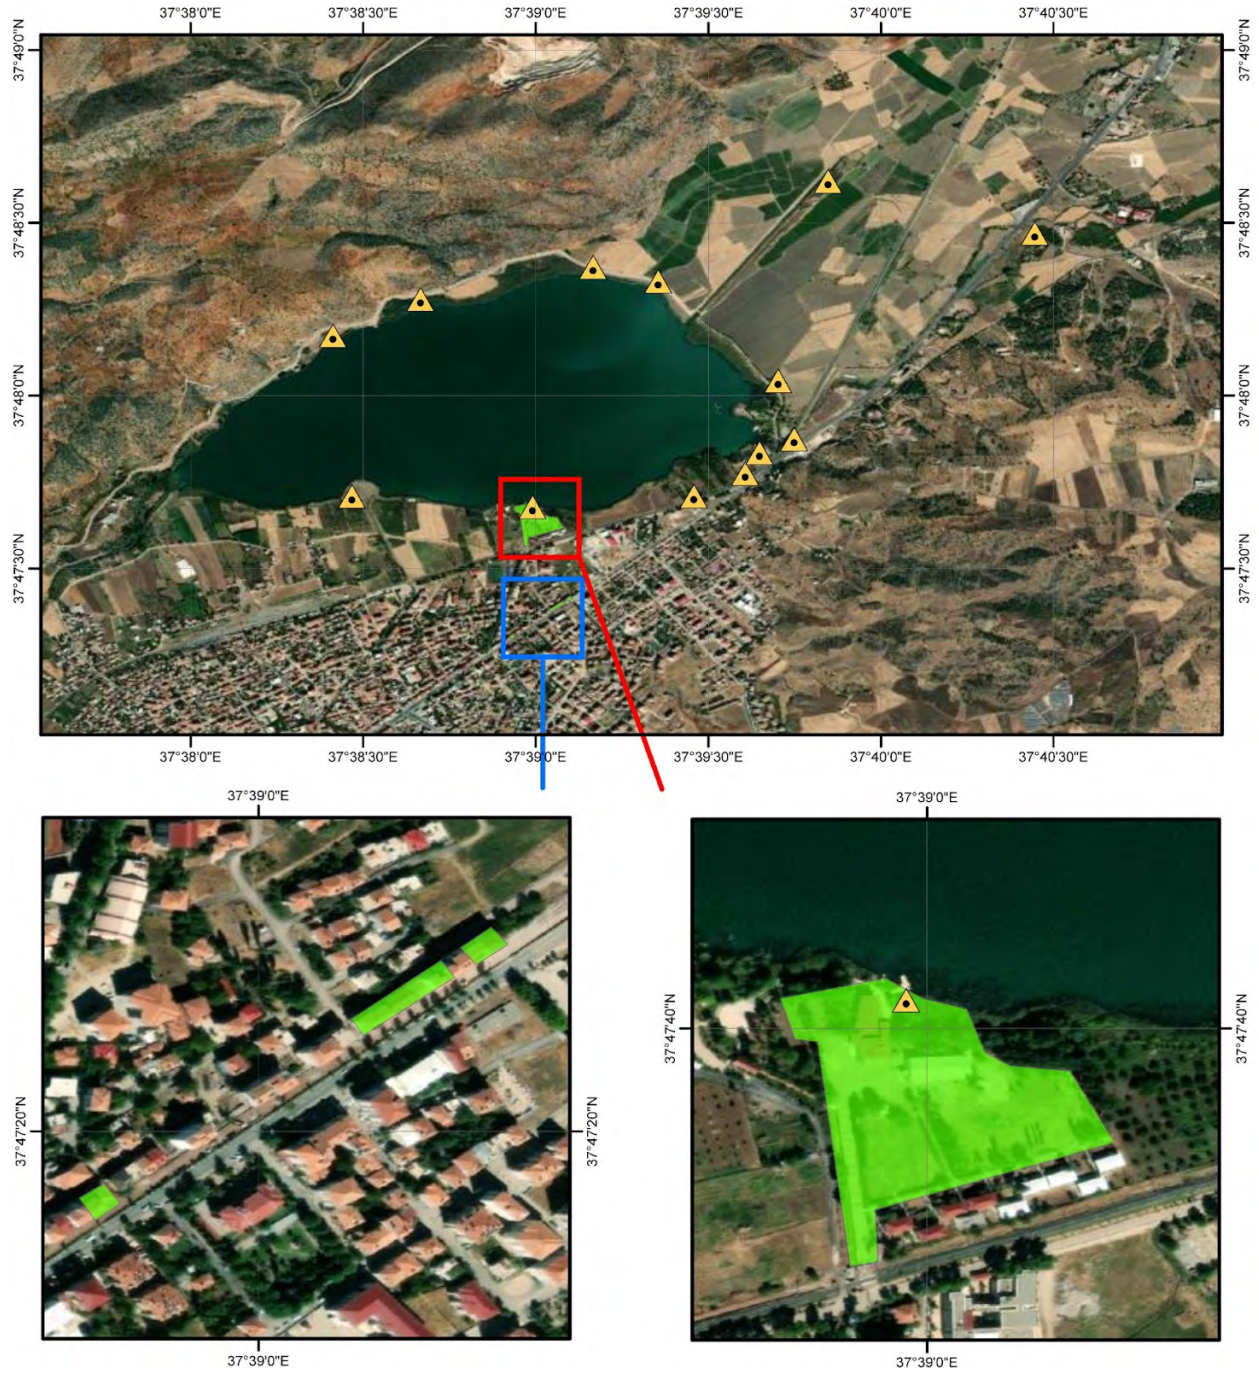
**Figure 4.1.** Gölbaşı areas inspected by GEER Teams. Top: General locations, triangles indicate areas with lateral spreading, squares indicate areas with inspected buildings. Bottom left: buildings inspected in the Golbaşı area. Bottom right: lateral spreading near the Golbaşı lake with drone images.

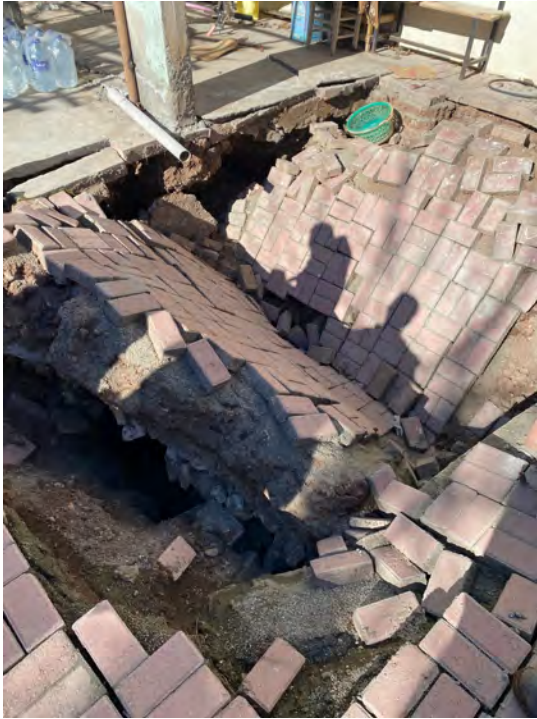
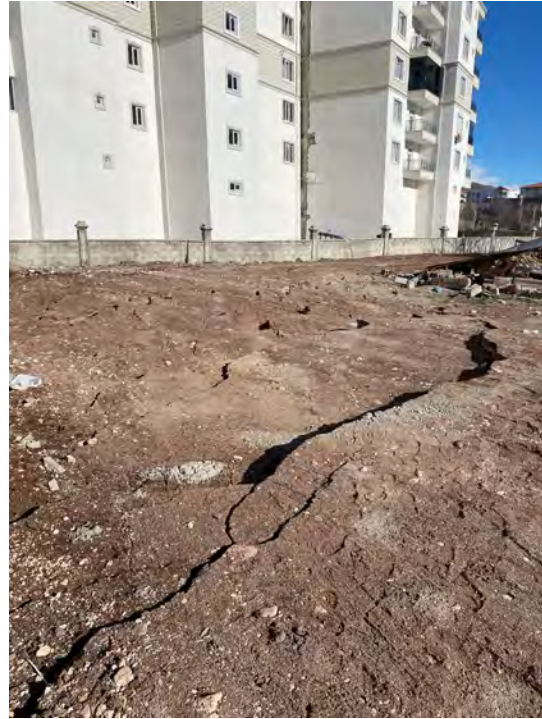
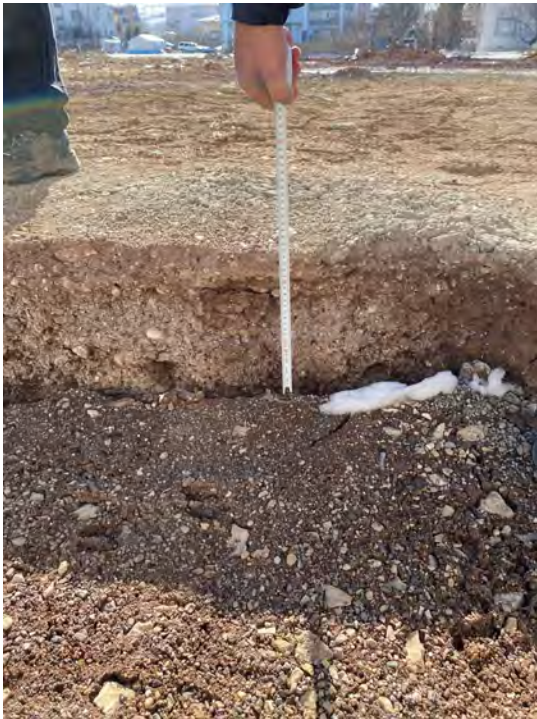
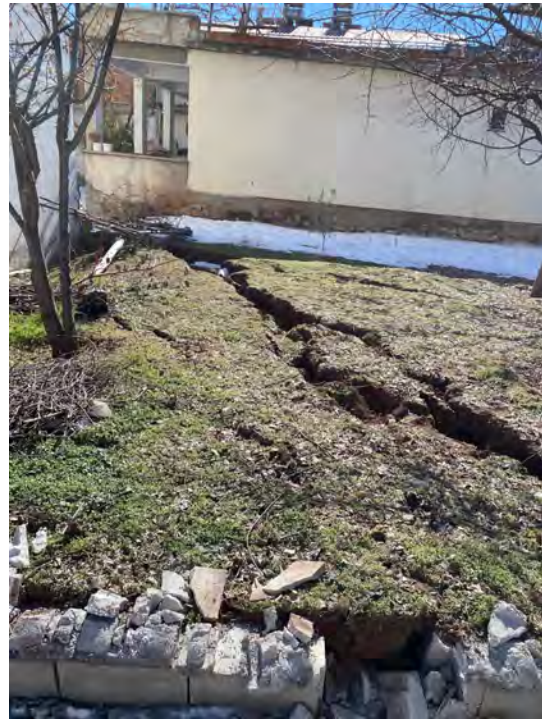
**Figure 4.3.** Liquefaction-induced cracks and fractures Gölbaşı (37.780058 N, 37.628457 E).

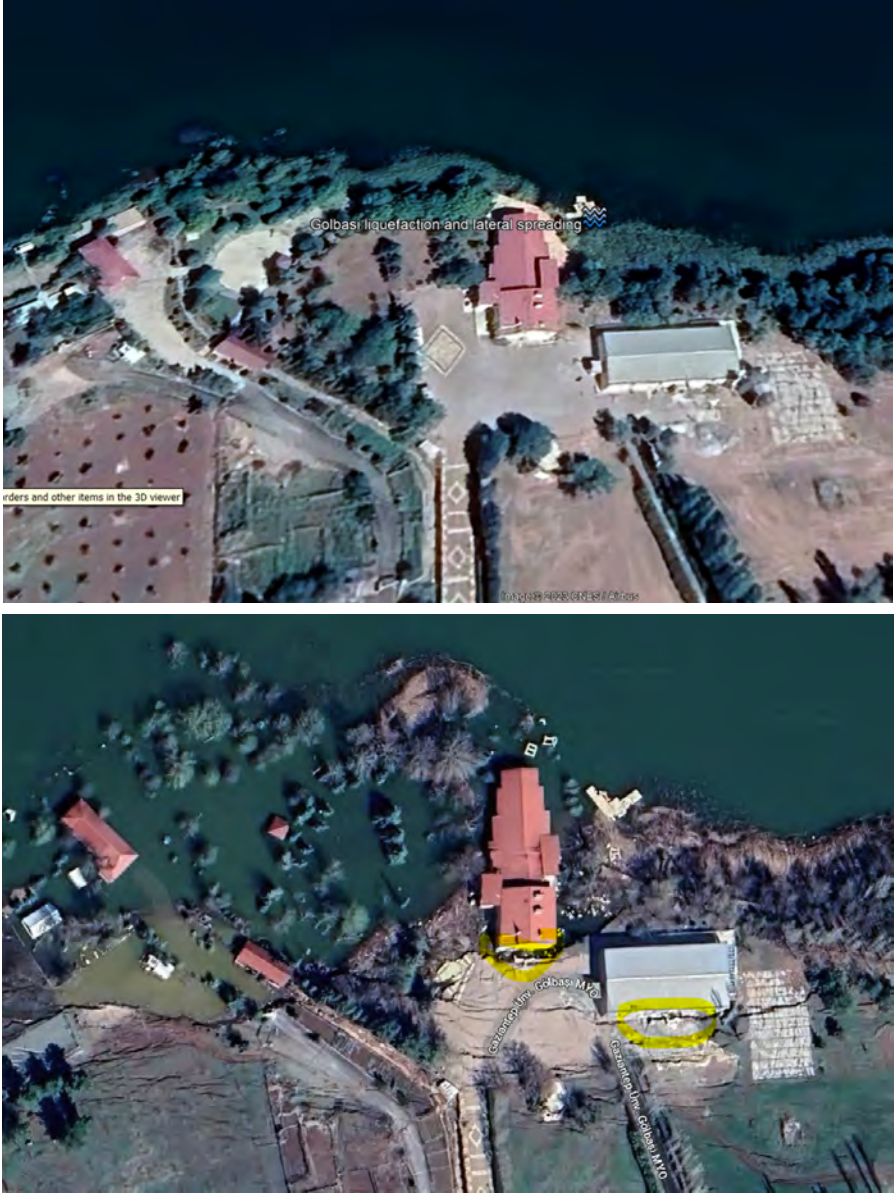
**Figure 4.4** Aerial view of the lateral spreading area. Top: Google Earth Image on 9/2022. Bottom: Google Earth image on 3/2023. Referential Coordinates: 37.79° (Lat), 37.65 (Lon)

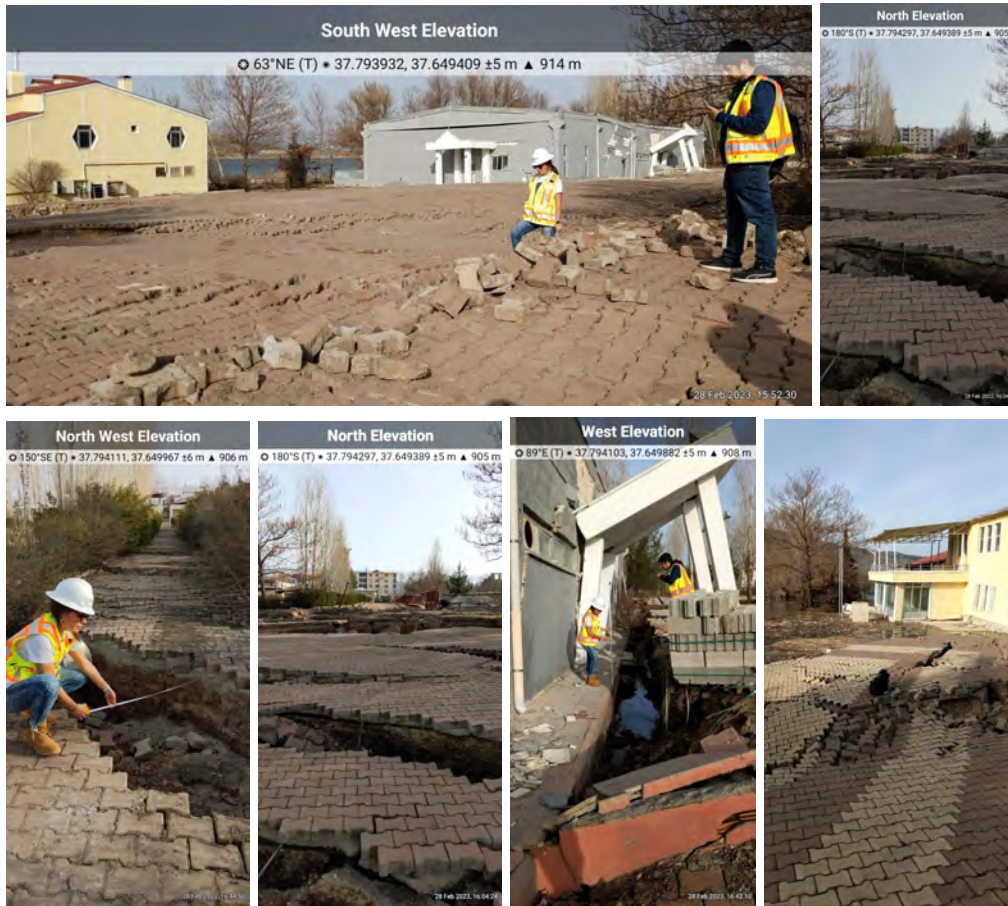
**Figure 4.6** Localized lateral spreading patterns. Photos taken on February 28, 2023.

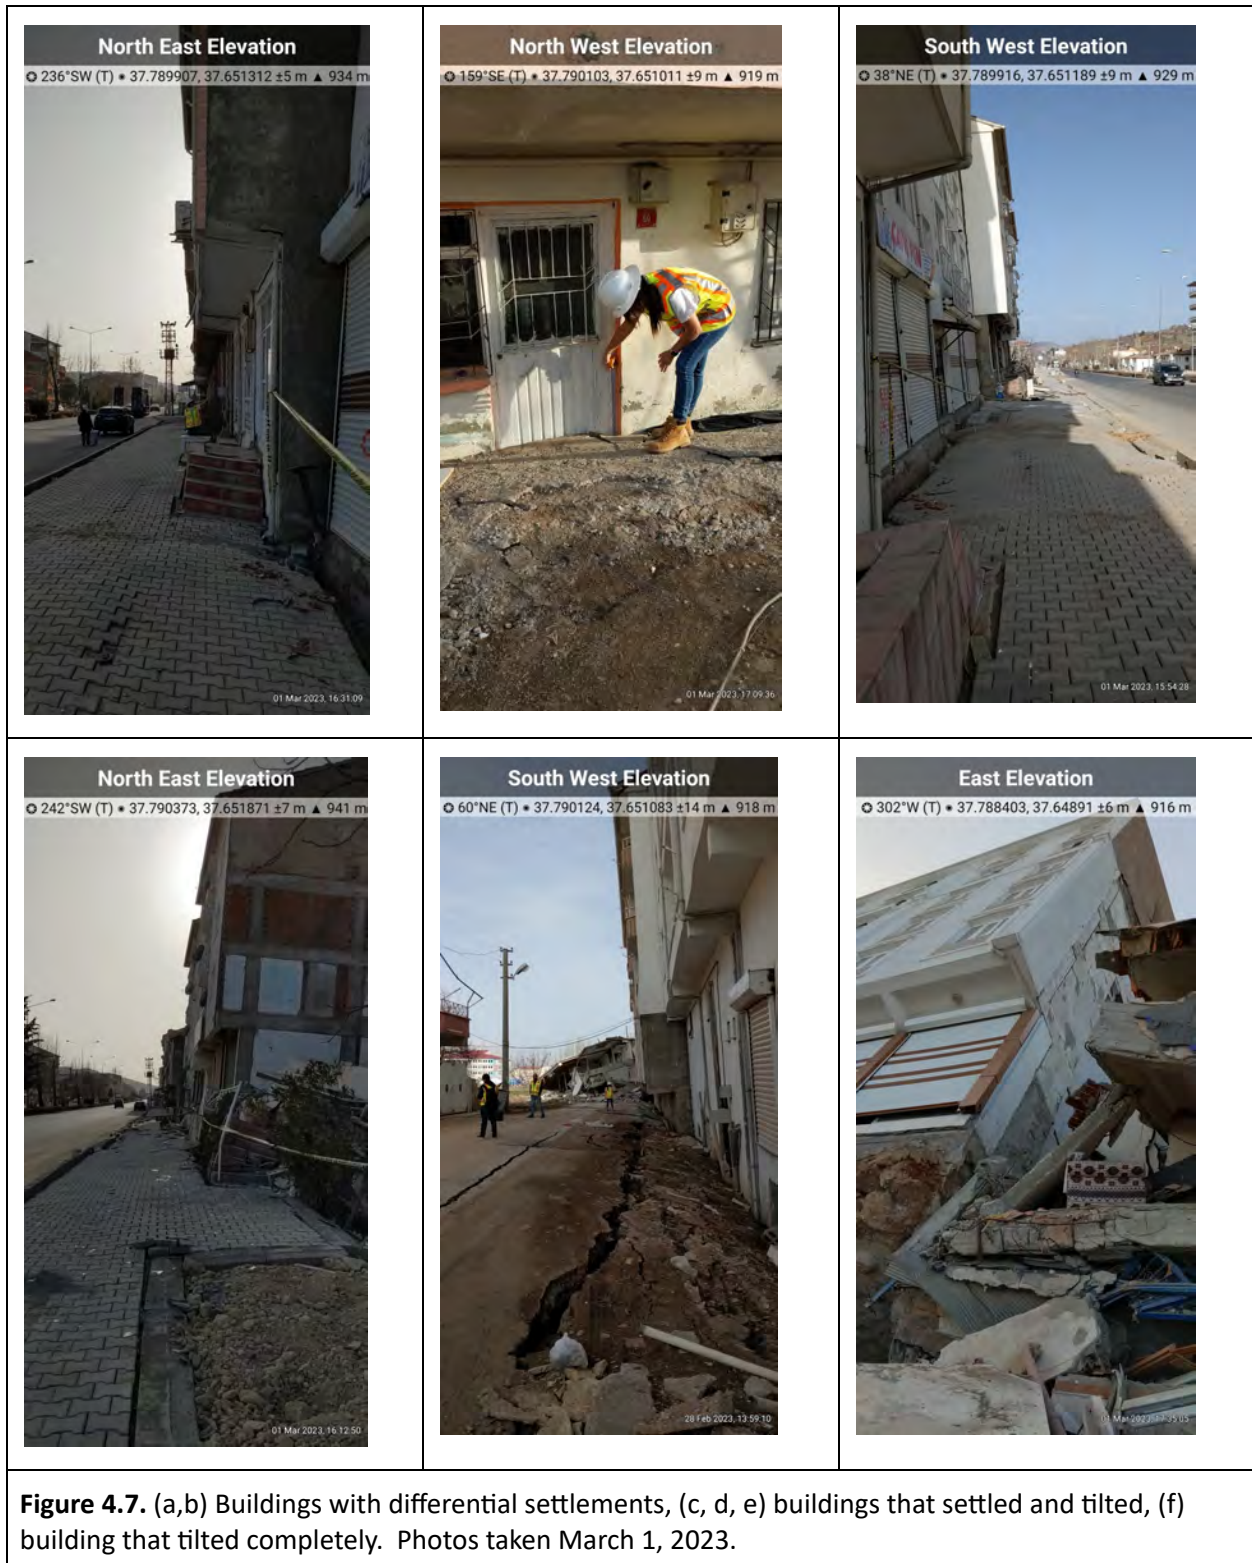
Figures 4.7 -4.8 illustrate representative liquefaction-induced damage patterns in buildings at Gölbaşı. Figure 4.1 shows the general location of these buildings and the coordinates in the photos show specific locations. The patterns are complex, but the presence of ejecta is apparent and there is significant cracking. Specific descriptions are on the figure captions, but in general the observations can be grouped in four categories: (1) buildings with differential settlement (e.g., Fig. 4.7a,b), (2) buildings with uniform settlements (e.g., Fig. 4.8), (3) buildings with differential settlements and tilting (e.g., Fig. 4.7 c,d,e), and (4) few buildings with a significant tilt and only supported by near buildings (e.g., 4.7f)

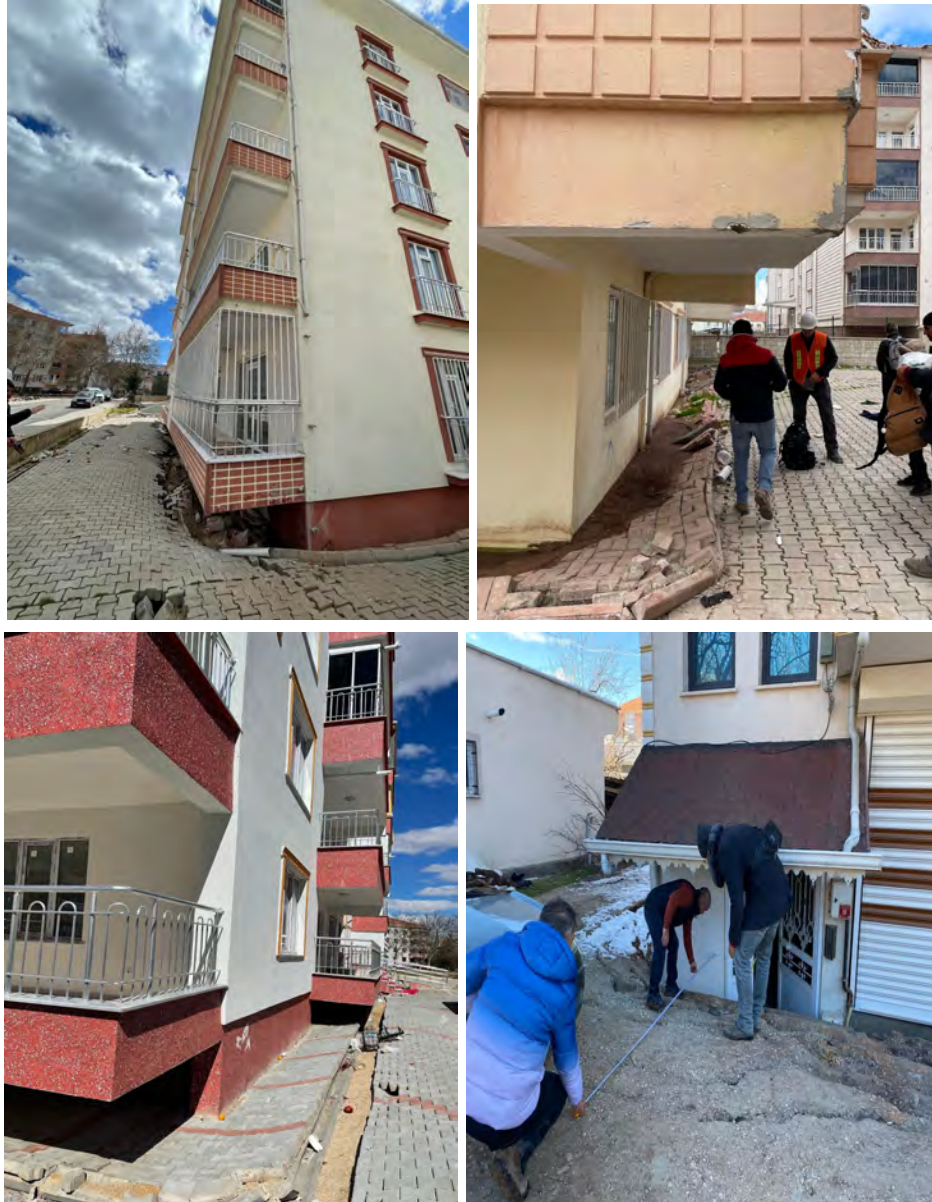
**Figure 4.8.** Buildings with uniform settlements in the Gölbaşı area (37.78686 N, 37.63738 E).

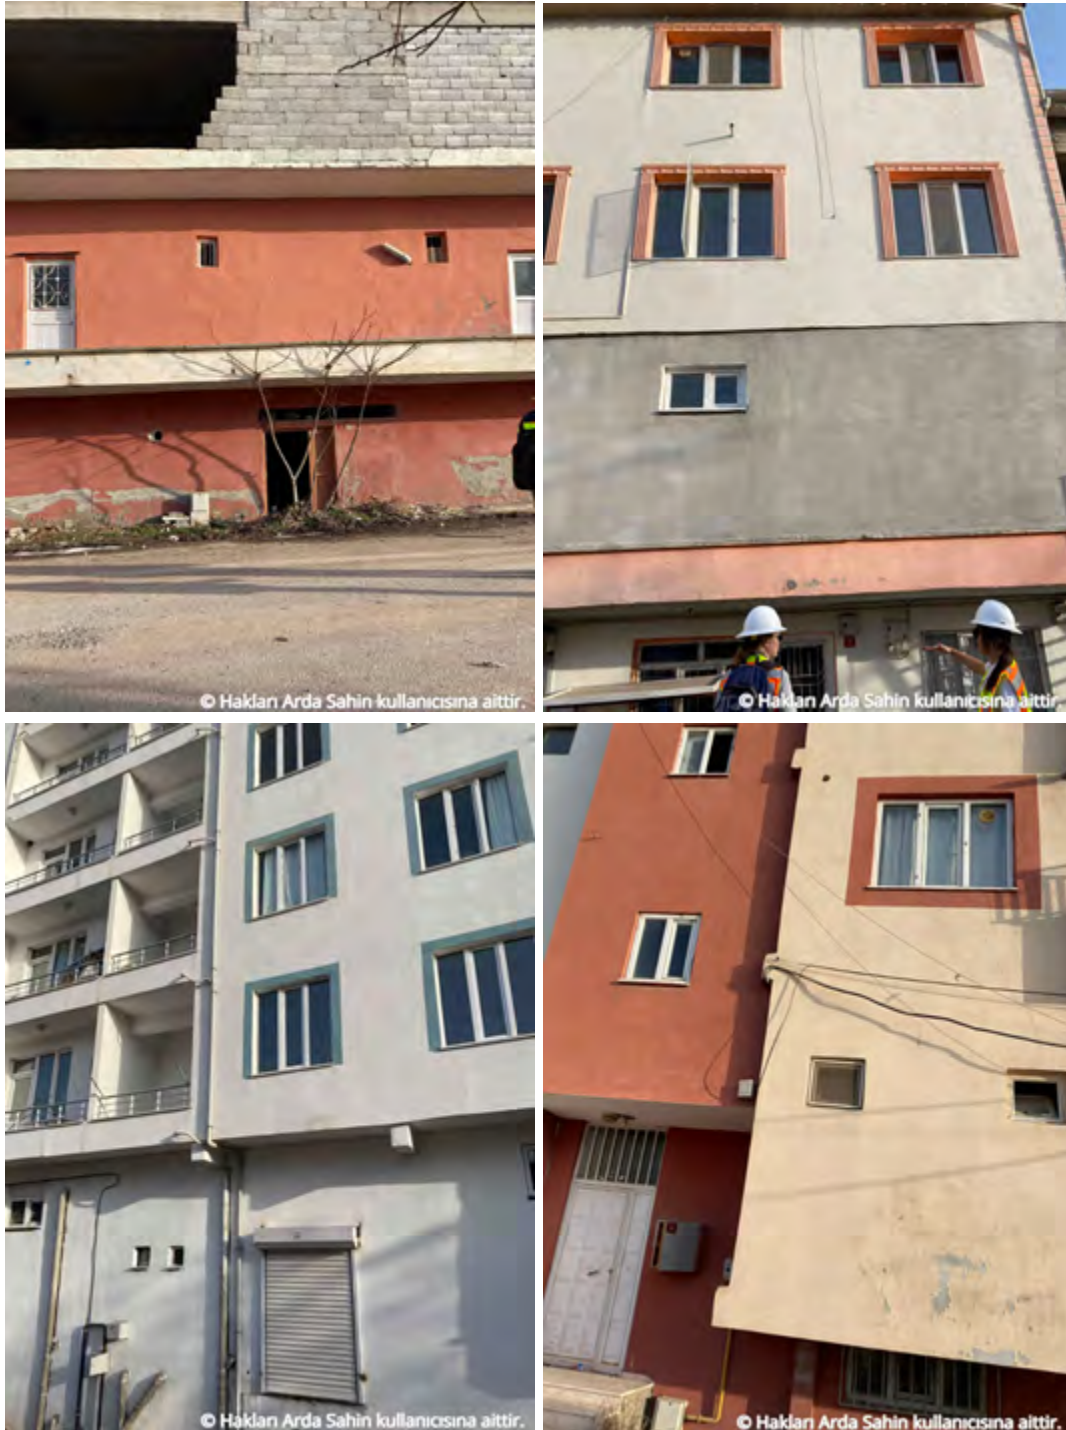
**Figure 4.9.** Top left: coordinates -37.78994, 37.65102, no tilt, vertical Settlement 20 cm, GF3, D1. Top right: coordinates -37.79000, 37.65115, no tilt, vertical settlement 30cm, GF3,D0. Bottom left: coordinates- 37.79003, 37.65122, no tilt, settlement 99 cm, GF3, D1. Bottom right: coordinates- 37.78978, 37.65076, 1 degree tilt, 10 cm settlement, D0, GF2.

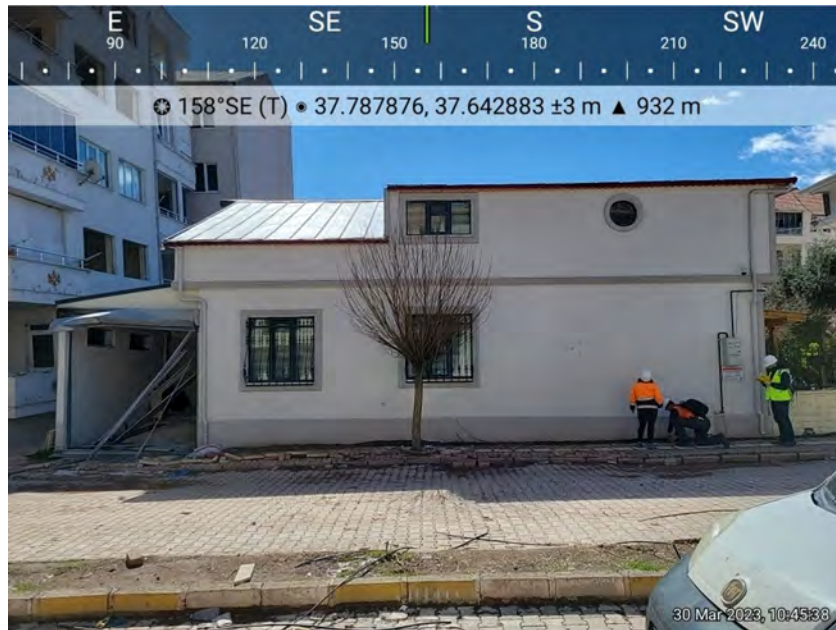
Negligible settlement was observed at the two-story single-residential building (37.787737N, 37.642873E). The building is a 10.32 m north-to-south and 13.4 m east-to-west with an additional 2 m wide garage on the east side (Figure 4.12a). The building is approximately 5.6 m high. The structure appears to be cinder block and plaster construction with no apparent basement. Although there was negligible settlement documented, there was damage to the structure that appeared to be due to ground deformation at the structure to the east. Figure 4.12b shows the notable settlement at the east-adjacent structure. An approximately 10-cm crack was observed on the south side of the building near the connection between the house and the garage; additionally, a 1 degree tilt towards the house was measured on the east wall of the garage.

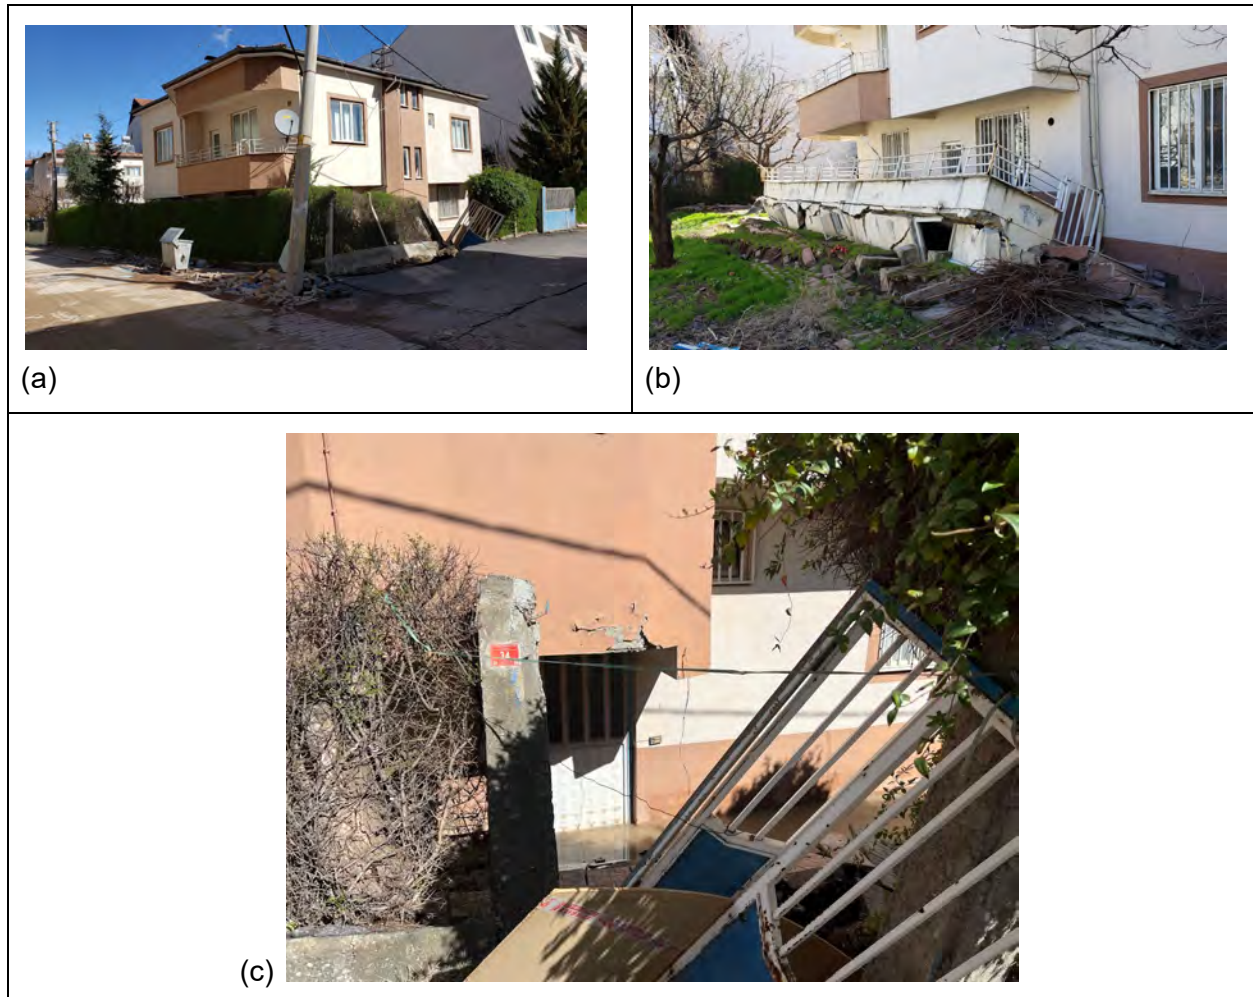
**Figure 4.13.** Settled two-story residential building with a partial basement in Gölbaşı: (a) view of building from southwest corner (N37.787388°, E37.642918°), (b) collapsed deck over partial basement along north wall (N37.787781°, E37.642868°), (c) front door entrance at southwest corner with over 1.1 m of measured settlement (N37.787494°, E37.643019°). Photographs taken on March 30, 2023.

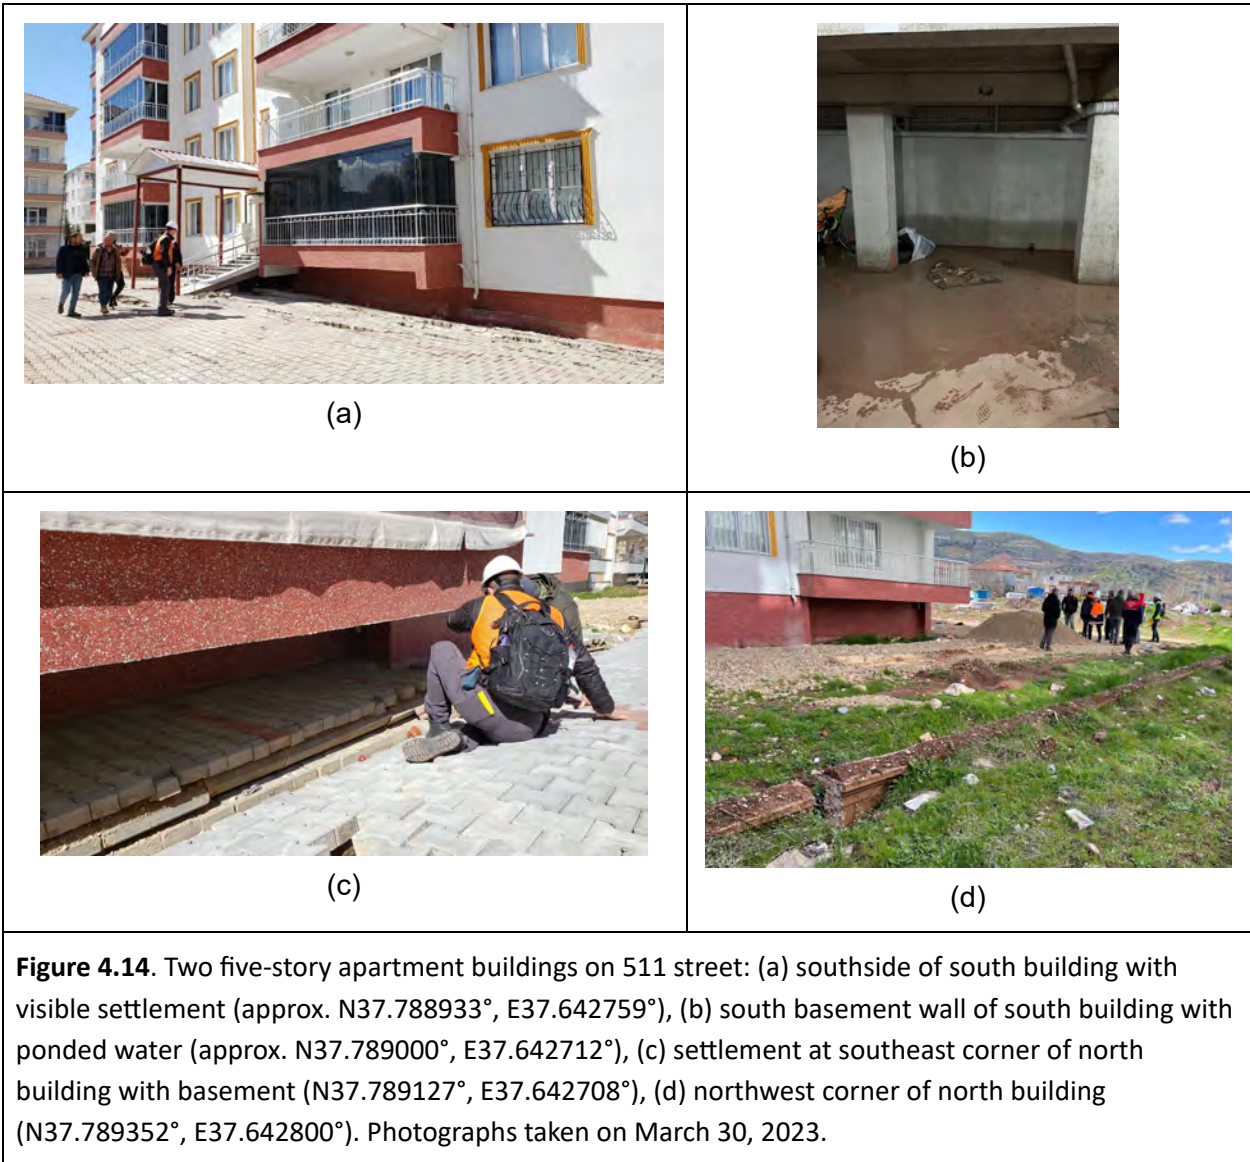
## 4.2 İskenderun, Hatay
