MAY 6, 2023

# FEBRUARY 6, 2023 TÜRKIYE EARTHQUAKES: REPORT ON GEOSCIENCE AND ENGINEERING IMPACTS

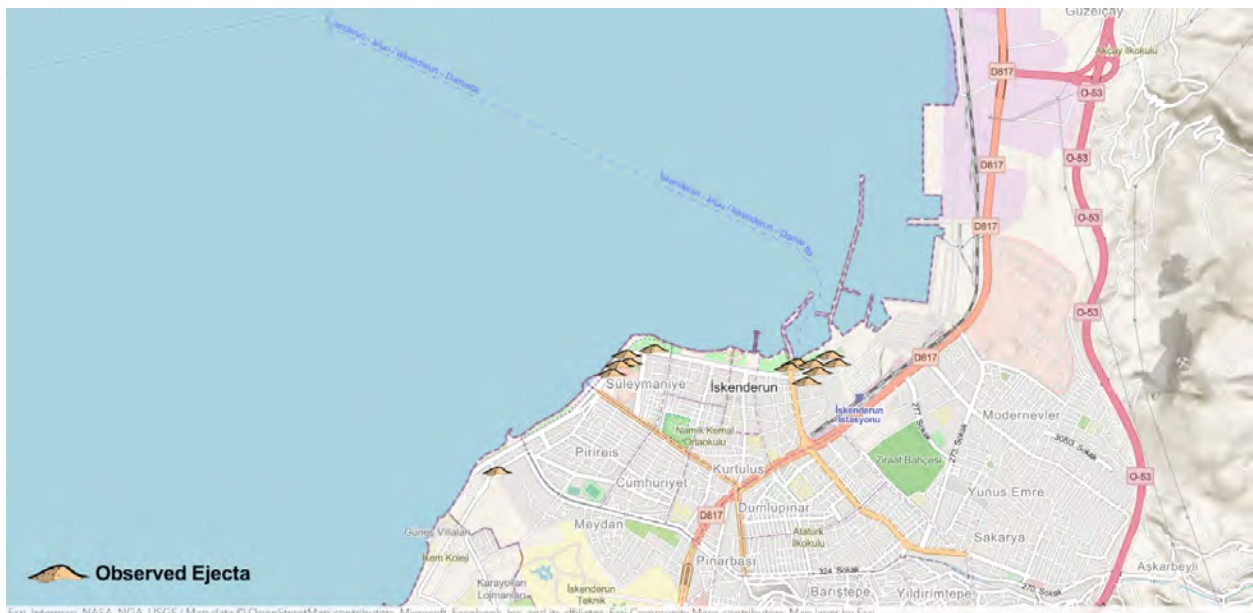
**Figure 4.15.** Areas visited between February 26 and March 5 (Phase 2) where liquefaction induced hazards were observed.

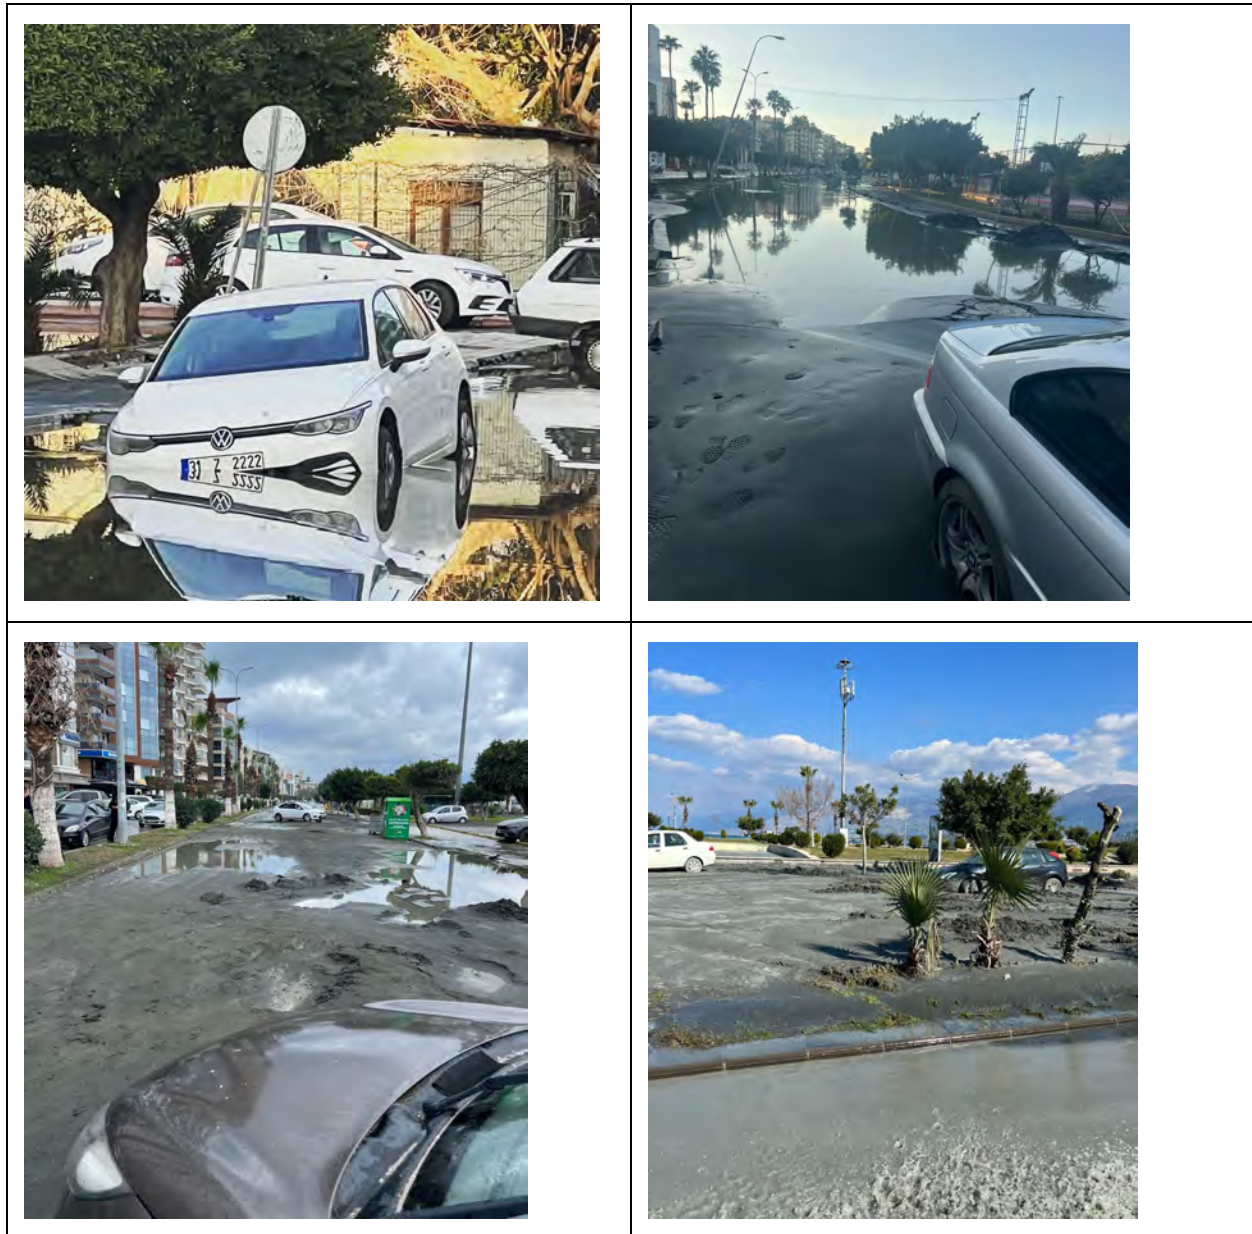
**Figure 4.16** Liquefaction induced sand ejecta that inundated portions of Atatürk Boulevard after the Mw7.8 mainshock photographed by a local in the area prior to the second main shock.

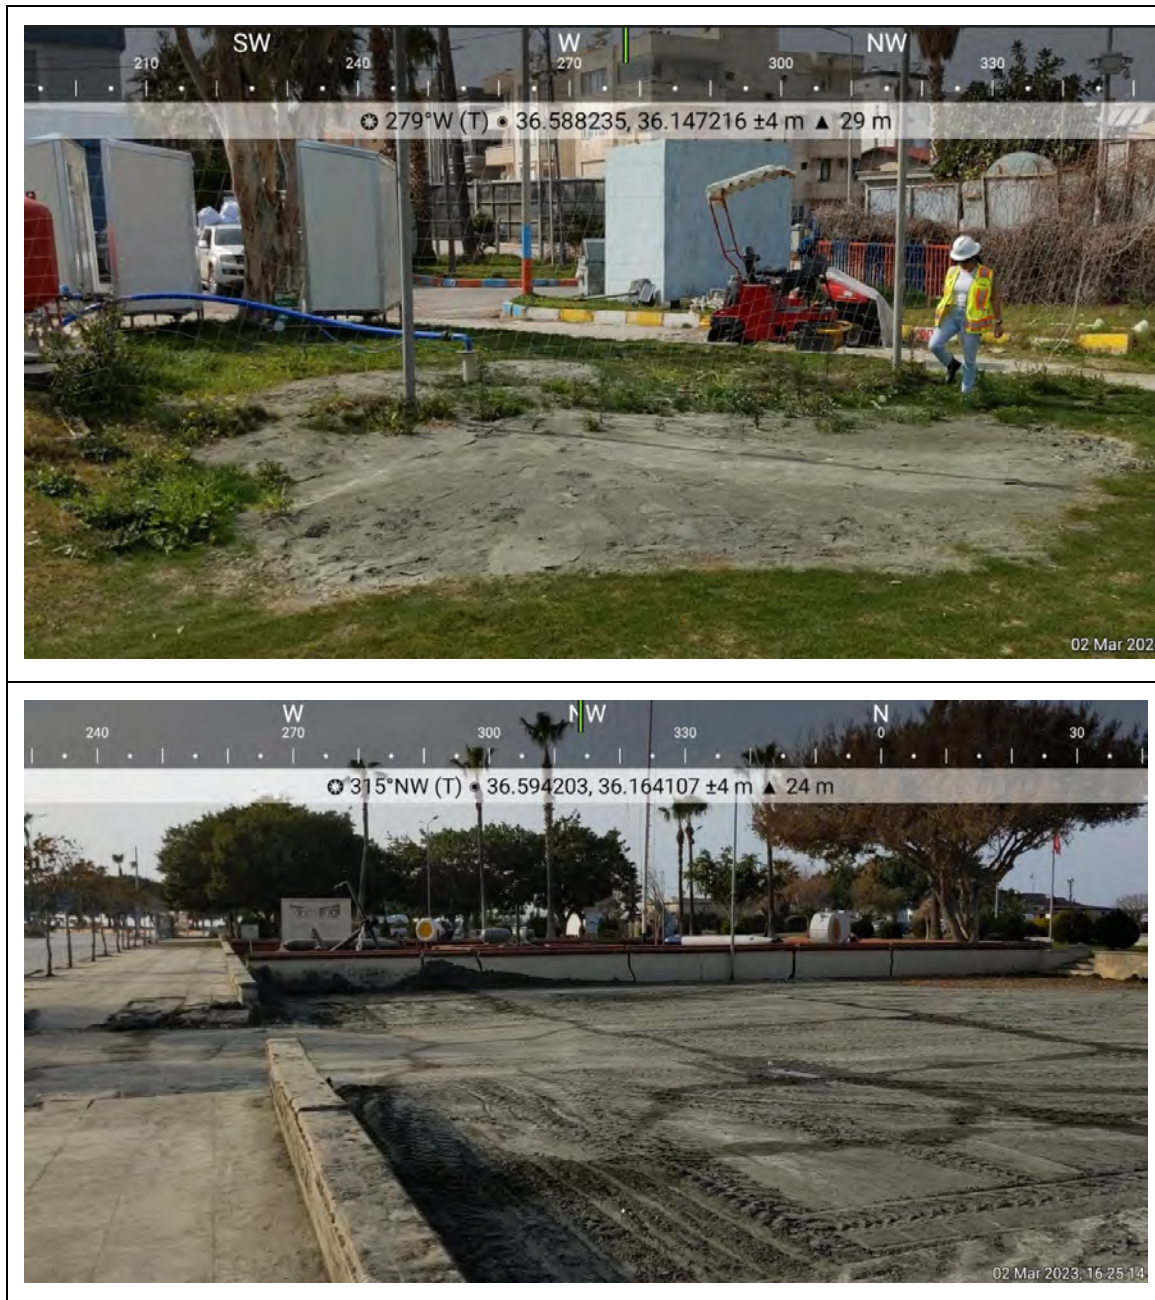
**Figure 4.17.** Liquefaction ejecta observed along the waterfront park along Atatürk Boulevard. (36.59431, 36.16419)

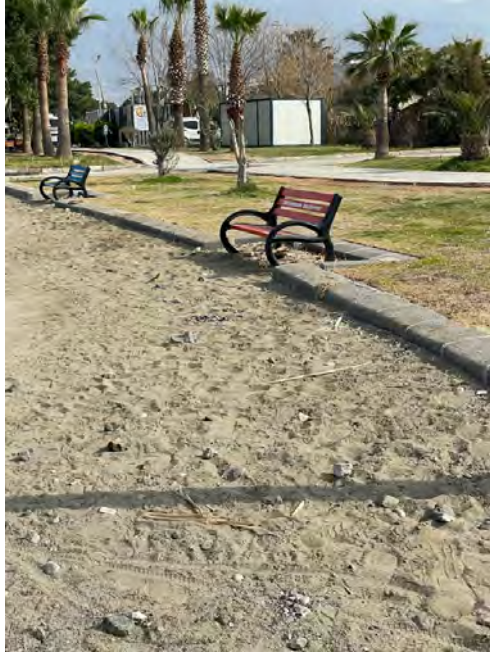
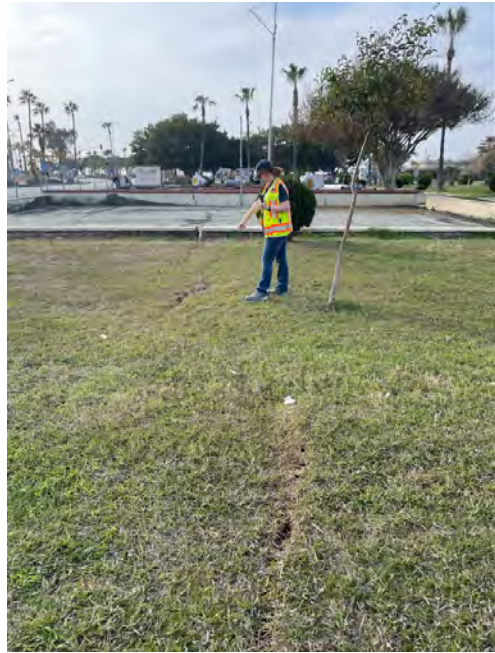
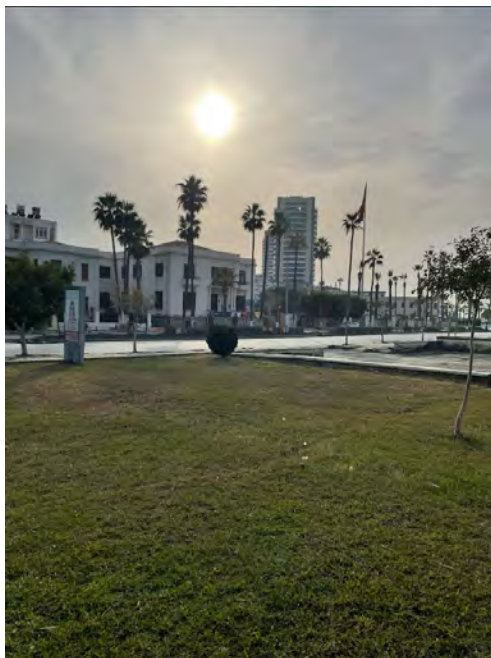
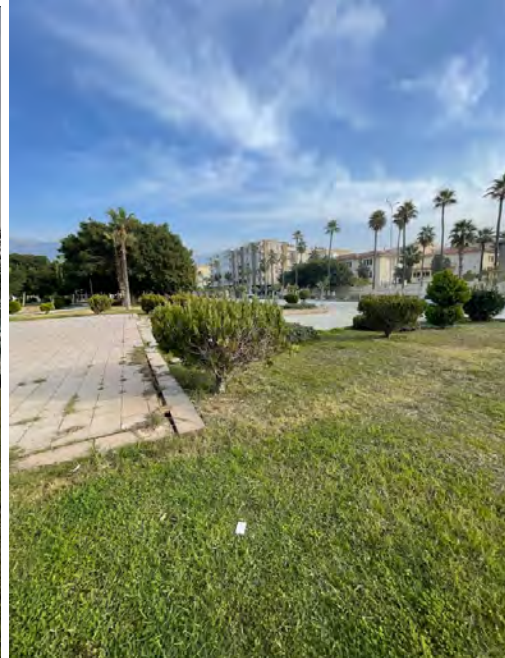
**Figure 4.18** Despite Atatürk Boulevard being covered by ejecta after the earthquakes, no ejecta was observed in the grass areas of the neighboring waterfront park. Coordinates: 36.59431, 36.16426.

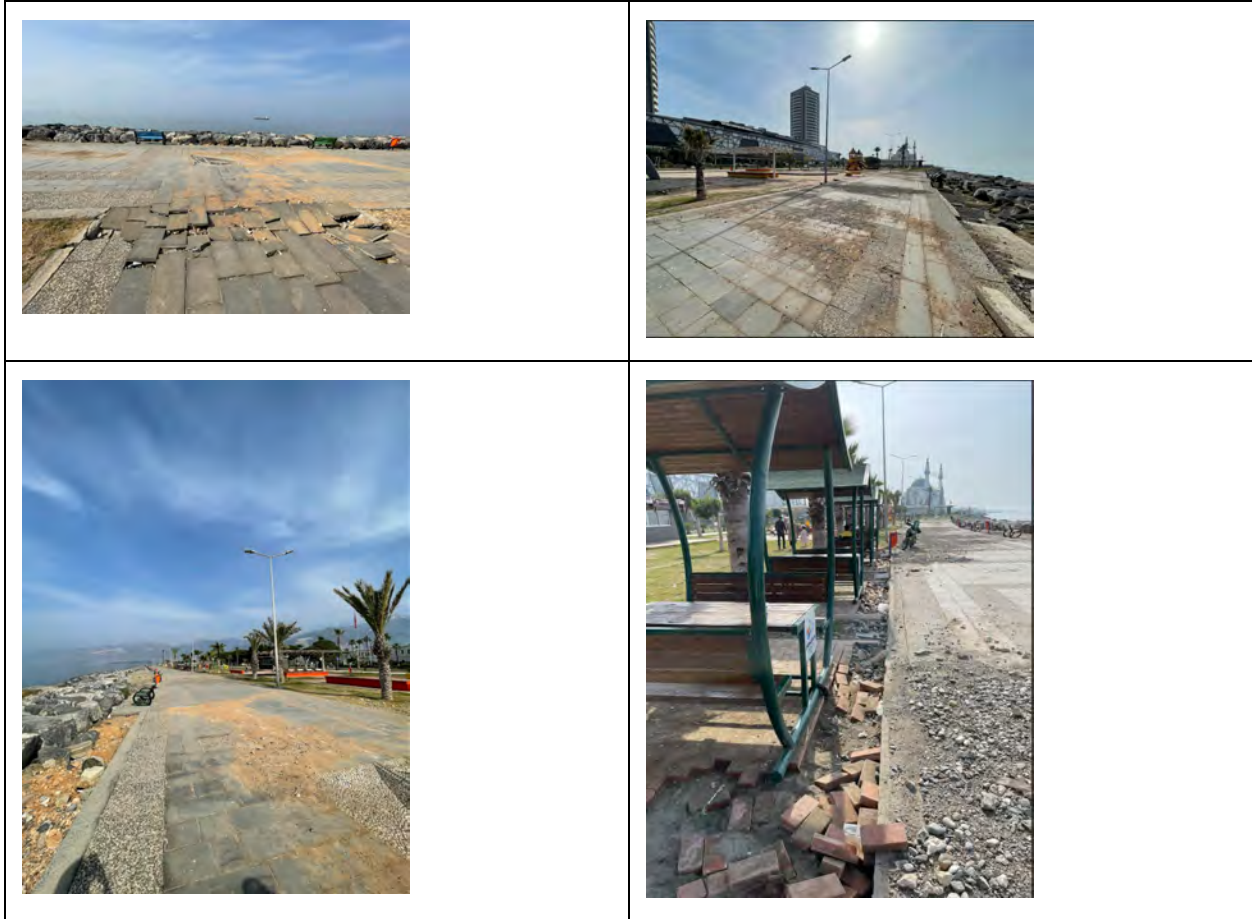
**Figure 4.19.** Observed cracks and base course ejecta along the waterfront boardwalk. (March 2, 2023; 36.59456N, 36.16024E)

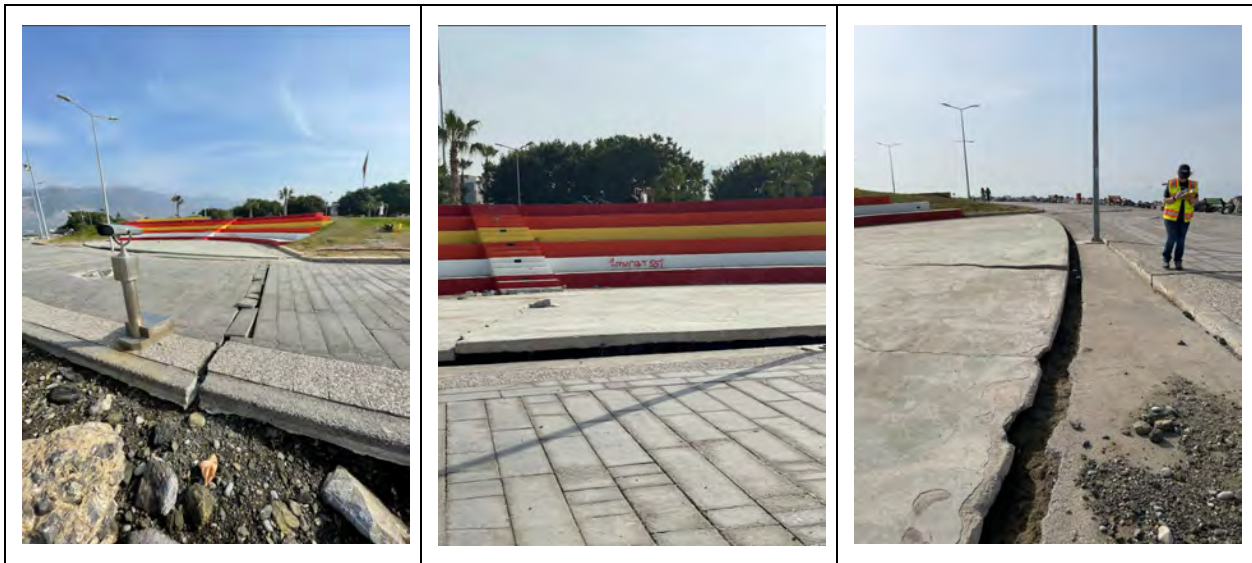
**Figure 4.20.** Lateral and vertical displacement at the amphitheater located on the waterfront boardwalk. (March 2, 2023; 36.59573N, 36.16206E)

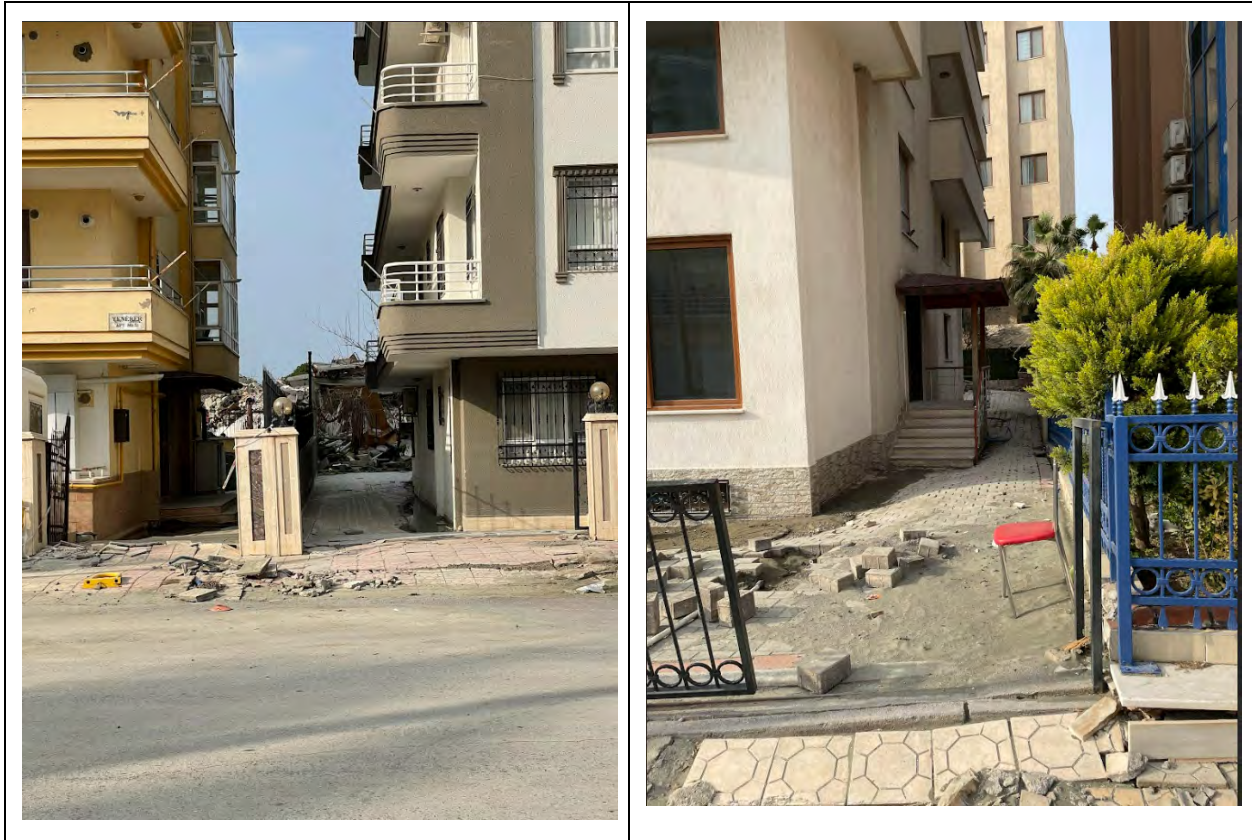
The northern end of the Atatürk Boulevard around Çay neighborhood was built with 4 to 5 story residential buildings. A majority of these buildings did not appear to suffer significant structural damage but instead experienced significant damage due to liquefaction induced ground failure. The measured building settlements in this area were as much as 60 cm with respect to the free field (Figure 4.21).

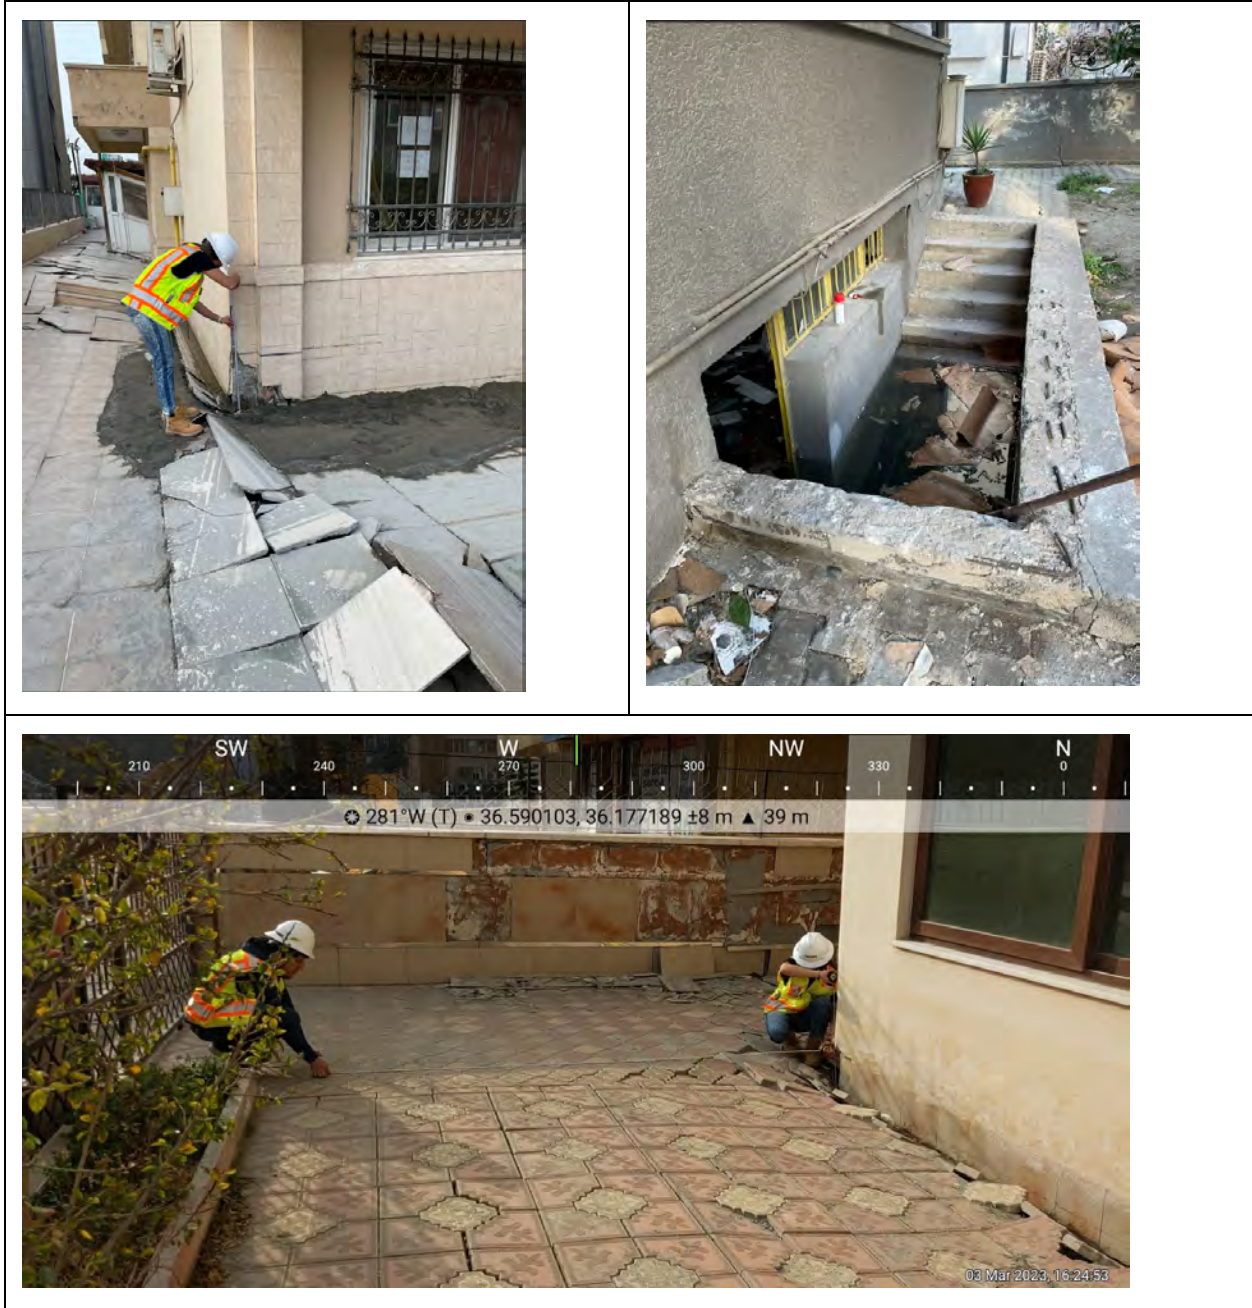
**Figure 4.21.** (5 images in all) Some four- to five-story buildings located to the northern end of the Atatürk Boulevard near Çay neighborhood experienced liquefaction induced settlement over 60 cm in some locations. Some of the buildings that included a basement experienced less liquefaction-induced settlement but the basement levels were flooded.

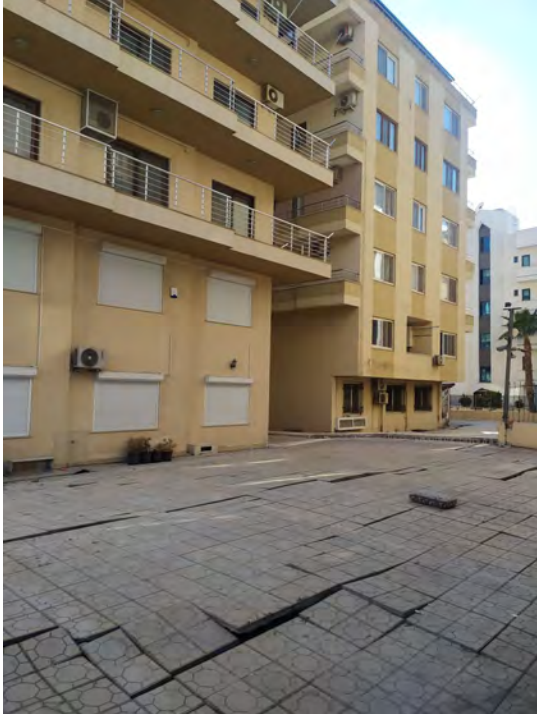
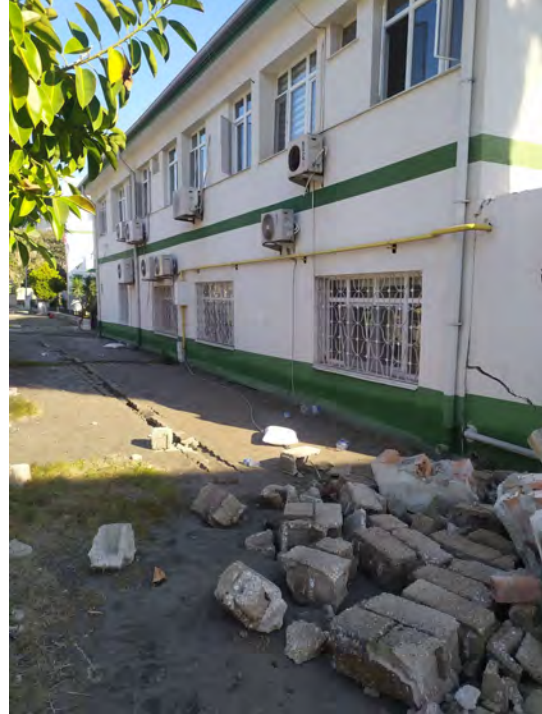
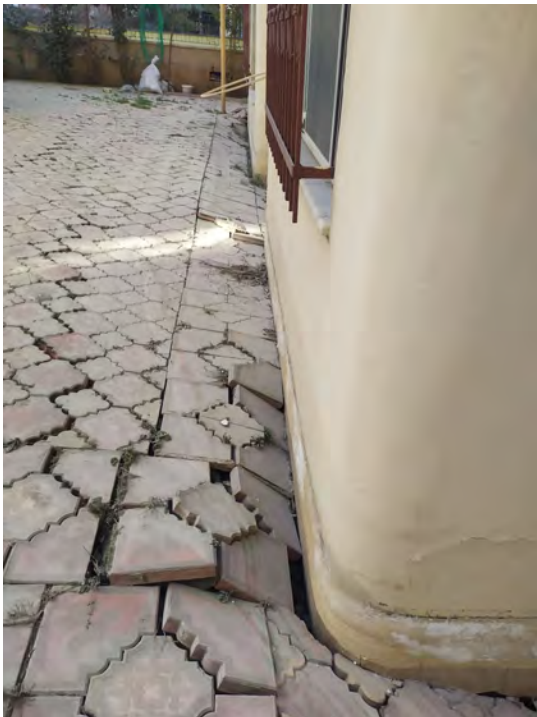
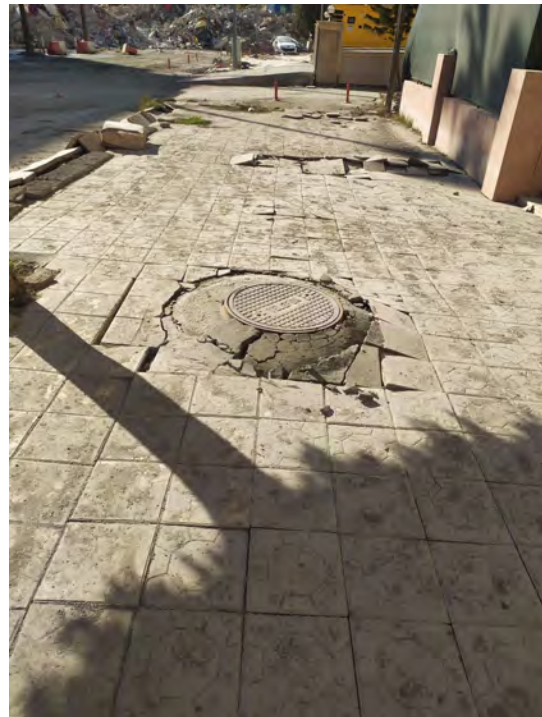
**Figure 4.23:** Liquefaction-induced building settlements in Iskenderun, Hatay (36.589045 N, 36.176512 E).

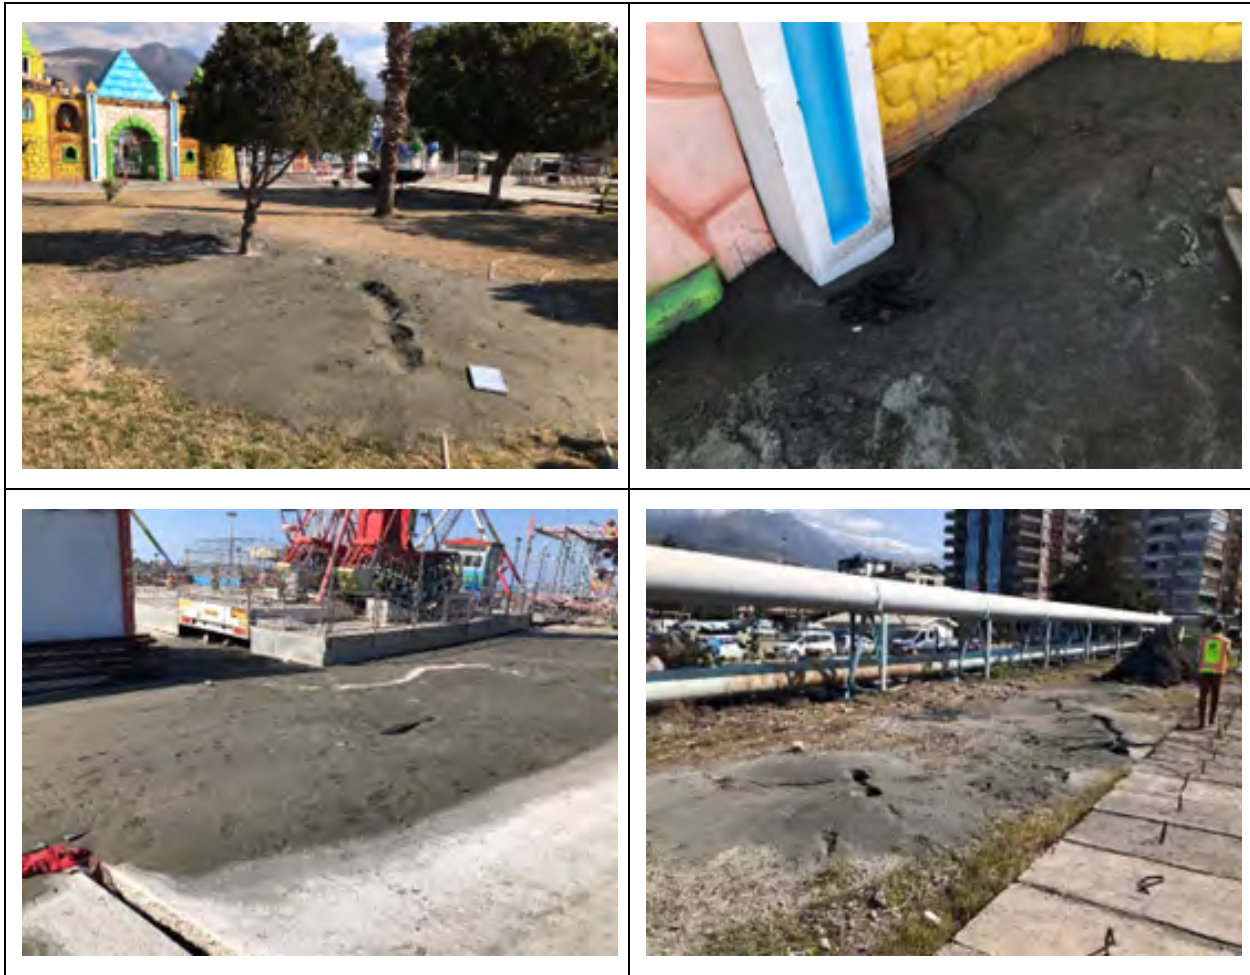
**Figure 4.24:** Liquefaction-induced ejecta in Atatürk Boulevard (36.591661 N, 36.175382 E).

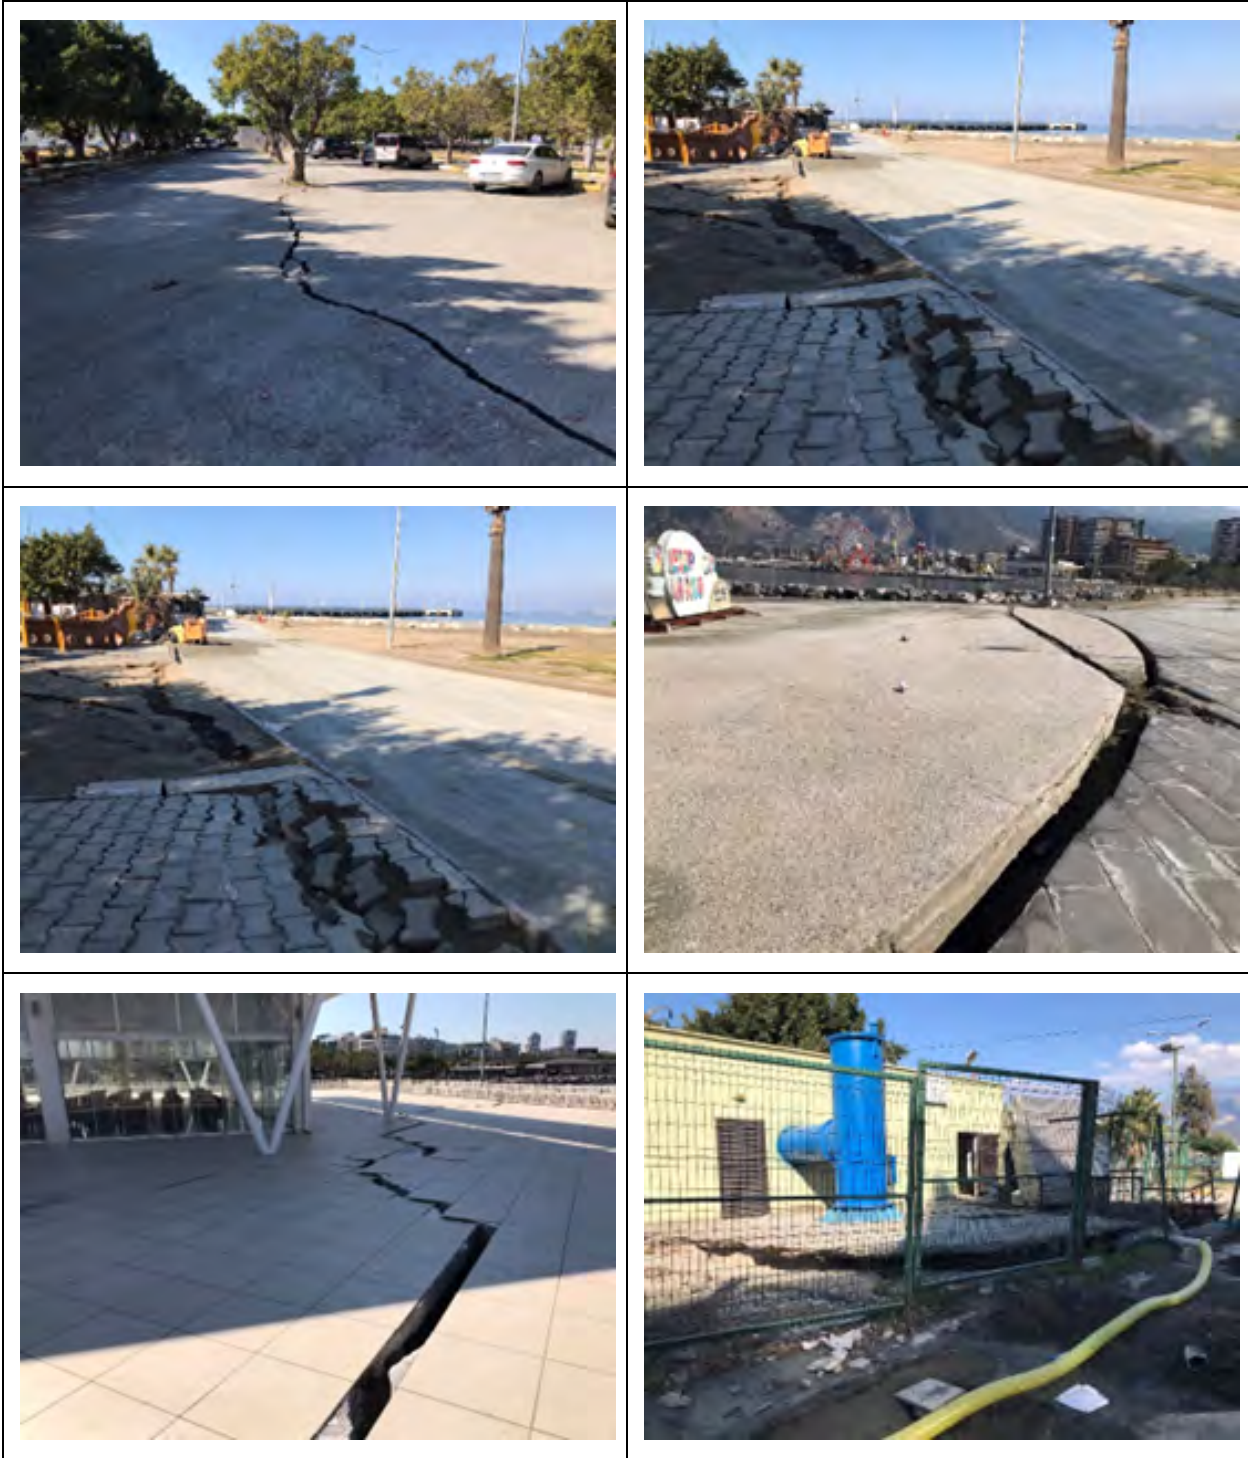
**Figure 4.25:** Examples of liquefaction-induced lateral spreading at Atatürk Boulevard (36.59147 N, 36.174378 E).

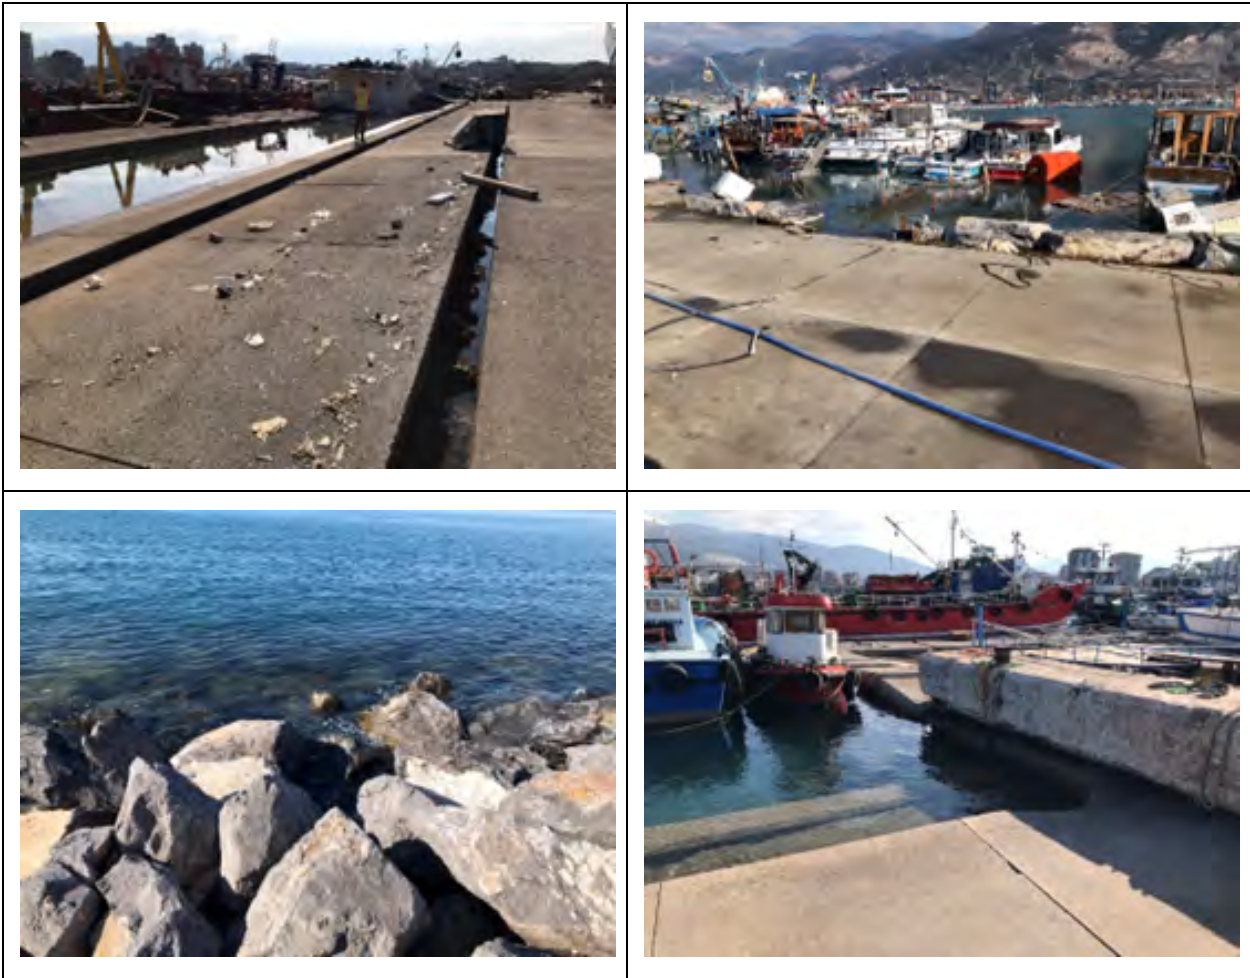
The İskenderun Harbor is located on Atatürk Boulevard, where there was evidence of liquefaction-induced lateral spreading after the earthquakes. The lateral spreading varied between 50-100 cm on the dock (Figure 4.26). According to the eyewitnesses, the docks were found directly on the sand layer, and the sand ejected due to ground shaking and continued for more than one day. They stated that the whole port settled 80-100 cm (Figure 4.26), and boulders on the breakwater spread 3-15 meters away from its original position (Figure 4.26).

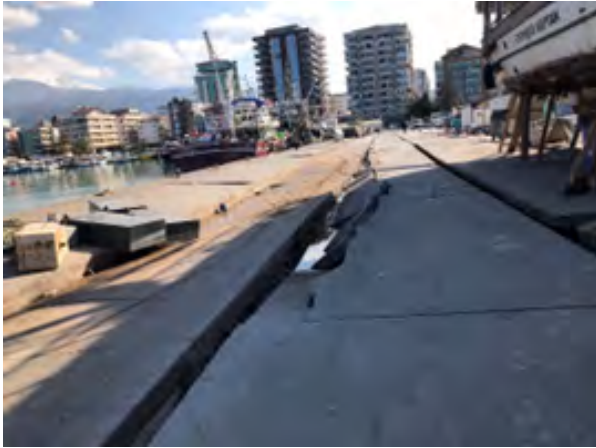
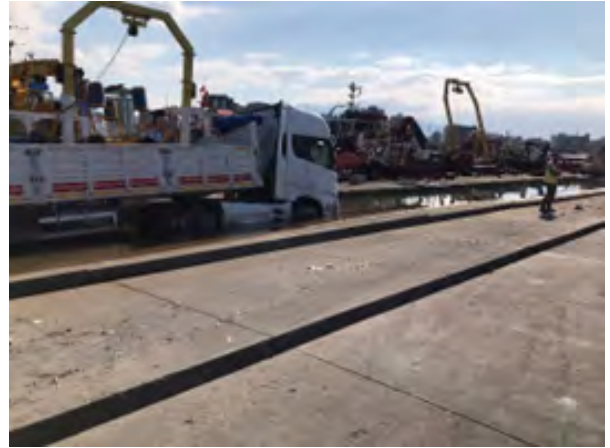
**Figure 4.26:** (6 images in all) Lateral spreading and settlements at Iskenderun Harbor (36.59308 N, 36.175733 E)

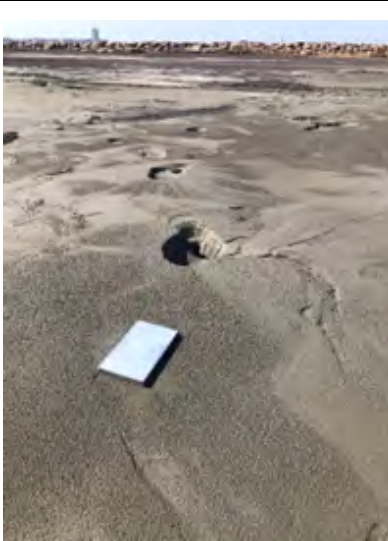
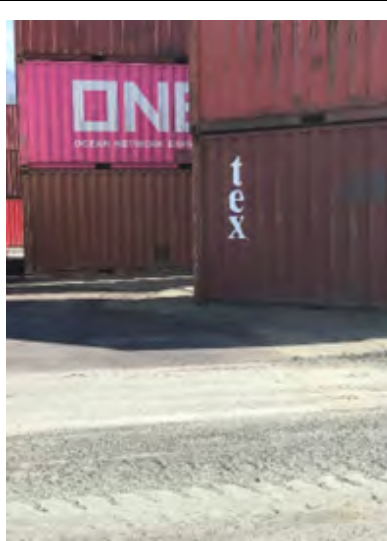
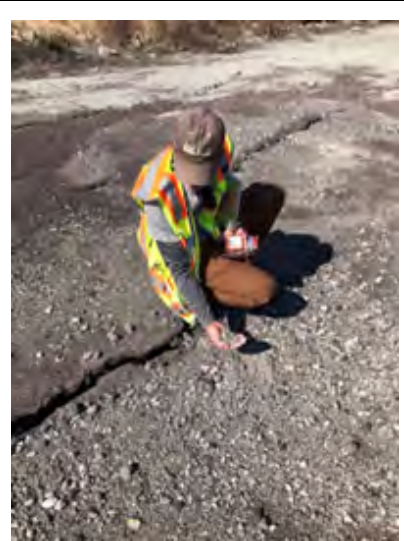
**Figure 4.27:** Sand boils, cracks and gravel ejecta due to seismic soil liquefaction in a private port in Iskenderun (36.603545 N, 36.19225 E).

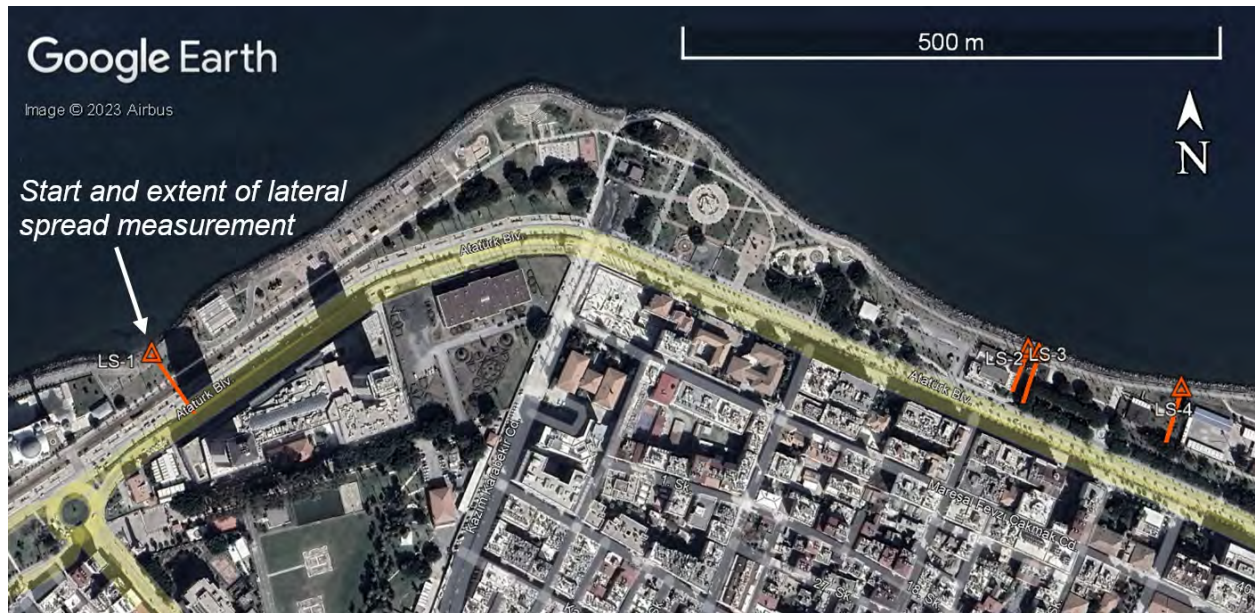
**Fig 4.28.** Map of measured lateral spread locations (LS-1 to -4) extending from the seawall in Iskenderun, Hatay Province, Türkiye (Google Earth® image dated February 16, 2023, centered near N36.5928°, E36.1632°).

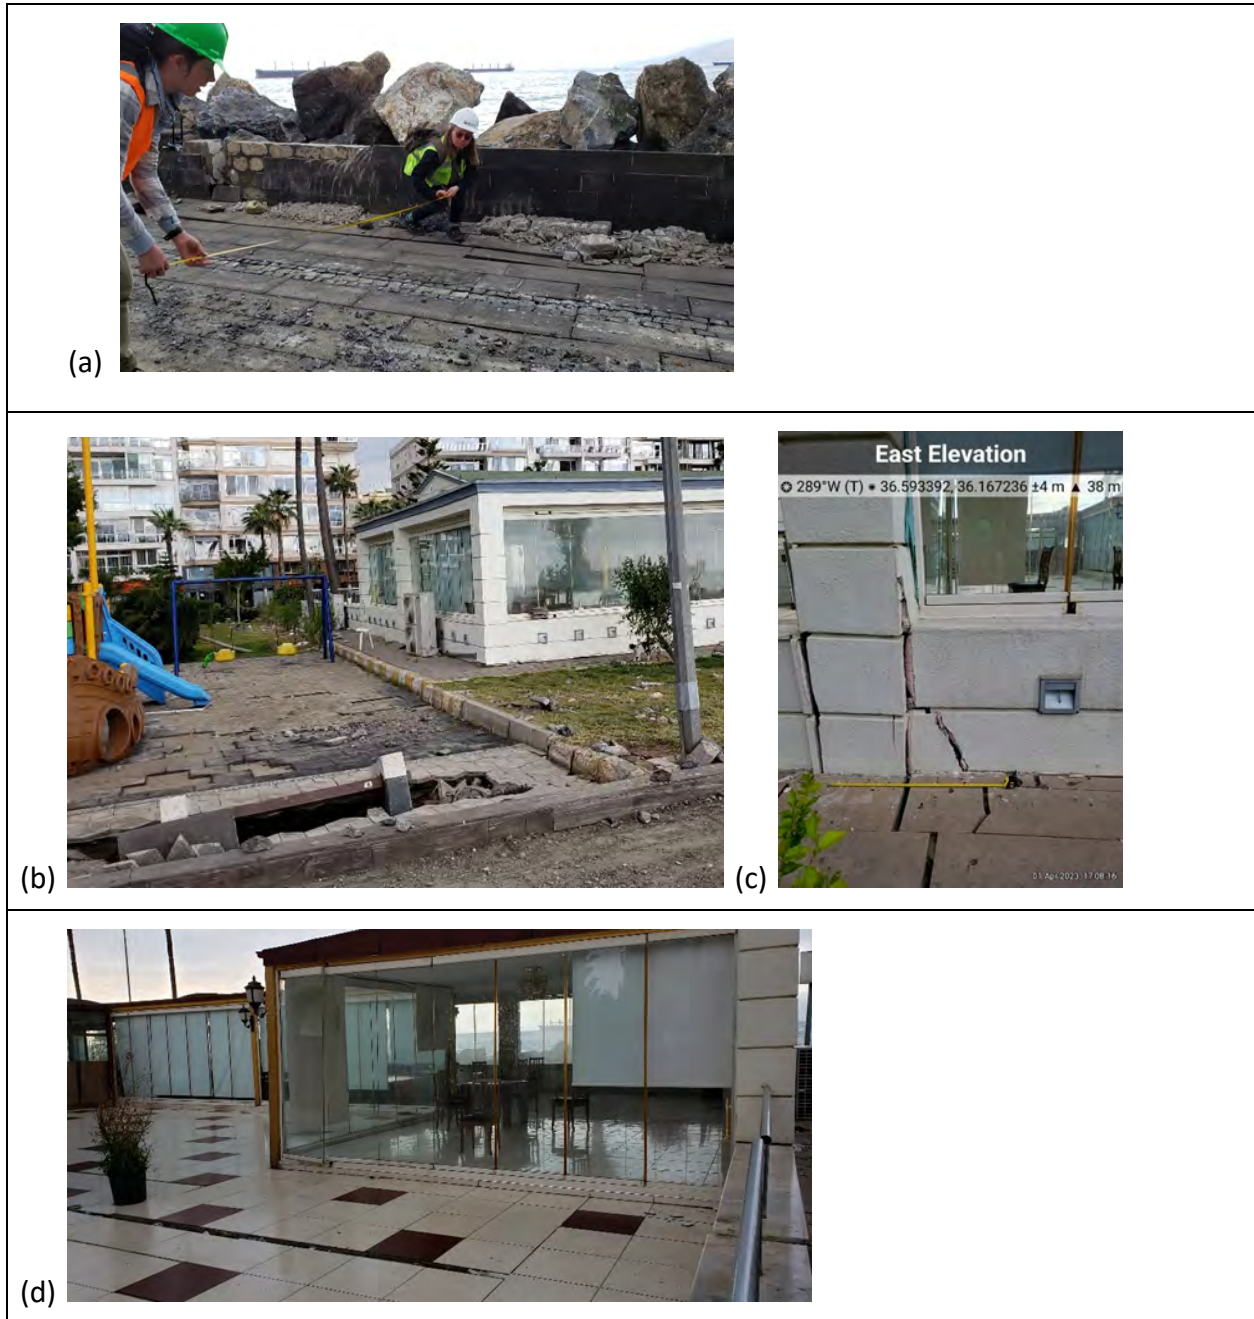
**Fig 4.30.** Photos of lateral spread LS-2 taken April 1, 2023: (a) seawall at start of LS-2 (N36.59367°, E36.167191°), (b) sunken park bench and spreading along eastern wall of Doğan restaurant patio (N36.59367°, E36.167191°), (c) cracks near column at southeast corner of patio (N36.593392°, E36.167236°), (d) cracking along back of patio (N36.59345°, E36.16712°).

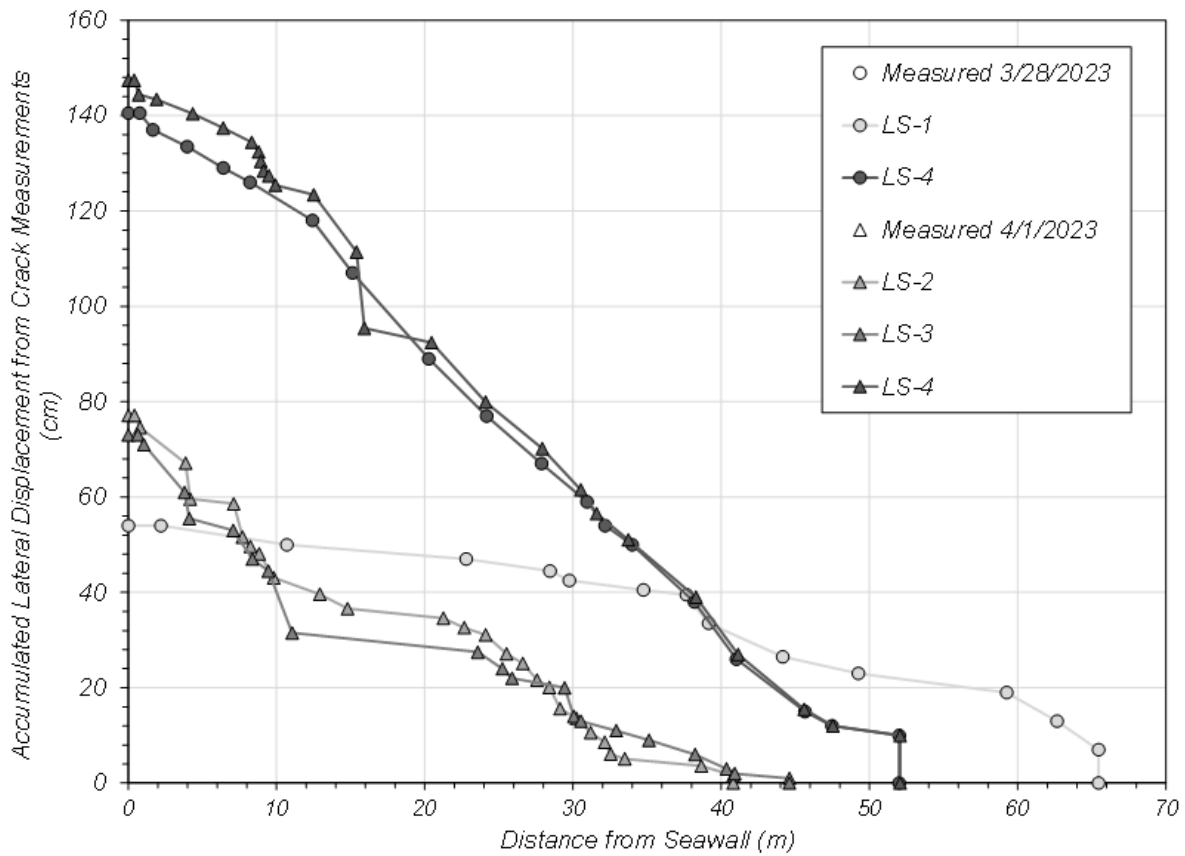
**Fig 4.33.** Accumulated lateral displacements as measured from crack opening widths along LS-1 to -4 relative to distance from the seawall in Iskenderun.

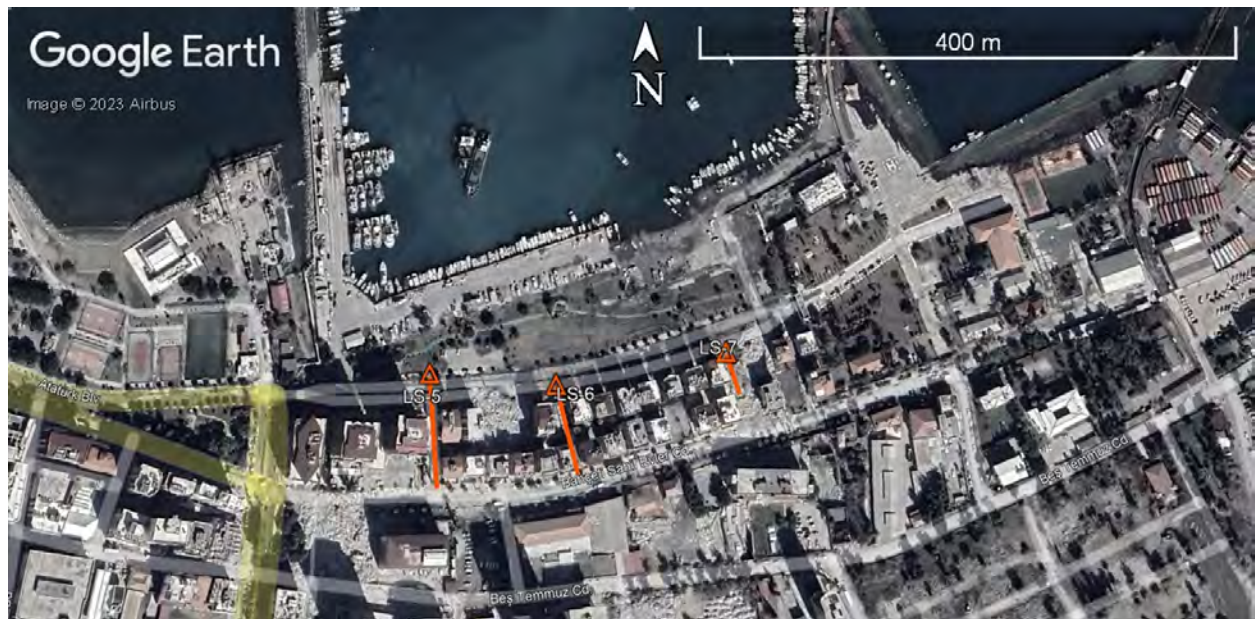
**Fig 4.34.** Map of measured lateral spread locations (LS-5 to -7) extending from Atatürk Boulevard in the Çay district of İskenderun, Hatay Province, Türkiye (Google Earth® image dated February 16, 2023, centered near N36.5906°, E36.1784°).

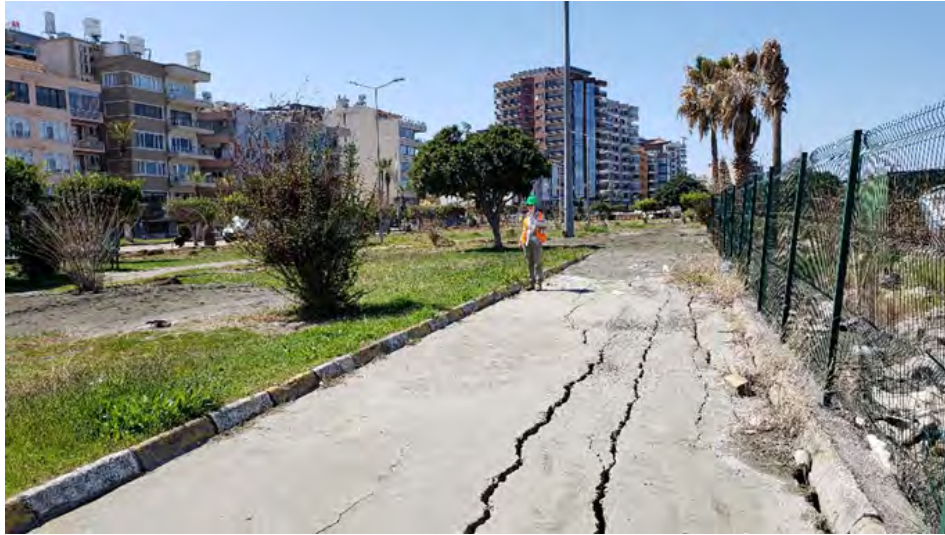
**Figure 4.35.** Sand boils and lateral spreading near boat dock in Cay district of Iskenderun, Hatay Province, Türkiye (N36.591476°, E36.178898°).
