MAY 6, 2023

# FEBRUARY 6, 2023 TÜRKIYE EARTHQUAKES: REPORT ON GEOSCIENCE AND ENGINEERING IMPACTS

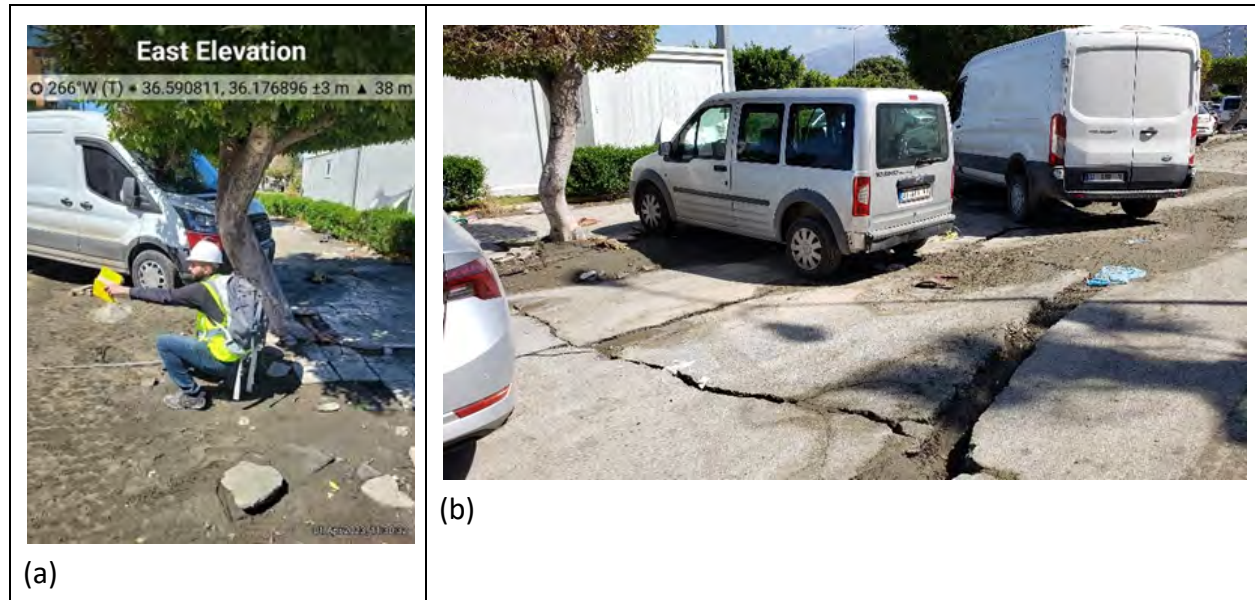
Figures 4.36 to 4.38 depict photos along each lateral spreading transect. Figures 4.36a-e depict measurements along LS-5, which begins at the sidewalk near the park along the north side of Atatürk Blvd. A separated block of about 2-m-wide and >30-m-long was observed along Atatürk Blvd, exhibiting a minor down-drop vertical offset of about 5 cm and bounded by 10-12 cm and 18-20 cm wide lateral extension cracks (Fig 4.36b). Additional minor cracking was observed southward along LS-5, including a 5 cm crack aligned with the front edge of a nearby building foundation at the south side of Atatürk Blvd.

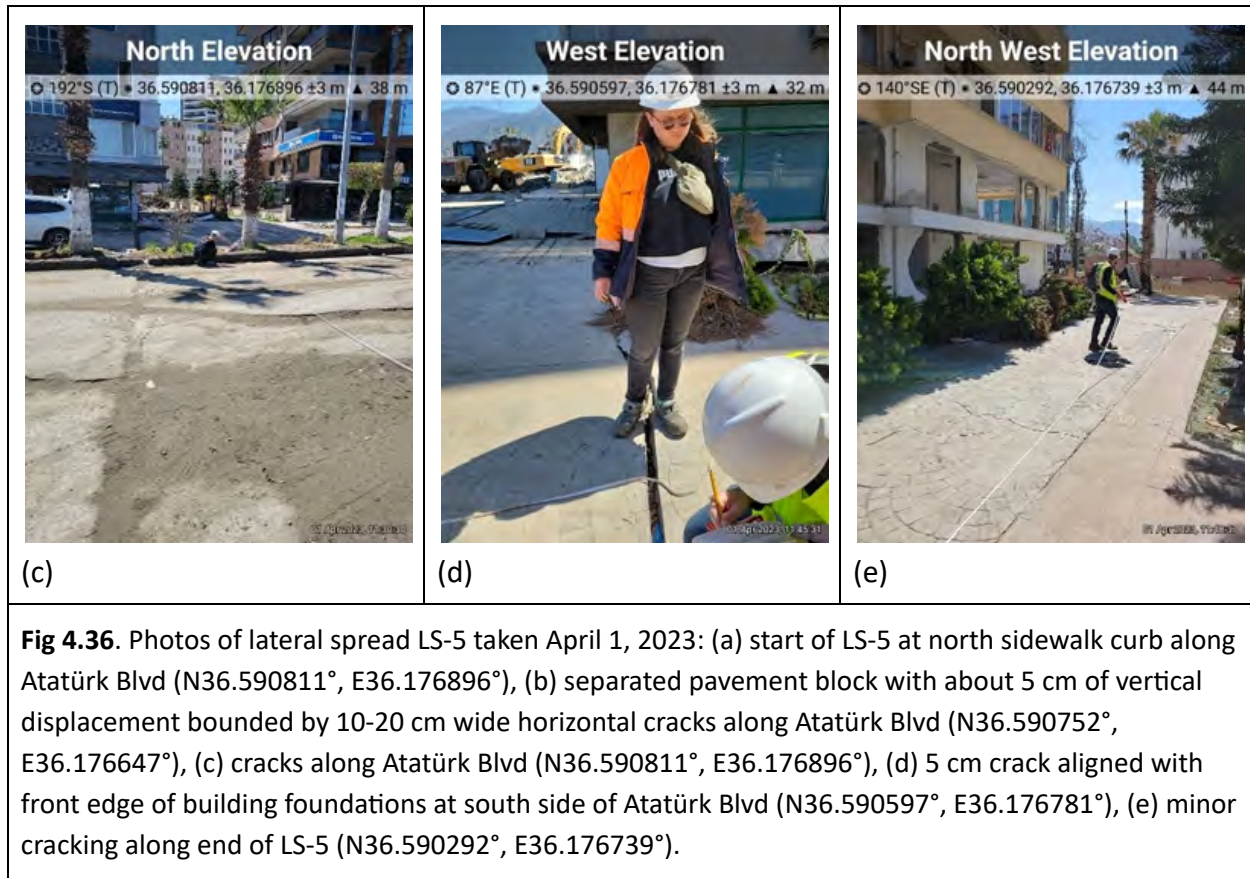
Figures 4.37a-d depict measurements along LS-6, which begins at the south side of Atatürk Blvd and runs between two rows of buildings parallel to Atatürk Blvd. The adjacent buildings had settled and measurements of settlement are discussed in Section 4.6 of this report. Observed ground cracking was typically minor directly adjacent to the buildings, but became more pronounced in the alley/backside area between the two rows of buildings. Measurements taken along a lot boundary wall in this area (Figures 4.37b-c) depicted extension cracks totaling over 17 cm in width over an 8 m segment (>2% extensional strain). The building at the south of LS-6 (No. 24 Kaan Ela) was built over deep foundations, but the failure of adjacent fill had created a void along the foundation perimeter (Figure 4.37d). Shore parallel cracks were not observed in this area but may have been accommodated by the void.

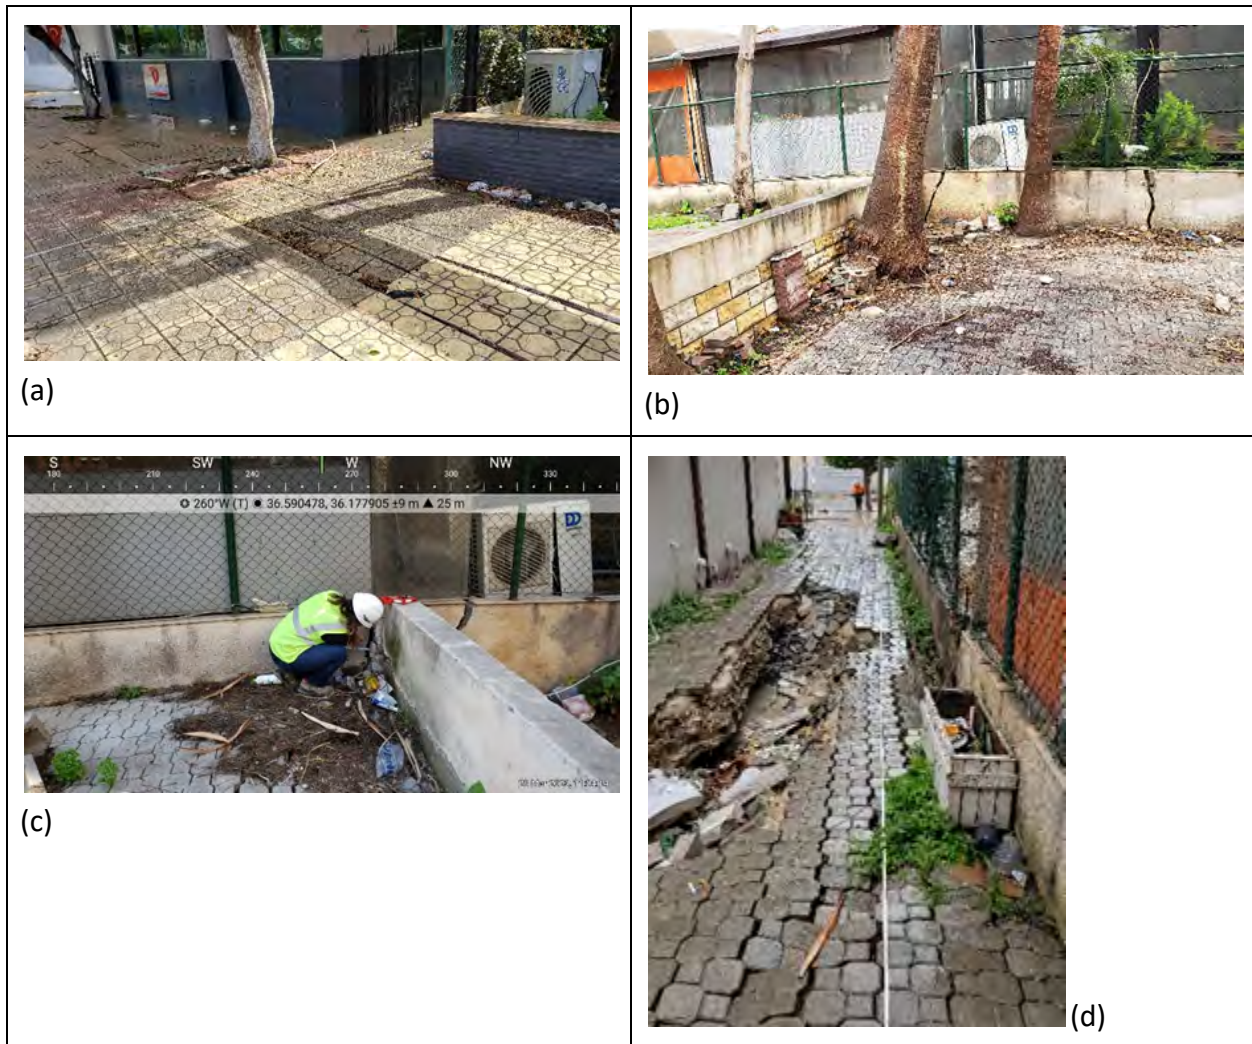
**Figure 4.37.** Photos of lateral spread LS-6 taken March 28 and 29, 2023: (a) start of LS-6 at south sidewalk along Atatürk Blvd in front of building Belli Apartment #18A (N36.590652°, E36.177784°), (b) cracking along wall behind buildings (N36.590435°, E36.177746°), (c) cracking along wall behind buildings (N36.590478°, E36.177905°), (d) end of LS-6 along the side of building Kaan Ela #24 (N36.590458°, E36.17794°).

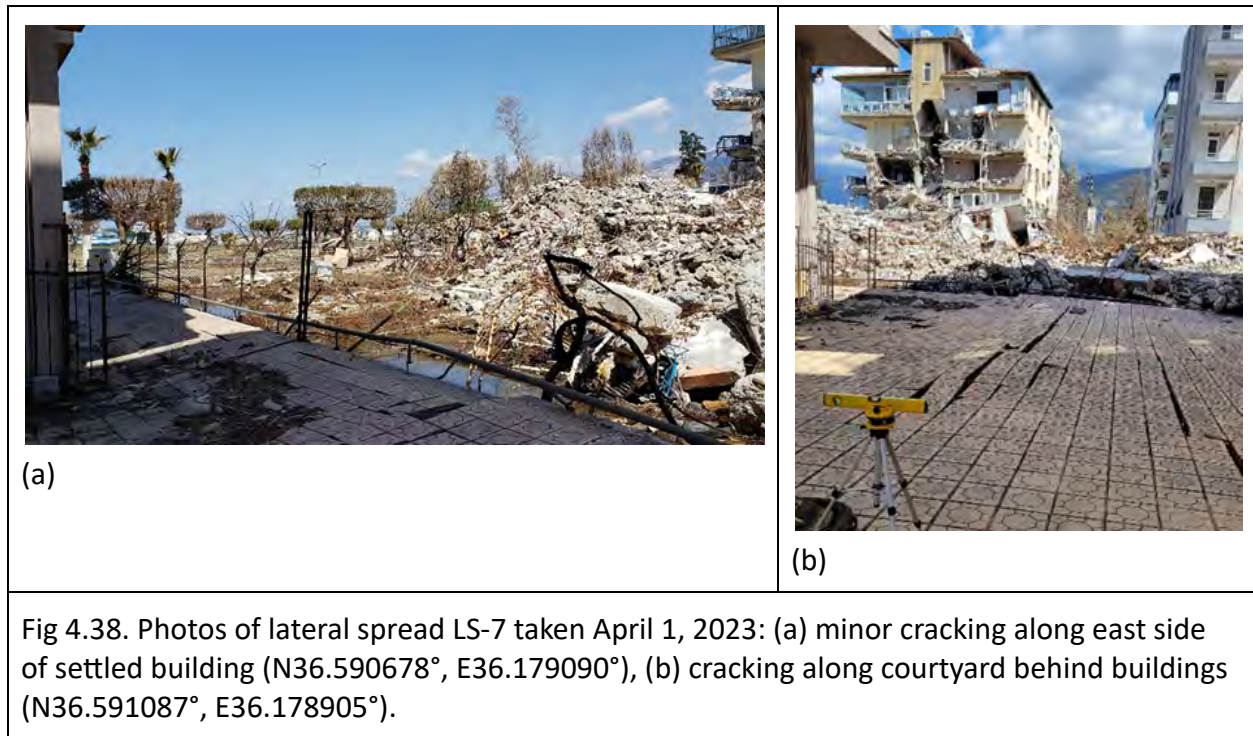
Figures 4.38a-b depict measurements along LS-7, which begins at the south side of Atatürk Blvd and runs along the east edge of the “four buildings” case study site of Section 4.6.1.3. Observed ground cracking was typically minor directly adjacent to the northeast corner building (No. 28). The east side of this building was an empty lot being used for holding post-earthquake debris. Cracking along LS-7 became more pronounced in the alley/backside area of the buildings, where the hogsback deformation bulge was observed (Figure 4.38b).

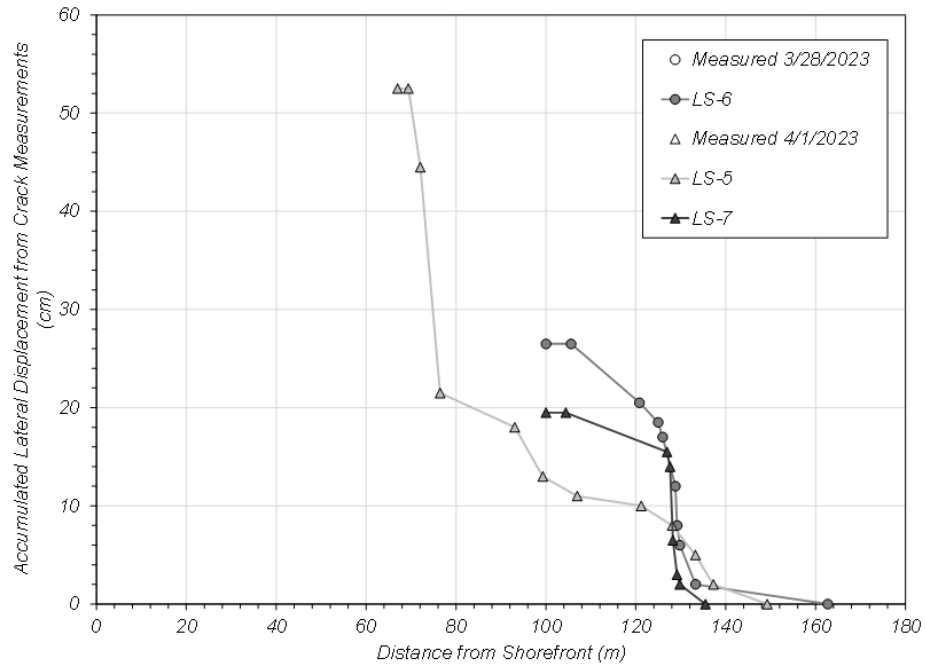
Fig 4.39. Accumulated lateral displacements as measured from crack widths along LS-5 to -7 relative to distance from the approximate shorefront of the Çay district in İskenderun.

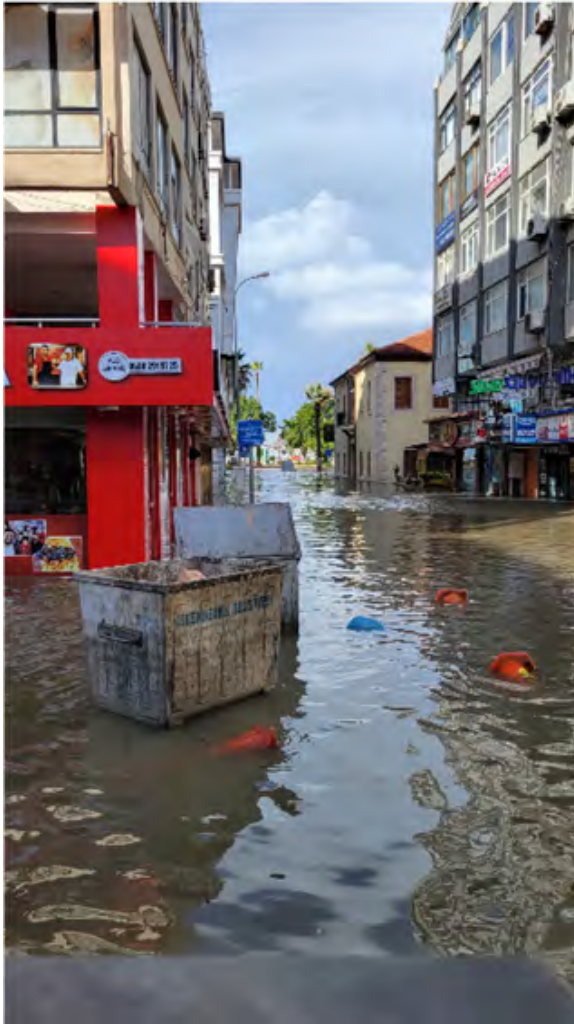
The GEER Phase 3 team observed notable flooding that took place on March 29th 2023 (Figure 4.40); on this day there was heavy rainfall and strong winds in the İskenderun area. The flooding was observed from the Cay district and southeast along Ataturk Boulevard and the shoreline to past Mithatpaşa Cadiz. The photos show that there was flooding at least two roads in from the shoreline, including past Mareşal Fevzi Çakmak Caddesi (Figure 4.40a), and past Bahçeli Sahil Evler Caddesi (Figure 4.40b) in the Cay district. The flooding on April 1st was observed by the team to advance from the shoreline. The team returned to İskenderun and Çay on April 1, 2023 when flooding had largely subsided, however there was significant standing water remaining. Drone footage taken on April 1 2023 with observations of standing water in the Çay district is shown in Figure 4.41.

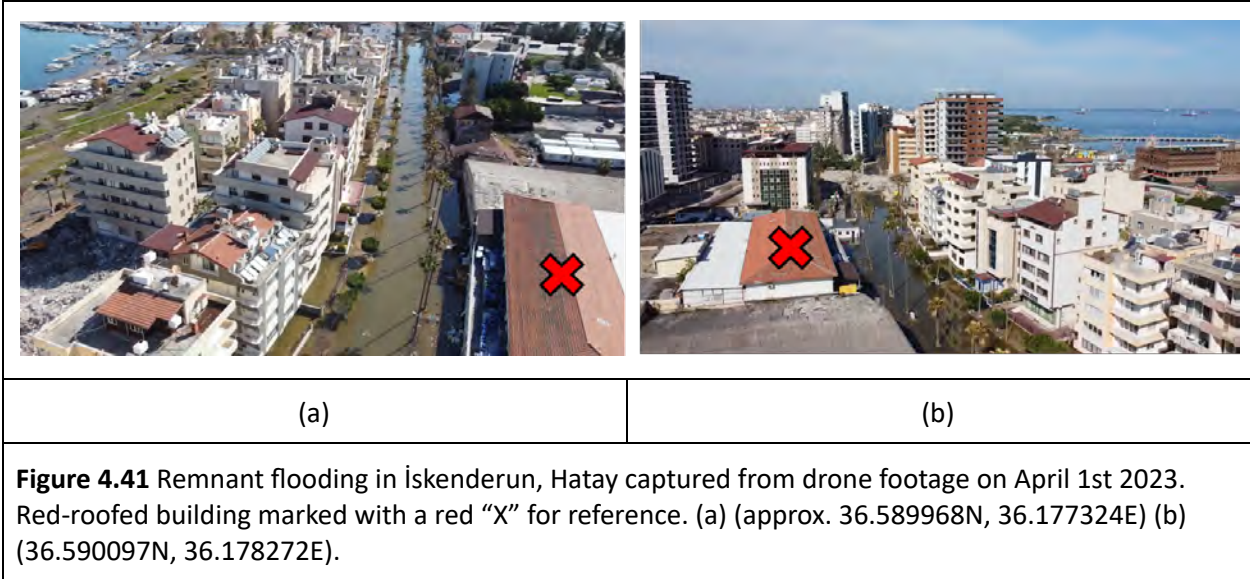
#### 4.2.5 U-box D817 wall underpass flooding and performance - İskenderun, Hatay

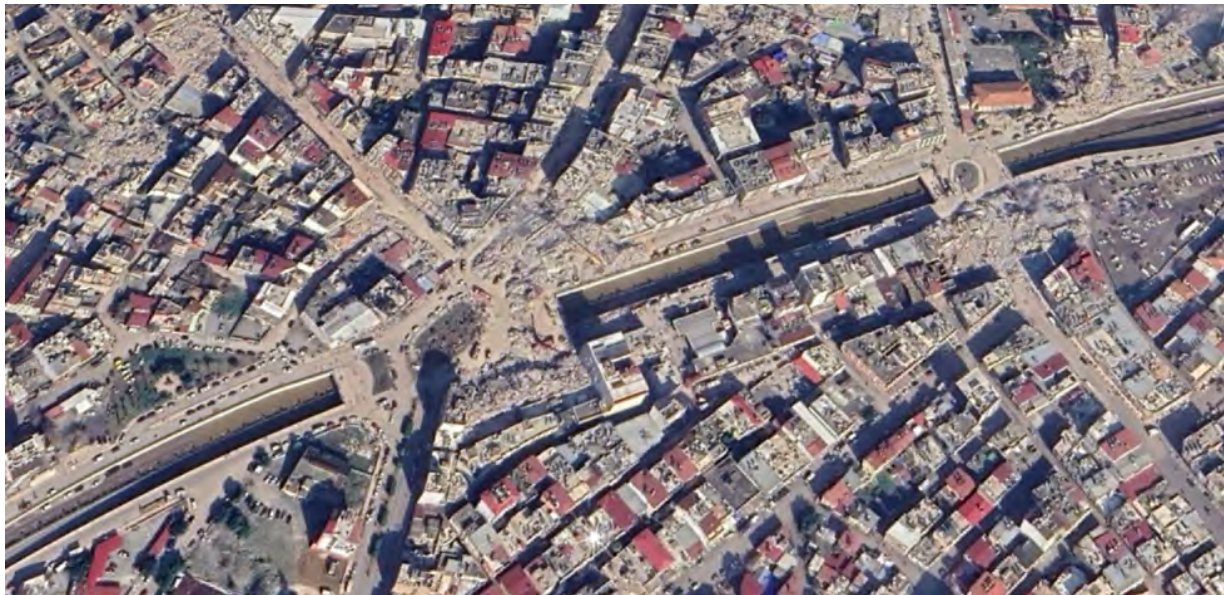
**Figure 4.42.** Image of u-box underpass in İskenderun, Hatay from Google Earth on 8-February-2023, showing flood water in the underpass.

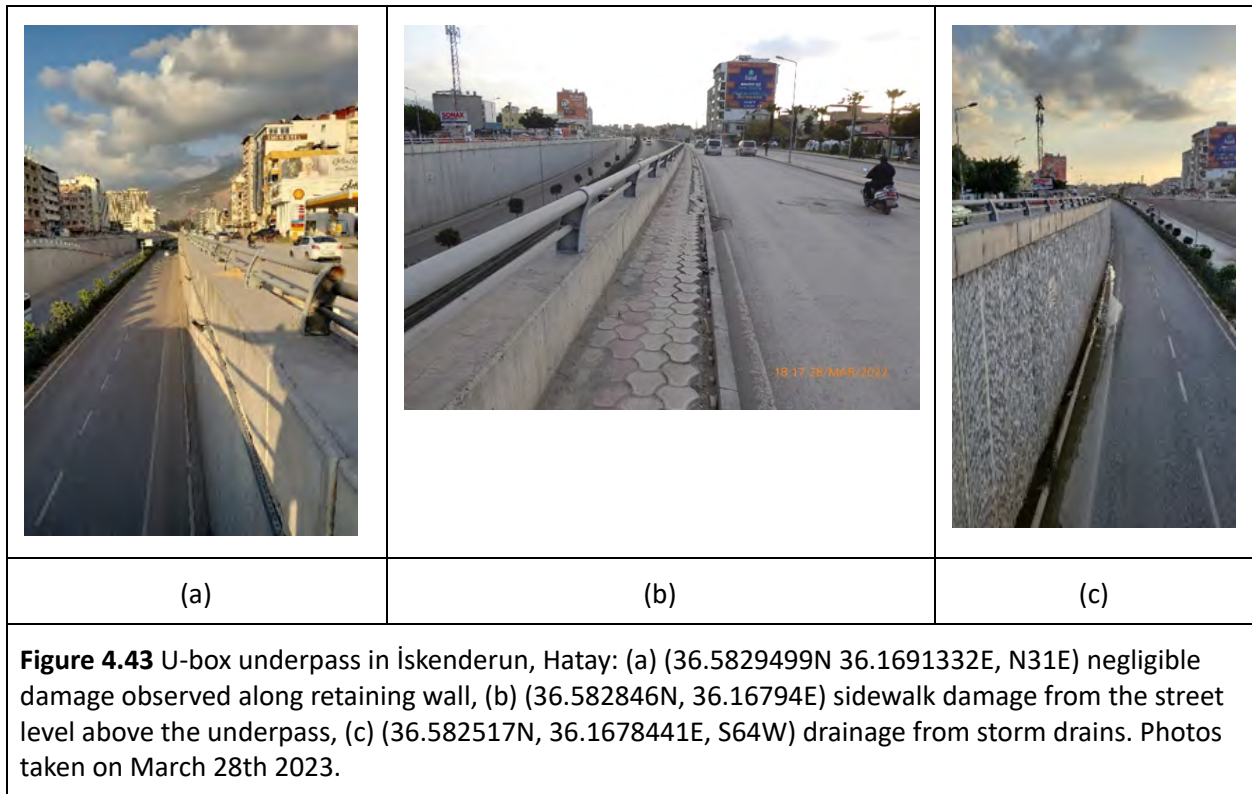
#### 4.2.6 Building Settlement and Tilting- İskenderun, Hatay

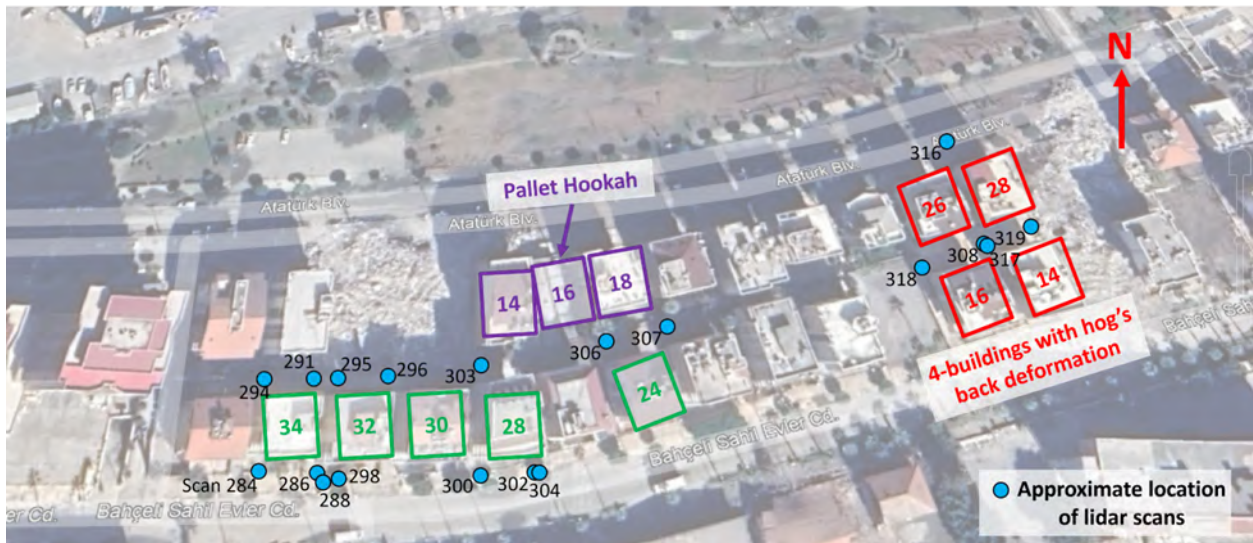
**Figure 4.44.** Location of the surveyed buildings by the Phase 3 team in the Çay district of İskenderun along with approximate locations of lidar scans. Approximate location of the middle of the figure is 36.590595N, 36.177981E).

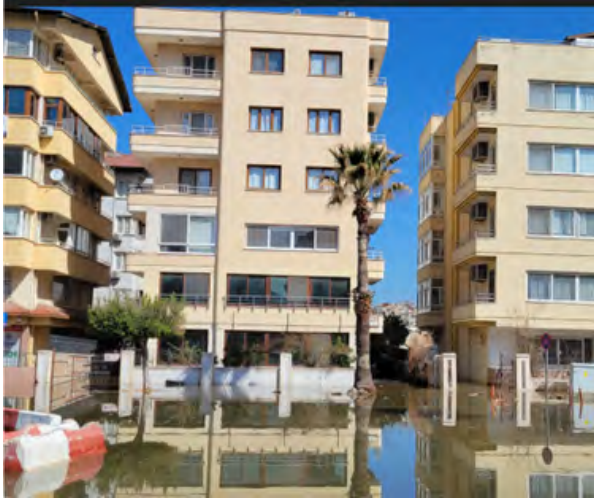
access to the electrical panel room. Lidar scans were performed at this location; the data are being processed and will be included in the next version of the report.

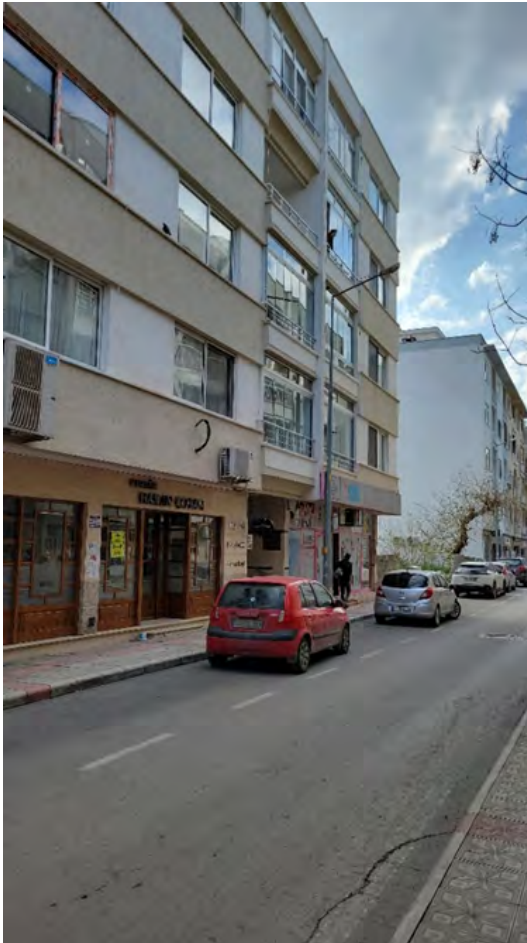
sidewalk adjacent to No. 33 indicates that liquefaction settlement took place (Figure 4.50b). Surveys of settlement from the sidewalk to the northwest edge, center and northeast edge measured settlements of 5 cm, 7 cm, and 6 cm, respectively, indicating a slight sag in the center of the building. Figure 4.50c shows the laser-level survey at the center of the building. The front of the building (northeast edge) was measured as 26.55 m in width. The length of the building is approximately 19 m (estimated on Google Earth from the northwest edge). The building is approximately 16.1 m in height. The building owner reported that there is no basement. No exterior damage was observed.

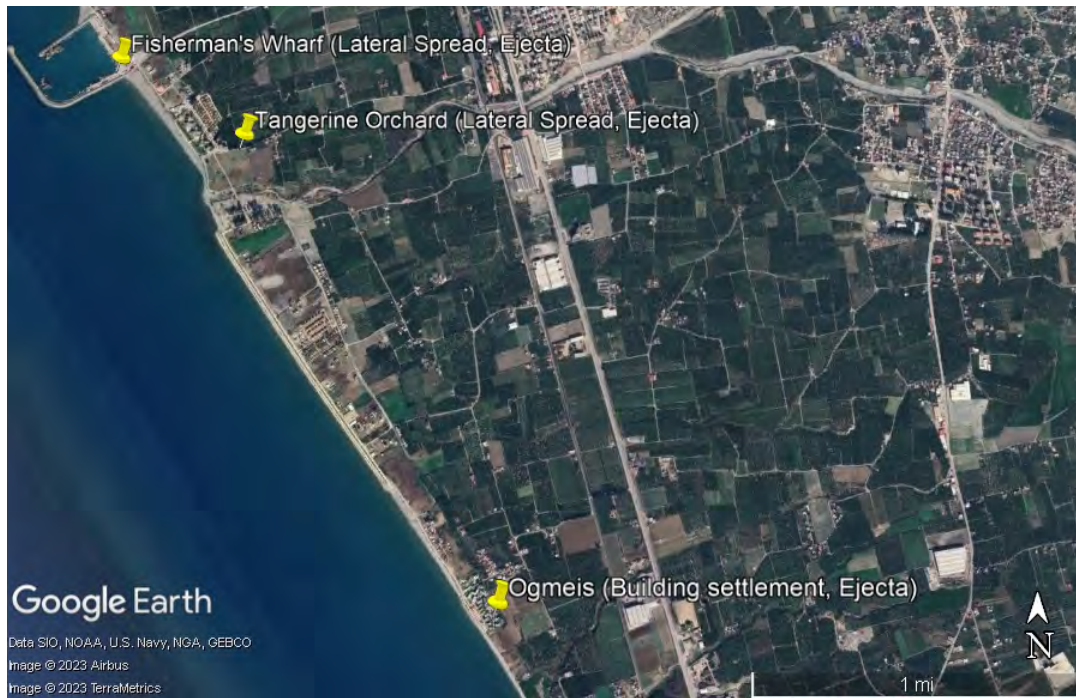
Figure 4.51. Overview of locations visited in Dörtyol.

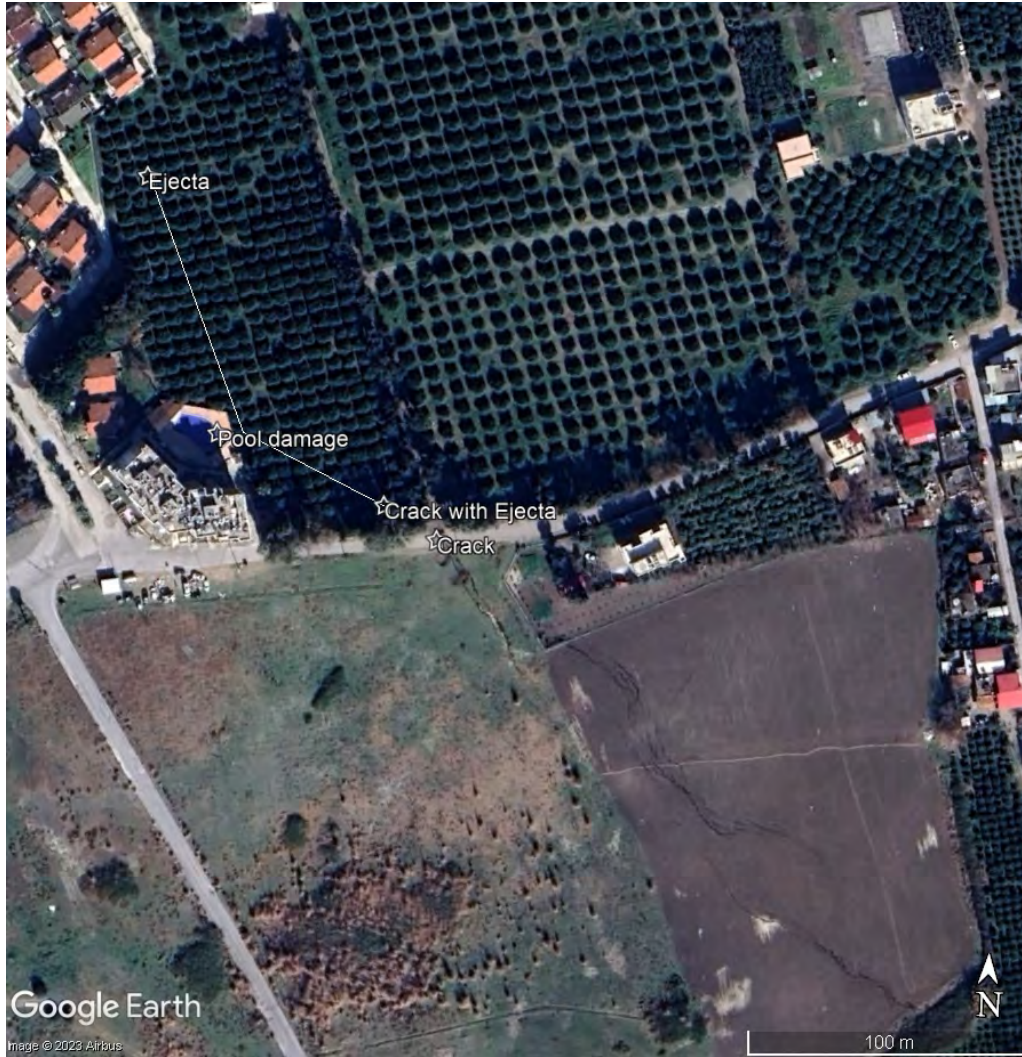
**Figure 4.52.** Overview of locations visited along the network of cracks that intersected the tangerine orchard.

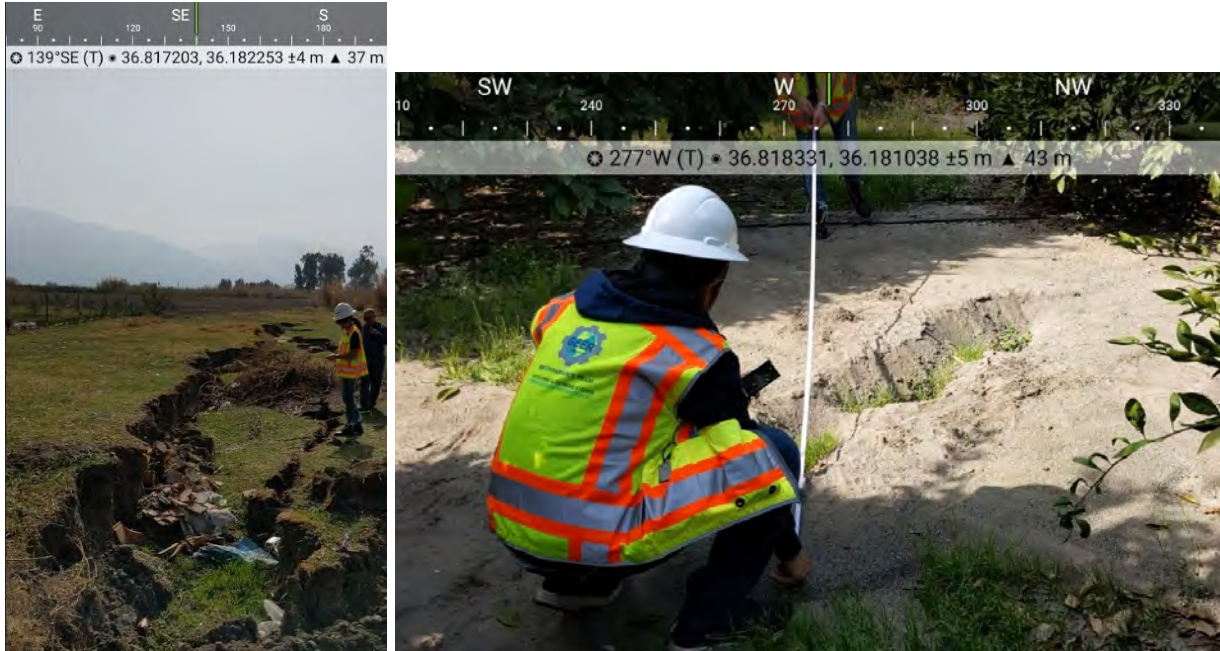
**Figure 4.53.** a) large crack on the south side of the road across from the orchard (36.817203, 36.182253); b) crack immediately on the north side of the road which measured 10.5m long and 2.5m wide (36.817305, 36.182039). Photos taken March 3, 2023.

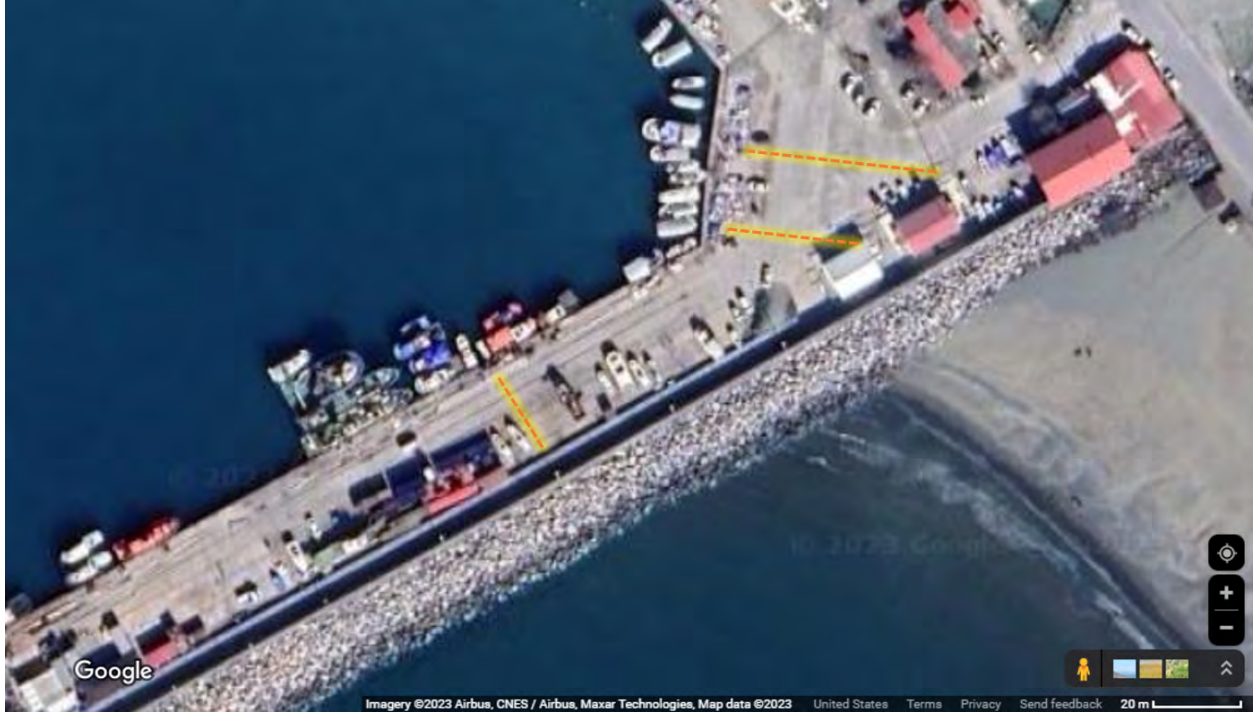
**Figure 4.54.** Locations at Fisherman’s Wharf where GEER Team 2 measured displacements.

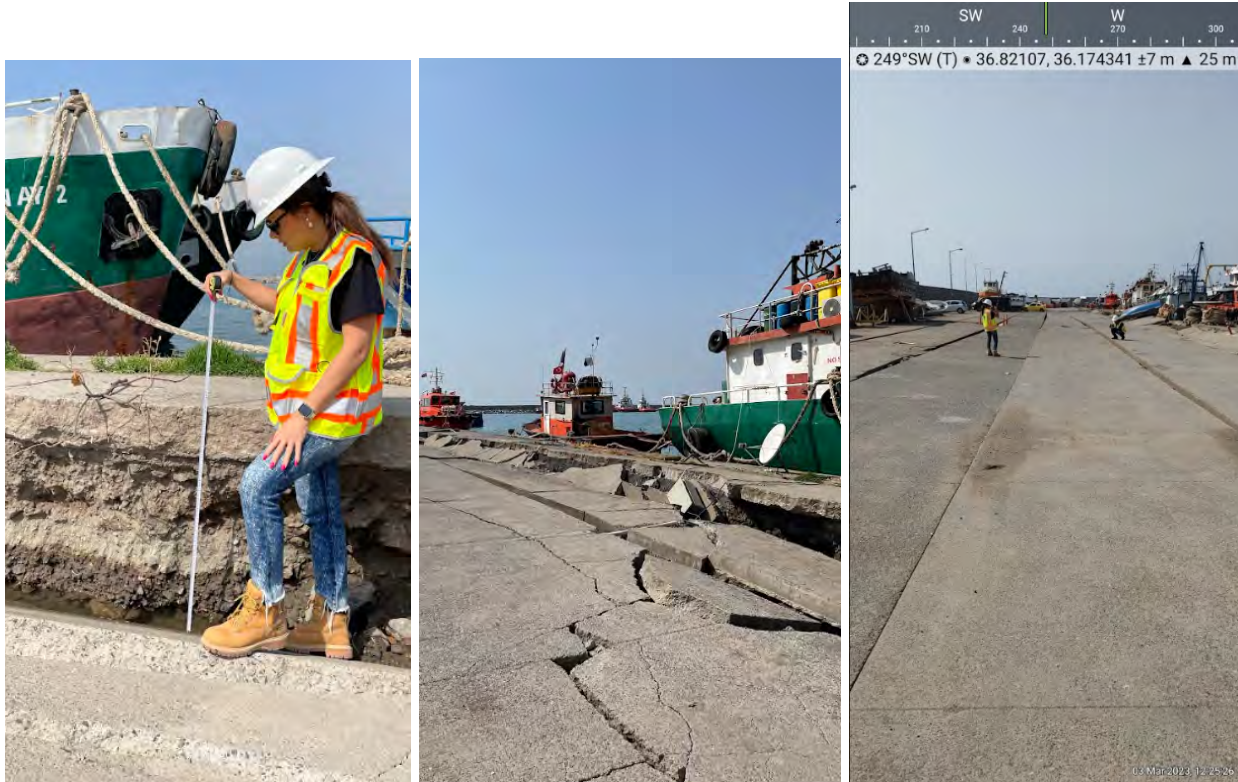
**Figure 4.55.** Images of damage taken along the Fisherman’s Wharf during GEER Team 2 reconnaissance. Photos taken March 3, 2023 (36.820771 N, 36.173860 E)

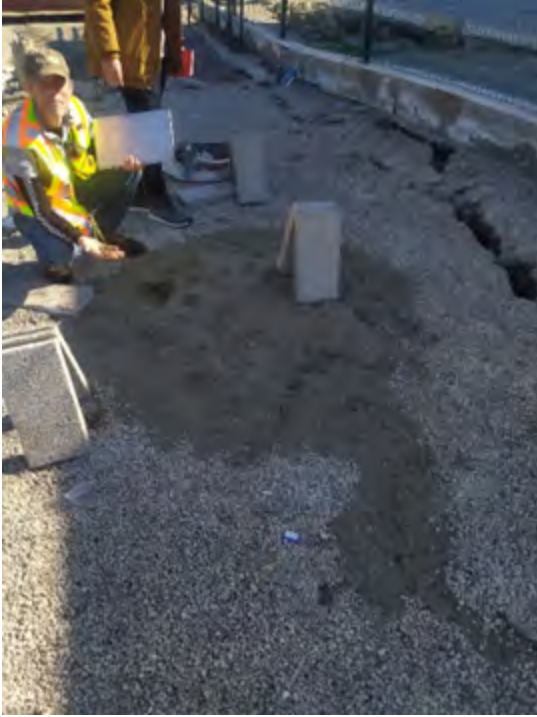
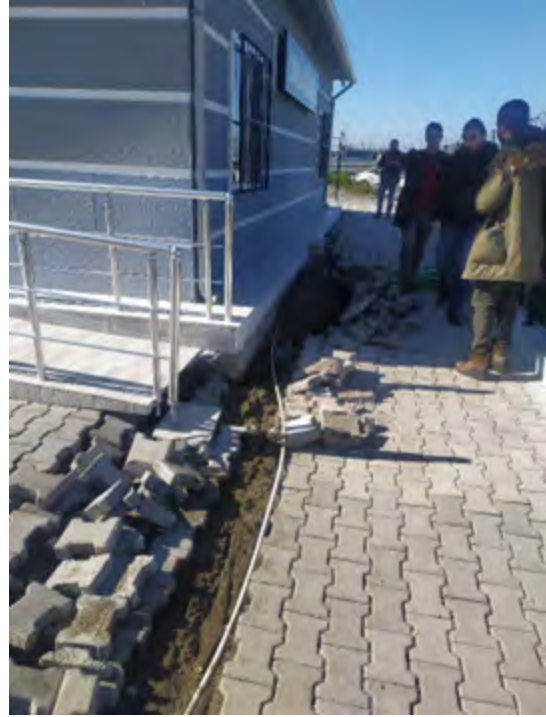
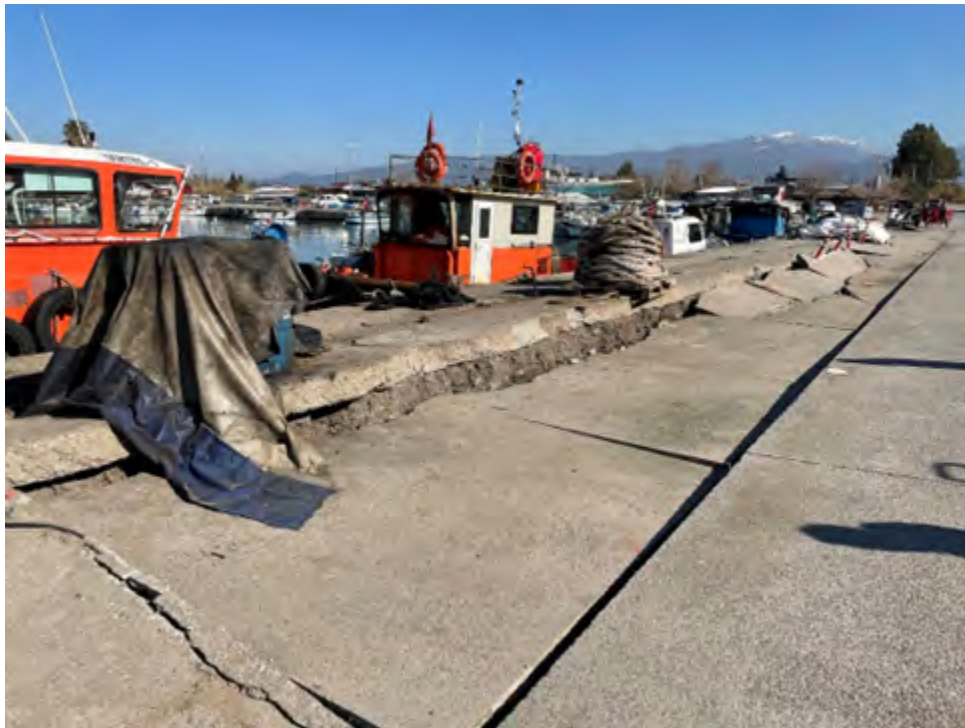
**Figure 4.56:** Liquefaction-induced lateral spreading and surface manifestation of liquefaction at Fisherman's Wharf, Dörtyol-Hatay (36.820771 N, 36.173860 E)

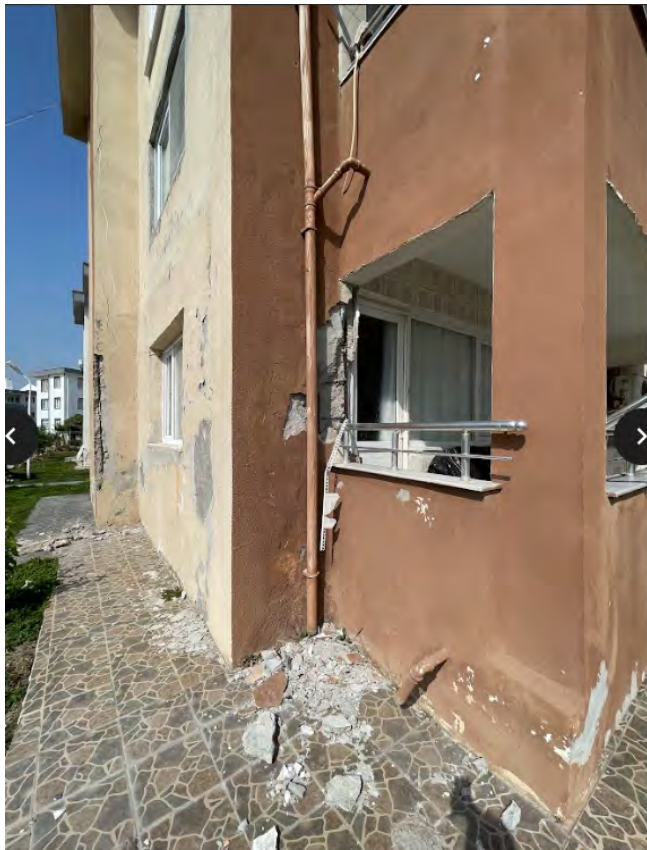
**Figure 4.57.** Building damage in the Öğmeiř neighborhood related to settlement. Photo taken March 3, 2023 (Coordinates: 36.79628, 36.19710).

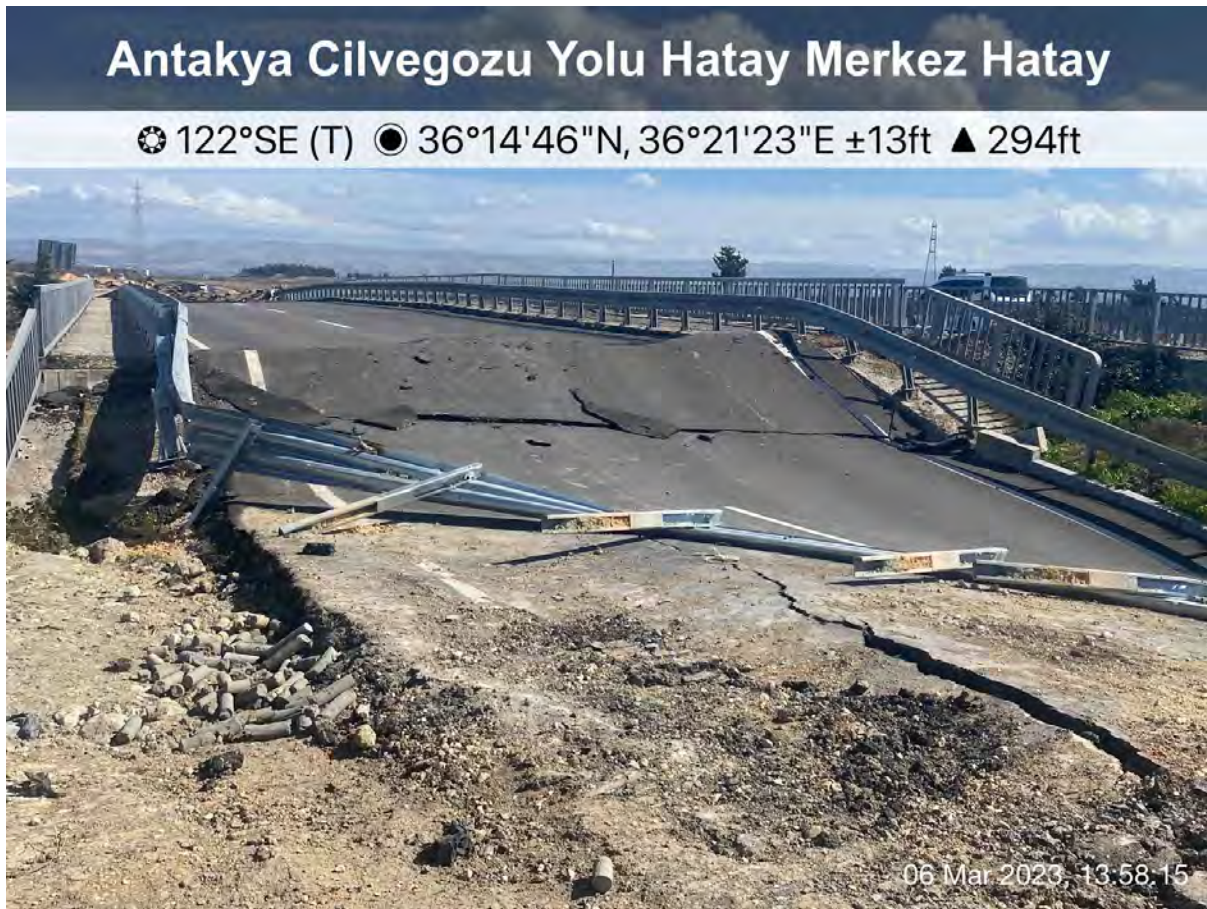
**Figure 4.58.** Bridge failure across the Orontes River in Demirköprü, Hatay Province on Highway D420.

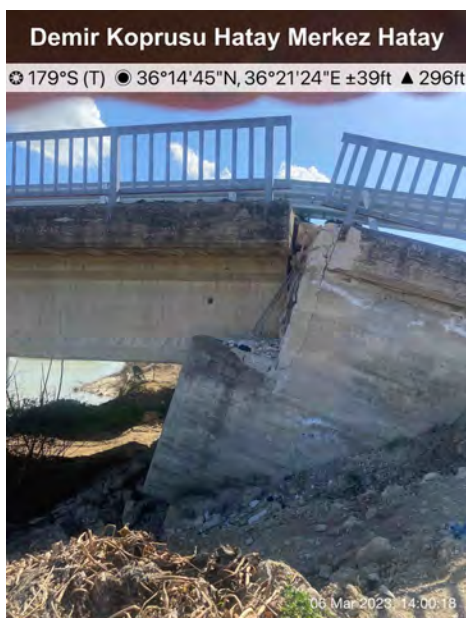
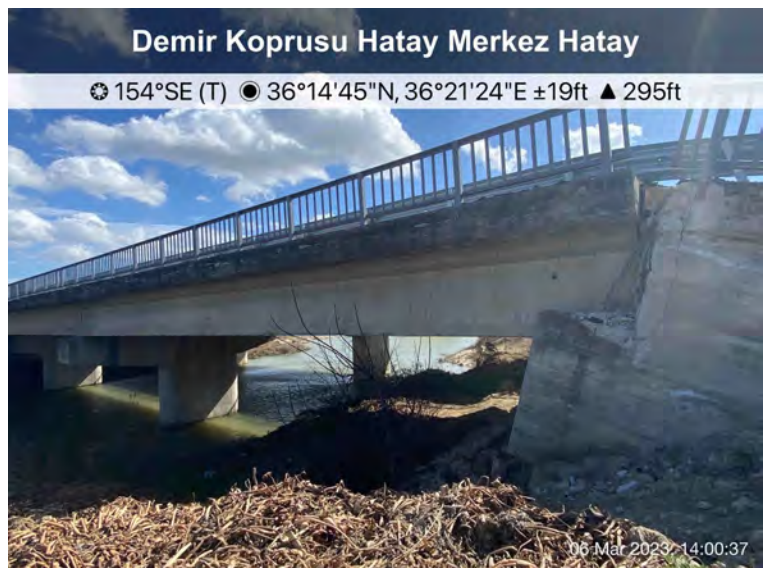
**Figure 4.59.** Abutment rotation and collapse of bridge across the Orontes river, Demirköprü, Hatay Province on Highway D420.

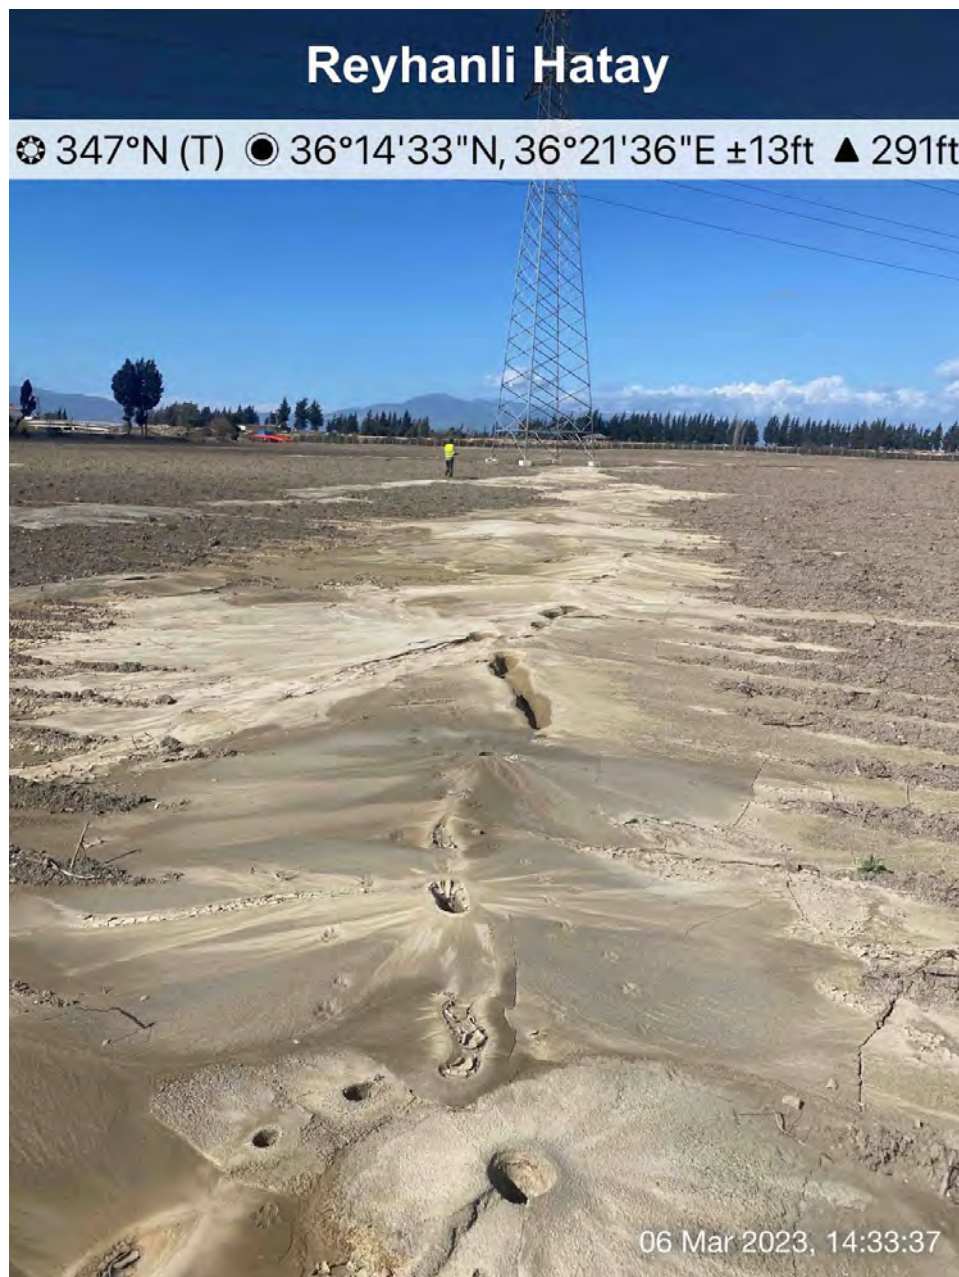
**Figure 4.60.** Barren plowed field along the Orontes River, south of Demirköprü, Hatay Province containing numerous liquefaction features.

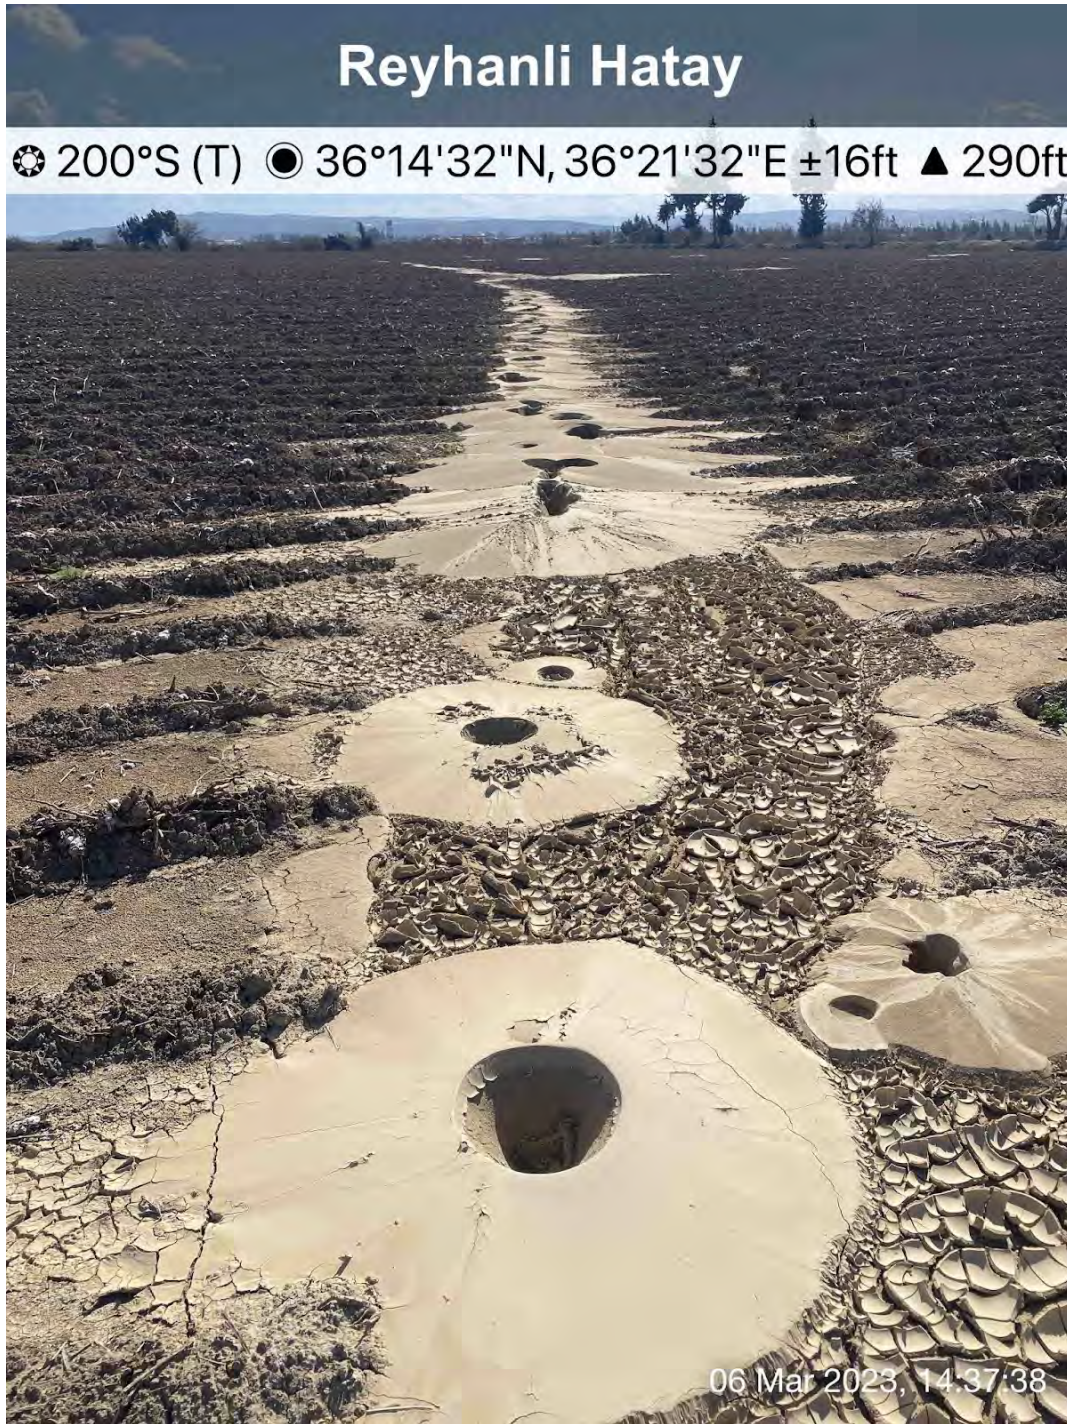
**Figure 4.62.** Sand blows typically aligned linearly, presumably along extensional cracking/fracturing likely resulting from lateral spreading along the nearby Orontes River, south of Demirköprü, Hatay Province.

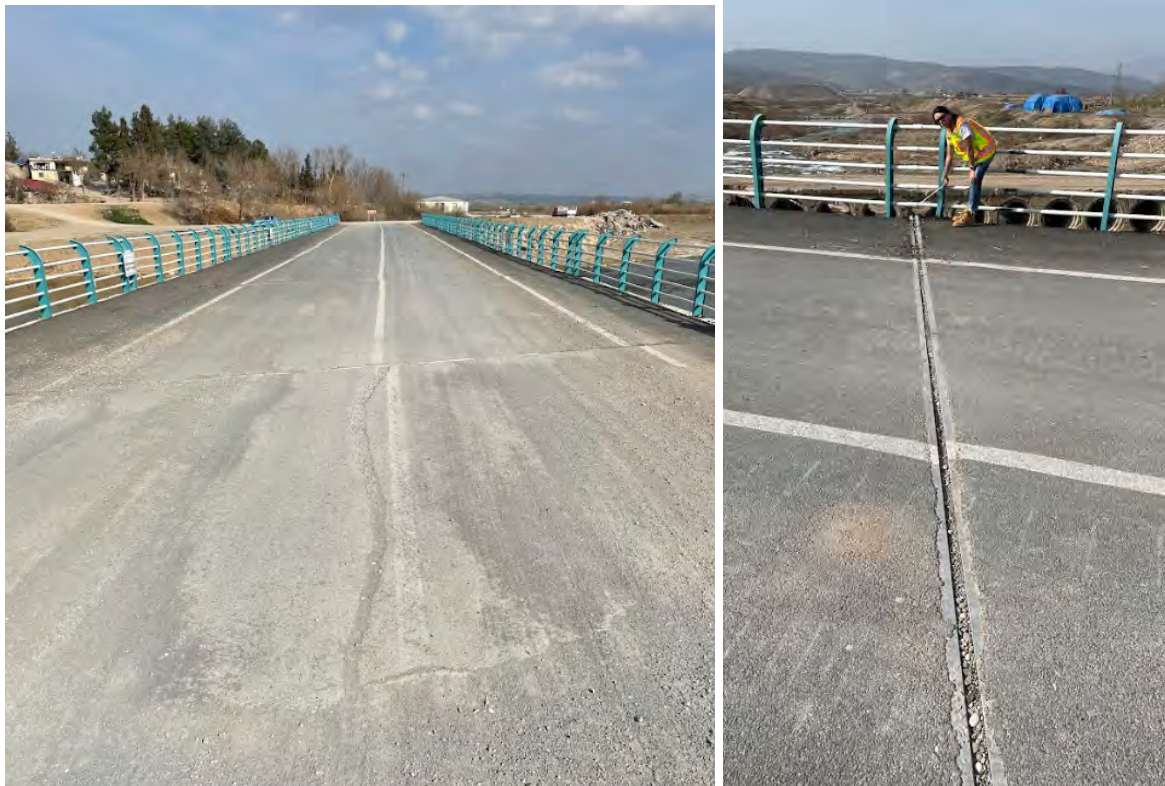
**Figure 4.64.** Isolated bridge near Kılılı (37.4123, 36.9066) with good performance. Photos taken March 4, 2023.
