MAY 6, 2023

# FEBRUARY 6, 2023 TÜRKIYE EARTHQUAKES: REPORT ON GEOSCIENCE AND ENGINEERING IMPACTS

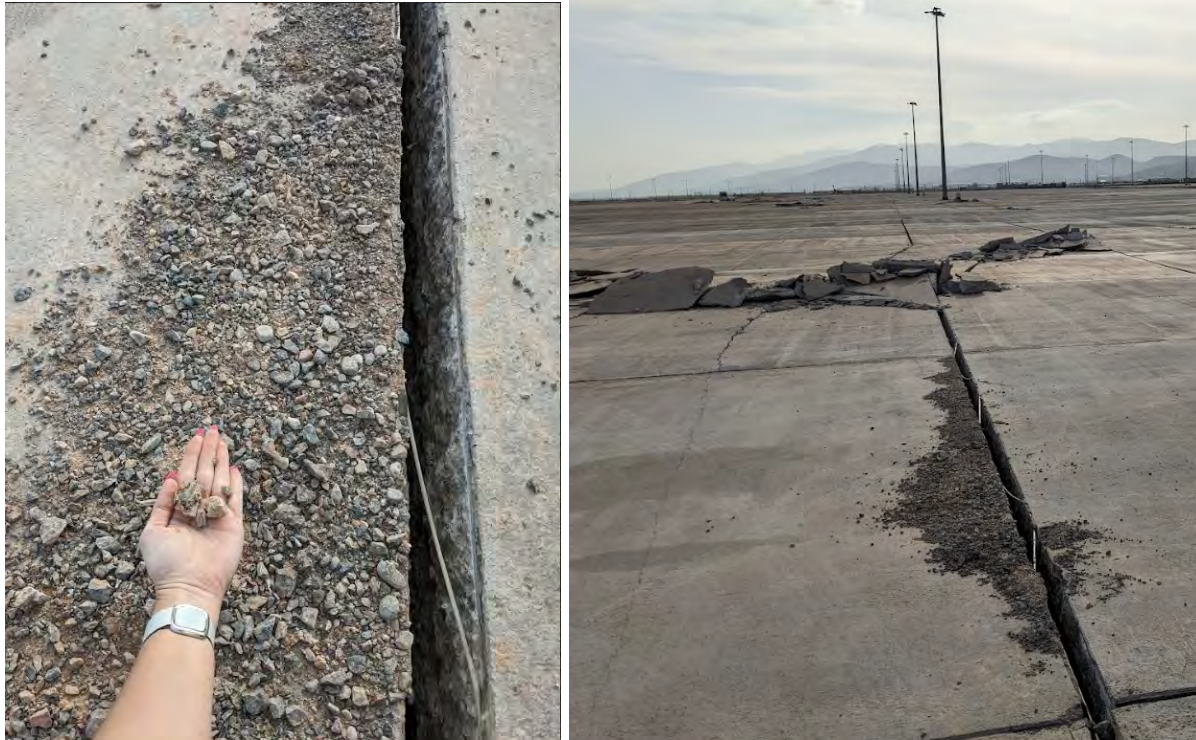
**Figure 4.65.** Observations of ground cracks and gravelly ejecta in the Lojistik area south of Türkoğlu (37.372, 36.861). Photos taken March 4, 2023.

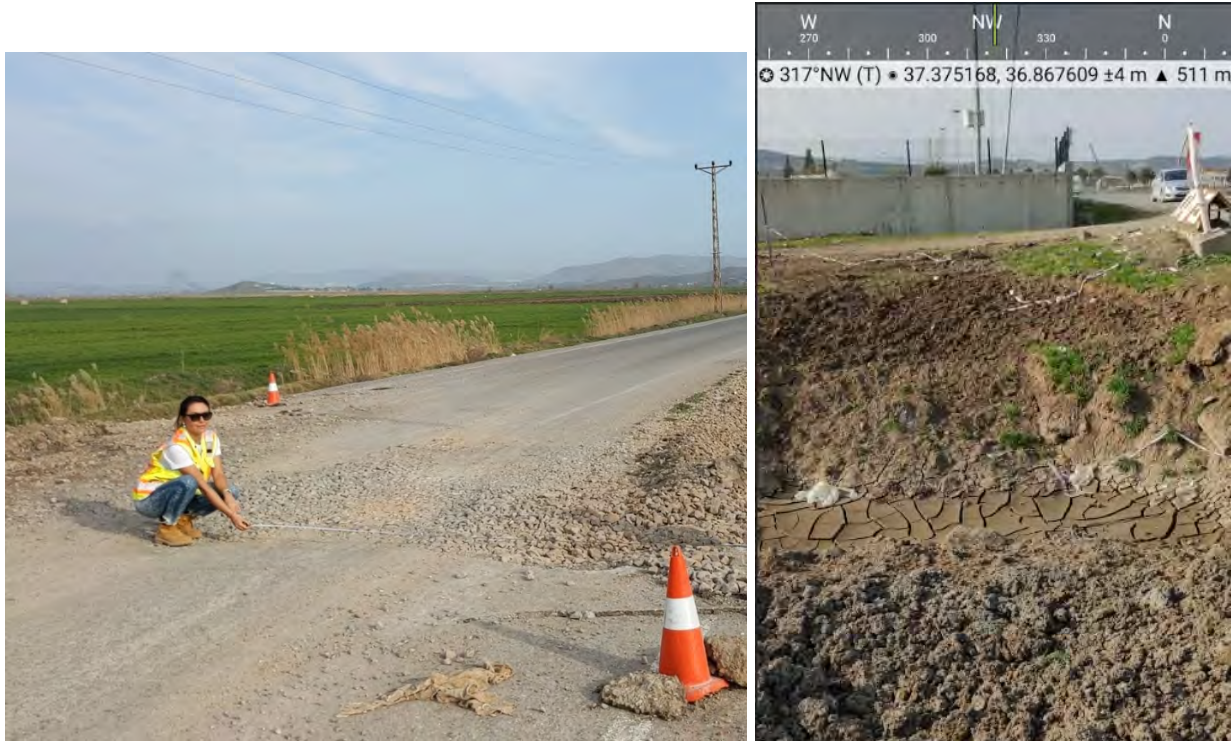
**Figure 4.66.** a) Observed damage to a 5.7 m-long section of road with a horizontal offset of 3.2 m (37.370574, 36.869232); b) possible ejecta with high fines near a culvert south of Lojistik (37.3752, 36.8676). Photos taken March 4, 2023.

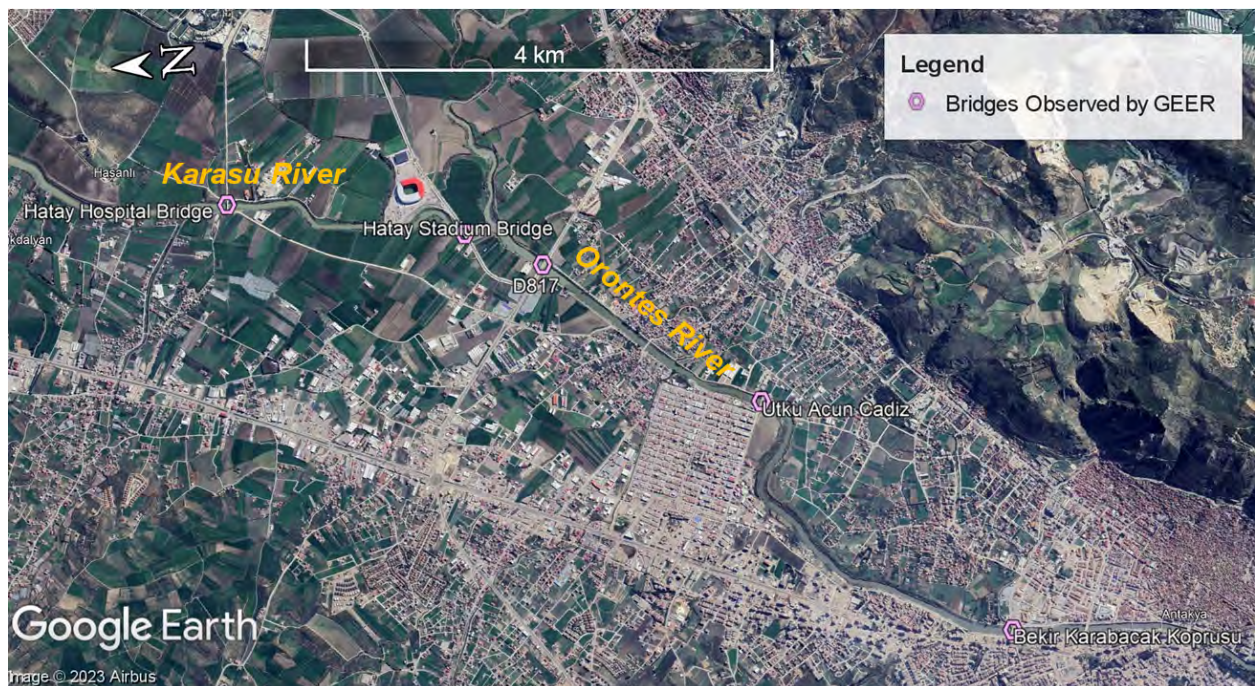
**Figure 4.67.** Map of observed bridges in Antakya, Hatay Province, Türkiye (Google Earth<sup>®</sup> image dated February 14, 2023, centered near N36.2401°, E36.1882°).

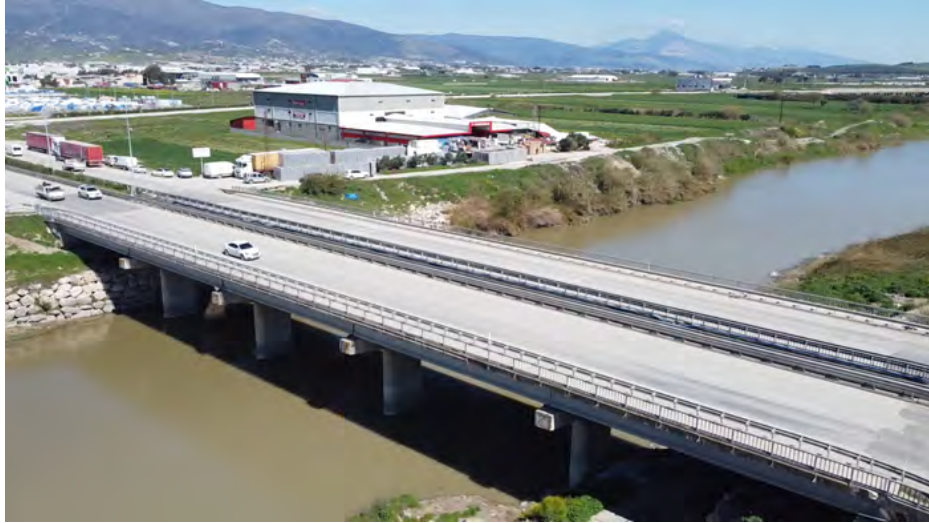
**Figure 4.68.** Drone image of D817 Bridge crossing the Orontes River from the south end of bridge (N36.248220°, E36.199871°).

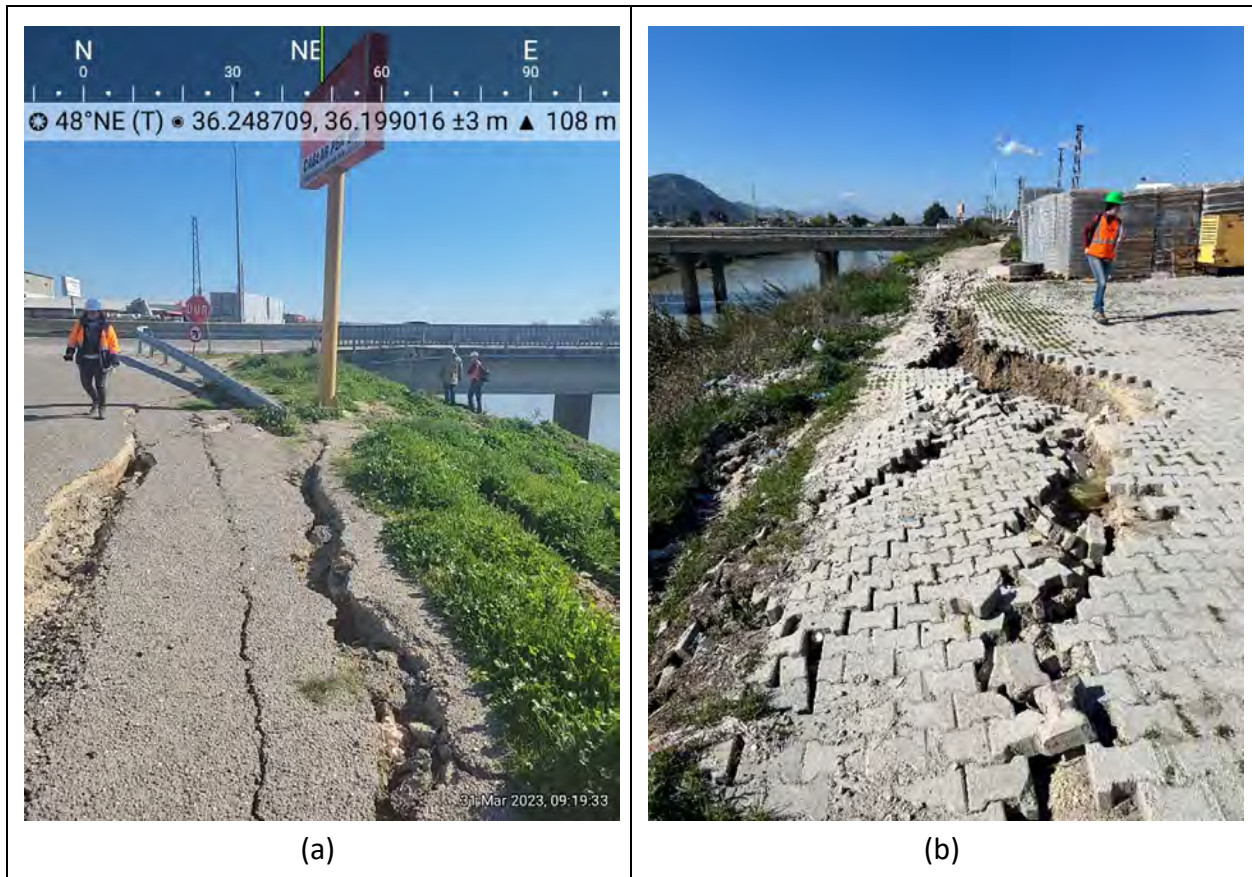
**Figure 4.70.** Local slope failures along northwest bank near the D817 Bridge: (a) southwest side of bridge with 30 to 40 cm lateral movement and 50 to 60 cm vertical movement (N36.248709°, E36.199016°), (b) northeast side of bridge (N36.249590°, E36.200036°).

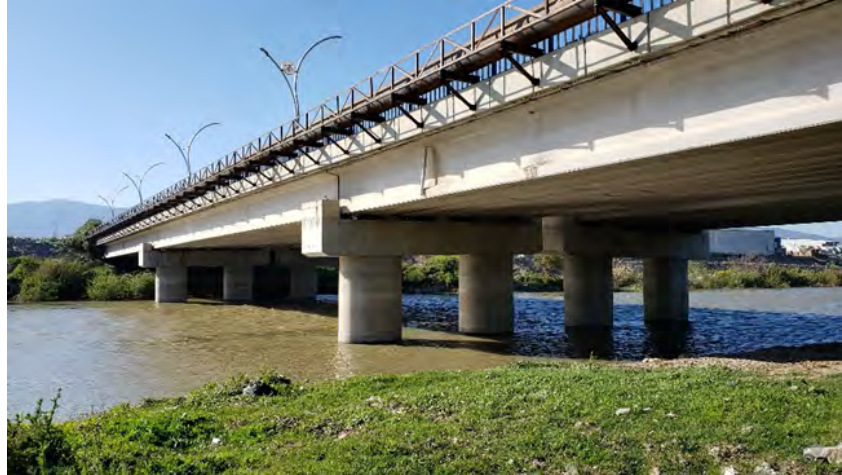
**Figure 4.71.** The Utku Acun Cadiz Bridge crossing the Orontes River, as viewed from southeast corner of bridge (N36.232597°, E36.185509°).

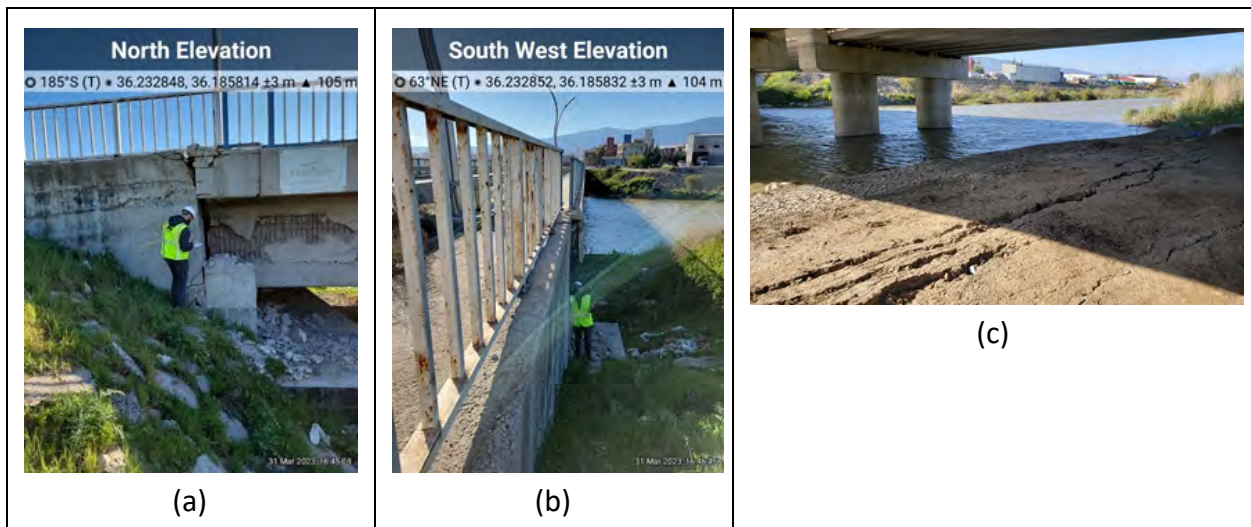
**Figure 4.72.** Damage at east abutment of Utku Acun Cadiz Bridge: (a) north side of abutment tilting 1° to 2° back (eastward), with a separation gap of over 12 cm near the deck (N36.232848°, E36.185814°), (b) west-bound deck shifted about 17 cm to the north over east abutment (N36.232852°, E36.185832°), (c) ground cracks below east abutment (N36.232674°, E36.185562°).

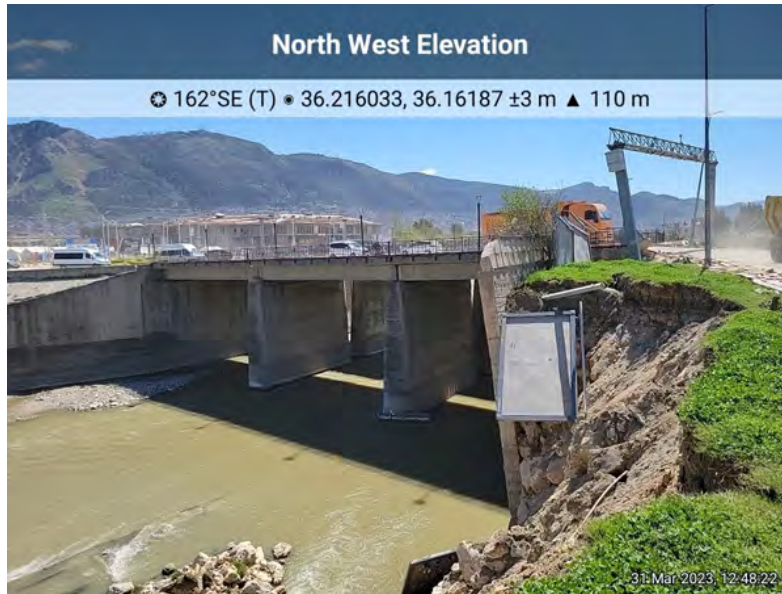
**Figure 4.73.** The Bekir Karabacak Koprusu Bridge crossing the Orontes River, as viewed from near a retaining wall failure at the northwest wingwall of the bridge (N36.216033°, E36.16187°).

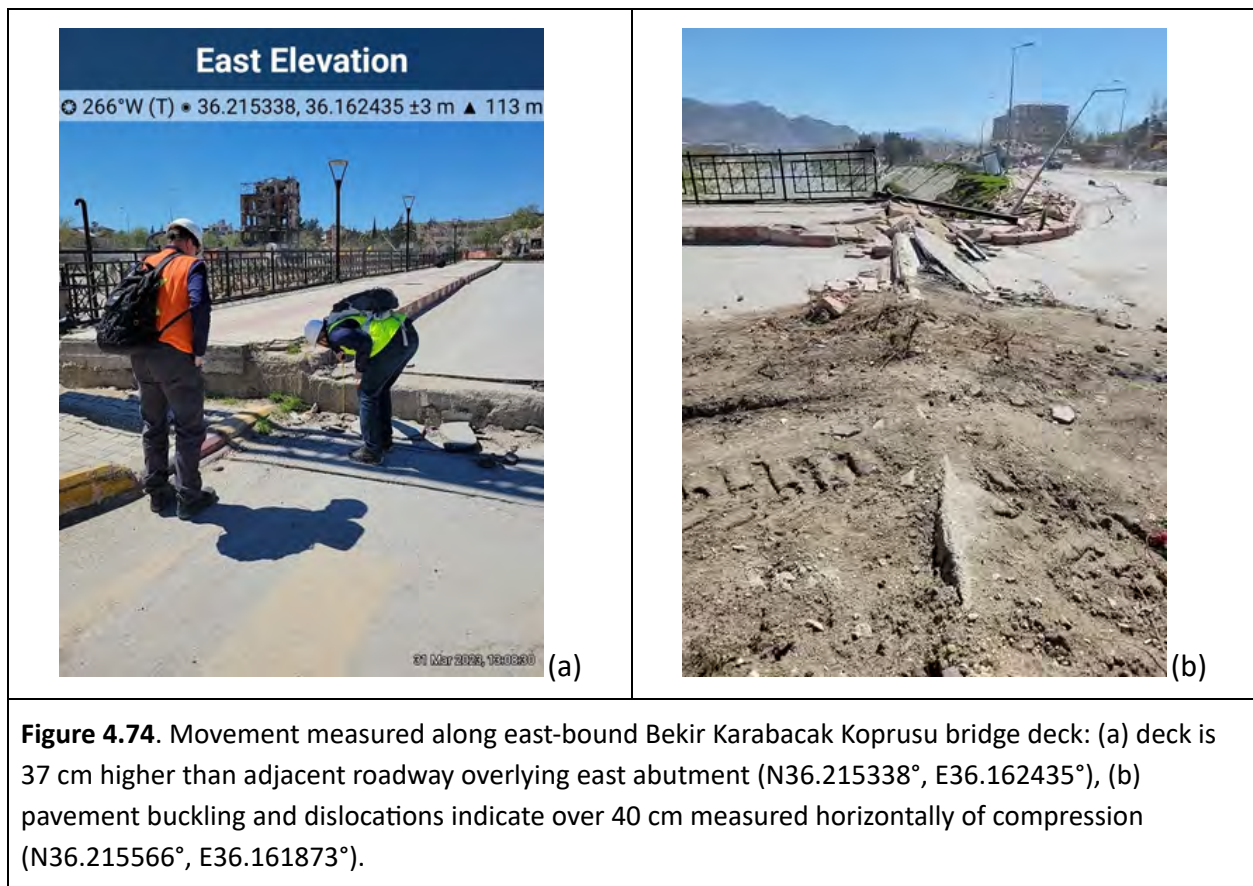
**Figure 4.74.** Movement measured along east-bound Bekir Karabacak Koprusu bridge deck: (a) deck is 37 cm higher than adjacent roadway overlying east abutment (N36.215338°, E36.162435°), (b) pavement buckling and dislocations indicate over 40 cm measured horizontally of compression (N36.215566°, E36.161873°).

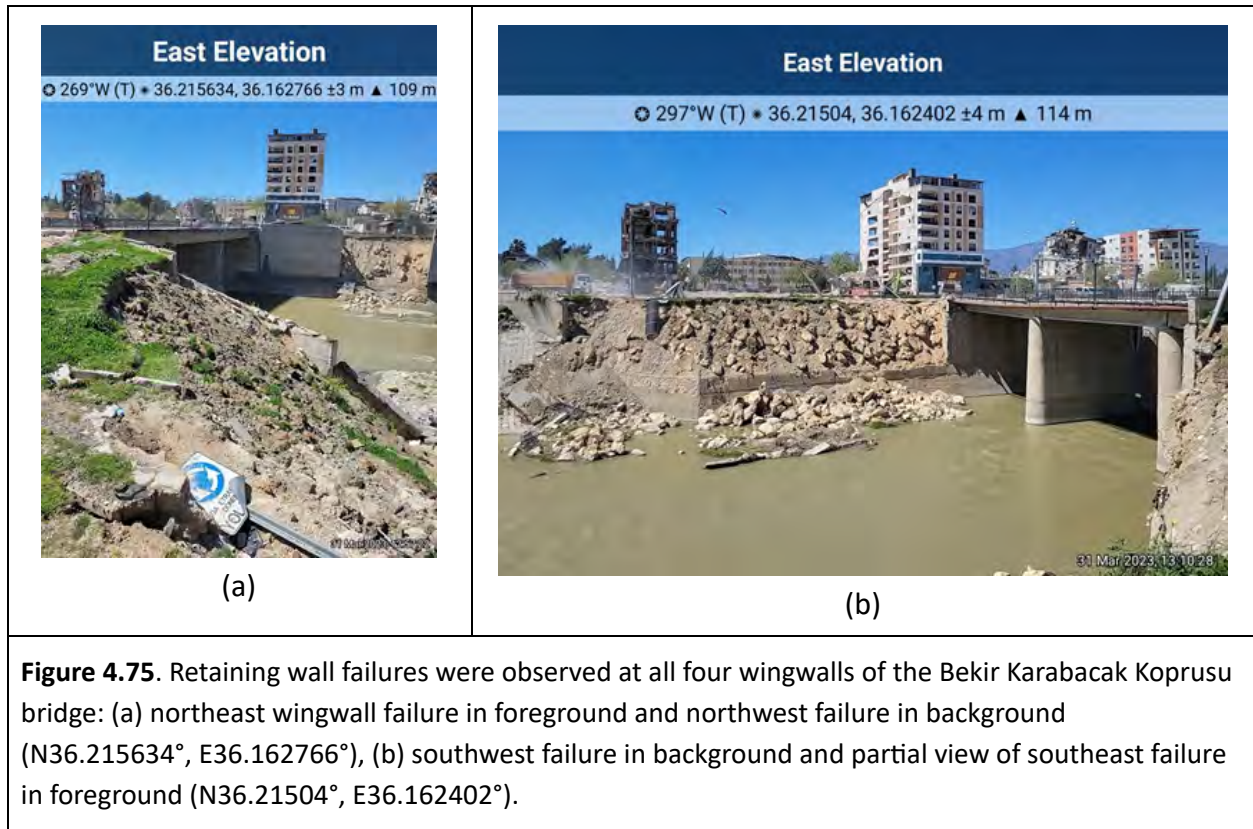
#### 4.6.4 Hatay “Stadium” Bridge crossing the Karasu River

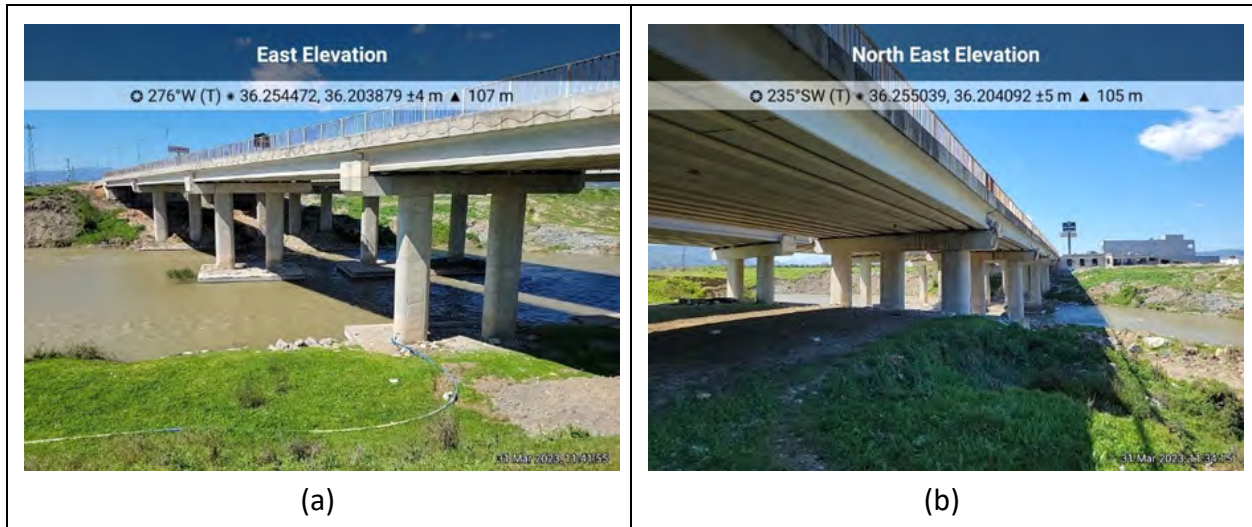
**Figure 4.76.** Hatay Stadium Bridge crossing the Karasu River from the east end of bridge: (a) east-bound bridge (N36.25472°, E36.203879°), (b) west-bound bridge (N36.255039°, E36.204092°).

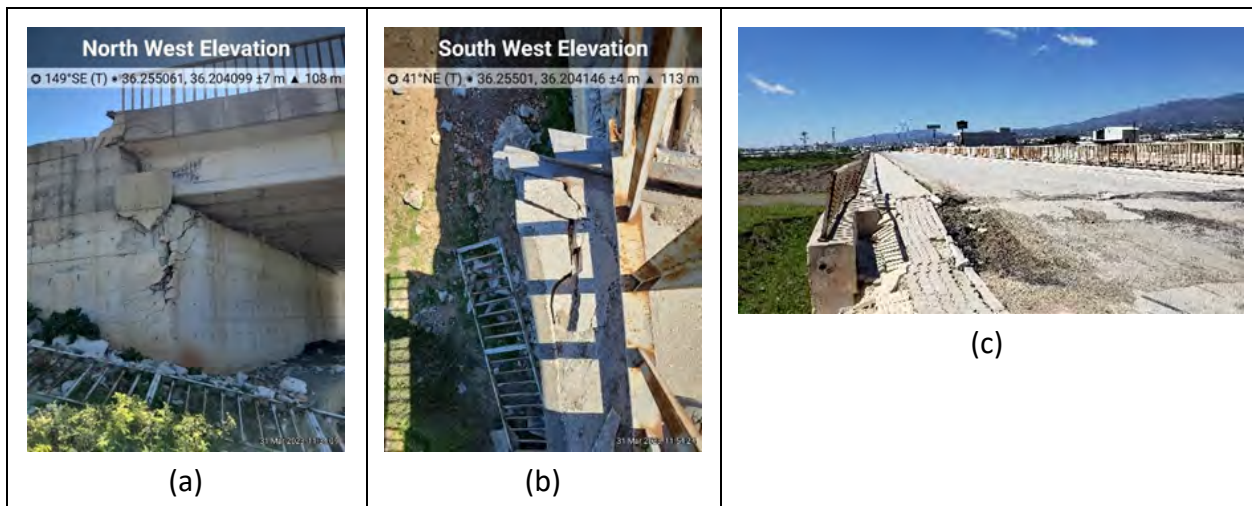
**Figure 4.77.** Damage at east abutment of Hatay Stadium Bridge: (a) cracking and spalling on the beams and abutment at north edge of deck support (N36.255061°, E36.204099°), (b) right-lateral offset at north edge of deck (N36.25501°, E36.204146°), (c) pavement damage and misalignment of deck at south end of abutment (N36.254772°, E36.204323°).

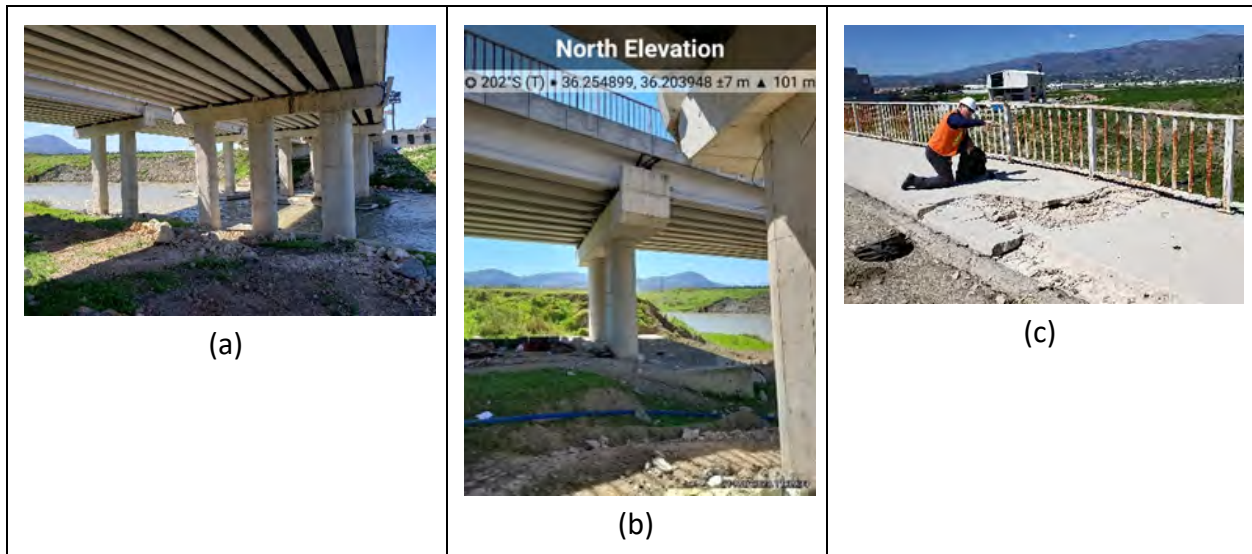
**Figure 4.78.** Damage at eastern-most bent of Hatay Stadium Bridge: (a) cracking at substructure deck supports (N36.254879°, E36.203865°), (b) pile caps are undamaged (N36.254899°, E36.203948°), (c) concrete spalling of pavement extends across west-bound bridge (N36.254791°, E36.203671°).

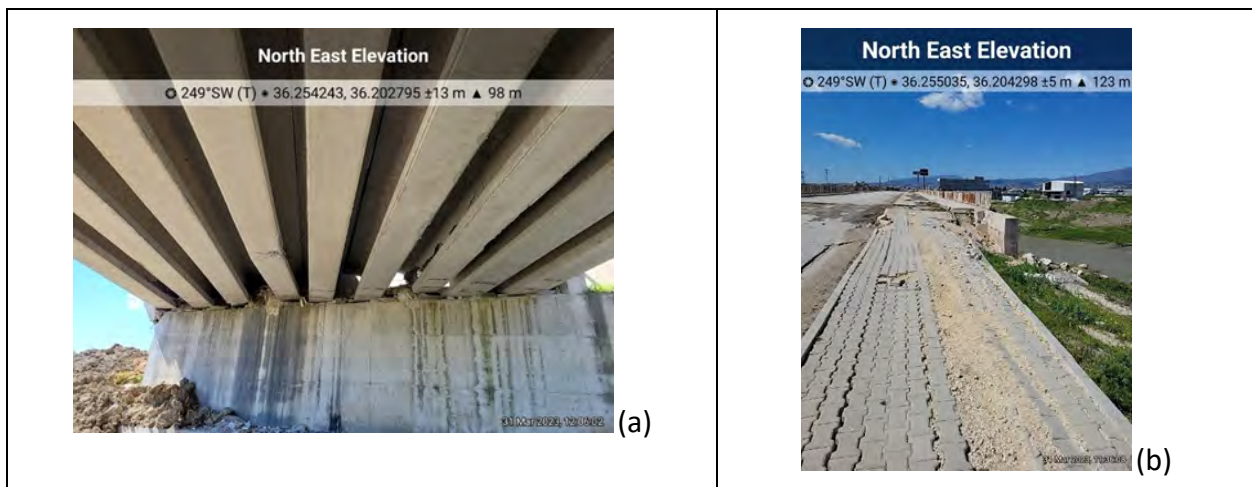
**Figure 4.79.** Damage at west abutment and superstructure of Hatay Stadium Bridge: (a) spalling and out-of-plane flexural failure of one of the beams bending of east-bound deck support (N36.254243°, E36.202795°), (b) pavement damage and misalignment of deck at north end of abutment (N36.255035°, E36.204298°).

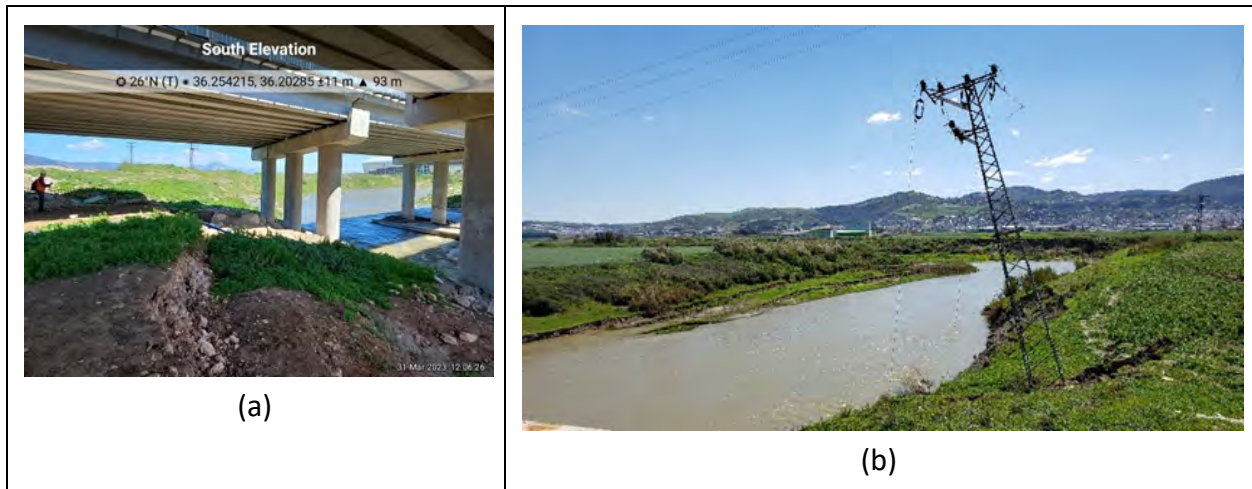
**Figure 4.80.** Local slope failures near Hatay Stadium Bridge: (a) slumping beneath west end of bridge (N36.254215°, E36.20285°), (b) translational stability failure on east bank and rotational failure affecting transmission lines on west bank of Karasu river (N36.253994°, E36.202873°).

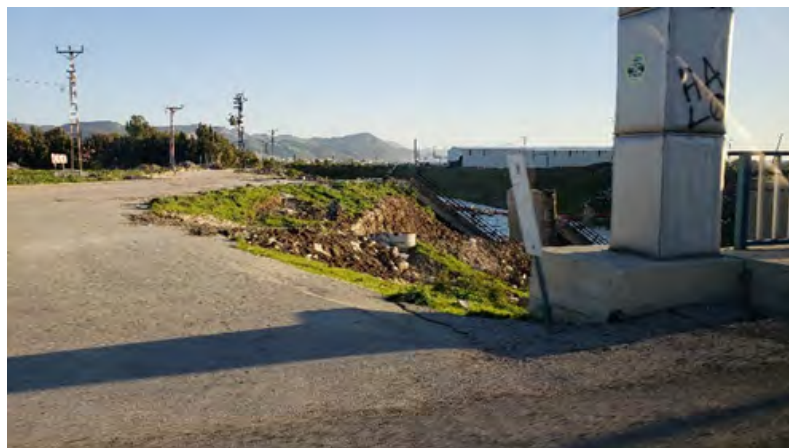
**Figure 4.81.** Local slumping failure and collapse of old bridge deck along the East bank to the South (background of photo) of the main Hatay Devlet Hospital Bridge (foreground of photo) (N36.27264°, E36.208344°).

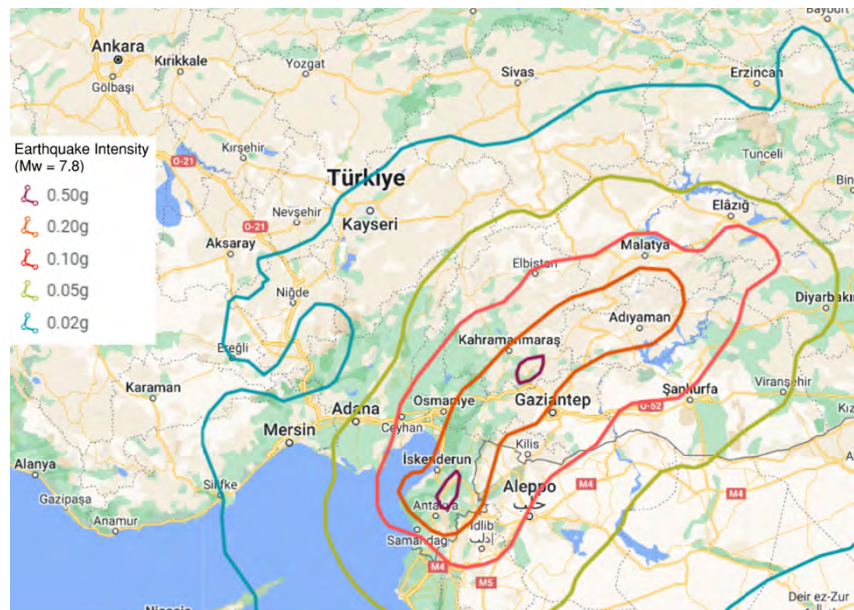
**Figure 5.1.** USGS shakemap PGA contours for the Mw 7.8 Pazarçık-Kahramanmaraş Earthquake.

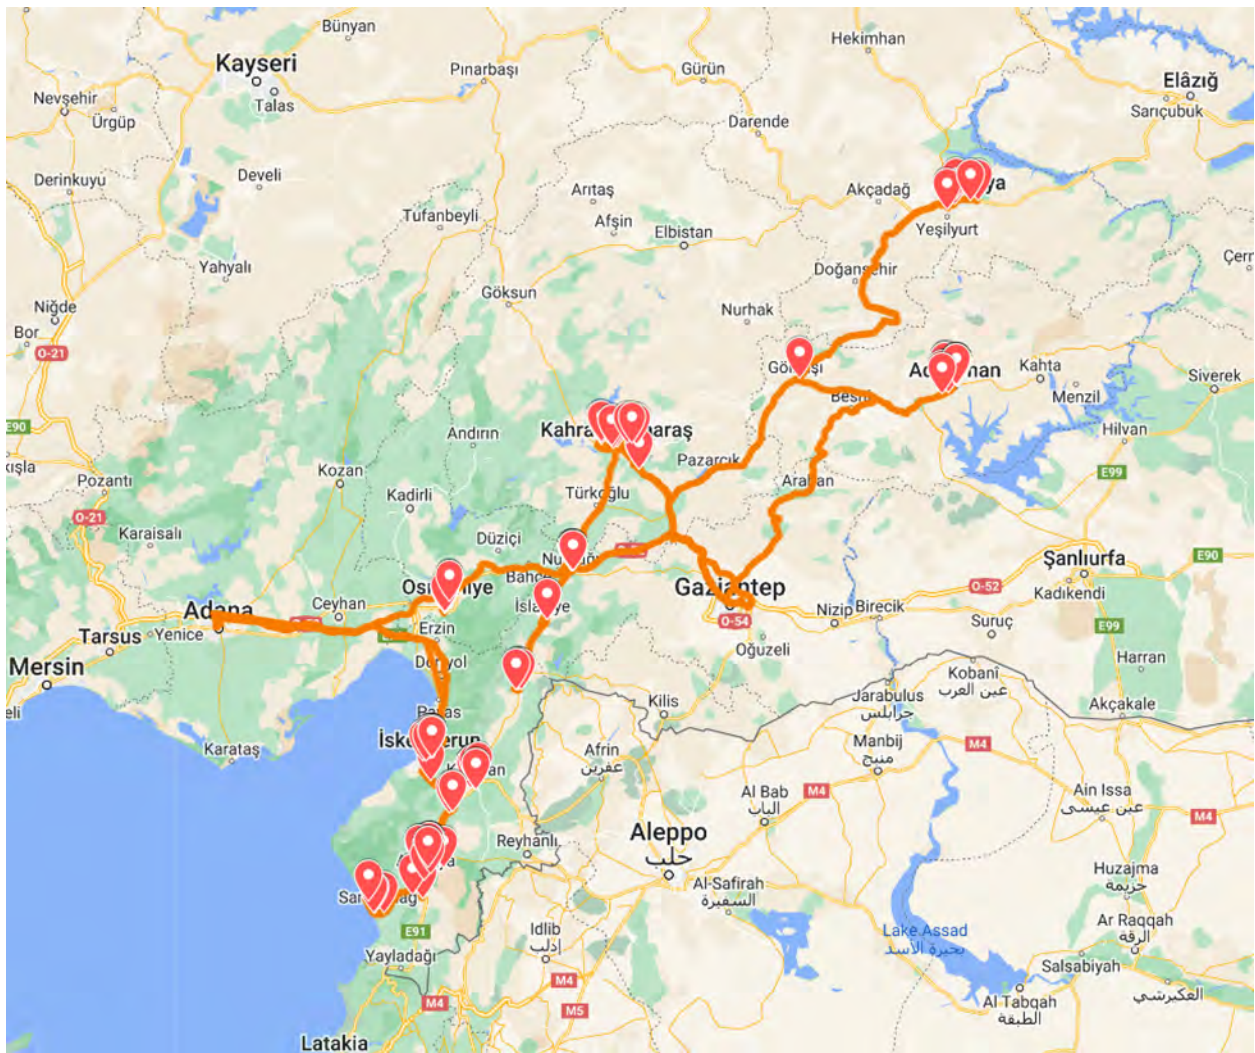
**Figure 5.3.** Map showing the route of EERI Buildings team in the field with the locations of the observed buildings.

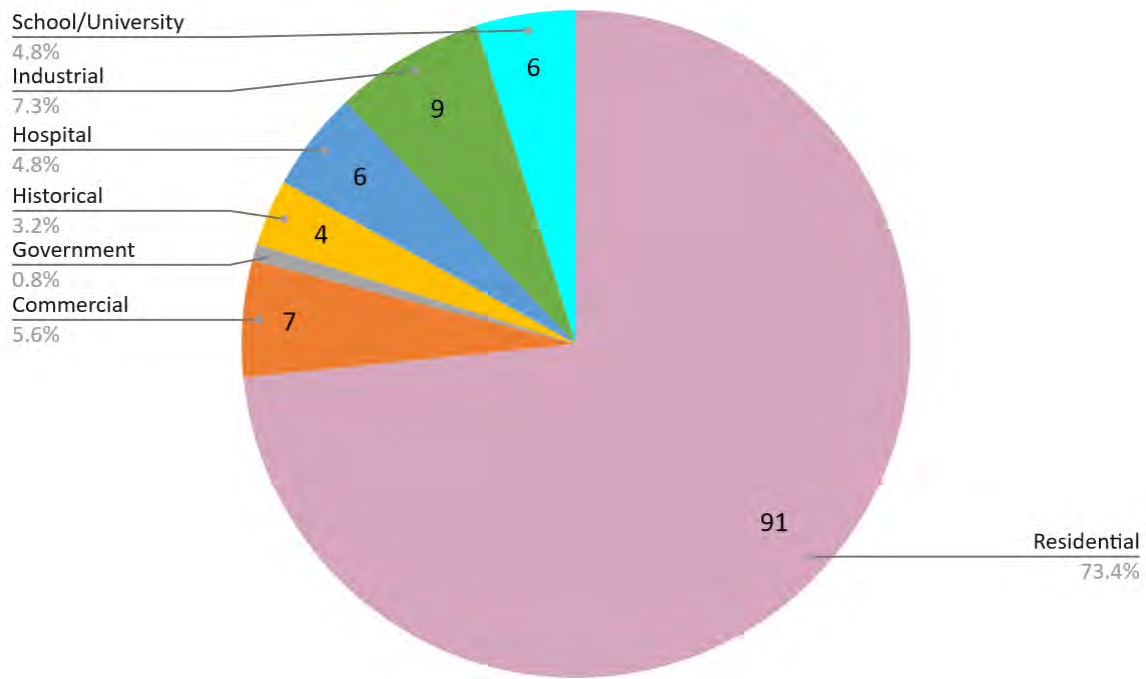
**Figure 5.4.** Occupancy type distribution of buildings visited by the buildings team.

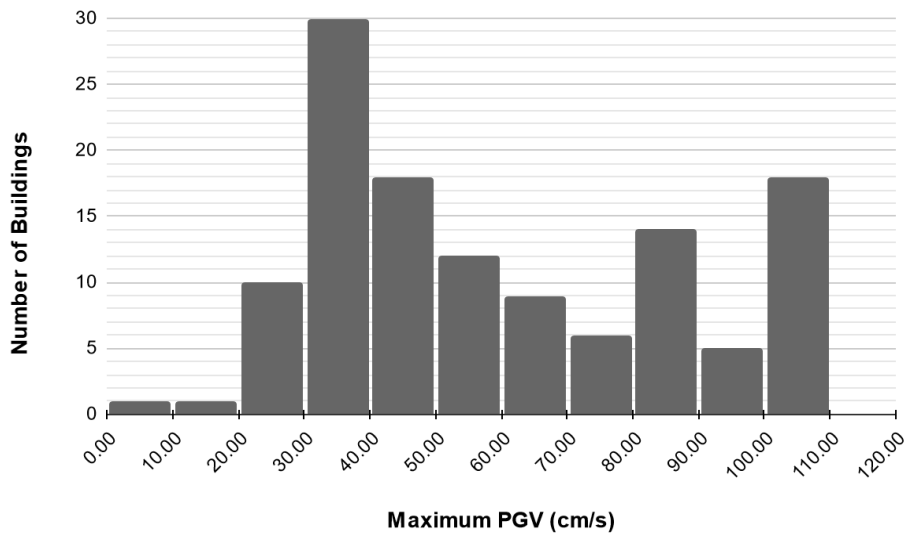
**Figure 5.7.** Distribution of the maximum PGV at the sites visited from the three earthquake sequence: **M** 7.8 Kahramanmaraş, **M** 7.7 Elbistan and **M** 6.3 Defne earthquakes.

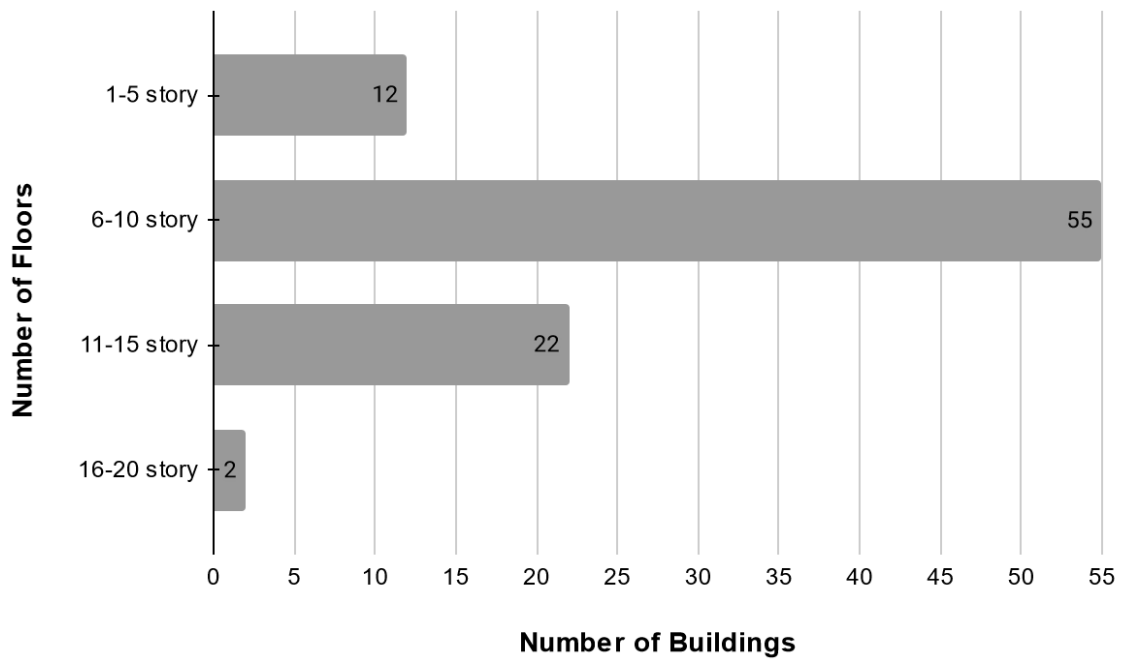
**Figure 5.8.** Distribution of the residential buildings visited by the buildings team in terms of the number of floors.

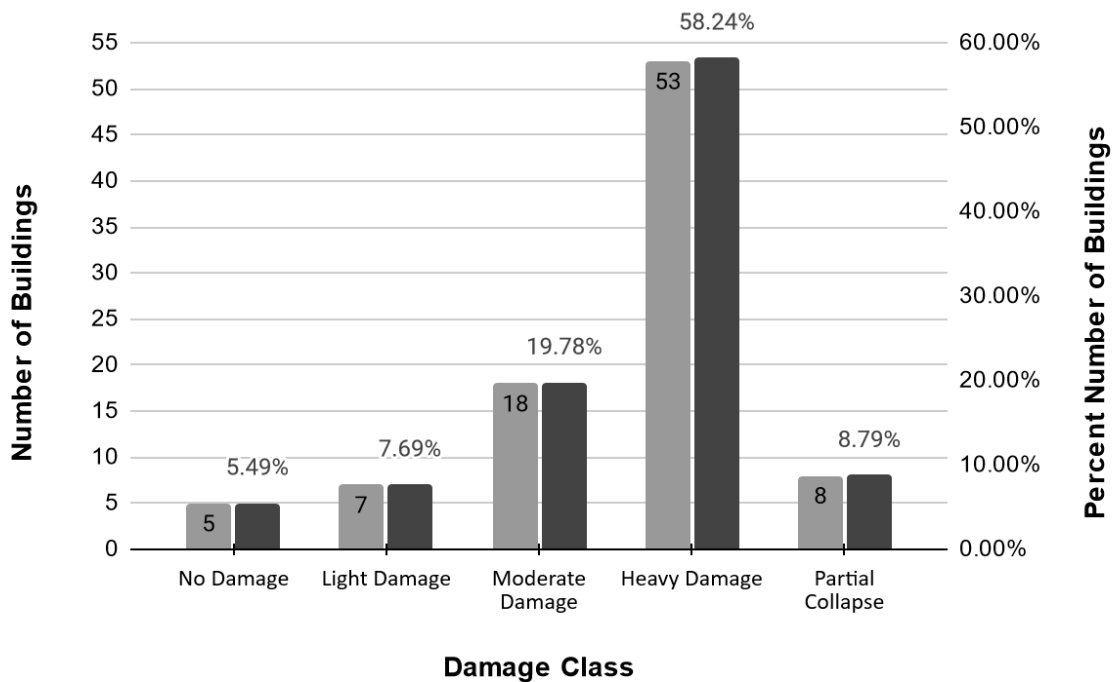
**Figure 5.9.** Distribution of the residential buildings visited by the buildings team in terms of damage class.

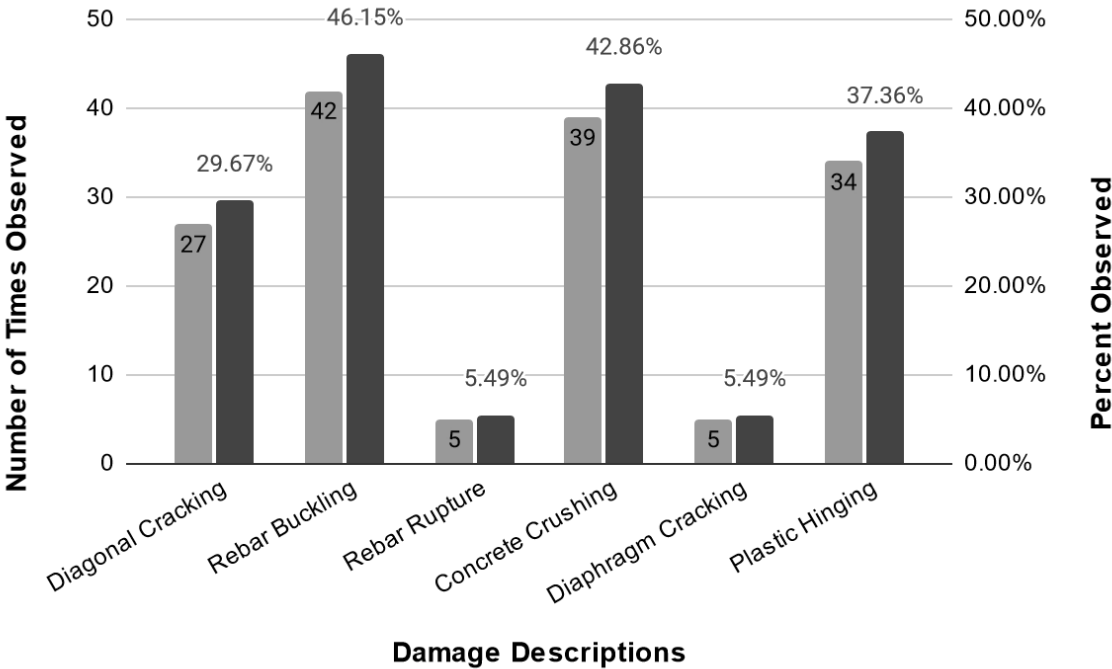
Figure 5.10. Types of damage observed in the residential buildings visited by the EERI Buildings team.

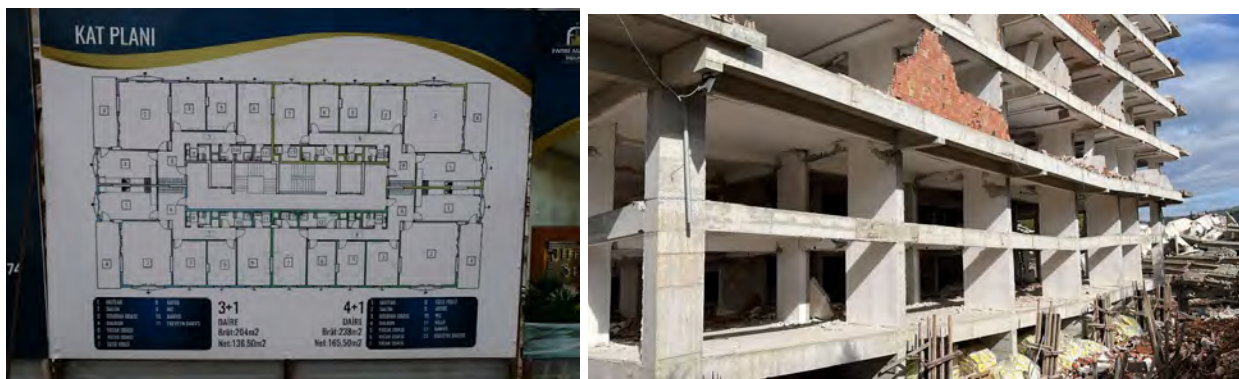
**Figure 5.11.** RC shear wall frame system building under construction, Antakya (plan on the left; floor plate on the right)

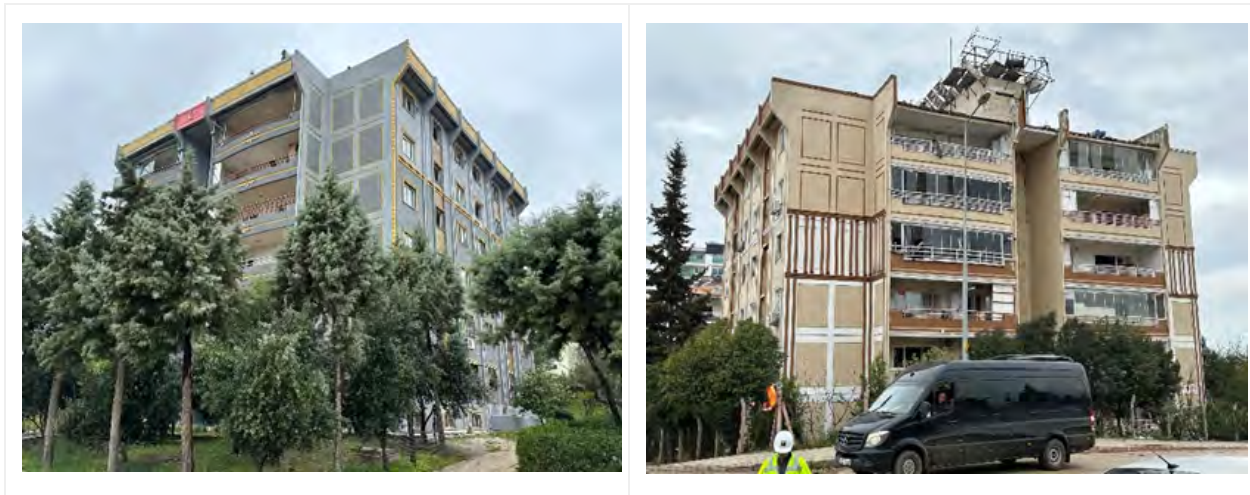
**Figure 5.14.** Structures with tunnel-form construction for government buildings, Kırıkhan

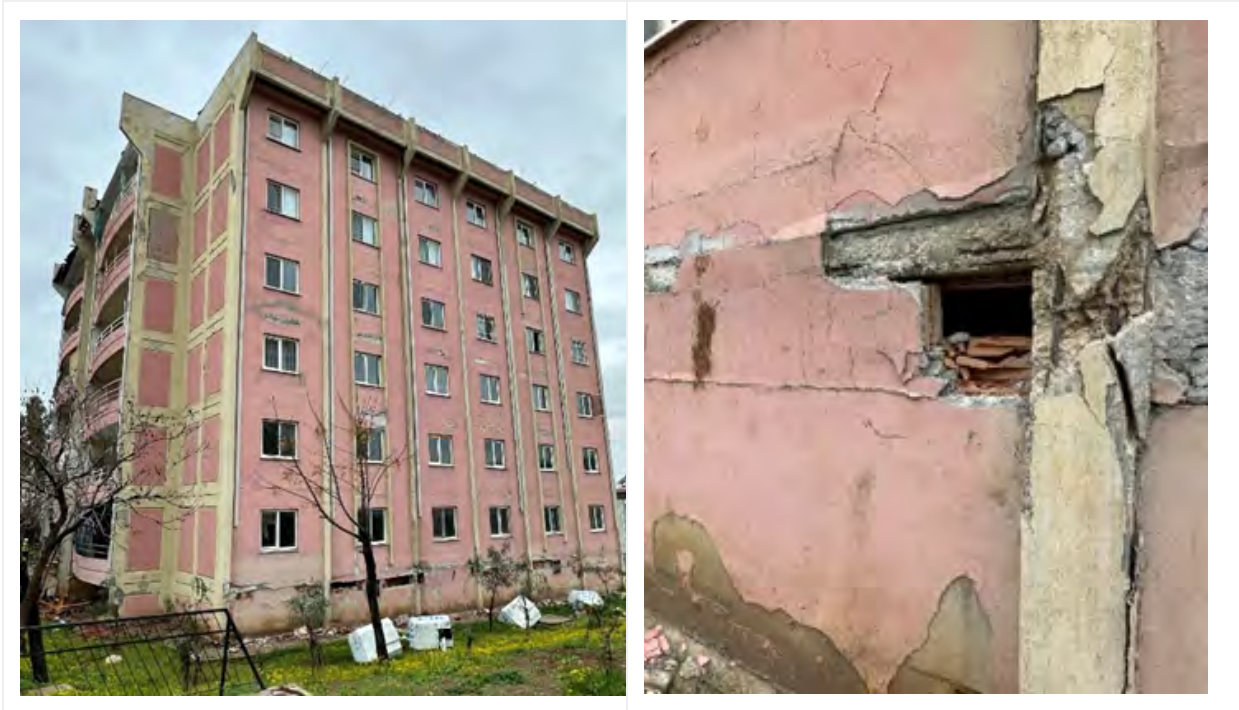
**Figure 5.15:** Localized short column effect induced by partial failure of masonry infill walls.

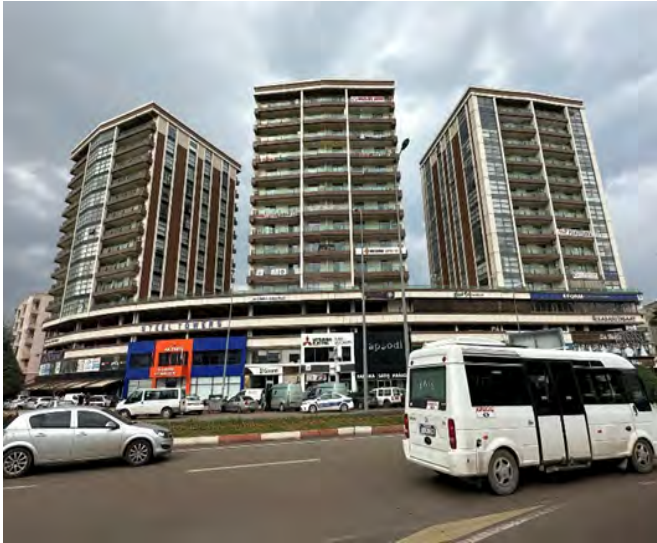
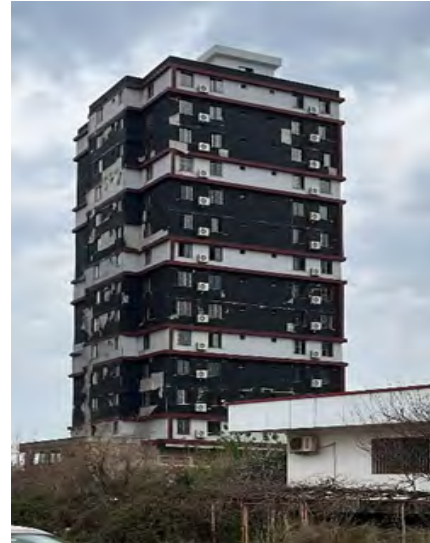
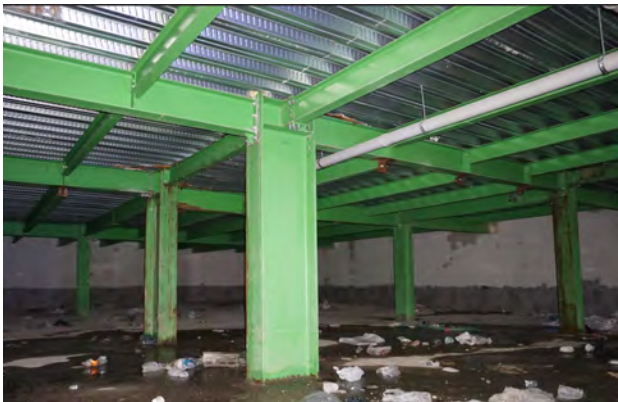
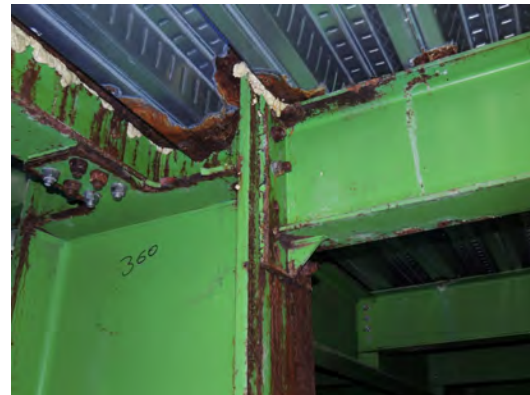
**Figure 5.16.** RC core with steel gravity framing (tower photo at the top, framing and steel connection photos at the bottom)

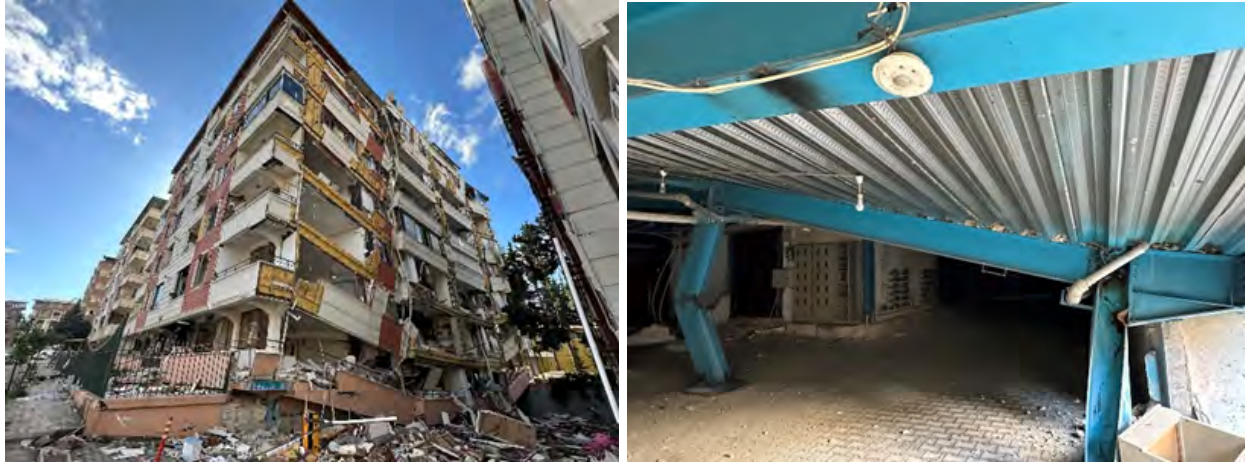
**Figure 5.17.** Steel-framed structure with failure at the base of the steel columns

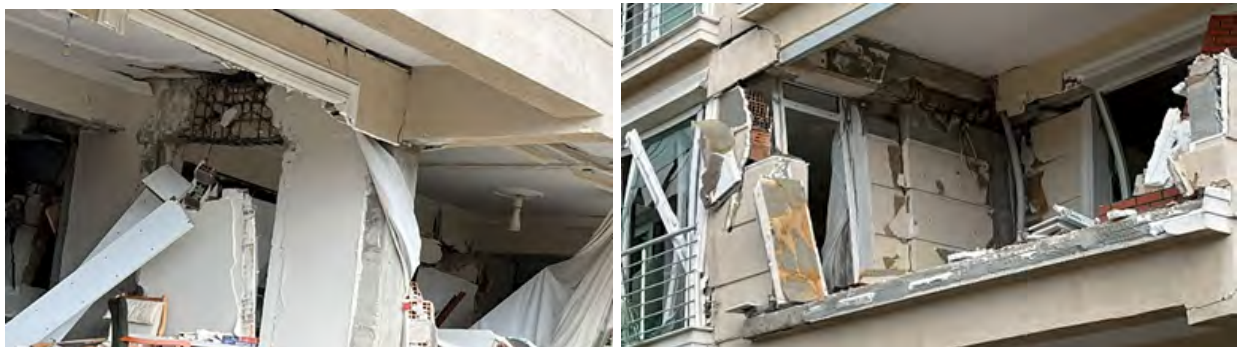
**Figure 5.19.** Significant structural damage to cantilever beams and coupling beams

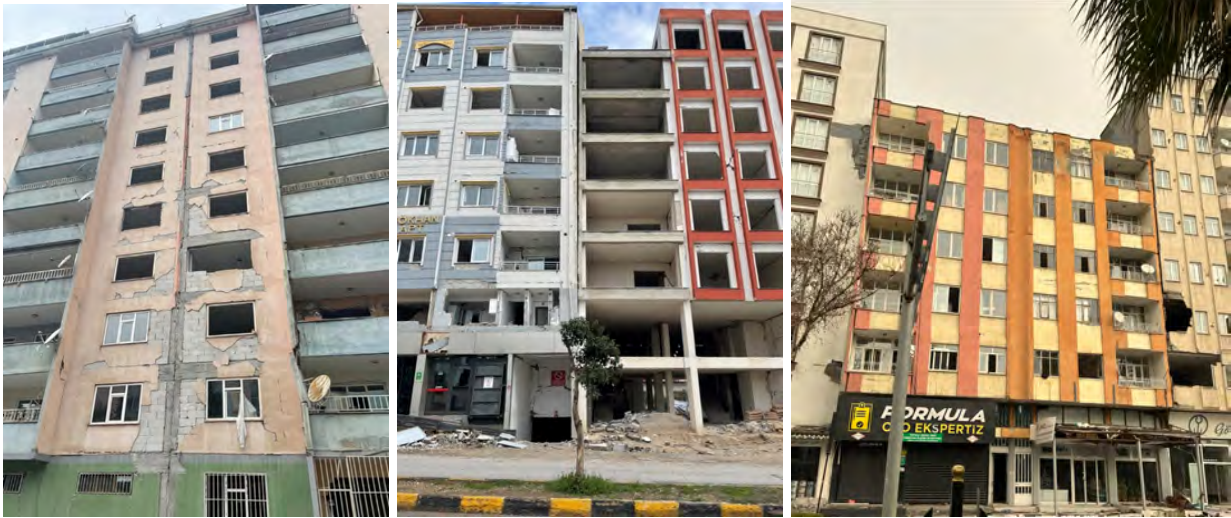
**Figure 5.20.** Insufficient separation in seismic joints between buildings
