MAY 6, 2023

# FEBRUARY 6, 2023 TÜRKIYE EARTHQUAKES: REPORT ON GEOSCIENCE AND ENGINEERING IMPACTS

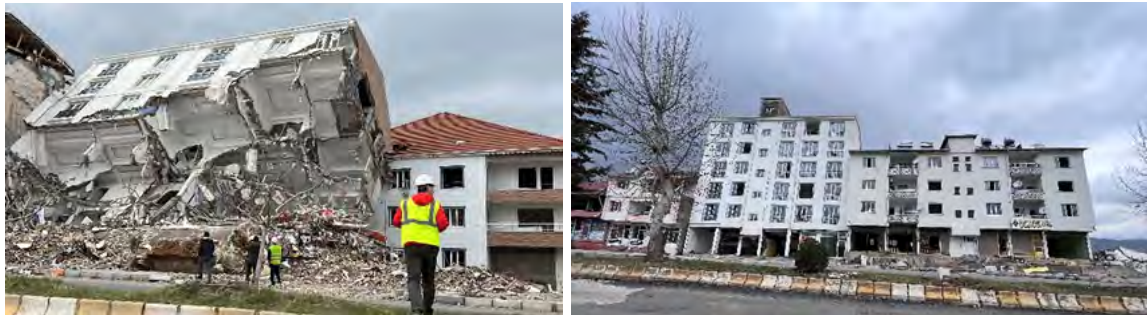
**Figure 5.22.** Overturning and tilting of structures due to liquefaction, İskenderun

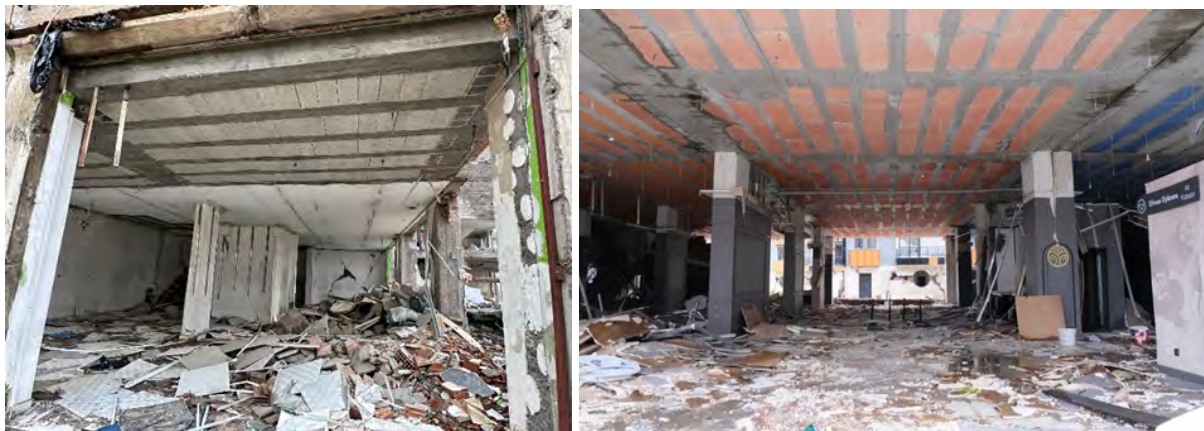
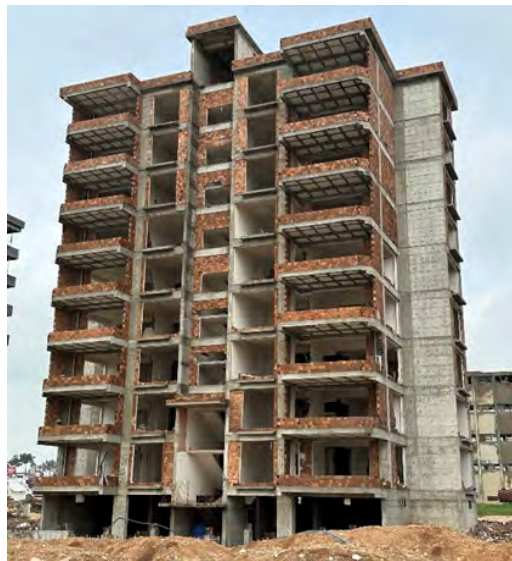
**Figure 5.25:** Filler-joist floor systems (asmolen) with different filler blocks including bricks or hollow masonry blocks.

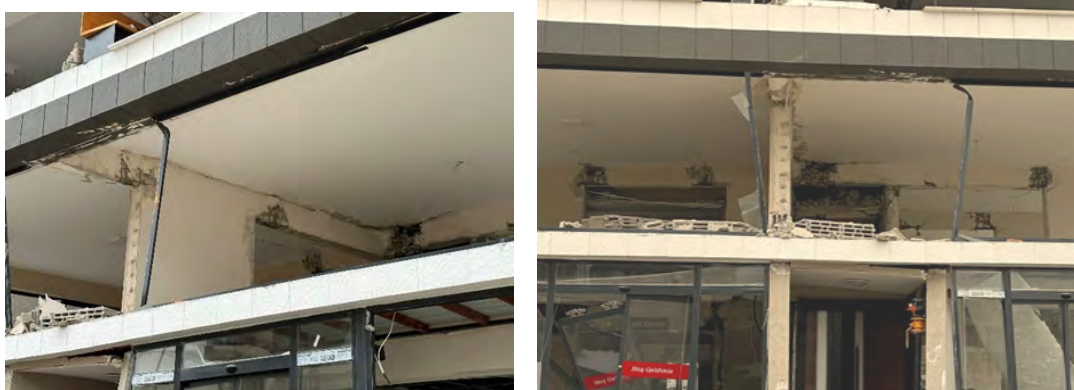
**Figure 5.27.** Plastic hinges at beam ends.

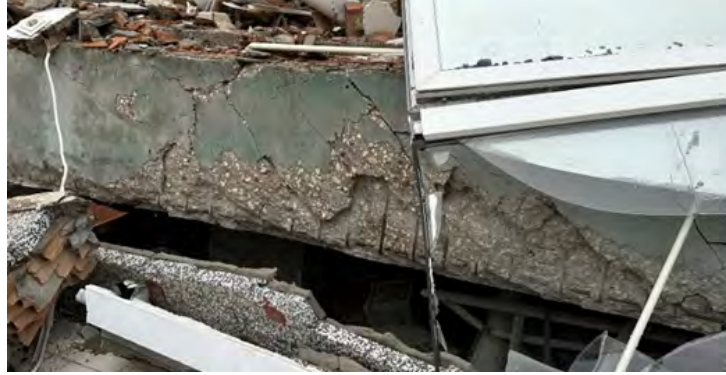
**Figure 5.28.** Uniformly distributed well-detailed transverse steel in a shear damaged beam in a collapsed building.

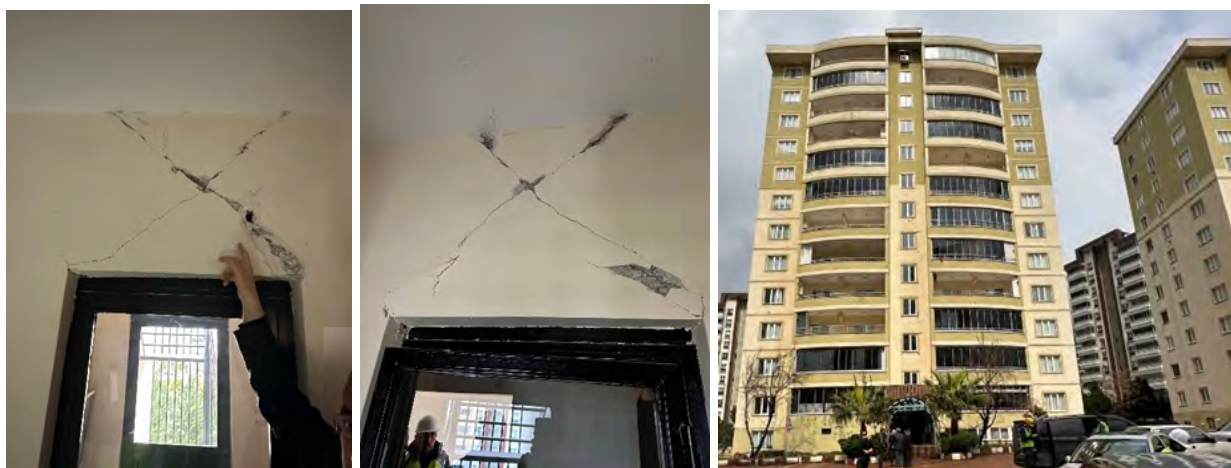
**Figure 5.29.** Diagonal cracks in beams connecting shear walls in a building constructed using tunnel forms .

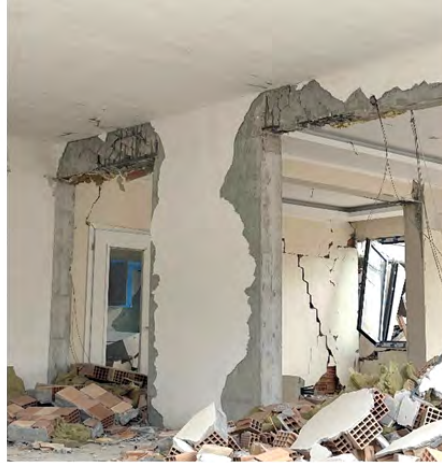
**Figure 5.30.** Damage distribution along the shorter beam including diagonal cracking.

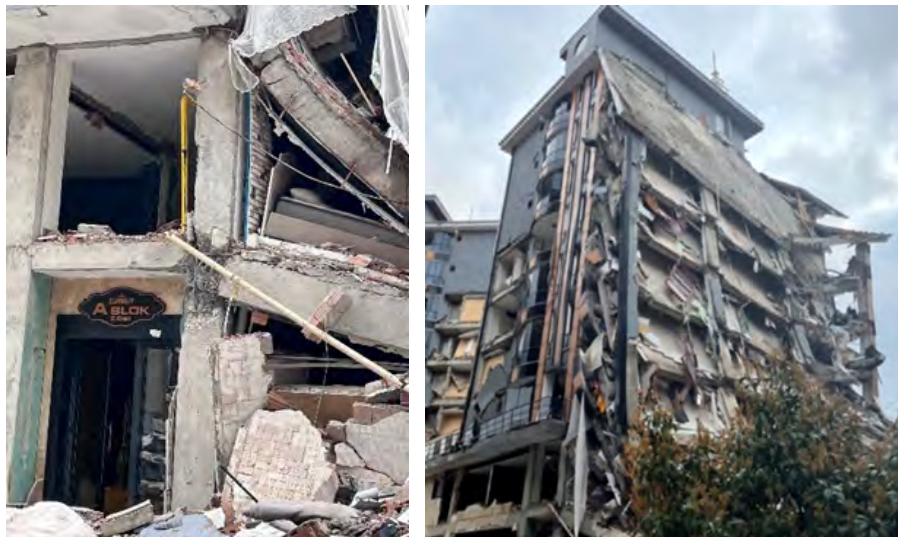
**Figure 5.31:** Column joint region with no transverse steel, which is exposed after the right side of the building collapsed.

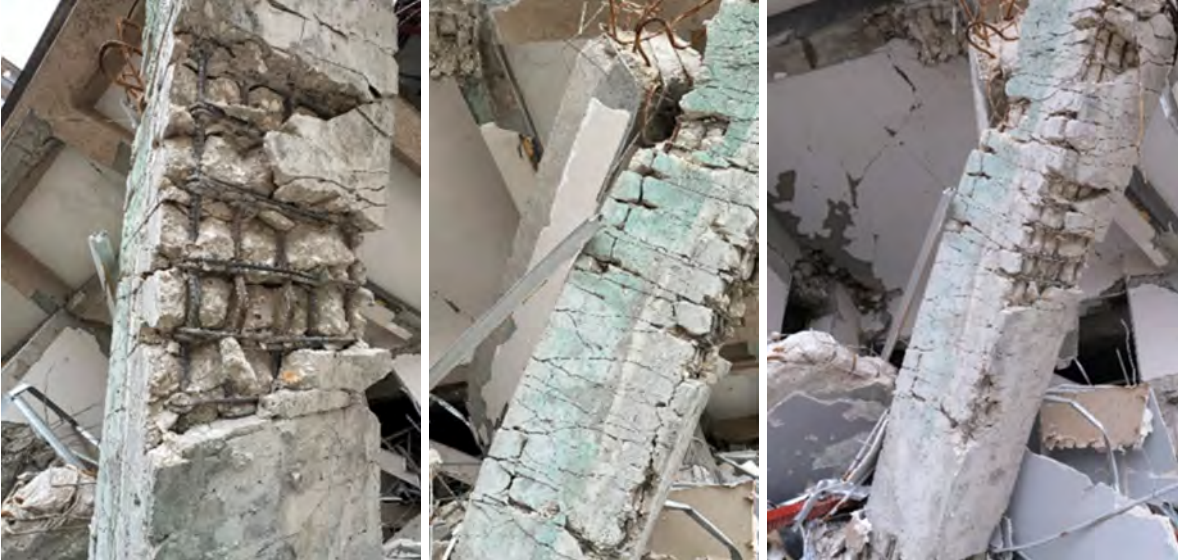
**Figure 5.32.** Column with overlapping ties experienced uniform cracking along its length.

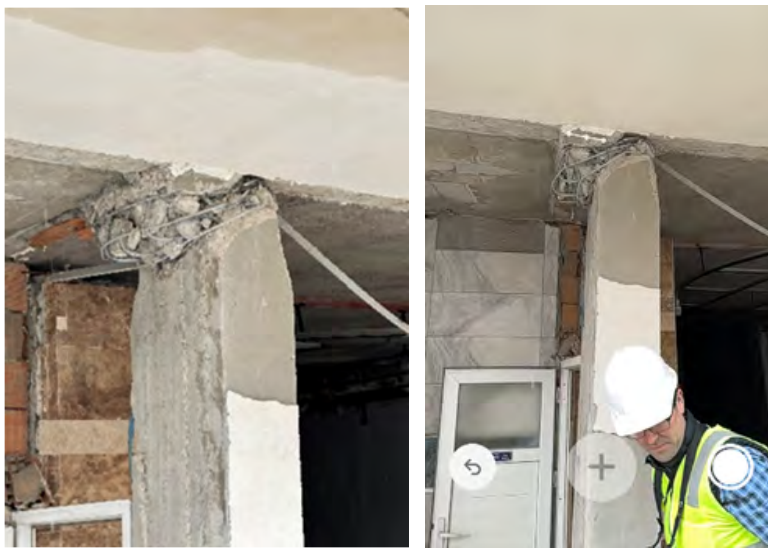
**Figure 5.33:** Column failure in the weak-axis direction.

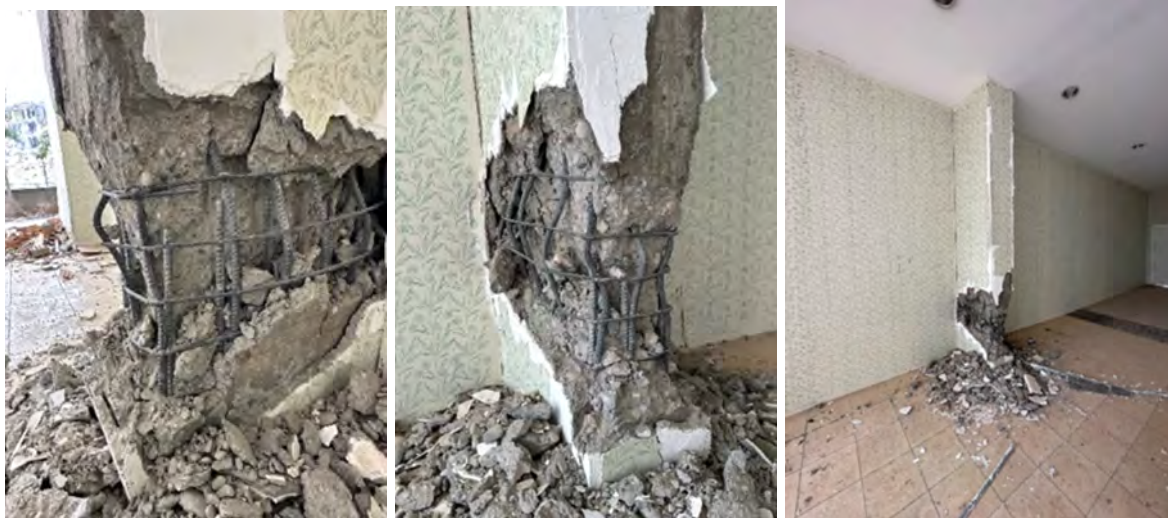
**Figure 5.34:** Failure of a column with lap splices near the bottom and insufficient transverse steel.

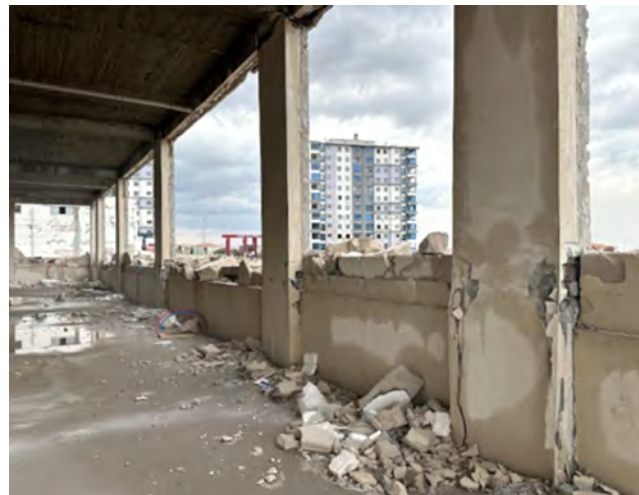
**Figure 5.35.** Short column effect and damage due to partial height infill walls.

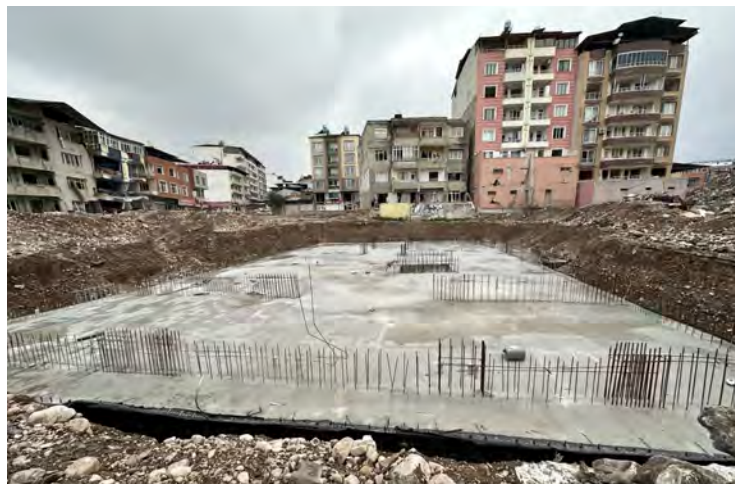
**Figure 5.36.** Short lap splices above the foundation at the bottom of first columns and story shear walls in a building under construction.

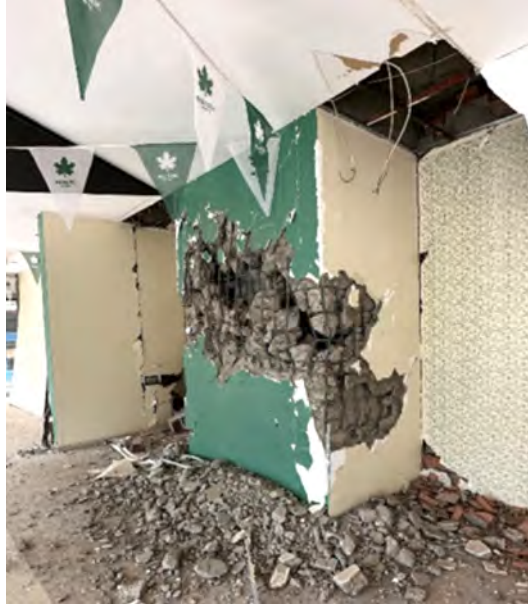
**Figure 5.37:** Damage in both orthogonal directions of a U-shaped RC shear wall.

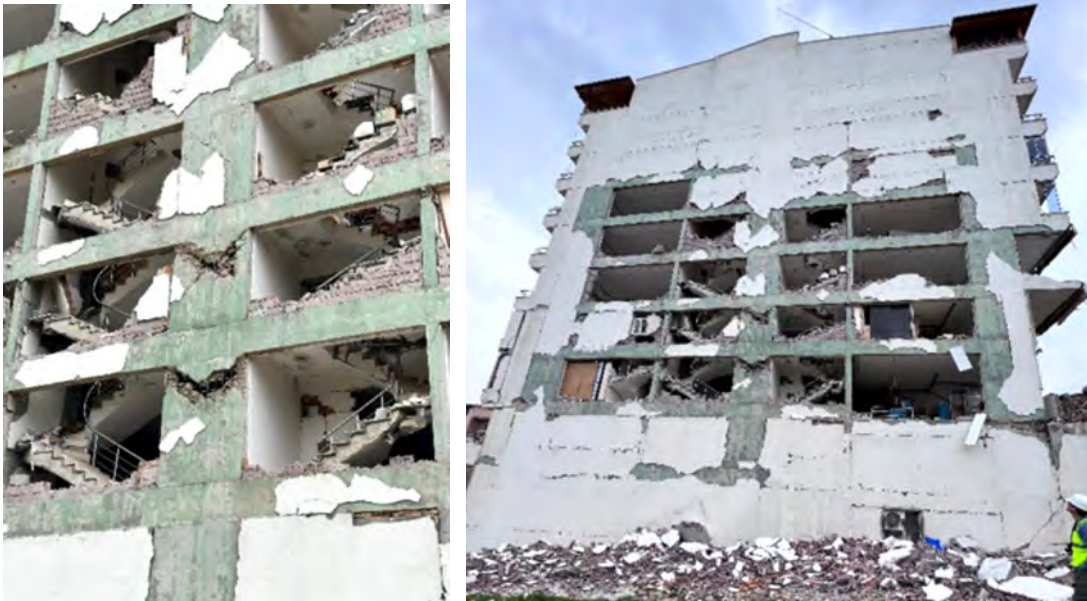
**Figure 5.38.** Damaged shear walls in the lower stories of a building.

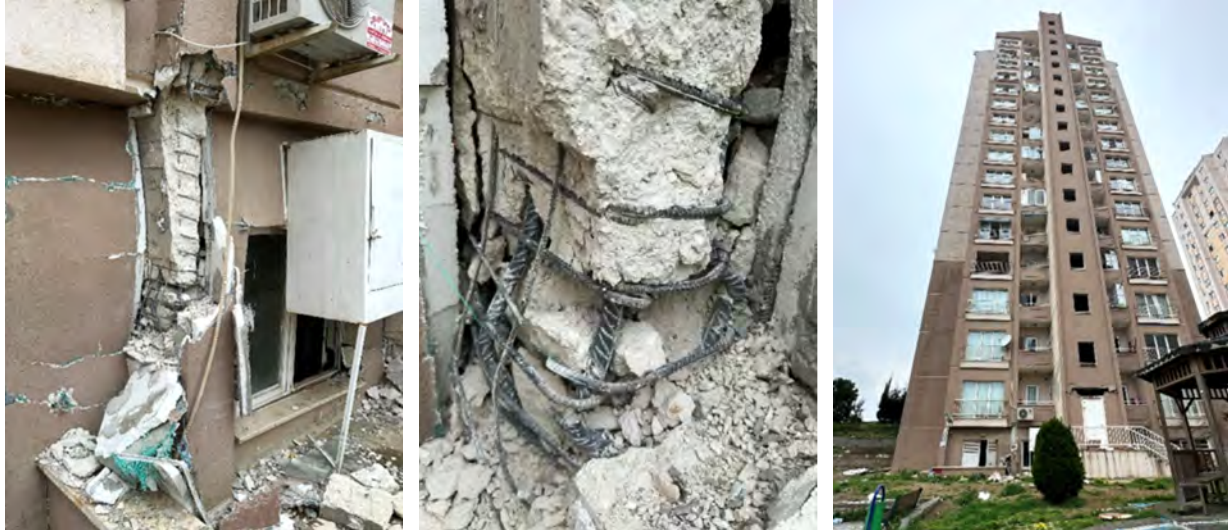
**Figure 5.39.** Damage in the first story of a tunnel-form shear wall building.

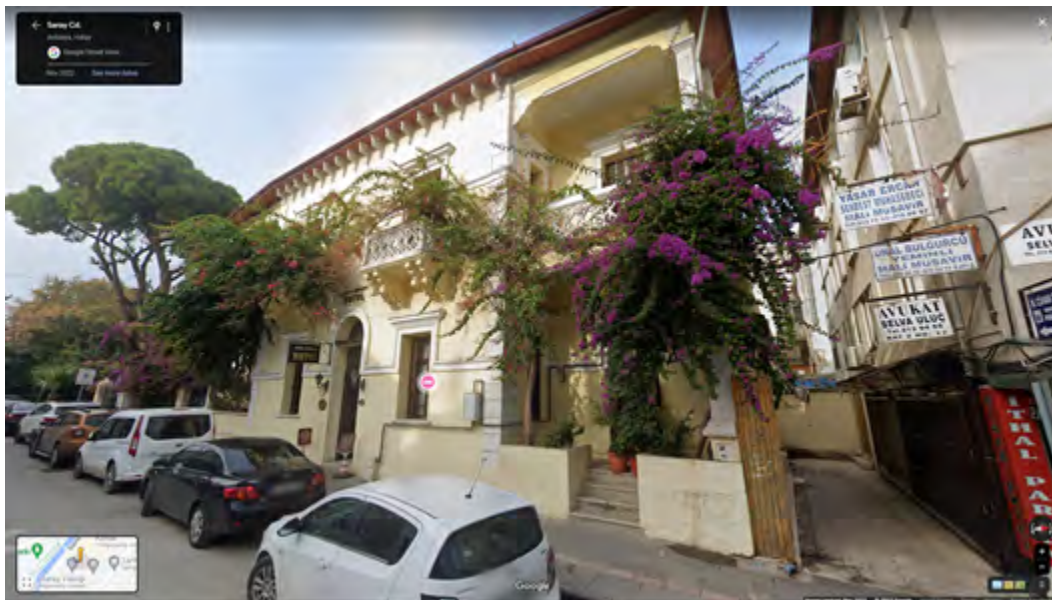
**Figure 5.40.** Building housing the Antik Beyazit Hotel prior to the earthquake (source: Google Maps).

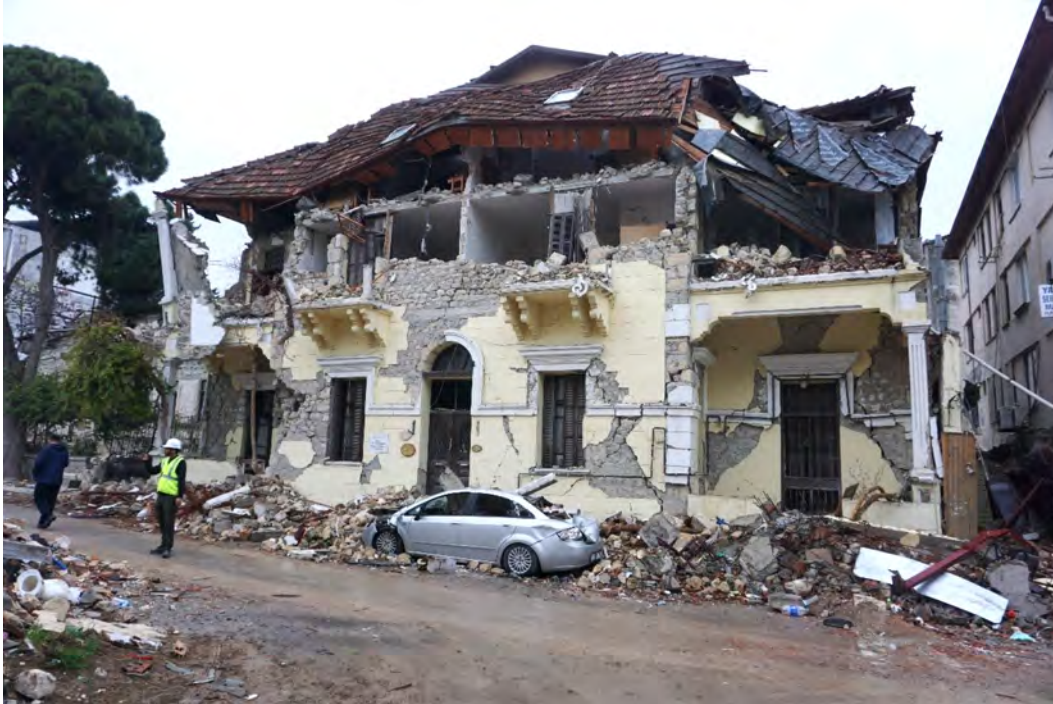
**Figure 5.41.** Damage to the unreinforced masonry building housing the Antik Beyazit Hotel.

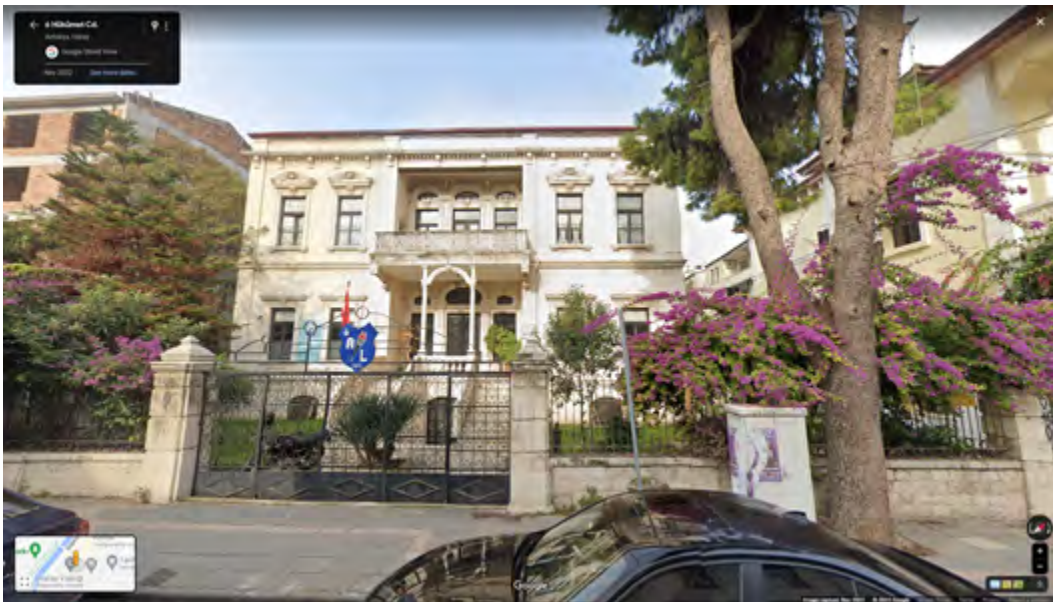
**Figure 5.42.** Building next door to the Antik Beyazit Hotel prior to the earthquake (source: Google Maps).

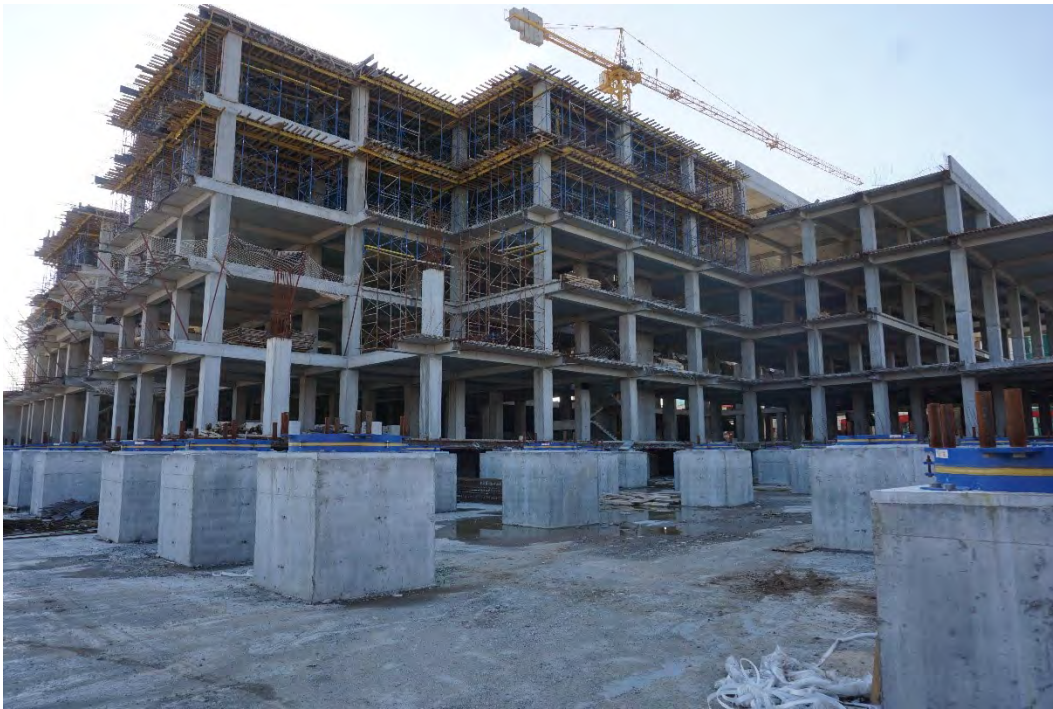
**Figure 5.48.** Base isolated hospital building under construction in Kahramanmaraş.

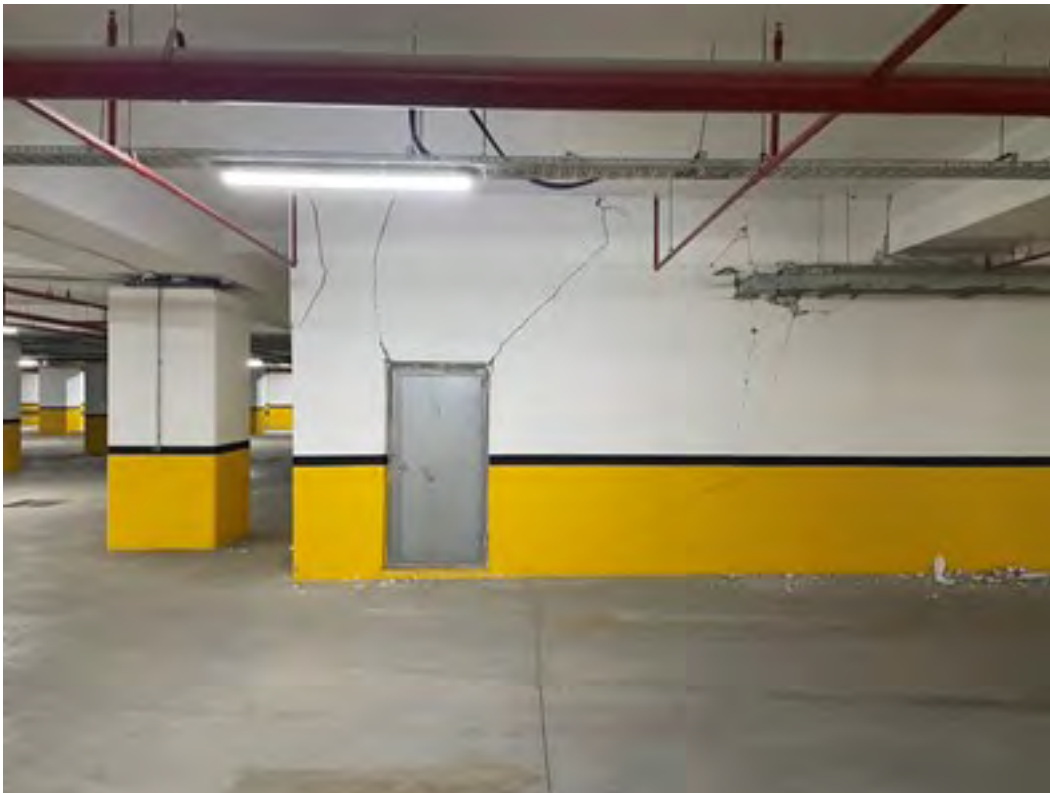
**Figure 5.51.** Cracking of masonry infill wall in Malatya.

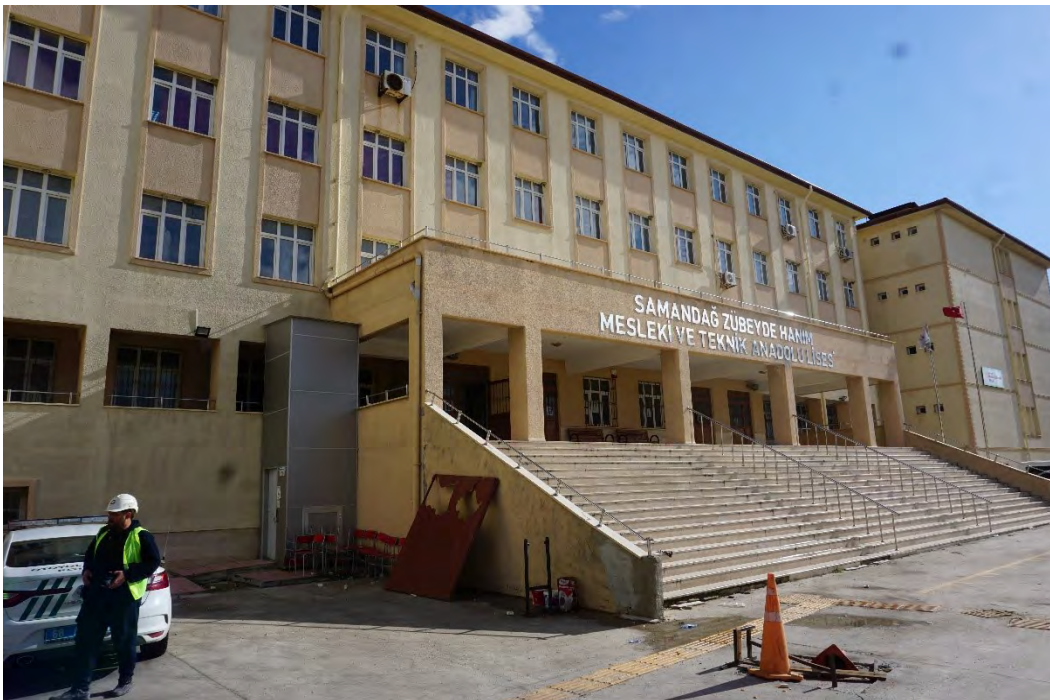
**Figure 5.47.** School building in Samandağ.

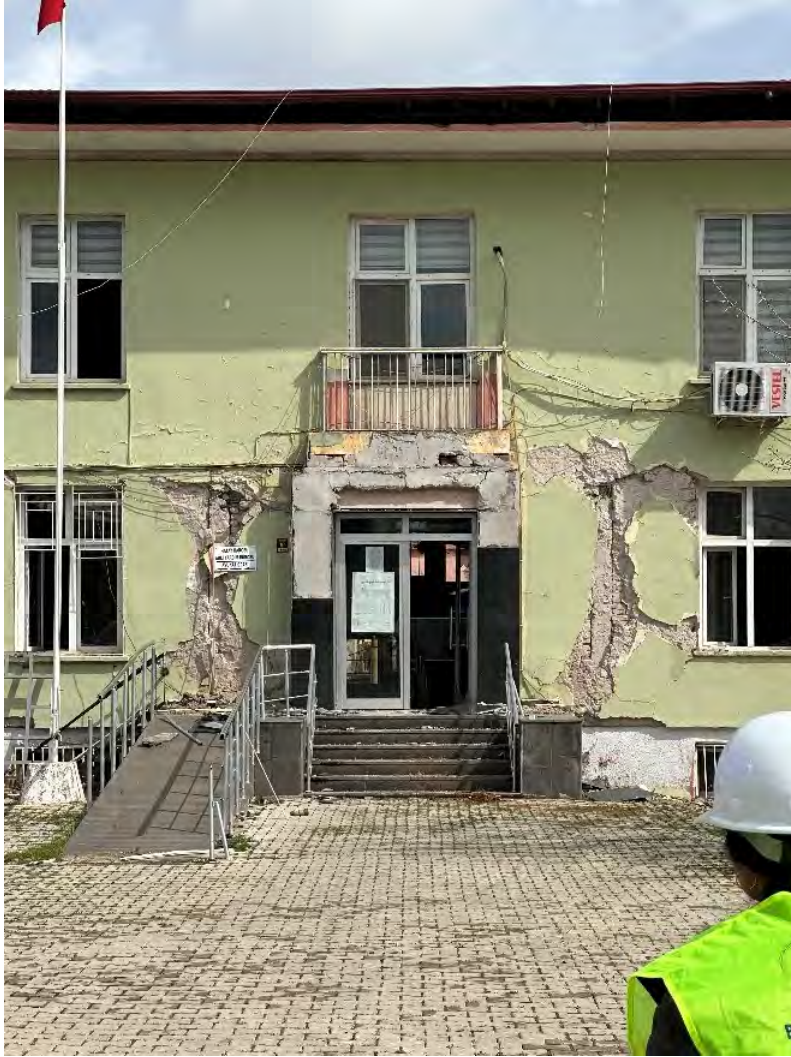
**Figure 5.55.** Damage to exterior walls of Hasa courthouse.

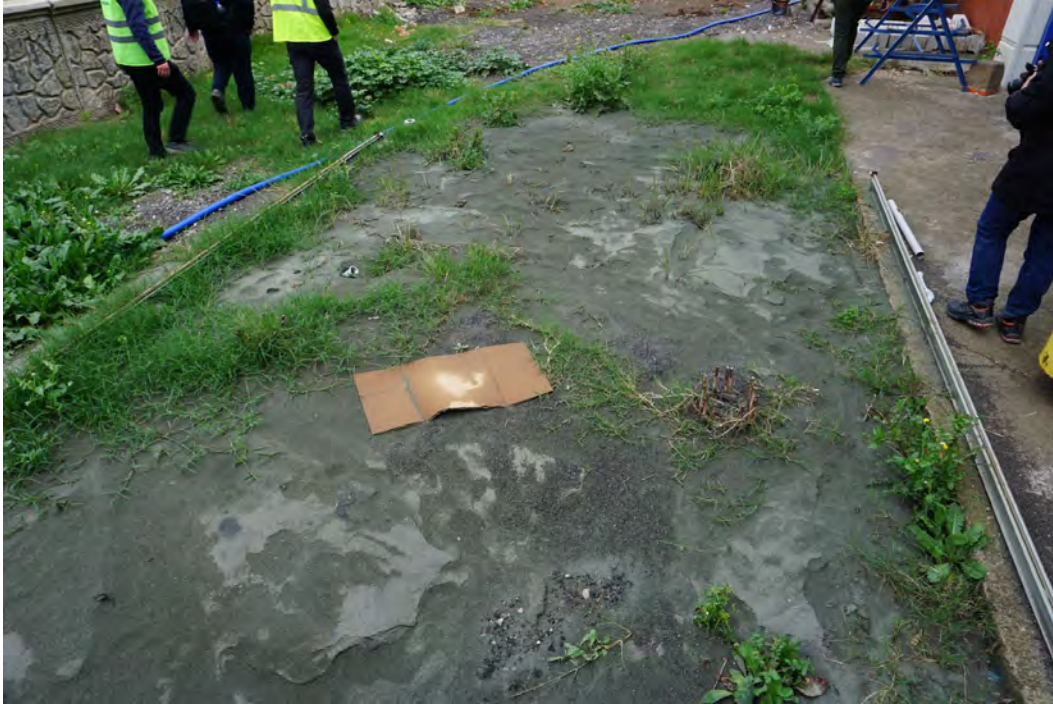
**Figure 5.56.** Evidence of liquefaction adjacent to a building of Iskenderun Technical University. Perhaps fittingly, the photographed area is used as an outdoor laboratory for the University's geotechnical engineering department.

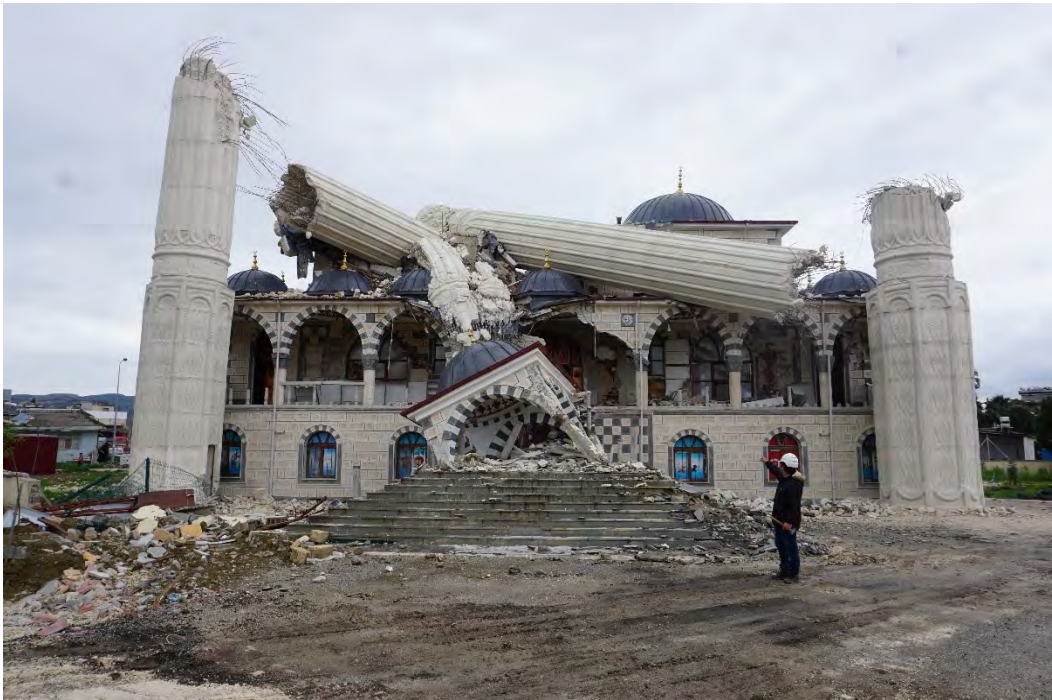
**Figure 5.53.** Damage to the Odabaşı Camii mosque north of downtown Antakya.

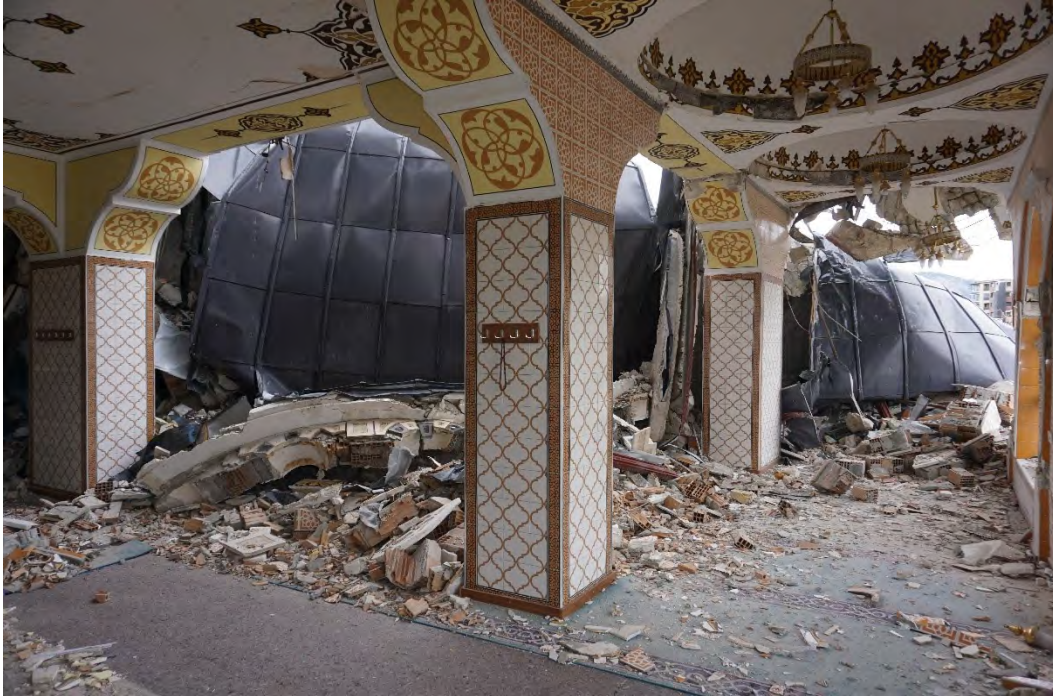
**Figure 5.59.** Interior of Odabaşı Camii mosque with collapsed dome.

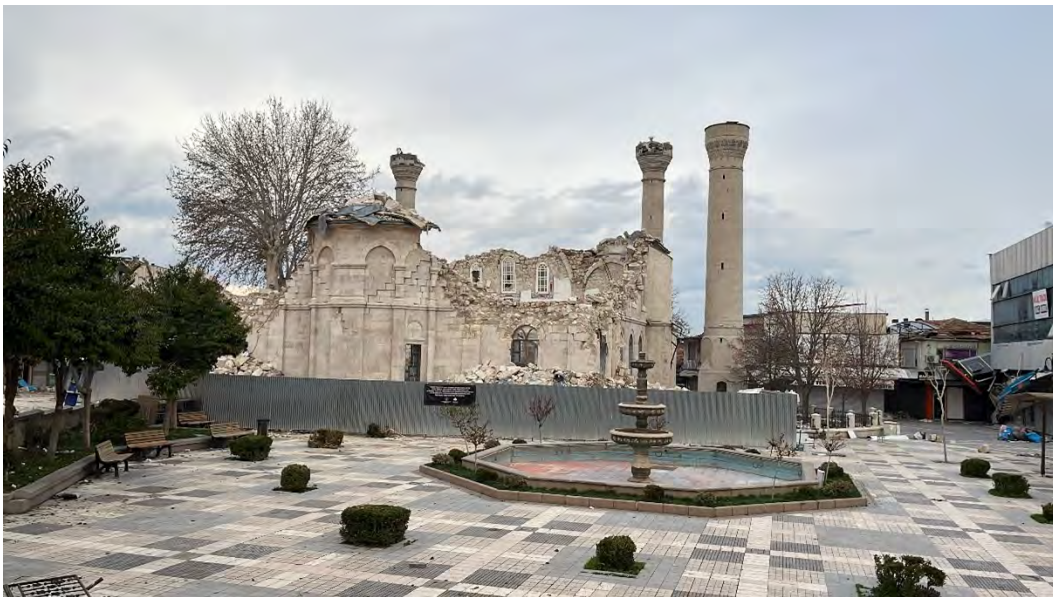
**Figure 5.60.** Damage to Yeni Cami mosque in Malatya.

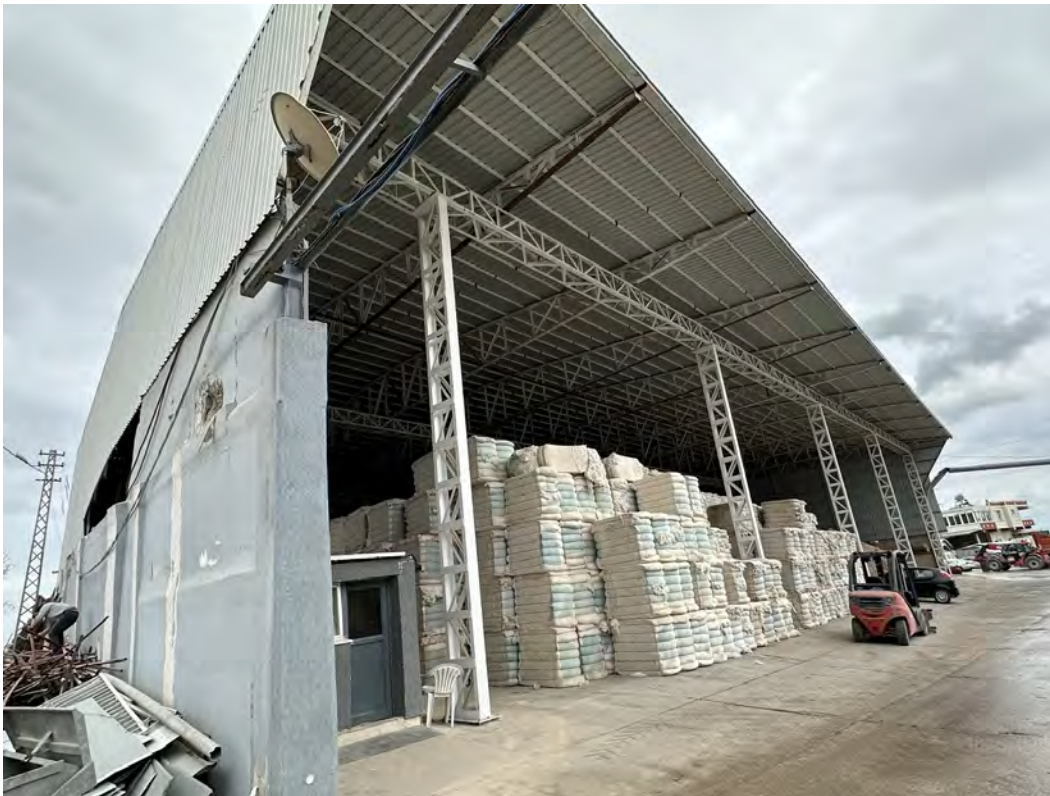
**Figure 5.61.** Good performance of steel frame industrial structure in Kırıkhan. Note the damage to the infill wall on the left side of the photograph.

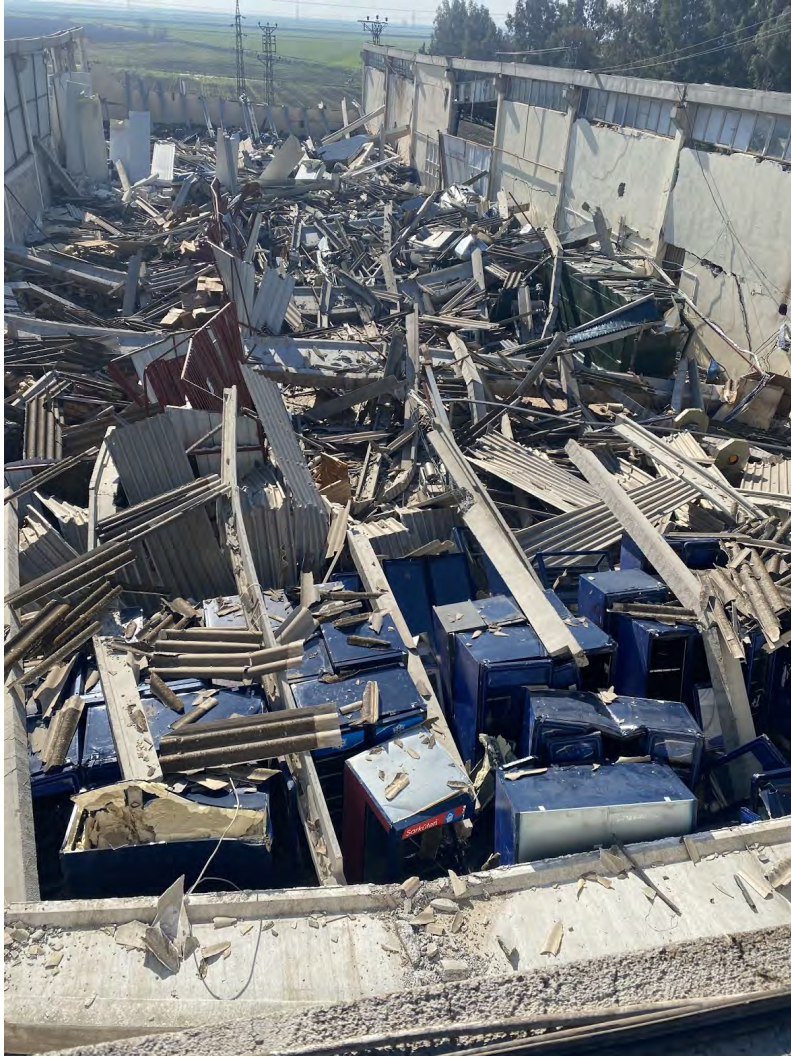
**Figure 5.62.** Remnants of precast concrete industrial building in Kırıkhan. The photograph was taken by the owner prior to the cleanup of debris.

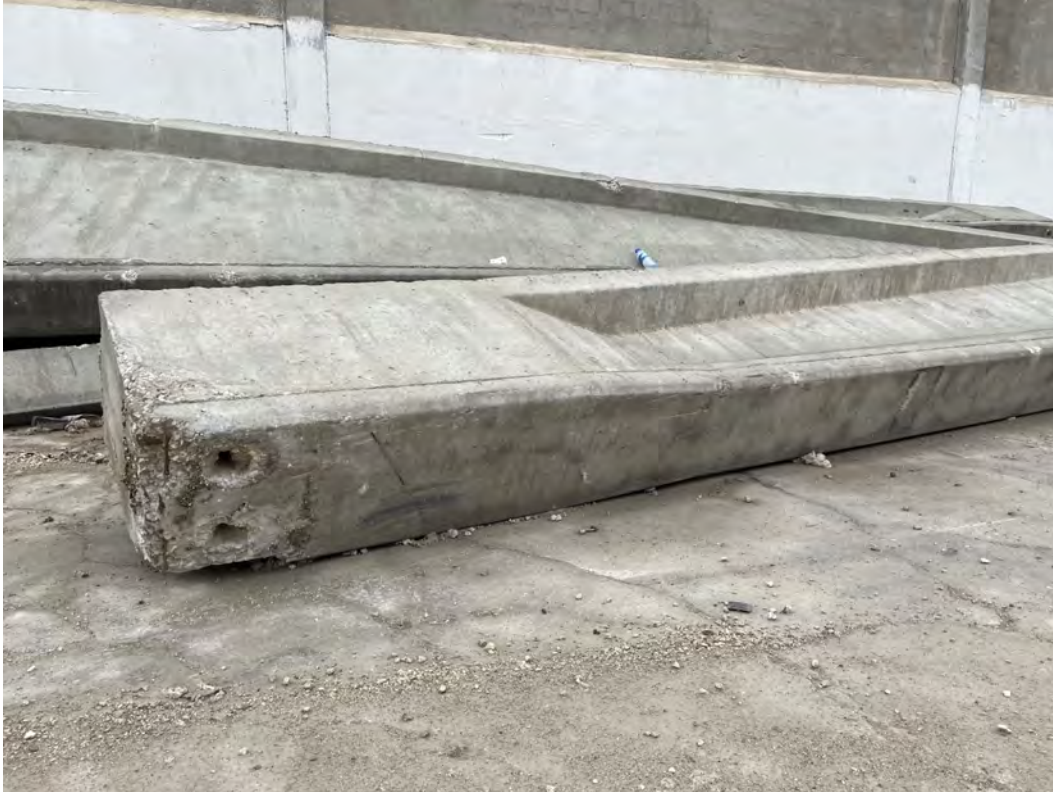
**Figure 5.63.** Precast connection at failed girder of Kırıkhan industrial building shown above.

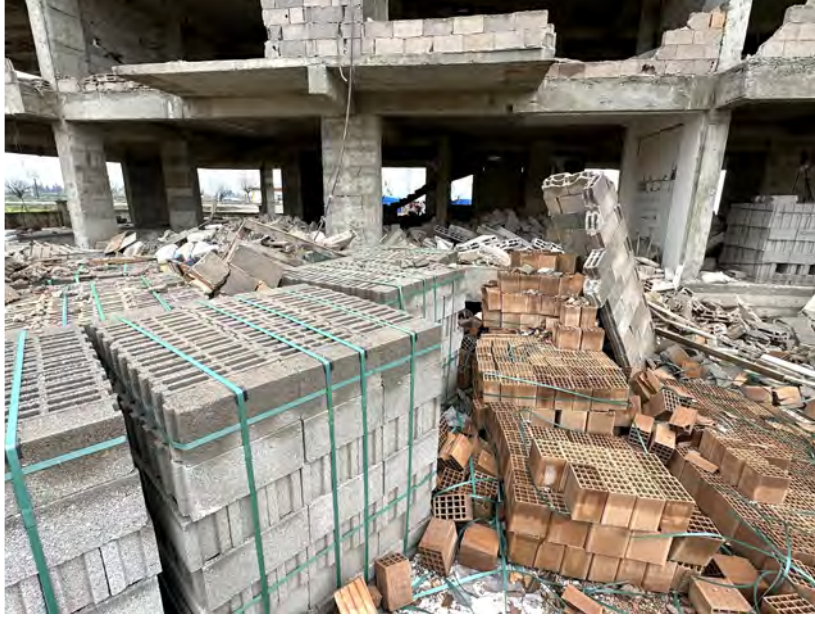
**Figure 5.64.** Lightweight masonry units and hollow clay bricks are commonly used as infill wall materials.

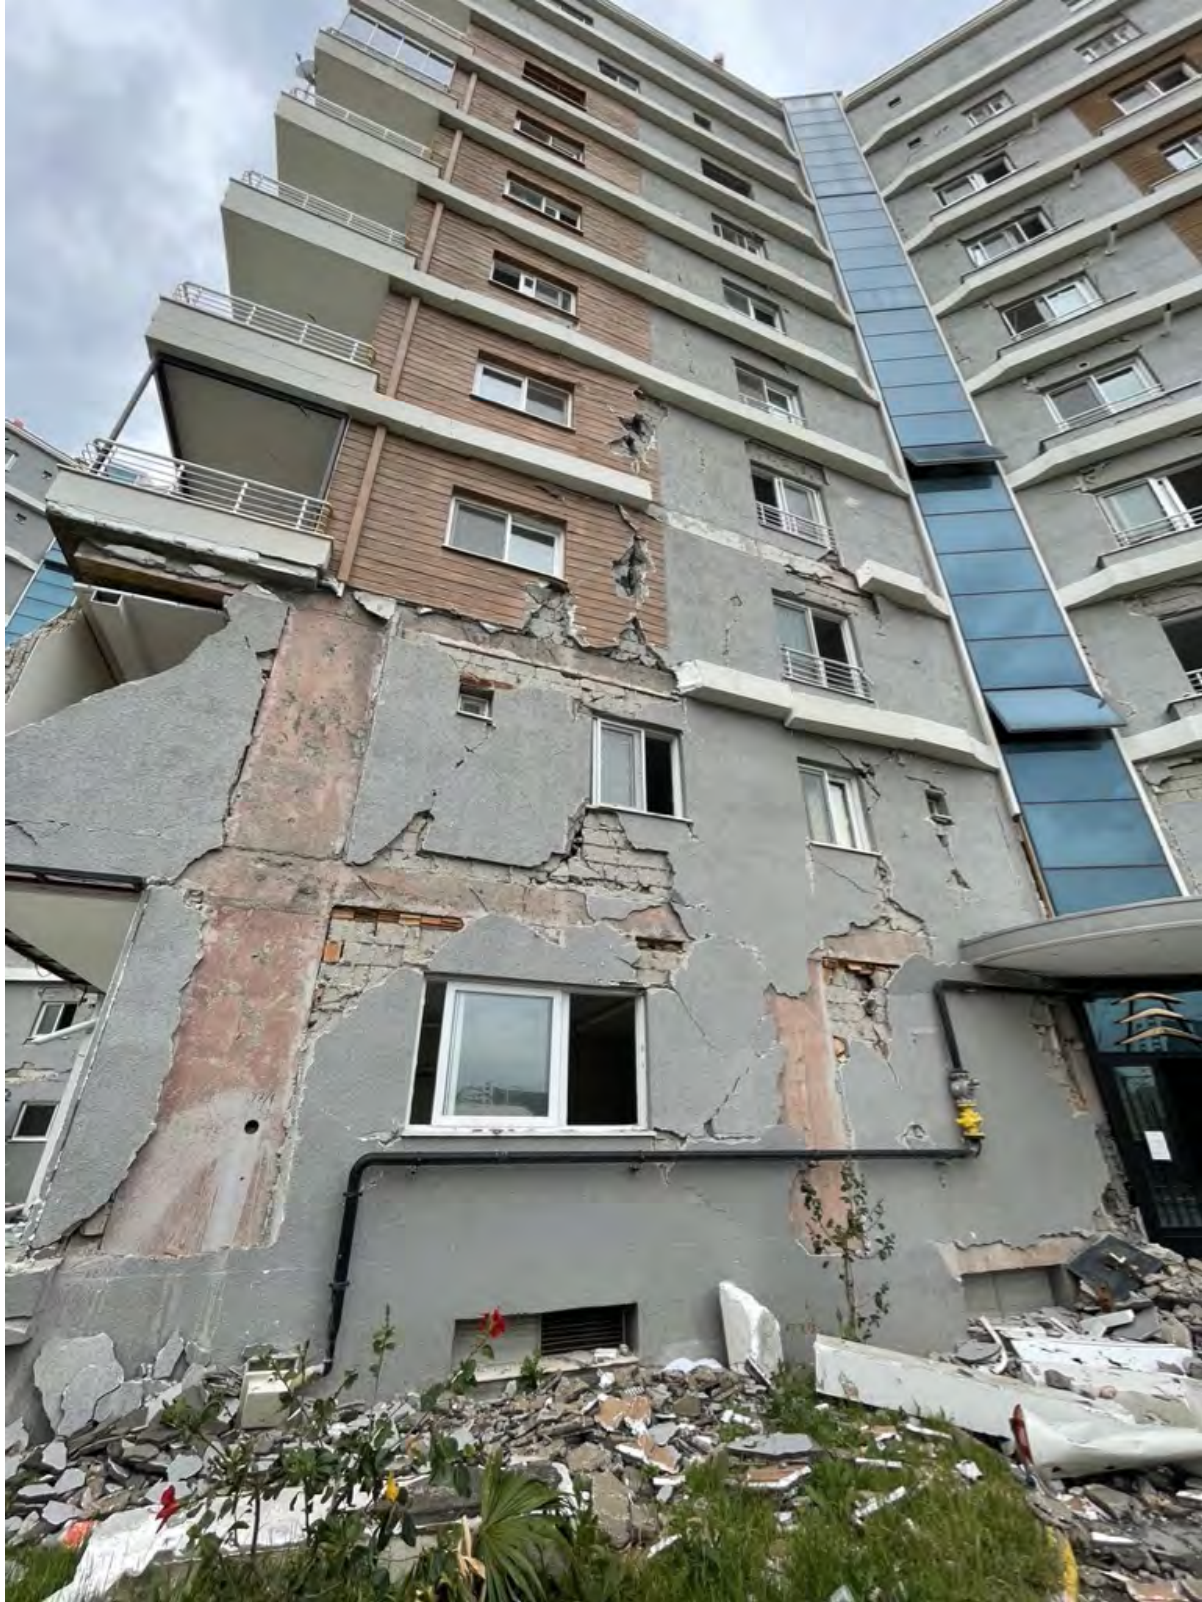
**Figure 5.65.** Cracking of infill wall facade with delamination of insulation and waterproof membrane in residential building near İskenderun.

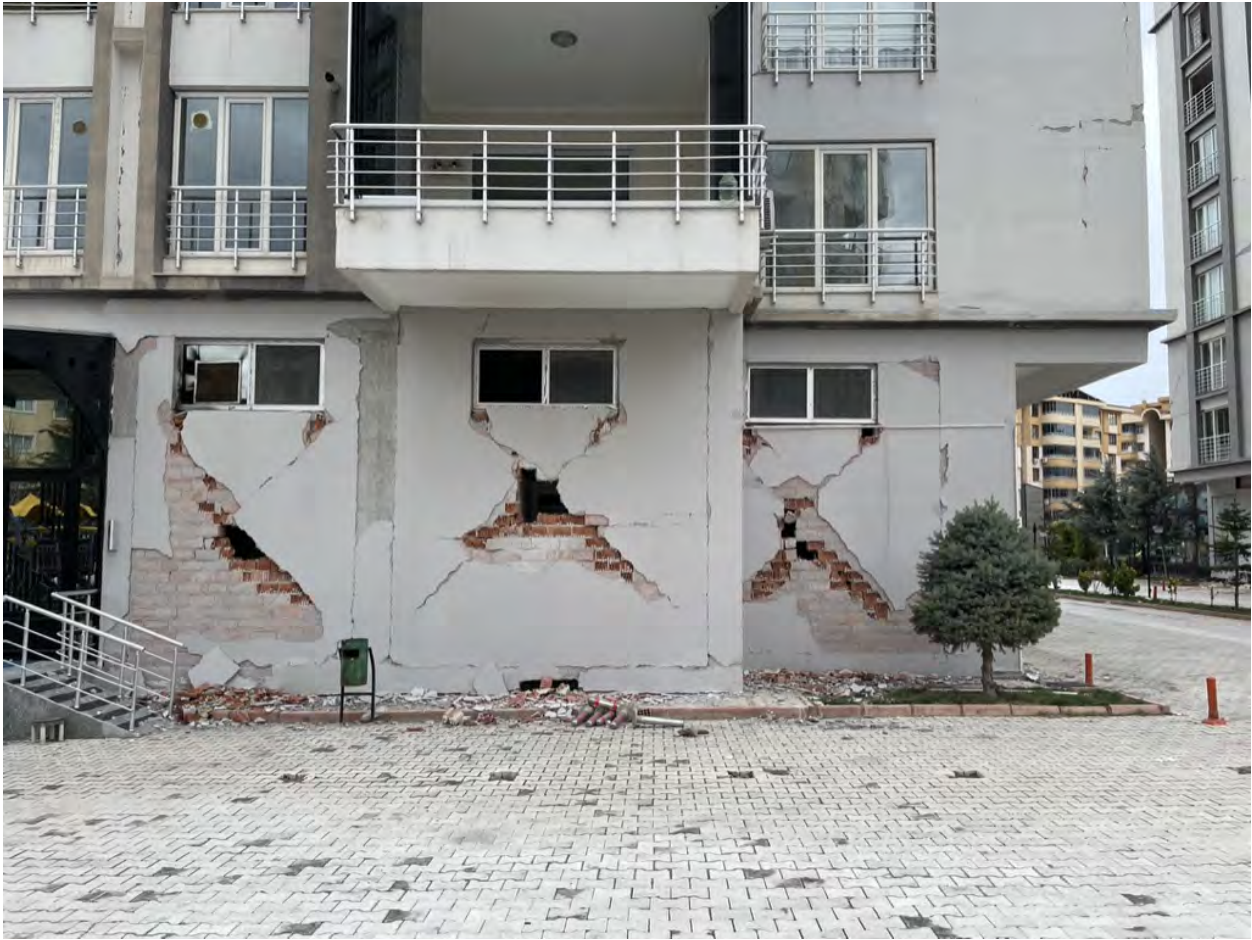
Figure 5.66. Shear cracking in infill partitions at ground floor of residential building in Malatya.
