MAY 6, 2023

# FEBRUARY 6, 2023 TÜRKIYE EARTHQUAKES: REPORT ON GEOSCIENCE AND ENGINEERING IMPACTS

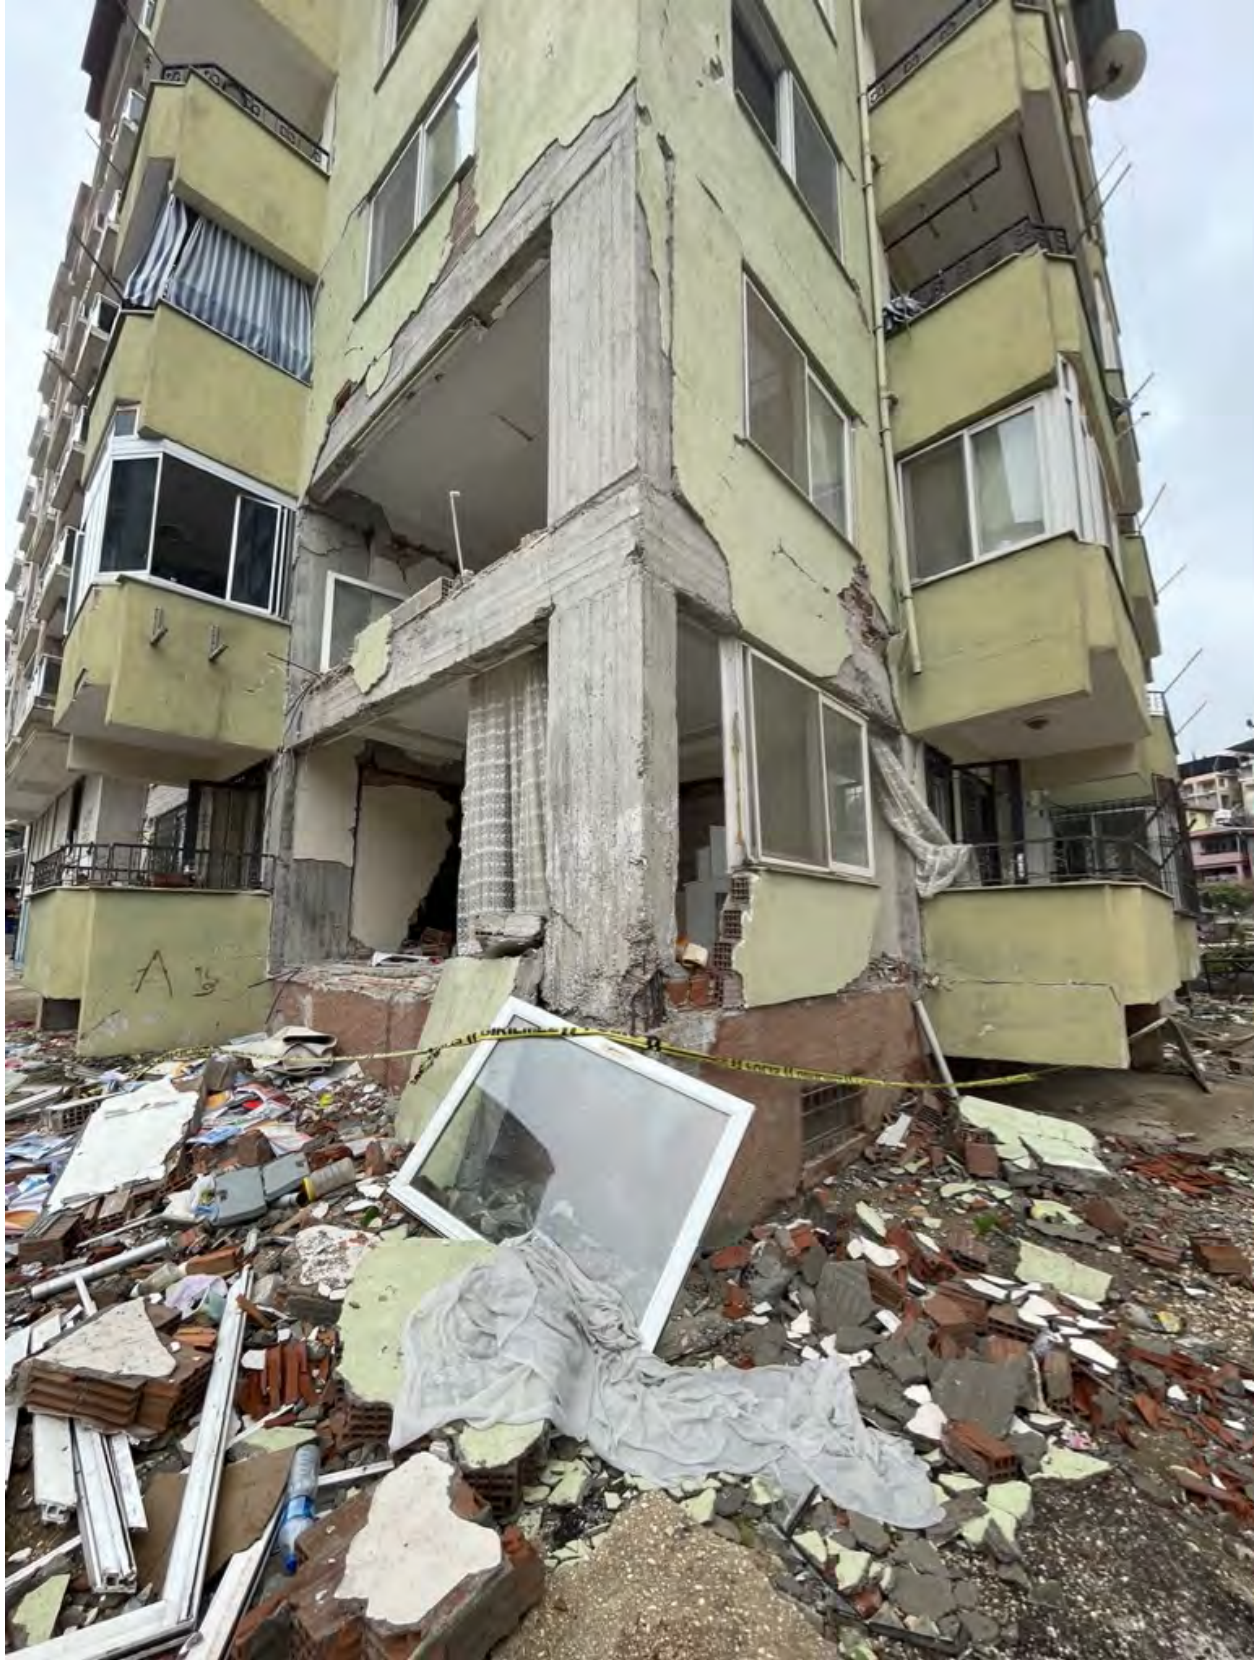
**Figure 5.67.** Failure of masonry infill wall at lower floors of a residential building in Kırıkhan.

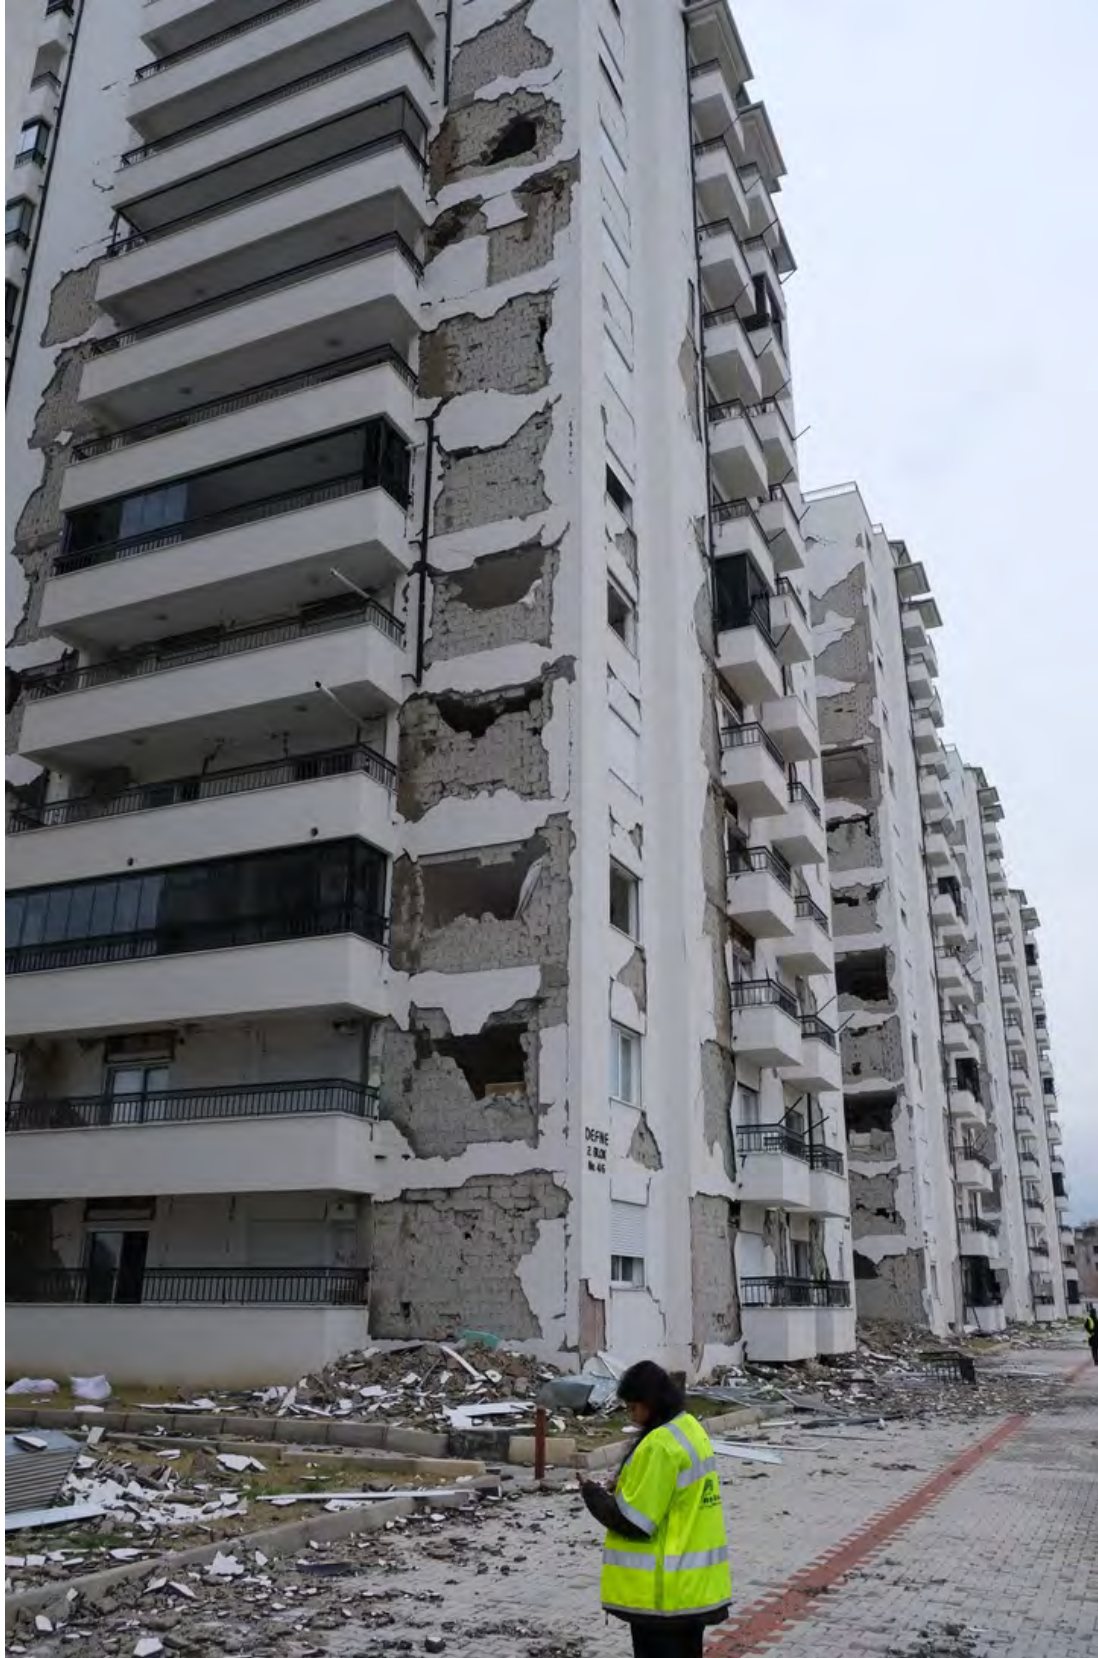
**Figure 5.68.** Infill facade damage up the height of a residential tower in İskenderun.

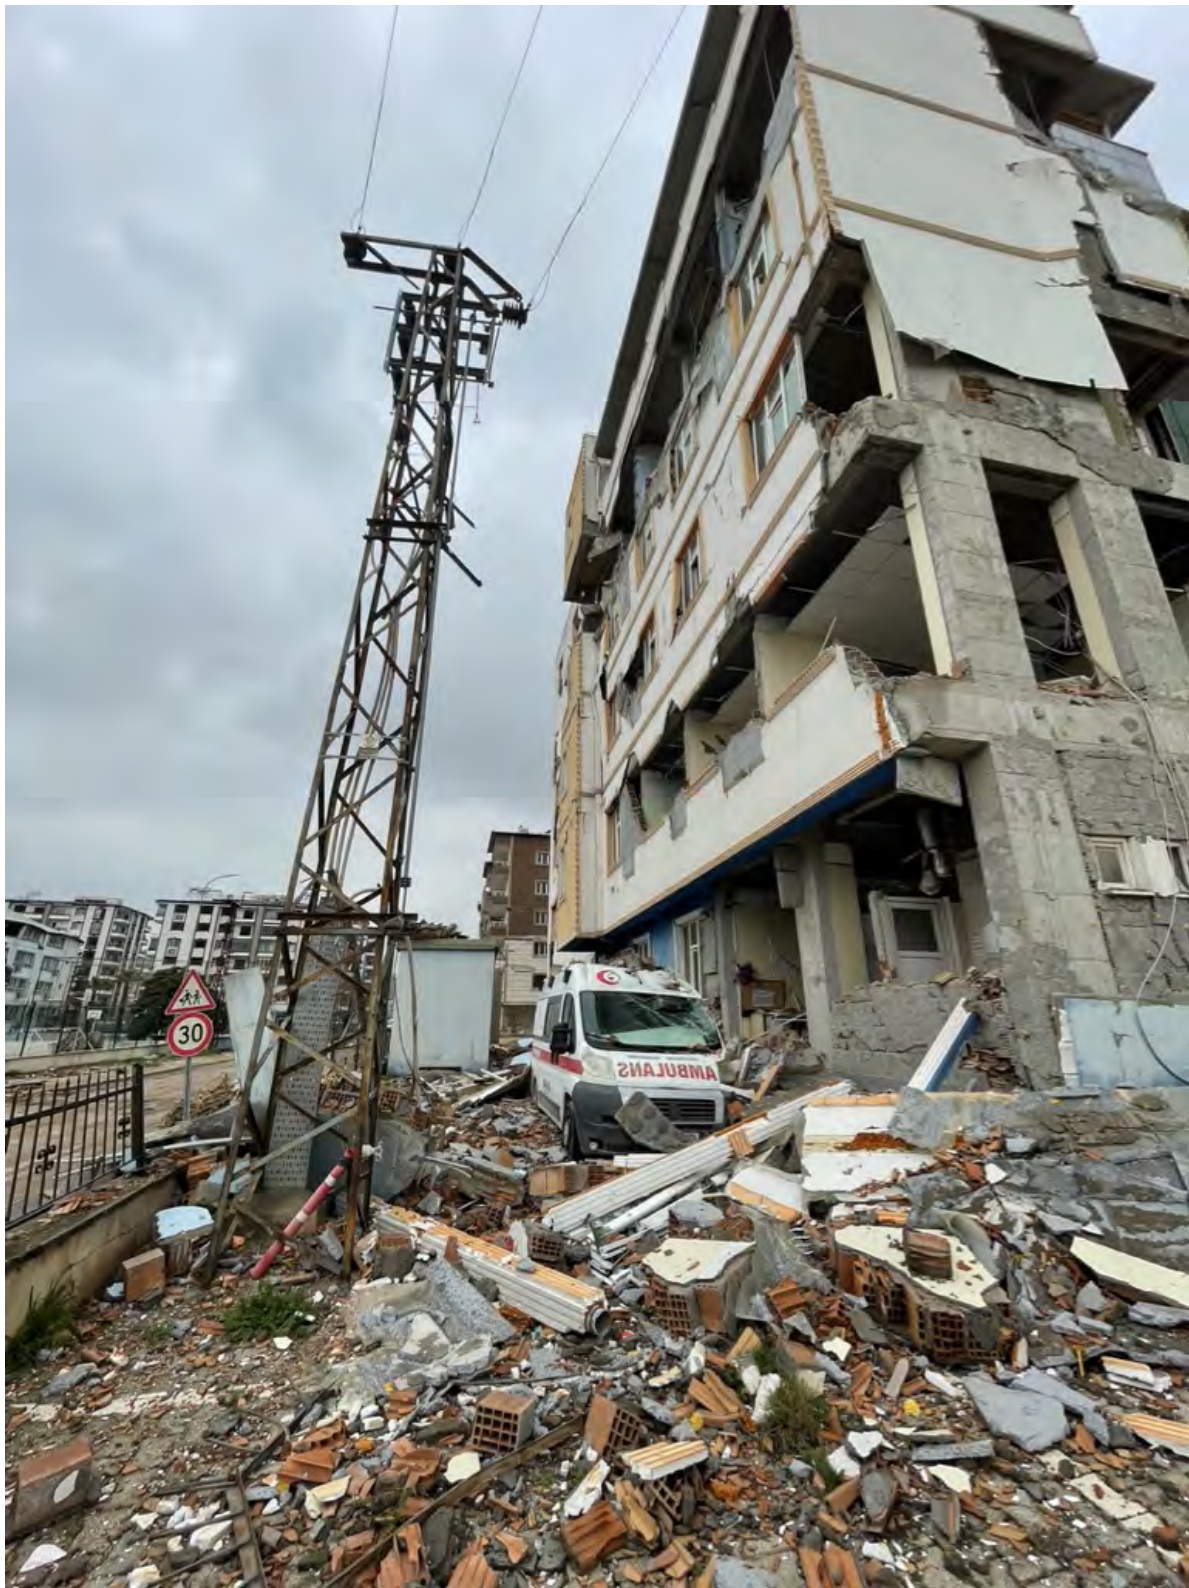
**Figure 5.69.** Failure of infill facade at a hospital near Kırıkhan that damaged an ambulance and the power feed to the building.

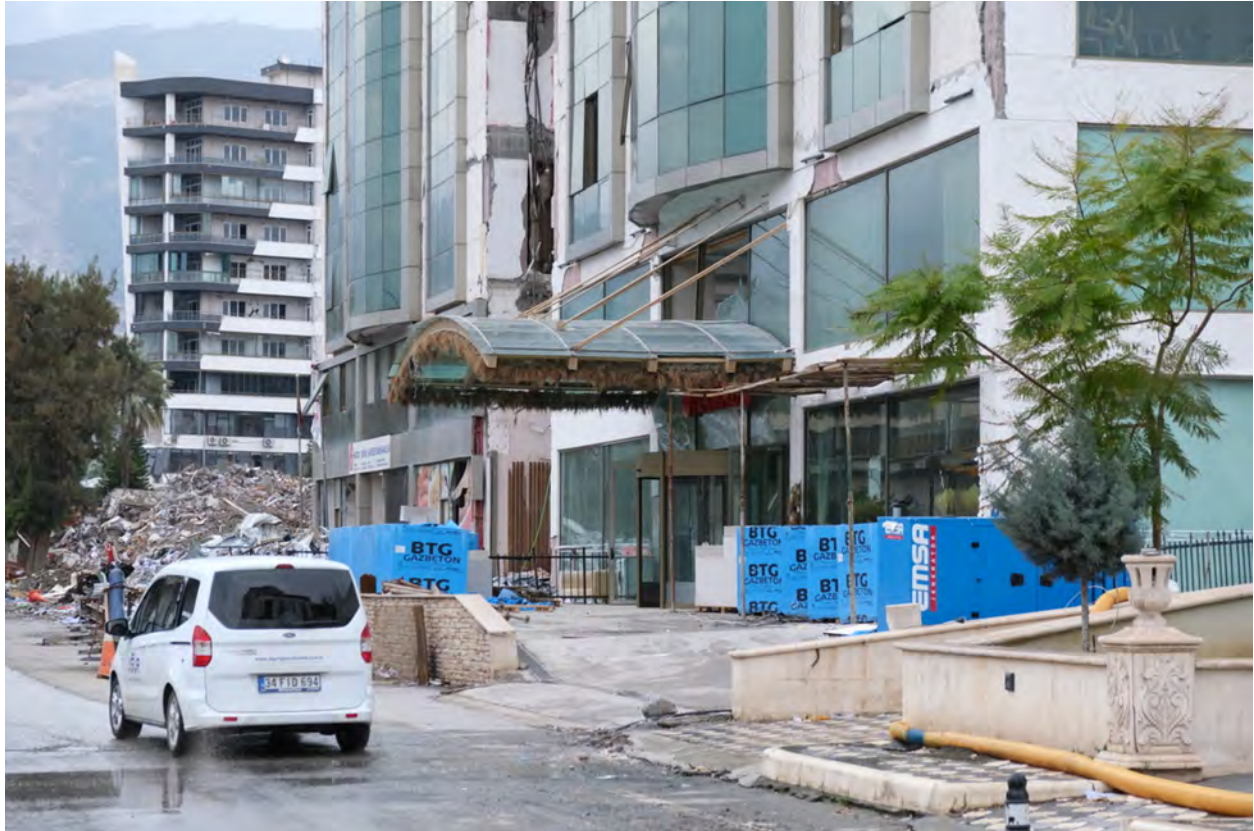
**Figure 5.70.** Damage to individual glass panels in storefront glazing facade in commercial building in Iskenderun.

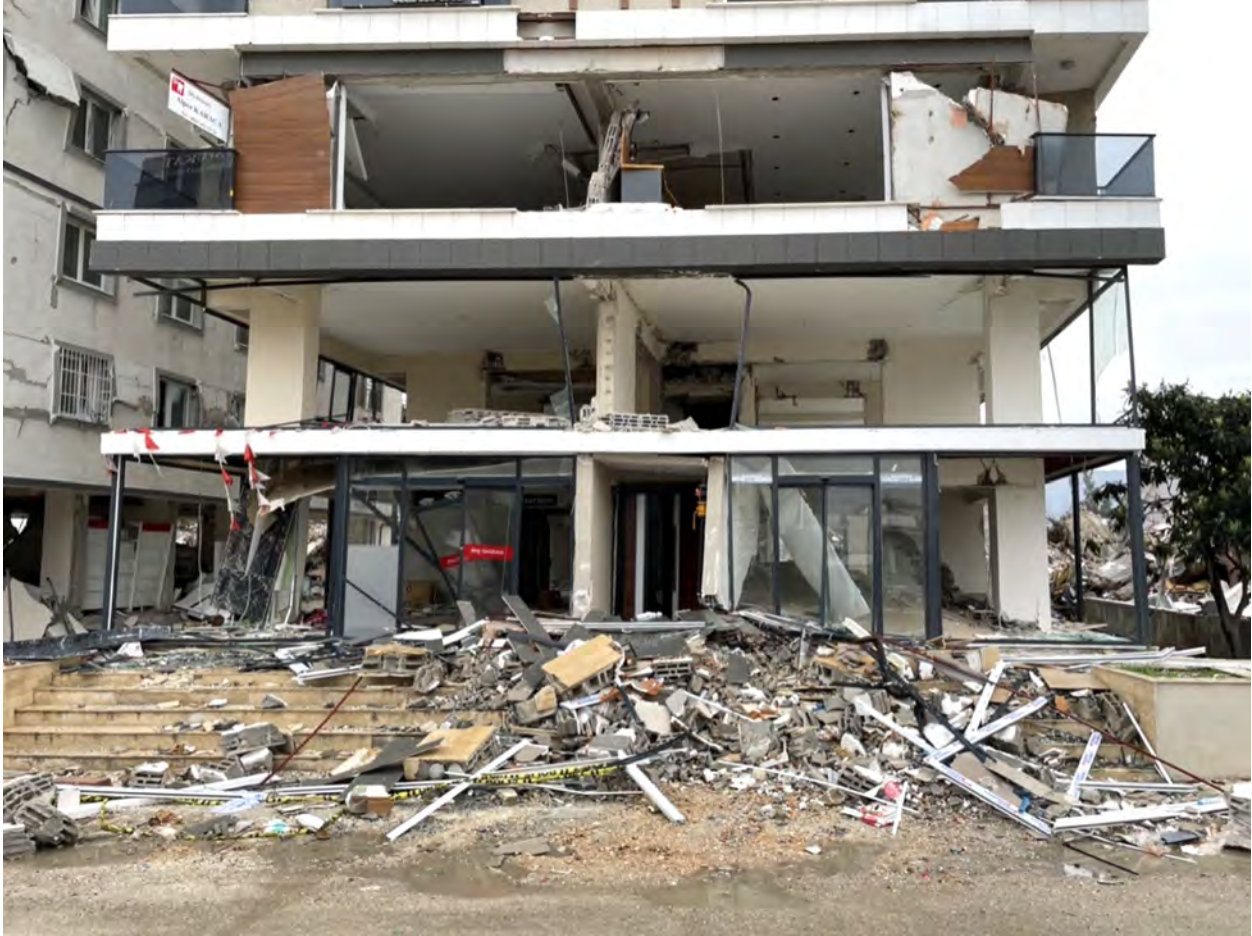
**Figure 5.71.** Damage to metal frame and glass panels in storefront glazing facade in mixed use building near Antakya.

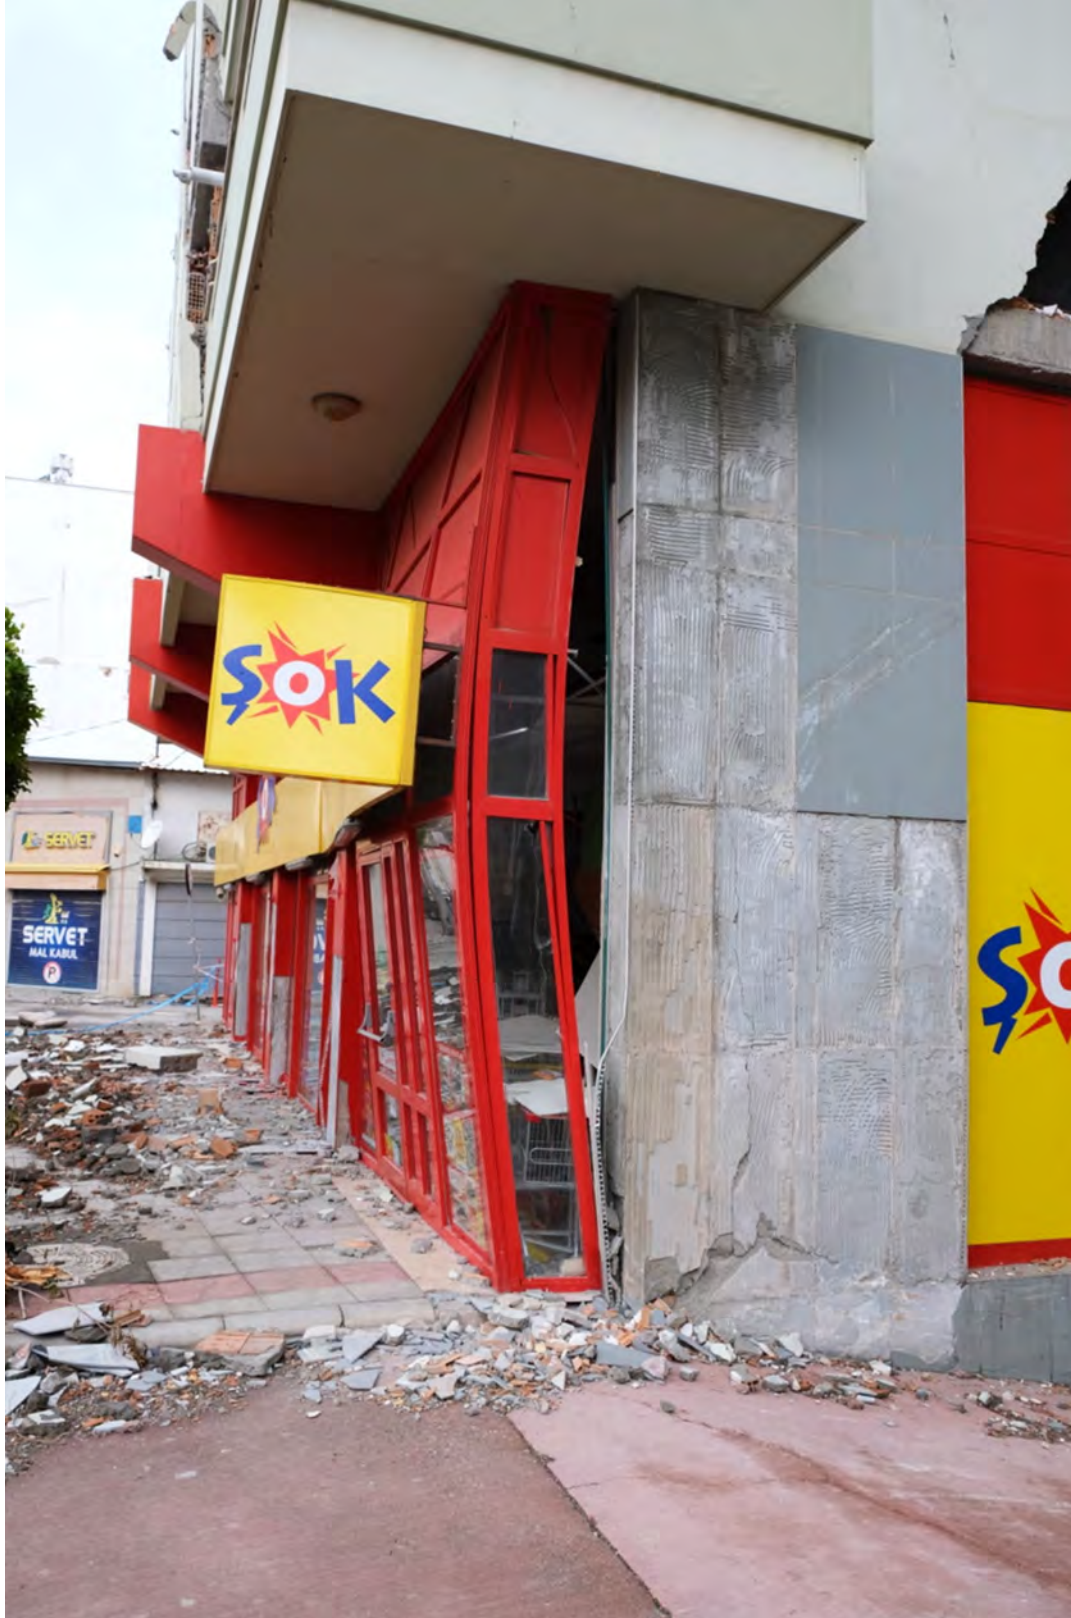
**Figure 5.72.** Global buckling of metal frame of storefront glazing at ground floor of mixed use building in Iskenderun.

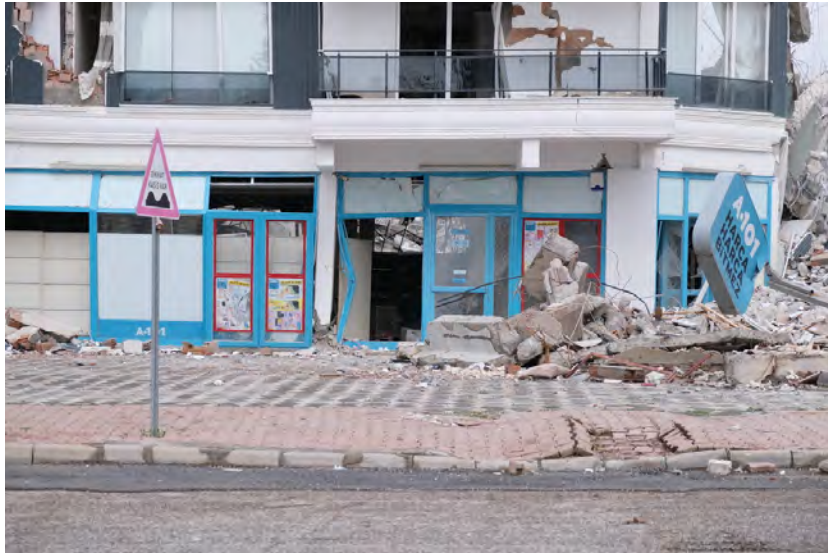
**Figure 5.73.** Failure of metal frame in storefront glazing due to structural damage in columns of a mixed use building near Adiyaman.

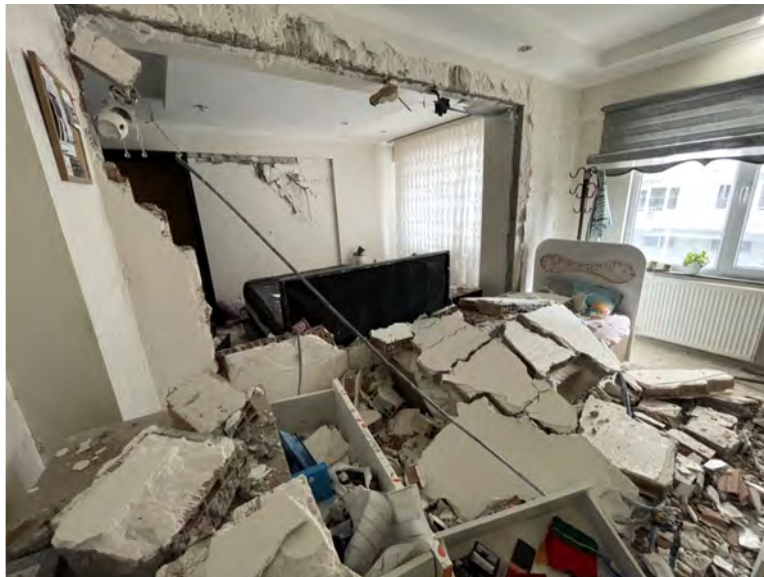
**Figure 5.74.** Failure of infill partition in a residential building near Malatya.

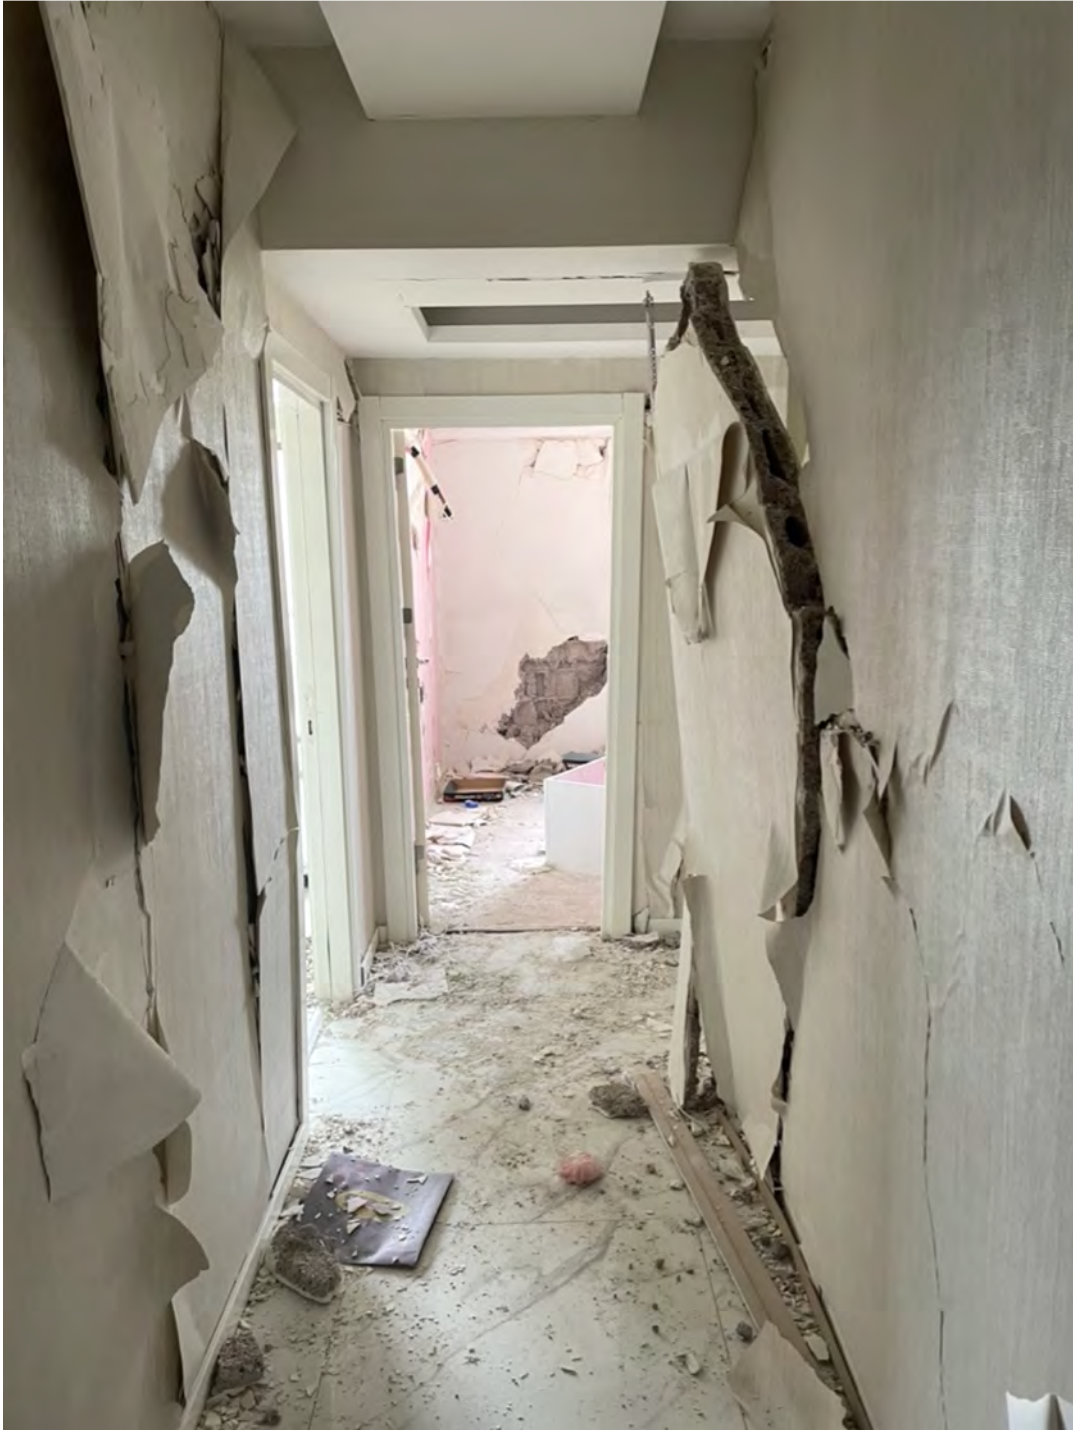
**Figure 5.75.** Infill partition damage in a residential building near Adiyaman.

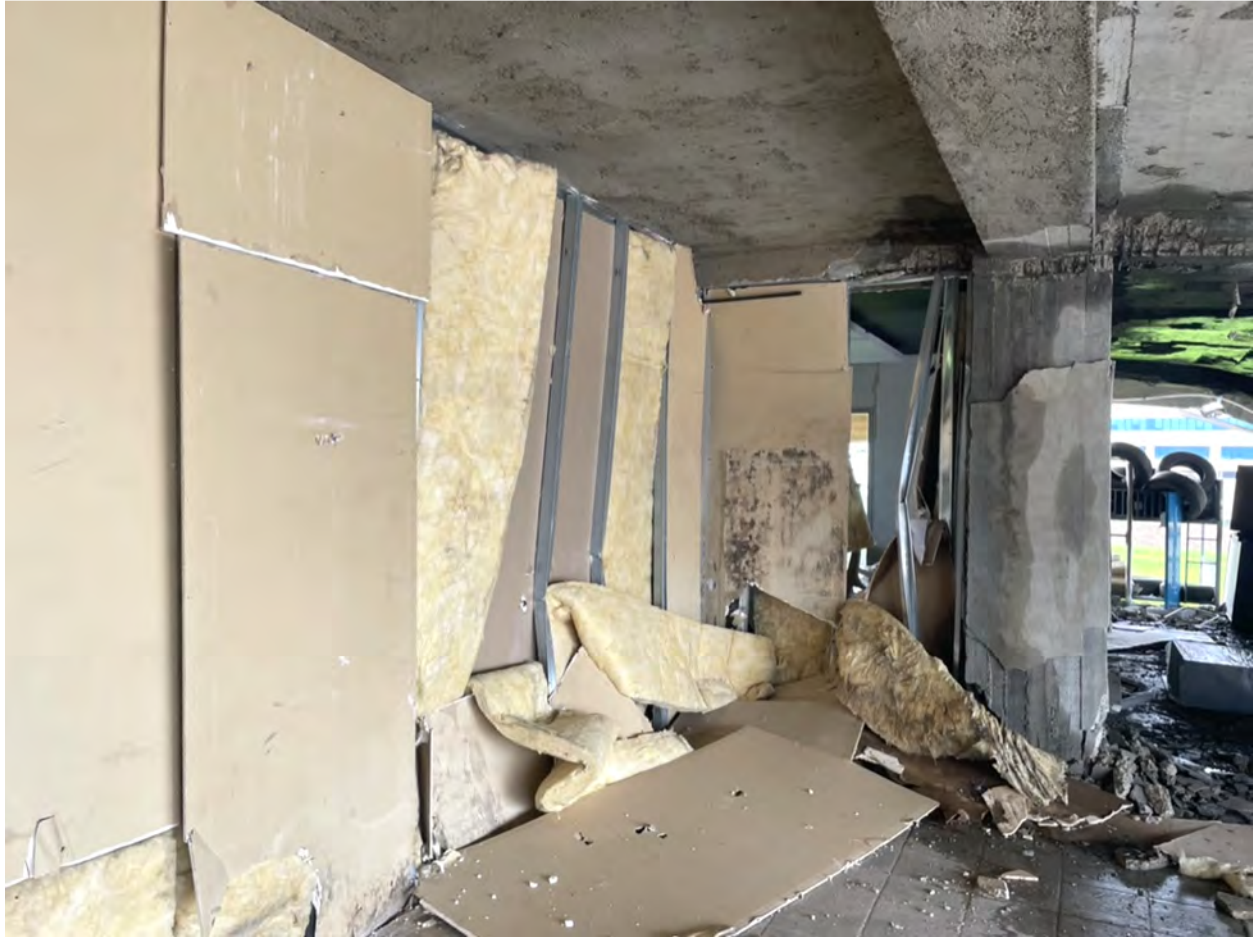
**Figure 5.76.** Damage to steel frame partitions with drywall sheathing in commercial building in Kahramanmaraş.

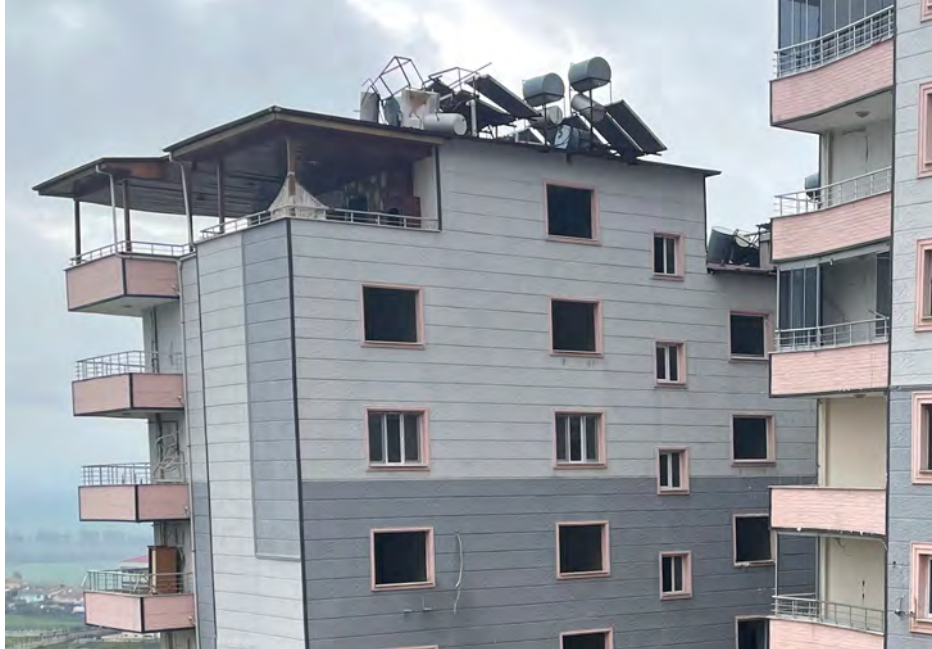
**Figure 5.77.** Varying levels of damage to rooftop solar water heaters in a residential building near Kırıkhan.

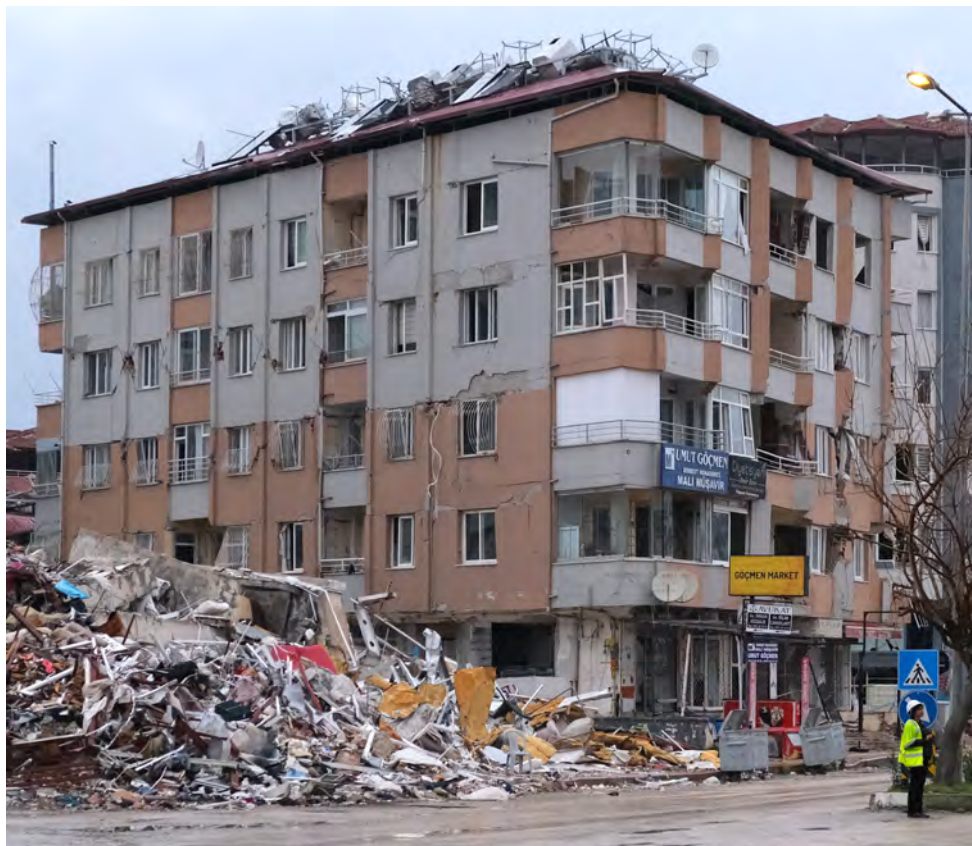
**Figure 5.78.** Failure of rooftop solar water heaters in Antakya.

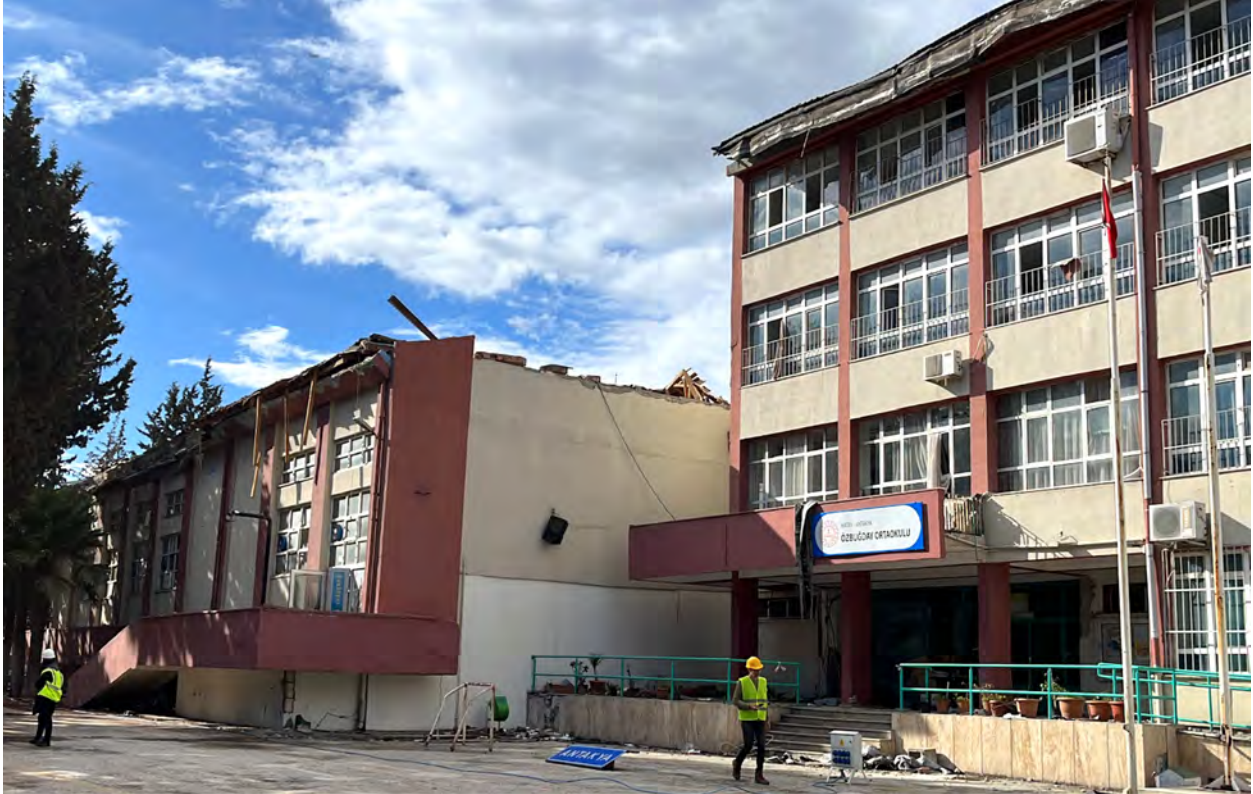
**Figure 5.79.** Collapse of wood-frame gable roof structure in a school building in Antakya.

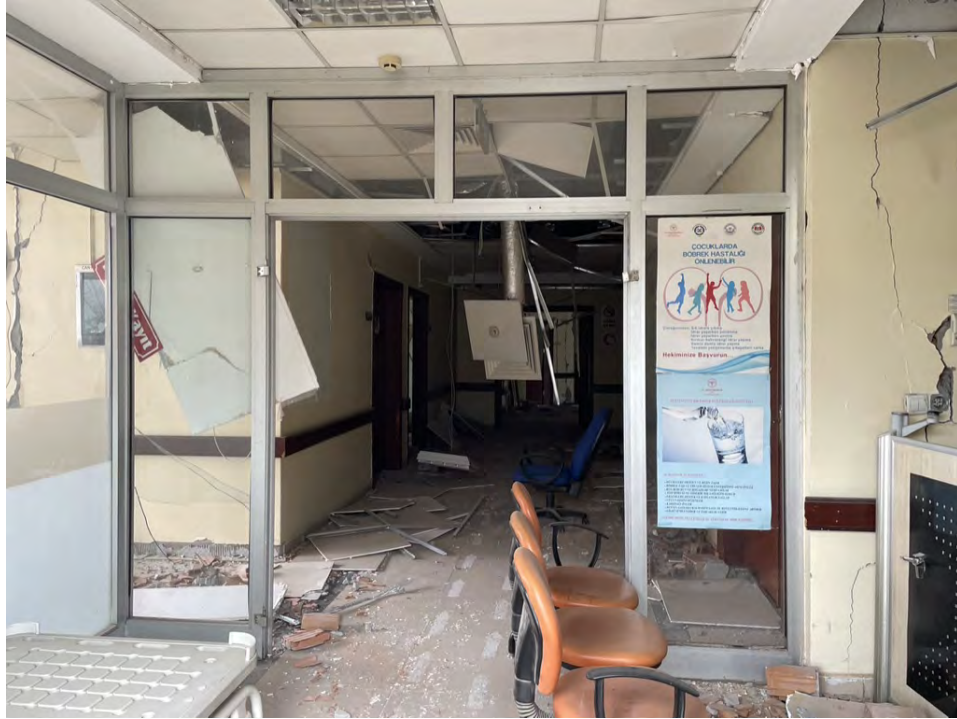
**Figure 5.80.** Fallen ceiling tiles and HVAC ducts near a hospital entrance in Kırıkhan.

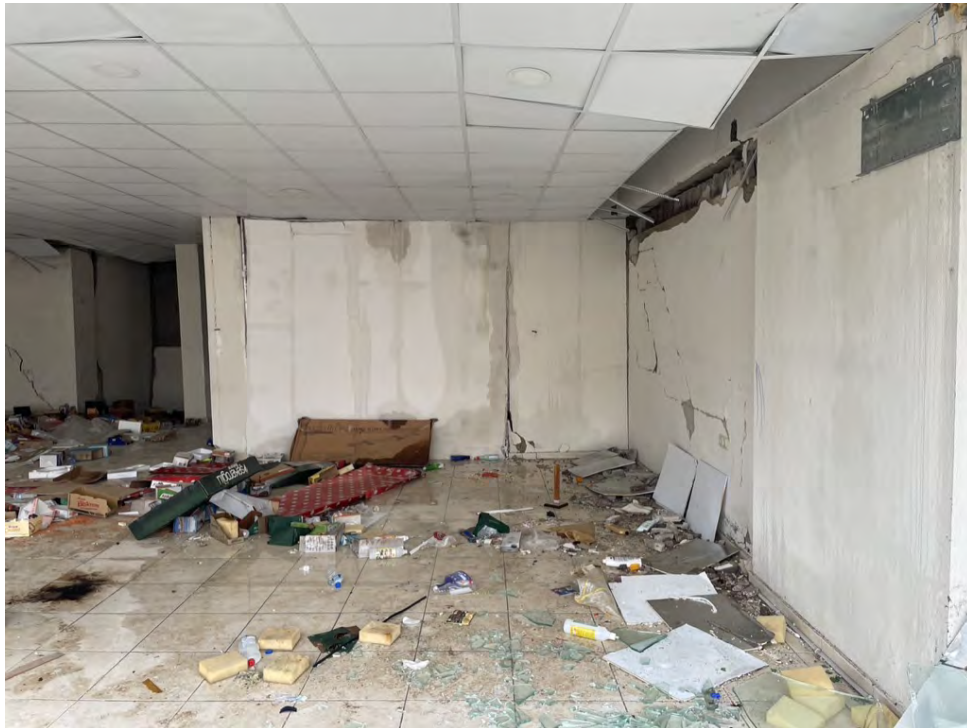
**Figure 5.81.** Failure of perimeter metal framing of suspended ceiling in mixed use building in Hassa.

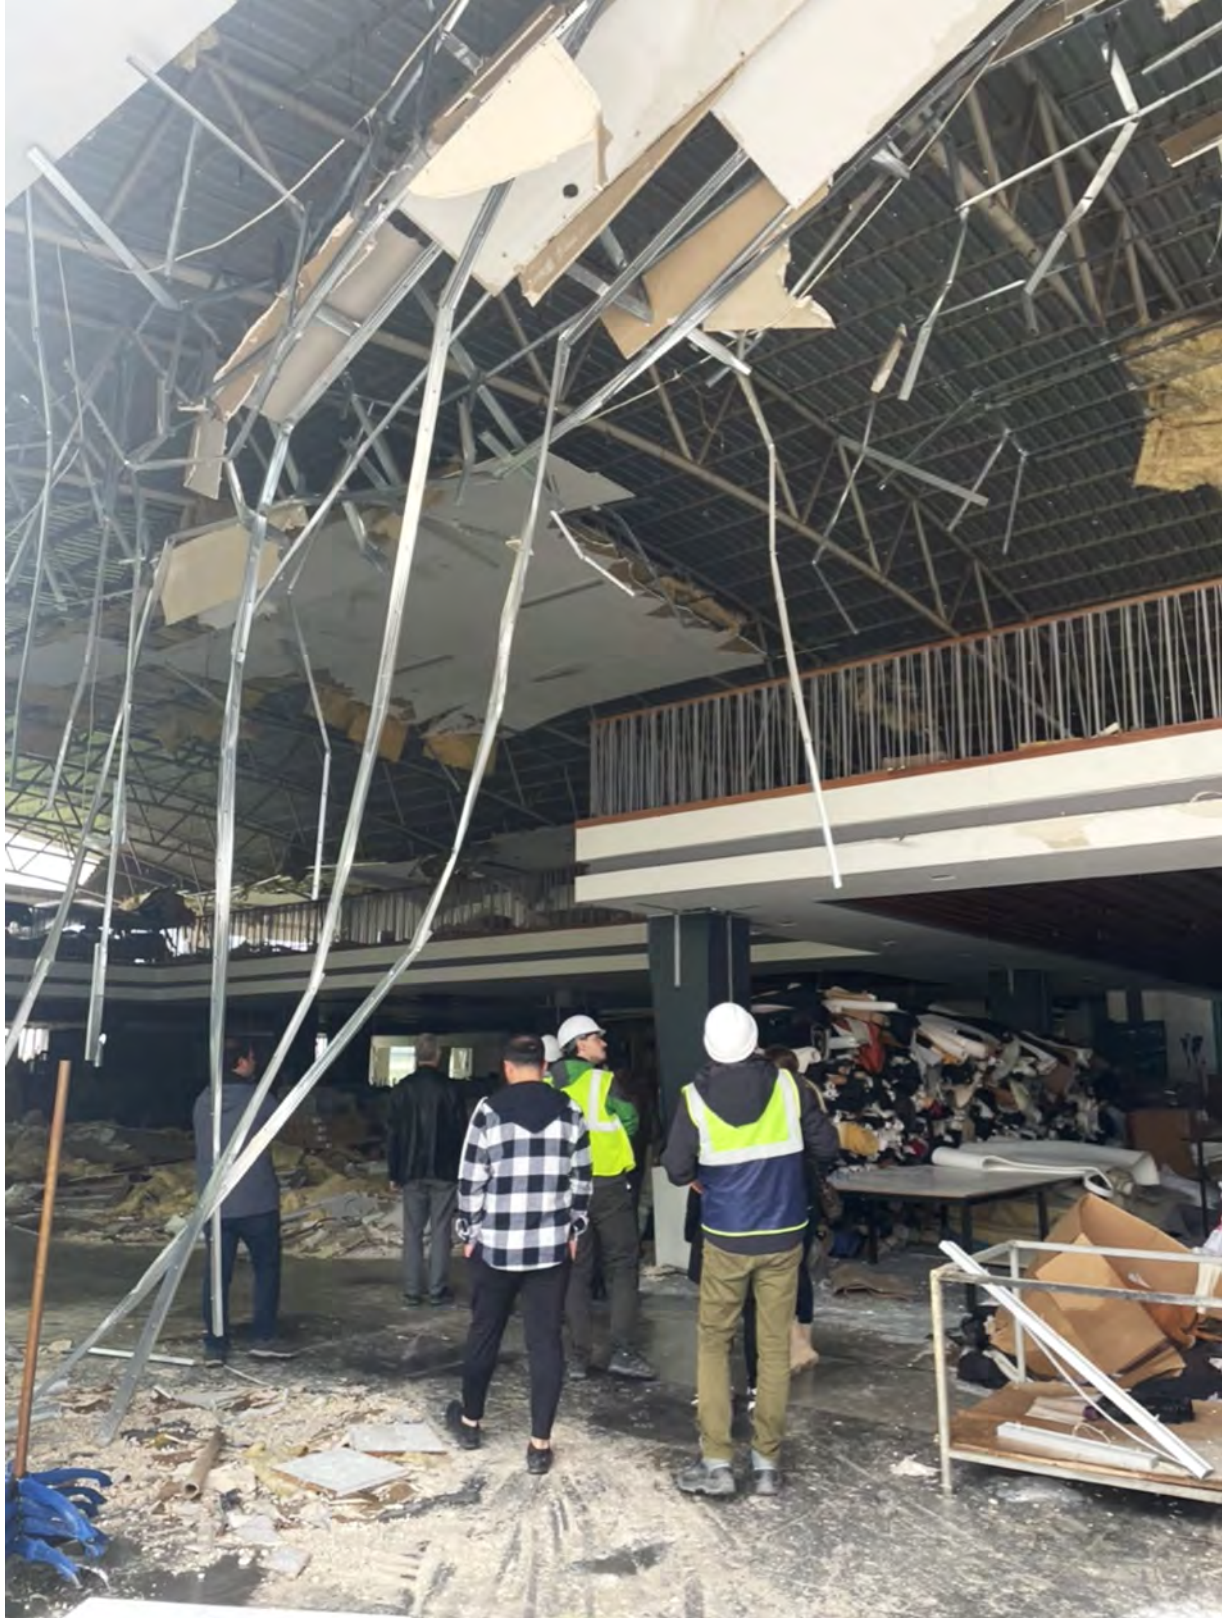
**Figure 5.83.** Loss of gravity support of suspended ceiling in commercial building in Kahramanmaraş.

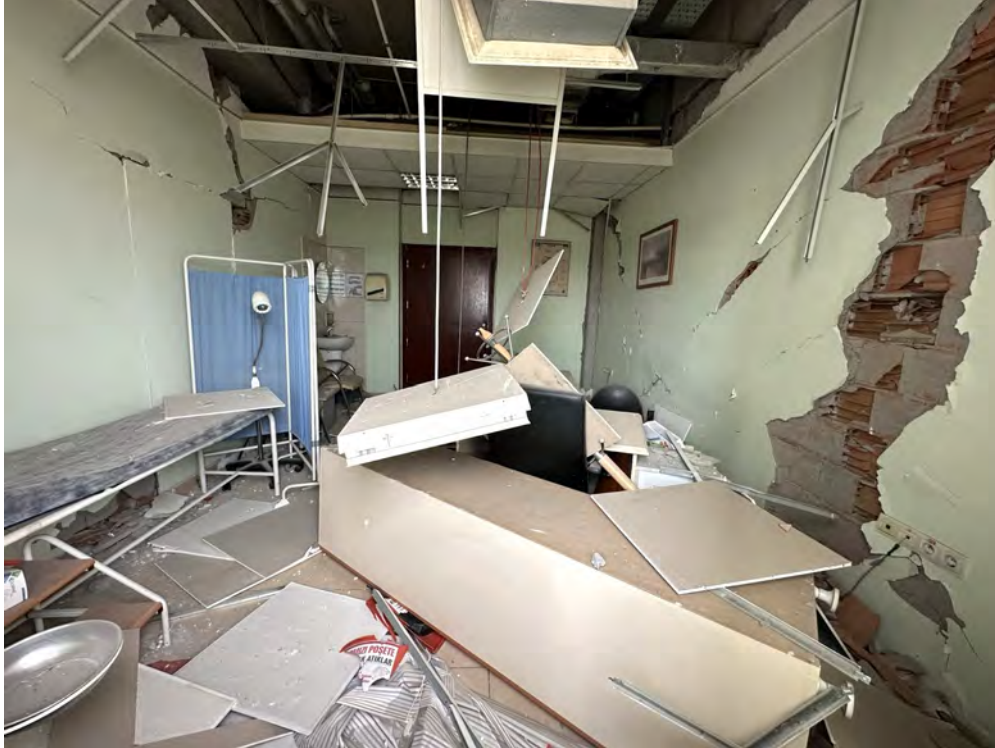
**Figure 5.85.** Toppling of large storage shelf in a hospital room in Kırıkhan (along with damage to masonry infill walls and suspended ceilings).

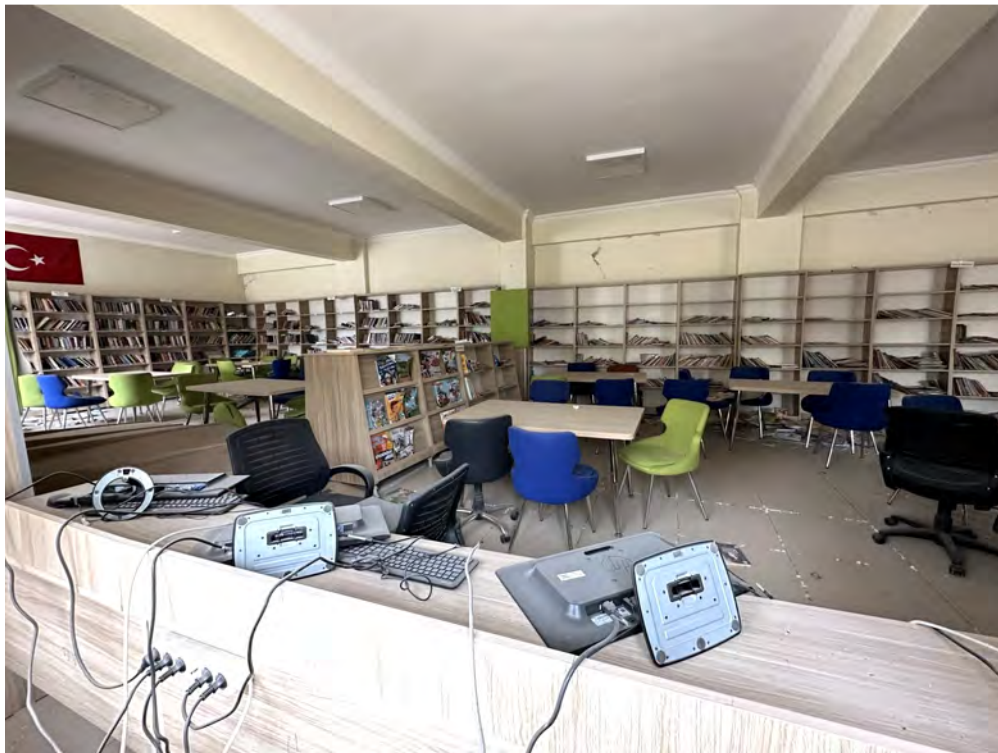
**Figure 5.86.** Toppling of computers and books from bookshelves in a library in Nurdağı.

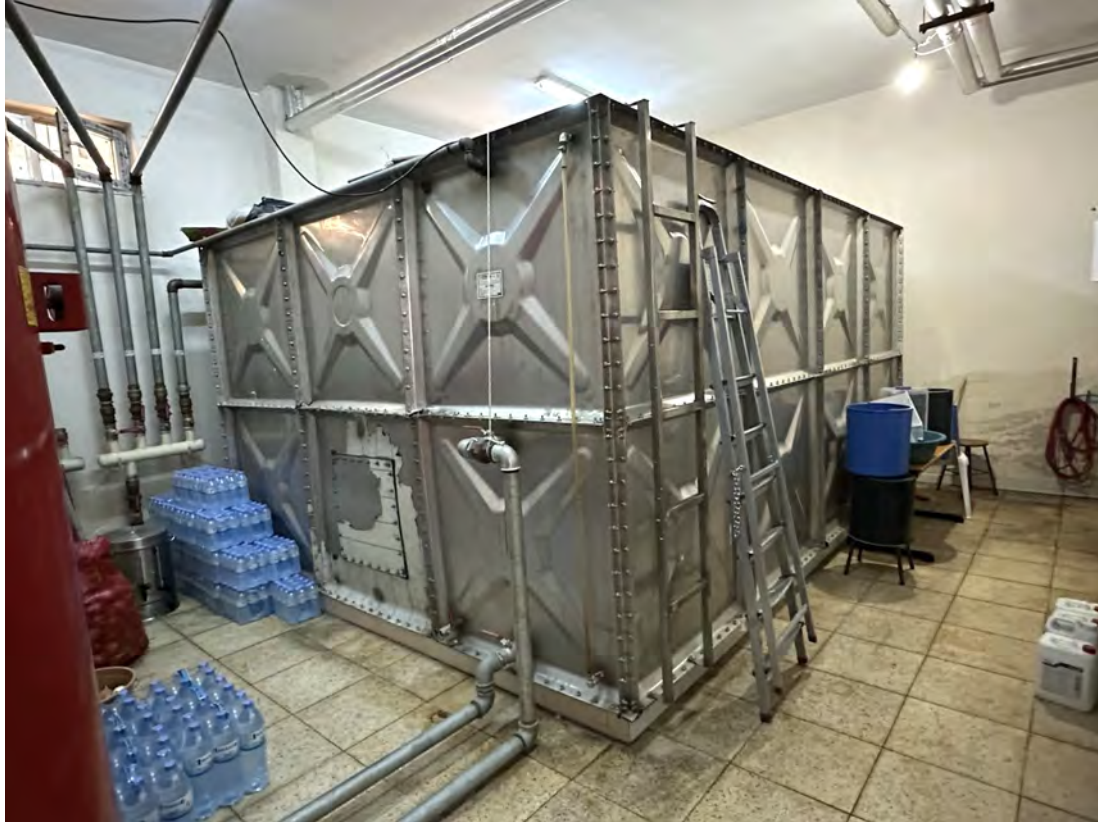
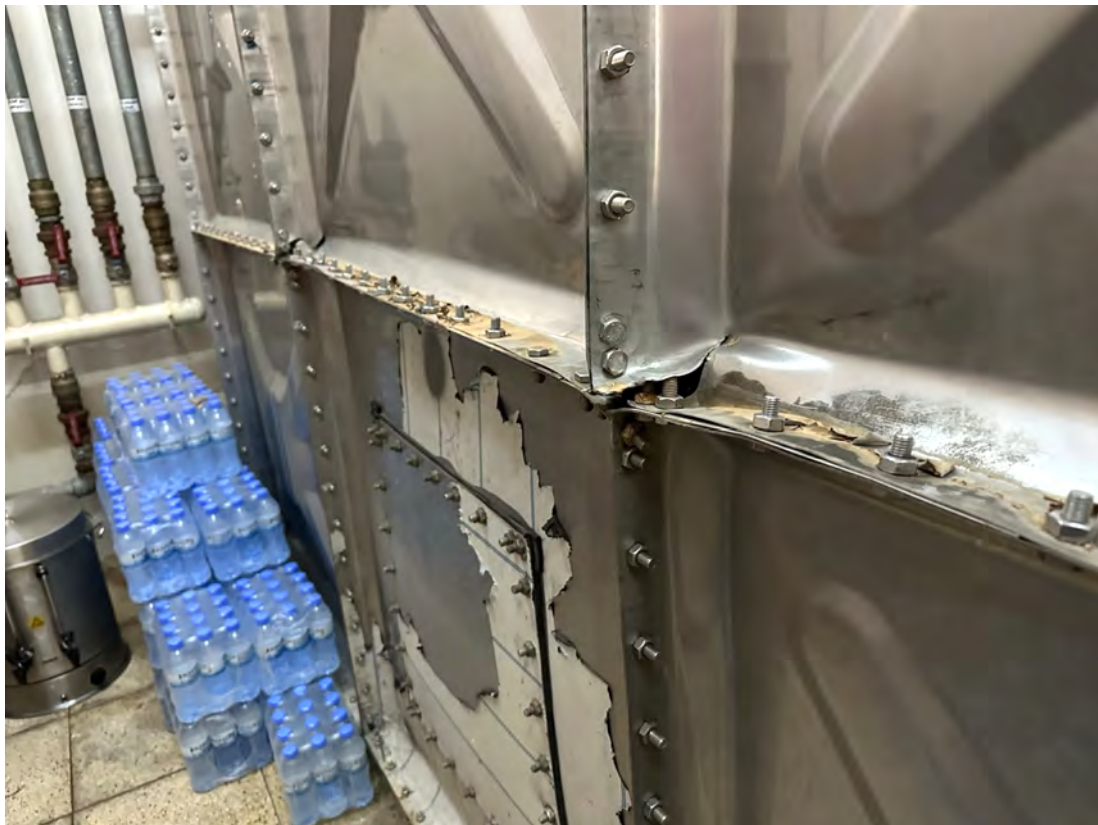
Figure 5.87. Damage to water tank in a school in Kahramanmaraş.
