MAY 6, 2023

# FEBRUARY 6, 2023 TÜRKIYE EARTHQUAKES: REPORT ON GEOSCIENCE AND ENGINEERING IMPACTS

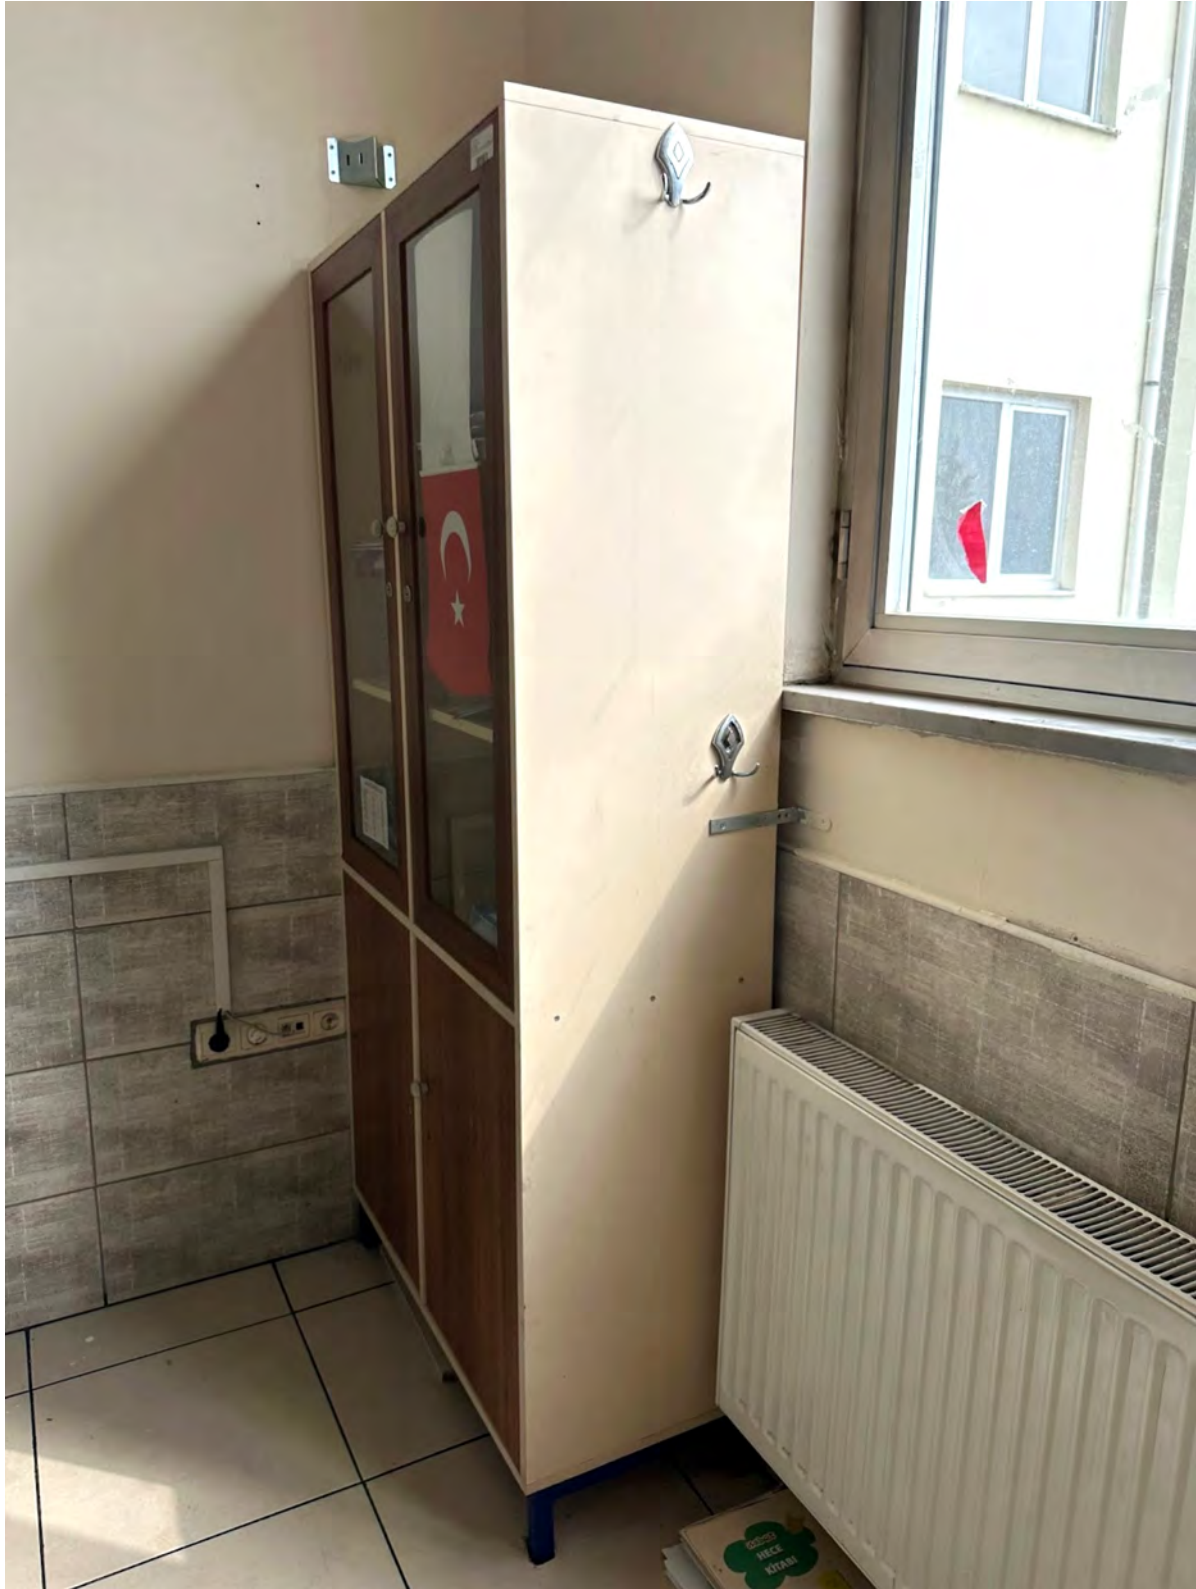
**Figure 5.88.** Example of a large bookshelf with seismic restraints (side and top) in a school building in Kahramanmaraş.

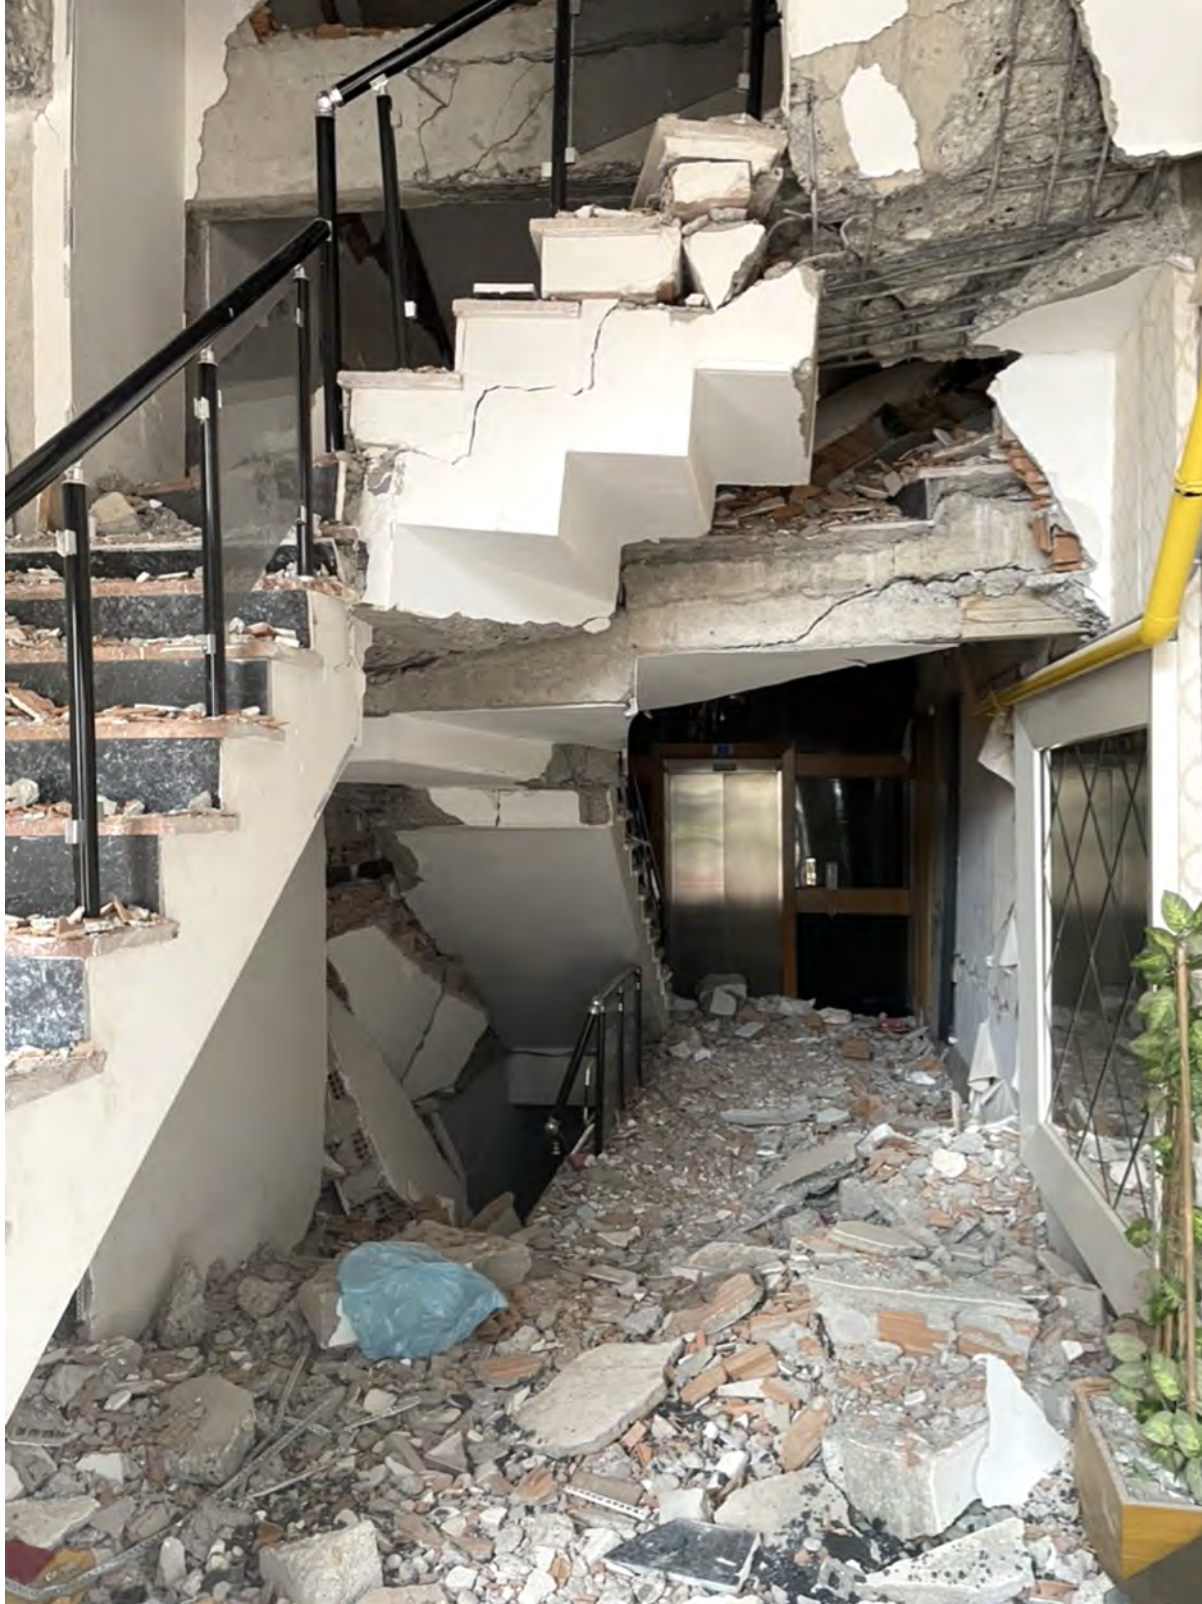
**Figure 5.89.** Structural damage to a stairwell in a residential buildings in Adiyaman (including debris from failed masonry infill wall)

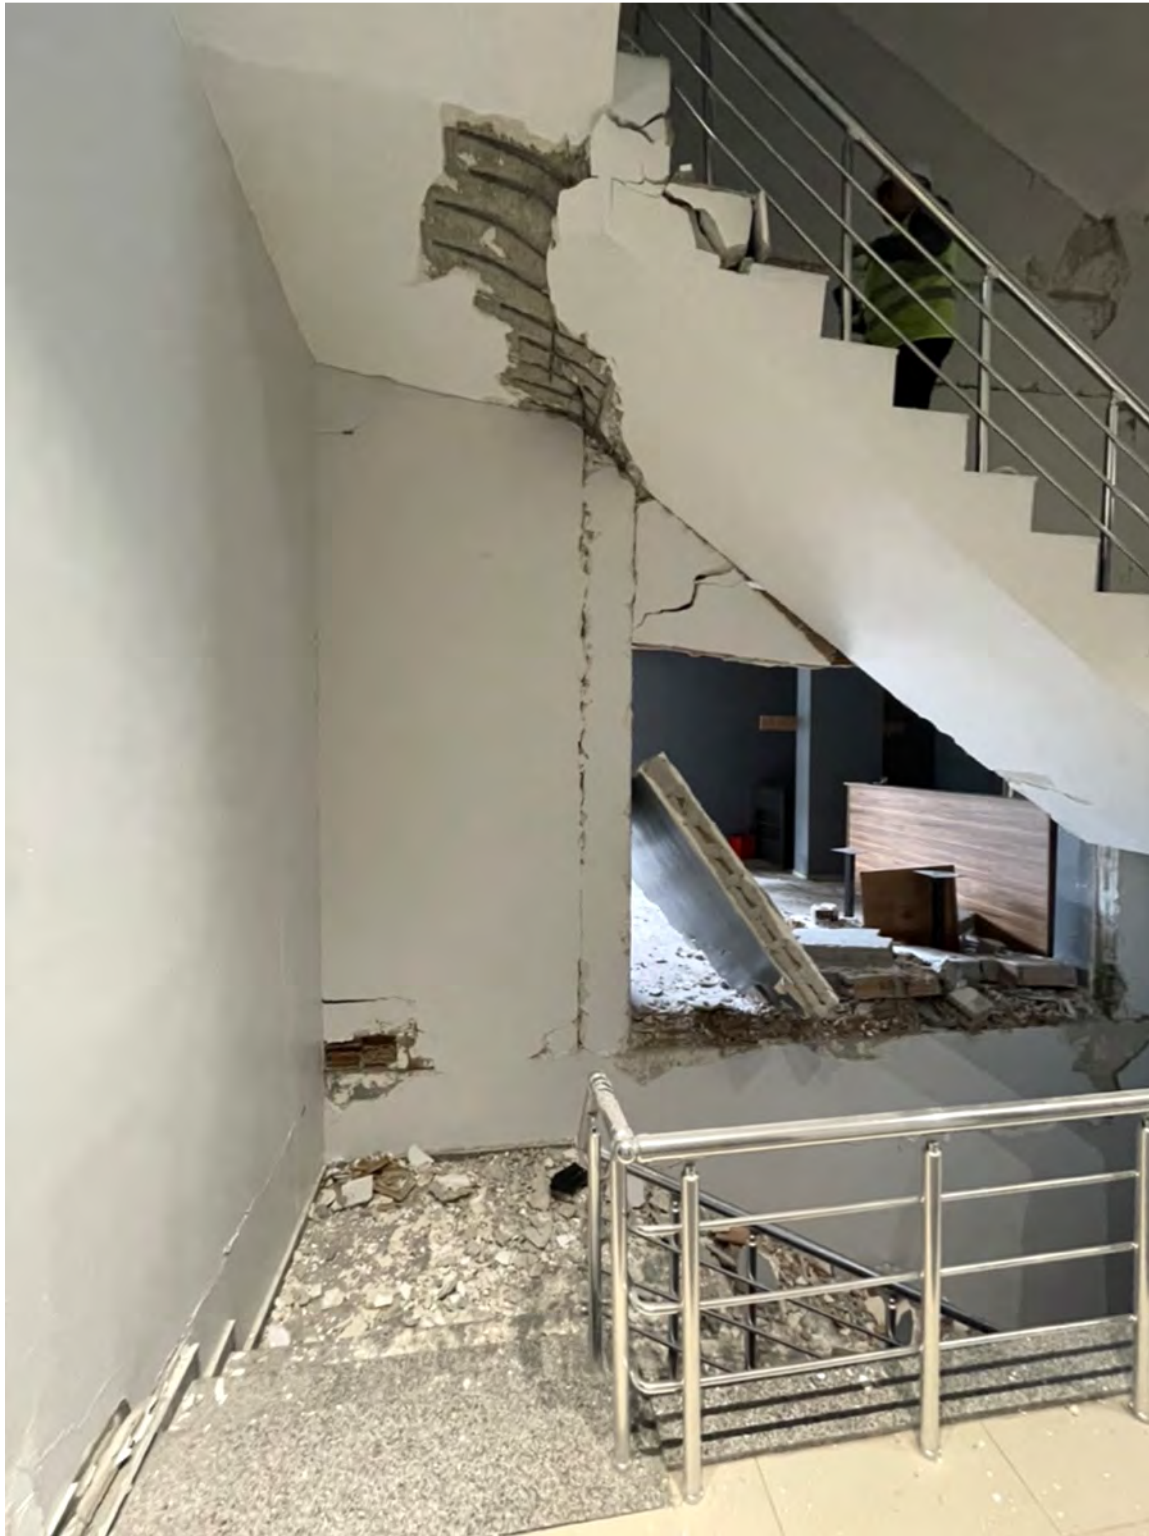
**Figure 5.90.** Structural damage to a stairwell in a residential buildings in Malatya (including debris from failed masonry infill wall)

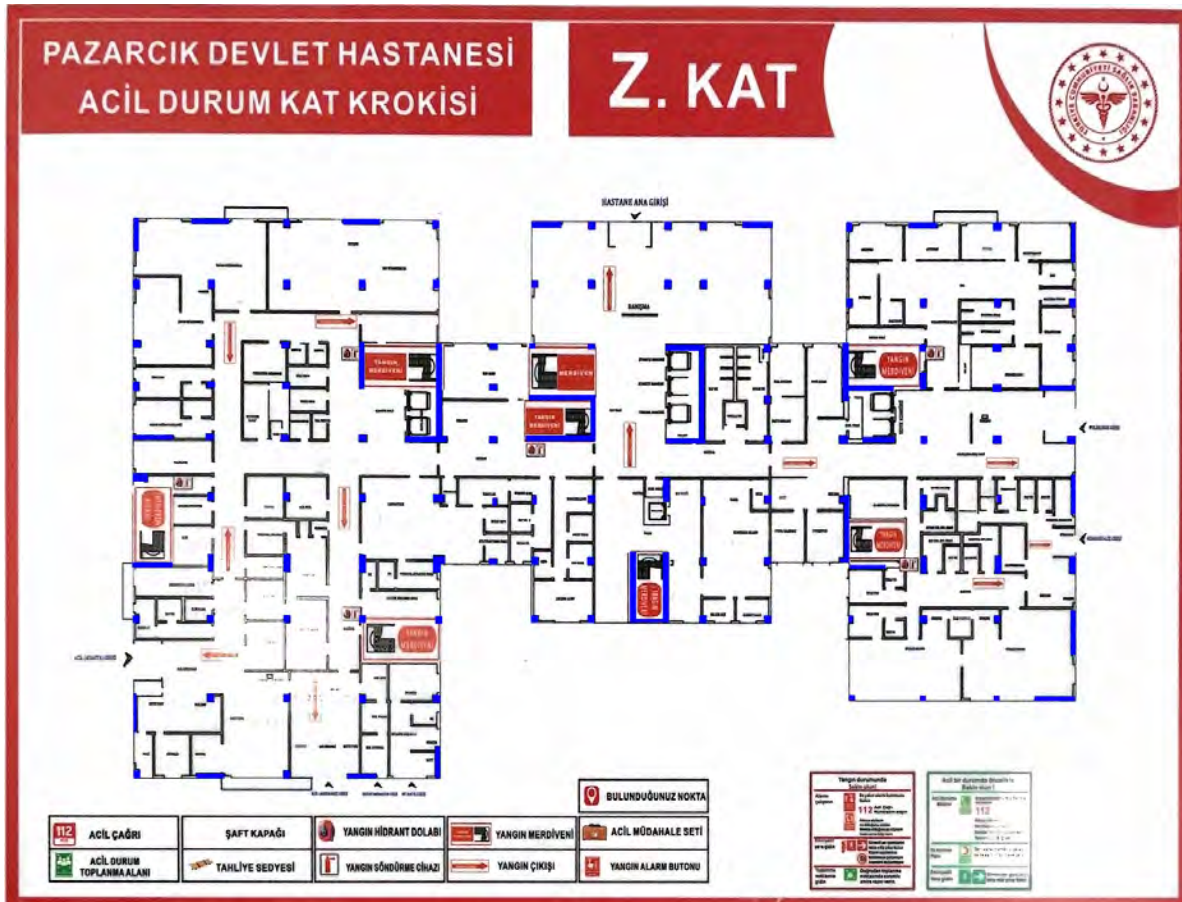
Figure 6.3. Pazarcık Government Hospital Floor Plan. Blue lines indicate concrete shear walls.

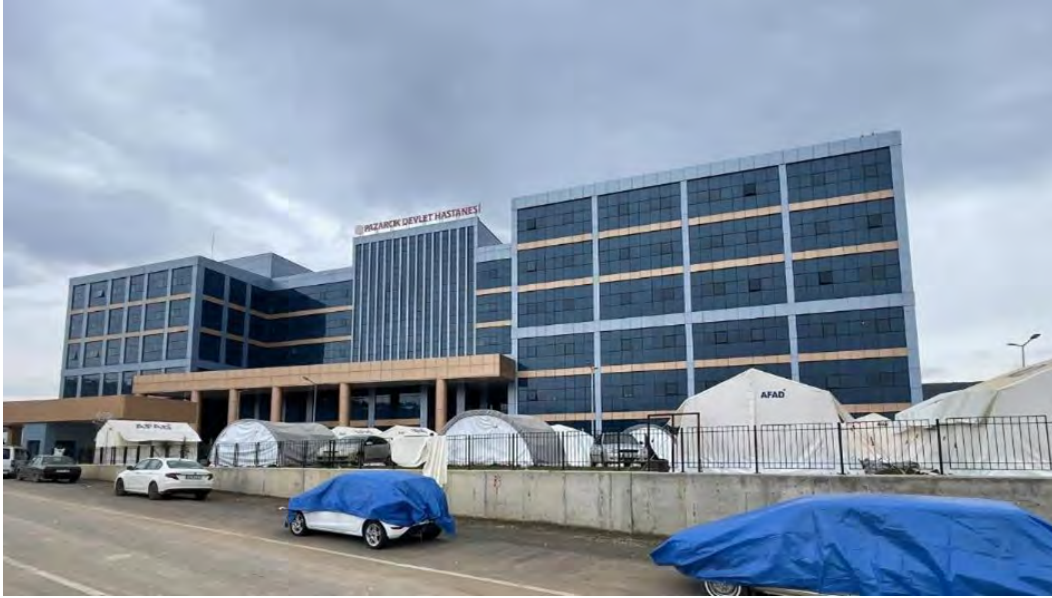
**Figure 6.4.** Pazarcik Government Hospital,  $PGA = 1.50g$ ,  $PGV = 103 \text{ cm/sec}$ . This hospital (125 beds), completed in 2022 had no significant structural damage observed or reported but suffered considerable nonstructural damage, which led to evacuation. Outpatient type urgent care services were provided Day 0 (immediately after the earthquake). Most patients were transferred to other hospitals. Clinics were consolidated on the first floor on Day 10. The rest of the hospital was closed and underwent removal and replacement of most finishes prior to reopening (in progress Week 6).

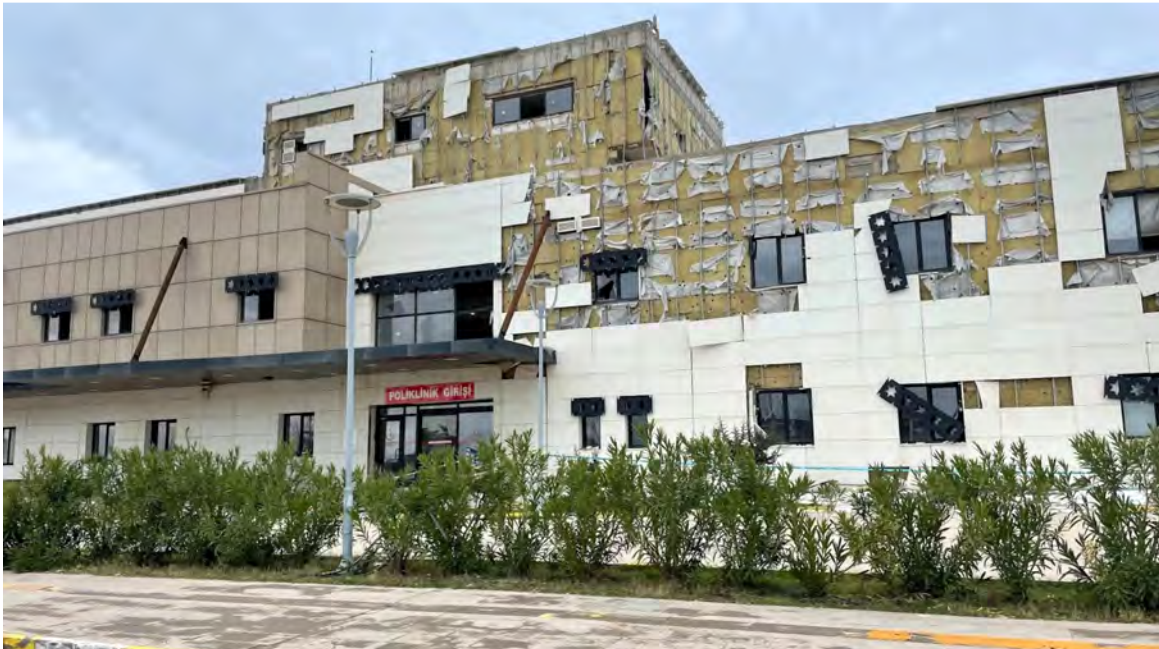
**Figure 6.5.** Nurdağı Government Hospital as observed on March 17, 2023.  $PGA = 0.55g$ ,  $PGV = 86 \text{ cm/s}$ . This small local hospital (25 beds) was only one year old at the time of the earthquake. It suffered widespread nonstructural damage, but only limited structural damage. It was immediately evacuated and closed. An emergency tent hospital was set up on the premises to serve the community.

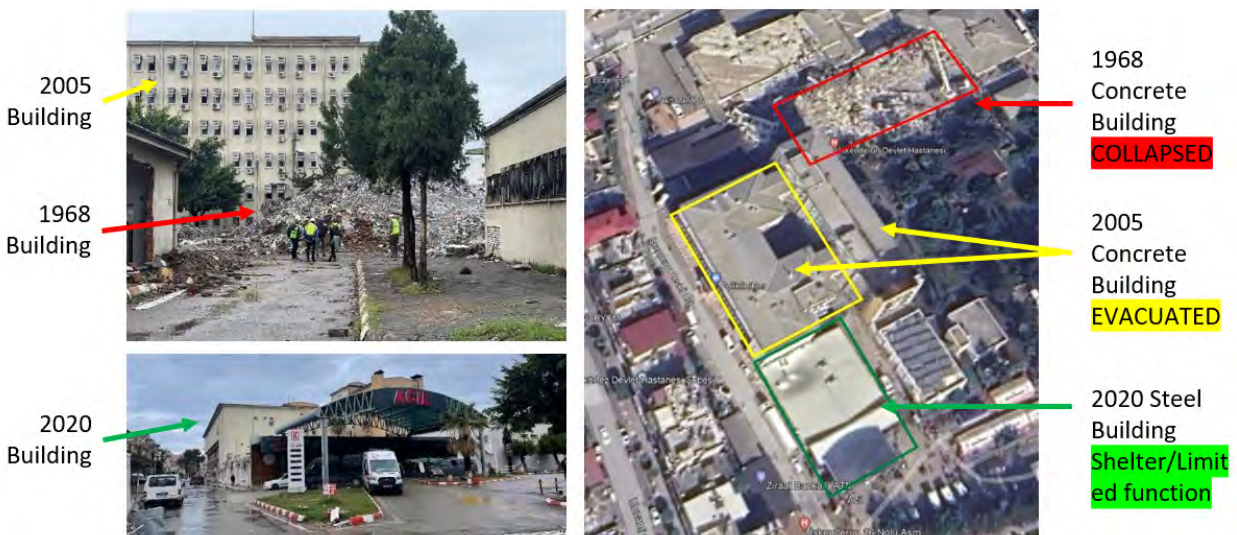
**Figure 6.6.** İskenderun Government Hospital as observed on March 15, 2023 (photos on right) , PGA = 0.28g, PGV = 55cm/s, This hospital contained multiple buildings constructed between 1968 and 2020. The 1968 building collapsed, the 2005 suffered extensive nonstructural damage and could not be occupied. All patients were relocated to the floor of the 2020 steel building before being transferred to other facilities.

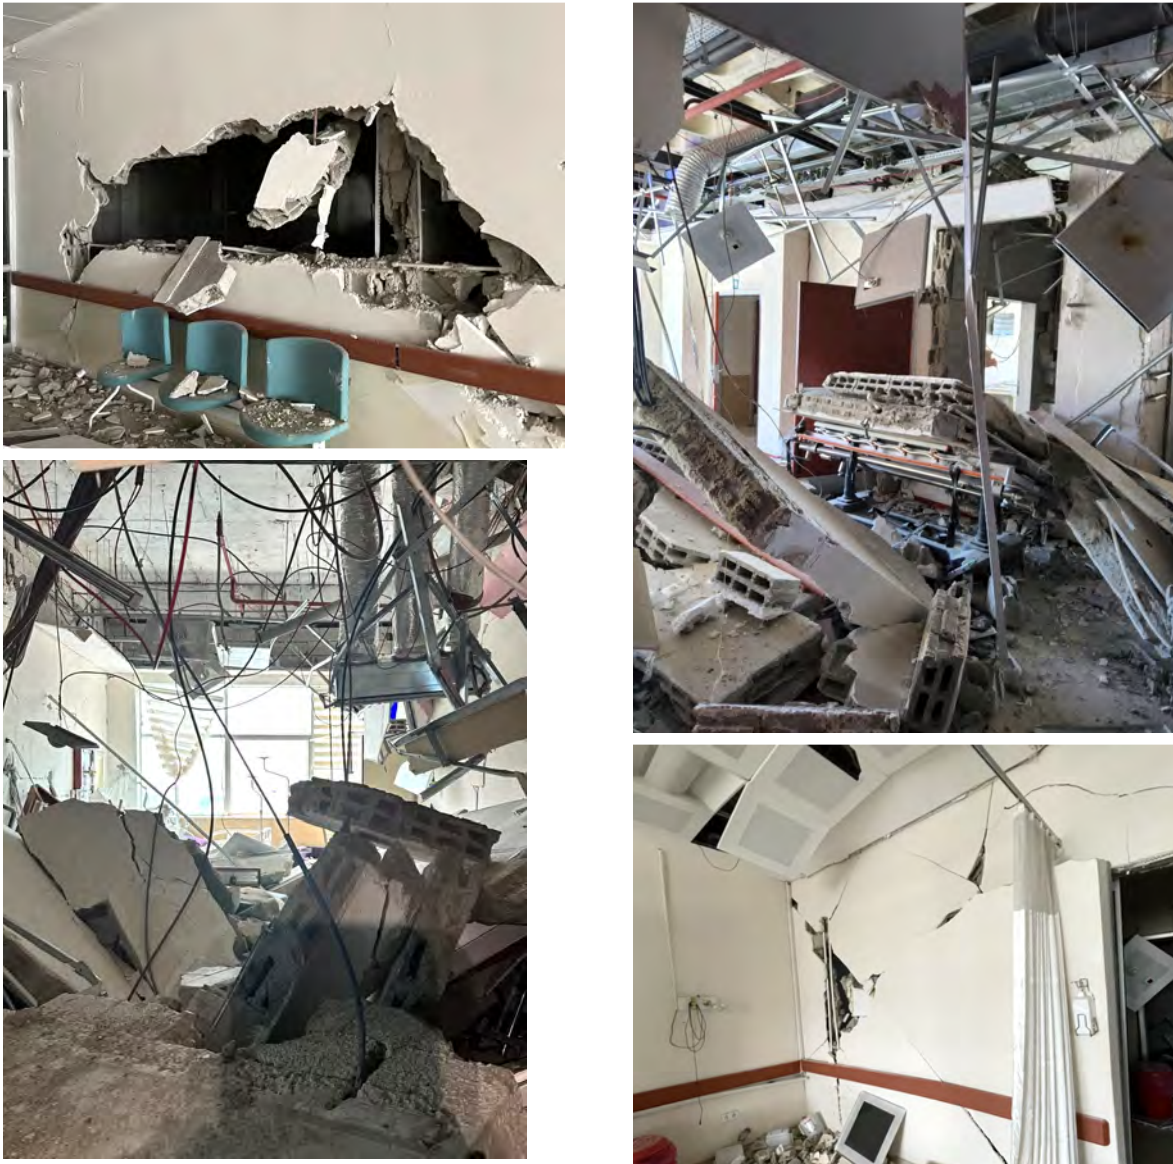
**Figure 6.7.** Masonry partition wall damage at Türkoğlu Dr. Kemal Beyazit Government Hospital as observed on March 13, 2023, PGA = 0.57g, PGV = 103 cm/s.

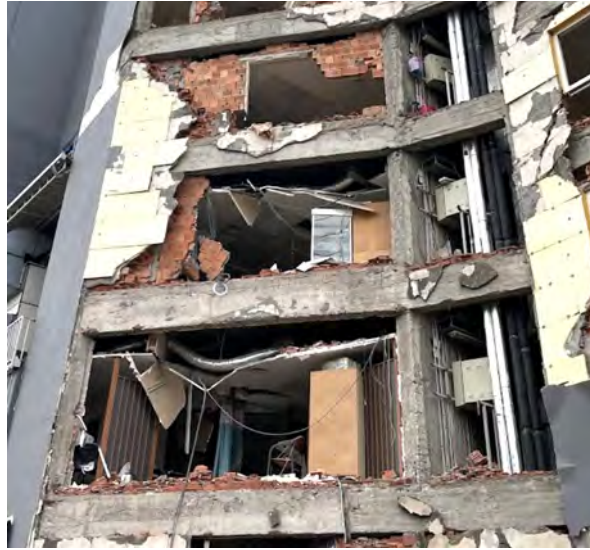
**Figure 6.8.** Exterior masonry infill wall damage at Megapark Private Hospital as observed on March 13, 2023, PGA = 0.34g, PGV = 51cm/s.

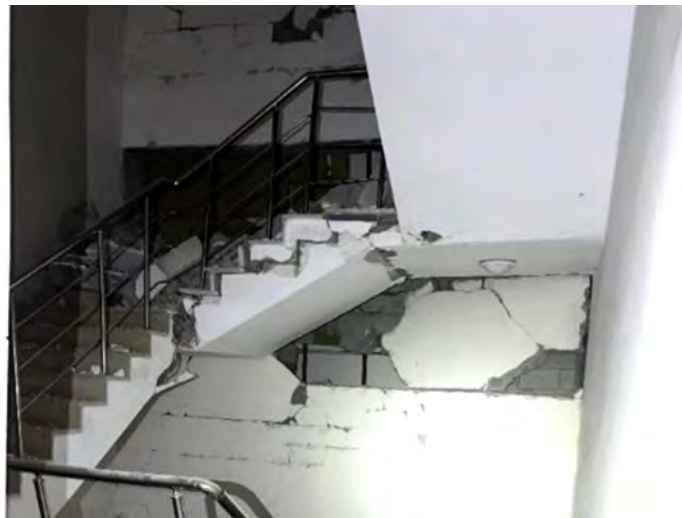
**Figure 6.9** Egress stair adjacent to masonry wall at Türkoğlu Dr. Kemal Beyazit Government Hospital as observed on March 13, 2023.

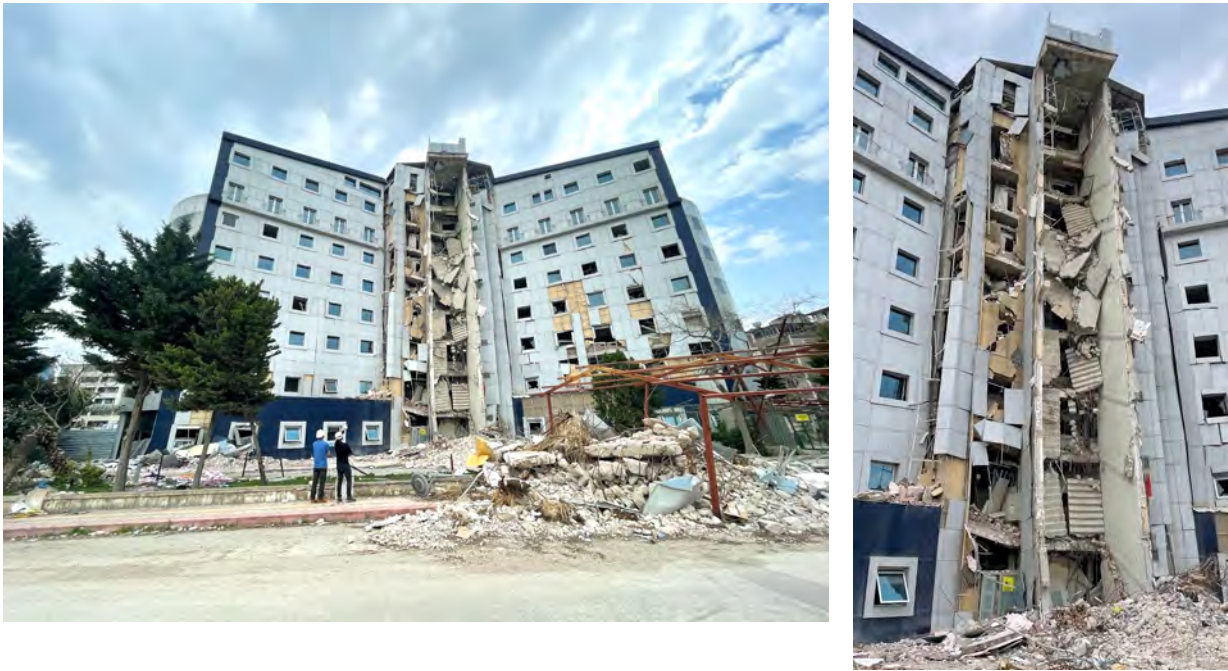
**Figure 6.10** Collapsed egress stair Defne Private Hospital, Antakya, Hatay as observed on March 18, 2023. PGA = 0.98g, PGV = 132 cm/s.

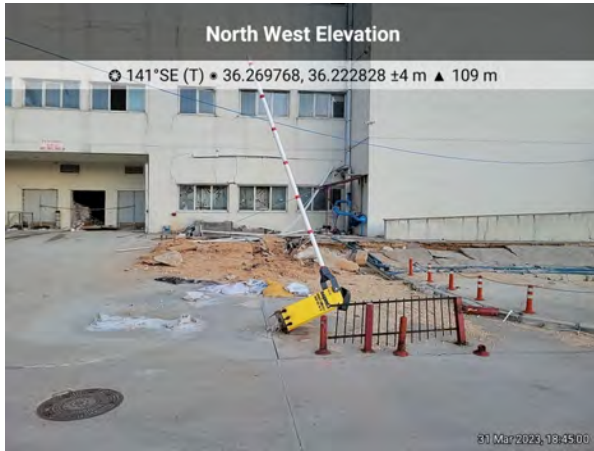
The free-field soils had settled relative to the hospital building throughout its perimeter, exceeding 40 cm in some areas (Figure 6.11a-b). The hospital and surrounding parking lot and facilities appear to be built over recently placed fill, due to their higher elevation than the surrounding river valley. The building elevation remained stable, indicating differential settlement occurred. Pipelines and utilities connected to the building were damaged as a result of this settlement.

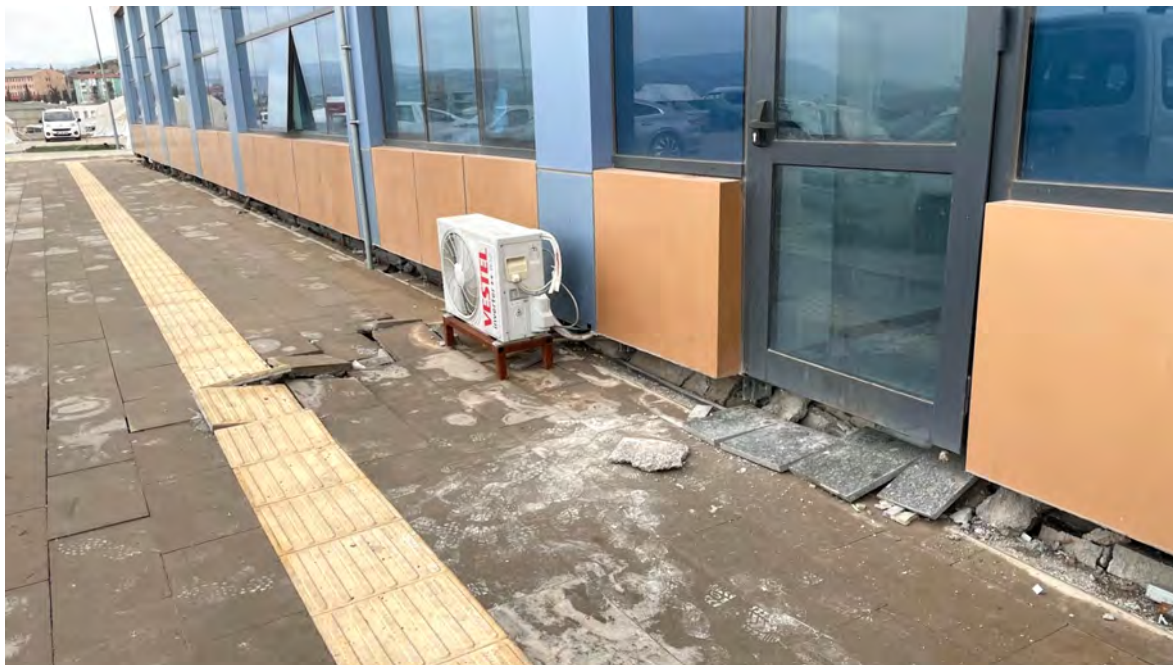
**Figure 6.12** Free-field soil settlement at Pazarçık Government Hospital in Kahramanmaraş as observed on March 17, 2023.

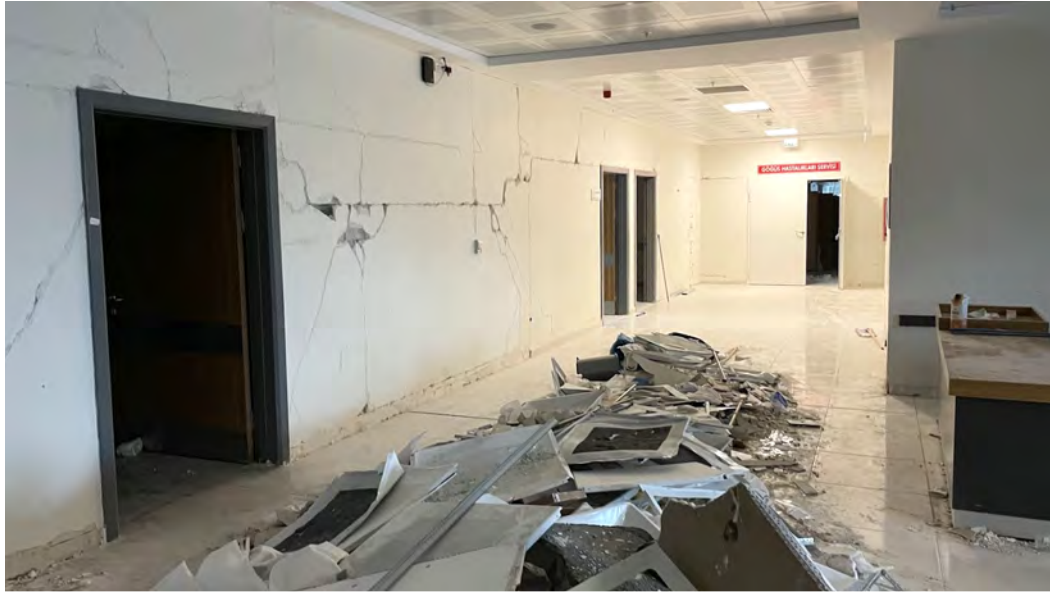
**Figure 6.13** Interior partition damage and ceiling repair.

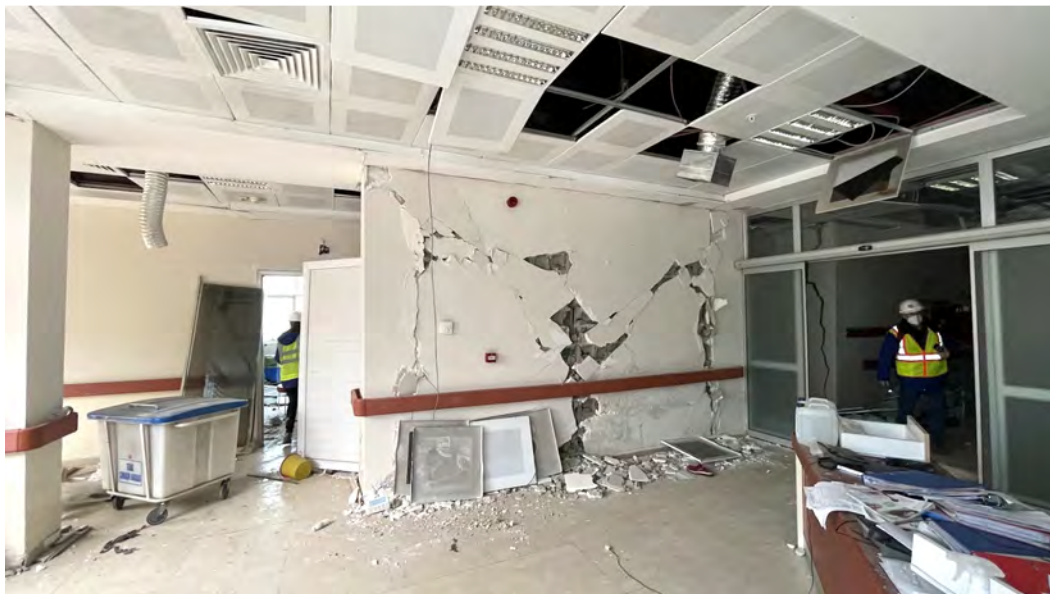
**Figure 6.14** Interior partition and ceiling damage.

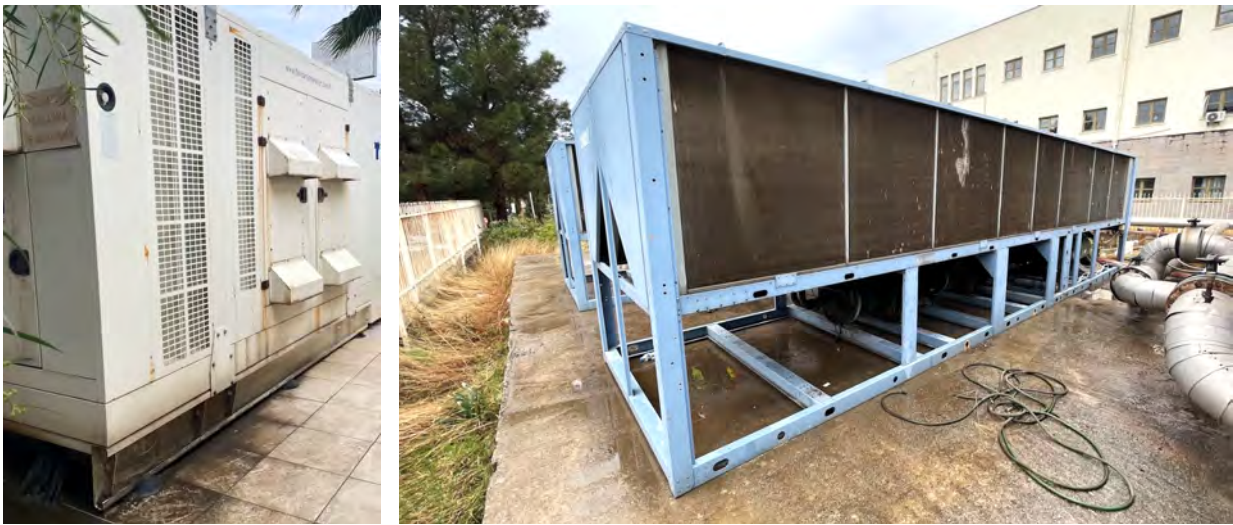
**Figure 6.15.** Unanchored generator (left) and unanchored chiller (right) in Iskenderun, Hatay province.

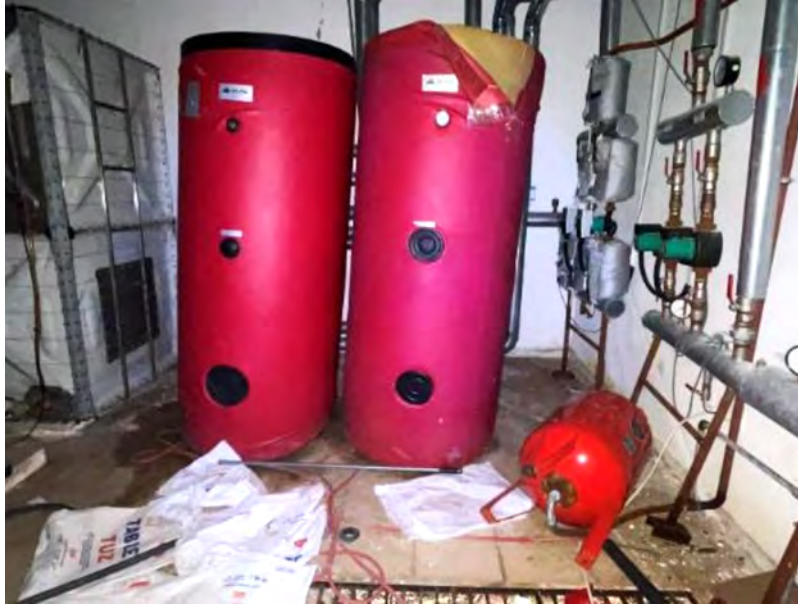
**Figure 6.16.** Toppled tanks in [Nurdağı Government Hospital](#).

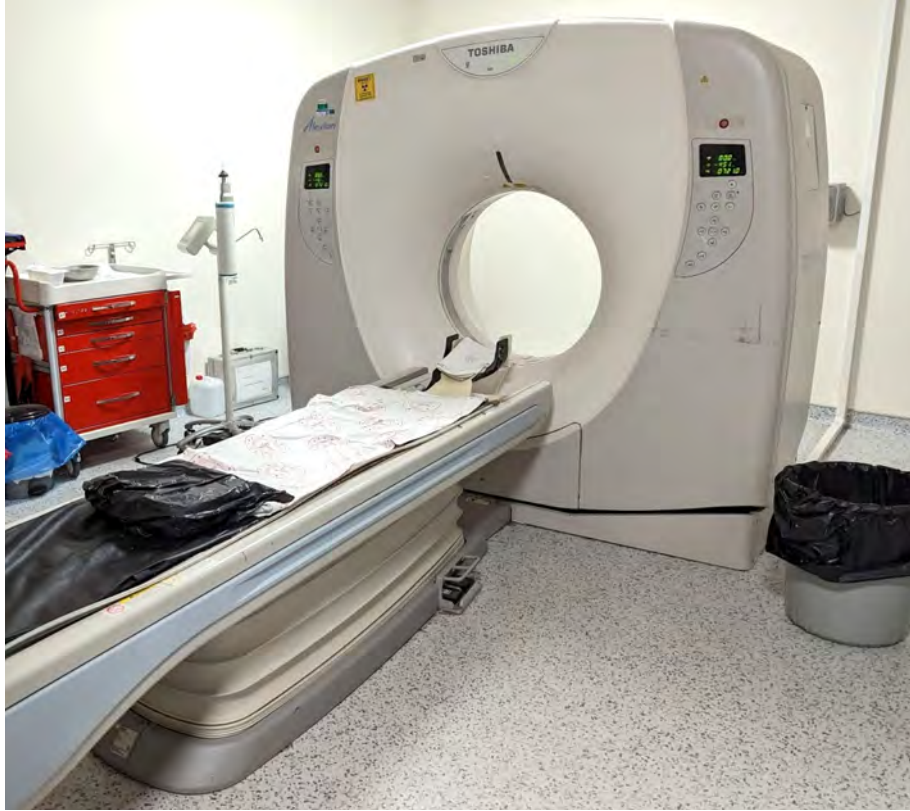
**Figure 6.17** CT Scanner required recalibration in Pazarcık, Kahramanmaraş province.

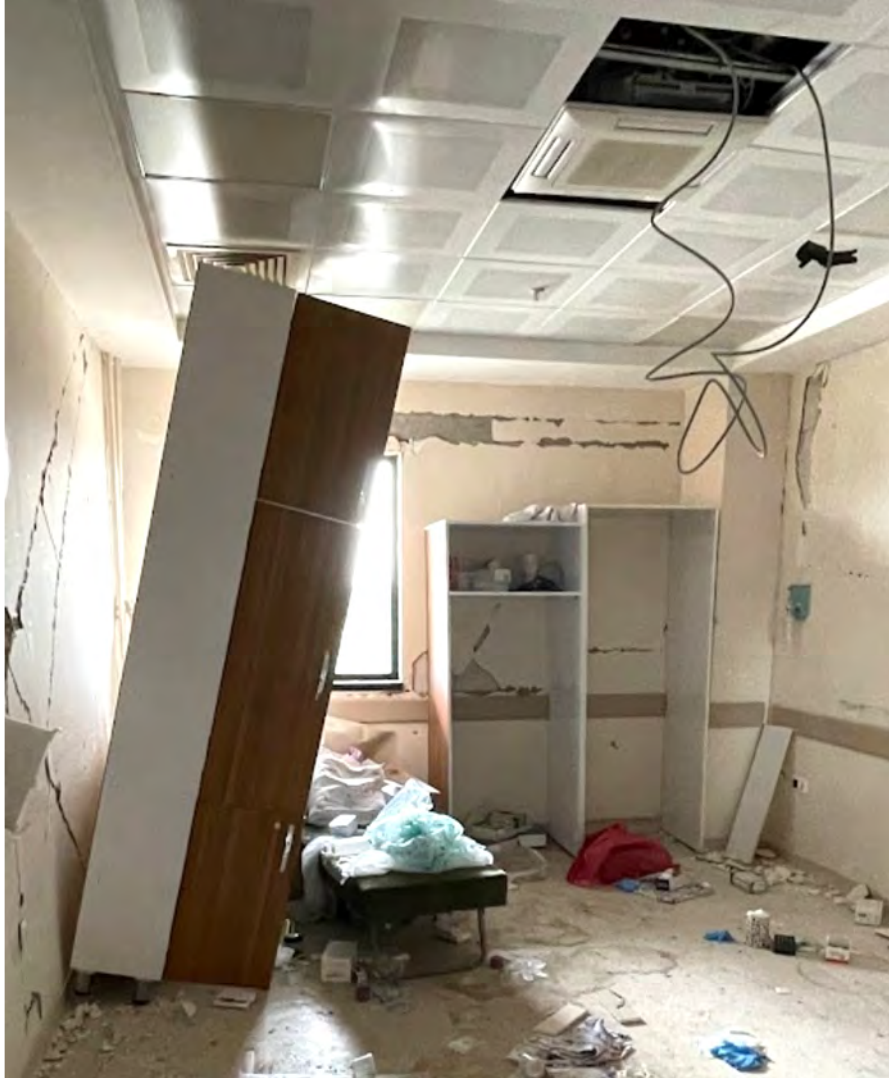
Figure 6.18. Cabinet failure at Nurdağı Government Hospital.

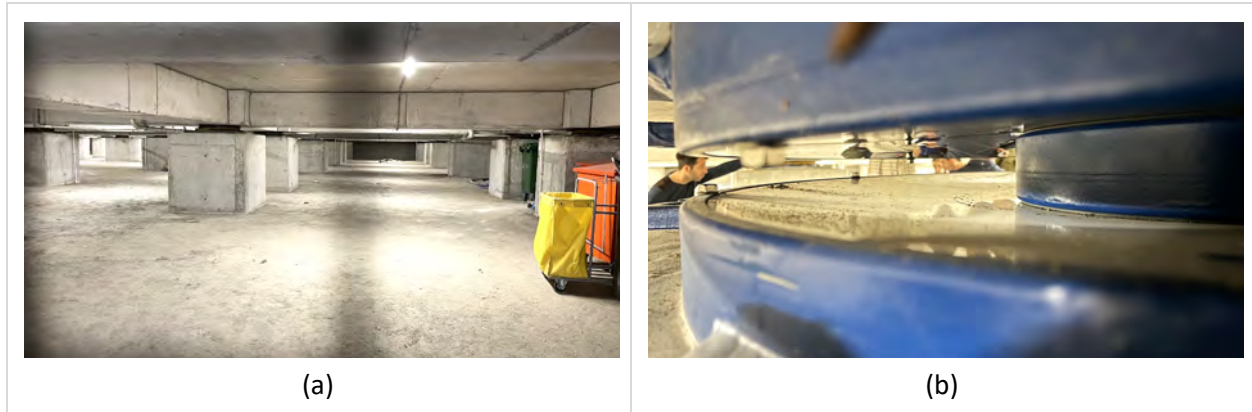
**Figure 6.19** Isolators at Dörtyol Government Hospital as observed on March 16, 2023.

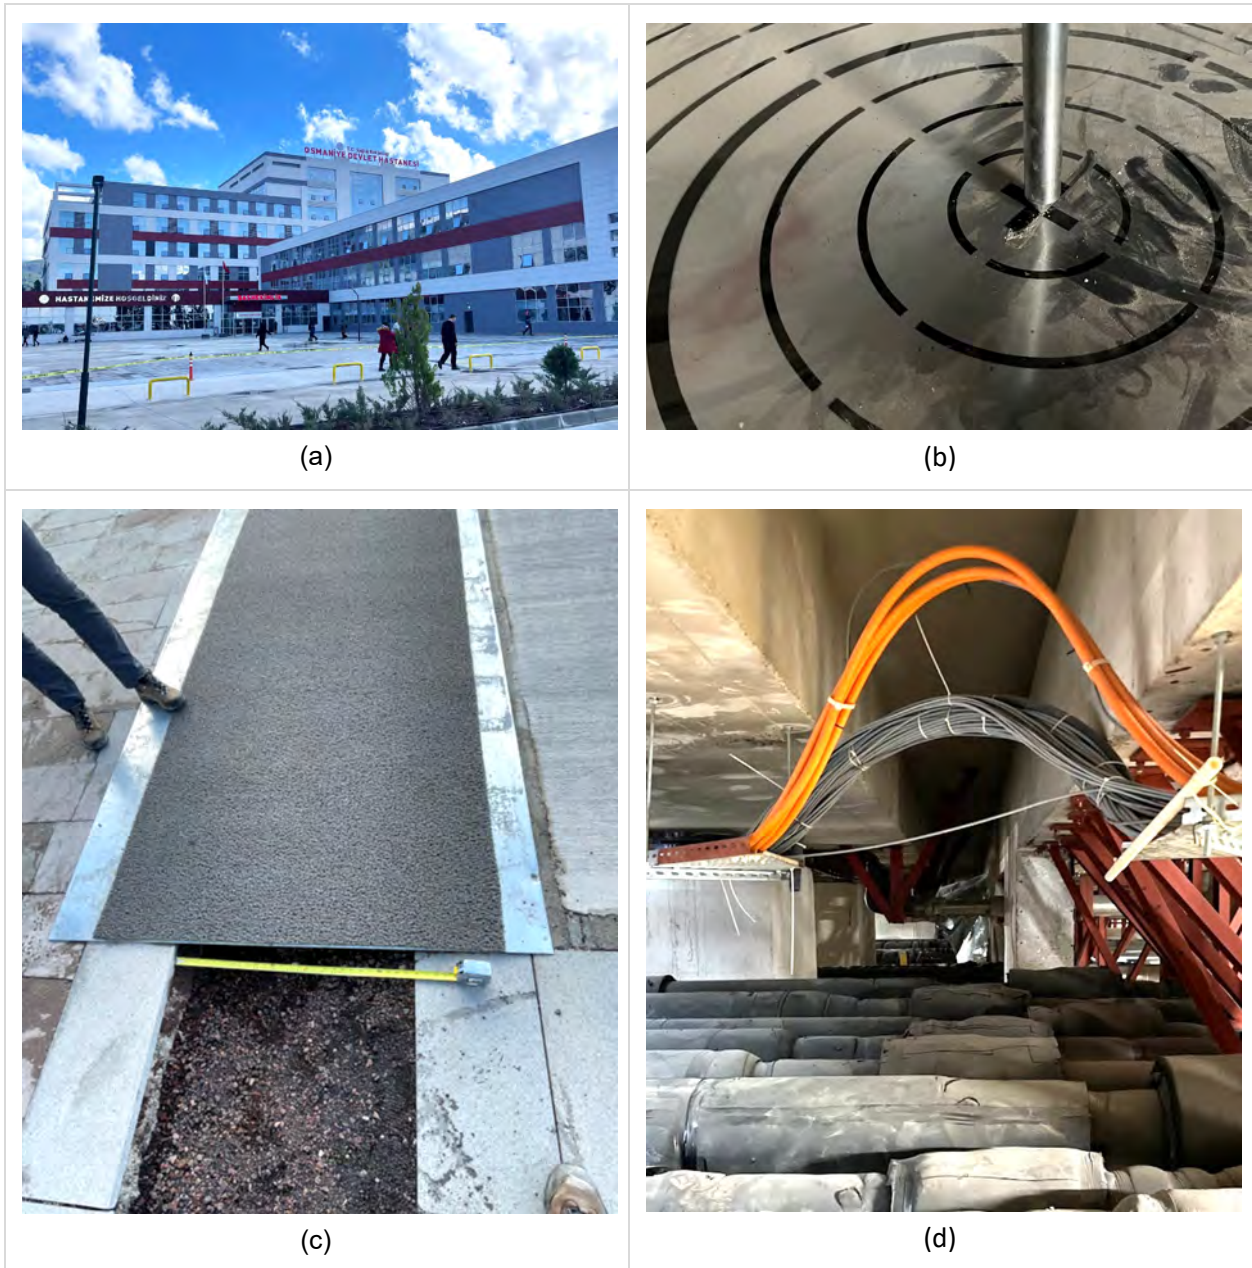
**Figure 6.20** Osmaniye Government Hospital as observed on March 16, 2023: (a) building exterior, (b) isolation system scratch plate, (c) moat with soil backfill, (d) Utilities crossing isolation plane.

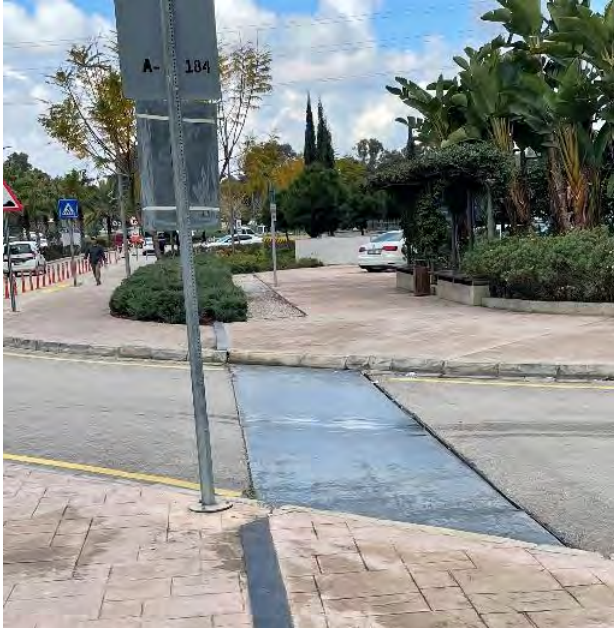
**Figure 6.21** Concrete sidewalk crossing the moat gap at Adana City Hospital as observed on March 16, 2023.

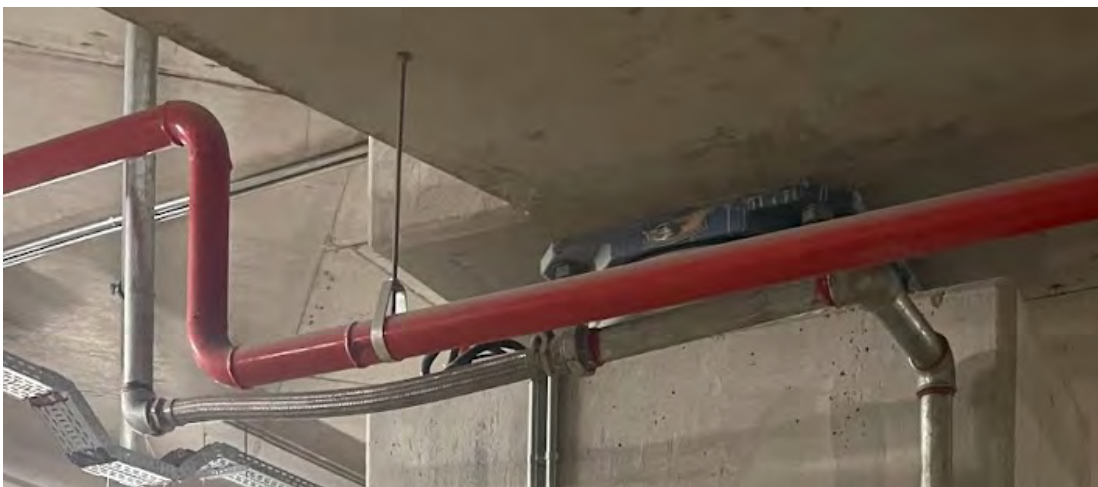
**Figure 6.22.** Utilities crossing isolation plane as observed at the Adana City Hospital on March 16, 2023.

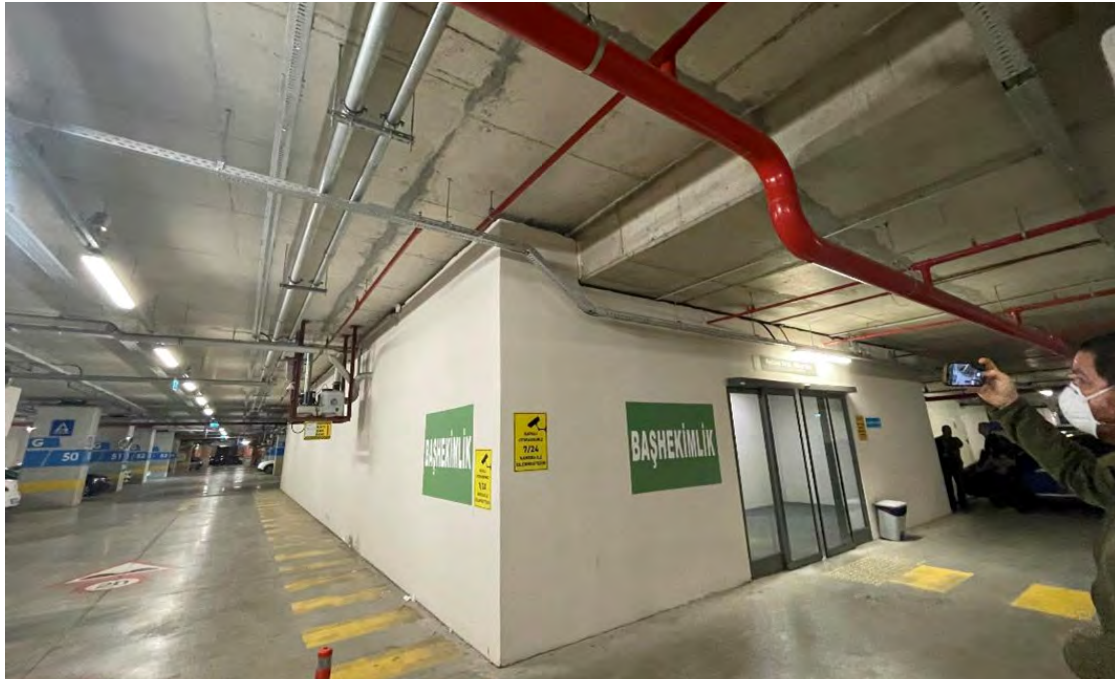
**Figure 6.23** During the Hospital’s team visit to Adana City Hospital on March 16, 2023, it was observed that there was insufficient clearance for partitions to accommodate isolator displacement. The plane of isolation is located at the top of basement columns, just beneath the ceiling, and partition walls will move with the slab-on-grade below the plane of isolation. To address this issue, the partitions need to be separated with the full isolator displacement where they abut the concrete beams that move with the superstructure above the plane of isolation. Additionally, the red sprinkler piping is supported from the concrete superstructure above the plane of isolation, but it penetrates through the partitions without any oversize holes to allow for isolator movement.
