MAY 6, 2023

# FEBRUARY 6, 2023 TÜRKIYE EARTHQUAKES: REPORT ON GEOSCIENCE AND ENGINEERING IMPACTS

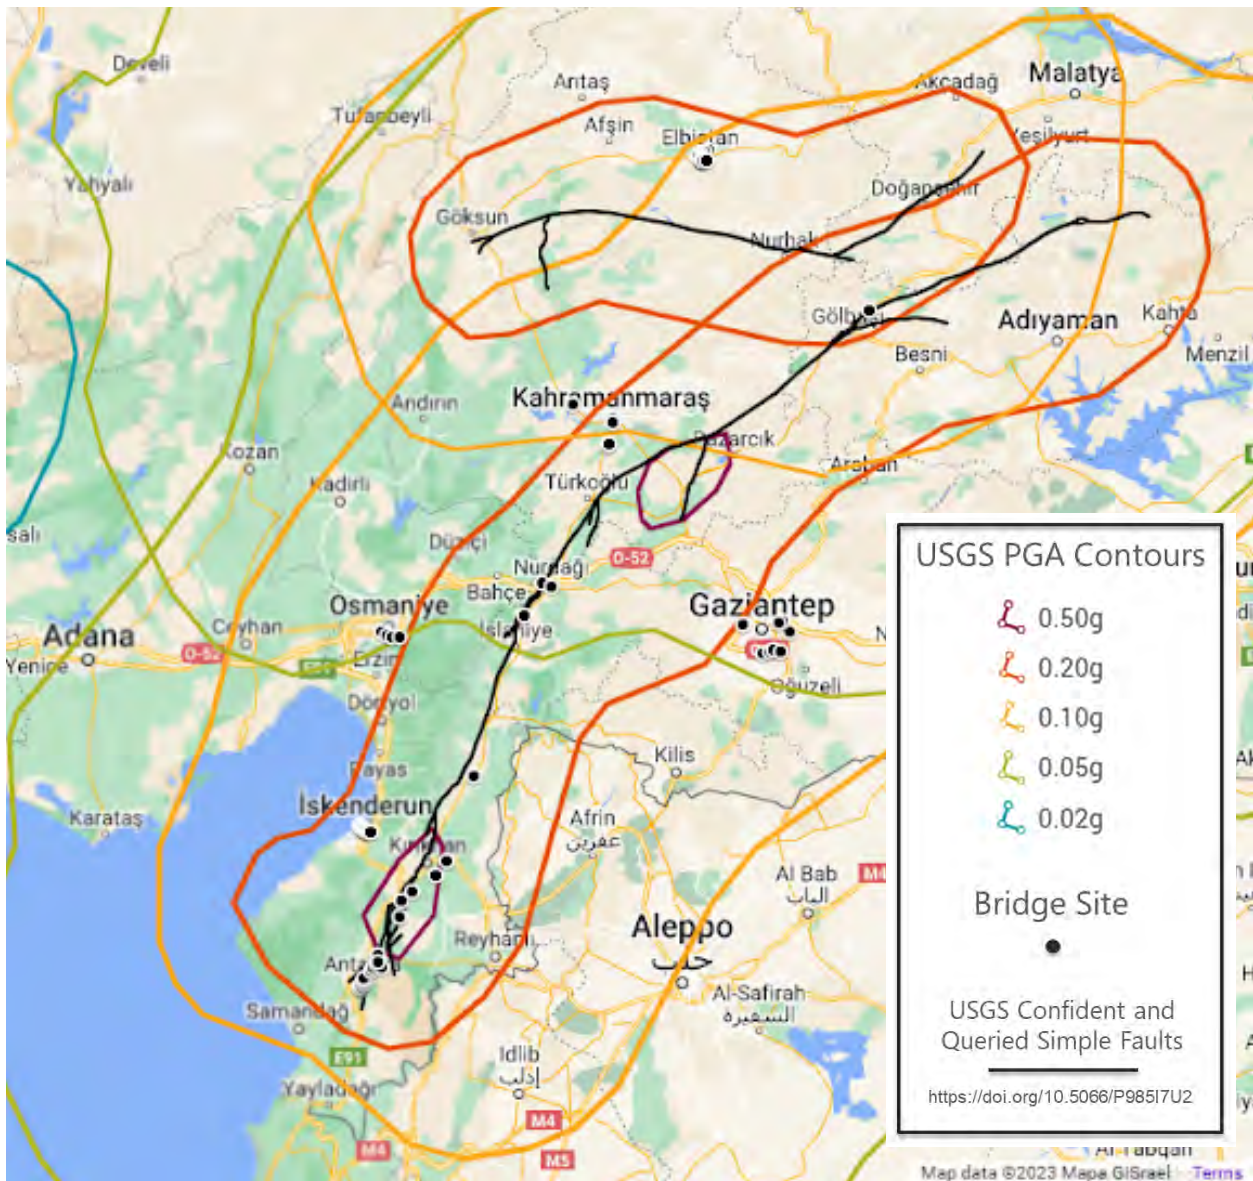
Figure 7.2. Location of visited bridge sites.

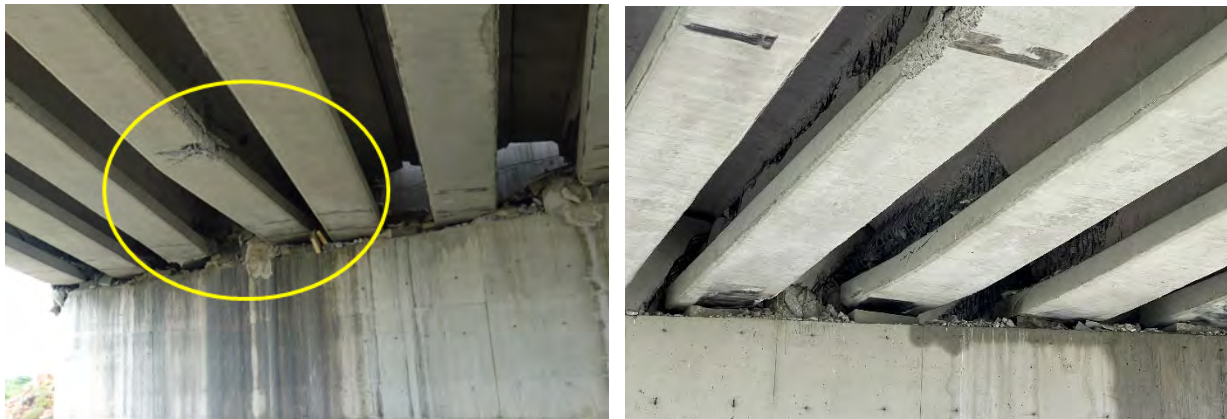
**Figure 7.3.** Severely damaged concrete bridge girders resulting in reduced load carrying capacity, (ID No. 33 in Appendix A).

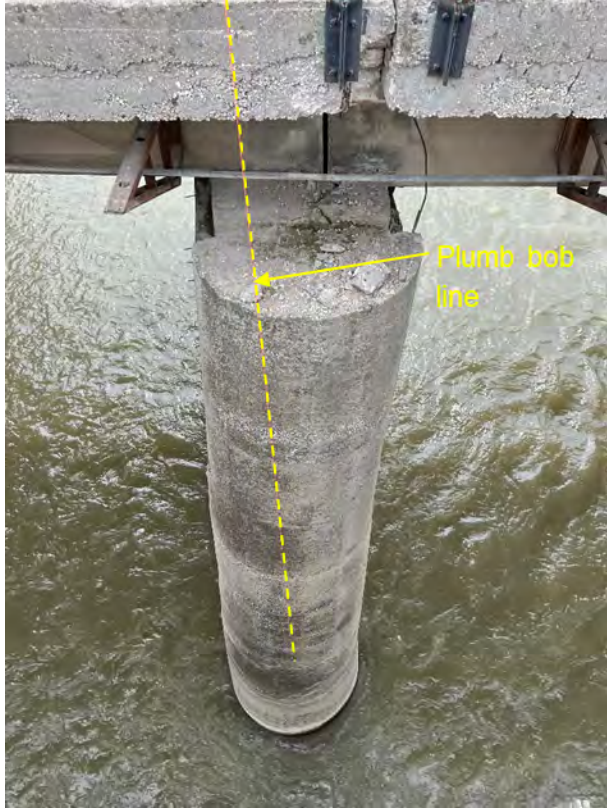
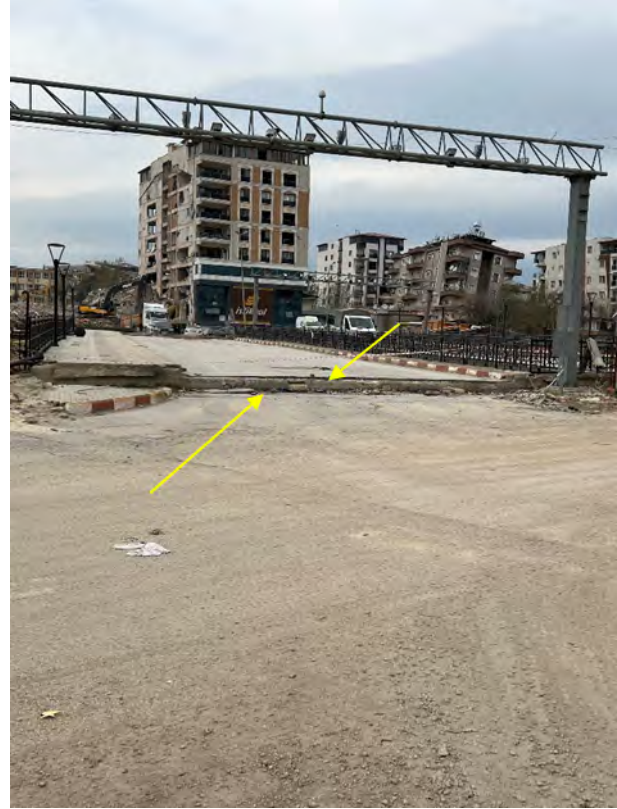
**Figure 7.4.** Significant residual displacement of pier (left) and abutment settlement (right), (ID No. 16 in Appendix A).

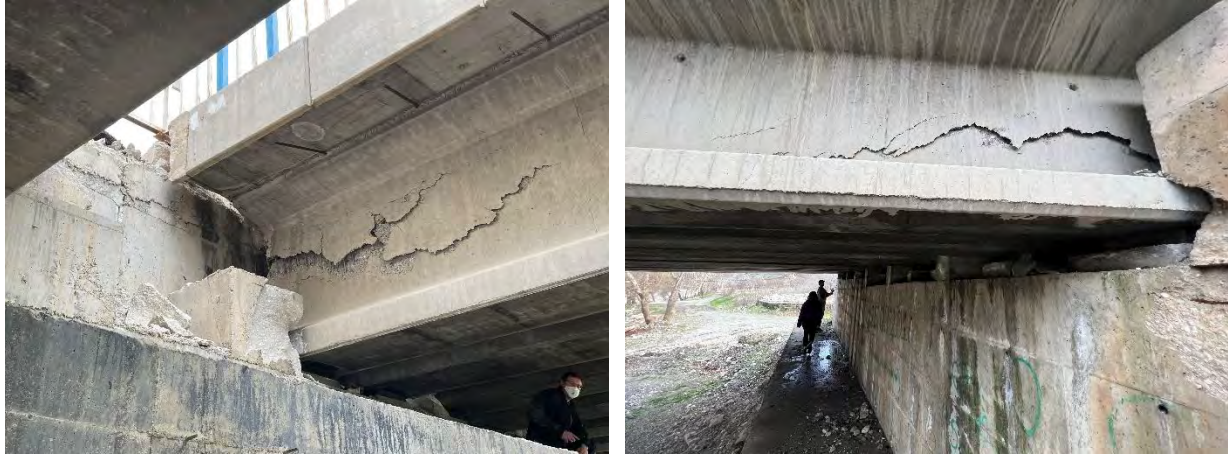
**Figure 7.6.** Longitudinal cracking at end of precast concrete girders.

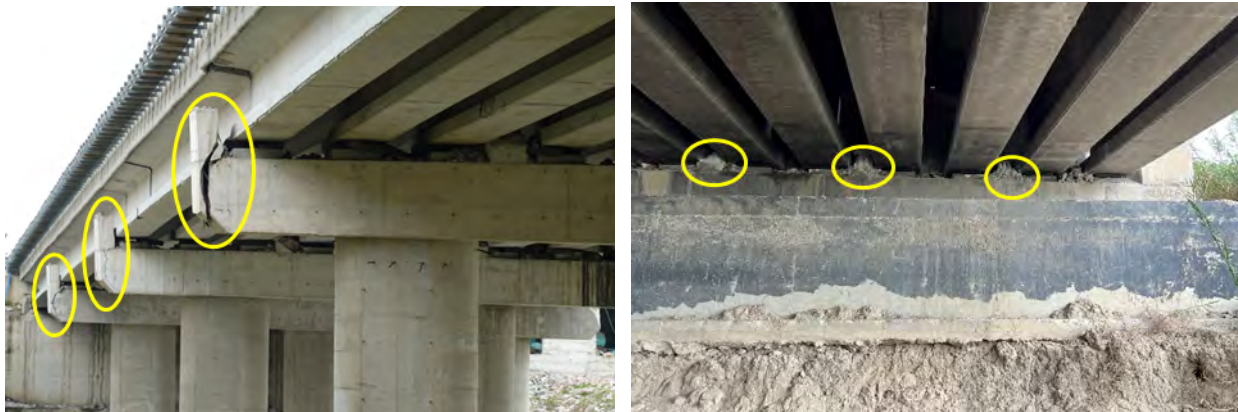
**Figure 7.7.** Damage to lateral support wings at bents (left) and to shear keys (right).

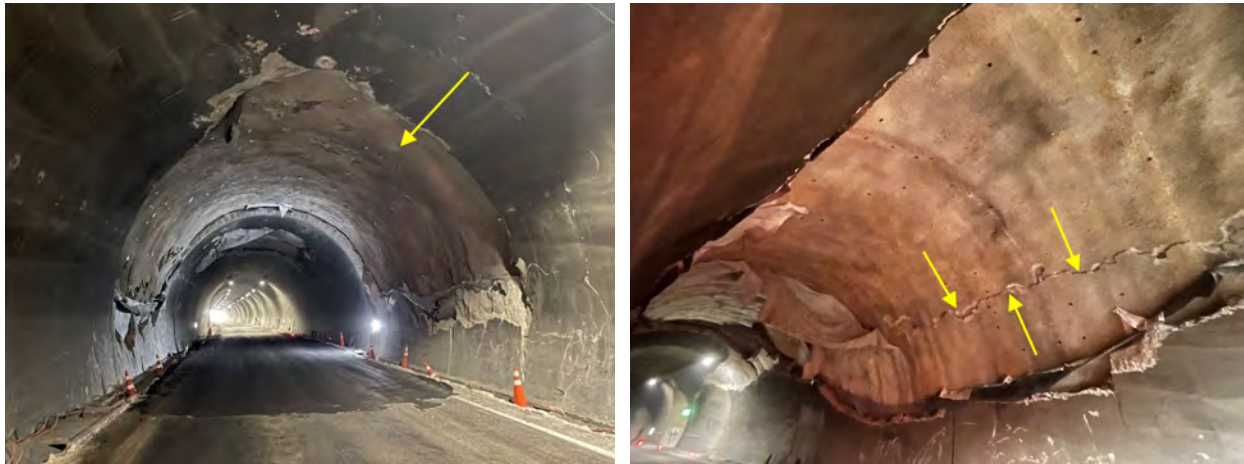
**Figure 7.8.** Collapse tunnel liner (left) and longitudinal crack in the outer tunnel casing (right) observed in the south bore (ID No. 84 in Appendix A).

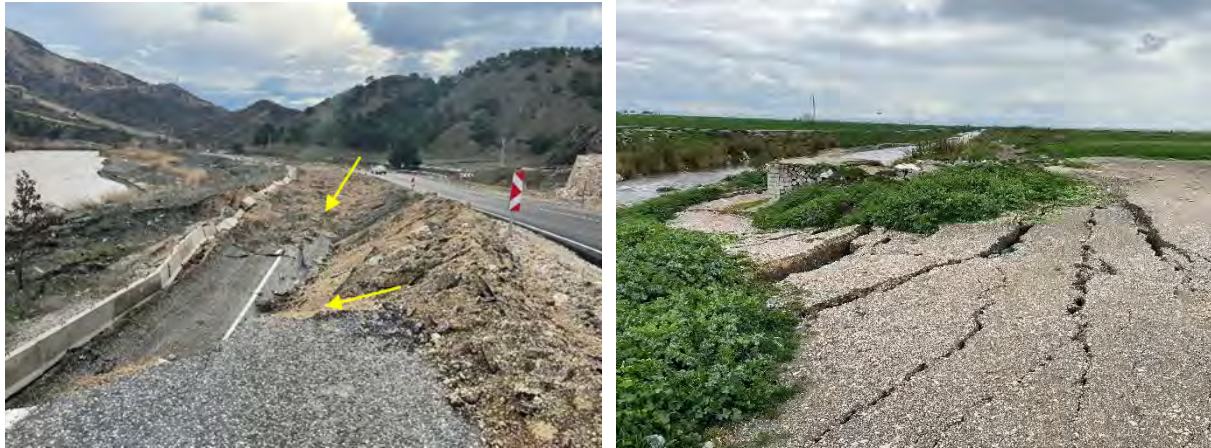
**Figure 7.9.** Embankment and roadway failure near a dam located (left, ID No. 83 in Appendix A) and near a bridge (right, ID No. 45 in Appendix A).

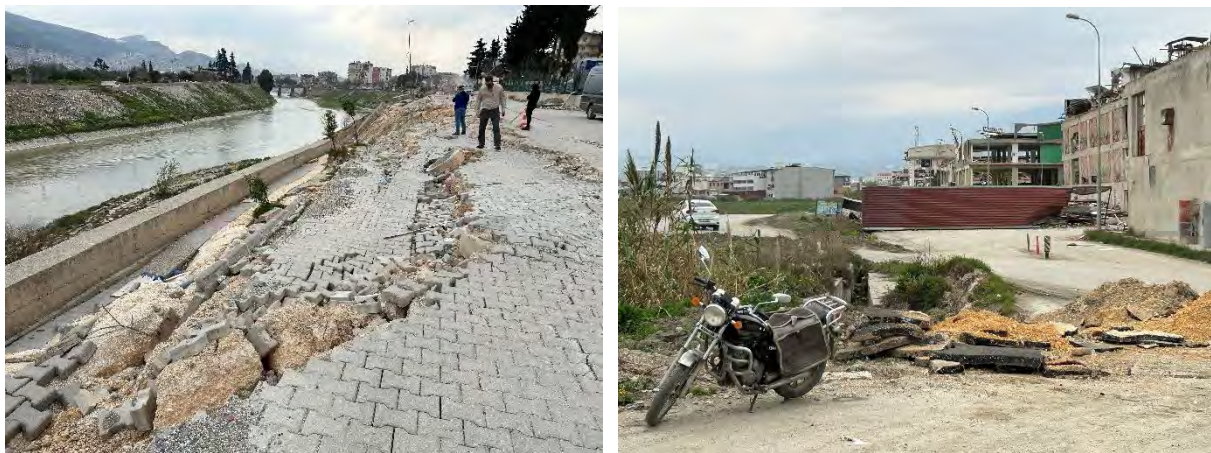
**Figure 7.10.** Embankment and roadway failure in Antakya (left, ID No. 19 in Appendix A), makeshift road around collapse debris in Antakya (right, near ID 20 in Appendix A).

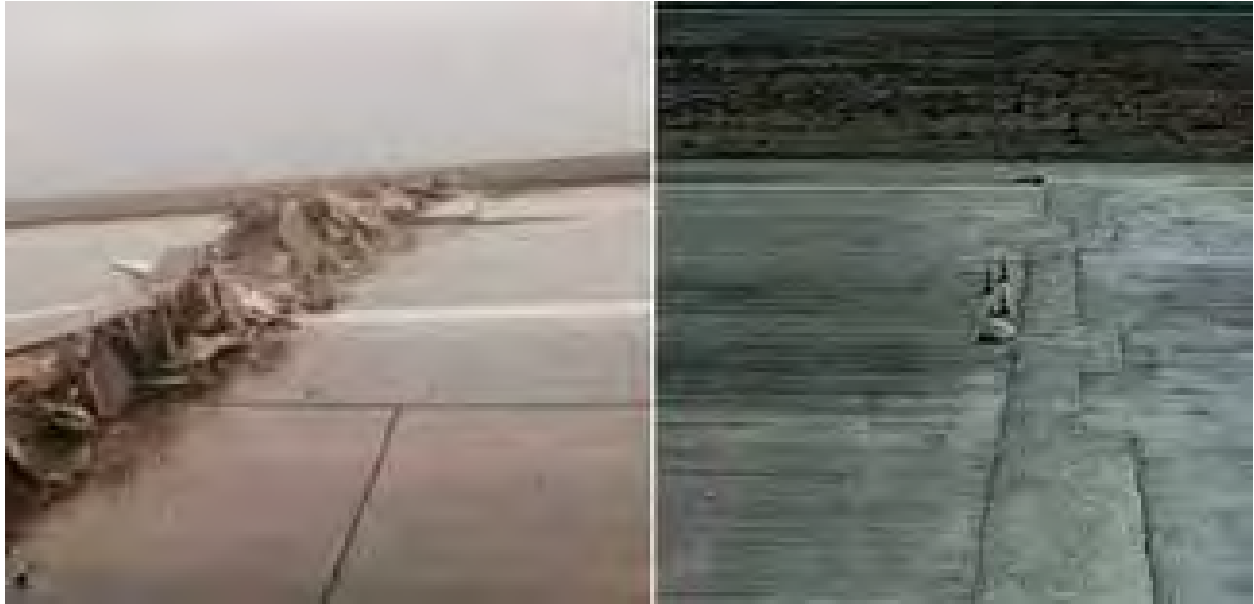
Figure 7.11. Condition of Hatay airport runway after earthquake sequence (left) and after repairs (right)

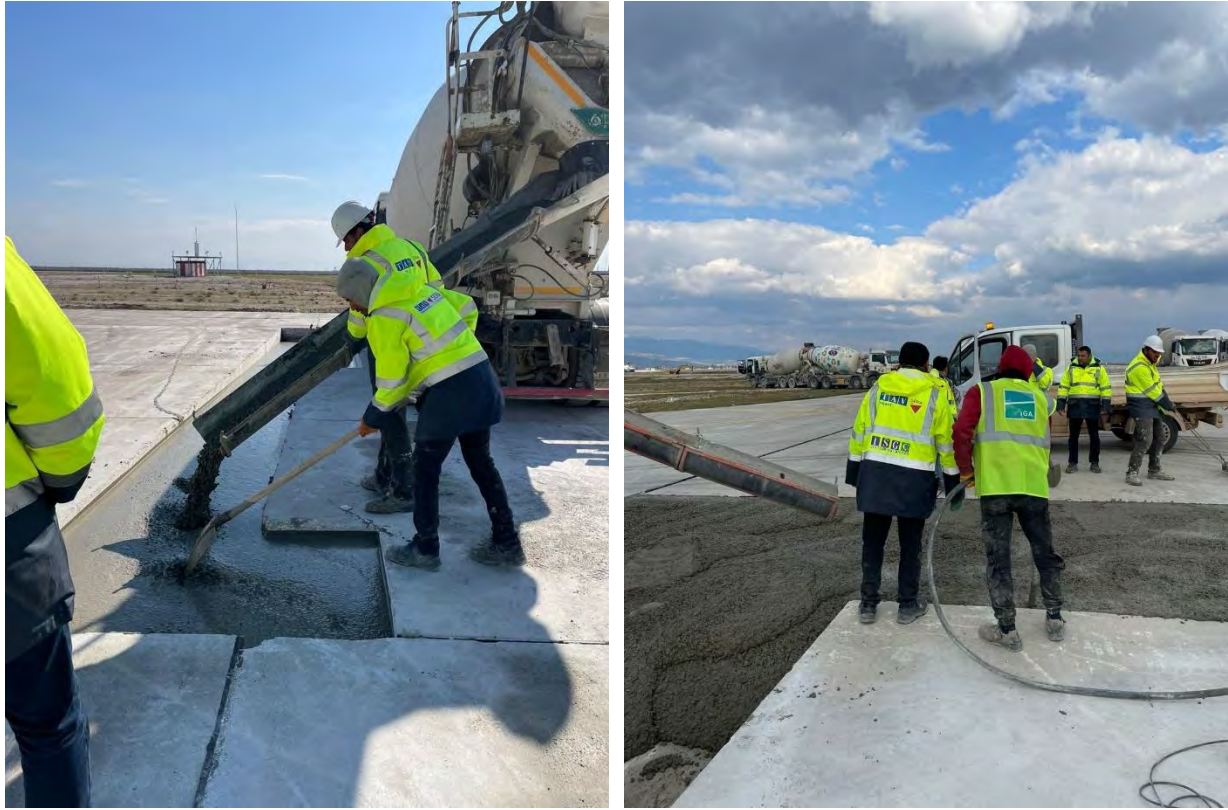
Figure 7.12. Repair work to the Hatay airport runway

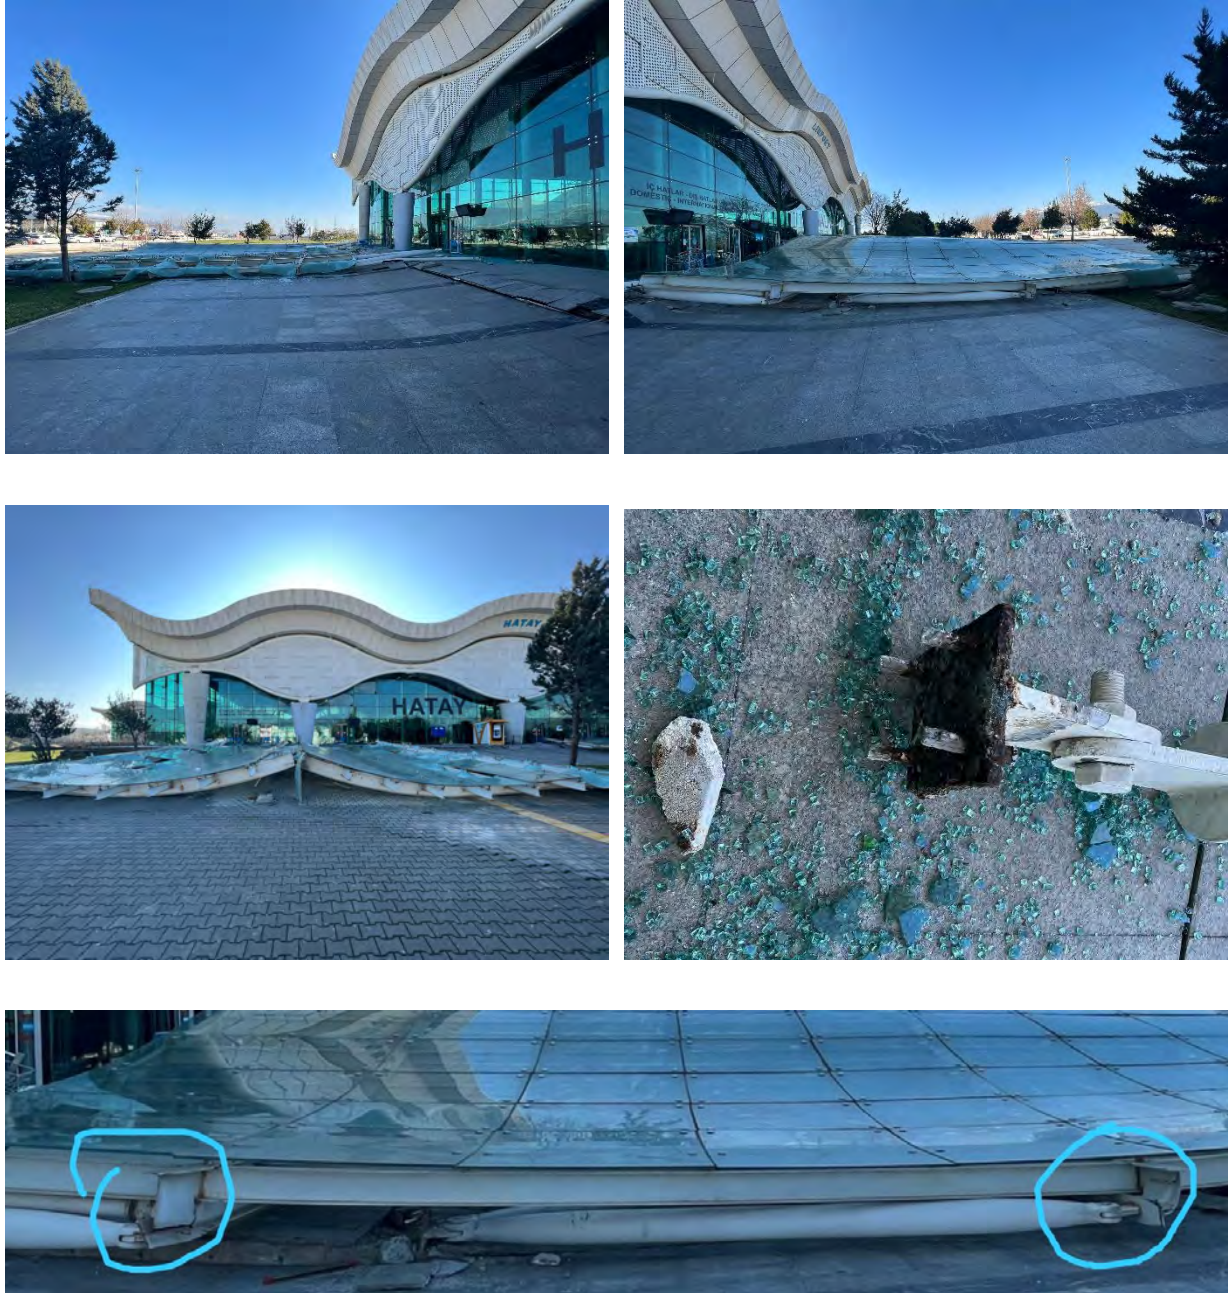
Figure 7.13. Collapsed canopy at entrance to Hatay Airport

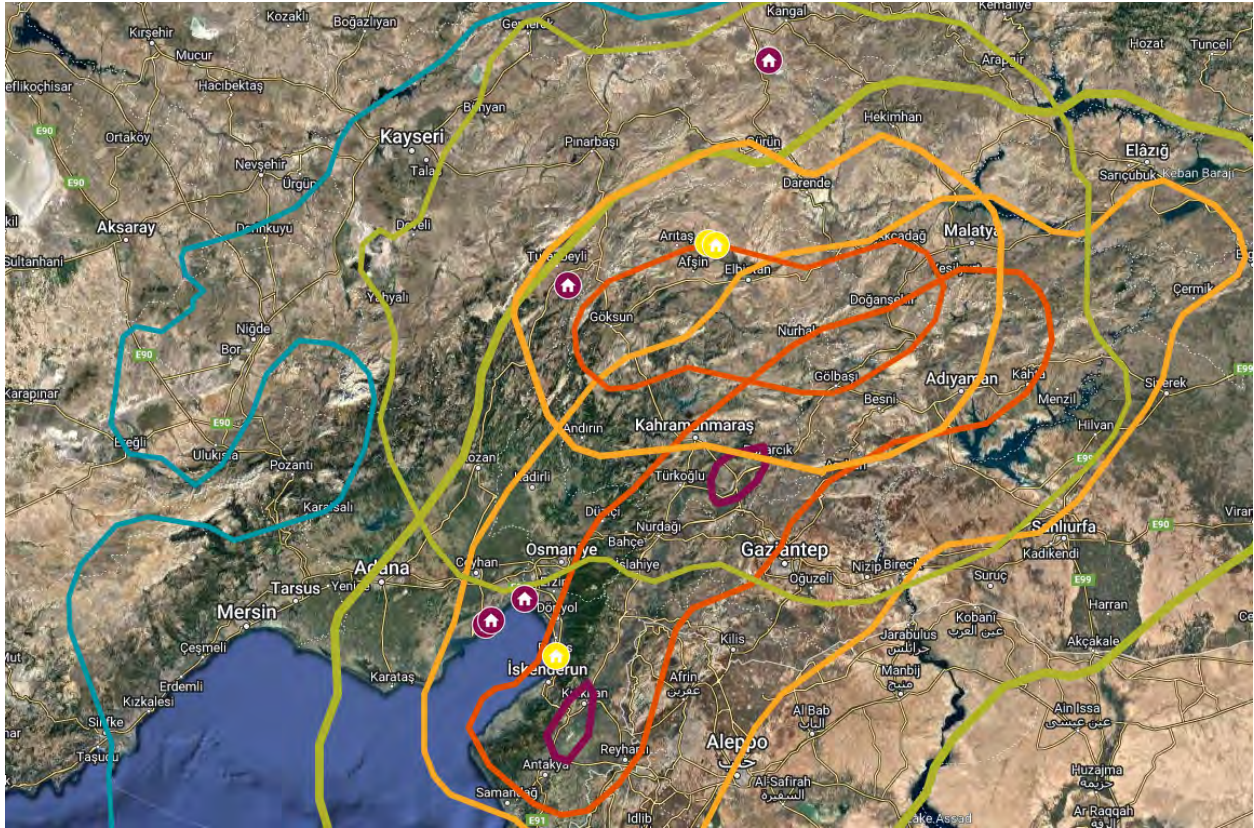
Figure 7.14. Map of coal and gas plants visited (indicated with yellow markers) and not visited (indicated in purple markers) overlaid on peak ground acceleration contours from USGS (footnotes 5 and 6).

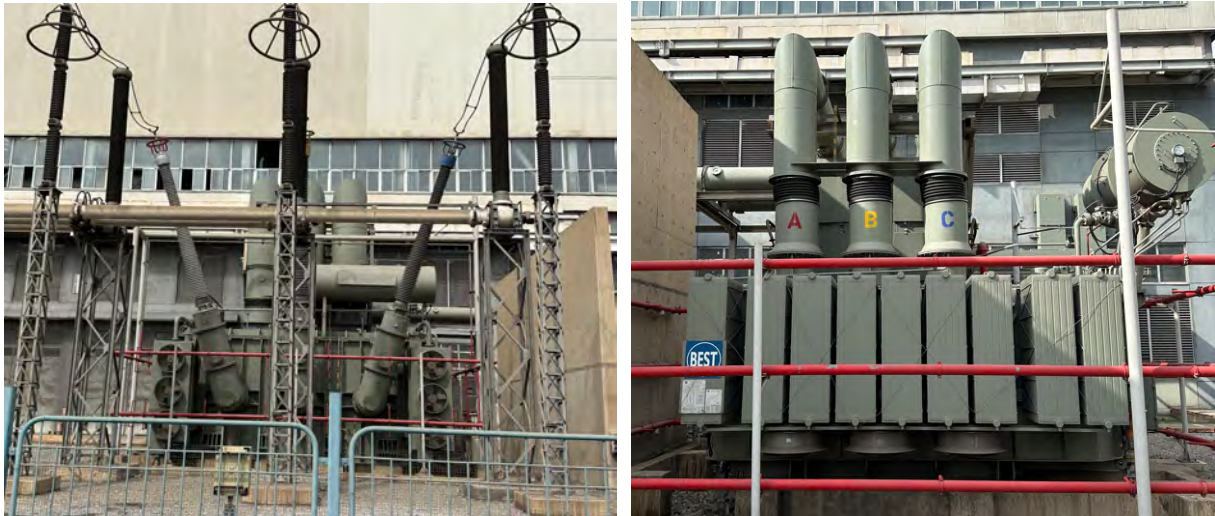
**Figure 7.18.** İskenderun plant a) example of transformer that sustained broken bushing and b) unanchored transformer that moved 10 cm laterally

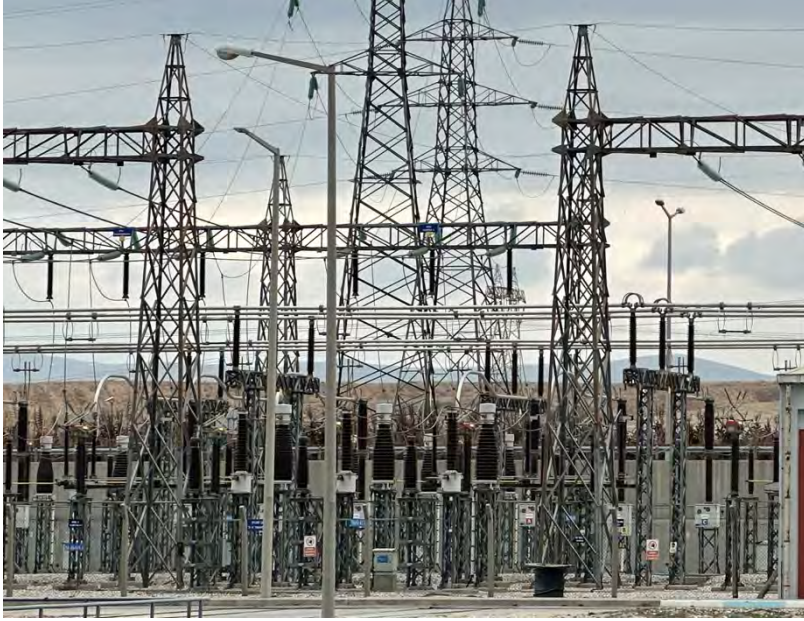
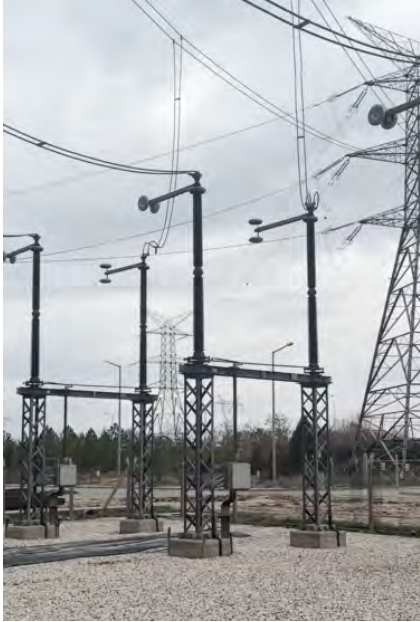
**Figure 7.19.** Afşin-Elbistan coal plant B switchyard equipment.

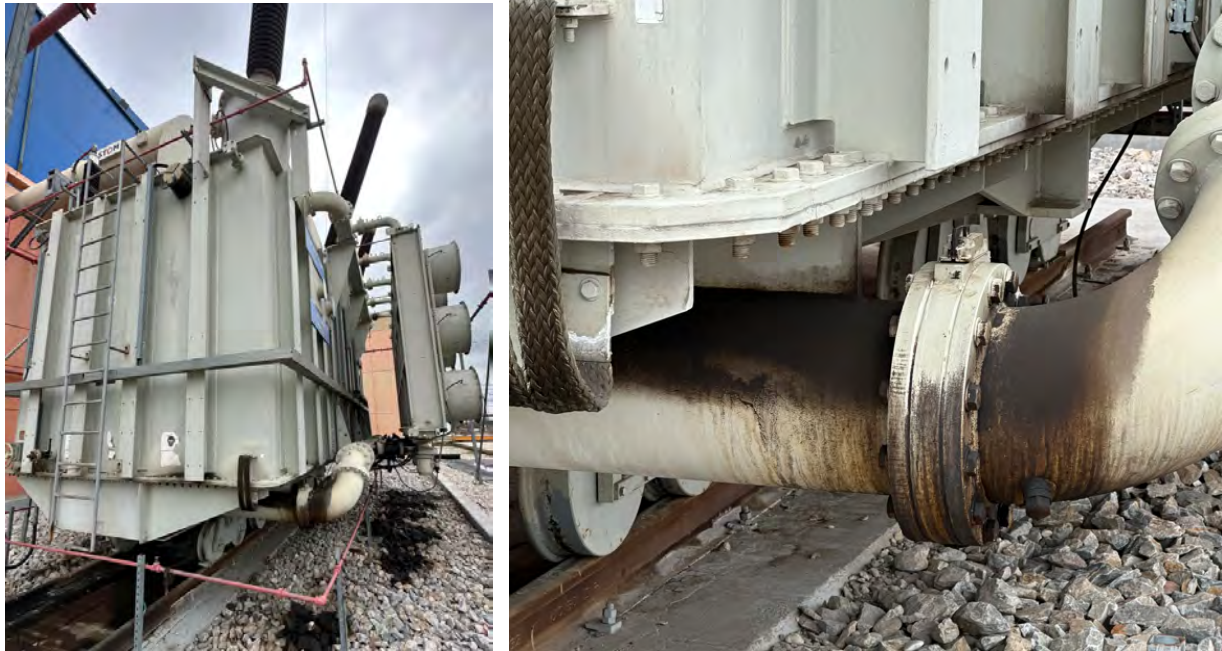
Figure 7.20. Afşin-Elbistan coal plant B transformer with oil leak at flange.

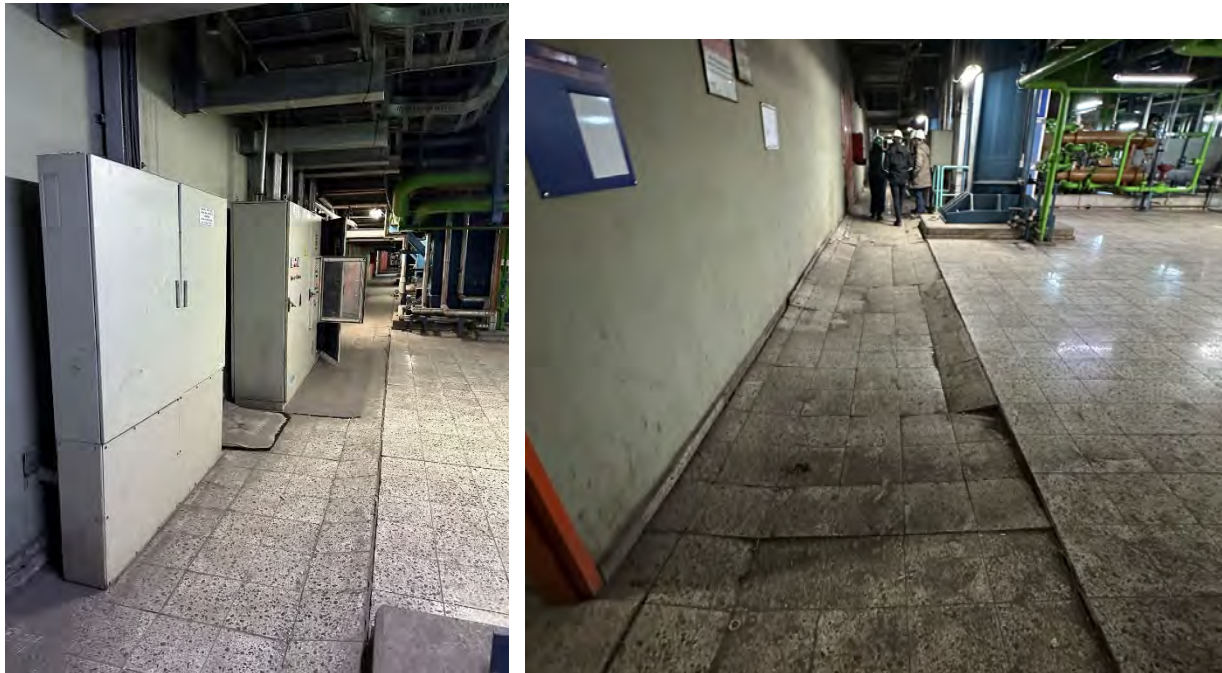
Figure 7.21. Afşin-Elbistan coal plant B – settlement observed in the powerhouse.

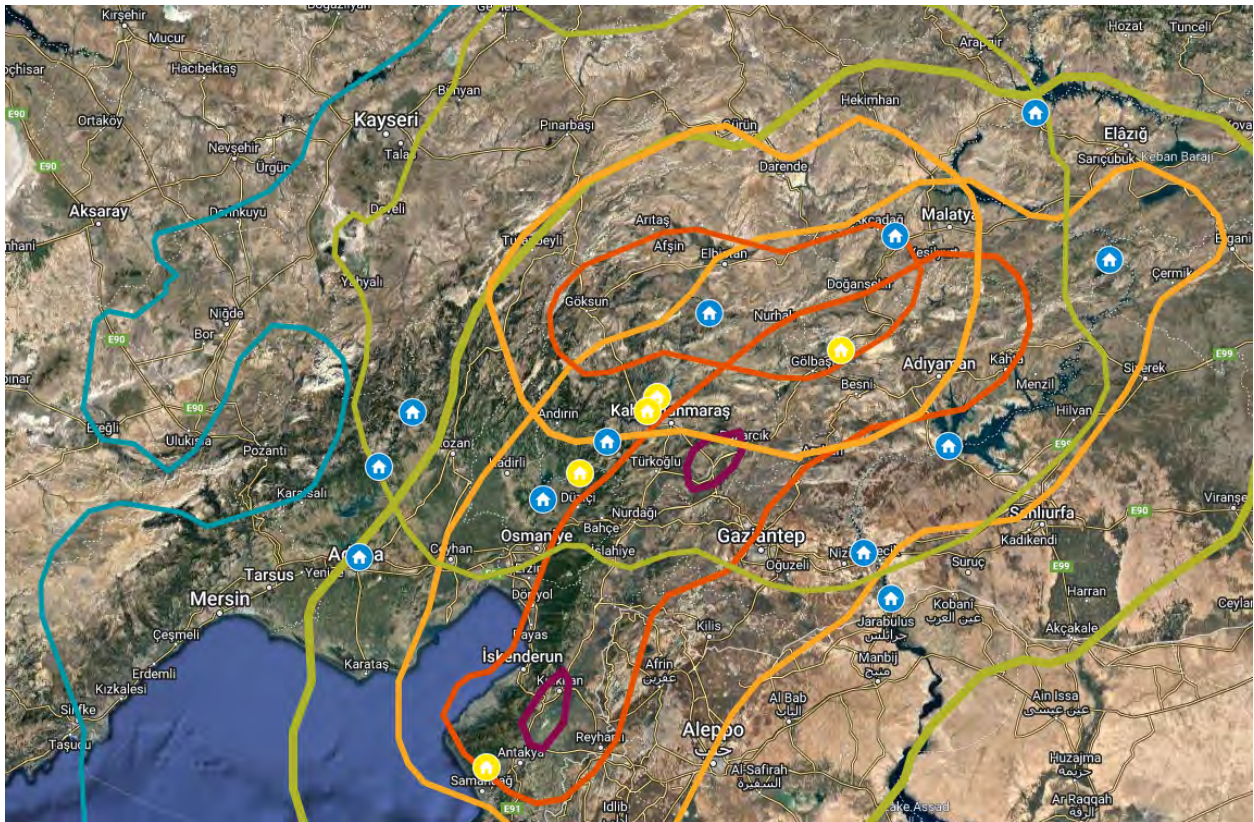
**Figure 7.22.** Map of hydroelectric dams visited (indicated with yellow markers) and not visited (indicated in blue markers) overlaid the USGS PGA contour maps for M7.8 and M7.7 earthquakes.

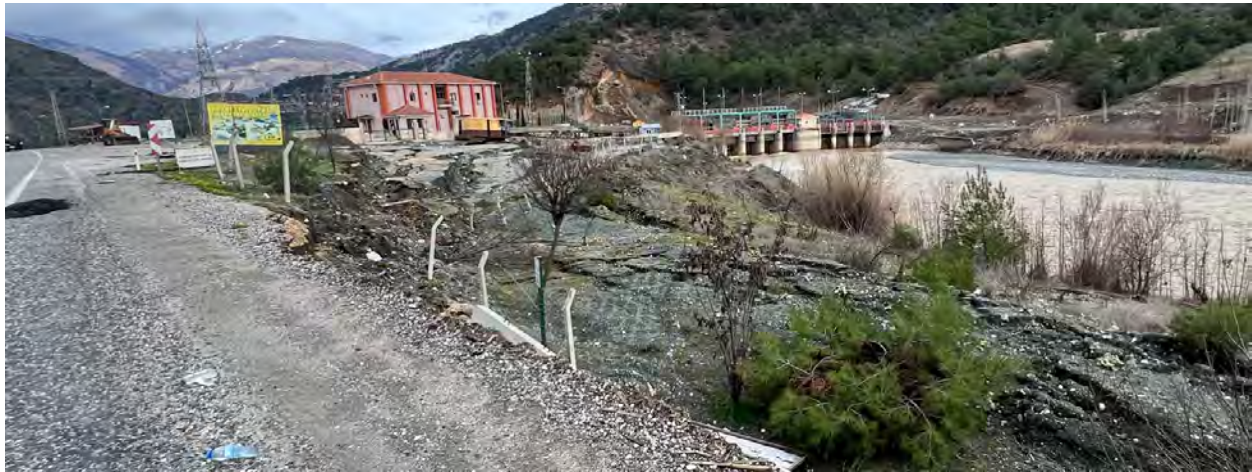
Figure 7.25. River bank failures at Alabalik dam.

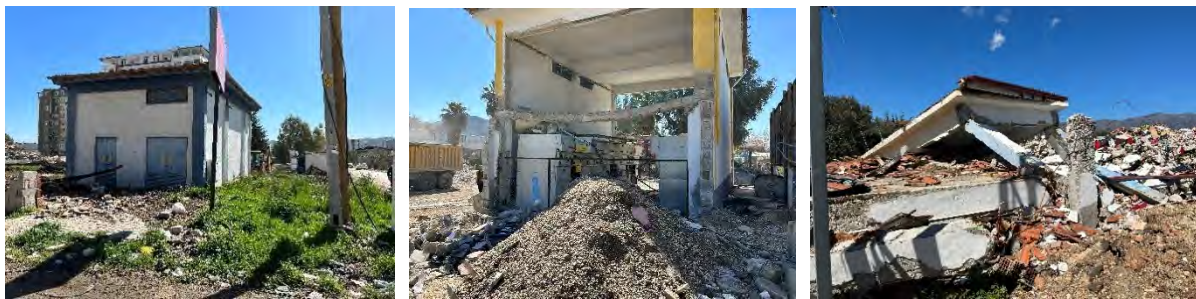
**Figure 7.26.** Example of range of damage to substation buildings in Antakya.

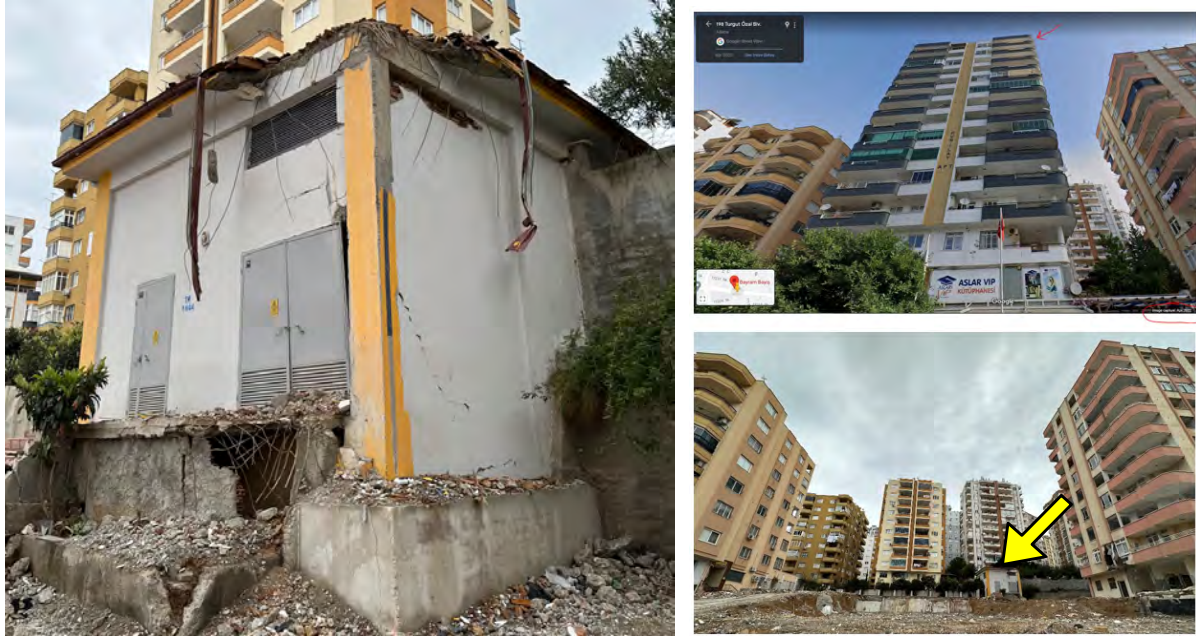
**Figure 7.27.** Example of substation in Adana struck by the collapse of an adjacent multi-story building (ID No. 2 in Appendix A).

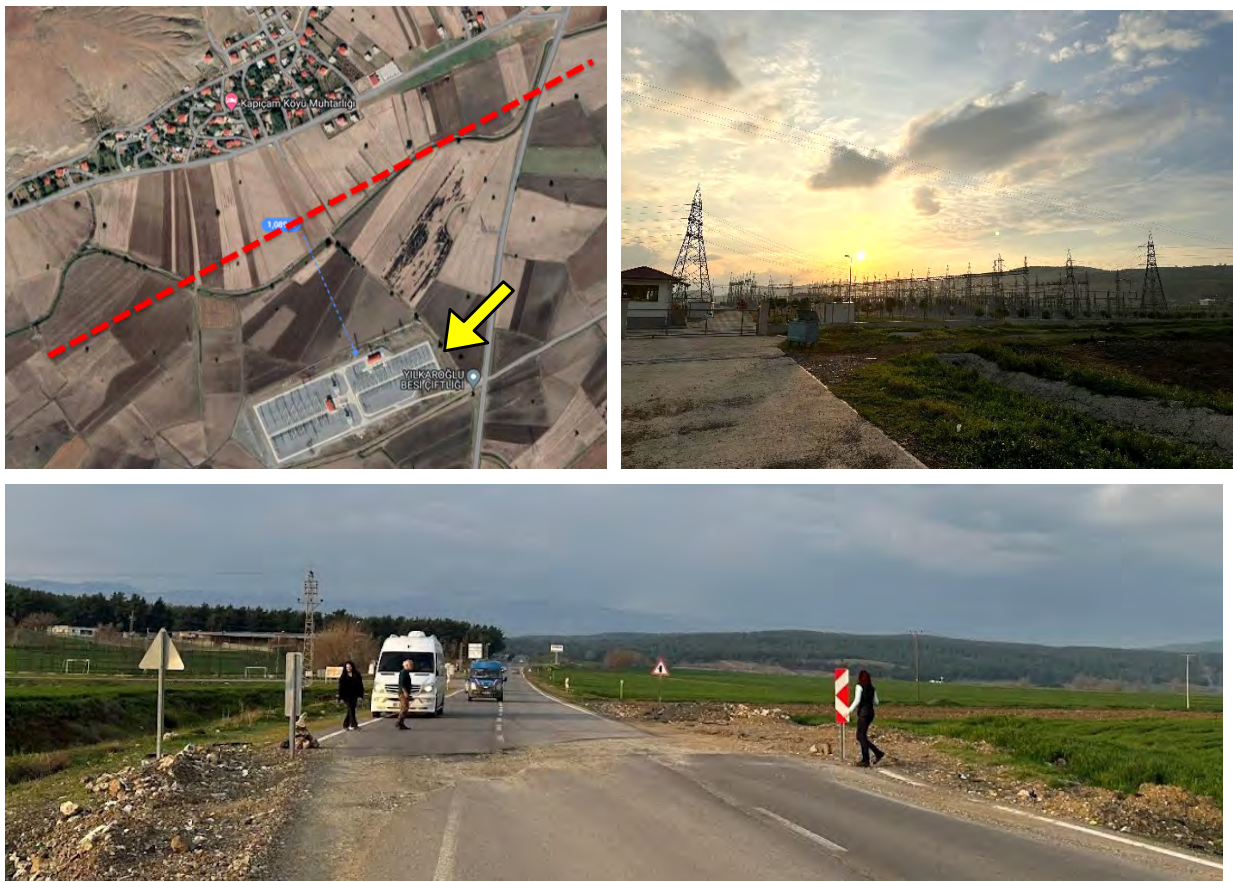
**Figure 7.28.** Kapiçam substation nearby surface fault rupture (ID No. 165 in Appendix A).

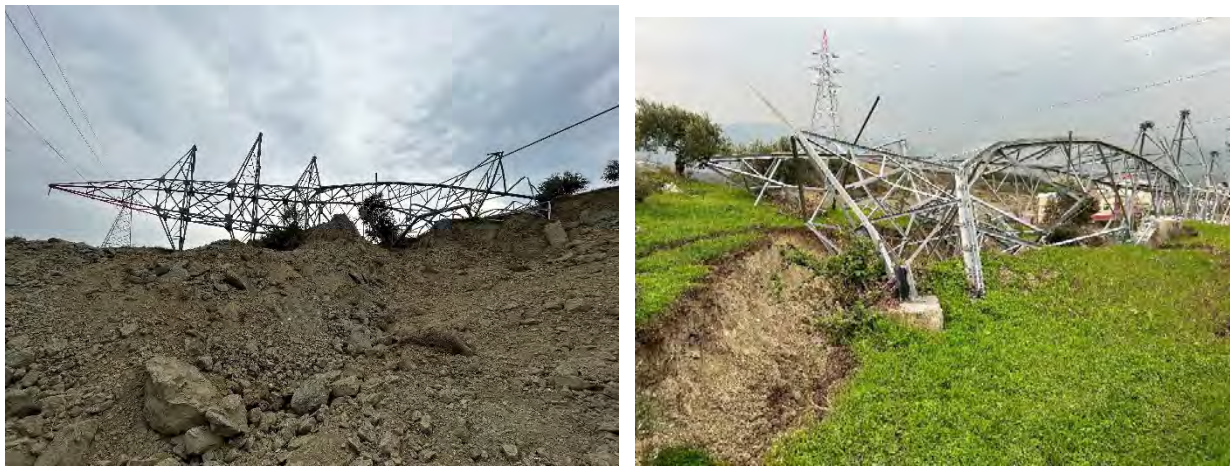
**Figure 7.29.** Collapsed transmission tower (ID No. 39 in Appendix A).

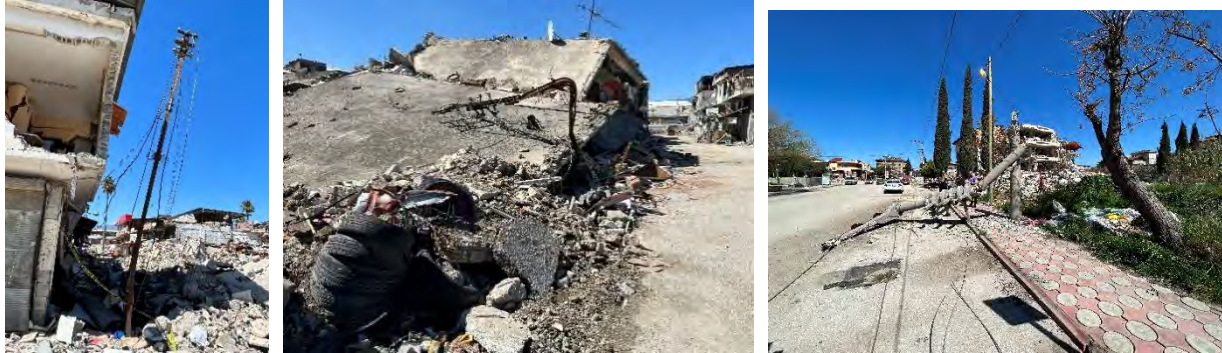
**Figure 7.30.** Distribution overhead structures damaged by debris (Antakya).

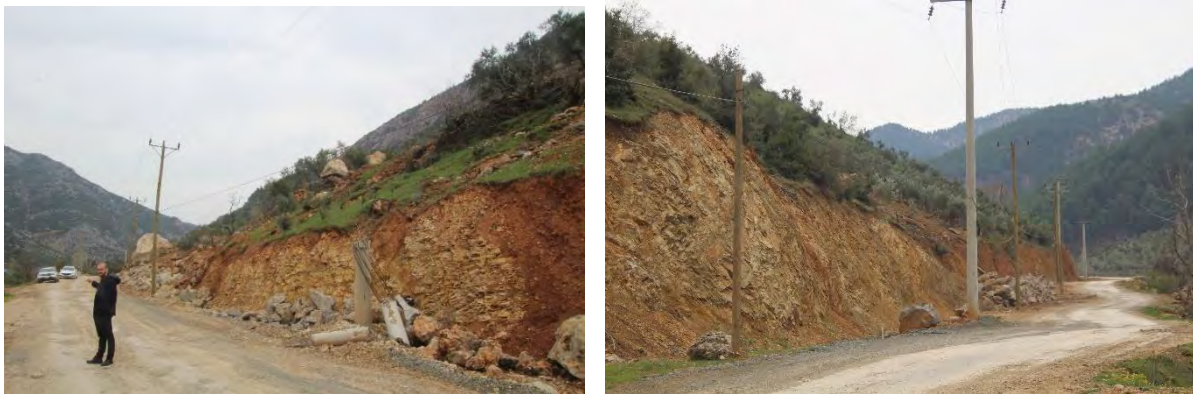
**Figure 7.31.** Rockfall damaged concrete distribution poles, replacement wood poles (near ID 141).

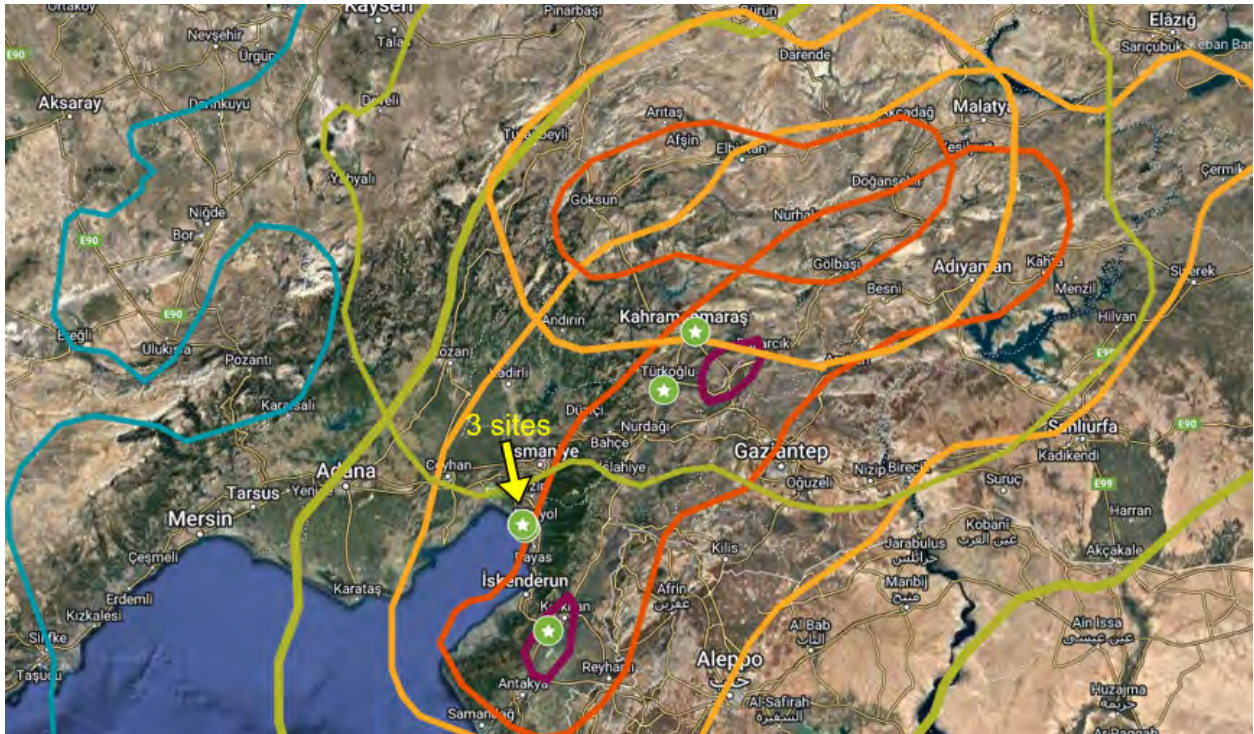
**Figure 7.32.** Map of LPG storage and distribution facilities visited overlaid atop USGS PGA contour maps for M7.8 and M7.7 earthquakes.

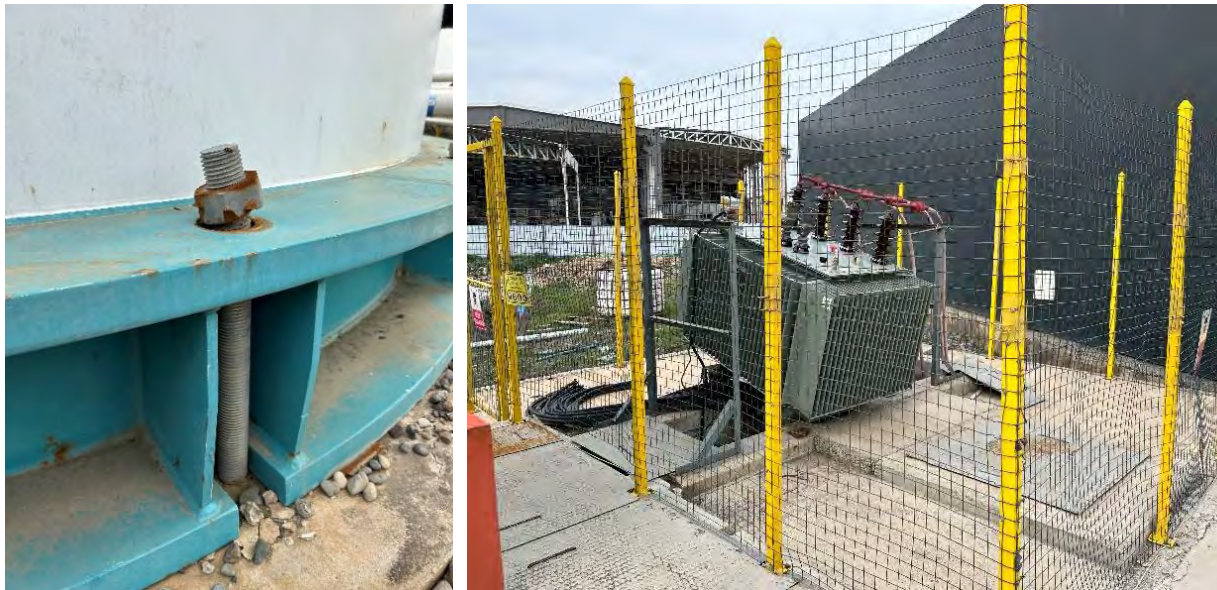
**Figure 7.38.** Deformed anchors and damaged generator at LPG production facility in Turkoglu (ID 144 in Appendix A).

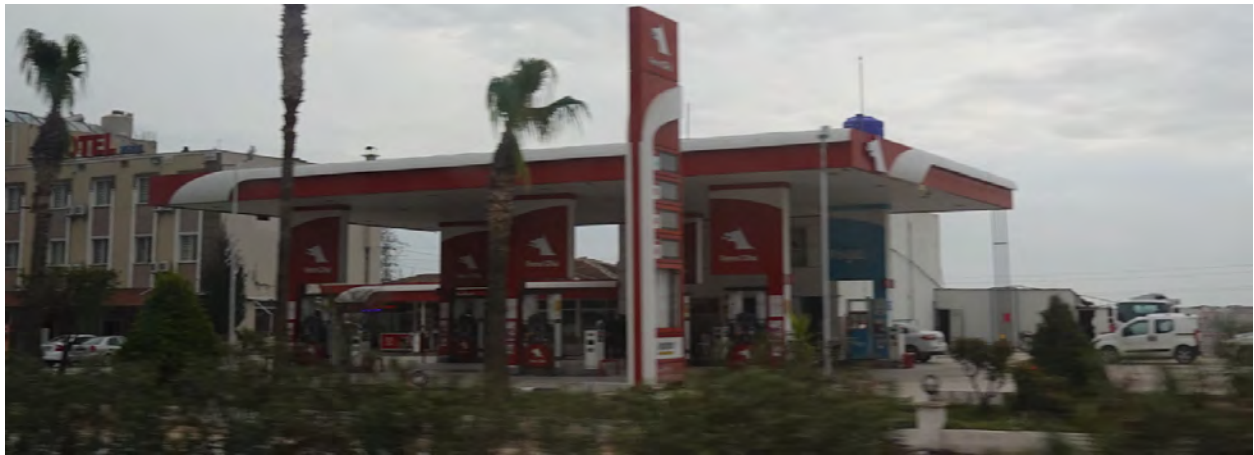
**Figure 7.39.** Example of petrol station in Antakya without evident structural damage.

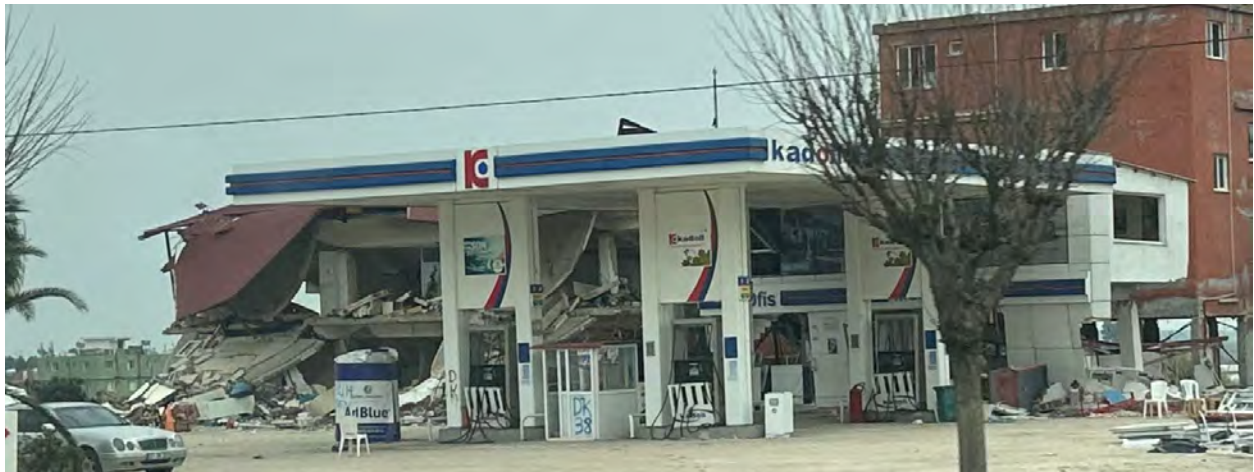
**Figure 7.40.** Example of petrol station in Antakya with standing canopy structure and heavily damaged one-story accessory building.

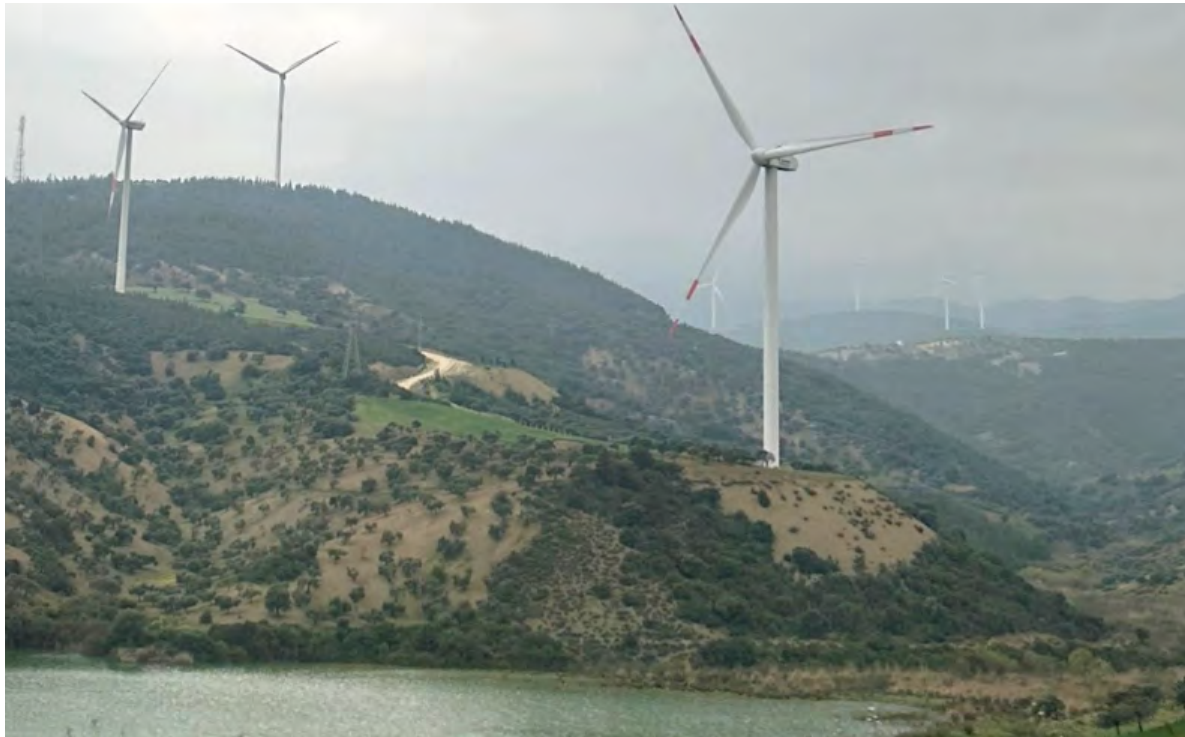
**Figure 7.41.** Example of wind turbines located west of Antakya.
