MAY 6, 2023

# FEBRUARY 6, 2023 TÜRKIYE EARTHQUAKES: REPORT ON GEOSCIENCE AND ENGINEERING IMPACTS

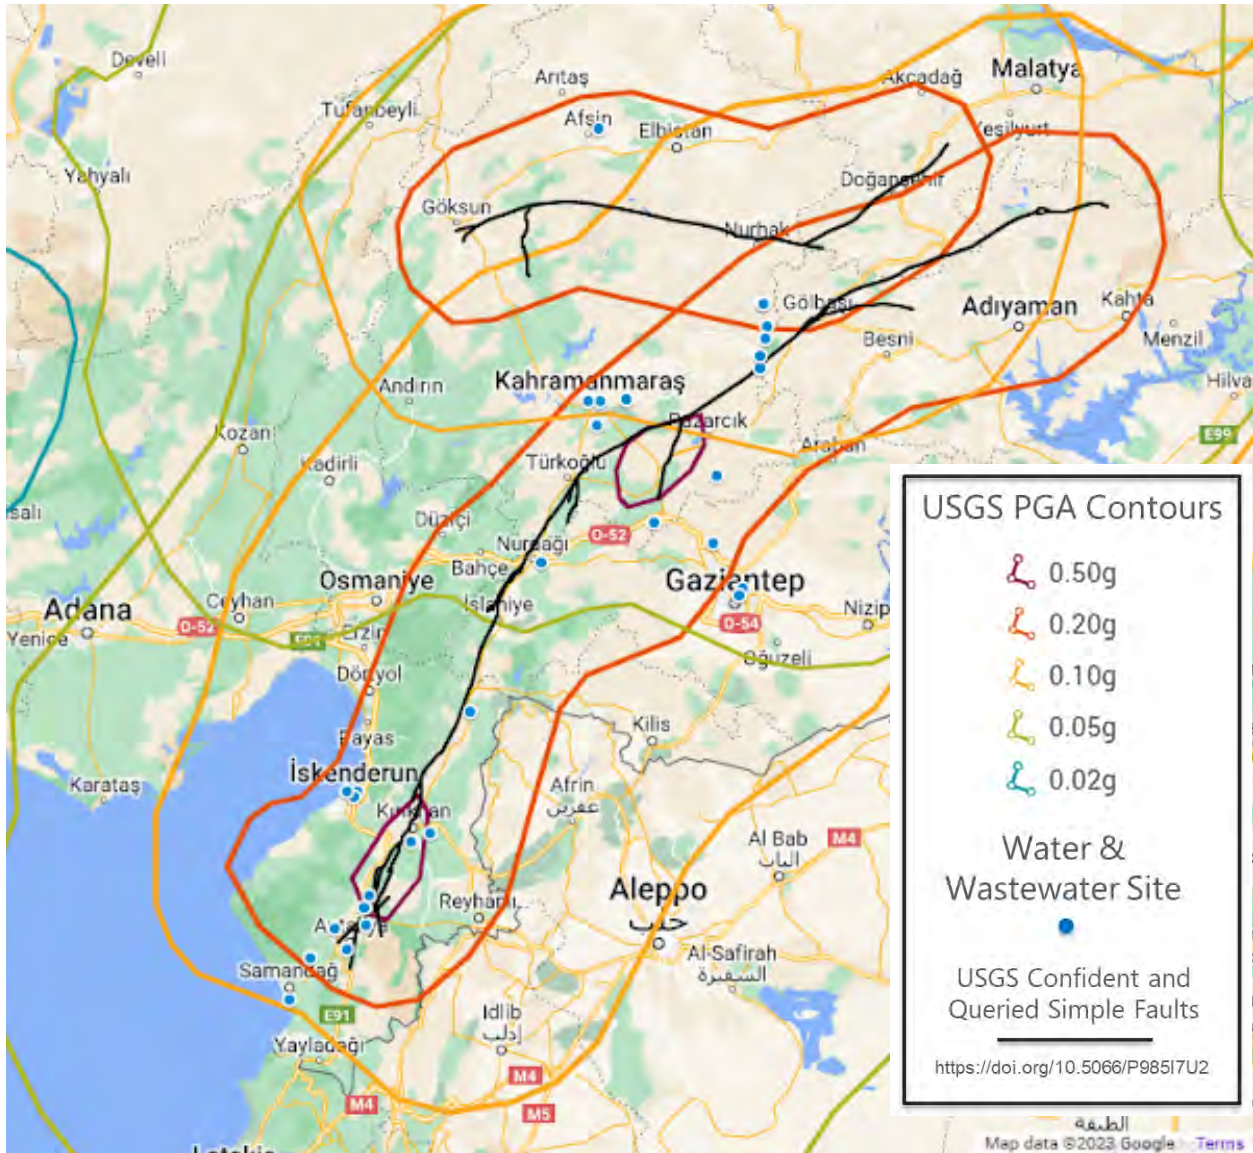
Figure 7.42. Water and wastewater facilities visited by the EERI Lifelines Team

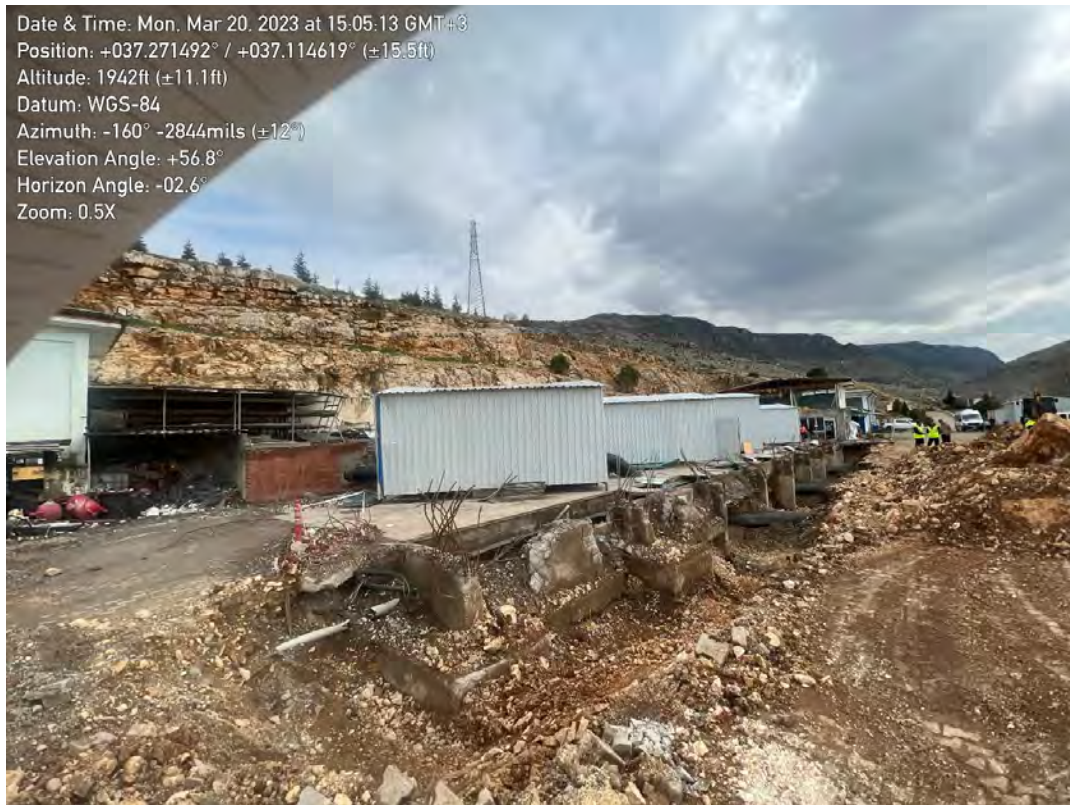
**Figure 7.43.** Mizmilli pump station (ID No. 79 in Appendix A). Building removed around pumps housed in protective structures.

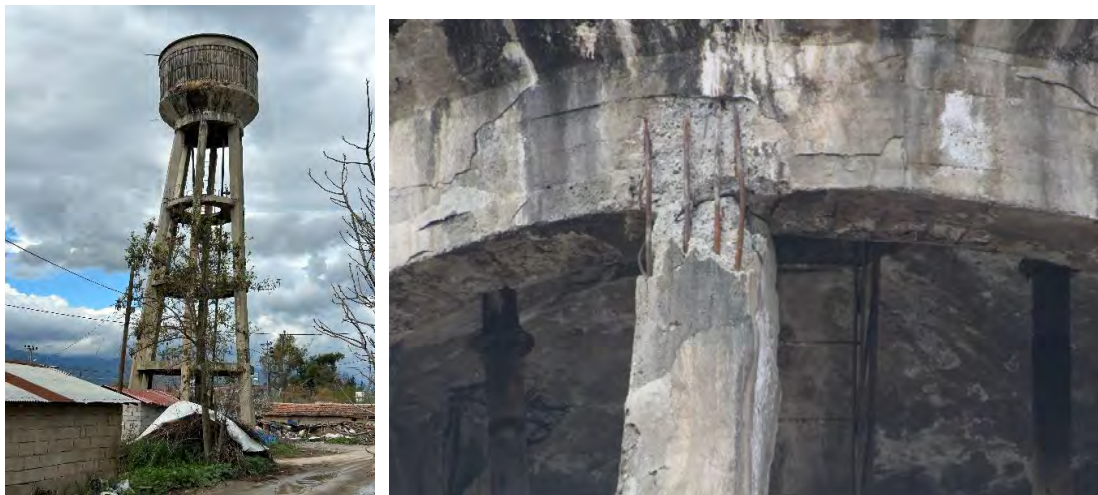
**Figure 7.44.** Water tower in İçada, Hatay, with significant residual drift and beam-column joint failures, several at joints with no transverse column/joint reinforcement visible (ID No. 100 in Appendix A).

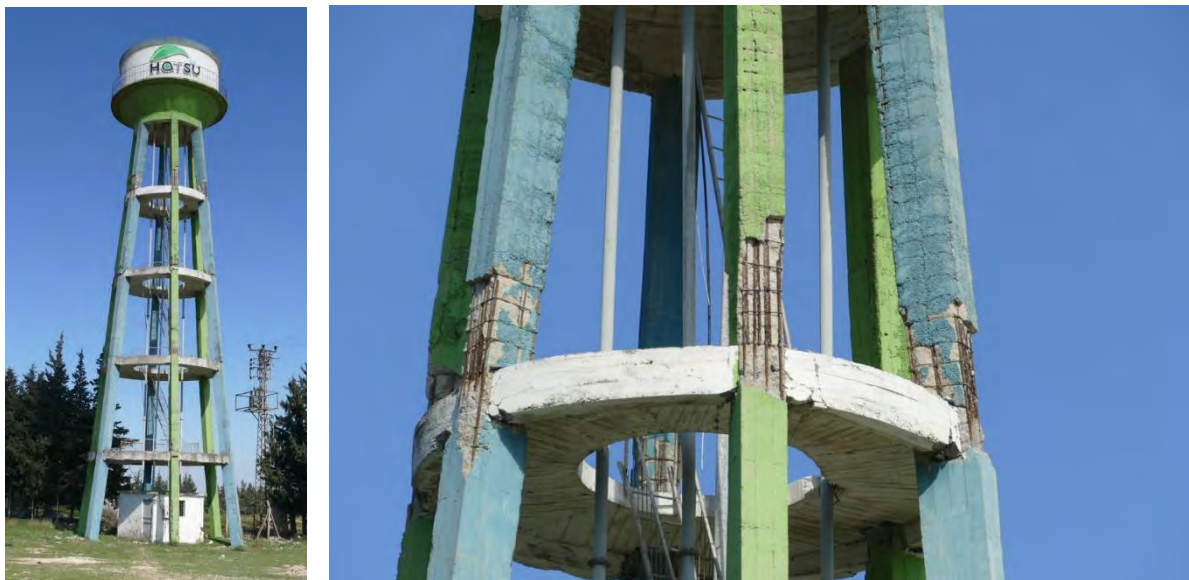
**Figure 7.45.** Water tower in Antakya with lesser residual drift and extensive cover spalling of concrete columns above upper ring beam levels (ID No. 109 in Appendix A).

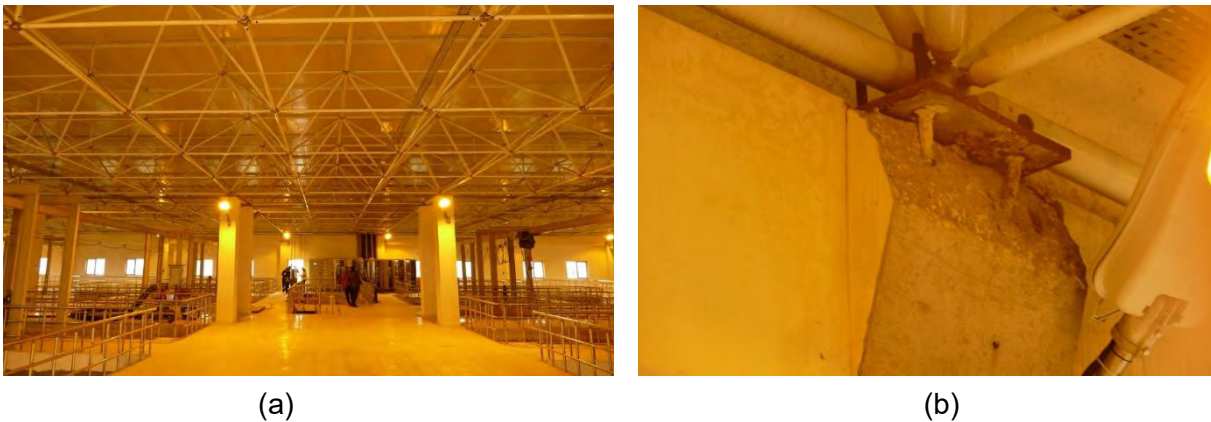
**Figure 7.46.** (a) Interior overview of light-weight, space truss roof framing system within sedimentation-tank building. Truss is uniform with no enlargement of cross-tie chord members. (b) Concrete breakout damage at anchorage of roof space truss node to corbel at the exterior concrete wall. Anchorage damage beyond minor cracking was observed in very few locations.

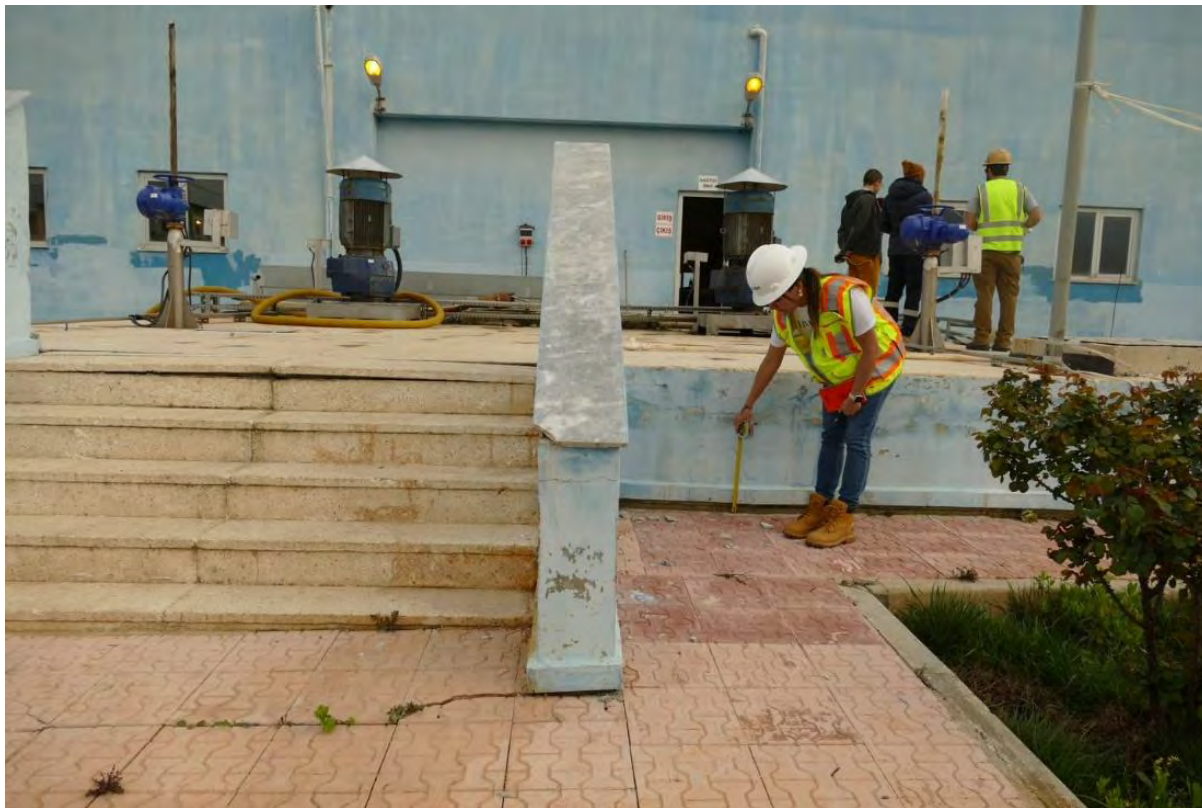
**Figure 7.47.** Measurement of estimated settlements of approximately 5 cm adjacent to sedimentation process building (background)

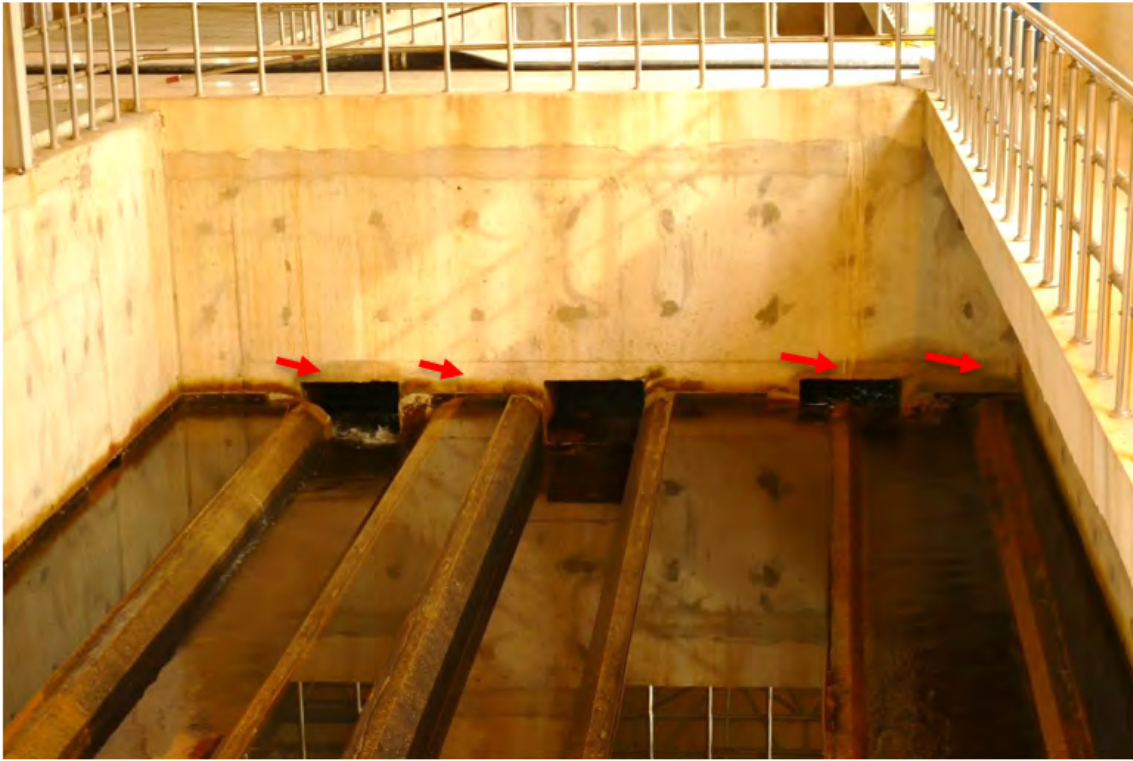
**Figure 7.49.** Displacement of concrete curbs under inertial forces caused sedimentation channels to leak and be bypassed entirely (arrows indicate displacement of curbs from original position)

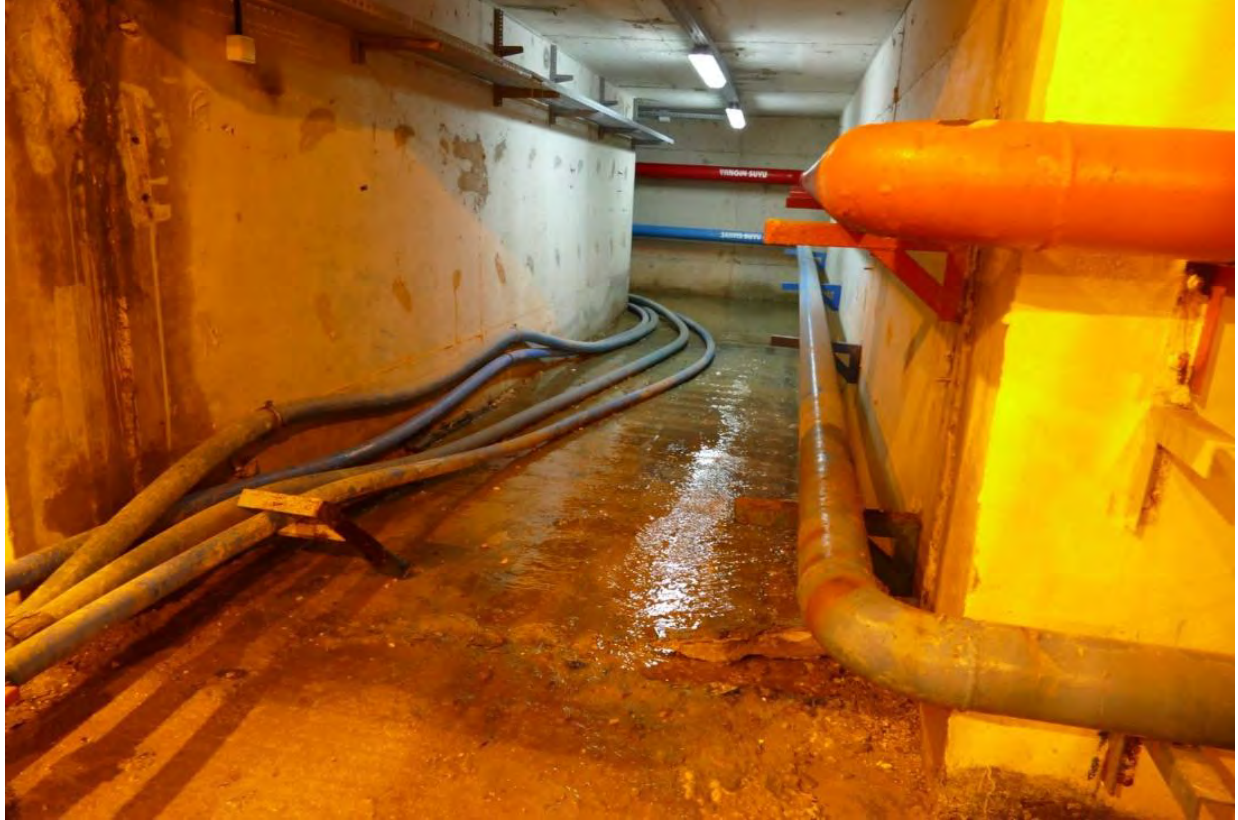
**Figure 7.50.** Observed water infiltration in below-ground utility tunnels believed by facility operators to be potentially an indication of damage and leaks in below-ground piping infrastructure.

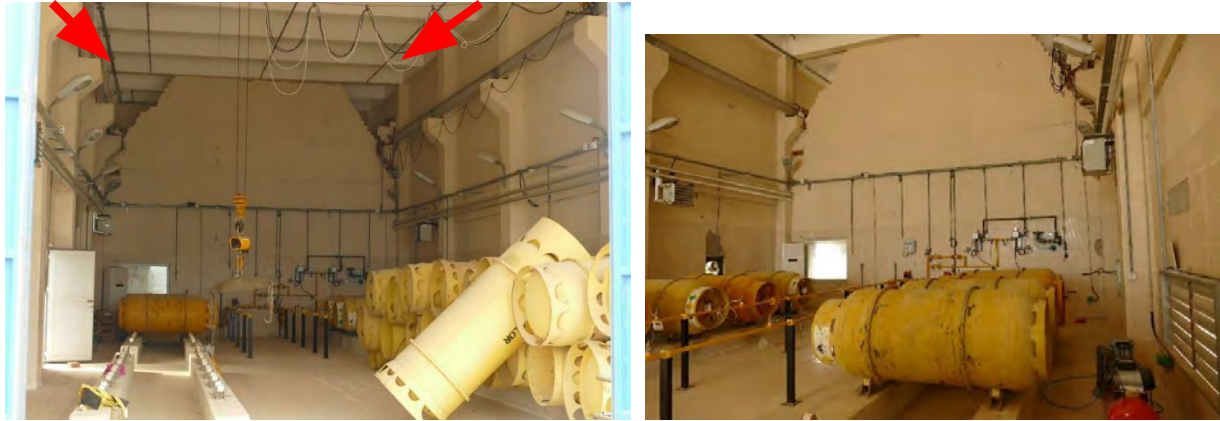
**Figure 7.51.** Large, pressurized chlorine gas canisters and associated piping for the treatment process remain below a partially collapsed URM wall approximately 8 m tall (arrow).

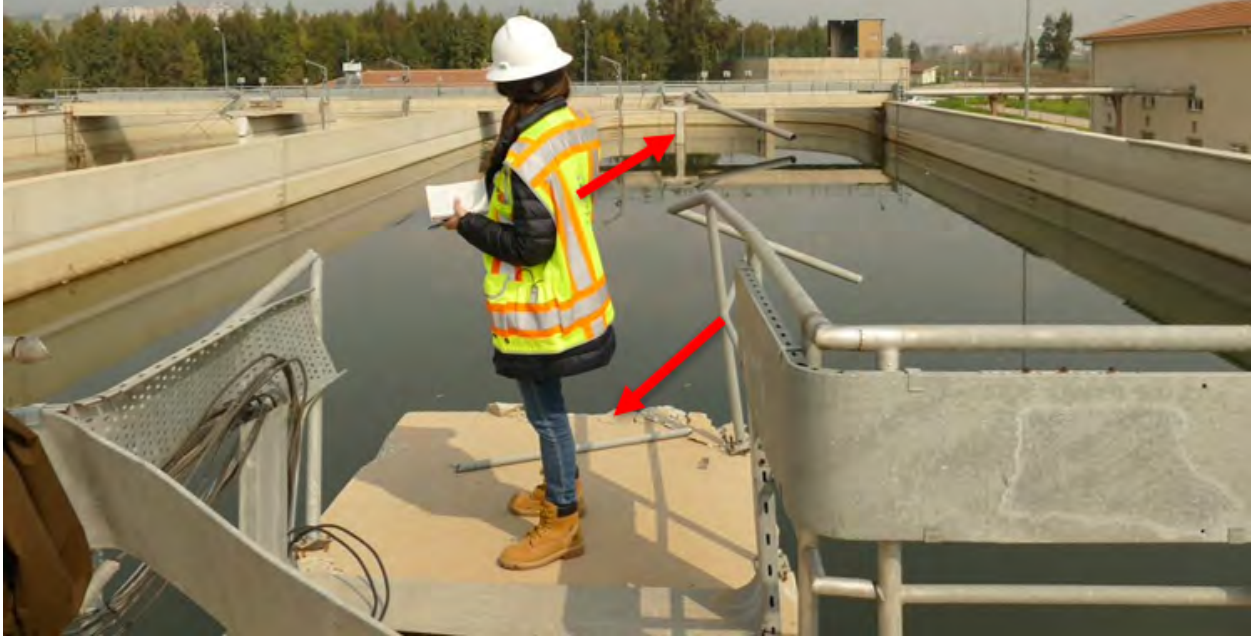
**Figure 7.52.** Collapsed central dividing wall (between arrows) and damaged piping now submerged within aeration tank (Kırıkhan, Hatay) (ID No. 30 in Appendix A).

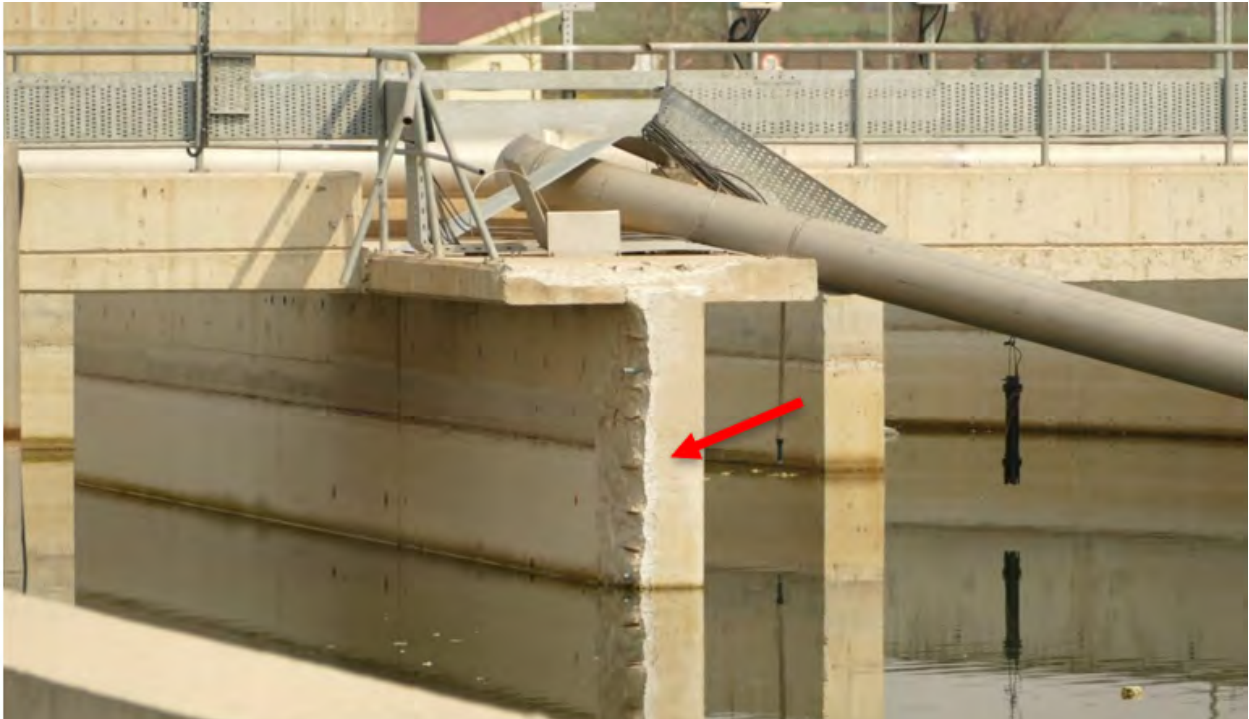
**Figure 7.53.** Concrete pour joint (arrow) dividing collapsed portion of interior wall (now below water surface) from surviving portion of dividing wall with stiffening walk bridges; no reinforcing provided across joint (Kırıkhan, Hatay) (ID No. 30 in Appendix A).

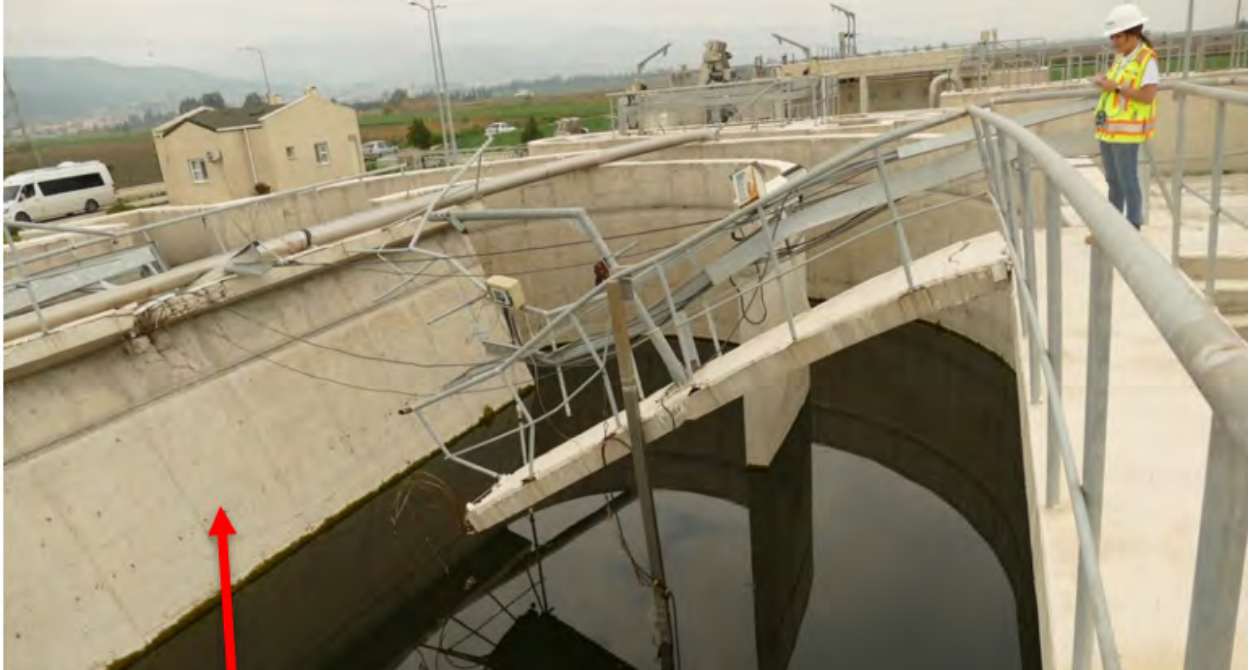
**Figure 7.54.** Partially collapsed dividing wall (arrow) where stiffening walk bridges existed only on one opposing side at each end of wall. Configuration promoted a torsional response of the dividing wall as bridges pulled out from the dividing wall in tension (Serinyol, Hatay) (ID No. 31 in Appendix A).

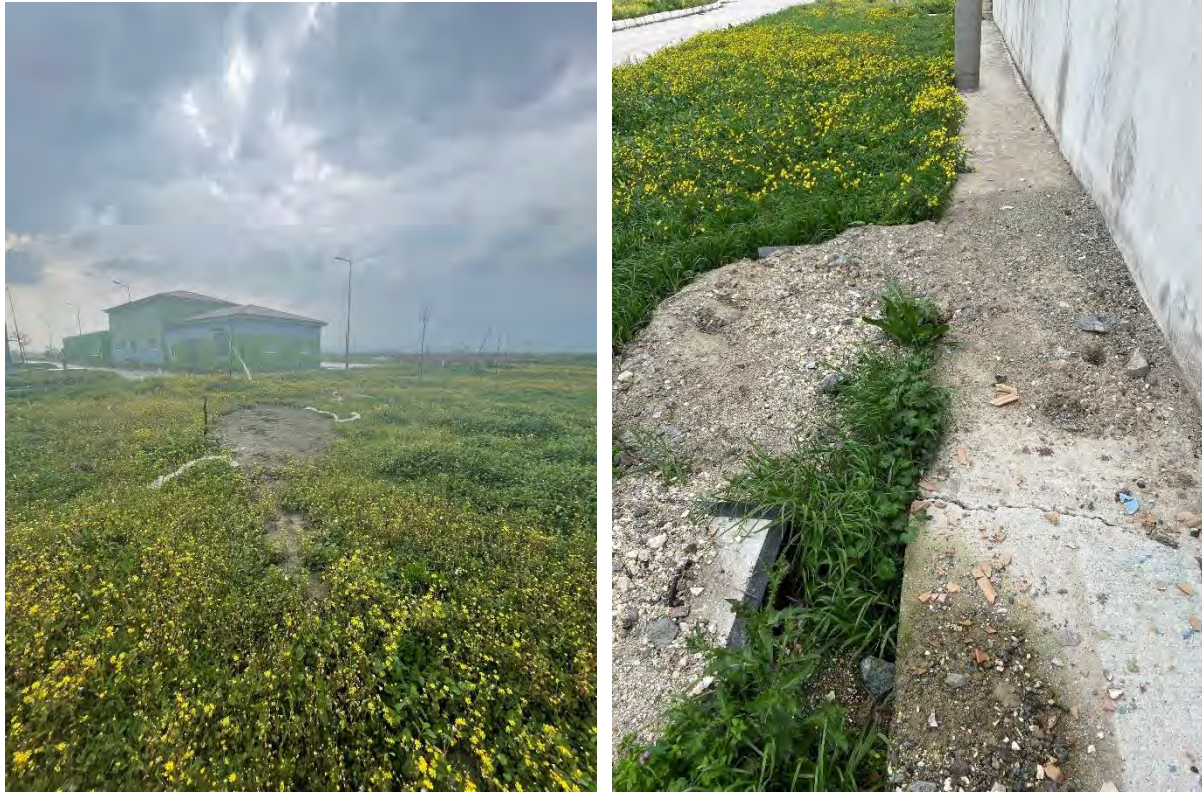
**Figure 7.55.** Free-field liquefaction ejecta observed at Narlıca Wastewater treatment facility (Narlıca, Hatay) (ID No. 34 in Appendix A).

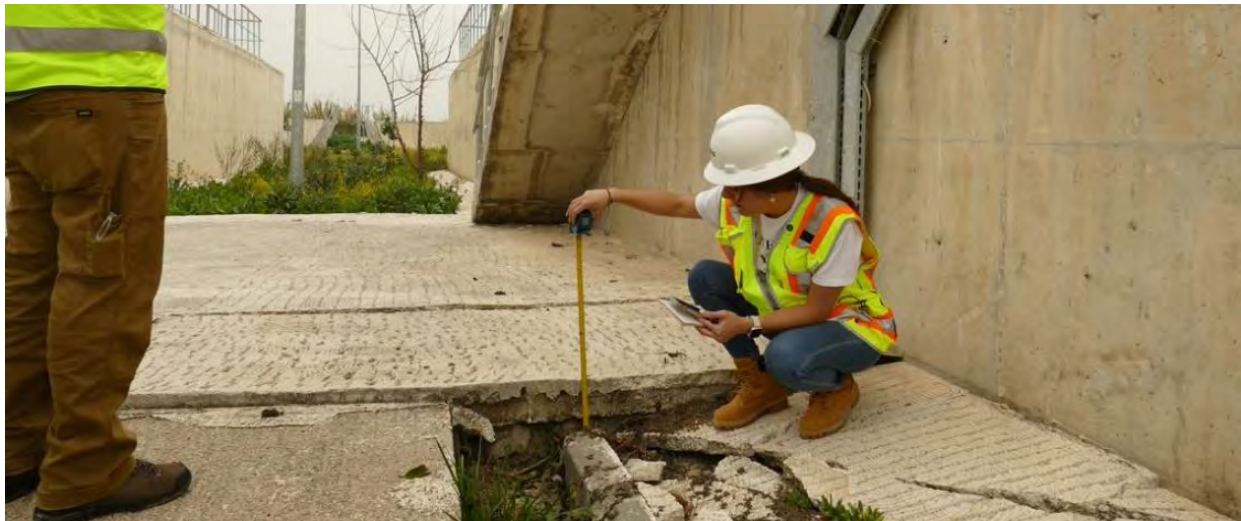
**Figure 7.56.** Free-field settlements of approximately 16 cm adjacent to tanks structures led to damage and leaks in below-ground piping (Serinyol, Hatay) (ID No. 31 in Appendix A).

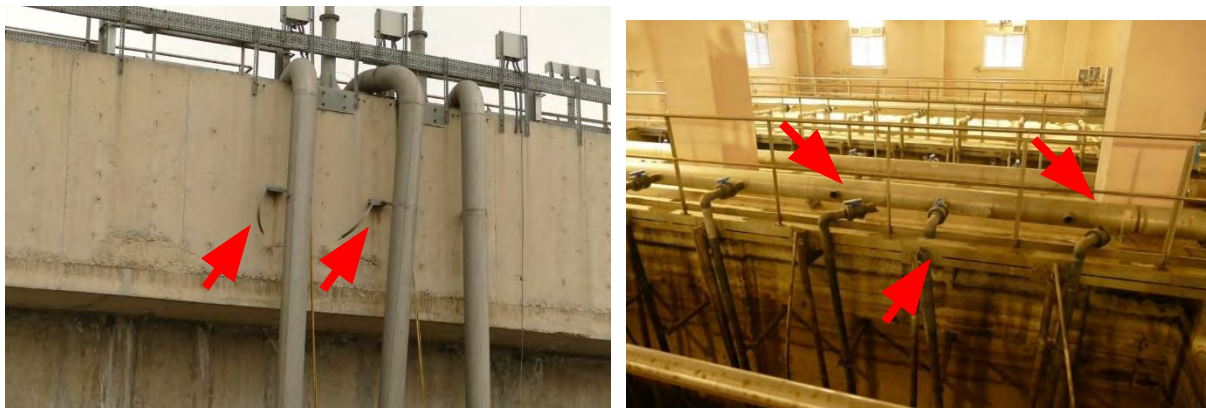
**Figure 7.57.** (a) Displaced large-diameter vertical pipes with fractured strap bracing (arrows). (b) Fractured vertical, plastic pipes (arrows) with long unbraced lengths (Narlica, Hatay) (ID No. 34 in Appendix A).

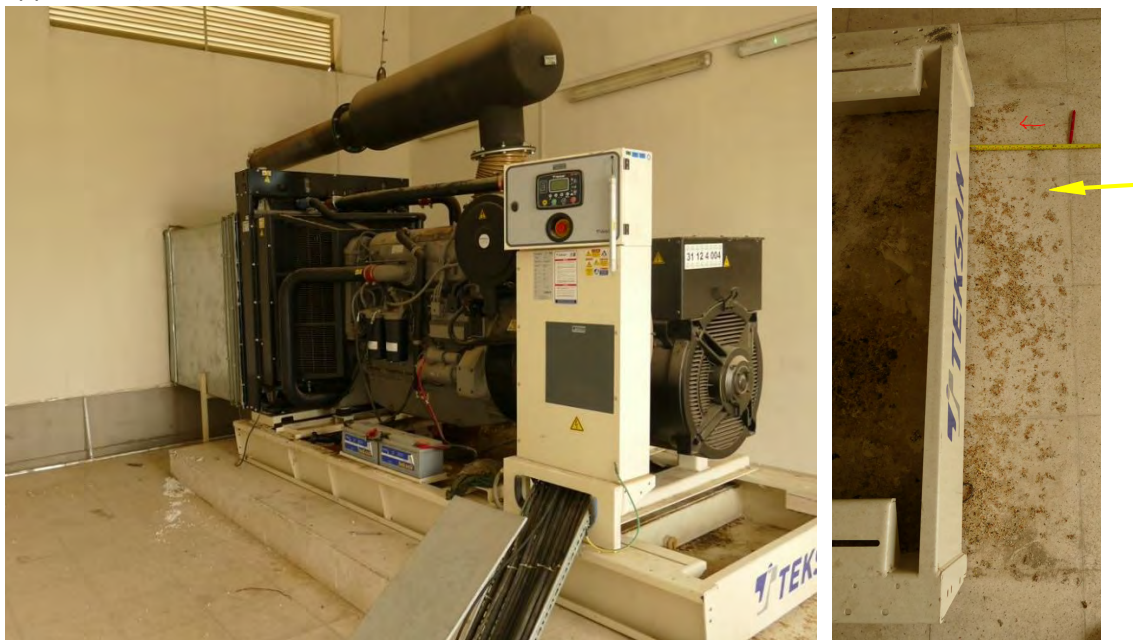
**Figure 7.58.** 265 kW Generator was unanchored and displaced approximately 30 cm to the north (figure left). Electrical and exhaust connections were flexible, but cooling structure impact led to oil leak (Serinyol, Hatay) (ID No. 31 in Appendix A).

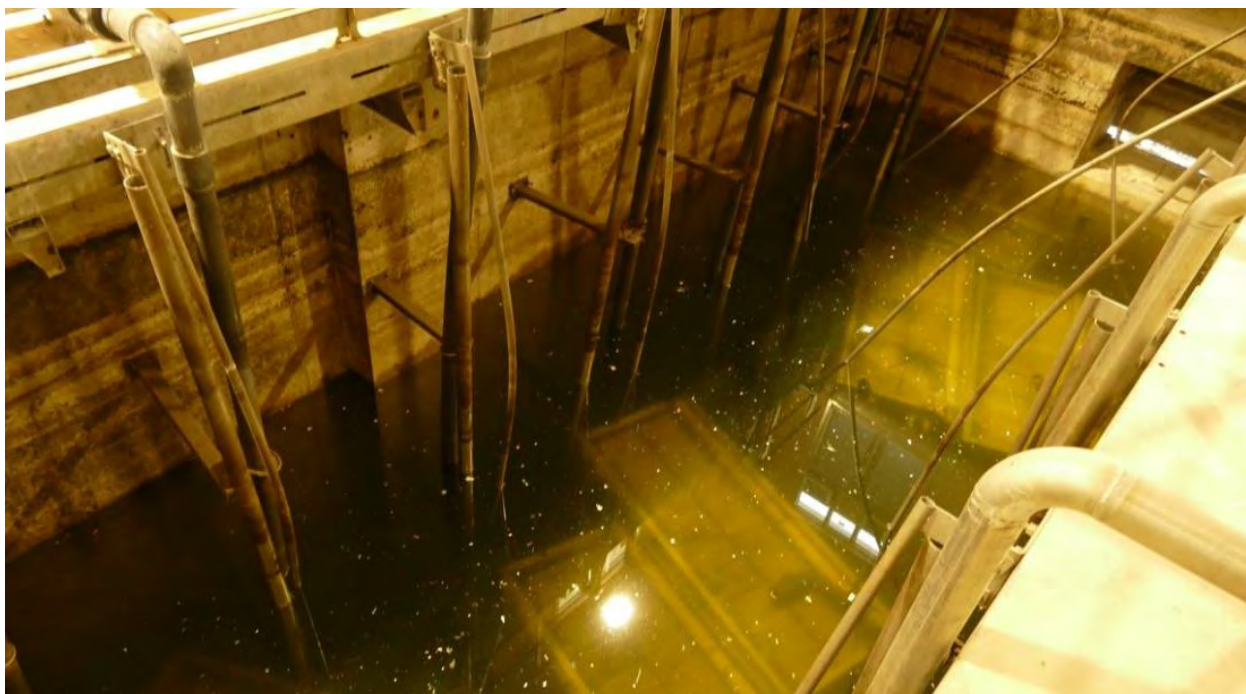
**Figure 7.59.** Filter media / membranes floating in treatment tank after shaking free from their attachments at the Narlica Plant. Membranes reportedly damaged in other tanks where they were exposed to air for long periods. (ID No. 34 in Appendix A).

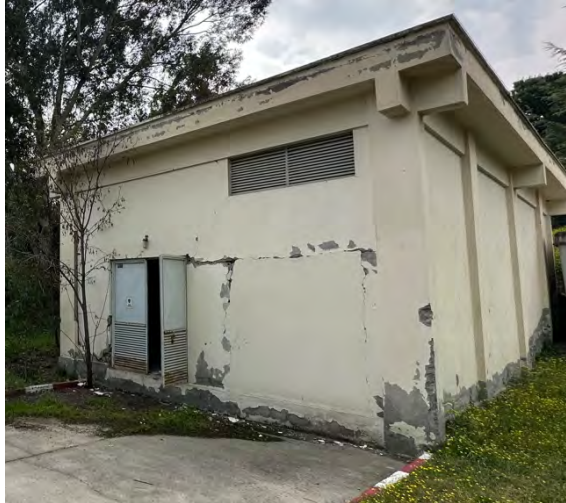
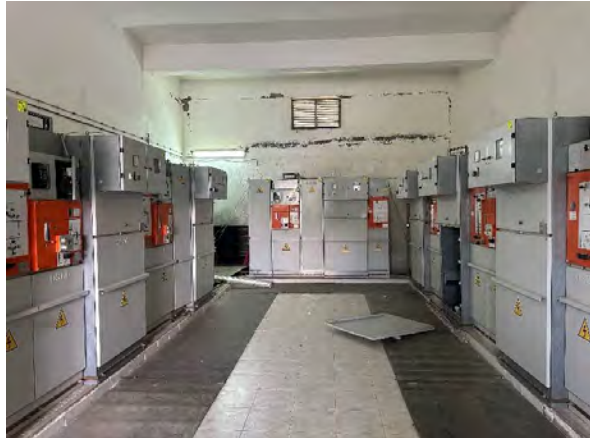
**Figure 7.60.** Infill damage at local substation

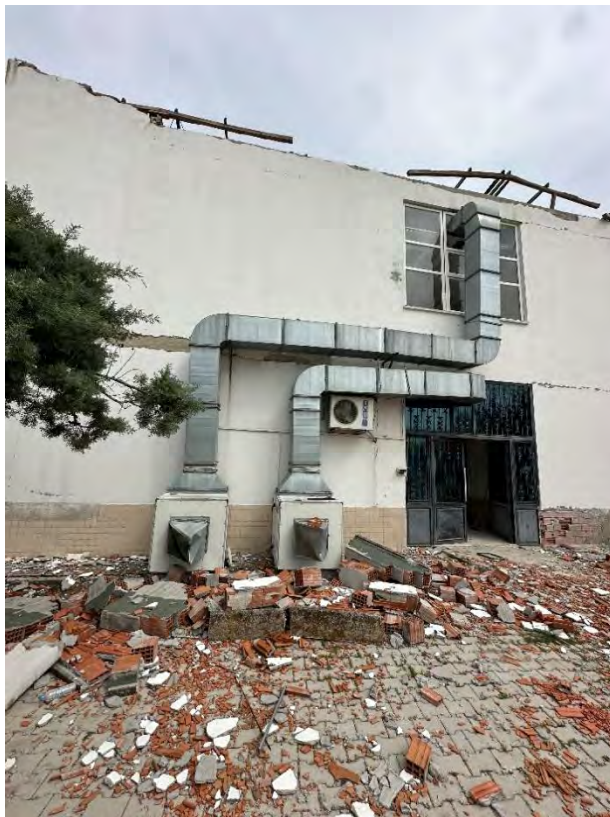
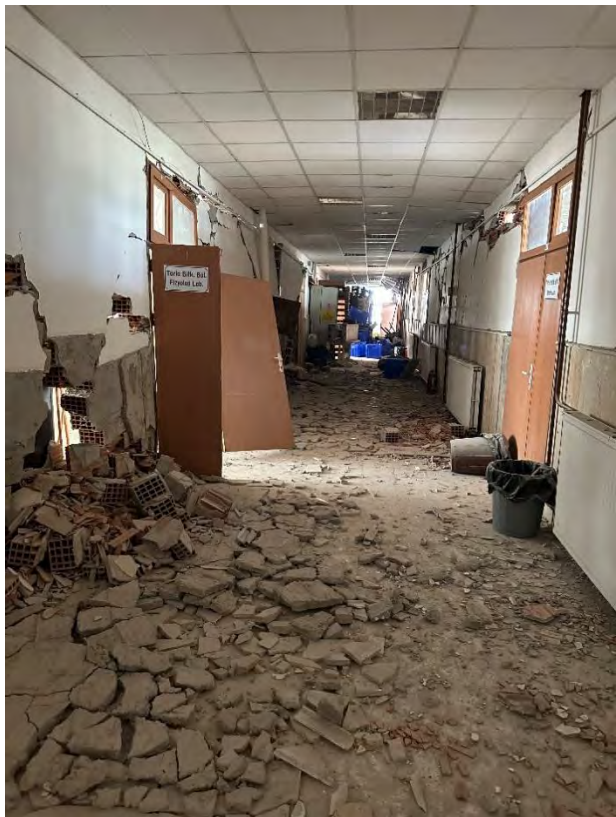
**Figure 7.61.** Example of masonry infill damage at the Agricultural Science building.

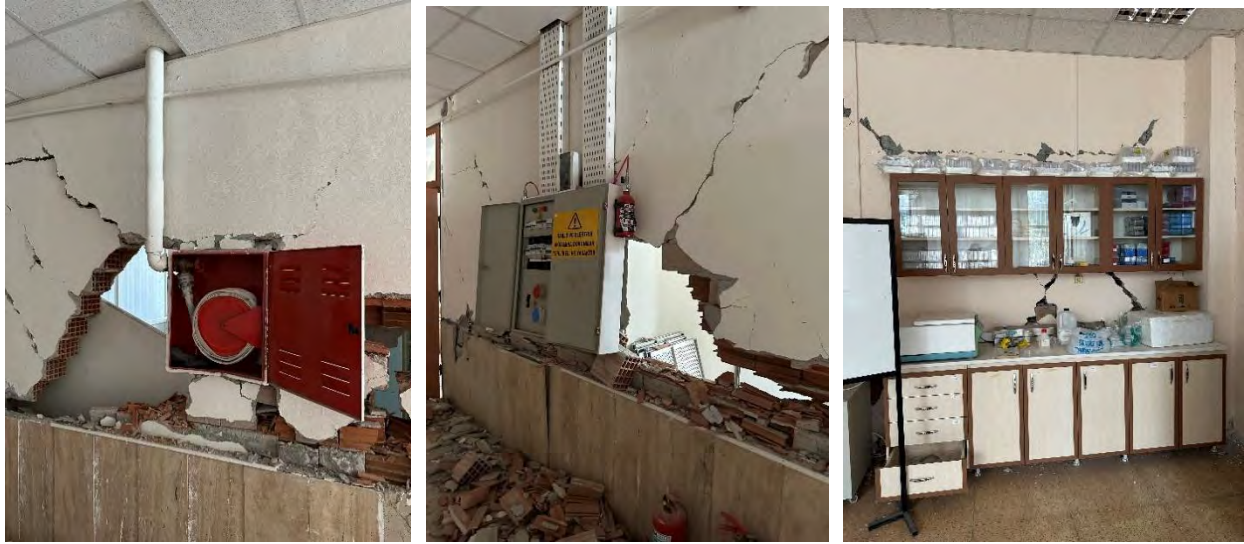
Figure 7.62. Example of equipment surviving masonry infill damage at the Agricultural Science building

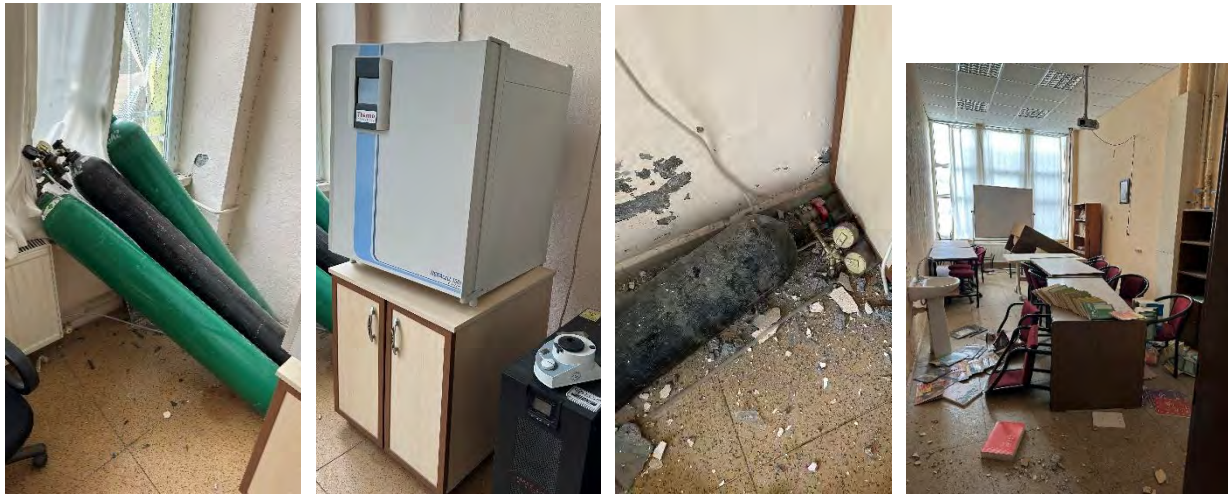
Figure 7.63. Example of displaced and toppled equipment at the Agricultural Science building.

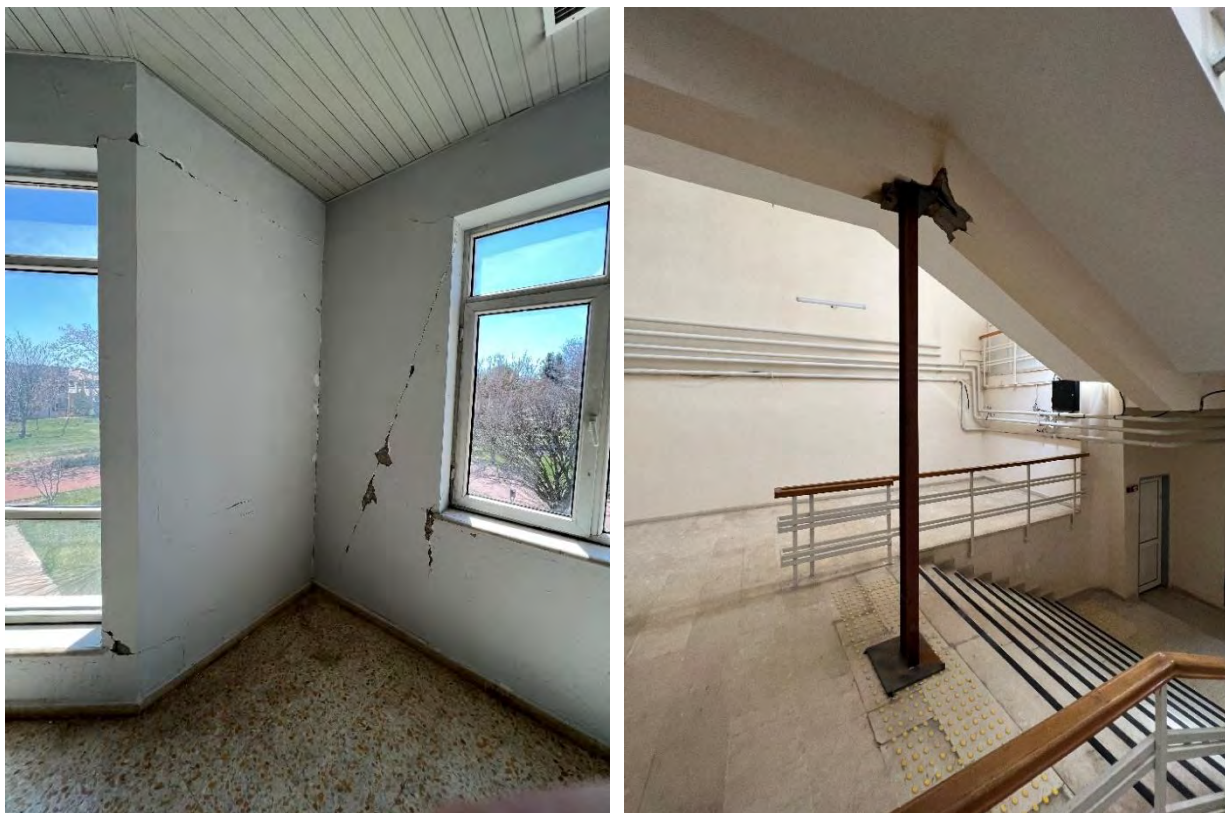
**Figure 7.66.** Cracking of infill wall in canteen (left) and spalling of underside of stair and steel shoring post in library (right).

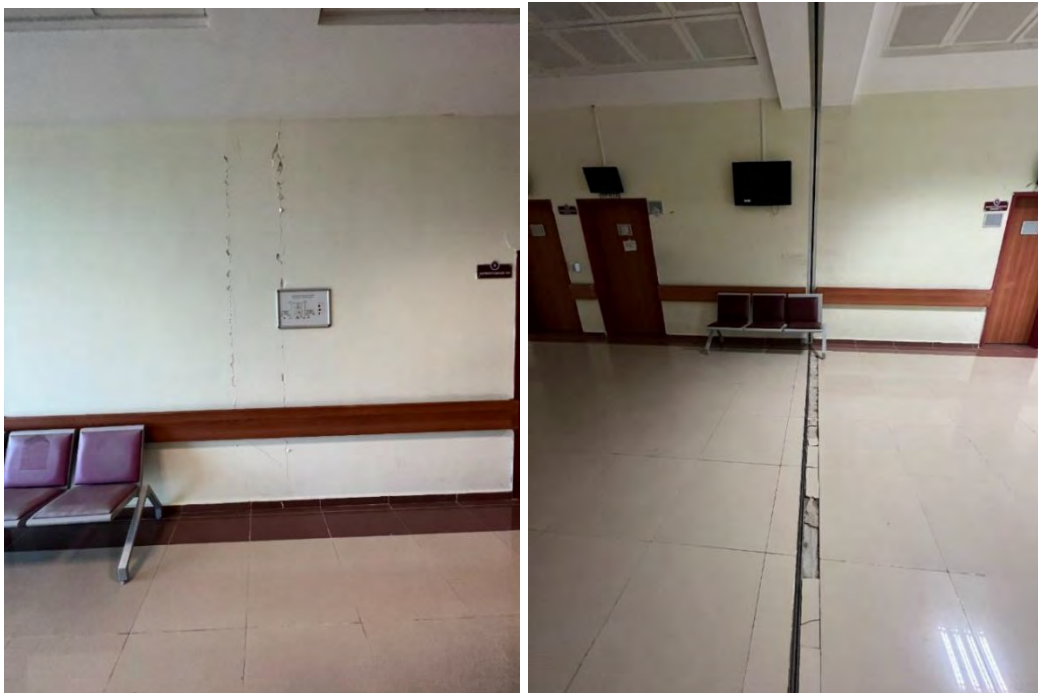
**Figure 7.67.** Cracking at joint between infill wall and column (left) and cracking of tiles at expansion joint (right)

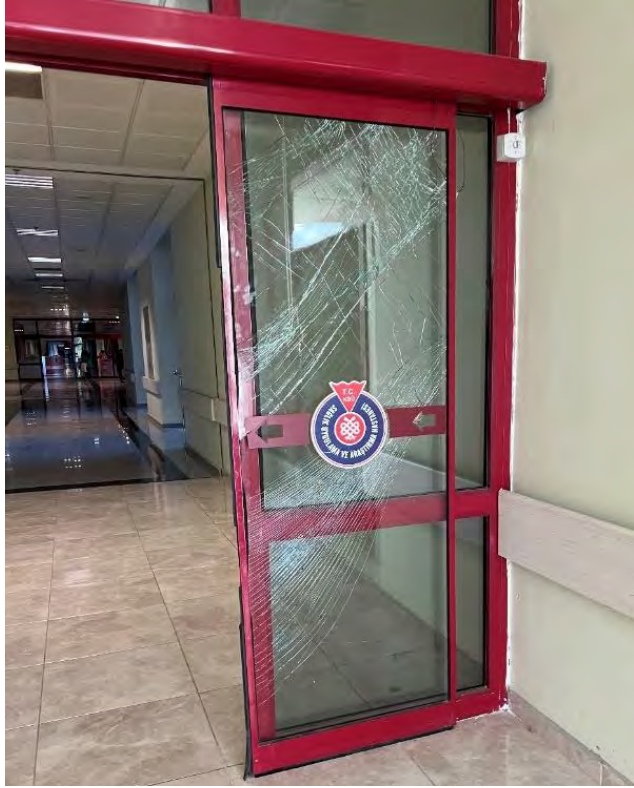
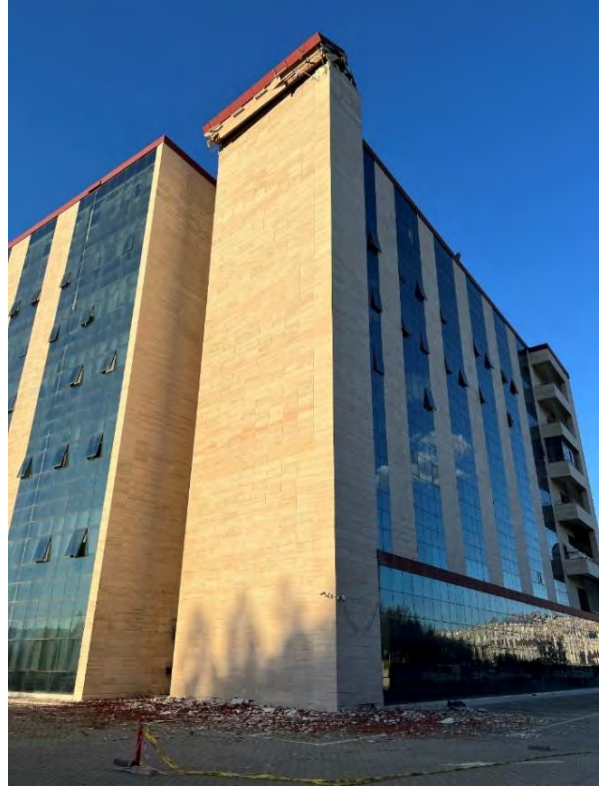
**Figure 7.68.** Cracking of glazing in automatic sliding door (left) and damage to hospital/clinic rooftop structure (right)

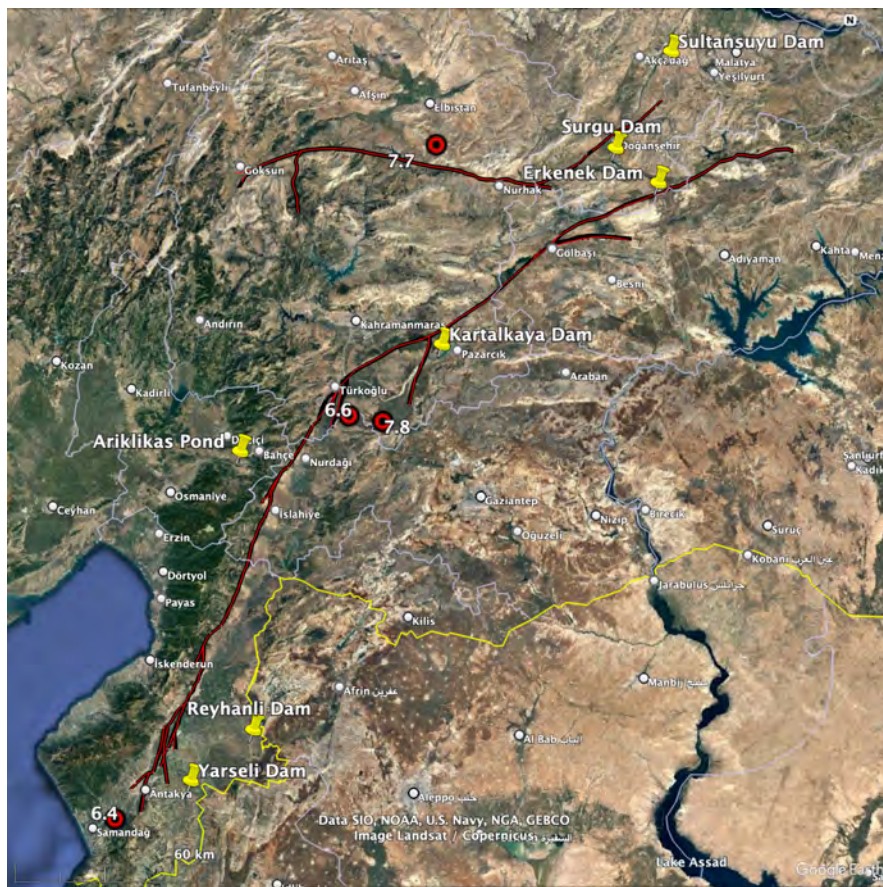
**Figure 8.1.** Showing locations of the earth dams visited by GEER and the surface fault rupture from both events (Google Earth).

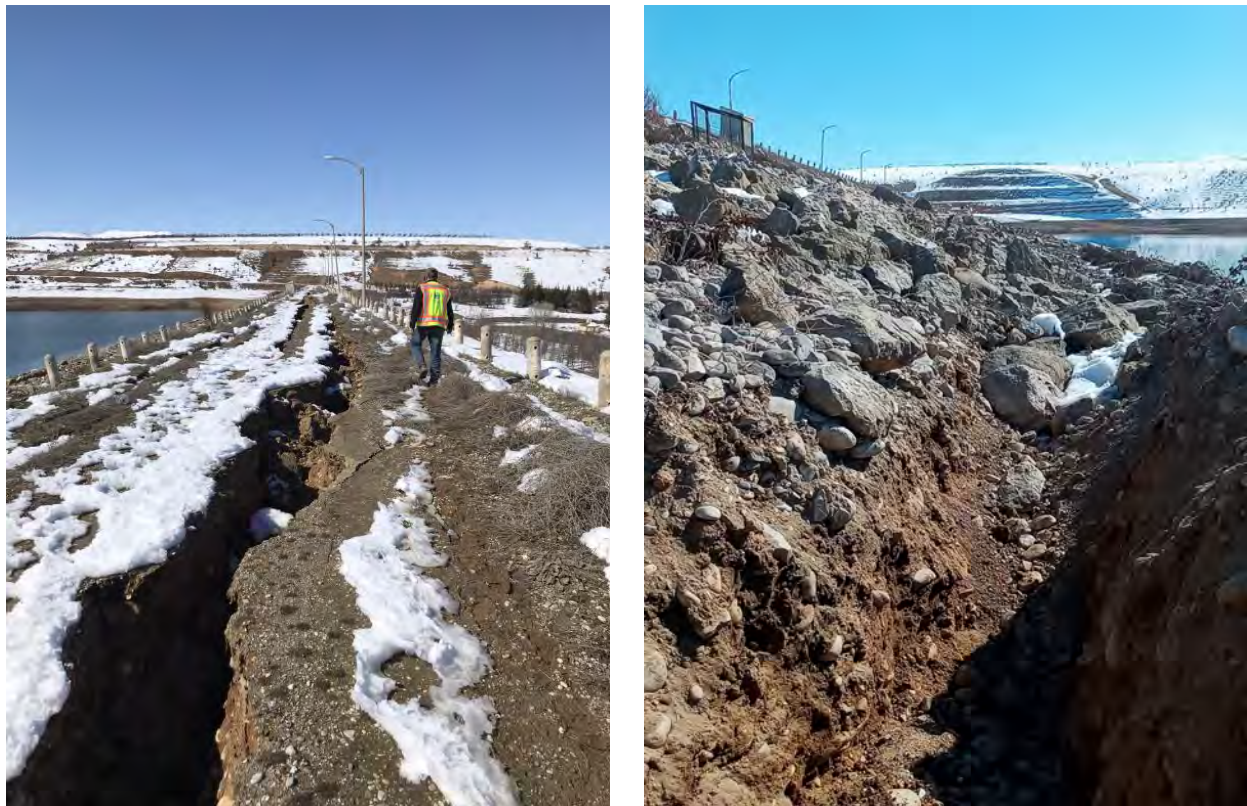
**Figure 8.2.** Left image shows crest cracking and deformations. Right image shows large face scarps on the upstream face rough half way down the face.

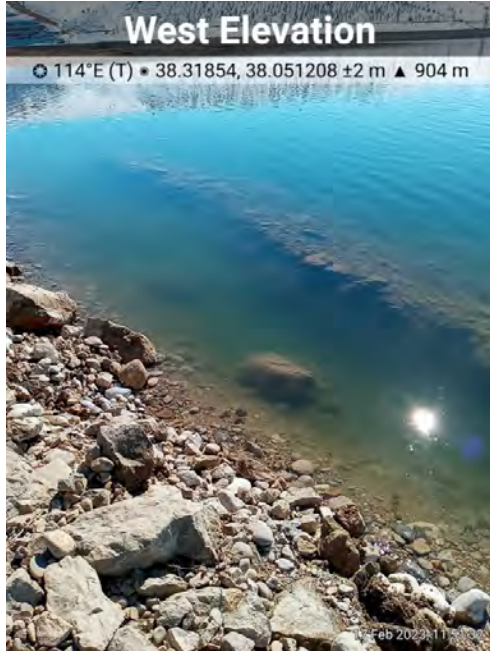
**Figure 8.3.** Lateral translation of the toe coincident with the location of the large face scarps.
