MAY 6, 2023

# FEBRUARY 6, 2023 TÜRKIYE EARTHQUAKES: REPORT ON GEOSCIENCE AND ENGINEERING IMPACTS

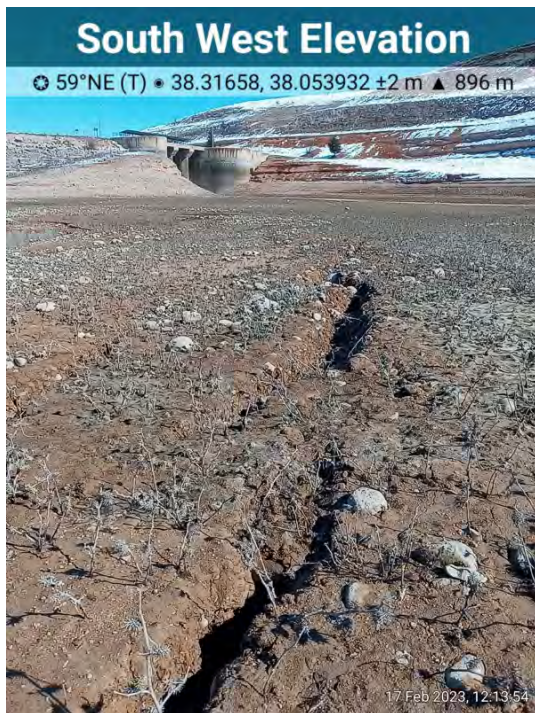
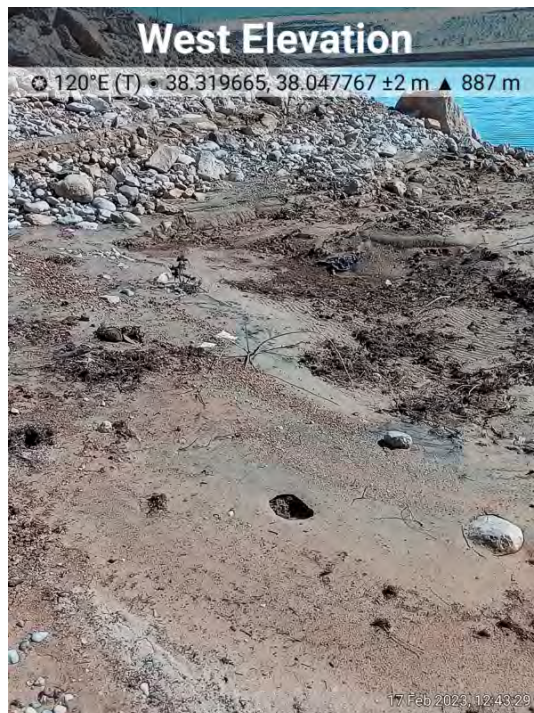
**Figure 8.4.** Left image shows ground cracking indicating lateral spreading, and the right image shows sand boils at the skirts of the right abutment indicating liquefaction.

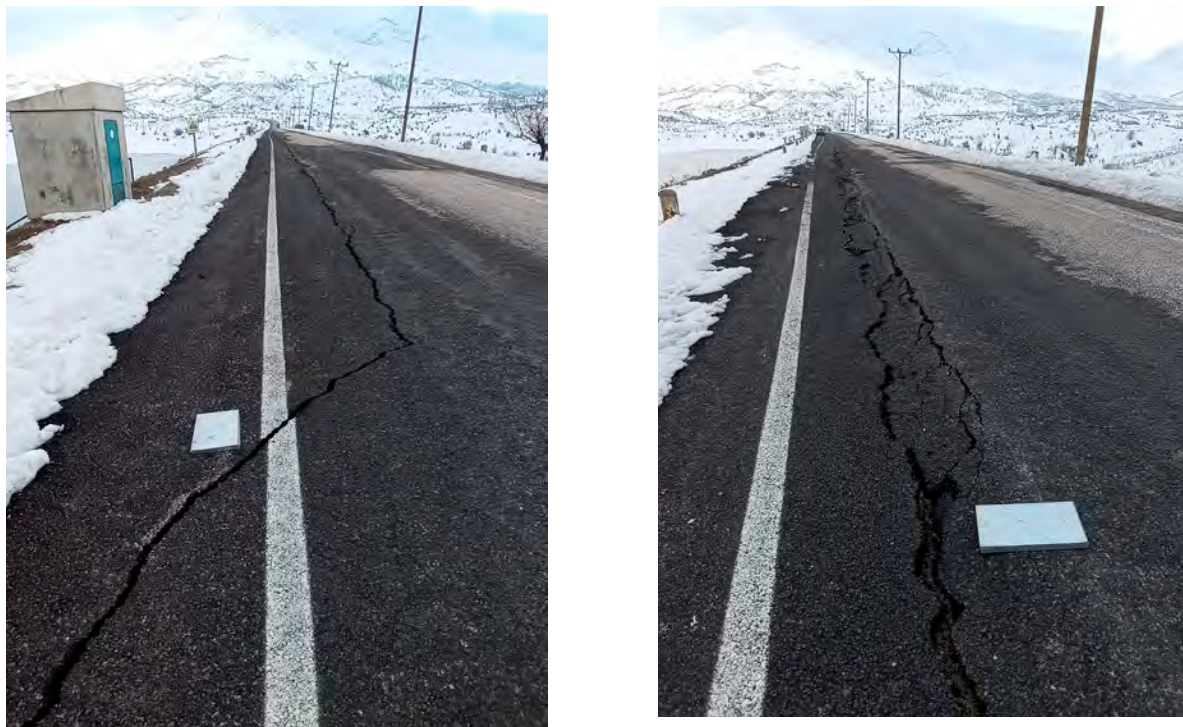
**Figure 8.5.** Crest cracking observed looking both directions along the crest.

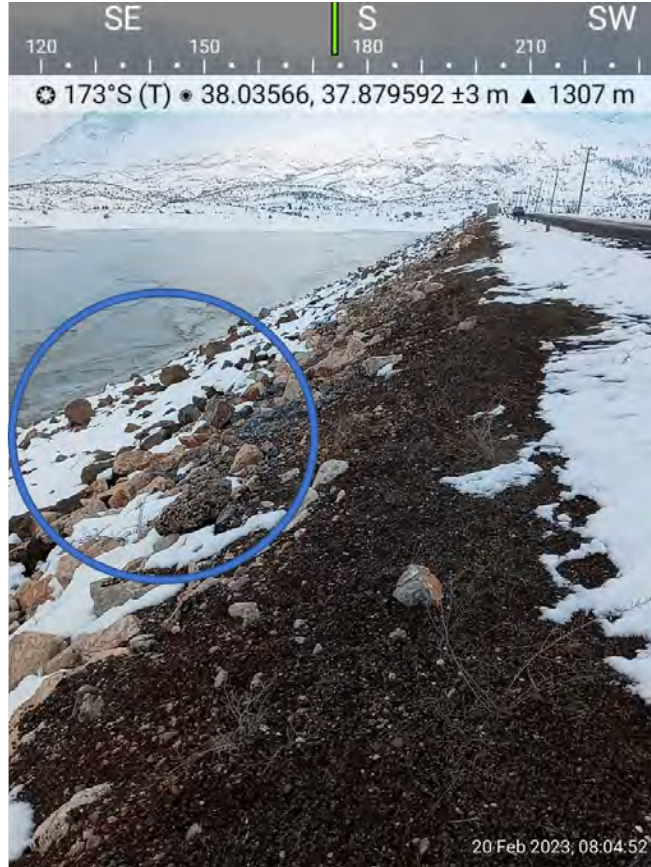
**Figure 8.6.** Bulging on the upstream face (circled) is coincident with the location of the crest cracking which may indicate seismic induced slope deformations.

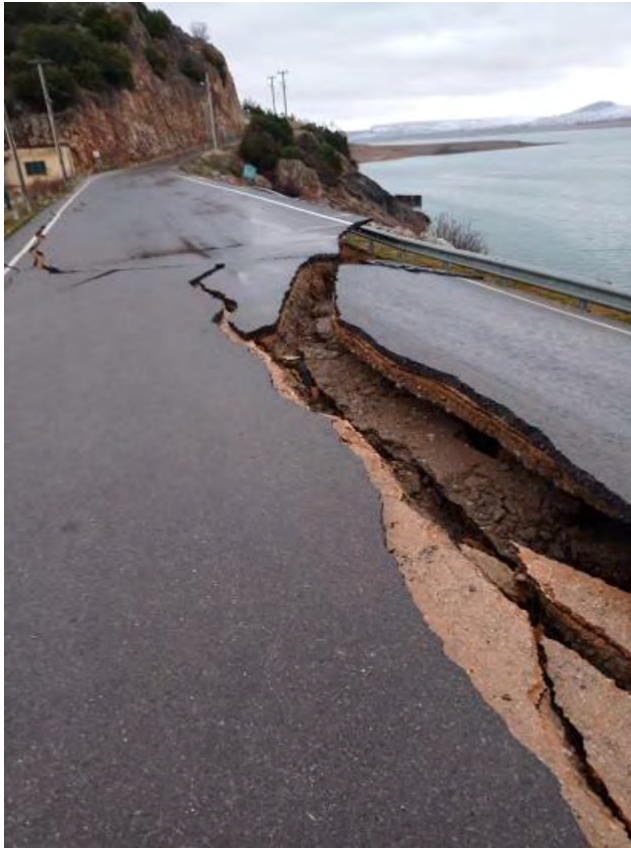
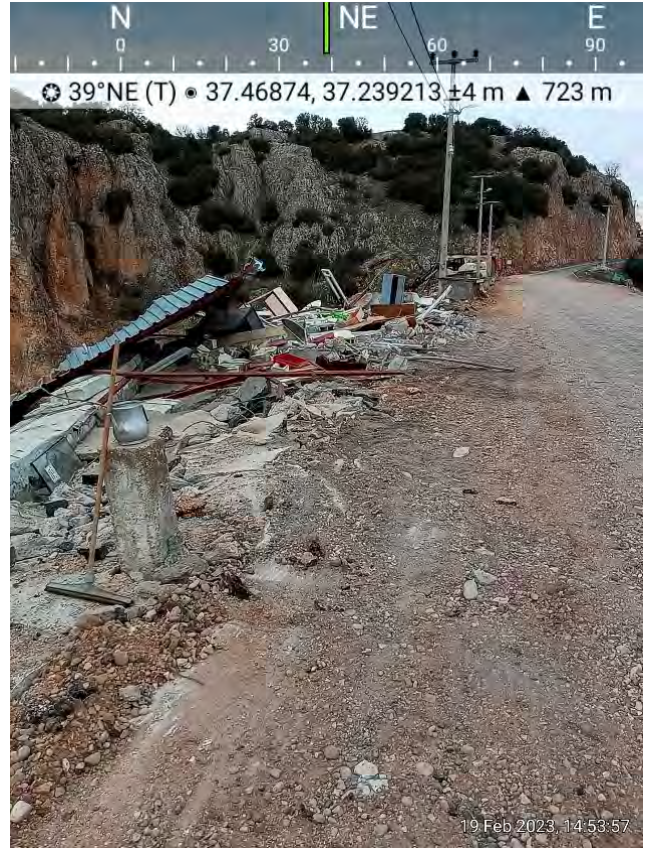
**Figure 8.7** Left image, crest damage after the earthquakes, photo provided by dam operator. Right image, crest structure damaged by strong ground shaking.

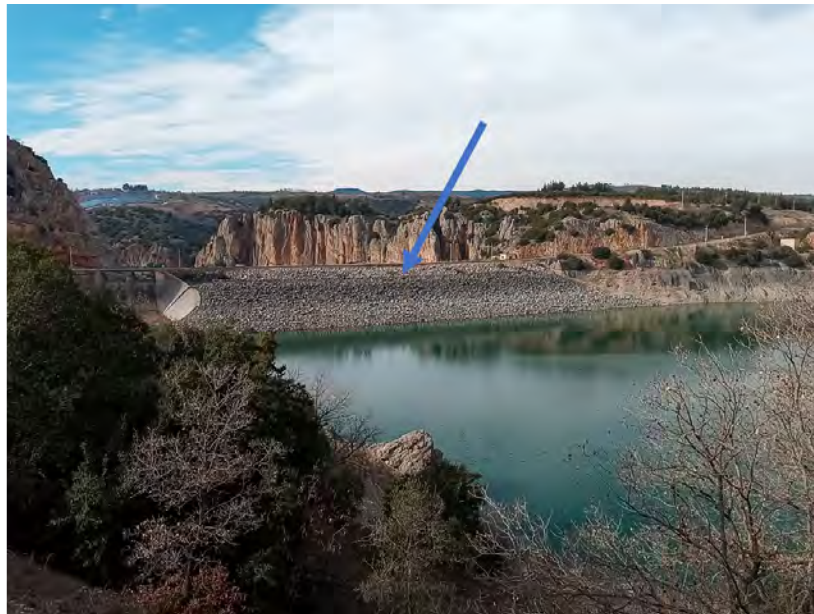
**Figure 8.8.** Arrow points to the midpoint of the dam where the largest crest deformations were observed. The highwater line (aka bathtub ring) as indicated by the black line shows a “swayback” response due to seismic compression.

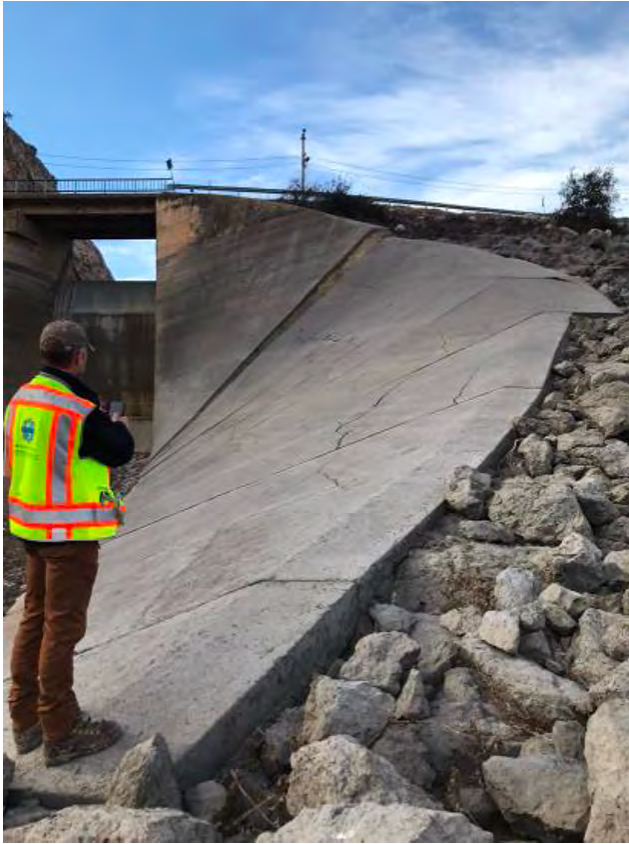
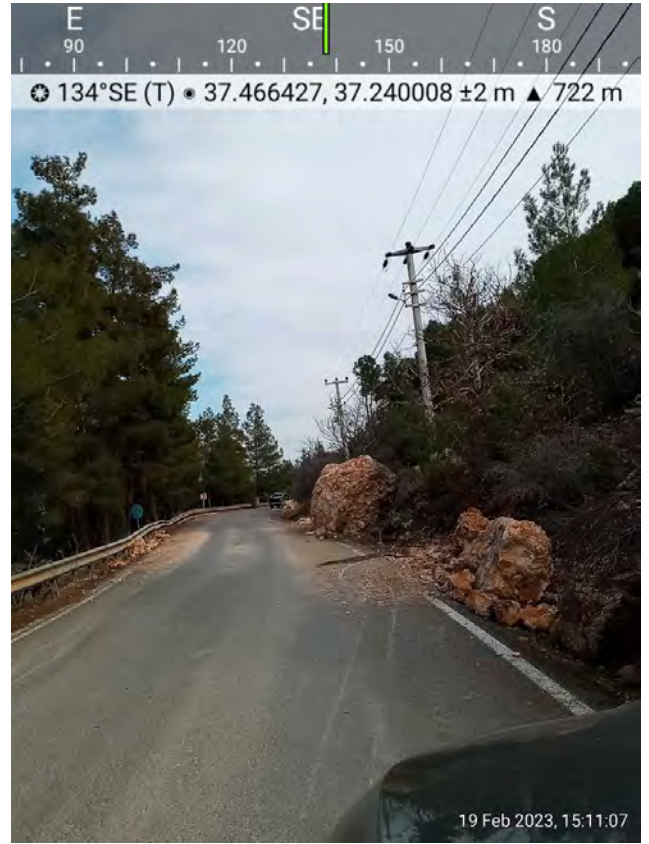
**Figure 8.9.** Left image, cracking of outlet structure that appears superficial. Right image, rock fall was prevalent in this area indicating intense high frequency shaking.

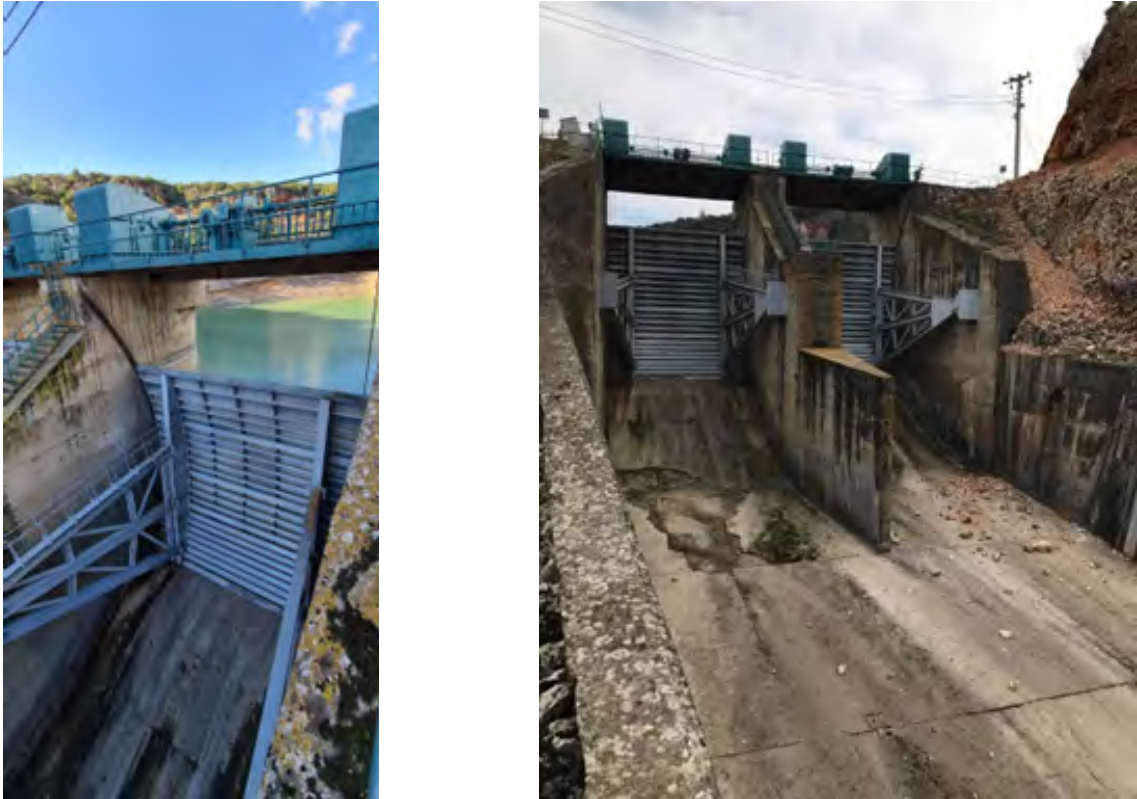
**Figure 8.10.** Auxiliary elements of the Kartalkaya Dam.

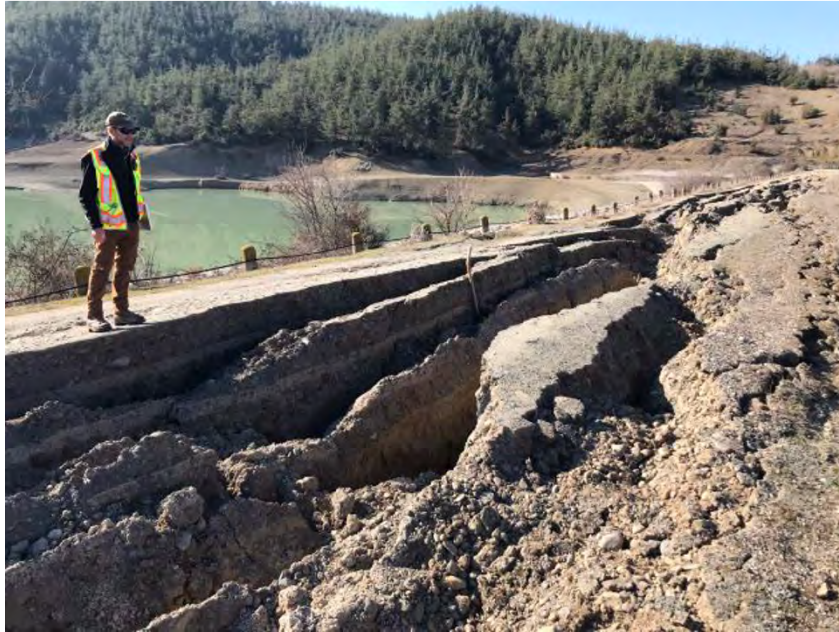
**Figure 8.11.** Significant crest cracking on Arıklıkış Pond earth dam.

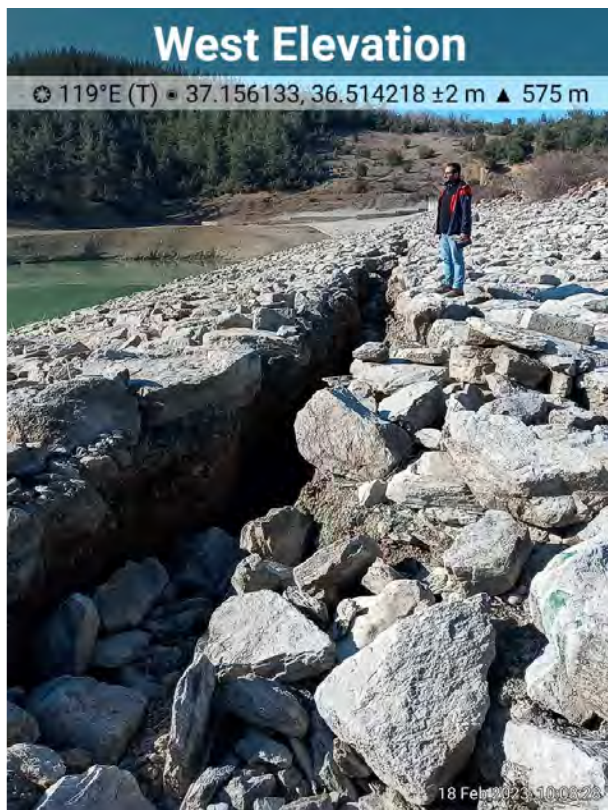
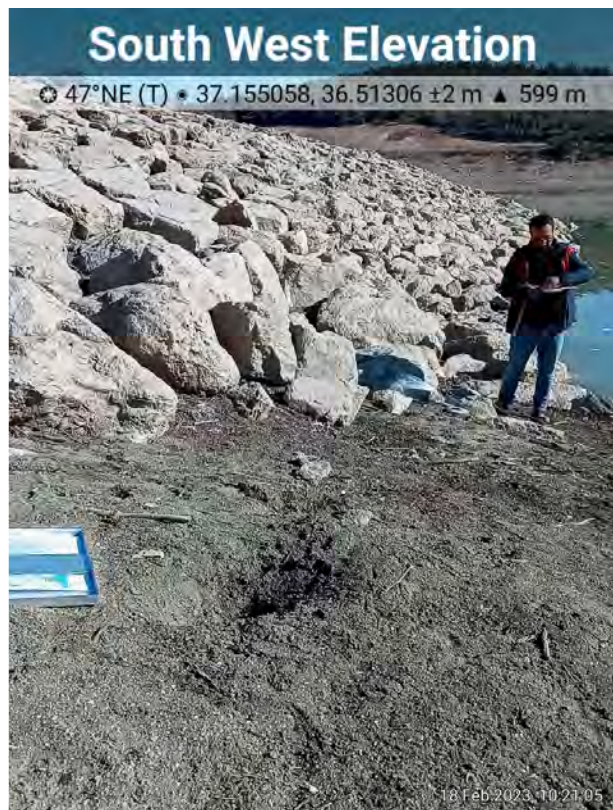
**Figure 8.12.** Left image showing significant face cracks halfway down the upstream face. Right image showing sand boils at the toe of the earth dam.

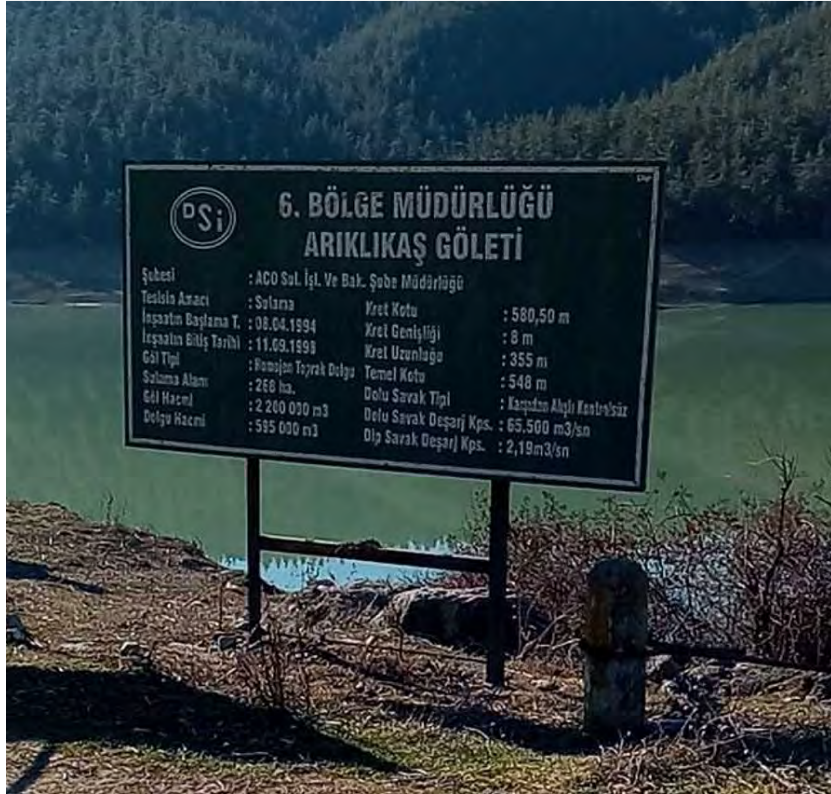
Figure 8.13. Earth dam specs for Arıklıkaş Pond.

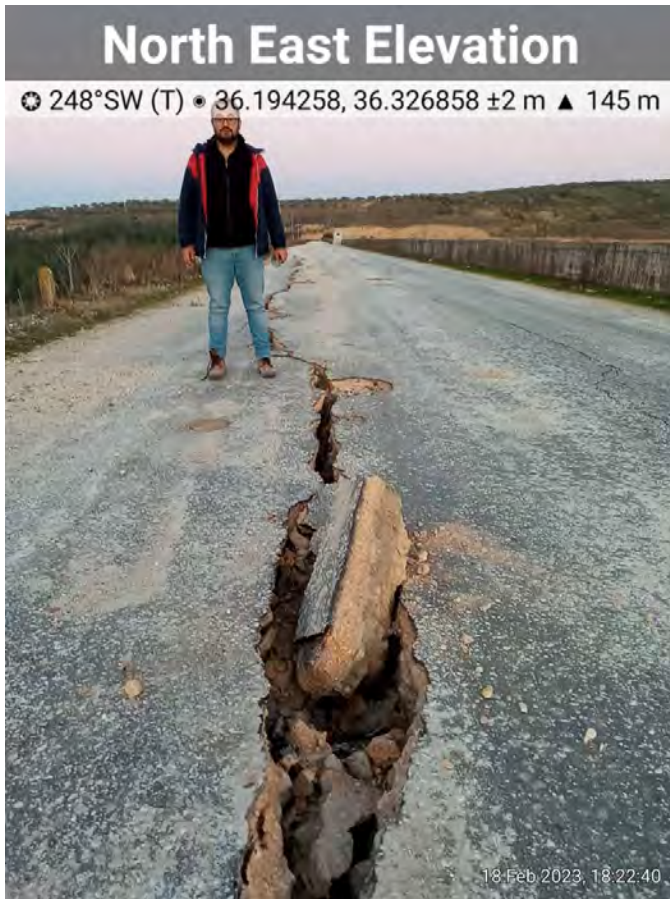
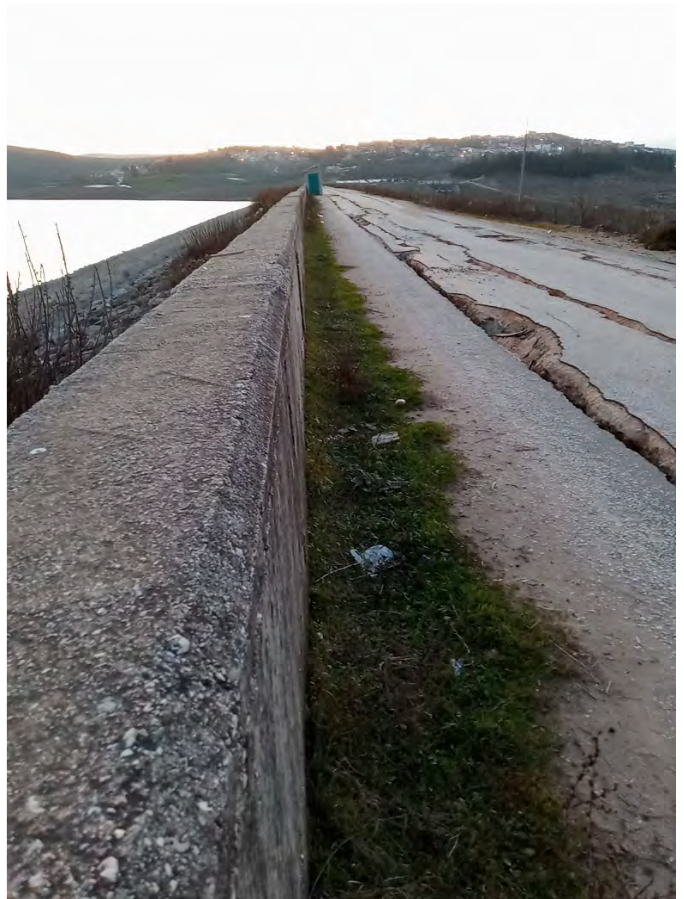
**Figure 8.14.** Left image shows crest cracking of Yarseli Dam. Right image shows slight tilt of the parapet wall and coincident crest cracking.

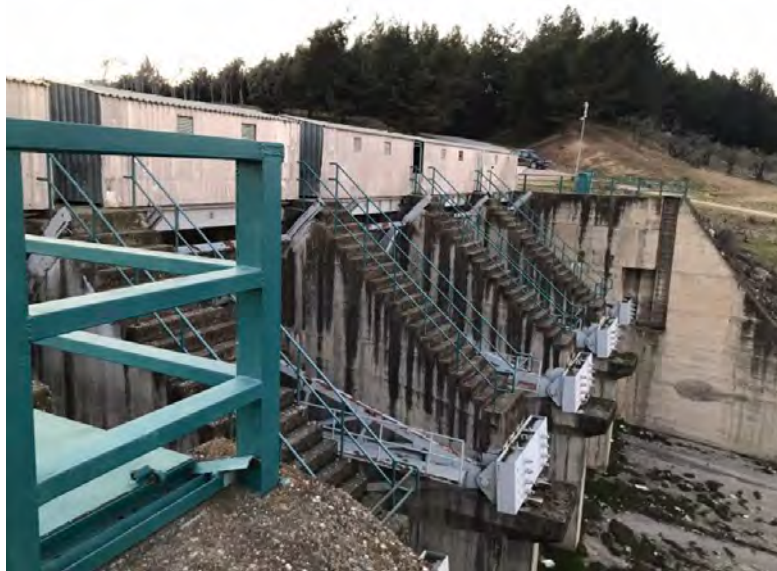
**Figure 8.15.** No observed cracking in the outlet structures.

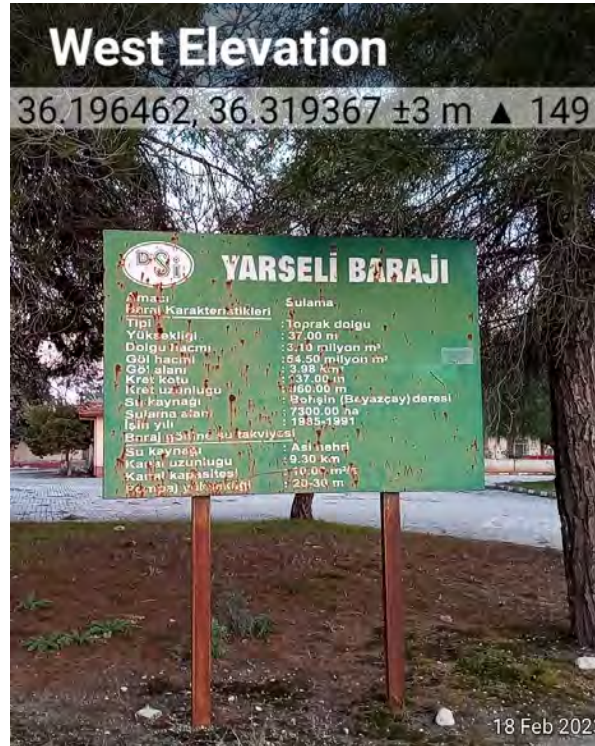
**Figure 8.16.** Yarseli dam specifications.

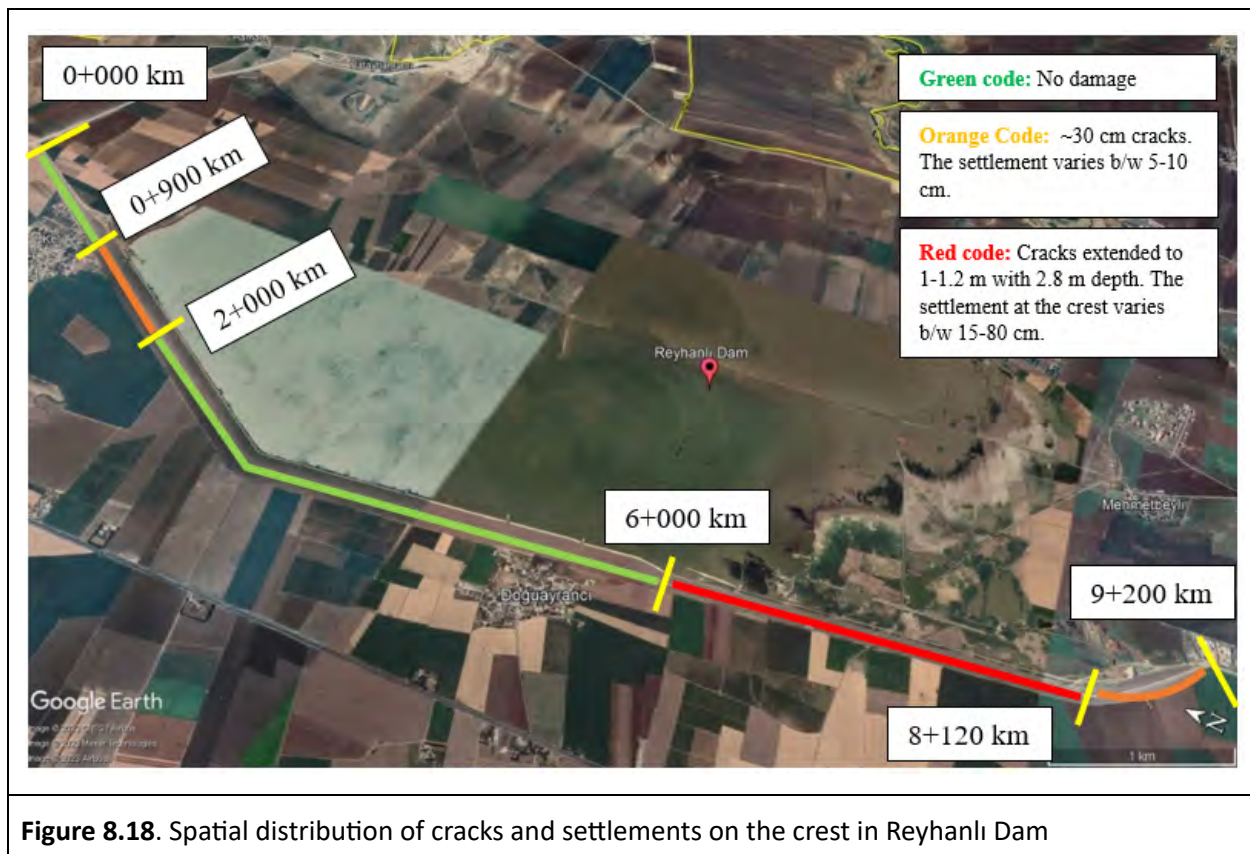
**Figure 8.18.** Spatial distribution of cracks and settlements on the crest in Reyhanlı Dam

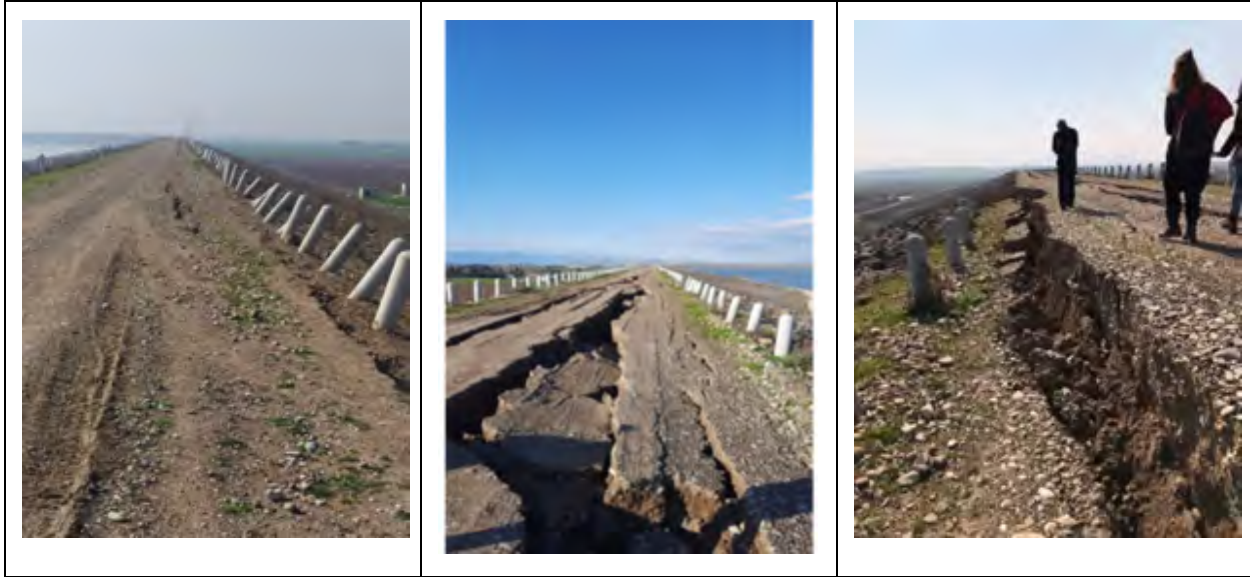
**Figure 8.19.** Deformations reported on the crest of the Reyhanlı Dam

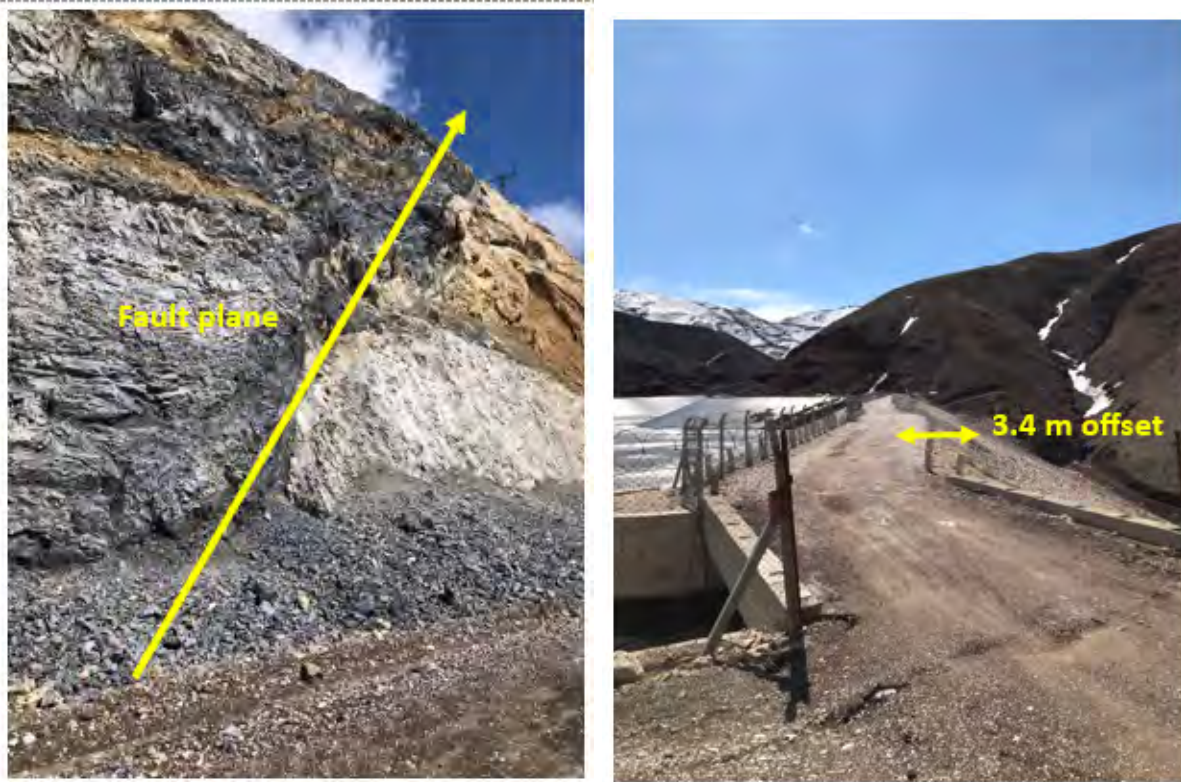
**Figure 8.20.** Left image shows the faulting in a cut near the dam. Right image shows evidence of the 3.4 meters of offset in the dam embankment.

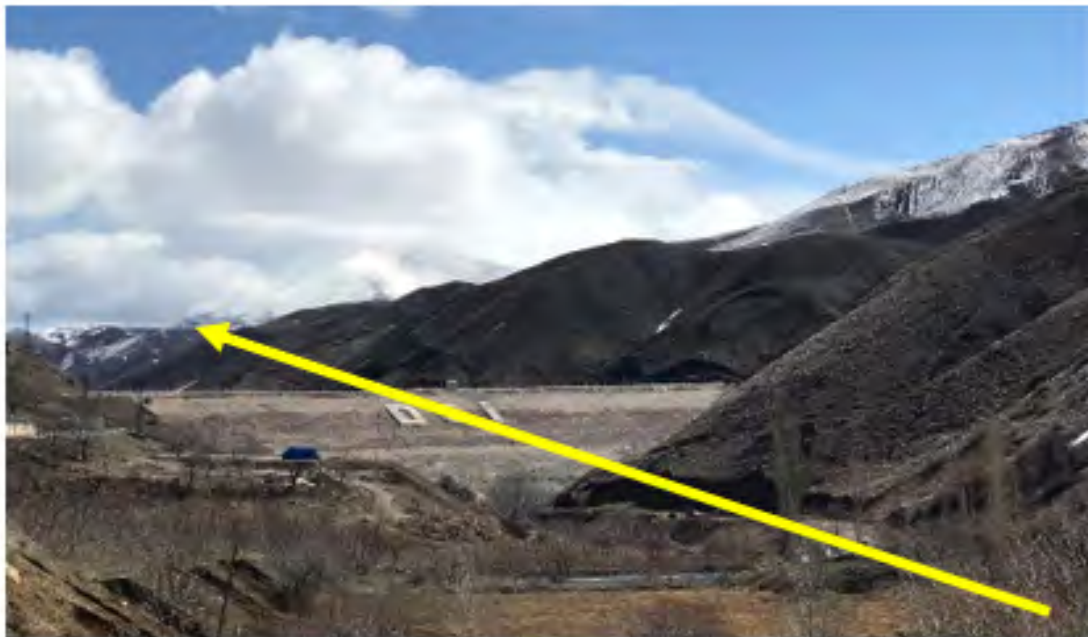
**Figure 8.21.** Image showing the general trend of the surface fault rupture through the Erkenek dam.

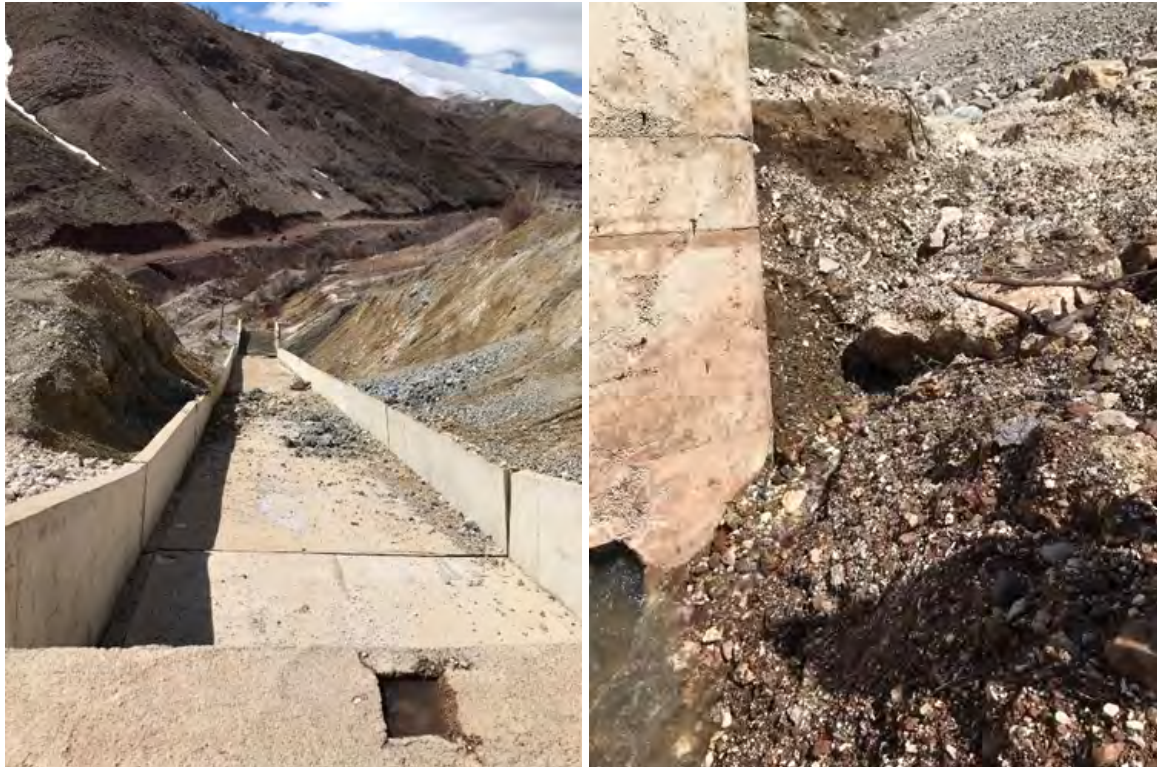
**Figure 8.22.** Left image, outlet structure of Erkenek dam. Right image, water issuing from the base of the outlet structure that appeared after the events.

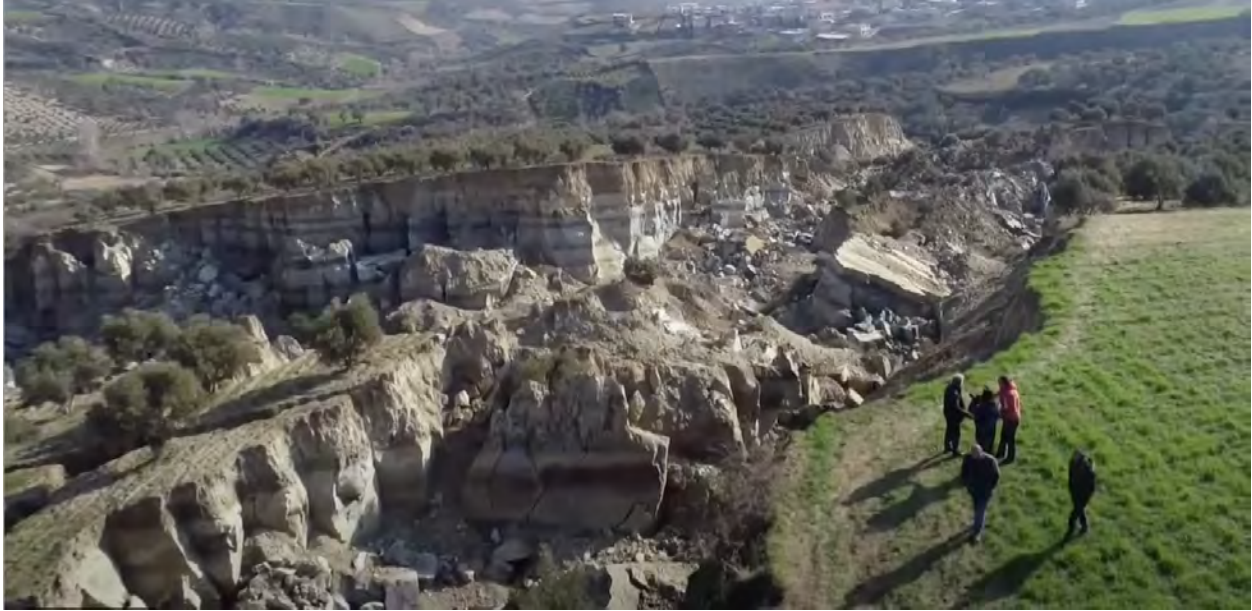
**Figure 9.1** Large ground cracks and translated blocks in an olive grove observed in Tepehan.

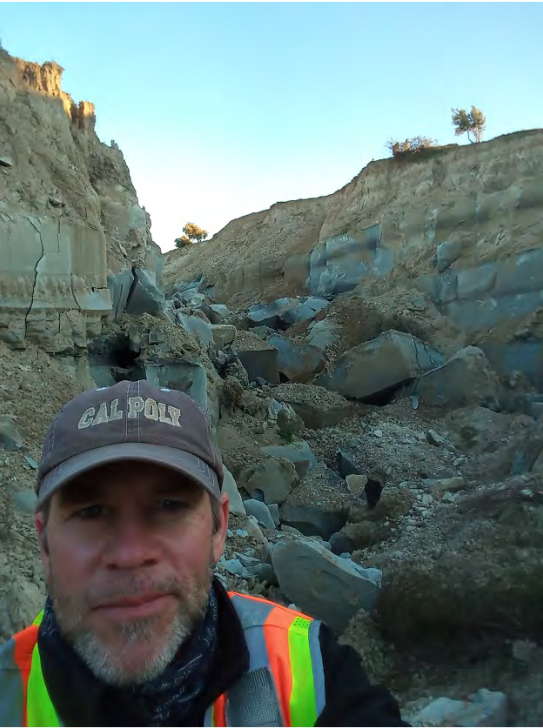
**Fig 9.2.** Near the headscarp of the Tepehan ground cracks. Note the layered geologic units. These were observed to be dipping at roughly 8-10 degrees downslope.

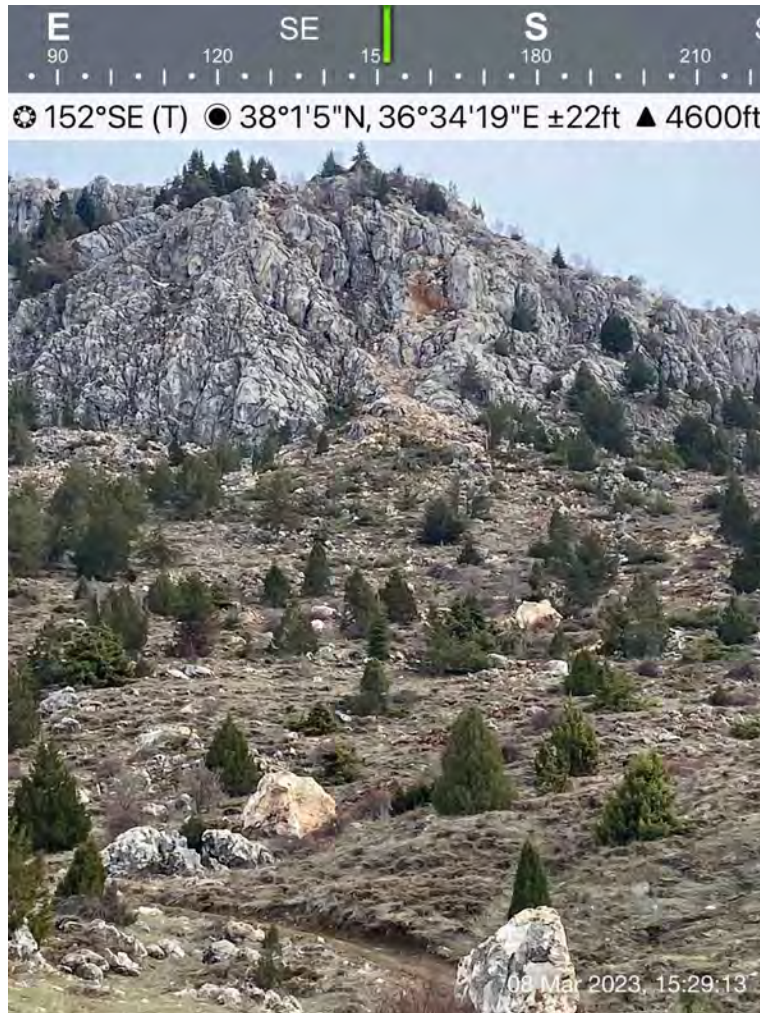
**Figure 9.3.** Earthquake induced rockfall from the M7.7 Sürgü-Çardak earthquake. Note: source and debris located near the town of Karaahmet.

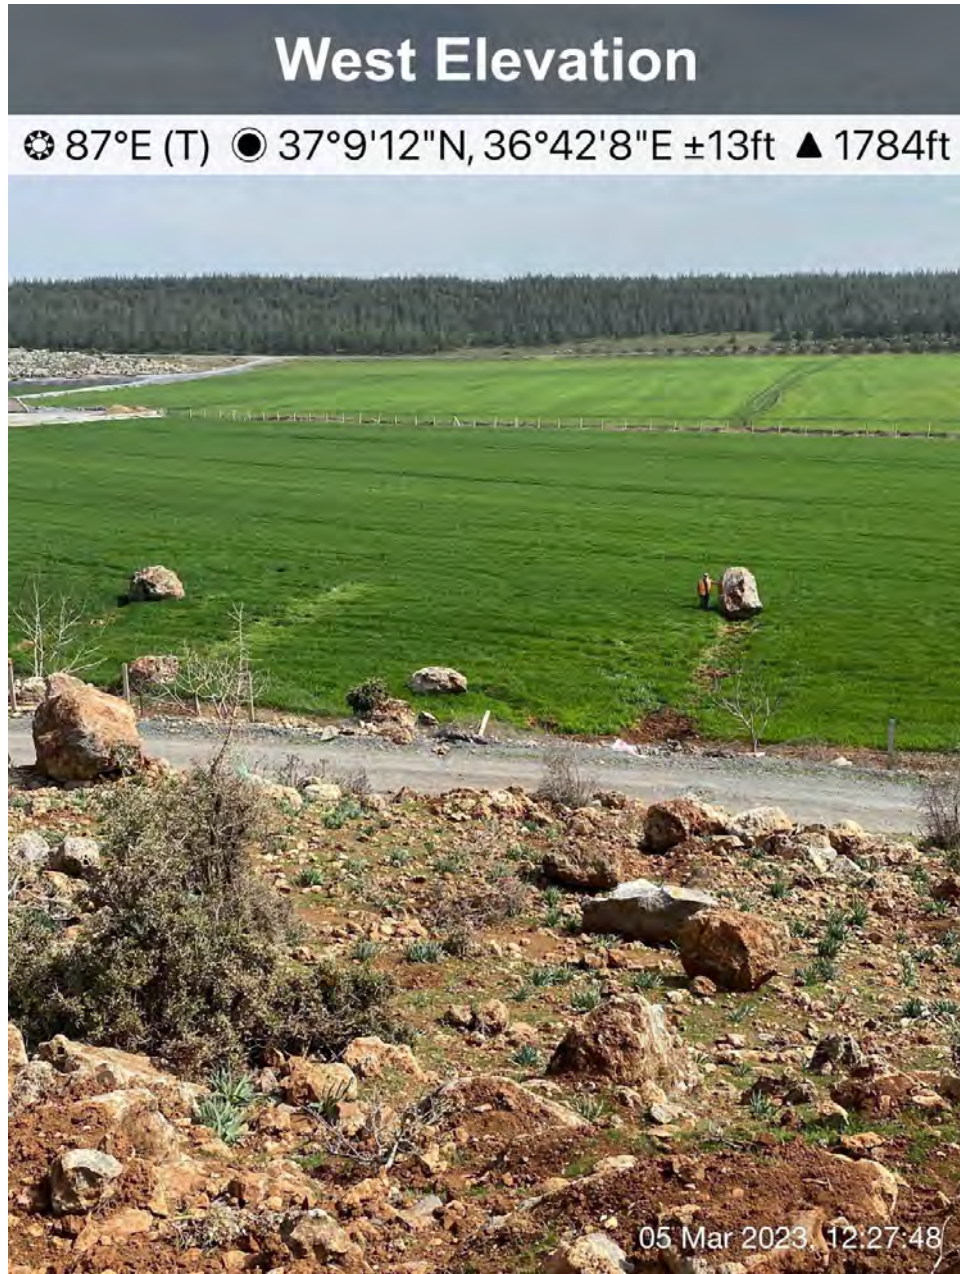
**Figure 9.5.** Rockfall runout south of the town of Gökçedere near the East Anatolian fault.

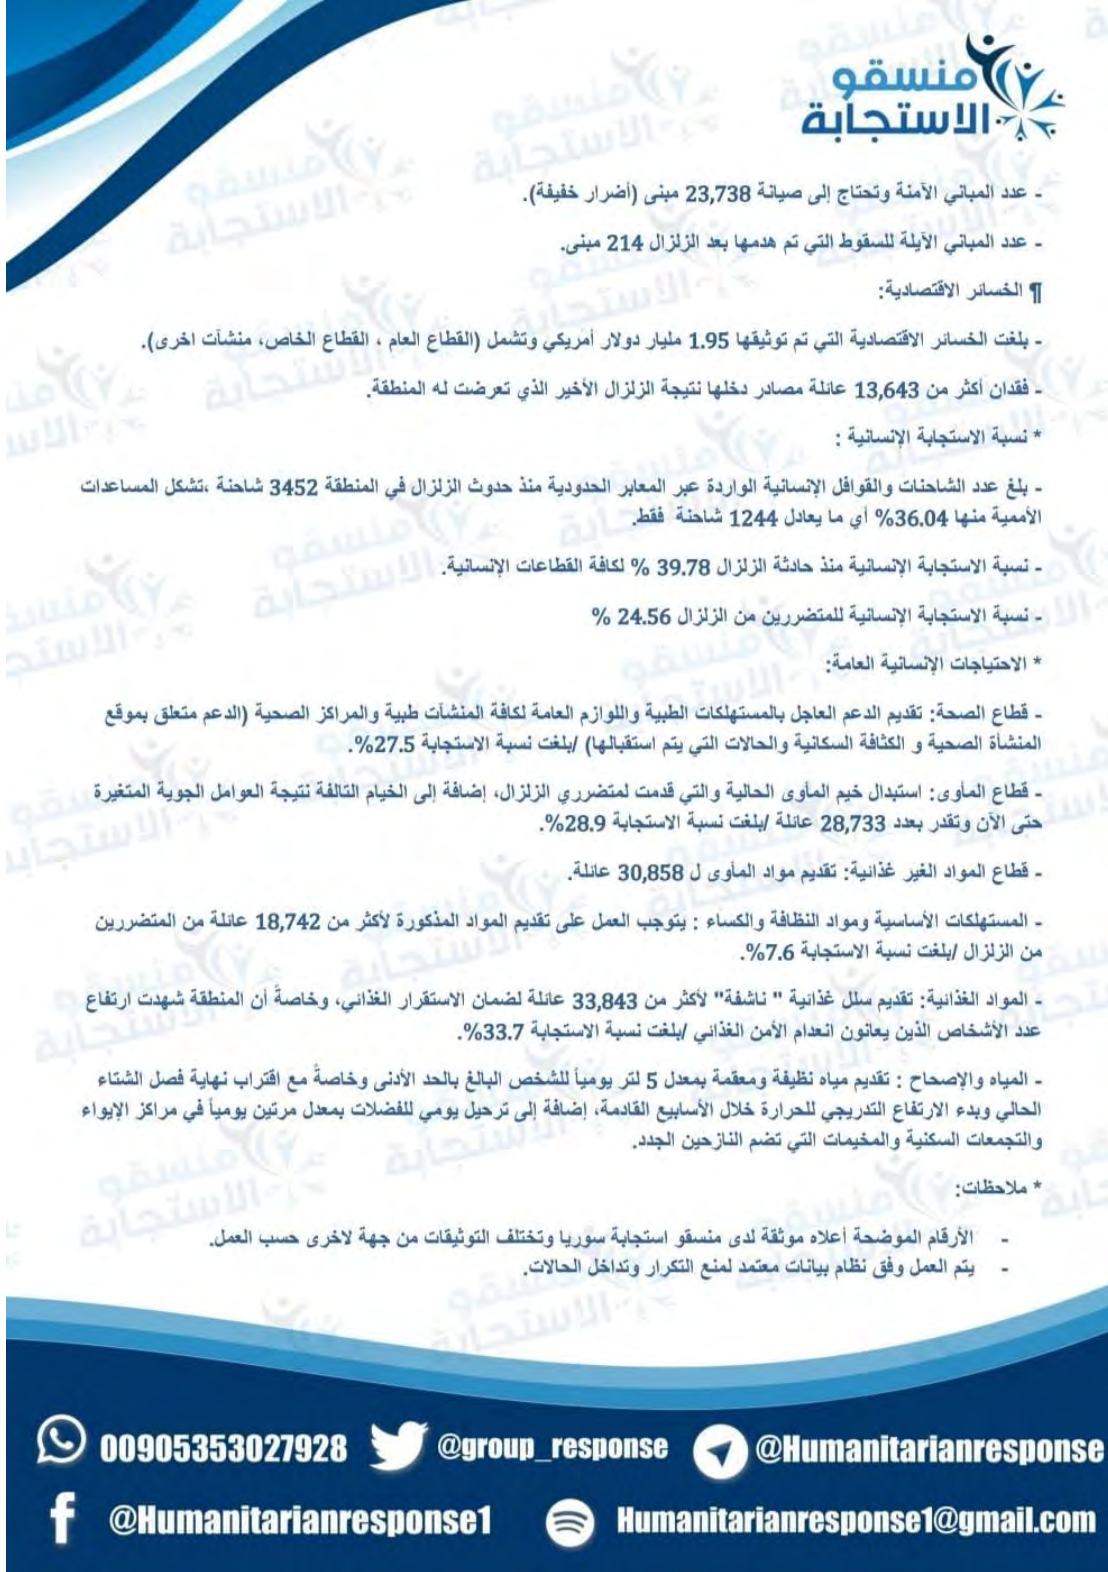
Figure 10.1. NGO report on the earthquake damage statistics in Syria.
