Preliminary Earthquake Reconnaissance Report: Türkiye Earthquake Sequence on February 6, 2023

Field Assessment Team Lead

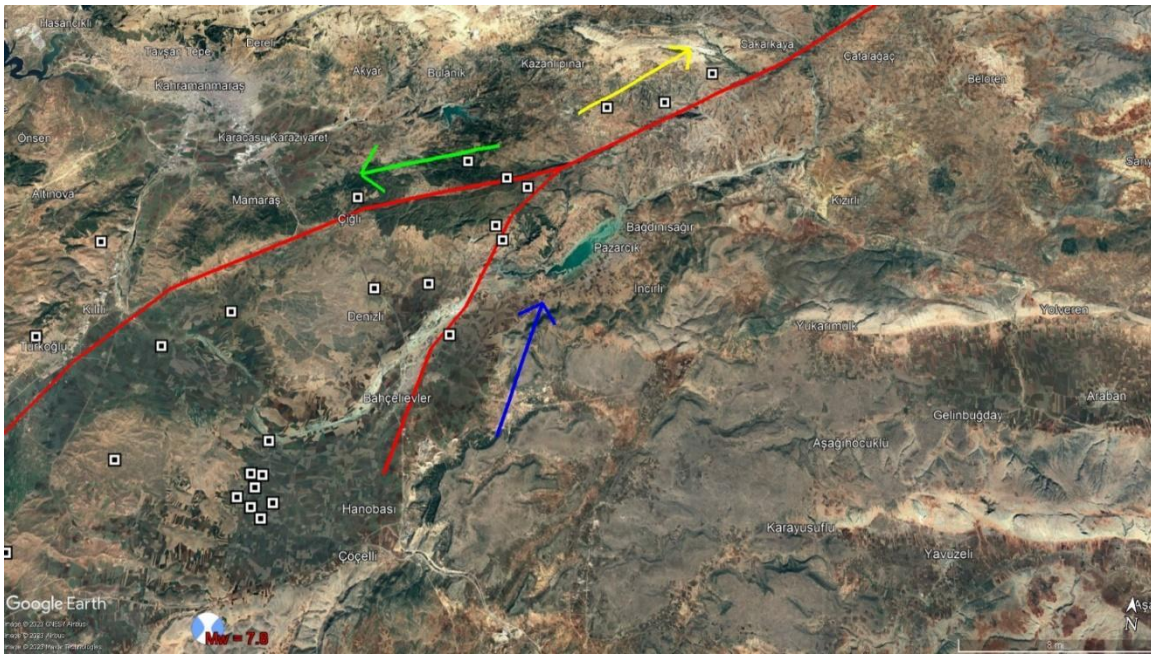
Figure 2-2 The fault rupture propagation of M_w 7.8 earthquake

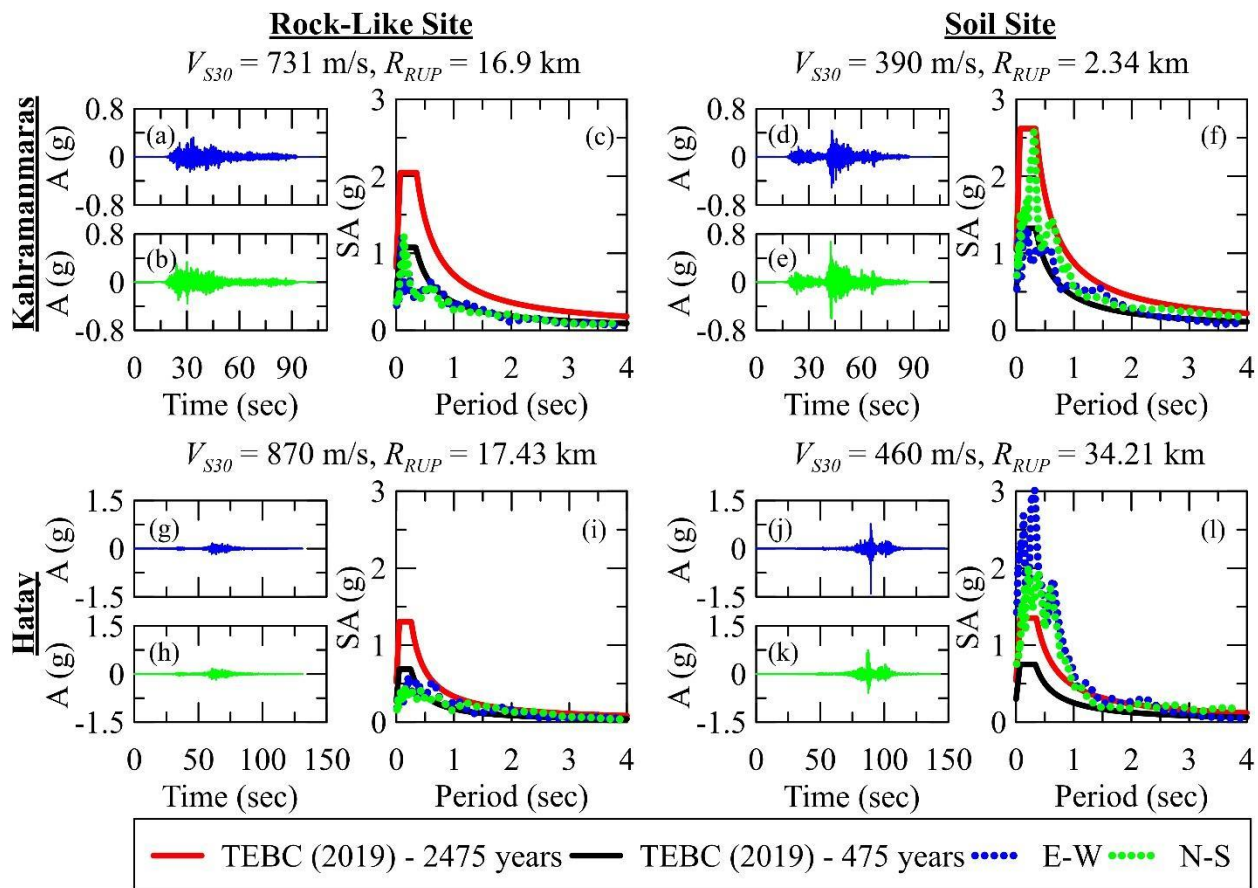
Figure 2-4 The baseline corrected acceleration (A) time histories in (a) E-W, (b) N-S directions, and (c) 5% damped response spectral accelerations (SA) and design spectra suggested by TEBC (2019) for return periods of 2475 years and 475 years for station ID of 4611 located in Kahramanmaraş. The same information is presented for (d, e, f) station ID of 4616, (g, h, i) station ID (Hatay) of 3116, and (j, k, l) station ID (Hatay) of 3135 ($M_w = 7.8$ event).

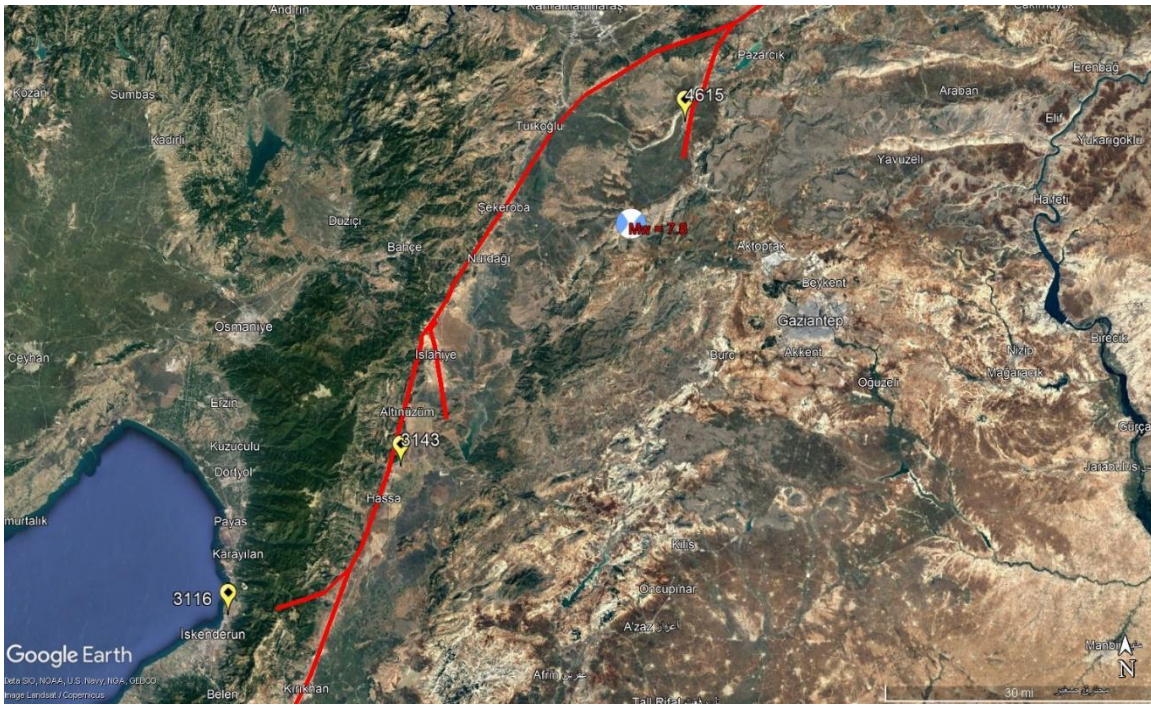
Figure 2-6 Station 3116, 3143 and 4615 along with the fault rupture in M_w 7.8 event.

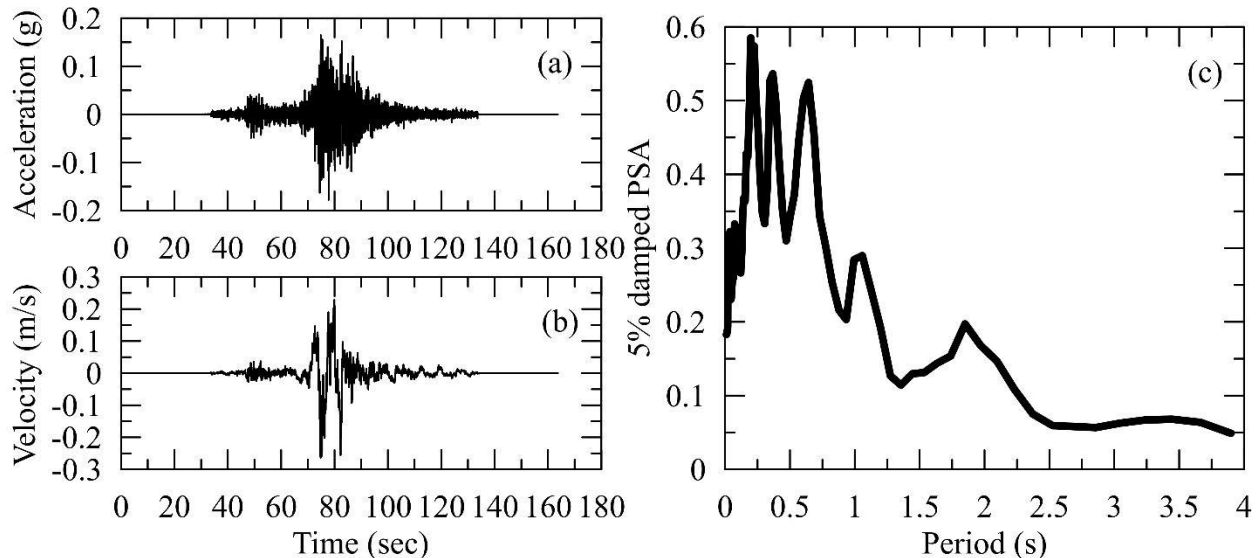
Figure 2-7 The (a) acceleration and (b) velocity time histories, and (c) pseudo-spectral acceleration of Station 3116 (Hatay) for M_w 7.8 event.

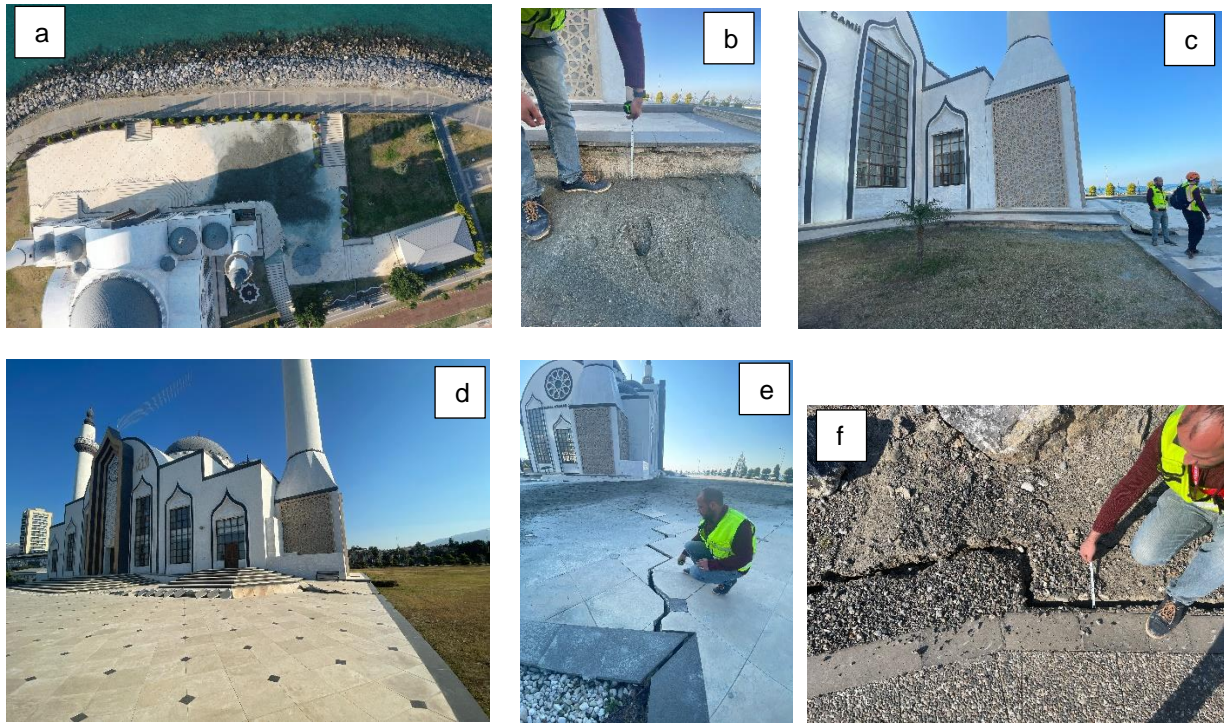
Figure 3-2 Liquefaction manifestations in Nihal Atakas Mosque (~ 36°35'35.27"N/ 36° 9'26.74"E): a) Bird's-eye view of the sand ejecta at the corner; b) settlements of the sand near the mosque; c) front view outlining the settlements; d) severe deformations observed on the marble ground due to liquefaction induced settlements; e) lateral spreading in front of the mosque; f) lateral spreading near the mosque towards the sea.

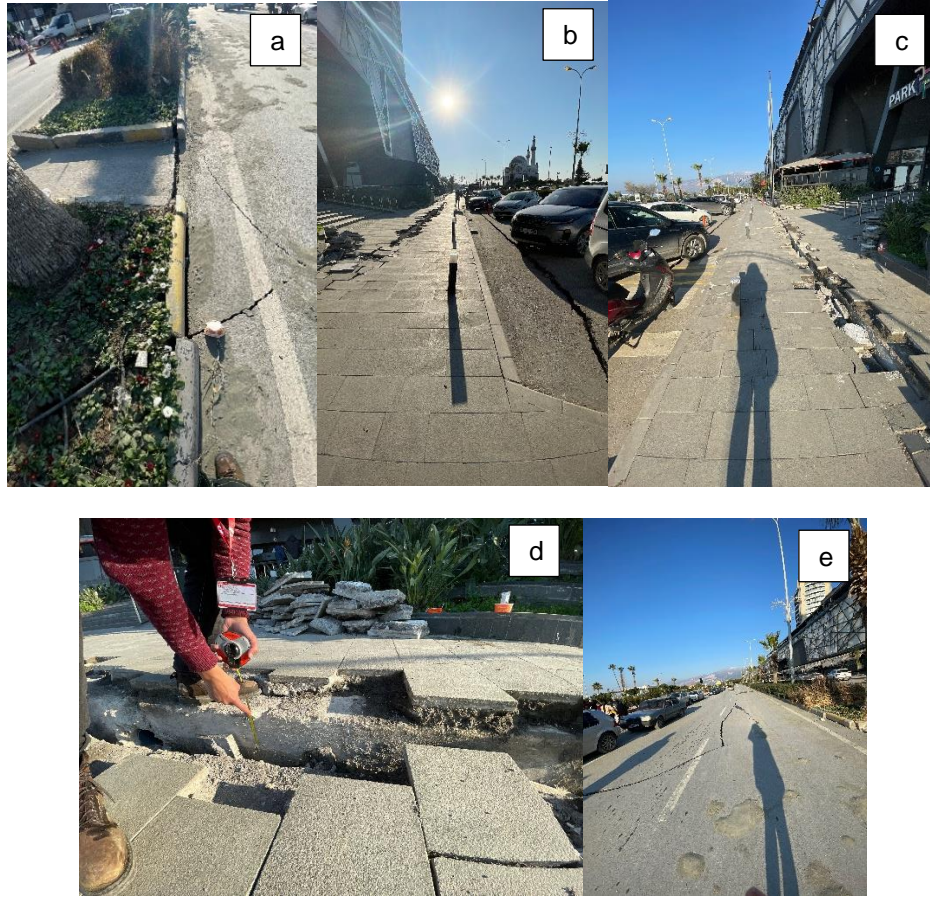
Figure 3-3 Liquefaction manifestations on Ataturk Boulevard near Forbes Shopping Center (~ 36°35'36.52"N/ 36° 9'34.67"E): a) sand boils on Ataturk Boulevard; b) cracks formed due to lateral deformation; c) cracks formed due to lateral deformation; d) liquefaction induced settlements; e) cracks formed due to lateral deformation.

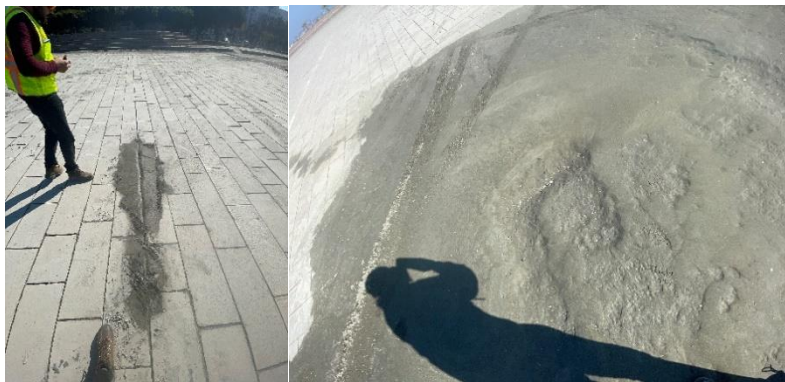
Figure 3-4 Liquefaction manifestations (sand boils) on Ataturk Boulevard near Ataturk (~ 36°35'29.50"N/ 36° 10'20.23"E)

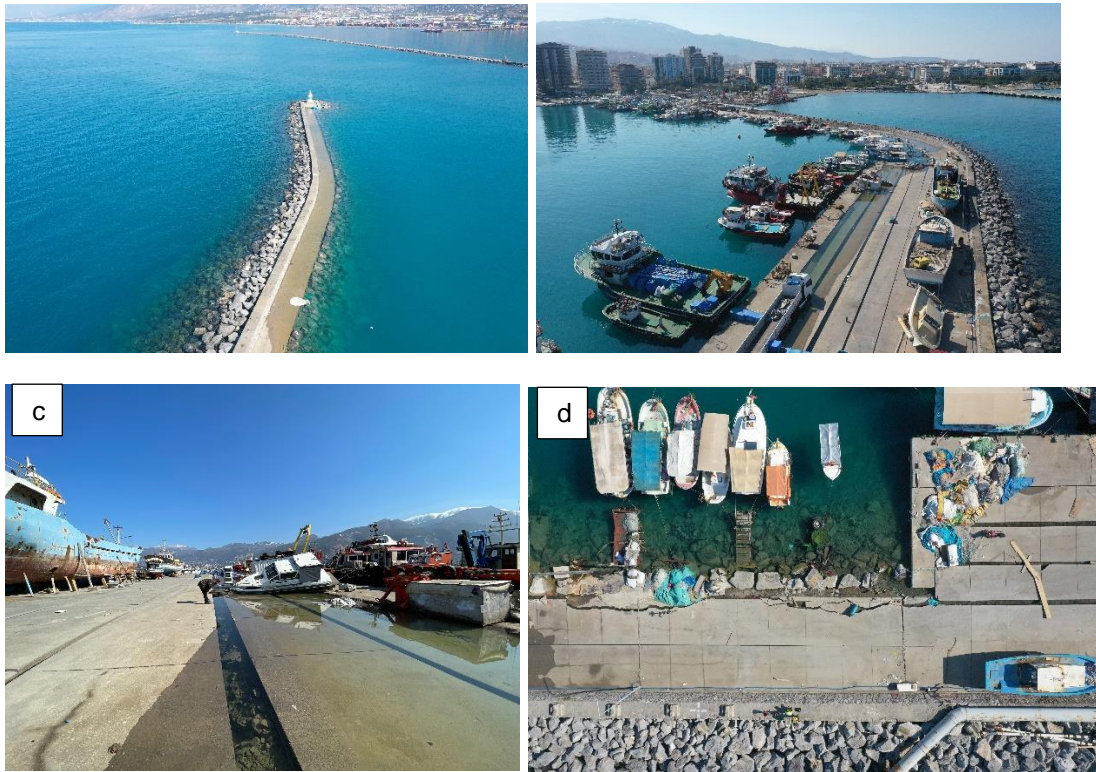
Figure 3-8 Ground Settlements and Lateral Deformations on Iskenderun Dock (~ 36°35'40.67"N/ 36° 10'38.69"E): a) Ground subsidence at the pier and the lighthouse; b) Ground subsidence at the dock; c) Ground subsidence and lateral deformations of the concrete panels; d) lateral deformations and cracks on the concrete panel

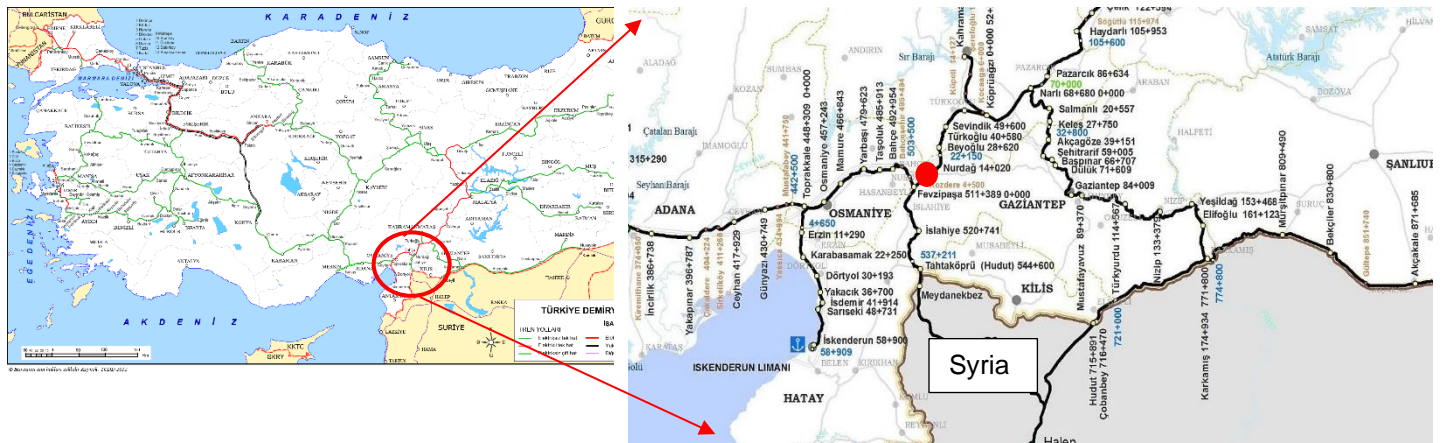
Figure 3-13 Overview map of the railroad map of Türkiye-Syria and landslide location (~ 37°06'43.41"N/ 36° 39'34.91"E)

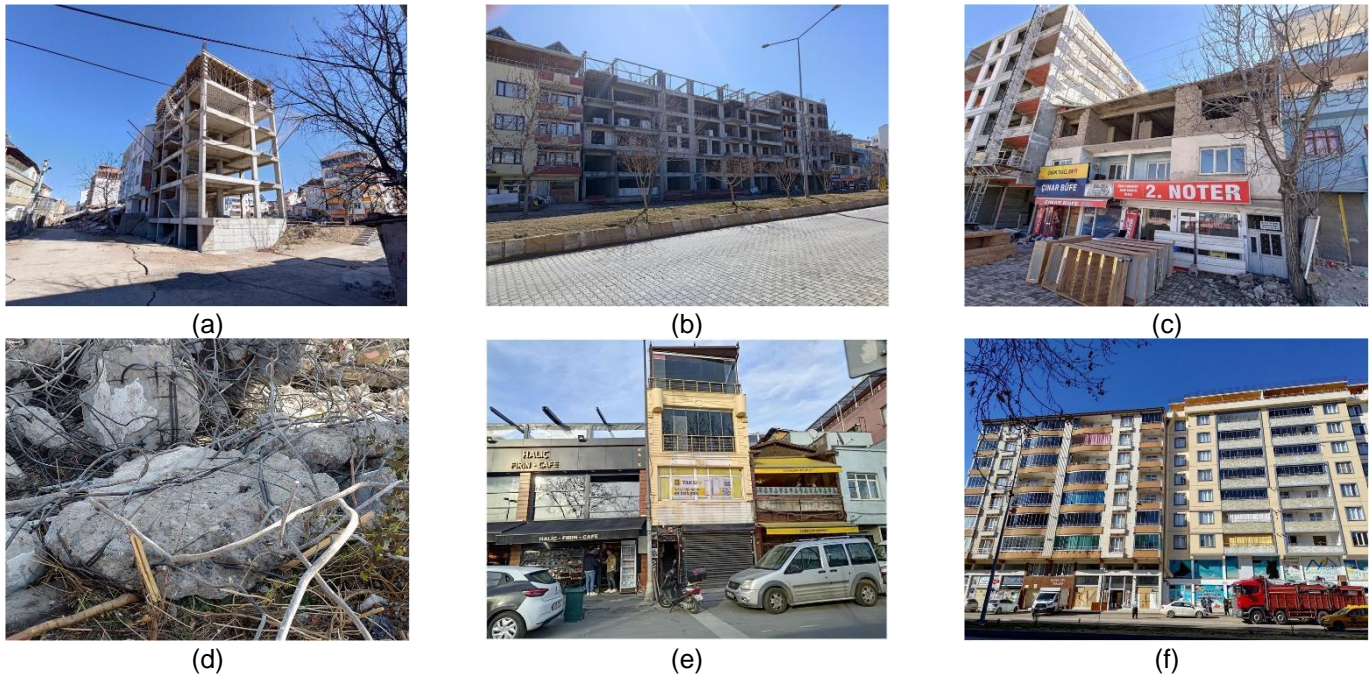
Figure 4-2 (a) and (b) two buildings with different construction practices, (c) a building with an added third story, (d) poor concrete and plain reinforcement, (e) and (f) no separation between buildings.

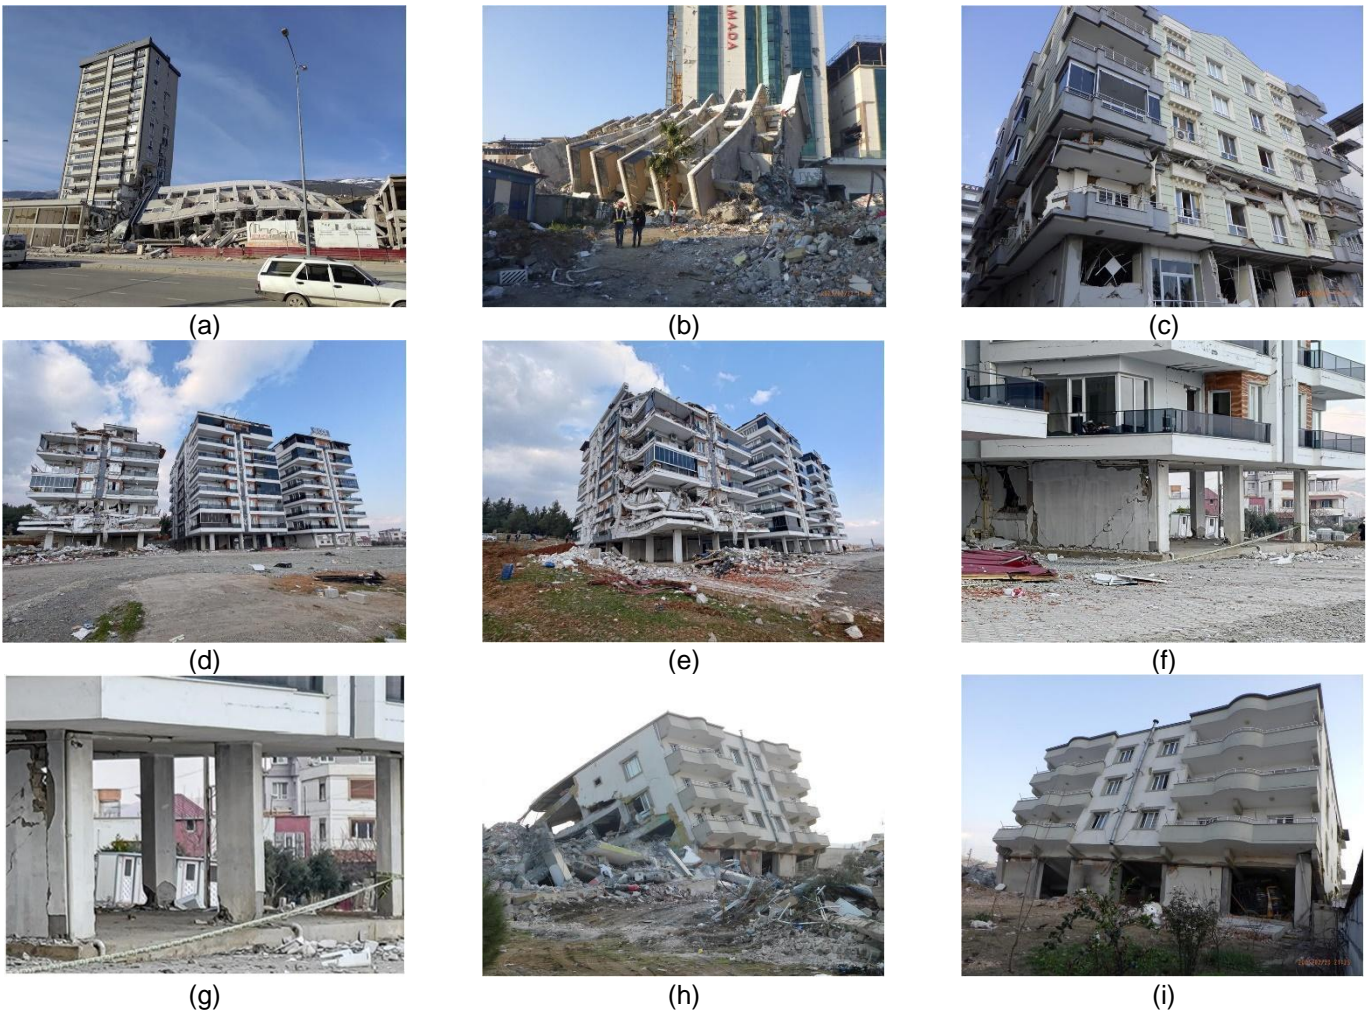
Figure 4-3 (a) and (b) lie-down collapsed buildings, (c) a building with pancaked third story, (d) and (e) three similar buildings with different damage states, (f) close-up photograph of the first story of the right building, (g) bi-directional and one-directional plastic hinges, (h) and (i) a knee-down collapsed building.

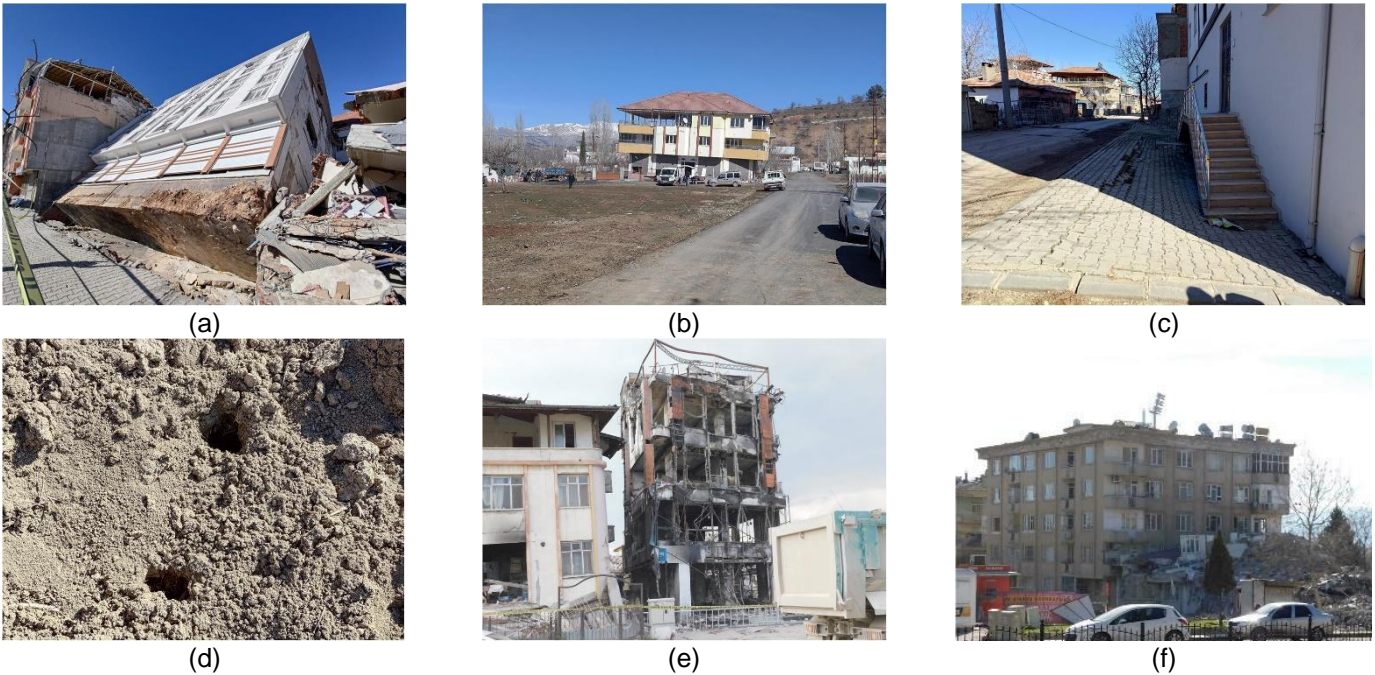
Figure 4-4 (a) An overturned building, (b) unequal settlement of a building, (c) settlement of ground, (d) sand boils, (e) secondary disaster, (f) damaged facilities atop a roof.

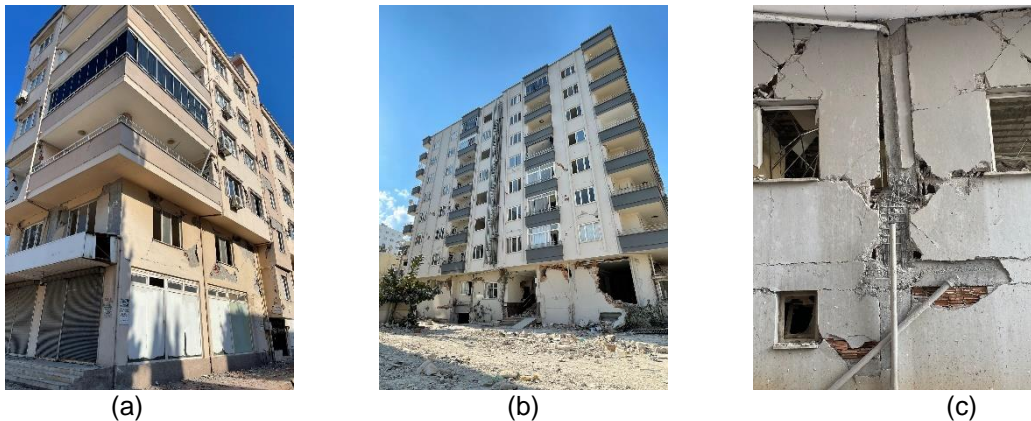
Figure 4-8 Residential building damages (a) due to overhangs, (b) captive/short column due to strong infill walls

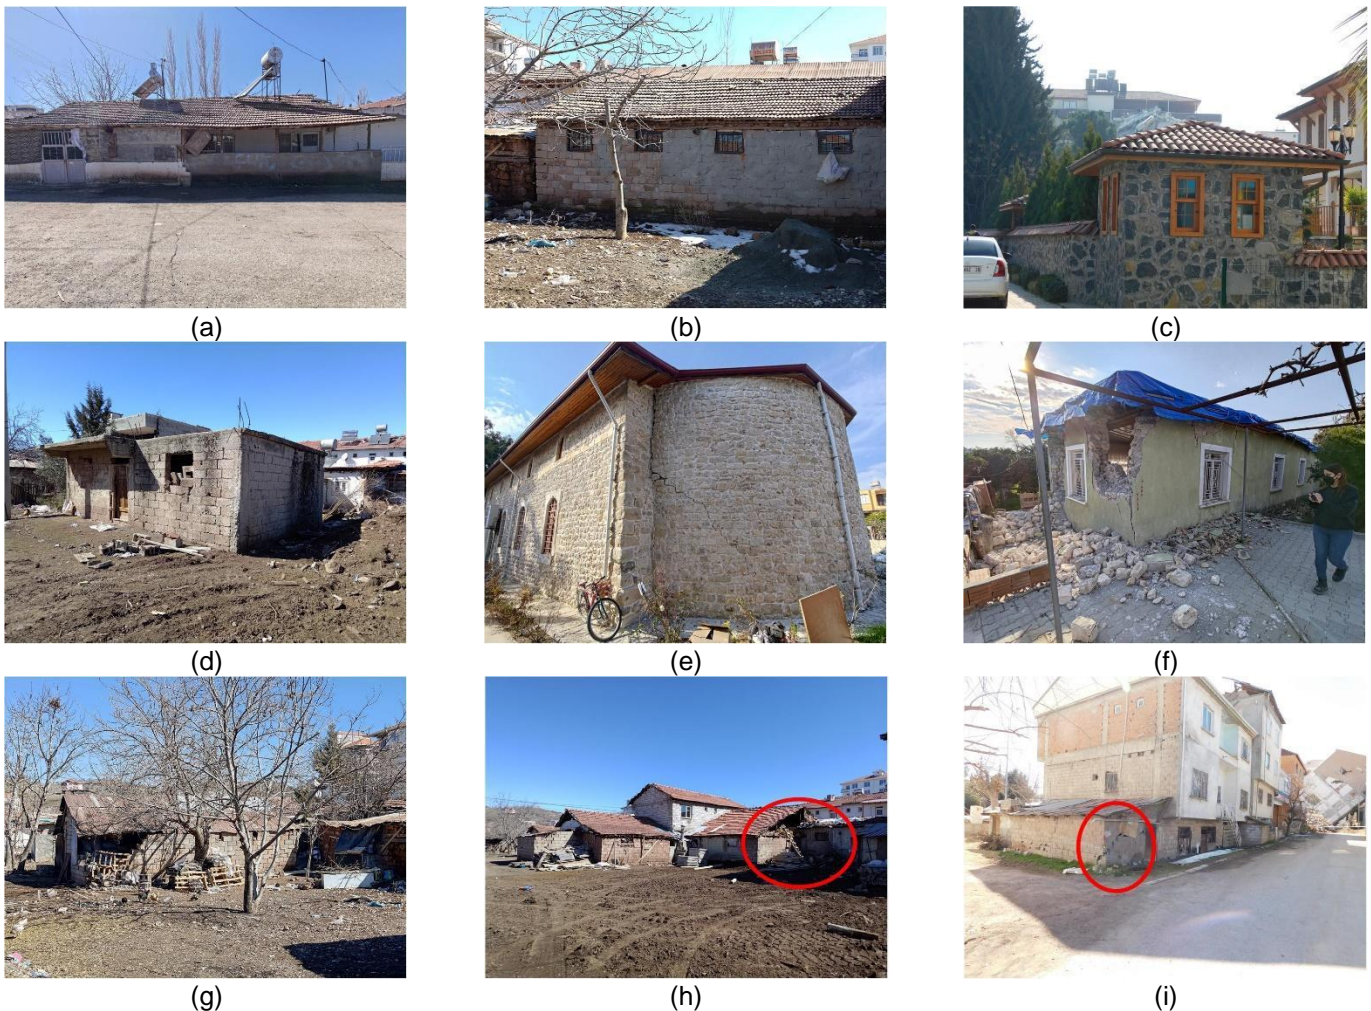
Figure 4-9 (a) to (c) essentially intact or slightly damaged masonry buildings, (d) and (e) moderately damaged masonry buildings, (f) to (h) severely damaged masonry buildings, (i) a pure sliding mode of failure mechanism of a brick wall.

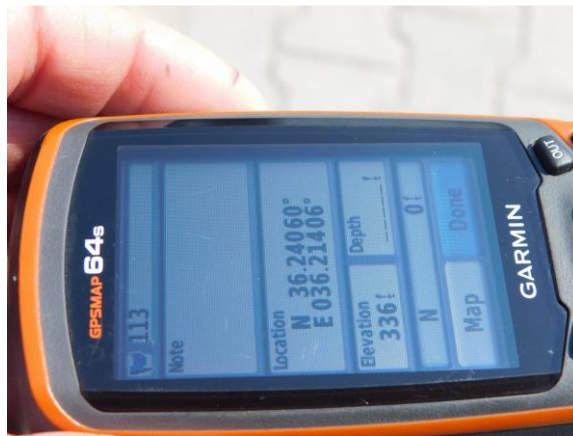
Figure 5-1 Garmin GPS Unit used in the field to determine coordinate location of bridges inspected for damage

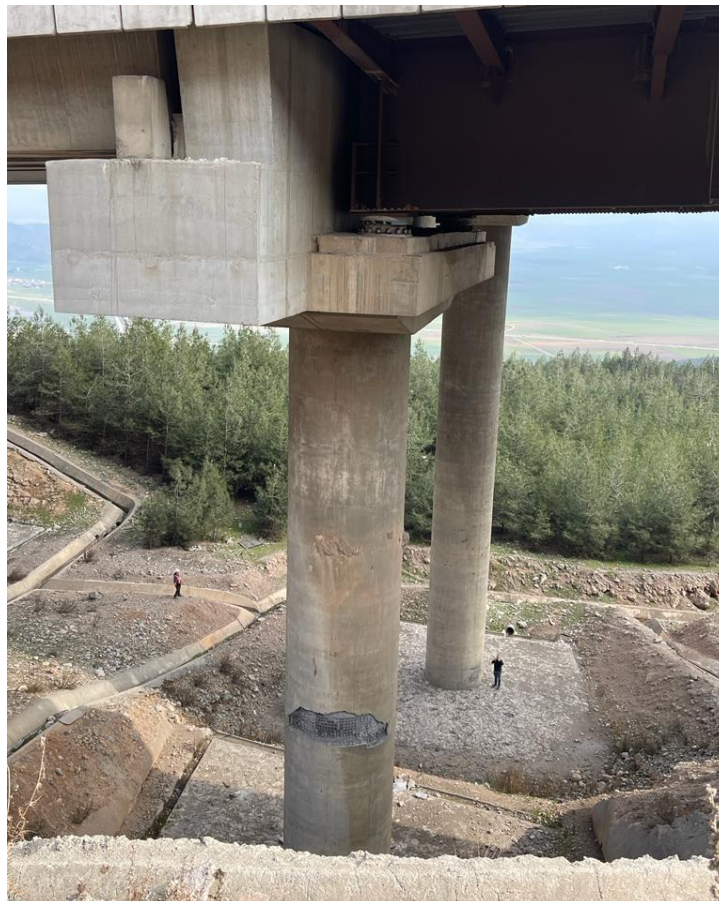
Figure 5-6 Overall view of bent with 10' diameter RC bridge columns and plastic hinge for one column at about 1/4 the way up its height, Bridge 1

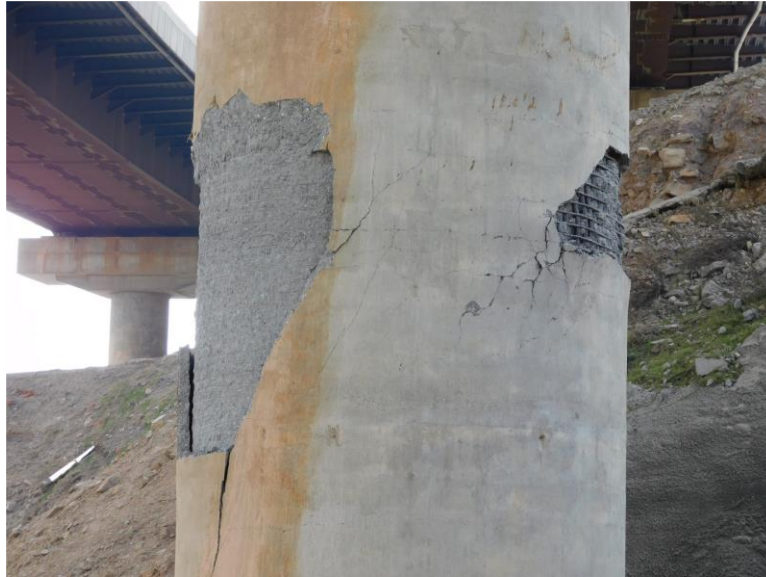
Figure 5-8 Side view of plastic hinge region of 10' diameter RC bridge column, Bridge 1

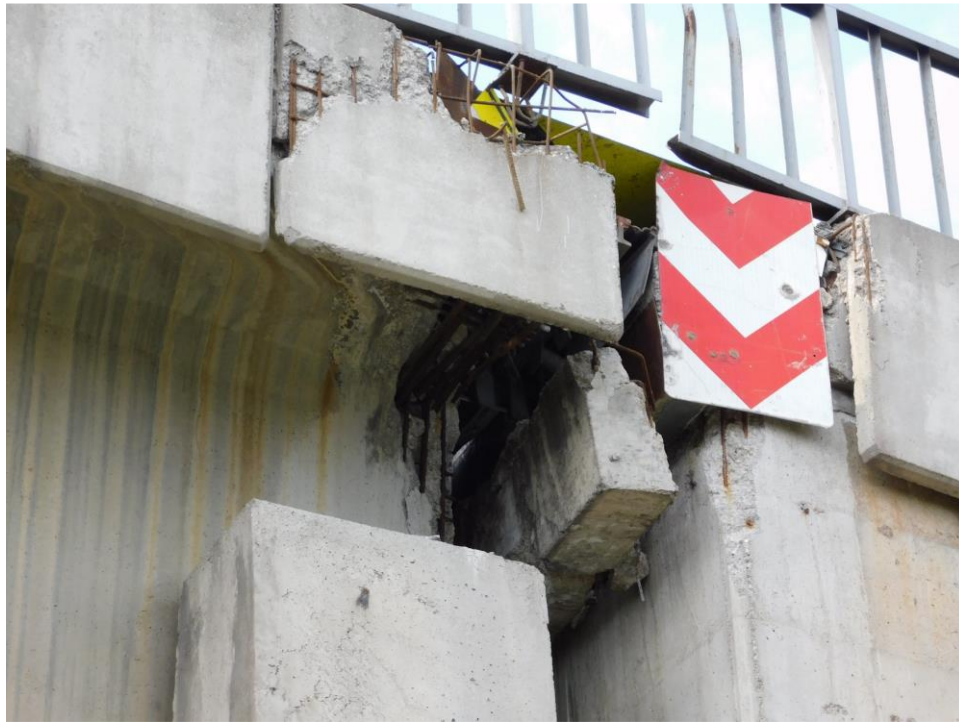
Figure 5-12 Damage at abutment, Bridge 1

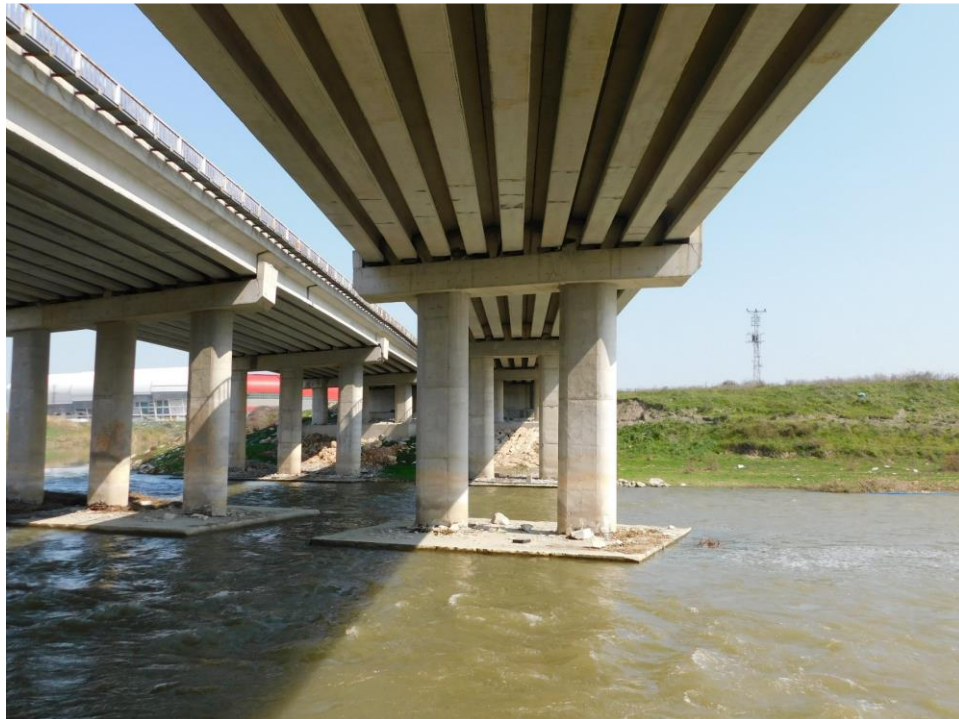
Figure 5-13 Overall view from under Bridge 2

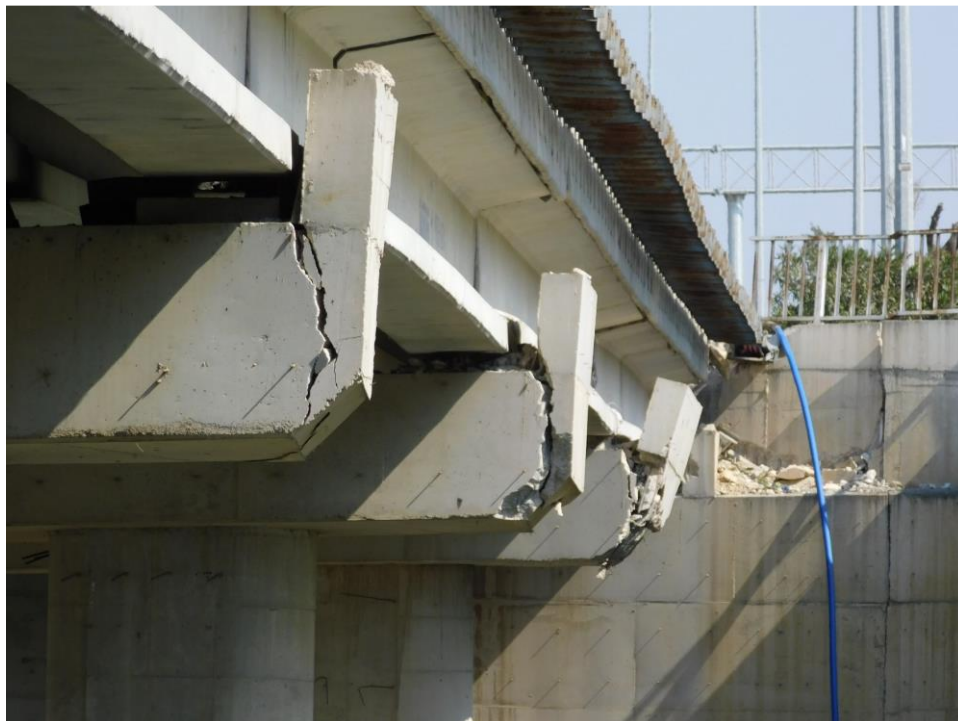
Figure 5-14 Failed exterior shear keys, Bridge 2

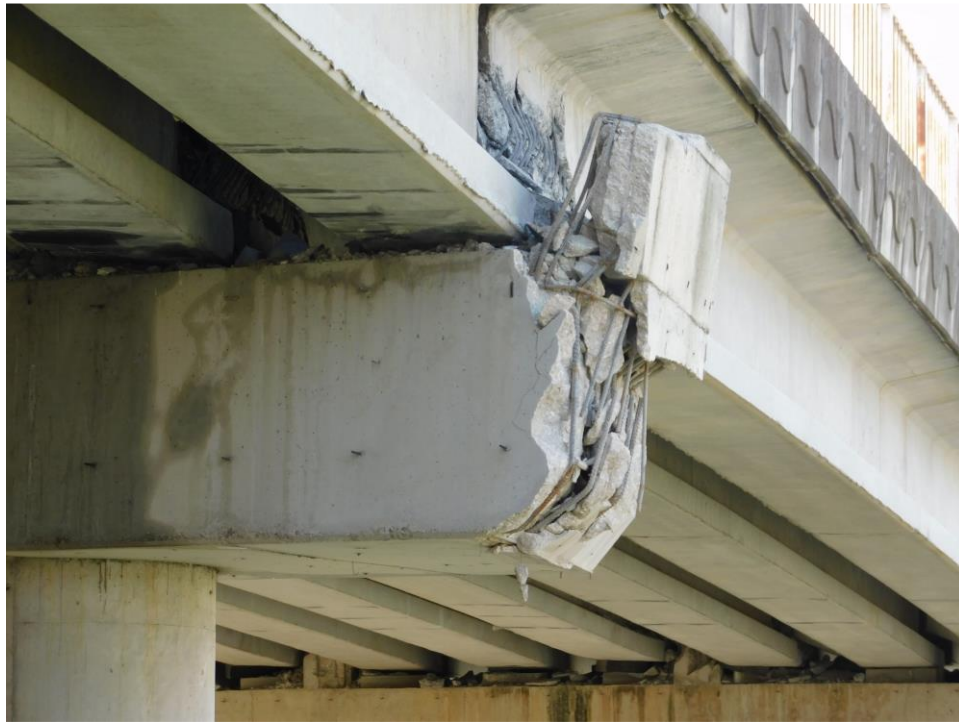
Figure 5-15 Closer view of failed exterior shear key and end-of-girder damage, Bridge 2

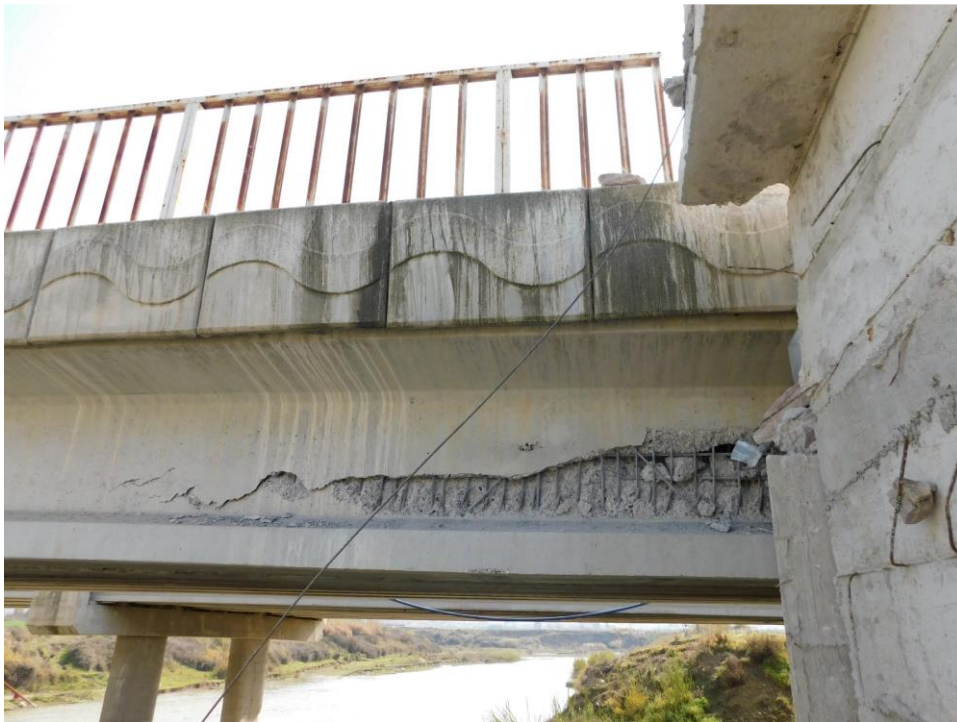
Figure 5-18 Damage to end of precast girder, Bridge 2

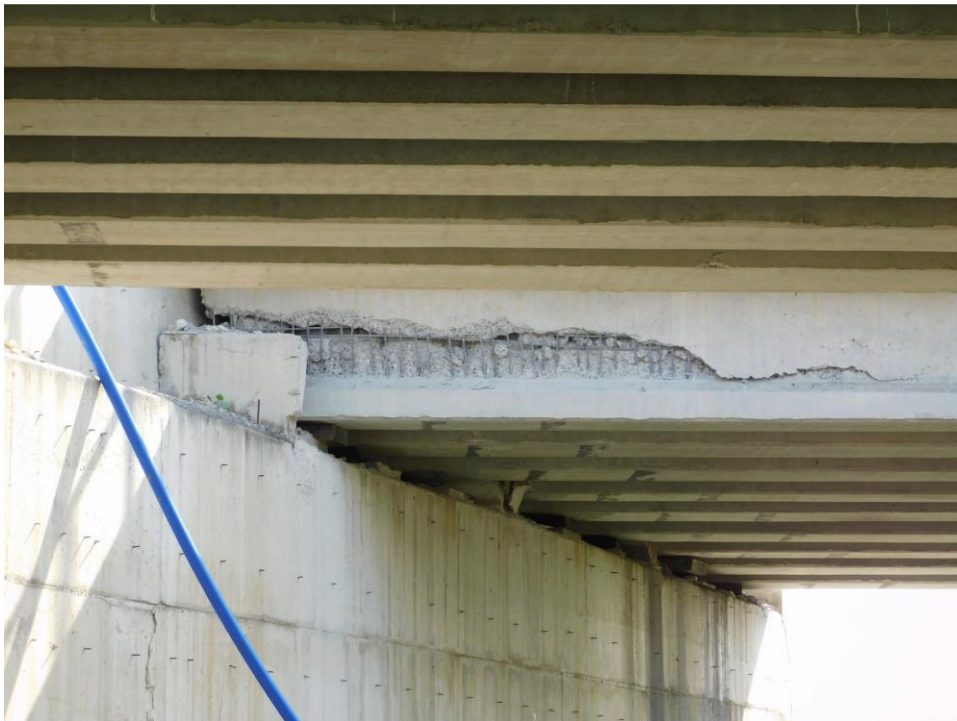
Figure 5-20 Damage over long range to end of exterior precast girder, Bridge 2

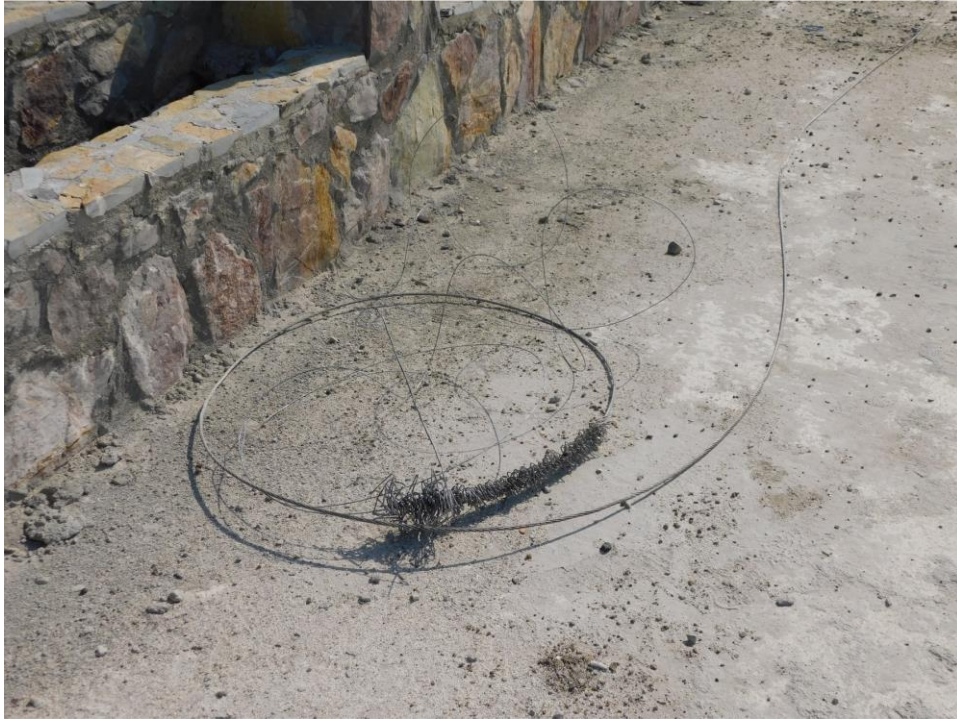
Figure 5-21 Prestressing cable at end of precast girder, Bridge 2

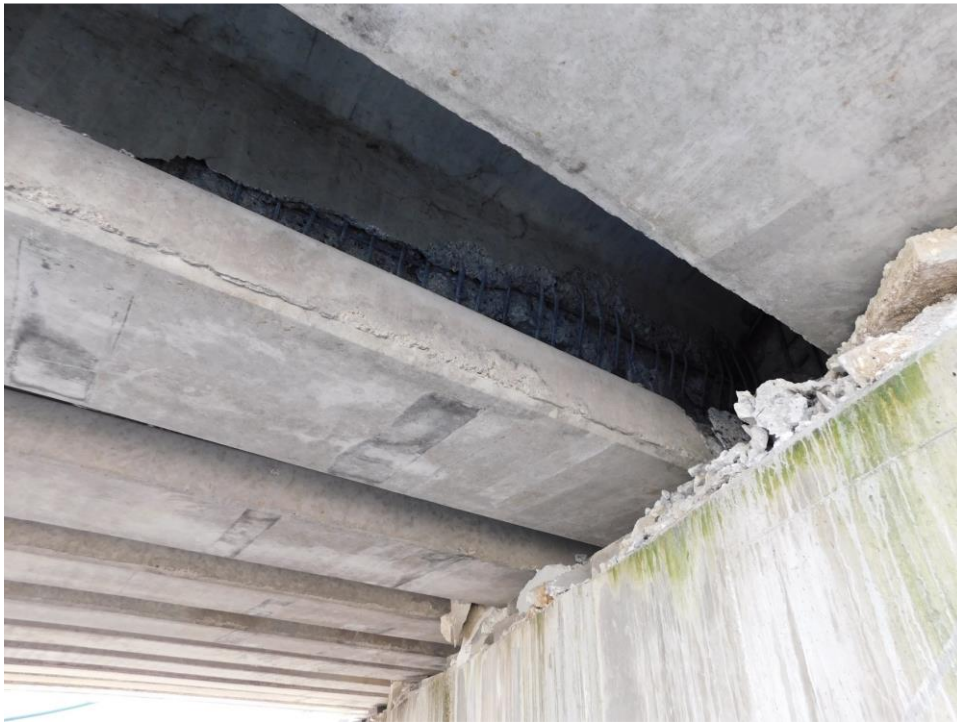
Figure 5-23 Interior girder damage at end of precast girder, Bridge 2

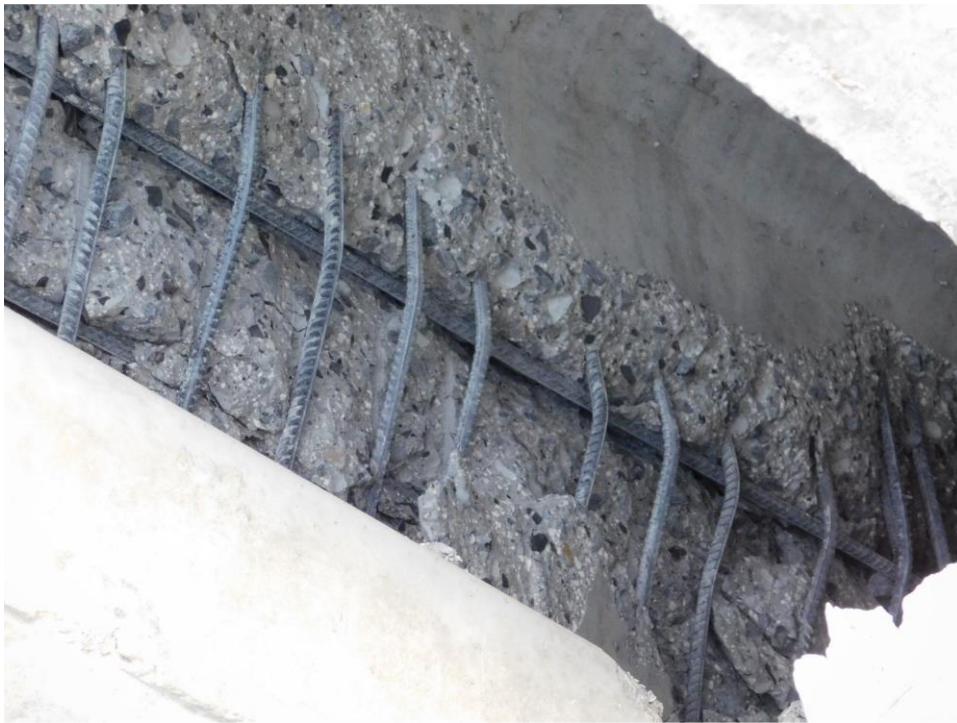
Figure 5-24 Close-up view of interior girder damage at end of precast girder, Bridge 2

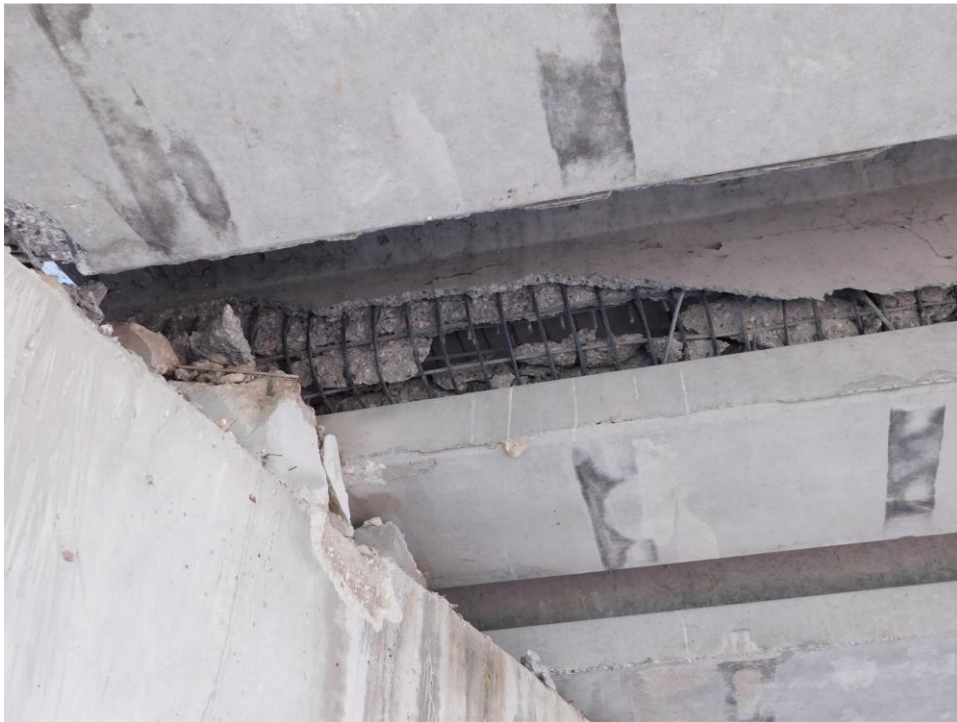
Figure 5-25 Significant interior girder damage at end of precast girder, Bridge 2

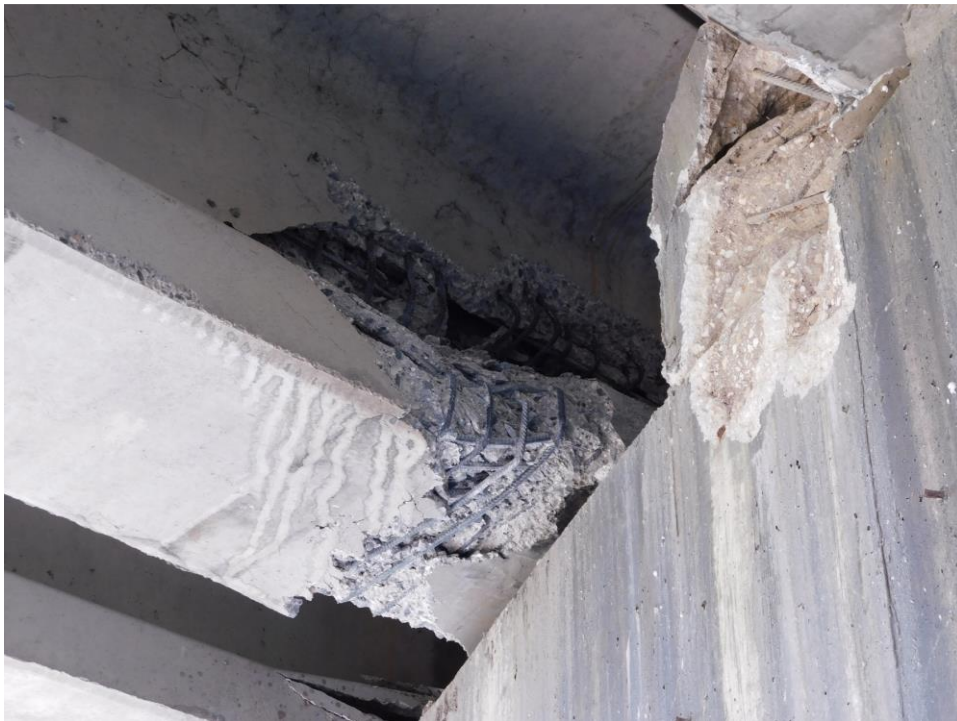
Figure 5-26 Significant interior girder damage at end of precast girder, Bridge 2

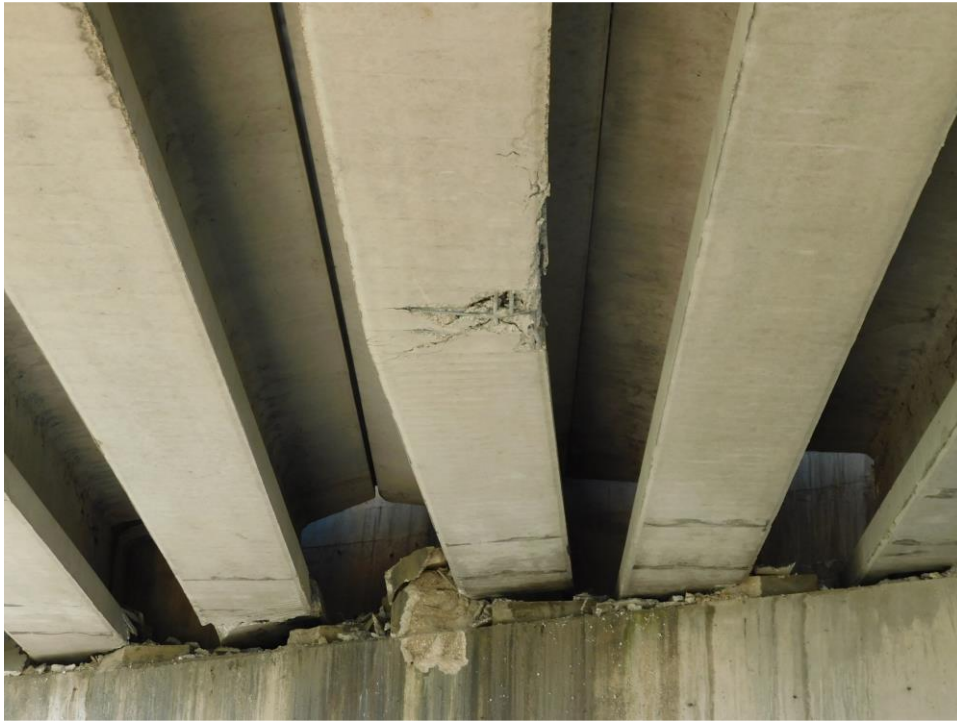
Figure 5-28 Lateral/vertical bending and damage of interior girder at mid-span and shear key damage at girder end, Bridge 2
