Preliminary Earthquake Reconnaissance Report: Türkiye Earthquake Sequence on February 6, 2023

Field Assessment Team Lead

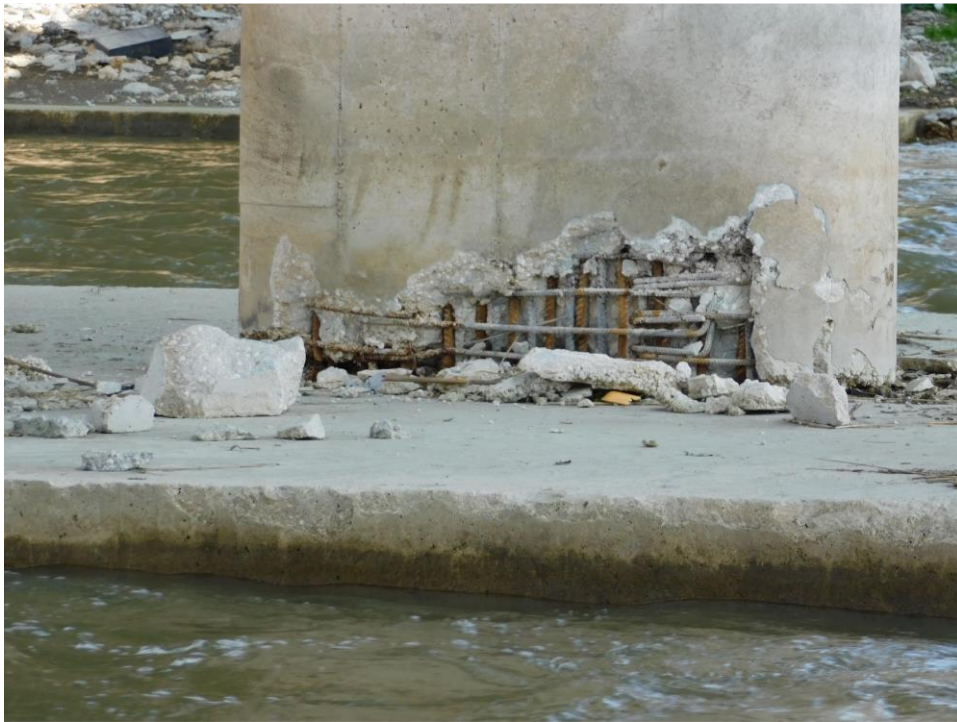
Figure 5-29 Plastic hinging at base of RC column, Bridge 2

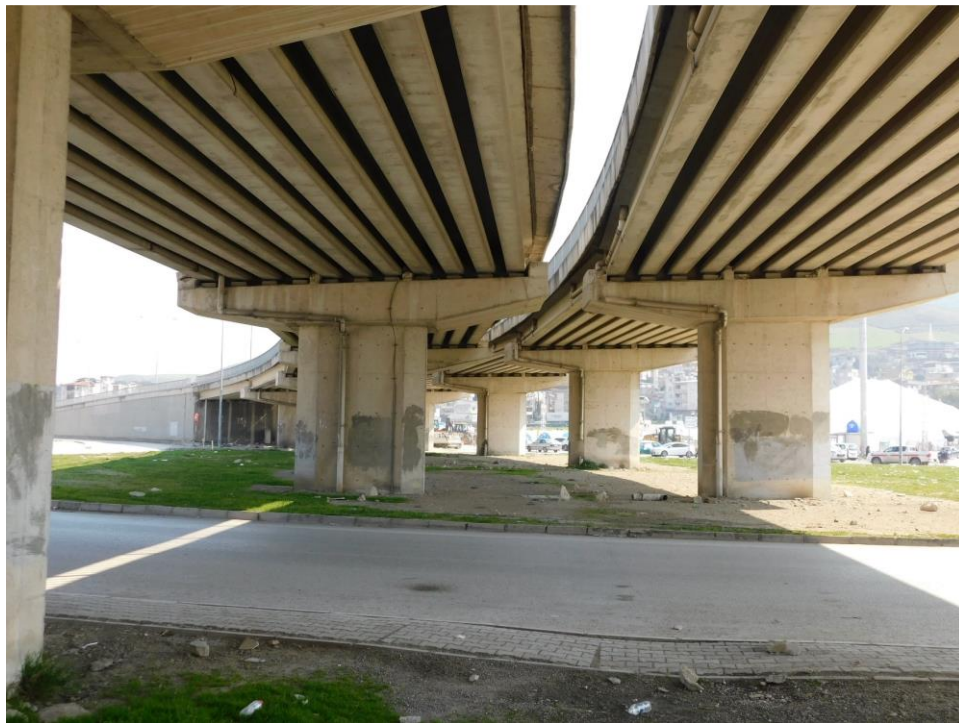
Figure 5-33 View under Bridge 3, showing 11 precast I-girders per span for each bridge

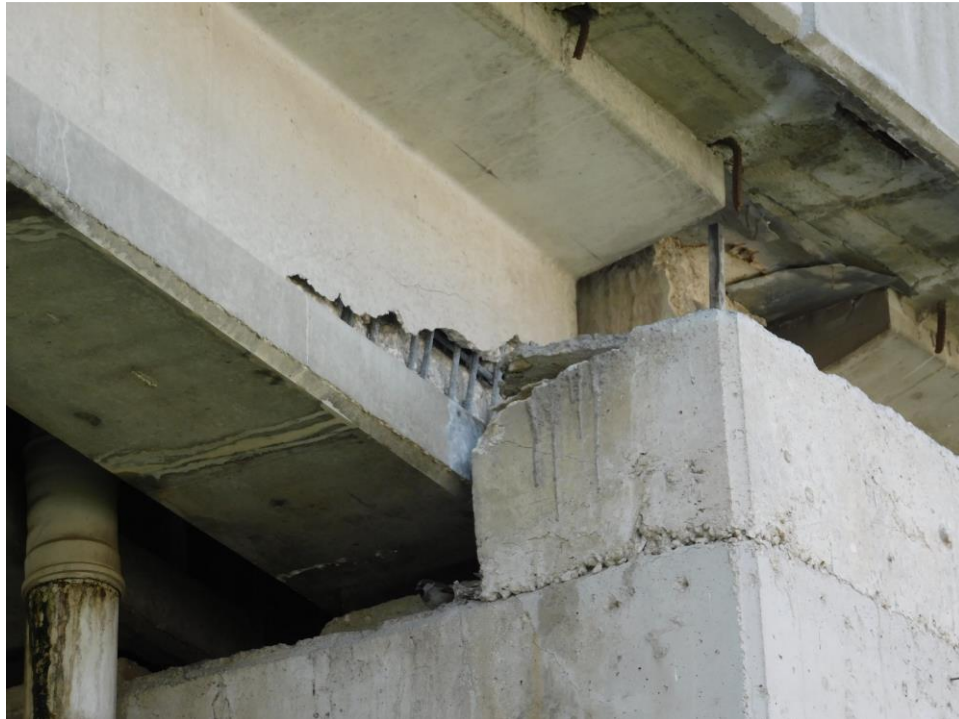
Figure 5-35 Close-up view of damage at end of Bridge 3 precast girder

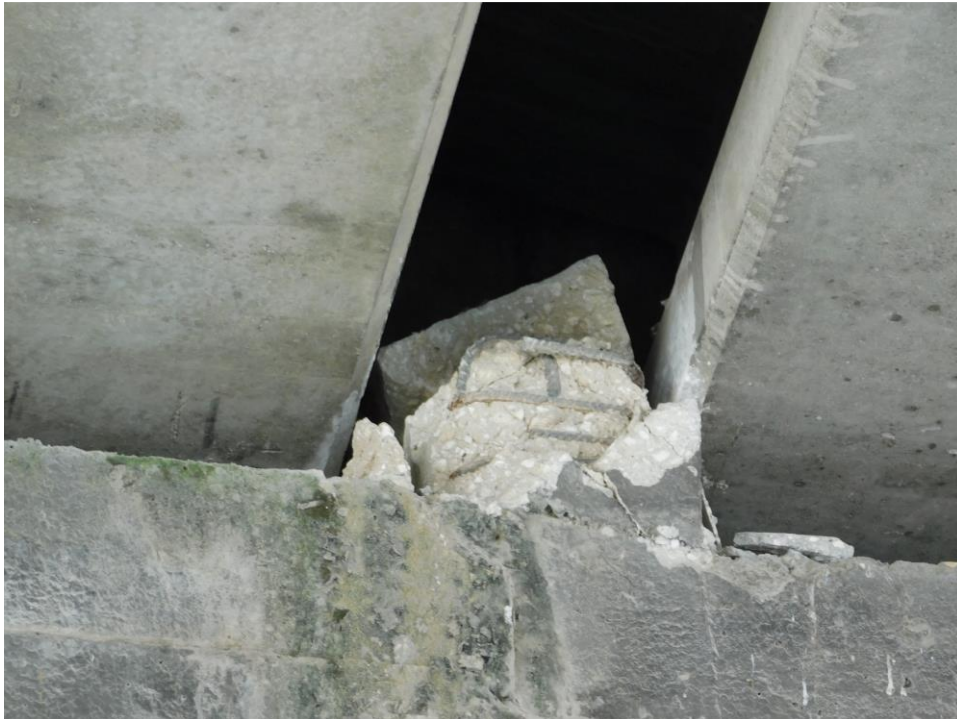
Figure 5-37 Damage of internal shear key at bent of Bridge 3

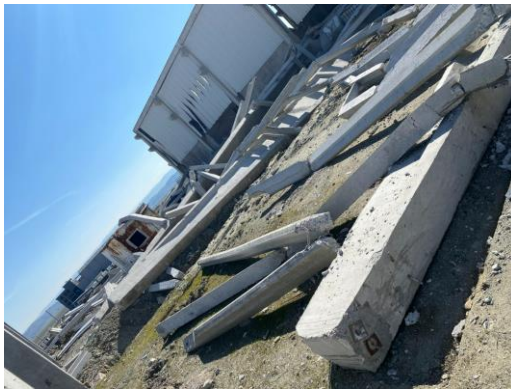
Figure 6-2 Damage of Precast buildigs in Turkoglu OIZ (a) precast tapered beam failure owing to the loss of support, (b) cladding pannels due to panel-to-structure failure

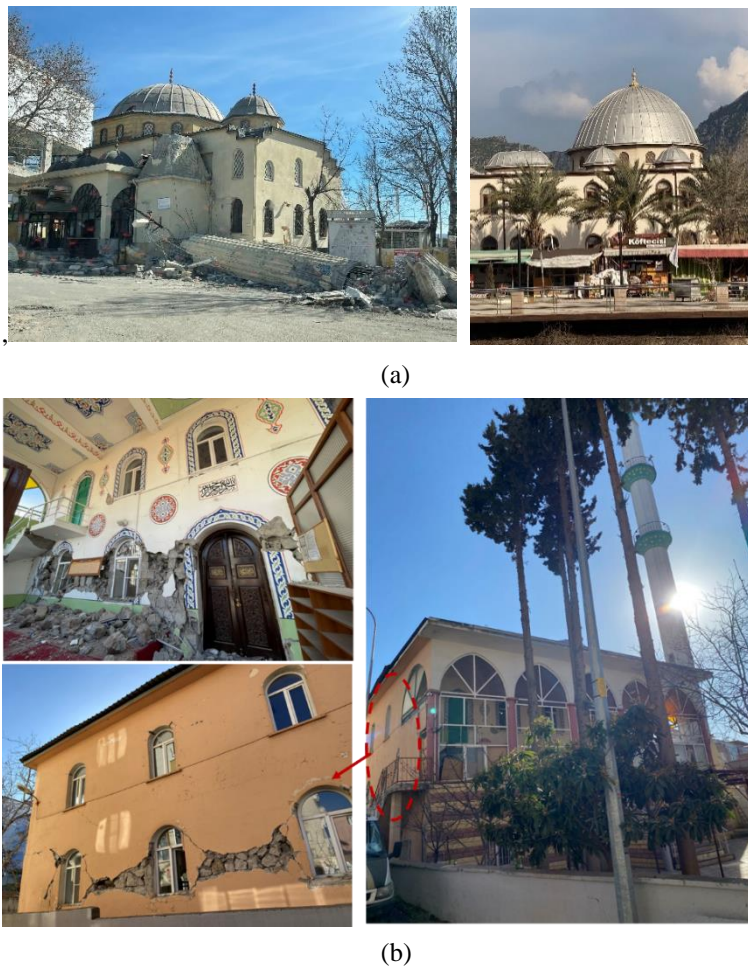
Figure 7-2 Damage of Mosques (a) Haci Murat Mosque in Kahramanmaras, (b) Merkez Cumhuriyet Mosque in Pazarcik
