LUGU, TAIWAN SEPTEMBER 18, 2022, M_w 6.9 EARTHQUAKE PRELIMINARY VIRTUAL RECONNAISSANCE REPORT (PVRR)

Virtual Assessment Team (VAT) Lead: Erica Fischer, Oregon State University	
Virtual Reconnaissance Assessment Team (VRAT) Authors: (in alphabetical order)	
<p>Sofia Aldea, Universidad Tecnica Federico Santa Maria Jorge Archbold, Universidad del Norte James Bantis, Stanford University Miguel Bravo, University of Cambridge Julian Carrillo, Universidad Militar Nueva Granada Luis Ceferino, New York University Katherine Cheng, UC Davis Diego Cordero, CMG Ahmed Elkady, University of Southampton Hector Guerrero, UNAM Selim Günay, UC Berkeley Manny Hakhamaneshi, California High-Speed Rail Authority Pablo Heresi, U Técnica Federico Santa María</p>	<p>Vedant Mathur, UC Berkeley Amory Martin, Exponent Amy Metz, Oregon State University Zorana Mijic, Portland State University Eduardo Miranda, Stanford University Cesar Pajaro, Universidad del Norte Alan Poulos, Stanford University Maria Camila Lopez Ruiz, UC Berkeley Claudio Sepulveda, UC San Diego Elmon Toraman, New York University Anne Wein, USGS Kai Wu, Texas A&M University Juan S. Zambrano, Oregon State University</p>

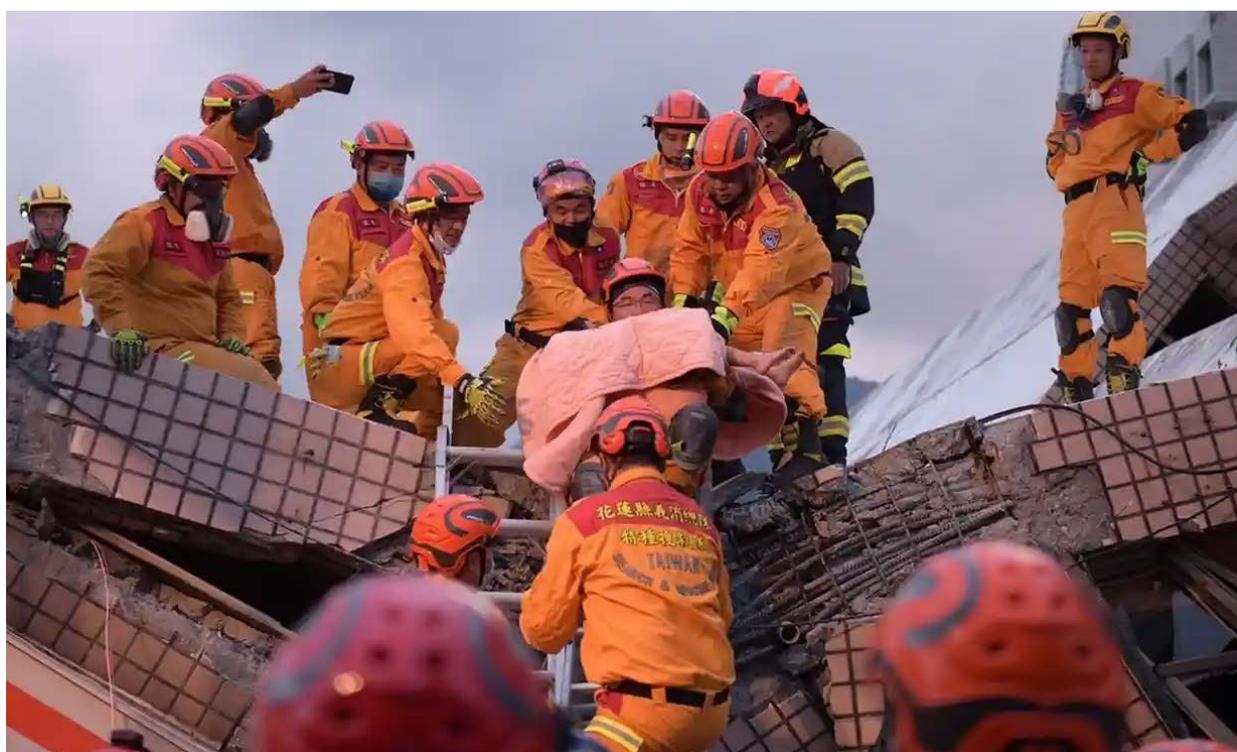
Figure 1.1. Rescue efforts from a collapsed mixed-use building.

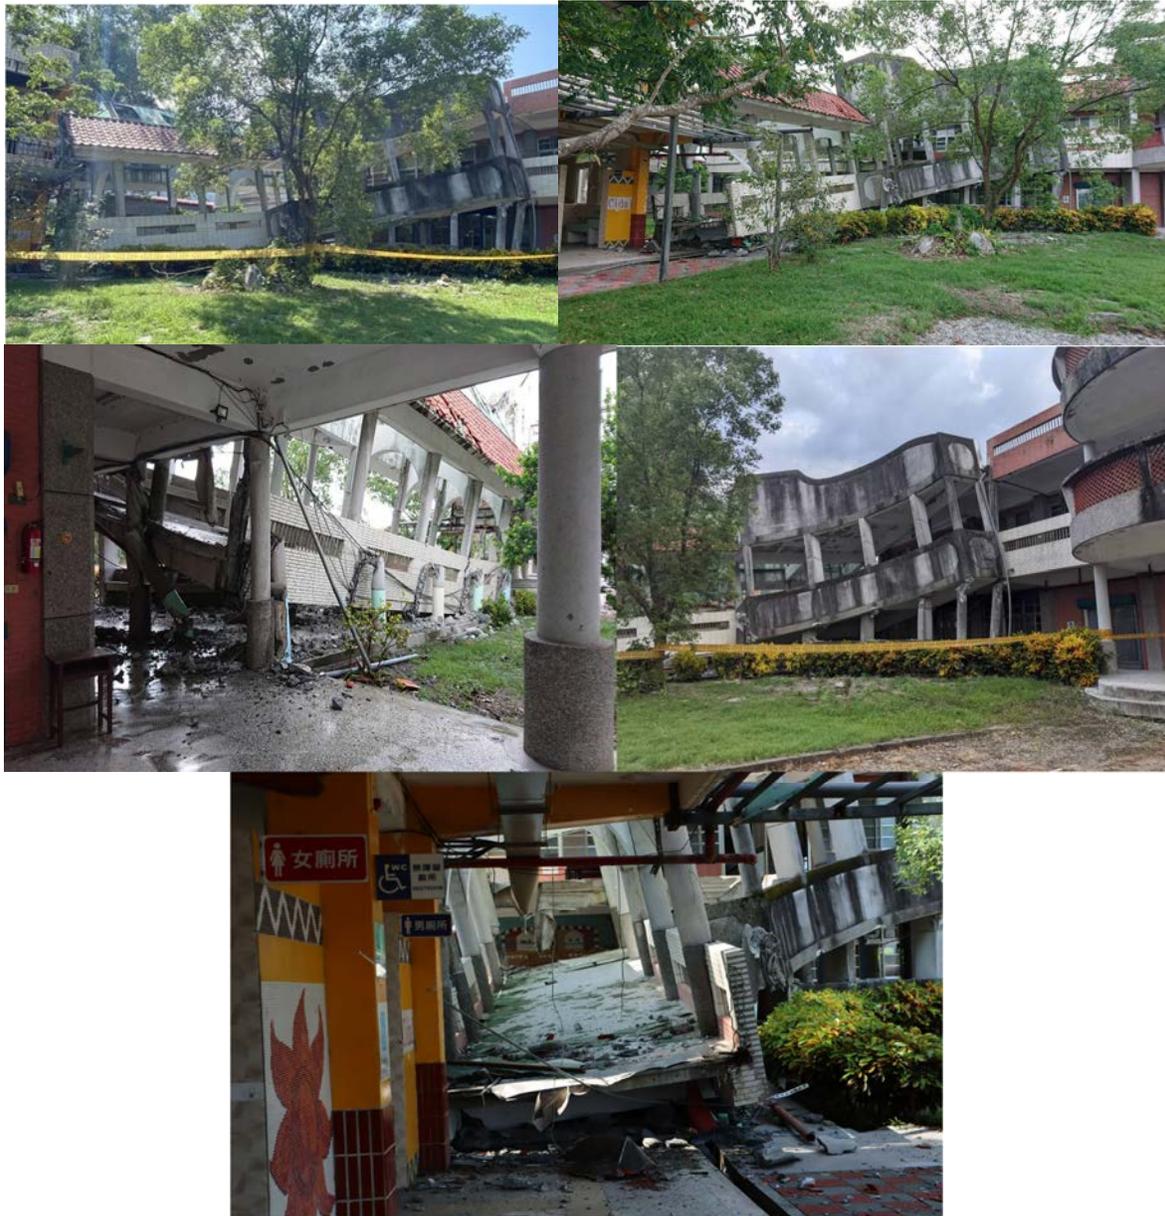
This corridor was originally two stories and due to column failure, the first story of the corridor collapsed, which is shown in Figure 4.1.

Figure 4.1. Damage to a double level corridor at Chun-Rih Elementary School (Yotaka, 2022; 公視新聞網, 2022; Everington & Taiwan News, 2022).

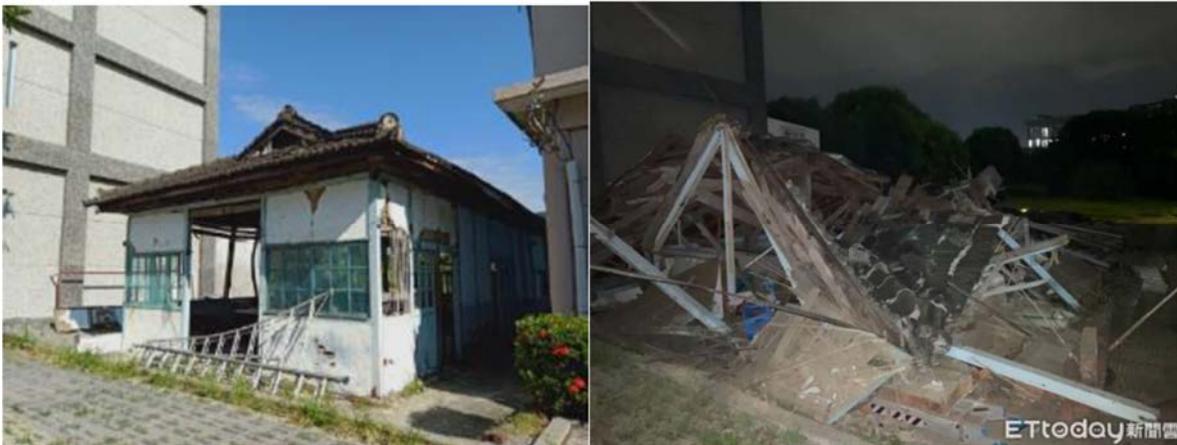
Figure 4.3. House in Taitun city (a) photo of house before the earthquake and (b) photo of house after the earthquake (柯振中、楊漢生, 2022).

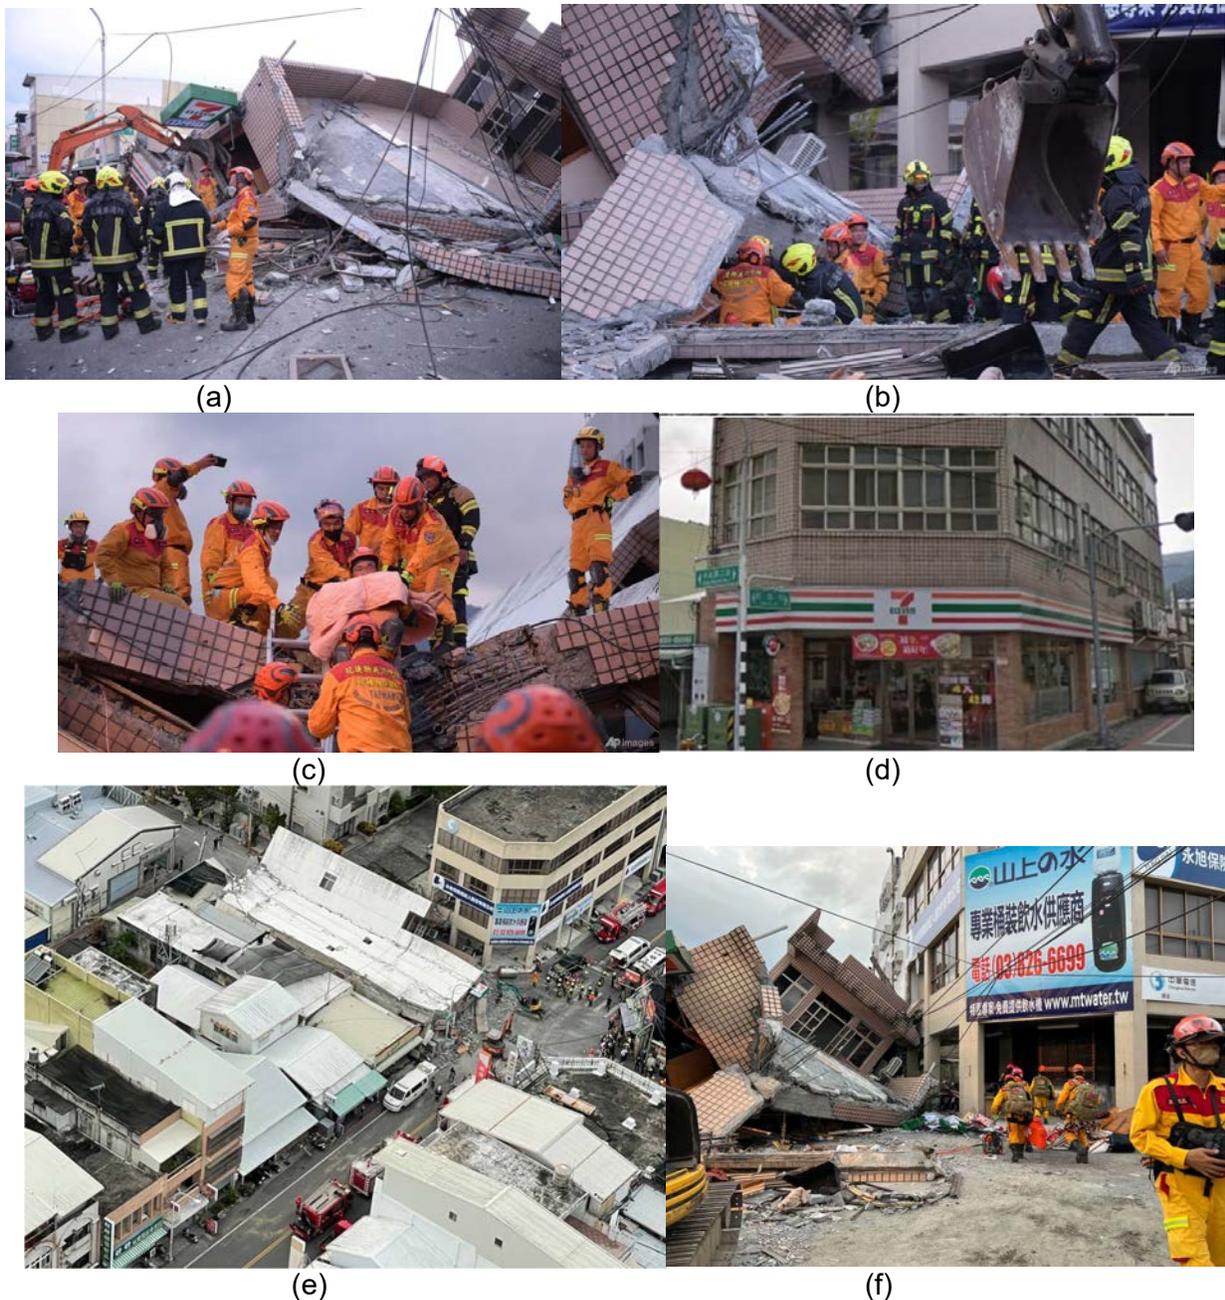
Figure 4.4. Three story mixed-use building collapse in Yuli town. Collapsed building and rescue efforts showing damaged structural components (CNA, 2022 September 19). (a) - (c) collapsed building state, (d) building before collapse, (e) aerial view of collapsed structure (CNA, 2022 September 20), (f) collapsed building impacting the neighboring building (NPR, 2022)

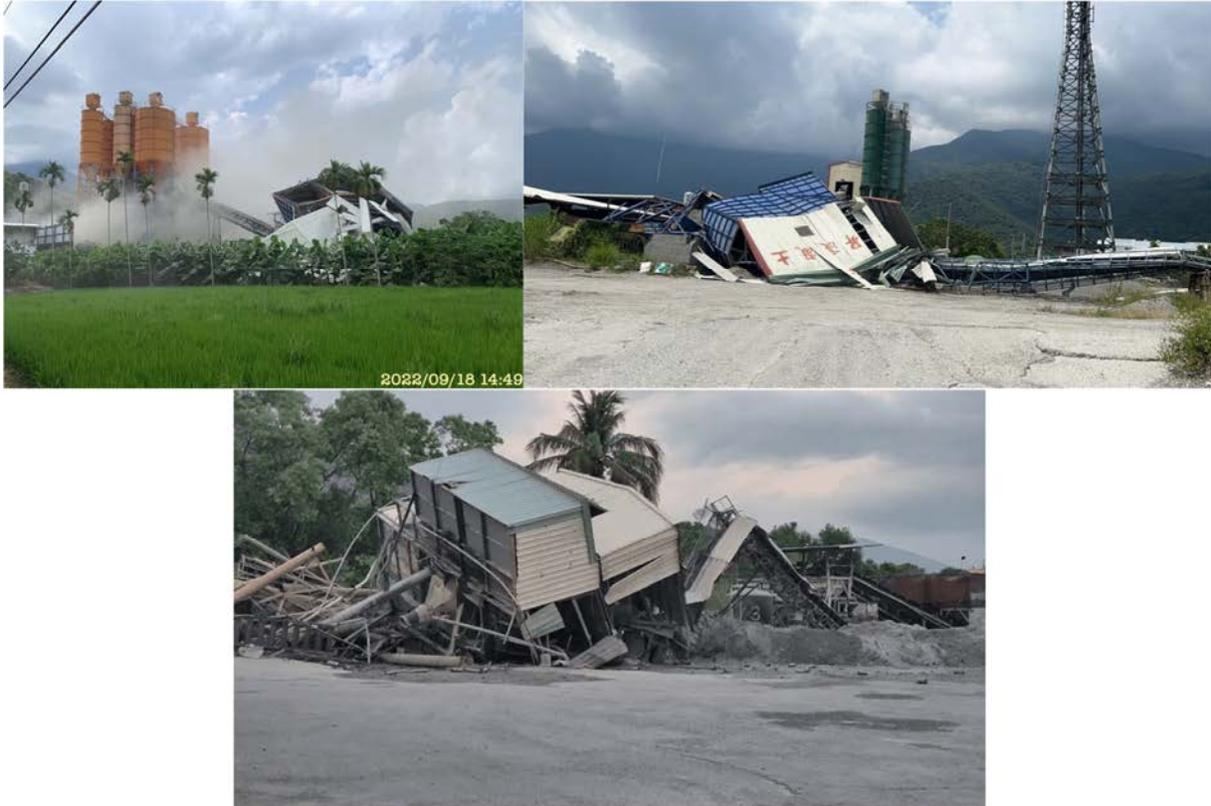
Figure 4.5. Partial collapse in a ready-mixed cement factory in Taitung's Guanshan Township resulting in one fatality (CNA, 2022 September 20).

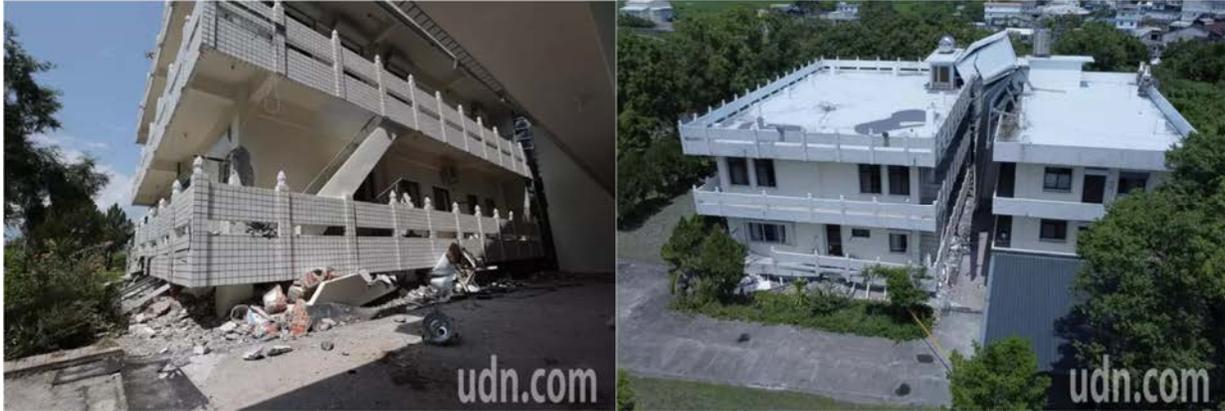
Figure 4.6. The Tianxuan Taoist Temple first floor collapsed in Yuli Township (Zhenghong, 2022).

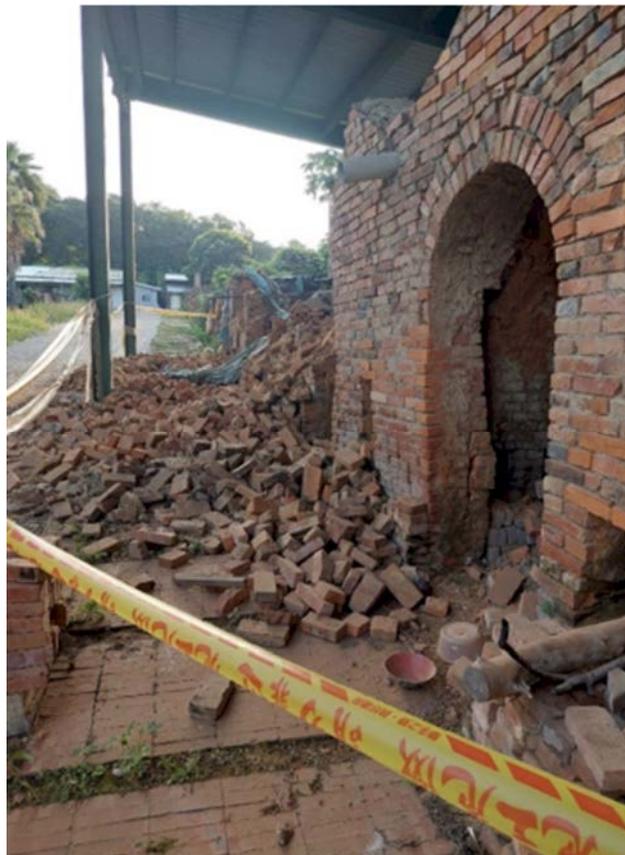
Figure 4.9. Partial collapse of Wan 'an brick factory kiln in Chishang, Taitung [Photo by Chuan-Mi, Cao (曹鈞蜜)].

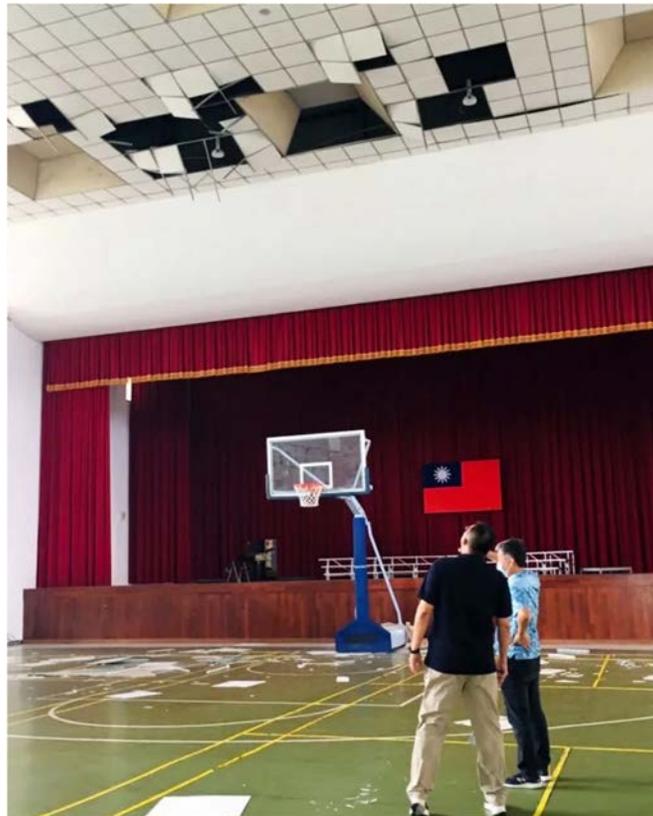
Figure 4.10. Damaged ceiling tiles at a school in Pingtung County (CDNS E, 2022).

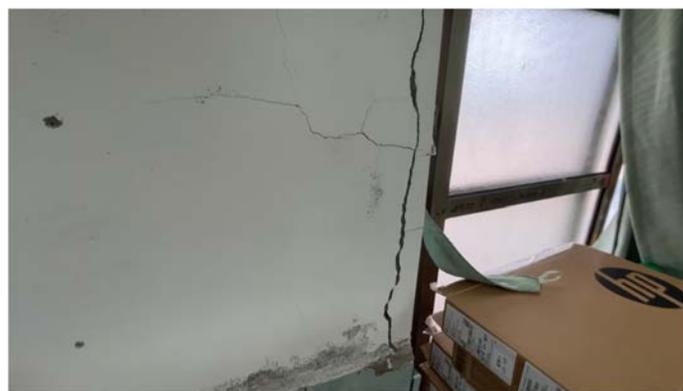
Figure 4.11. Cracks on walls inside schools (Chen & Van Trieste, 2022).

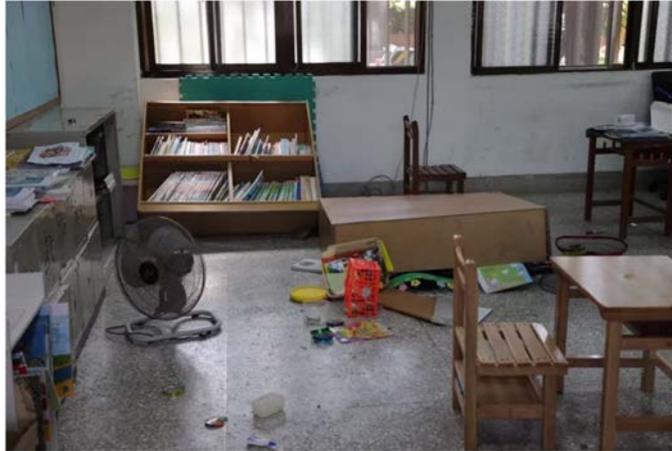
Figure 4.12. Fallen bookshelves due to the earthquake at Kasuga Elementary School in Yuli Town, Hualien County (Picture taken by reporter Xu Zhenghong) (Sihui et al.,2022).

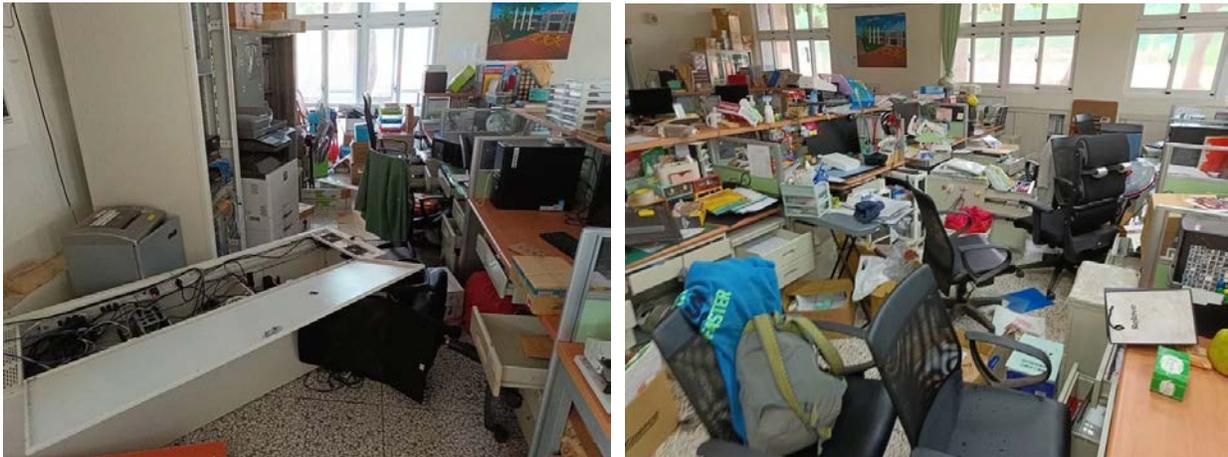
Figure 4.13. Items fallen off bookshelves and shelving units collapsed at the affected schools in Hualien County (Yanhua & Sihui, 2022).

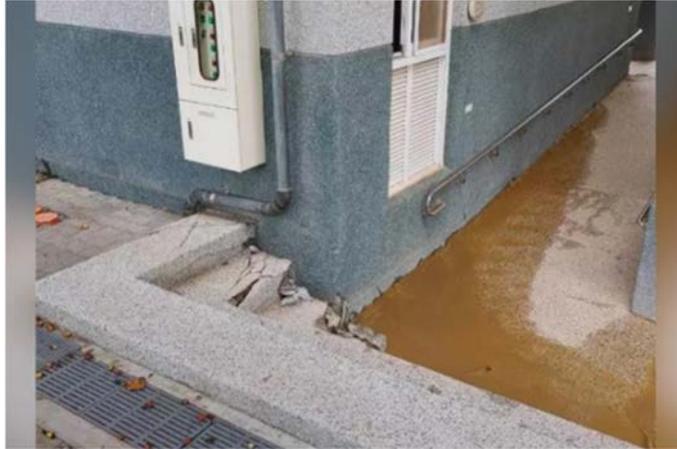
Figure 4.14. Flood from ruptured septic tank at Yuli Spring Elementary School (Yanhua & Sihui, 2022).

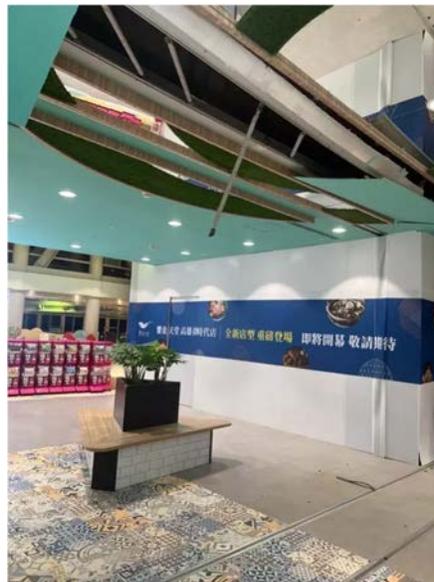
Figure 4.16. Ceiling tile damage within mall in Kaohsiung City called Kaohsiung Dream Era (Baoguang, 2022).

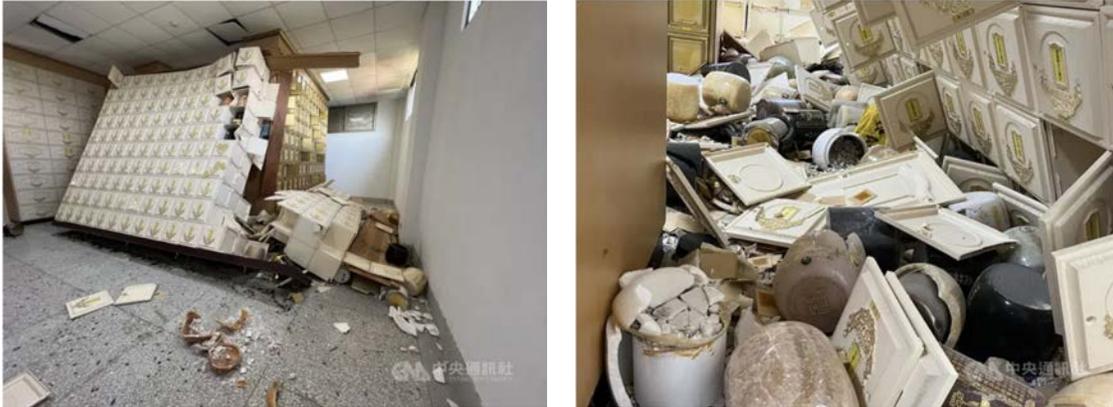
Figure 4.17. Damage due to dynamic overturning of wooden storage racks at a columbarium in Taitung (CNA, 2022 September 18; CNA Southern Local Group, 2022; Manda, 2022).

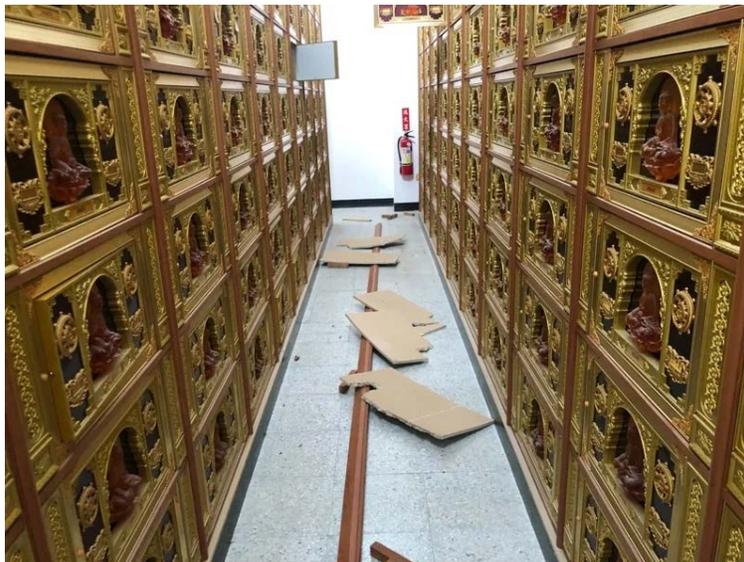
Figure 4.18. Damage to the columbariums of Matsuura and Changliang in Hualien Yuli Town showing damaged ceiling tiles on the floor and open doors to urn chambers (Photo courtesy of Yuli Town Office) (Sihui, 2022).

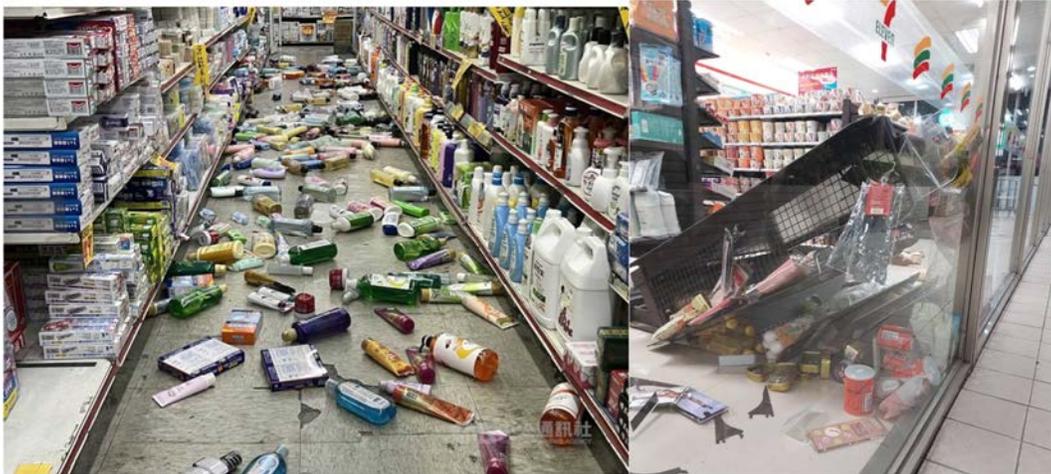
Figure 4.19. Collapsed -overturned- shelves and fallen products in supermarkets in Chishang, Taitung

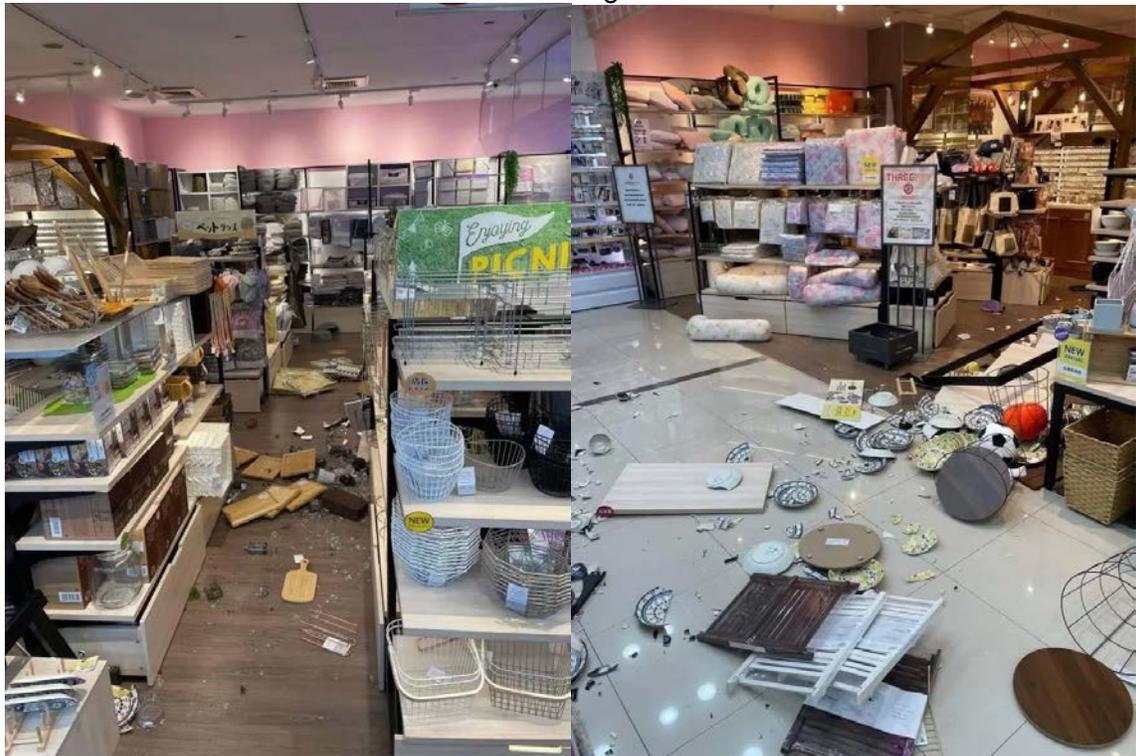
Figure 4.20. Items fell off shelves in a mall in Kaohsiung City

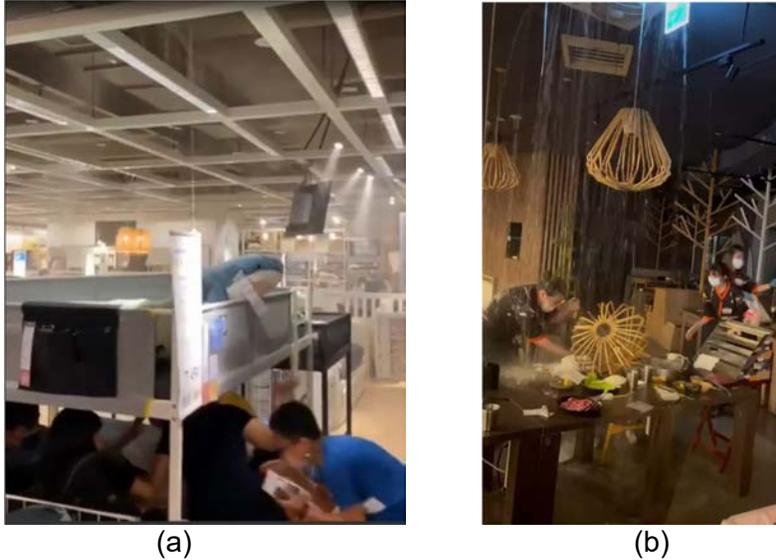
Figure 4.21. Rupture of sprinkler lines (a) in IKEA in Xinzhuang (Picture originally retrieved from Aixinzhuang, Facebook); (b) in a mall in Kaohsiung City called Kaohsiung Dream Era (Baoguang, 2022; 三立新聞網, 2022; 鐘如庭, 2022).

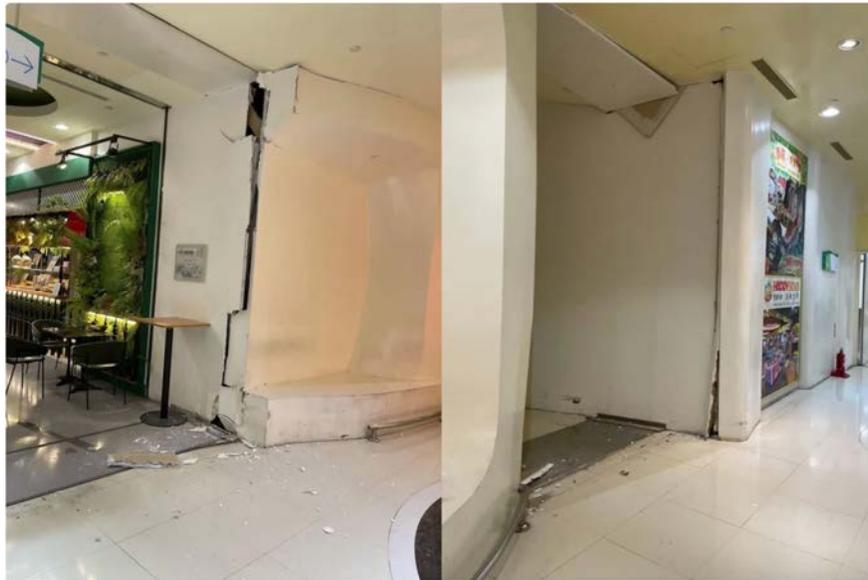
Figure 4.22. Damage to non-structural walls within a shopping center (CDNS L, 2022).

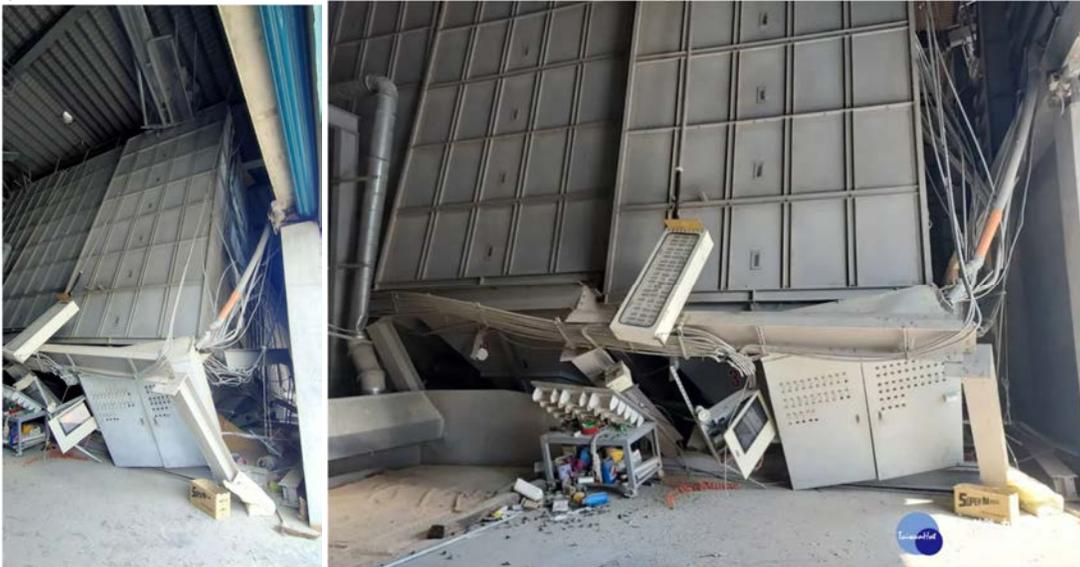
Figure 4.23. Damage to the refrigerated storage and drying equipment of a rice milling plant located in Guanshan Town (地方中心／台東報導, 2022; CNA, 2022 September 17).

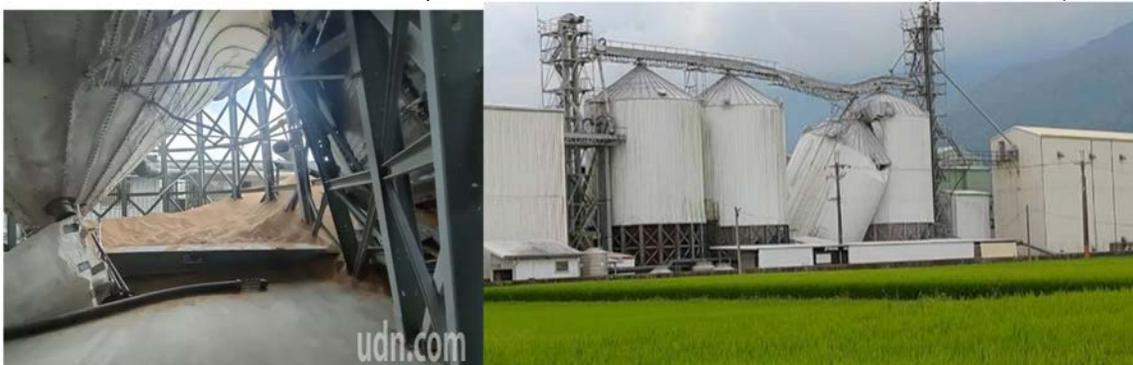
Figure 4.24. One of four rice storage tanks that collapsed due to the earthquake at the Farmers Association's Rice milling plant (Xin Qinkun Rice Factory) in Guanshan Township, Taitung

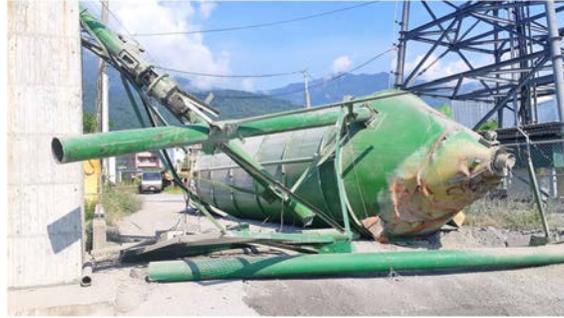
Figure 4.25. Collapsed concrete storage tank next to power lines in Taitung County's Guanshan Township (Shan, 2022).

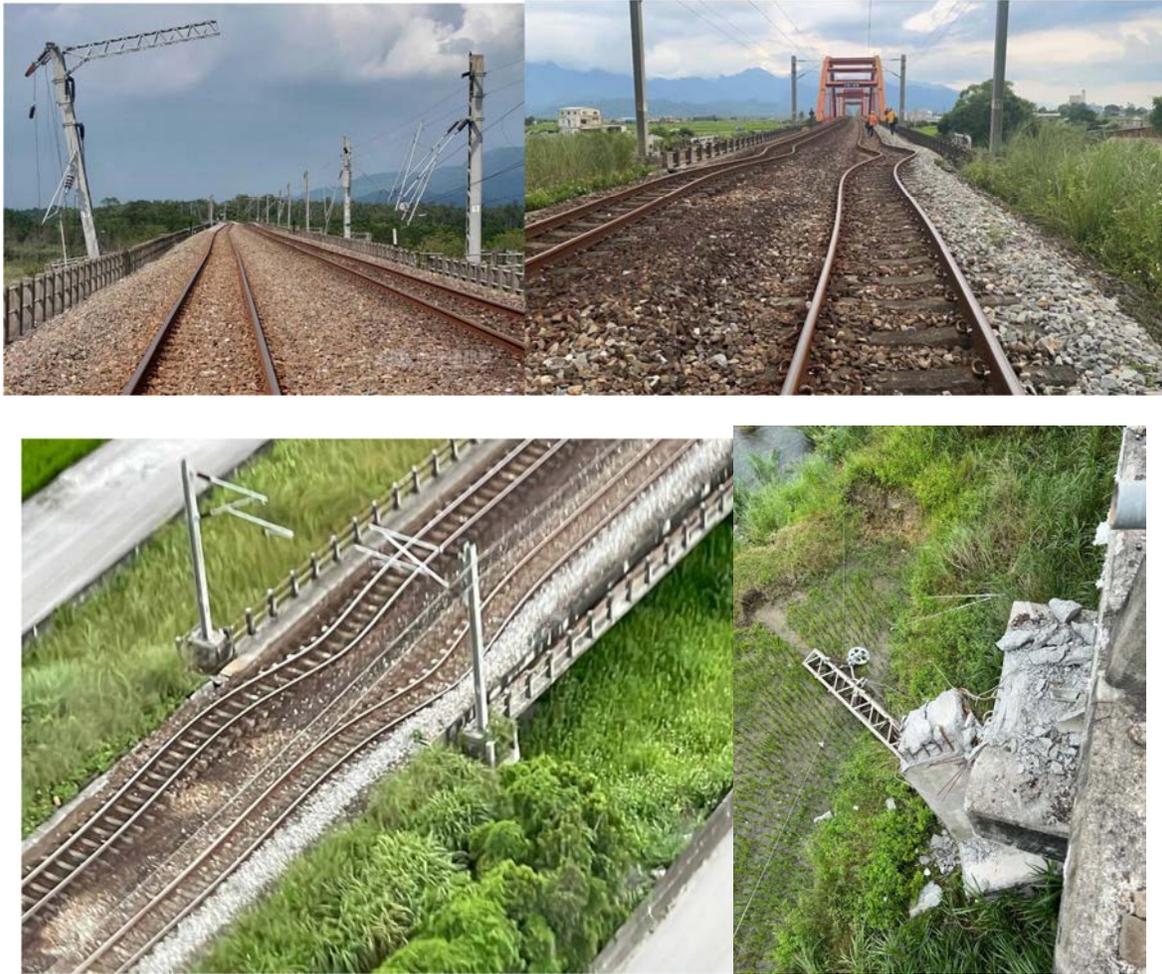
Figure 5.2. Buckled rail tracks and collapsed train power lines (Qiongyu, 2022; CNA, 2022 September 20).

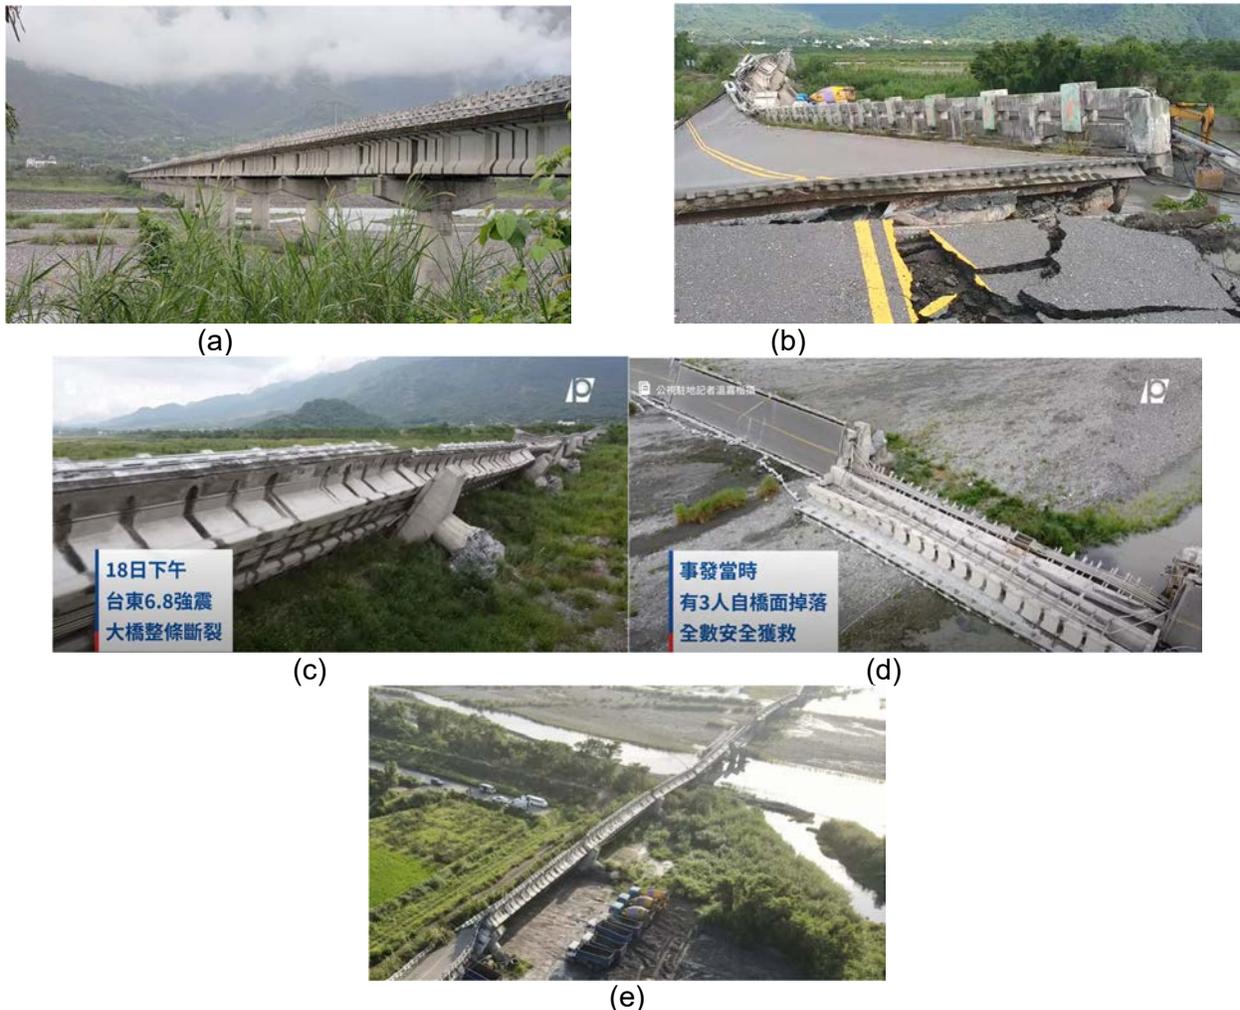
Figure 5.6. Gaoliao bridge (a) Before collapse (Photo by reporter Hua Mengjing); (b) - (e) Photos of the Gaoliao bridge after the earthquake (華夢靜, 2022; 華夢靜, 2022; Public Television News Network, 2022).

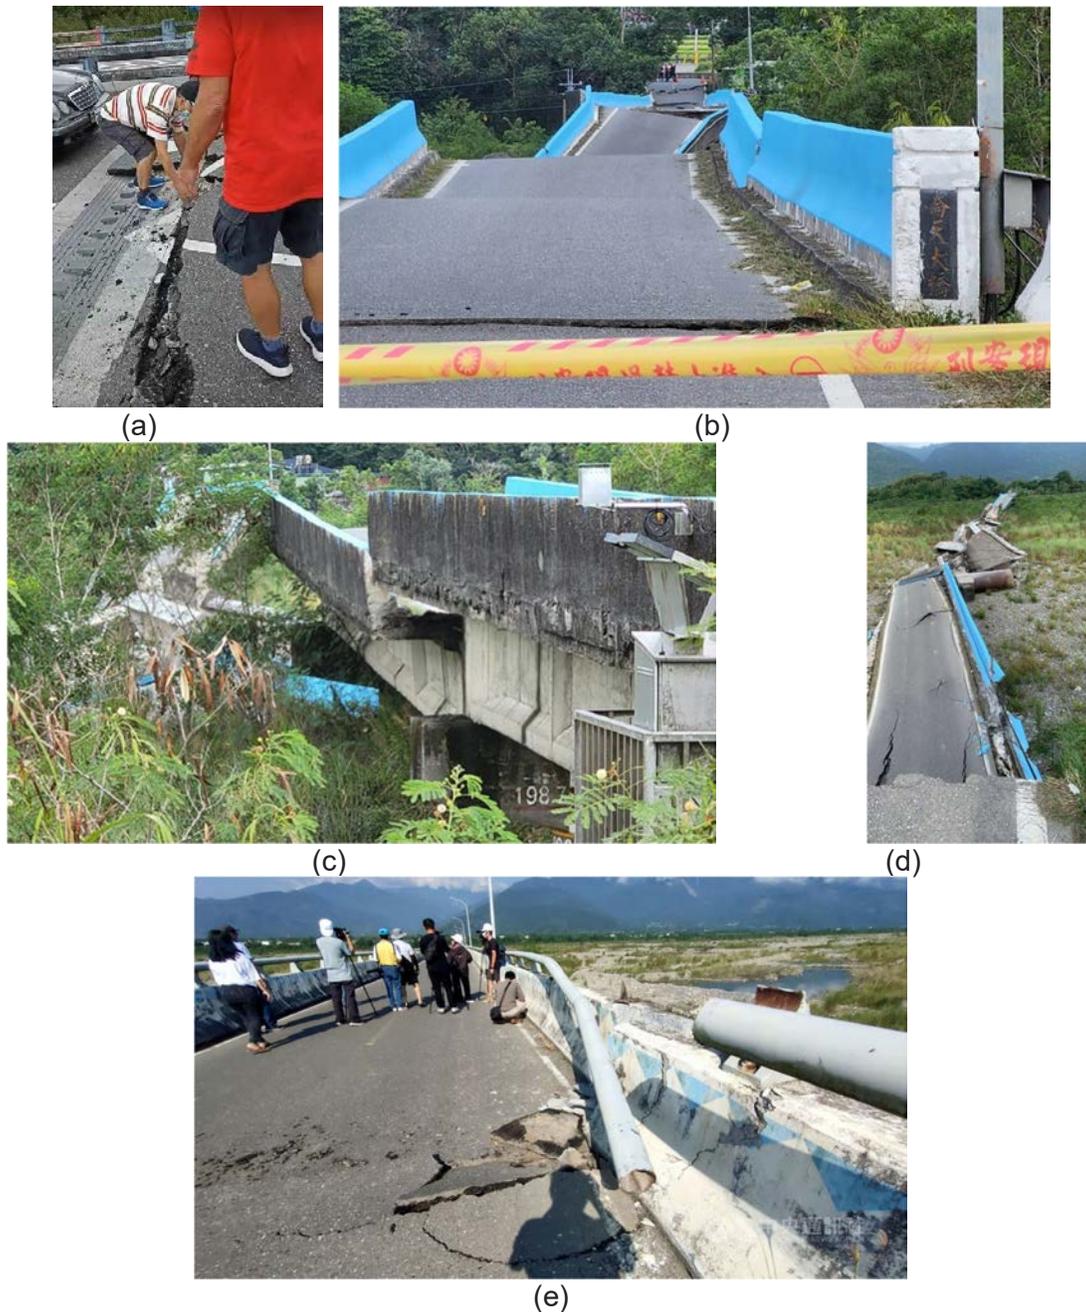
Figure 5.7. Deck damage to bridges (a) Yuli Bridge (CNA, 2022 September 20); (b) - (c) Luntian Bridge (NCREE, 2022b); (d) collapse of the Luntian Bridge (華夢靜, 2022); (e) Baohua Bridge in Luye Township (CNA, 2022 September 18).

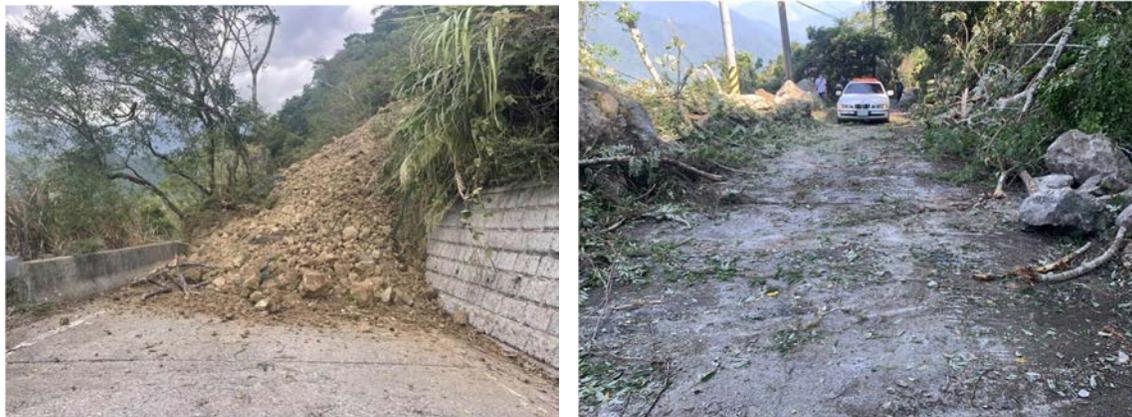
Figure 5.8. Rockfalls on the Sixty Stone Mountain Road in Hualien (CNA, 2022 September 20; CNA Southern Local Group, 2022 September 18).

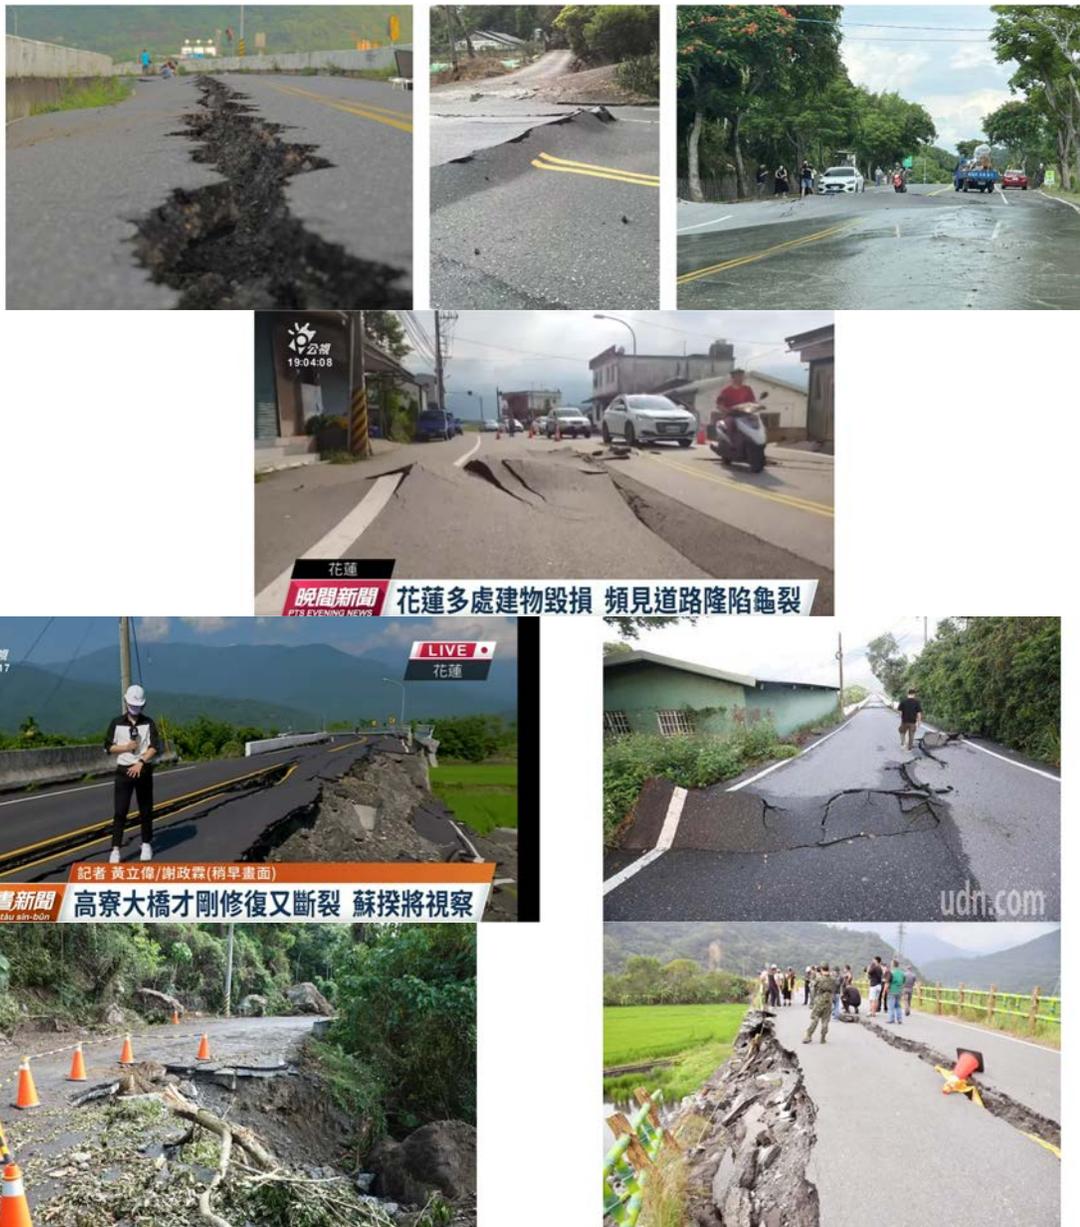
Figure 5.9. Roadway damage (a) Crack in the roadway close to the collapsed Kaoliao bridge in eastern Taiwan's Hualien county (Incredible Images, 2022); (b) Buckling of roadway on Dongli Road (NCREE, 2022b); (c) Buckling of road on Provincial Highway No. 9 in Fuli Township (華夢靜., 2022); (d) Buckling of road in Hualien County; (e) Cracking of road near Gaolin Bridge (Public Television News Network, 2022a); (f) Pavement failure (Hicks, 2022); (g) Road damage due to landslide in Huadong, Taitung area. Photo by Kang Zhongcheng (王瑞琪, 2022); (h) Road near Zhuofu Bridge in Zhuoxi Township was severely cracked (CDNS C, 2022).

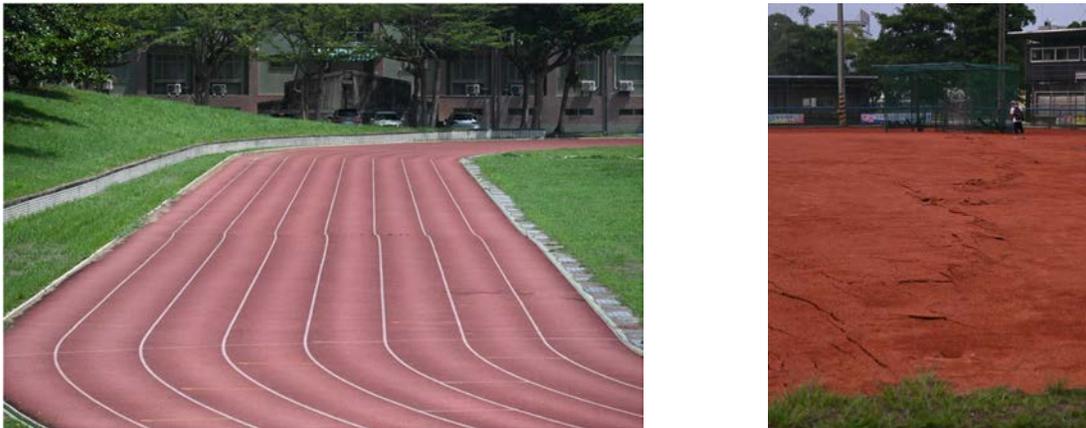
Figure 6.3. Surface rupture on sports fields (a) Running track at Yuli Township (Yu, 2022 a) and (b) En echelon cracks on the baseball field in Yuli Township (Yu, 2022 b)

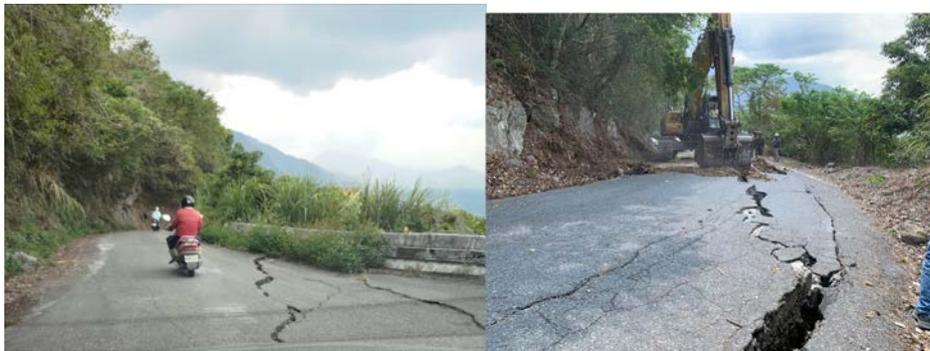
Figure. 6.5. Vertical crack formation on the roadway forming headscarp of the landslide at Fuli township Hualien. (Liu, 2022)

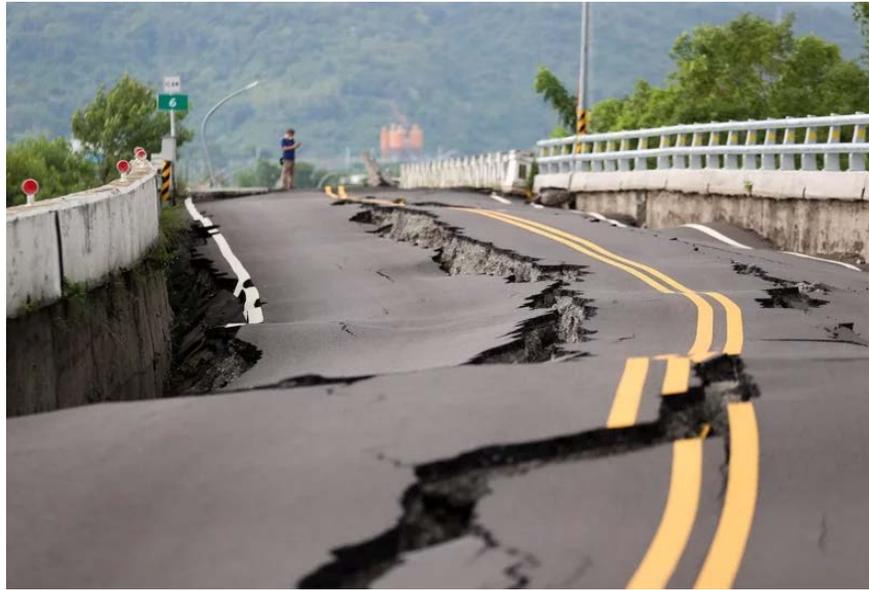
Fig. 6.6. Collapse of the bridge abutment and the excessive lateral movement of the retaining wall contributed to the collapse of the Gaolio Bridge in Hualien (Chenghan, 2022)

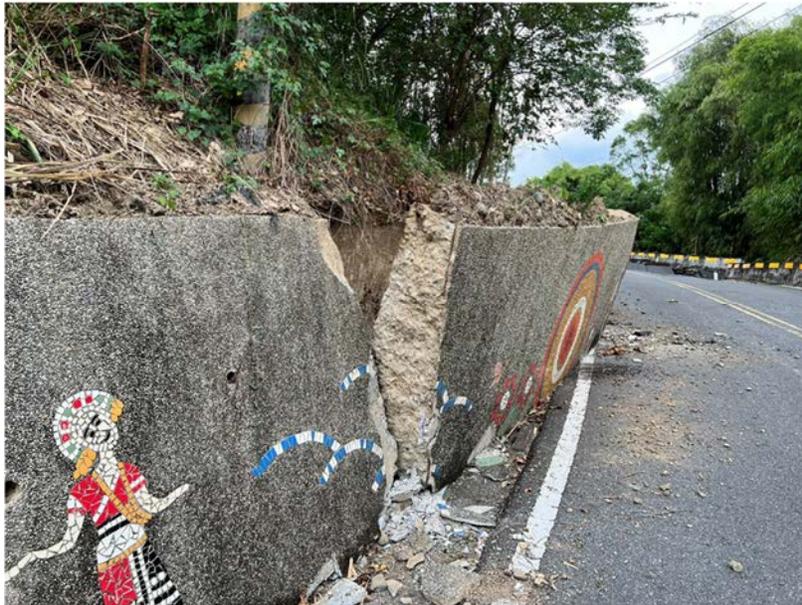
Figure. 6.7. Failure of the retaining wall along Highway 9 in the Longitudinal Valley(Yen, 2022)

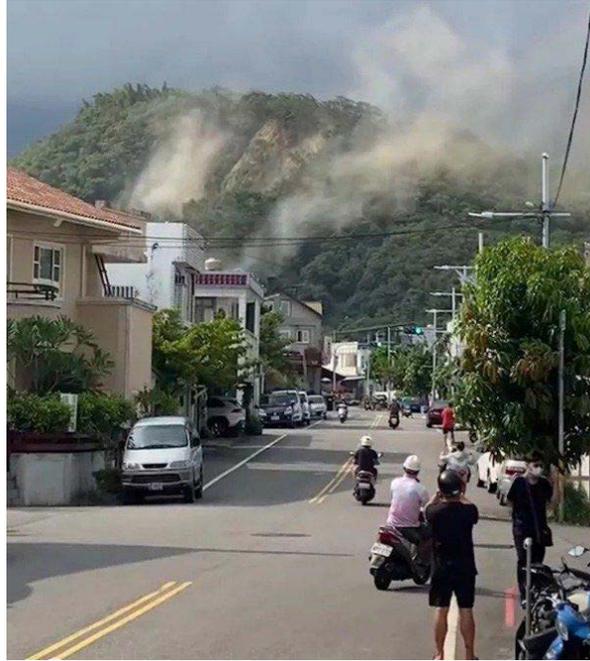
Figure 6.11. Landslide occurred in Orange Mountain in Chenggong Town, Taitung city (2022)
