M6.4 Paratebueno Earthquake

June 8, 2025

NHERI DesignSafe Project ID: PRJ-6007

JOINT RECONNAISSANCE REPORT (JRR)

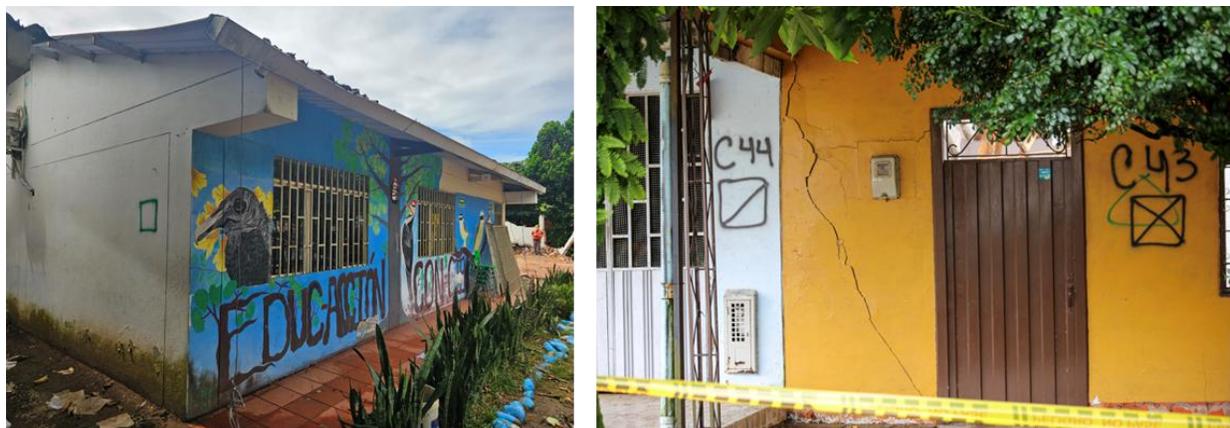
Figure 1.7. Post-earthquake safety tags observed in Paratebueno: (left) safe, (b) restricted use and unsafe (Credit: Archbold and Carrillo).

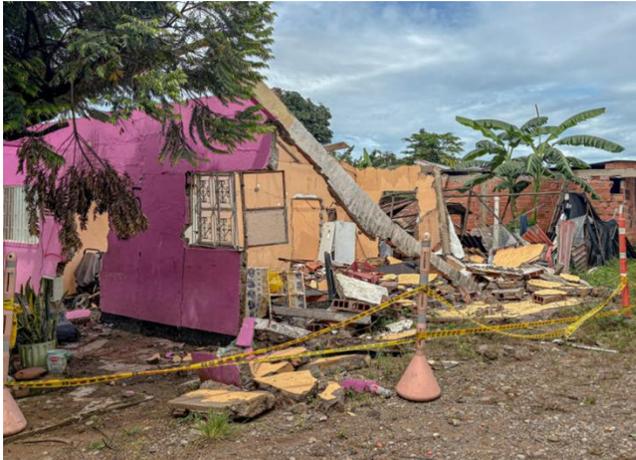
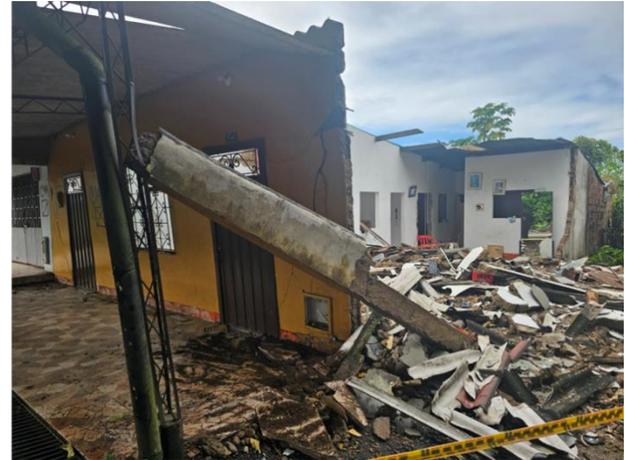
Figure 4.2. Examples of URM single family house collapse in Santa Cecilia (Credit: Archbold and Carrillo).

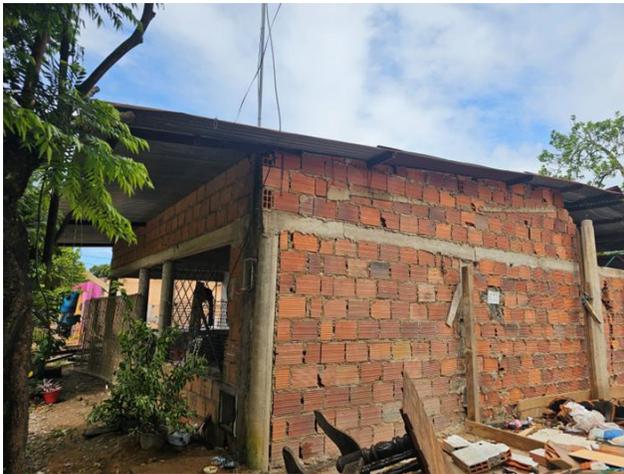
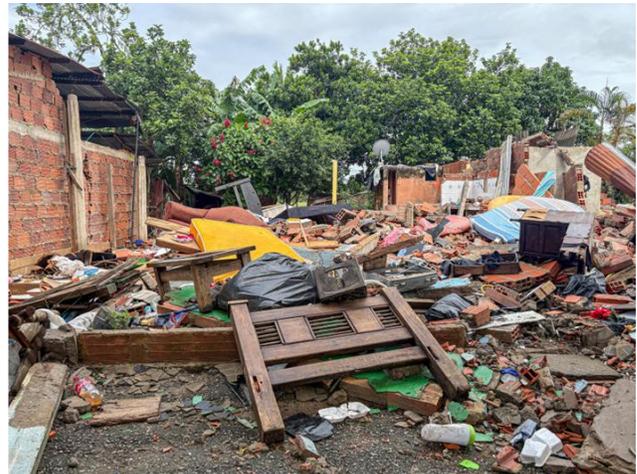
Figure 4.3. Comparing damage of a partially-confined masonry house (left) compared to an unreinforced masonry house on the same block in Santa Cecilia (Credit: Archbold and Carrillo).

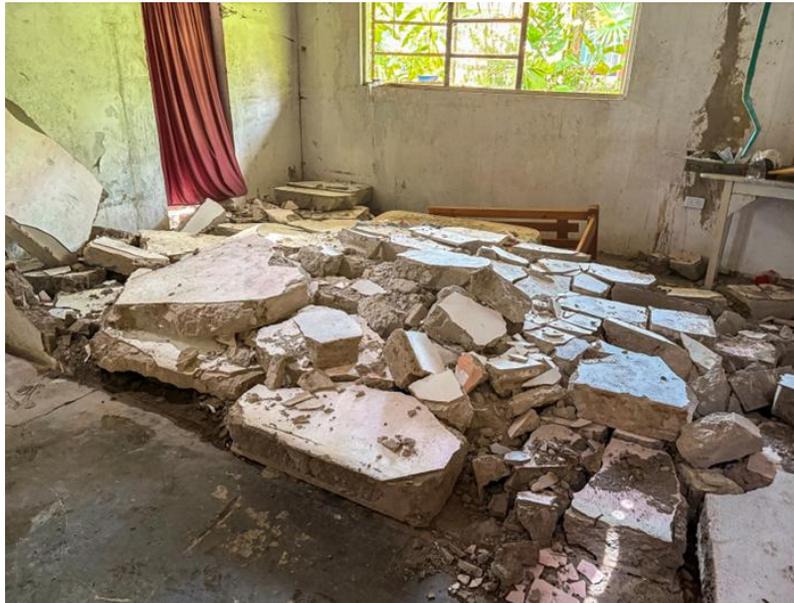
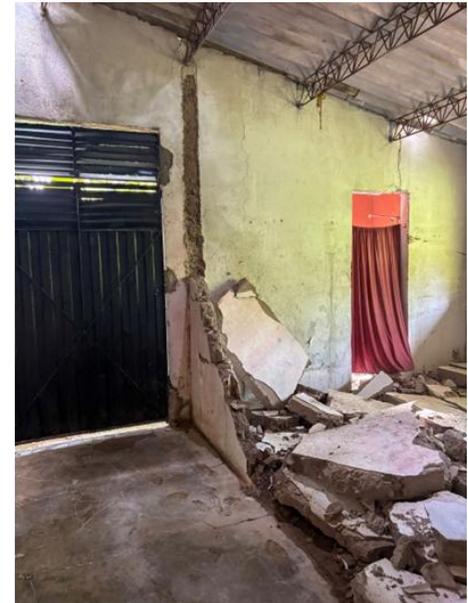
Figure 4.4. Interior view of a collapsed masonry wall in residence in Japón, Cundinamarca; room was unoccupied at the time of the earthquake, preventing potential injury (Credit: Archbold and Carrillo).

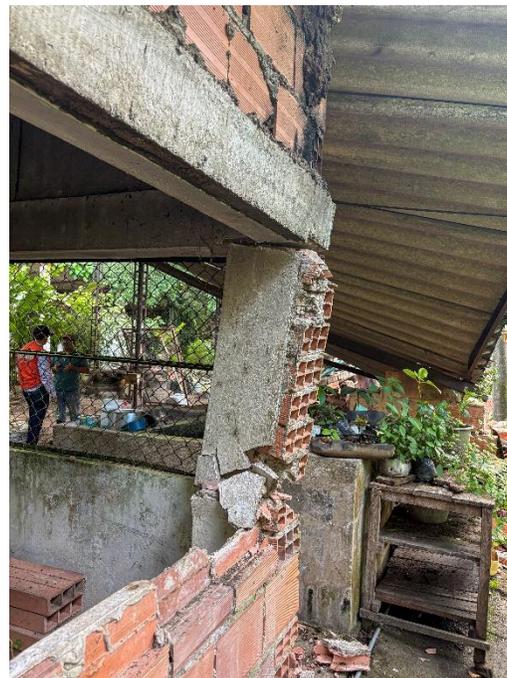
Figure 4.5. Severely damaged outdoor kitchen structure outside residence in Japón, Cundinamarca; structure was supported by unreinforced masonry piers (Credit: Archbold and Carrillo).

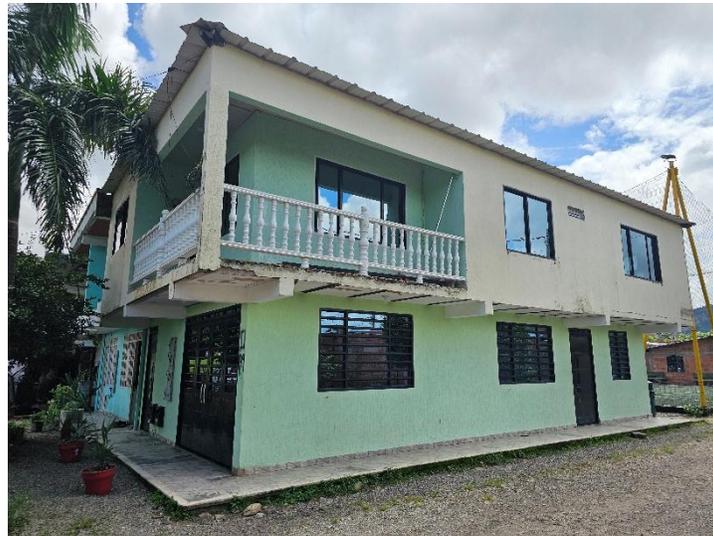
Figure 4.6. Performance of a two-story concrete frame house with infill walls in Japon, Cundinamarca (Credit: Carrillo).

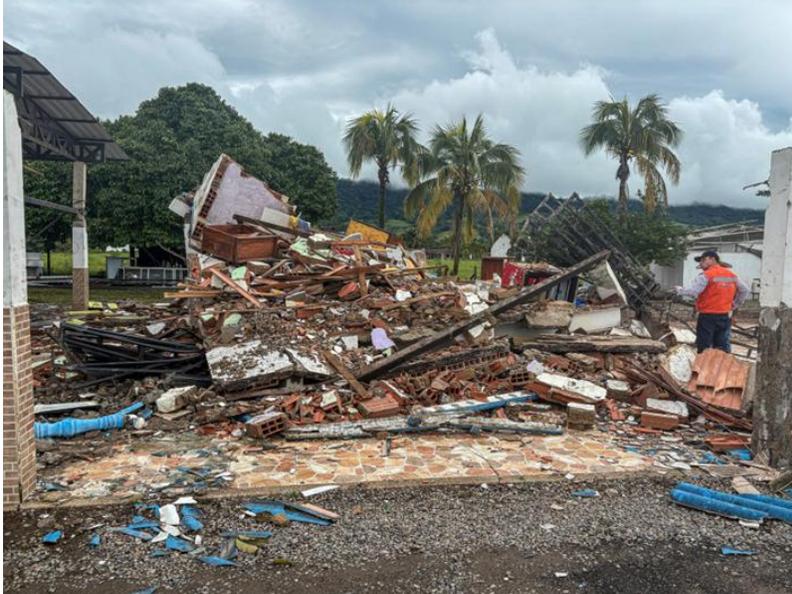
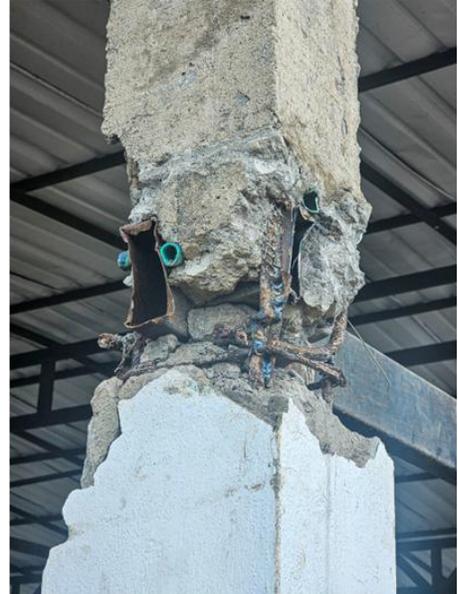
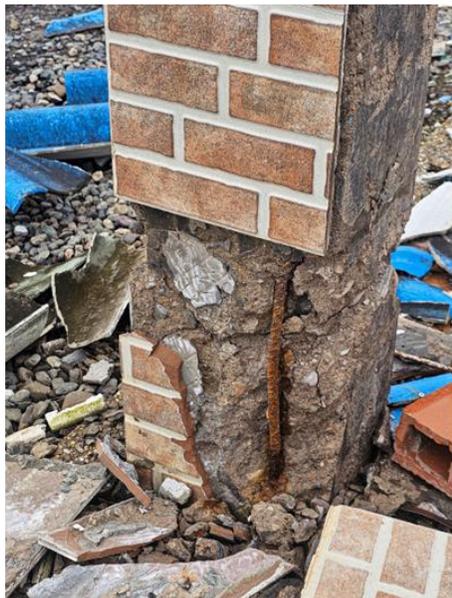
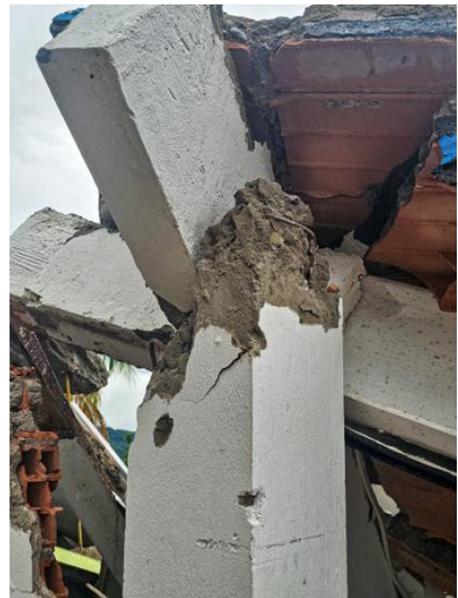
Figure 4.8. Structural details observed in collapse of the Siete Cueros commercial building in Santa Cecilia, Paratebueno—same site shown in Figure 4.7 (Credit: Archbold and Carrillo).

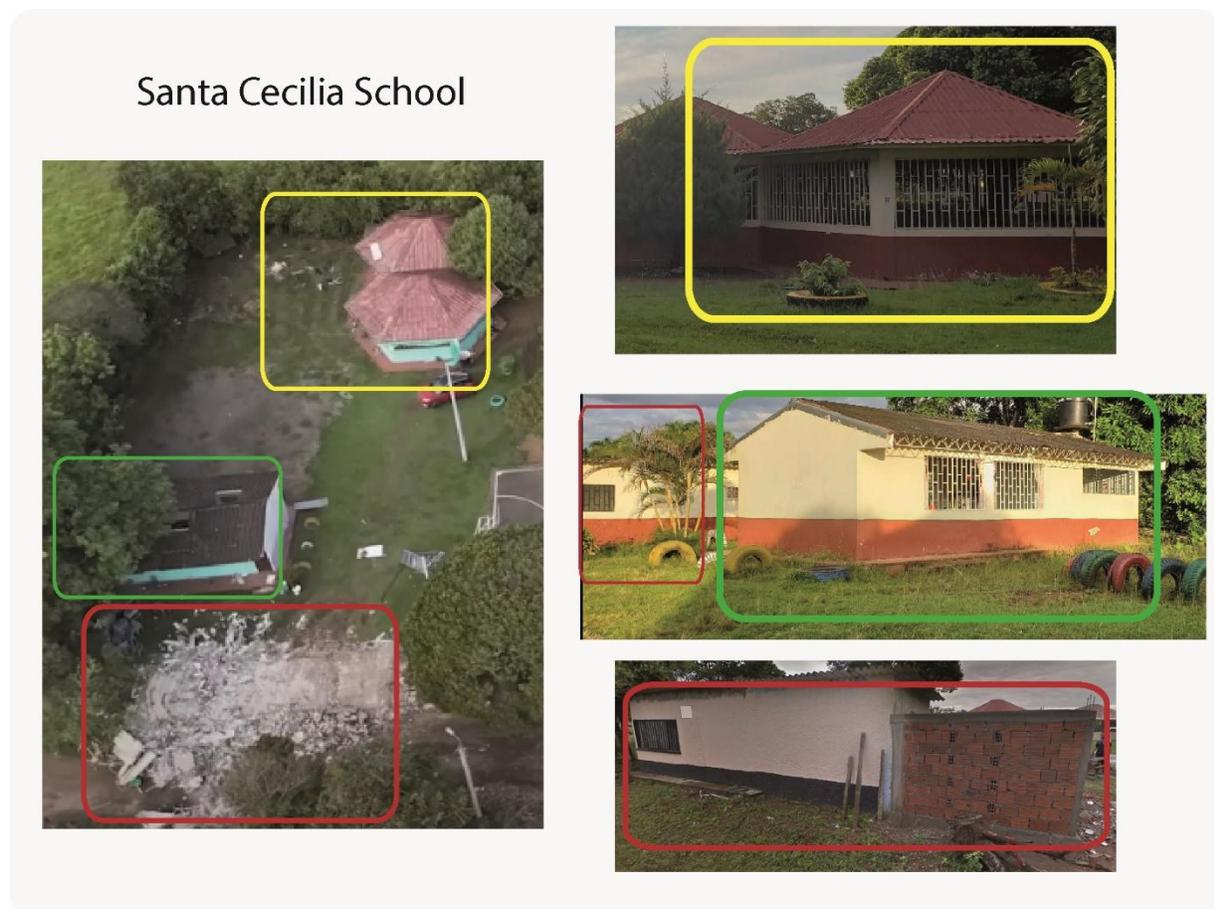
Figure 4.9. General view of Santa Cecilia School. Building of the school (left) after the earthquake (Source: El tiempo, 2025b) and (right) details of the structures (Source: Google Maps).

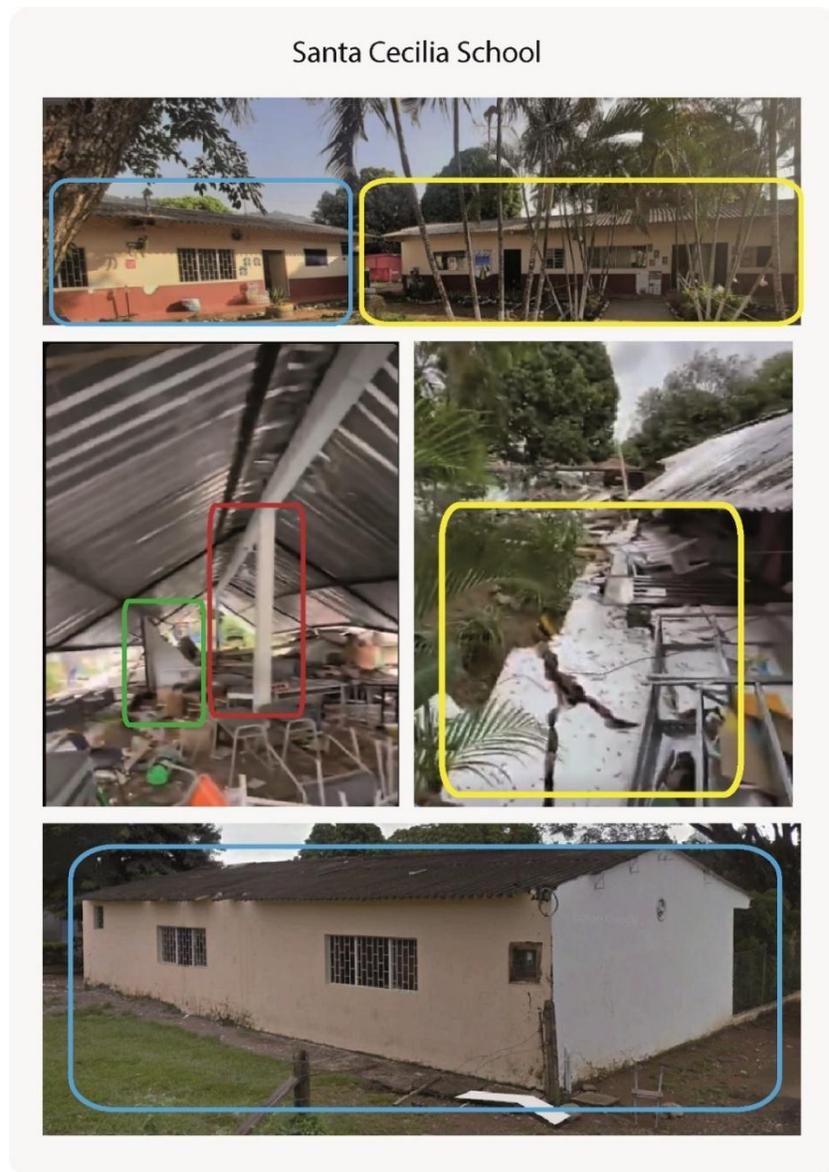
Figure 4.10. Collapsed buildings in Santa Cecilia School and details of the collapse: (top) structure before the earthquake (Source: IEDR Santa Cecilia, 2025); (middle) damages and collapse of the school (Source: Facebook, 2025); (bottom) school module before the earthquake (Source: Google Maps).

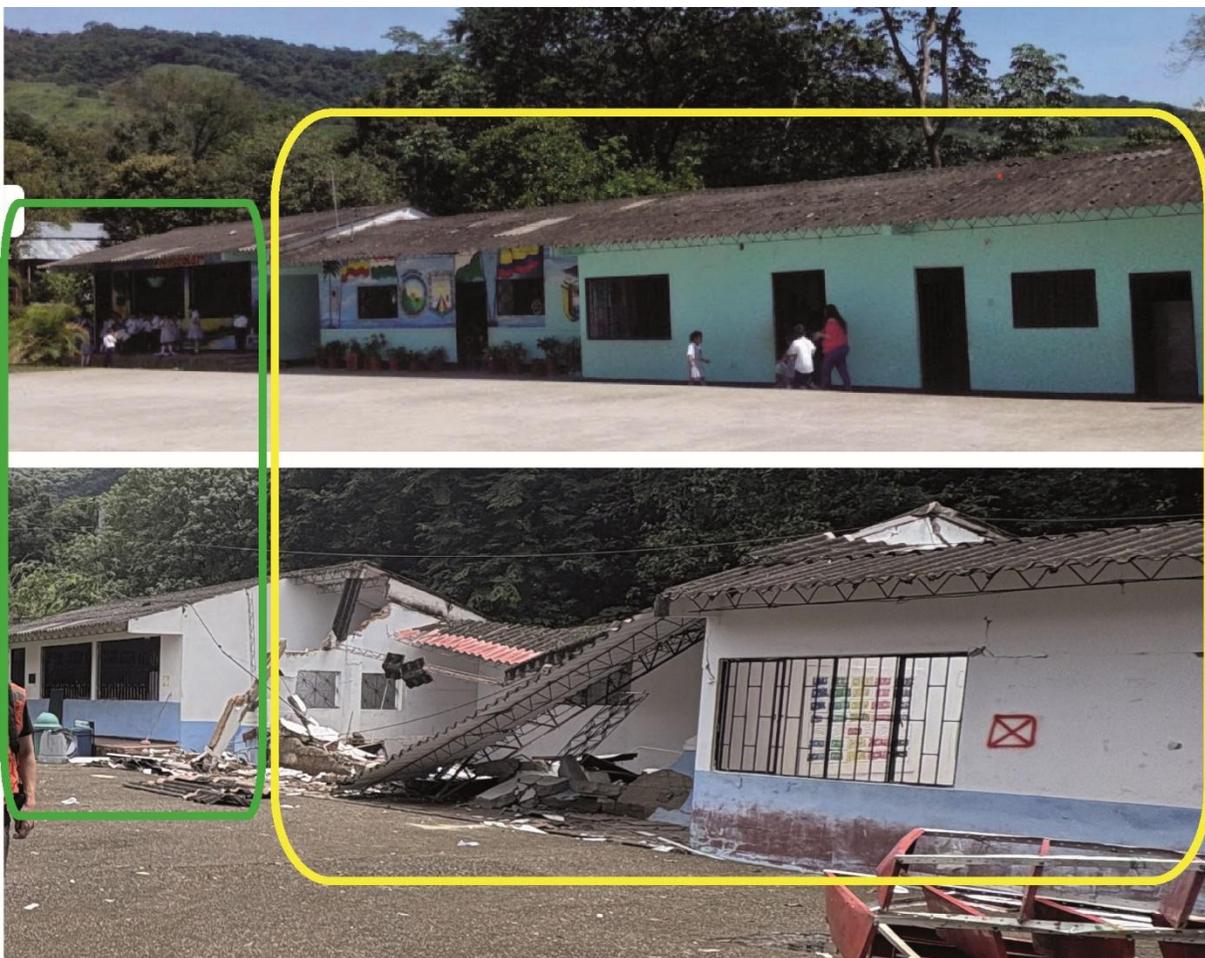
Figure 4.12. Collapsed and undamaged buildings at Japón municipality school campus: (top) structure before earthquake (Source: Google Maps); (bottom) collapsed building (Credit: Archbold and Carrillo).

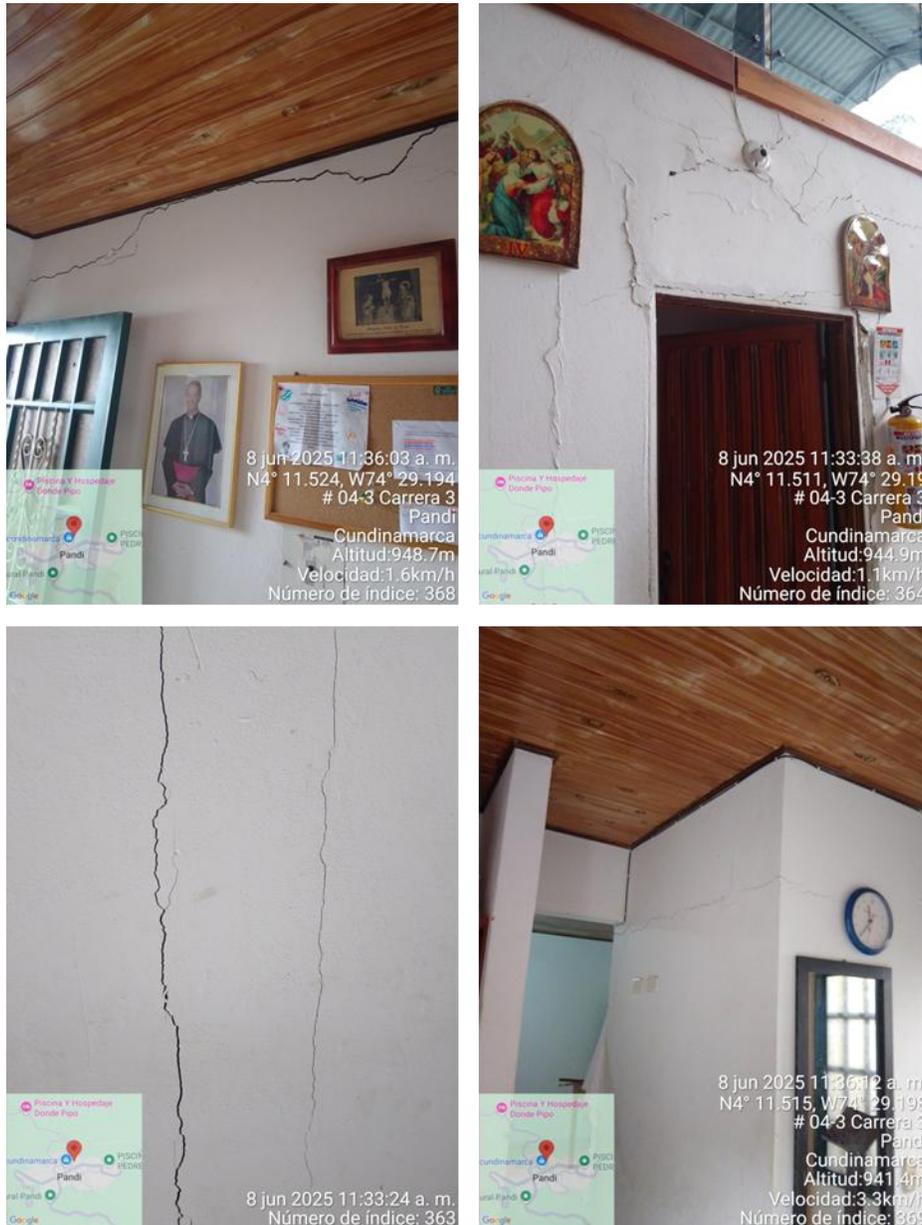
Figure 4.14. Observed damaged at the town’s church in Pandi, Cundinamarca (Source: RiesgosCundi, 2025).

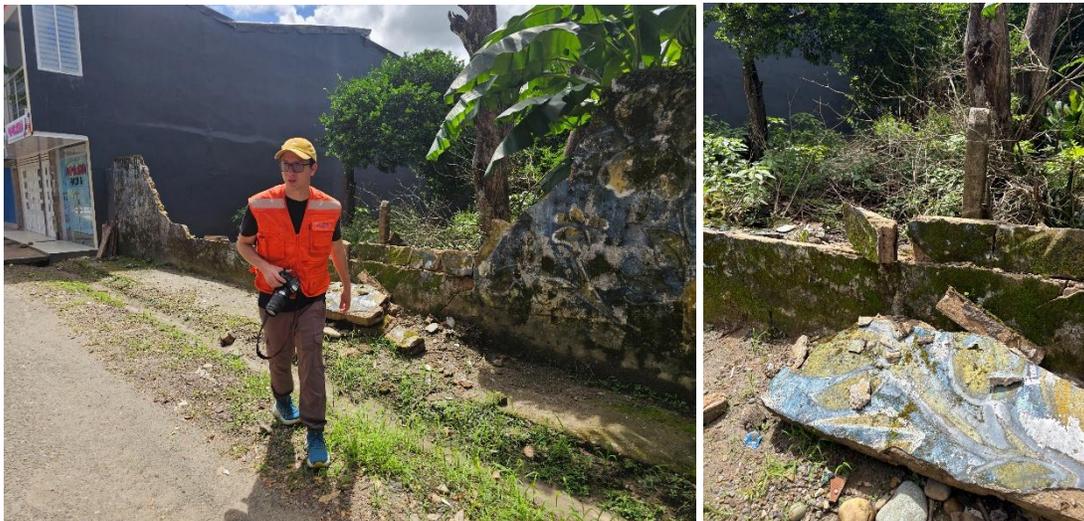
Figure 4.15. Failure of site walls in Paratebueno (Credit Archbold and Carrillo).

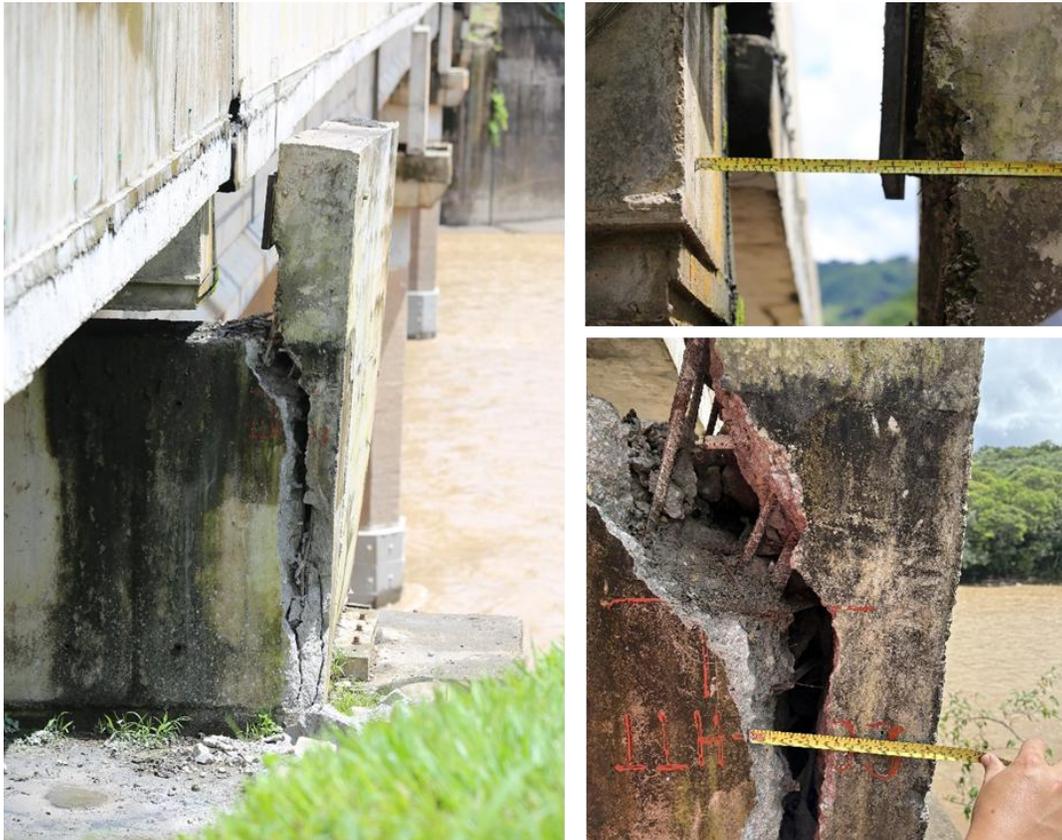
Figure 5.1. Puente Río Humea: shear key with a diagonal shear failure in the stem wall (Credit: Archbold and Carrillo).

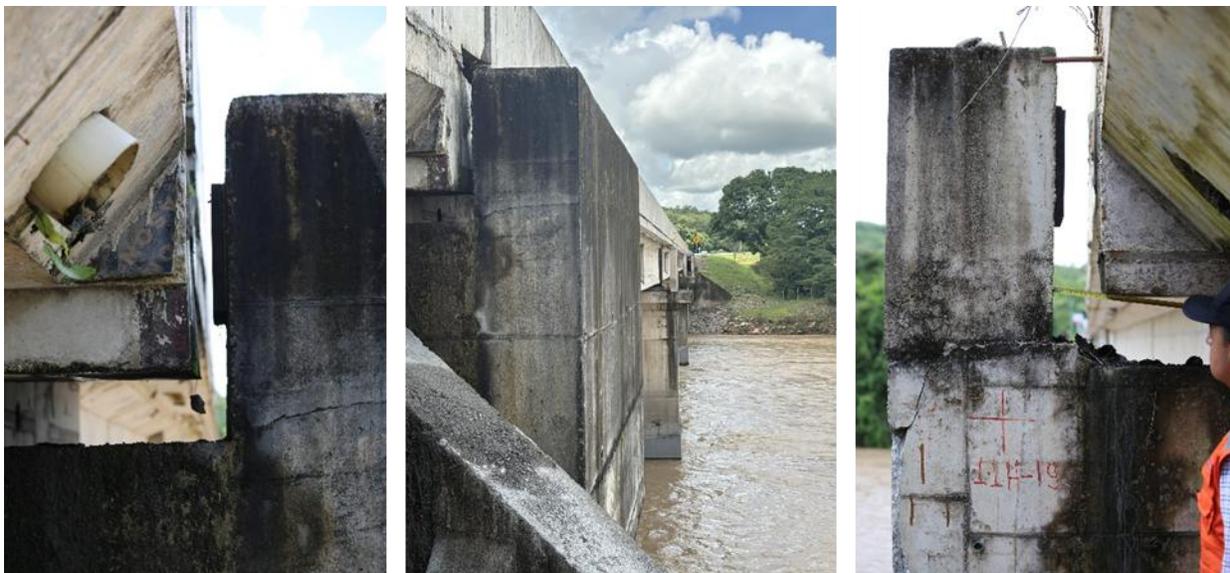
Figure 5.2. Puente Río Humea: shear keys with a horizontal shear failure mechanism (Credit: Archbold and Carrillo).

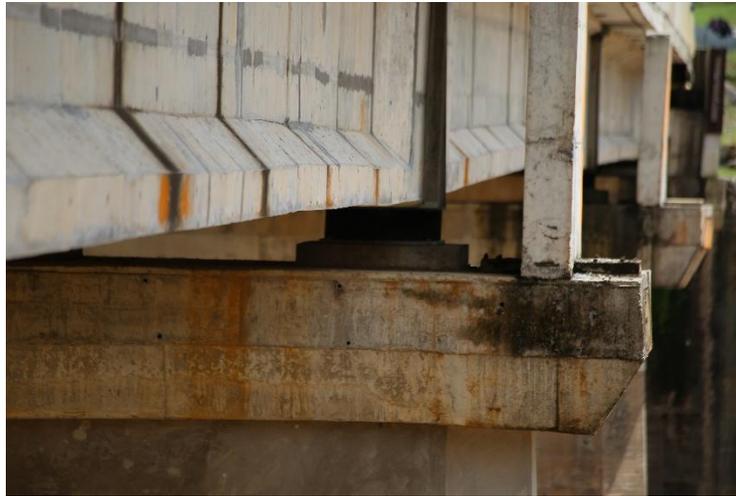
Figure 5.3. Puente Río Humea: midspan bridge bearings (Credit: Archbold and Carrillo).

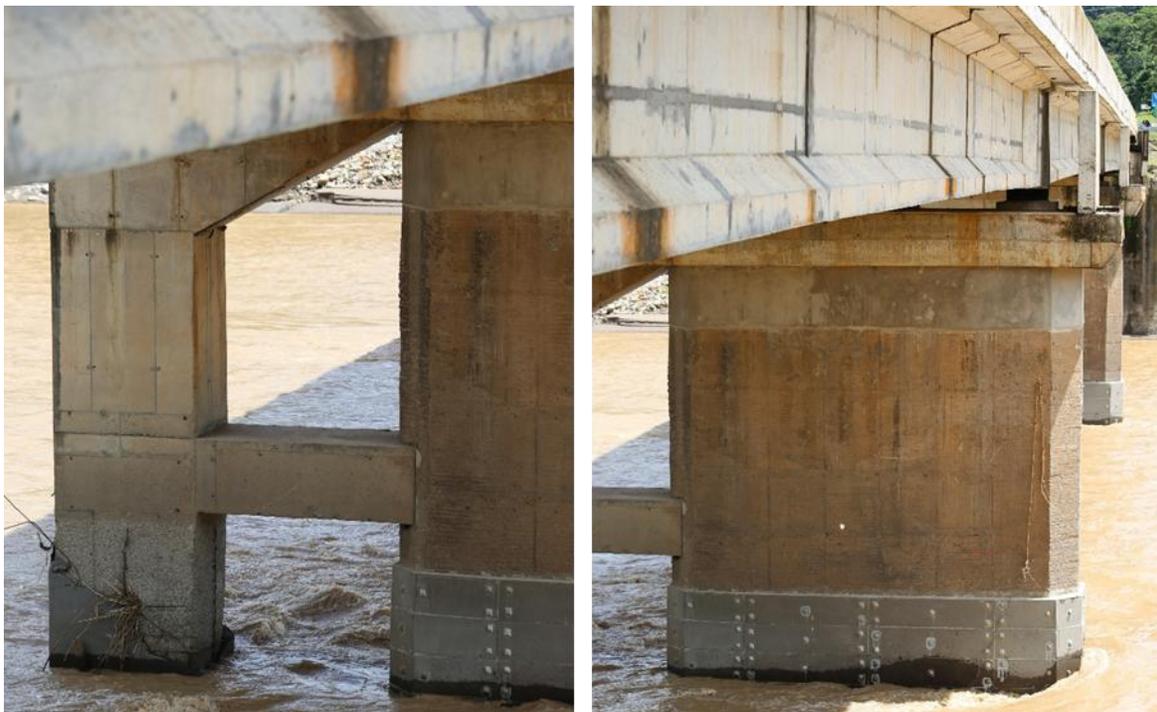
Figure 5.4. Puente Río Humea: bridge piers with steel jackets (Credit: Archbold and Carrillo).

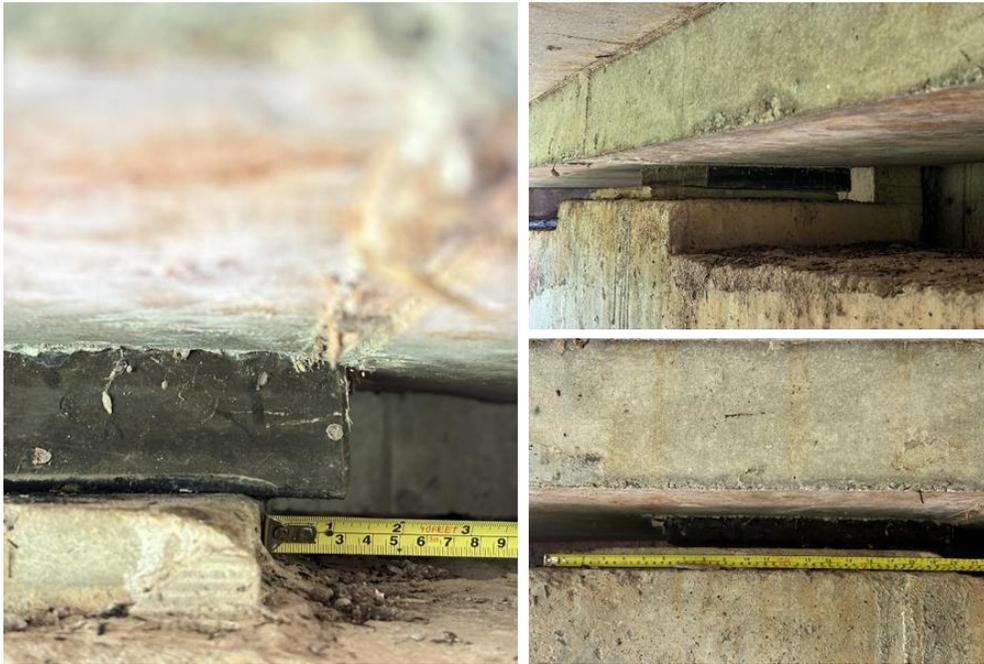
Figure 5.5. Puente Río Humea: abutment bearings longitudinal and transverse movement (Credit: Archbold and Carrillo).

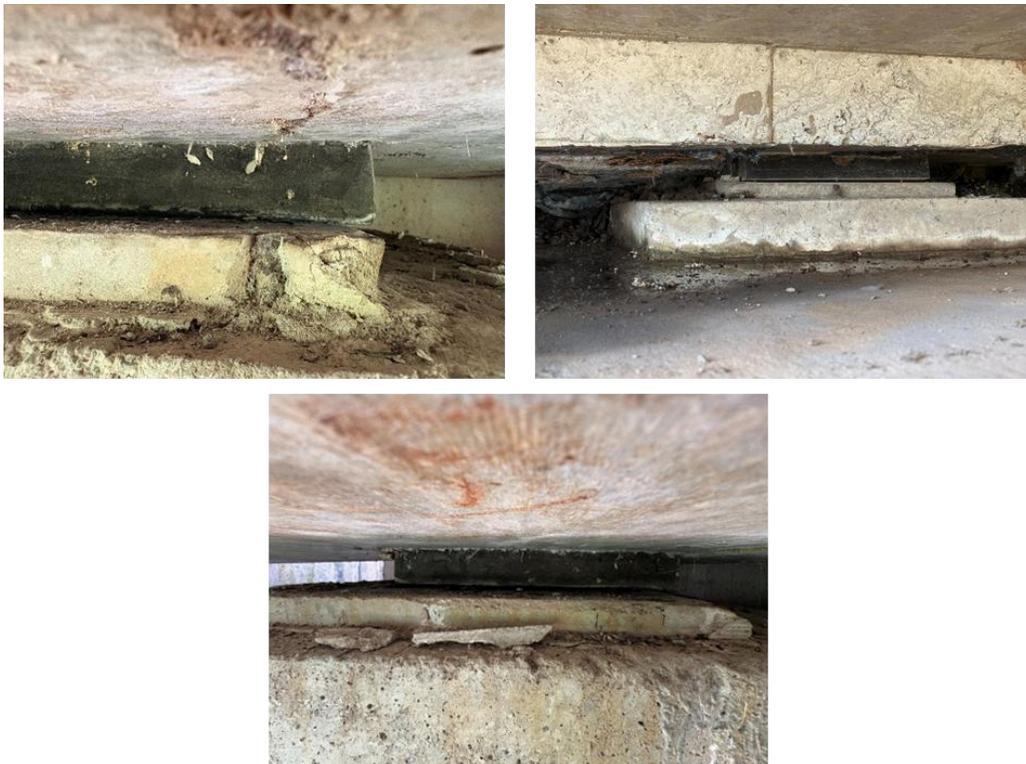
Figure 5.6. Puente Río Humea: abutment bearings vertical uplifting (Credit: Archbold and Carrillo).

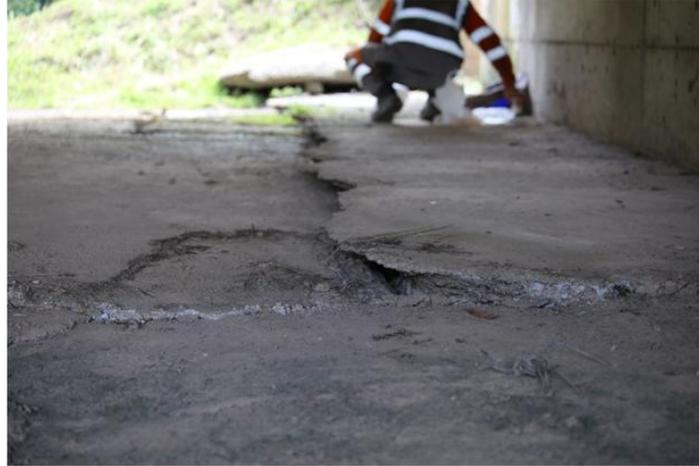
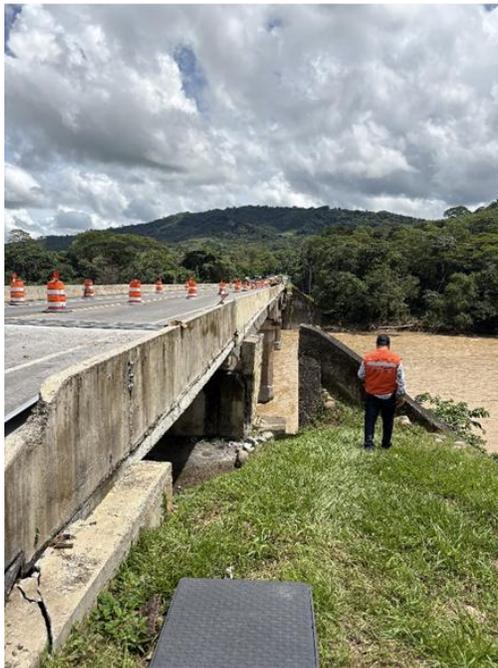
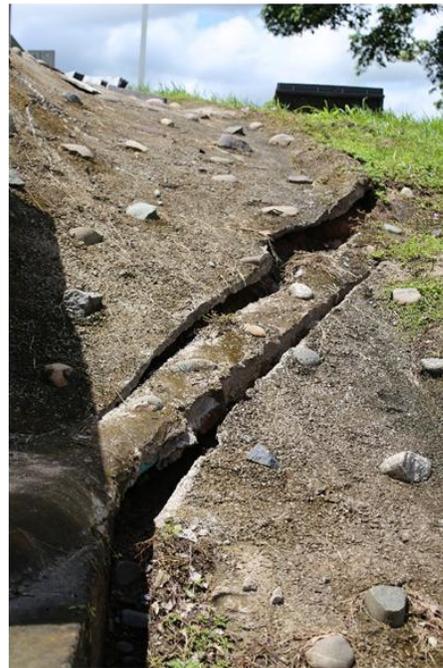
Figure 5.7. Puente Río Humea: damage around the abutments and signs of lateral spreading (Credit: Archbold and Carrillo).

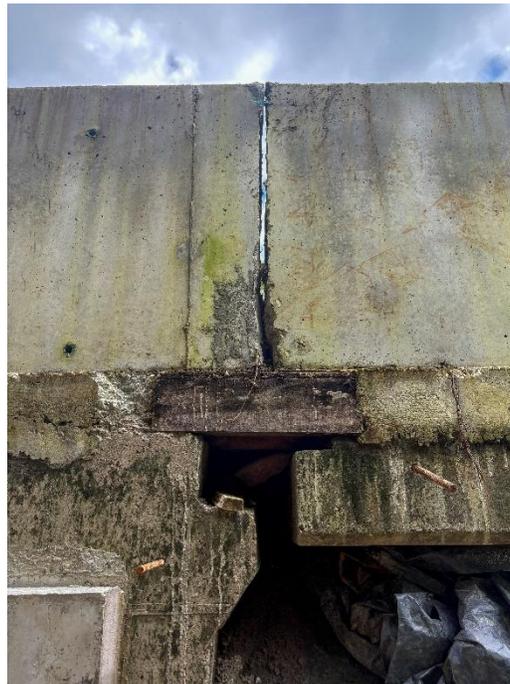
Figure 5.8. Abutment seat detail of bridge along the Cumaral–Paratebueno road in Japón (Credit: Archbold and Carrillo).

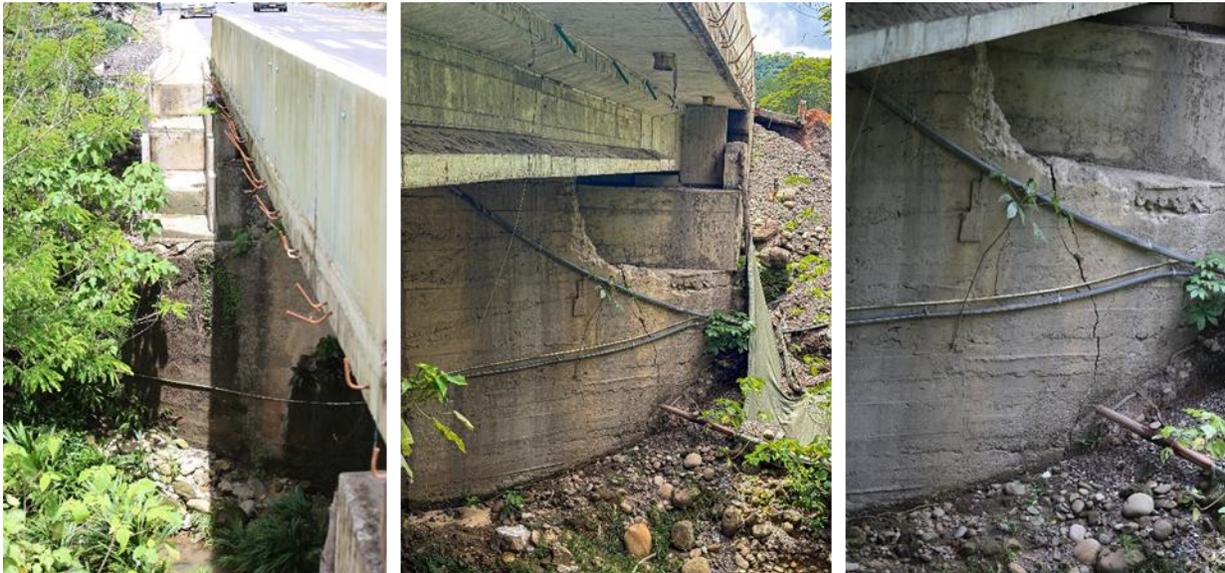
Figure 5.9. Vertical crack of the abutment due to differential settlement of bridge along the Cumaral–Paratebueno road in Japón (Credit: Archbold and Carrillo).

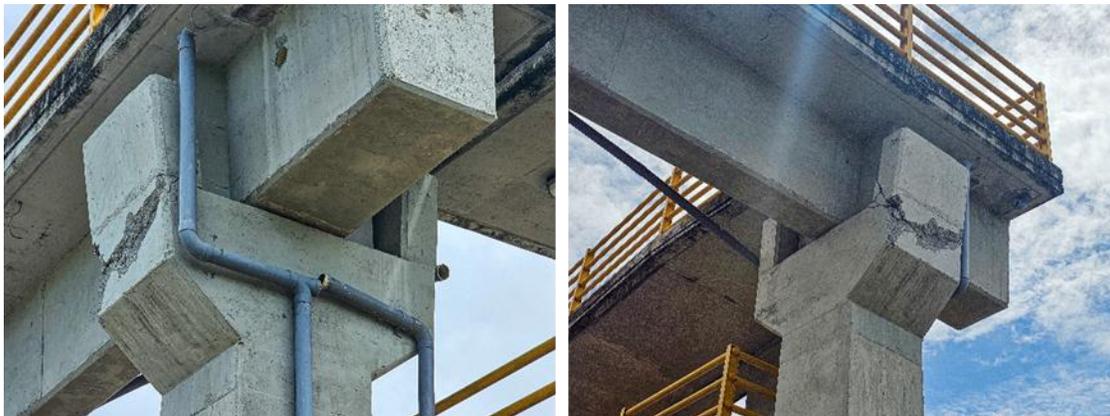
Figure 5.11. Pedestrian bridge along main highway connecting Cumaral with Paratebueno, near the entrance to town of Japón, Cundinamarca: shear keys with diagonal shear failure (Credit: Archbold and Carrillo).

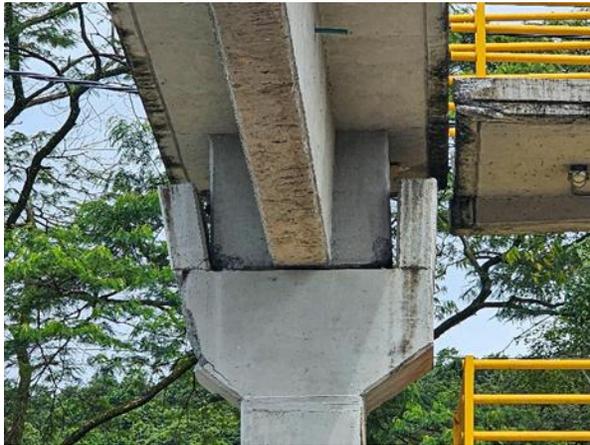
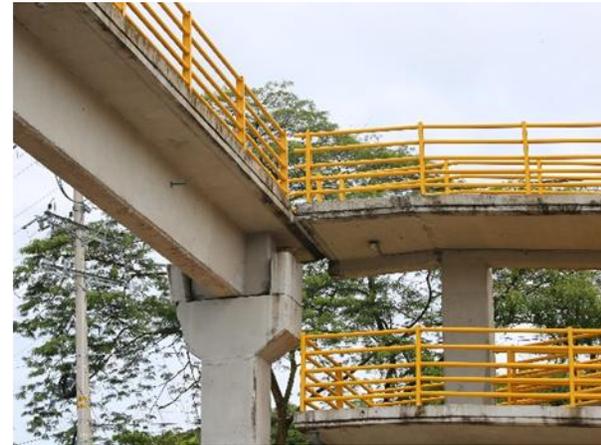
Figure 5.12. Pedestrian bridge along main highway connecting Cumaral with Paratebueno, near the entrance to town of Japón, Cundinamarca: signs of pounding between the ramp and the deck of the bridge (Credit: Archbold and Carrillo).

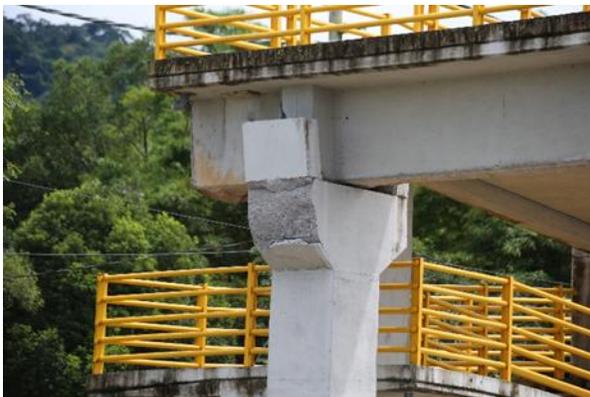
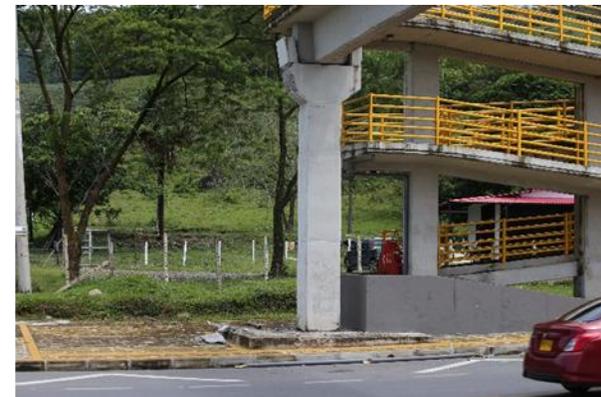
Figure 5.13. Pedestrian bridge along main highway connecting Cumaral with Paratebueno, near the entrance to town of Japón, Cundinamarca: fallen debris from the pier cap spalling (Credit: Archbold and Carrillo).

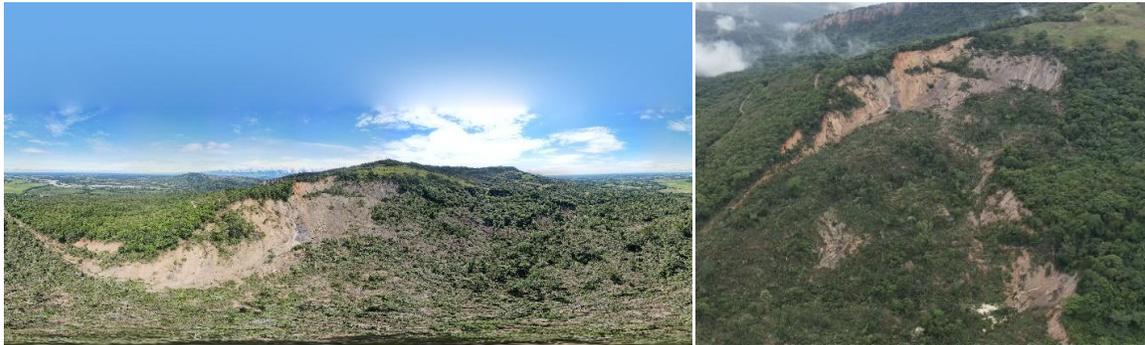
Figure 6.1. Earthquake-induced landslide near the municipality of Paratebueno (Sources: SGC, 2025a, 2025d).

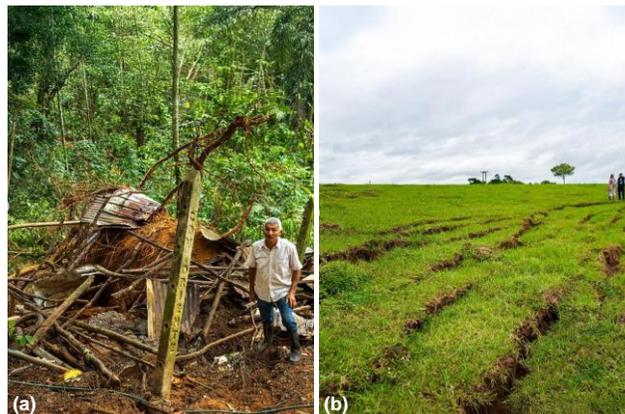
Figure 6.2. Damage associated with the landslide: (a) tree collapsed onto a rural structure; (b) tension cracks and surface fissures observed near the landslide (Source: Instagram @serviciogeologicocolombiano, 2025).
