Water Infrastructure Performance

WW Infrastructure Performance – Earthquake Facilities

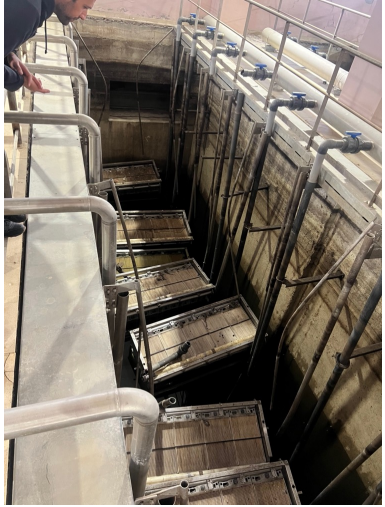
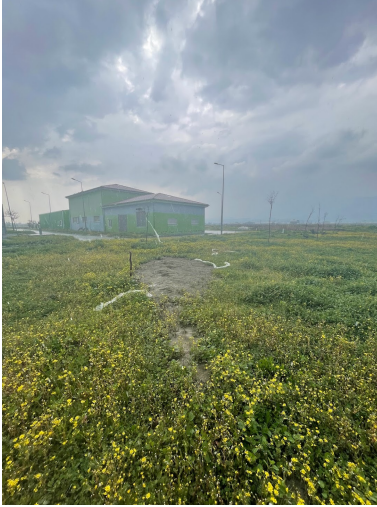
WWTP Narlia, Hk

- Estimated PGA/PG
 - 0.57g / 97 cm/s for M7.8
 - 0.03g / 13 cm/s for M7.7
 - 0.54g / 87 cm/s for M6.3
- Opened in 2019
- Located under structures
- Not in operation due to the damage to the membranes

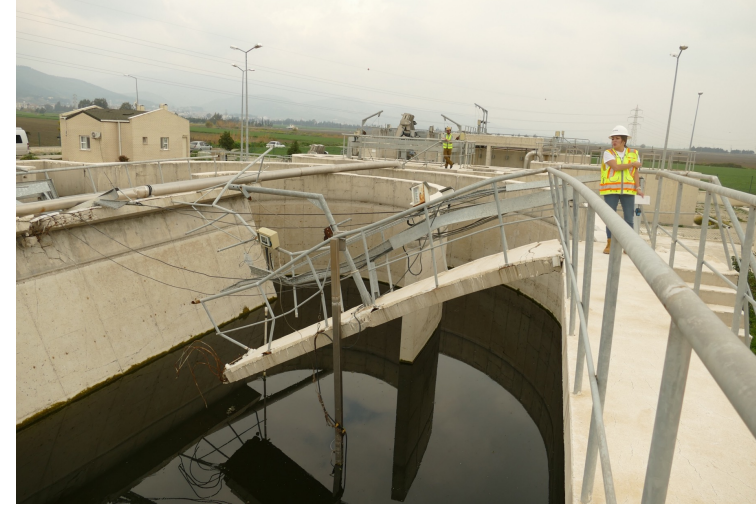
WWTP Kirikhan, Hk

- Estimated PGA/PG
 - 0.60g / 97 cm/s for M7.8
 - 0.03g / 17 cm/s for M7.7
 - 0.14g / 12 cm/s for M6.3
- Opened in 2019
- No ground improvement
- Settlement around the pools
- Not in operation due to structural damage in the pools

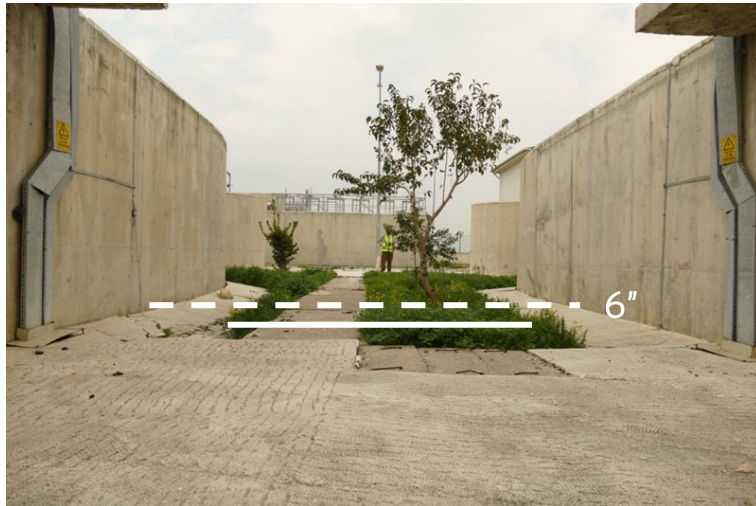
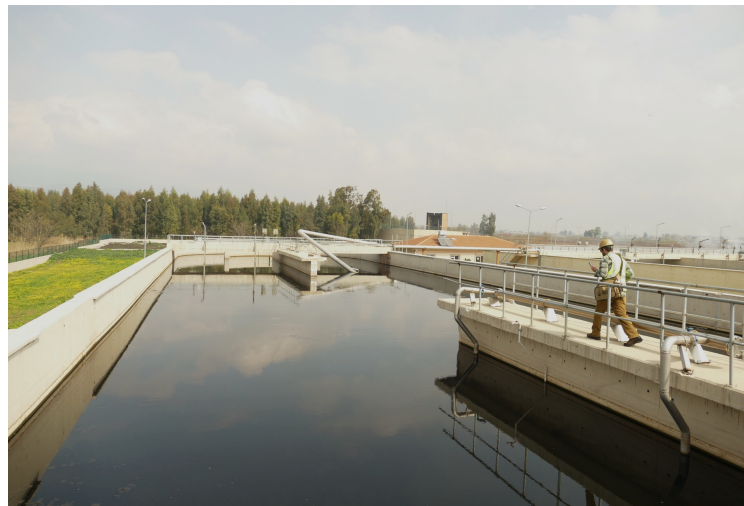
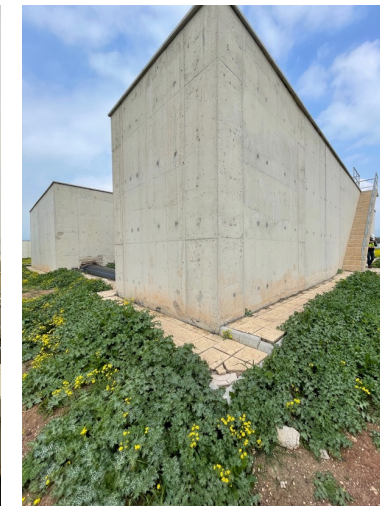
WWTP Seriql, Hk

- Estimated PGA/PG
 - 0.72g / 104 cm/s for M7.8
 - 0.03g / 12 cm/s for M7.7
 - 0.43g / 48 cm/s for M6.3
- Opened in 2017
- No ground improvement
- Significant settlement around structures – up to 0.85 ft
- Not in operation due to structural damage in the pools

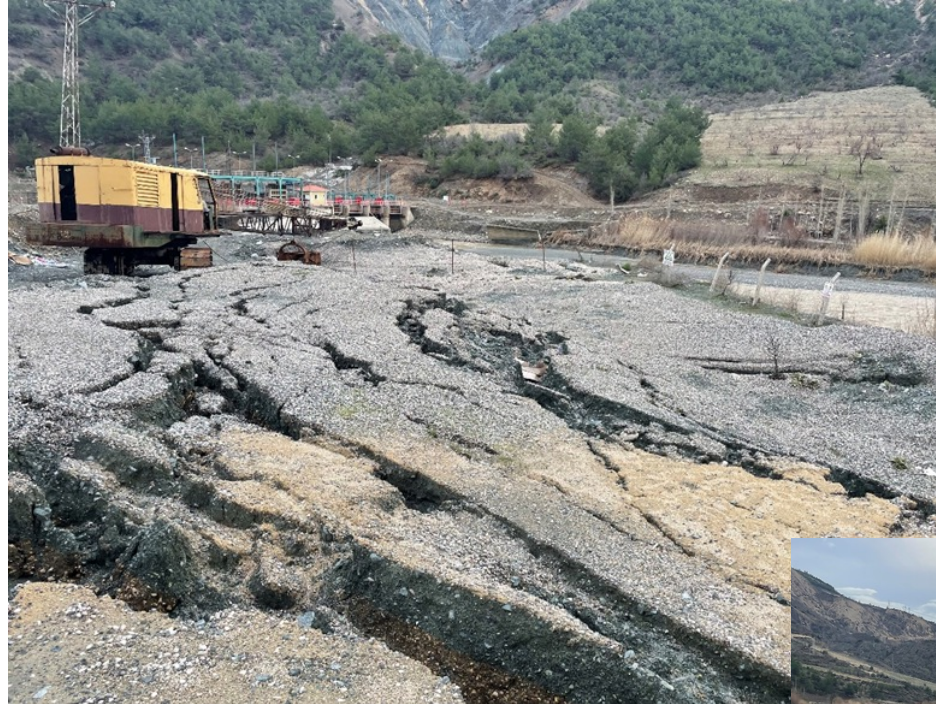
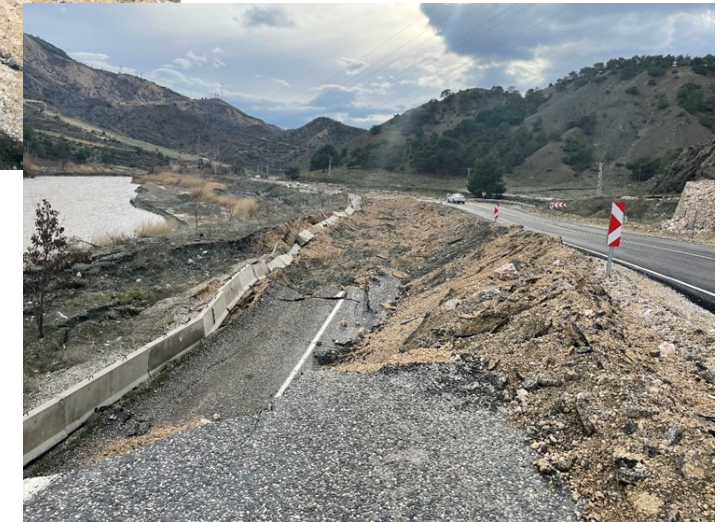
■ Alabalik Dam

- 5MW river dam
- Near fault
- Slope stability issues upstream
- Cracking in some concrete structures
- Nearby landslides
- Estimated PGA/PGAs:
 - 0.40g – 83 cm/s for M7.8
 - 0.26g – 56 cm/s for M7.7

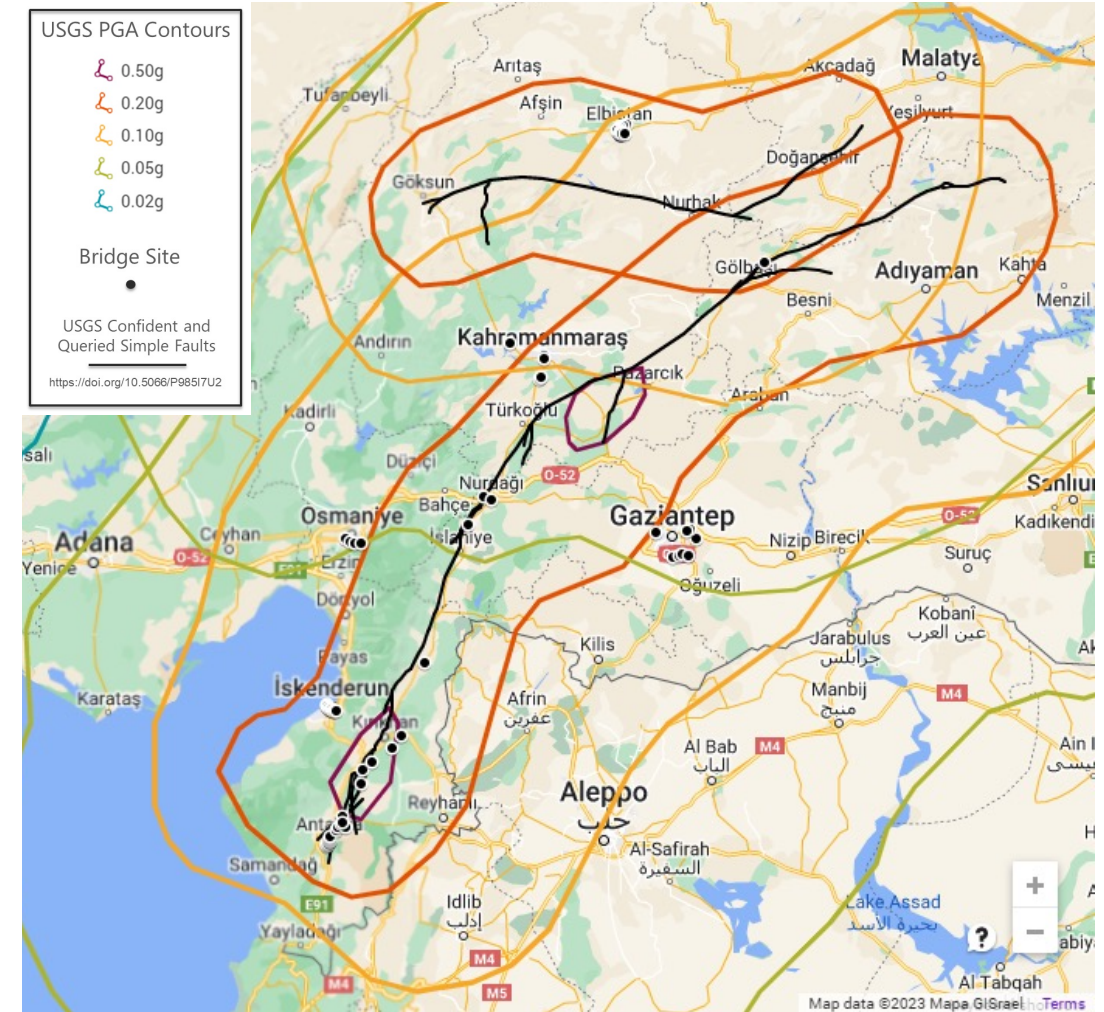
- 66 bridge sites
- 98 bridges
 - 1 bridge – 35 sites
 - 2 bridges – 30 sites
 - 3 bridges – 1 site

- 2 collapsed
- 8 severe
- 13 moderate
- 75 little/none

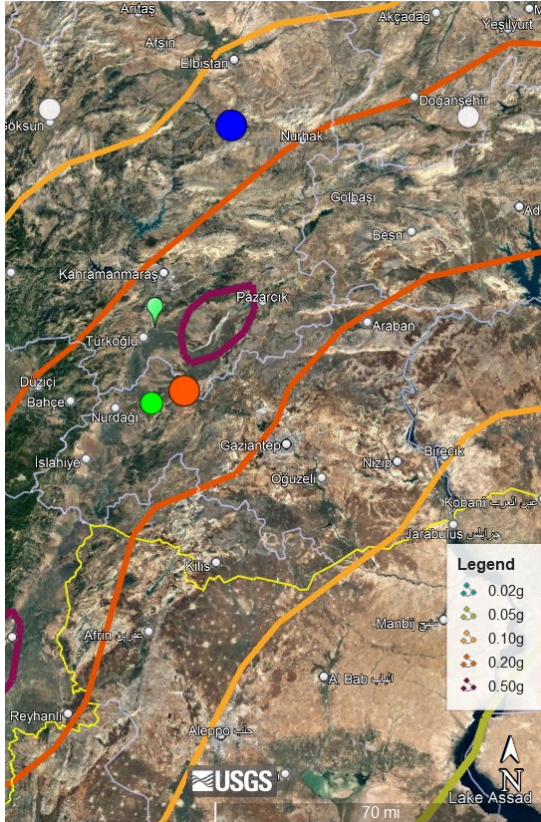
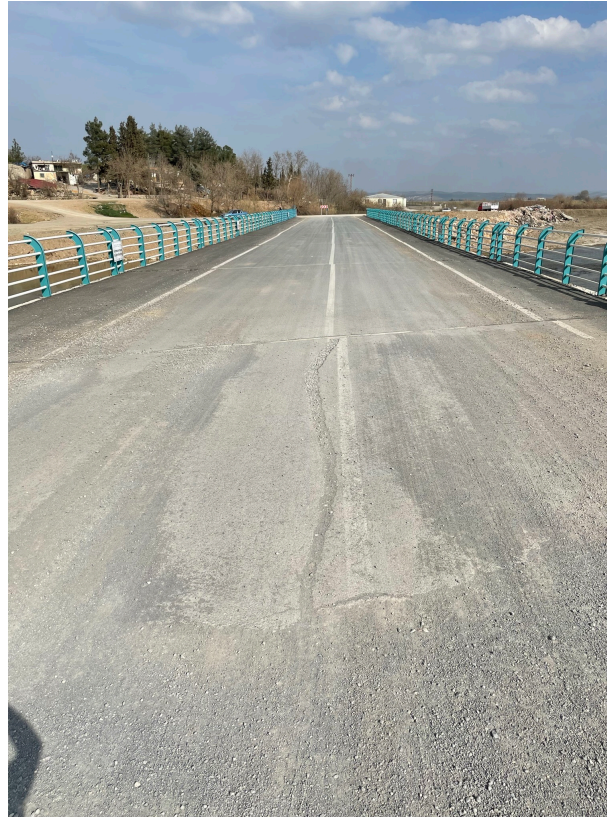
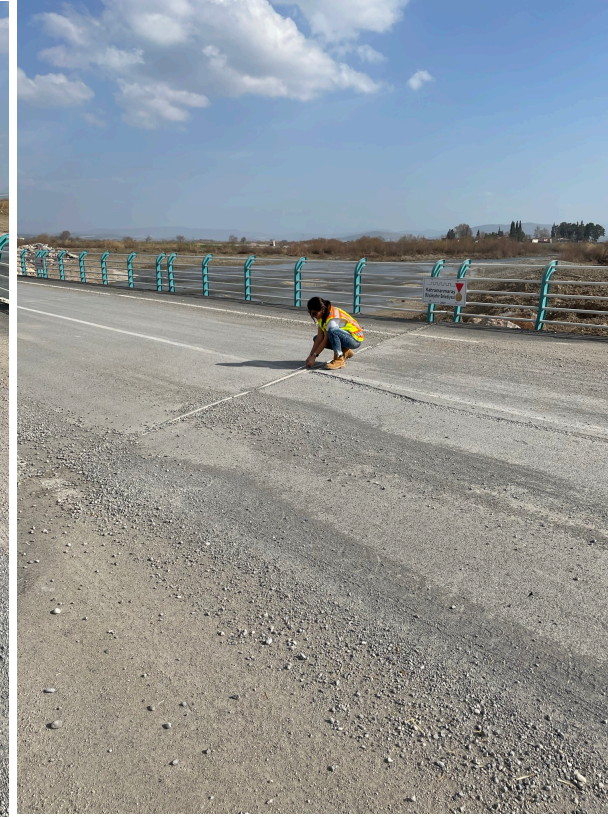
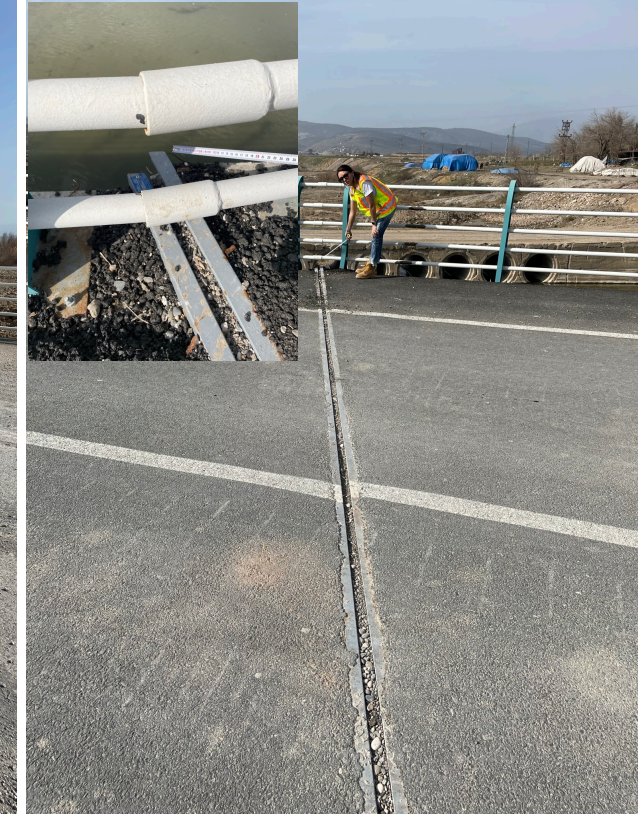
■ Türkoğlu, Kahramanmaraş

Total lateral displacement ~ 15 in (38 cm)
 The largest displacement ~ 6 in (15 cm)

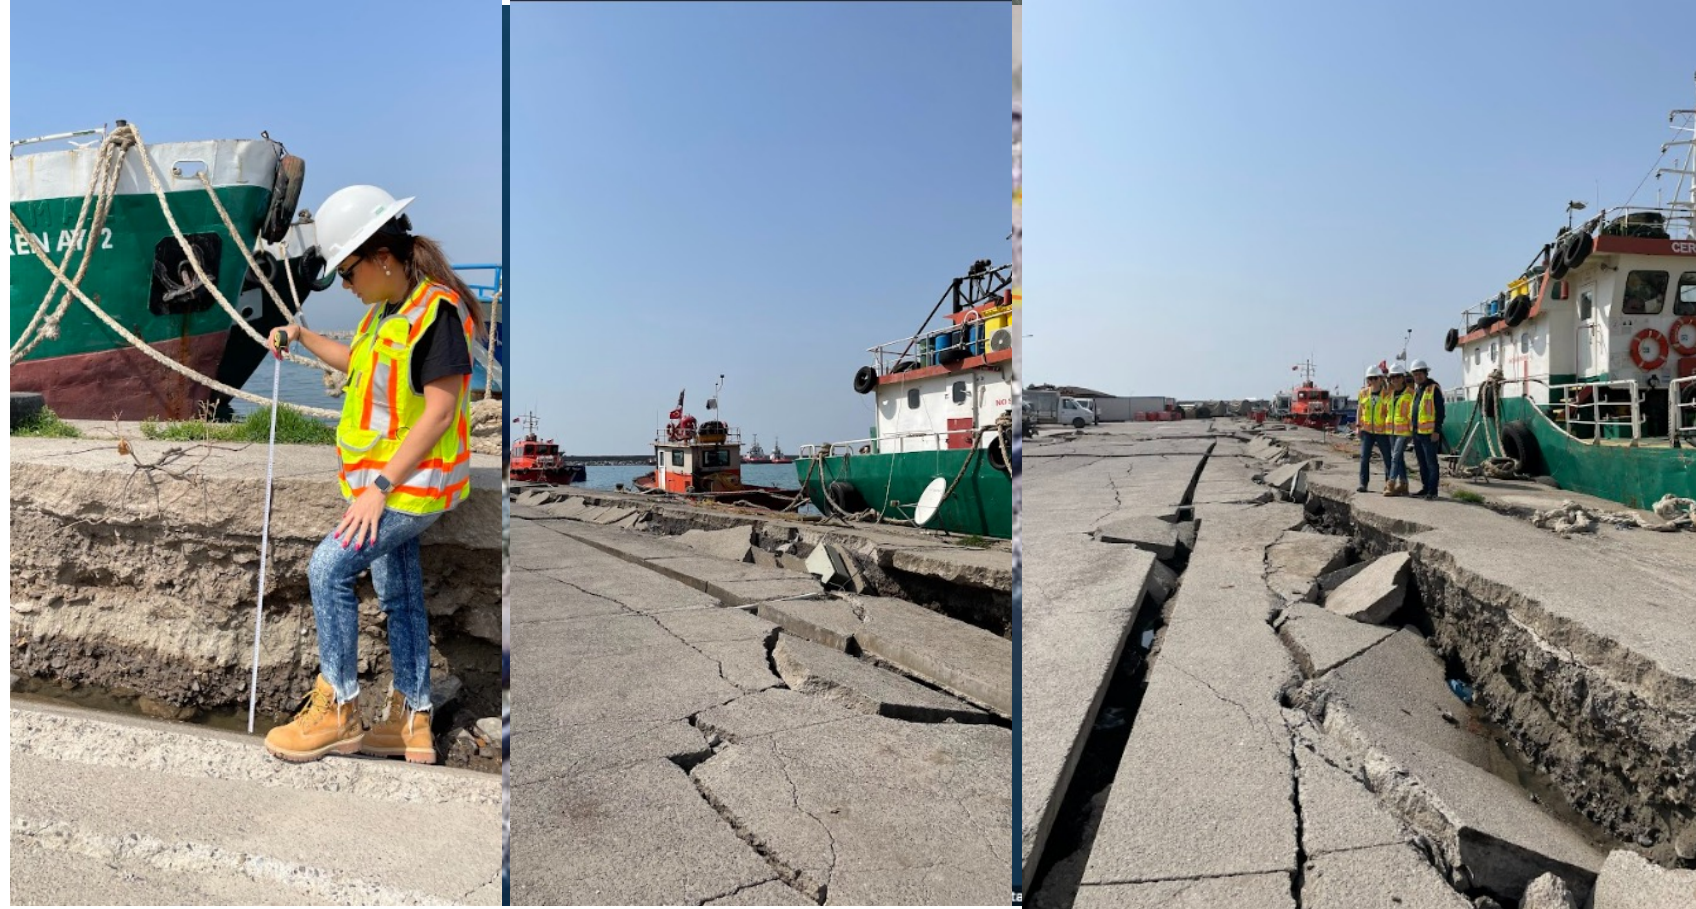
- Dörtyol, Hakkari
 - Significant lateral spreading (~ 3 ft)
 - Seismically induced settlement (~2.3 ft).
