Prevalent Structural Engineering Problems Observed in RC Buildings After Kahramanmaras Earthquakes

Zeynep TUNA DEGER, Ph.D.
Istanbul Technical University

Earthquake Reconnaissance

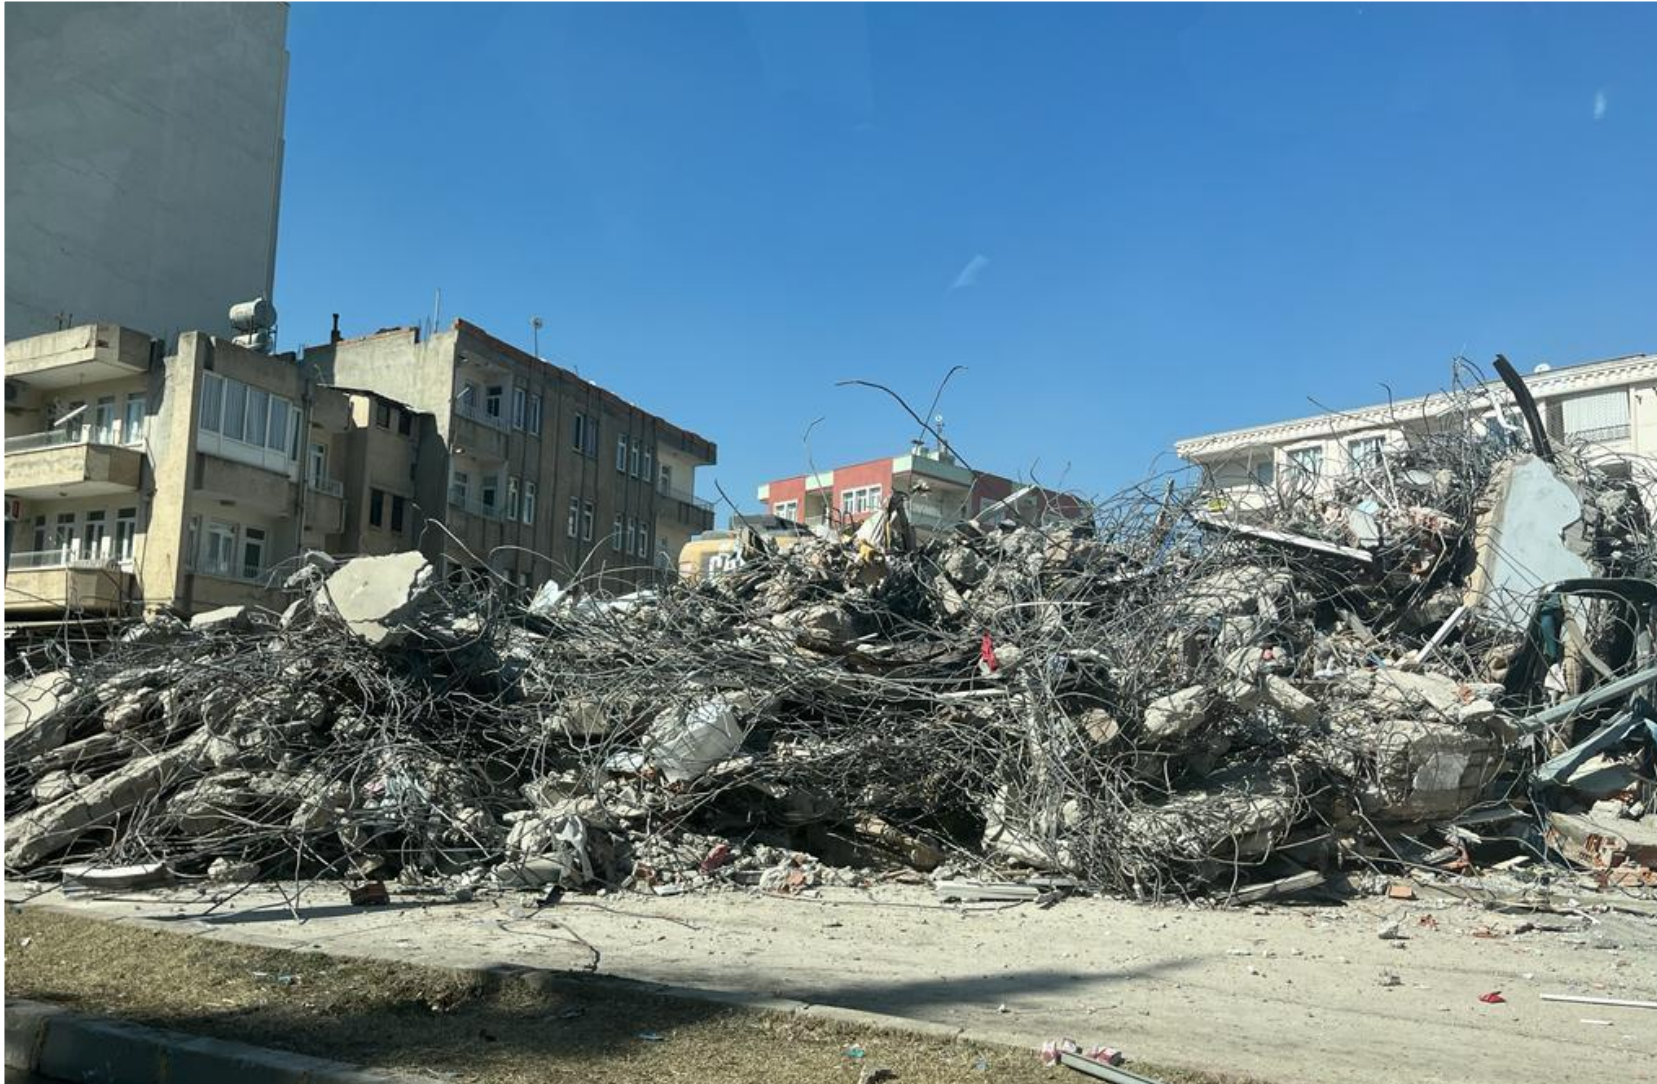
Poor material quality

- Site-mixed concrete
- Min code requirements

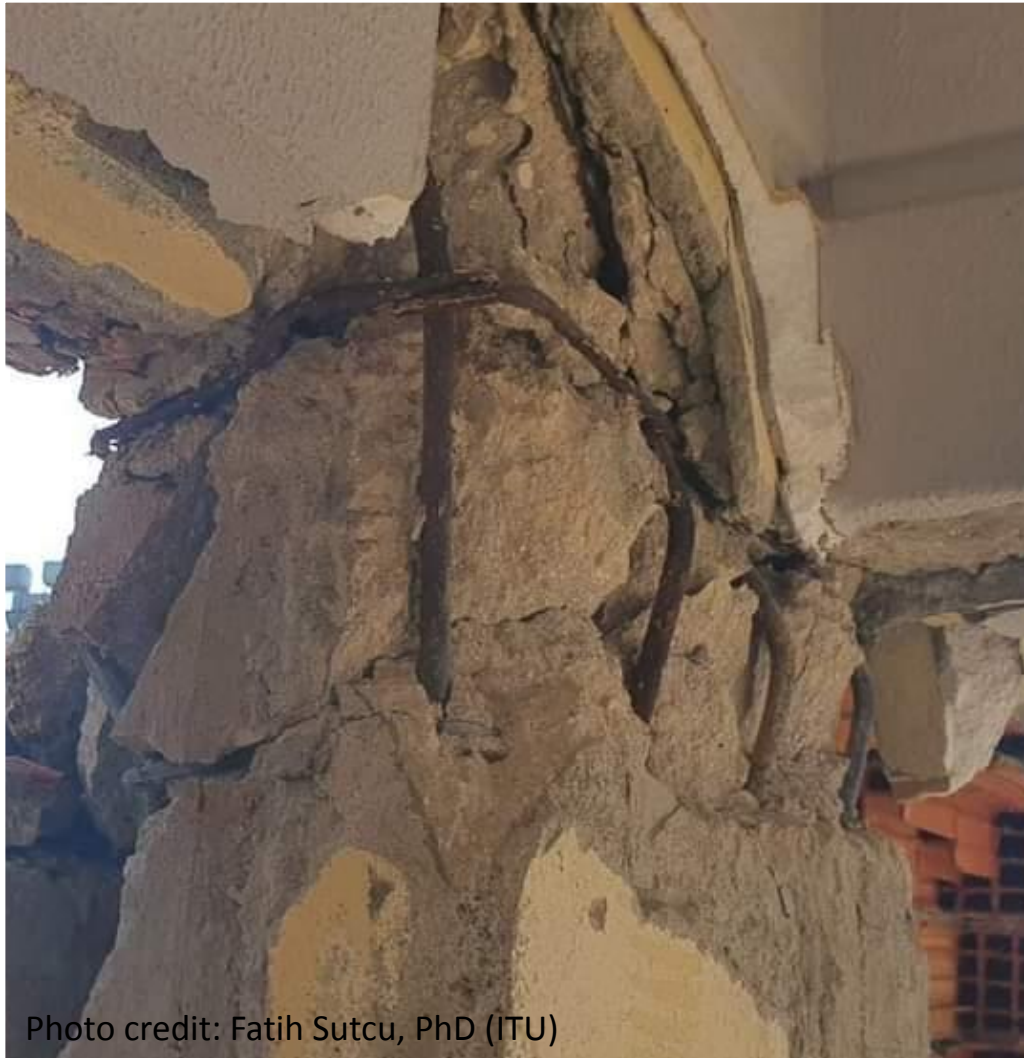
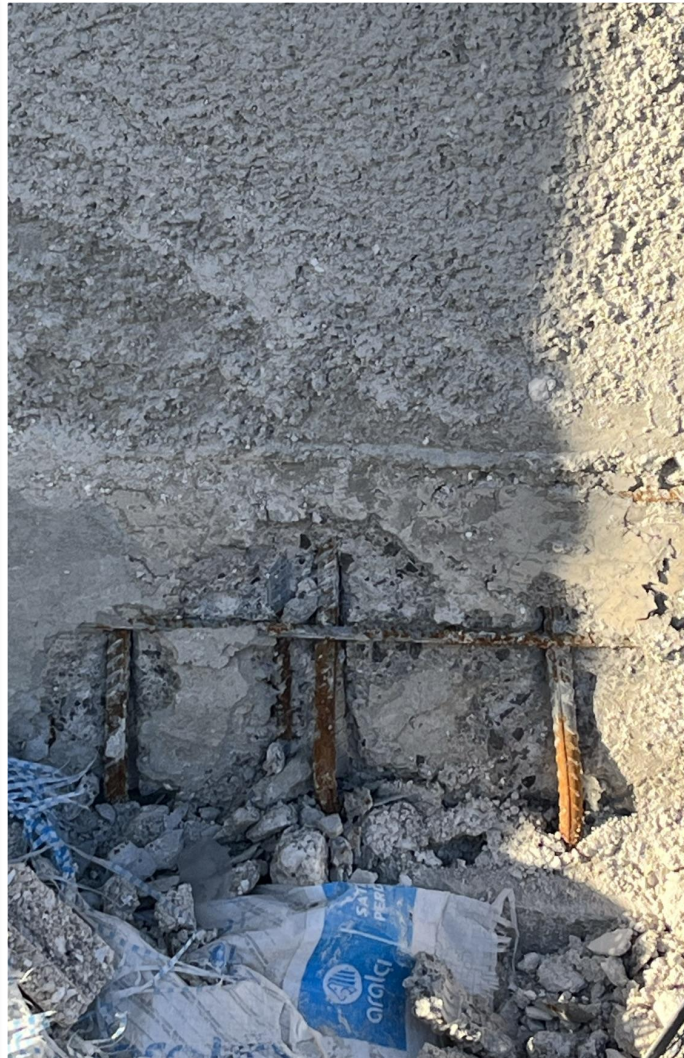
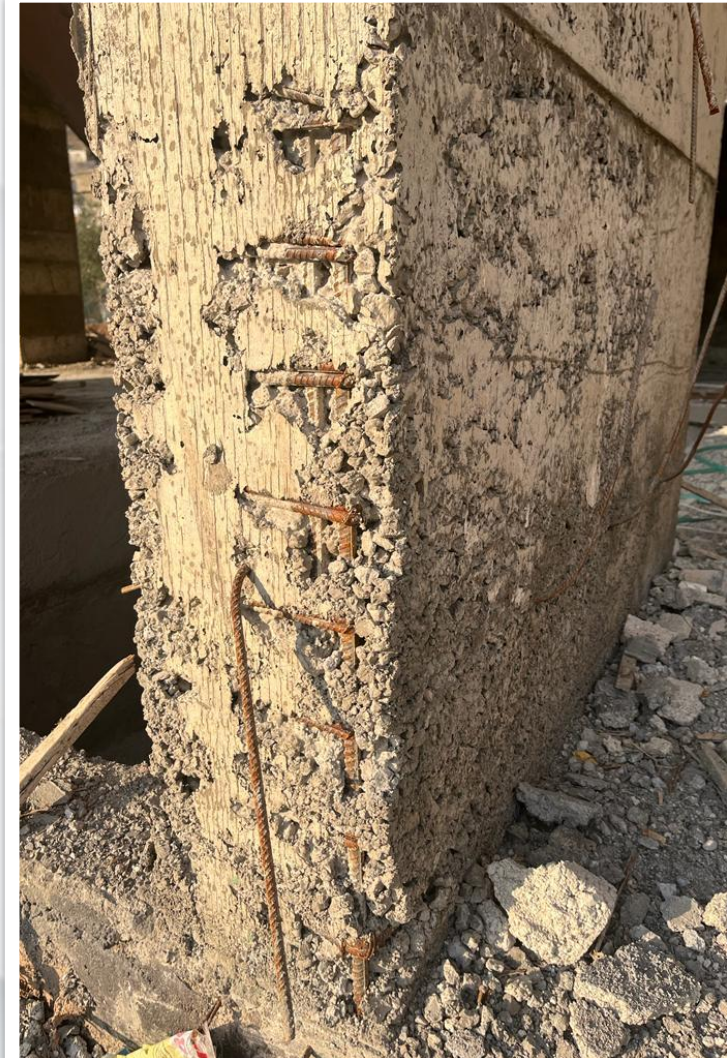
Corrosion of the rebars

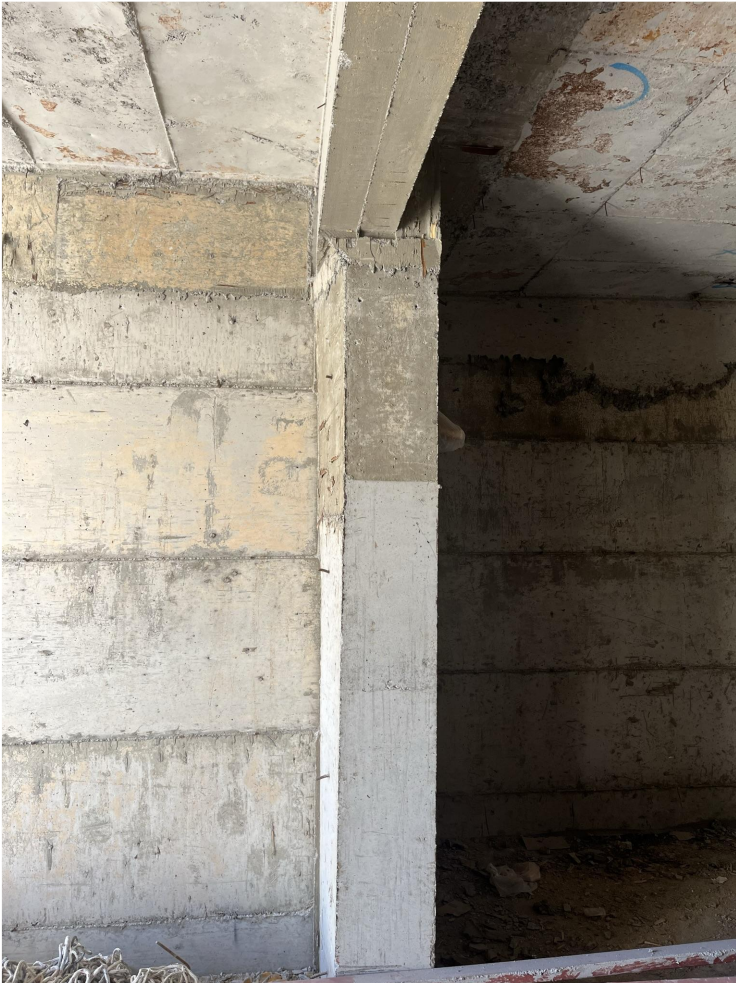
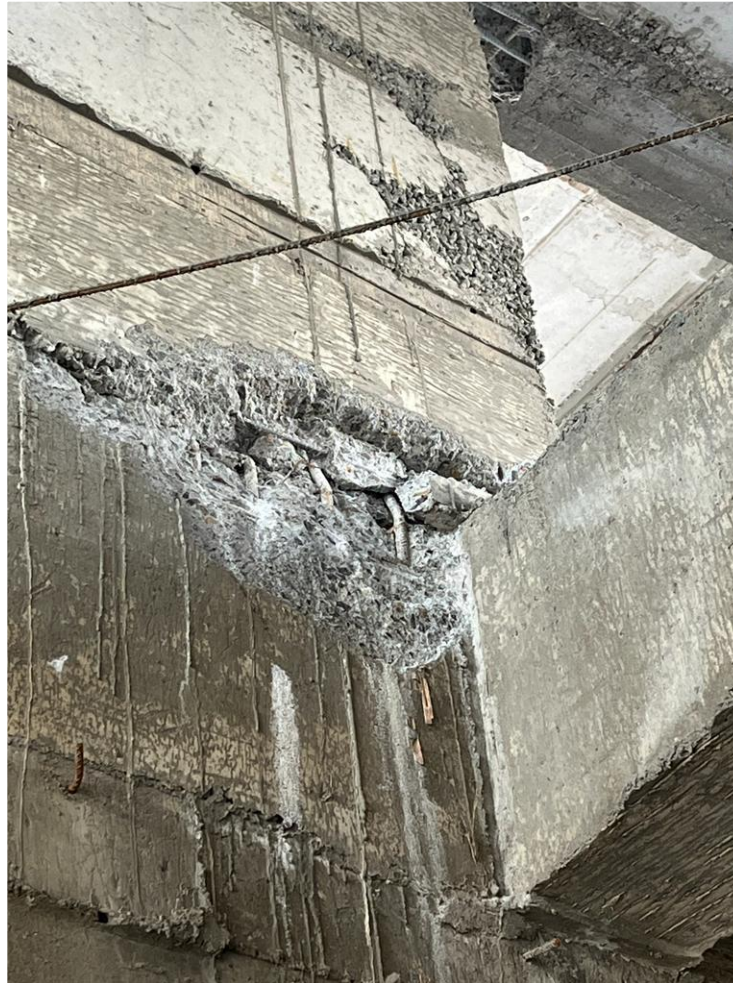
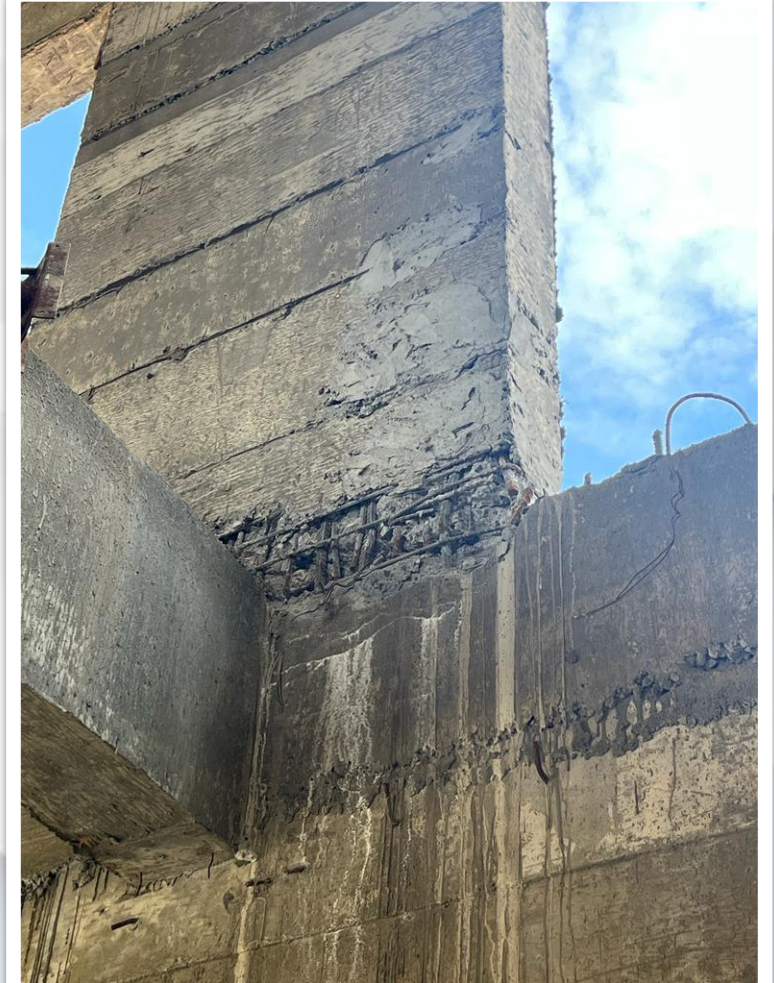
Lack of proper formwork construction

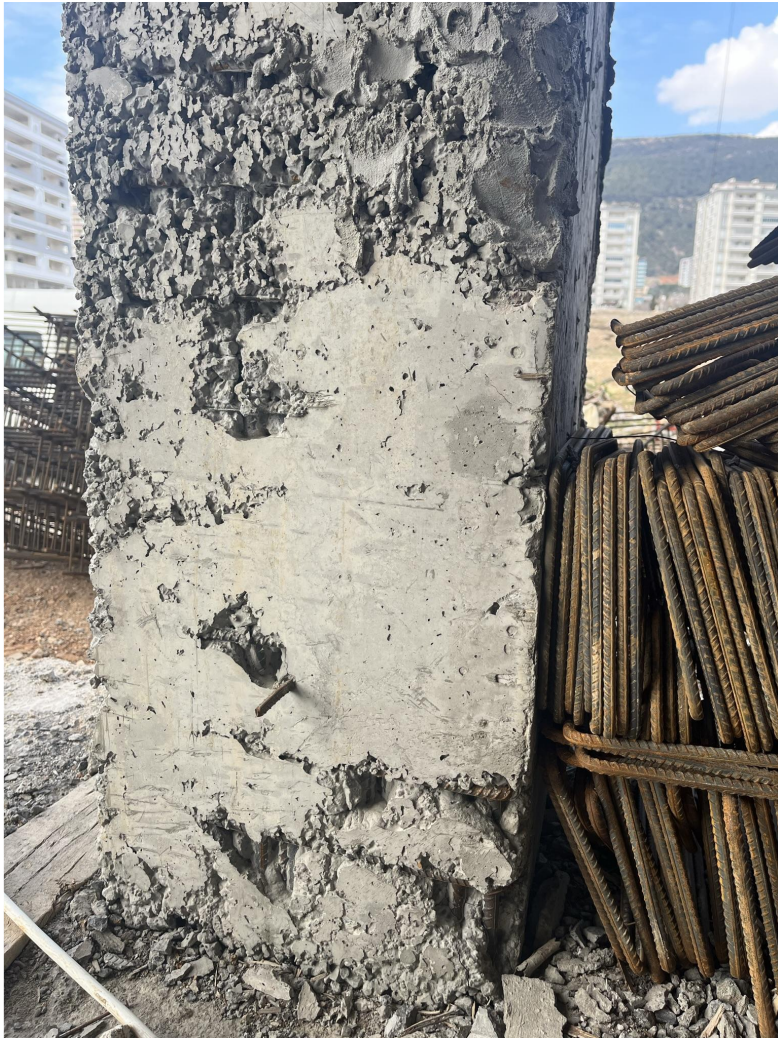
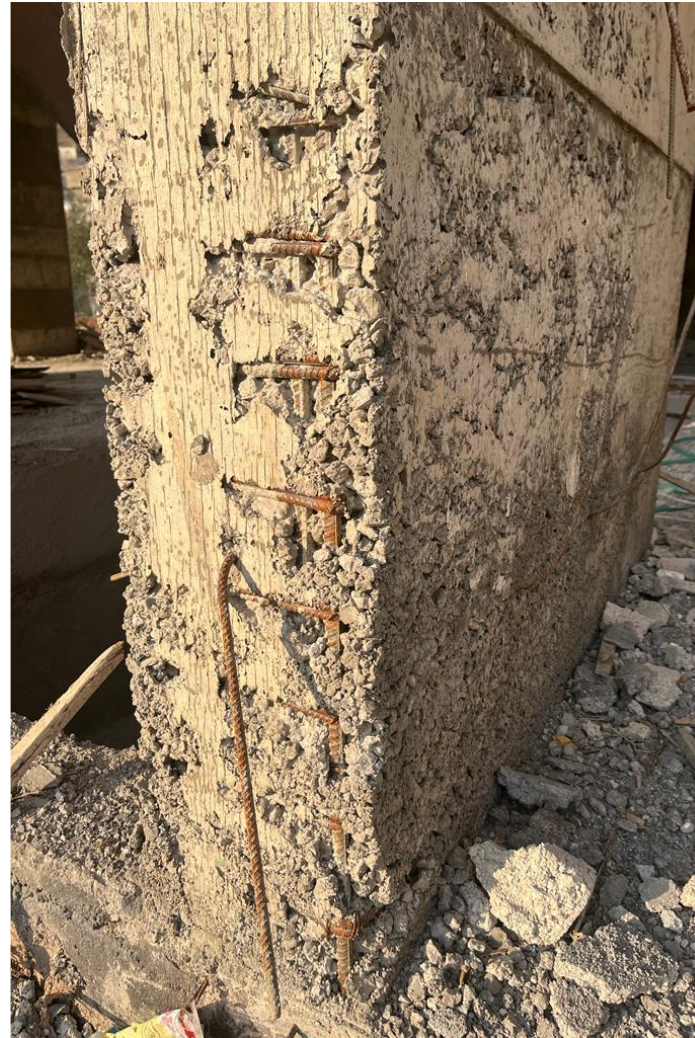
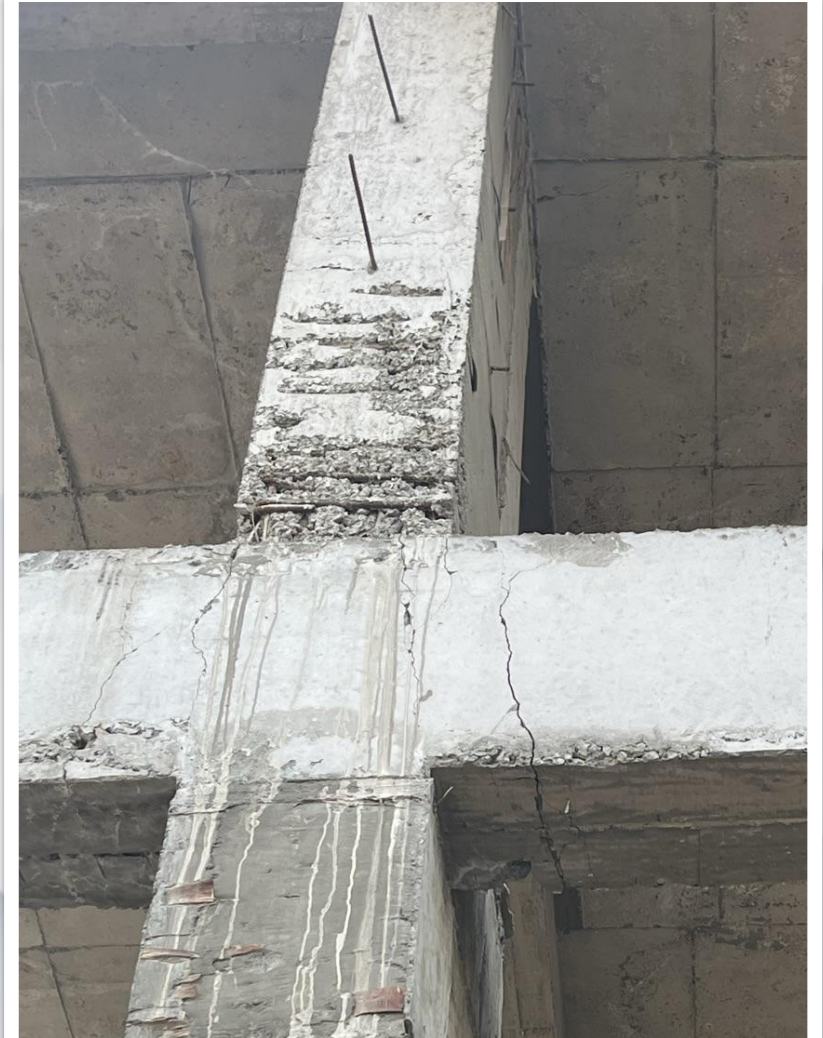
Lack of proper concrete work

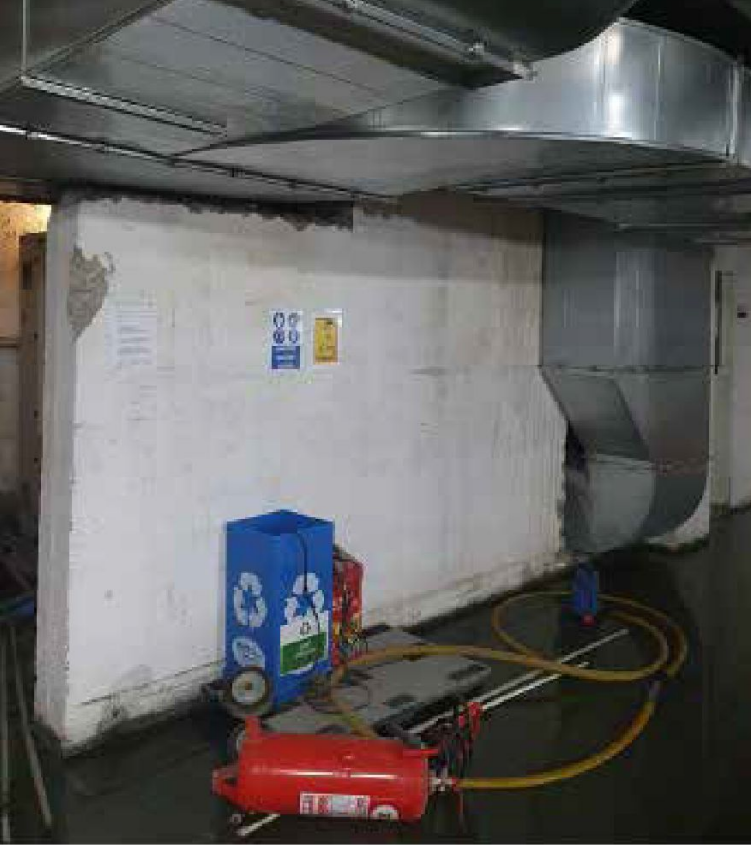
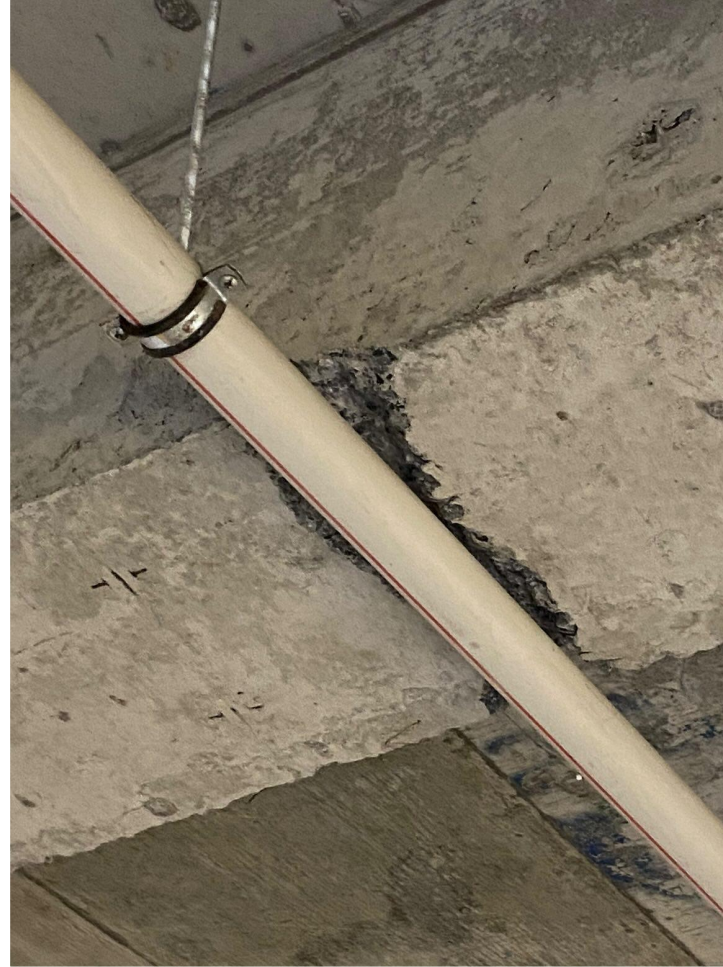
Adıyaman, Private Hospital

Mechanical installation problems

Ventilation system
passing through the shear wall!!

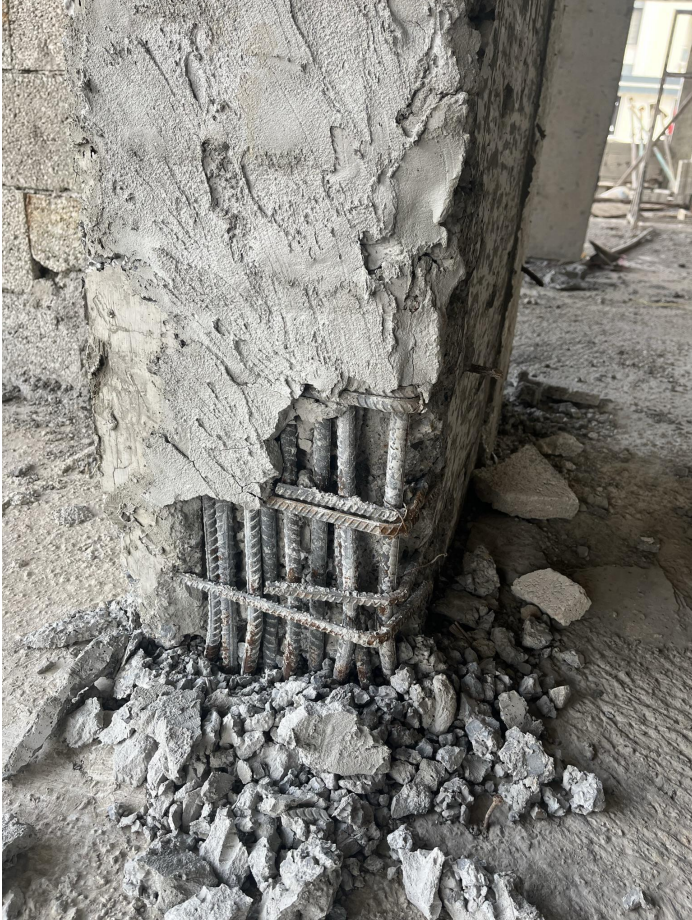
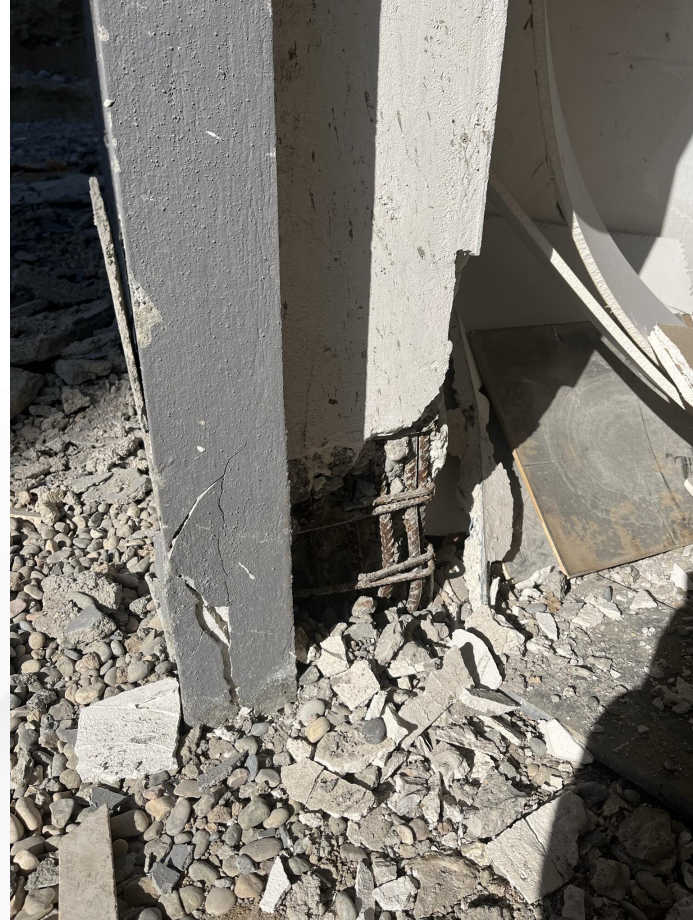
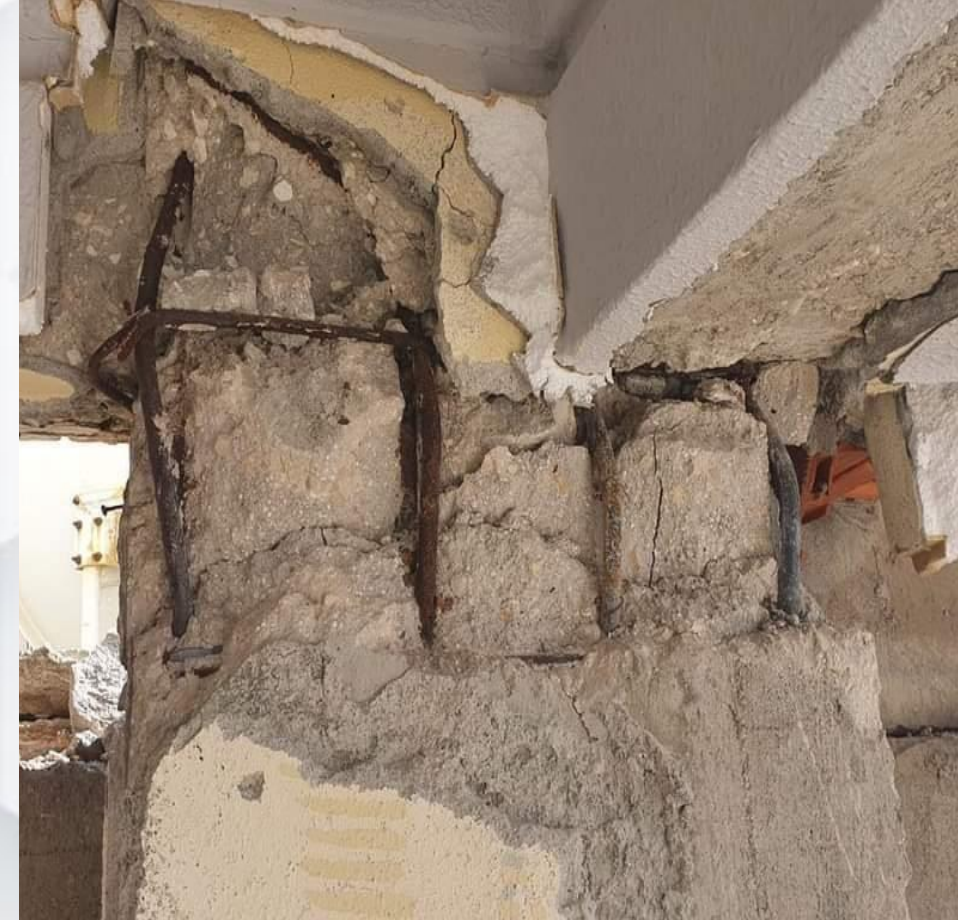
**Onikişubat, Kahramanmaraş
Residential building**

Stirrup hook angle

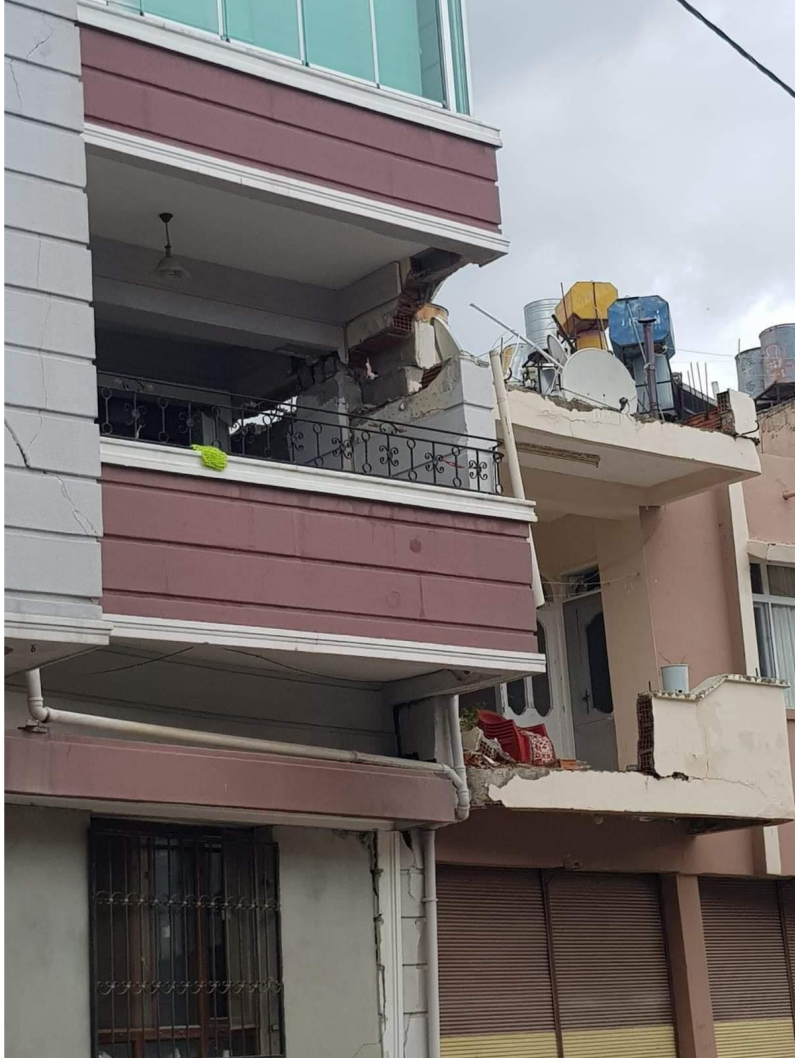
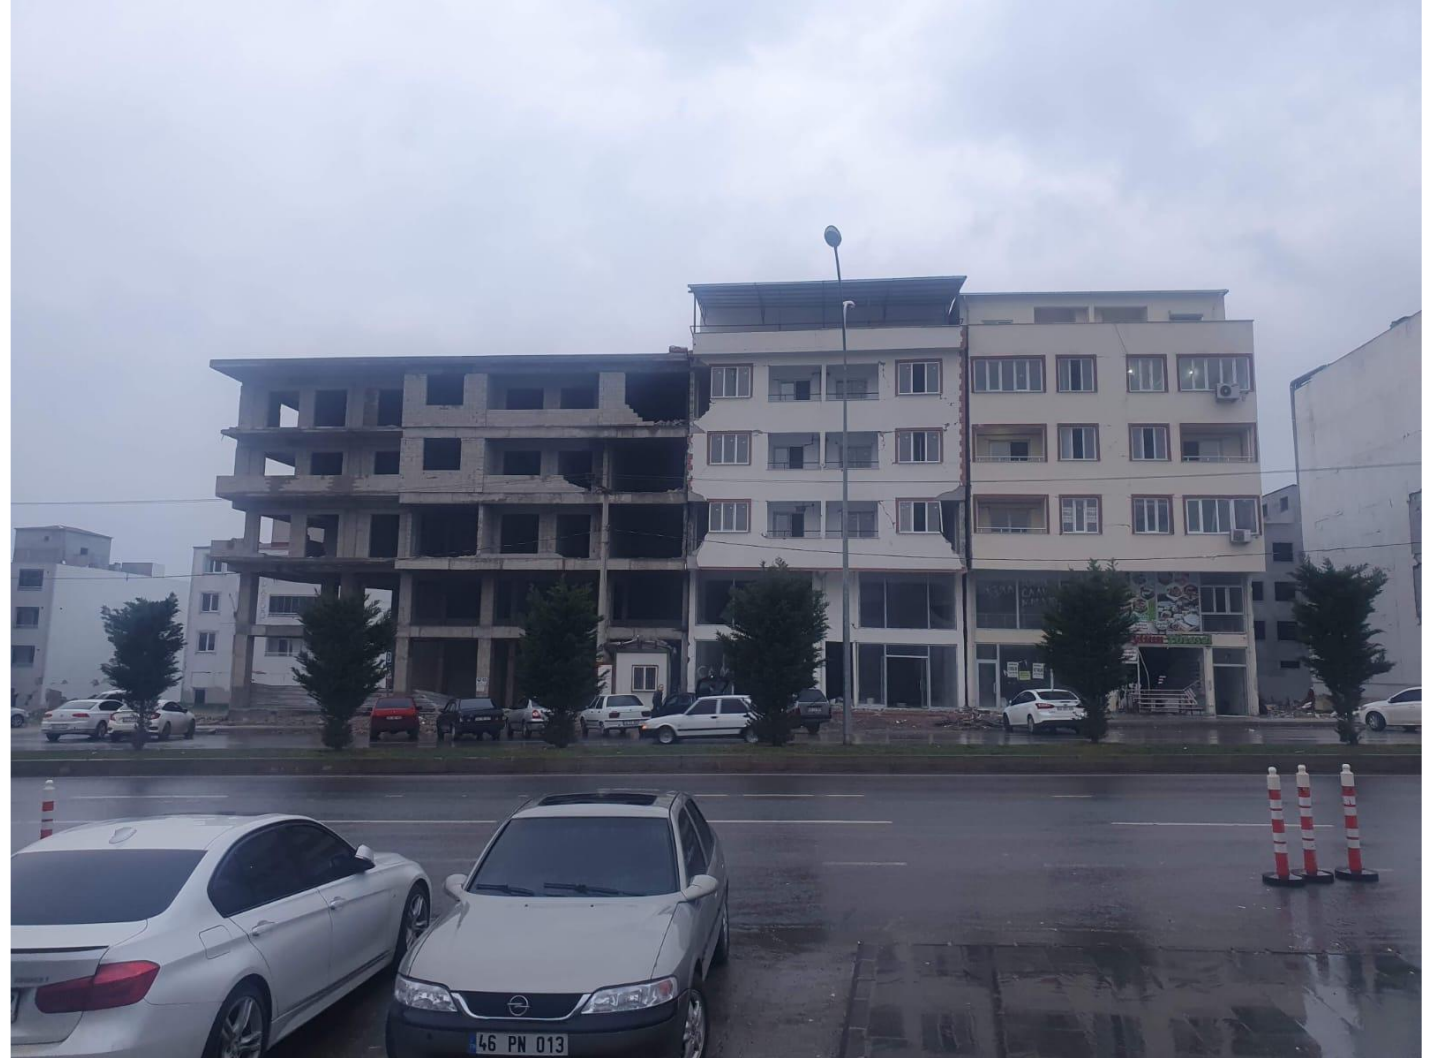
Pounding Effect

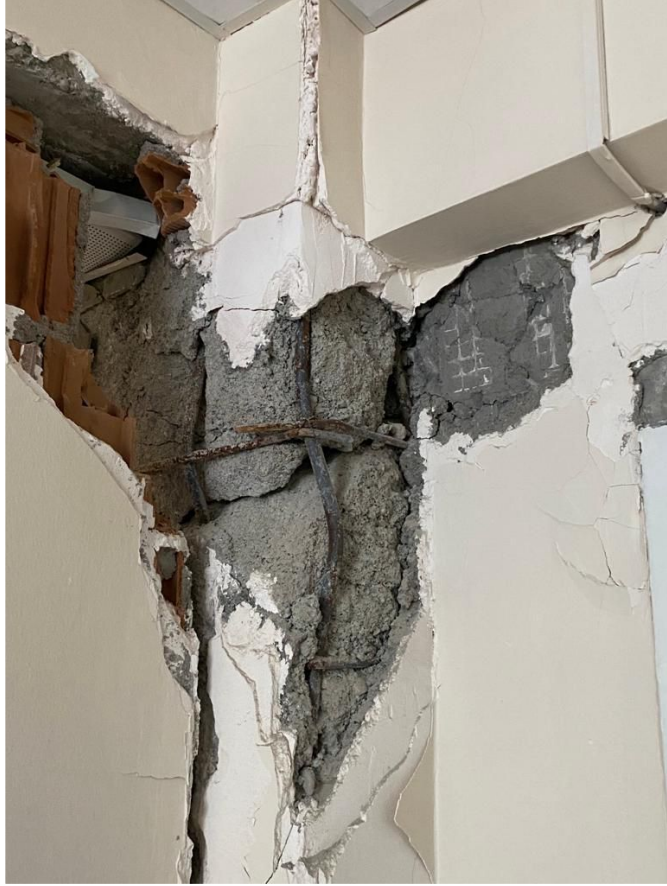
Adıyaman, Public Hospital

Lack of sufficient transverse reinforcement

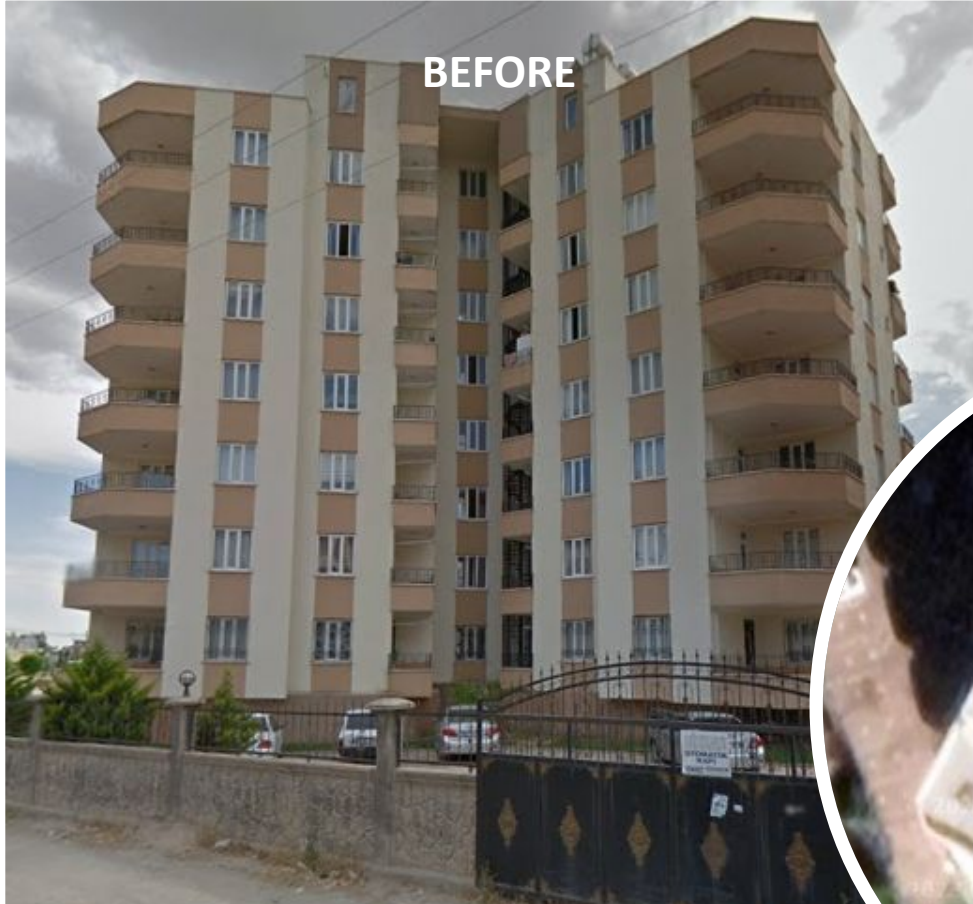
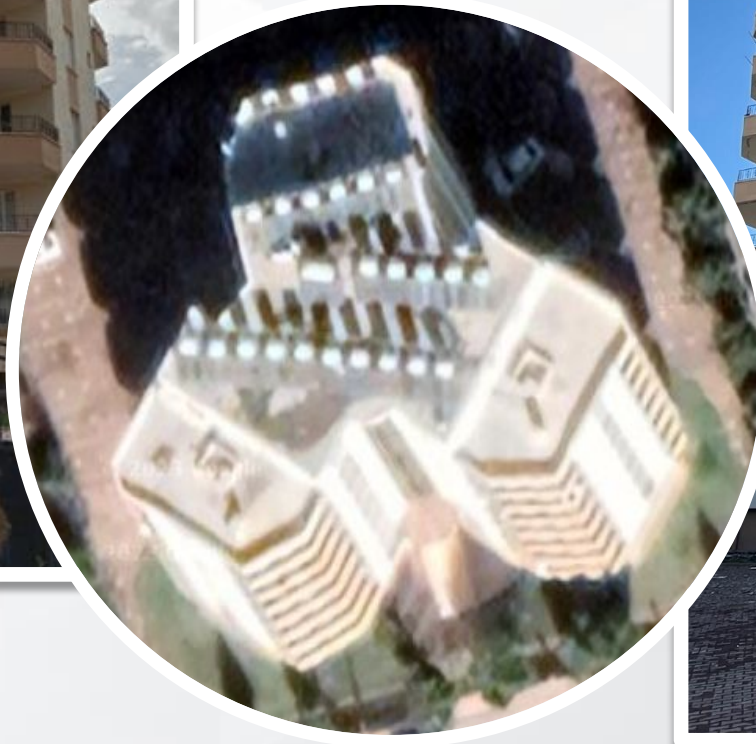
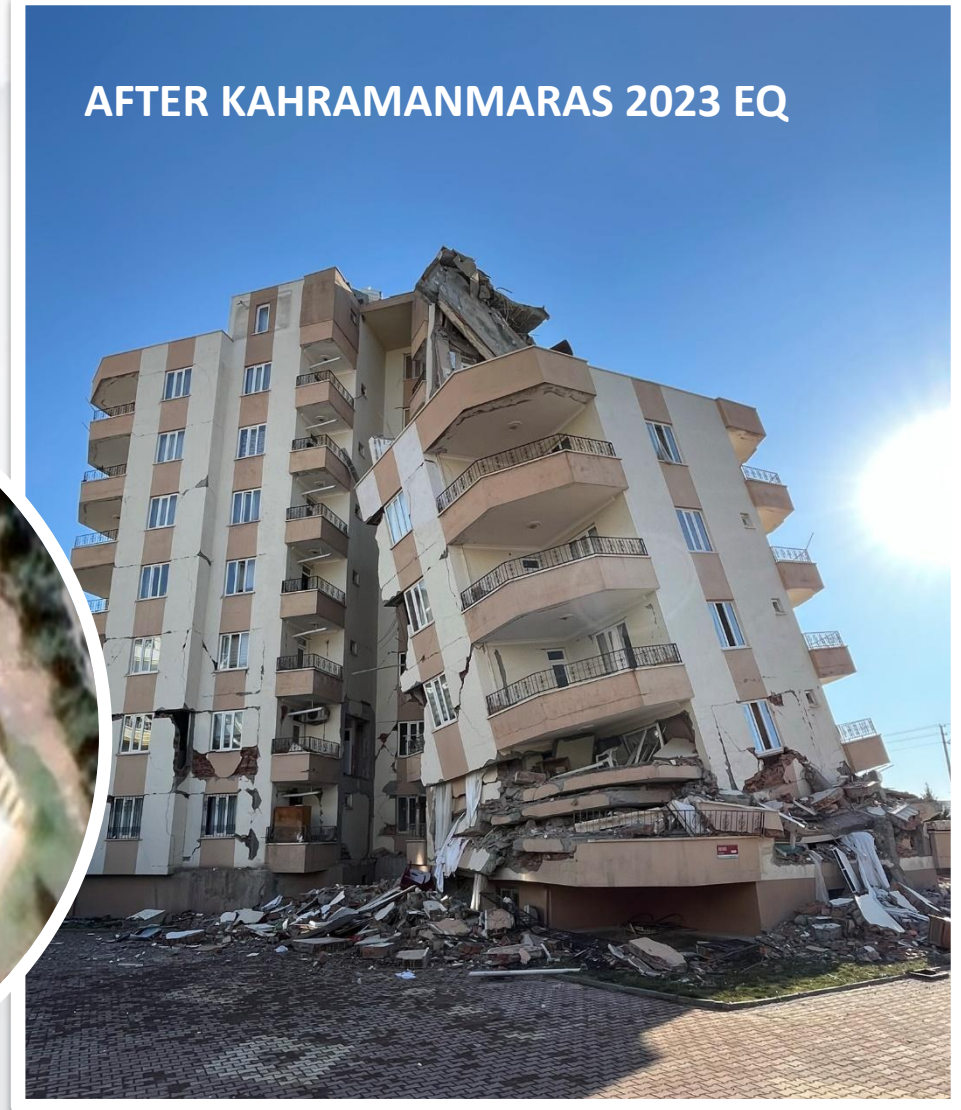
Invitation to torsion

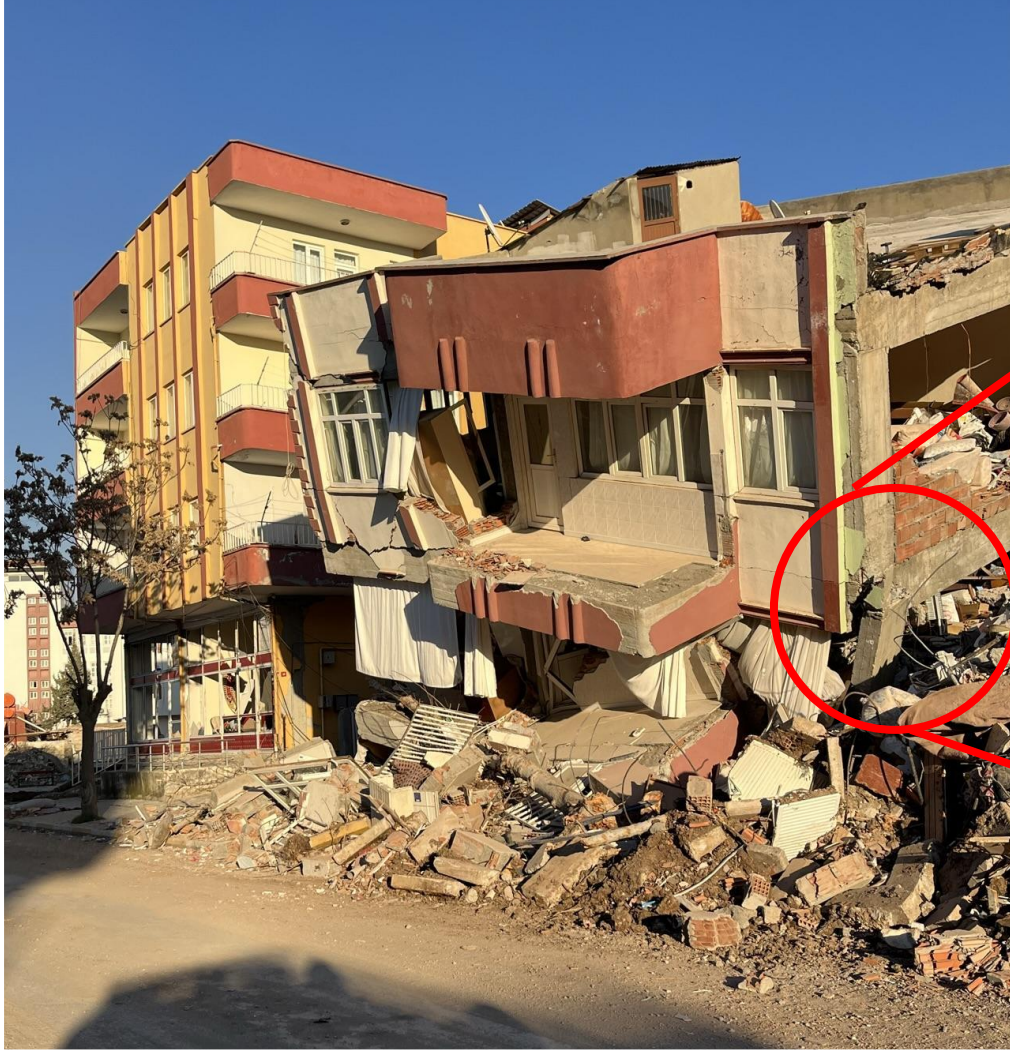
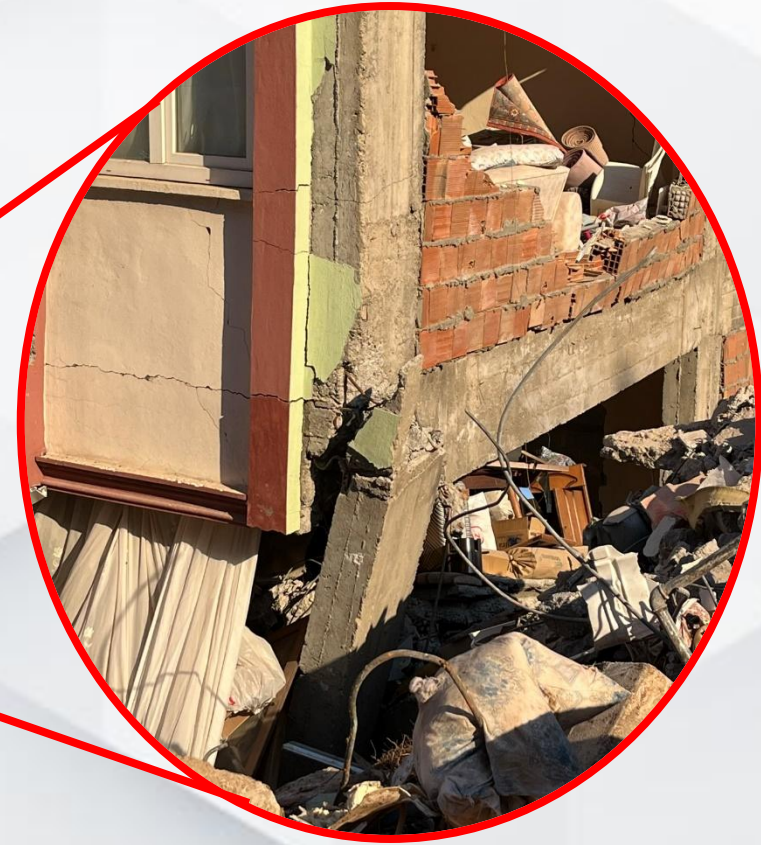
Strong column – weak beam

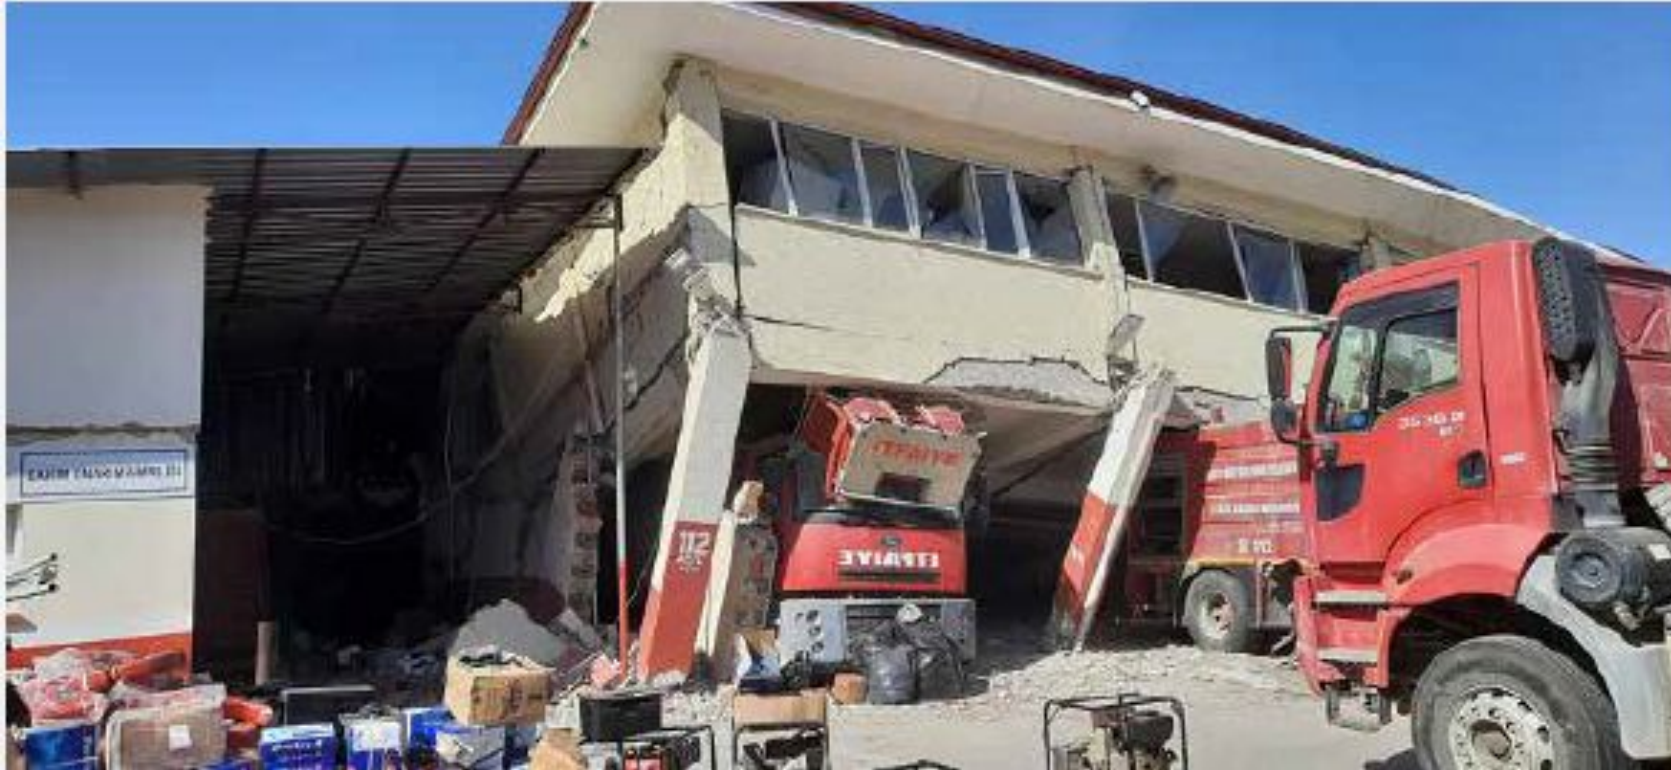
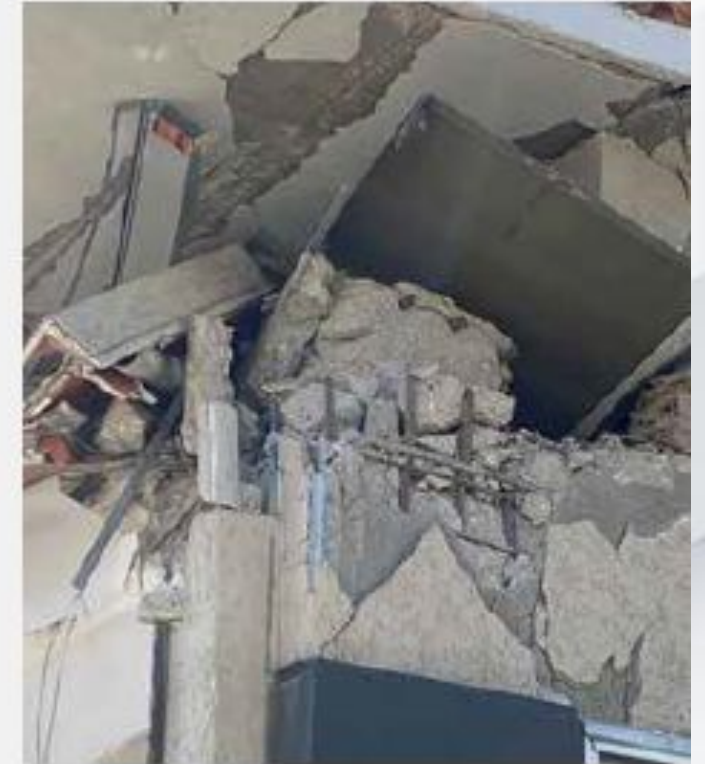
Strong column – weak beam

- Higher first story height
- Soft story collapse
