Prevalent Structural Engineering Problems Observed in RC Buildings After Kahramanmaras Earthquakes

Zeynep TUNA DEGER, Ph.D.
Istanbul Technical University

Earthquake Reconnaissance

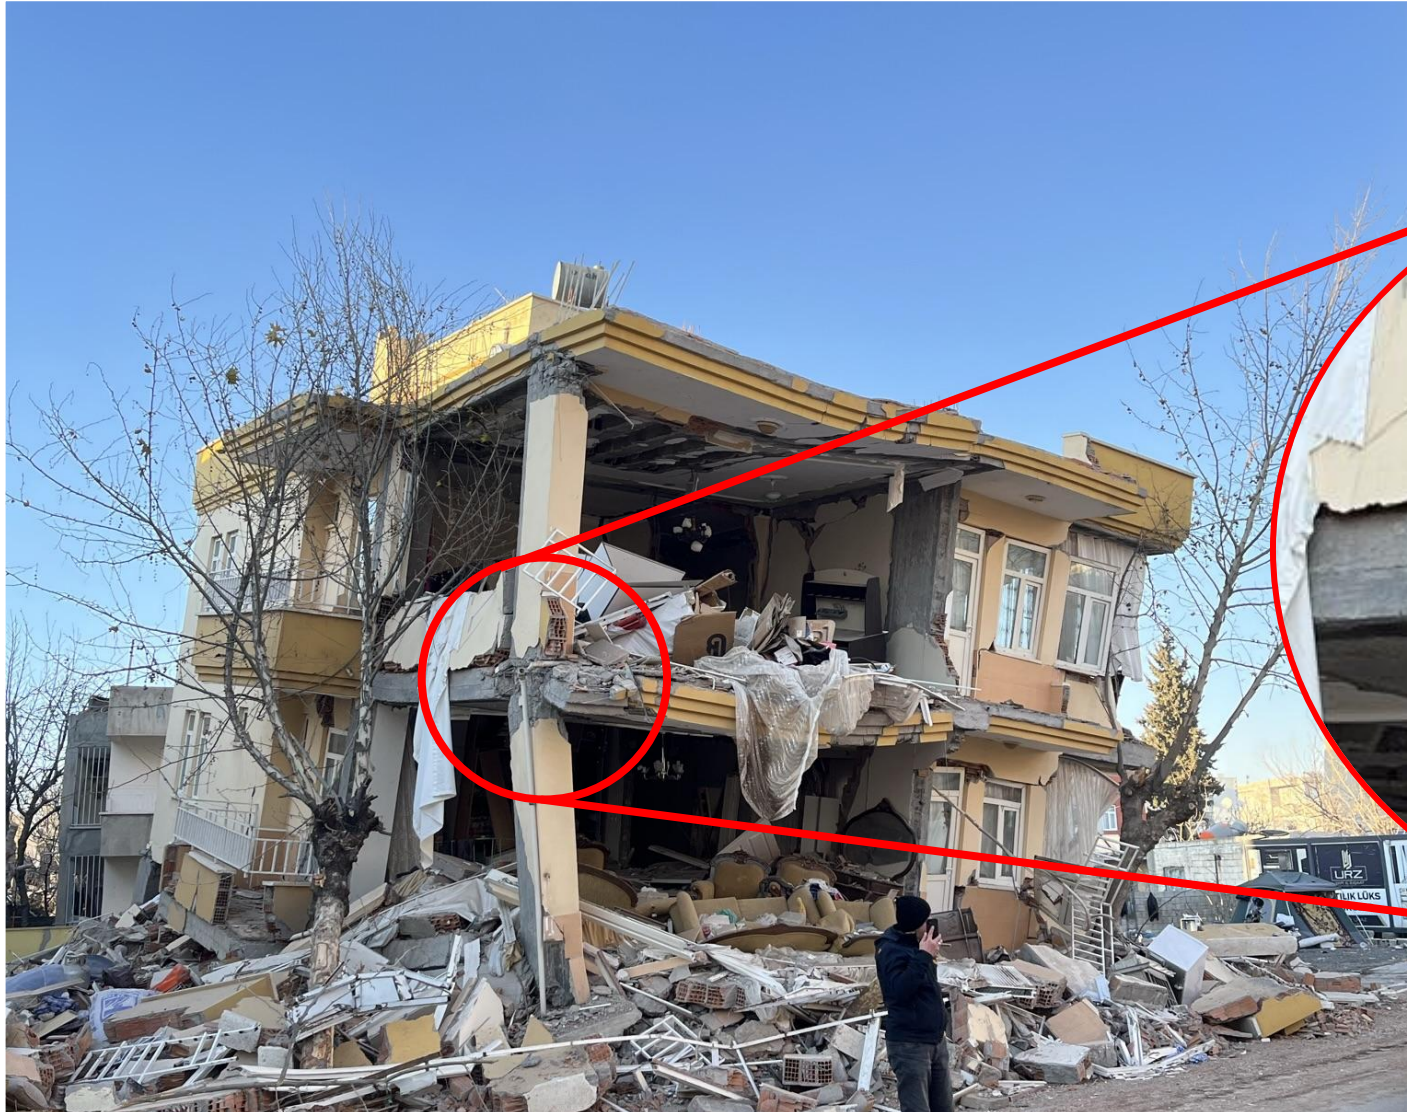
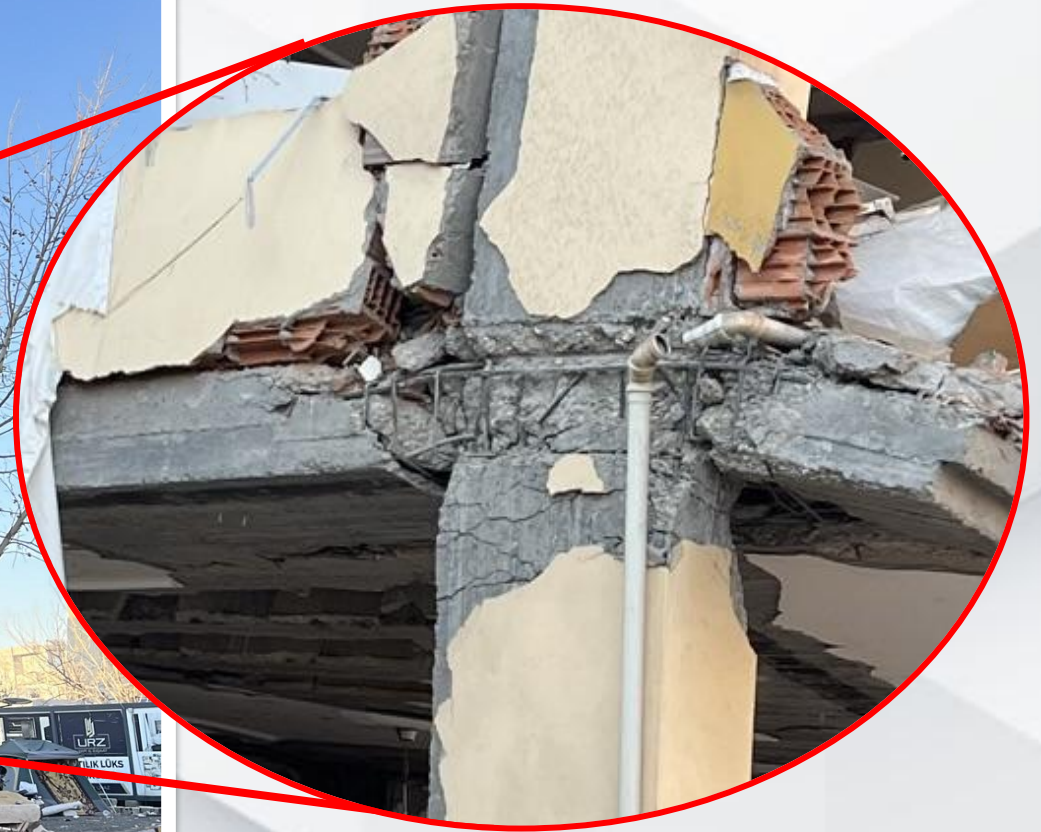
Poor joint design

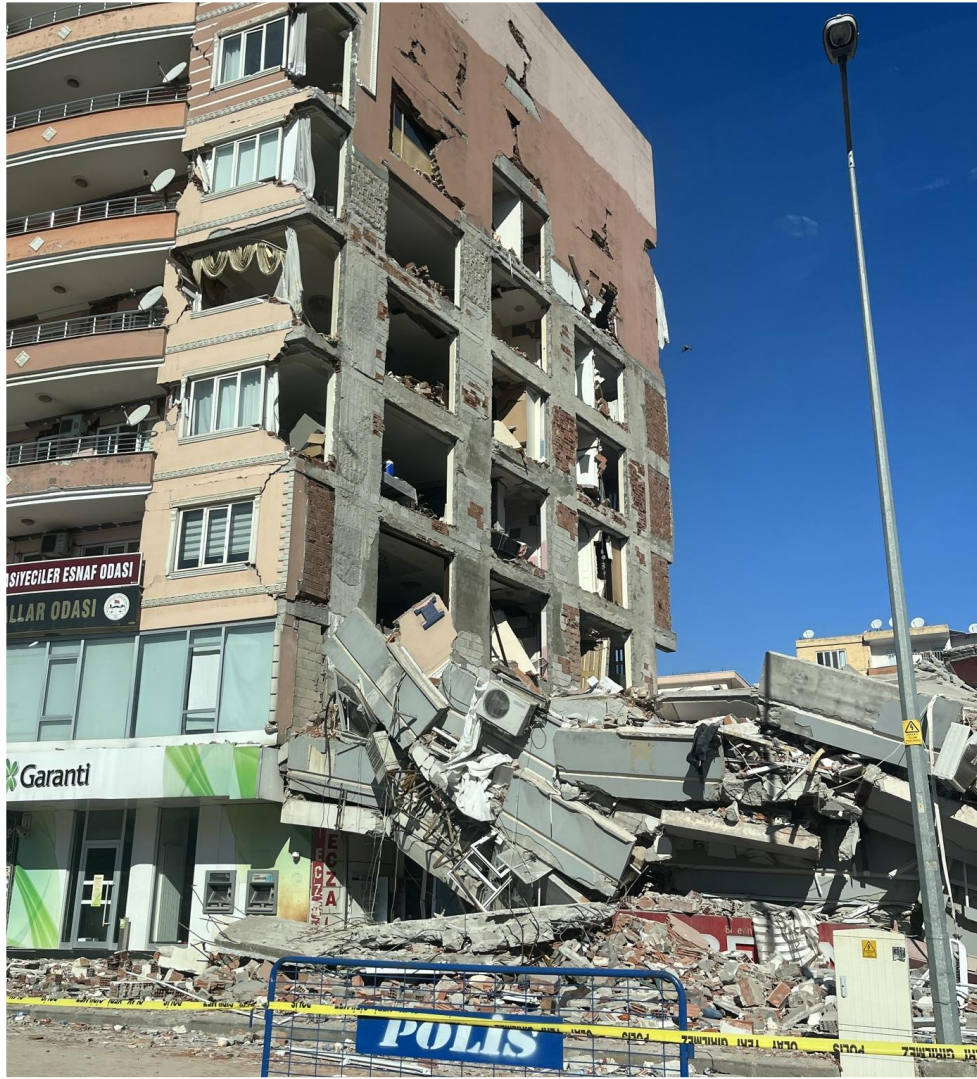
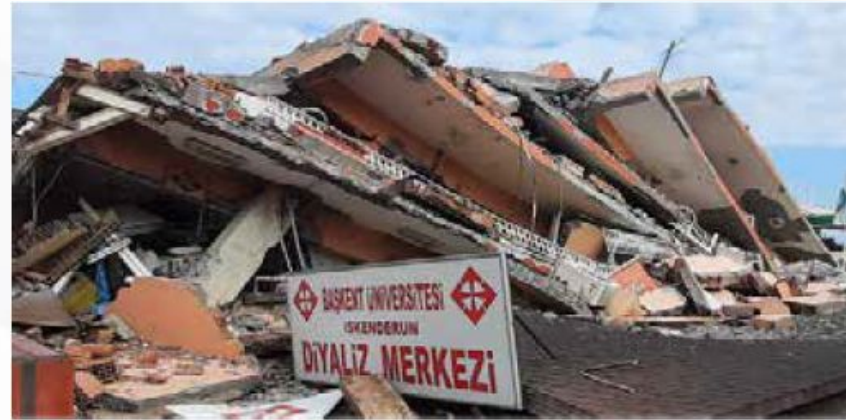
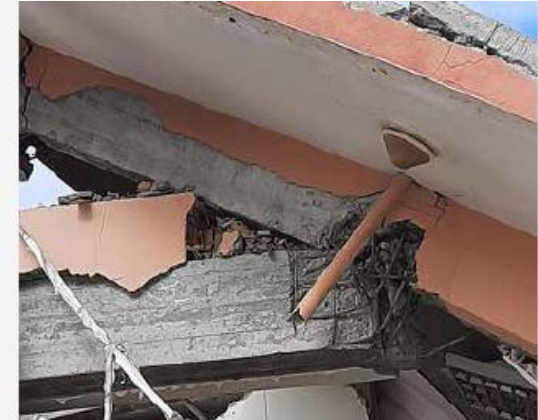
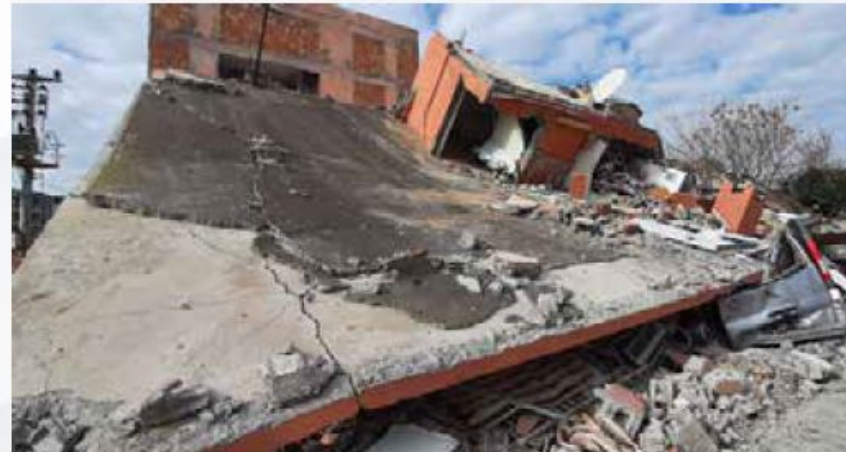
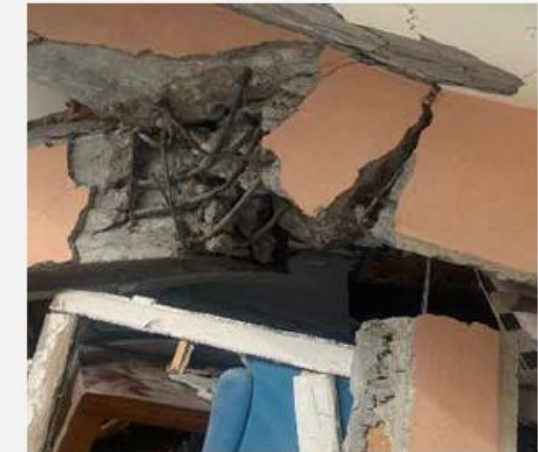
Pancake collapse

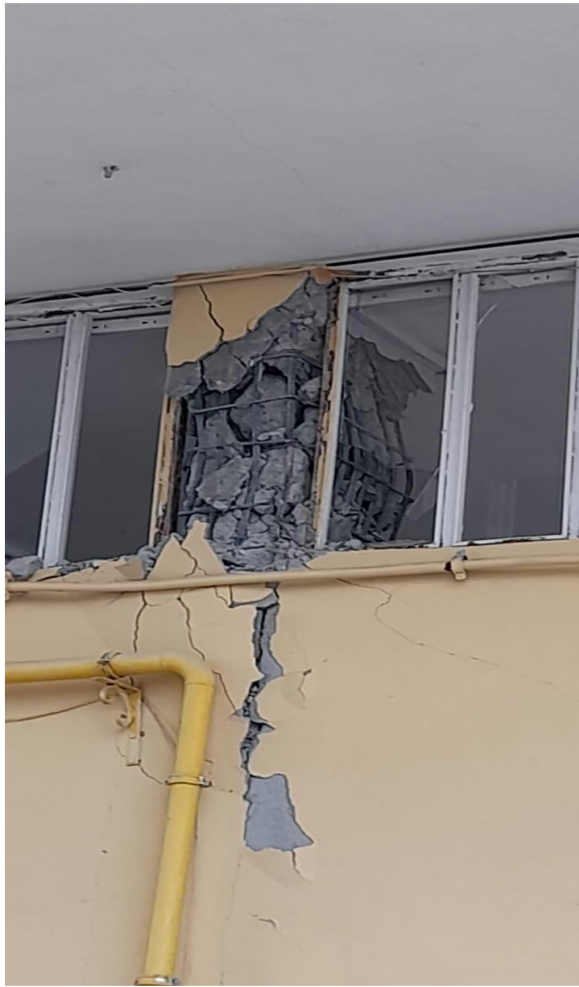
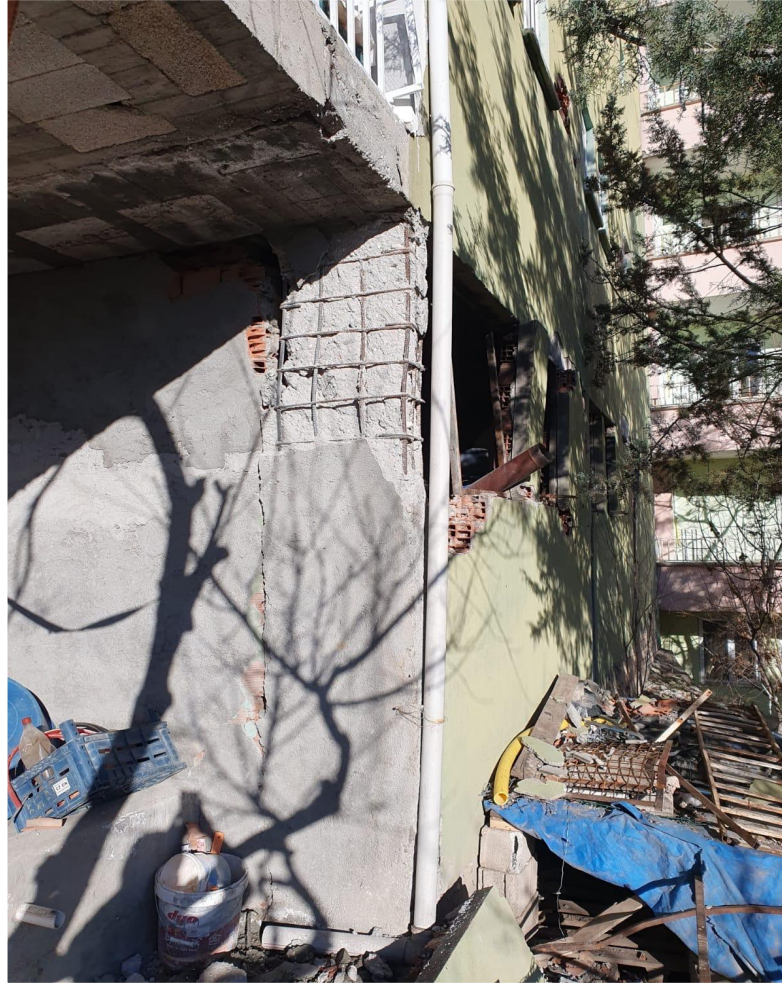
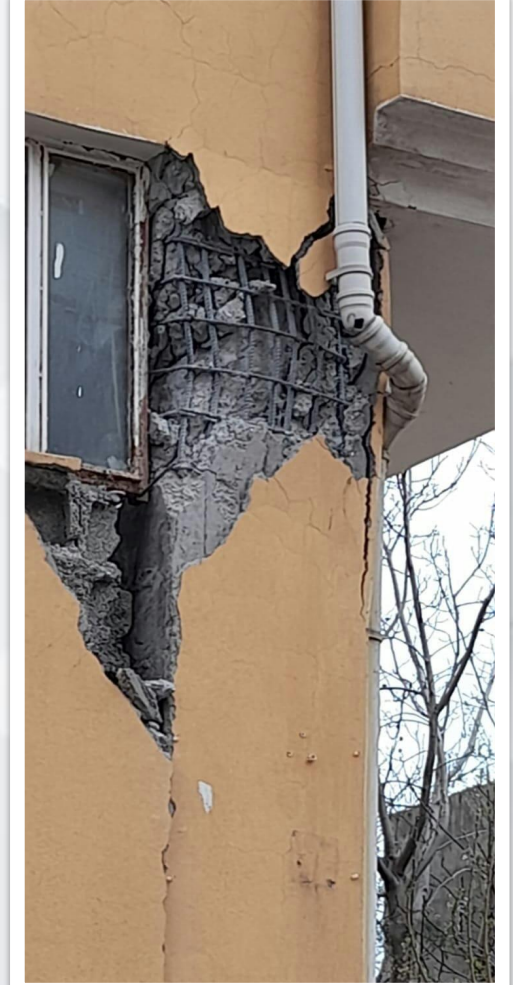
Short Column

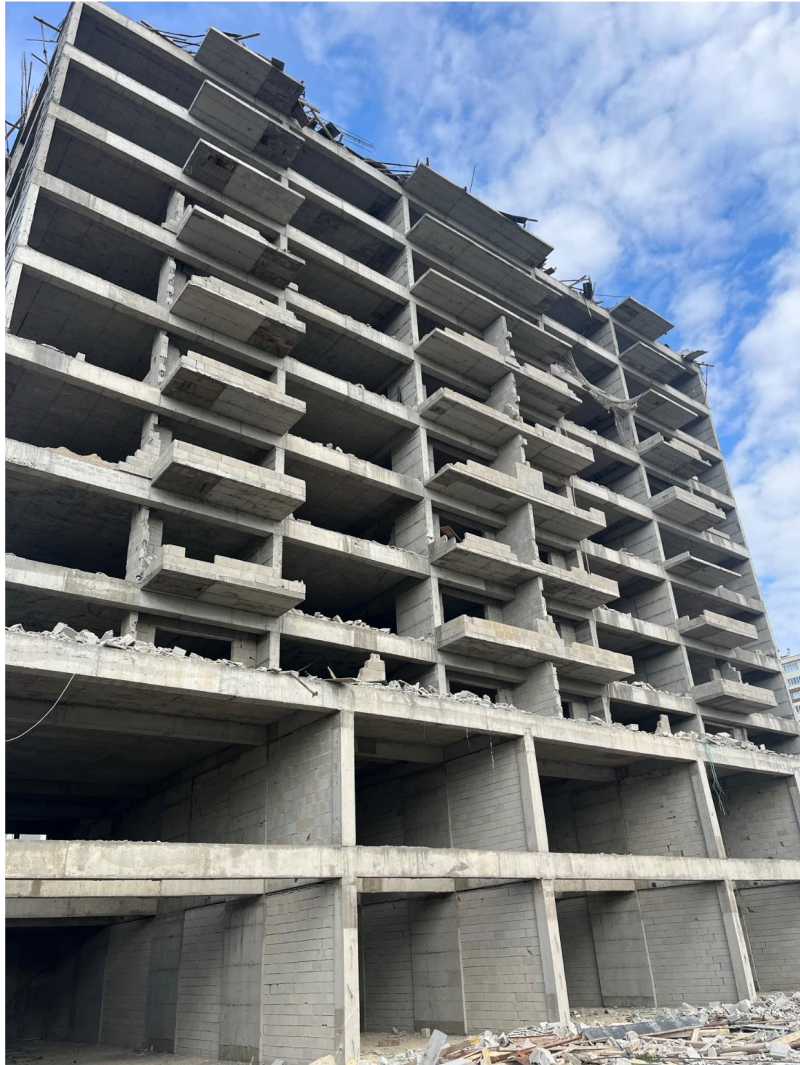
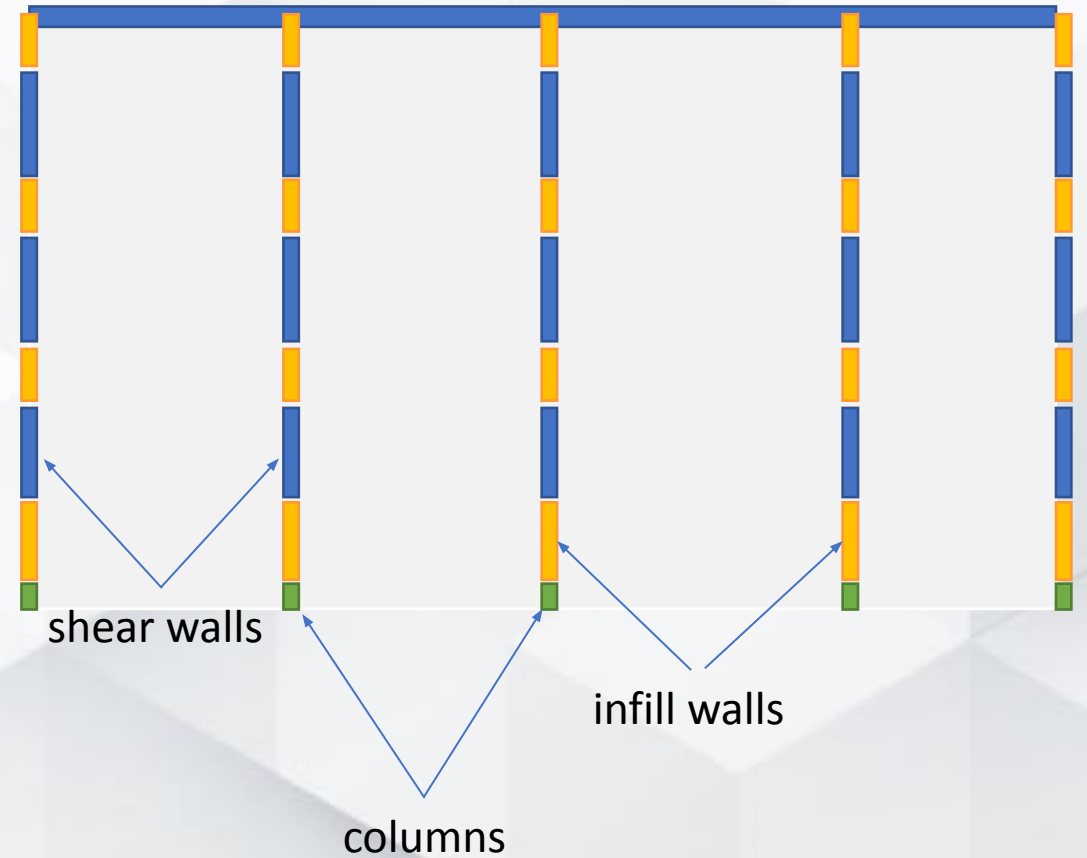
A building under construction, Kahramanmaraş

Unfavorable wall configuration
