**IMPRESSIONS OF THE
GUERRERO-MICHOACAN, MEXICO
EARTHQUAKE OF 19 SEPTEMBER 1985**

A PRELIMINARY RECONNAISSANCE REPORT

**Committee on Natural Disasters
Commission on Engineering and Technical Systems
National Research Council**

**October 1985
Publication No. 85-05**

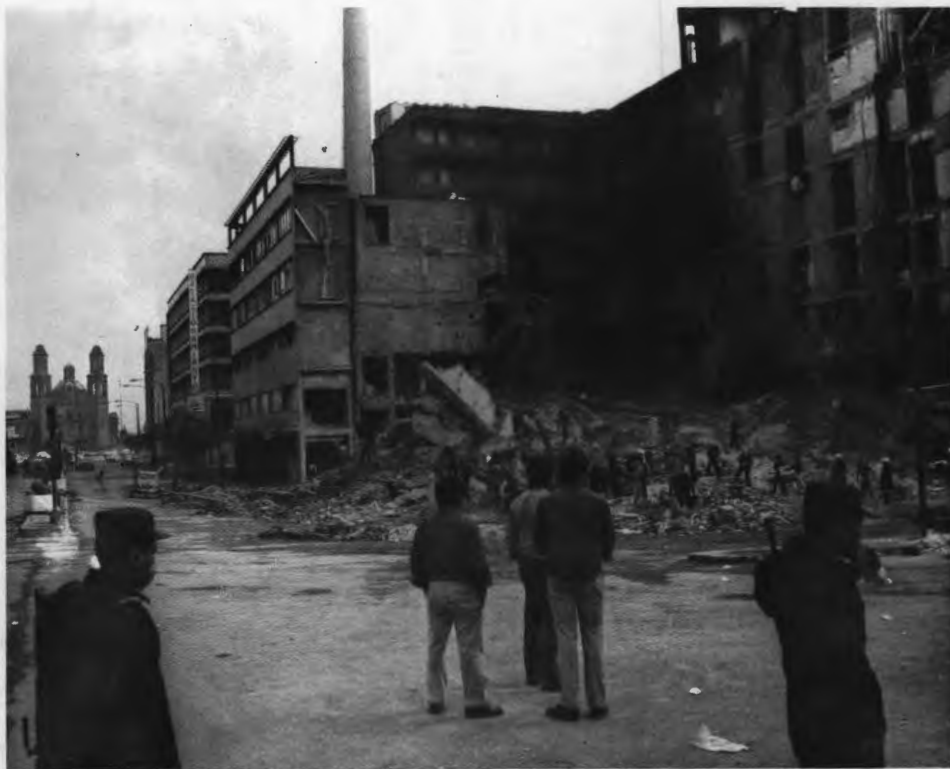
Propane gas systems did not suffer significant damage. Collapsed buildings caused some gas leakage. The only reported major fire from gas leakage was at the St. Regis Hotel where gas from ruptured pipelines ignited and caused a major explosion.

Collapsed Regis Hotel

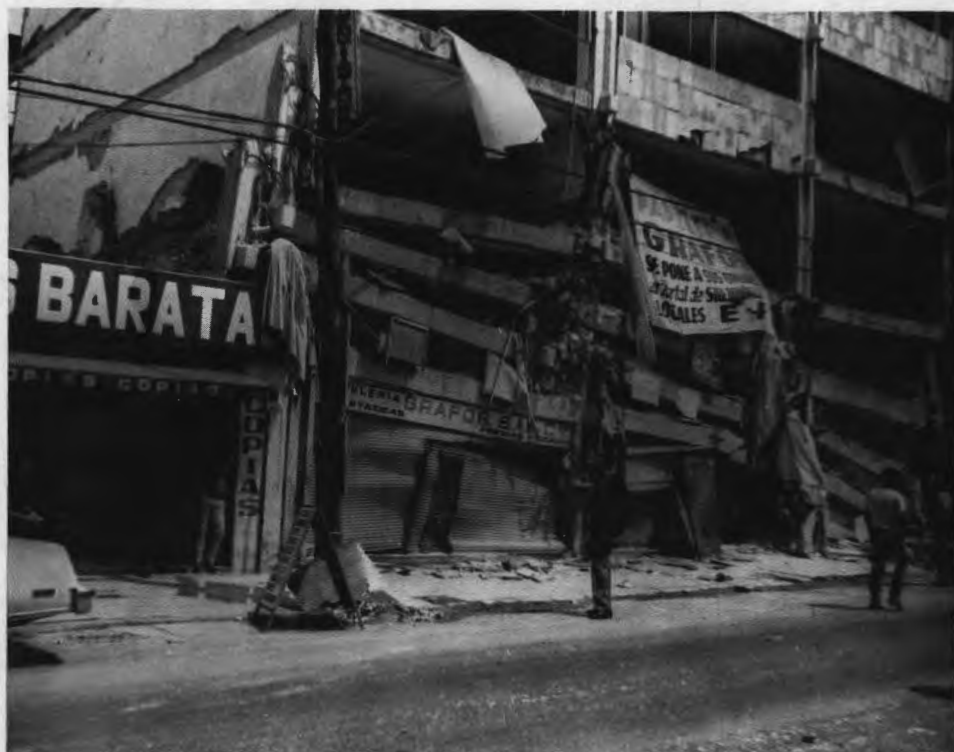
7-story commercial building --
lower floor collapse

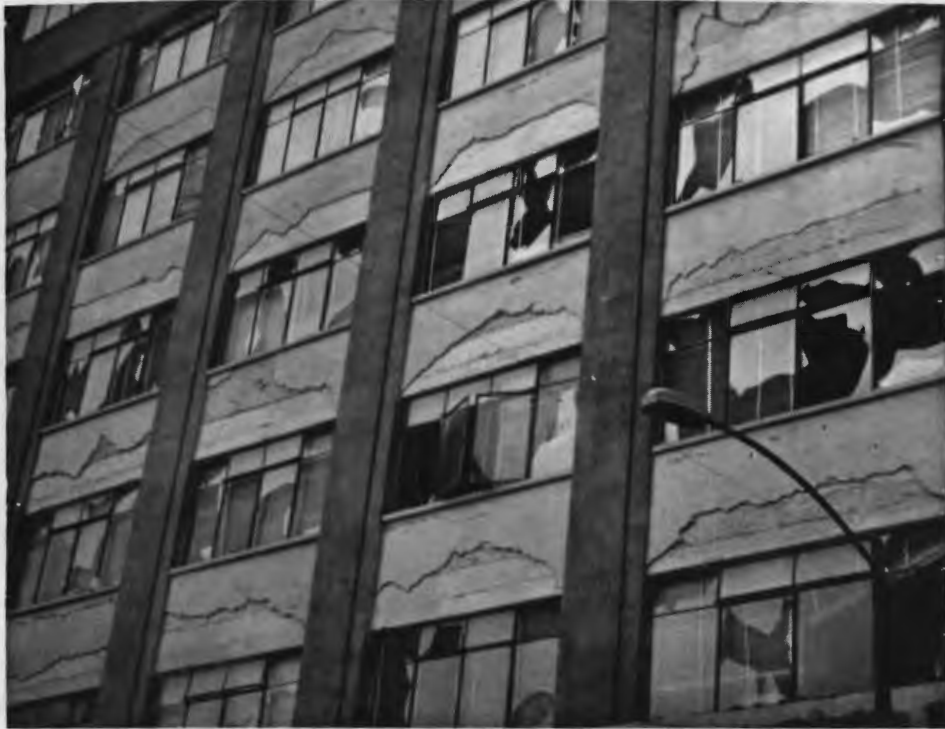
Building near Regis Hotel -- glass and stucco spandrel cracking

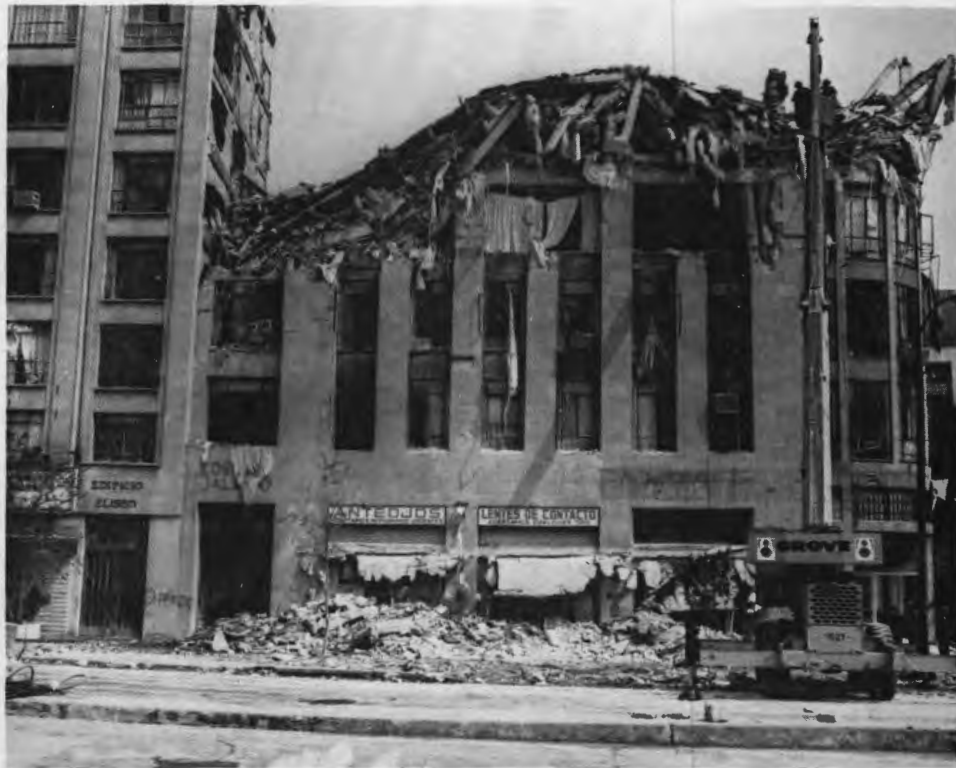
Older concrete building --
upper floor collapse

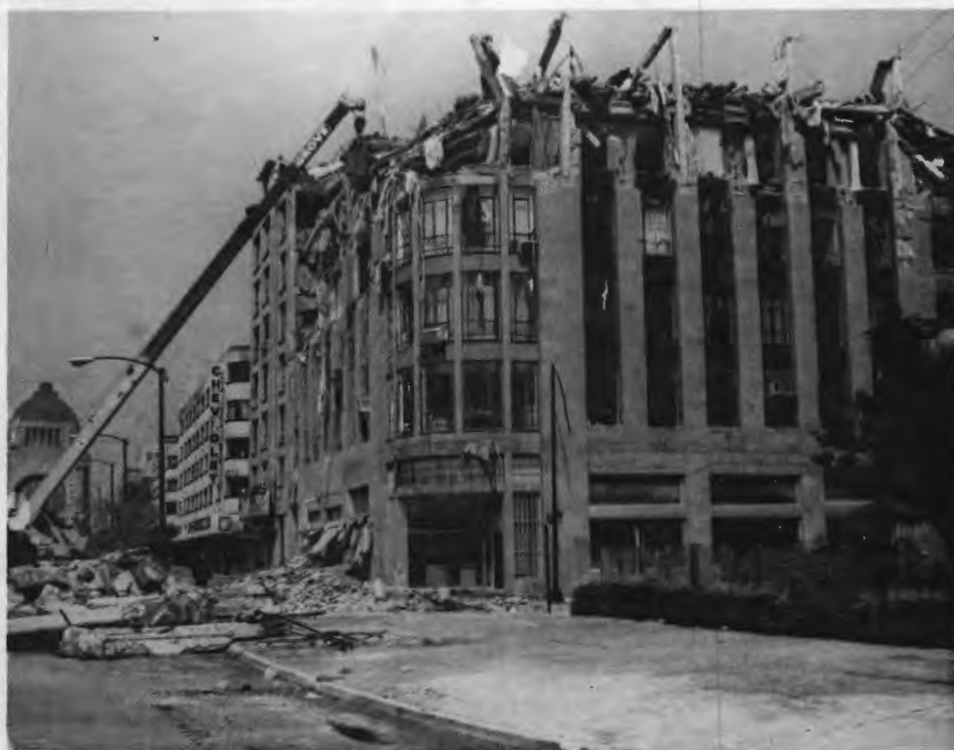
Older concrete building --
upper floor collapse

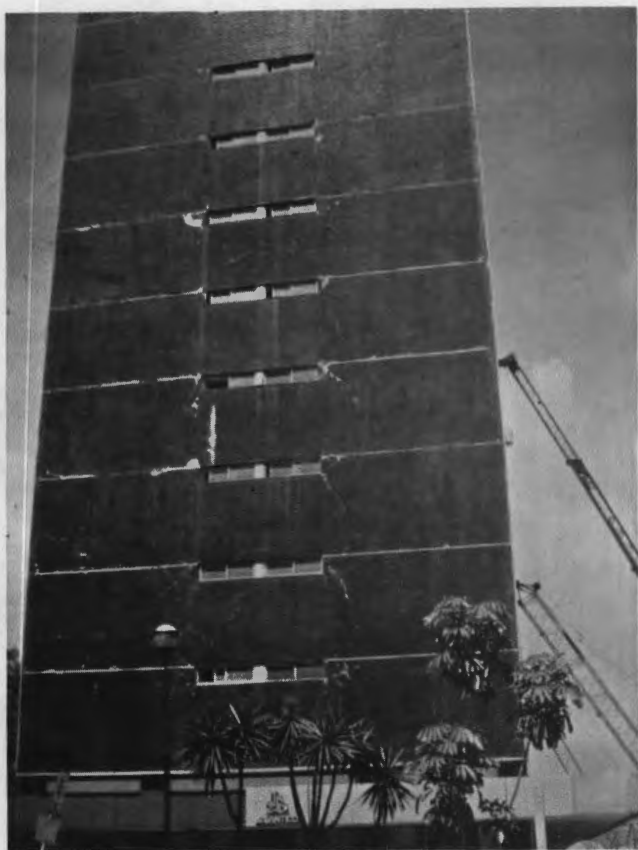
Nuevo Leon Housing Project -- remaining building end wall showing open first floor. The back of this building collapsed completely and caused many deaths.

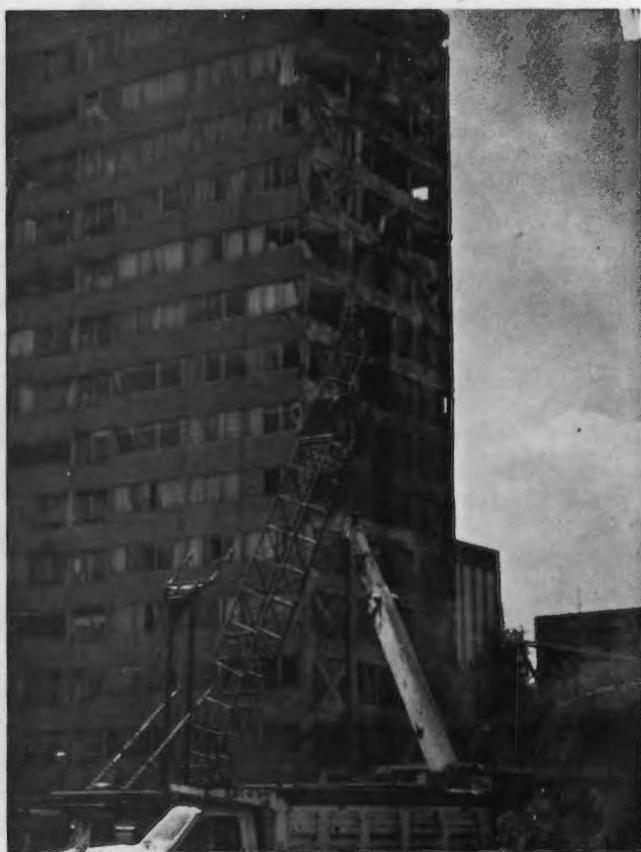
Nuevo Leon Housing Project showing the braced wall adjoining the building completely collapsed.

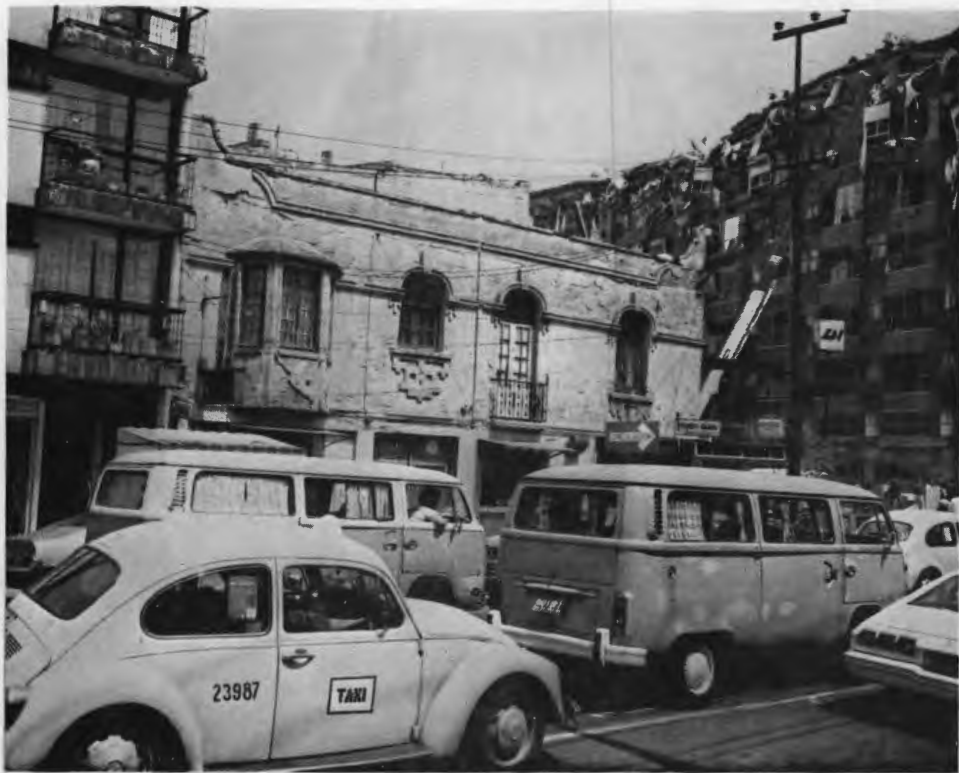
Intact old masonry building. Damaged government office building in background -- top floor collapse.

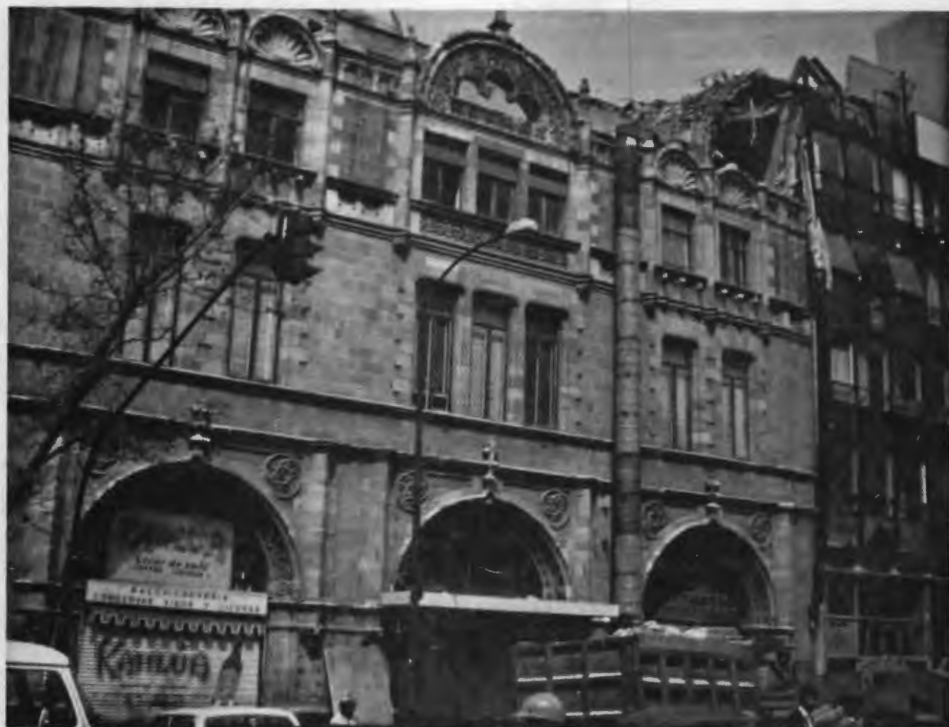
Undamaged old masonry building. Next door is newer office building with upper floor collapse

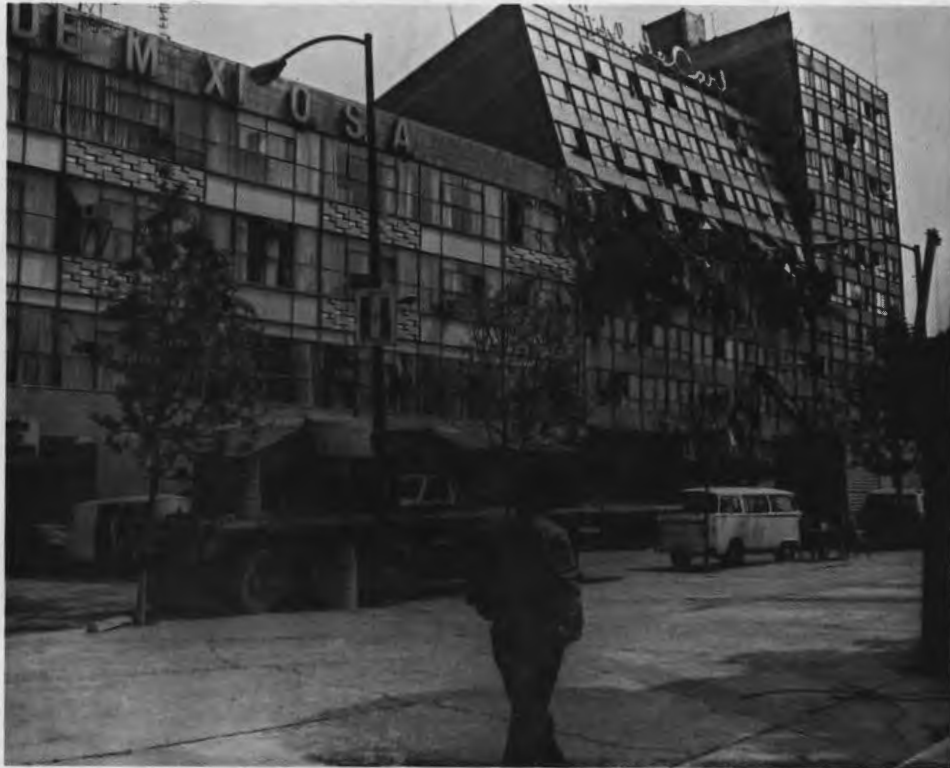
Hotel DeCarlo -- mid-floor collapse

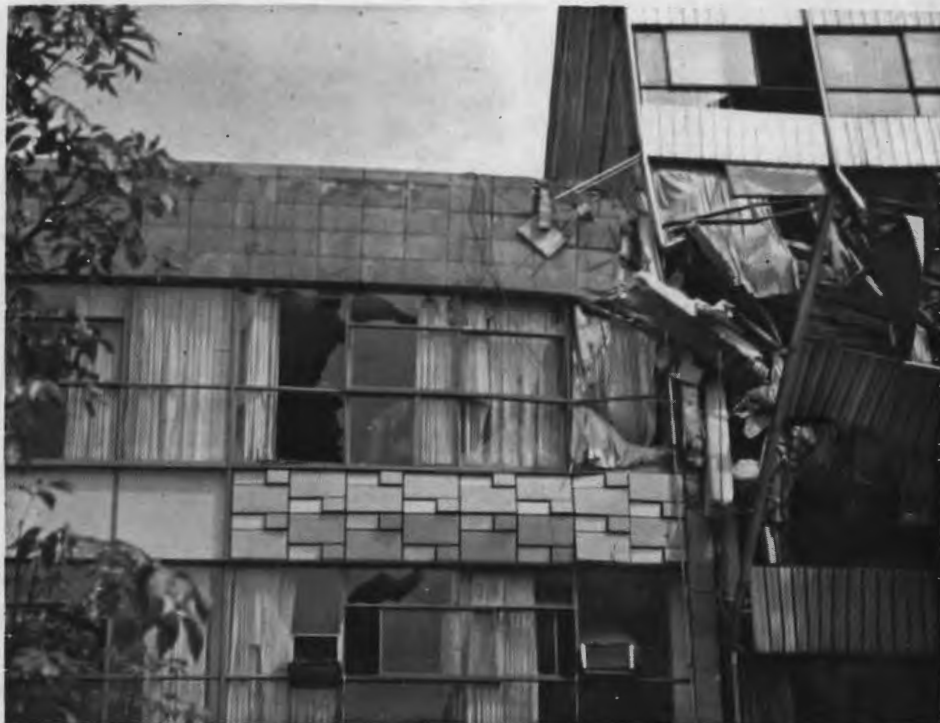
Hotel DeCarlo detail

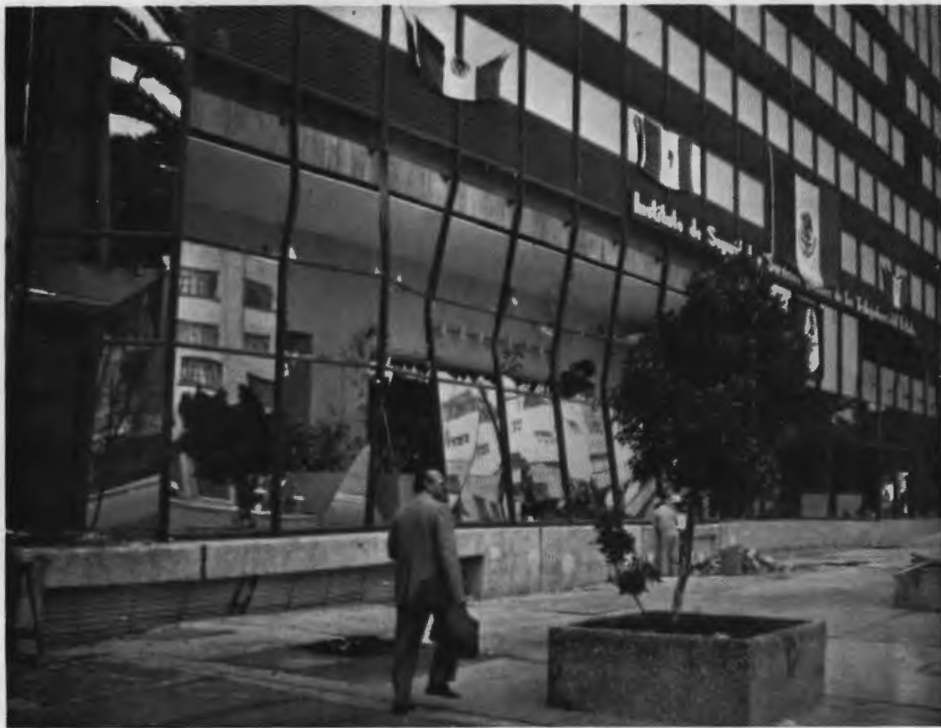
Distorted glass framing

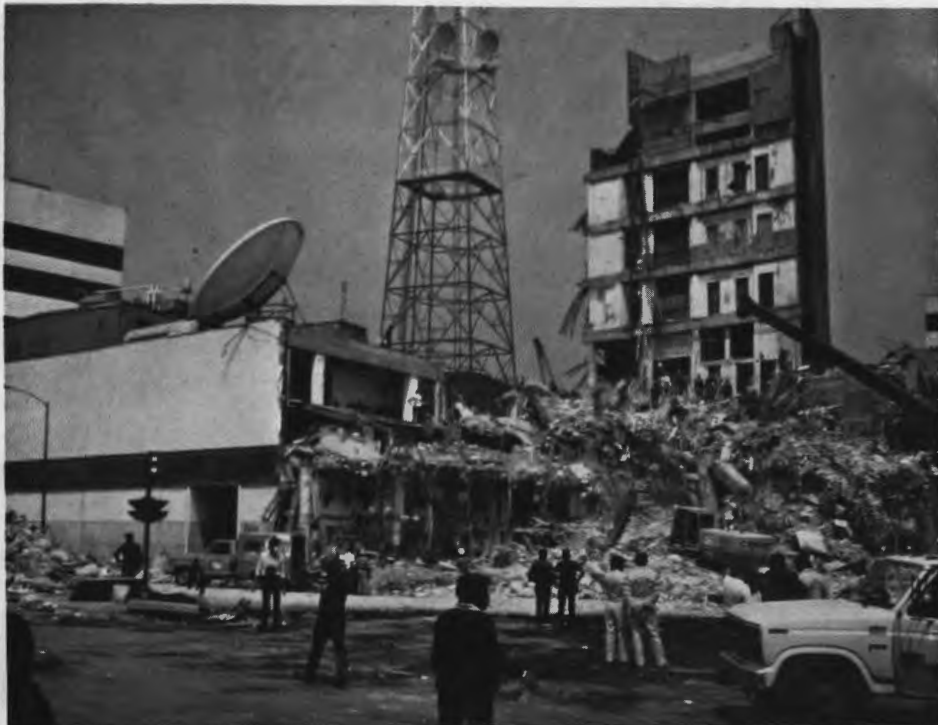
Telefonos de Mexico, the National Telephone Company, suffered major damage to its long distance telephone transmission equipment and heavy loss of life among personnel when the top three stories of its five-story office building collapsed. All service outside of Mexico City was lost, and no estimate was possible about when service would be restored. Telephone communications within Mexico City appeared to be completely operational.

Central telecommunications complex

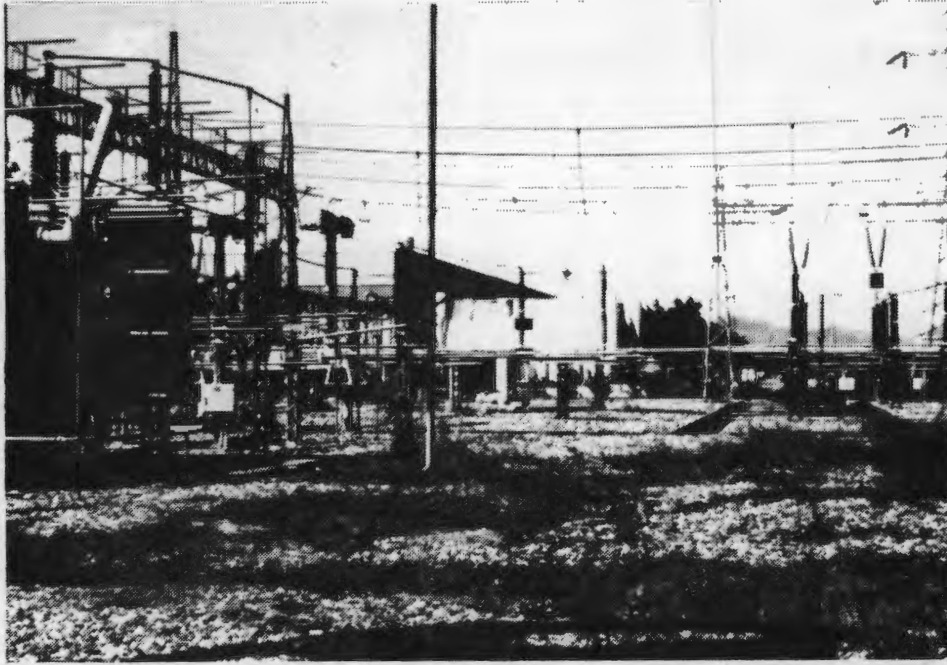
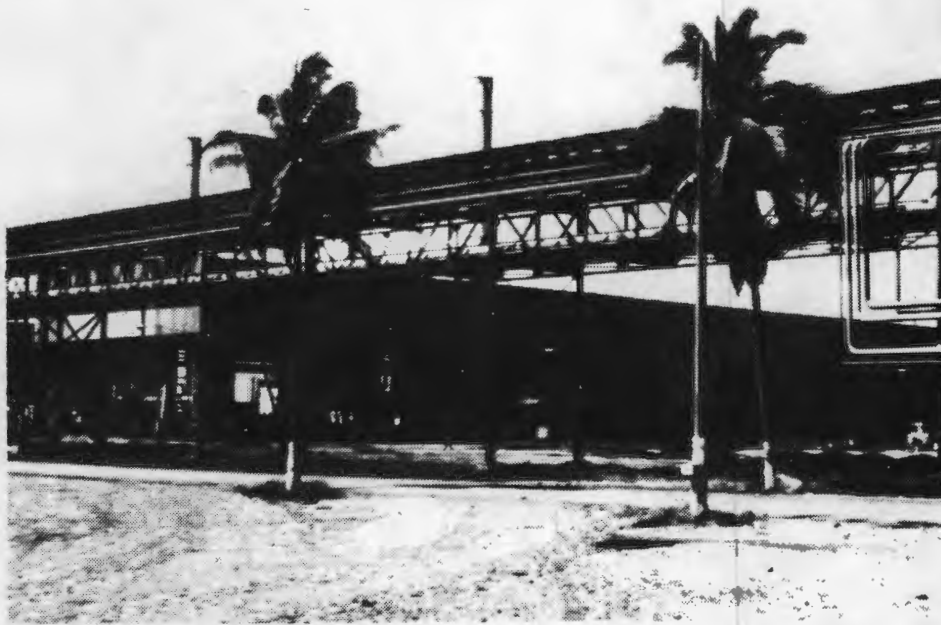
Except for its concrete structures, the steel plant had minimal damage from the earthquake. Equipment damage was limited to high voltage switchyard equipment that caused partial loss of offsite power. The plant's emergency onsite power generating system was put into operation immediately. One emergency turbine generator of the two unit system would not start. The cause is not yet confirmed and may be earthquake related. All of the many steel frame industrial structures performed well. The only building damage was to a large concrete administration building. An underground water pipe cracked. Long runs of pipes and cable trays on overhead steel frame structures had no apparent damage.

SICARTSA Steel Mill. The top photograph shows the switchyard where a disconnector switch similar to the one seen near the center of the photograph fell due to a cracked ceramic insulator. A transformer similar to the one at the left also suffered a cracked oil seal. The lower photograph shows a pipe support structure with a large structural steel building in the background. Both are representative of the types of components located at this plant, all of which performed well during the earthquake. A concrete frame administration building had severe damage to masonry panels and was evacuated.
