**EARTHQUAKE ENGINEERING RESEARCH INSTITUTE
COMMITTEE ON CONTINUING EDUCATION**

SUBCOMMITTEE TO CREATE SLIDE
SETS ON THE SEPTEMBER 19, 1985
MEXICO EARTHQUAKE

**MEXICO - SET I:
GENERAL OVERVIEW**

FEBRUARY 1987

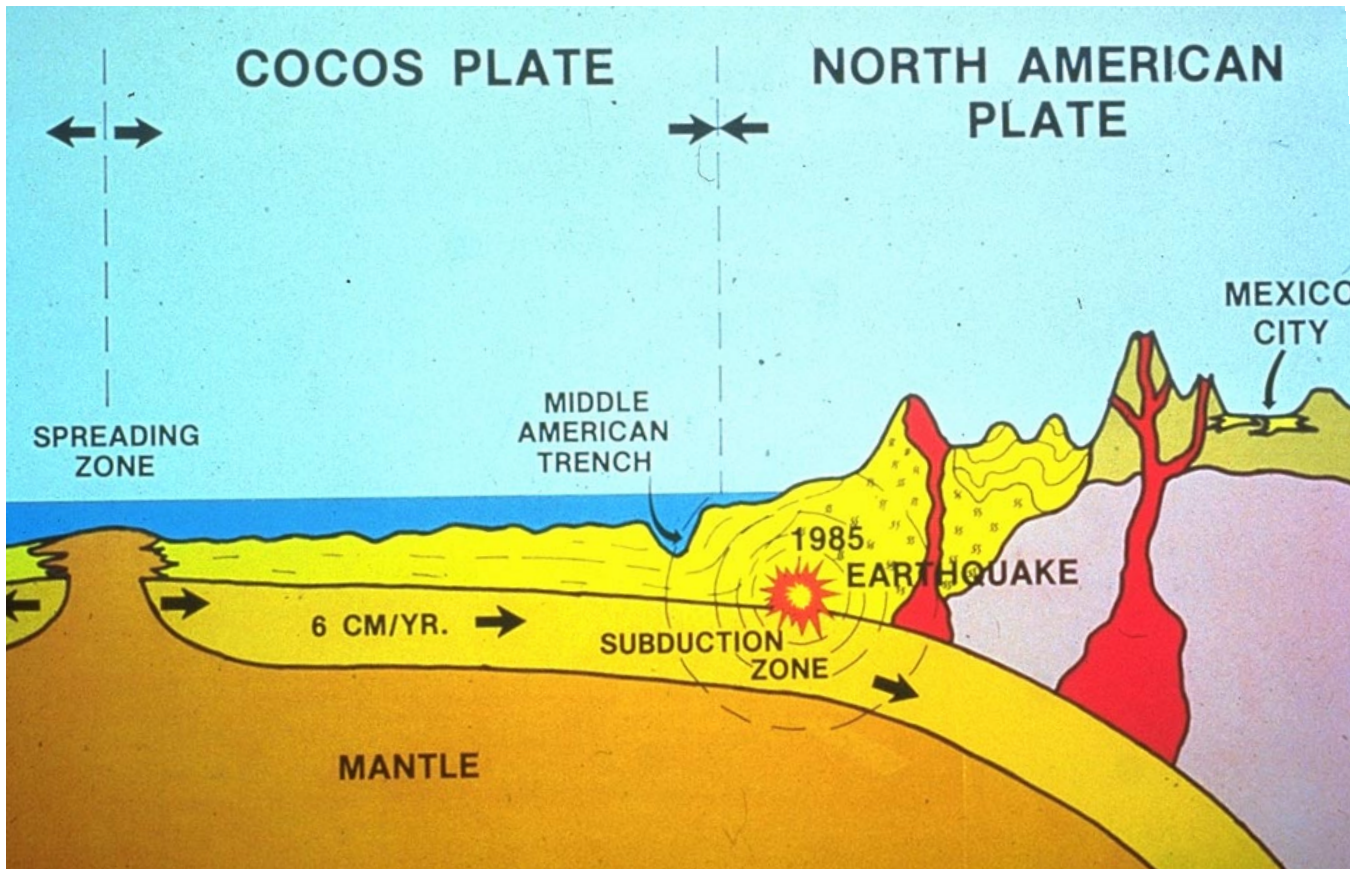
Cocos and North American Plate Intersection

Geologic profile across the Cocos and North American plates showing subduction zone and rate of movement per year. This is a high seismicity zone having frequent large earthquakes.

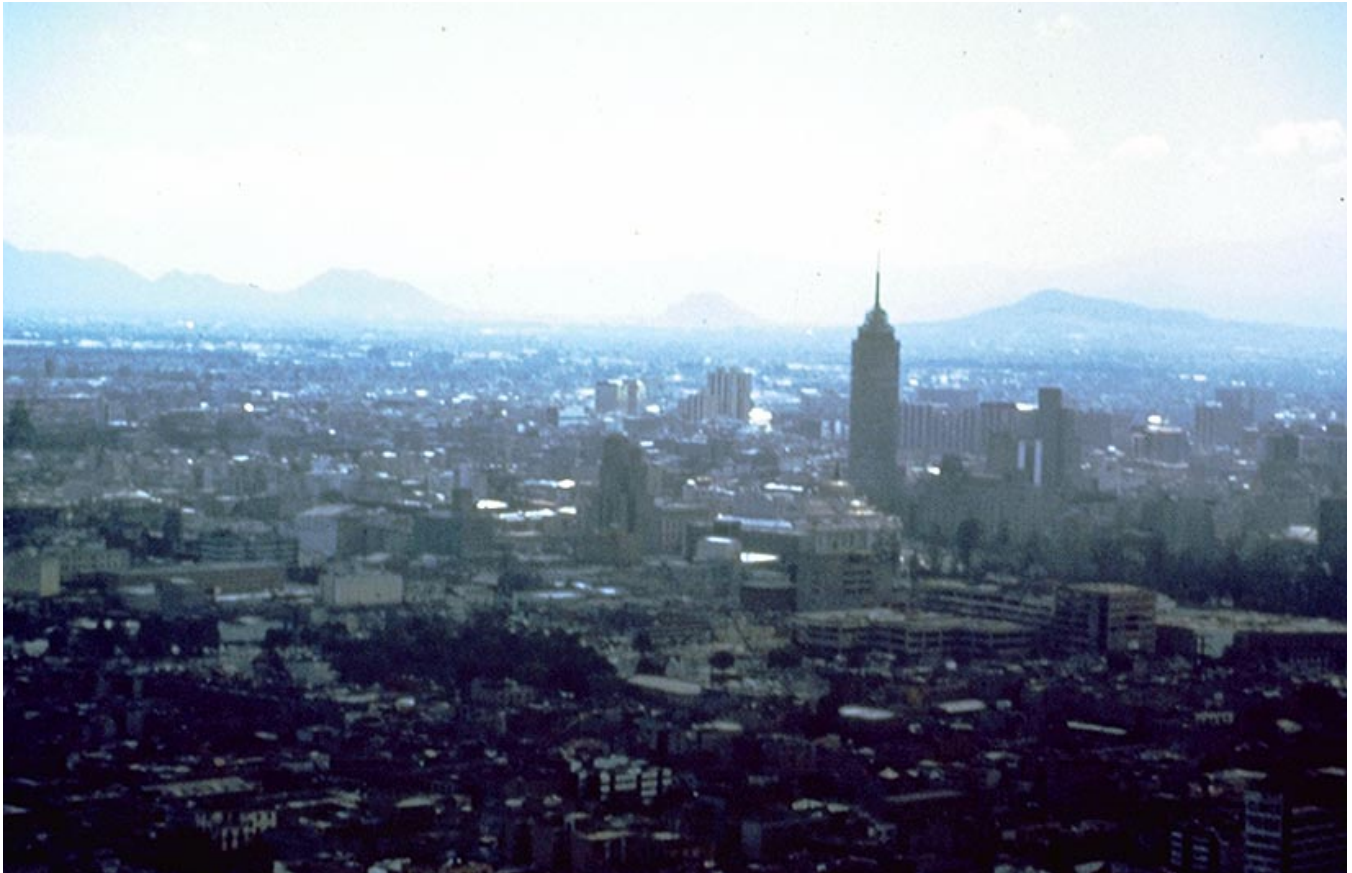
Mexico City Aerial View

Aerial view of Mexico City showing the central historic district and the Latino Americana tower. The density of buildings and the large proportion of undamaged buildings can be seen.

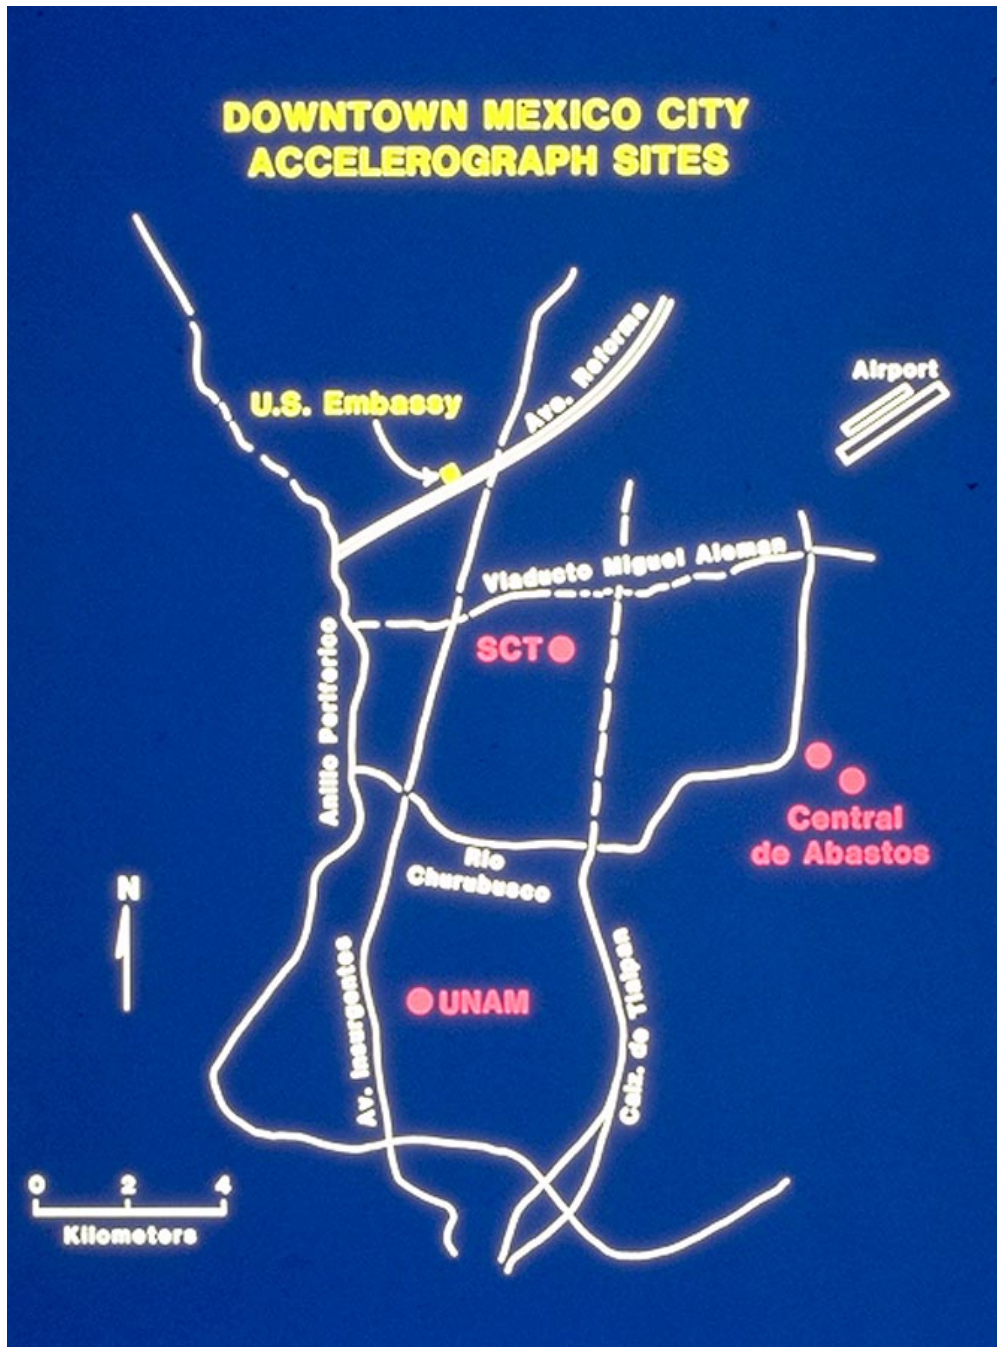
Location of Accelerograph Stations

Location of three key accelerograph stations whose records were available shortly following the quake. The SCT station gave the best record for the zone of heavy damage.

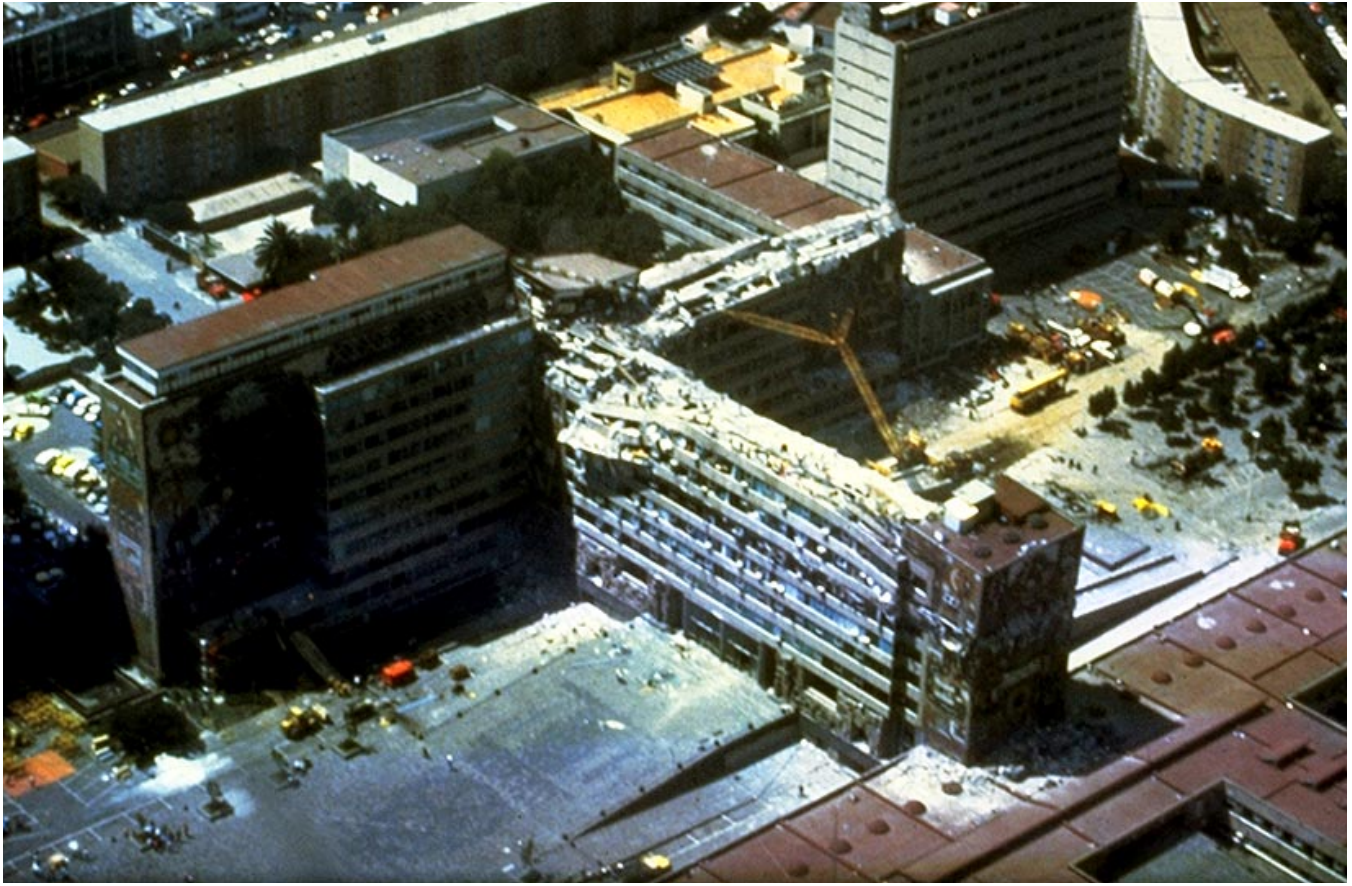
Aerial View of SCT Looking Southwest

Aerial view looking southwest of the Communications Center, location of free-field accelerograph station.

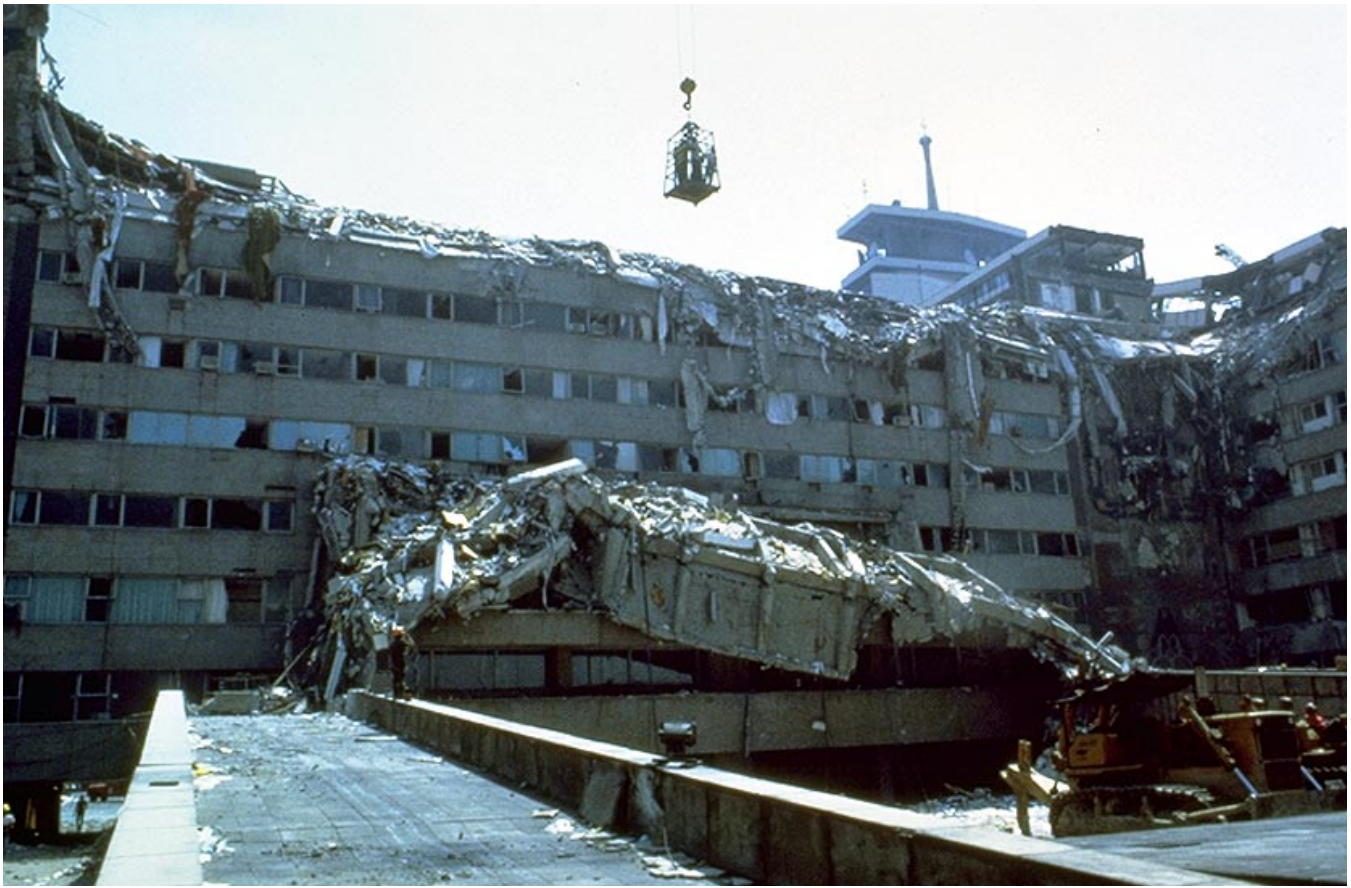
Interior Collapsed Intersection of SCT

Closeup of northwest interior corner of the Communications Center where the progressive collapse appears to have been initiated. Heavy damage at this facility virtually cut off external communication between Mexico and other countries.

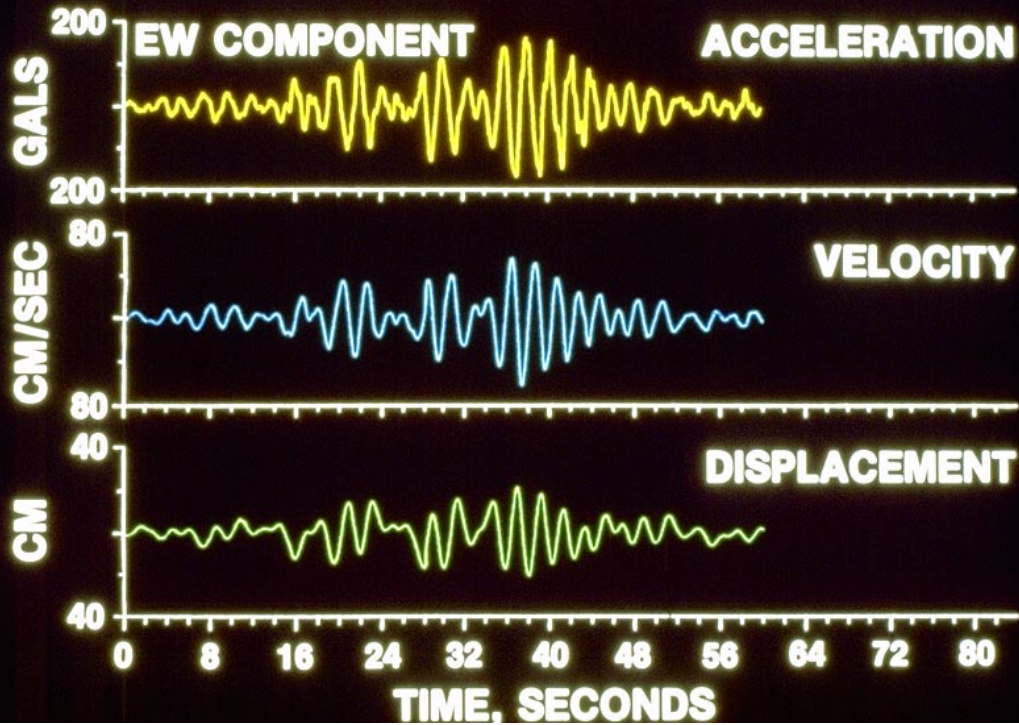
SCT Ground Shaking Records

SCT (communication center) east-west components of acceleration, velocity, and displacement for the Sept. 19, 1985 earthquake.

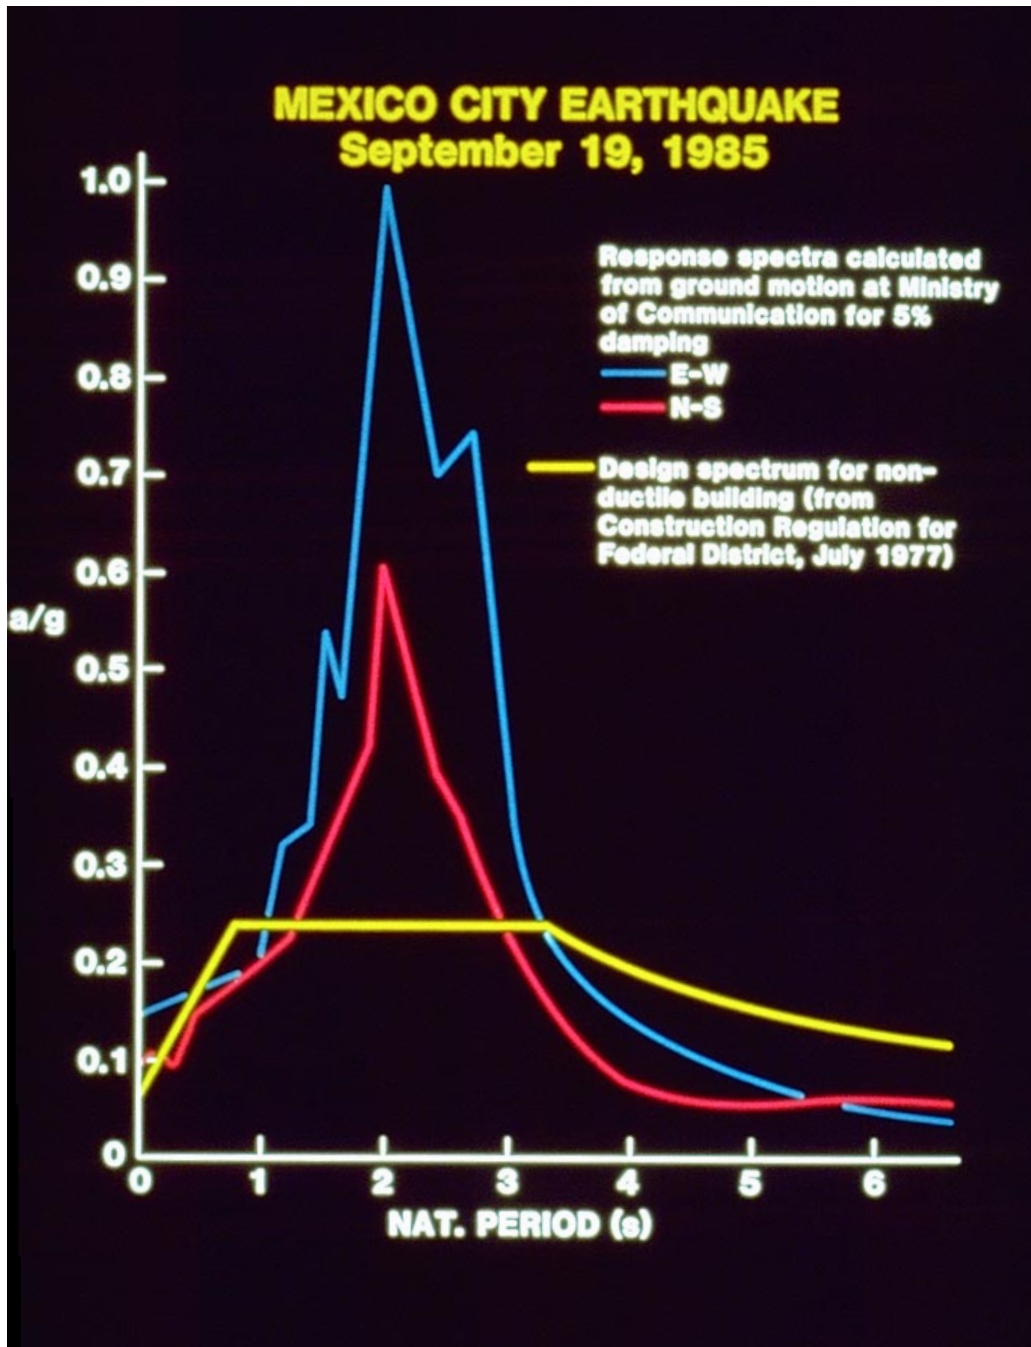
SCT Response Spectra

East-west component response spectra for the SCT site, September 19, 1985 quake.

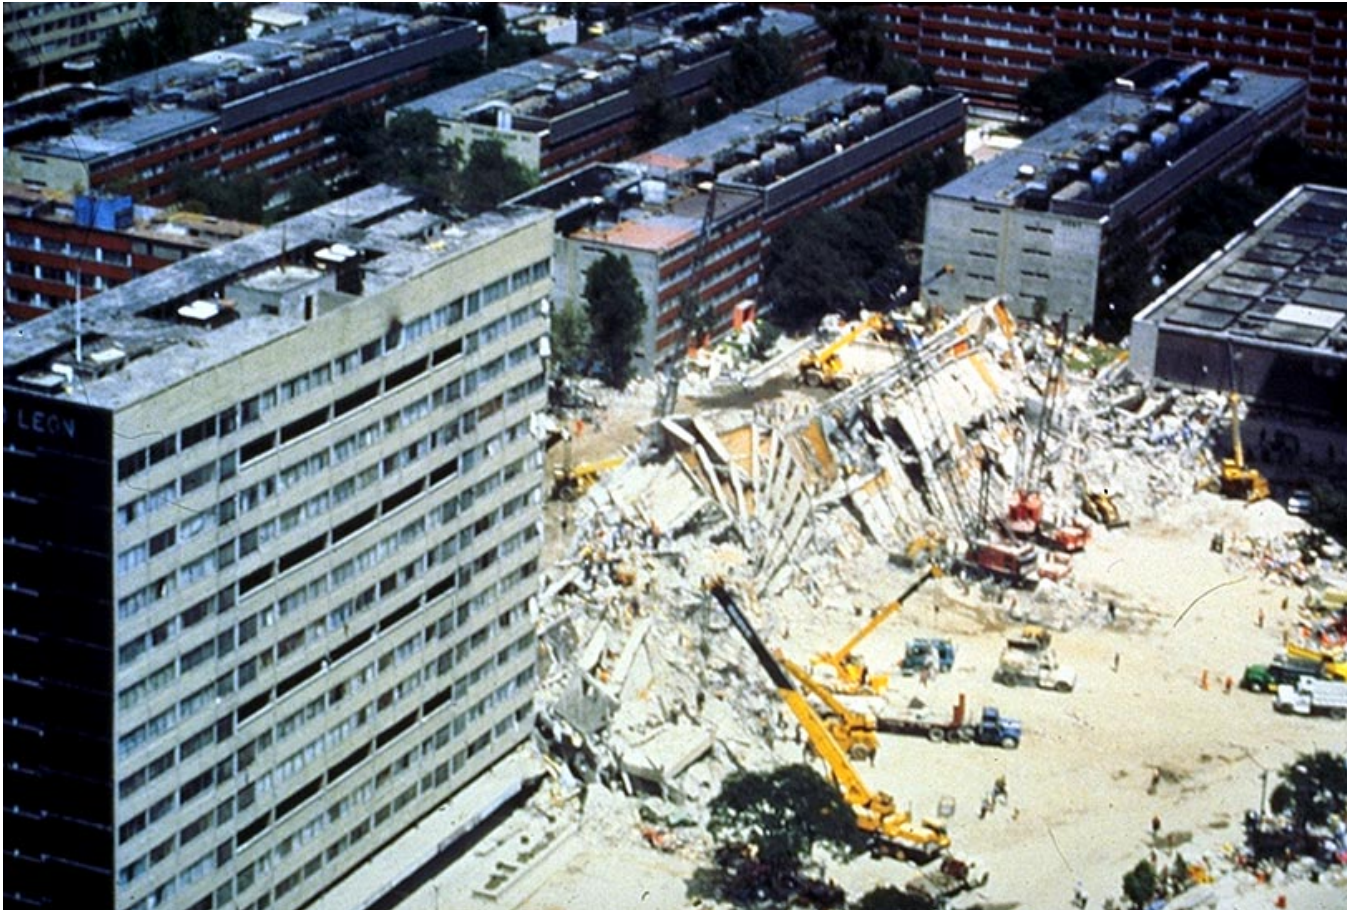
Aerial view of Nuevo Leon Looking Northwest

Aerial view looking northwest of the collapsed Nuevo Leon Building. Hundreds died in the collapse.

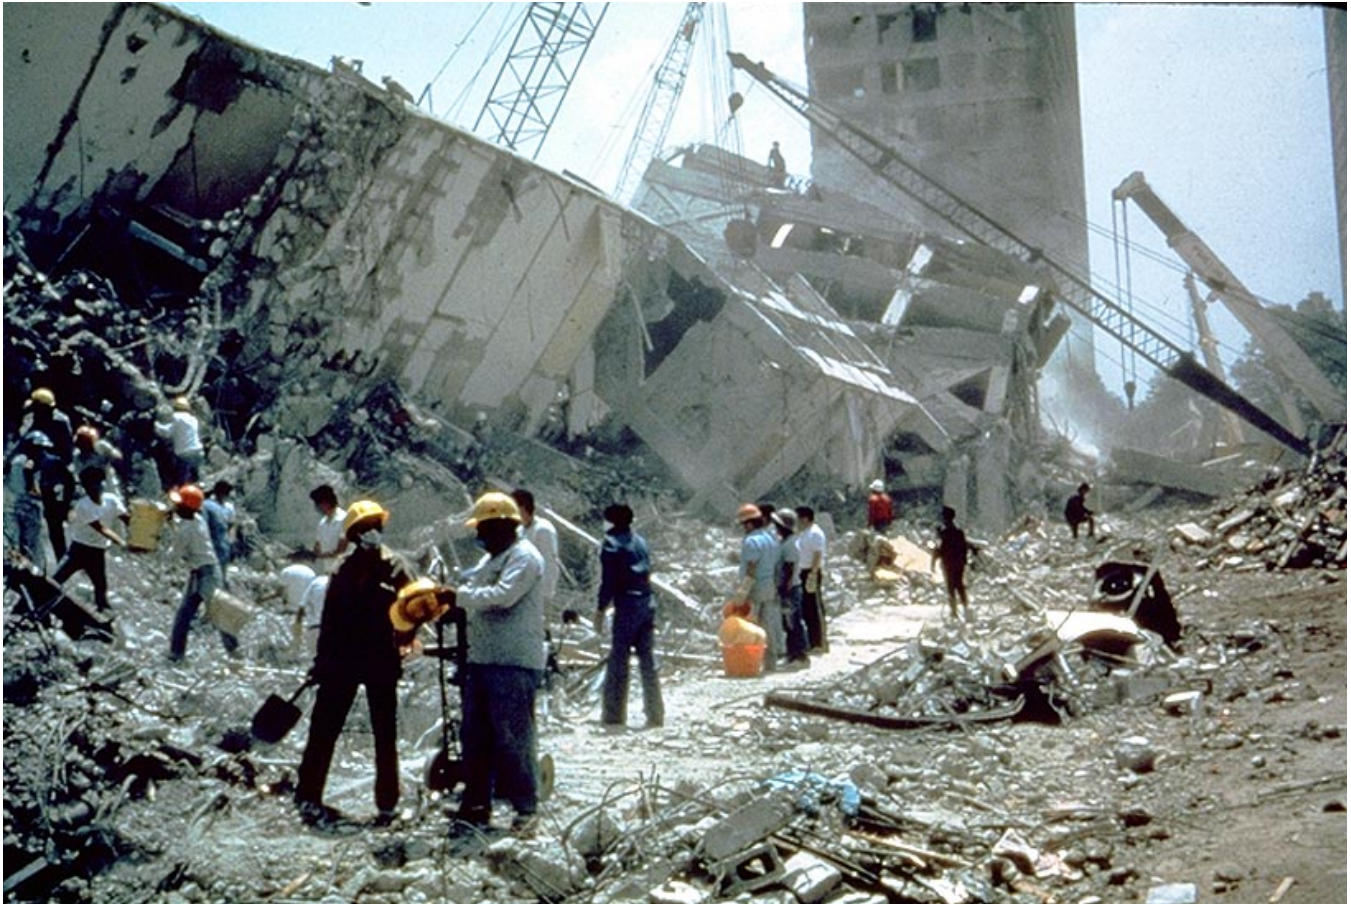
Debris Removal at Nuevo Leon

Workmen removing debris on the west side of Nuevo Leon. Foundation modifications may have contributed to the failure of the structure.

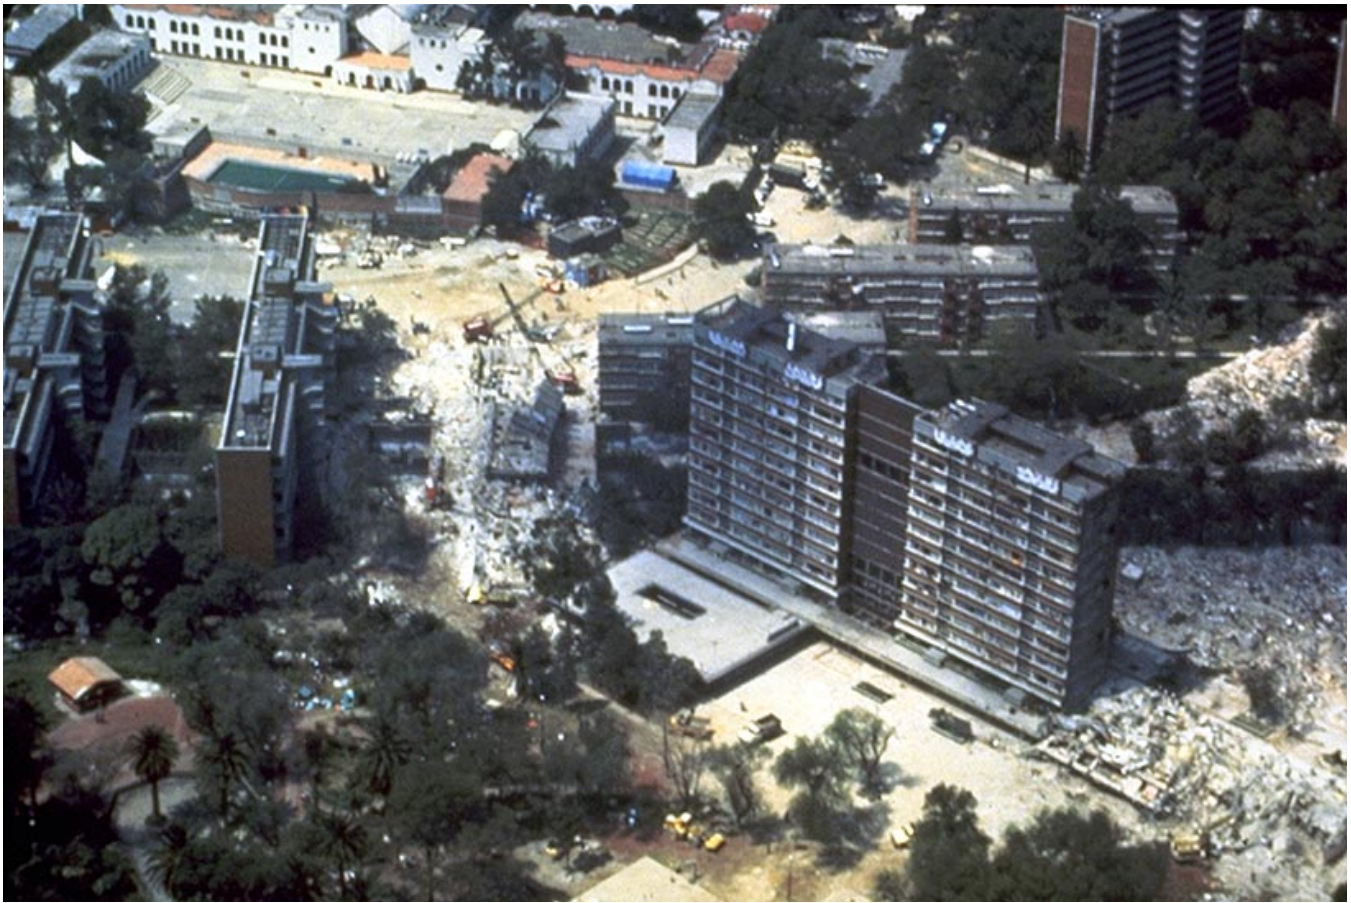
Damage in Juarez Apartment

Aerial view of two of the buildings in the Juarez apartment complex. Two collapsed structures are visible; the rightmost structure was 13 stories and the one at the left was 8 stories. Only the northern 1/3 of the 13 story building collapsed. The remaining portion was later removed using dynamite.

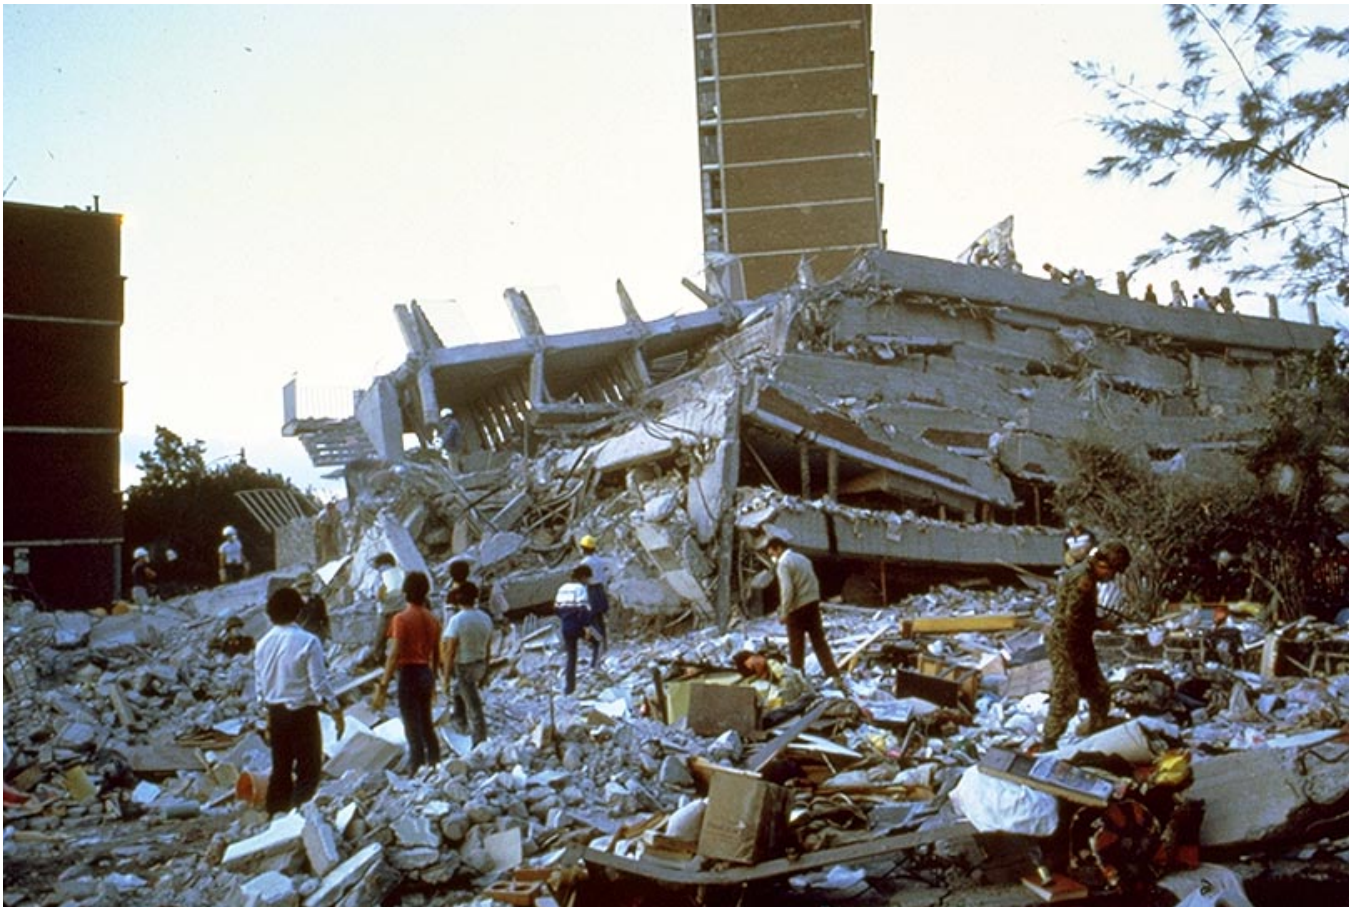
Eight Story Structure

View looking north of the collapsed 8-story building. The 13-story building is visible in the background. Several other eight-story buildings, partly visible at the left apparently suffered little damage.

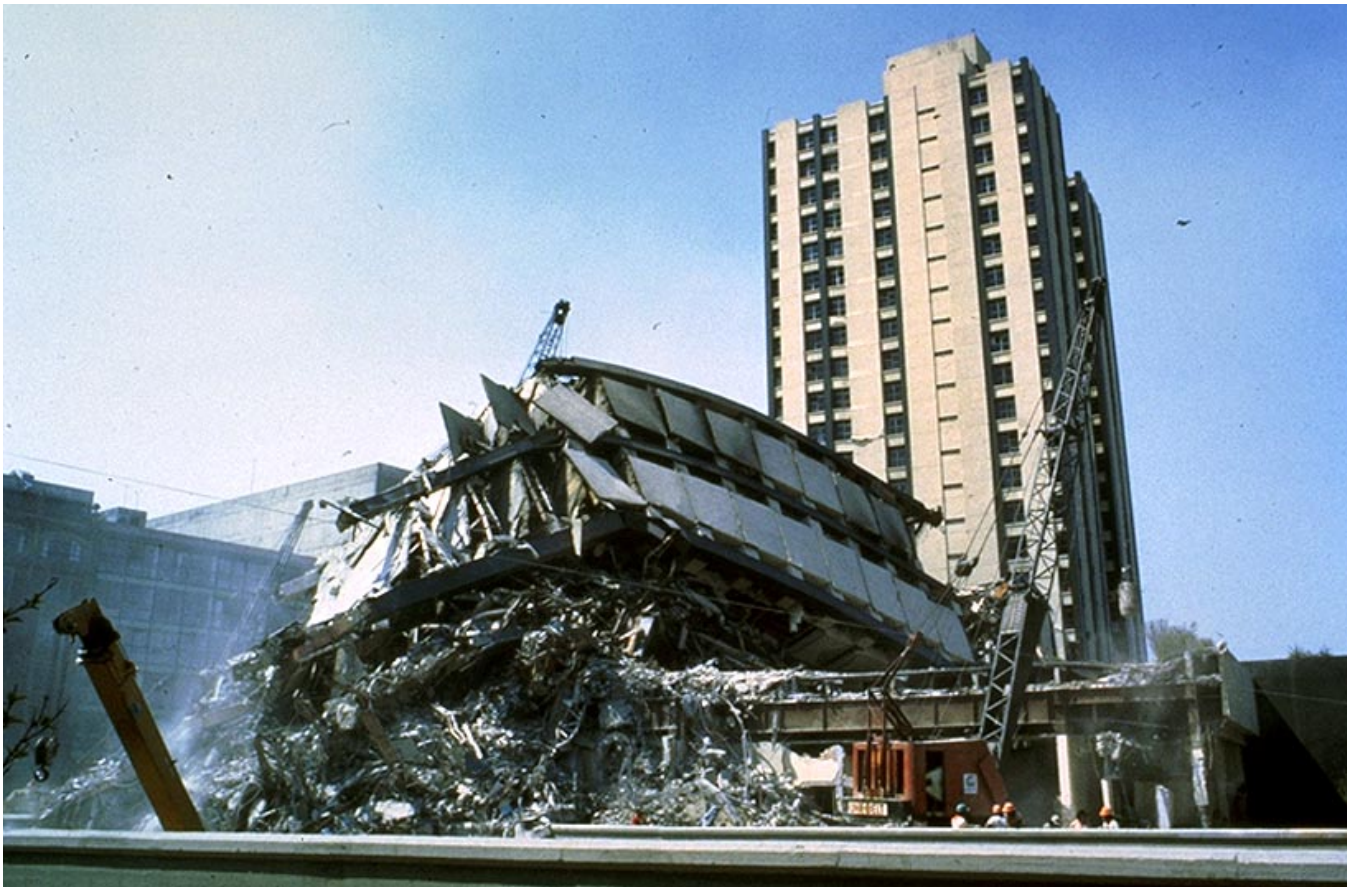
Pino Suarez Towers Looking North

View looking north of the Pino Suarez Towers. Originally there were five structures at this site. Three central 21-story buildings and two flanking 14-story buildings. These government office towers were one of the few steel frame structures to collapse during the earthquake (although it should also be noted that the majority of buildings in Mexico City use concrete construction).

Two 21-story buildings may be seen in the background. A 14-story building north of the 21-story building collapsed on top of an adjacent 14-story building to its south, leading to its collapse.

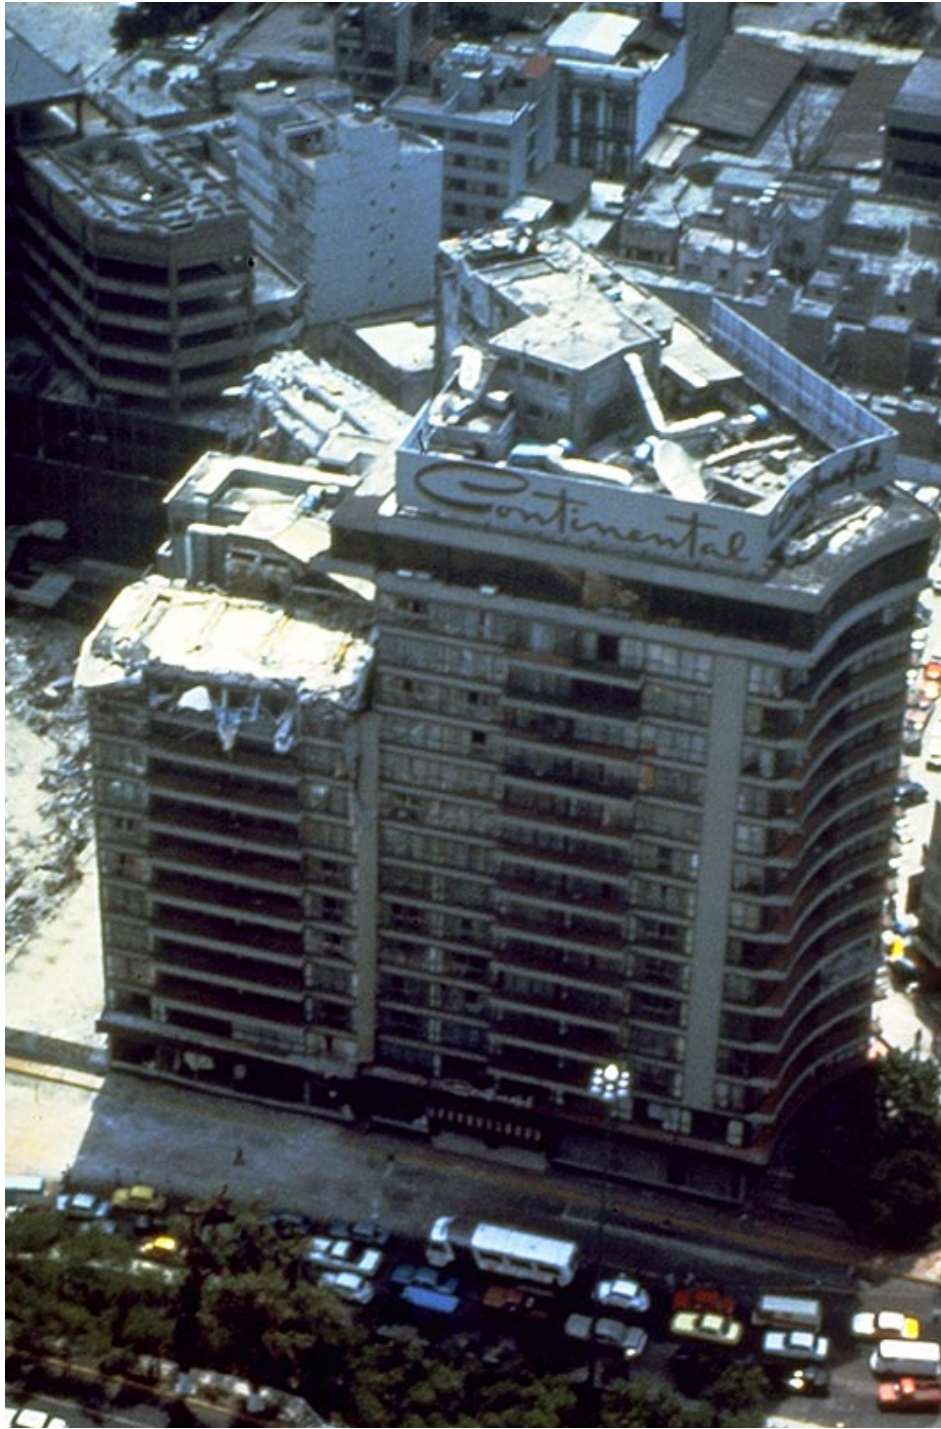
Aerial View of Continental Hotel

Aerial view of the Continental Hotel, where different sections of the building collapsed when pounding or hammering occurred at nonstructural Joints.

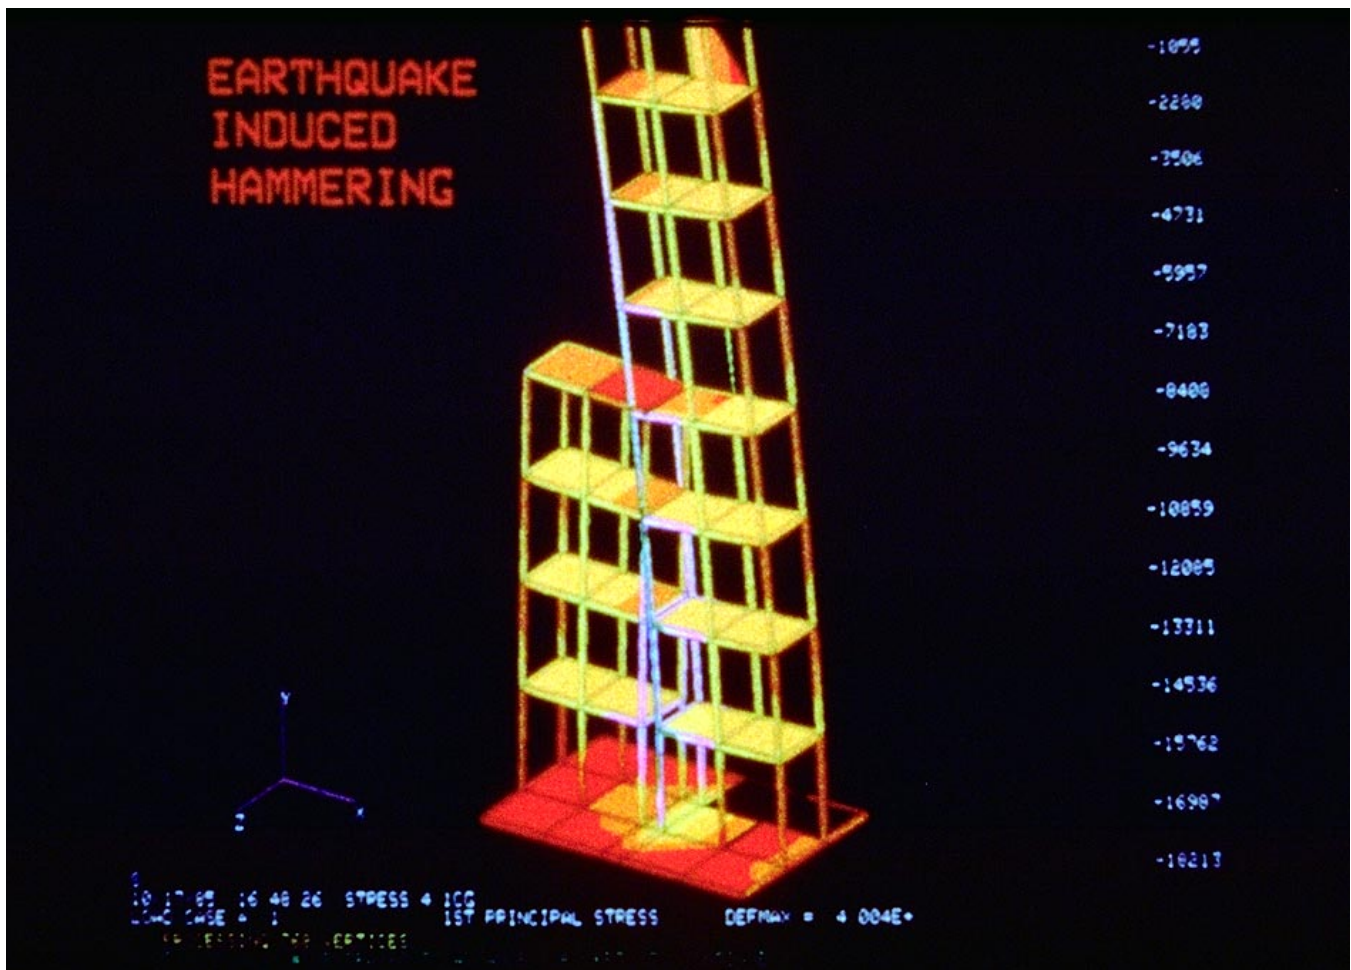
Hammering of Unequal Height Buildings

Building hammering was widespread in Mexico City. This slide depicts collision between two buildings of unequal height.

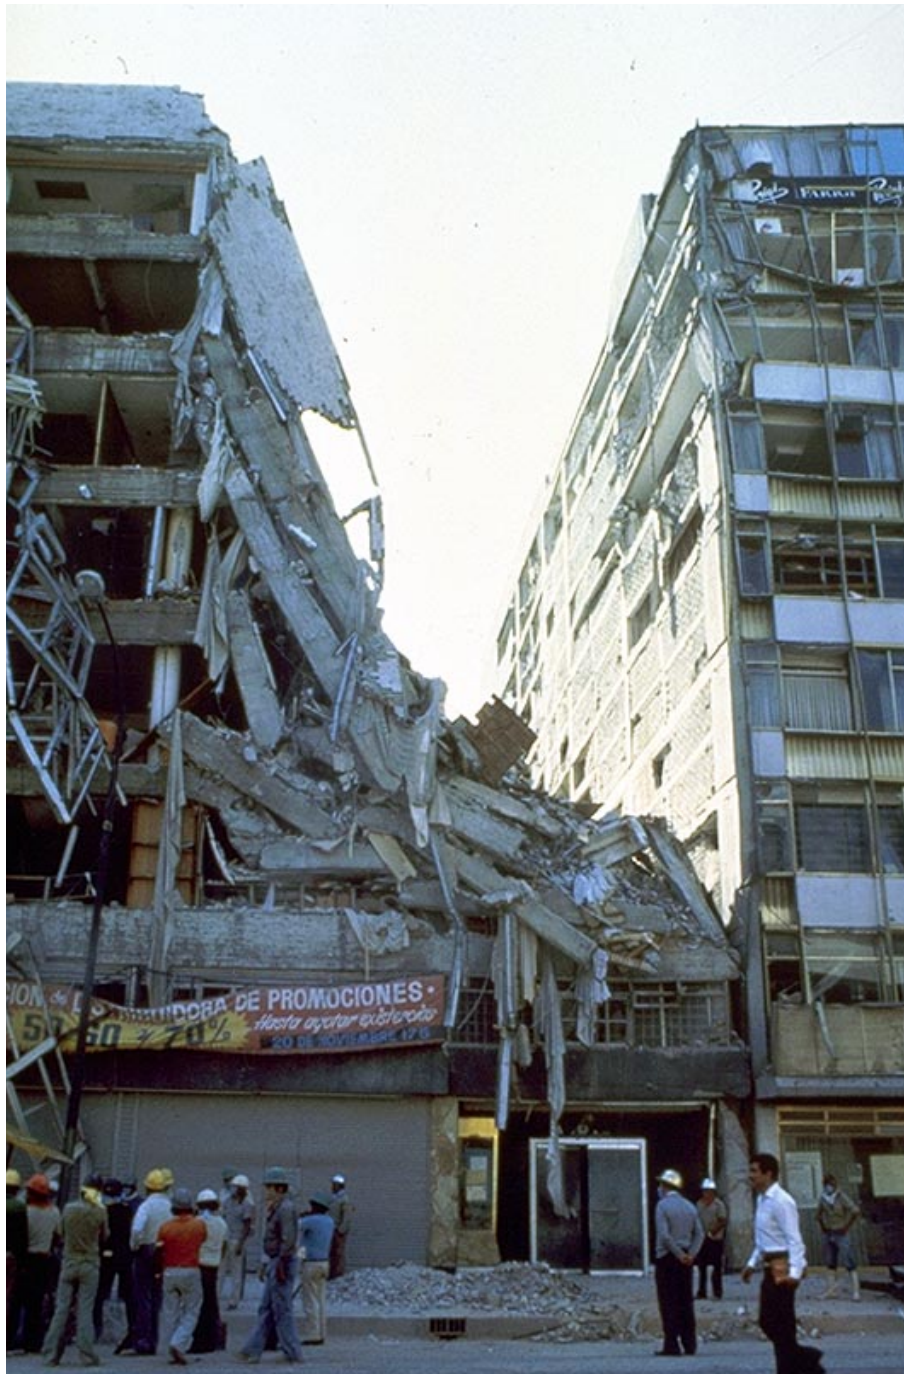
Hammering of Equal Height Buildings

Eight story office building near the Pino Suarez Towers. Failure was induced by hammering with collapse occurring first in the building on the left. The building on the right was near collapse.

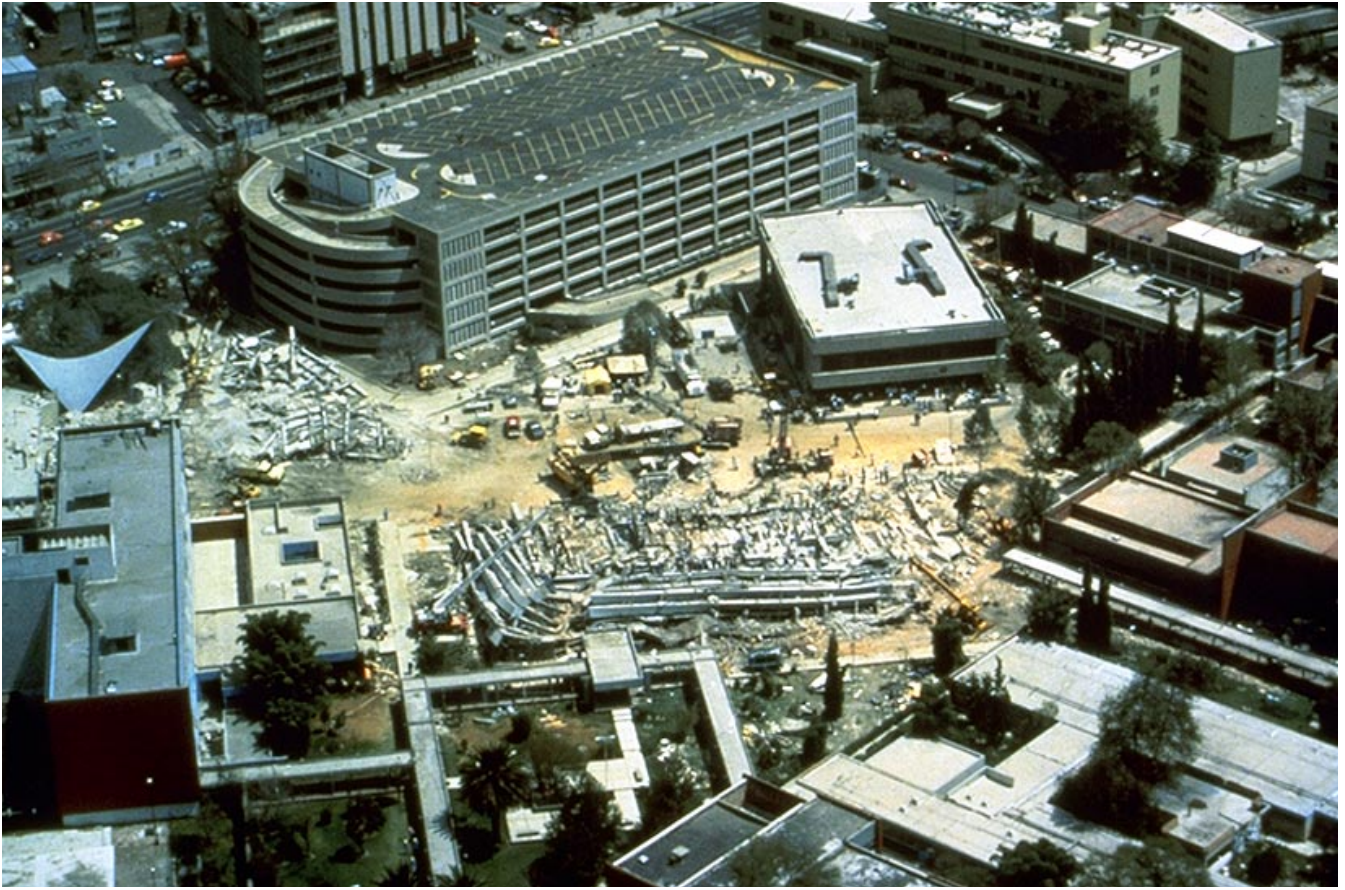
Aerial view of Hospital General

Aerial view looking southwest of the Hospital General where two buildings (6 and 8 stories) collapsed.

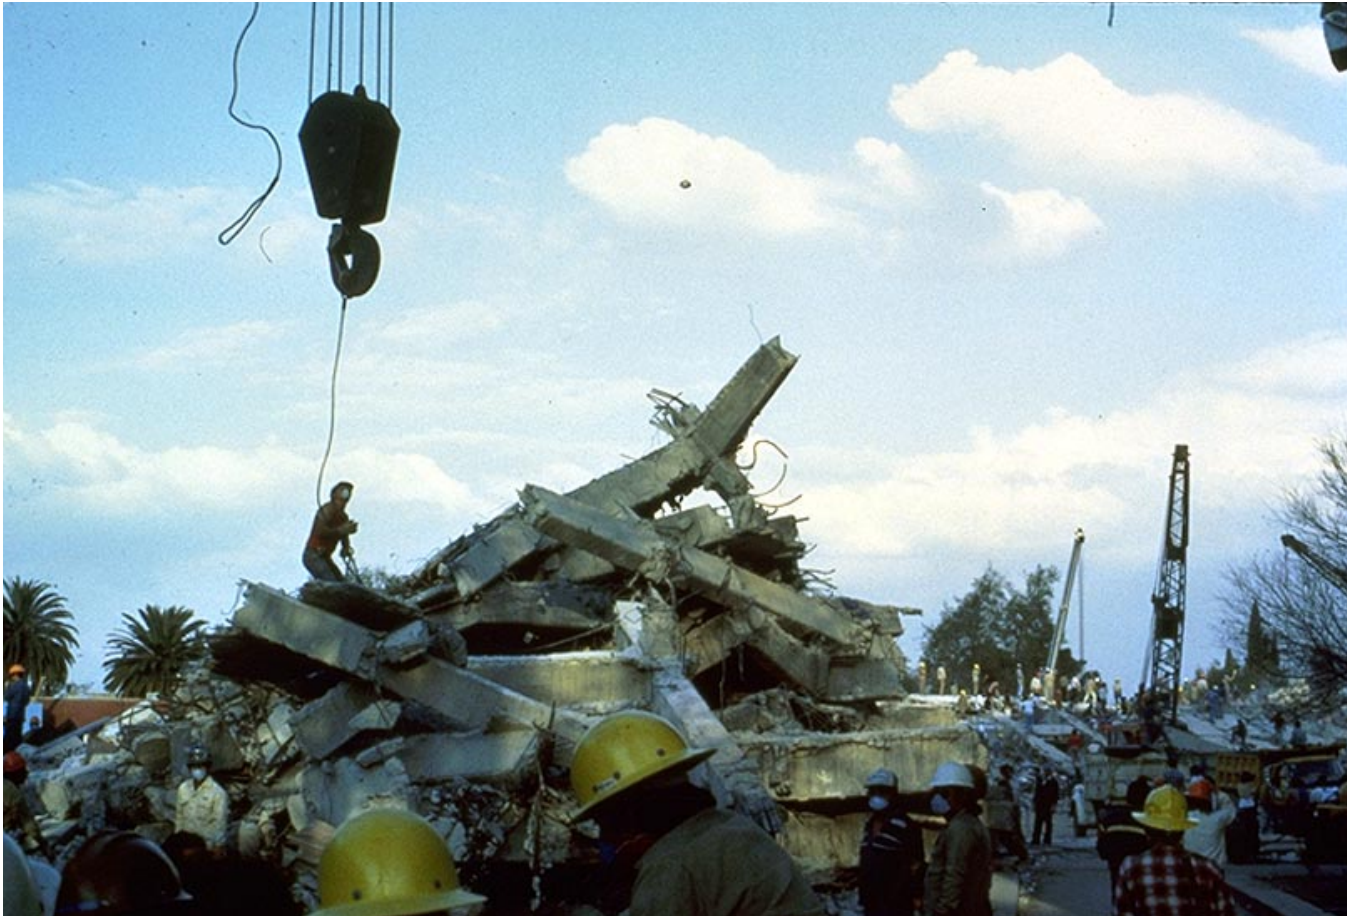
Rescue Operations at Hospital General

The collapse of a number of buildings at the Hospital General required massive rescue operations. Rescue was slow due to the difficulty in searching through debris and search for survivors.

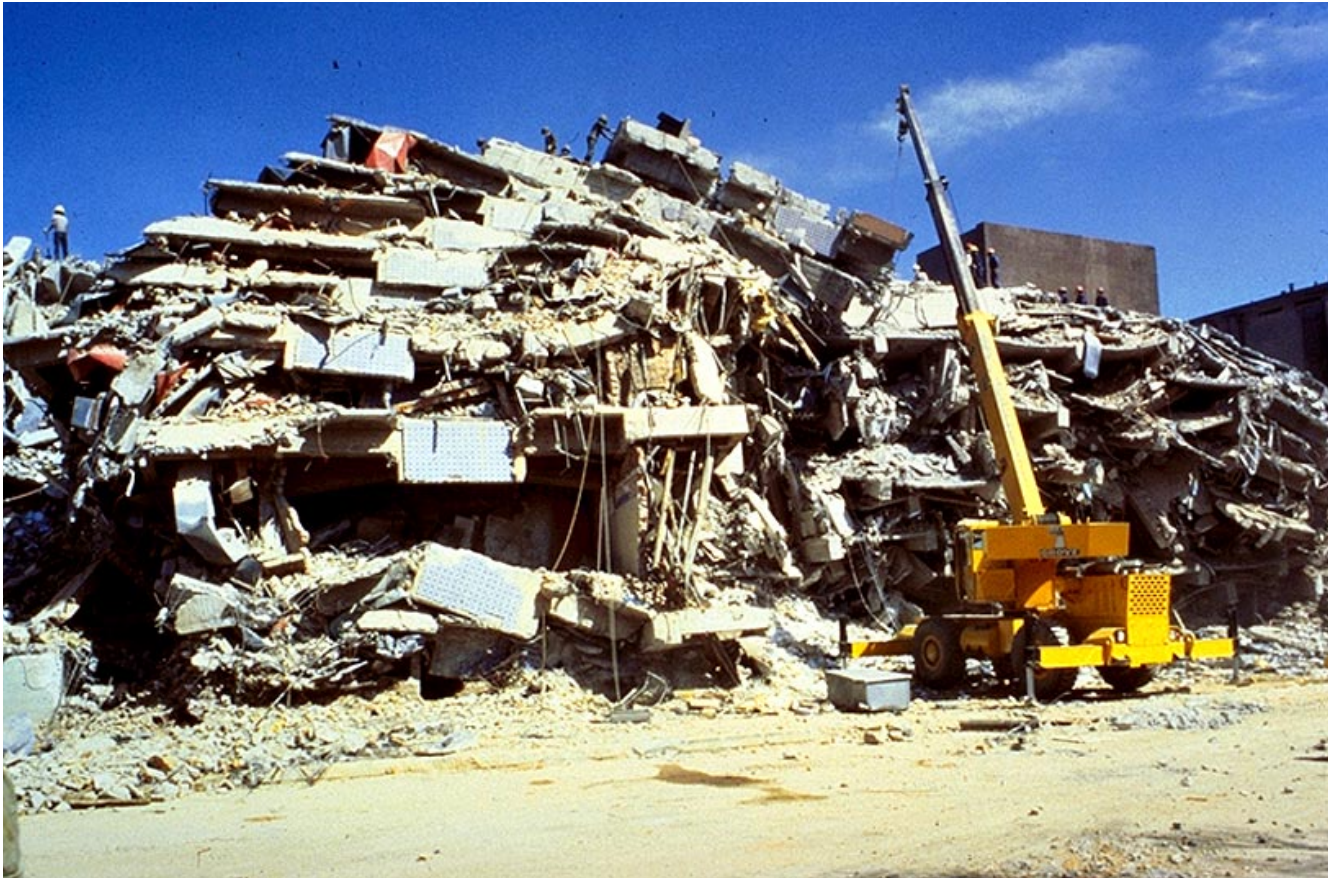
Juarez Hospital

View looking east of the Hospital Juarez, where several hundred persons were trapped in the maternity ward.
