**EARTHQUAKE ENGINEERING RESEARCH INSTITUTE
COMMITTEE ON CONTINUING EDUCATION**

SUBCOMMITTEE TO CREATE SLIDE
SETS ON THE SEPTEMBER 19, 1985
MEXICO EARTHQUAKE

**MEXICO - SET I:
GENERAL OVERVIEW**

FEBRUARY 1987

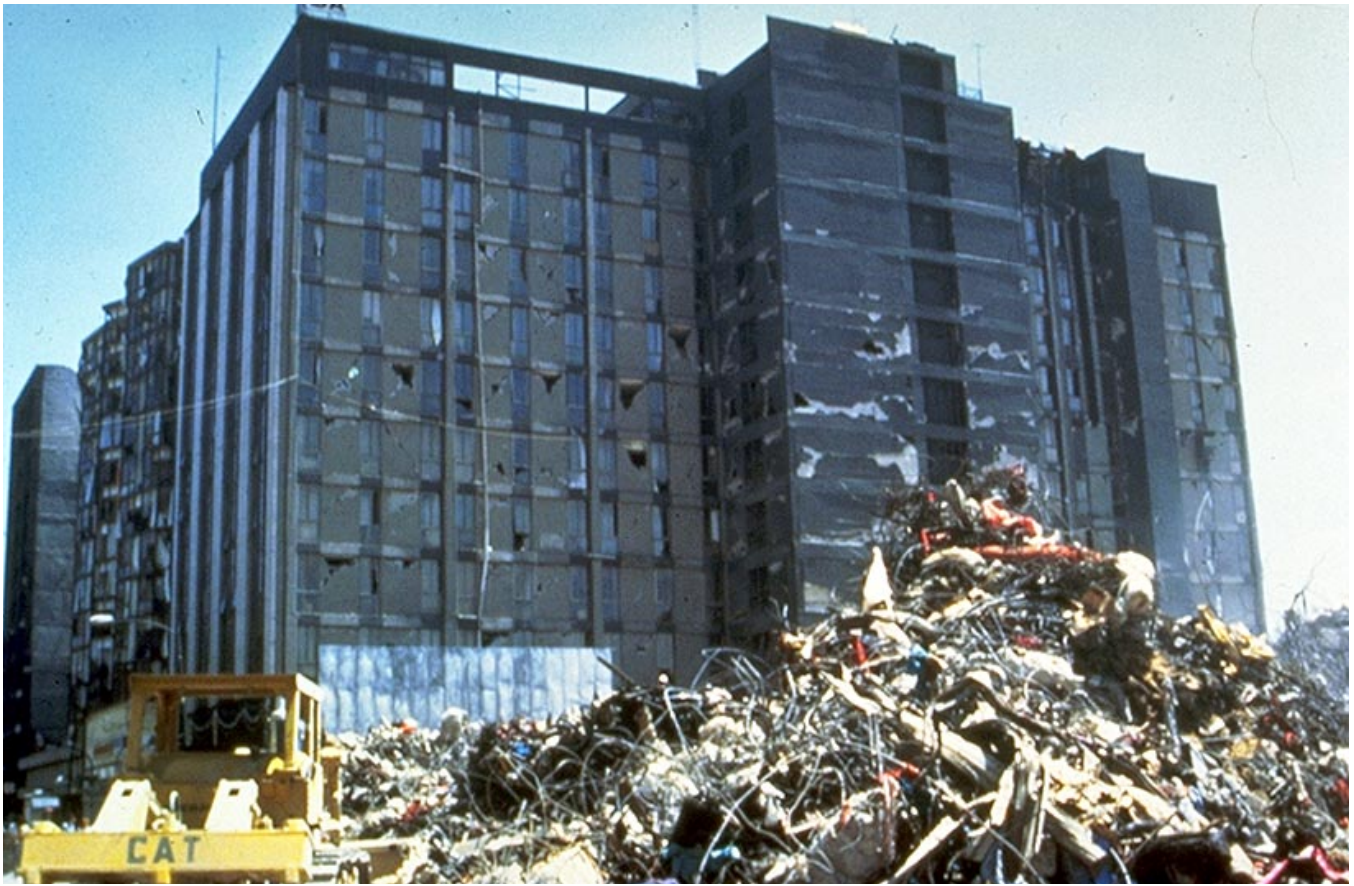
Severely Damaged Building

Most of the 1,000,000 + engineered buildings in Mexico City were undamaged or at least relatively undamaged. There were also buildings that met the intent of most buildings codes for major earthquakes, that heavy damage is permitted but collapse is prevented. The neighboring building in the foreground was not so fortunate.

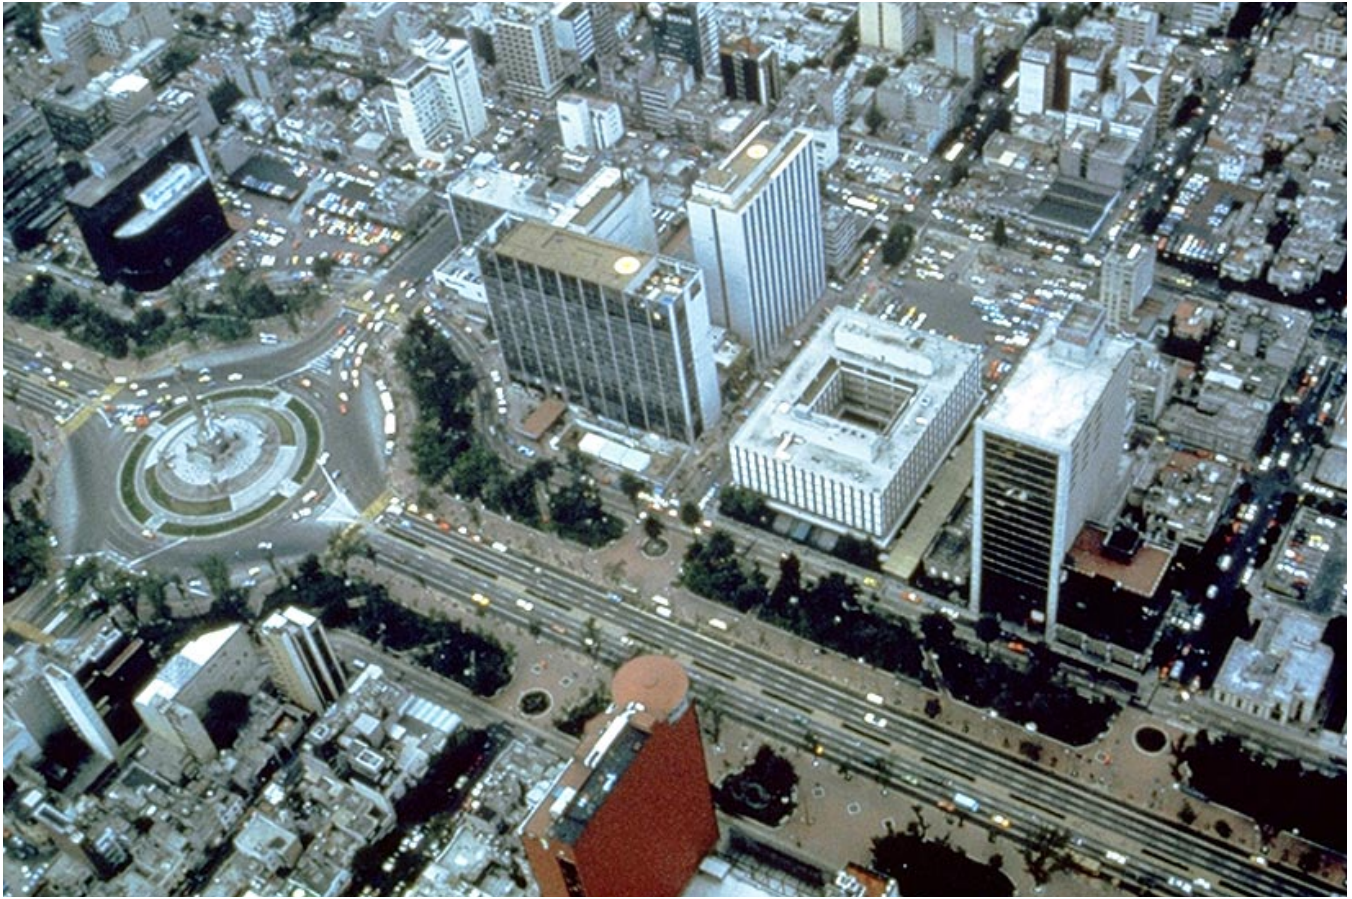
Aerial View of Relatively Undamaged Buildings

Aerial view of the U.S. Embassy and the Sheraton, a 21-story structure which had only minimal damage and was in use after the earthquake.
