**EARTHQUAKE ENGINEERING RESEARCH INSTITUTE
COMMITTEE ON CONTINUING EDUCATION**

SUBCOMMITTEE TO CREATE SLIDE
SETS ON THE SEPTEMBER 19, 1985
MEXICO EARTHQUAKE

**MEXICO - SET II:
PATTERNS OF BUILDING
FAILURE**

FEBRUARY 1987

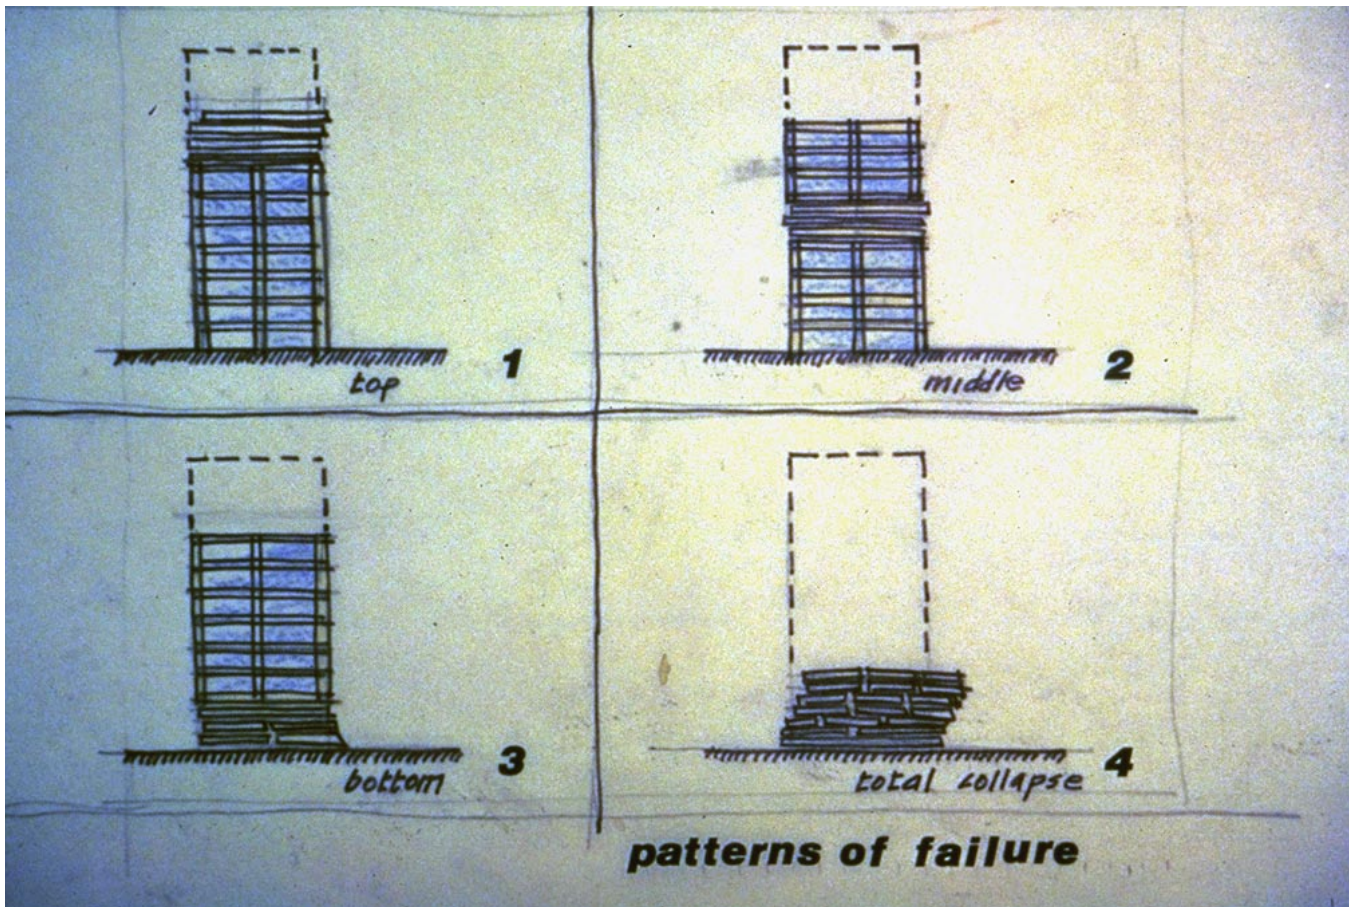
Slide #1

This graphic shows the four characteristic patterns of building failure apparent in Mexico City.

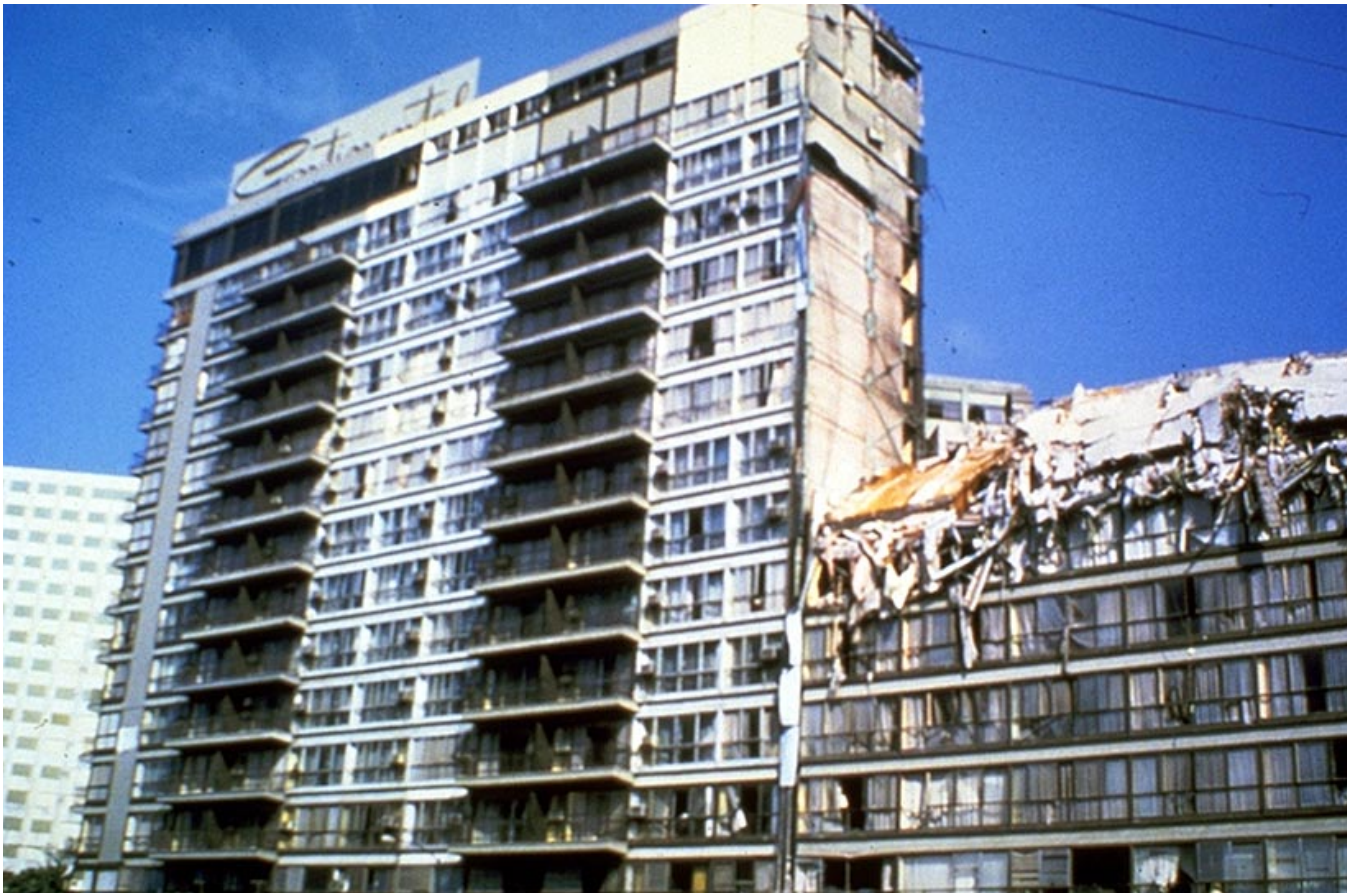
Slide #2

Upper Floor Collapse

Total collapse of the upper floors of the hotel building on the right. The portion of the hotel on the left is intact. Note cross-bracing on the infill end wall, believed to have been added after an earlier earthquake.

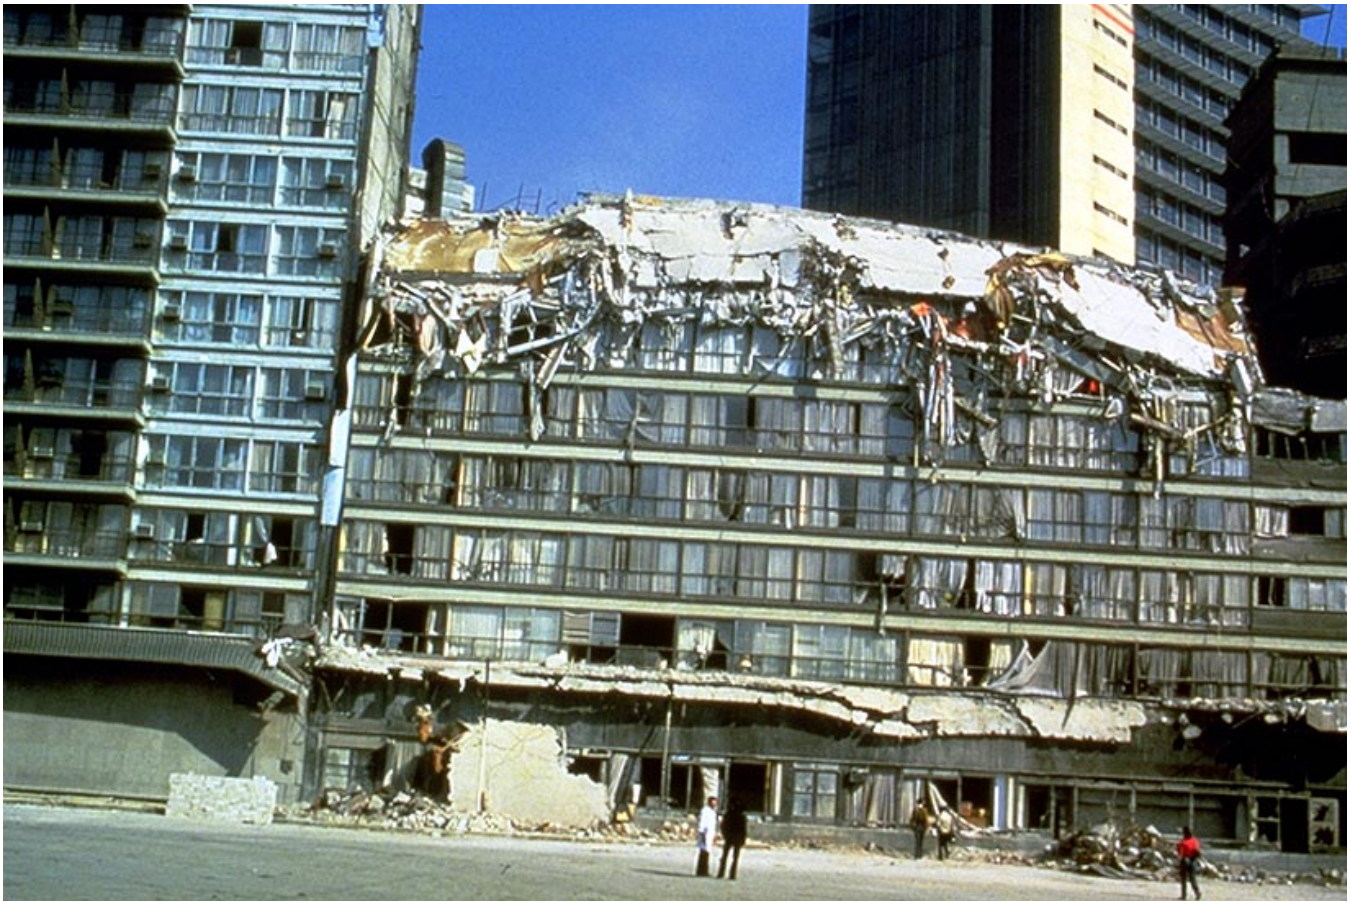
Slide #3

Upper Floor Collapse

Detail of upper floor failure to Hotel Intercontinental. Note damage to overhanging, concrete canopy at second floor, and damage at vertical seismic joint.

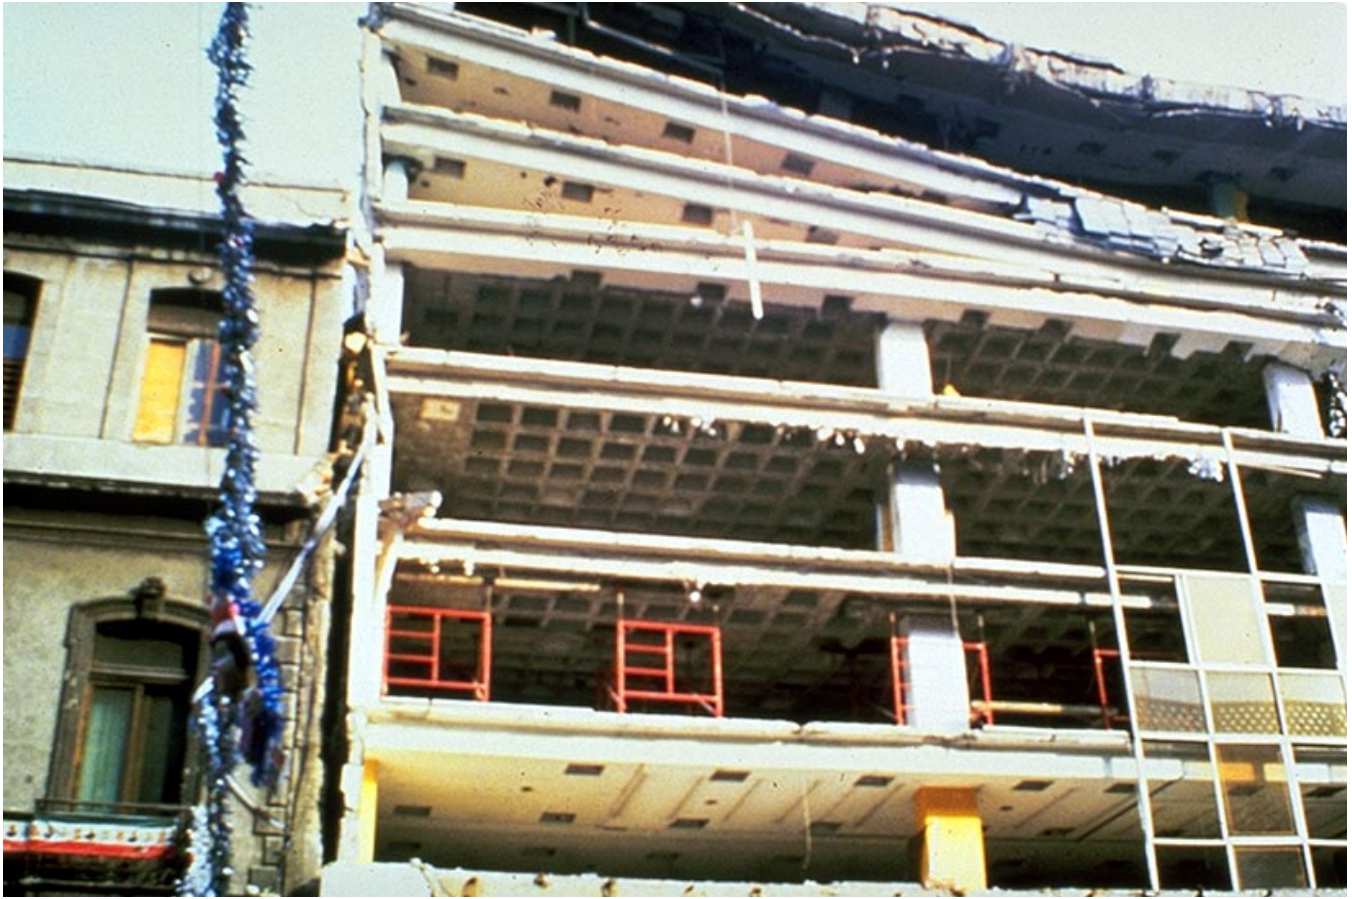
Slide #4

Upper Floor Collapse

Typical upper floor collapse. Note typical waffle slab structure and absence of suspended ceiling. Metal and glass curtain was removed subsequent to earthquake.

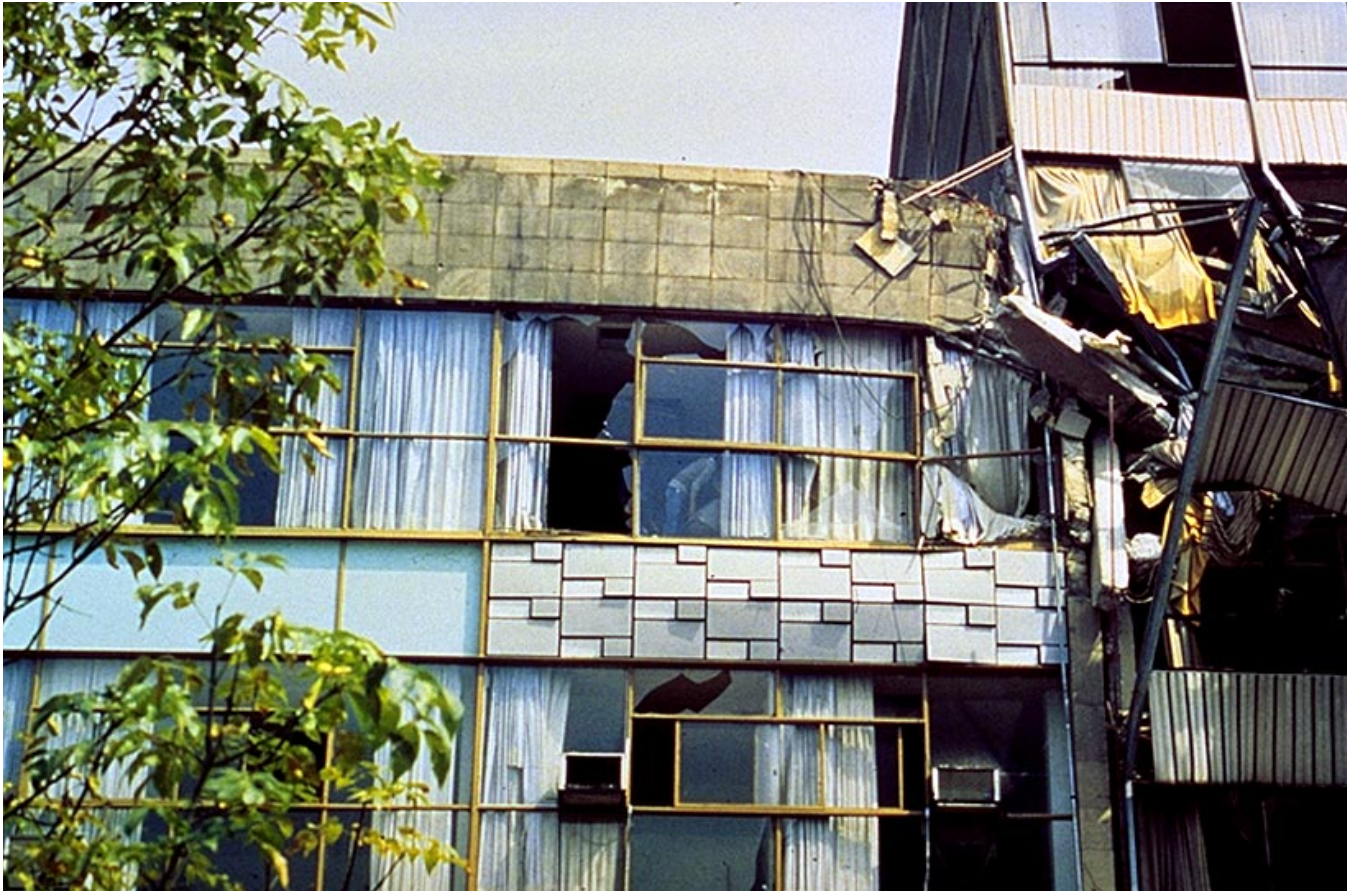
Slide #5

Pounding Damage

Damage caused by pounding results in intermediate floor collapse. Note that in spite of severe structural distortion, much glass is unbroken.

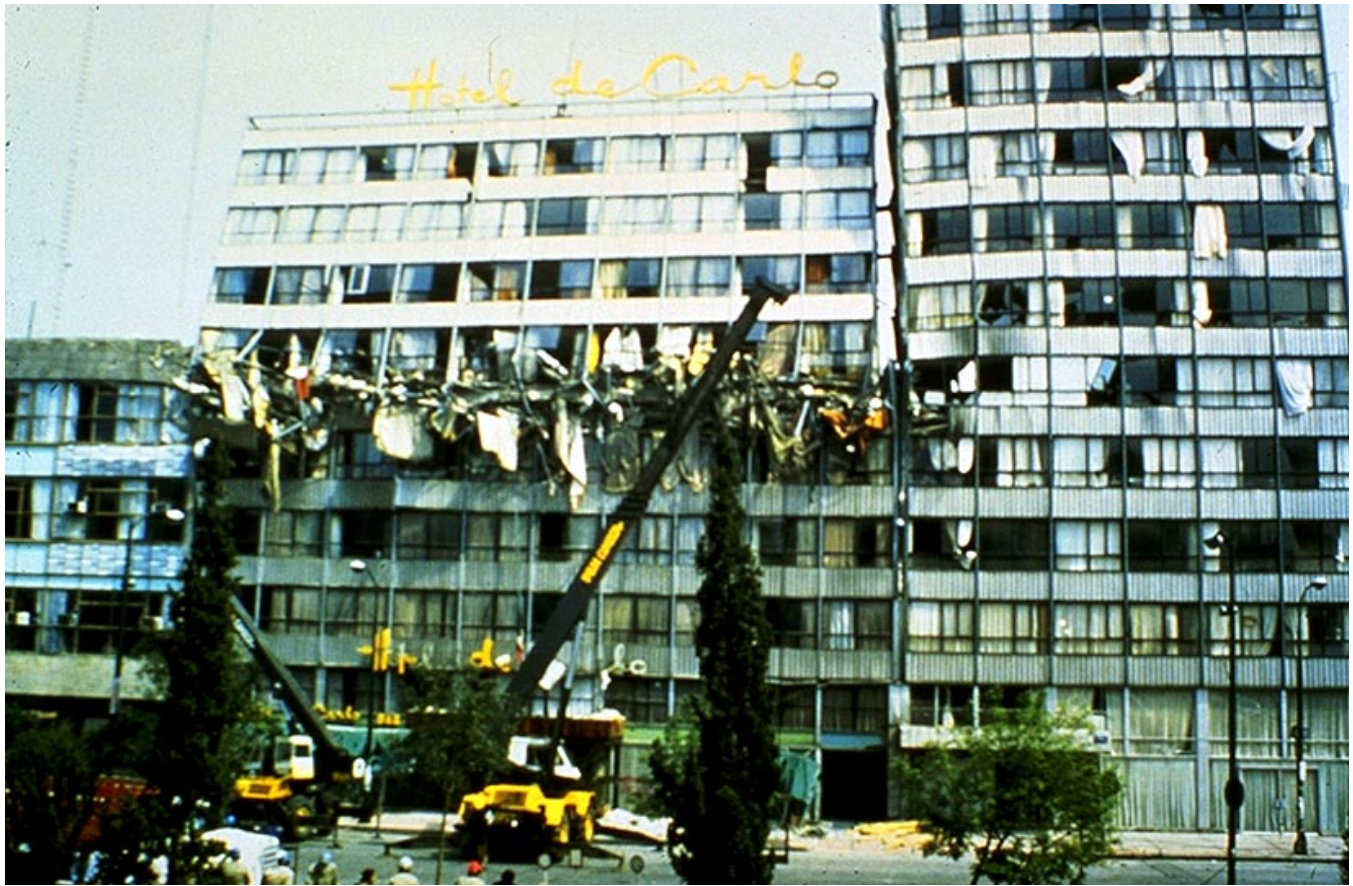
Slide #6

Intermediate floor collapse

Intermediate floor collapse, caused by pounding from the building at left. Note severe distortion of portions of building to the right.

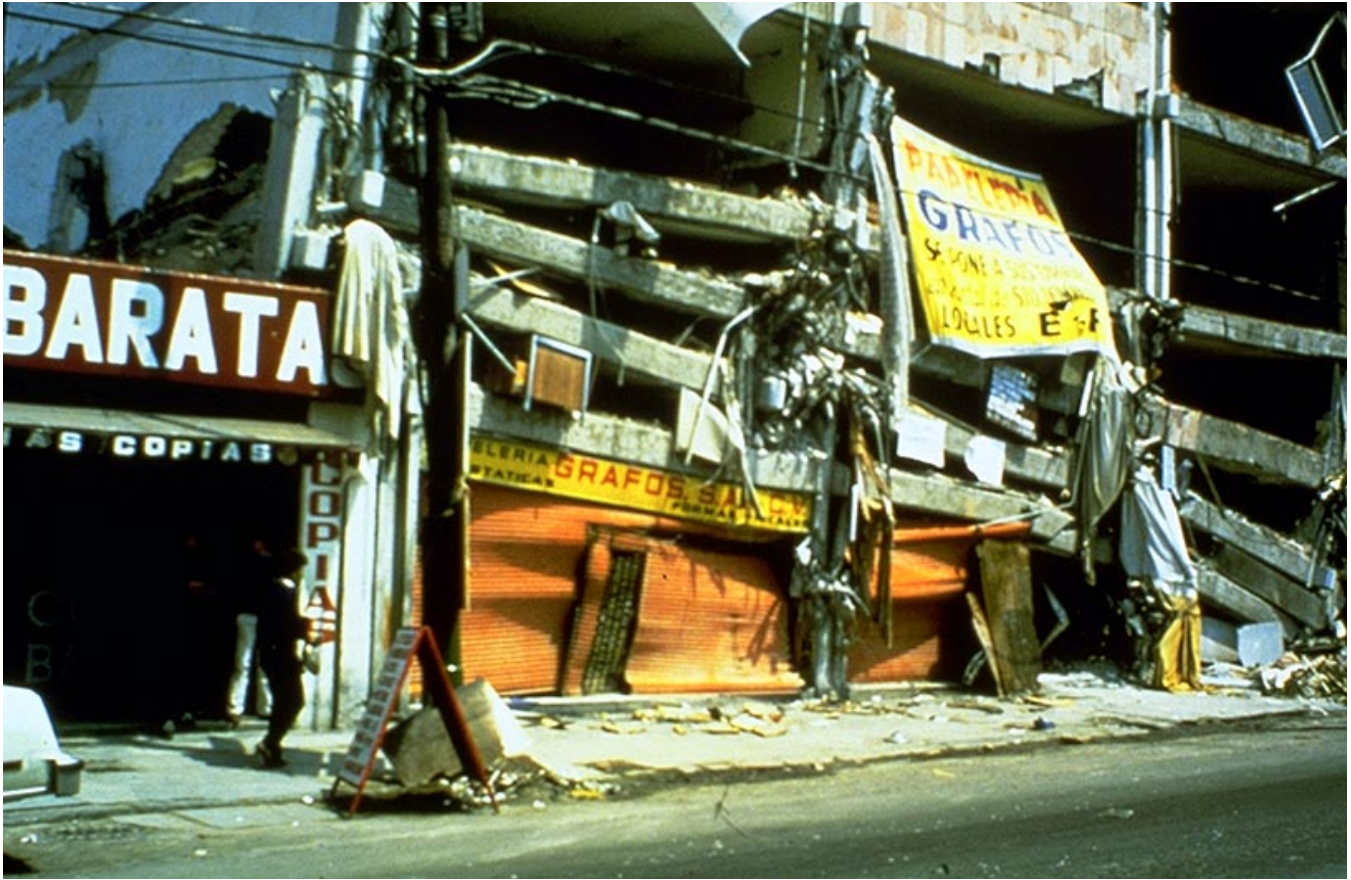
Slide #7

Lower Floor Collapse

Collapse of a number of lower floors of a commercial building. Upper floors remain intact. Note open first floors contrasted to upper floor with the consequent stiffness differential probably leading to the failure.

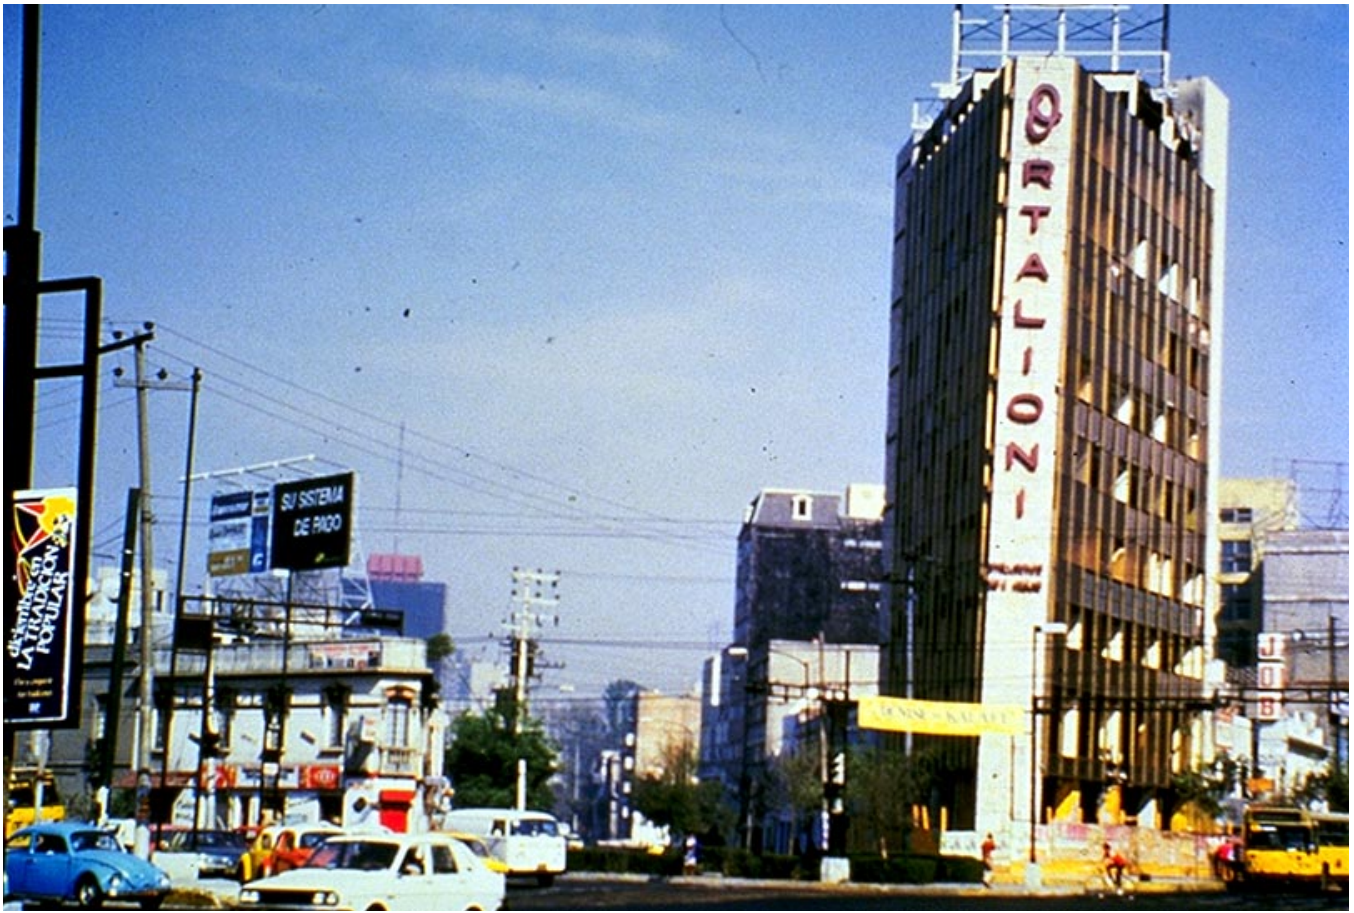
Slide #8

Building Distortion

Severe distortion of building that is triangular in plan to fit the site requirement at a multiple street intersection. Form of building results in the torsional behavior shown.

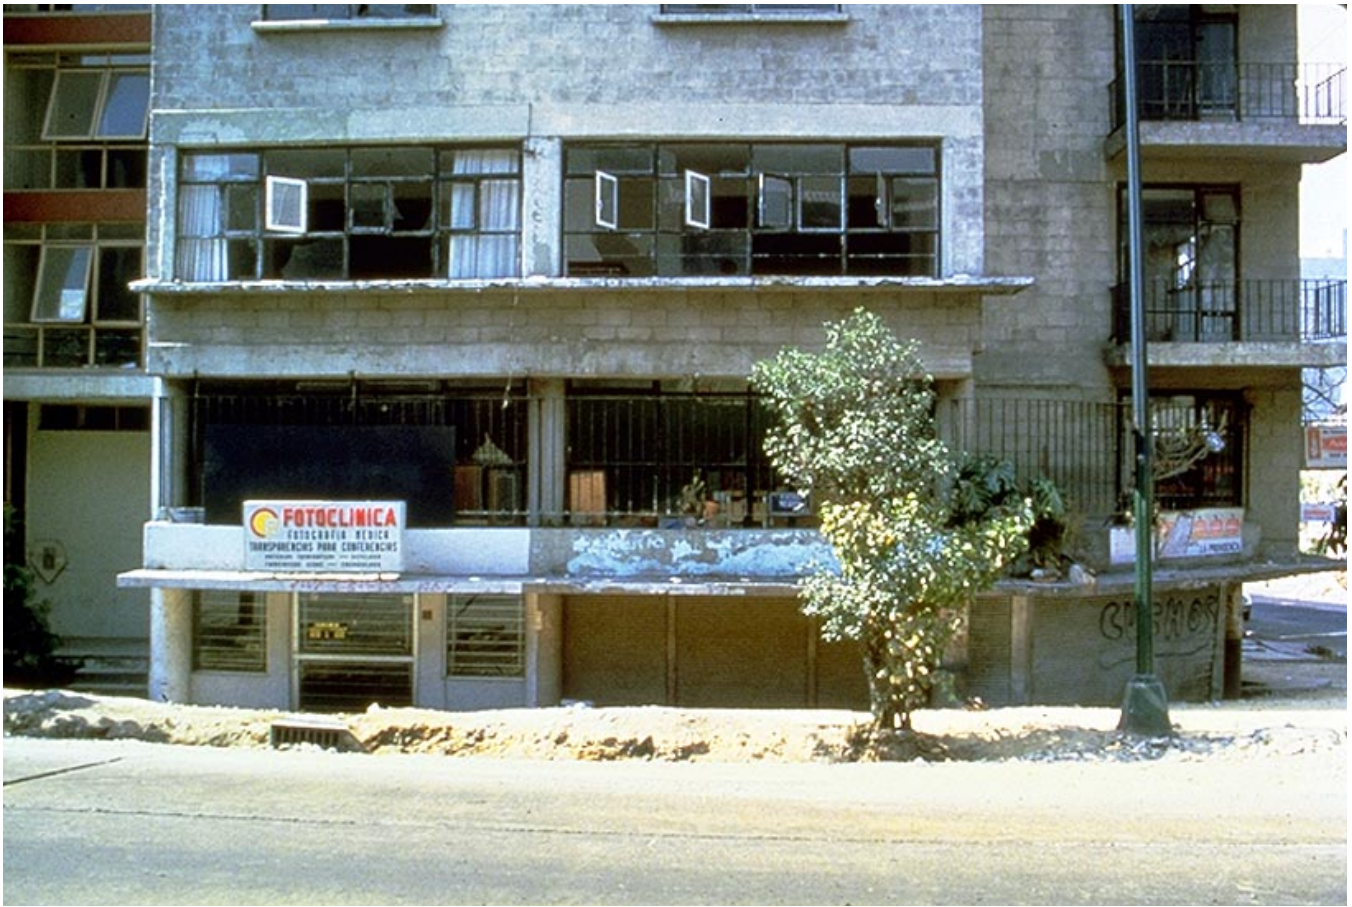
Slide #10

Building Subsidence

Moderate sized apartment house in corner location has sunk approximately half a story below grade level, while remaining structurally intact.

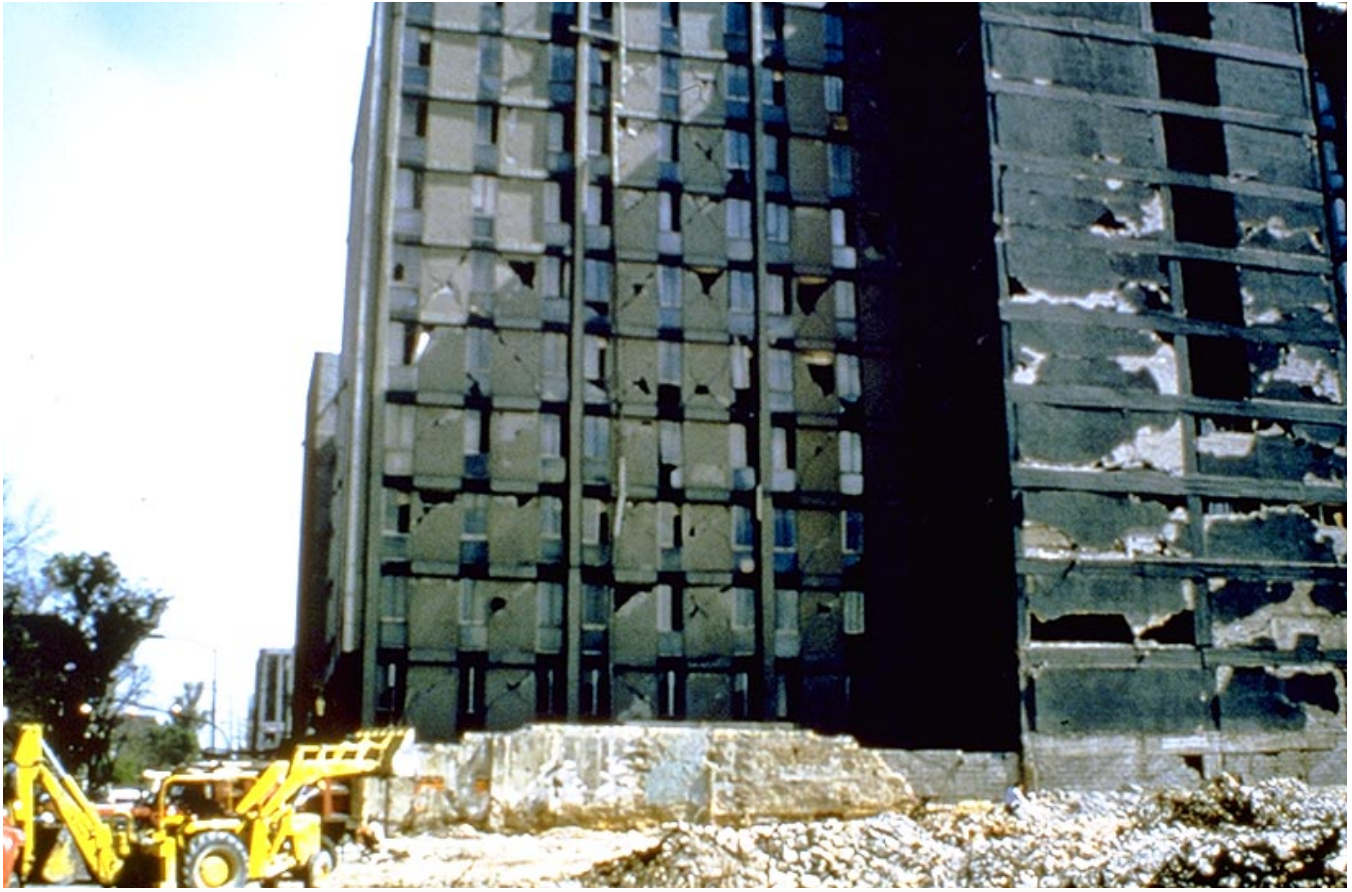
Slide #11

Infill Wall Damage

Typical patterns of damage in unreinforced masonry infill wall. Note damage concentration towards bottom of walls.

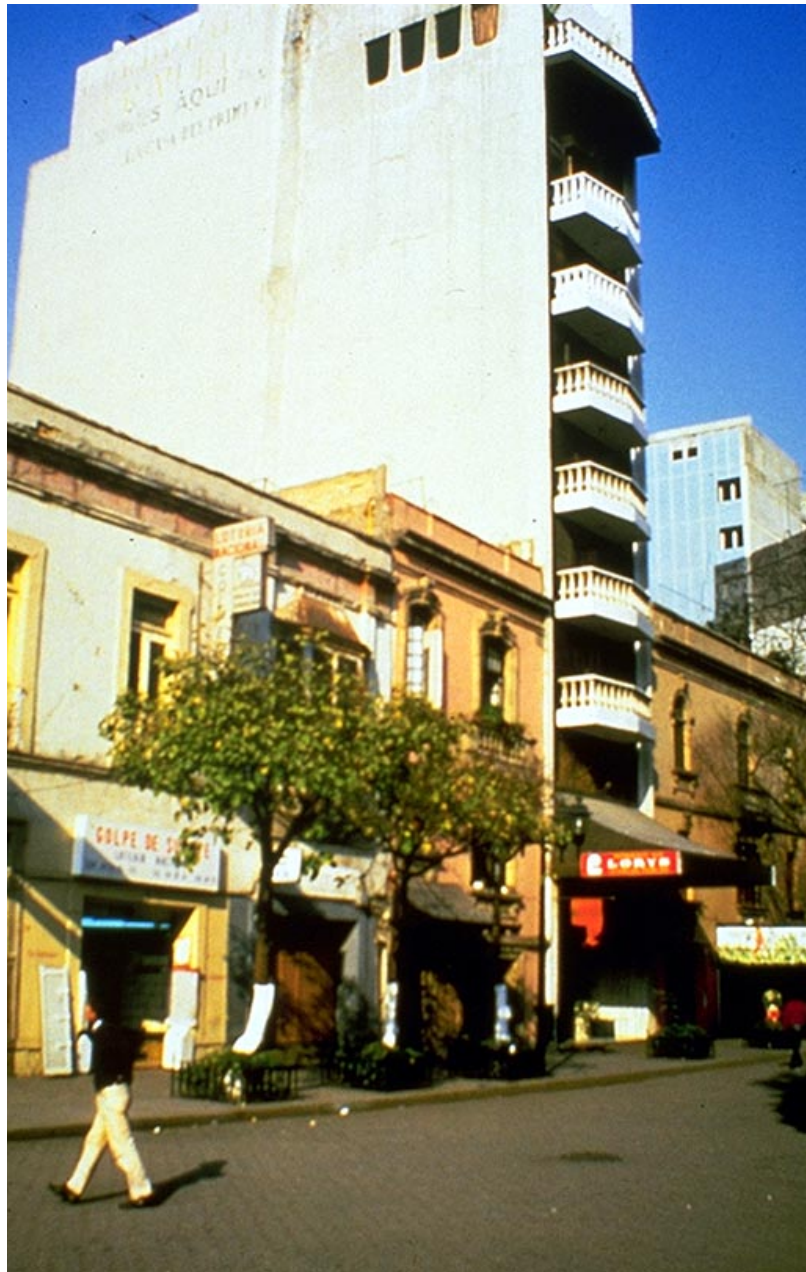
Slide #12

High Rise Supported by Masonry Buildings

The nine story building has a soft first floor and very poor configuration. The masonry buildings to each side have provided lateral support so that the building acts as a set-back tower on a base. This behavior is an argument against large seismic separation designed to prevent pounding.

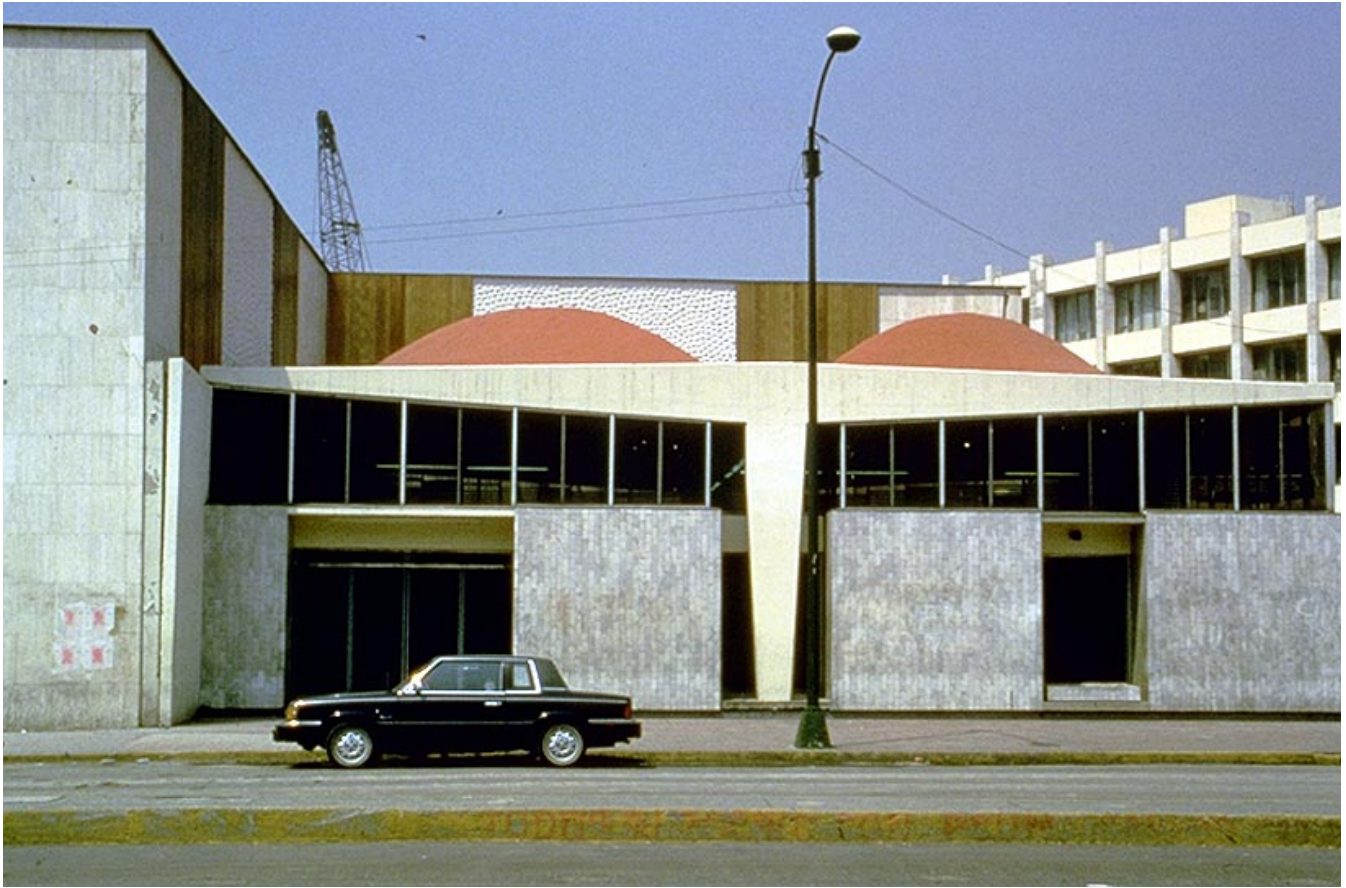
Slide #13

Unbalanced Cantilever Structure

This unusual structure has a roof supported by four columns at the center of the roof perimeter. There are no supports at the corners. The lack of damage, even to glass, shows the lack of response to ground motion.

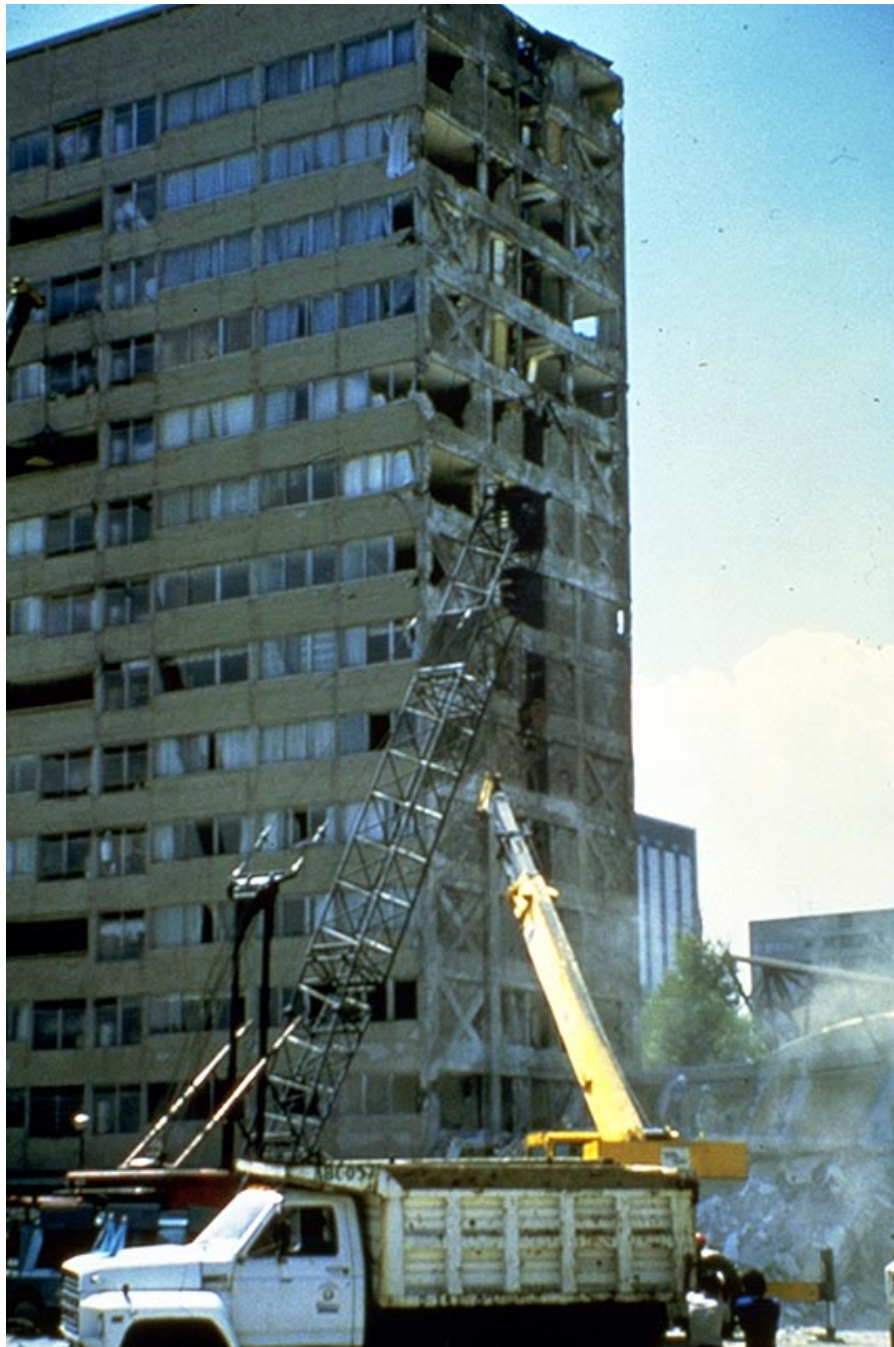
Slide #14

High-Rise Residential Damage

Immediately to the right of the structure shown, a similar structure has totally collapsed. Severe damage can be seen in corner columns and in columns on the open portions of the facade.

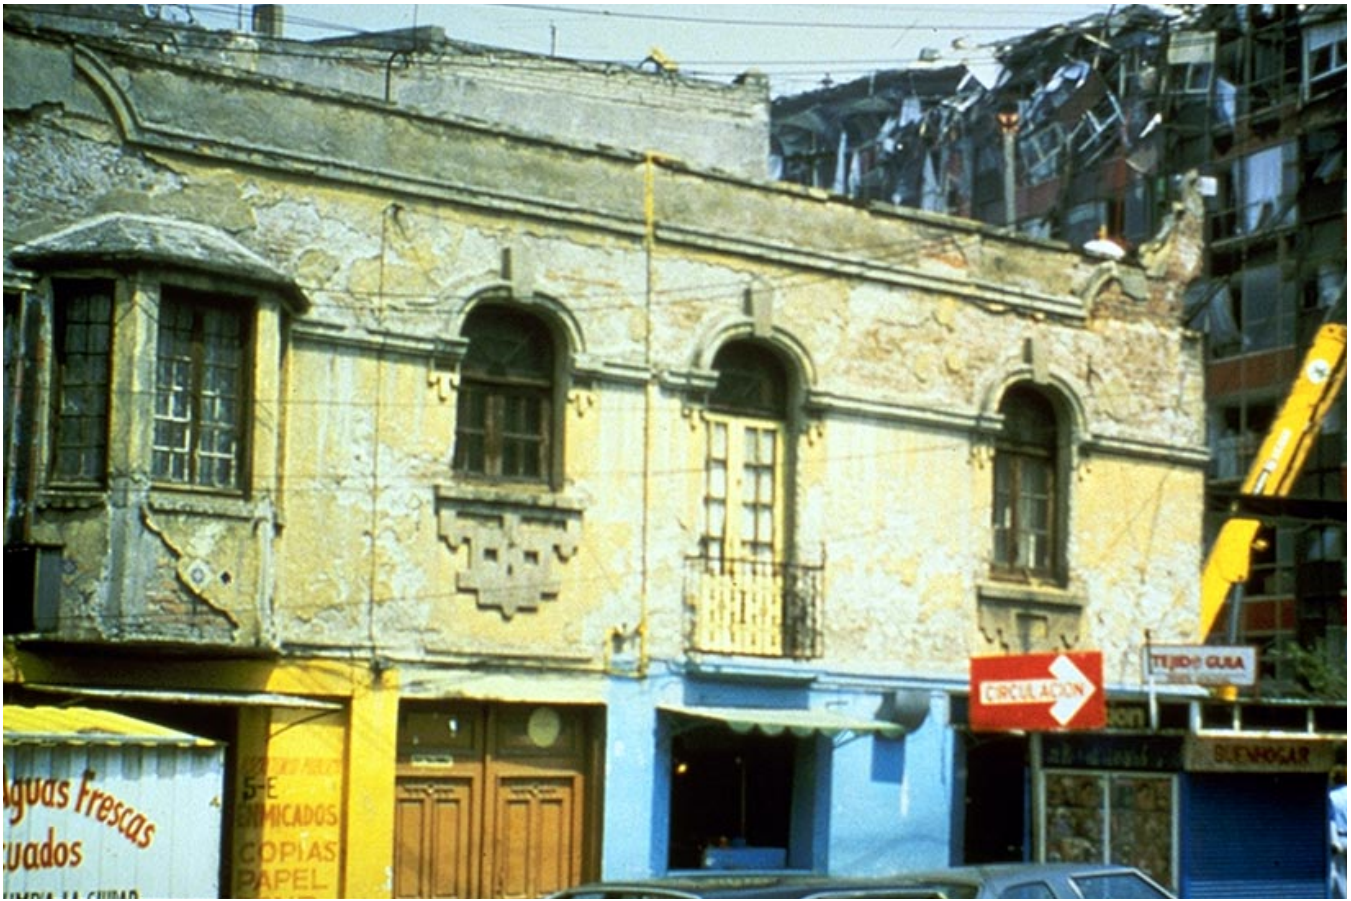
Slide #15

Response of Masonry vs. Response of Tall Buildings

The old masonry building in foreground has suffered little damage. The large office building in the background has lost its top floor and suffered serious structural damage elsewhere.

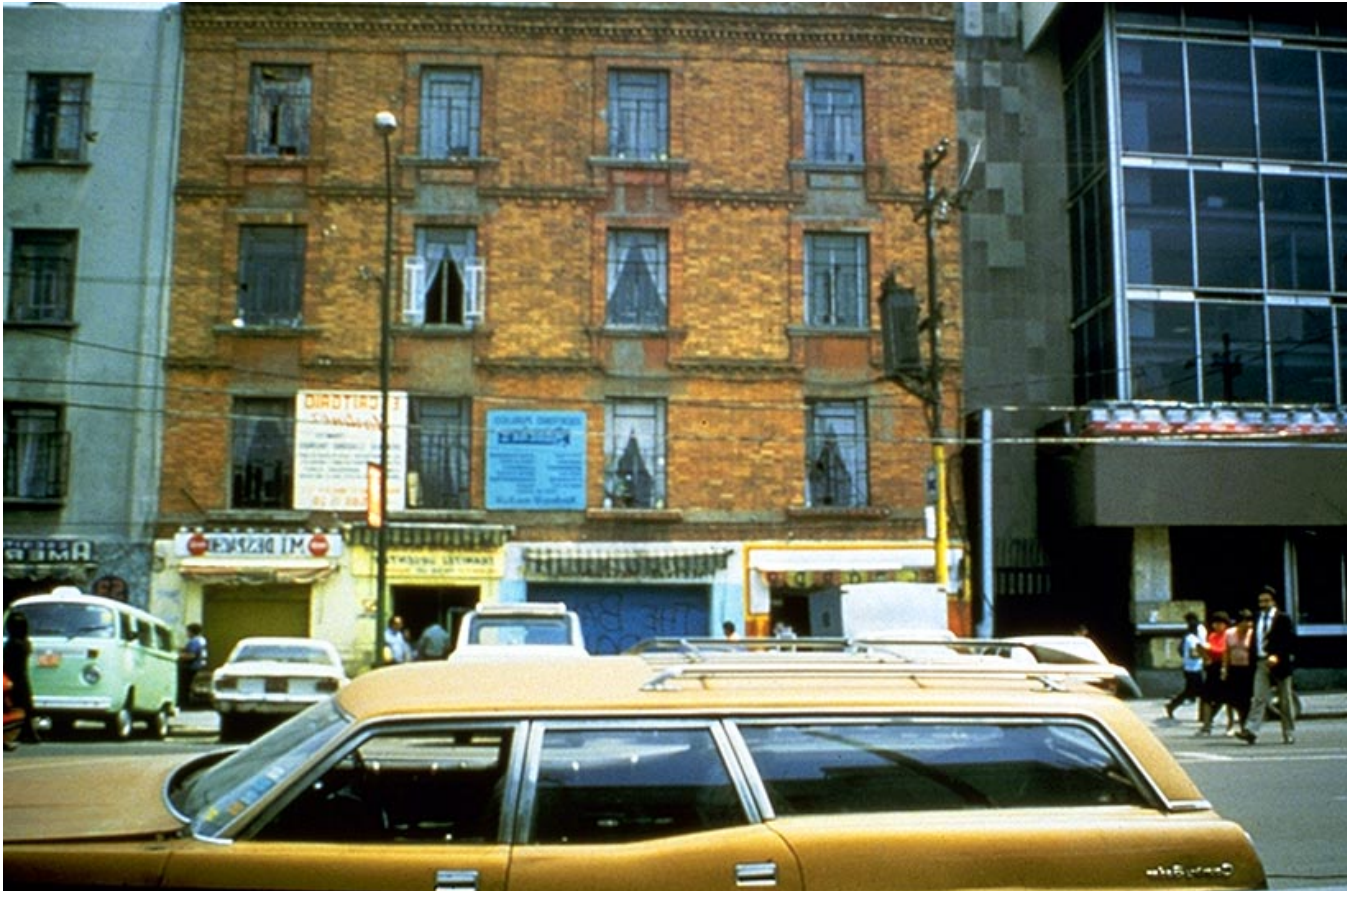
Slide #16

Undamaged Masonry Buildings

This slide shows lack of damage to low-rise buildings including low quality unreinforced masonry buildings. It shows lack of response of these building types to the particular ground motion in Mexico City.

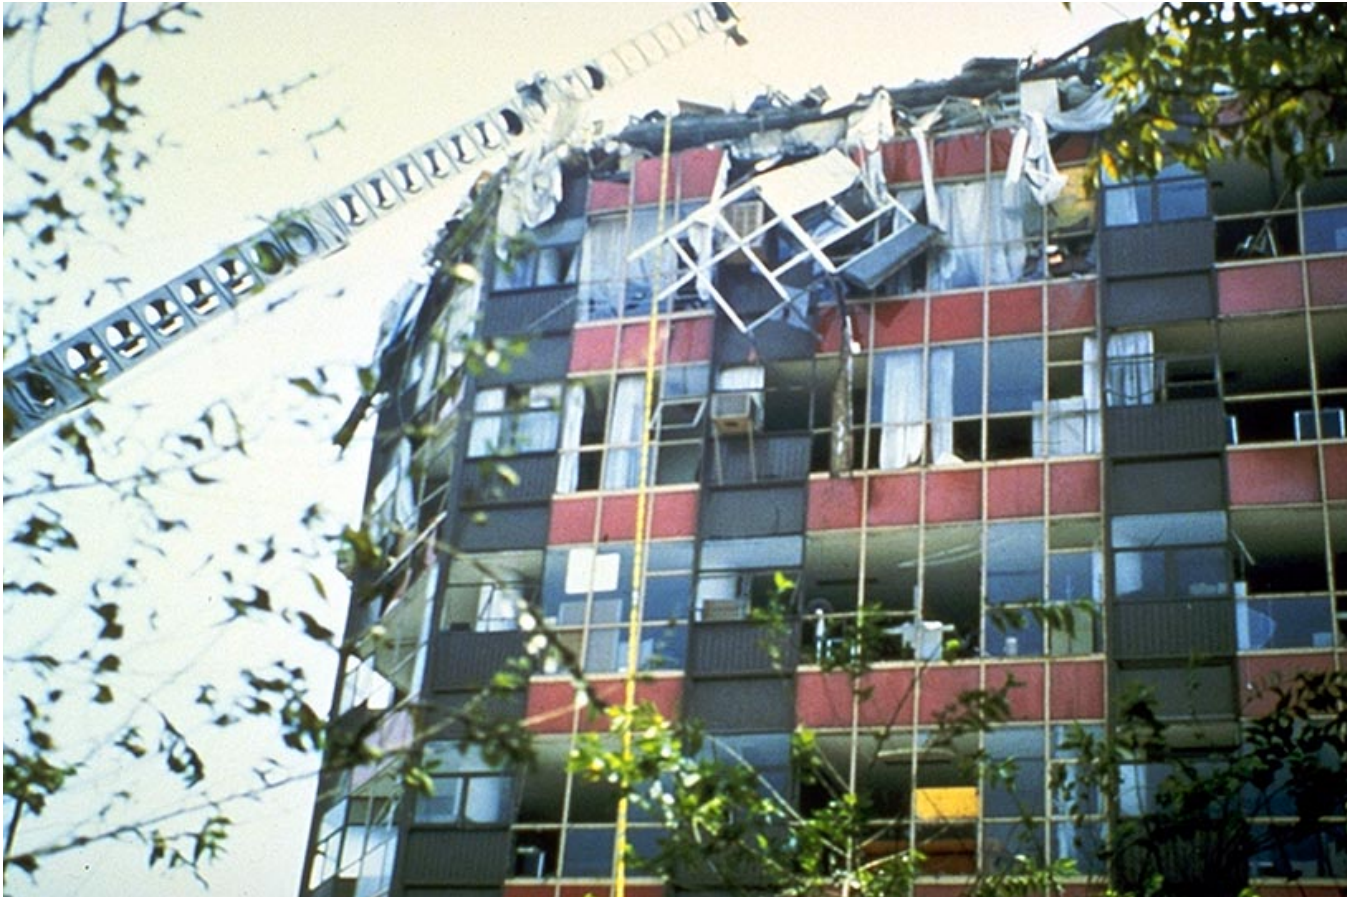
Slide #17

Curtain Wall Damage

Curtain wall damage to building with severe structural damage and collapse of top floor. In spite of damage and distortion, window glass is unbroken.

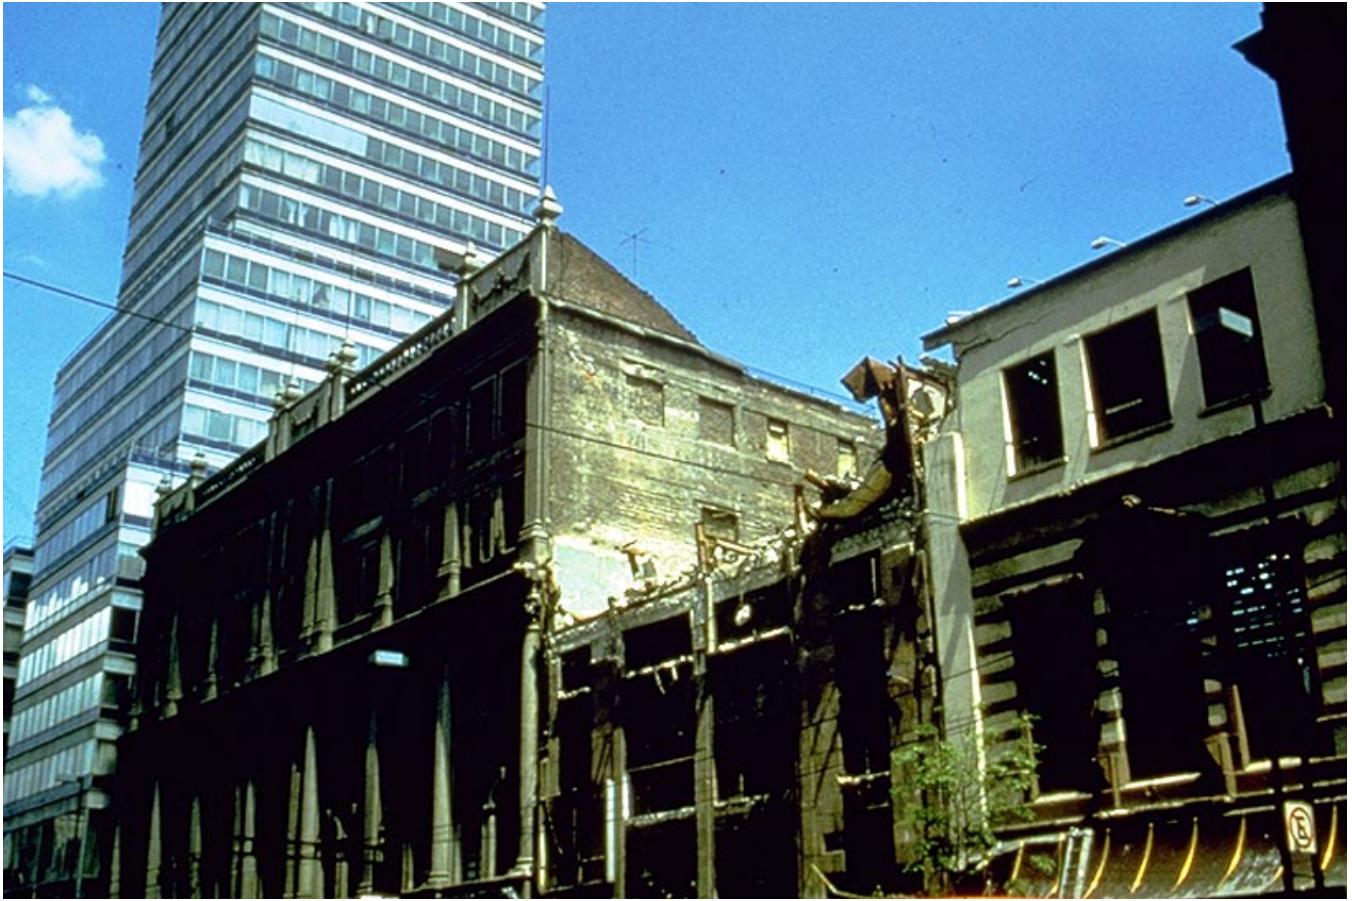
Slide #18

Latino Americana Tower

Undamaged glass wall of Latino-Americana tower designed in 1948. Note serious damage to older building in foreground, one-half black away from the tower.

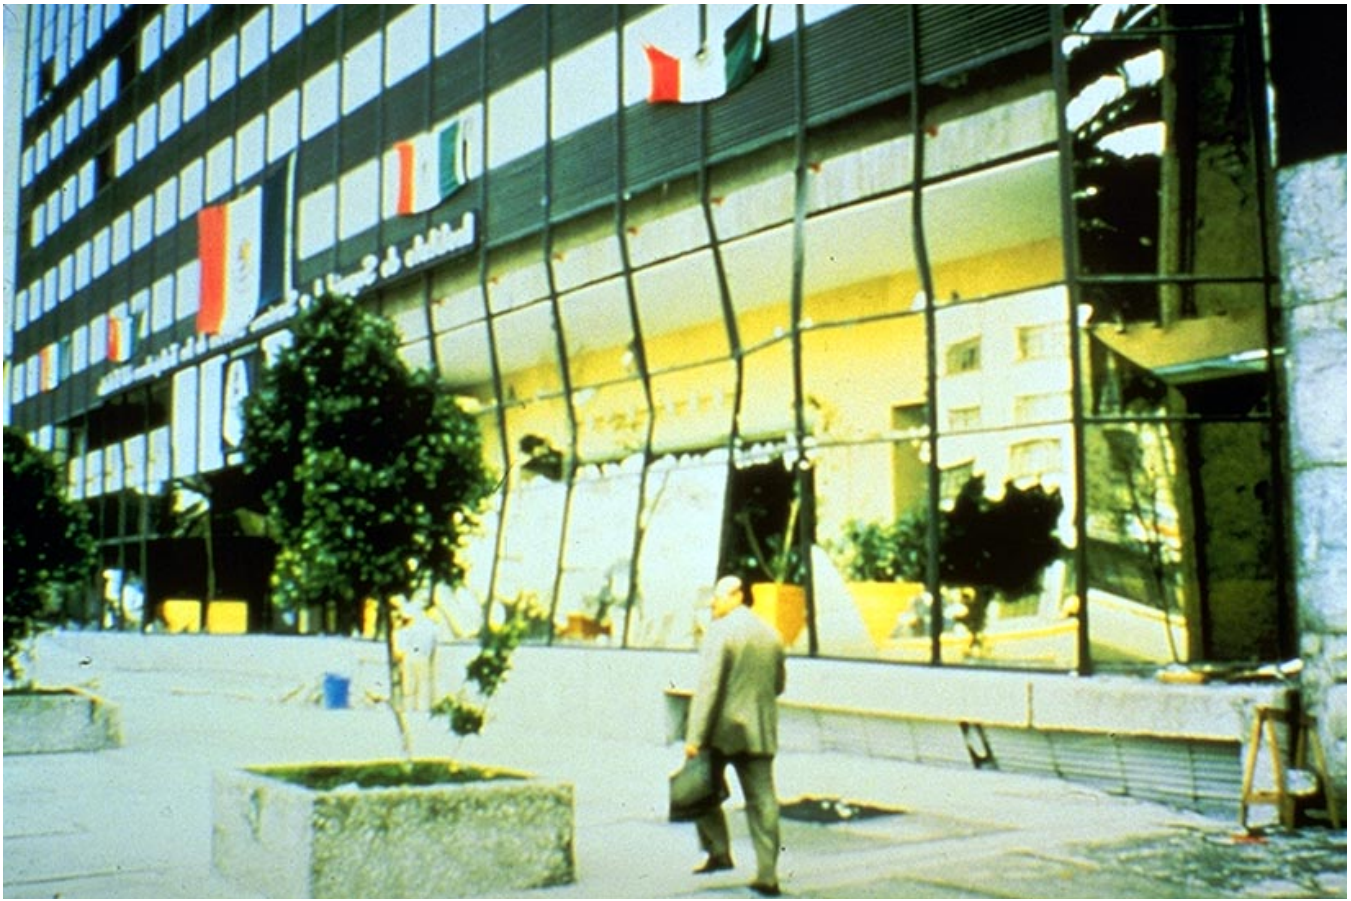
Slide #19

Glass Damage

Distorted vertical glazing windows indicate deflection of second story slab. In spite of severe distortion to framing, much glass is still intact.
