**EARTHQUAKE ENGINEERING RESEARCH INSTITUTE
COMMITTEE ON CONTINUING EDUCATION**

SUBCOMMITTEE TO CREATE SLIDE
SETS ON THE SEPTEMBER 19, 1985
MEXICO EARTHQUAKE

**MEXICO - SET II:
PATTERNS OF BUILDING
FAILURE**

FEBRUARY 1987

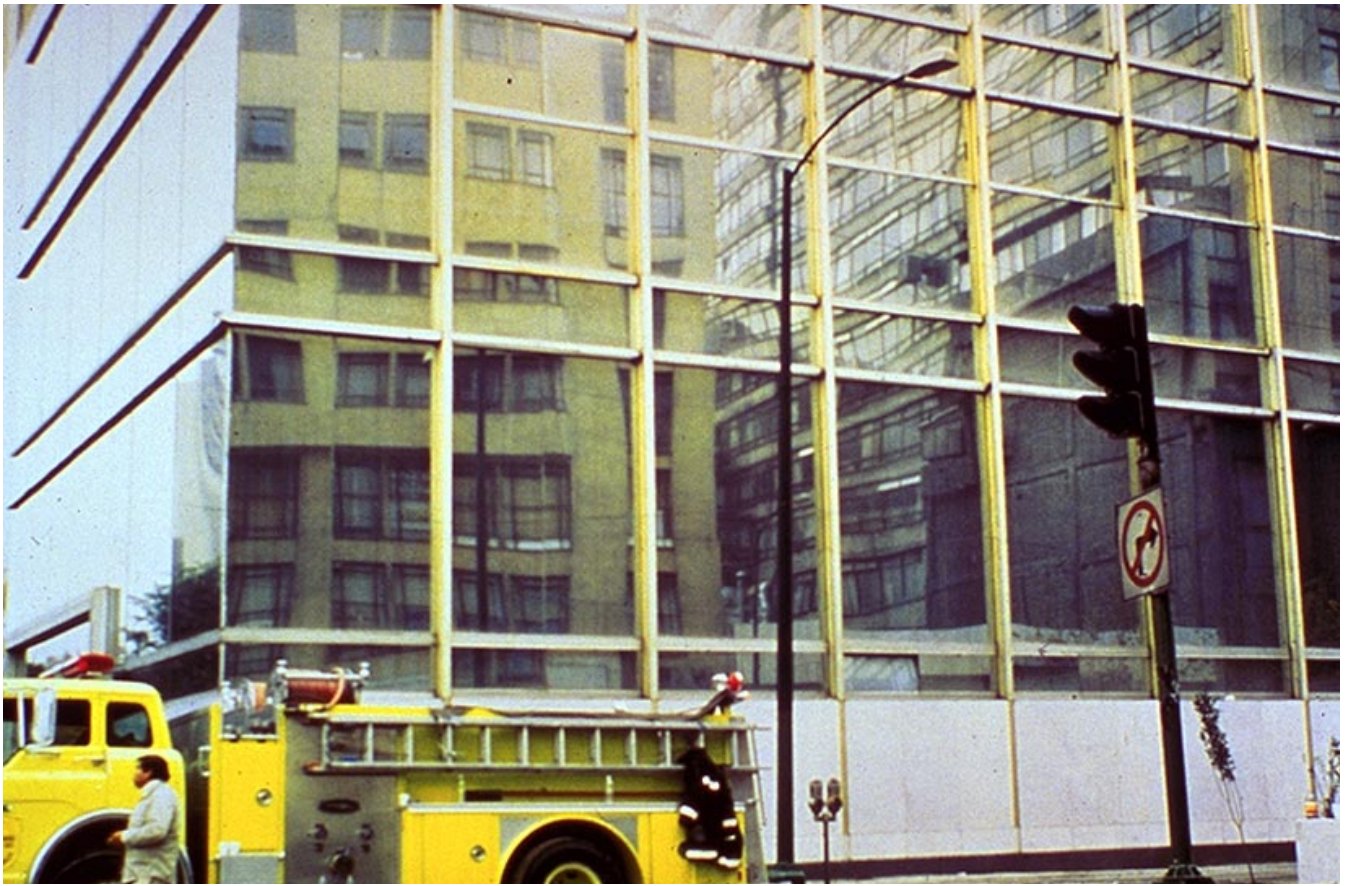
Slide #20

Undamaged Curtain Wall

Undamaged glass facade including glass at corner. This building is one block away from the Regis Hotel, an area of very severe damage.
