**EARTHQUAKE ENGINEERING RESEARCH INSTITUTE  
COMMITTEE ON CONTINUING EDUCATION**

SUBCOMMITTEE TO CREATE SLIDE  
SETS ON THE SEPTEMBER 19, 1985  
MEXICO EARTHQUAKE

**MEXICO - SET III:  
EXAMPLES OF DAMAGE TO  
BUILDINGS IN MEXICO CITY**

FEBRUARY 1987

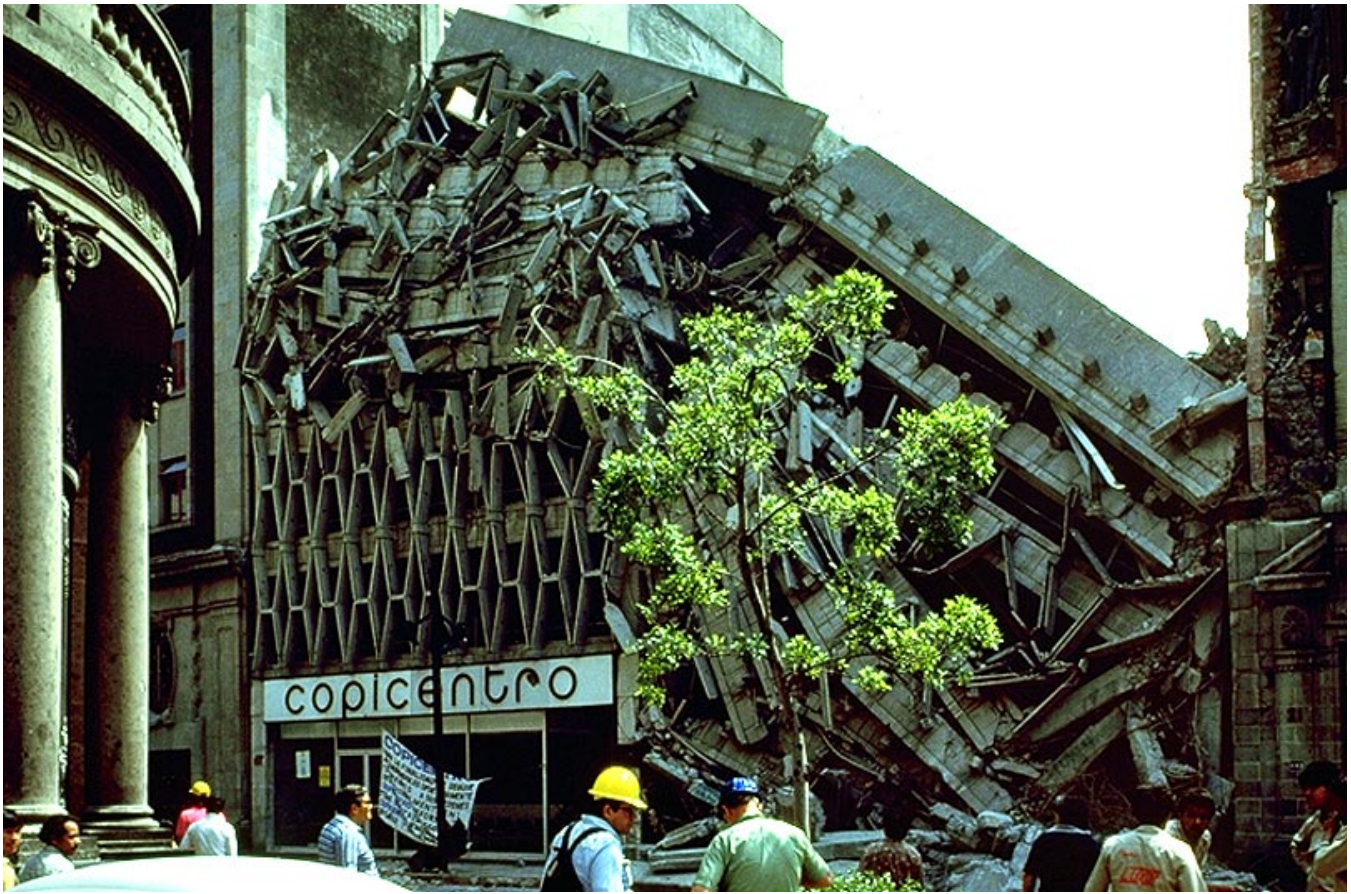
Slide #1

## Concrete Parking Garage

Nine story parking structure. Cast in place concrete. Damage to adjacent building from pounding. Building is much larger than it appears here. Continues nearly a full block and wraps around adjacent building.

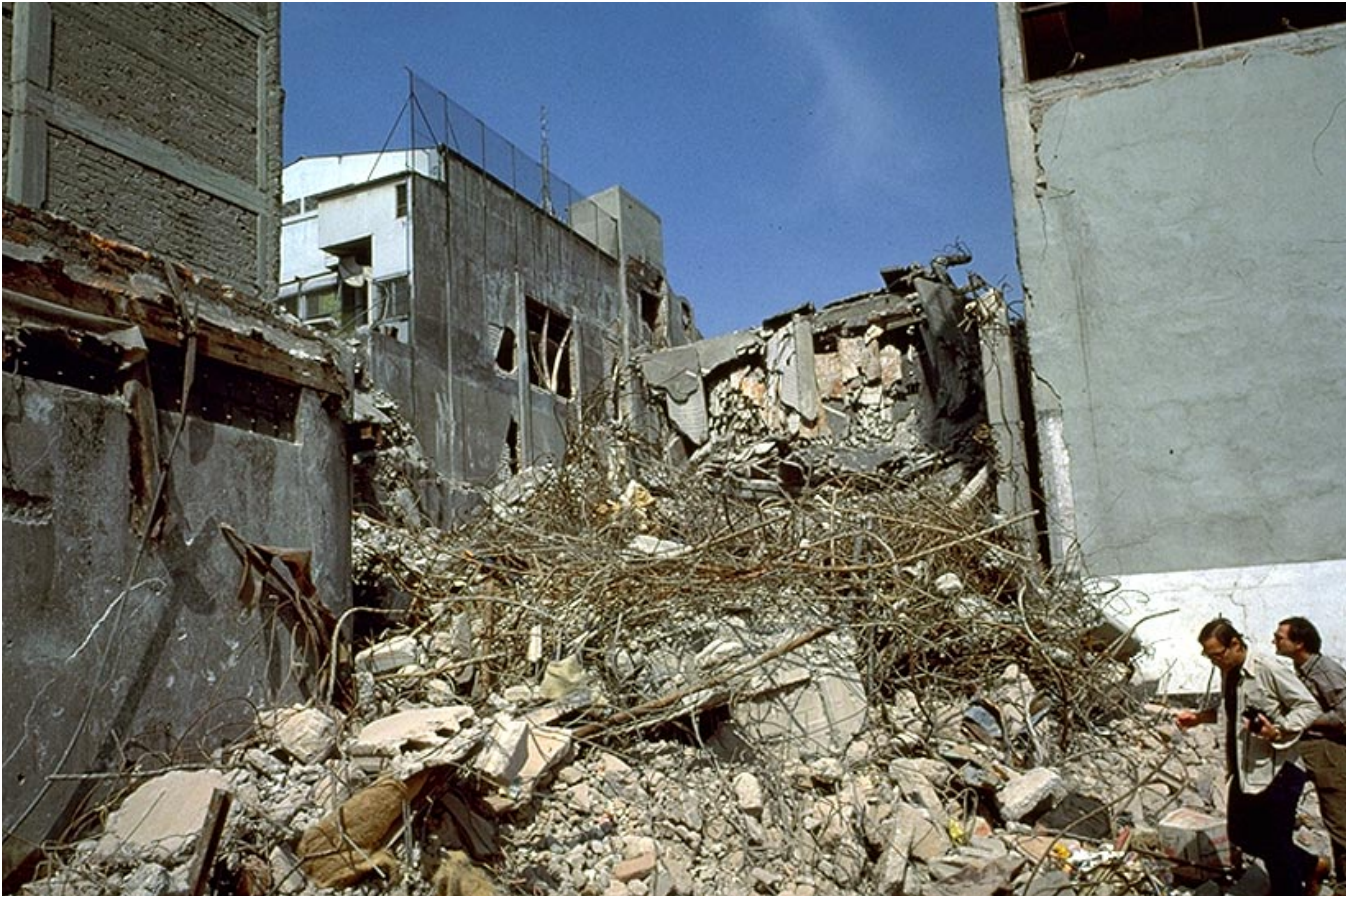
Slide #2

## Concrete Parking Structure

Rear view of building in slide #1. This portion is nearly a block away and shows how large the building is. The pile of rubble in the foreground shows reinforcing steel which will be reclaimed.

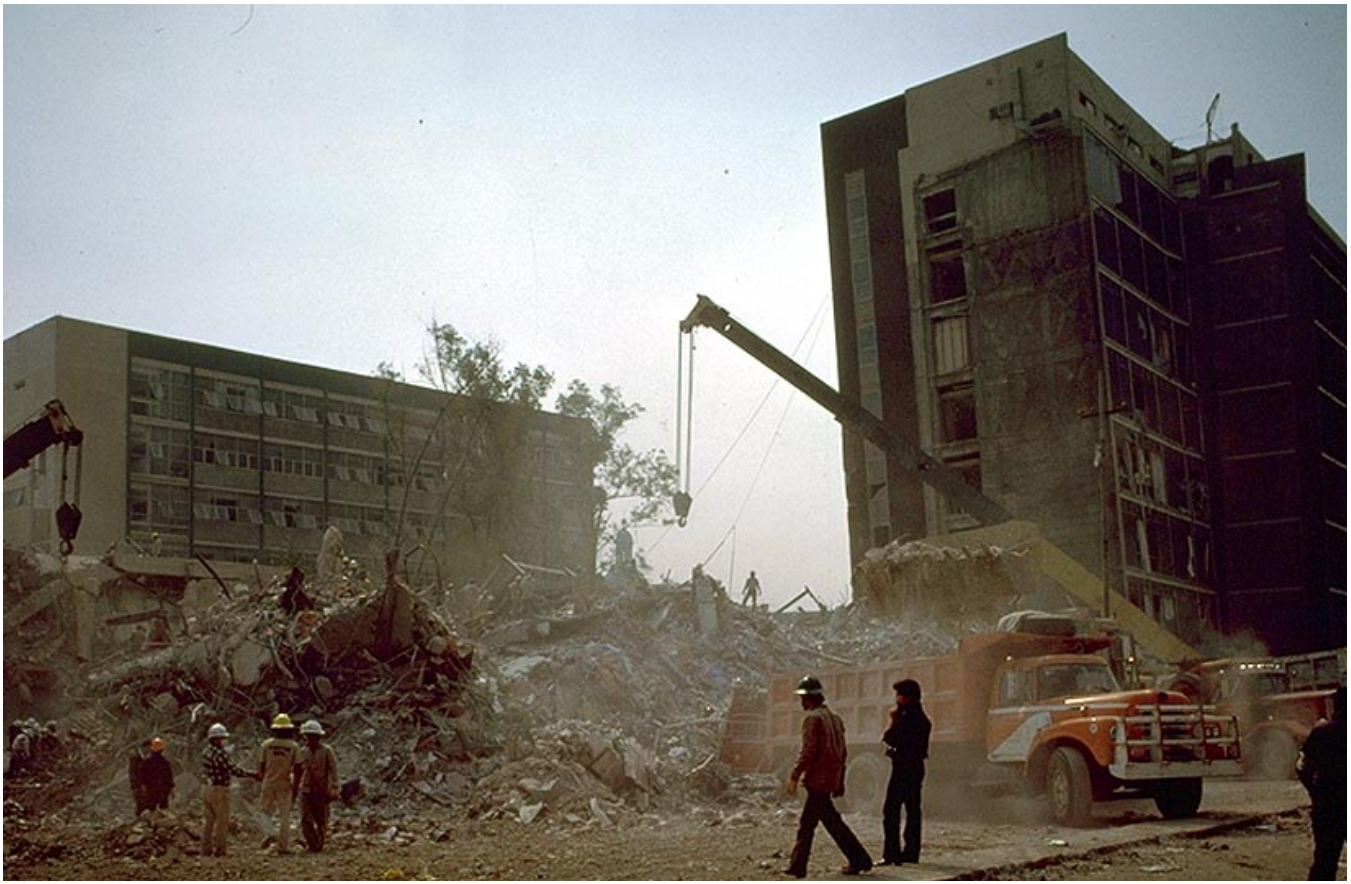
Slide #3

## Tilted Building

Approximately 10 stories. Concrete braced frame with brick infill. Top is tilted approximately 8 feet. Shows evidence of foundation failure.

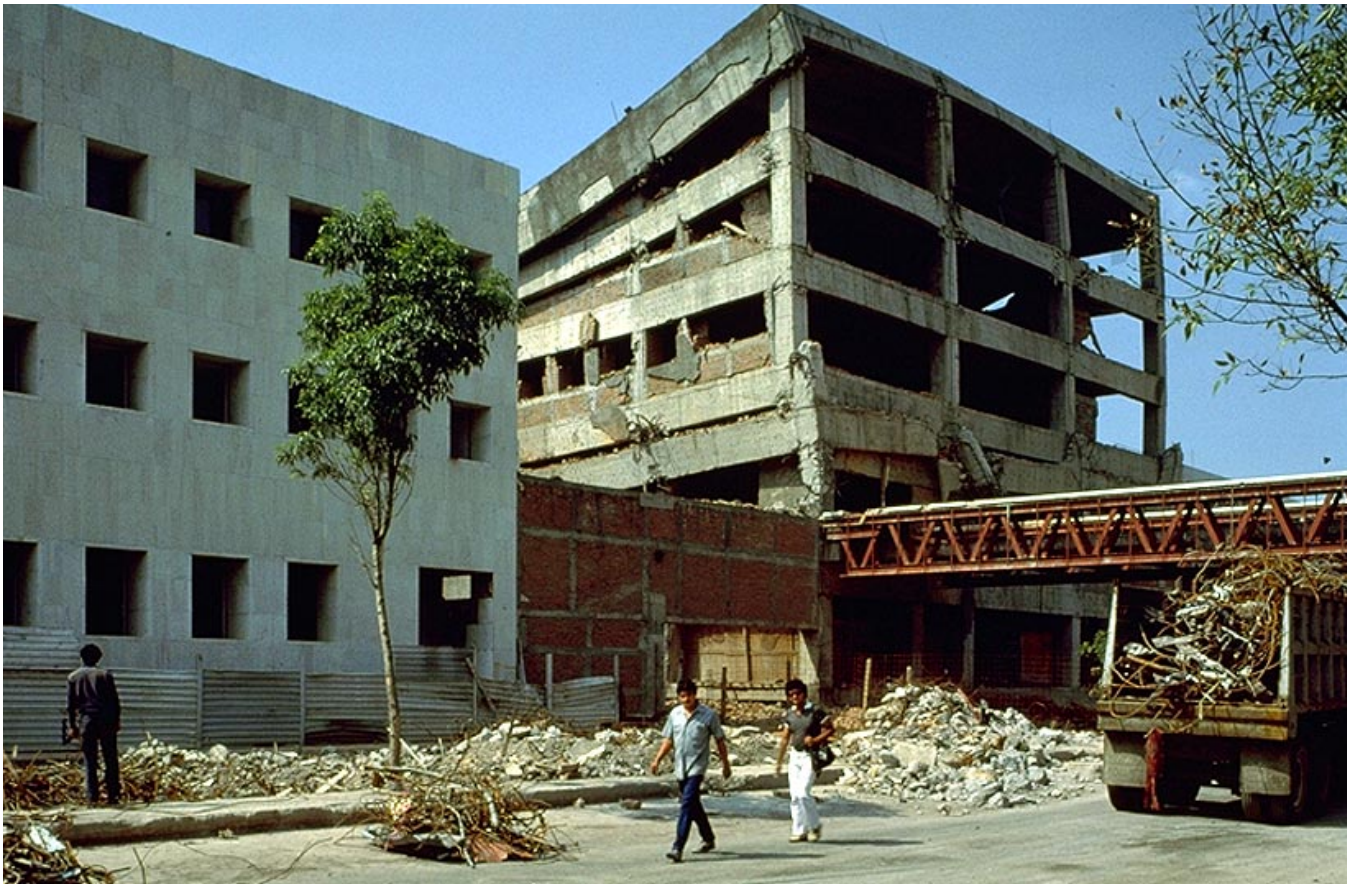
Slide #4

## Bank of Mexico

New buildings under construction. Concrete frame with unreinforced brick walls. Where infill walls were not in place, lightly reinforced (non-ductile) concrete frames failed.

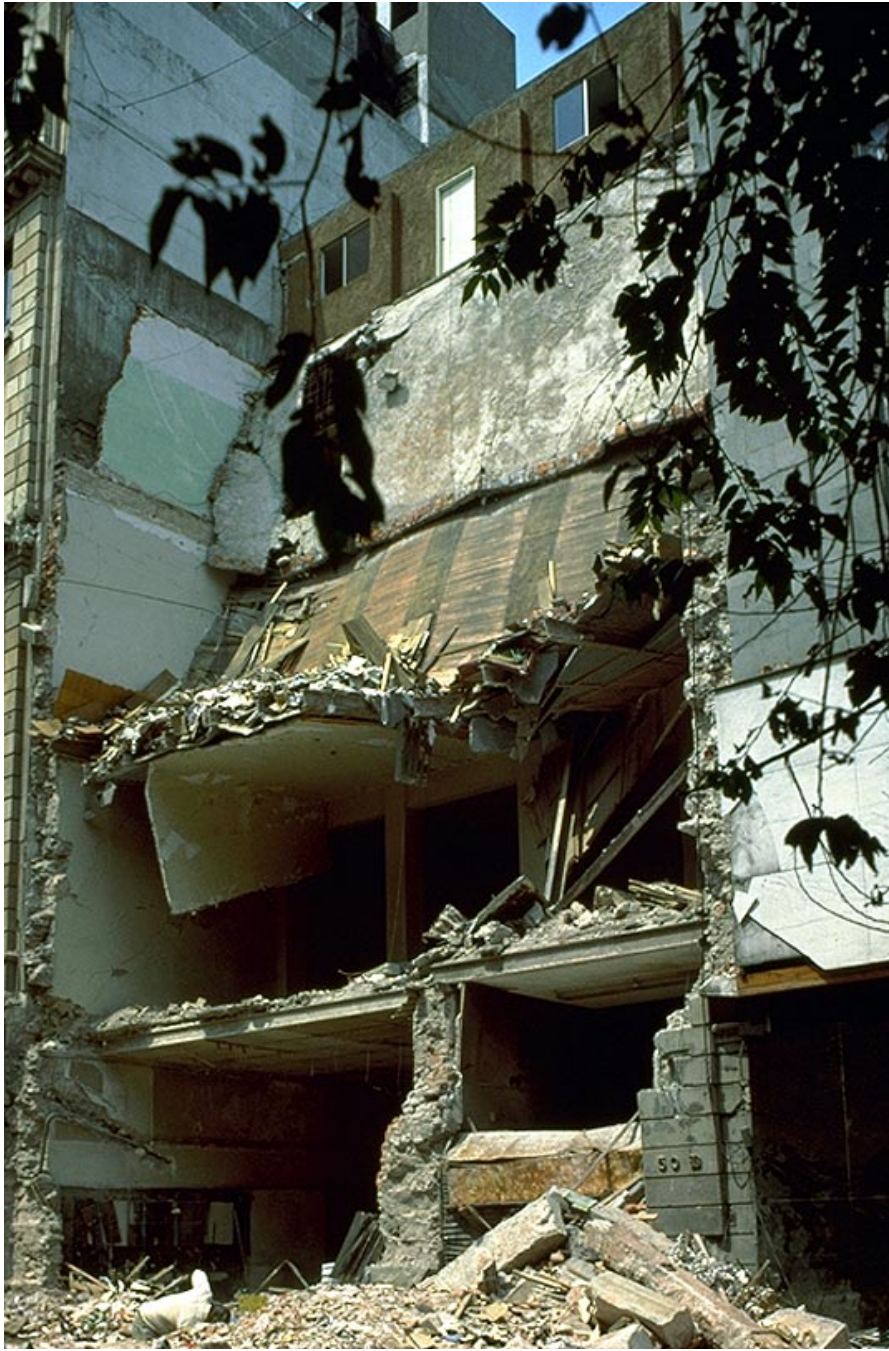
Slide #5

## Infill Building

Small 4 story building, built between common walls. Apparently as adjacent supporting walls moved with adjacent buildings, floors and roof lost vertical support.

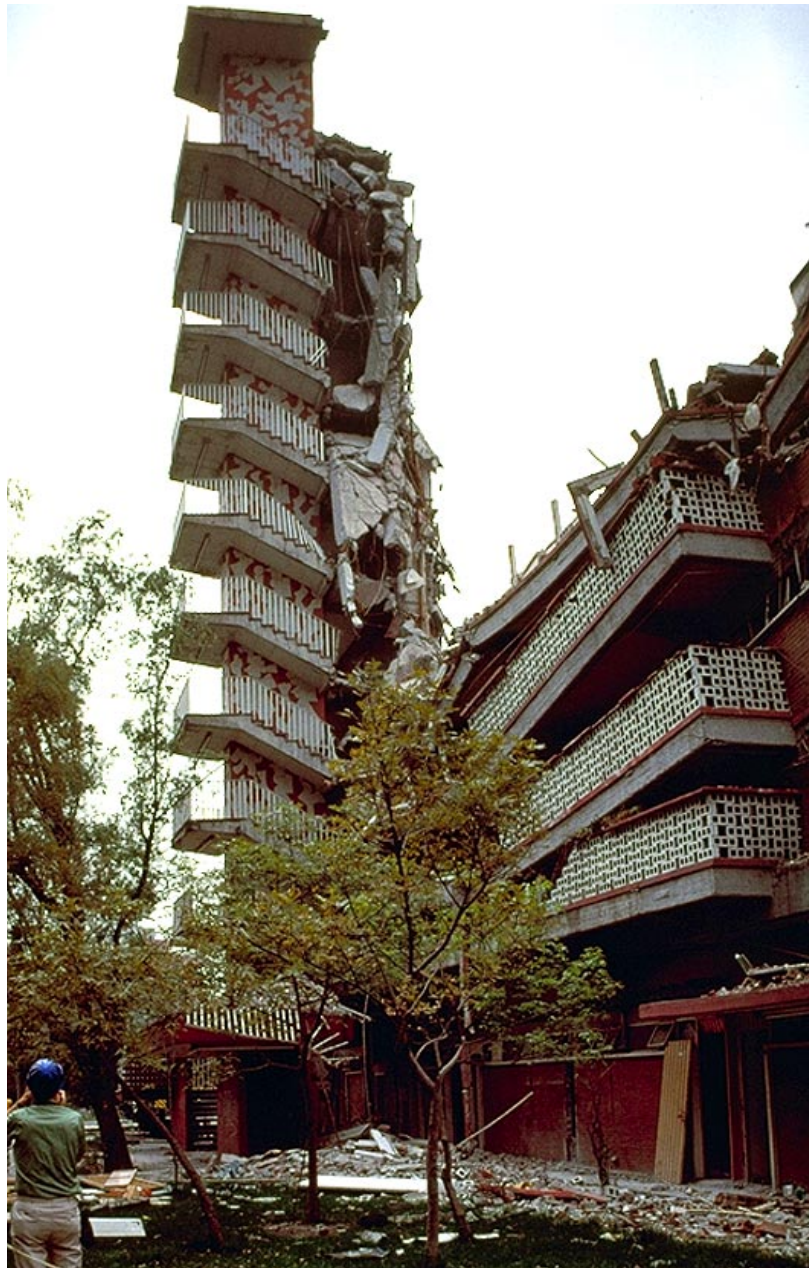
Slide #6

## Benito Juarez Housing Development

Eleven story apartment building. Concrete frame with unreinforced brick:

- 1) infill walls full height at ends-transverse,
- 2) infill walls to window sill in longitudinal direction,
- 3) interior partitions - 4 1/2" thick unreinforced brick. Cantilevered concrete pylon at exterior stair. Plan dimensions approximately 30' x 190'.

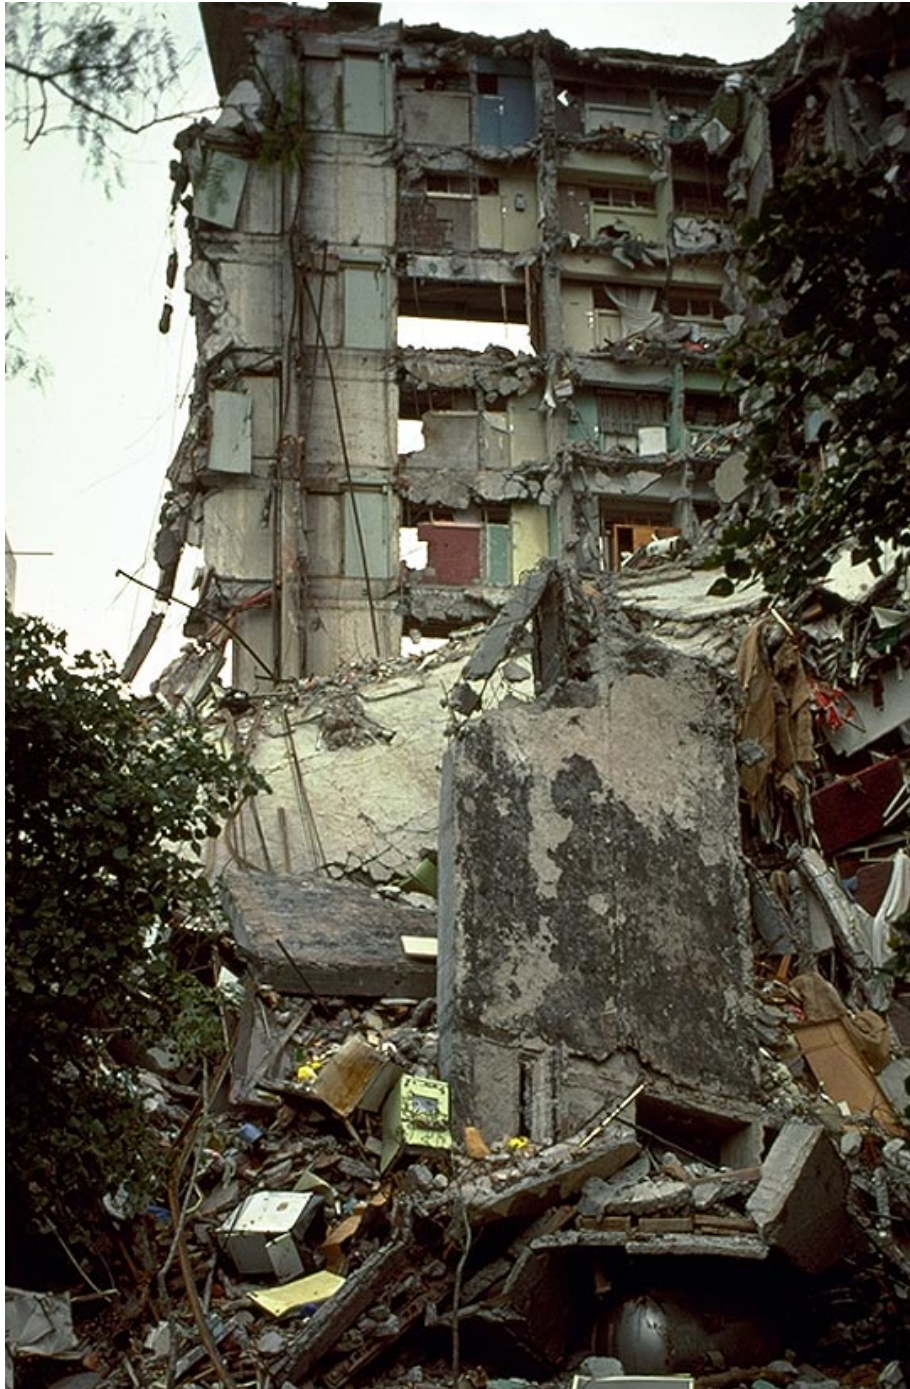
**Slide #7**

## **Benito Juarez Housing Development**

See slide #6

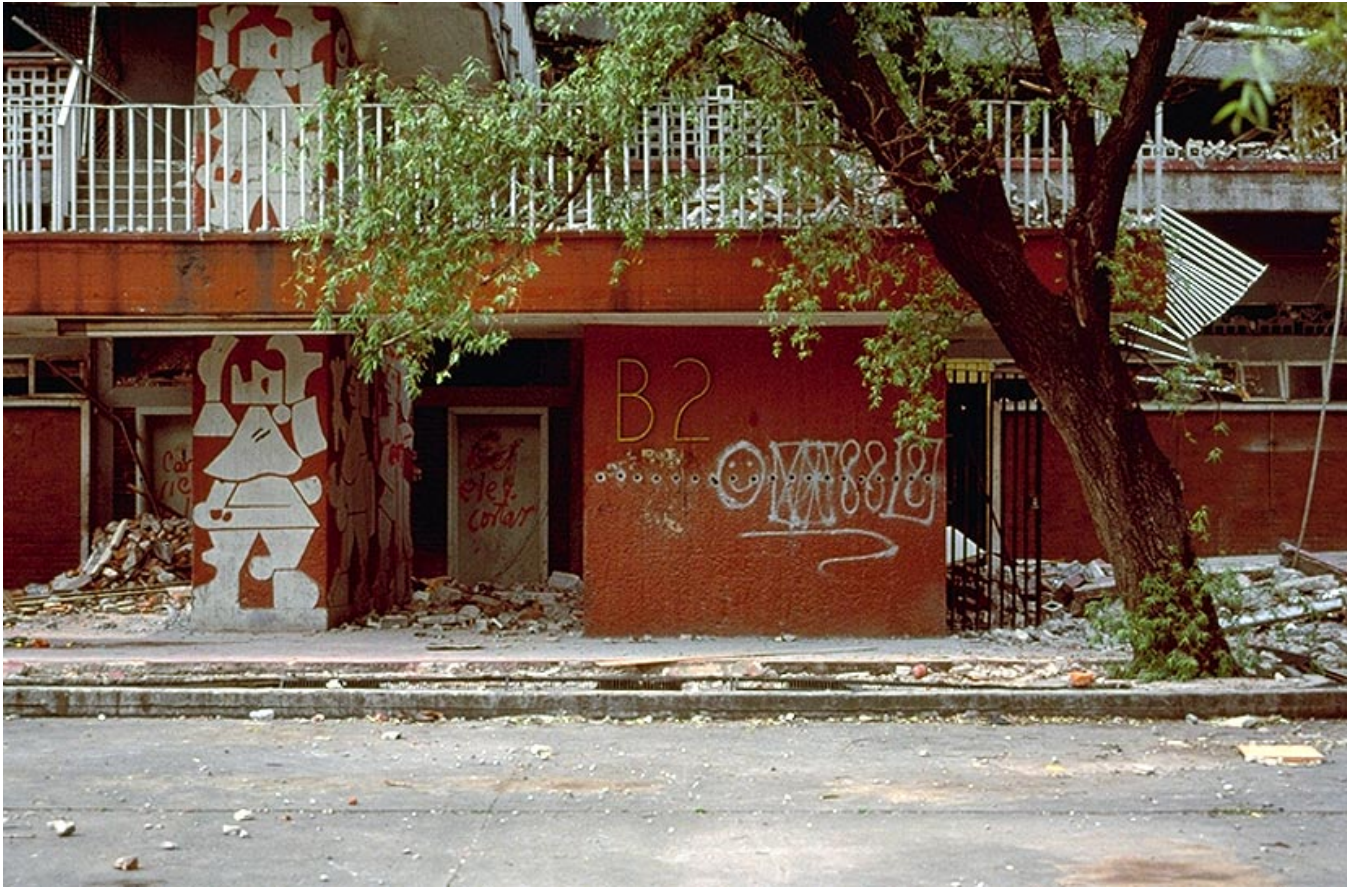
Slide #8

## Benito Juarez Housing Development

See slide #6. Additional comments: Demolition contractor has drilled closely spaced holes in walls to receive demolition charges.

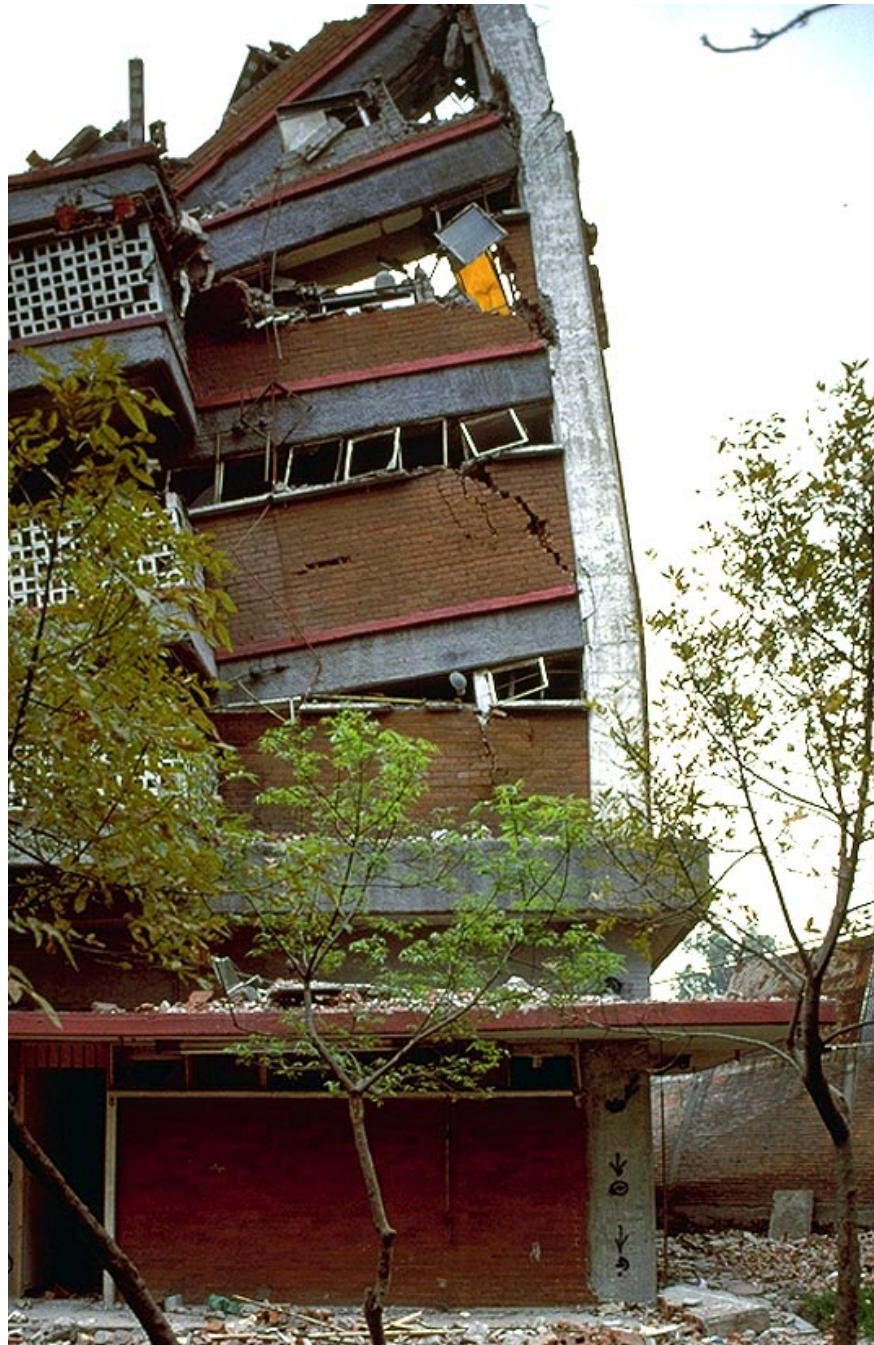
Slide #9

## Benito Juarez Housing Development

See slide #6. Additional comments: End transverse walls showing large amount of movement.

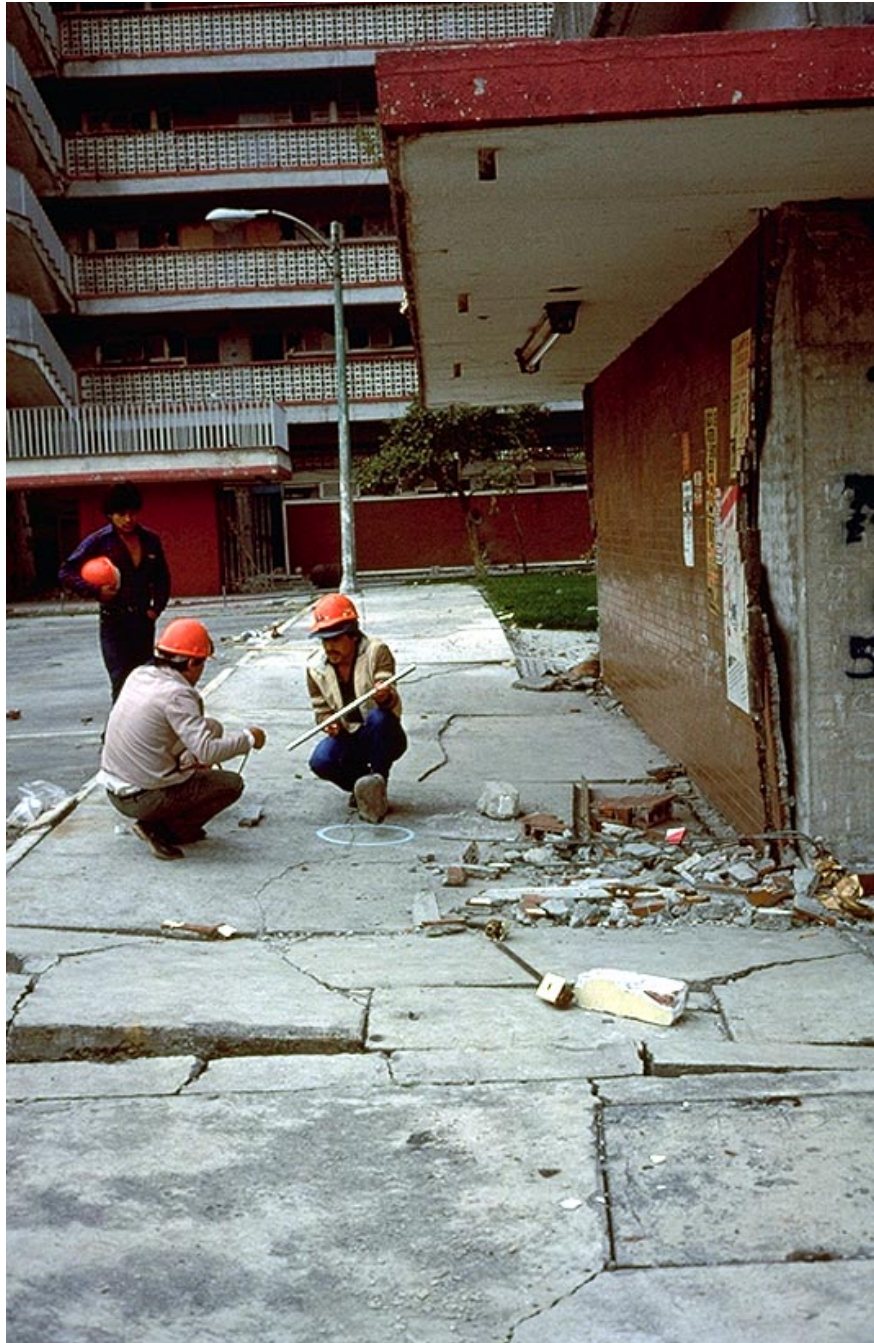
Slide #10

## Benito Juarez Housing Development

See slide #6. Additional comments: 1) Demolition contractor monitoring settlement and tilting, and 2) Tilting is progressing at approximately 2 cm. per day.

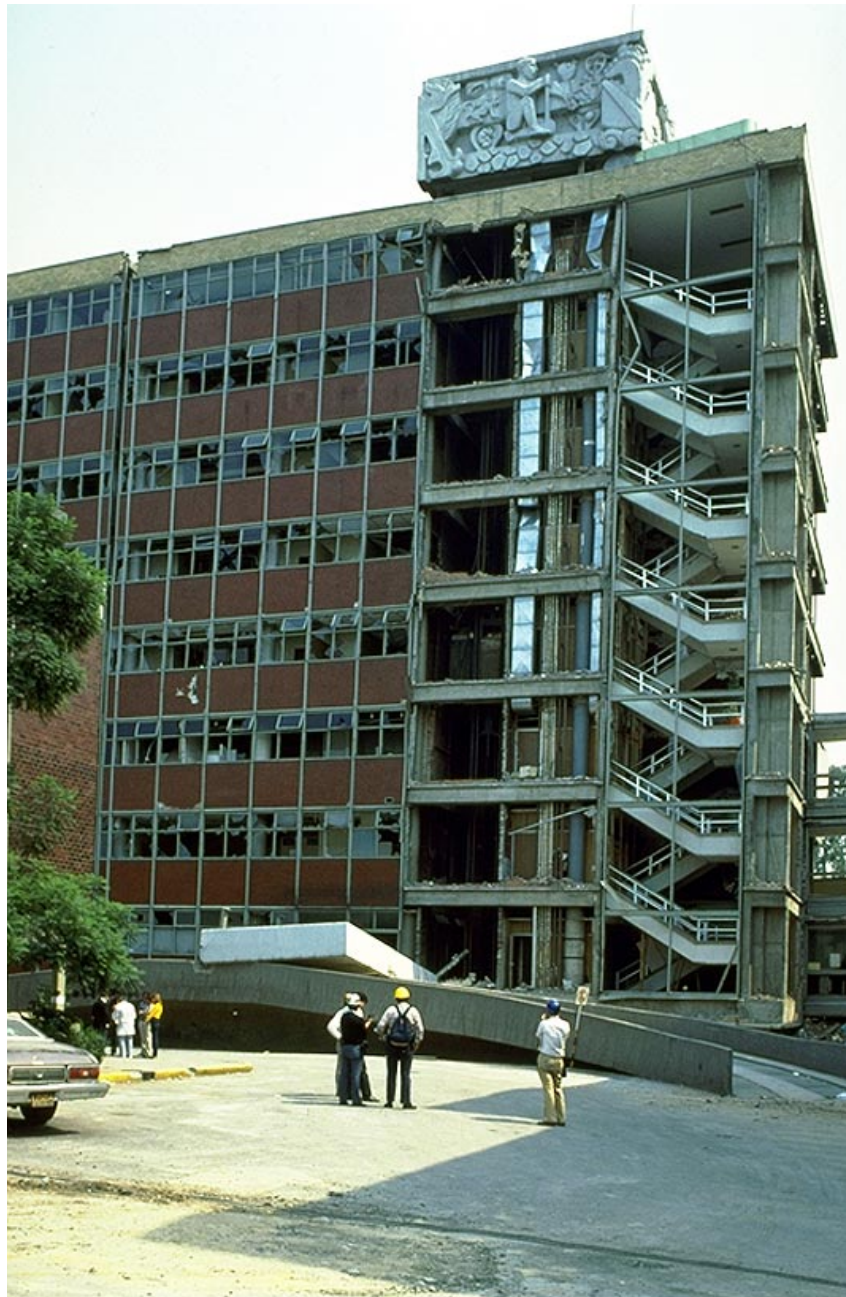
Slide #11

## Centro Medico Oncology Building

Eight stories concrete frame with infill walls; 4 bays transverse; 9 bays longitudinal. Heavy water storage tank on roof has caused failure of columns near entrance. Canopy has collapsed over ambulance entrance.

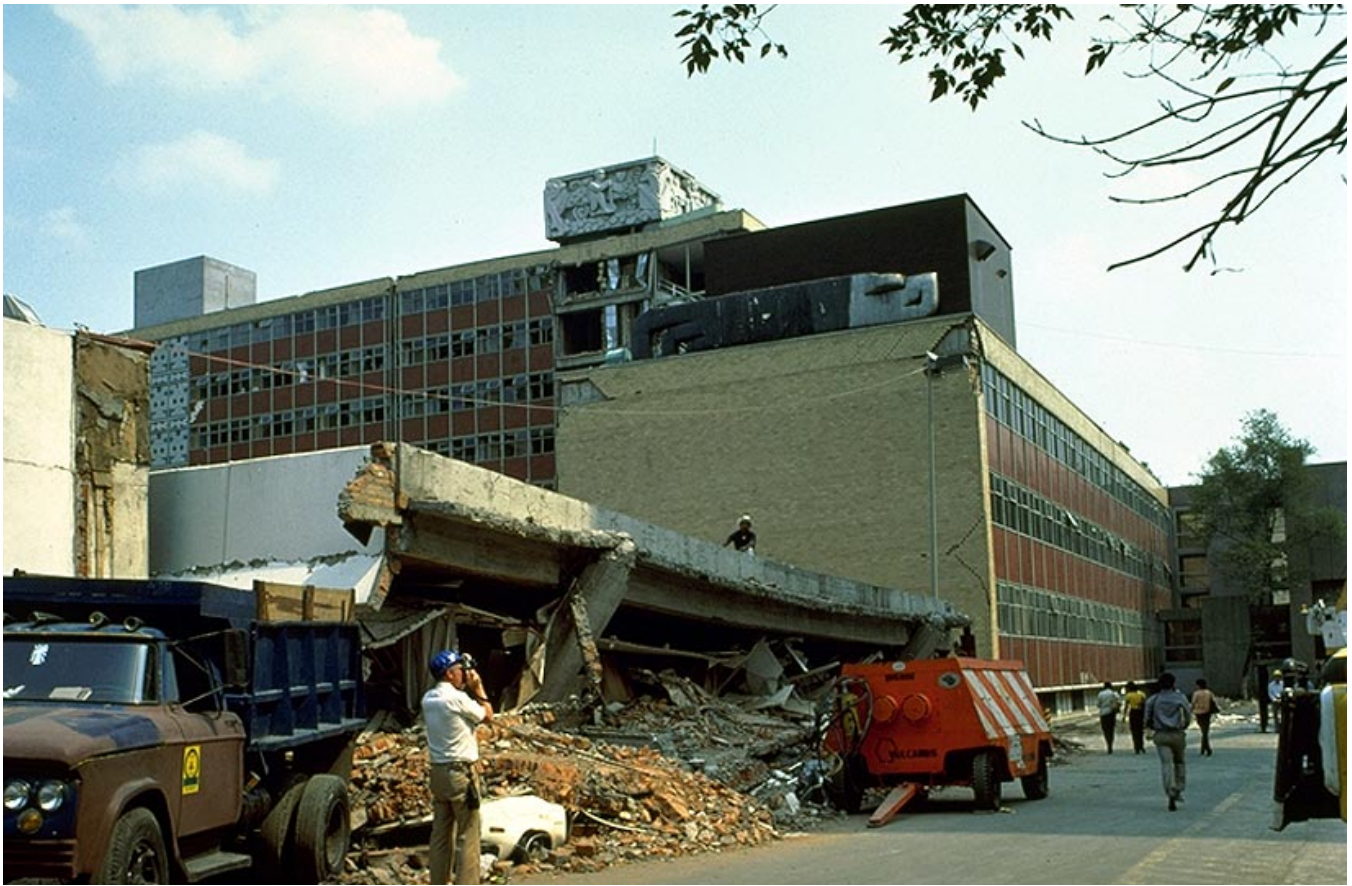
Slide #12

## Centro Medico Mechanical Building

Two story concrete frame structure. Total collapse. First story houses electrical generator. Second story housed laboratories.

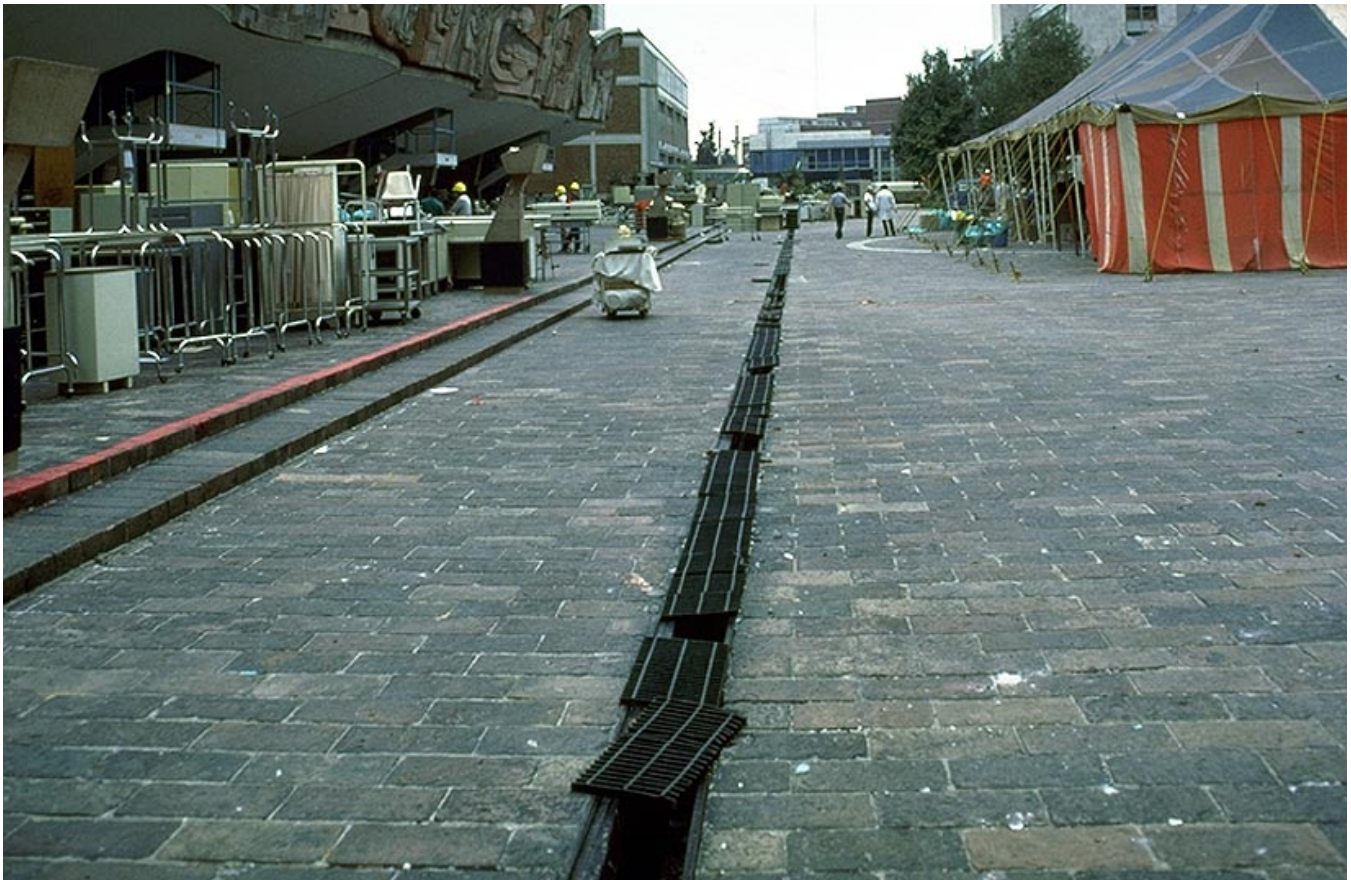
Slide #13

## Centro Medico Courtyard near classrooms

Drainage gutter showing displacement of grills. Gutter width has been reduced so that grills will no longer fit.

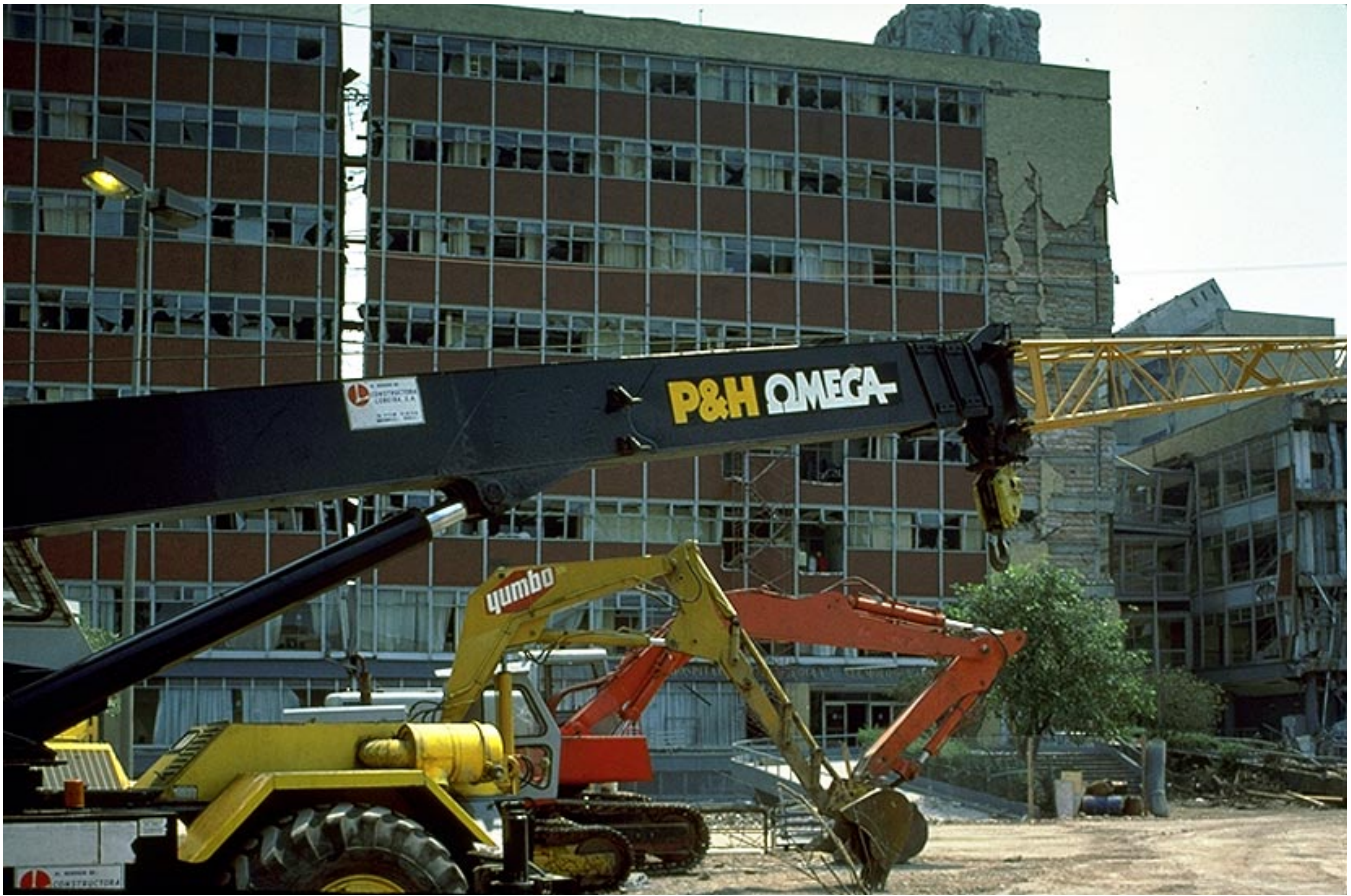
Slide #14

## Centro Medico Cardiology and Neurology Unit II

Eight stories concrete frame. Separation joint at mid point of building has grown to approximately 1 meter. North portion has drifted, south has not. South portion has concrete walls around the elevator shaft which apparently stiffened that wing.

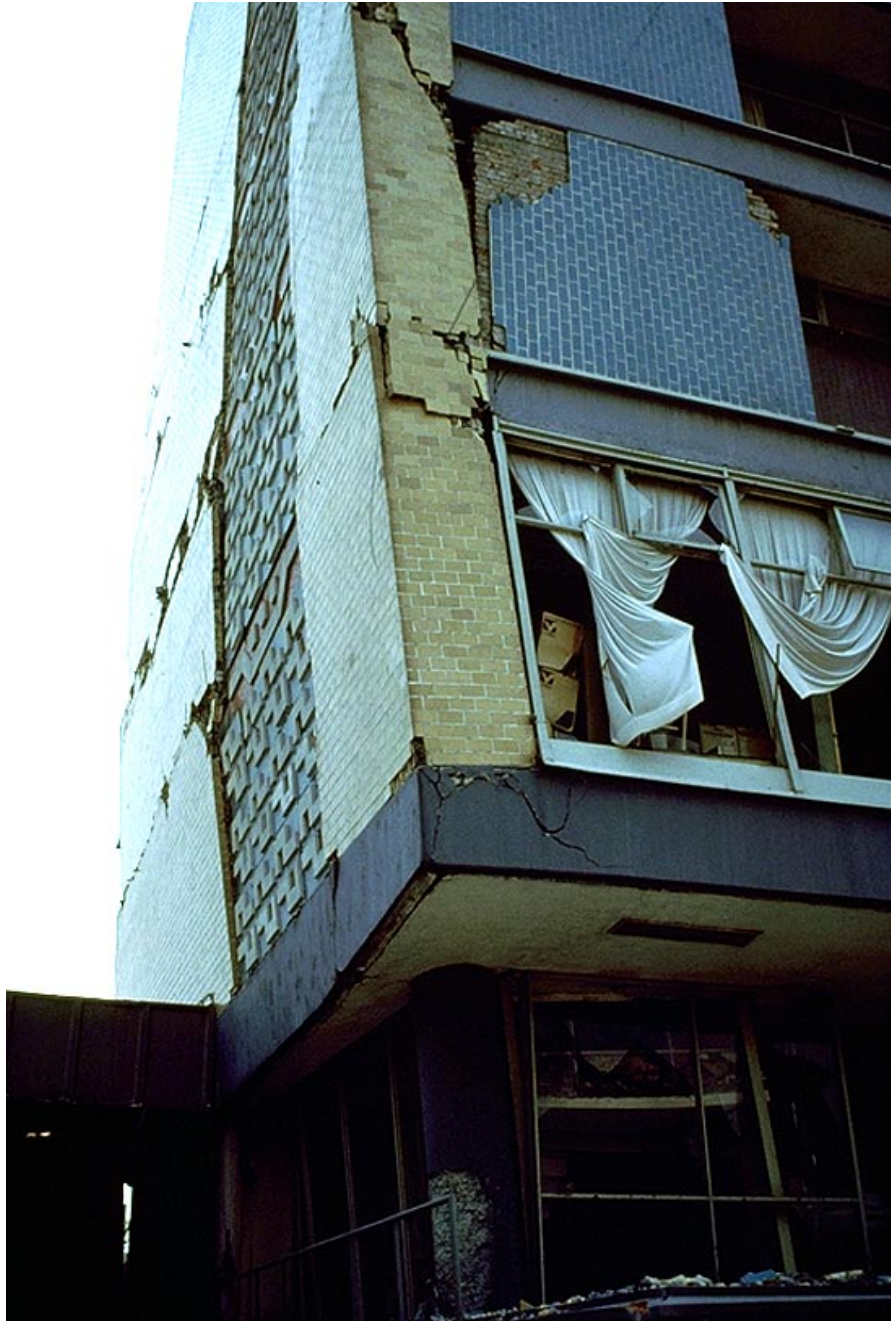
Slide #15

## Centro Medico Cardiology and Neurology Unit II

See slide #14. Additional comments: North end of building, 1) First story columns are heavily reinforced and have acted in a ductile manner, and 2) Upper floors have unreinforced brick walls along corridor, keeping the relative story drifts low.

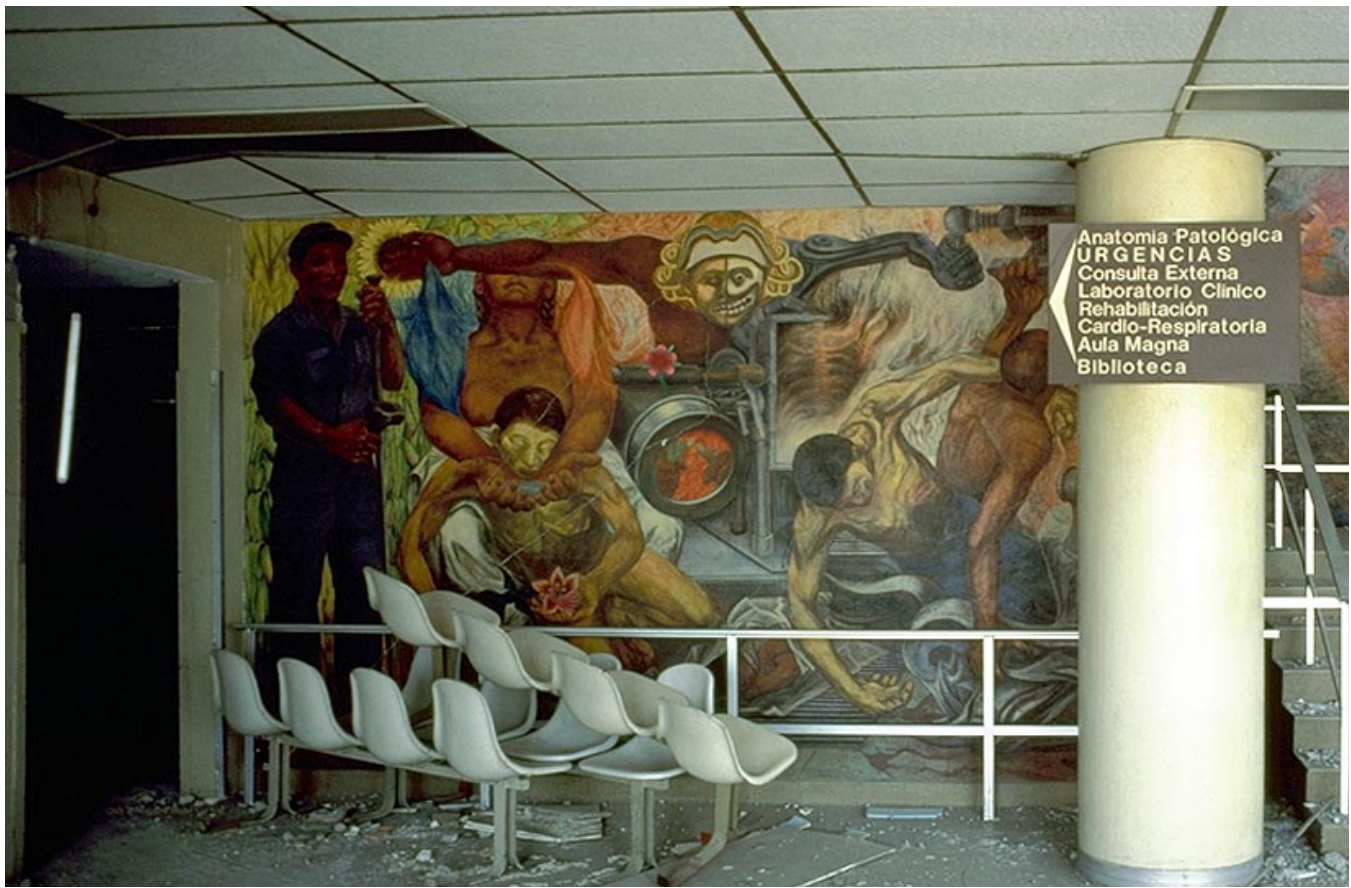
Slide #16

## Centro Medico Cardiology and Neurology Unit II

See slides #14 and #15. Additional comments: Interior damage at lobby.

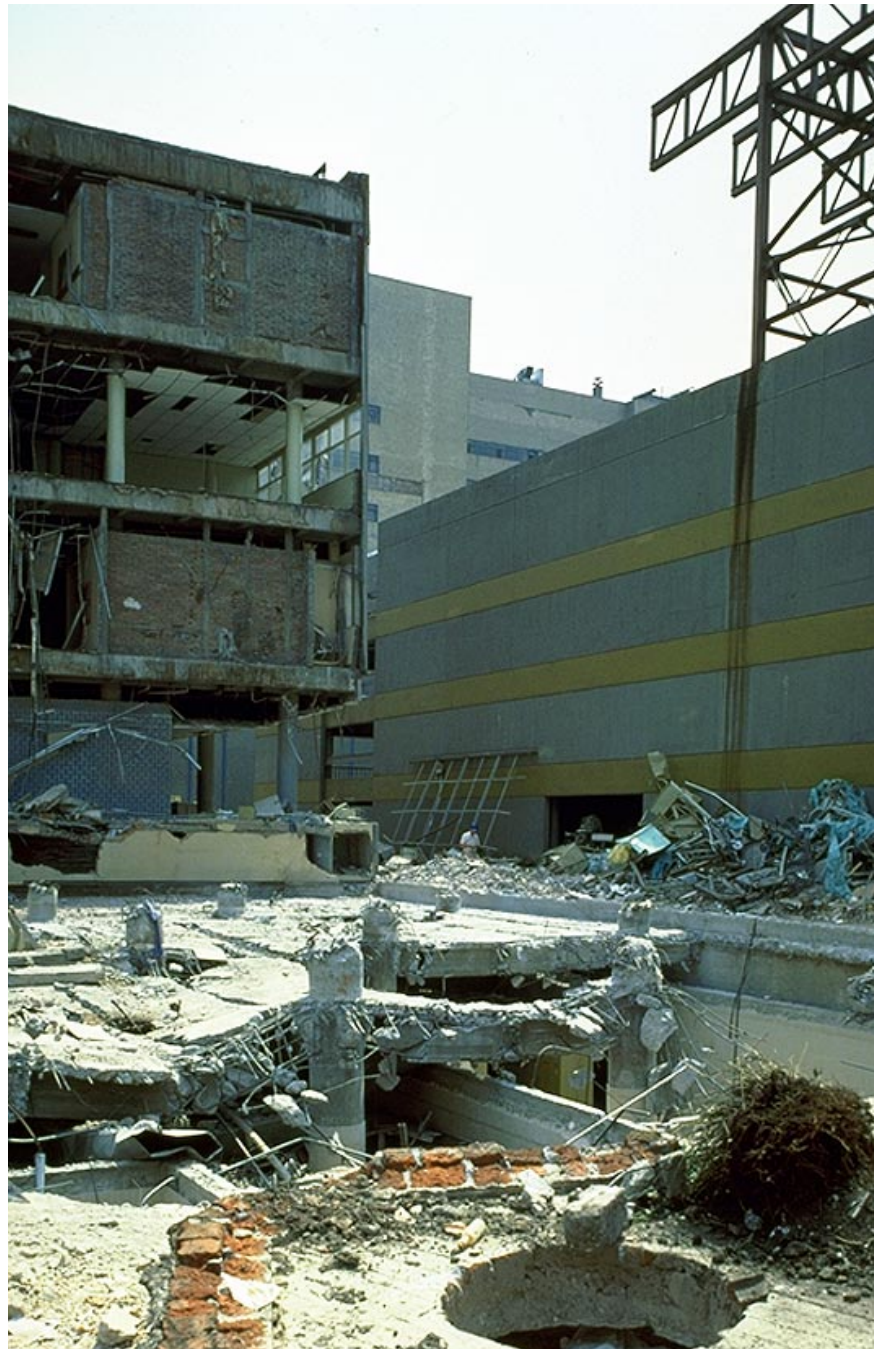
Slide #17

## Centro Medico Classroom Unit I

Four story classroom building. West portion has collapsed. Fairly new pre-stressed concrete parking garage to south was undamaged.

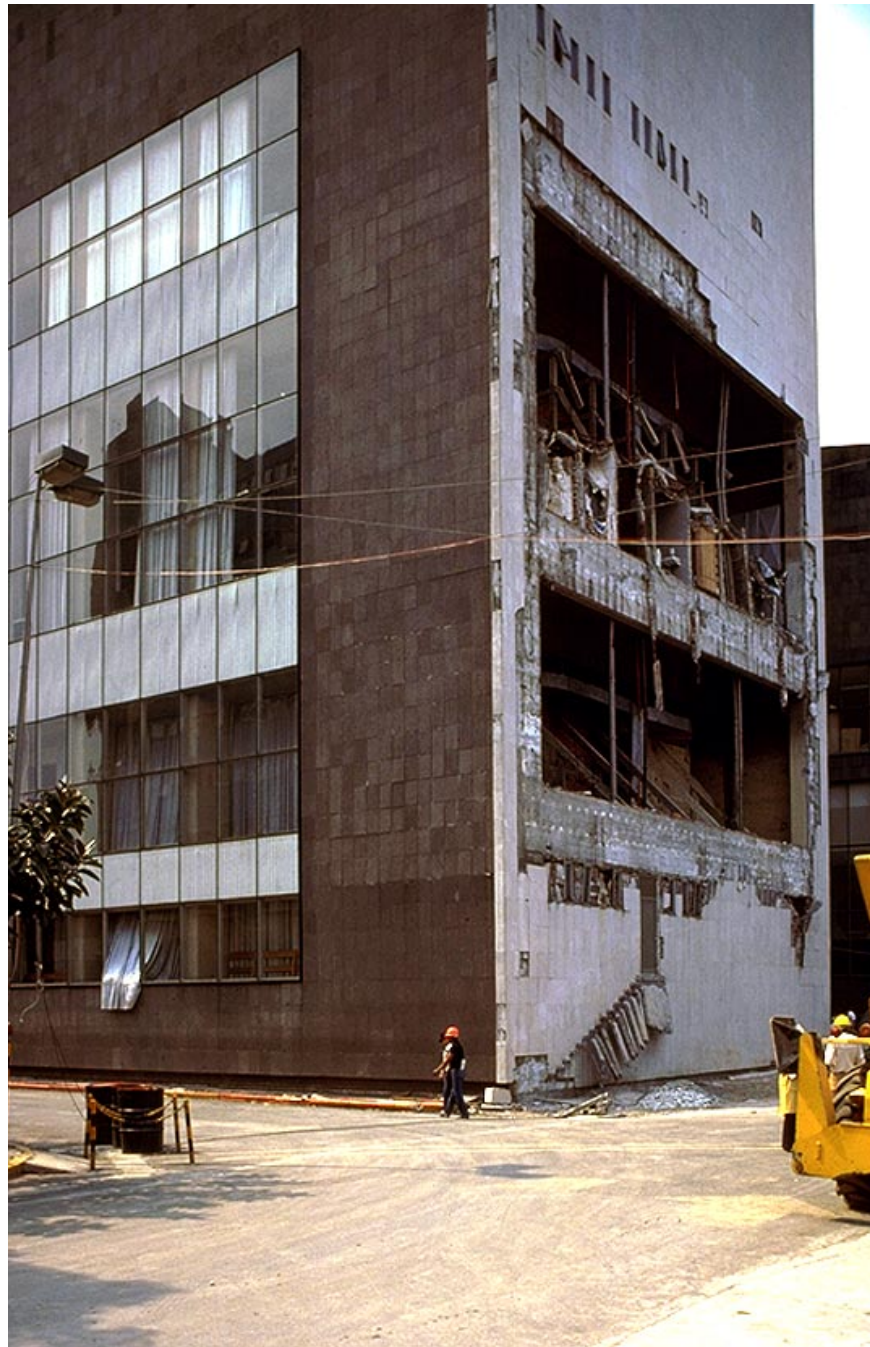
Slide #18

## Centro Medico Meetings Unit B

End wall made of unreinforced brick infill has collapsed, damaging concrete cantilever stairs.
