**EARTHQUAKE ENGINEERING RESEARCH INSTITUTE  
COMMITTEE ON CONTINUING EDUCATION**

SUBCOMMITTEE TO CREATE SLIDE  
SETS ON THE SEPTEMBER 19, 1985  
MEXICO EARTHQUAKE

**MEXICO - SET III:  
EXAMPLES OF DAMAGE TO  
BUILDINGS IN MEXICO CITY**

FEBRUARY 1987

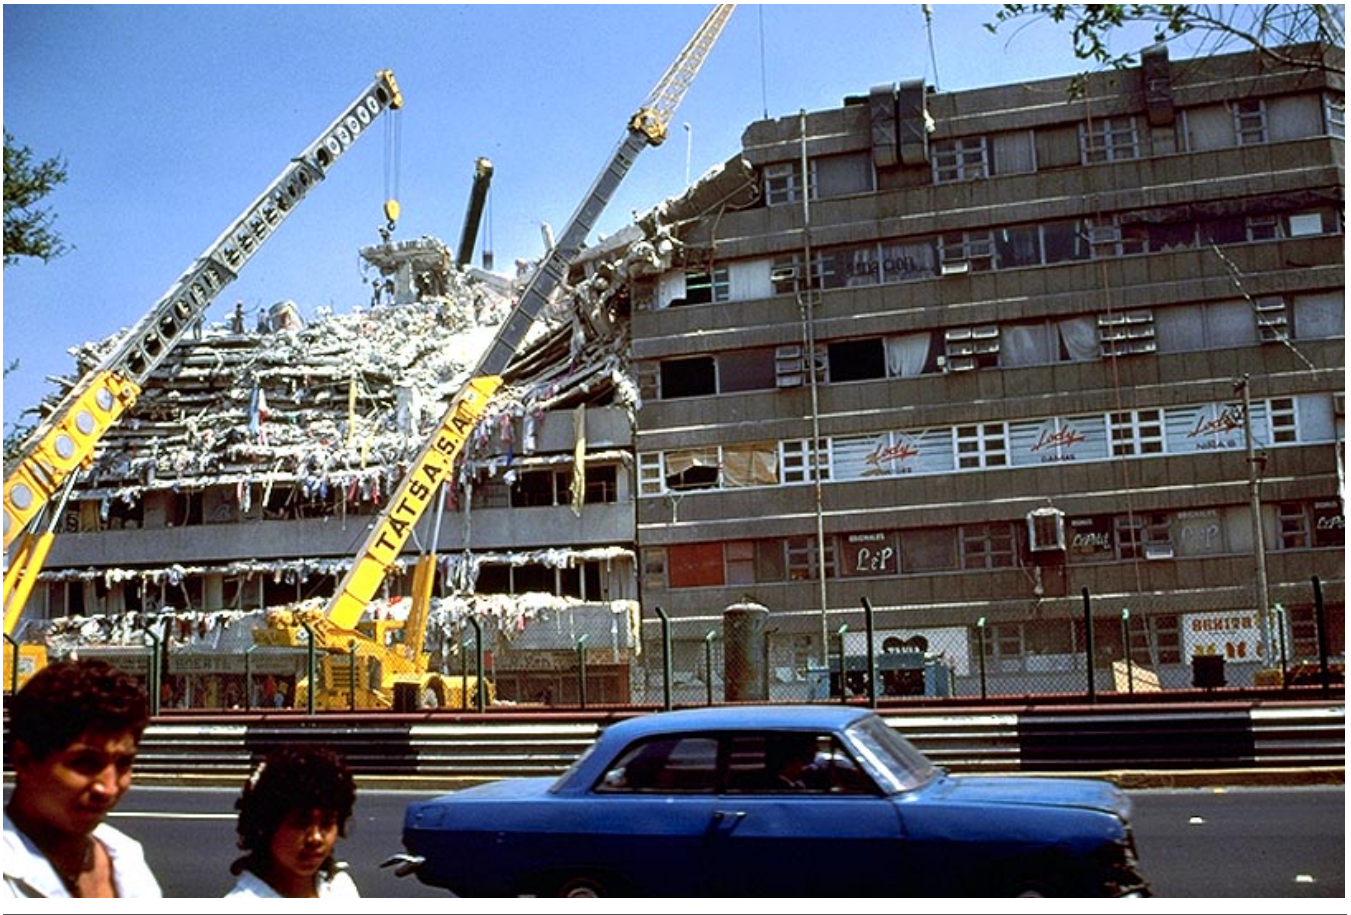
Slide #19

## Garment District

Pancake type collapse resulting in severe loss of life.

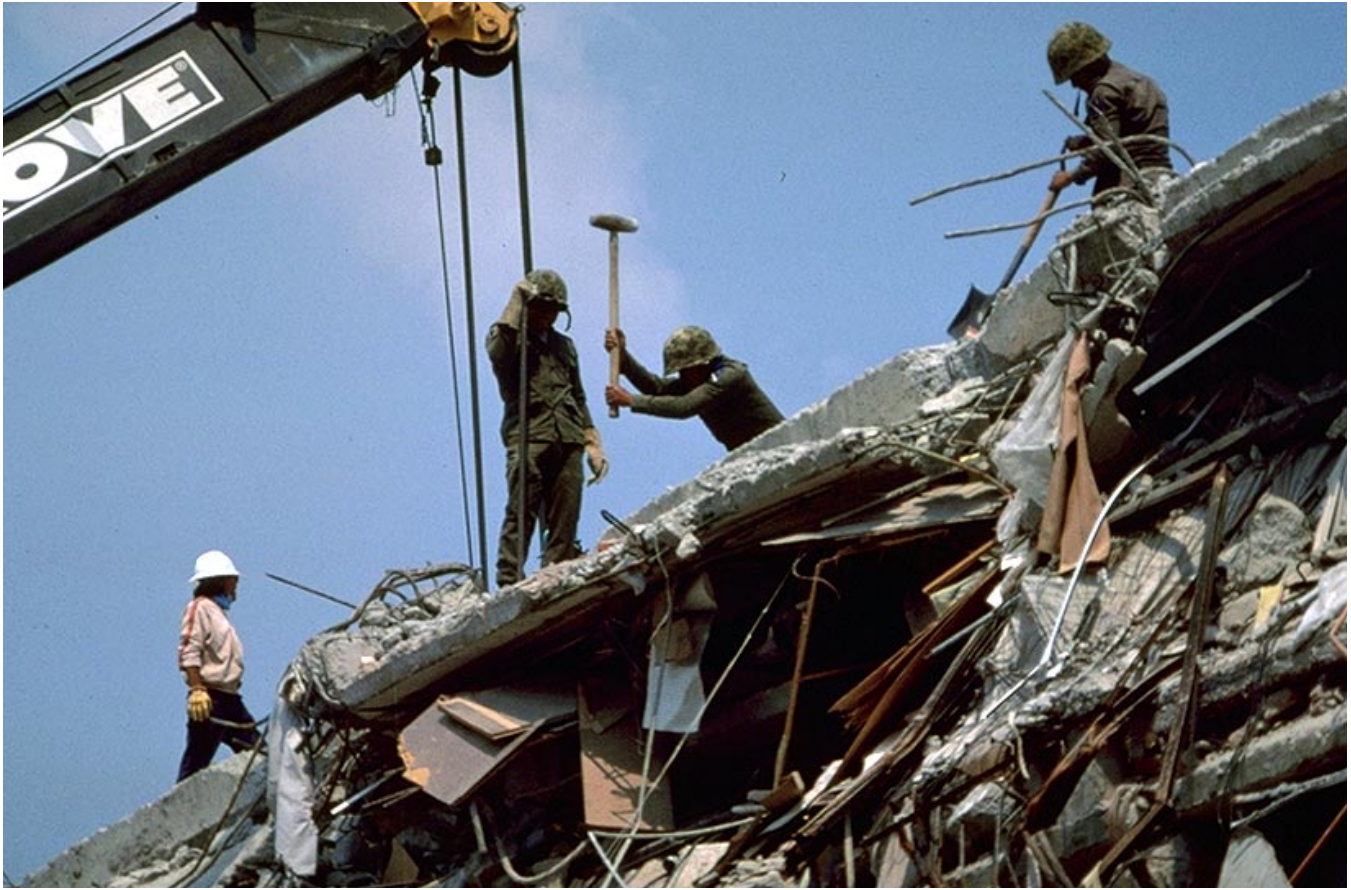
Slide #20

## Garment District

See slide #19. Volunteer and military workers worked around the clock with small equipment to remove building.
