San José del Palmar Chocó Earthquake –  
August 10, 2026  
Effects in Cali and the Cauca Valley  
Department– Colombia  
Report  
V. 3.0 16/08/2026

Ana Maria Parra Bastidas, PhD, MSc, PE in Colombia EIT in California  
Projects Engineer  
Carlos H. Parra y Asociados S.A.S.

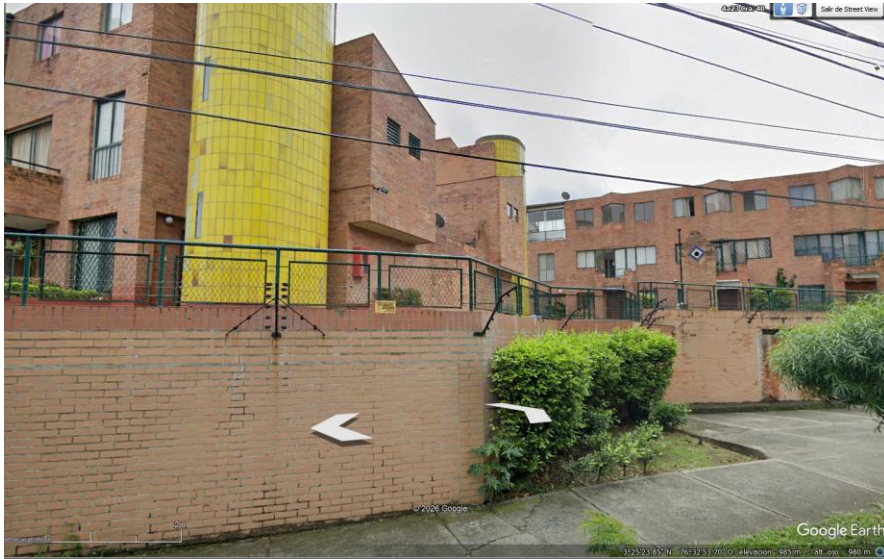
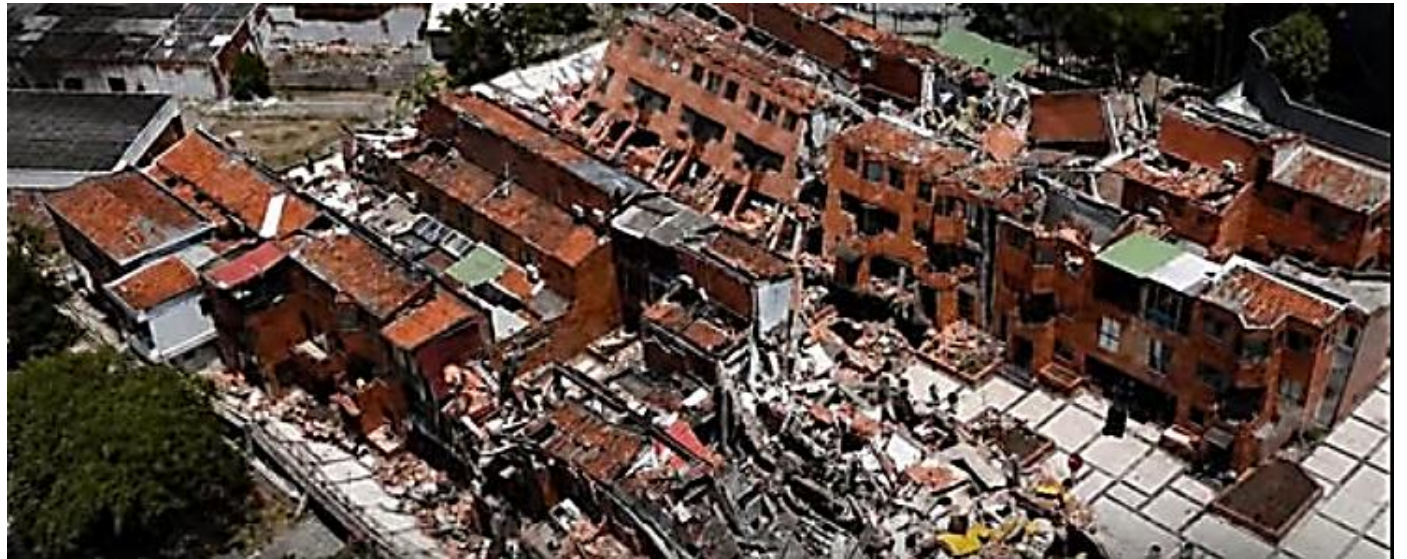
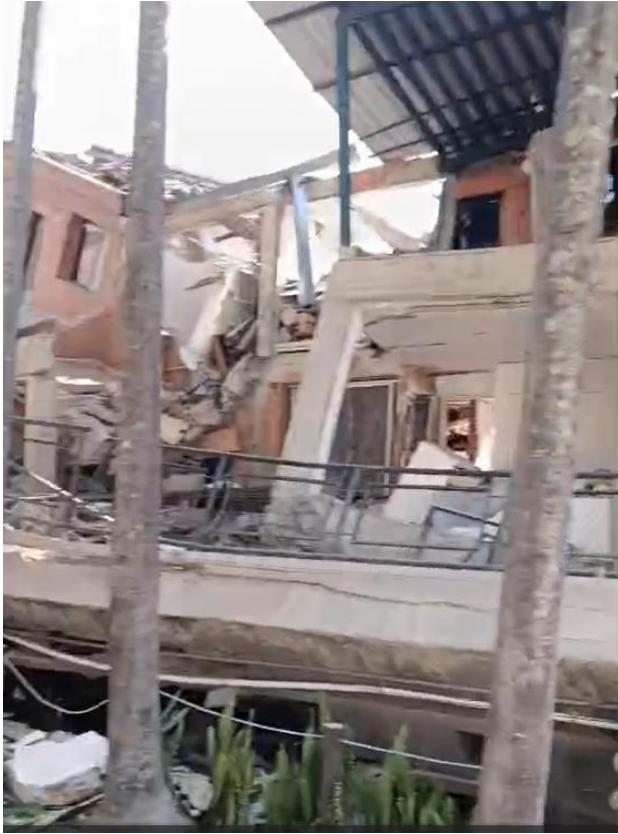
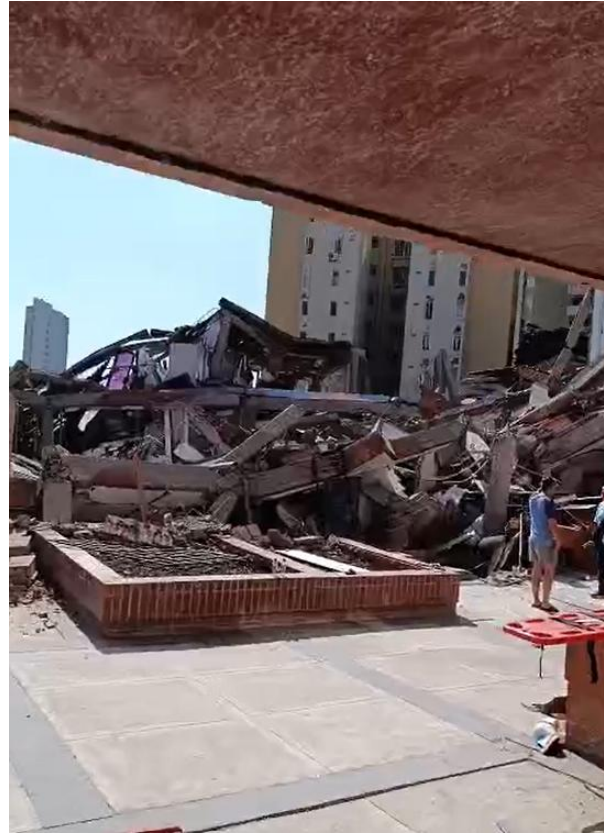
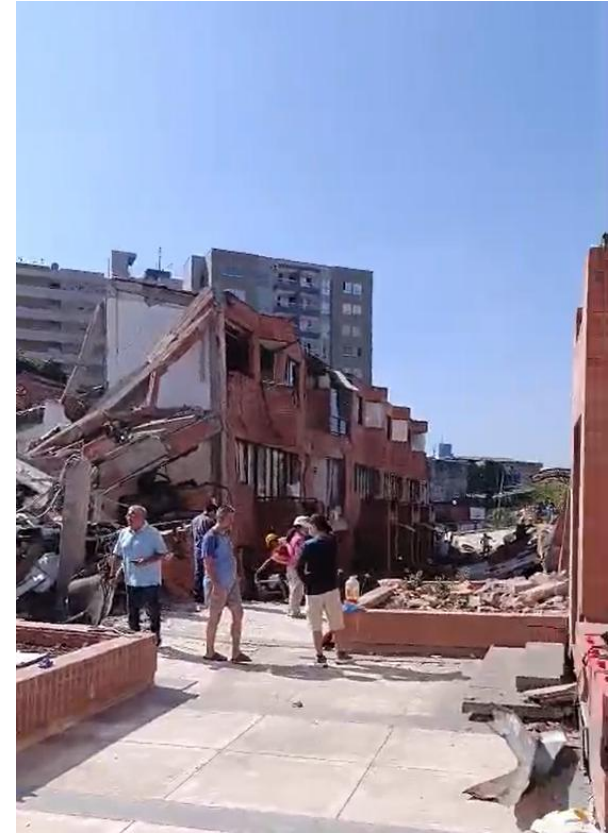
## 24. Pio XII Calle 4A Cra. 40 barrio el Lido

| Building | Microzona | Vibration period of the soil tank according to microzone |
|---|---|---|
| 24. Pio XII Calle 4A Cra. 40 barrio el Lido | 3 Foothill deposits | 0.6 a 1.20 seg. Average 0.95 seg. |

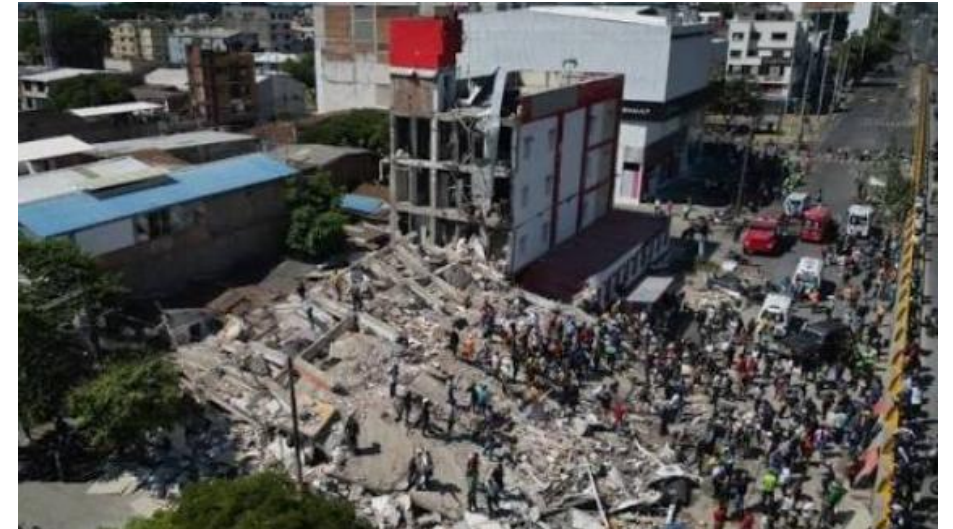
# 9. Motel Molino Rojo Calle 10 #38-21 Barrio Olímpico, 5 stories

| Building | Microzona | Vibration period of the soil tank according to microzone |
|---|---|---|
| 9. Motel Molino Rojo Calle 10 #38-21 Barrio Olímpico | 4C Cañaveralejo Alluvial fan | 1.5 a 2.0 seg. Average 1.8 seg. |

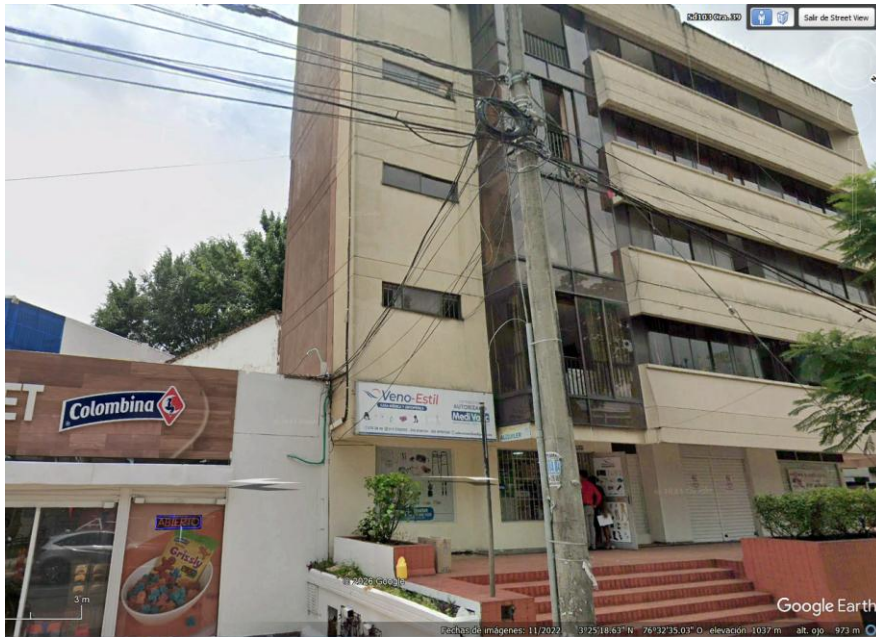
# 11. Edificio Marisol Carrera 39 # 5D-09 barrio Tequendama, 6 stories

| Building | Microzona | Vibration period of the soil tank according to microzone |
|---|---|---|
| 11. Edificio Marisol Carrera 39 # 5D-09 barrio Tequendama | 4C Cañaveralejo Alluvial fan | 1.5 a 2.0 seg. Average 1.8 seg. |

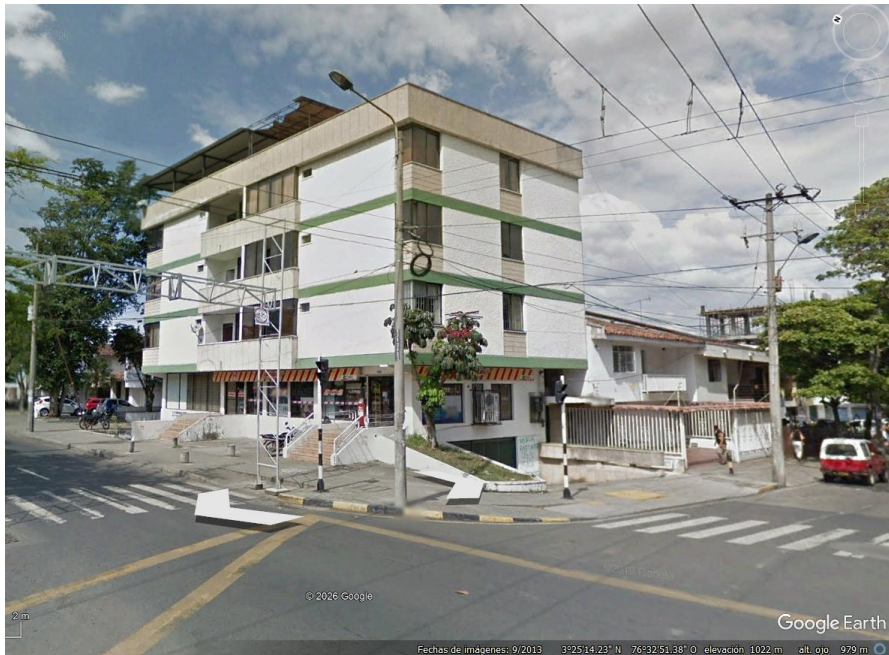
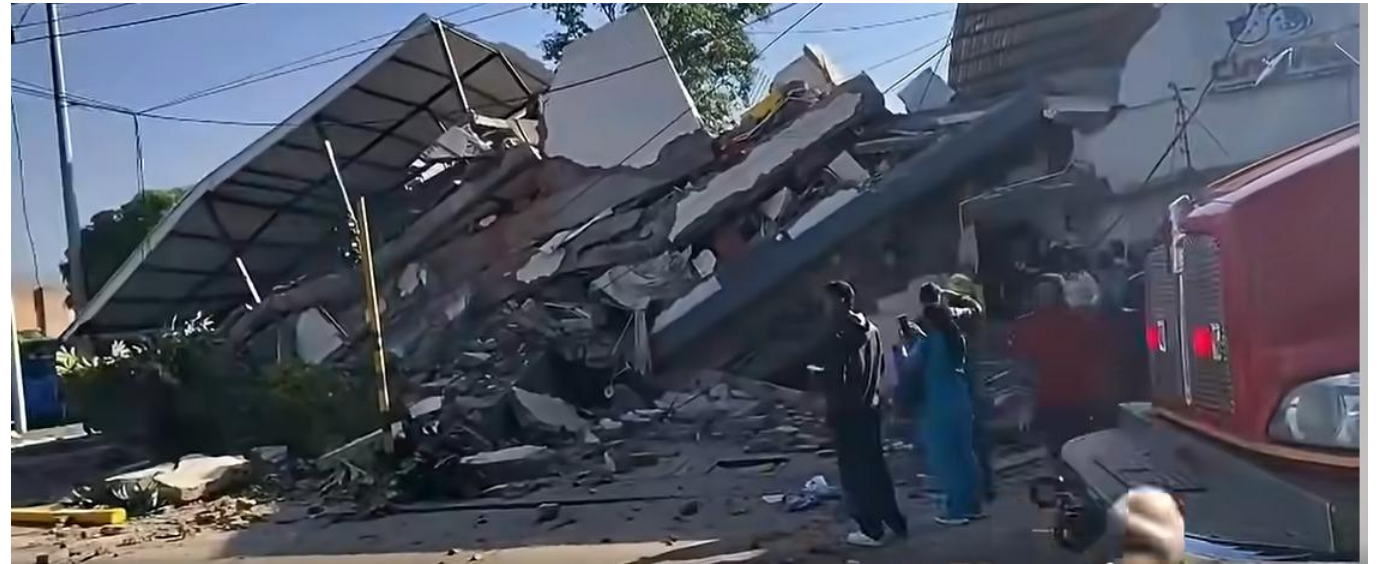
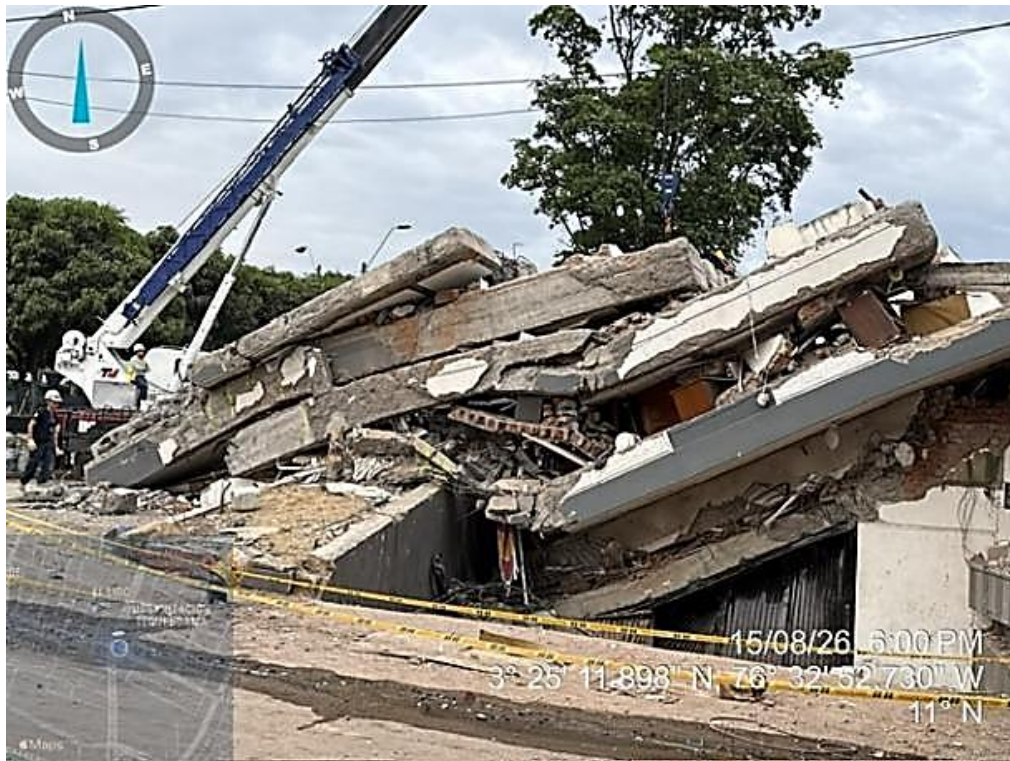
# 13. Calle 5 con 44 edificio local Drogas La Rebaja barrio El Lido, 4 stories

| Building | Microzona | Vibration period of the soil tank according to microzone |
|---|---|---|
| 13. Calle 5 con 44 edificio local Drogas La Rebaja barrio El Lido | 4C Cañaveralejo Alluvial fan and less than 200 m from microzone 3 Foothill deposits | 1.5 a 2.0 seg. Average 1.8 seg. |

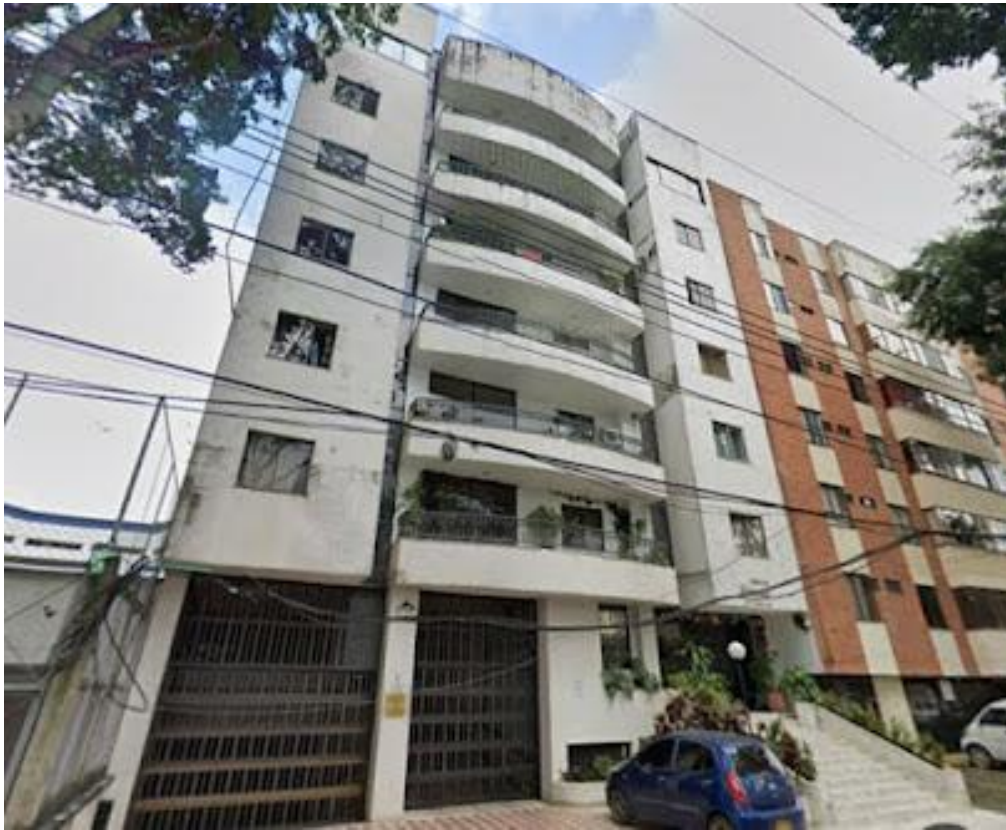
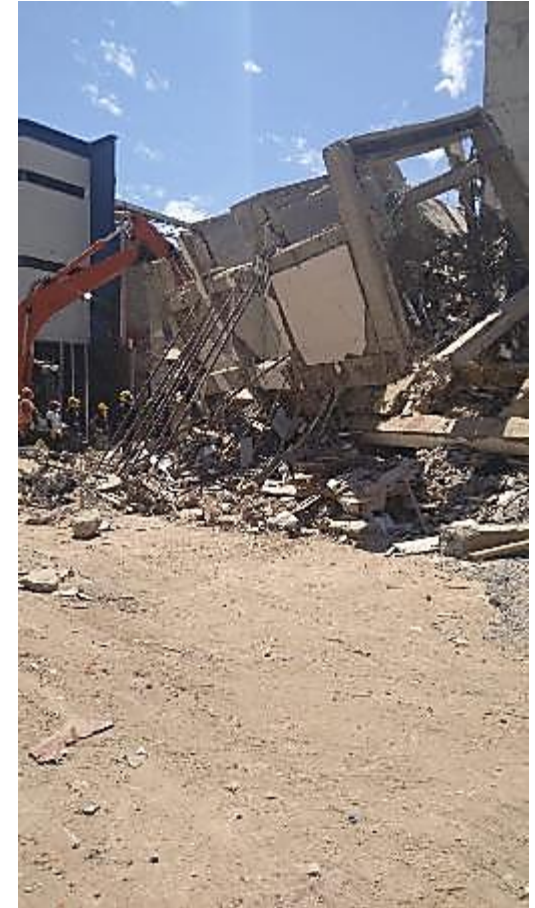
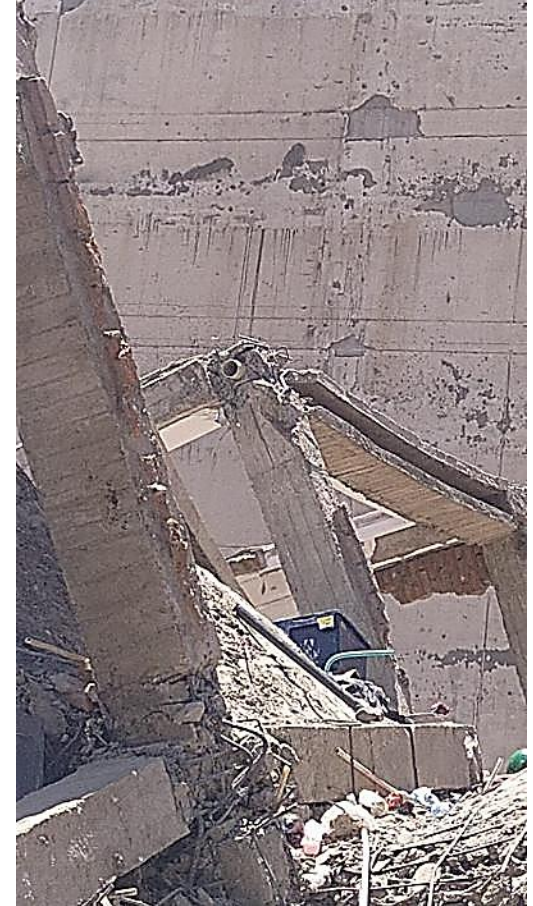
# 15. Carrera 44 con Calle 9A Edificio Vanessa barrio Los Cámbulos

| Building | Microzona | Vibration period of the soil tank according to microzone |
|---|---|---|
| 15. Carrera 44 con Calle 9A Edificio Vanessa barrio Los Cámbulos | 4C Cañaveralejo Alluvial fan | 1.5 a 2.0 seg. Average 1.8 seg. |

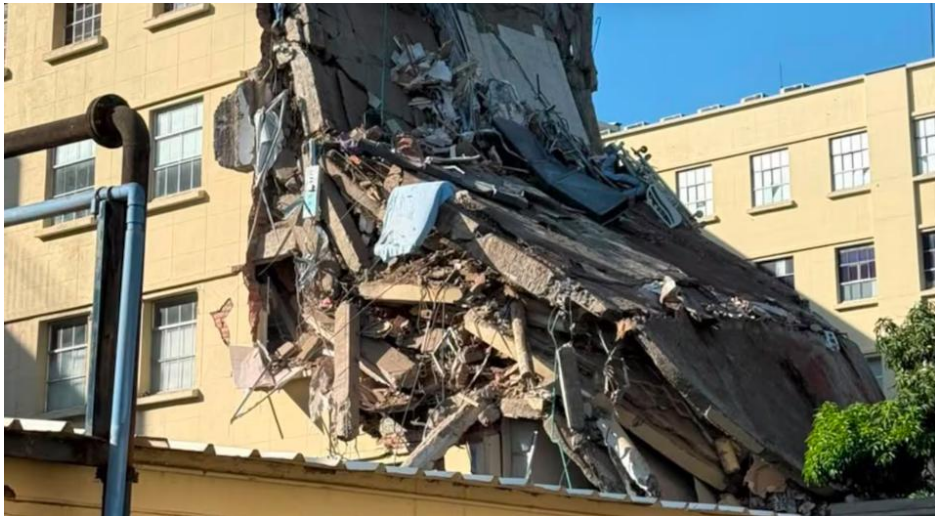
# Hospital Universitario del Valle (HUV)

- Four large medical centers have serious structural failures(<https://www.cali.gov.co/boletines/publicaciones/193598/emergencias-y-medidas-por-terremoto-en-cali/>):
  1. Hospital Universitario del Valle (HUV)
  2. Clínica Nuestra
  3. Clínica DESSA
  4. Clínica Colombia

- This hospital was retrofited before the San José del Palmar Chocó Earthquake – August 10, 2026 EQ.

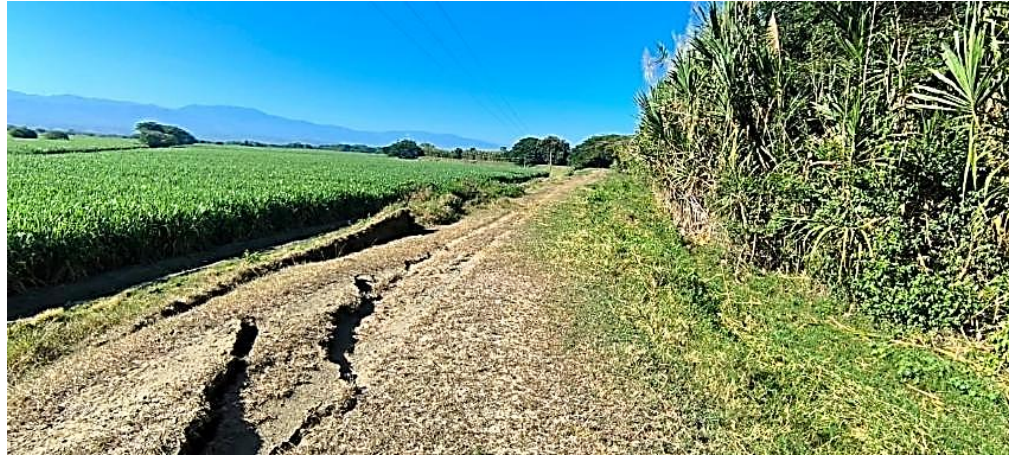
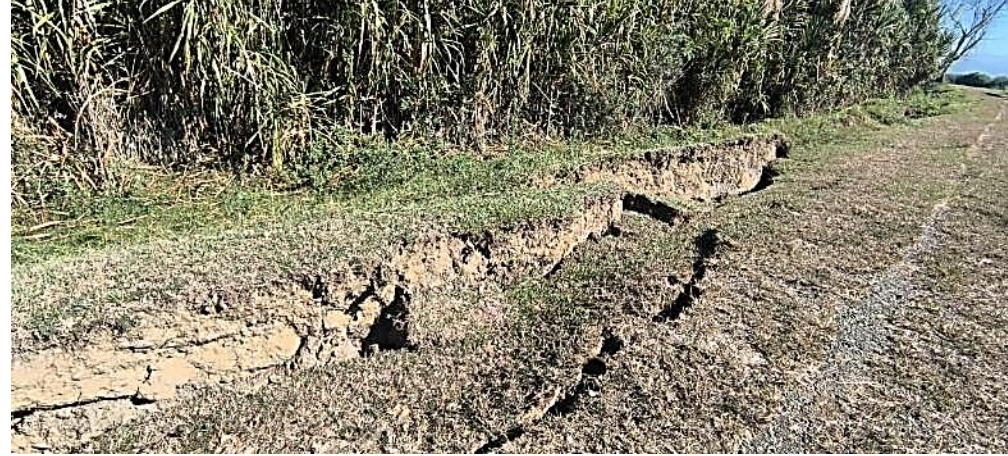
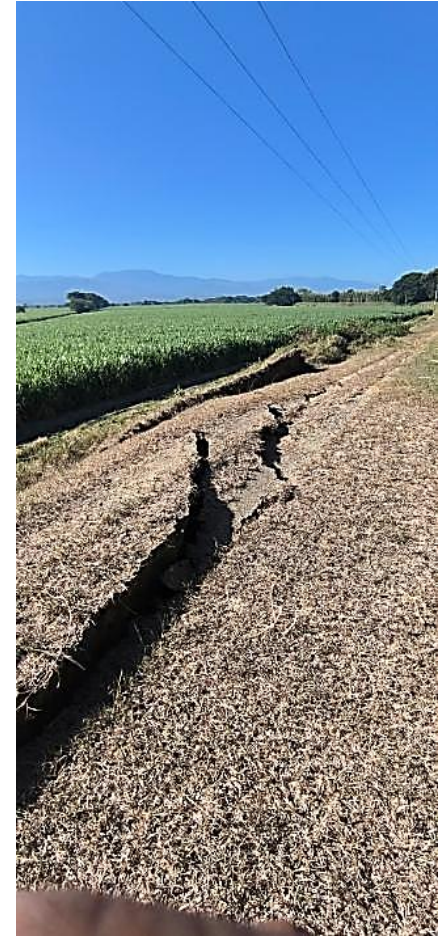
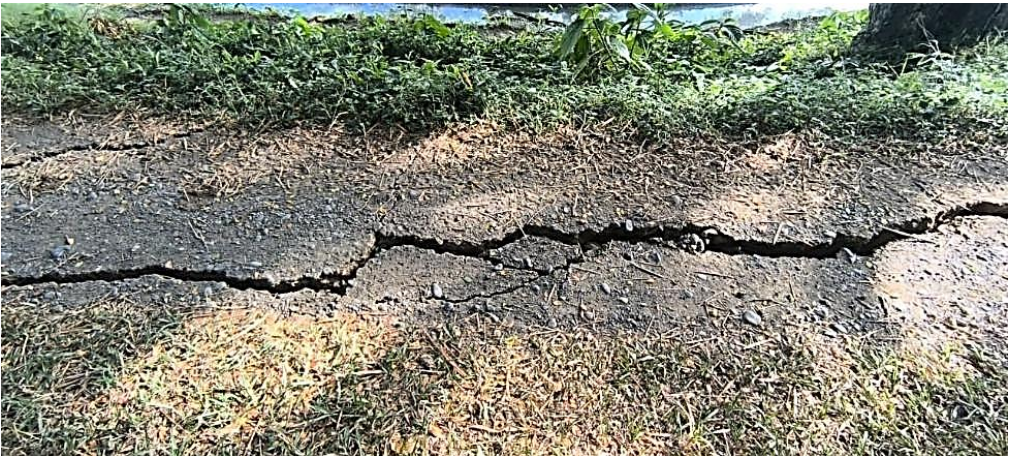
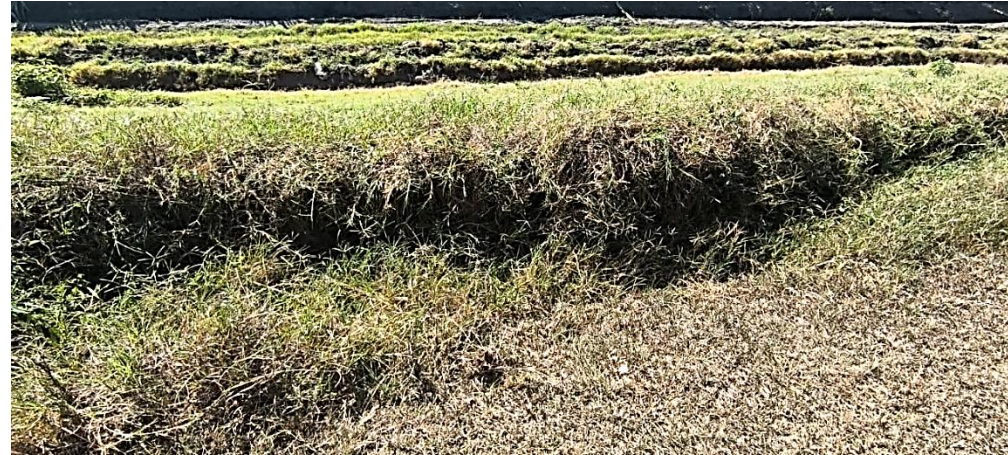
Levee cracks due to liquefaction at corregimiento El Overo, Bugalagrande, Cauca Valley

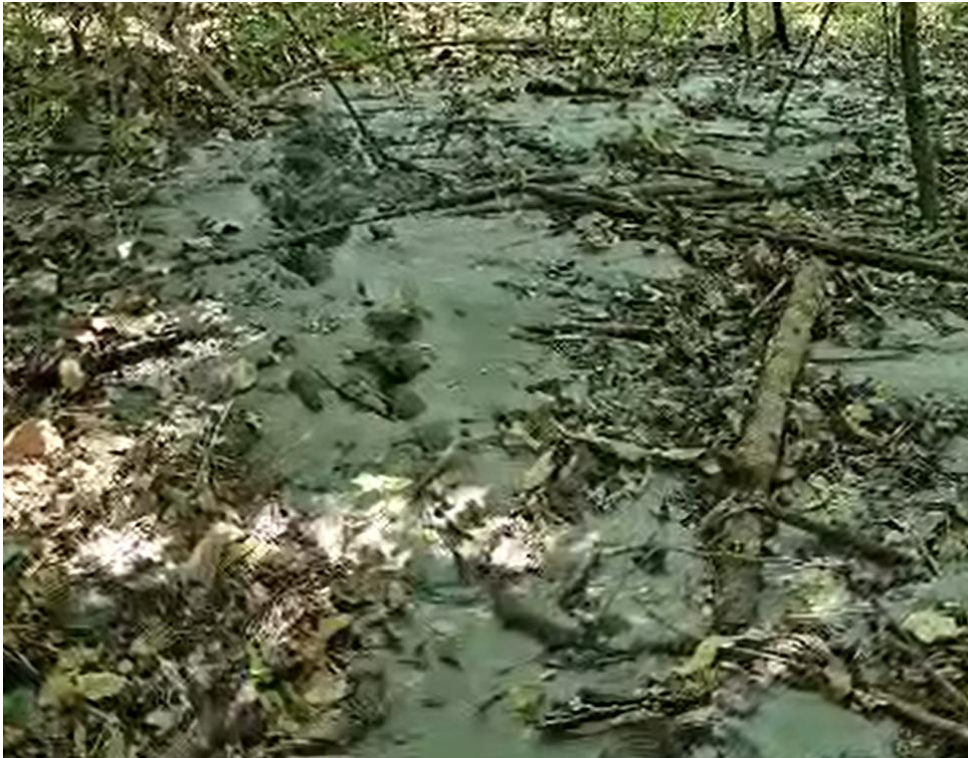
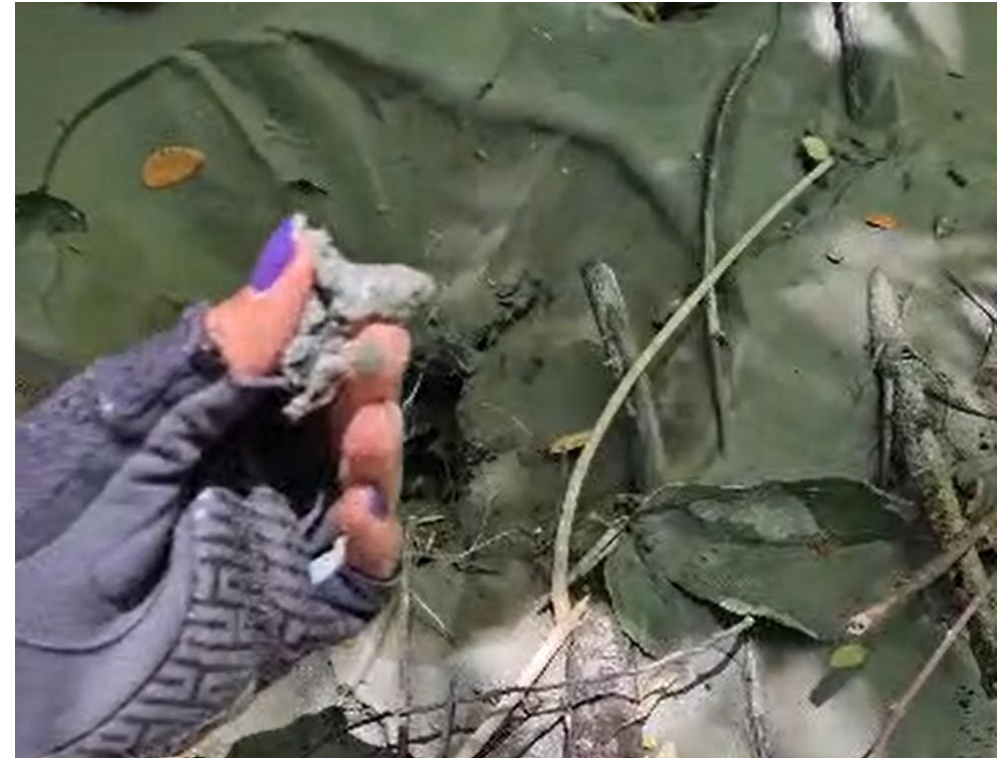
Sand boil, La Victoria, Cauca Valley

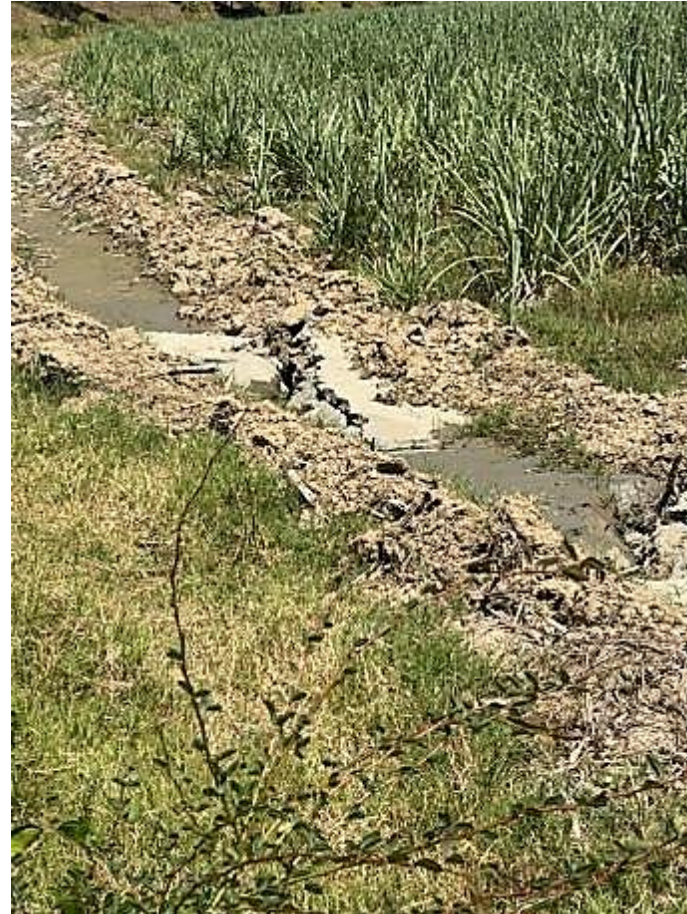
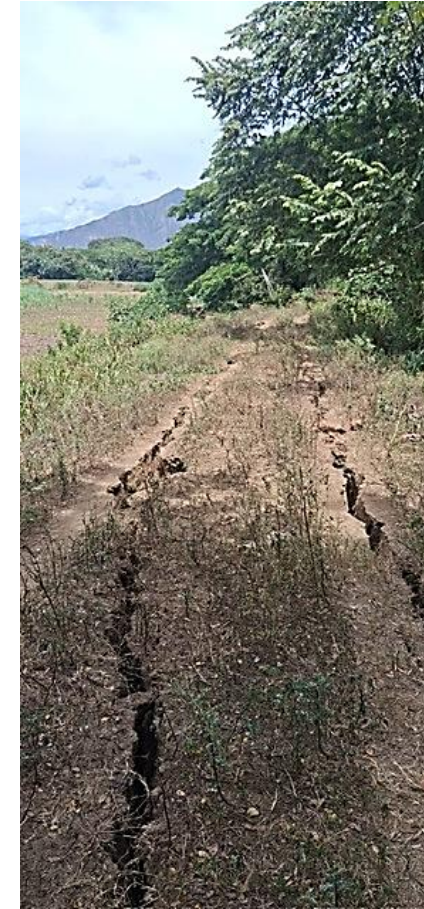
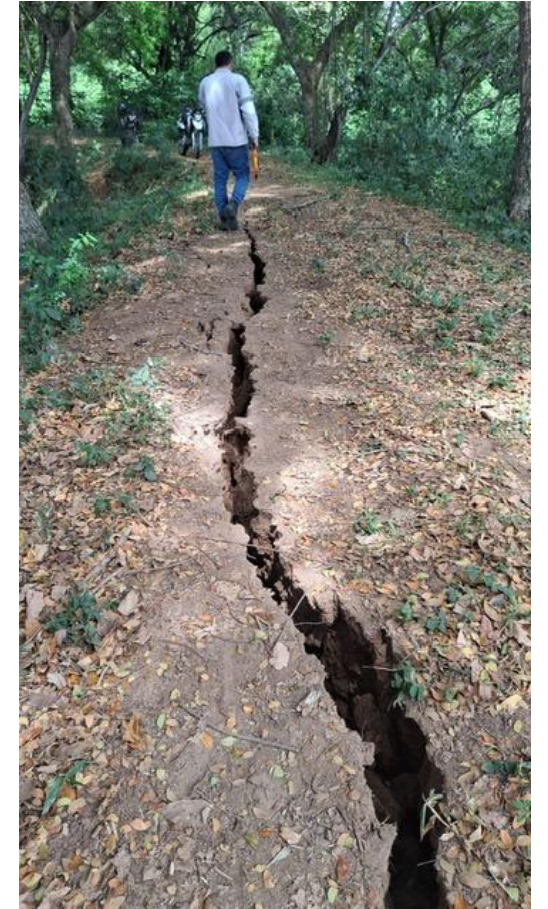
Sand boil, Bolivar, Cauca Valley

Levee cracks due to liquefaction Bolivar, Cauca Valley

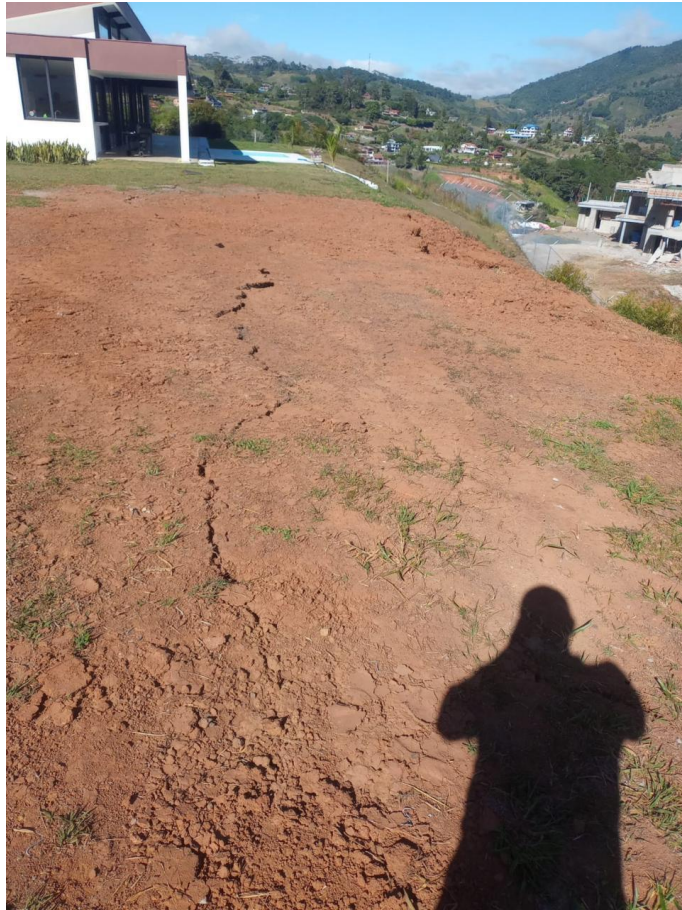
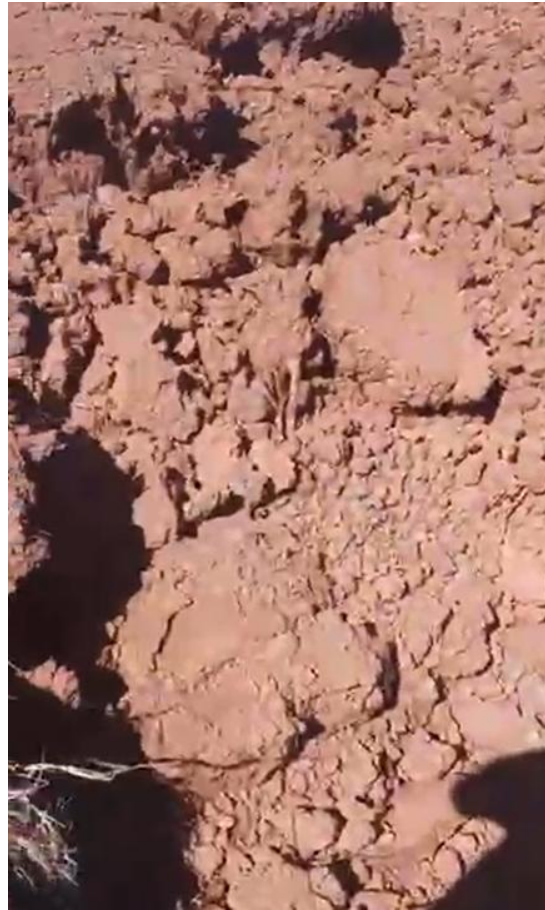
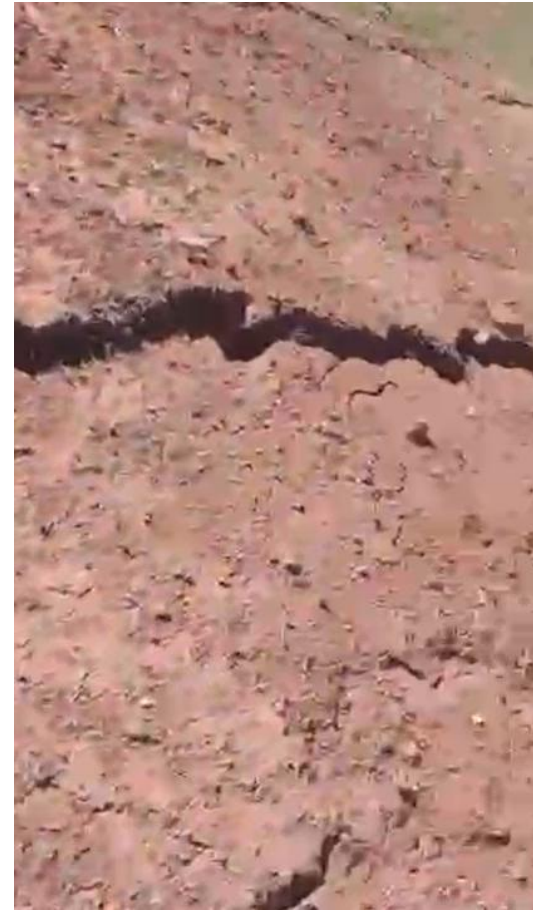
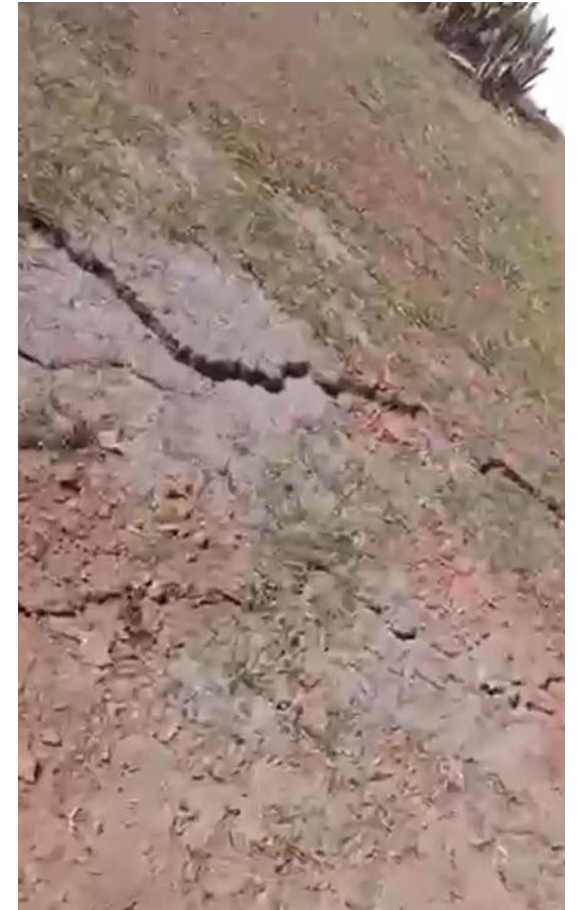
Restrepo, Cauca Valley

# Settlement and cracks due to shaking
