# Virtual Earthquake Reconnaissance Team (VERT): Phase 1 Response to M7.0 Izmir, Turkey October 30, 2020

**By:** Yolanda Alberto, Jaskanwal Chhabra, Erica C. Fisher, Manny Hakhamaneshi, Brisid Isufi, Amory Martin, Tonatiuh Rodriguez-Nikl, Sissy Nikolaou, Deniz Ay, Elmon Toraman, Mehmet Unal, Kai Wu

# Topic: Soft story buildings

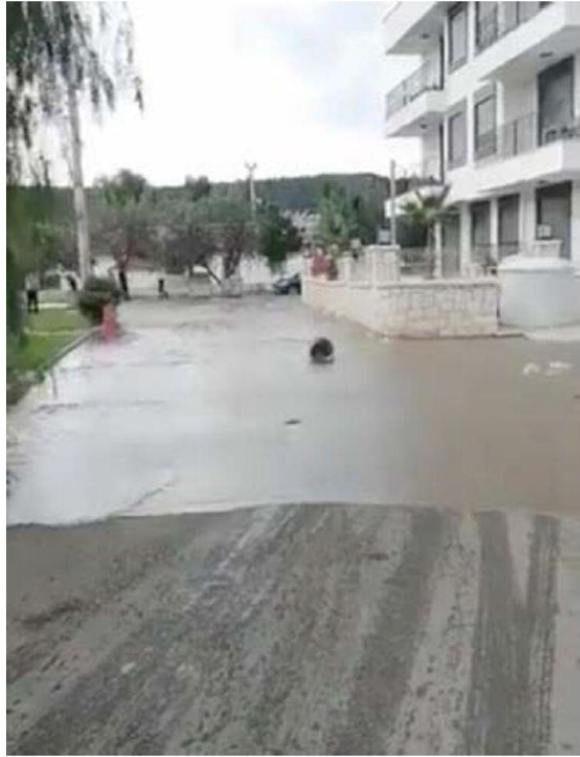
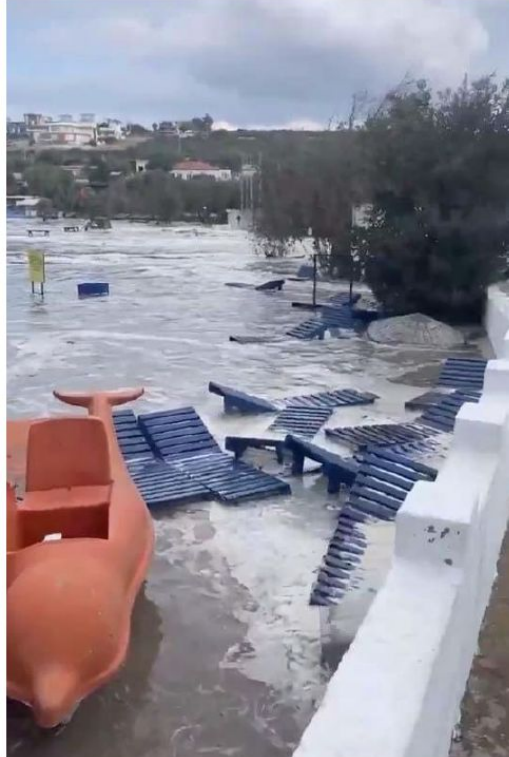
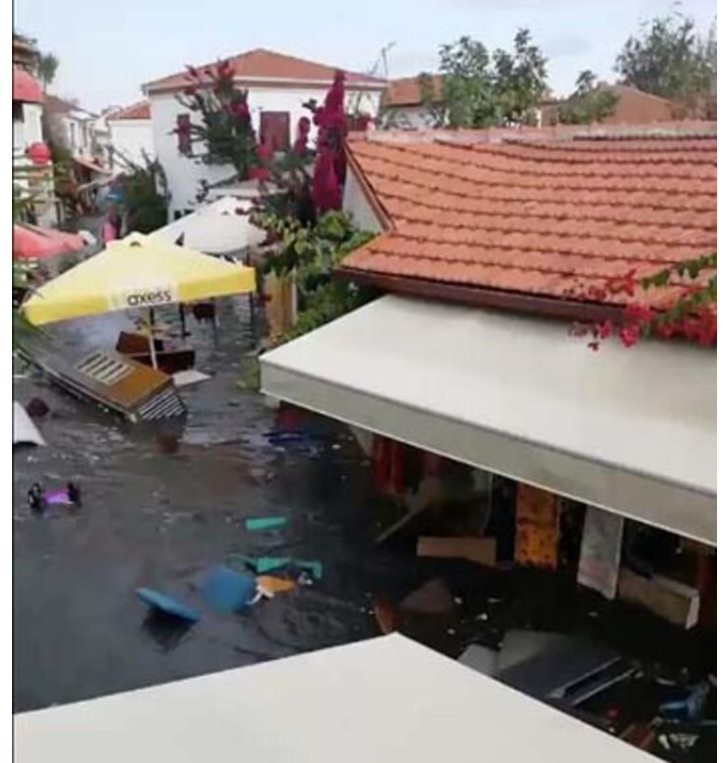
Tsunami damage in Seferihisar, Izmir<sup>4</sup>

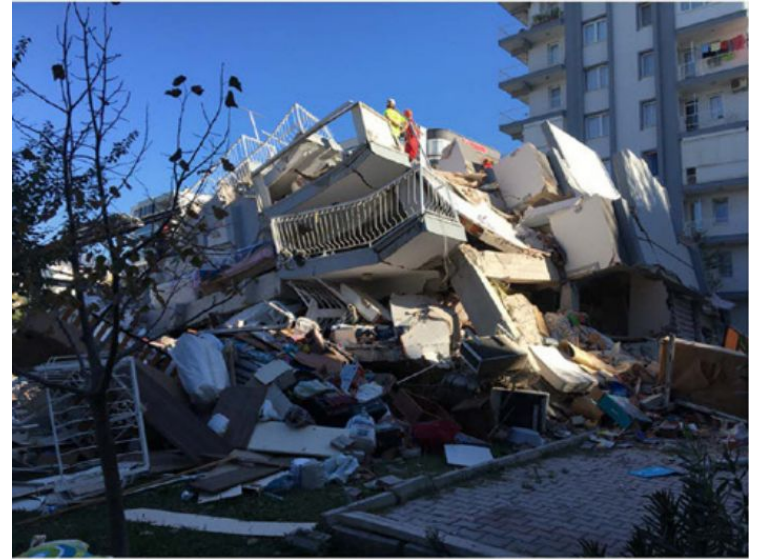
- At least **20 buildings collapsed** or were severely damaged in Izmir, Turkey.<sup>1</sup>
- Most of the affected buildings are **RC frame buildings with 8 - 9 stories**.<sup>2</sup> Most of the collapsed buildings were **built before year 2000**.<sup>3</sup>
- Preliminary observations indicate that causes of collapse include **soft story mechanisms, irregularities, quality of materials and detailing of reinforcement**.<sup>[2,3]</sup>

Collapsed building<sup>2</sup>

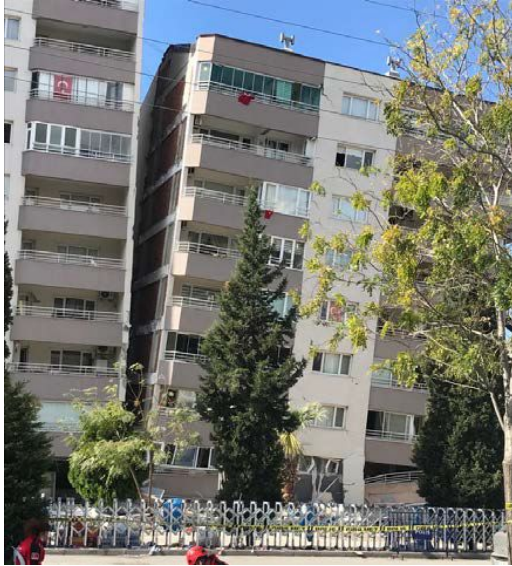
Failure of lower stories, ten story building <sup>3</sup>

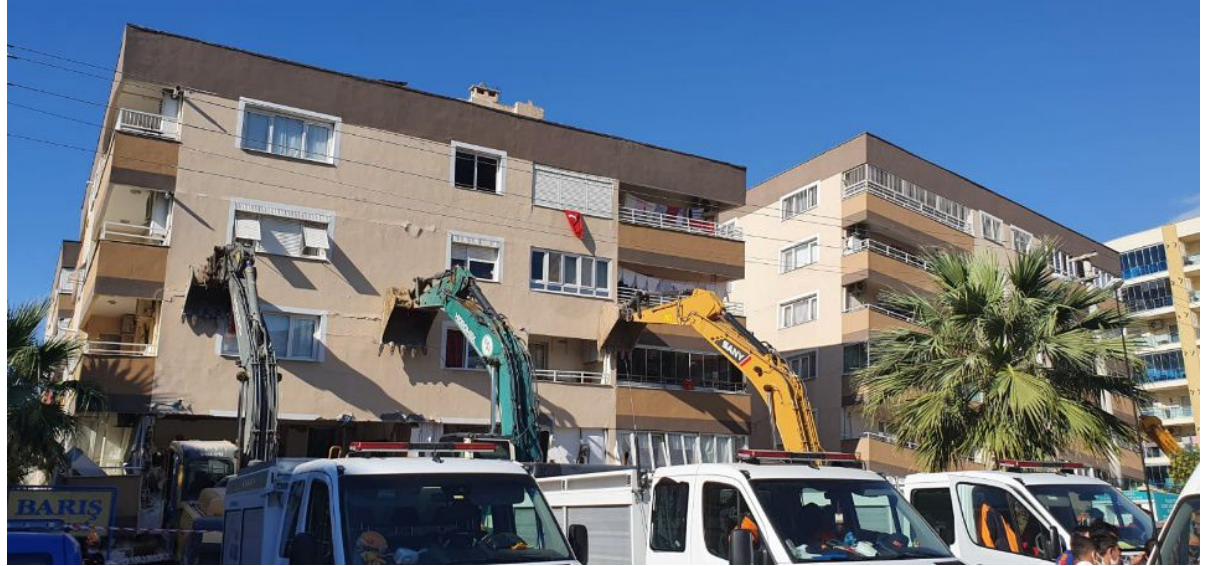
Failure of lower stories in an 8 story building <sup>3</sup>

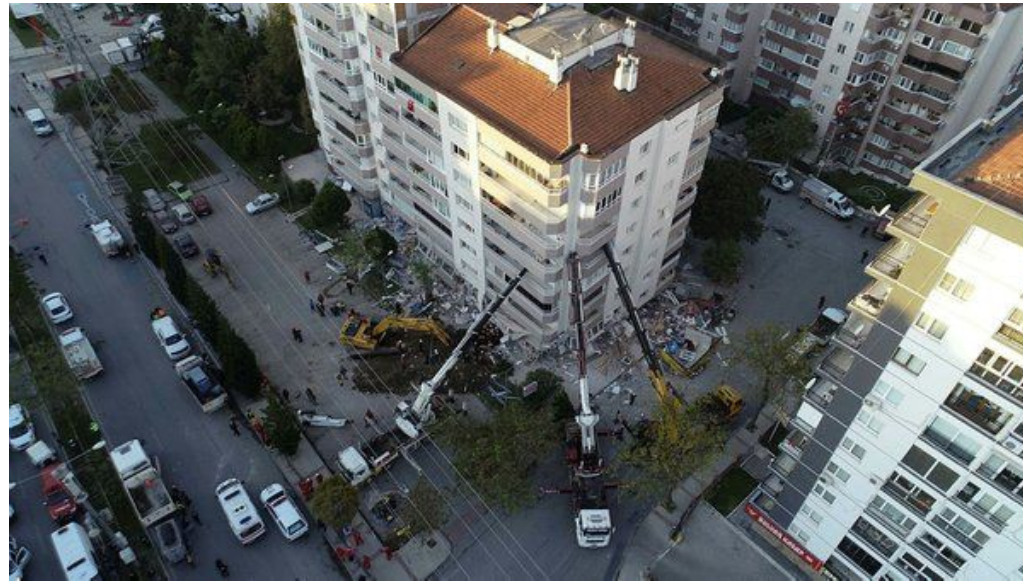
Failure of first 3 floors of a building in Demirkent Site in Bayraklı district<sup>4</sup>

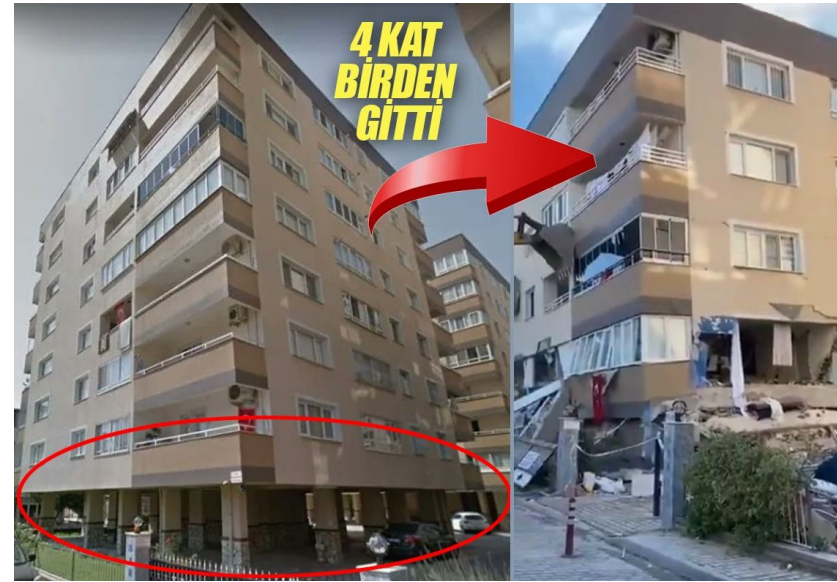
Collapse of two floors on the ground floor of the 8-storey Peace Site in Balled support Bayraklı<sup>5,6</sup>

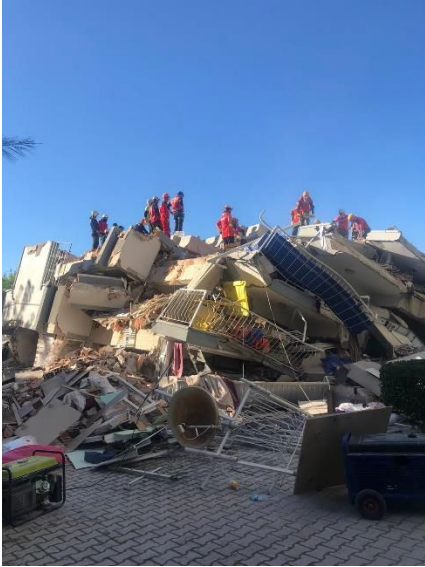
Pancake type collapse<sup>7</sup>

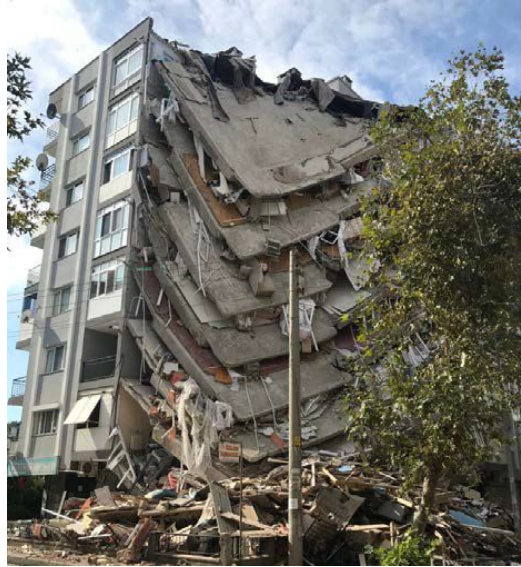
Partial collapse, pancake type, 8 story building<sup>3</sup>

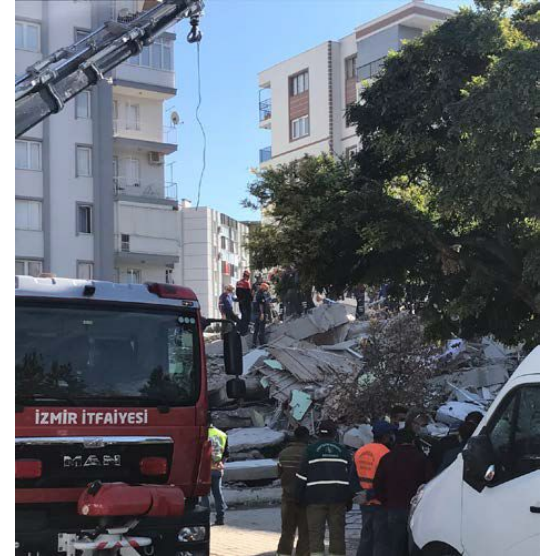
Collapsed eight story building<sup>3</sup>

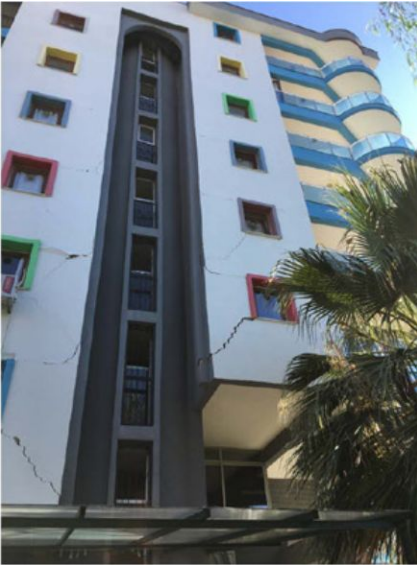
Damage to infills <sup>2</sup>

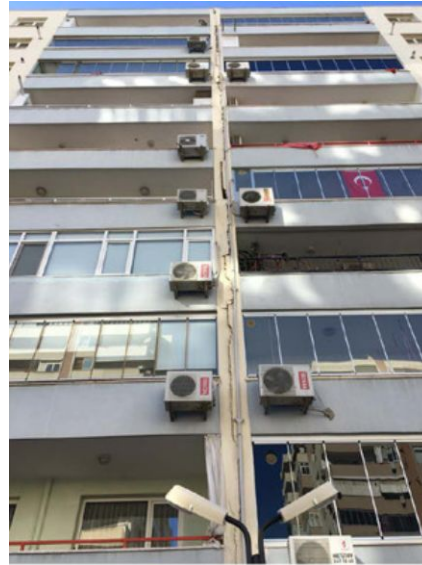
Pounding related damage <sup>2</sup>

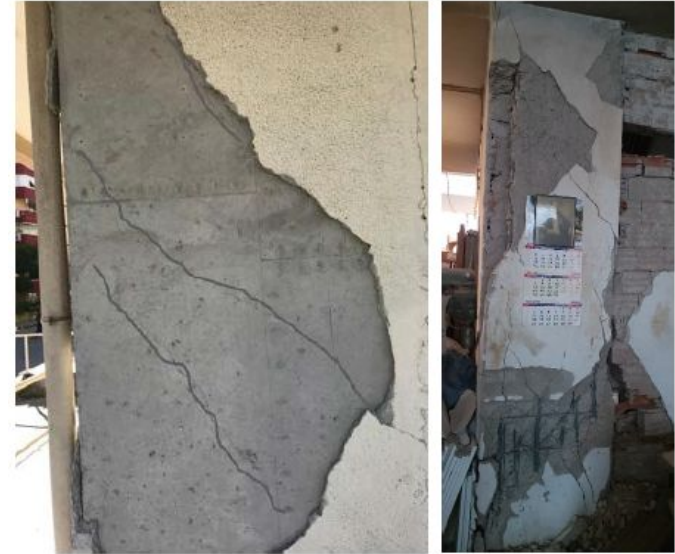
RC Column shear cracks <sup>3</sup>

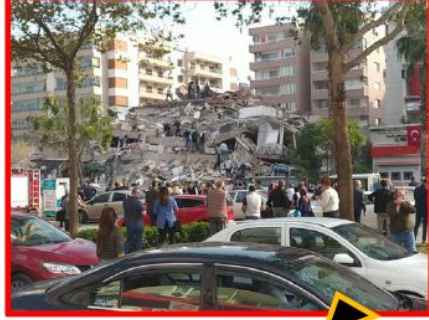
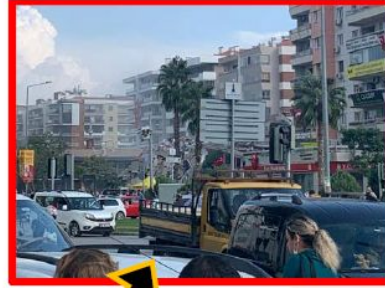
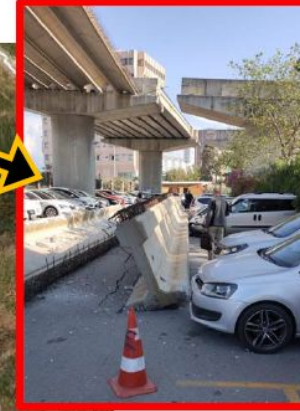
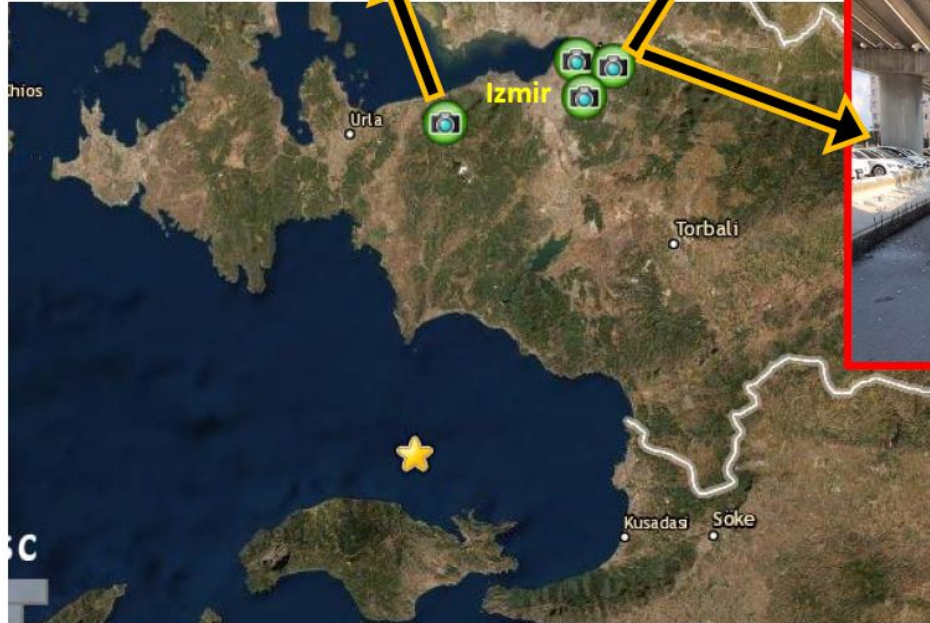
Other damage patterns and locations<sup>8</sup>

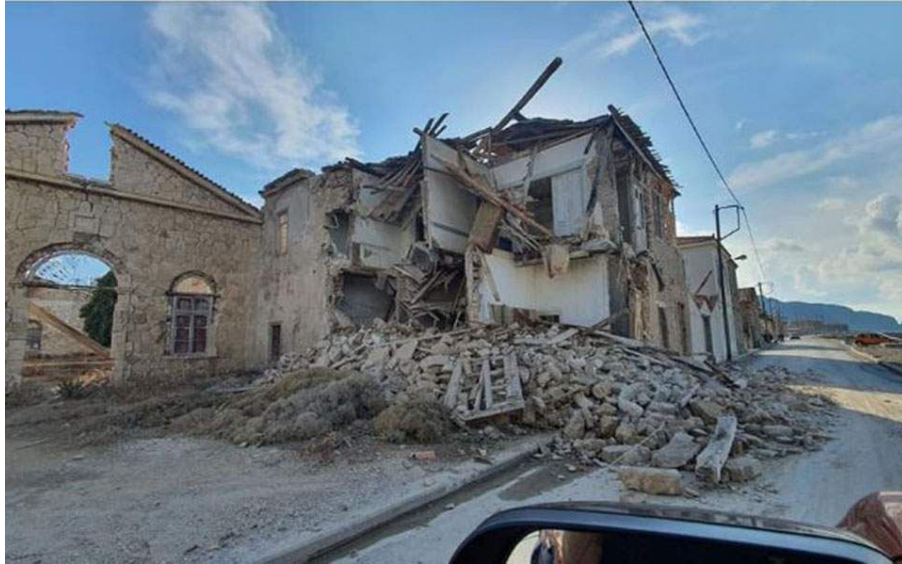
- Structural damage mostly of old buildings in Pythagorio, Karlovasi and Vathy <sup>1, 9, 10</sup>;
- A church in Karlovasi partially collapsed <sup>8,9,11</sup>.
- Port damage and tsunami-induced floor

Collapsed old building in Samos (Greece)<sup>9</sup>

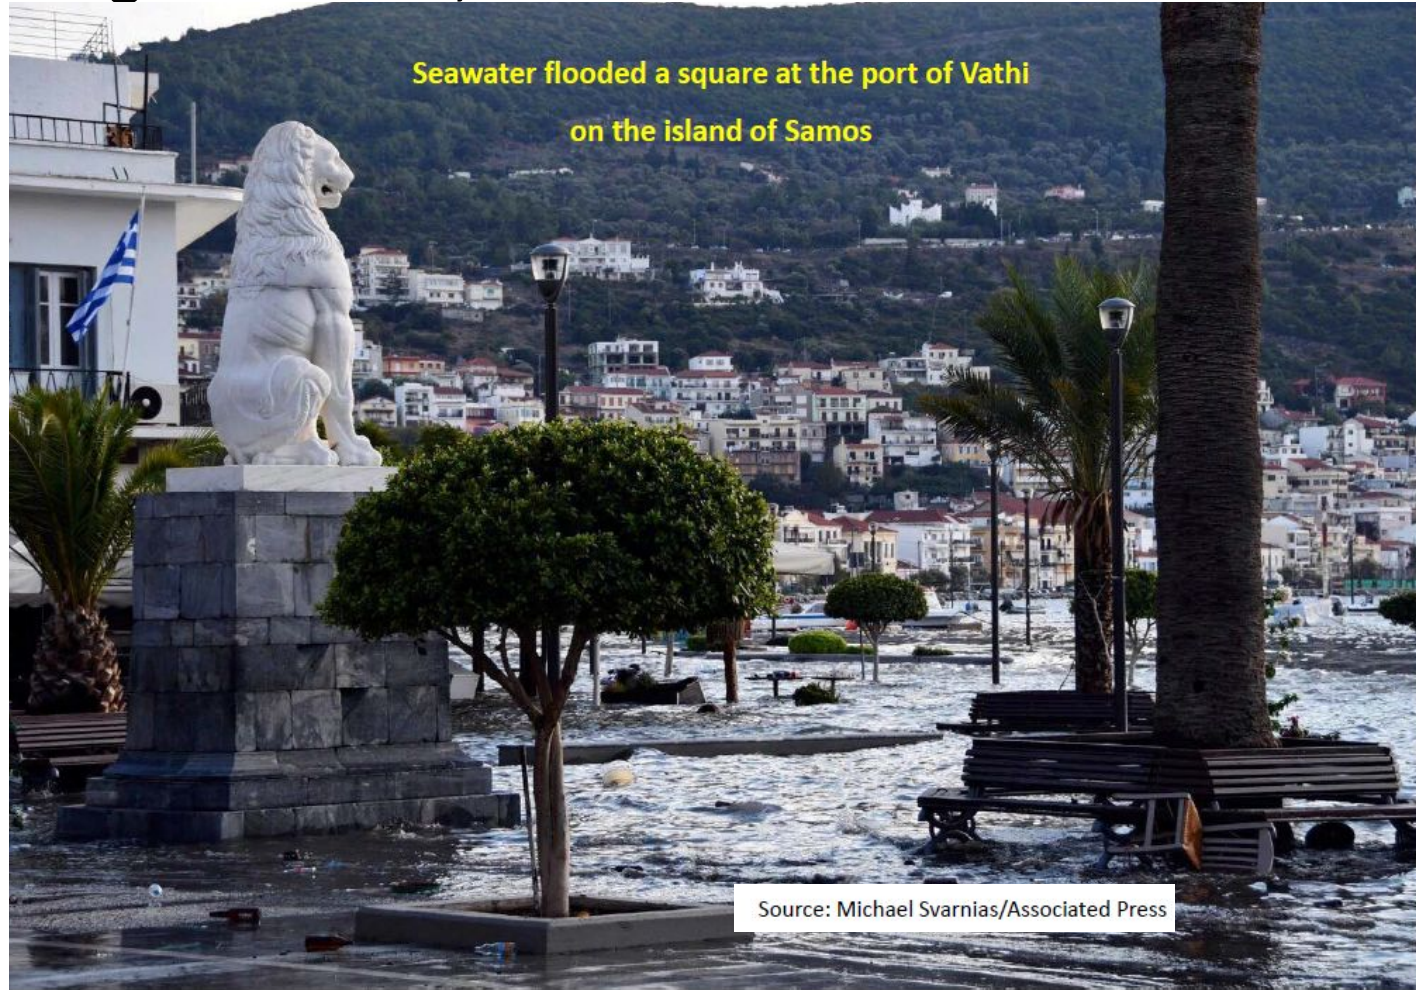
- Port of Vathi:  
Flood <sup>8</sup>

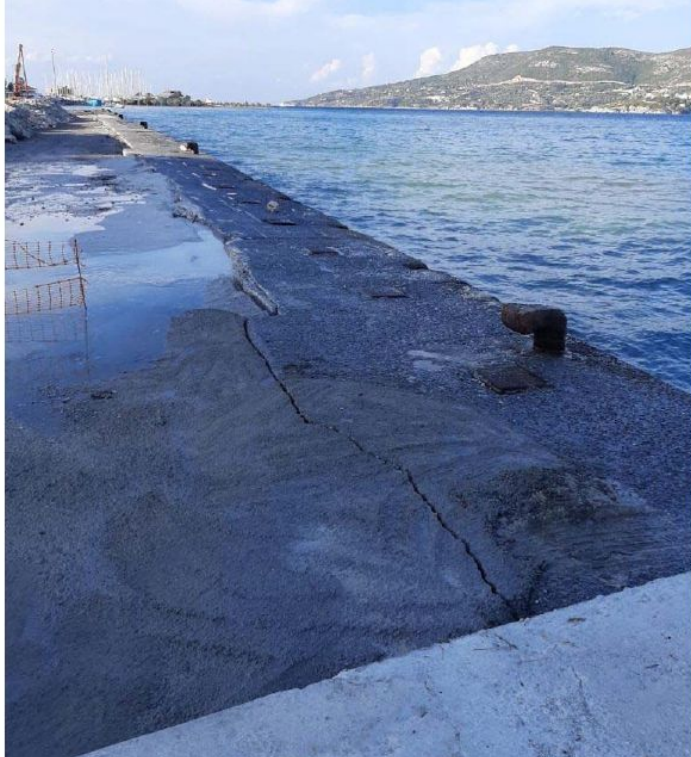
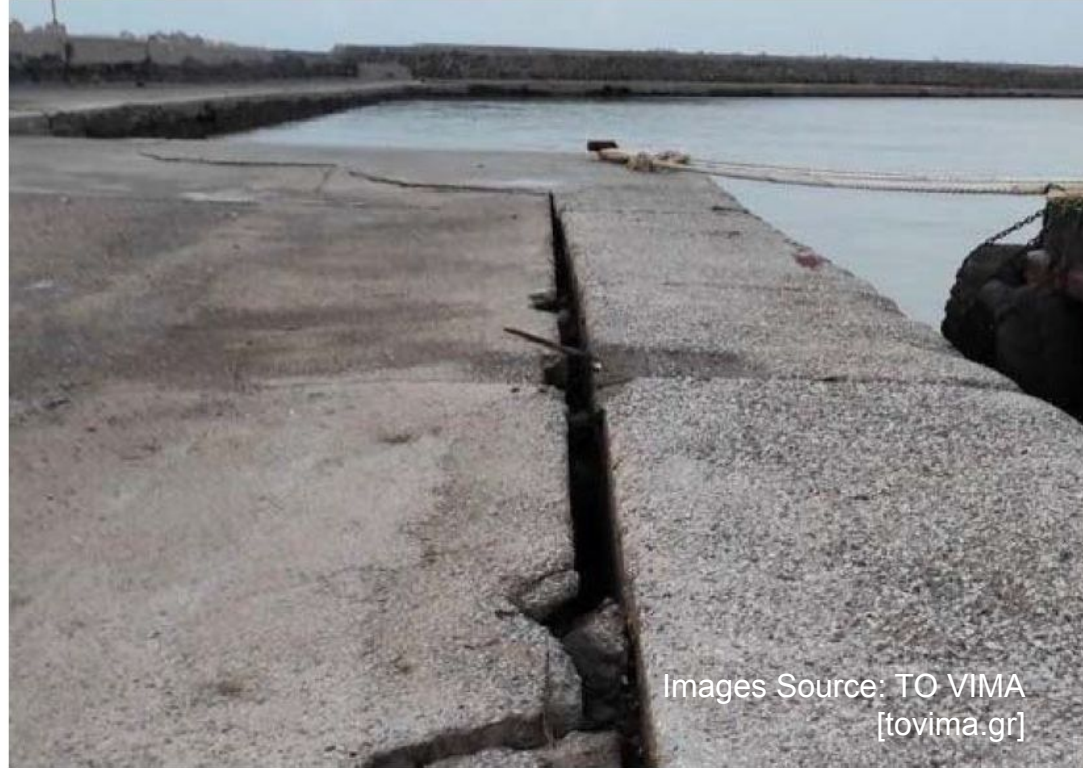
- Port of Vathi: Lateral Movement, Potential Liquefaction-Induced Spread <sup>8</sup>

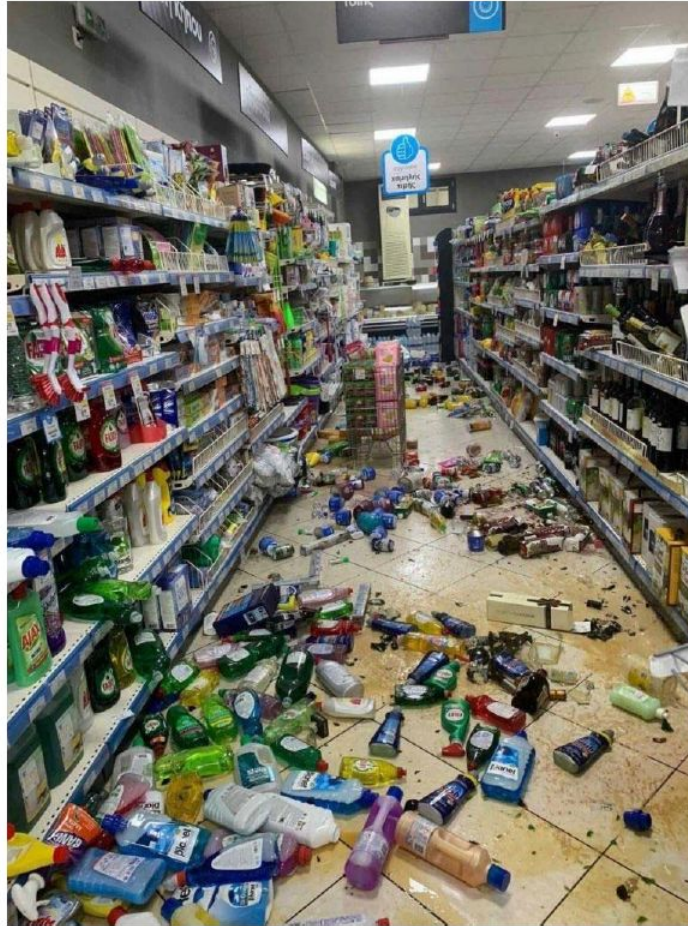
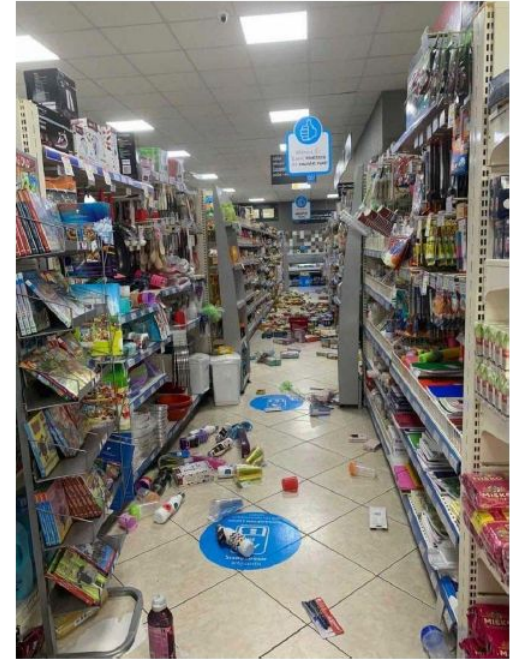
- Typical Non-Structural Damage in Samos supermarket <sup>8</sup>

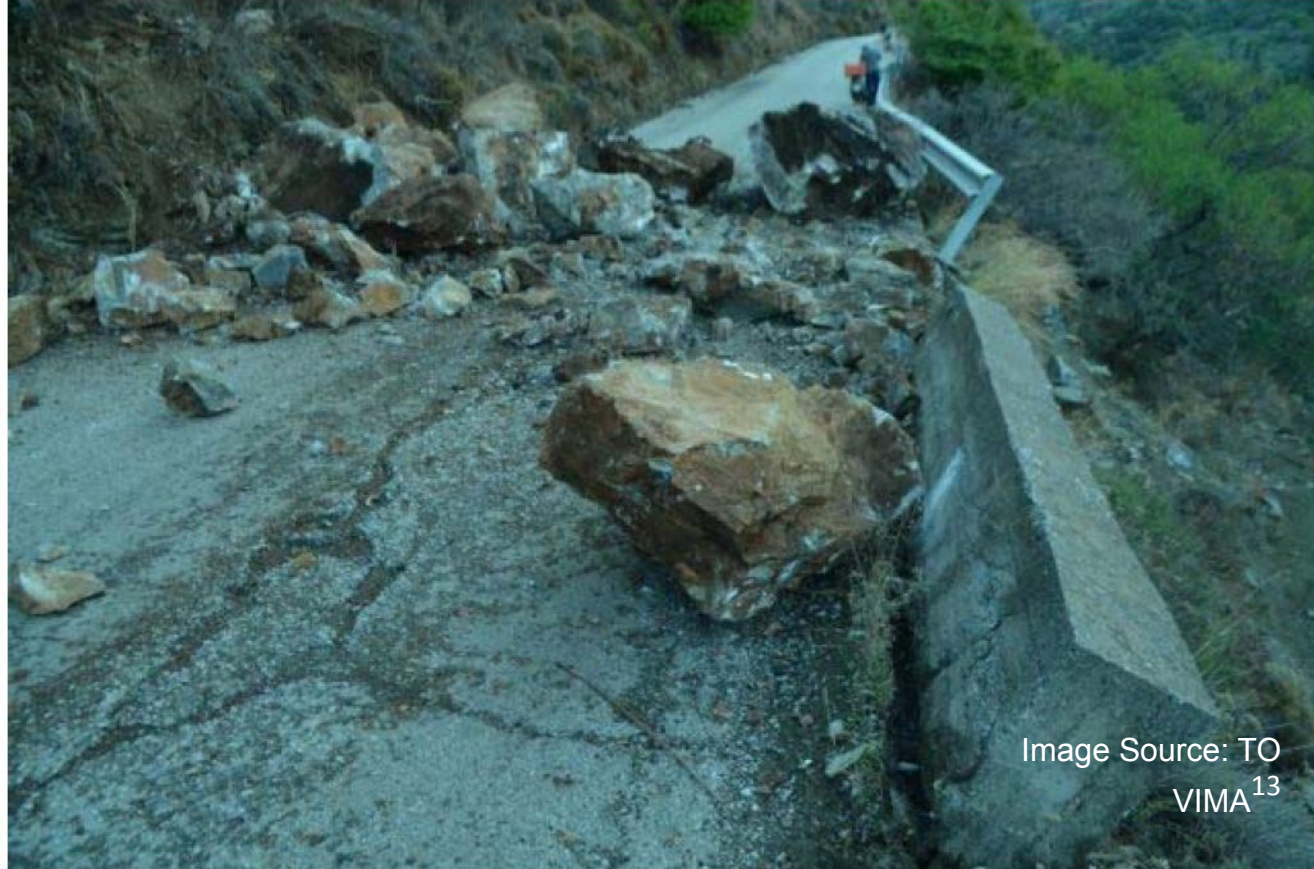
- Rockfalls in the island of Ikaria<sup>8</sup>

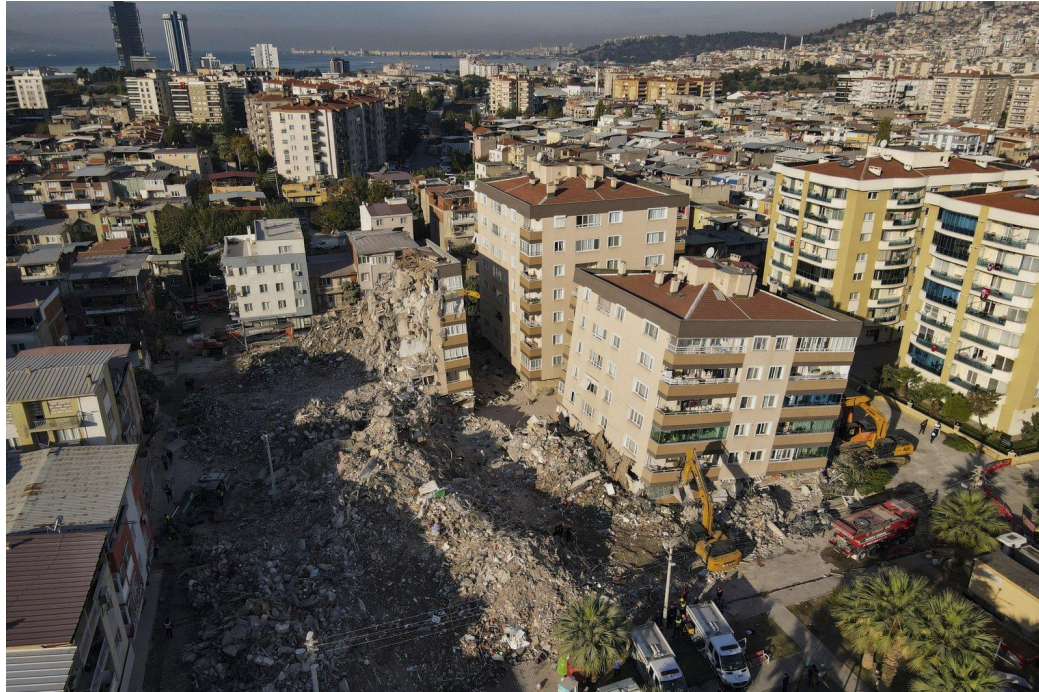
Collapsed buildings in part due to  
soil amplifications, Izmir<sup>8</sup>
