# EERI Earthquake Reconnaissance Team Report: M7.1 Puebla, Mexico Earthquake on September 19, 2017

Deborah Weiser, Jeffrey Hunt, Ezra Jampole, and Maurizio Gobbato

February 2018

A product of the EERI Learning From Earthquakes Program

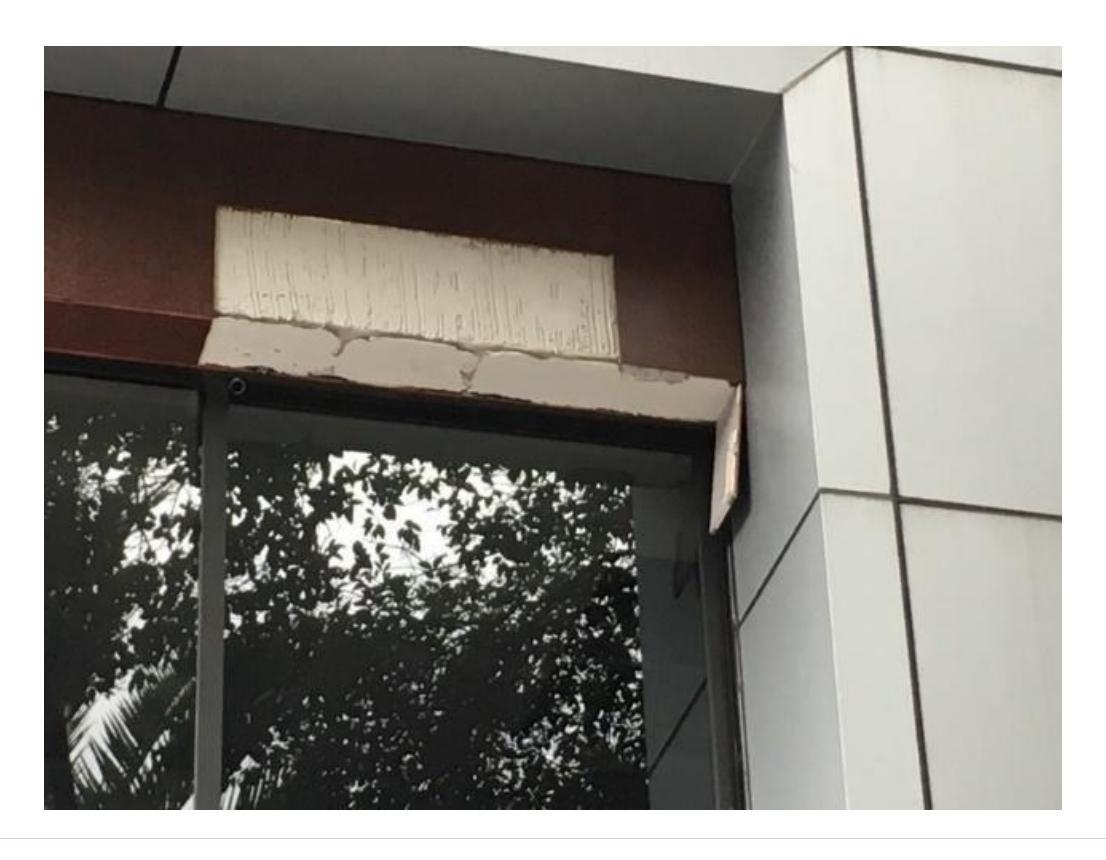
- DS 1 minor (mostly cosmetic) damage. See example in Figure 7. This damage typically involves minor cracks in masonry or concrete elements and/or minor damage to exterior non-structural components (ornamentation, facades, windows, etc.). Repairs would be localized and consist of patching/painting cracks and repairs to non-structural components.

Figure 7. Example of damage state 1: minor (mostly cosmetic) damage.

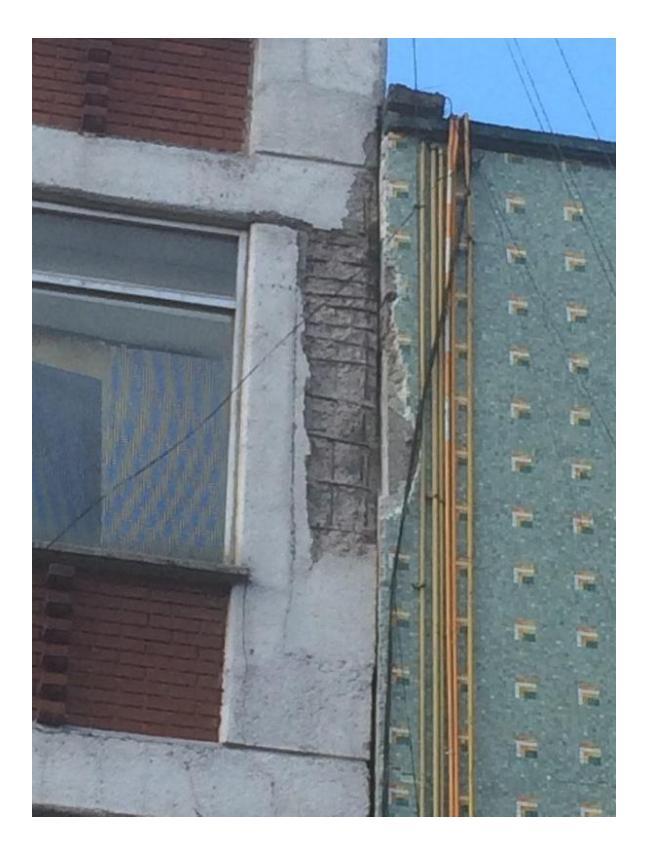
- DS 2 moderate structural damage. See example in Figure 8. This damage typically involves wider cracks and spalling in masonry or concrete elements. Cracks can be repaired in place by routing and repointing grout masonry walls, and patching/epoxy injecting cracks in concrete walls.

Figure 8. Example of damage state 2: moderate structural damage.

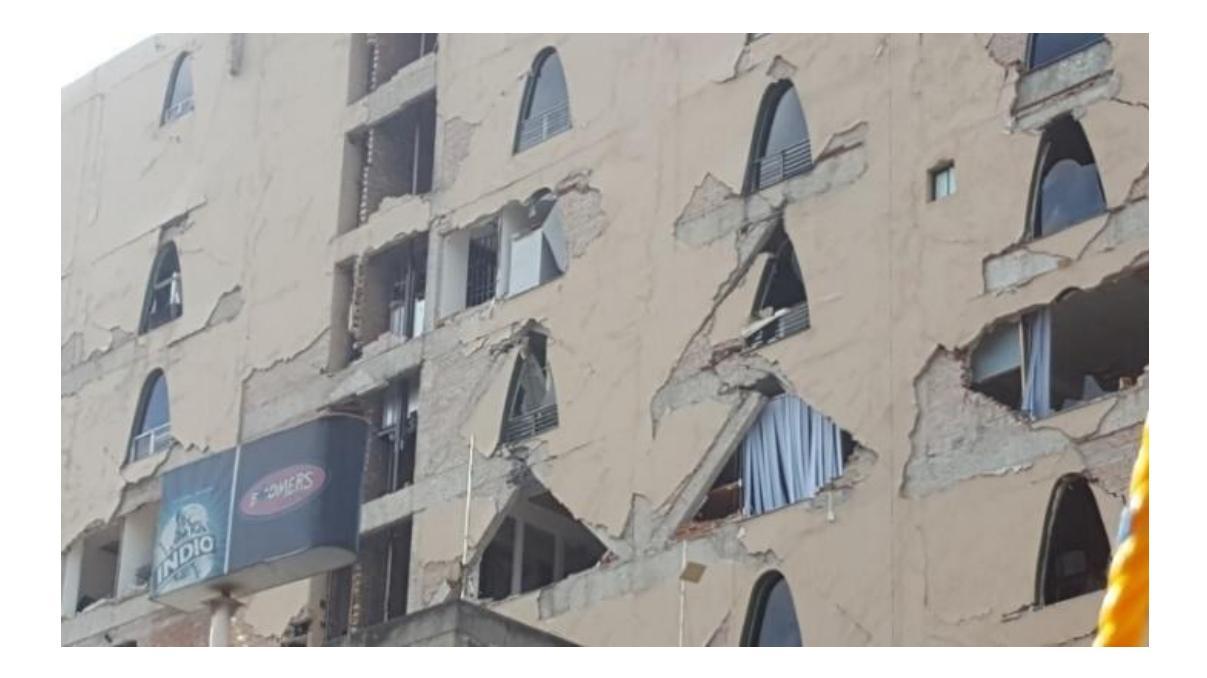
- DS 3 severe damage. See example in Figure 9. This damage involves severe shear cracks in masonry and concrete elements. Residual drift of a story may be present. Repair of damaged elements in place may not be economical.

Figure 9. Example of damage state 3: severe damage.

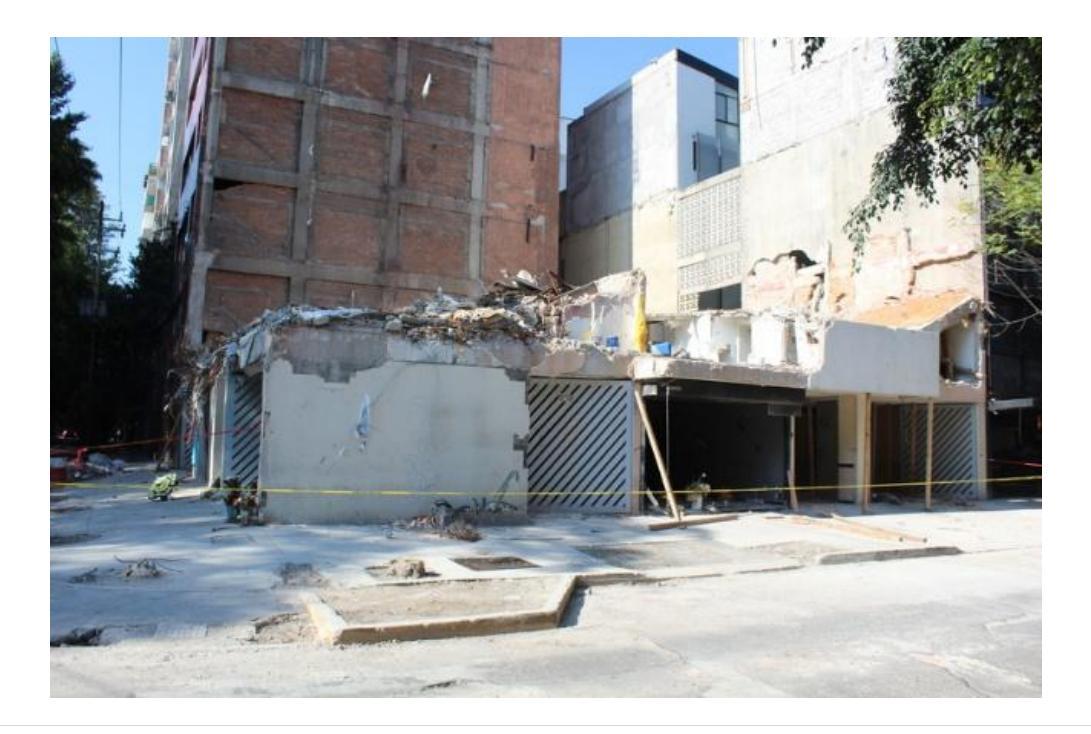
- DS 4 partial or complete collapse. See example in Figure 10.

Figure 10. Example of damage state 4: partial or complete collapse of structure.

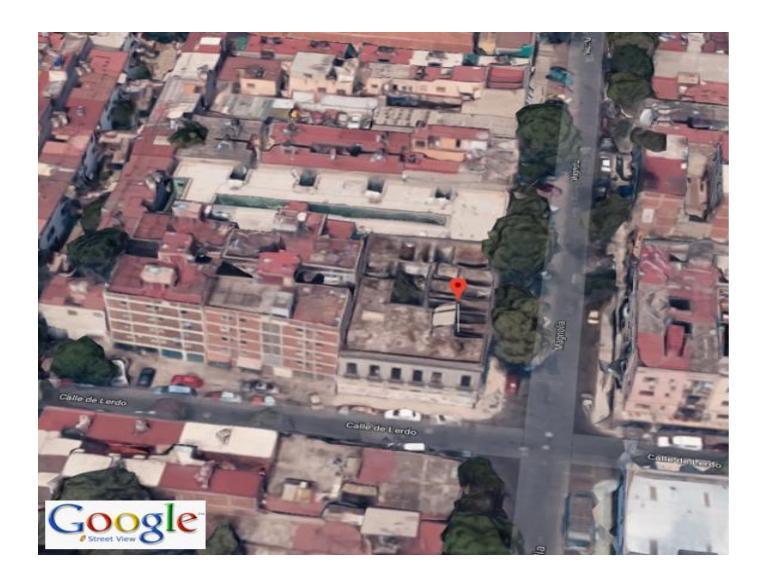
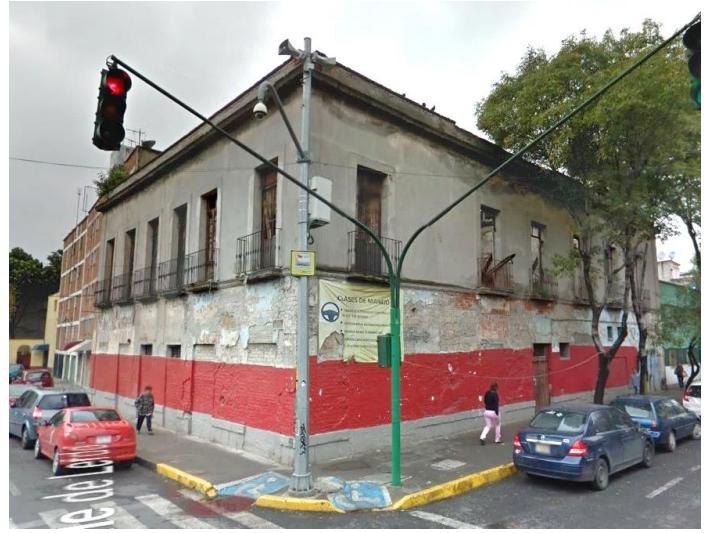
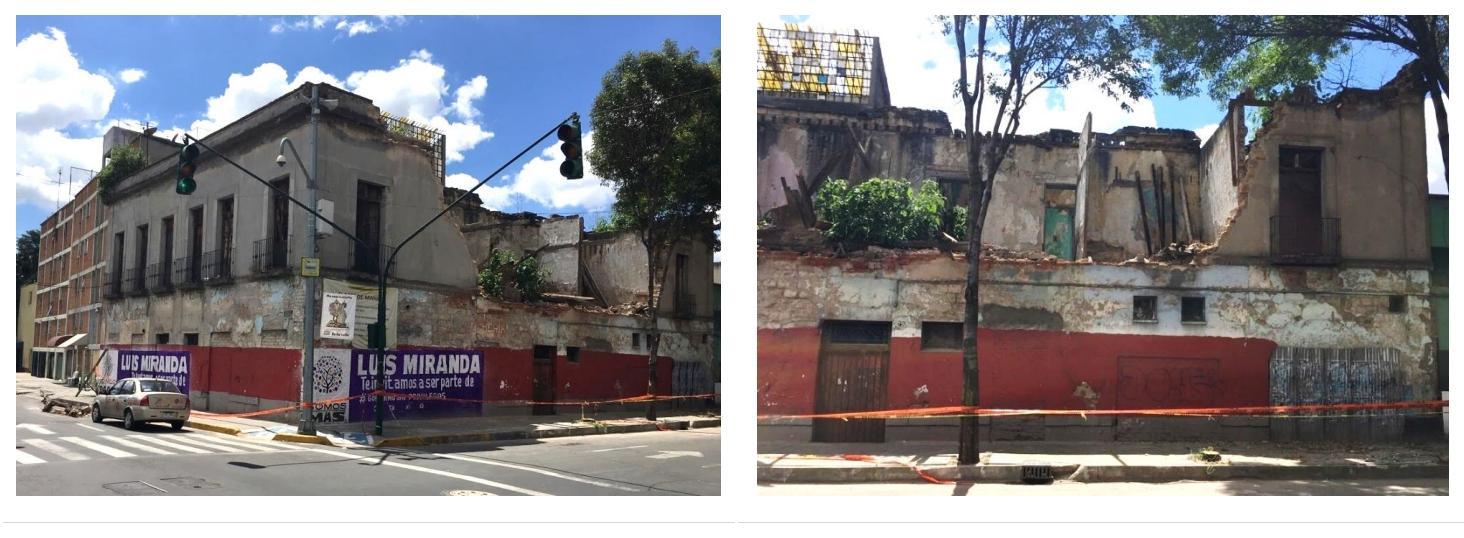
The team surveyed 35 URM buildings (out of a total of 713); among them, 23 were undamaged, 11 were classified as either DS1 or DS2 and only one as DS4. This last URM building is shown in Figure 17 and it suffered a partial collapse during the earthquake. The second-story structural and partition walls as well the roof partially collapsed. On the other hand, the first-story structural elements were still standing. This URM construction was a pre-1987 residential corner-building with plan irregularity and potential pounding from the adjacent buildings.

Figure 17. Structural damage on a partially collapsed 2-story URM residential building located at (lat., lon.) = (19.4425, -99.1430). (a) and (b): Photos prior to the earthquake from Google®; (c) and (d) Photos after the earthquake.

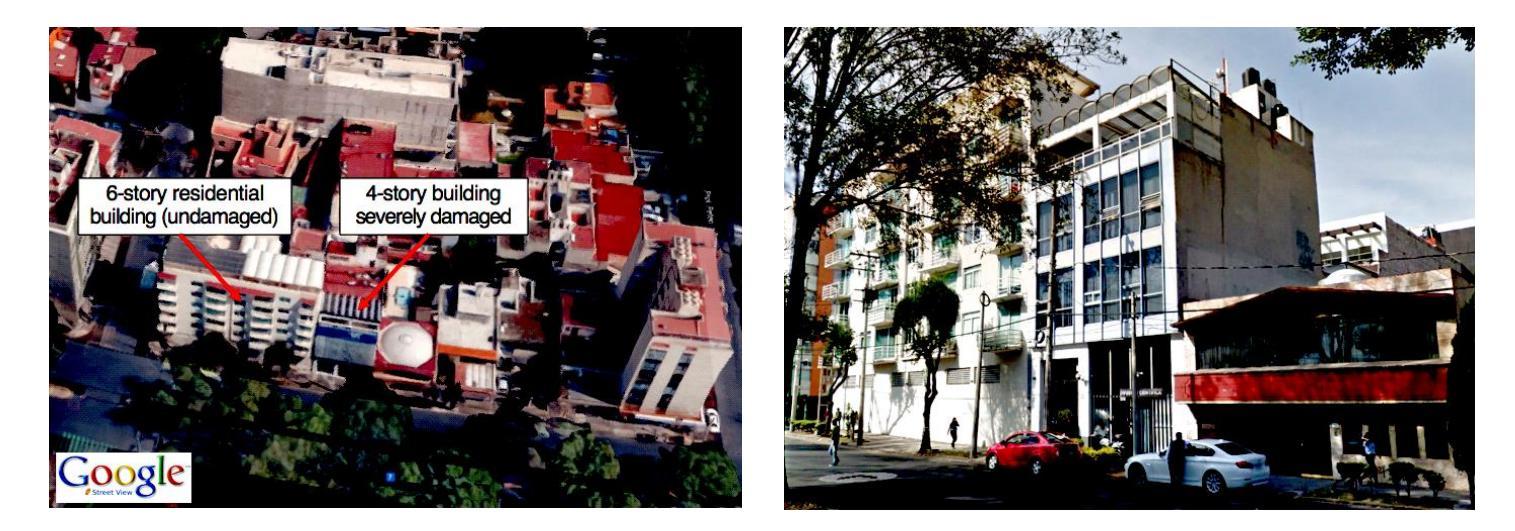
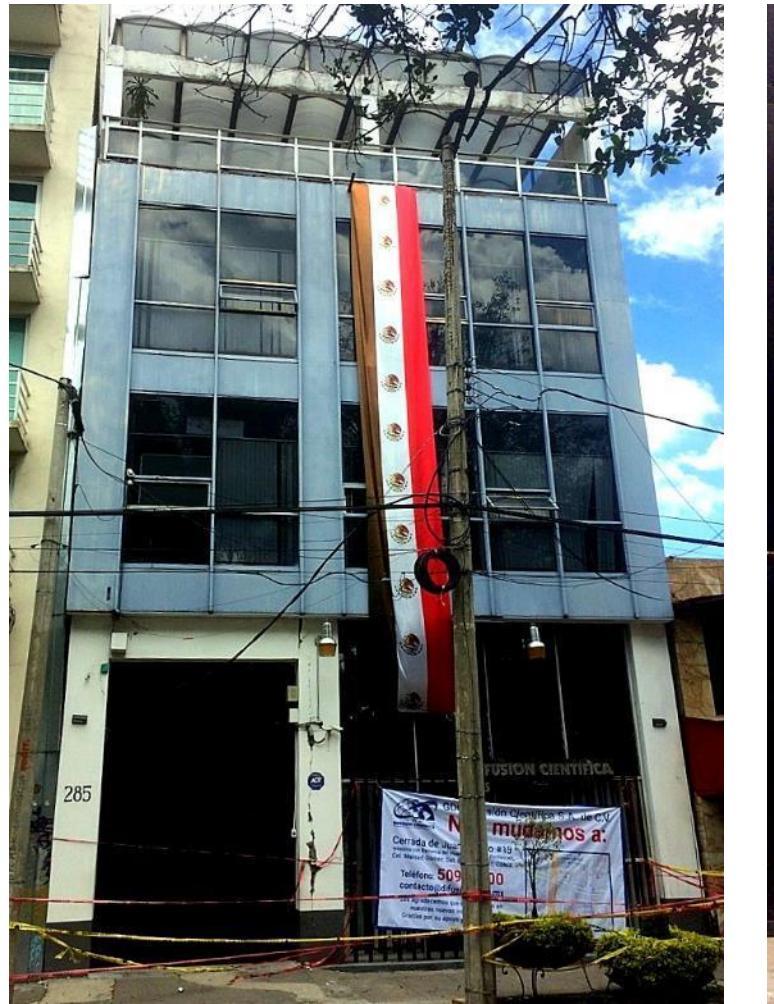
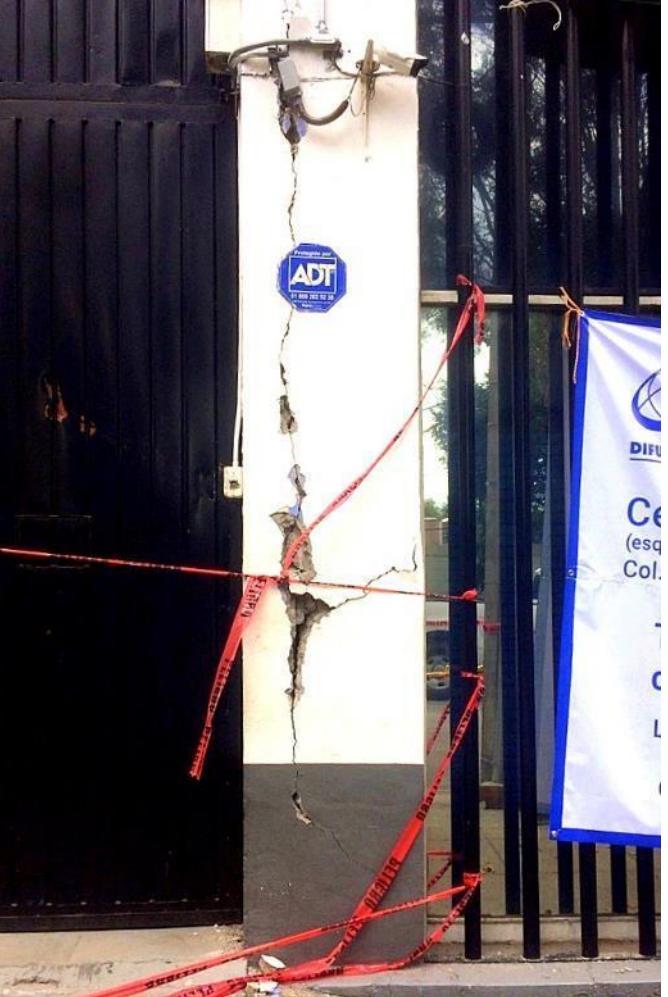
The team surveyed 73 RC-MRF constructions (out of a total of 713); among them, 50 were undamaged, 21 were classified as either DS1 or DS2 and only two as DS3. One of the severely damaged buildings was a 4-story post-1987 construction which experienced pounding effects from the adjacent building and, after the earthquake, had clearly observable residual drift and severe cracks on the columns. The pre- and post-earthquake photos of this structure are shown in Figure 18, and it can easily be noticed the vertical splitting failure on central column of the front façade probably caused by the insufficient amount of confinement. This was a common issue observed on many of the RC-MRF damaged during the earthquake. To further validate this point, Figure 19 shows the severe structural damage on the first-floor columns of an 8-story residential RC-MRF corner-lot building. It can be noticed how lateral confinement was clearly lacking and led to longitudinal rebar buckling, and the consequent massive spalling of the concrete.

Figure 18. Structural damage on a severely damaged 3-story RC-MRF commercial building located at (lat., lon.) = (19.368, -99.155). (a) and (b): Photos prior to the earthquake from Google®; (c) and (d) Photos after the earthquake.

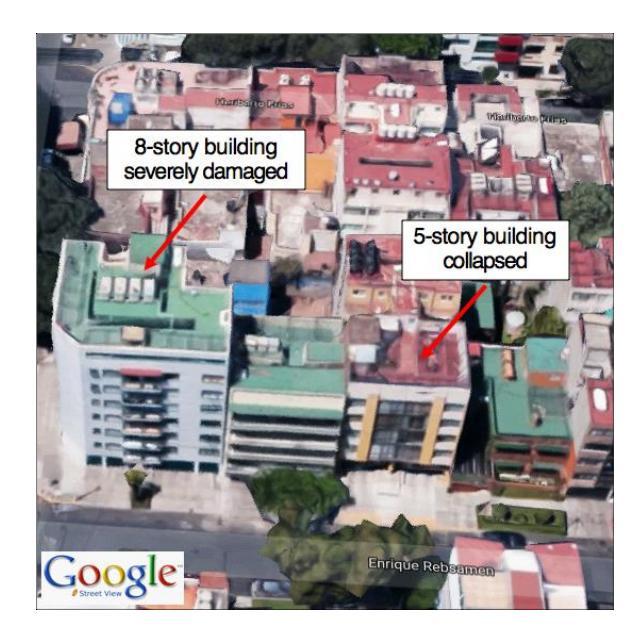
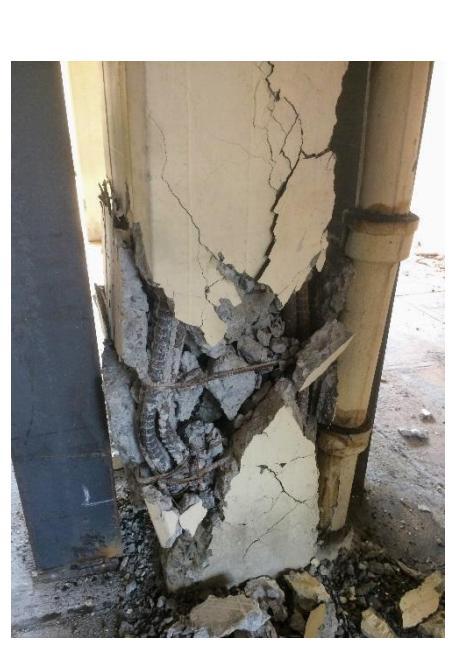
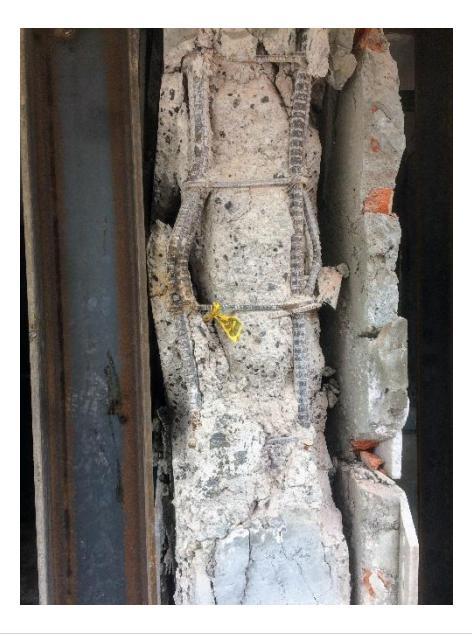
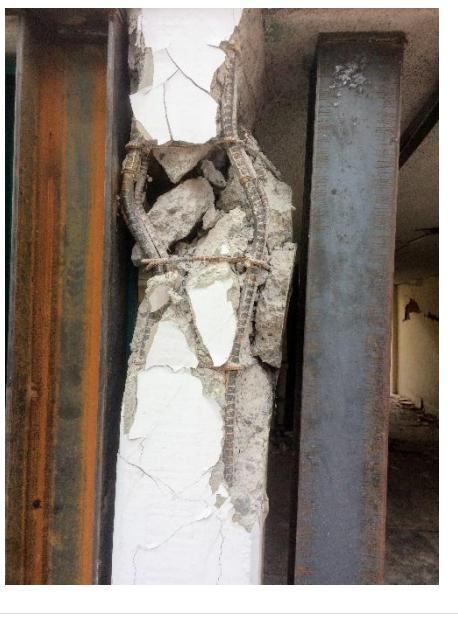
Figure 19. Structural damage on the first floor of an 8-story corner-lot RC residential building located at (lat., lon.) = (19.3987, -99.1589). (a): Photos prior to the earthquake from Google®; (b), (c) and (d) Photos of first-floor columns after the earthquake.

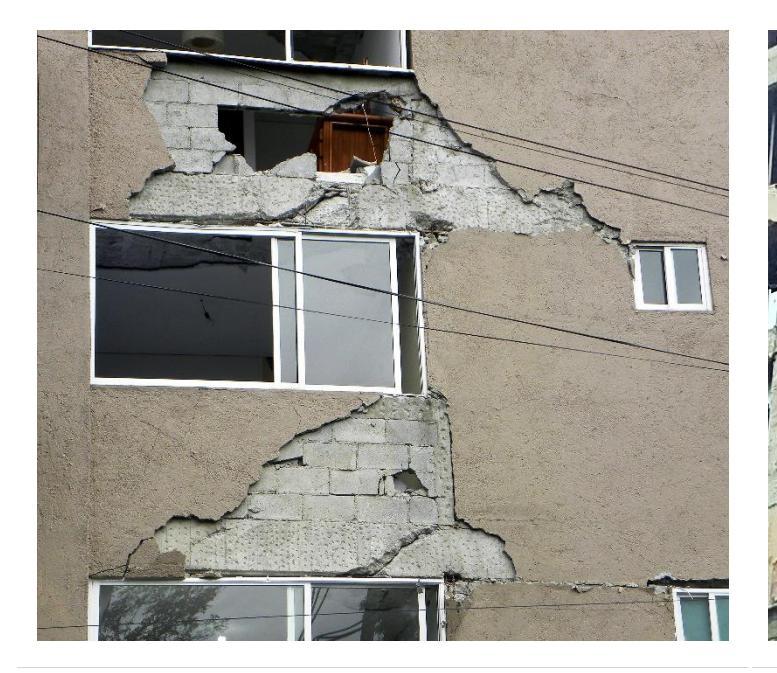
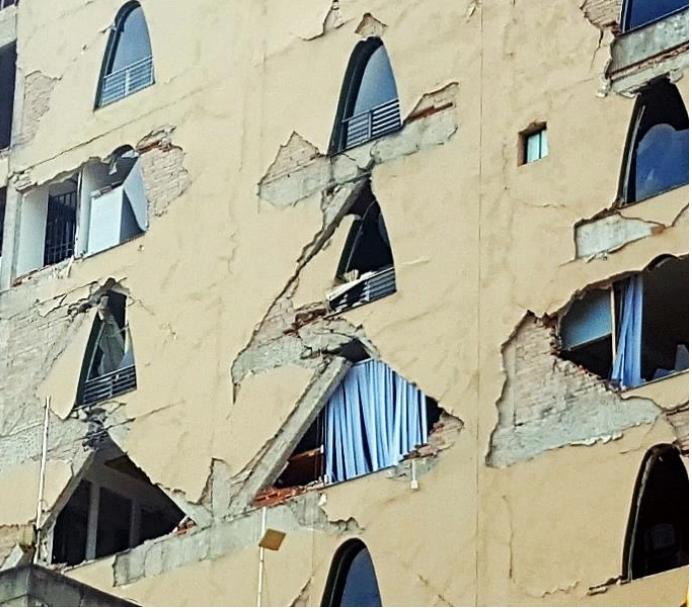
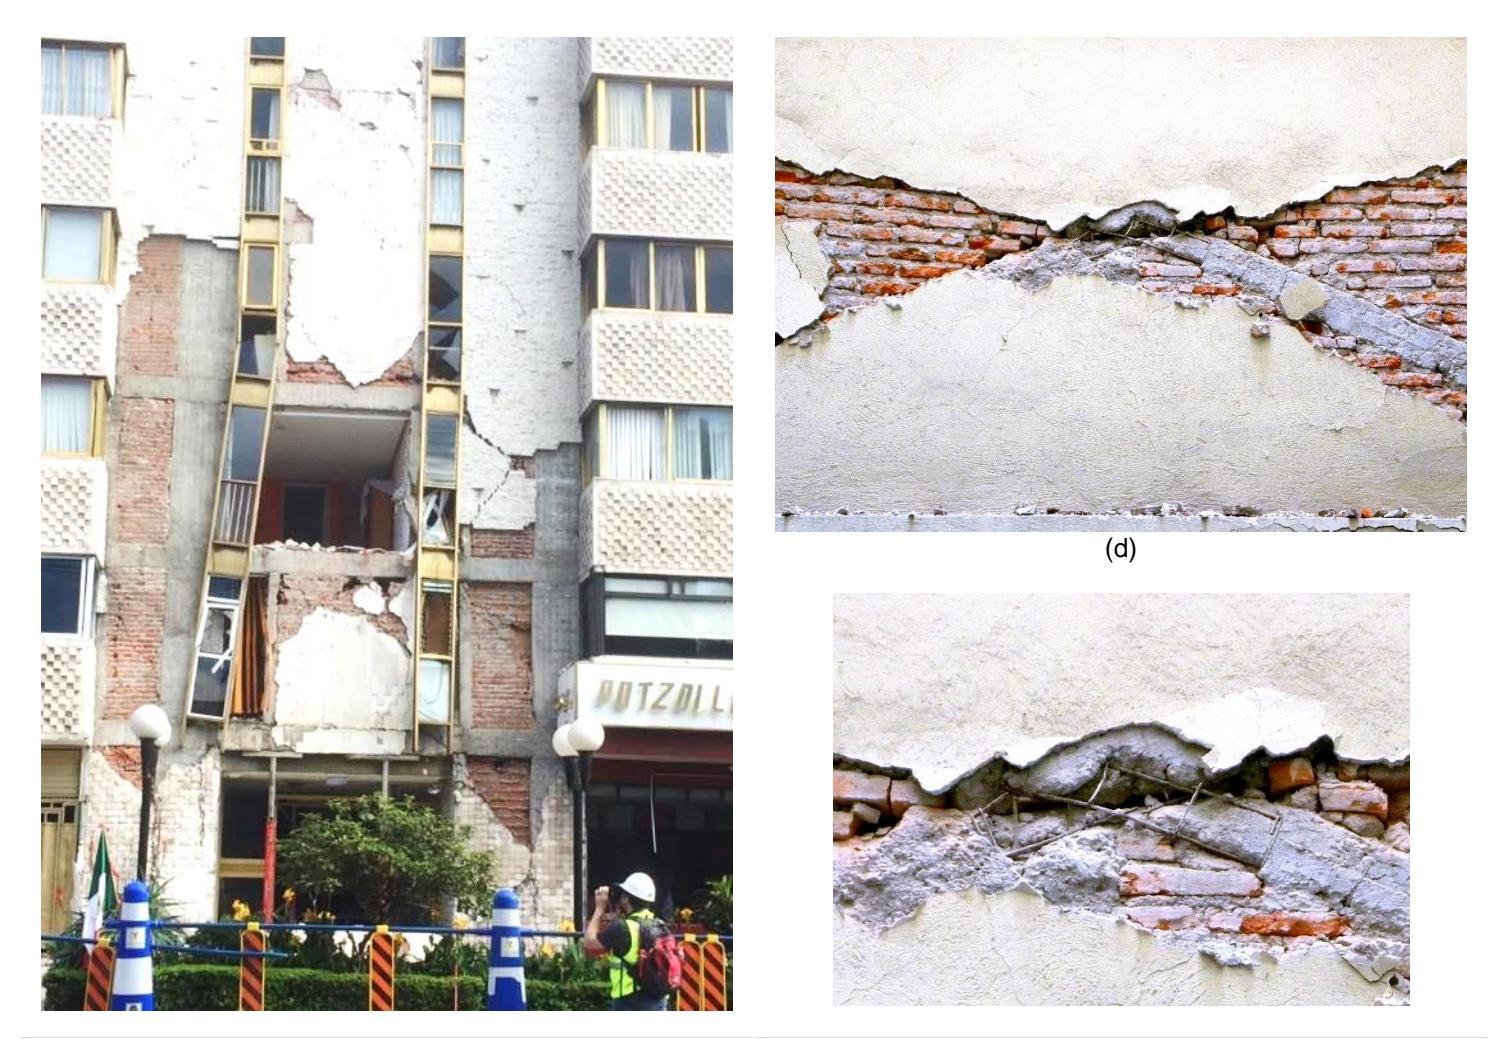
The team surveyed 553 RC buildings with URM infill constructions (out of a total of 713); These were either RC frames with URM infills or RC columns with waffle or flat slabs and URM infills. Among them, 409 were undamaged, 110 were classified as either DS1 or DS2 and 19 as DS3 and 15 as DS4. Additionally, among the 19 buildings categorized as DS3, 13 were built prior to 1987 (~70%); similarly, among the 15 buildings partially or completely collapsed, 13 were built prior to 1987 (~85%). The overall construction quality and level of detailing in the RC beam-to-column connections and/or in the RC bracing systems were generally poor and constitute one of the main drivers for the observed structural damage. Figure 20 gathers some examples of the observed types of damage on the RC with URM infills constructions surveyed: severe cracking and/or out-of-plane failure of the masonry infills, shear failure of the RC beams, spalling and/or buckling

of the diagonal RC braces embedded in the URM infills upon construction or retrofitting of some of the buildings. In all instances, and similarly to what was reported in the previous section for the RC-MRF buildings, the lack of proper confinement in the damaged RC members was a clear common factor among all buildings surveyed. Additionally, the poor quality of post-1987 retrofits demonstrated to be ineffective in preventing high levels of damage.

(a) Damage to RC beams, infill concrete blocks and exterior cladding of a 10story RC-frame with URM infills; (b): Damage to RC beams, infill clay bricks and exterior cladding of a 11-story RC-frame with URM infills and diagonal RC bracing system; (c): Damage to the Short RC beam connections, URM infills an exterior cladding of a 8-story RC frame with URM infills; (d) and (e): Damage to the RC bracing system in a poorly retrofitted residential 9-story RC frame with URM infills.

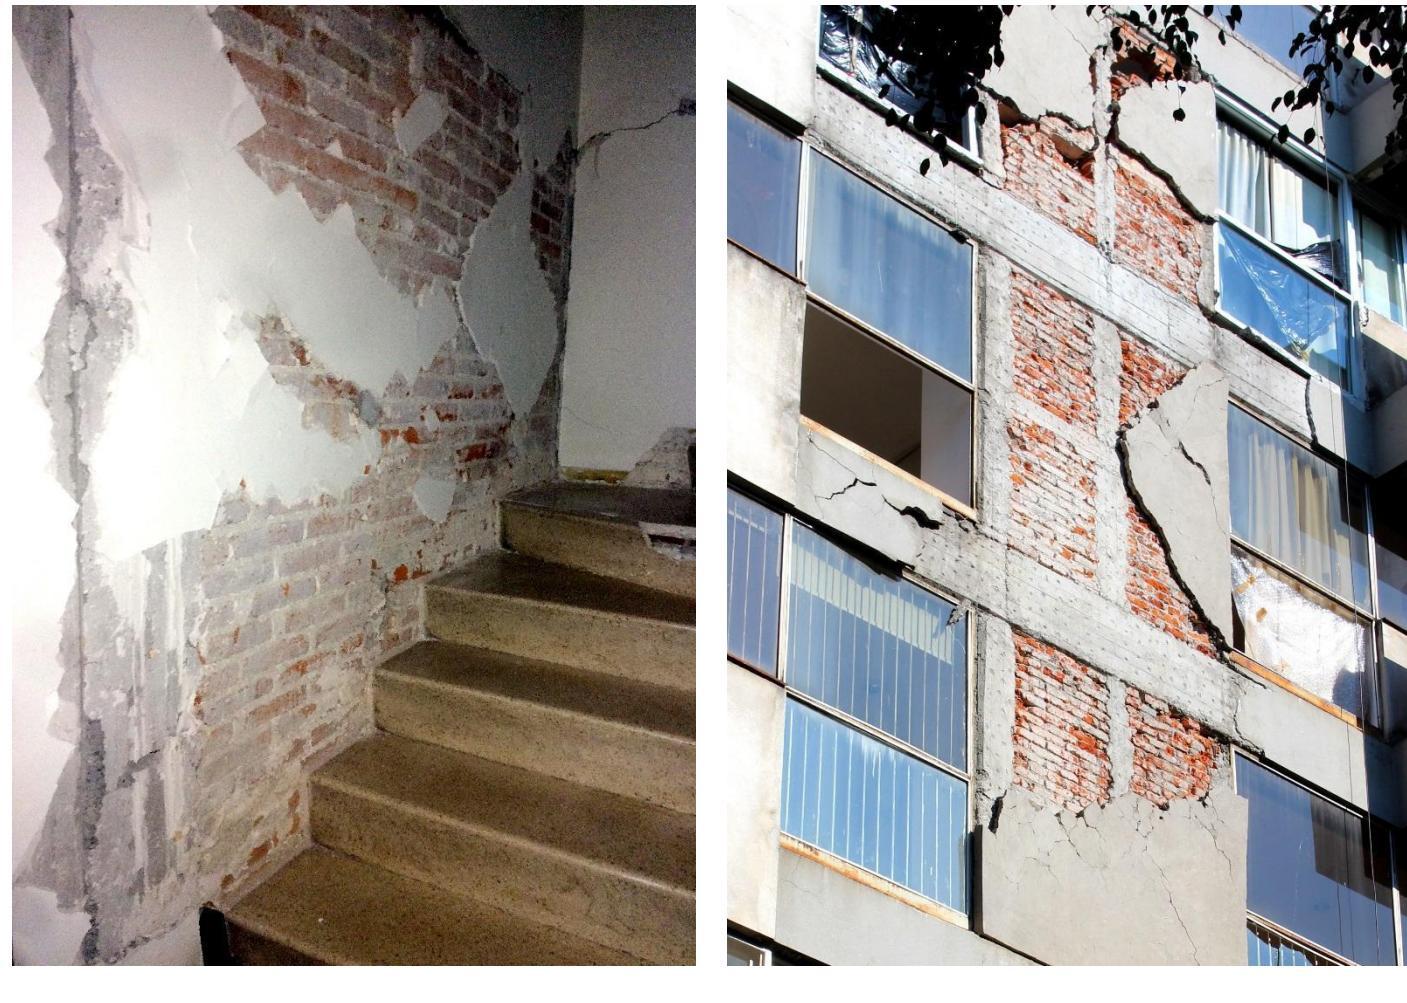
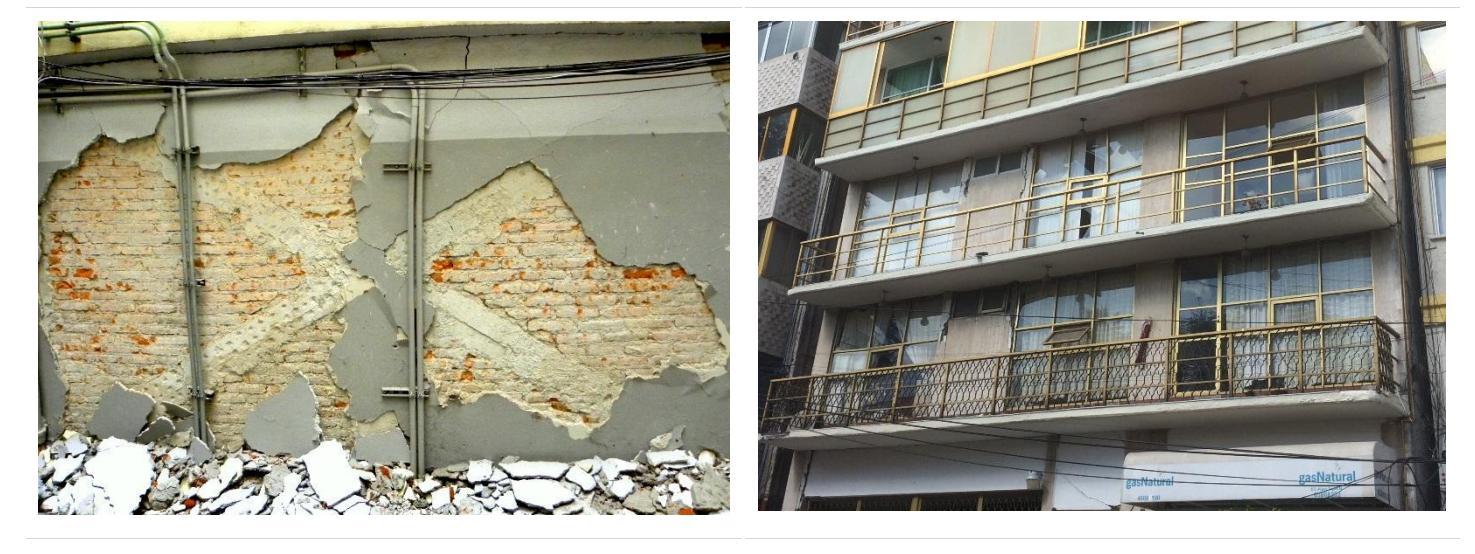
Damage to nonstructural components such as partition walls and facades (e.g., windows, cladding, etc.) can represent a significant portion of losses. These components are generally very sensitive to inter-story drift ratios and can control the overall building vulnerability at low seismic intensities for ductile RC-MRF or mid- to high-rise RC with URM infills structures. On the other hand, the behavior of low-rise non-ductile constructions would be affected by both structural and non-structural elements as they would both start failing at very low inter-story drift ratios; this is typically the case of low-rise URM constructions. The team observed several buildings with exterior non-structural damage to the concrete cladding on the facades, window, parapets on balconies and ornamental molding along the roof line of older buildings. In some cases, these types of non-structural damage could constitute a life hazard for the people who find themselves in the vicinity of the building during or immediately after an earthquake. Examples of observed nonstructural damage are provided in Figure 21.

Figure 21. (a) Damage to the interior cladding, partition wall, and stairs of a x-story RCframe with URM infills; (b): Damage to the exterior cladding of a x-story RC frame with URM infills; (c): Damage to the interior cladding of a x-story RC frame with URM infills retrofitted with RC braces; (d) Damage to windows and parapets of a x-story RC.
