MIDDLE EAST TECHNICAL UNIVERSITY

Earthquake Engineering Research Center

Geotechnical Aspects of February 6, 2023 Kahramanmaraş-Türkiye Earthquake Sequence (Mw=7.8 and Mw=7.6)

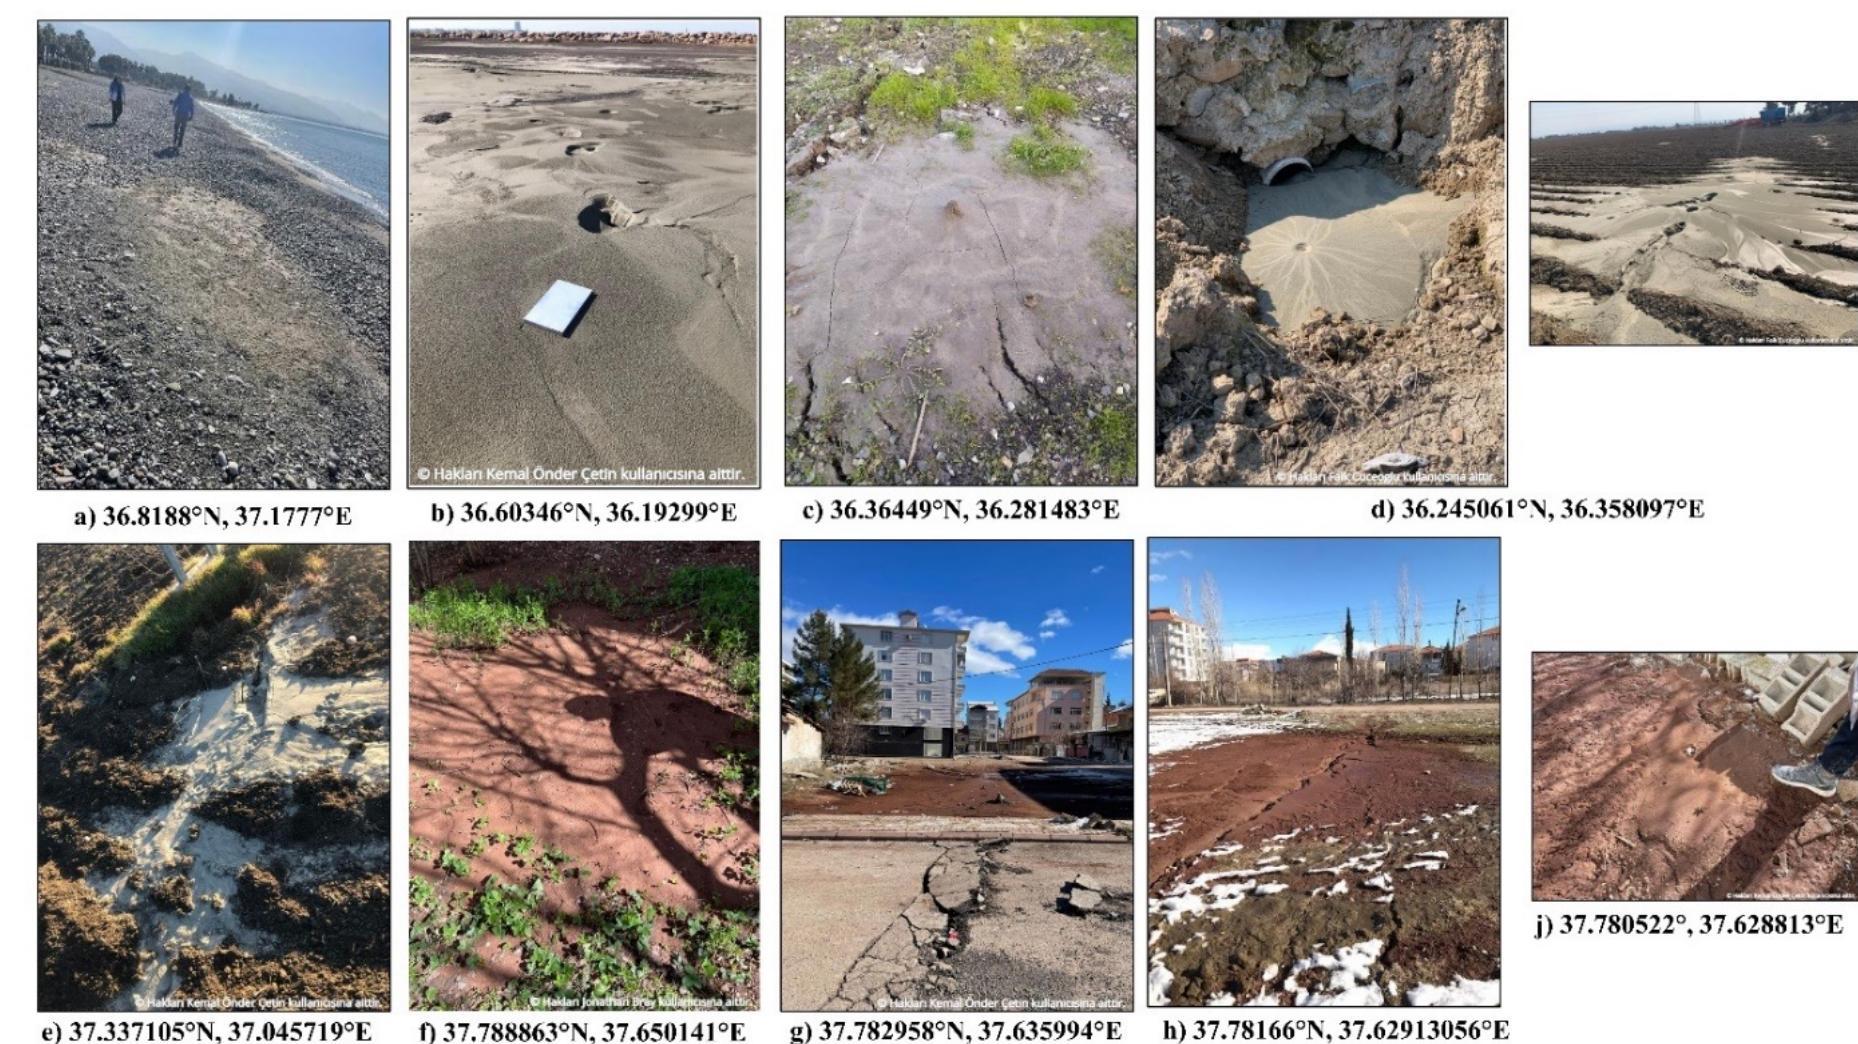
Free-field soil ejecta sites at a) Payaş Dörtyol-Hatay coastal line, b) A Port facility in İskenderun, c) İskenderun-Hatay, d) Demirköprü-Hatay, e) Emiroğlu-Kahramanmaraş, f, g, h, and j) Gölbaşı-Adıyaman after Kahramanmaraş Earthquakes

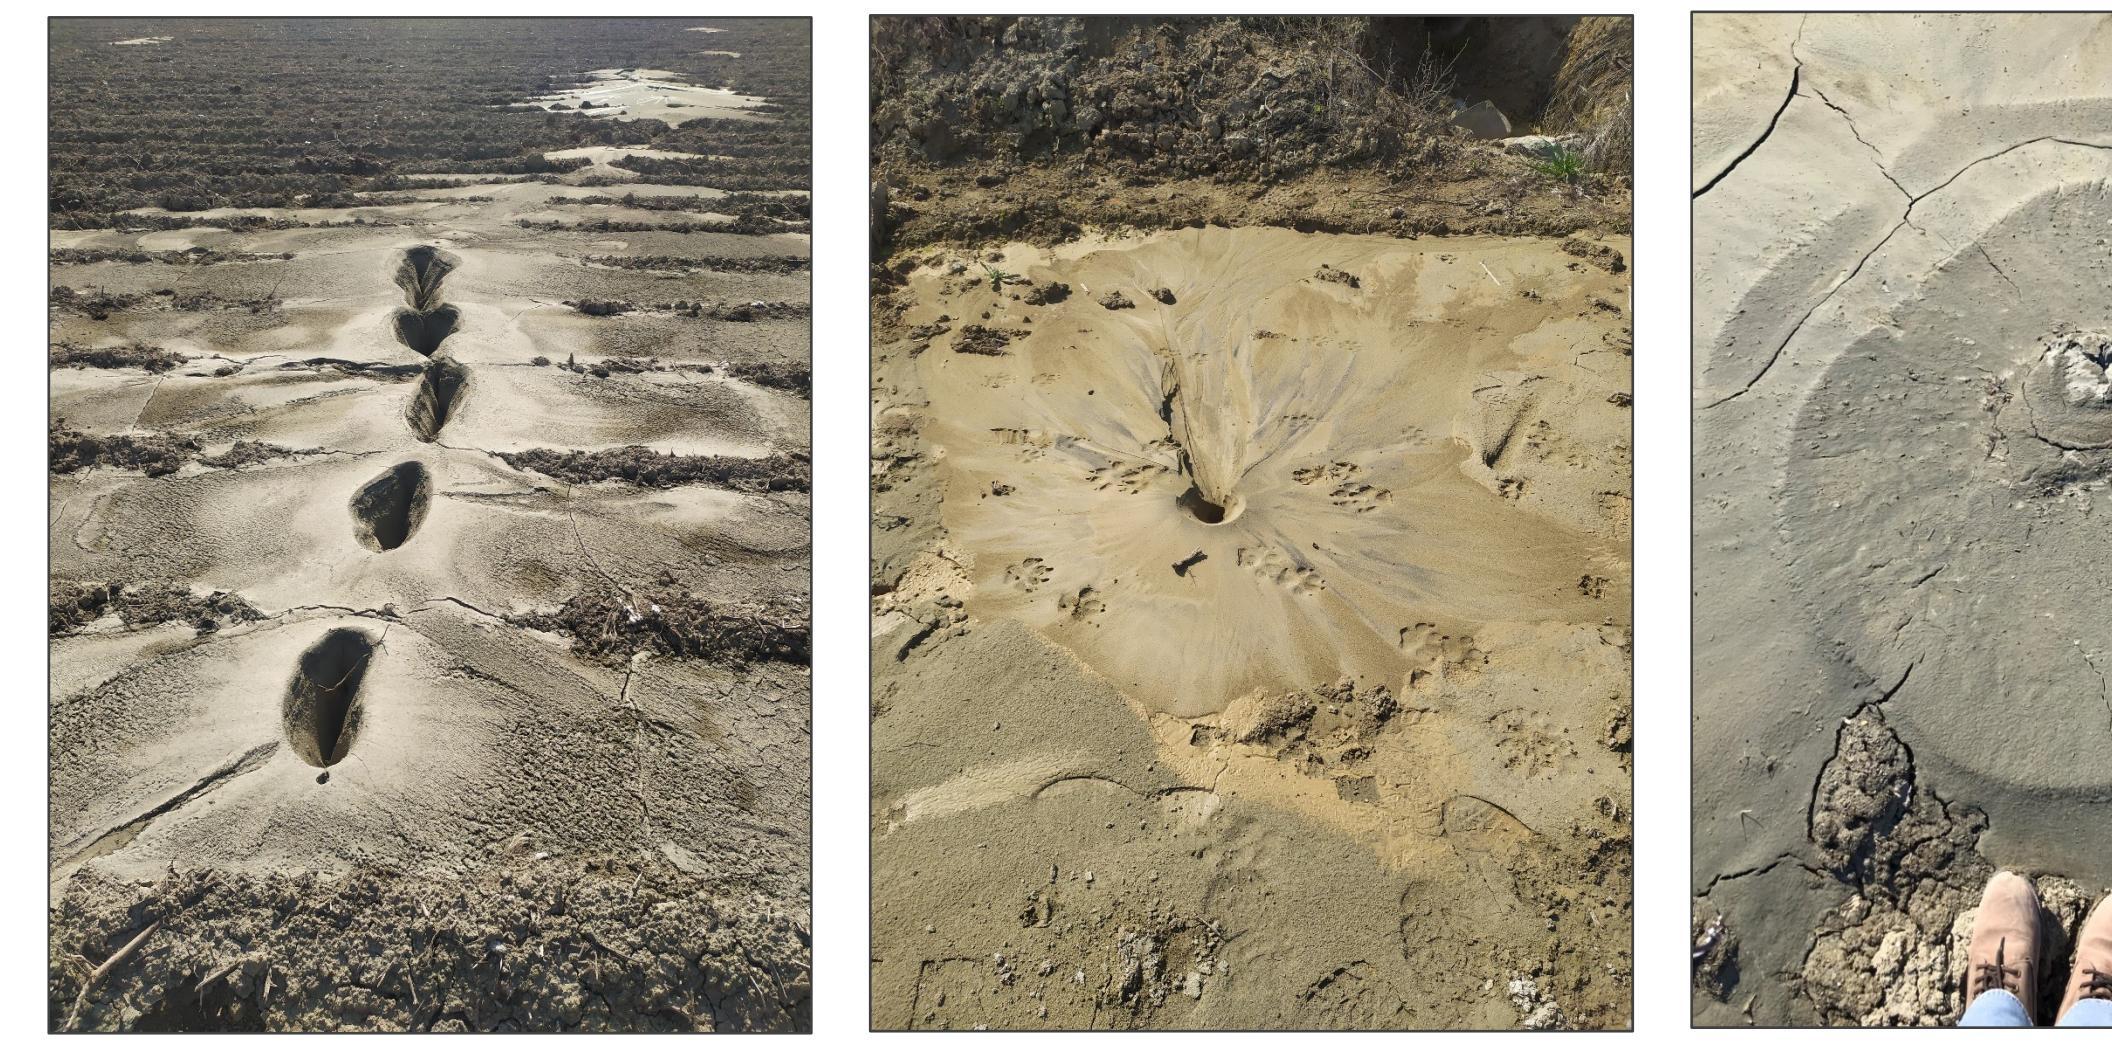
Free-field soil ejecta sites at Demirköprü-Hatay, Kumlu-Hatay and Gölbaşı-Adıyaman after Kahramanmaraş Earthquakes

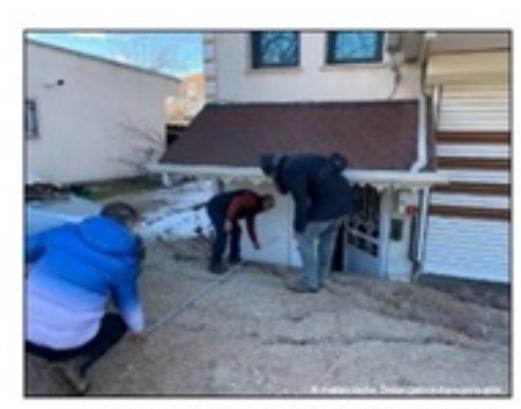
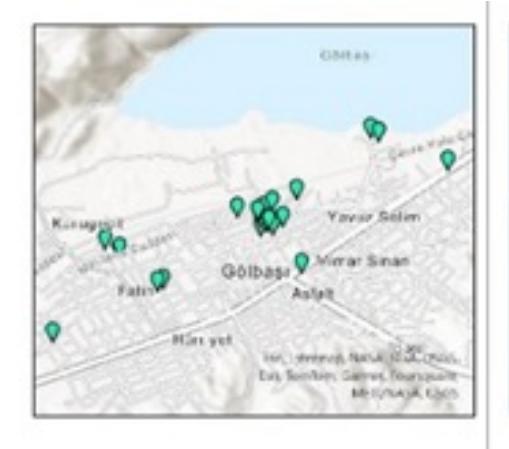
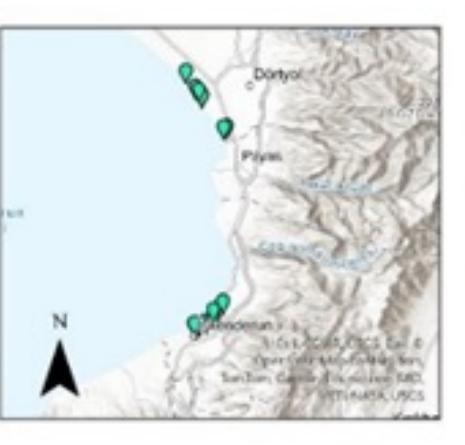
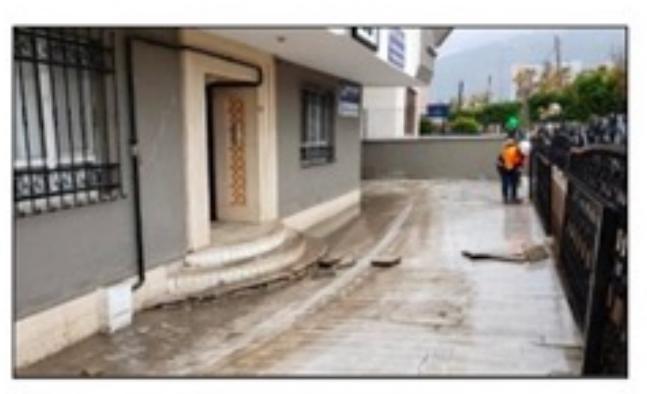
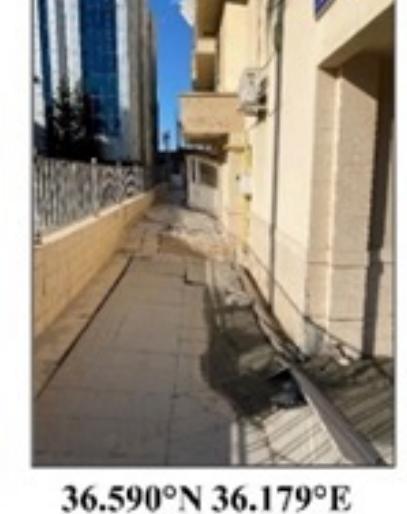
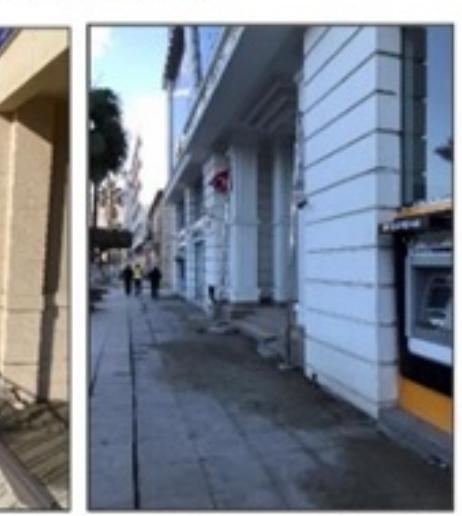
Liquefaction-induced settlement observed at a) Gölbaşı-Adıyaman, and b) İskenderun-Hatay

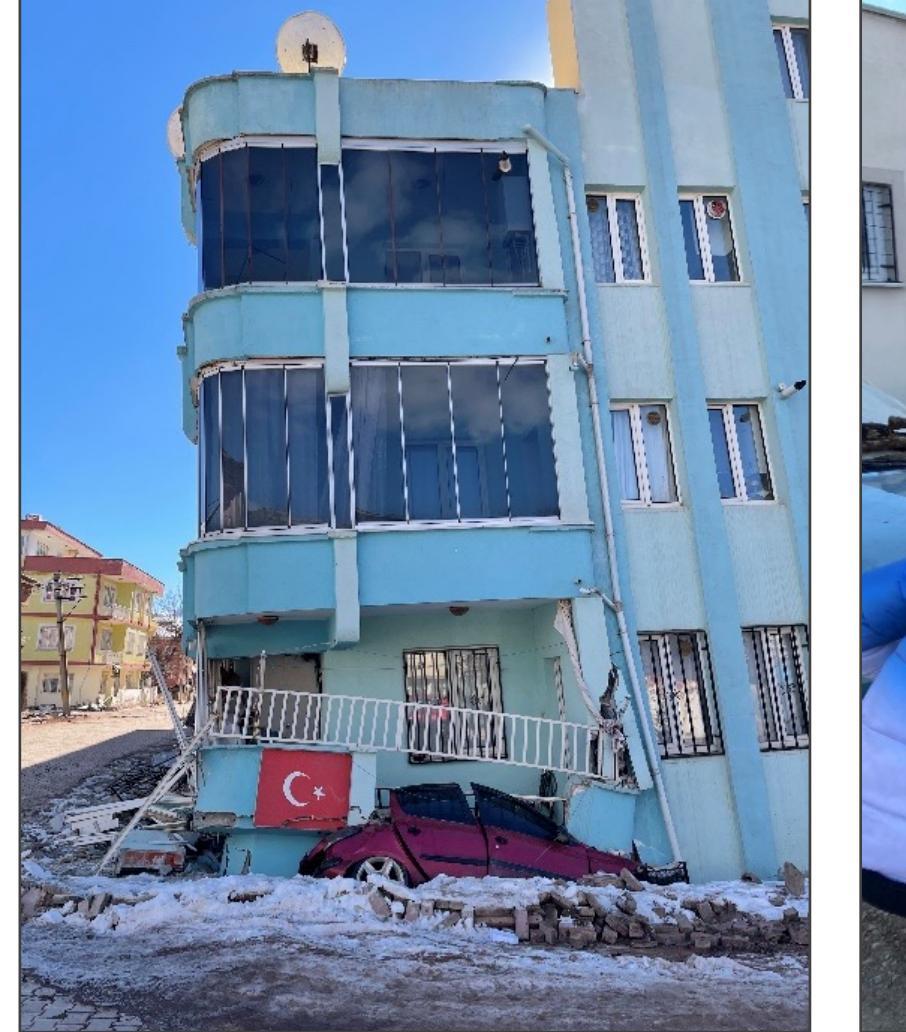
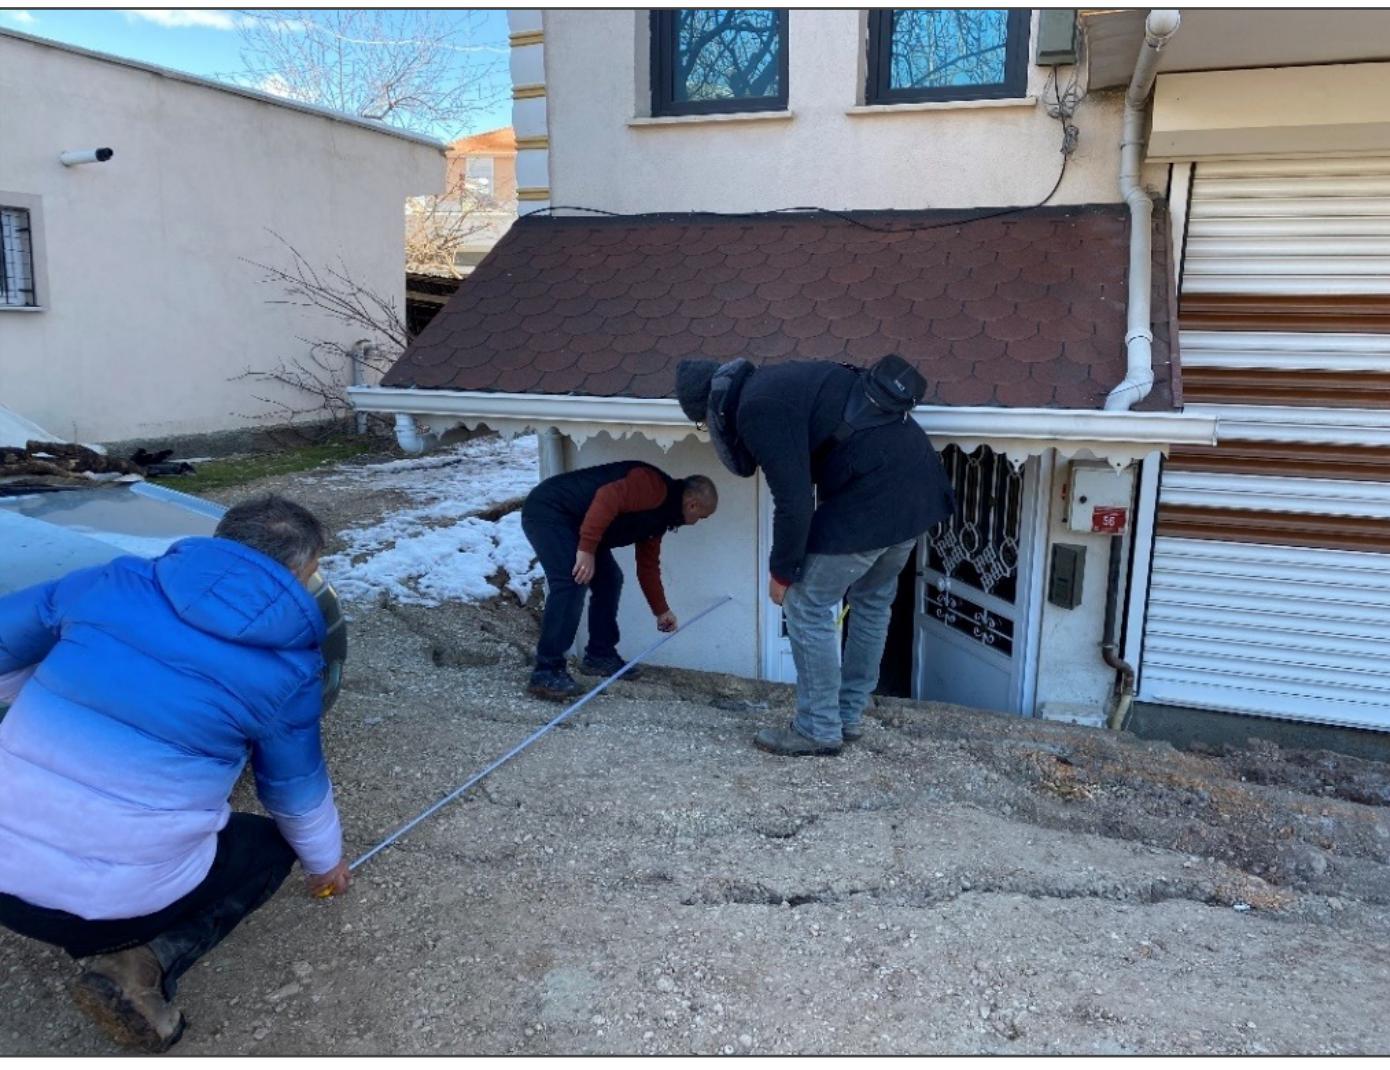
Liquefaction-induced settlement observed at Gölbaşı-Adıyaman

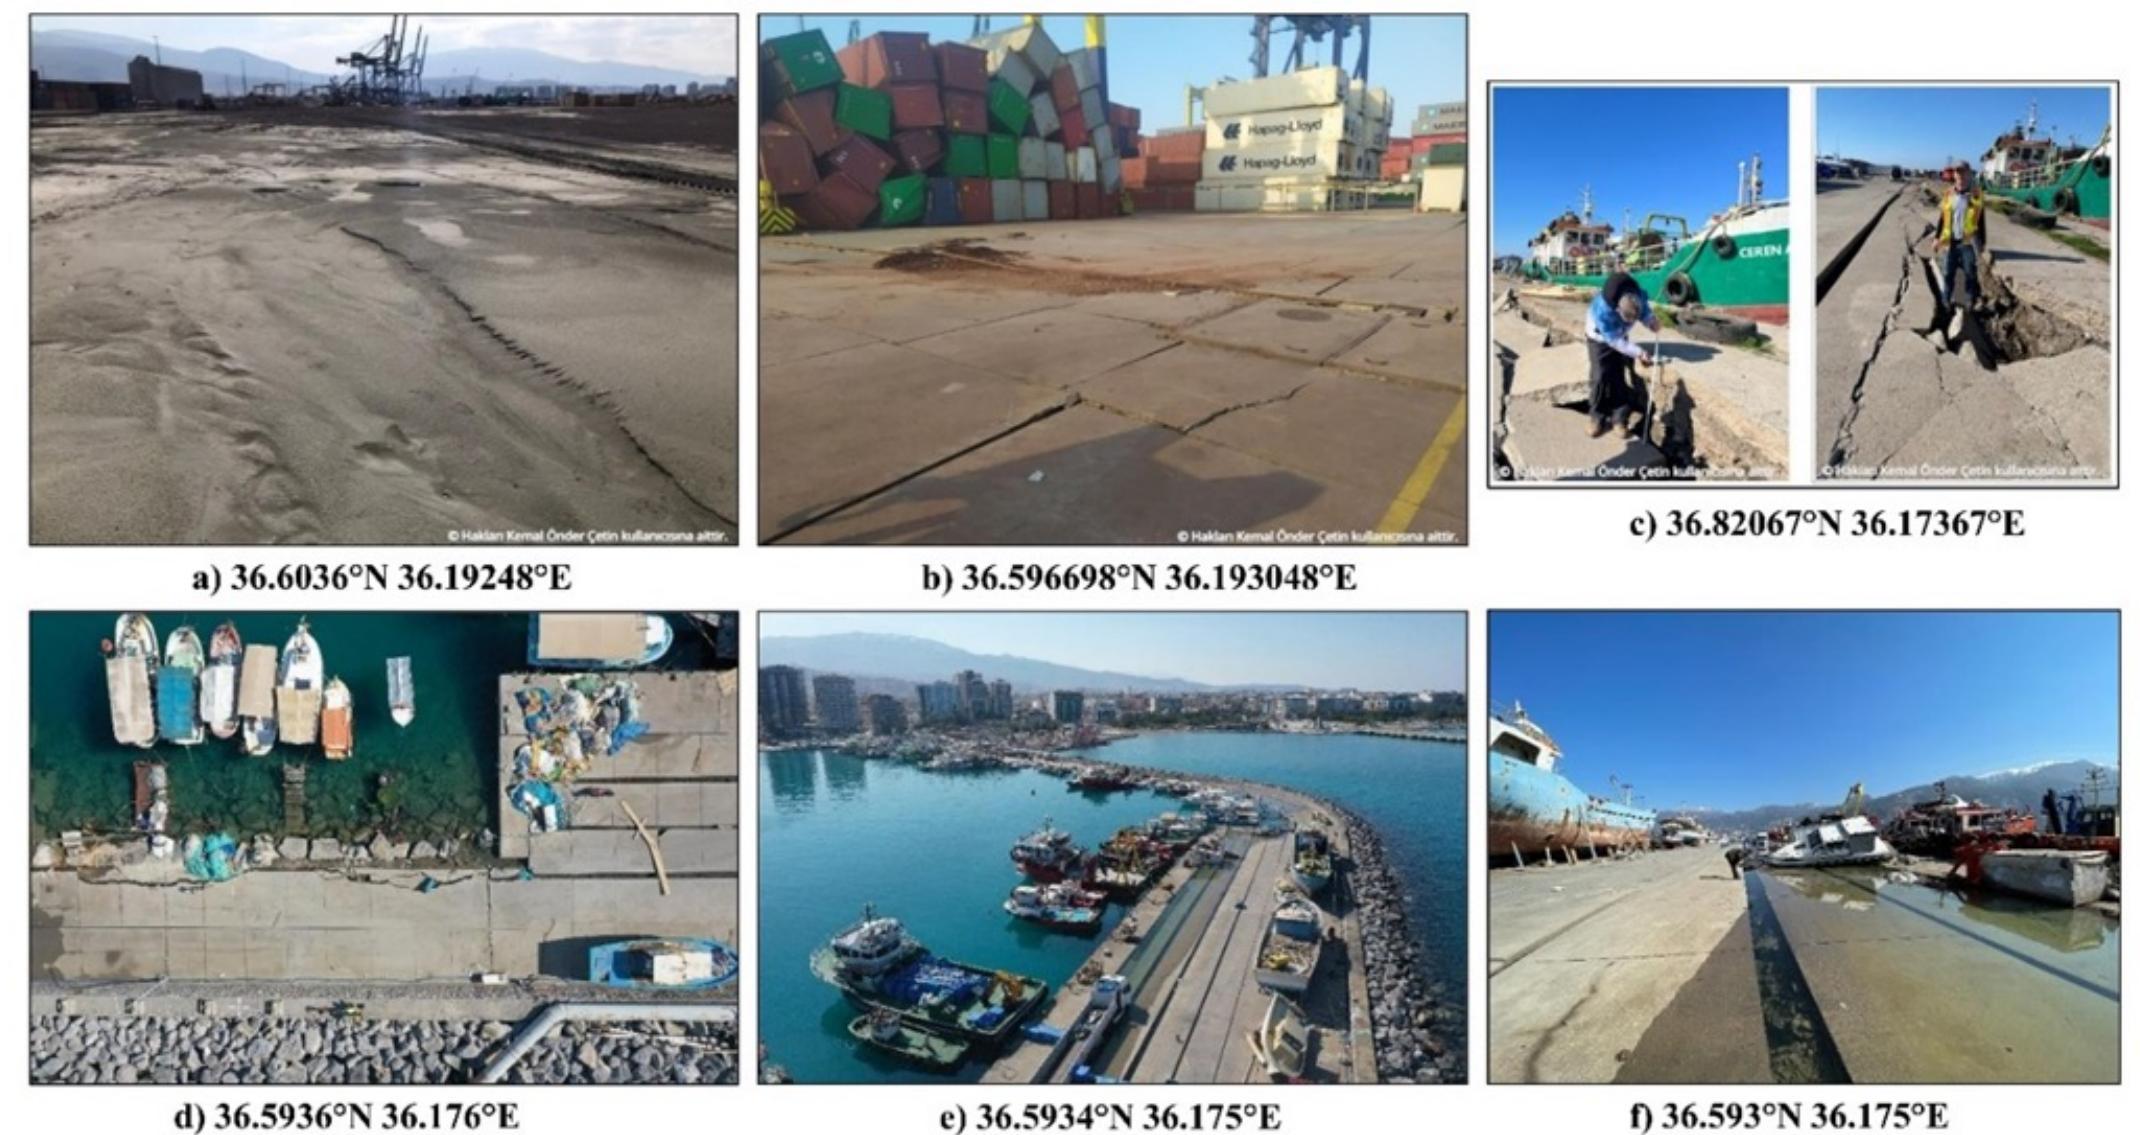
Liquefaction-induced deformations at port facilities in, b) Limak Port in Iskenderun, c) Fishery Warf, d, e, and f) Iskenderun State Harbor

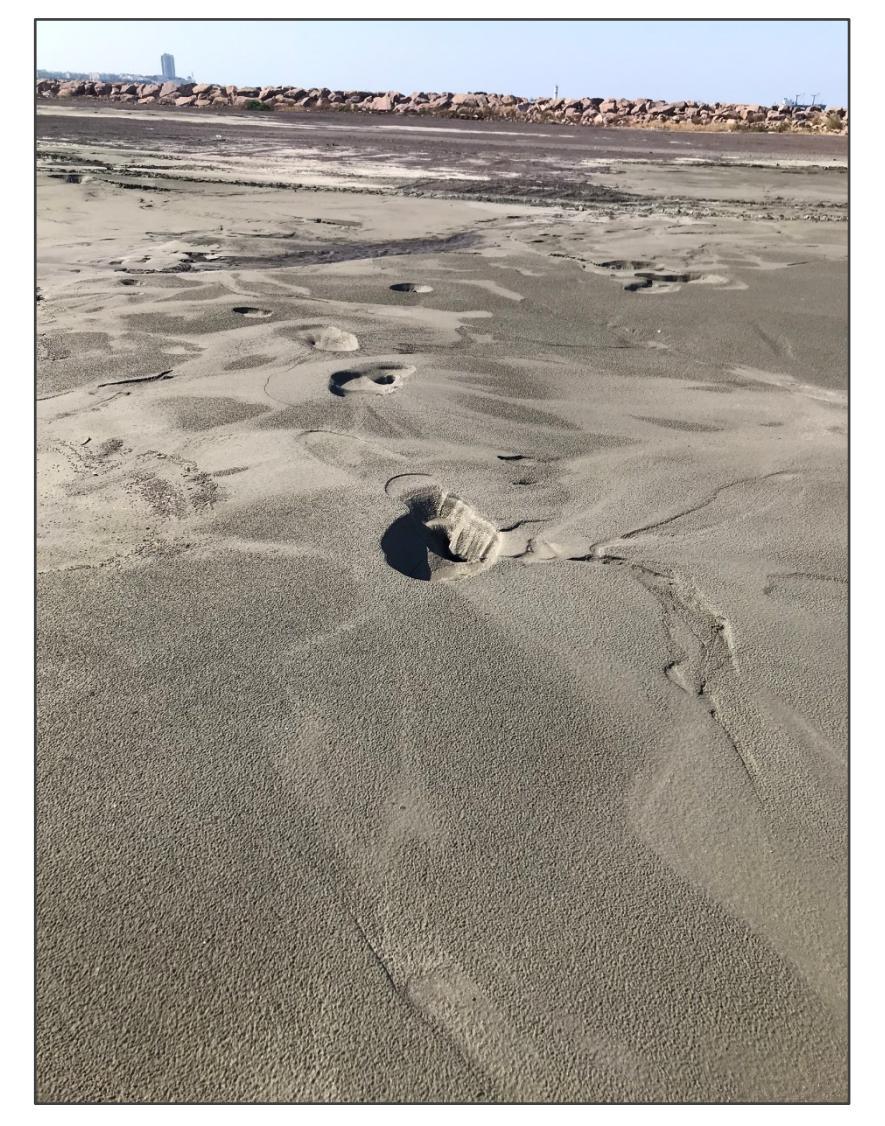
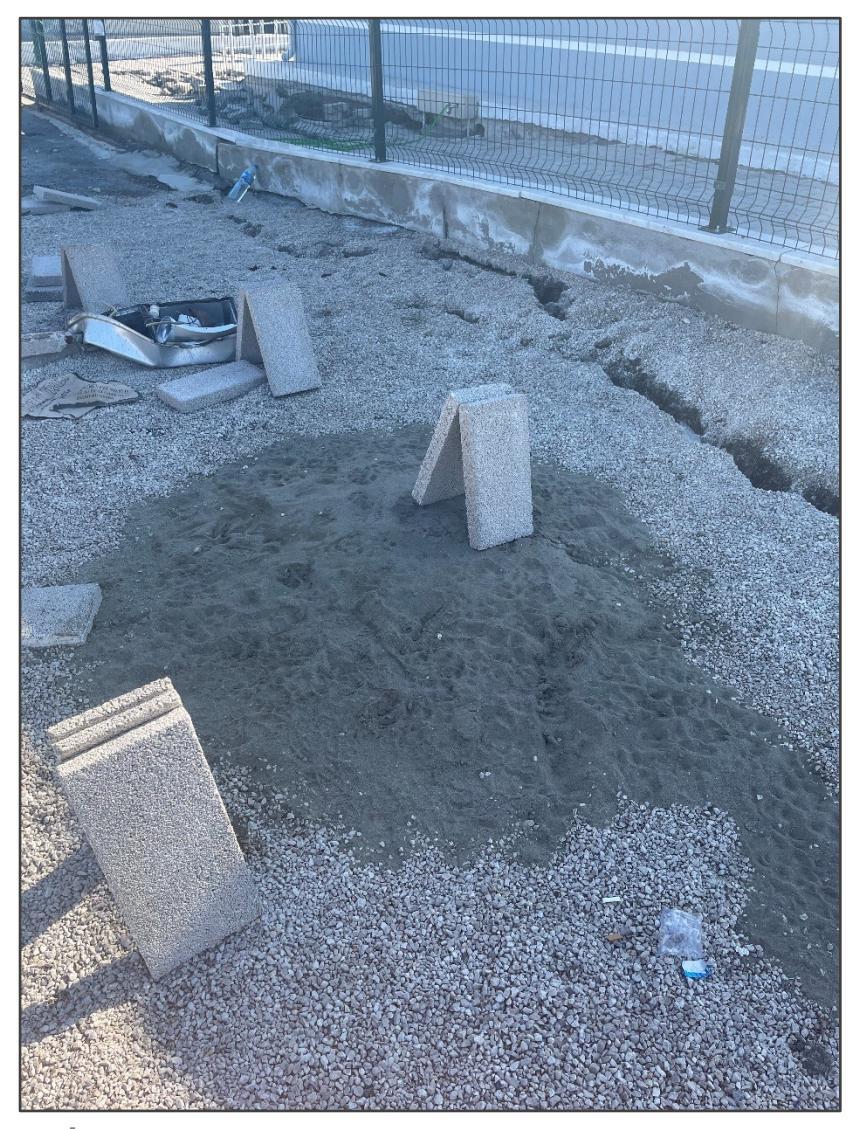
Liquefaction-induced deformations at a private port in İskenderun and Fishery Warf

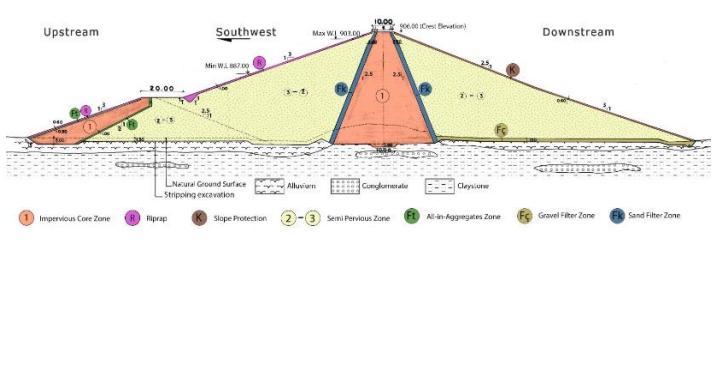
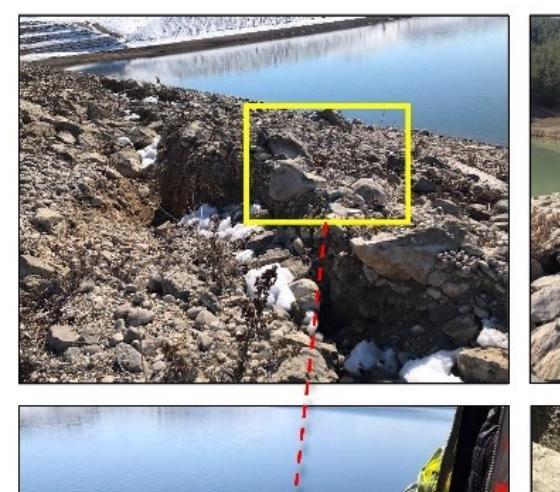
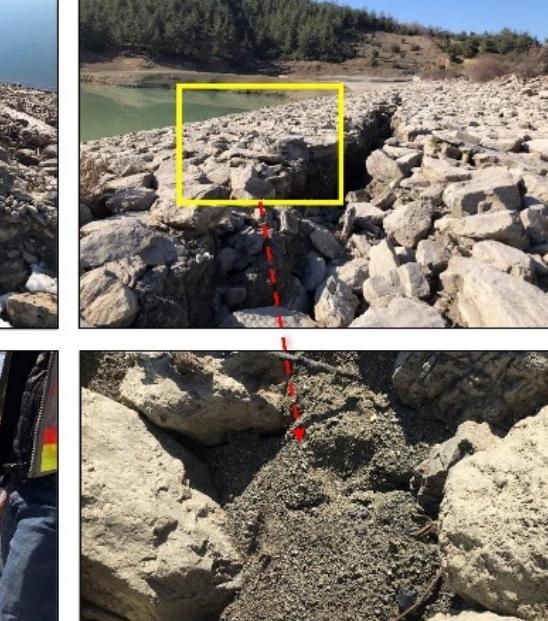
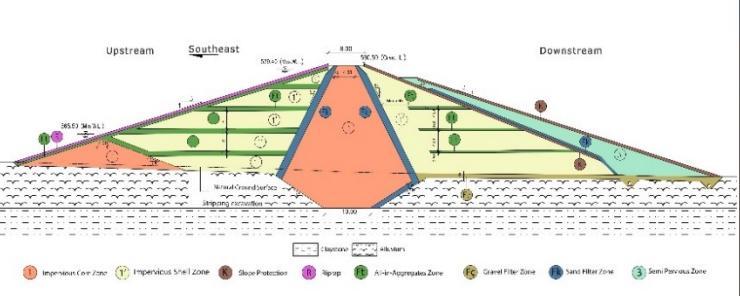
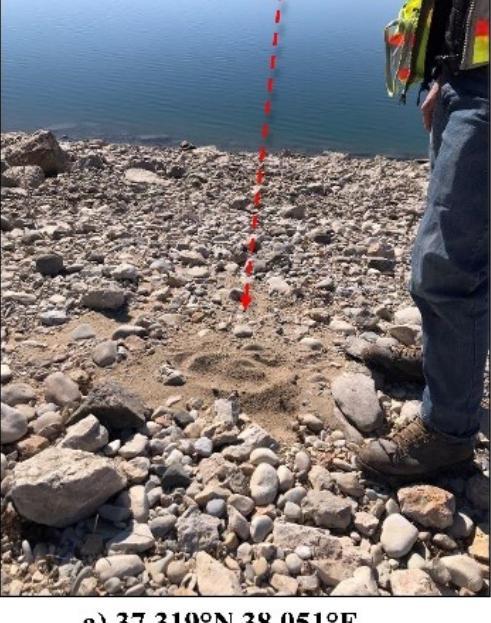
a) 37.319°N 38.051°E Surface manifestation of liquefaction observed at a) Sultansuyu Dam and b) Arıklıkaş Dam

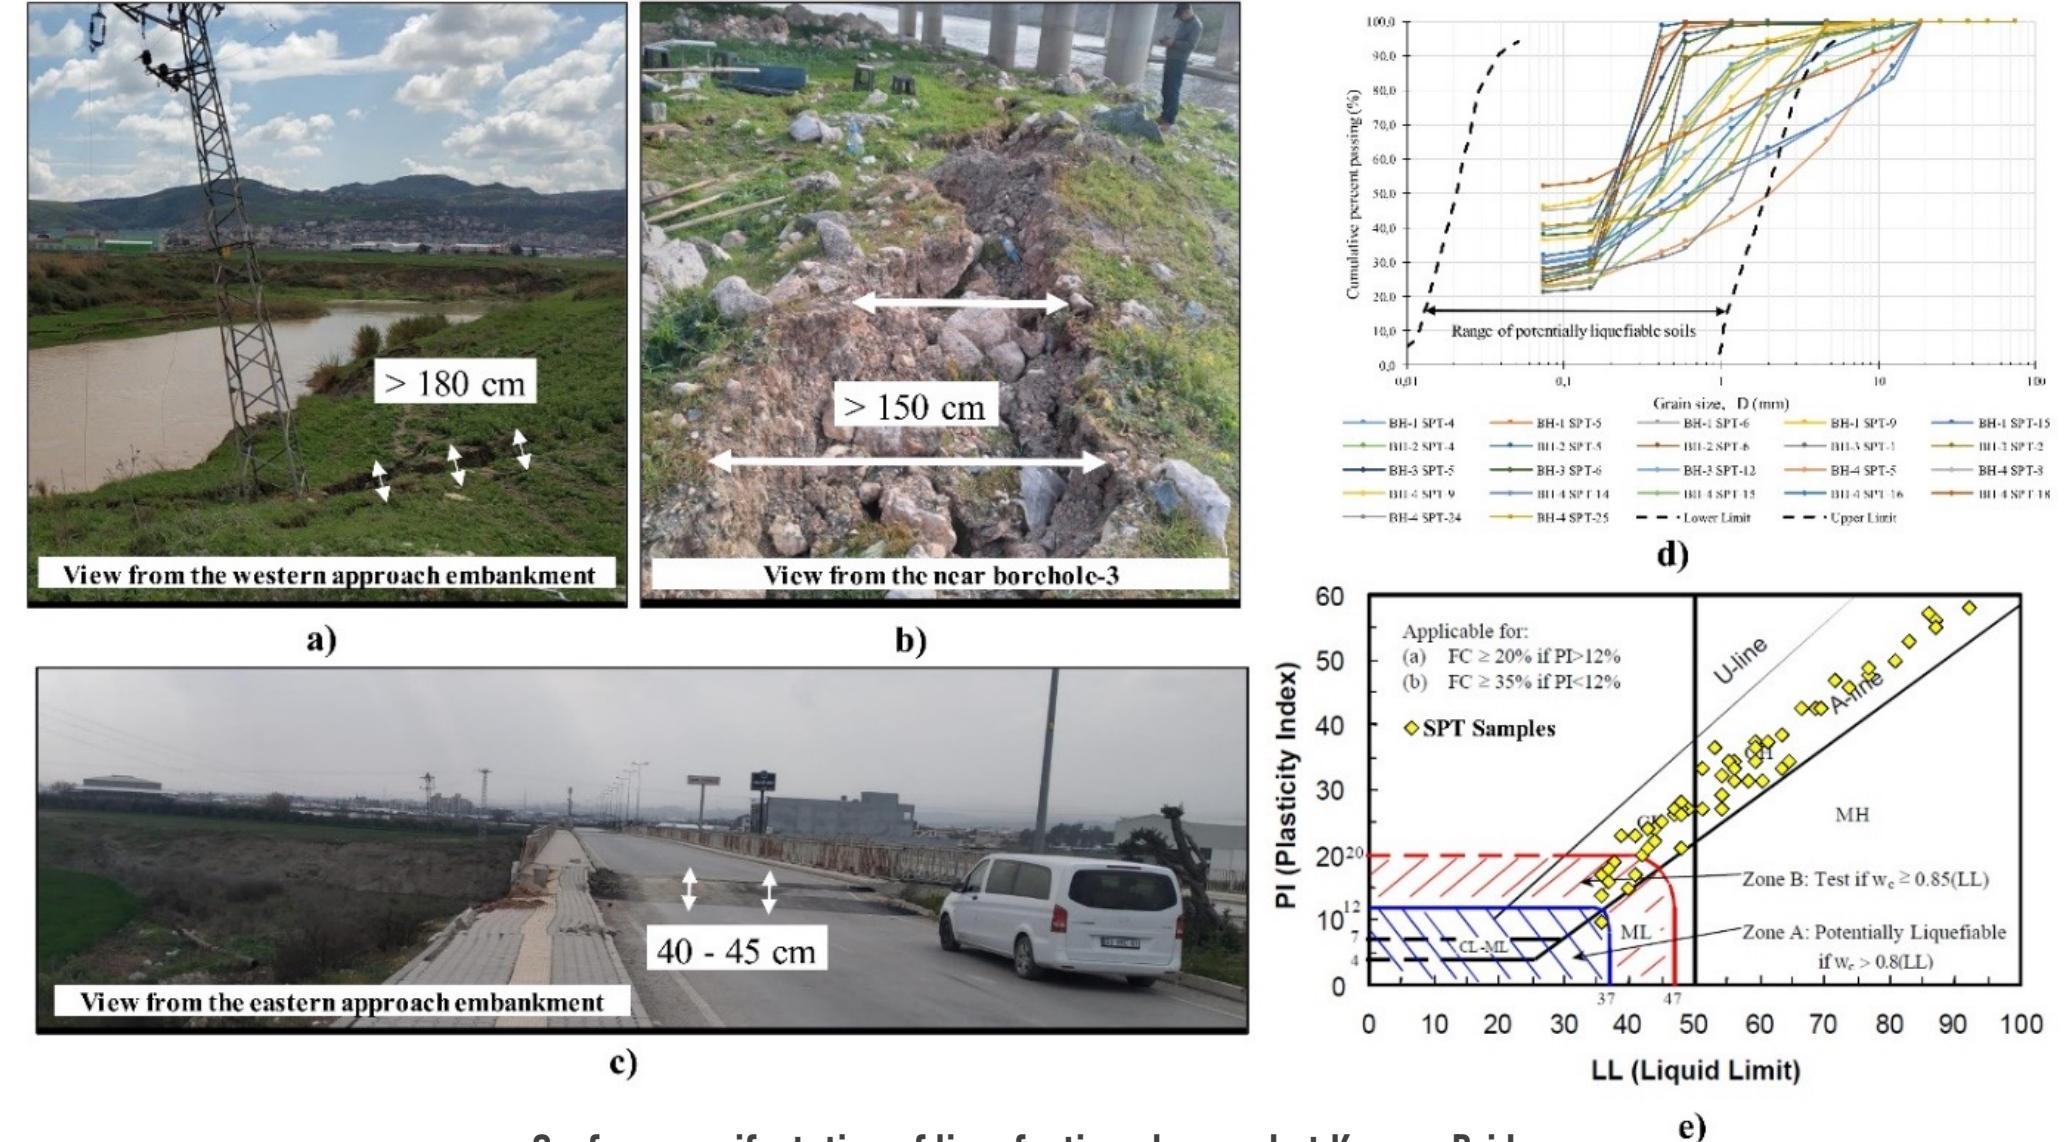
Surface manifestation of liquefaction observed at Karasu Bridge

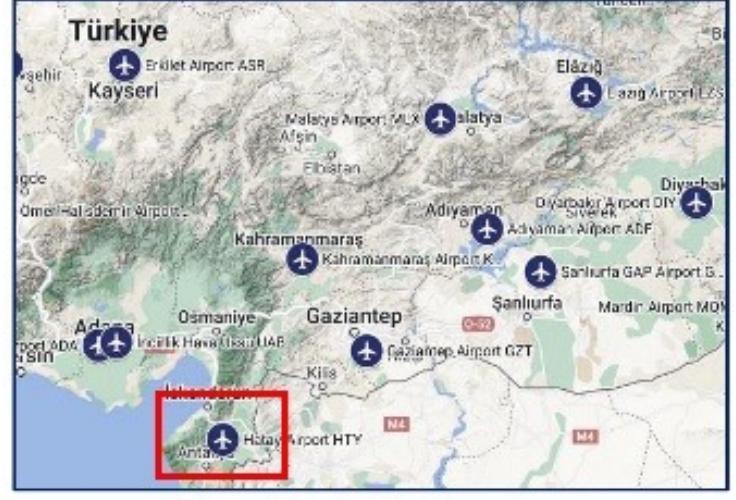
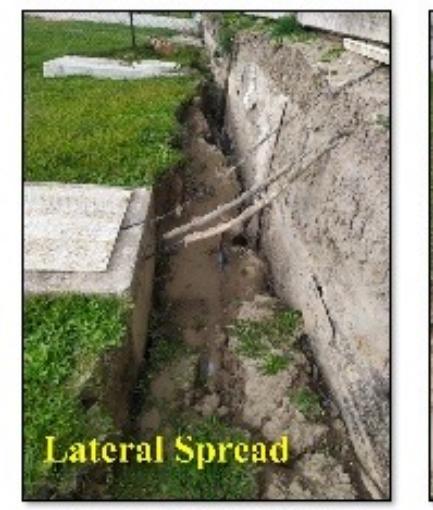
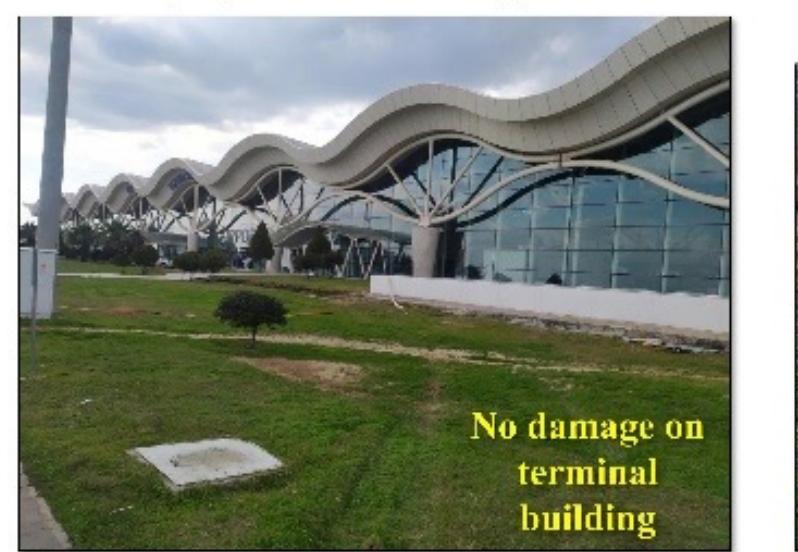
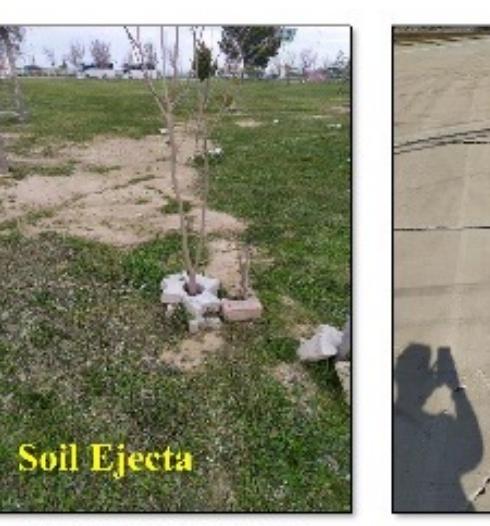
Surface manifestation of liquefaction observed at Hatay Airport

- Clayey soils with PI > 20 % produced ejecta in Gölbaşı-Adıyaman and at Hatay Airport.

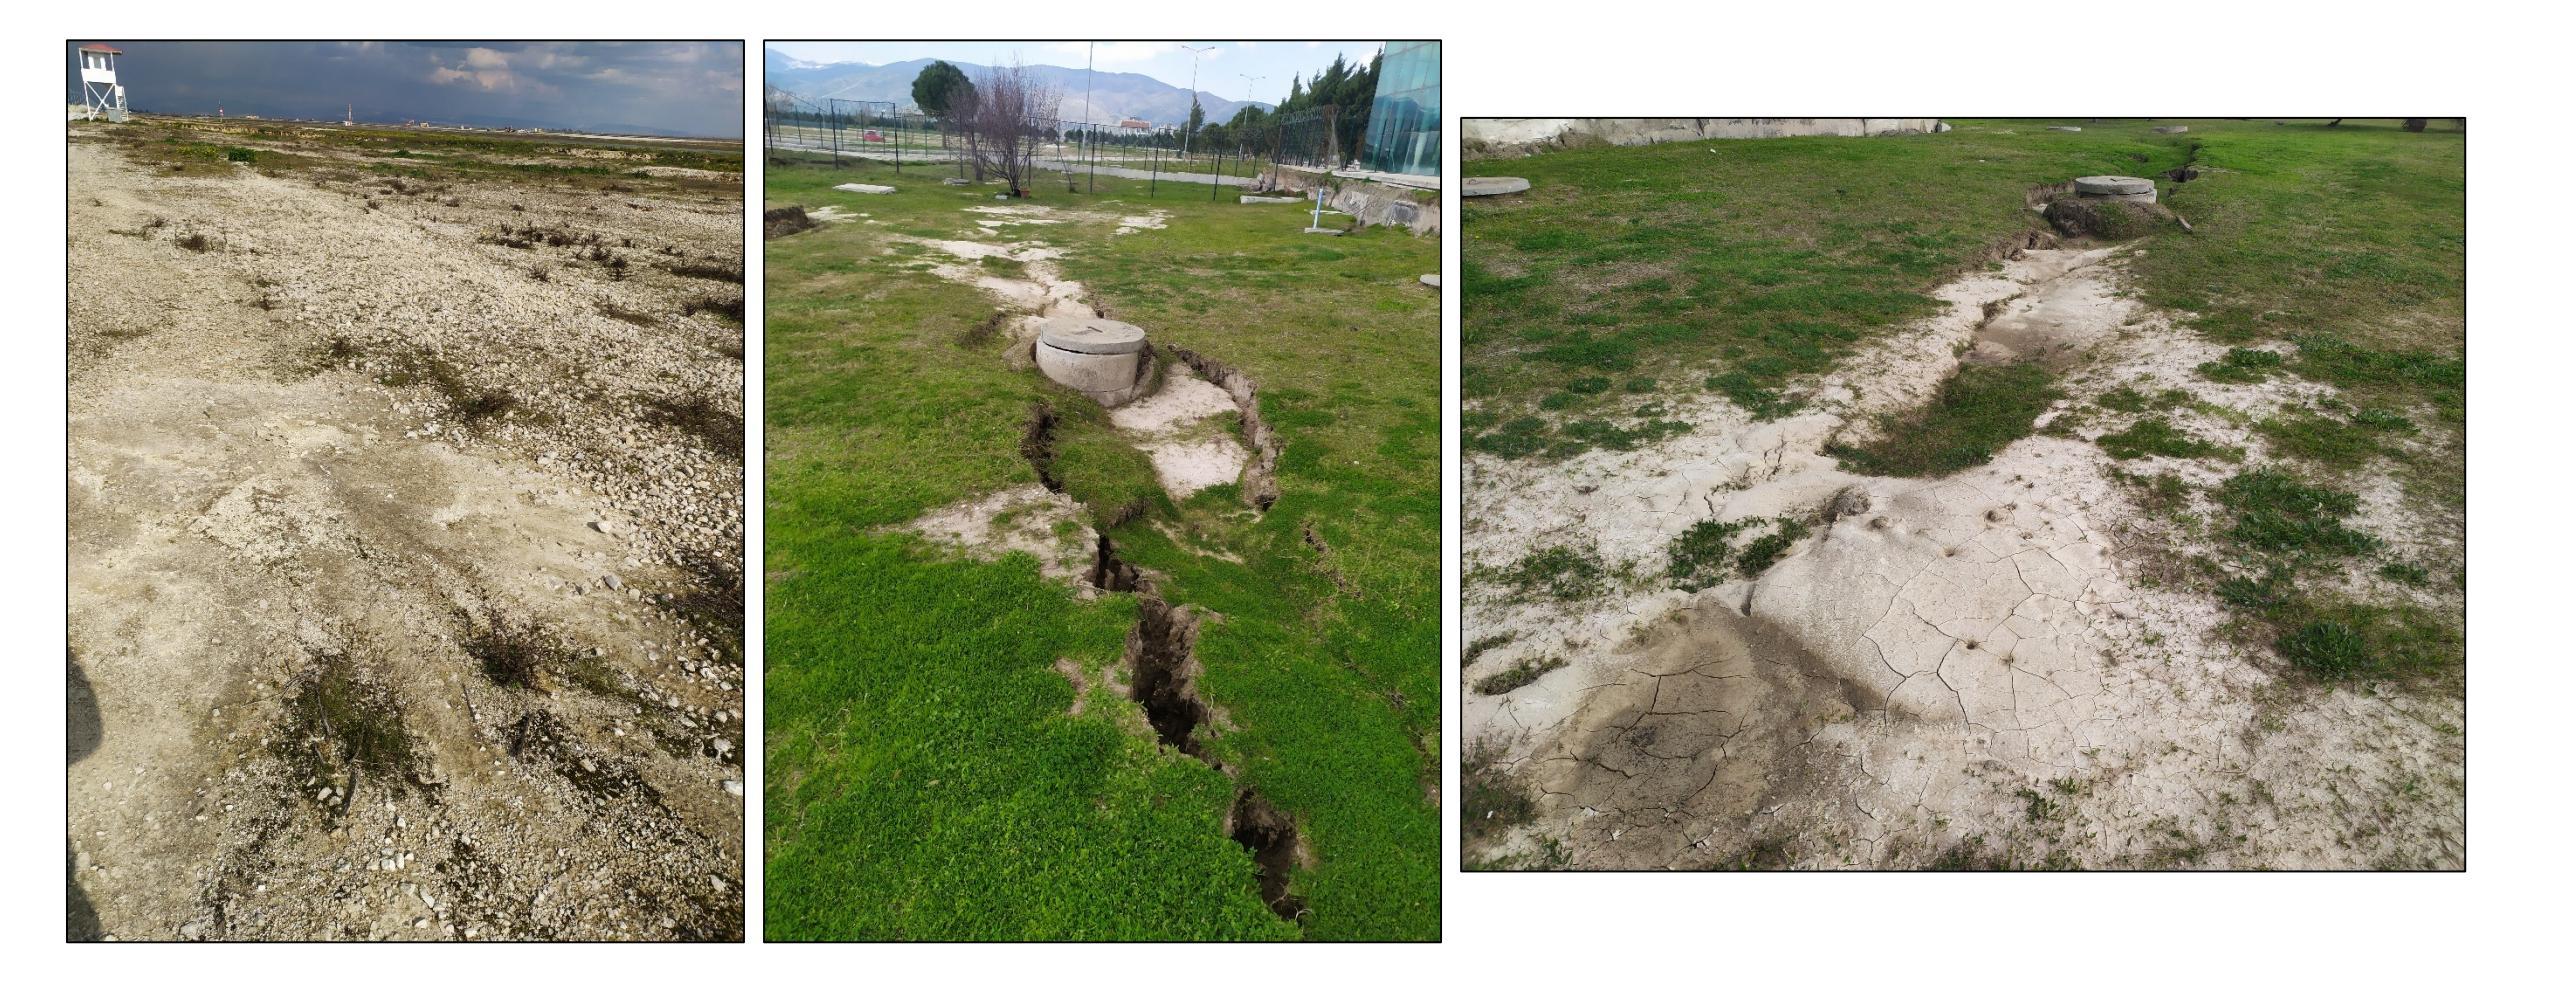
Surface manifestation of liquefaction observed at Hatay Airport

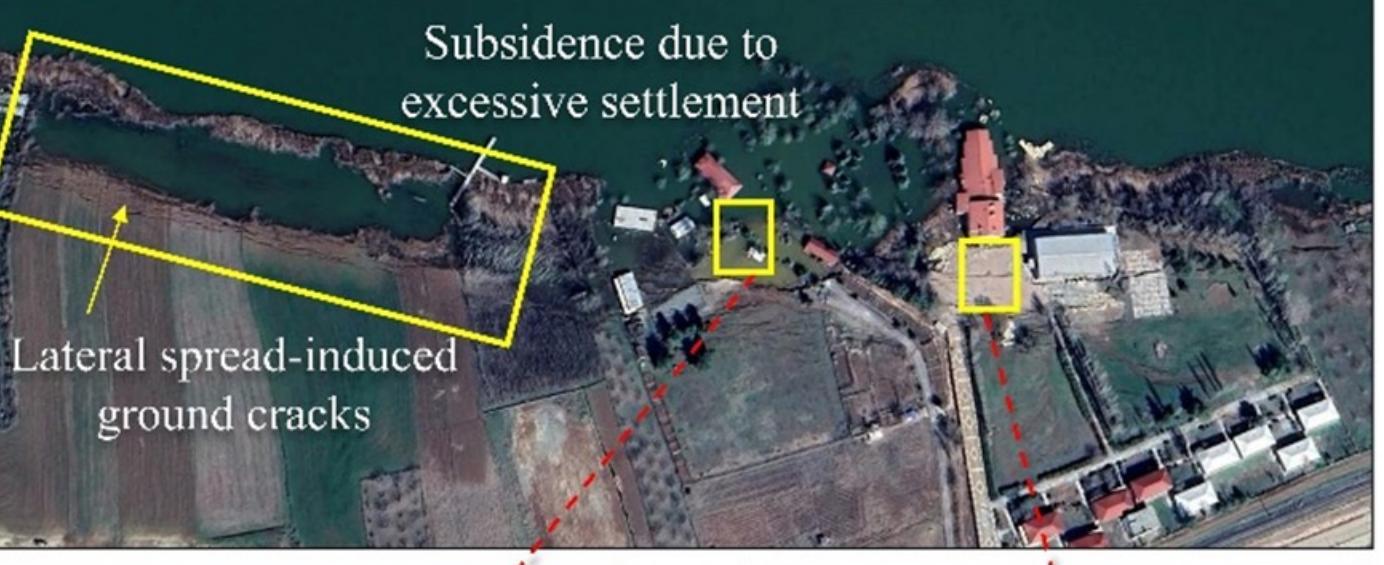
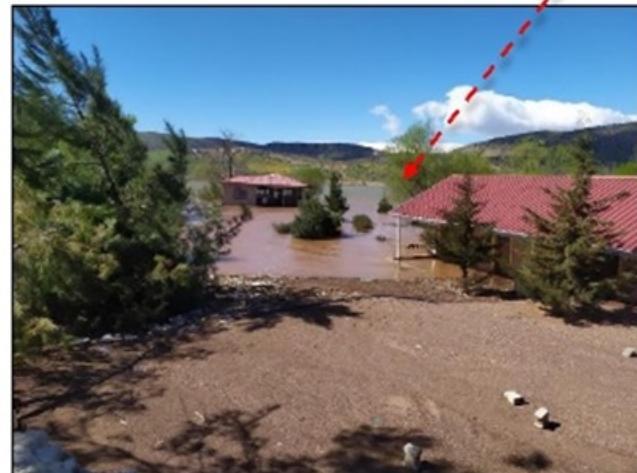
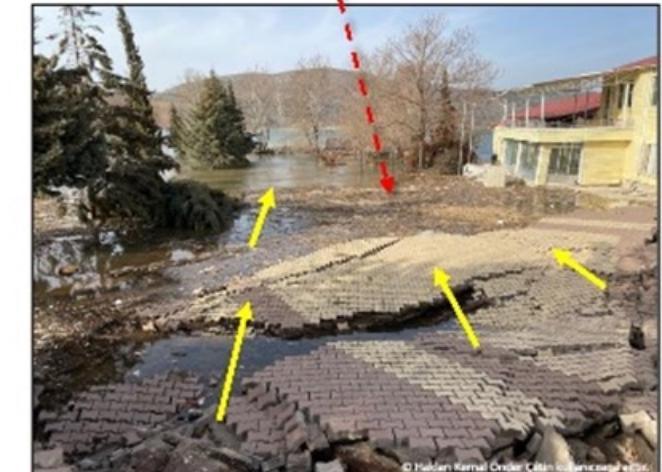
Lateral spreading and subsidence observed in Gölbaşı-Adıyaman adapted from Cetin et al. (2024)
