MIDDLE EAST TECHNICAL UNIVERSITY

Earthquake Engineering Research Center

Geotechnical Aspects of February 6, 2023 Kahramanmaraş-Türkiye Earthquake Sequence (Mw=7.8 and Mw=7.6)

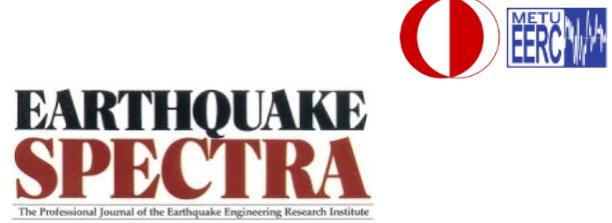
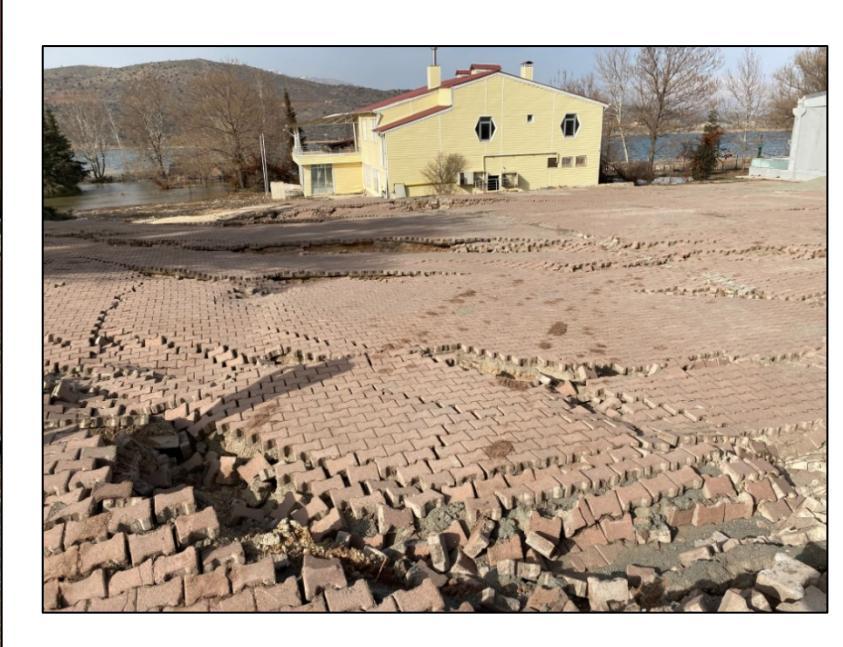
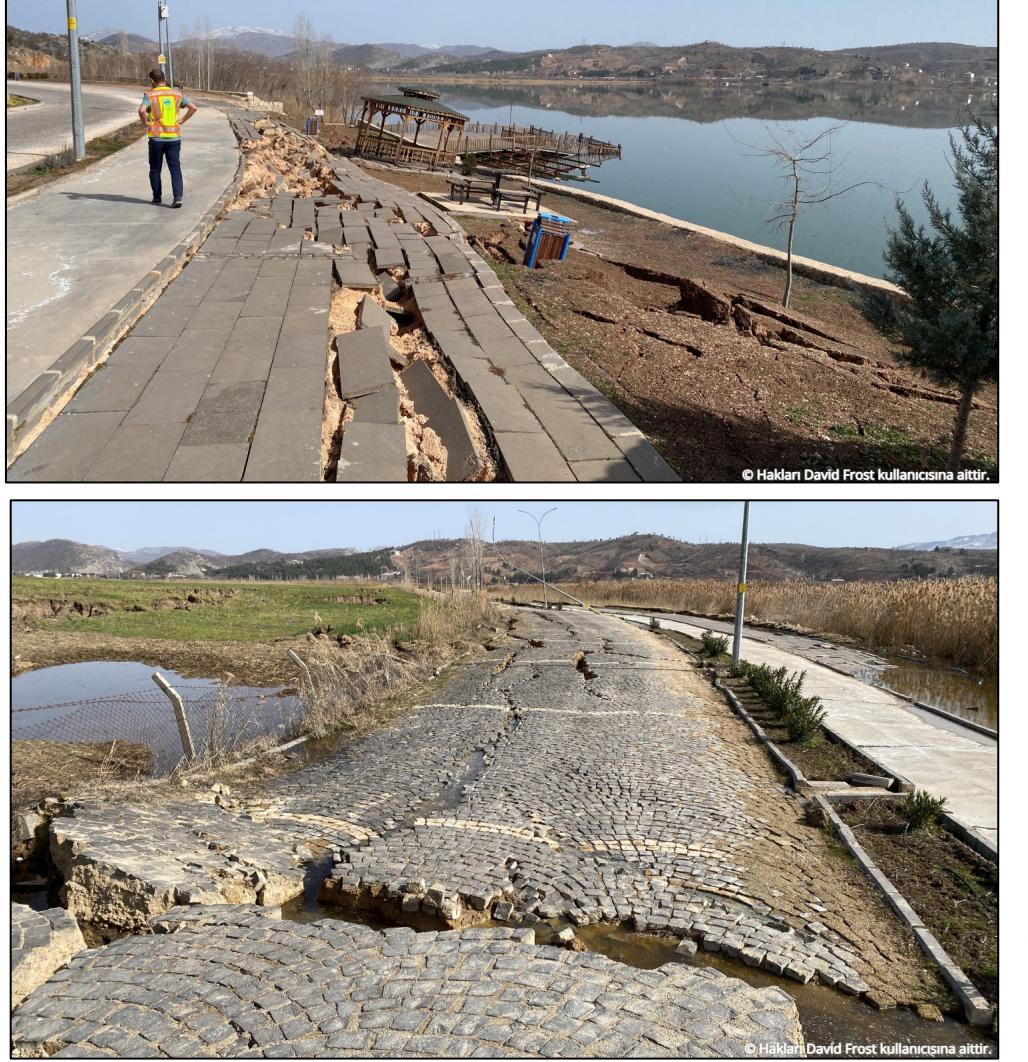
Lateral spreading and subsidence observed in Gölbaşı-Adıyaman adapted from Cetin et al. (2024)

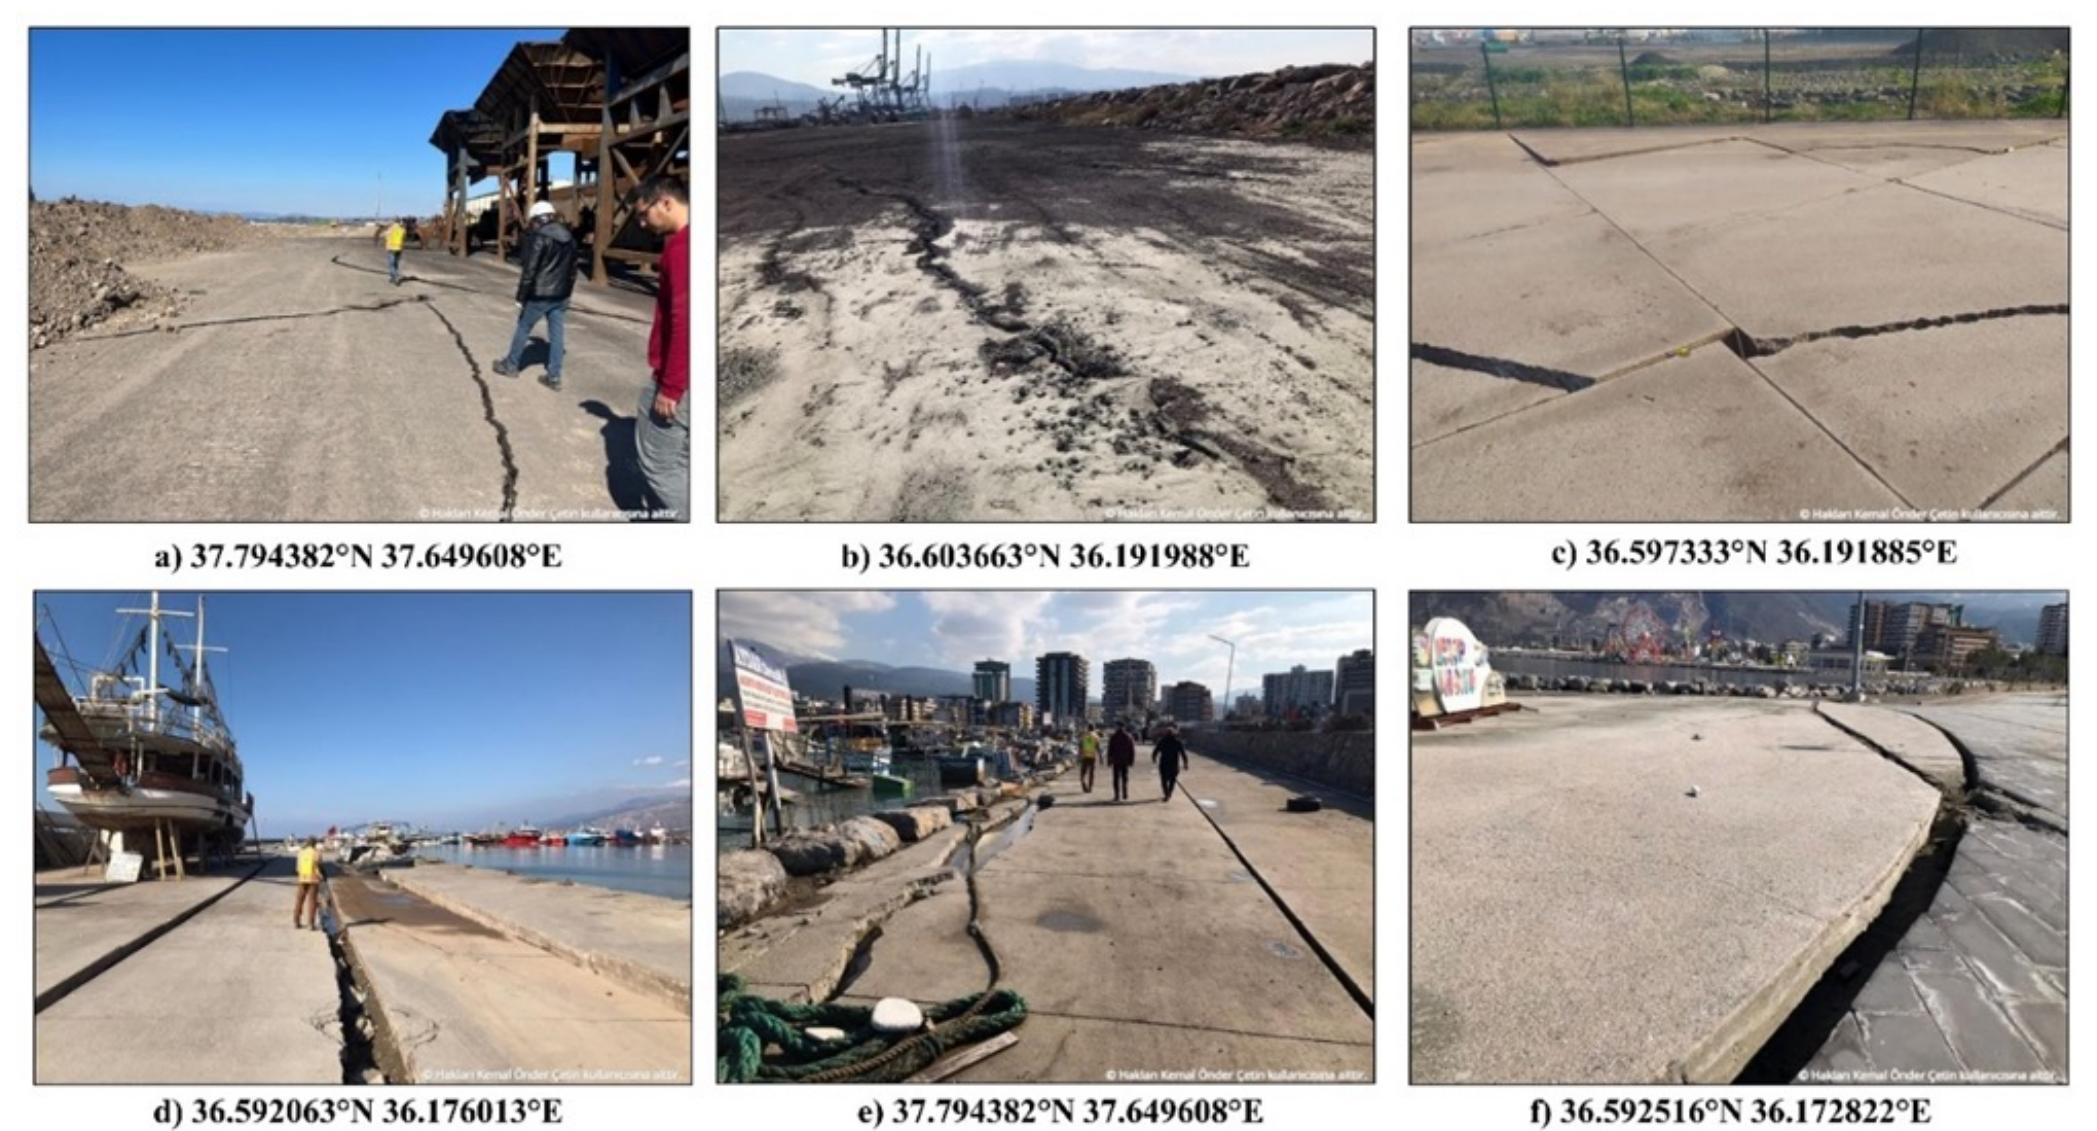
Lateral spreading observed in Hatay-İskenderun

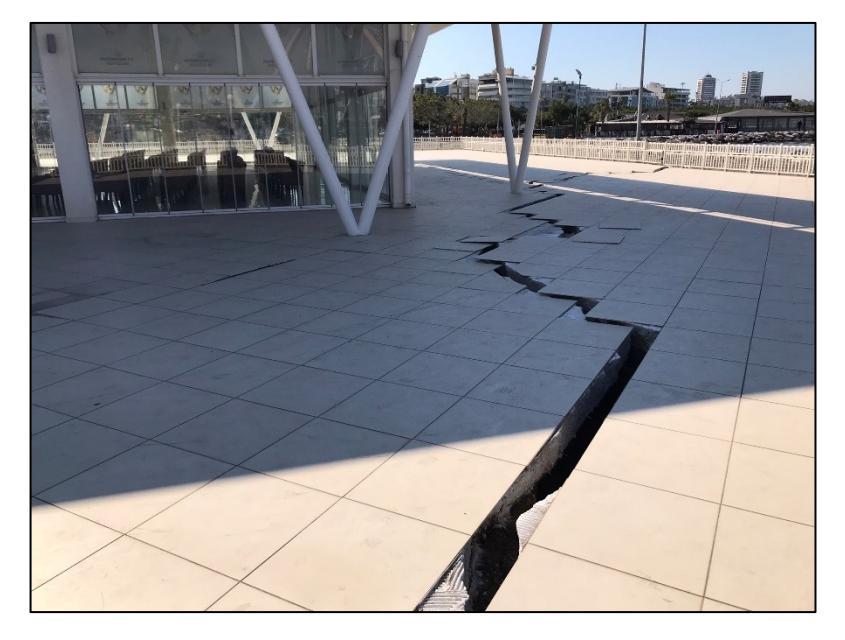
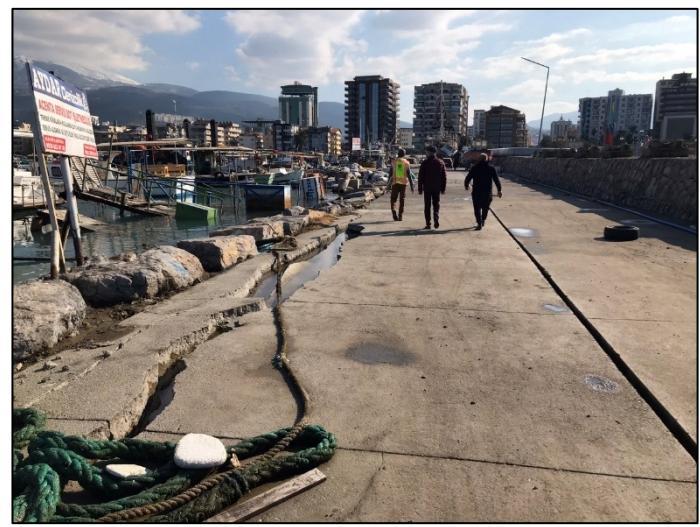
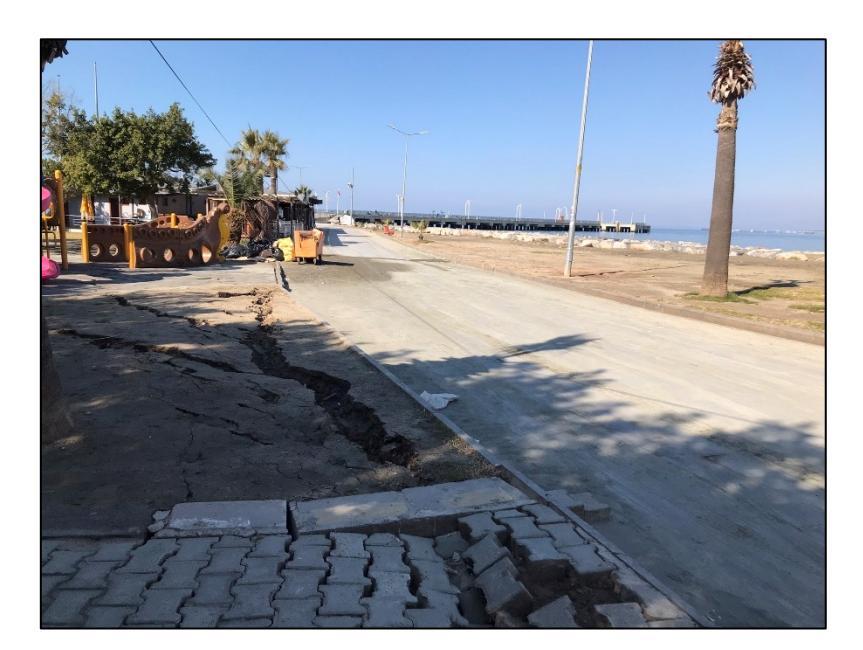
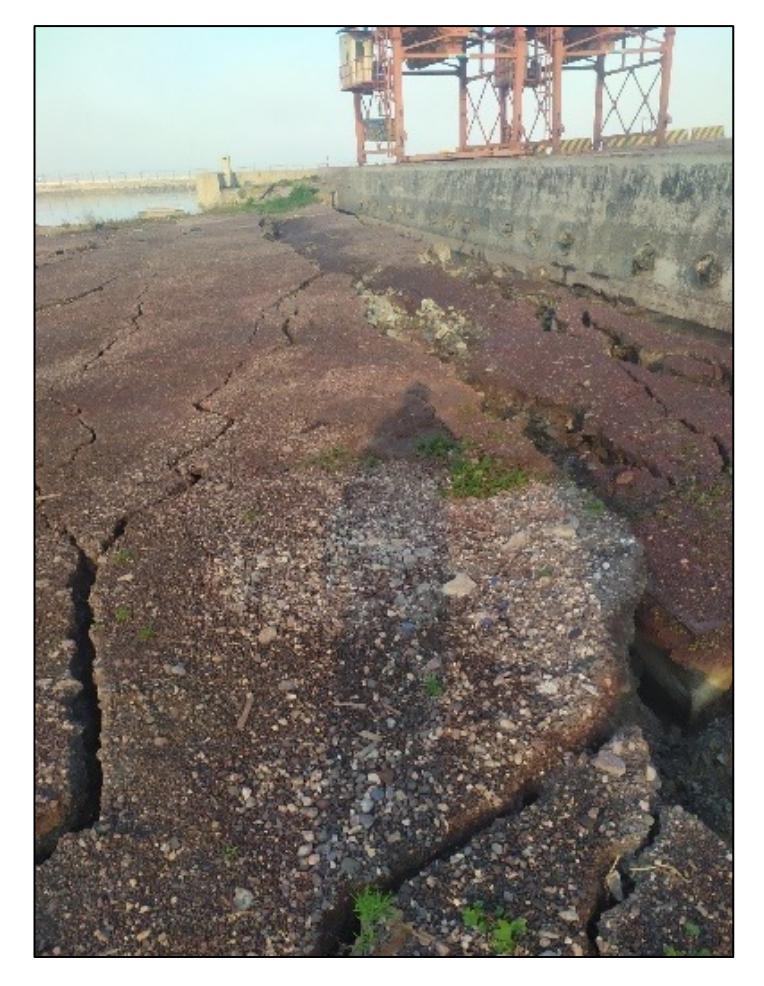
Lateral spreading observed in Hatay-İskenderun

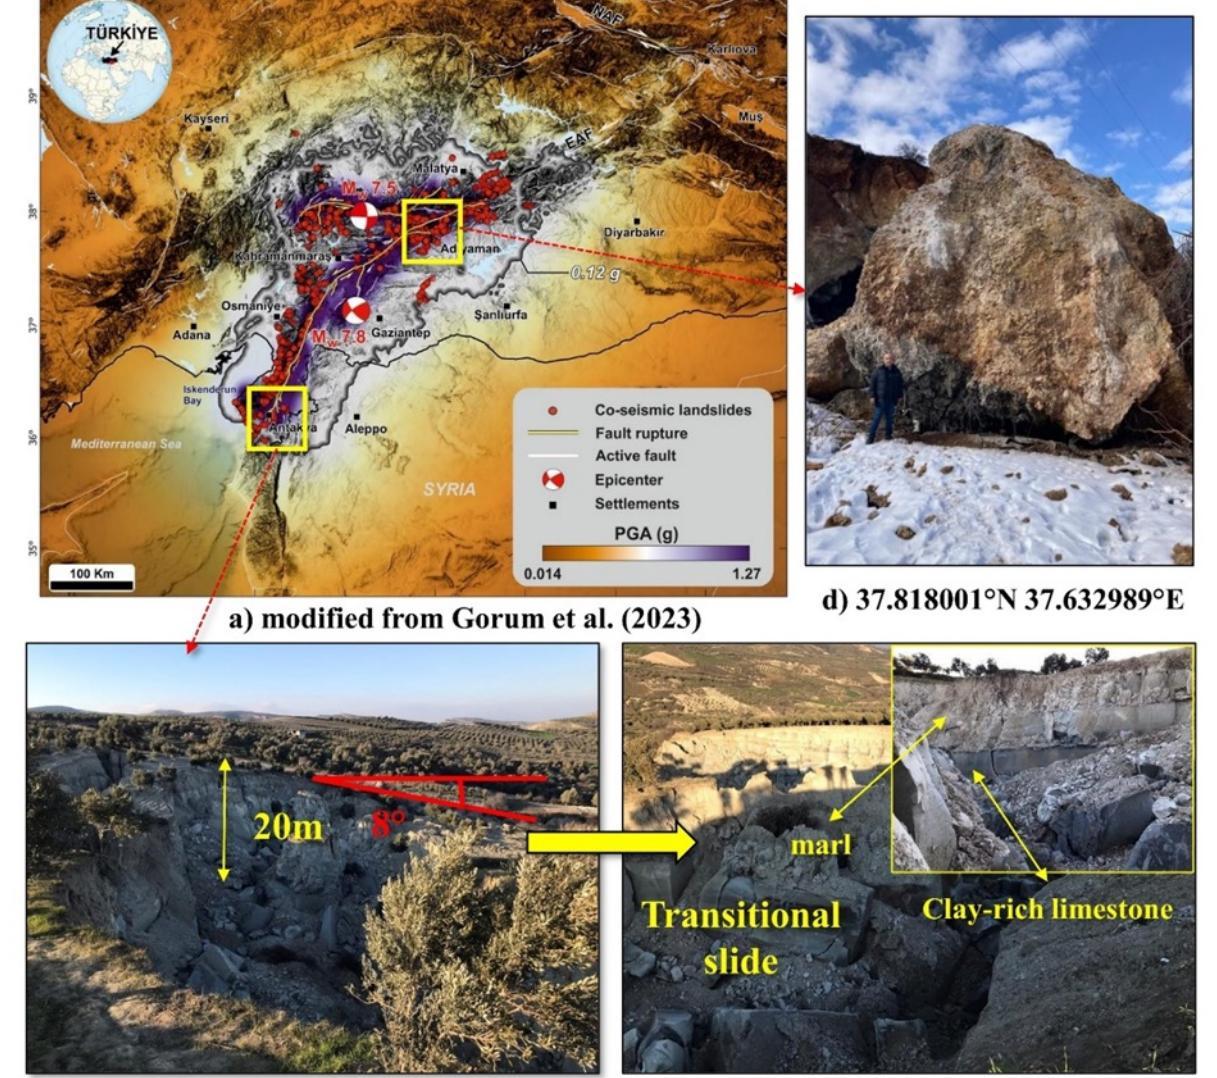
- A total of 3673 coseismic landslides associated with these events
- Over 90% of mapped landslides occurred within a 20km-wide zone along the fault rupture.

a) Spatial distribution of coseismic landslides overlain by the Kahramanmaraş Earthquakes fault rupture and PGA recordings for M>5.5 modified from Gorum et al. (2023),

b, c) transitional slide in Tepehan Village, and

d) rockfalls reported in Karamağara-Gölbaşı

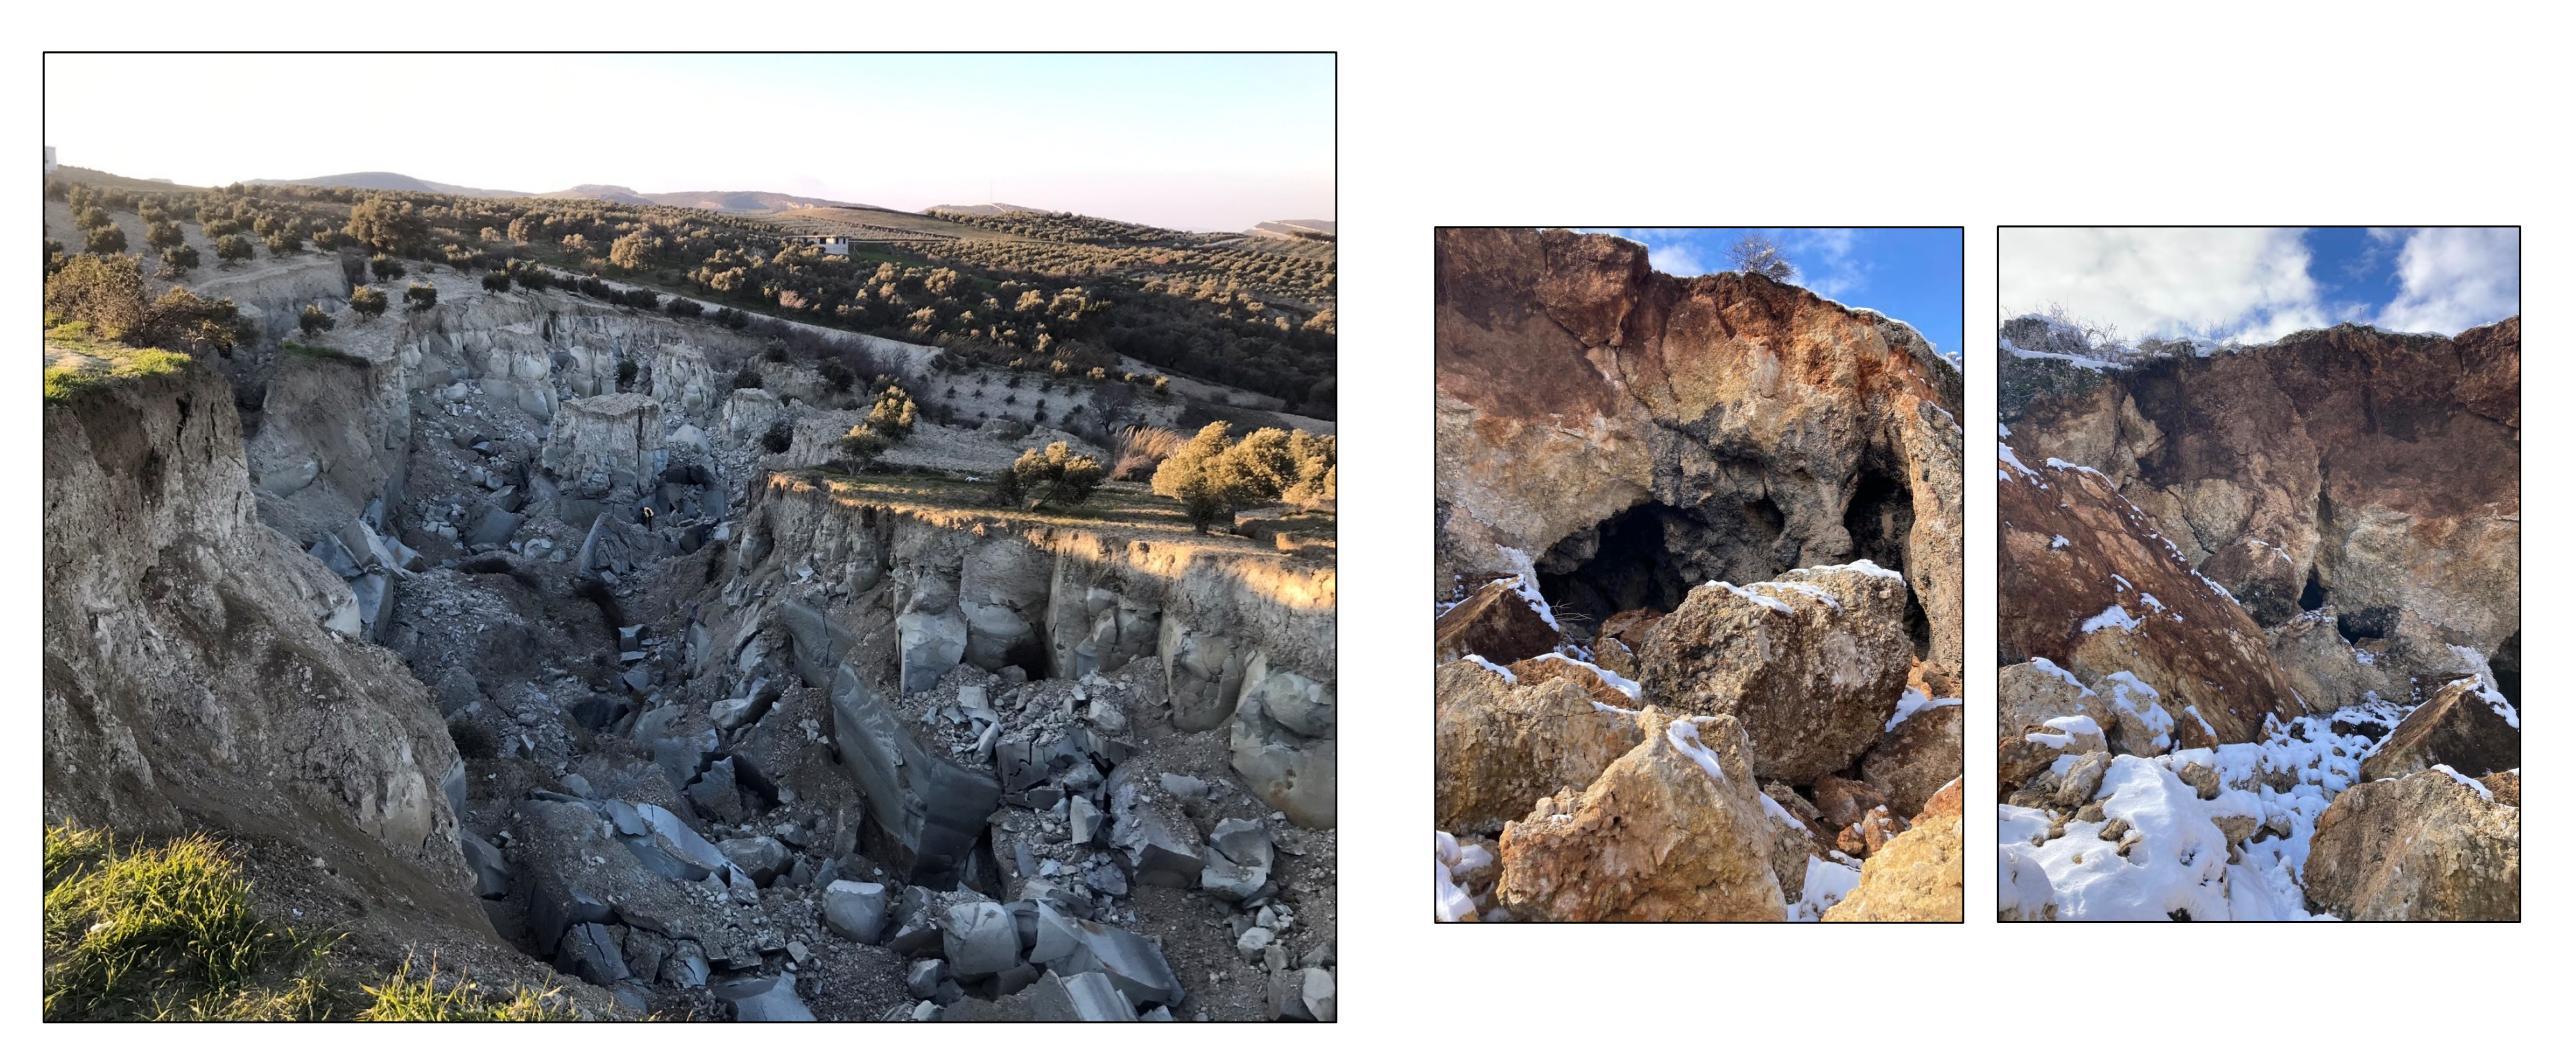
Landslide observed in Tepehan-Hatay and Rockfalls observed in Karamağara-Gölbaşı-Adıyaman

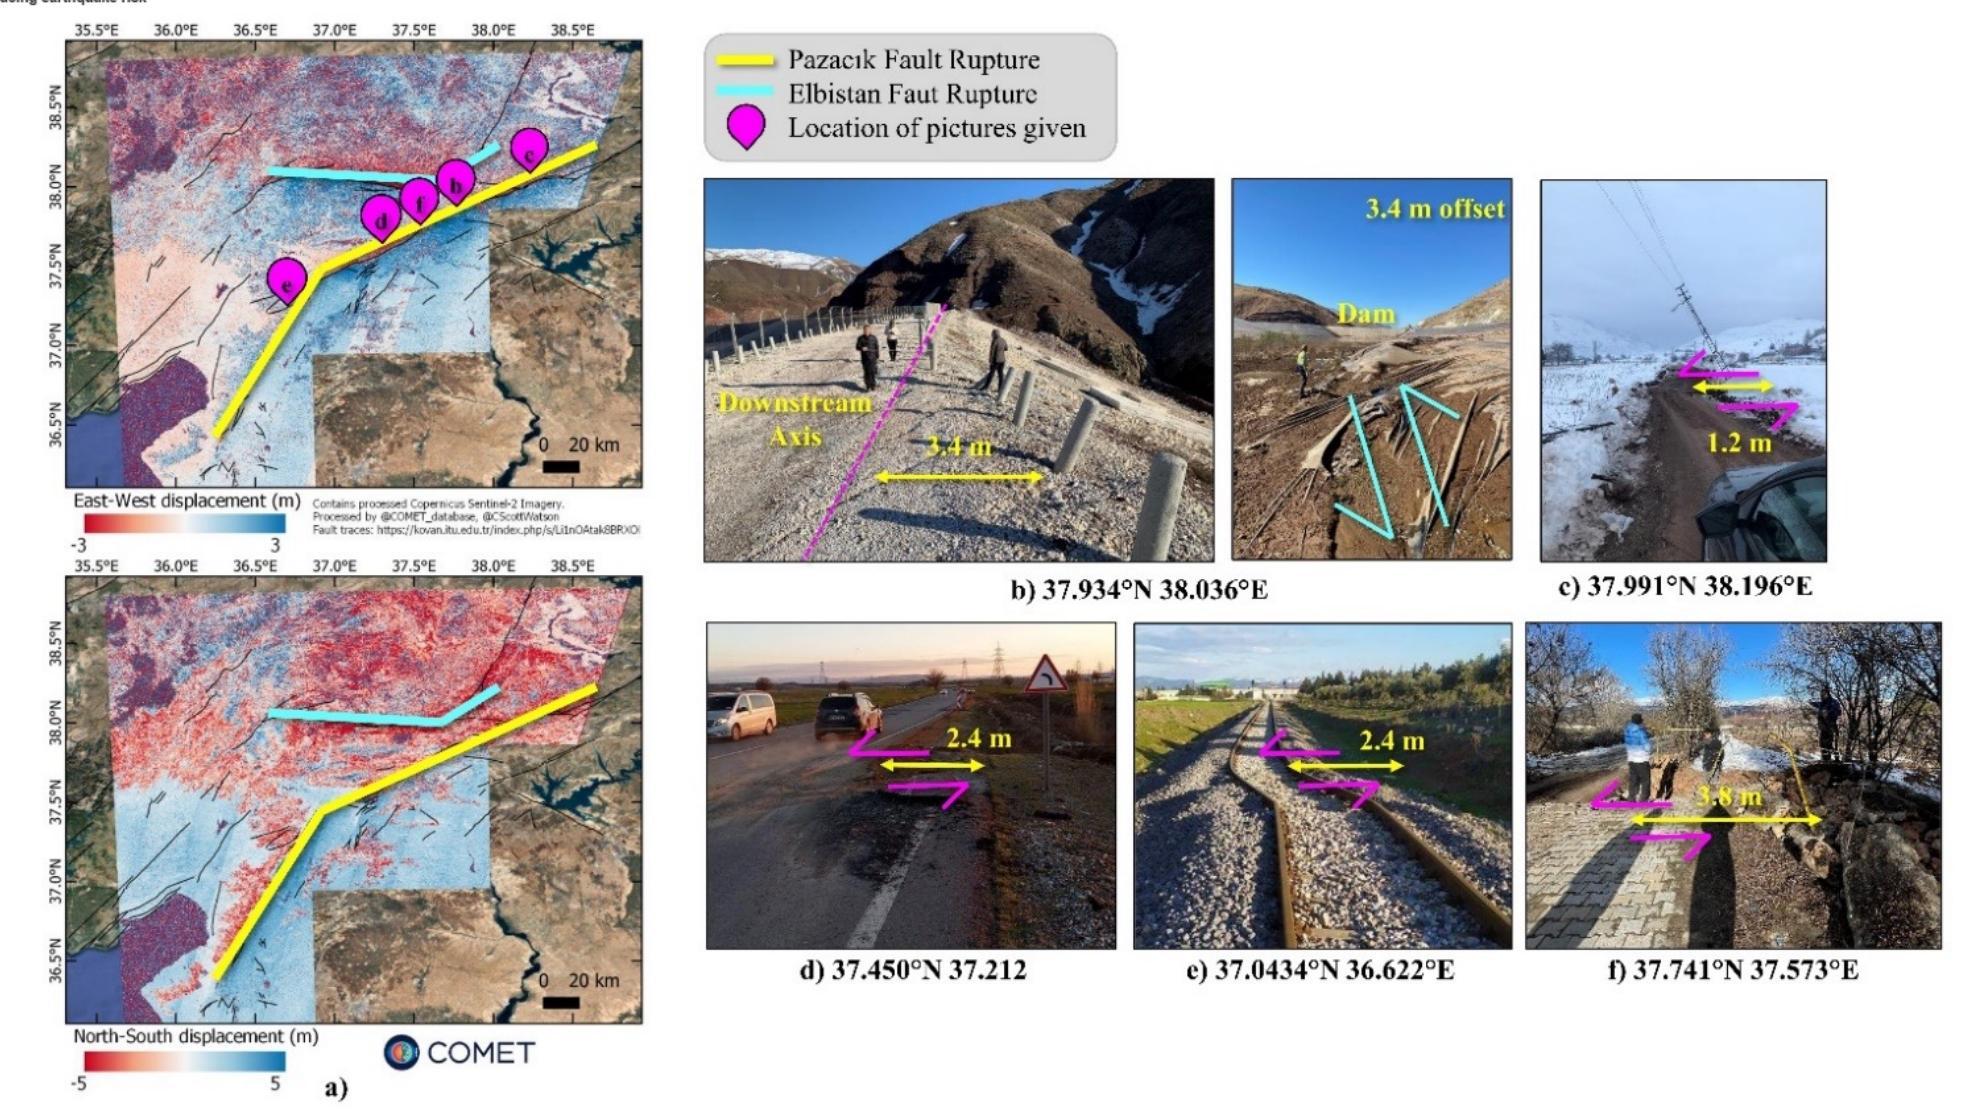
a) Sentinel-2 deformation analyses provided by COMET after Cetin and Ilgac (2023), b) fault offsets mapped b) across the Erkenek Dam, in c) Çelikhan, d) Pazarcık, e) Islahiye, and f) Balkar
