EERI Earthquake Reconnaissance Report: M_L 7.2 Earthquake of April 3, 2024 in Hualien, Taiwan

September 2024

A product of the EERI Learning From Earthquakes Program

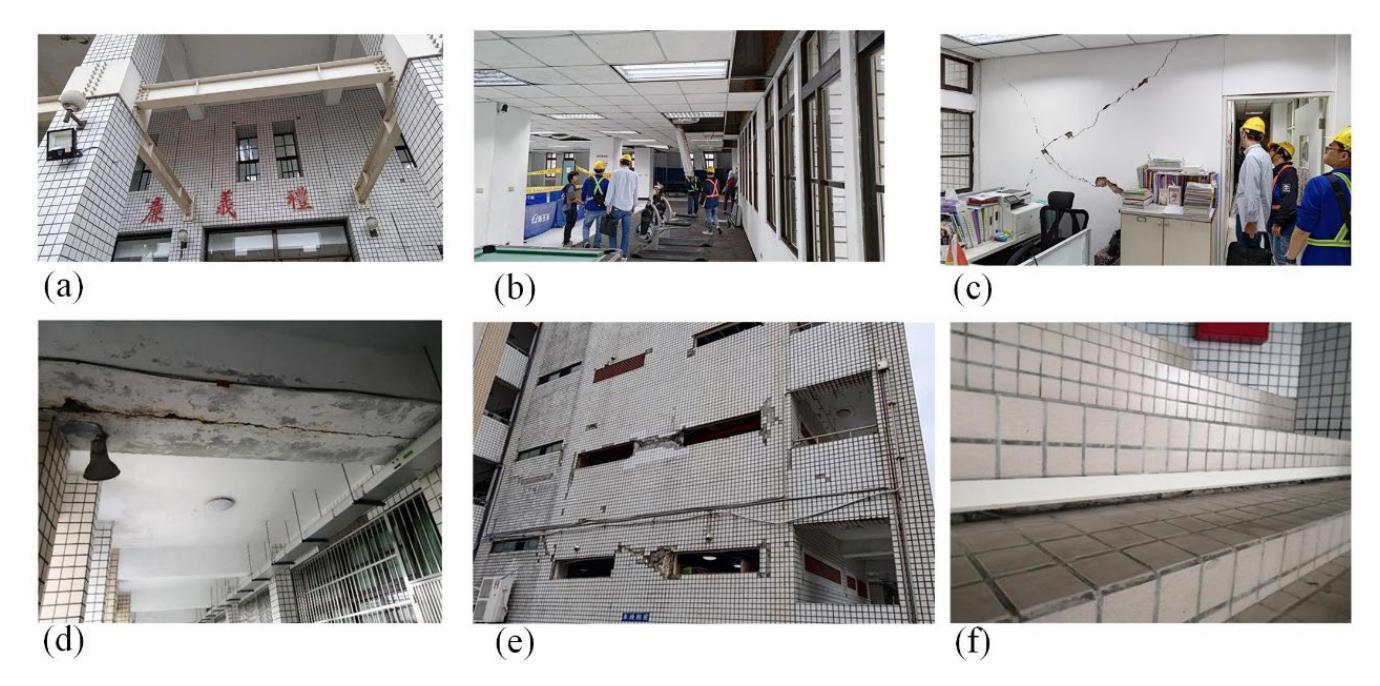
administration building collapsed, which typically results from the edge ceiling pushing against the wall under the exertion of earthquakes. This figure also shows that a vent pipe, originally concealed above the ceiling, was dislodged and thrust through the ceiling. On the 2nd story of the administration building, a partition brick wall cracked in two diagonal directions (Figure 6(c)). Figure 6(d) indicates that a longitudinal crack occurred at the bottom of a wide beam; this longitudinal crack was along the contact surface between two adjacent beams belonging to separate buildings. Because the two school buildings were arranged perpendicular to each other, different vibration periods of the buildings resulted in cracks at the interface. Soft material such as styrofoam that is typically used in expansion joints between such buildings was not observed. Figure 6(e) indicates that shear cracks occurred in short columns. Subsidence was also observed on the step of a stair on the long side of an indoor swimming pool (Figure 6(f)). Nevertheless, because both the swimming pool itself and the structure housing the swimming pool remained intact, the influence of the observed subsidence was limited. Except for the shear cracks and the failure of nonstructural components shown in Figure 6(e) and Figure 6(b), the overall seismic performance of the inspected buildings at Zhonghe Senior High School was satisfactory. This proves the effectiveness of the seismic retrofitting conducted before the Hualien earthquake of 3 April 2024.

Figure 6. (a) Previous seismic retrofit work, (b) collapse of edge ceiling and vent pipe, (c) shear cracks in partition brick wall, (d) horizontal crack along the interface of two side-by-side beams, (e) shear cracks in short columns, (f) subsidence on a stair step.

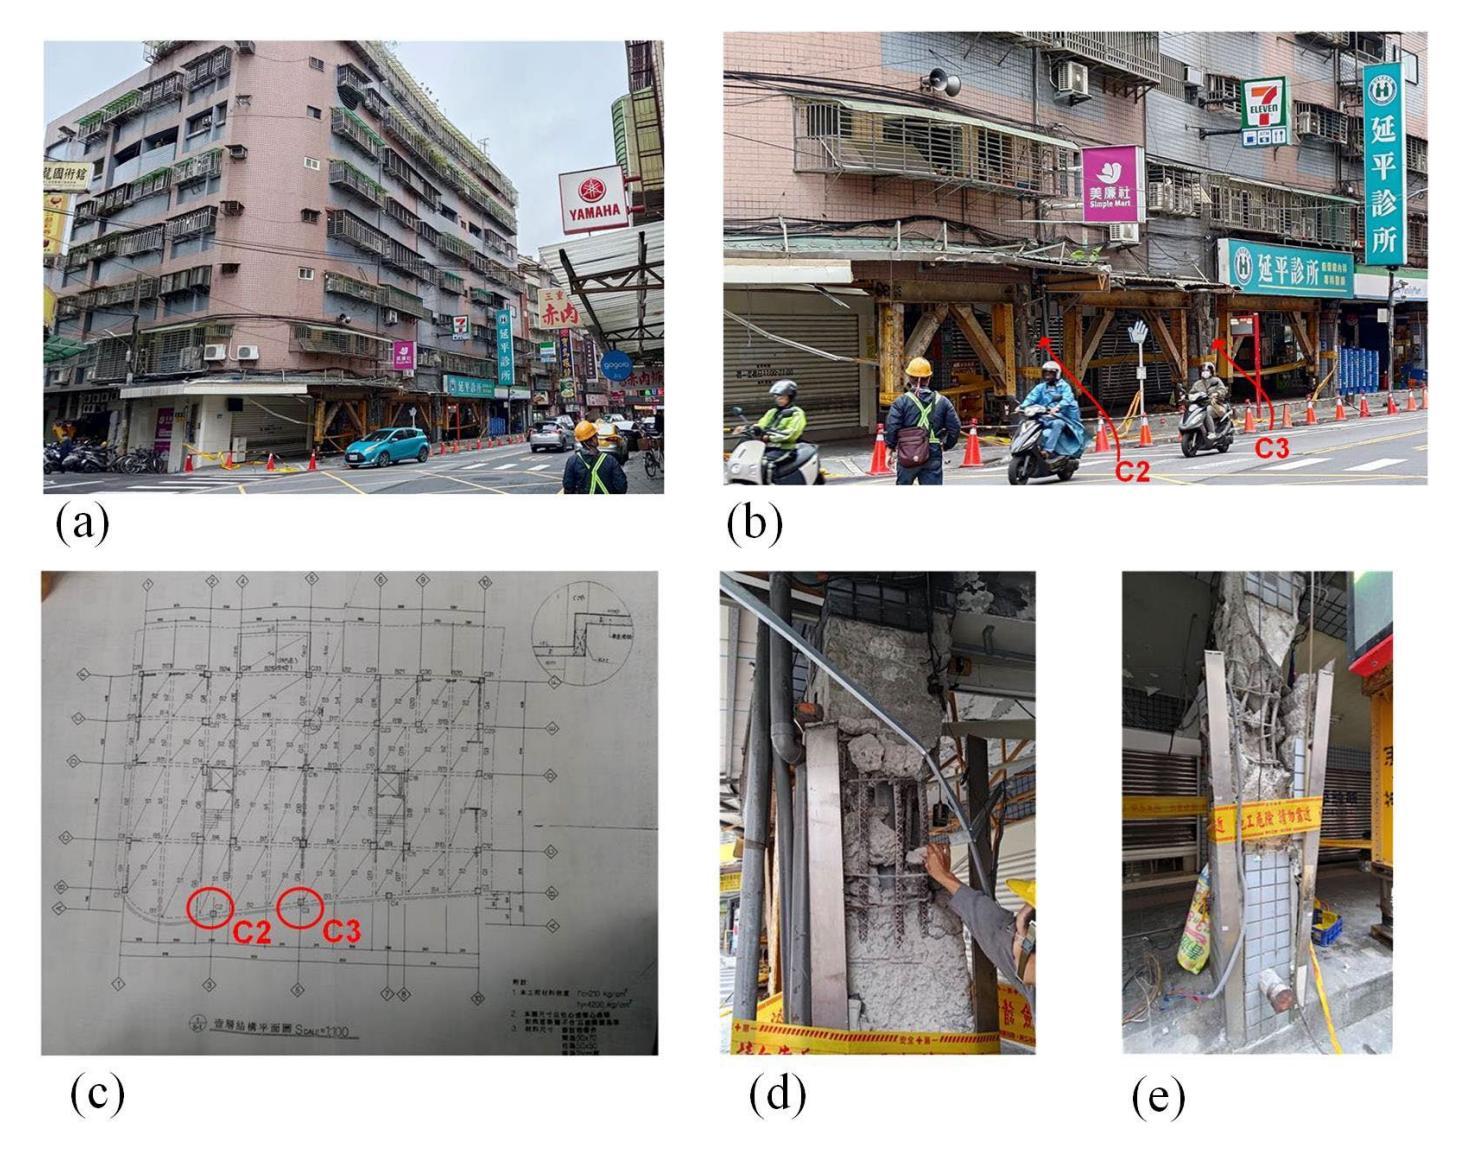
The first street building is a 32-year-old building with eight stories and one basement. The building is located at the intersection of two perpendicular streets (Figure 7(a)). Figure 7(b) presents a close-up view of Figure 7(a) to clearly display the three-span temporary shoring for two damaged columns due to the seismic event. According to the structural plan (Figure 7(c)), the two damaged columns are denoted as C2 and C3, each measuring 50 cm × 50 cm and are specifically highlighted in Figure 7(b) and Figure 7(c). Figure 7(d) and Figure 7(e) show the damage states of columns C2 and C3, respectively. The upper halves of the confined concrete of both columns C2 and C3 were crushed. In addition, the main reinforcements were buckled. Figure 7(d) reveals that a drainage pipe with a diameter of approximately 10 cm was embedded in the center of column C2. Additionally, the maximum spacing of stirrups of column C2 was approximately 40 cm (Figure 7(d)). According to the structural design drawings, the main reinforcements were uniformly

distributed over the four sides of the columns, there should have been six reinforcements on each side of the column. However, Figure 7(d) and Figure 7(e) show that the number of reinforcements of columns C2 and C3 were insufficient. According to the structural design drawing, the spacing of stirrups of columns C2 and C3 should be 15-25 cm, but the 40 cm spacing of stirrups of column C2 (Figure 7(d)) significantly exceeded the design spacing. Therefore, the poor construction quality of the street building was probably a critical factors leading to its structural failure.

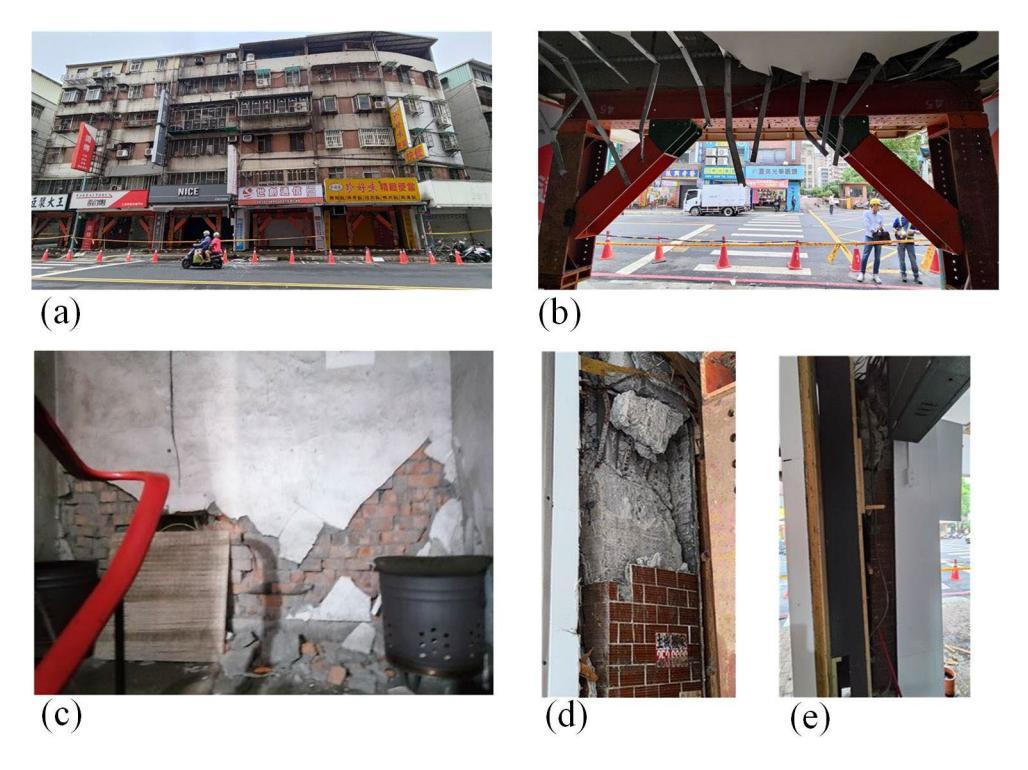
Figure 8. (a) The second street building, (b) an outlook from the arcade toward the street, (c) a damaged brick wall of a staircase, (d) and (e) damaged columns.

cross sections of corridor columns or adding braces along the corridor could effectively enhance the seismic retrofitting of street buildings.

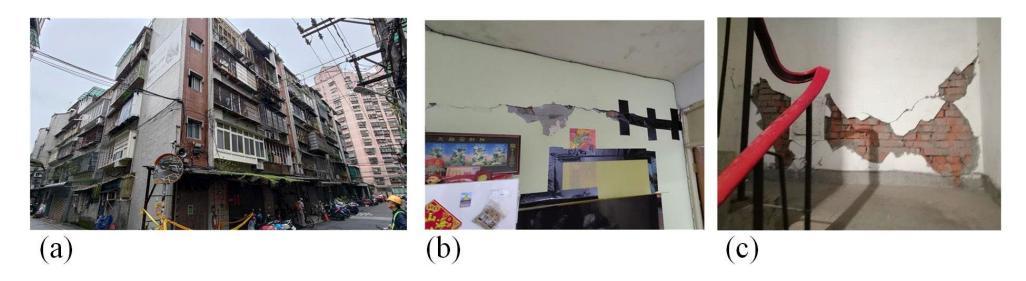
The third street building is a 41-year-old five-story building (Figure 9(a)). Because the building is located in lanes rather than on a main road, the first story is used for residence, which differs from those of the first and second street buildings. Figure 9(b) shows a horizontal crack in an indoor brick wall. The horizontal crack appeared along the interface between the bottom of a beam and the top of a wall. Figure 9(c) shows the cracks in a brick wall of a staircase. The shear cracks in the brick walls shown in Figure 8(c) and Figure 9(c) demonstrate the role of brick walls in resisting earthquake loads. Notably, out-of-plane toppling of brick walls was not observed during this seismic reconnaissance. This observation suggests that the brickwork adopted in Taiwan is generally effective in preventing brick walls from toppling out of plane, a phenomenon frequently observed elsewhere in the world during earthquakes.

Figure 9. (a) The third street building, (b) a horizontal crack in an indoor brick wall, (c) damaged brick wall of a staircase.

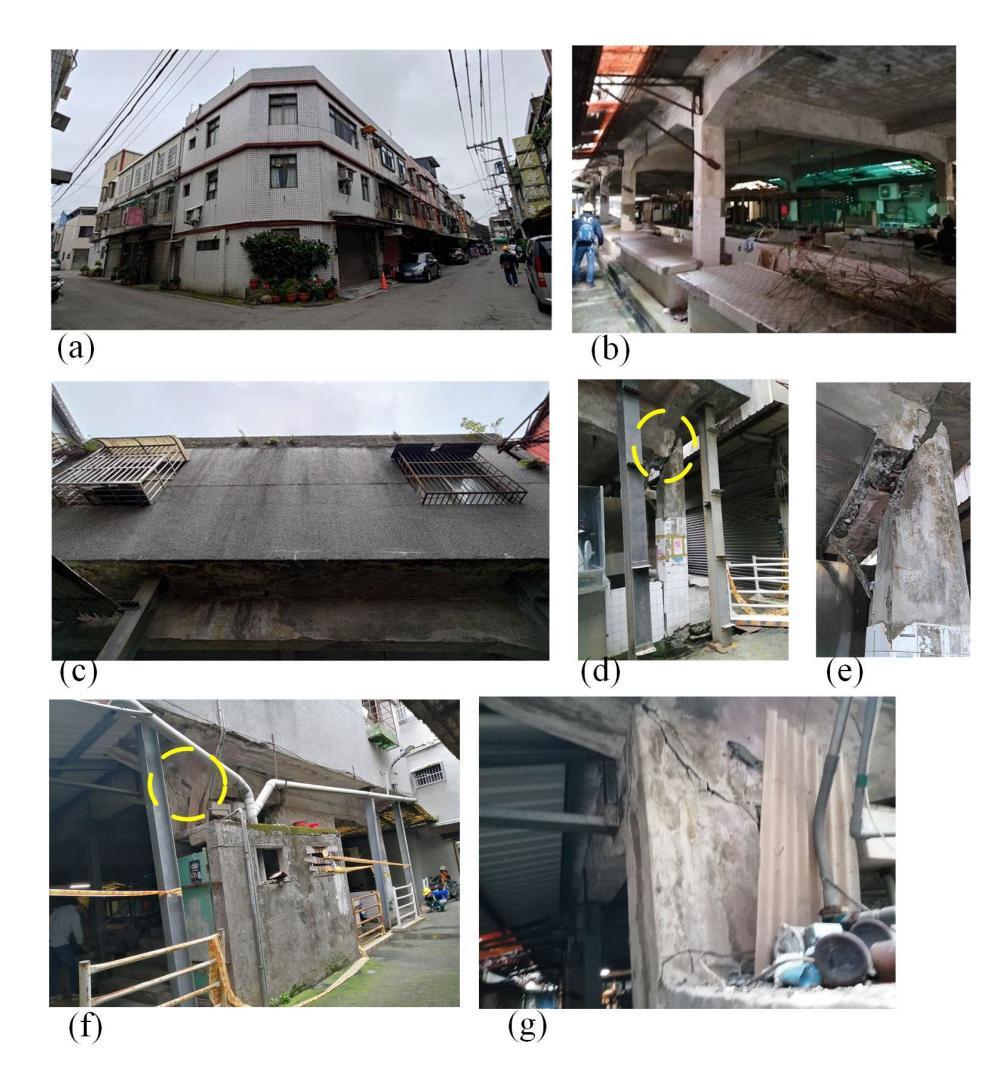
market on the ground floor, there is an upper second story, which serves as residential space (Figure 10(c)). The most notable damage observed was a shear cut at the top of a corner column (Figure 10(d)). Figure 10(e) shows a close-up of Figure 10(d) for clarity. The steel columns shown in Figure 10(d) were temporary shoring erected after the seismic event. There is a staircase located at the opposite longitudinal end (Figure 10(f)). The staircase consists of two RC columns and one brick wall. The upper half of one of the two staircase columns was also damaged (Figure 10(f)). Figure 10(g) shows a close-up of Figure 10(f) for clarity. Because only one end of the market features a staircase, the structure of the market is asymmetric in the transverse direction (i.e., the single-span direction). This asymmetry likely caused the severe damage to the corner column, which potentially experienced additional large deformation due to rotational response. The presence of a first-story traditional market with a second-story residence is unusual, and it is questionable whether the weight of the second story was appropriately considered during design of the market.

Figure 10. (a) Residential buildings encircling the market, (b) overview of the market, (c) exterior wall of the second story of the market, (d) shear cut at the top of an RC column, (e) close-up of (d), (f) staircase at one end of the market, and (g) close-up of (f).

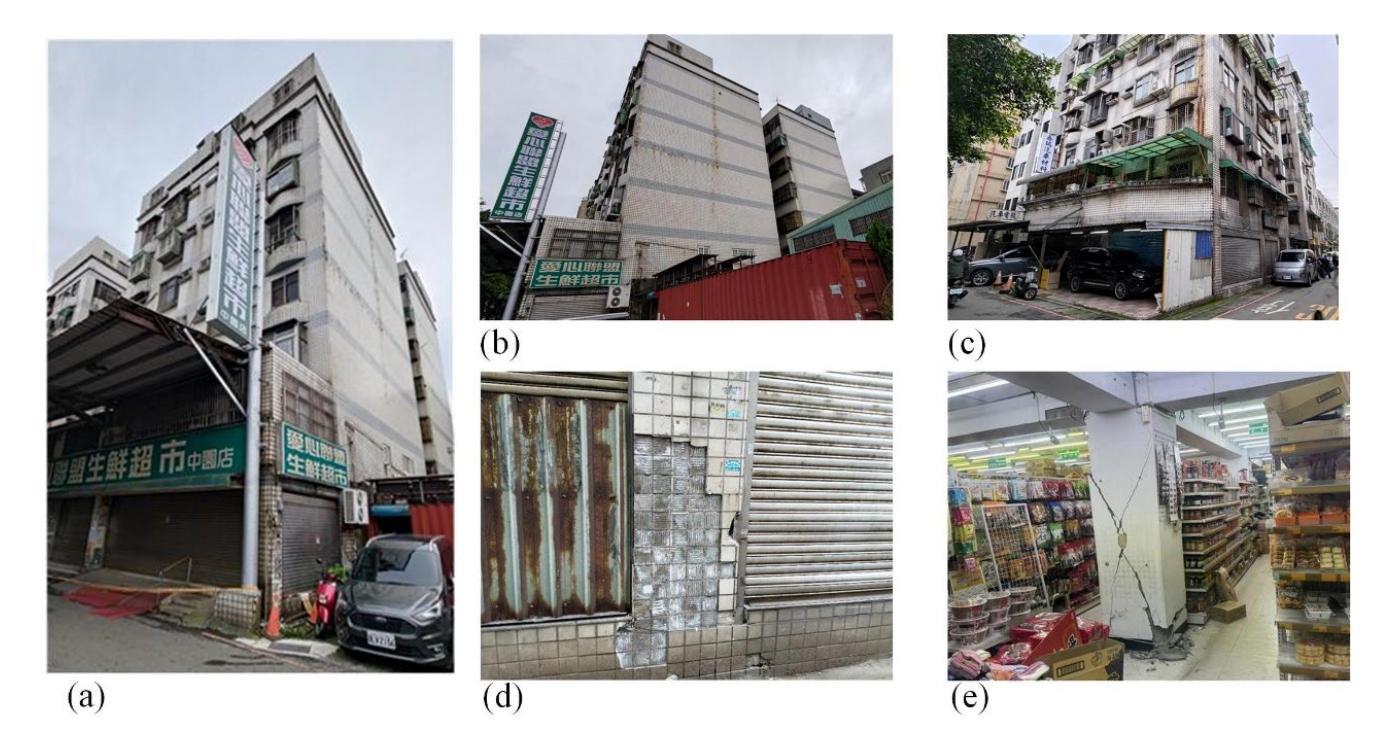
Because the inspected building was marked with red placards, the residents were evacuated and the reconnaissance team was prevented from entering it. The overall appearance of the building seemed in order except for some tiles that were spalling (Figure 11(d)). However, a photograph captured by the media (The Liberty Times, 2024b) revealed that a column inside the first-story supermarket underwent shear failure (Figure 11(e)). Potential remolding of the building likely contributed to the shear failure of the column. It is also worth noting that the side of the column perpendicular to the shear cracks appeared to be intact (Figure 11(e)). This observation suggests that either the seismic demand (i.e., earthquake load) was much greater or the seismic capacity of the inspected structure was much less in the direction parallel to the shear cracks than in the direction perpendicular to the cracks. More definite reasons for the column failure will emerge when the building is inspected thoroughly and related information regarding structural design is accessible.

Figure 11. (a) and (b) Photographs of the residential building, (c) a similar building neighboring the inspected building, (d) fallen tiles from an exterior column, and (e) shear cracks in a column within the supermarket (The Liberty Times, 2024b).

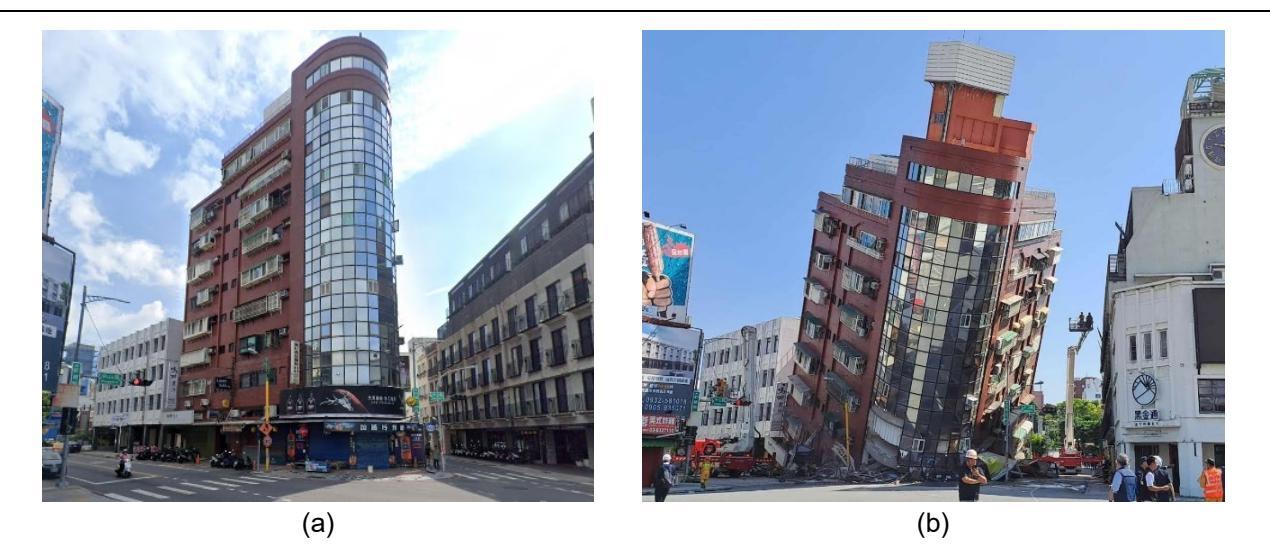
In Figure 12 and Figure 13, two cases of building collapses are shown caused by a weak first story. They occurred approximately 500 meters apart. The response spectra of the seismic ground motions recorded by the three closest stations to the buildings are shown in Figure 4(a), (b), and (c) and are compared to DBE and MCE design spectra. The closest station (HWA019) is around 300 meters from the building depicted in Figure 4. Therefore, the design spectra and the distances to the stations are the same. Even though the ground motions were recorded at specific locations, the magnitudes, distance from the source, and source mechanisms are consistent with those influencing the maximum demand in the buildings. It is important to note that the north-south component (NS) of the closest station (HWA019), as shown in Figure 4(a), corresponds to the demand defined by the MCE. This finding emphasizes the importance of the seismic demands imposed by the quake.

Figure 12. Damaged 9-story building (coord. 23.9744, 121.6118) due to a first soft story: (a) pre-earthquake state (credit: Google Maps), and (b) post-earthquake state.

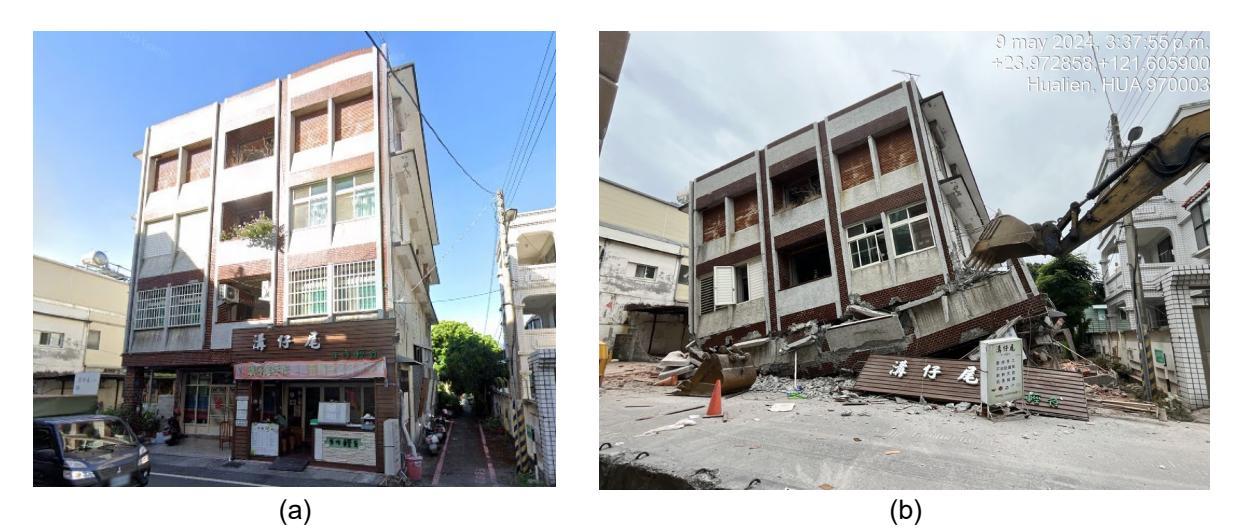
Figure 13. Damaged 4-story building (coord. 23.9726, 121.6057) due to a first soft story: (a) pre-earthquake state (credit: Google Maps), and (b) post-earthquake state.

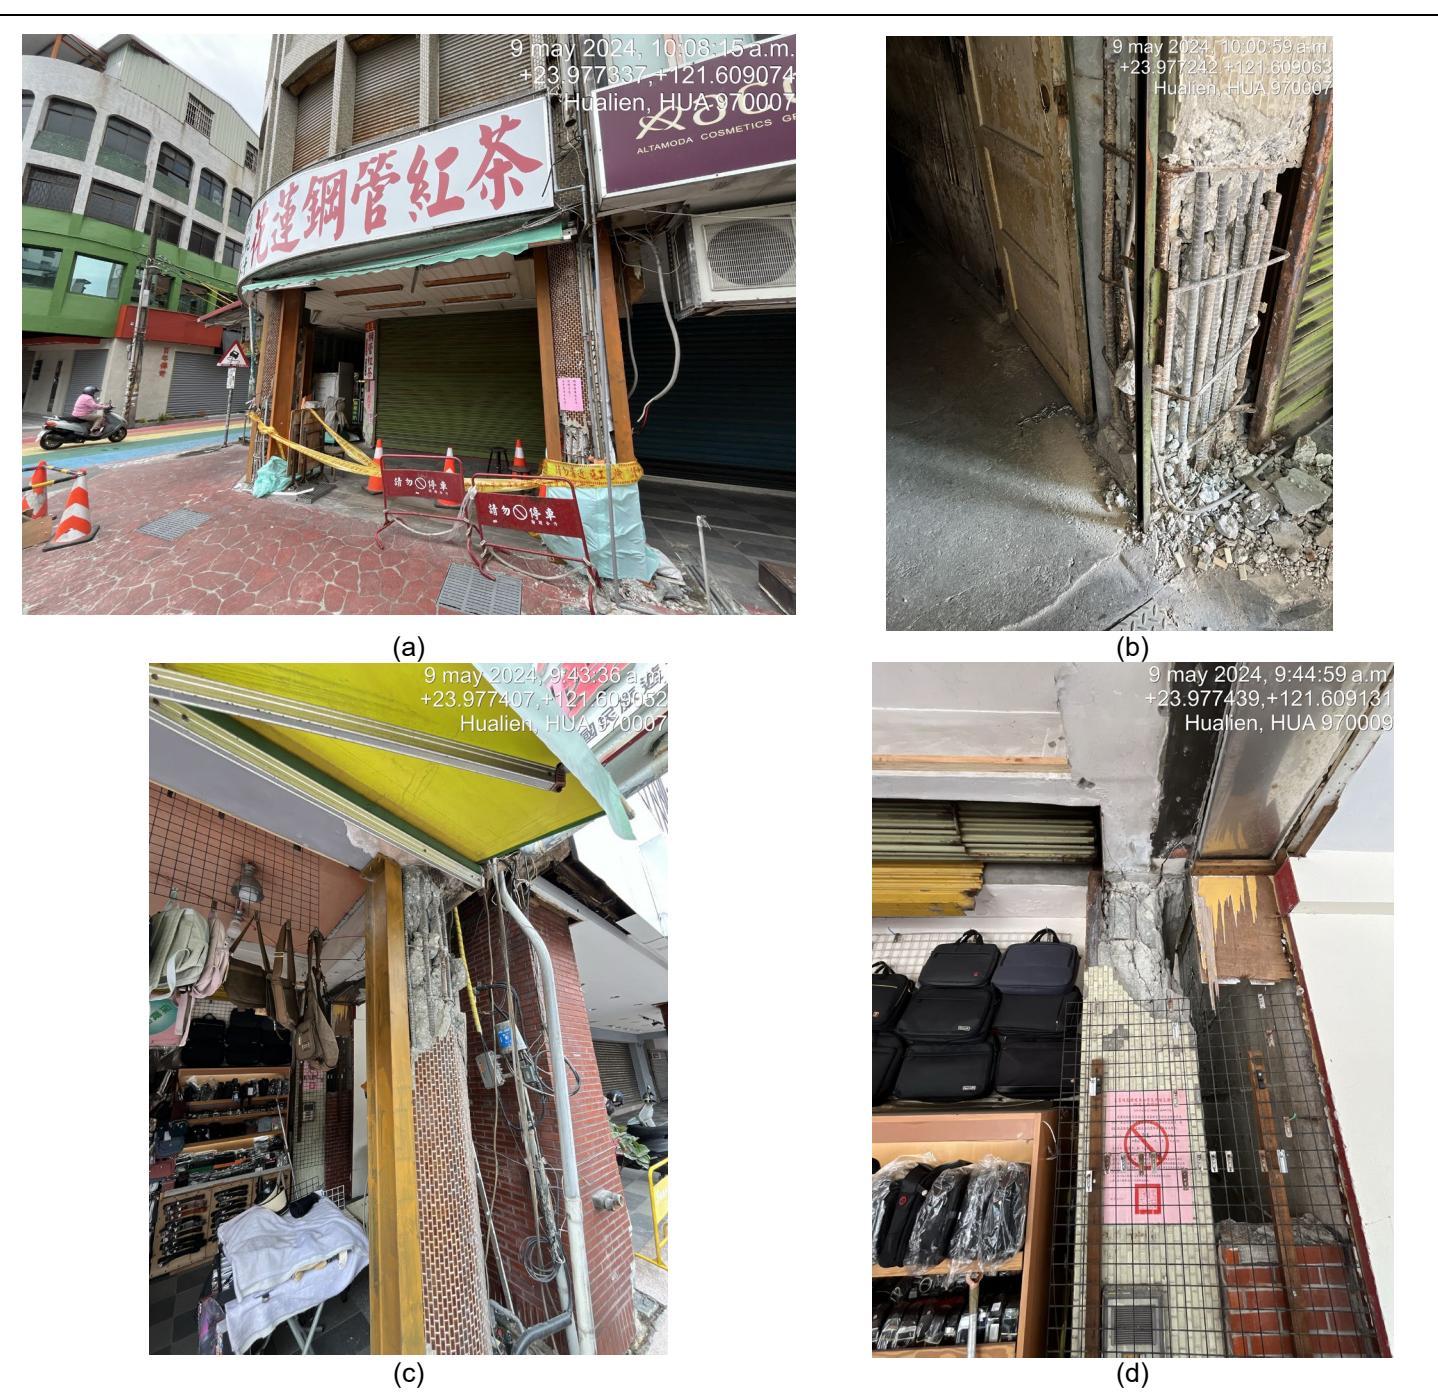
Many buildings have shops or similar commercial spaces on the ground floor, often with a large entrance hall and few dividing walls (Figure 12(a) and Figure 13(a)). This type of structural irregularity is known as soft story and it is one of the most commonly used structural configurations in collapsed buildings in other earthquakes (Ozkula et al., 2023; Tapia-Hernández et al., 2024). For example, Figure 14 shows a 4-story corner building with a soft ground story, highlighting the vulnerability of this configuration. This building was classified as the red-tagged building because of the severe structural damage in the reinforced concrete column of the ground floor.

Figure 14. Soft ground story with structural damage in columns (coord. 23.9773, 121.6092): (a) general view, (b), (c), and (d) details of damaged columns.

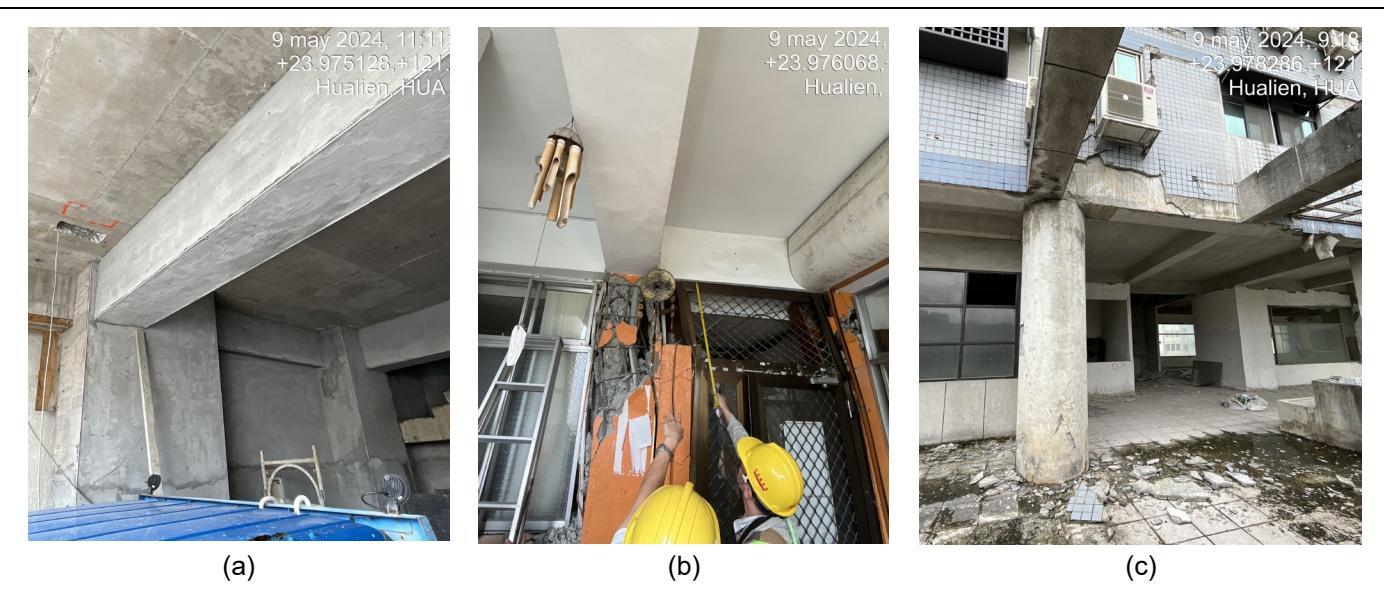
Examples of damage in reinforced concrete columns are depicted in Figure 15. It is worth noting that the cracking in these columns is caused by increased bending moments due to the horizontal offset, and other factors related to the detailing of the reinforcement steel. The combination of offset axial and bending stress might impact the behavior and capacity of columns under seismic demands and should be carefully considered during the design process.

Figure 15. Beams not aligned with the central axis of columns: (a) building under construction (Coord. 23.9751, 121.6149), (b) eccentricity in an RC column (Coord. 23.9760, 121.6125), and (c) damage in a circular RC column (coord. 23.9781, 121.9700).

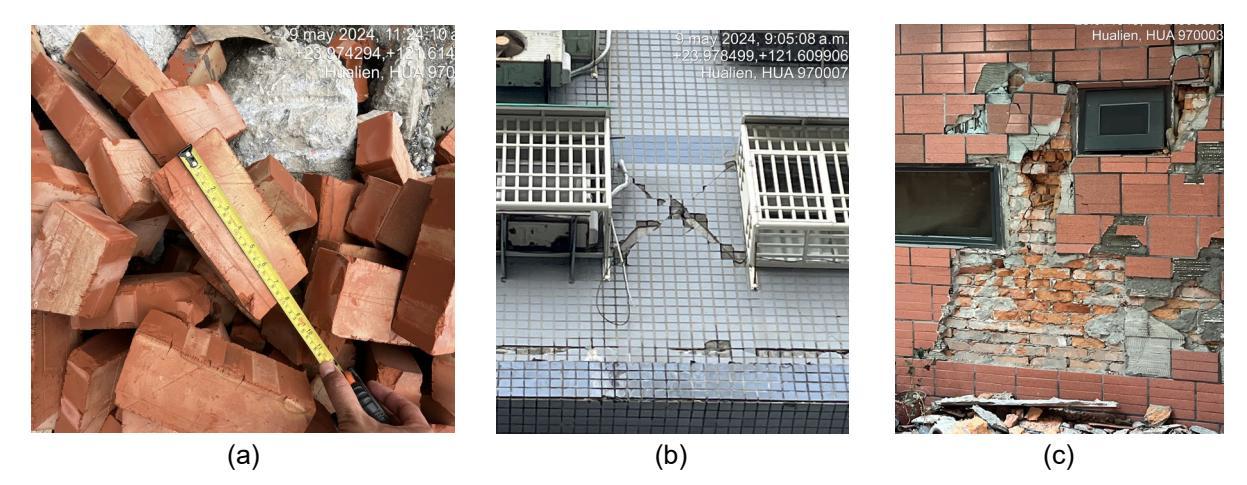
As shown in Figure 16, the masonry infill walls were usually built using solid clay bricks measuring 195×95×55 mm for confined and unconfined walls. The bricks seemed to have been fired at high temperatures, resulting in a strong and uniform material. It was common to observe heavy façades constructed with unconfined masonry walls and, in some cases, with lightweight foamed blocks supported by concrete slabs acting as cantilevers. Additionally, reinforced concrete piers and spandrels were seen in façades.

Figure 16. Behavior of infill walls: (a) bricks for the reconstruction, (b) unconfined infill wall, and (c) damaged masonry wall.

The strength degradation and lateral stiffness, as well as the primary mode of failure in walls, depend on boundary constraints, material characteristics, the combined effect of axial forces, height-to-width ratio, and lateral loads (Espinosa-Cazarín et al., 2023). Walls may fail due to sliding, rocking, diagonal shear, or local buckling in extruded pieces. Infill walls are particularly susceptible to high damage due to their interaction with reinforced concrete frames (Tapia-Hernández et al., 2024), regardless of the material type (Figure 16(c)).

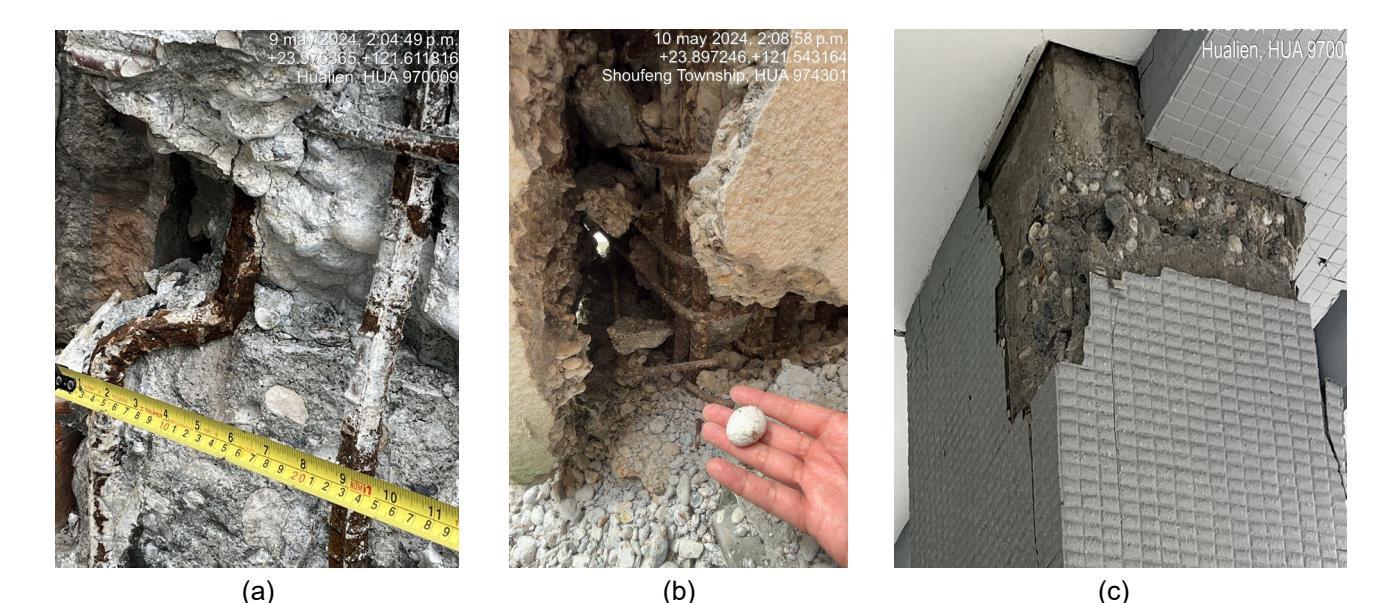
During the field inspection, it was discovered that the old concrete did not meet the strict regulations, specifically concerning the size and quality of the aggregates. The reinforced concrete columns where the concrete used river rocks as aggregates and sea sand containing chloride and other substances are shown in Figure 17, which significantly impact the material's mechanical properties.

Figure 17. Improper aggregate and sand in the concrete mixture: (a) plastic hinge with river stone (coord. 23.9759, 121.6127), (b) damaged RC wall (coord. 23.9751, 121.6116), and (c) RC column (coord. 23.9759, 121.6127).

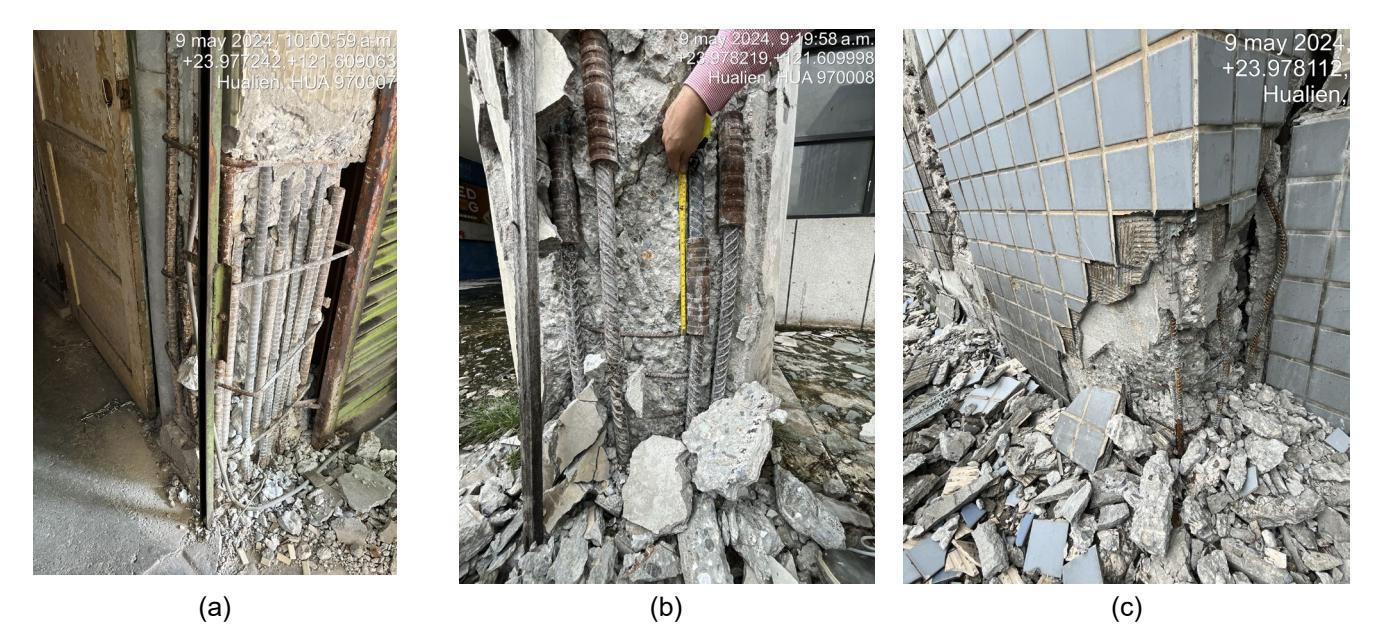
The inspection found corrugated (non-smooth) steel bars, even in old structures. Nevertheless, there were issues with the reinforcement continuity or the anchorage length between the slabs, beams, and columns (Figure 18(a)). It is understood that when column heights exceed the standard bar lengths available, it is necessary to splice the steel bars end-to-end by overlapping. Proper splicing and tying of the rebar are crucial for the integrity of the concrete components, especially in areas where inelastic incursion is expected. It is advisable to place the lap splice in the middle third of the columns to prevent stress concentrations at the top or bottom of the column.

Rebar couplers connect two reinforcing bars in the longitudinal direction, creating a mechanical splice. They are beneficial for reducing congestion in confined spaces and conserving rebar length. The use of coupler splicers for the mechanical overlapping in a damaged column is depicted in Figure 18(b), where all the coupler splicers located at the hinge rotation of the column, promoting damage concentration. Thus, placing the overlaps in areas with low bending demands is important to prevent the creation of weak points (ATC, 1996).

Additionally, in certain cases, the longitudinal steel bars were not positioned inside stirrups, leading to insufficient confinement of the core steel, as shown in Figure 18(c). Closed ties or stirrups should be formed in a single piece by looping standard stirrups or tie-end hooks around a longitudinal bar.

Figure 18. Improper details of the reinforcing bars: (a) congestion of steel bars in plastic hinge, (b) coupler splicers at the hinge rotation, and (c) longitudinal steel bars not joint to the stirrup.

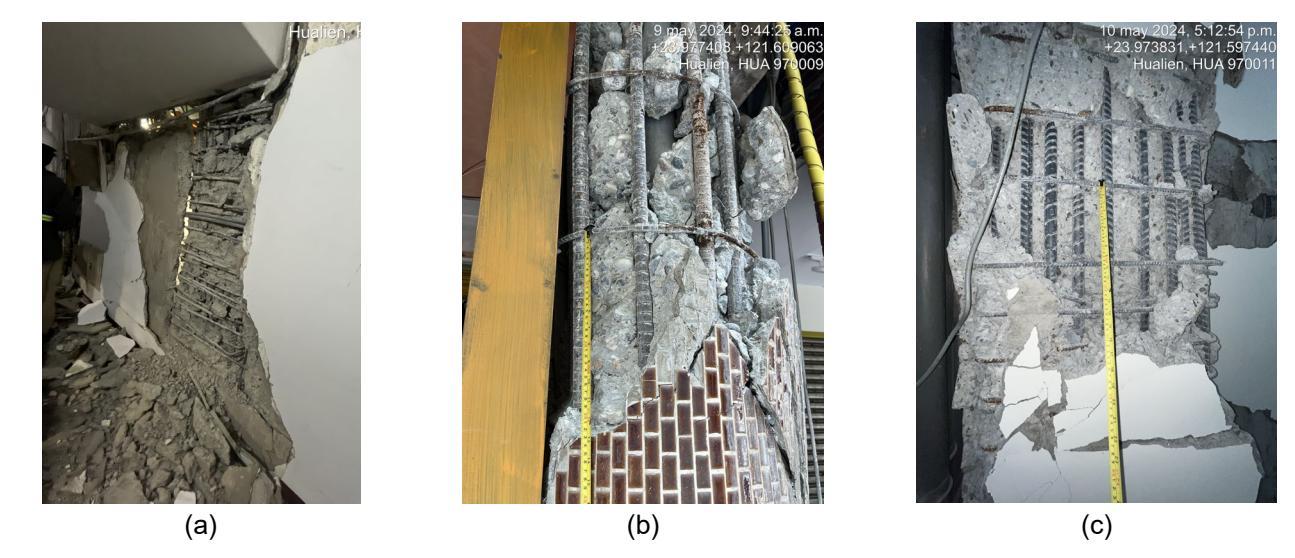
During the field inspection, it was observed that in some cases, stirrups were inadequately anchored with 90° hooks instead of the specified 135° hooks. This resulted in ineffective confinement when the cover concrete was lost (Figure 19(a)). The shear strength the concrete provides decreases as bidirectional bending rotations and crack widths increase. Placing the rebar according to modern seismic codes is important. An inadequate separation or insufficient stirrups in relation to the longitudinal bars might lead to damage concentrations, as shown in Figure 19(b) and (c).

Figure 19. Inadequate stirrup detailing, typical of pre-Chi Chi Earthquake: (a) 90° hooks in stirrups, (b) improper stirrup separation, and (c) insufficient shear capacity.

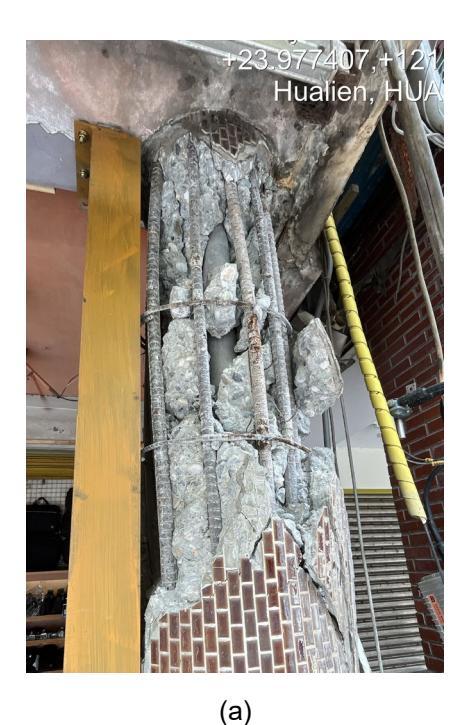
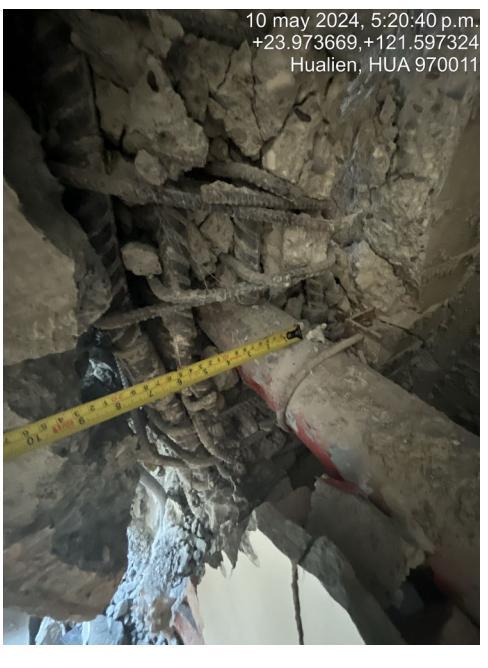
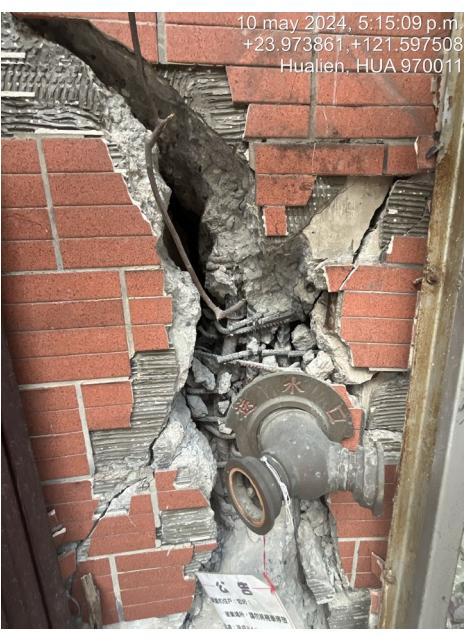
It is important to note that in some cases, the integrity of the columns was compromised due to pipes passing through the concrete core, as depicted in Figure 20. The presence of the pipes led to reduced strength for both axial and flexural capacity due to non-uniform stress distribution. Additionally, inadequate steel bar details resulted in excessive flexural cracking in the concrete components.

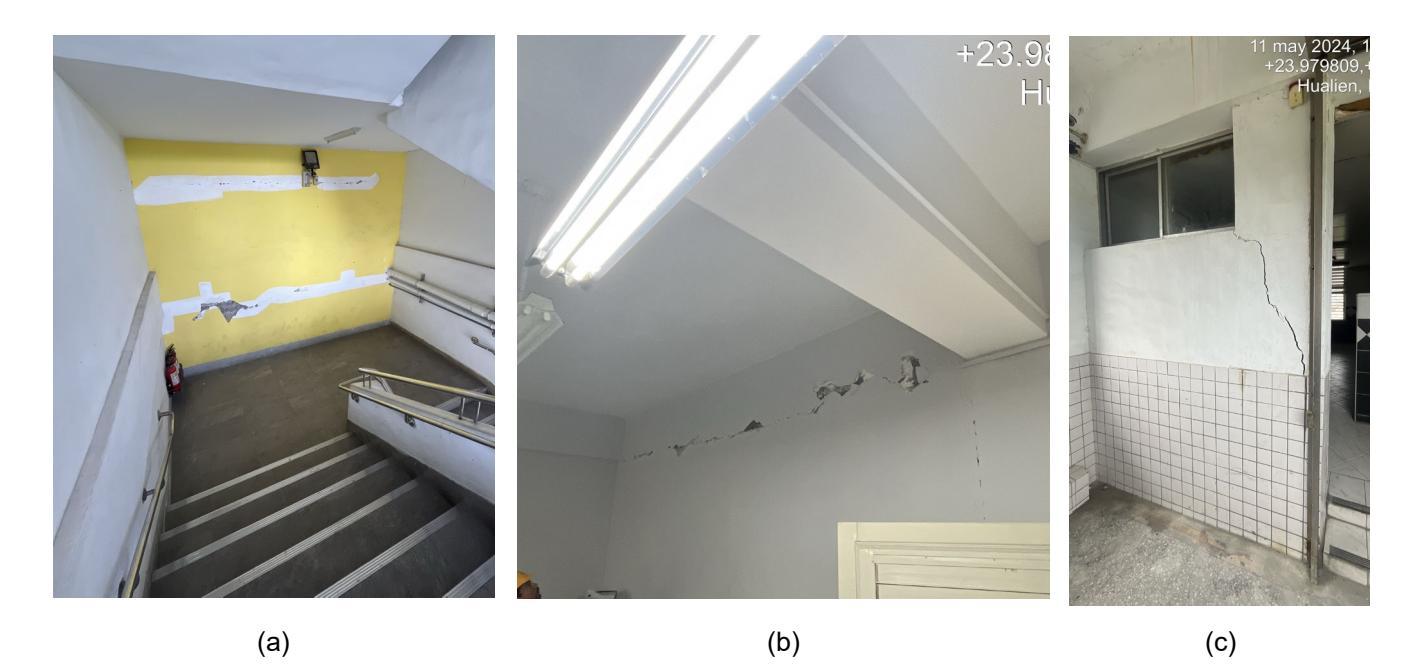
Mingli Elementary School had previously been retrofitted due to damage from earlier earthquakes. During field inspections, some horizontal cracking was identified in reinforced concrete shear walls, as shown in Figure 21. The design and response spectra of the nearest station (HWA019) are shown in Figure 4(a), located only 652 meters from the school's position. Due to the high imposed demands, it is concluded that more severe damage was expected without the structural retrofit. The damage was mainly identified in the junction of existing and added structural elements.

Figure 21. Affectations to the Mingli Elementary School during the earthquake: (a) cracking on a wall at the stairs, (b) cracking on a wall at a classroom, and (c) cracking on the restrooms

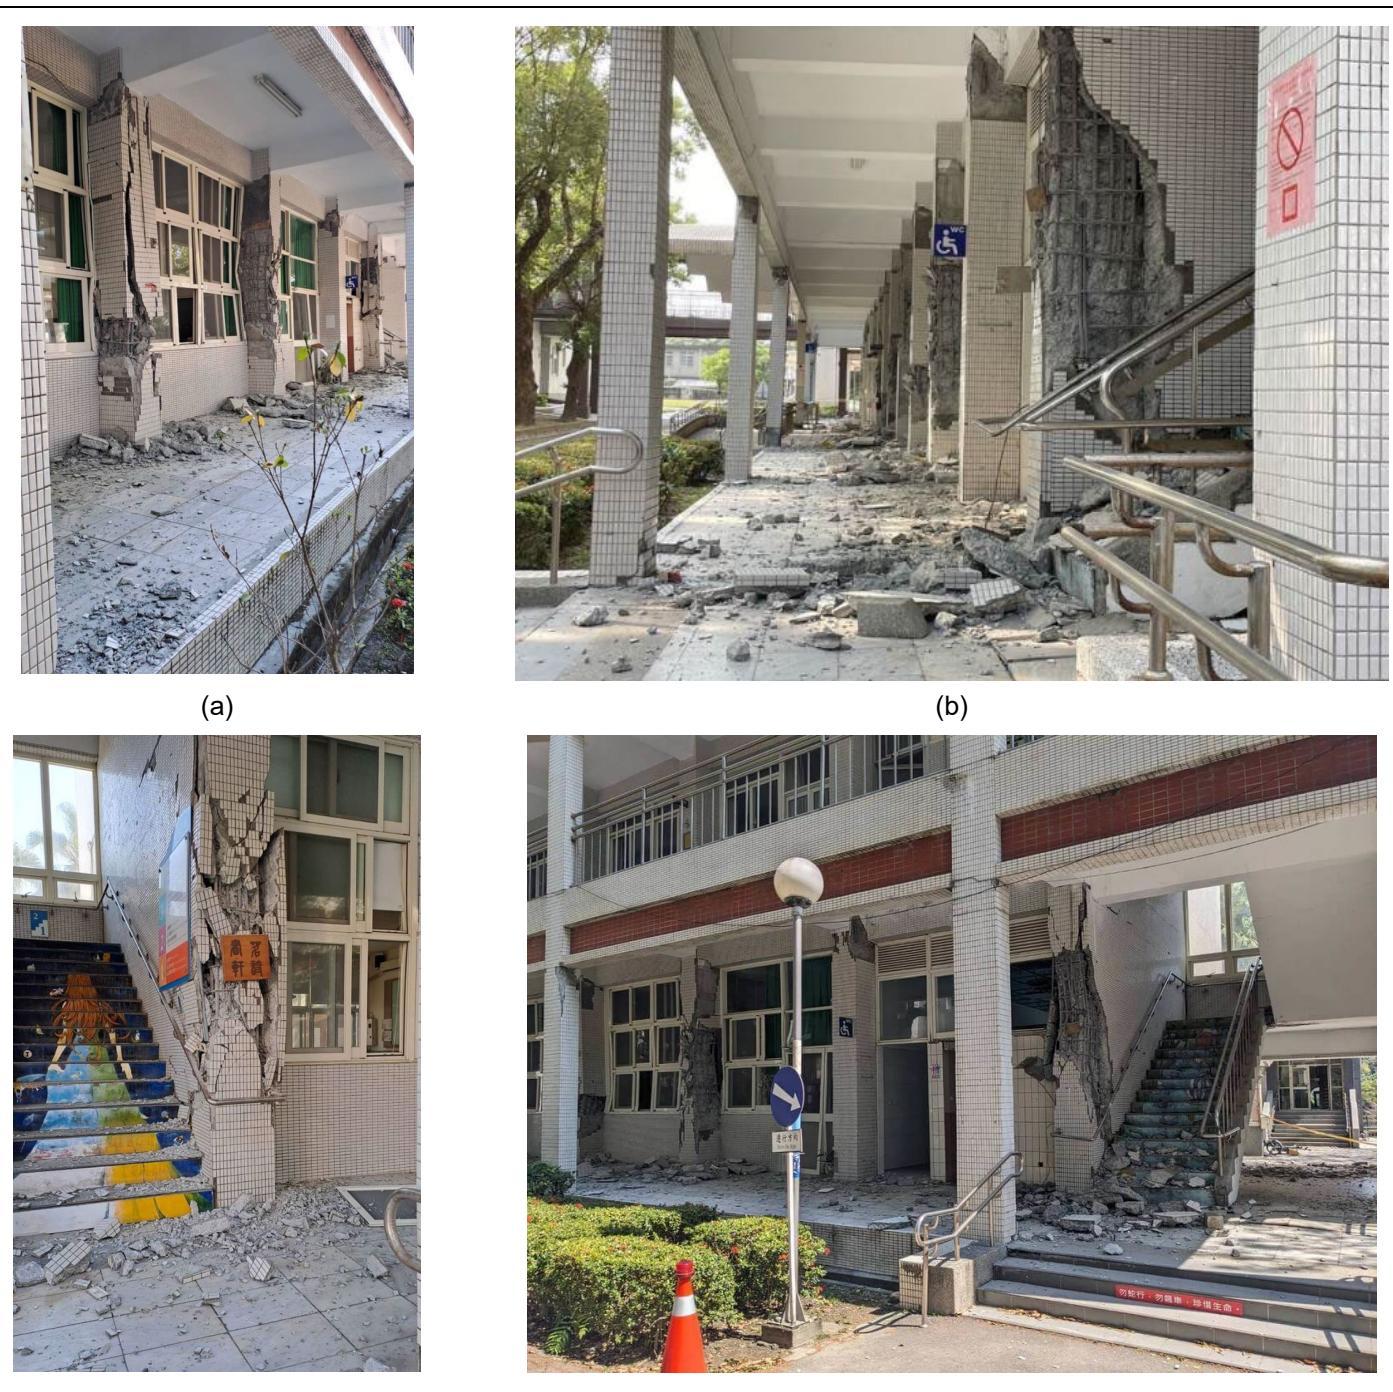
The National Hualien Girls' Senior High School consists of several buildings ranging from two to four stories height. One building was severely damaged, while the others showed only minimal affectations. The building that suffered severe affectations was not reinforced due to it held a safety certificate based on an early method for quick evaluation, which differs from NCREE's evaluation method (Hwang et al., 2022). Unfortunately, that structure experienced severe damage in the reinforced concrete columns due to short-column mechanism, leading the authorities to decide to demolish the building (Figure 22(a)). The distance from the school to nearest station (HWA019) was 537 meters (Figure 4(a)), clearly indicating that the expected damage was significant, which was the case for the building that was demolished. Nevertheless, the other buildings did not sustain significant damage, only some effects near the construction joints between buildings (Figure 22(b)). Therefore, it can be concluded that, apart from the demolished building, the school performed well.

Figure 22. Affectations to the National Hualien Girls' Senior High School: (a), (b), (c), and (d) severely damaged building that had to be demolished (https://www.cna.com.tw/news/ahel/202404030165.aspx).
