EERI Earthquake Reconnaissance Report: M_L 7.2 Earthquake of April 3, 2024 in Hualien, Taiwan

September 2024

A product of the EERI Learning From Earthquakes Program

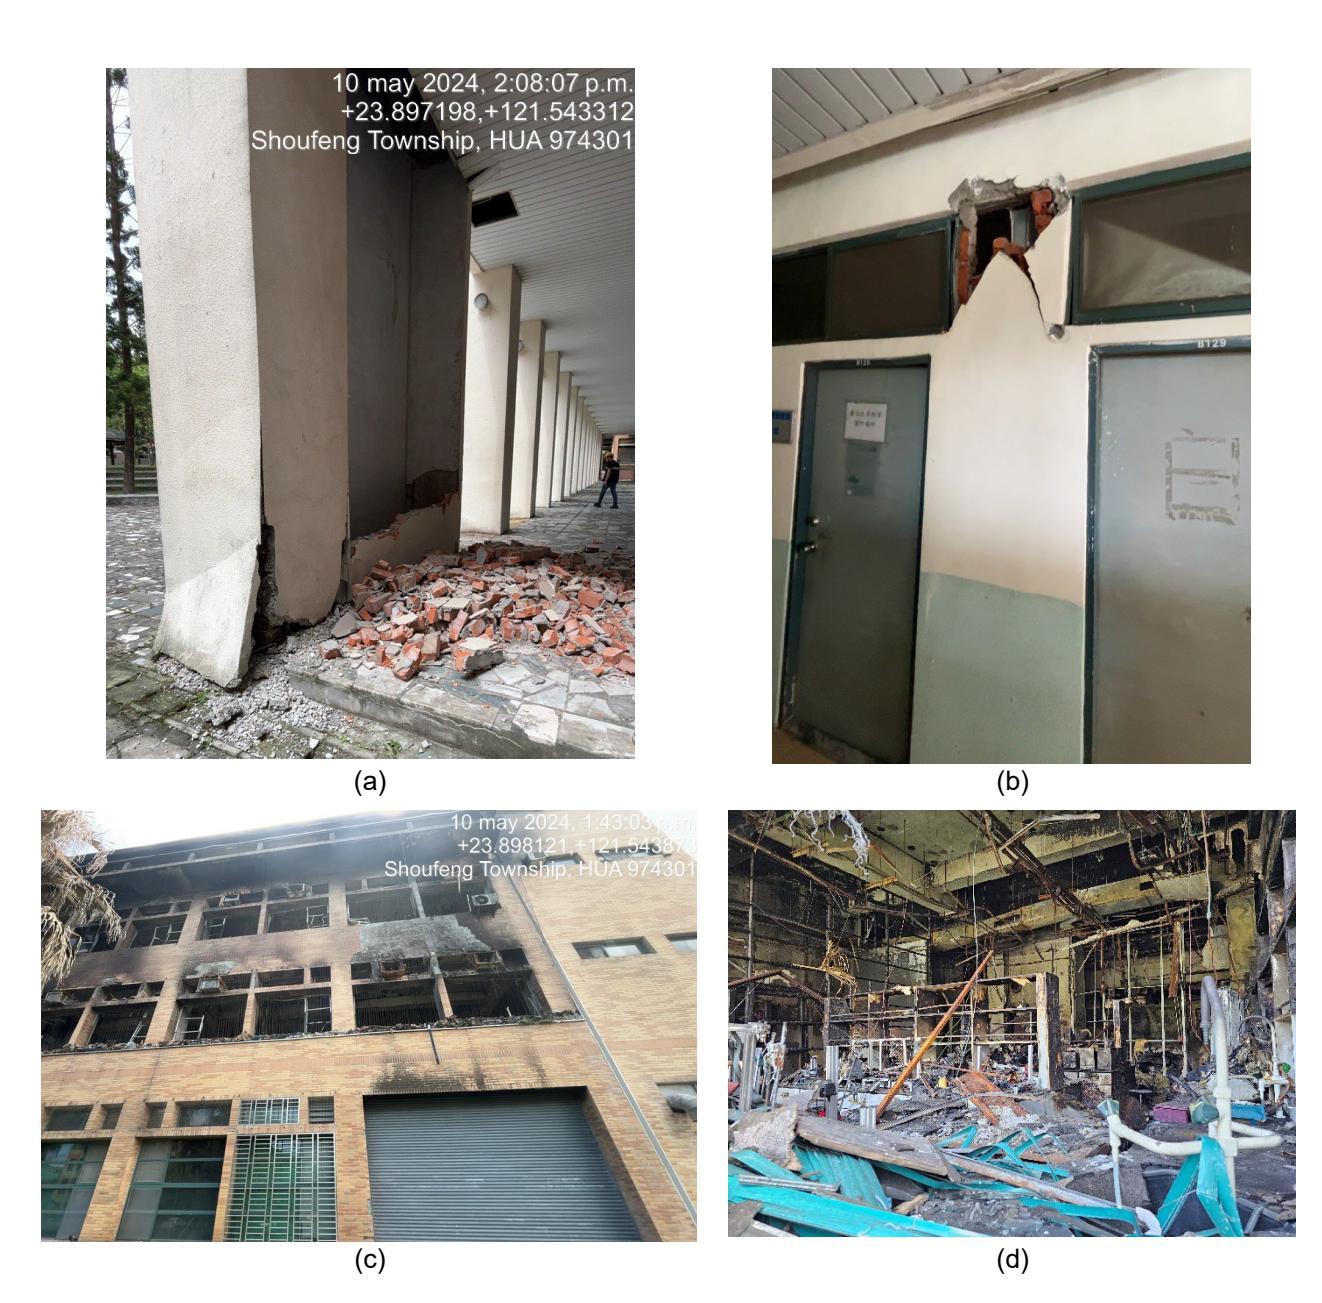
The Chemistry Building of the National Dong Hwa University sustained both structural and non-structural damage during the earthquake (Figure 23(a) and (b)). Furthermore, a fire that broke out after the earthquake caused significant destruction. The laboratories, equipment, and non-structural components suffered considerable losses (Figure 23(c) and (d)). The distance from the University to the nearest station (HWA051) was 3,860 meters. Analysis of the response spectra of HWA051 (Figure 4(d)) indicated that significant damage was expected, as the spectral accelerations exceeded the MCE spectra by a significant range for vibration periods shorter than 1.2 s.

Figure 23. Chemistry Building of the National Dong Hwa University: (a) moderate damage to a column along with failure of a non-structural wall, (b) damage to non-structural wall, (c) main façade of the Chemistry Building, and (d) damage inside the laboratories.

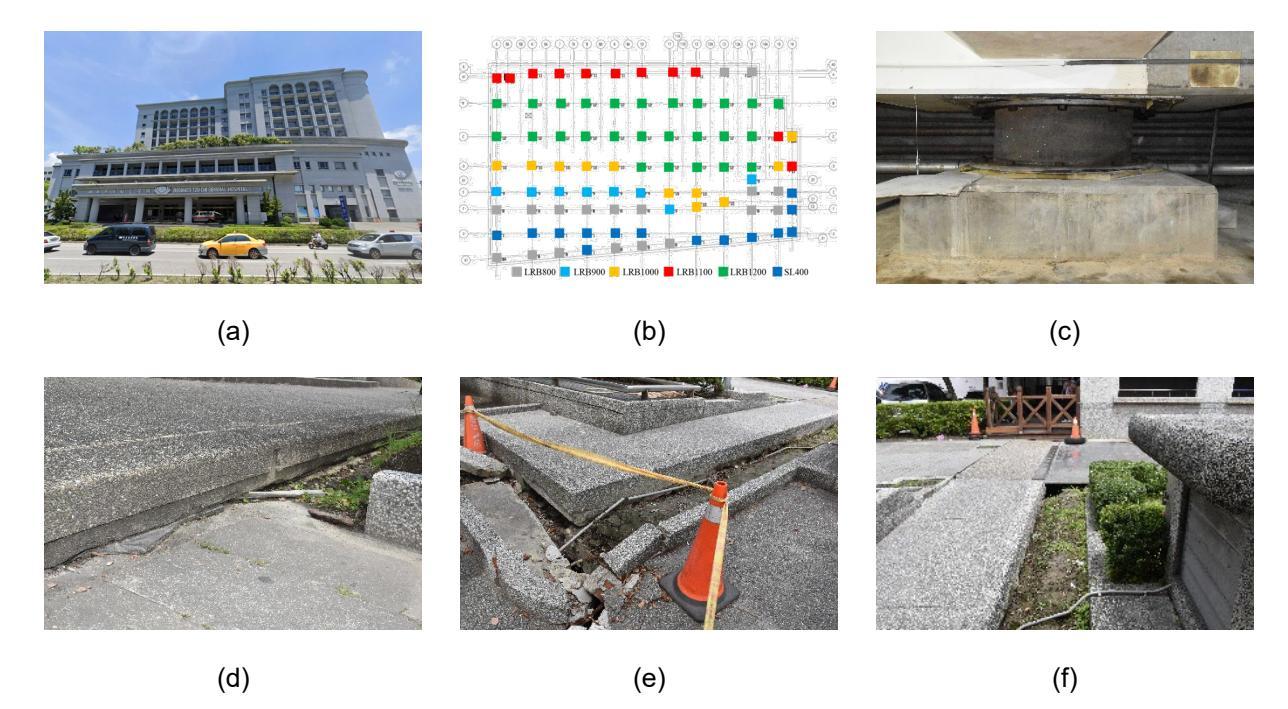
This building was equipped with 88 lead rubber bearings (LRBs) of various shapes and sizes (Figure 33(b)). Displacement records of the lead pendulums adjacent to the LRBs in the B2F isolation floor after the earthquake indicated significant residual displacement. Direct inspection of the LRBs also revealed noticeable residual deformation (Figure 33(c)). On-site measurements revealed that the earthquake caused a displacement of approximately 300 mm in the isolation floor in the long direction of the building and about 400 mm in the short direction.

Despite causing significant deformation and residual displacement of the isolation devices, the earthquake did not result in structural damage to the building. However, it did cause damage to some non-structural elements. Figure 33(d) illustrates the relative position of the first-floor isolation structure and the ground. Because of insufficient clear space, the isolation floor displacement during the earthquake led to compression against the exterior ground structures. This resulted in observable damage, such as cracked concrete pedestals in the flower beds and sidewalks (Figure 33(e)). Additionally, during the earthquake the driveway cover plates (Figure 33(f)) were compressed and deformed, but they were repaired shortly after the event.

Figure 33. Photographs and figures of the eleven-story hospital: (a) overall view (credit: Google Maps), (b) LRB layout, (c) LRB, (d) gap between isolation floor and ground, (e) damaged non-structural elements, (f) repaired driveway cover plates.

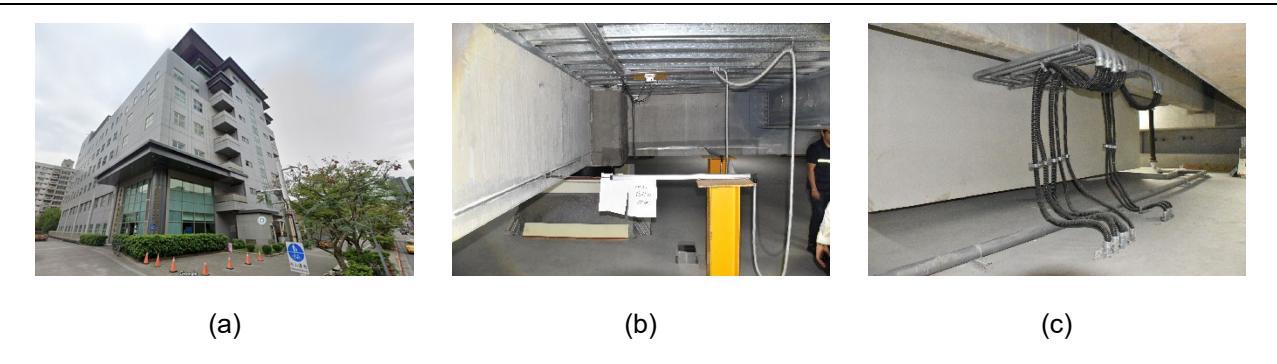
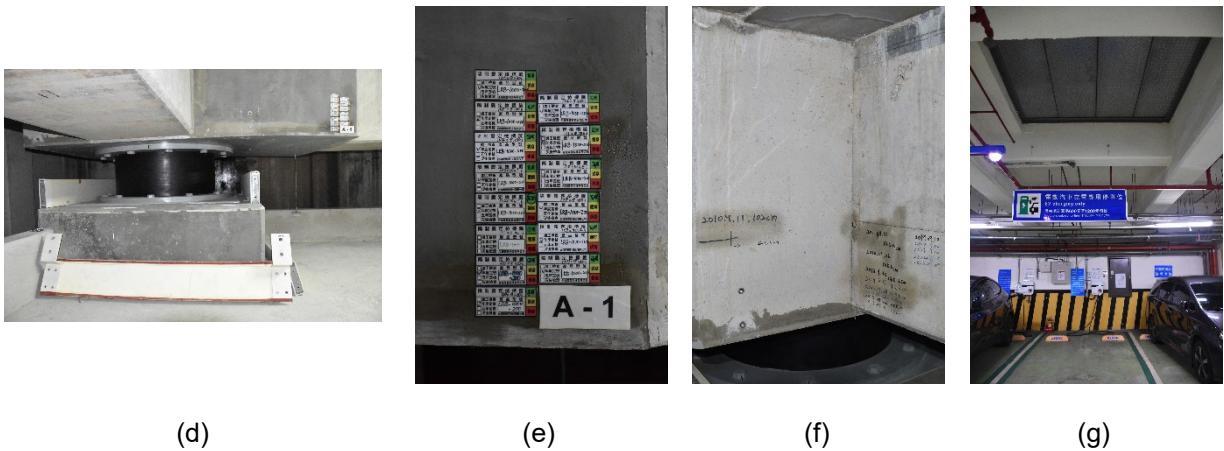
to accommodate deformation (Figure 34(c)), while those not passing through the isolation floor were fixed as in a typical structure. During the 0403 Hualien earthquake, the entire building, including the isolation devices and the SRC structure, did not undergo any structural damage. A site inspection of the connections between the isolation floor and the ground revealed no non-structural damage due to enough space reservation (800 mm) and well-configured sliding devices.

Because the field reconnaissance coincided with a comprehensive inspection of the isolation devices arranged by the owner following the 0403 Hualien earthquake, the LRB devices were observed directly (Figure 34(d)). No significant residual deformation was visible to the naked eye. Annual inspection records are maintained for each LRB (Figure 34(e)). For the LRB supports located near the exterior, simple displacement measurement tools such as laser rangefinders enabled direct measurement of the distance between the superstructure and the retaining wall. These measurements were recorded during the inspection of the structure, and the records indicated almost no residual displacement (Figure 34(f)). The B1F below the isolation floor served as a parking lot. Floor openings were reserved between the isolation floor and the parking lot, facilitating quick transportation if the LRBs required replacement (Figure 34(g)).

Figure 34. Photographs of the seven-story office building: (a) overall view (credit: Google Maps), (b) measuring instruments, (c) flexible hoses, (d) LRB, (e) annual inspection records, (f) measured record, (g) floor opening for LRB repair.
