**MINISTRY OF BUSINESS,
INNOVATION & EMPLOYMENT**
HĪKINA WHAKATUTUKI

Critical Damage States

Ken Elwood
Des Bull
Rick Henry
Alistair Cattanach
Nic Brooke
Peter Smith

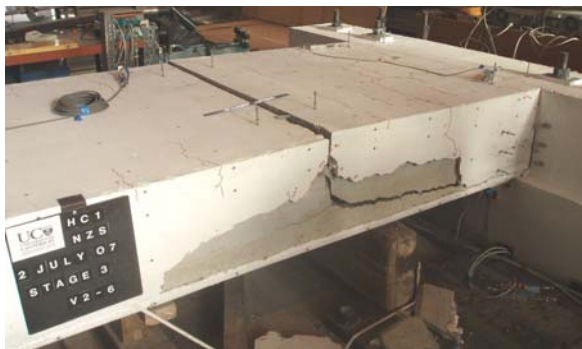
A1 - Transverse crack at end of hollow core or ribs (negative bending)

(a) Negative moment flexural failure

Lift the carpet 1 m out
Starts in the corner.
Use level to check for vertical offset.

Crack at top and bottom
– **likely temporarily wedged in place**

1. Transverse crack at end of hollow core or ribs (both negative and positive bending)
 - Any signs of cracking should be considered to have compromised gravity load path.
 - Vertical offset cracks are highest concern – use level across crack to test for offset.
 - Crack on top and bottom (near support) – **very dangerous**
 - Need immediate shoring for damaged hollow core.
2. Damage to support for flange hung double tee
 - Do not rely on support on “pig-tail” after crushing of concrete at support of flange hung double tee.
3. Reduced precast unit support
 - If reduced seating below that required for bearing stresses (on unconfined concrete), gravity support likely compromised.

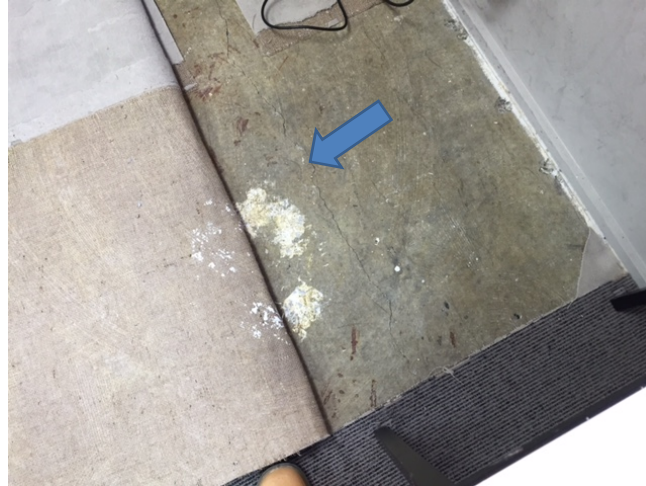
A1 - Transverse crack at end of hollow core or ribs (negative bending)

Example damage from the field:

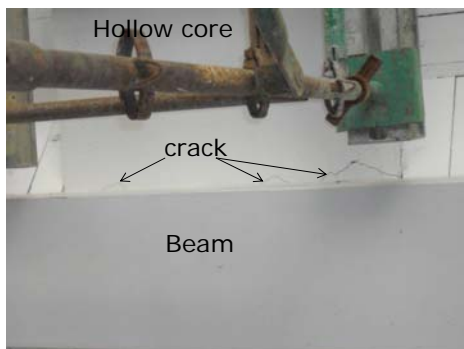
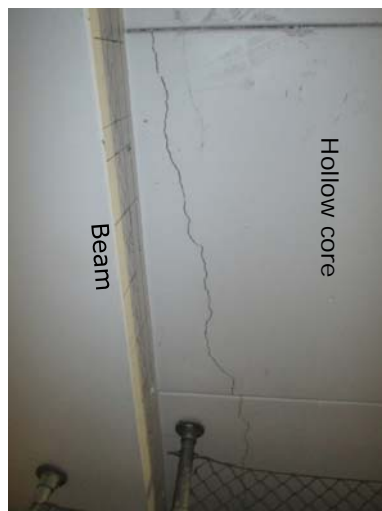
A1 - Transverse crack at end of hollow core or ribs (positive bending)

Example damage from the field (Hollow Core):

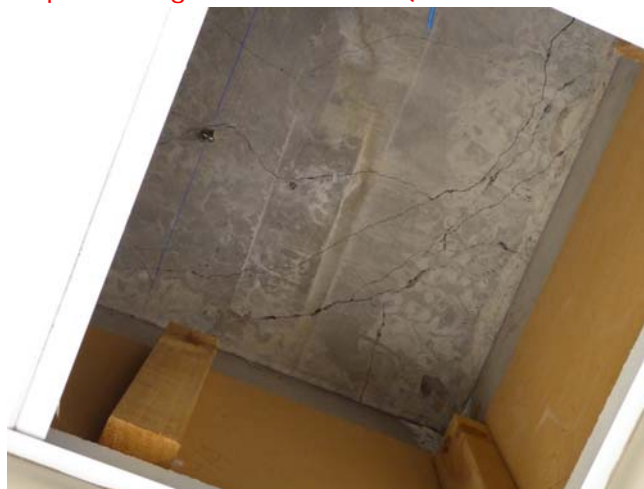
A1 - Transverse crack at end of hollow core or ribs (positive bending)

Example damage from the field (corner of hollow core):

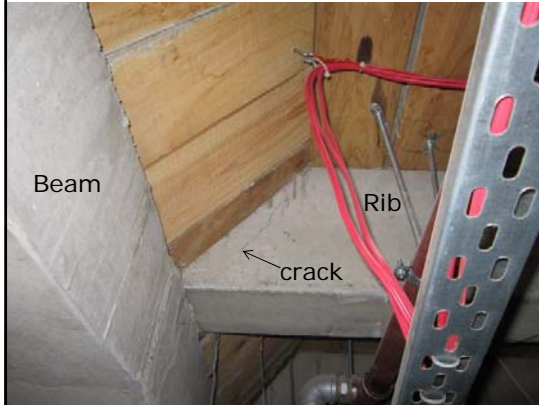
A1 - Transverse crack at end of hollow core or ribs (positive bending)

Example damage from the field (Ribs):

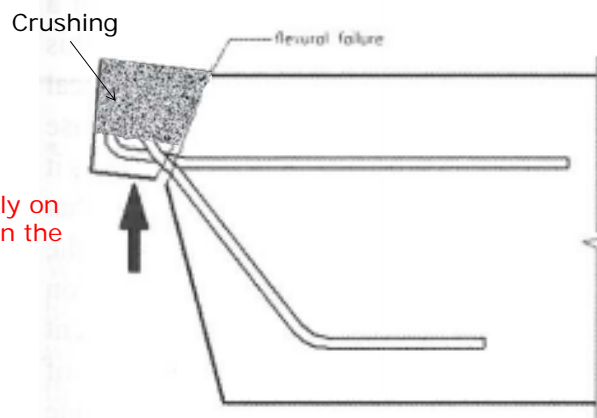
A2 – Damage to support for flange hung double tee

Do not rely on bearing on the "pig-tail"

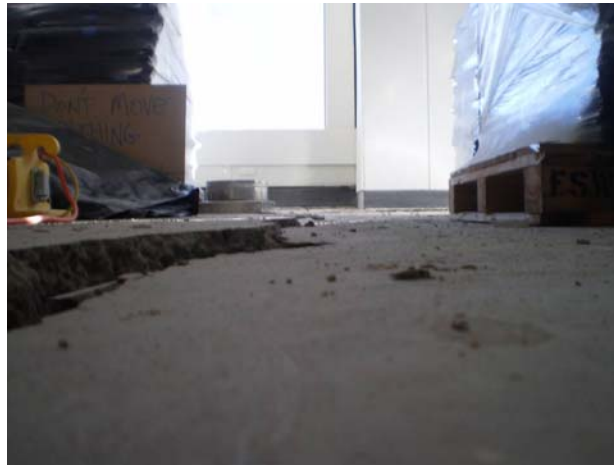
A2 – Damage to support for flange hung double tee

Example damage from the field:

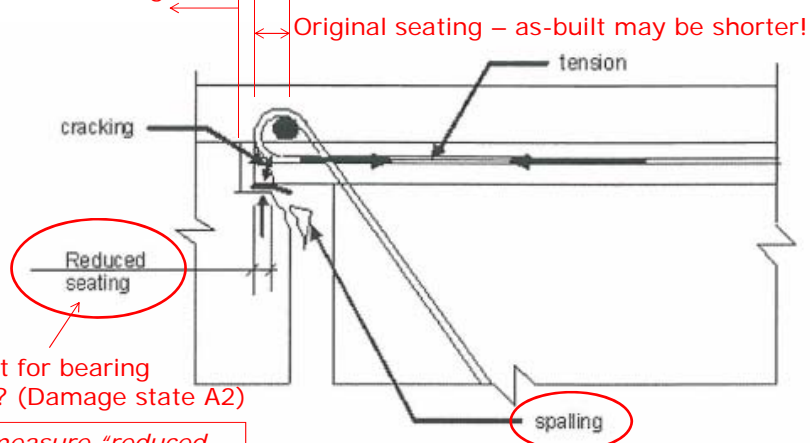
A2/B1 – Reduced precast unit support

Movement due to beam elongation

See Fenwick report Section 6.4

Sufficient for bearing stresses? (Damage state A2)

Try to measure "reduced seating" with a wire with a 10mm long 90 degree bend at the end pushed between the units.

1. Edge spalling will reduce the available bearing
2. If the end of the rib cracks and spalls, the bearing may be lost altogether

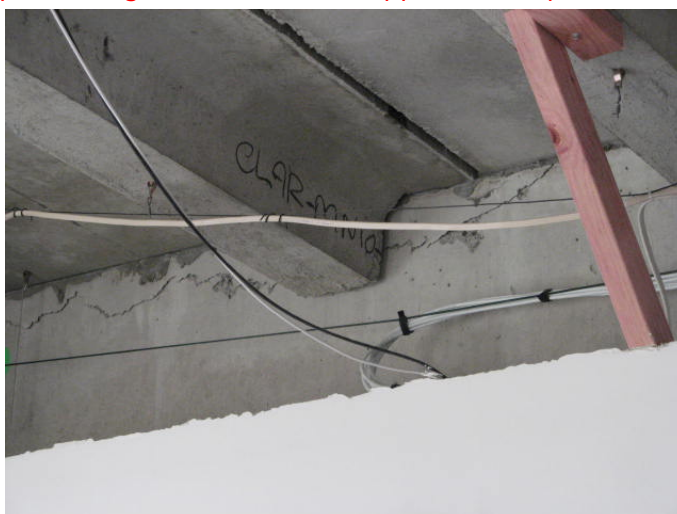
A2/B1 – Reduced precast unit support

Example damage from the field (applies to all precast units):

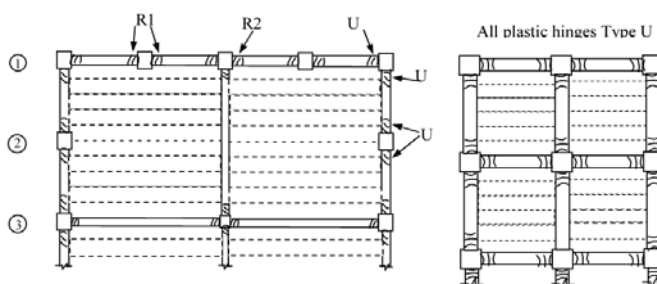
Figure 3-6: Part plan on floors showing plastic hinge elongation types, U, R1 and R2

Check expected dilation according to Fenwick et al (2010):

- Beam dilation at peak drift demand =
 - Up to 3% beam depth for unrestrained hinge (corner)
 - Up to 1.5% for restrained.
- Add up the maximum dilation tributary to a floor unit.
 - 80% to each end for cases with starter bars
 - 100% to one end if no starter bars

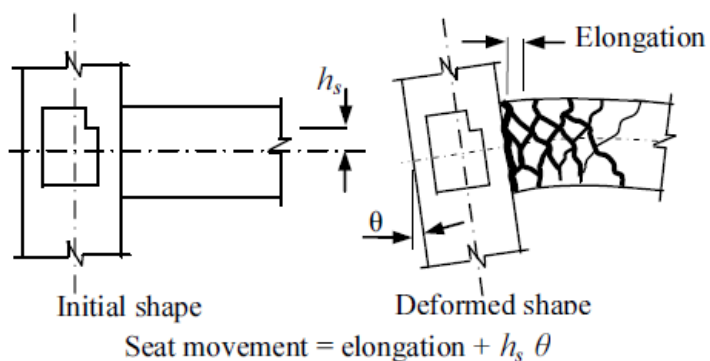
B1 – Reduced precast unit support

- Note: seat movement due to elongation and drift!

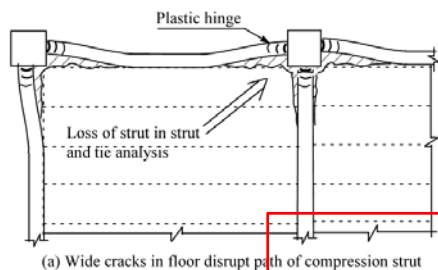
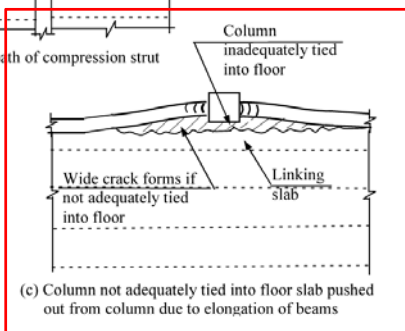
Figure 5-15: Influence of potential cracks on diaphragm action of floor

B2 - Loss of lateral support for columns over multiple stories

Focus:
Pre-1995 buildings with only mesh restraint for columns.

Also shear wall buildings at upper levels.

1. Reduced precast unit support
 - Further drift demands (with or without beam elongation) may lead to unseating.
 - see Fenwick et al 2010 report for assessment procedure.
2. Loss of lateral support for columns over multiple stories
 - Further aftershocks may lead to more eccentricity and/or axial load on column leading to buckling.
 - Assess carefully if securing is necessary if support lost over two or more stories.
3. Shear damage to corner columns (due to beam elongation and shear demands)
 - Further aftershocks may increase axial load and shear demand, leading to gravity failure.
 - Consider shoring beams if shear cracking in column is visible.

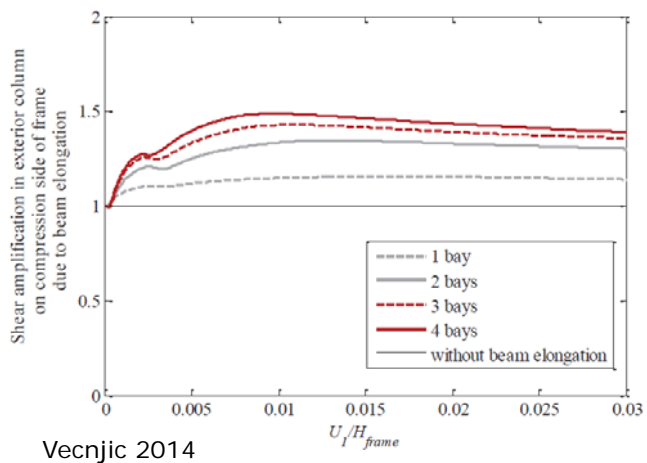
B3 – Shear damage to corner columns

Focus:
Pre-2005 buildings
where column shear
not based on plastic
hinges on both ends.

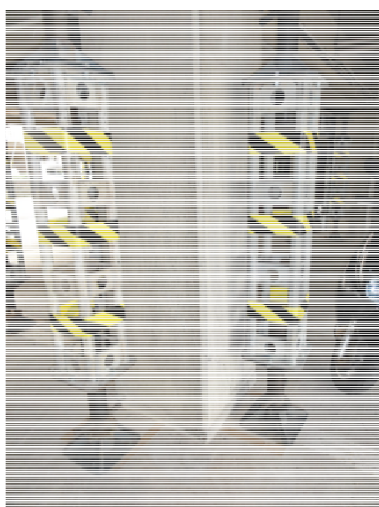
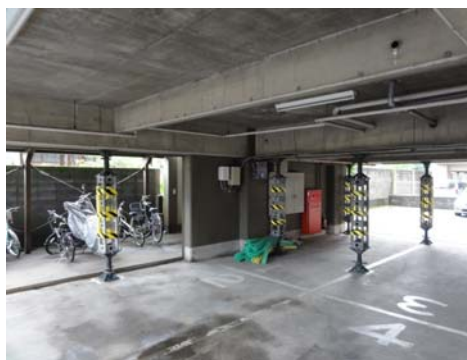
B3 – Shear damage to corner columns

Shoring for gravity load support in case of failure in aftershock:

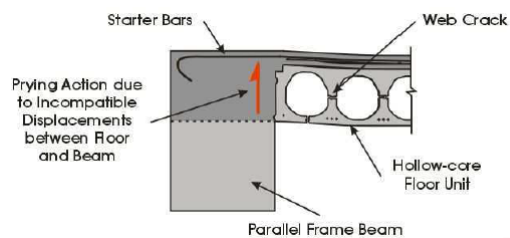
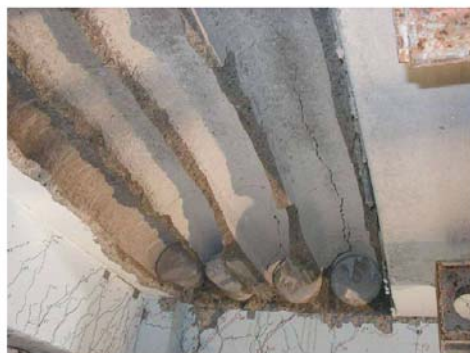
C2 – Web cracking in hollow core

Many hollow core unit adjacent to beams may have web cracks. Caution if floor appears flexible.

Becomes immediate concern if accompanied by transverse crack (Damage State A1)

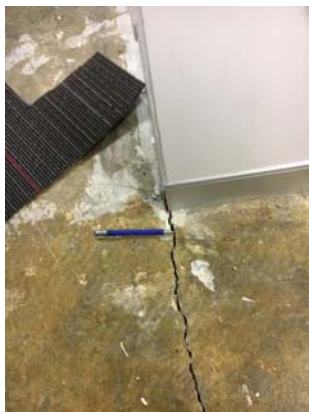
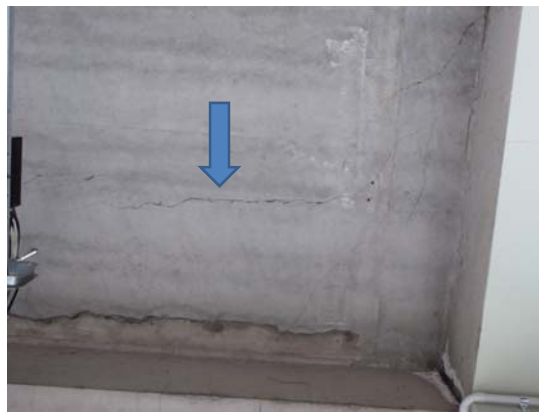
C3 - Longitudinal cracking of hollow core

Example damage from the field:

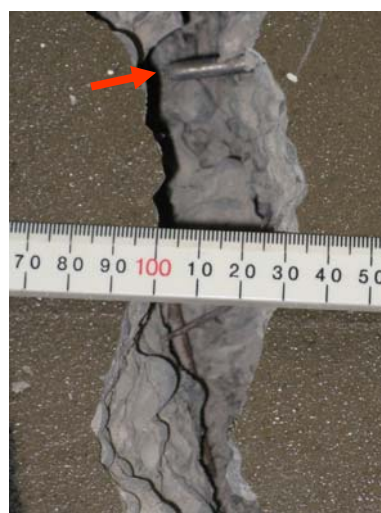
C4 – Mesh fracture

- 1-2mm cracks
→ 665 mesh fracture
- Mesh fracture on its own is not a immediate concern.
 - Reduces inertial loads from diaphragm into frame.
 - Can still develop compression strut.

- loss of support for columns (Damage State B2)
- Reduced seating for precast units (Damage State B1)
