Post-Earthquake Data Collection Workshop

Executive Summary

Anchorage, Alaska July 20-22, 2014

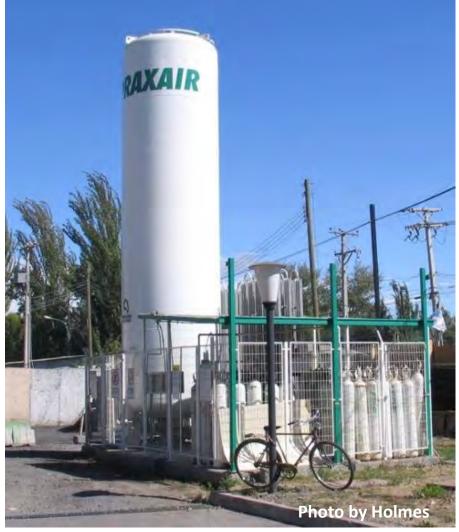
- Some hospitals lost internal systems
- Bulk oxygen storage tanks
 - Standard of practice is to anchor: no overturning reported.
 - Tensile yield failure of threaded fasteners.
 - Punching shear failure of tank leg.

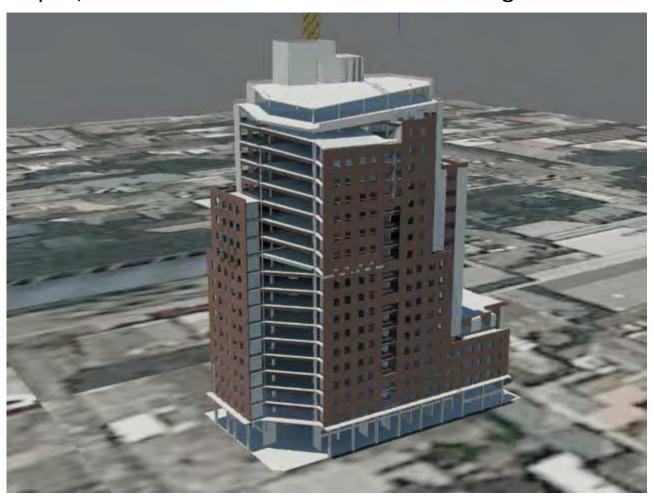
Repair, Stabilization and demolition of buildings

TO building: Temporary stabilization

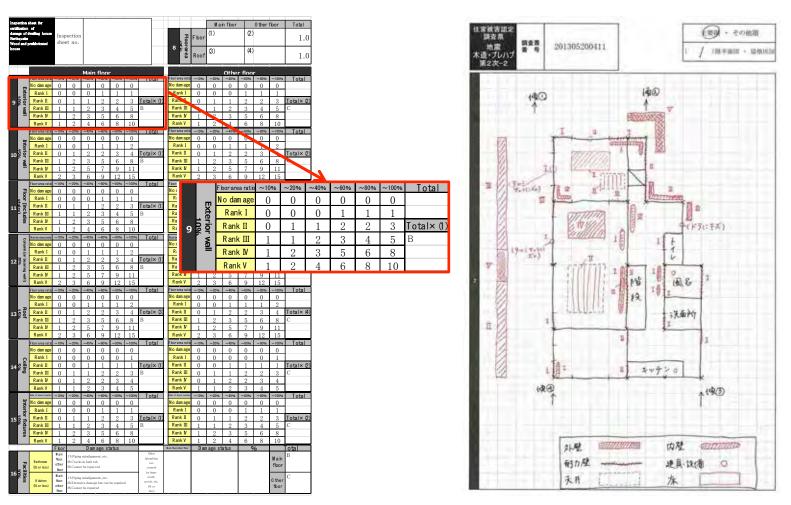
Record damaged parts on building floor plan Evaluate the rank and extent of damage of each building component.

Floor plan with results of damage inspection noted
