December 29, 2020, M6.4 Petrinja, Croatia earthquake: preliminary report

Authors: Nenad Bijelić, Svetlana Brzev

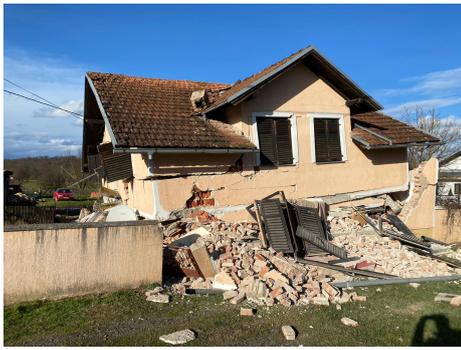
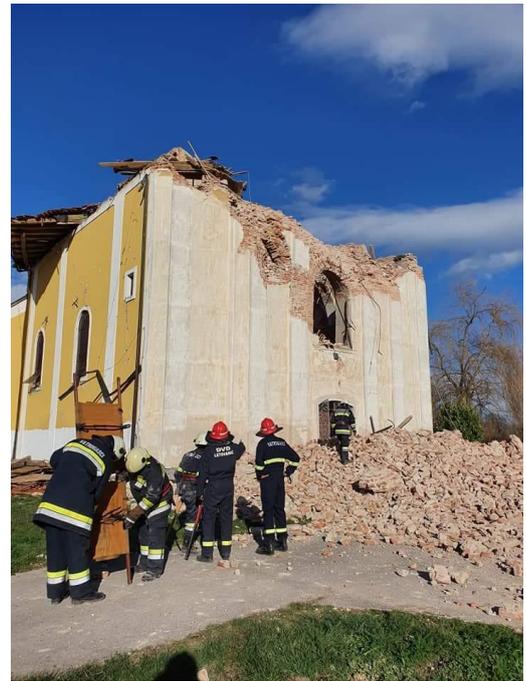
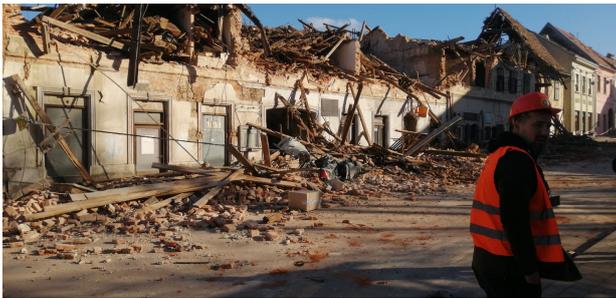
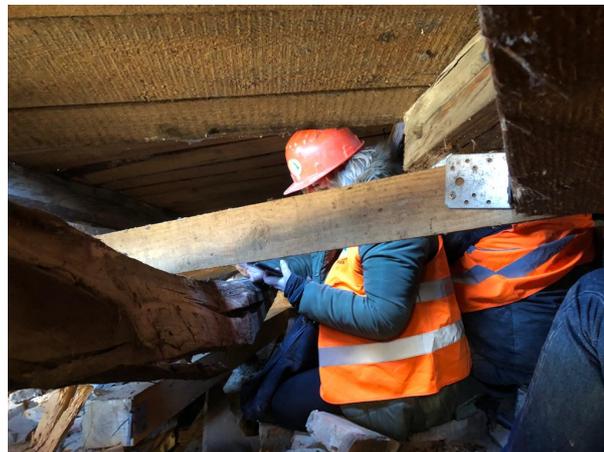
Figure 1. Photos of damage taken during post-earthquake building evaluation efforts. Bottom most photo shows volunteers getting trapped in a damaged building due to the main shock. Source: Croatian Center for Earthquake Engineering (HCPI, [8]), personal communication.
