# The 2 earthquakes of February 6<sup>th</sup> 2023 in Turkey

## Preliminary Report

by **Evangelia GARINI** and **George GAZETAS**

NTUA, Greece

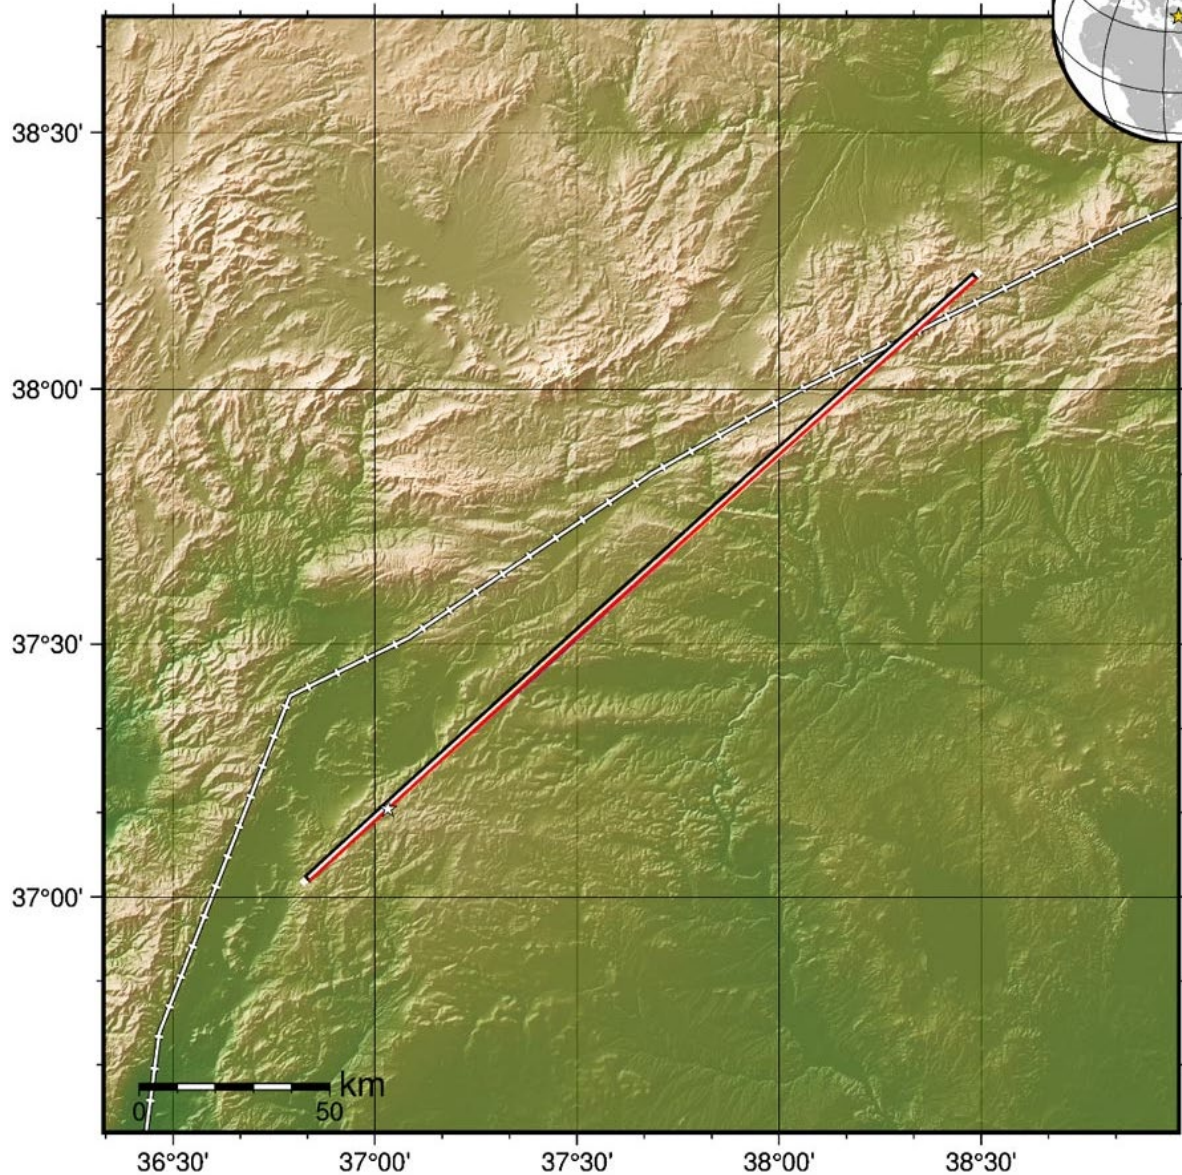
**Surface projection of the fault that ruptured** during the 6 Feb 2023 morning magnitude 7.8 quake in southern Turkey; white line is the plate boundary between Anatolia (north) and Arabia.  
**Source: USGS**

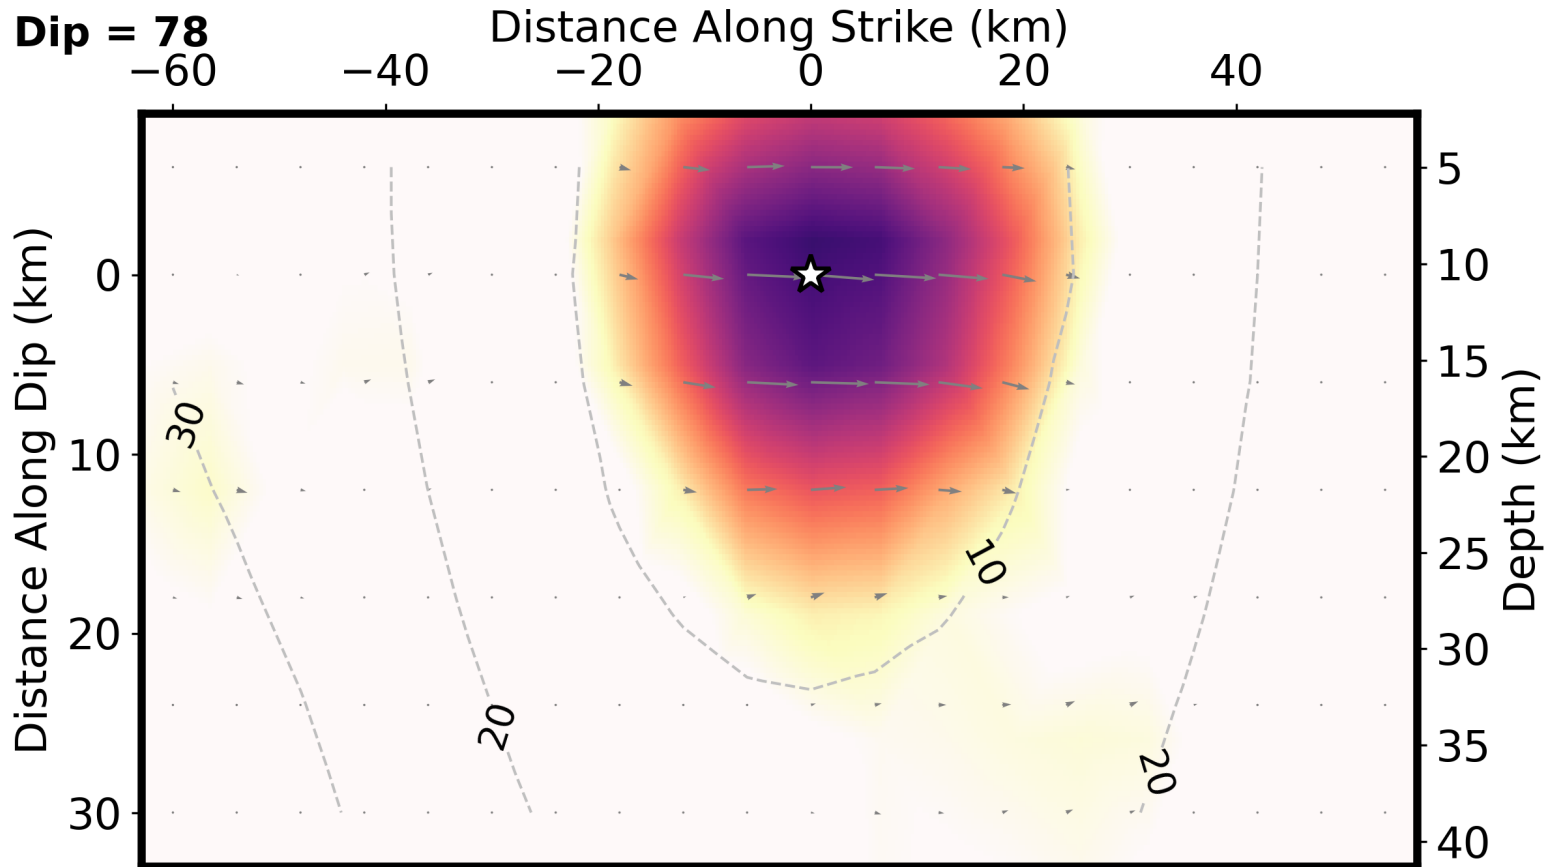
# Slip distribution Cross-section of 2<sup>nd</sup> shock $M_w$ 7.5

**Strike = 277**

**Dip = 78**

**Rupture Front Contours Plotted Every 10 s**

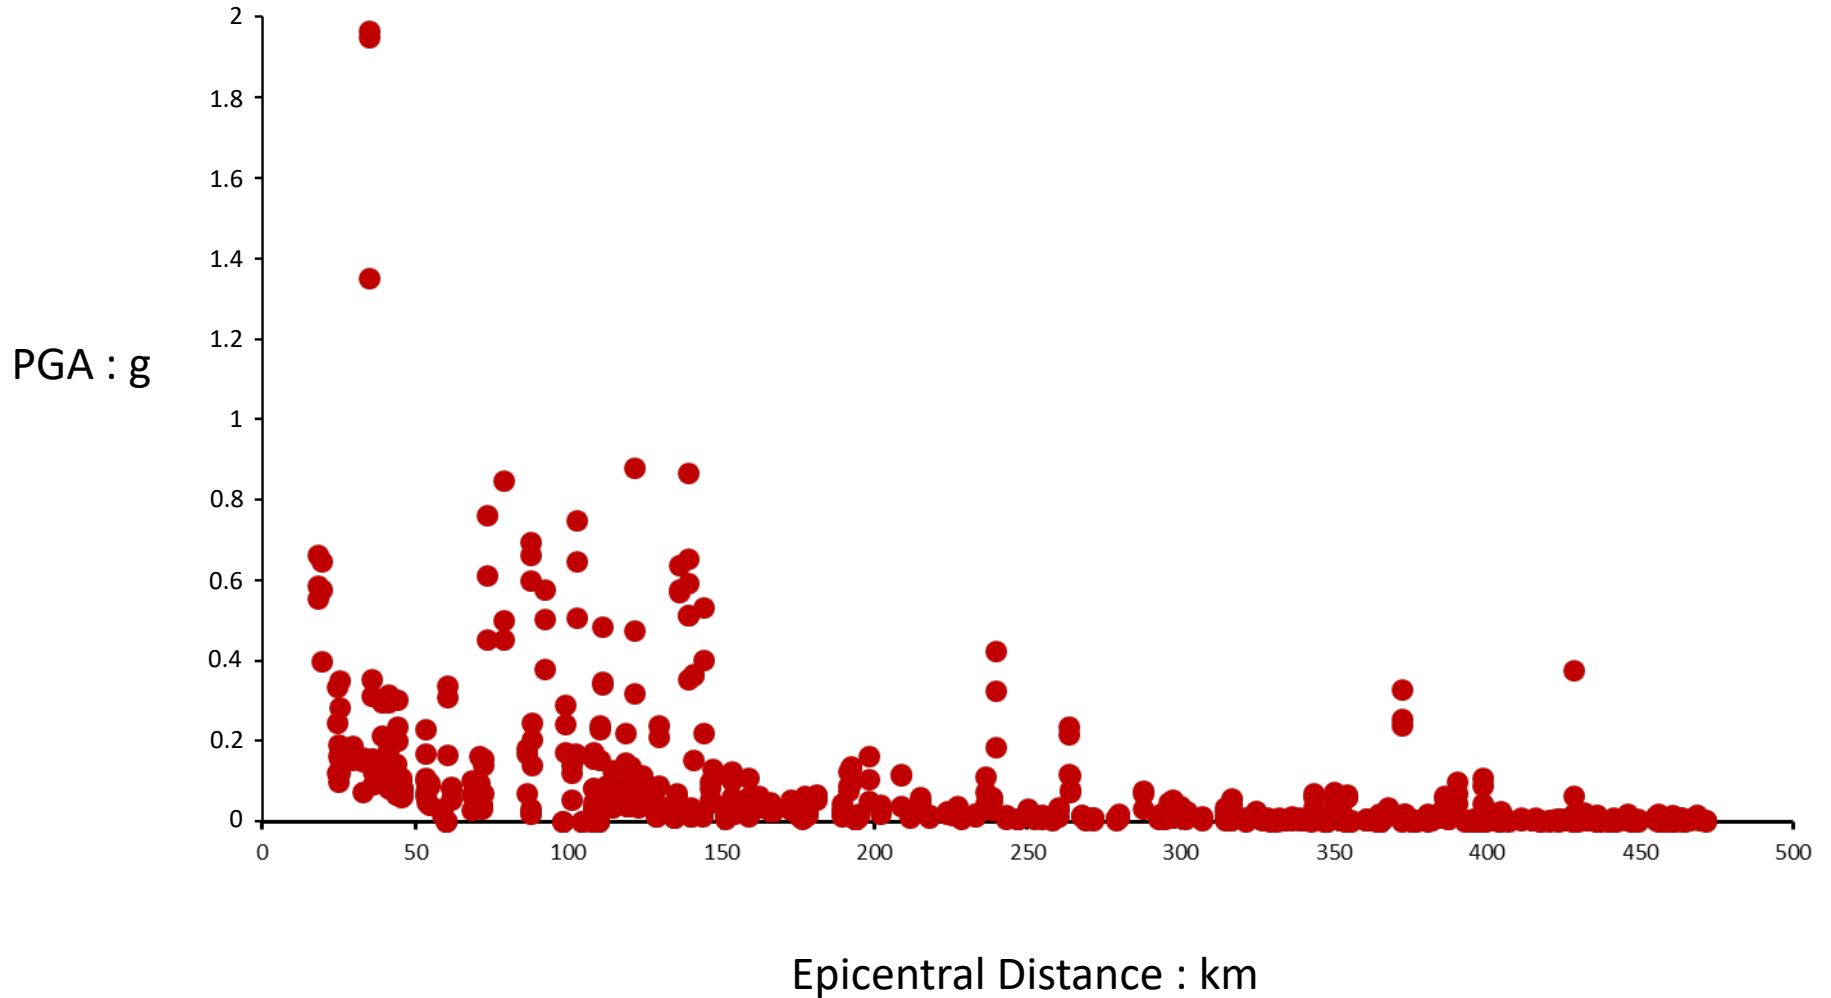
# Peak recorded ground acceleration VS epicentral Distance for the 1<sup>st</sup> Mainshock of $M_w$ 7.8

Accelerograms recorded by AFAD with  $PGA > 0.30$  g

Station Code	$R_{epi}$ : km	$PGA_{NS}$ : g	$PGA_{EW}$ : g	$PGA_{UD}$ : g
4614	35	1.949	1.967	1.353
3123	139	0.655	0.594	0.868
3142	103	0.647	0.750	0.506
NAR	19	0.647	0.579	0.399
3144	74	0.611	0.763	0.452
3145	88	0.600	0.696	0.663
4615	18	0.588	0.556	0.665
3139	92	0.577	0.505	0.379
3124	136	0.572	0.638	0.578
3136	144	0.534	0.402	0.220
3132	139	0.515	0.515	0.354
3146	111	0.484	0.347	0.341
201	122	0.474	0.880	0.319
3137	79	0.453	0.848	0.502
3131	141	0.363	0.366	0.154
4624	36	0.354	0.313	0.156
4632	25	0.353	0.286	0.188
4611	60	0.339	0.311	0.165
4629	24	0.337	0.247	0.122

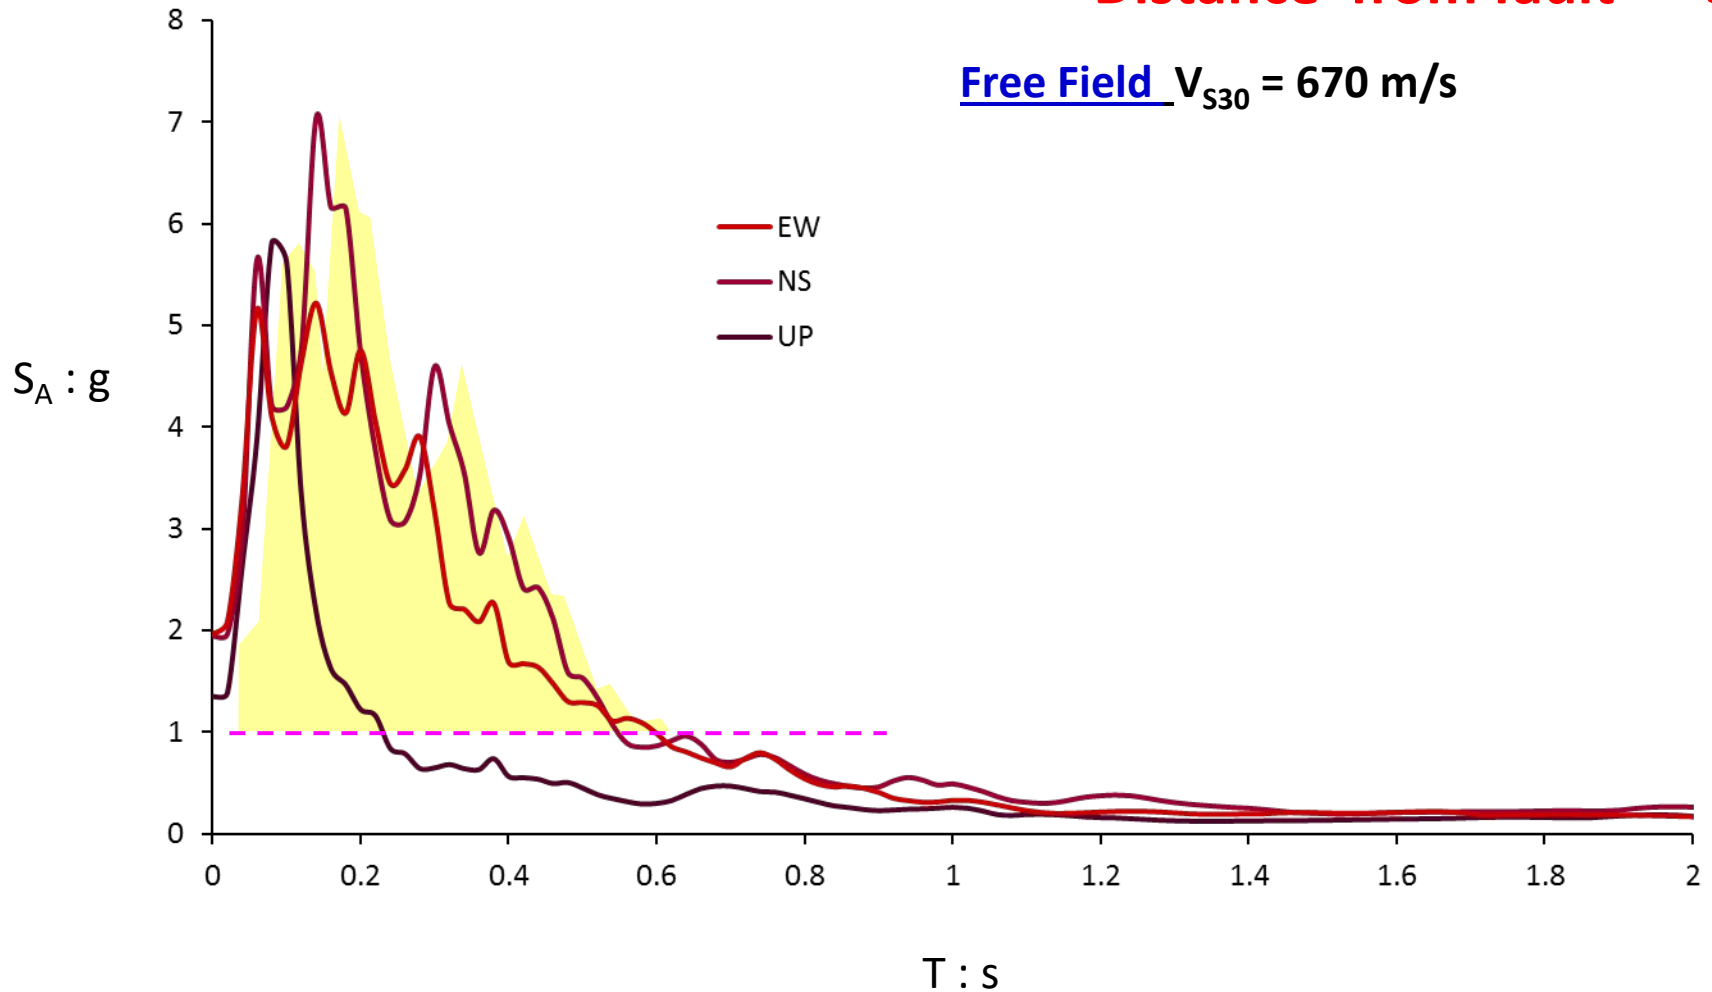
# 1<sup>st</sup> Mainshock $M_w 7.8$

Station 4614: at **Kahramanmaras**

**Distance from fault  $\approx 3$  km**

Free Field  $V_{s30} = 670$  m/s

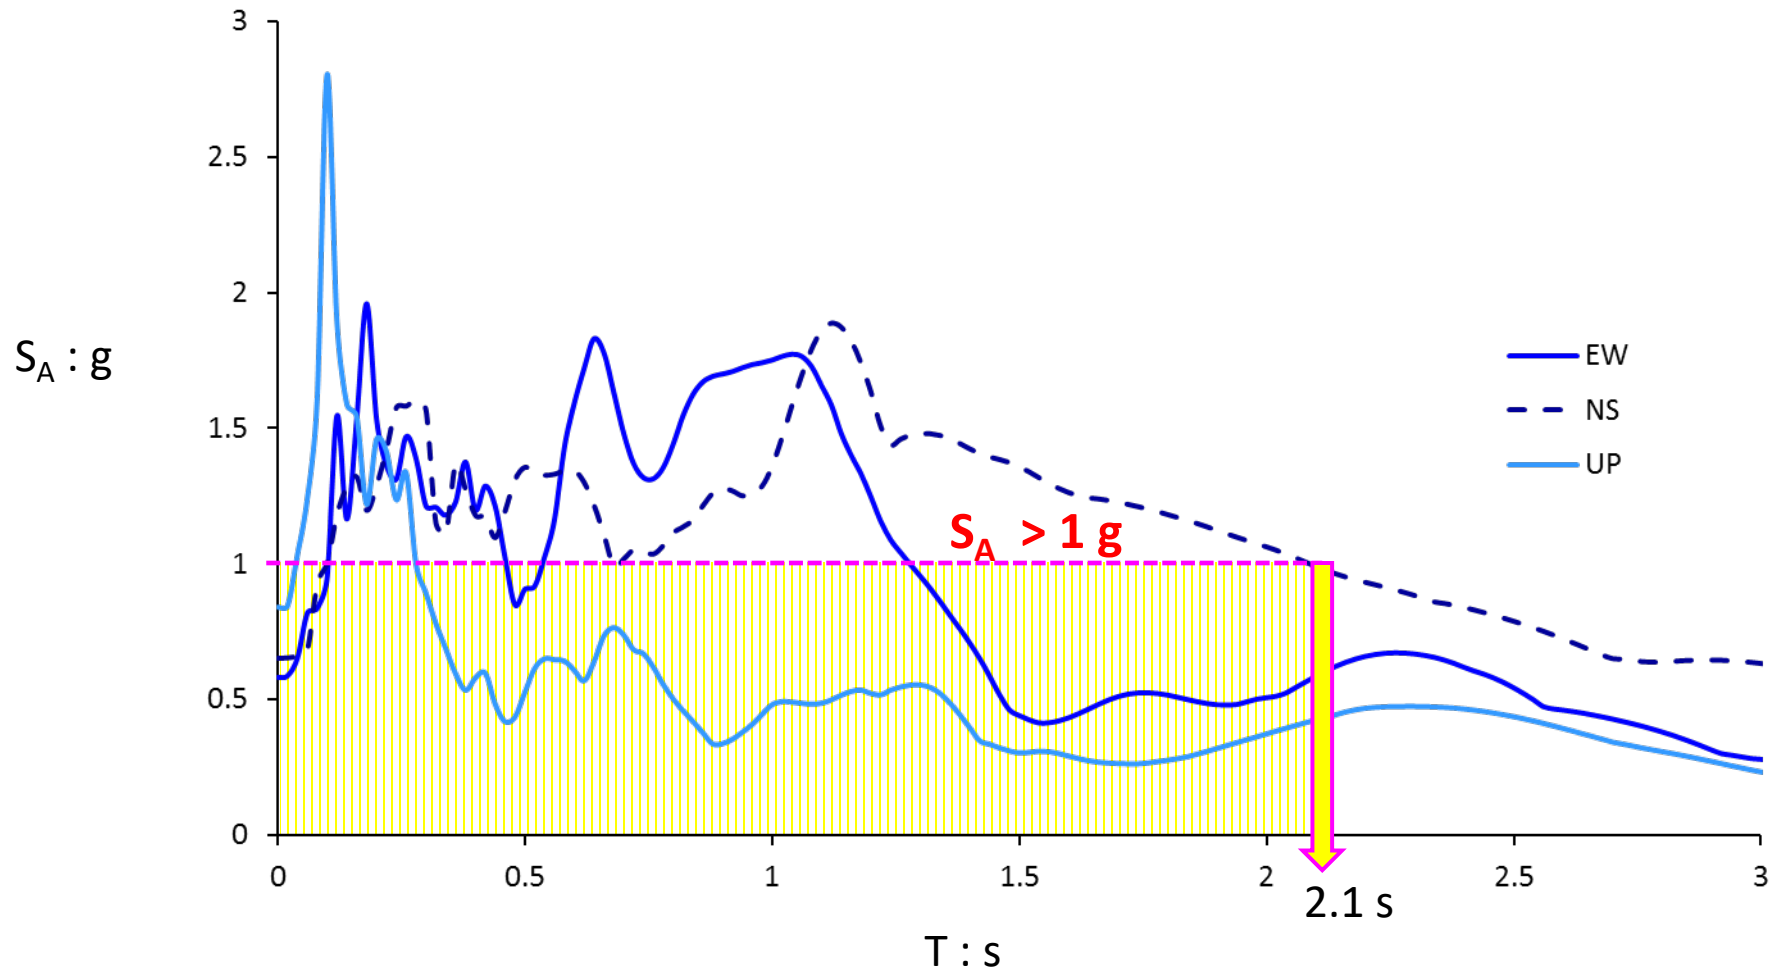
# 1<sup>st</sup> Mainshock $M_w 7.8$

Station 3123: at at **Pazarck**

Free Field  $V_{s30} = 470$  m/s

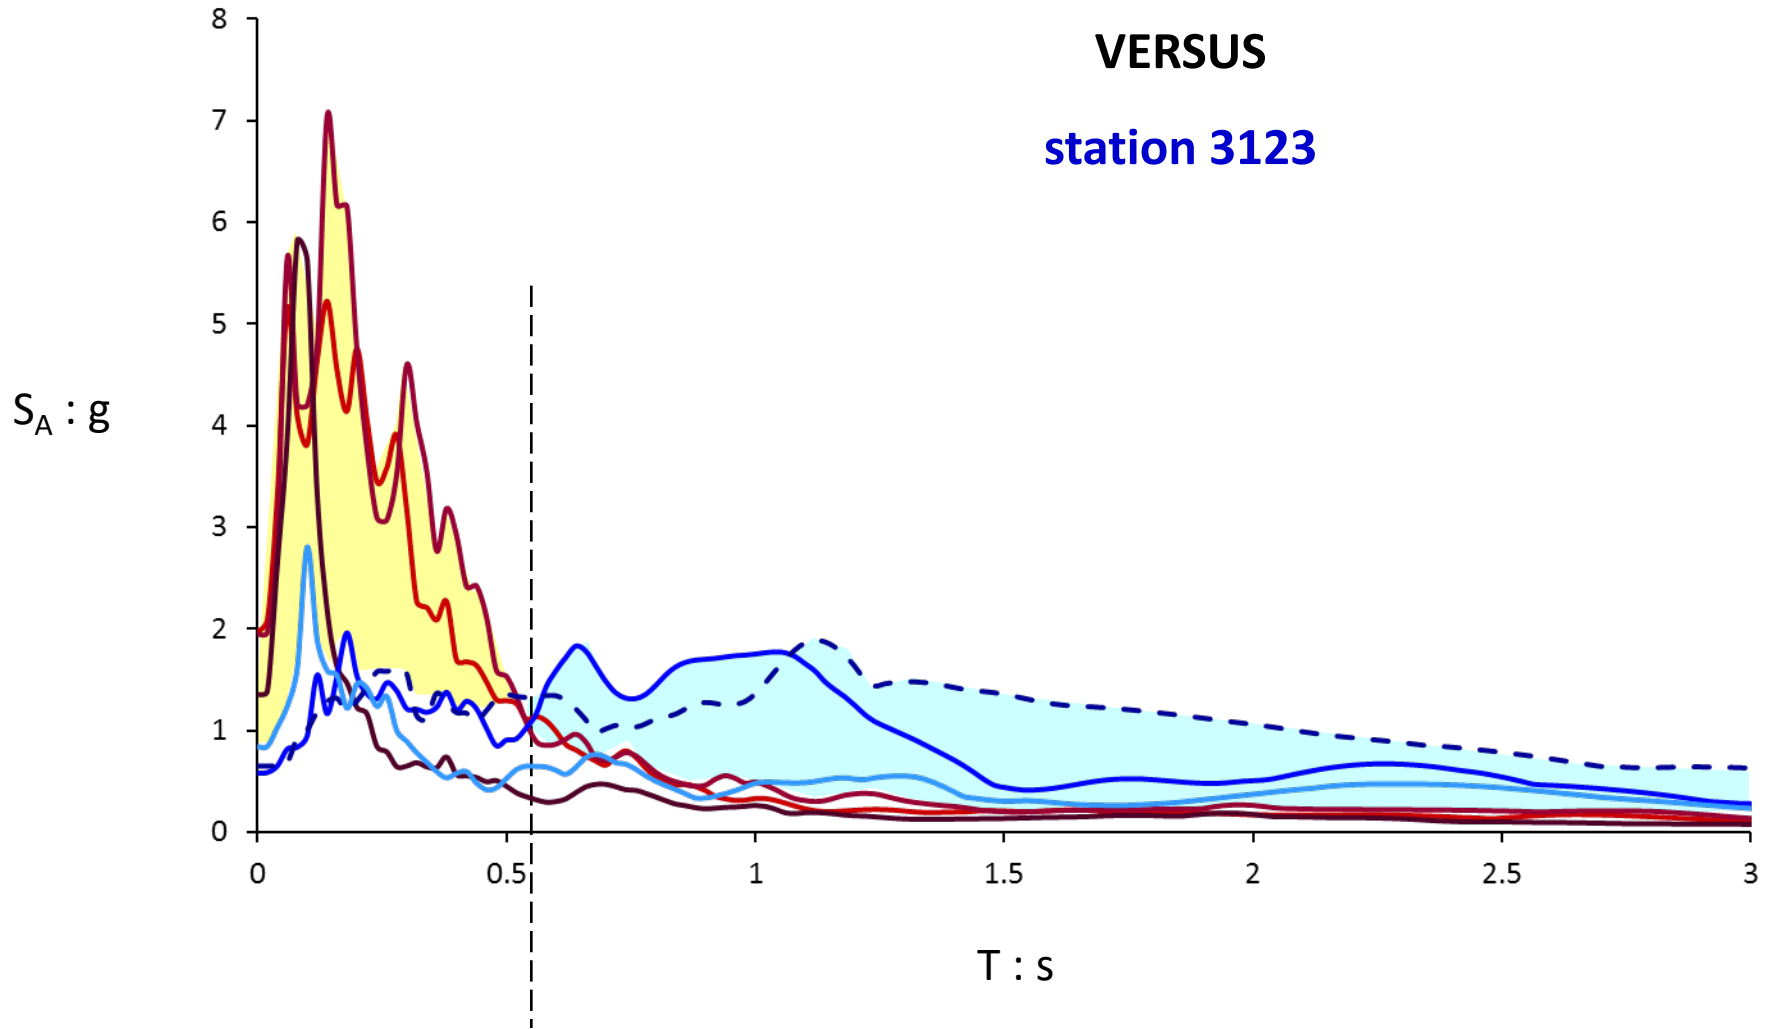
# 1<sup>st</sup> Mainshock $M_w$ 7.8

station 4614

VERSUS

station 3123

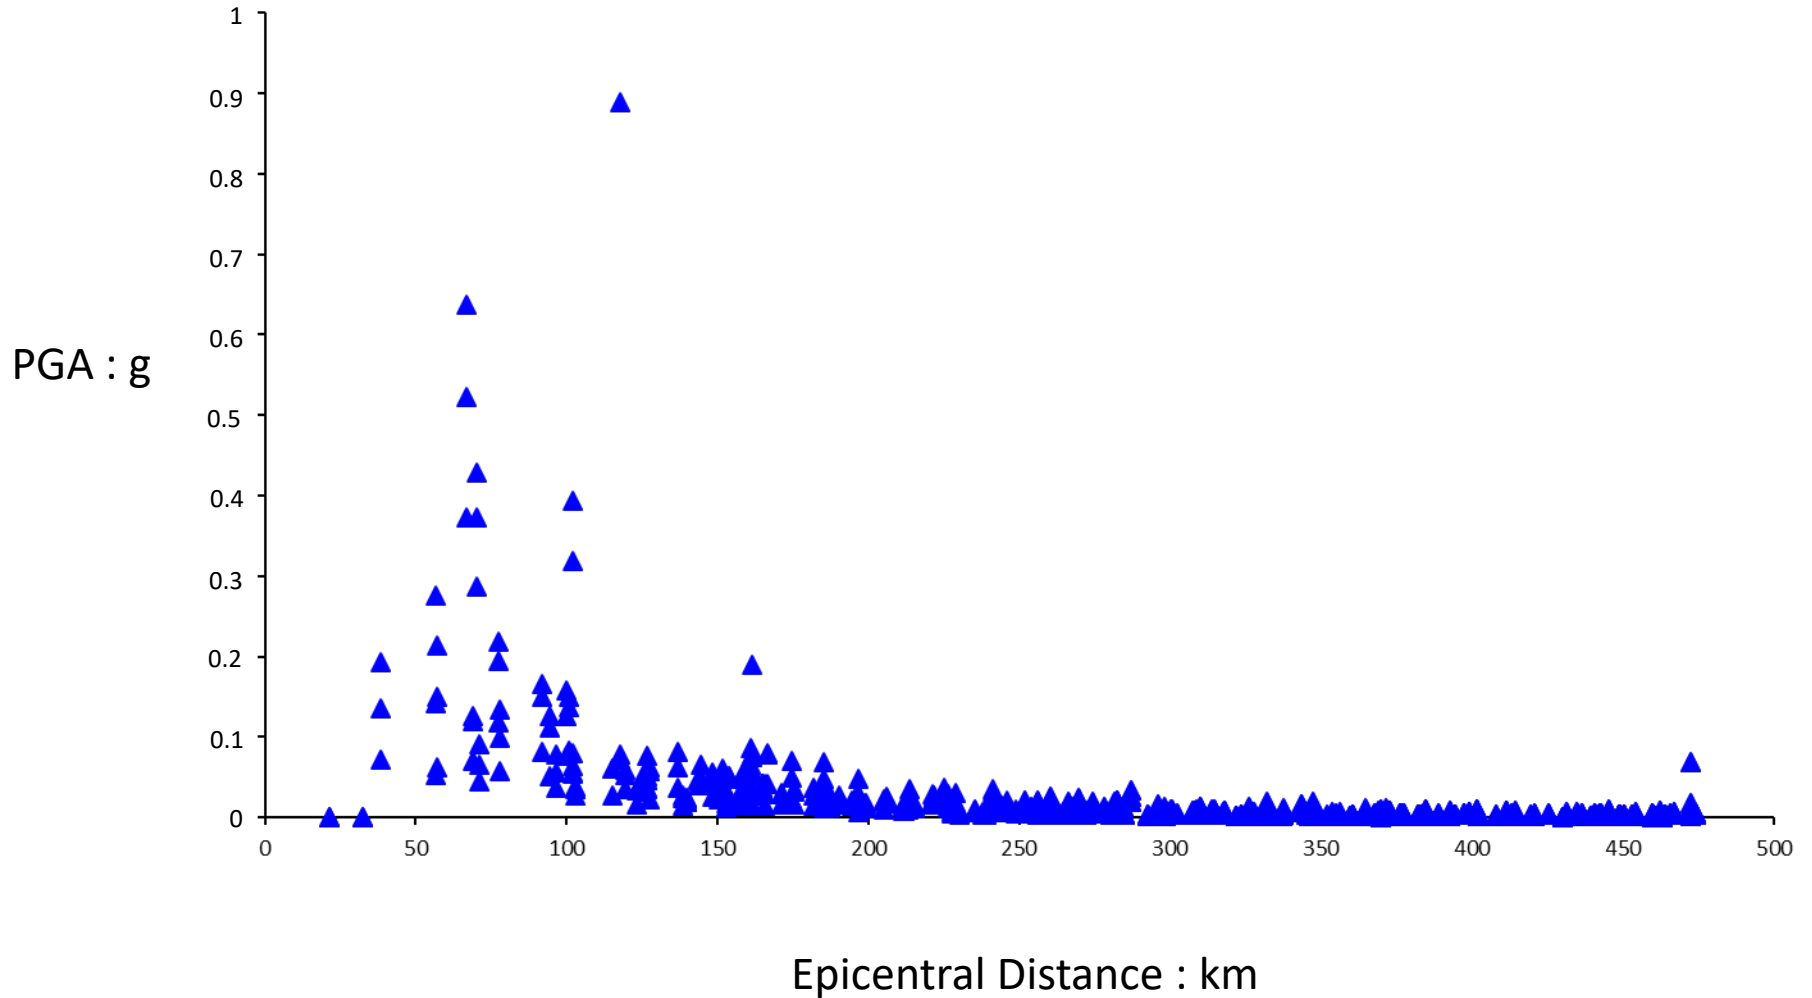
# Peak recorded ground acceleration VS epicentral Distance for the 2<sup>nd</sup> Mainshock of M<sub>w</sub>7.5

Accelerograms recorded by AFAD with  $PGA > 0.15$  g

Station Code	$R_{epi}$ : km	$PGA_{NS}$ : g	$PGA_{EW}$ : g	$PGA_{UD}$ : g
4612	67	0.638	0.523	0.373
4406	70	0.428	0.373	0.286
131	102	0.394	0.319	0.079
4409	57	0.214	0.150	0.062
3802	77	0.194	0.219	0.118
4611	38	0.193	0.135	0.072
4412	100	0.157	0.125	0.076
129	92	0.150	0.166	0.081
4405	101	0.137	0.150	0.083
NAR	78	0.134	0.099	0.057
213	69	0.119	0.127	0.070
4410	95	0.112	0.125	0.051
141	161	0.079	0.189	0.074

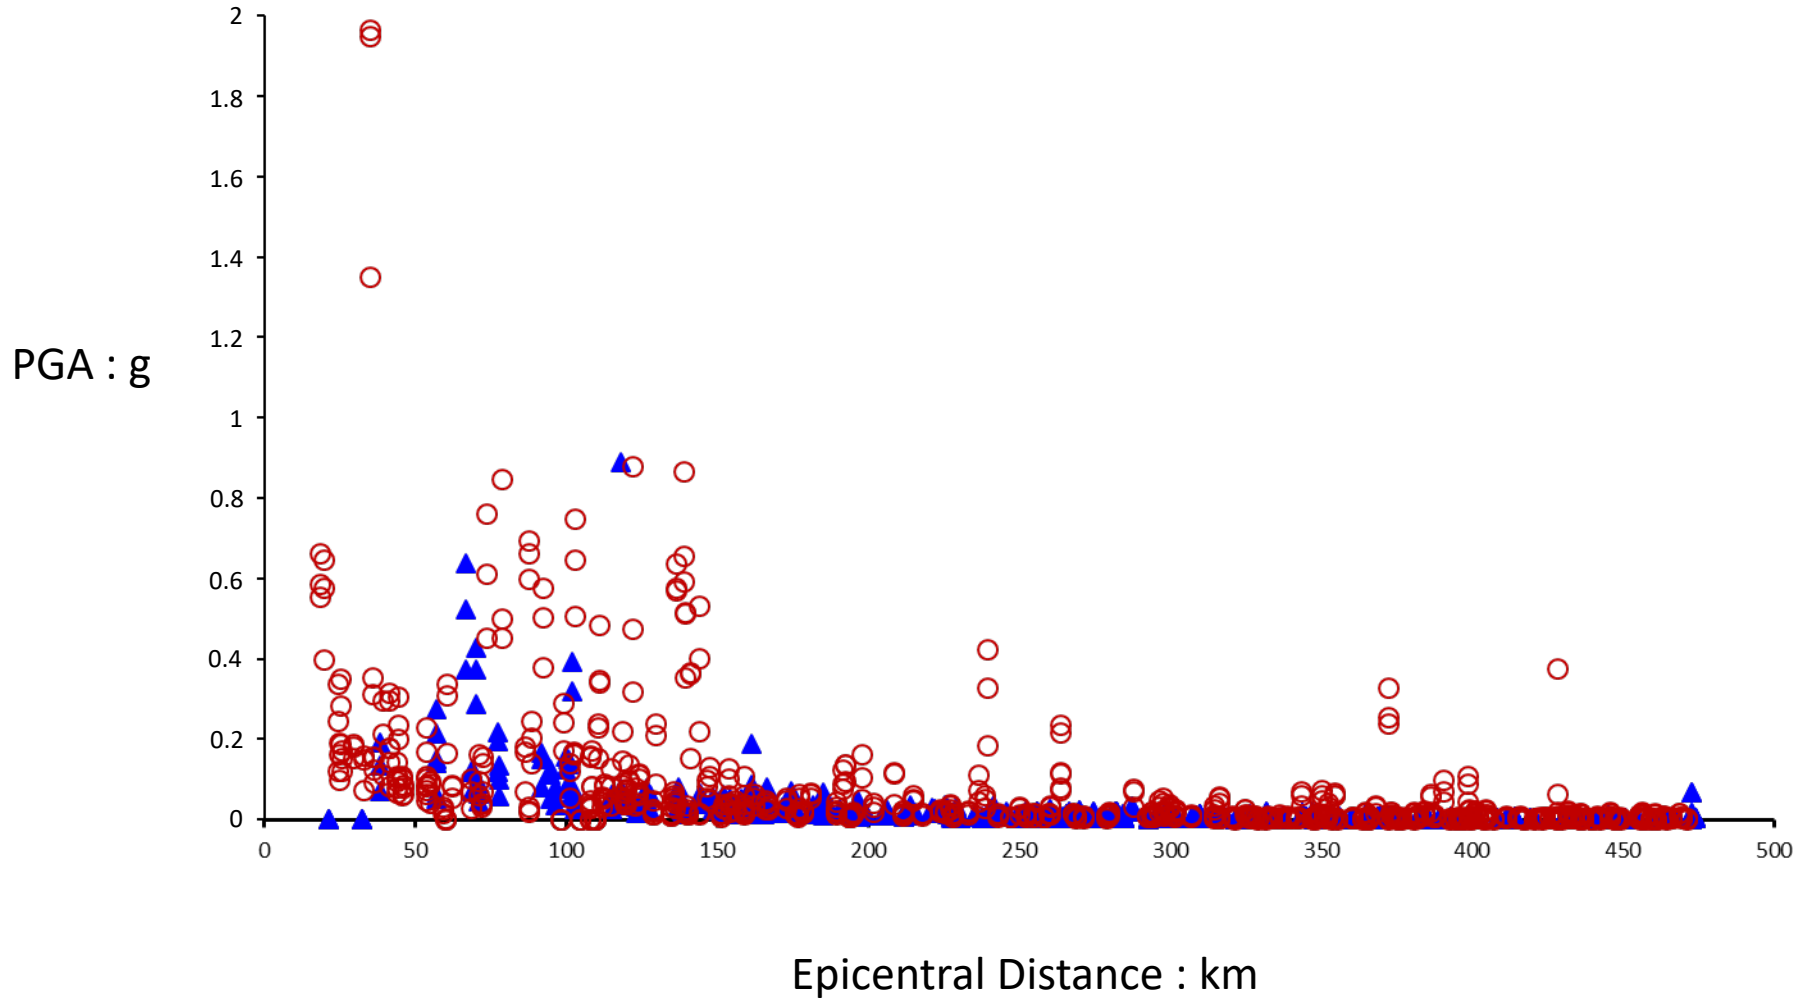
- 1<sup>st</sup> mainshock
- ▲ 2<sup>nd</sup> mainshock

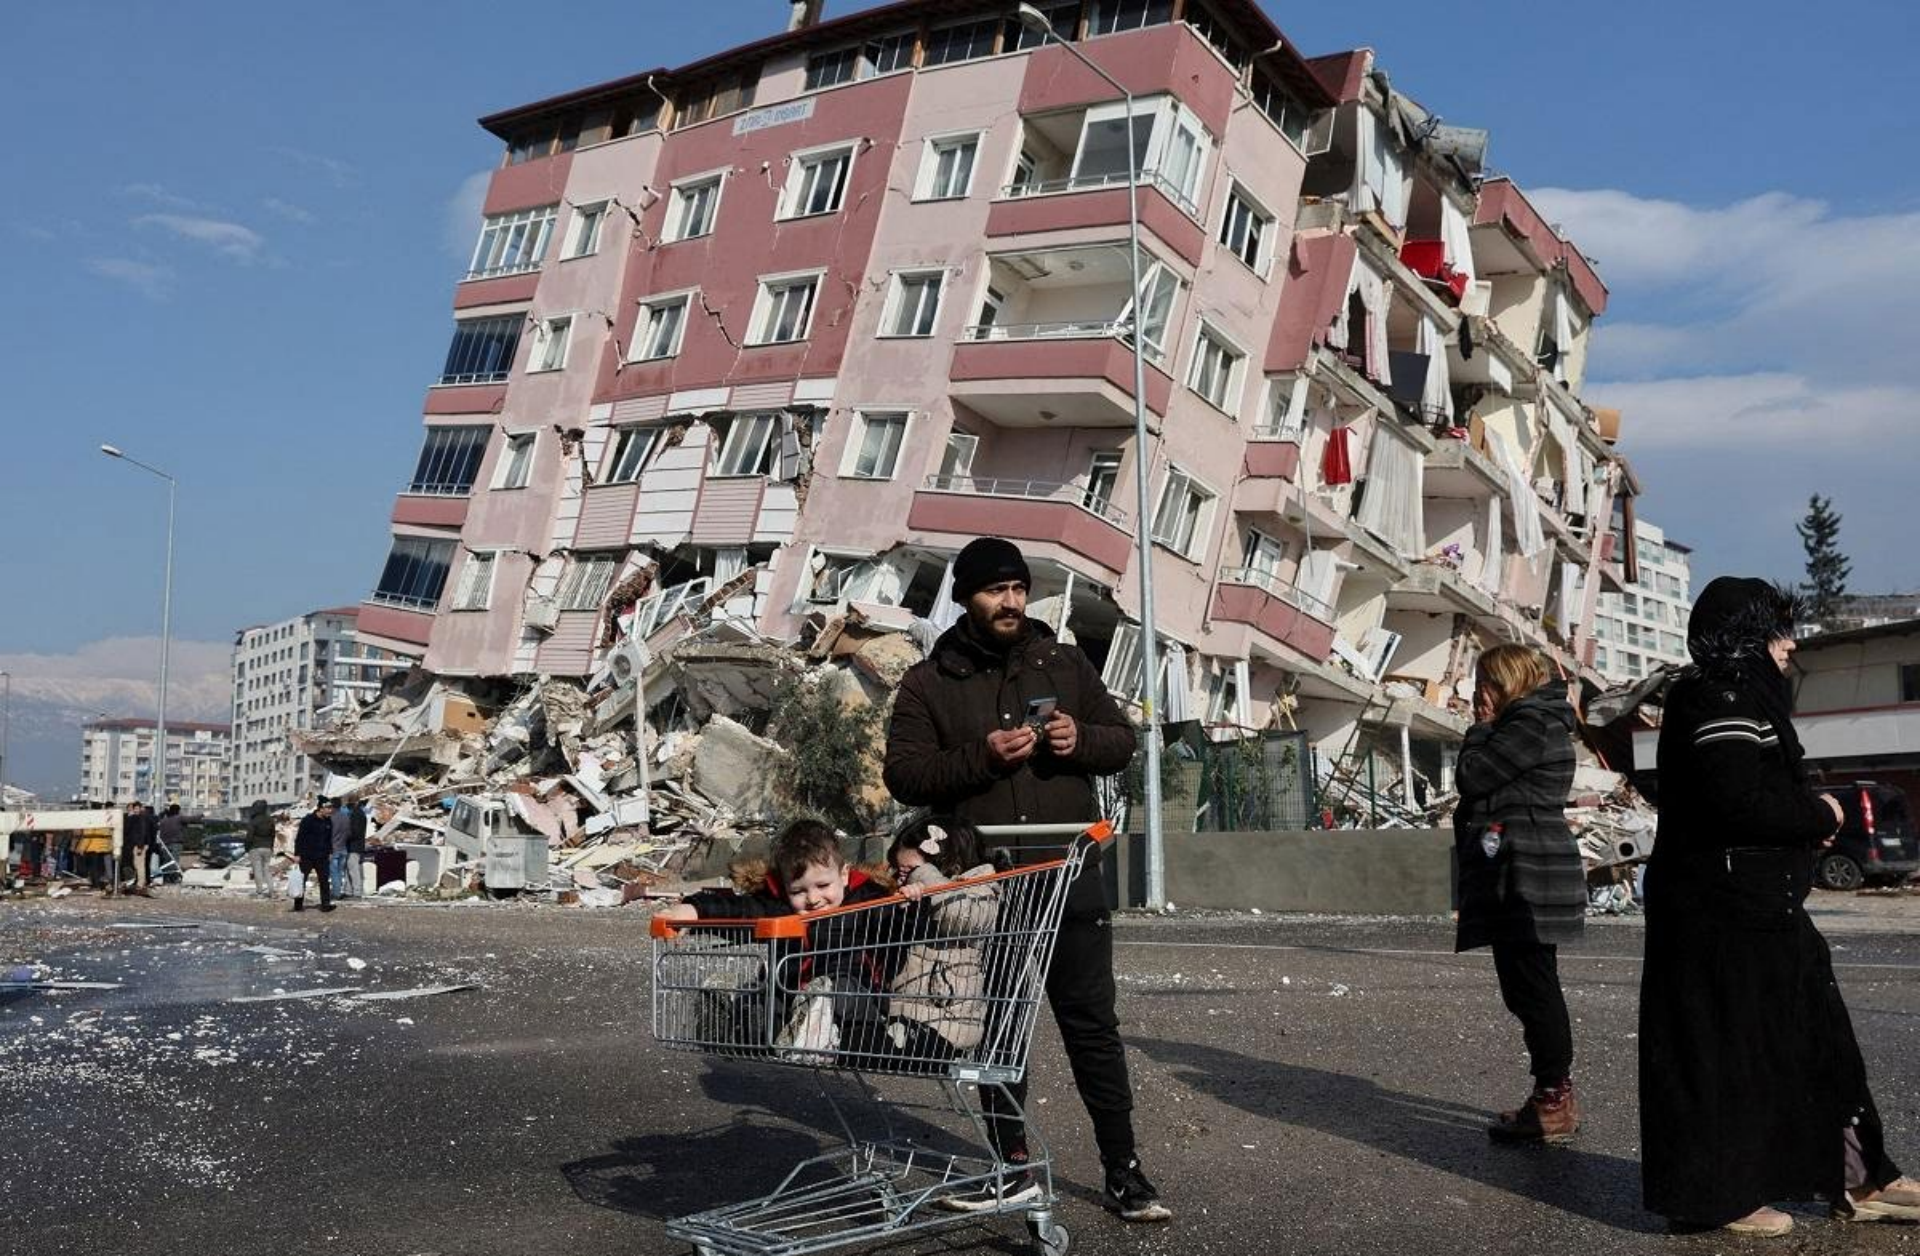
A collapsed building in Hatay, Turkey, February 7, 2023.  
(Photo: REUTERS/ Umit Bektas/ File Photo)

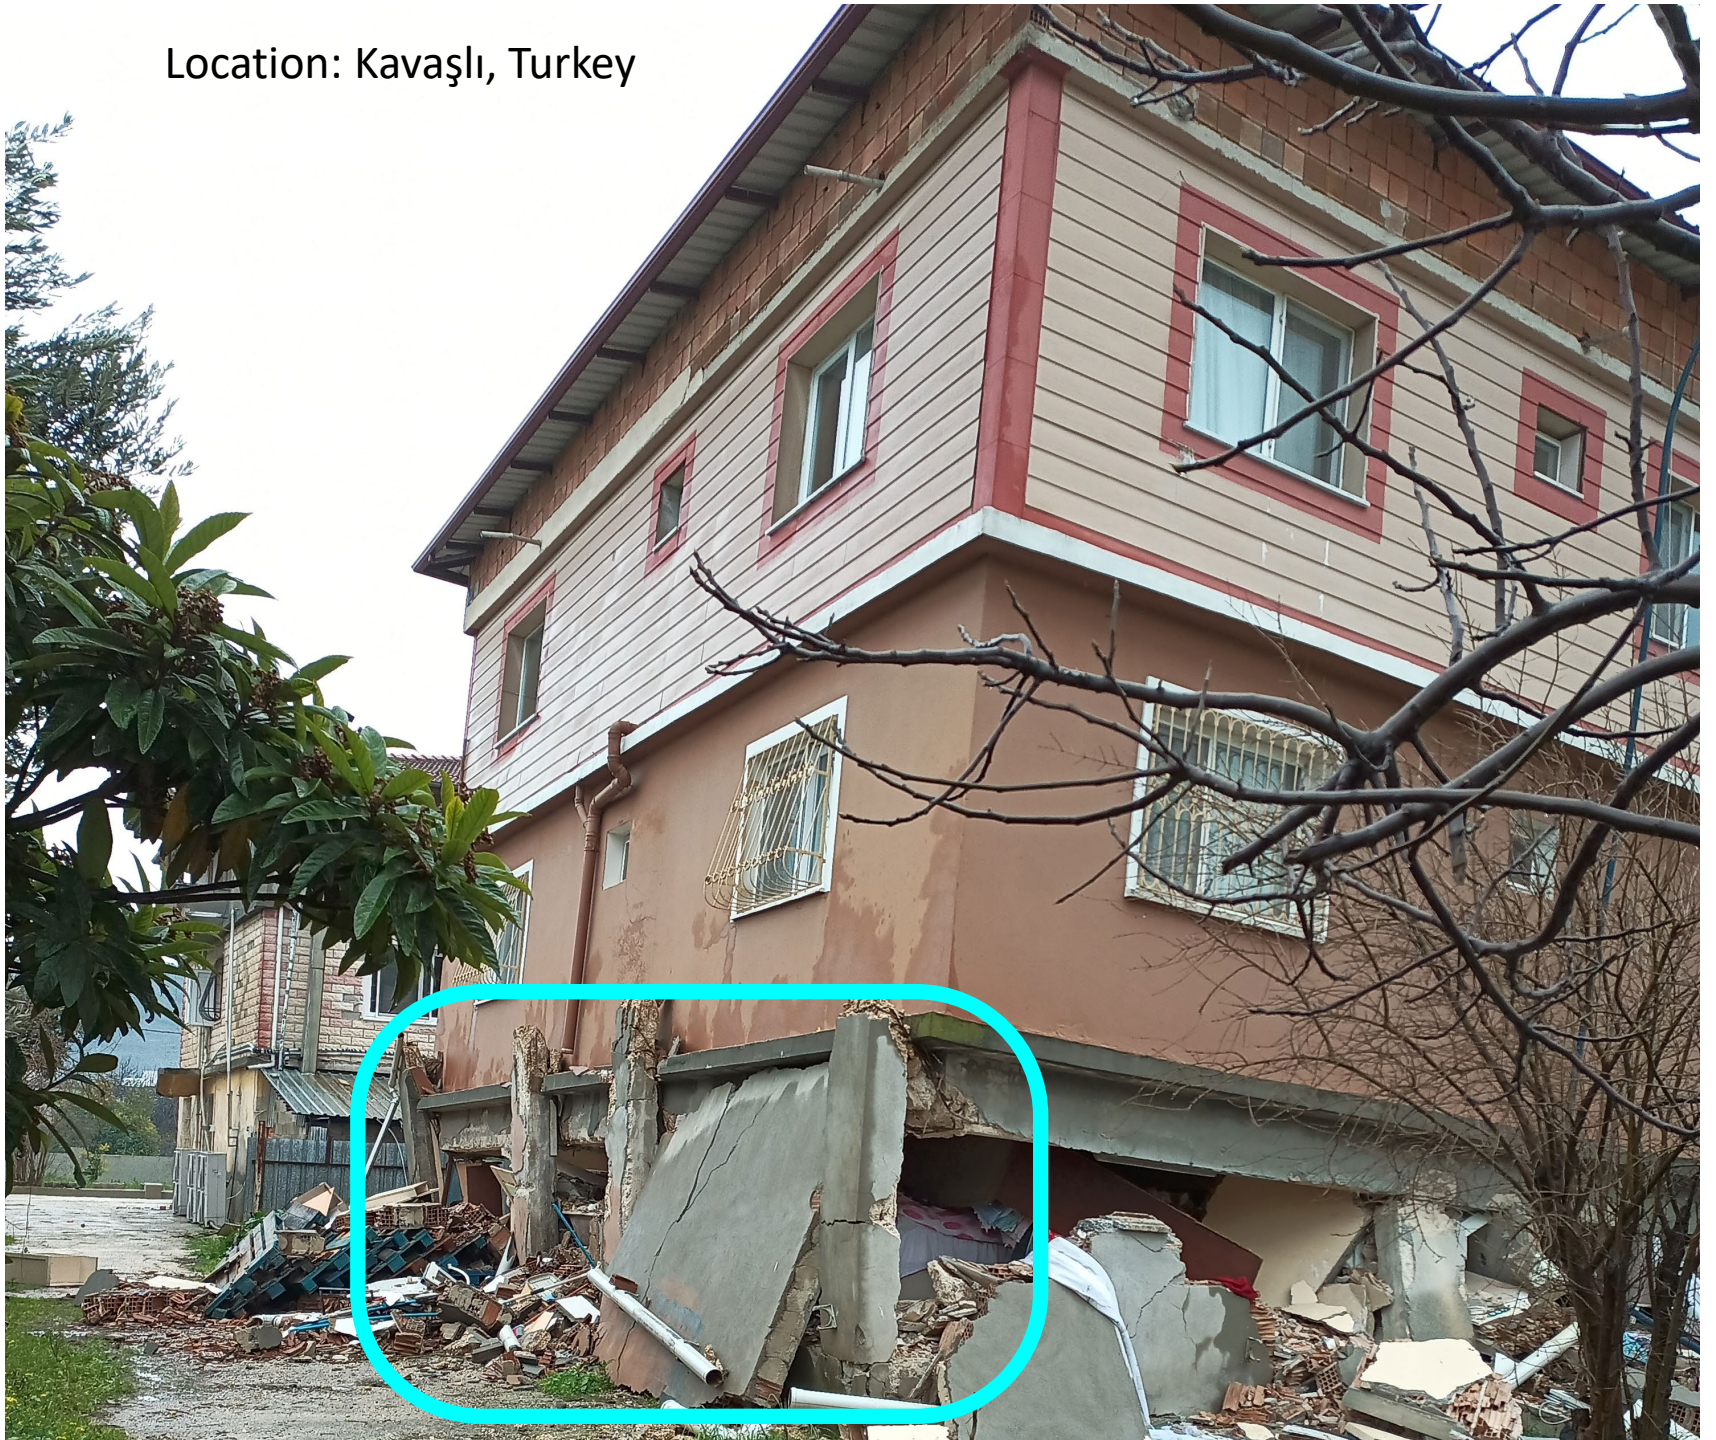
Flattened buildings in Hatay  
Credit: Anadolu Agency, Erçin Ertürk

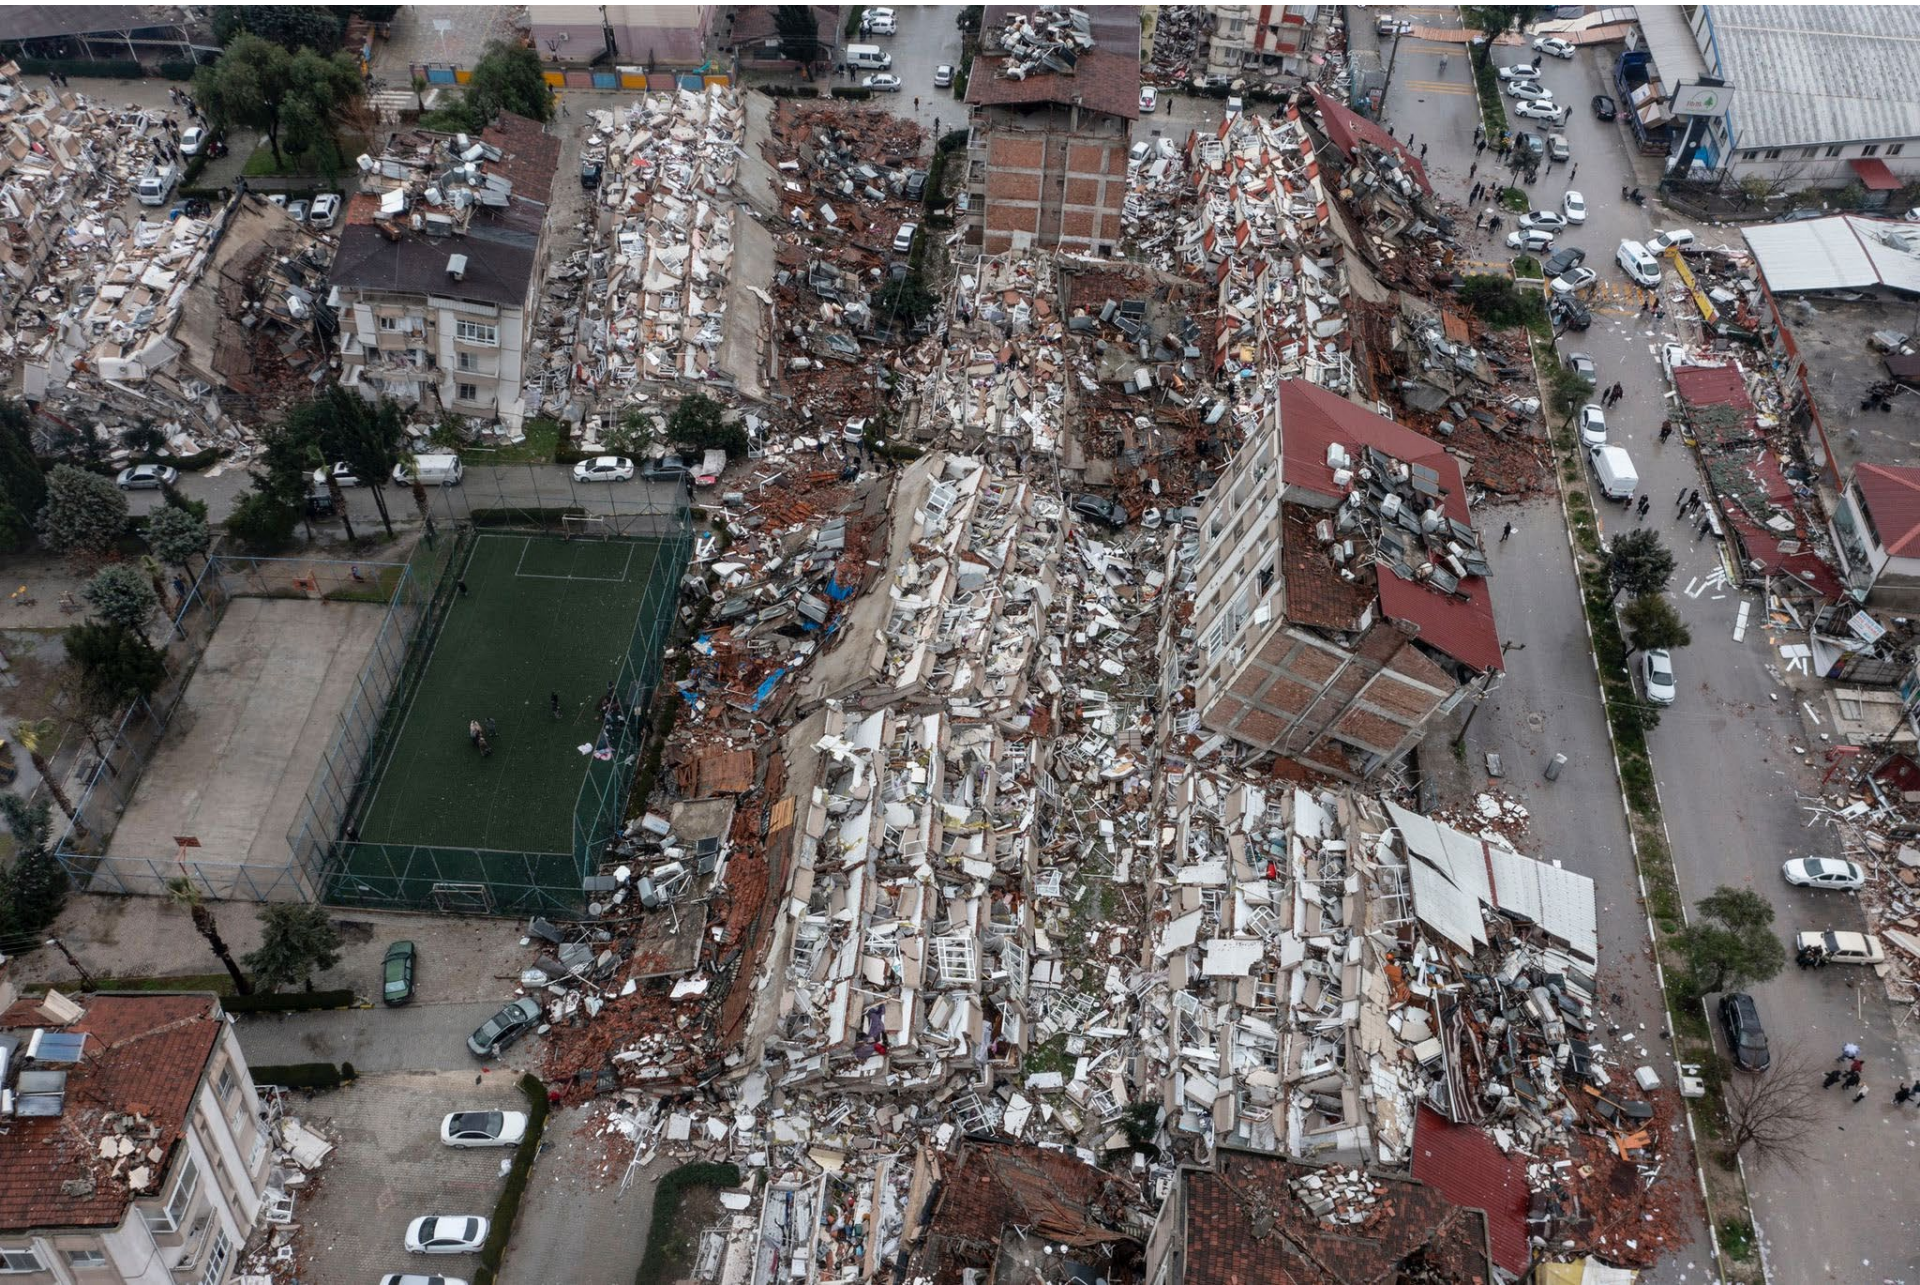
**A collapsed buildings in Kahramanmaras, Turkey, on Monday. (Ihlas News Agency/Reuters)**
