# The 2 earthquakes of February 6<sup>th</sup> 2023 in Turkey

## Preliminary Report

by **Evangelia GARINI** and **George GAZETAS**

NTUA, Greece

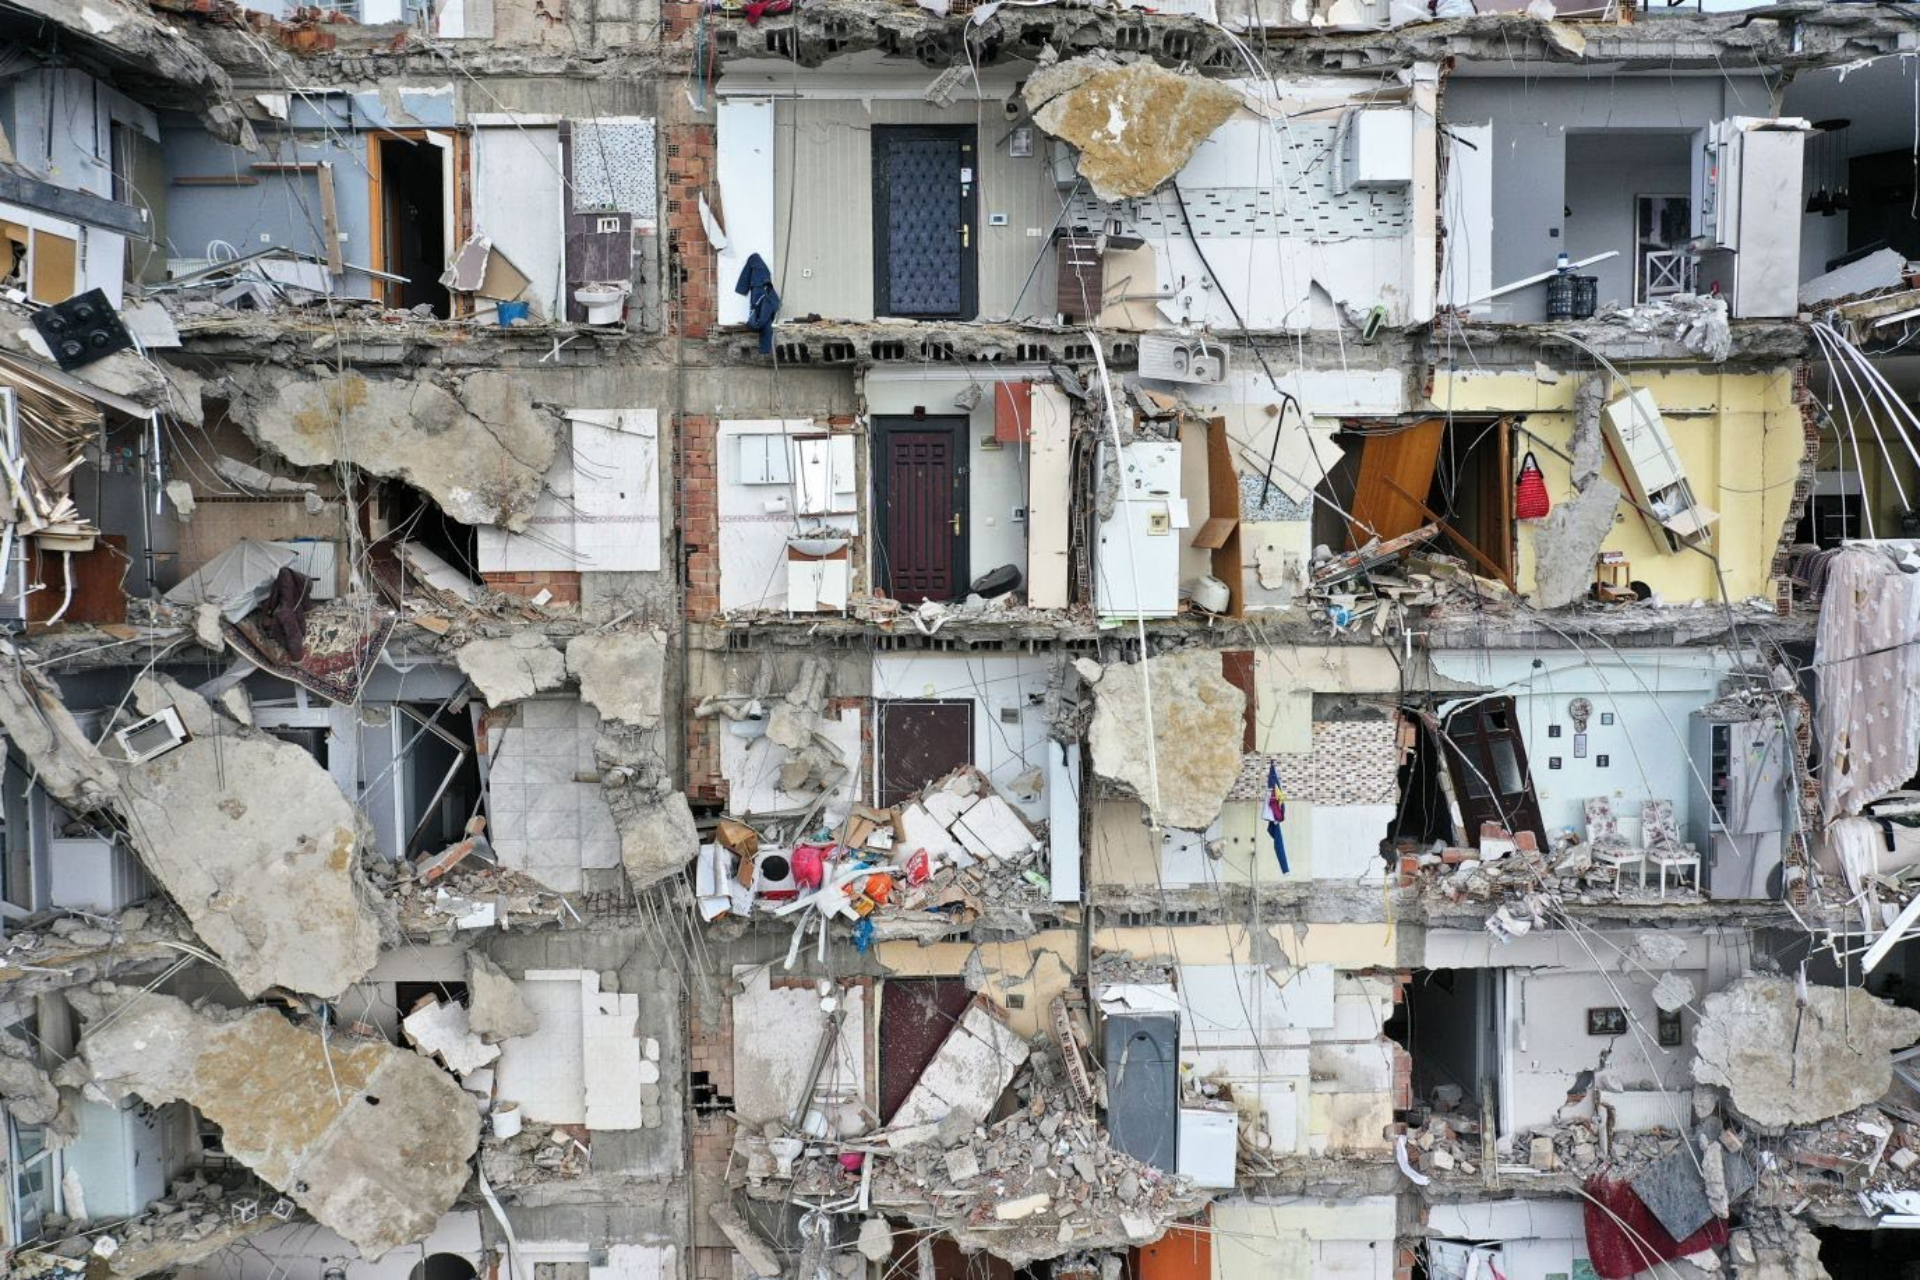
This aerial photo shows a damaged building in Adana. Oguz Yeter/Anadolu Agency via Getty Images

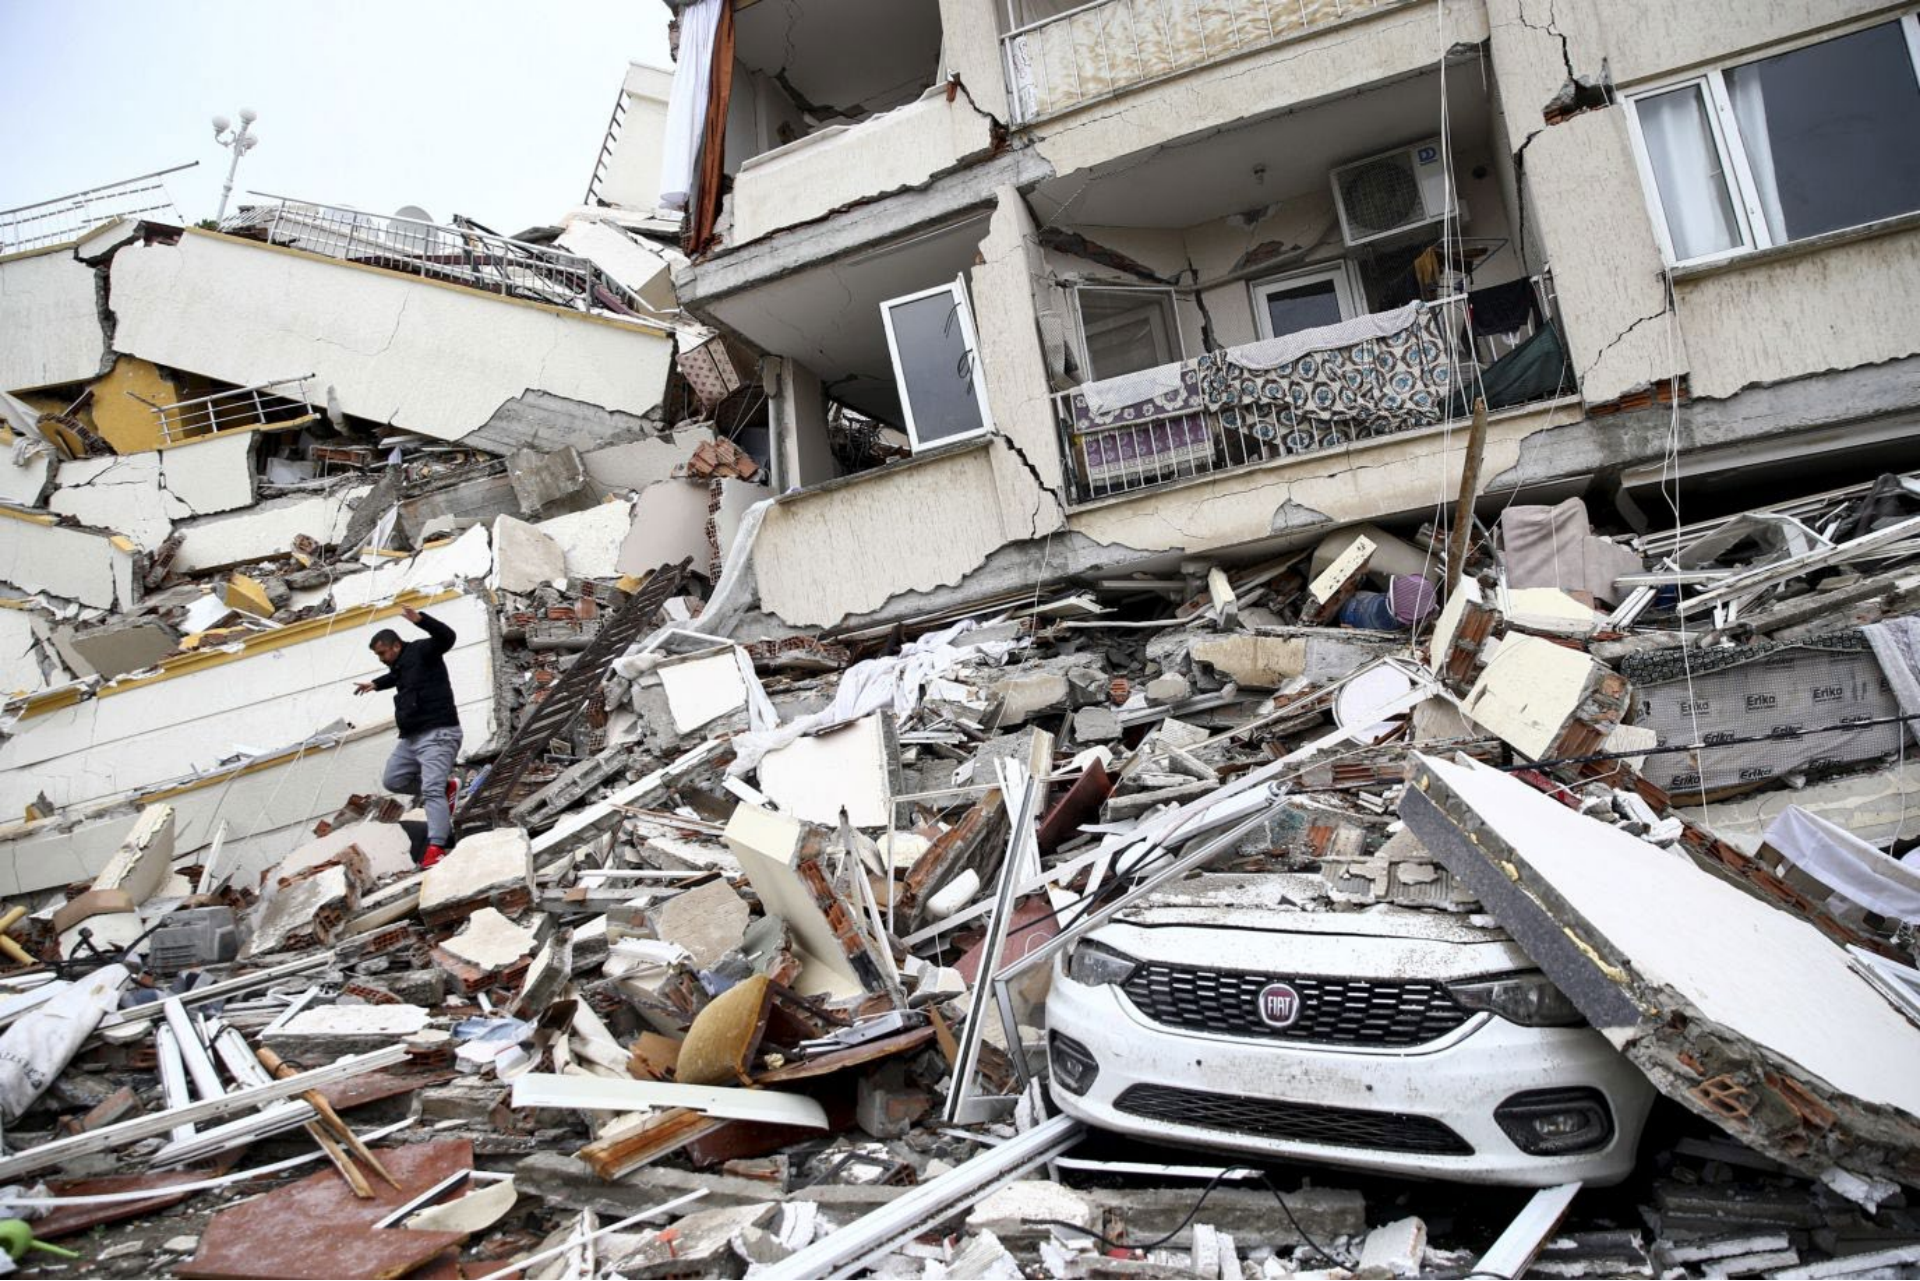
Rubble of a collapsed building in Hatay. Sezgin Pancar/Anadolu Agency/Getty Images

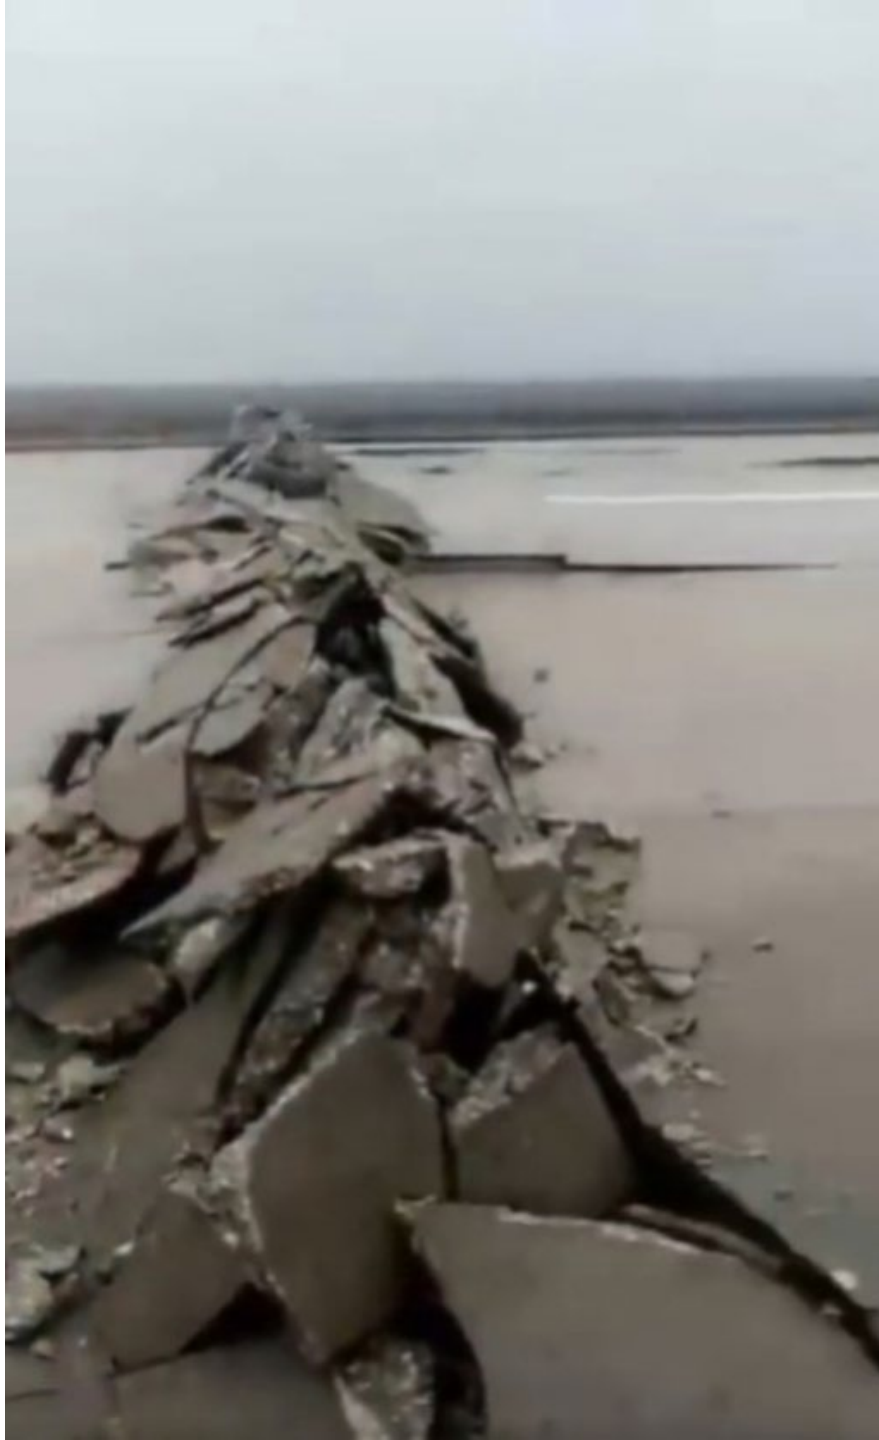
M7.8 and 7.5 earthquakes  
in Turkey damage runway  
of Hatay Airport

In Hatay Province, the runway of Hatay Airport was split and uplifted. Two provincial hospitals and a police station were destroyed, and a gas pipeline exploded

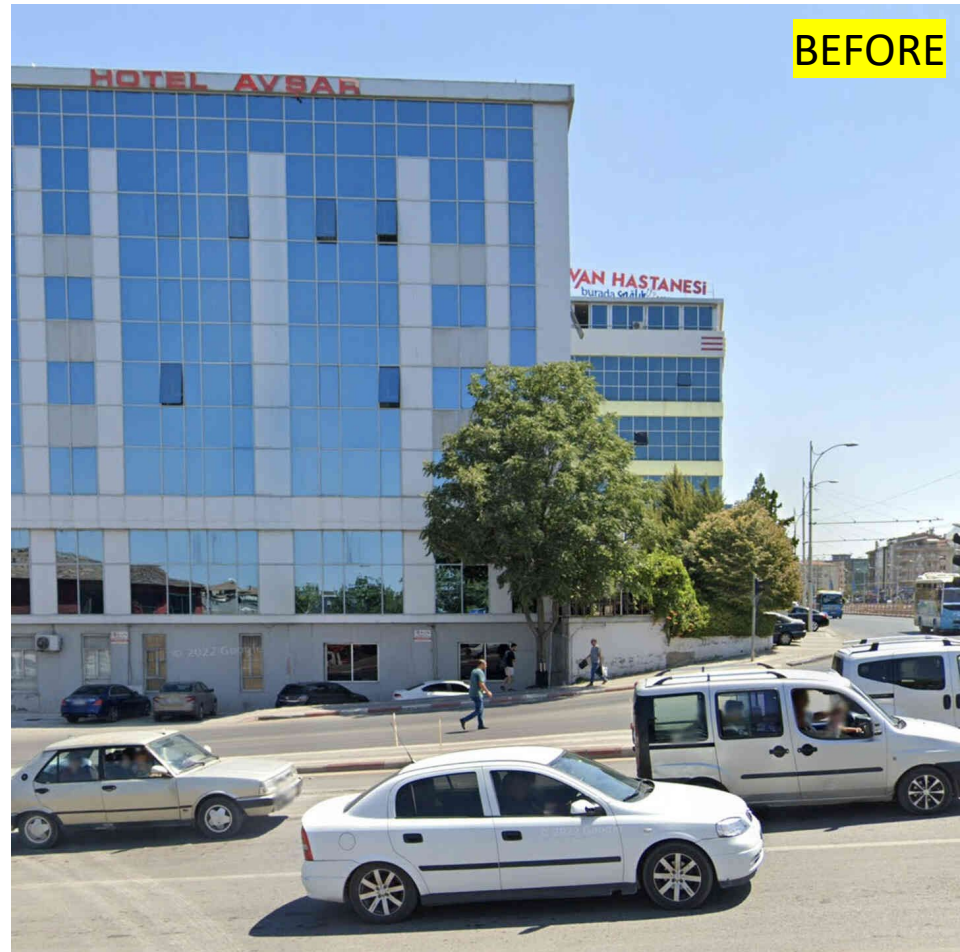
# Hotel Avsar

BEFORE

AFTER

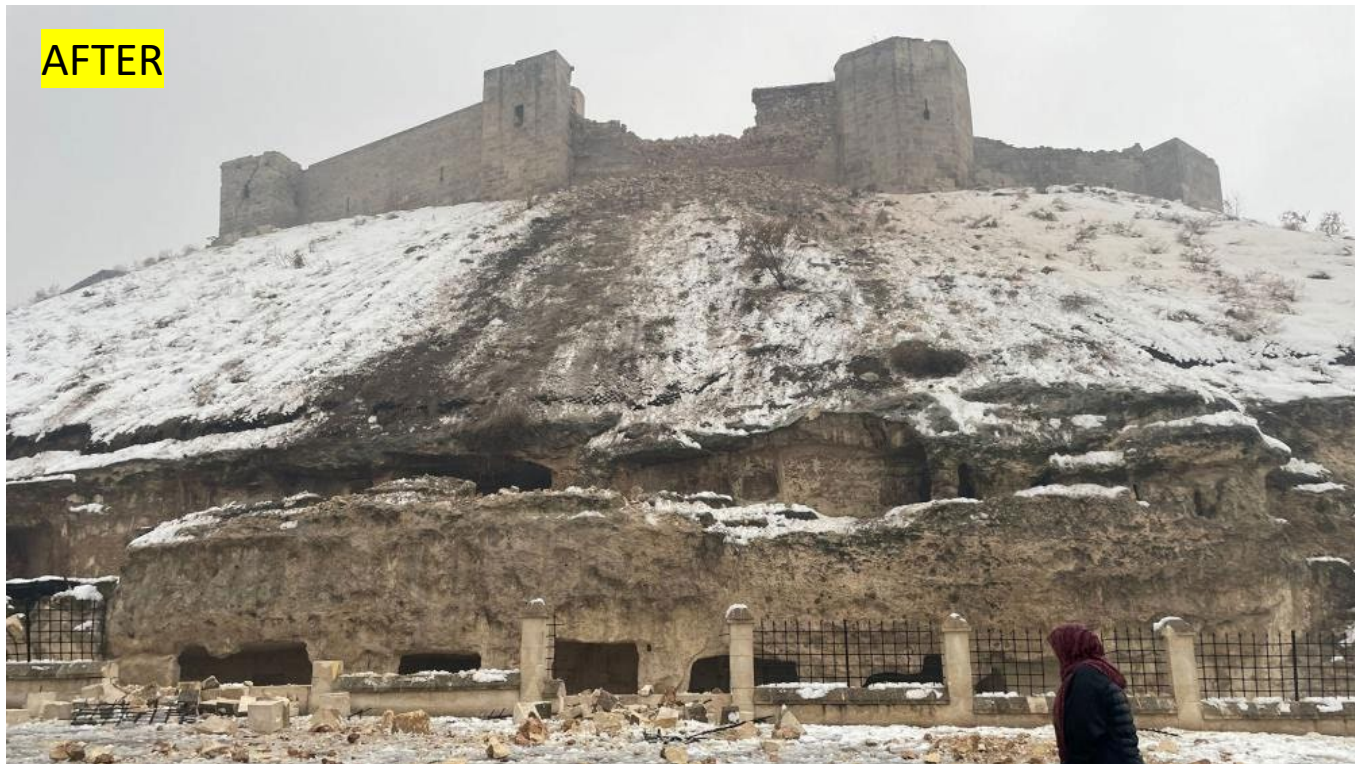
Gaziantep Castle in Turkey  
(Source: CNN webpage).

About 130 building collapses also occurred in Malatya. The ancient Gaziantep Castle was seriously damaged. Kahramanmaras, a city of more than 1 million people, has been hit hard, as too have Malatya, Hayat region and reports suggest up to 10 major cities heavily affected by collapsing buildings.

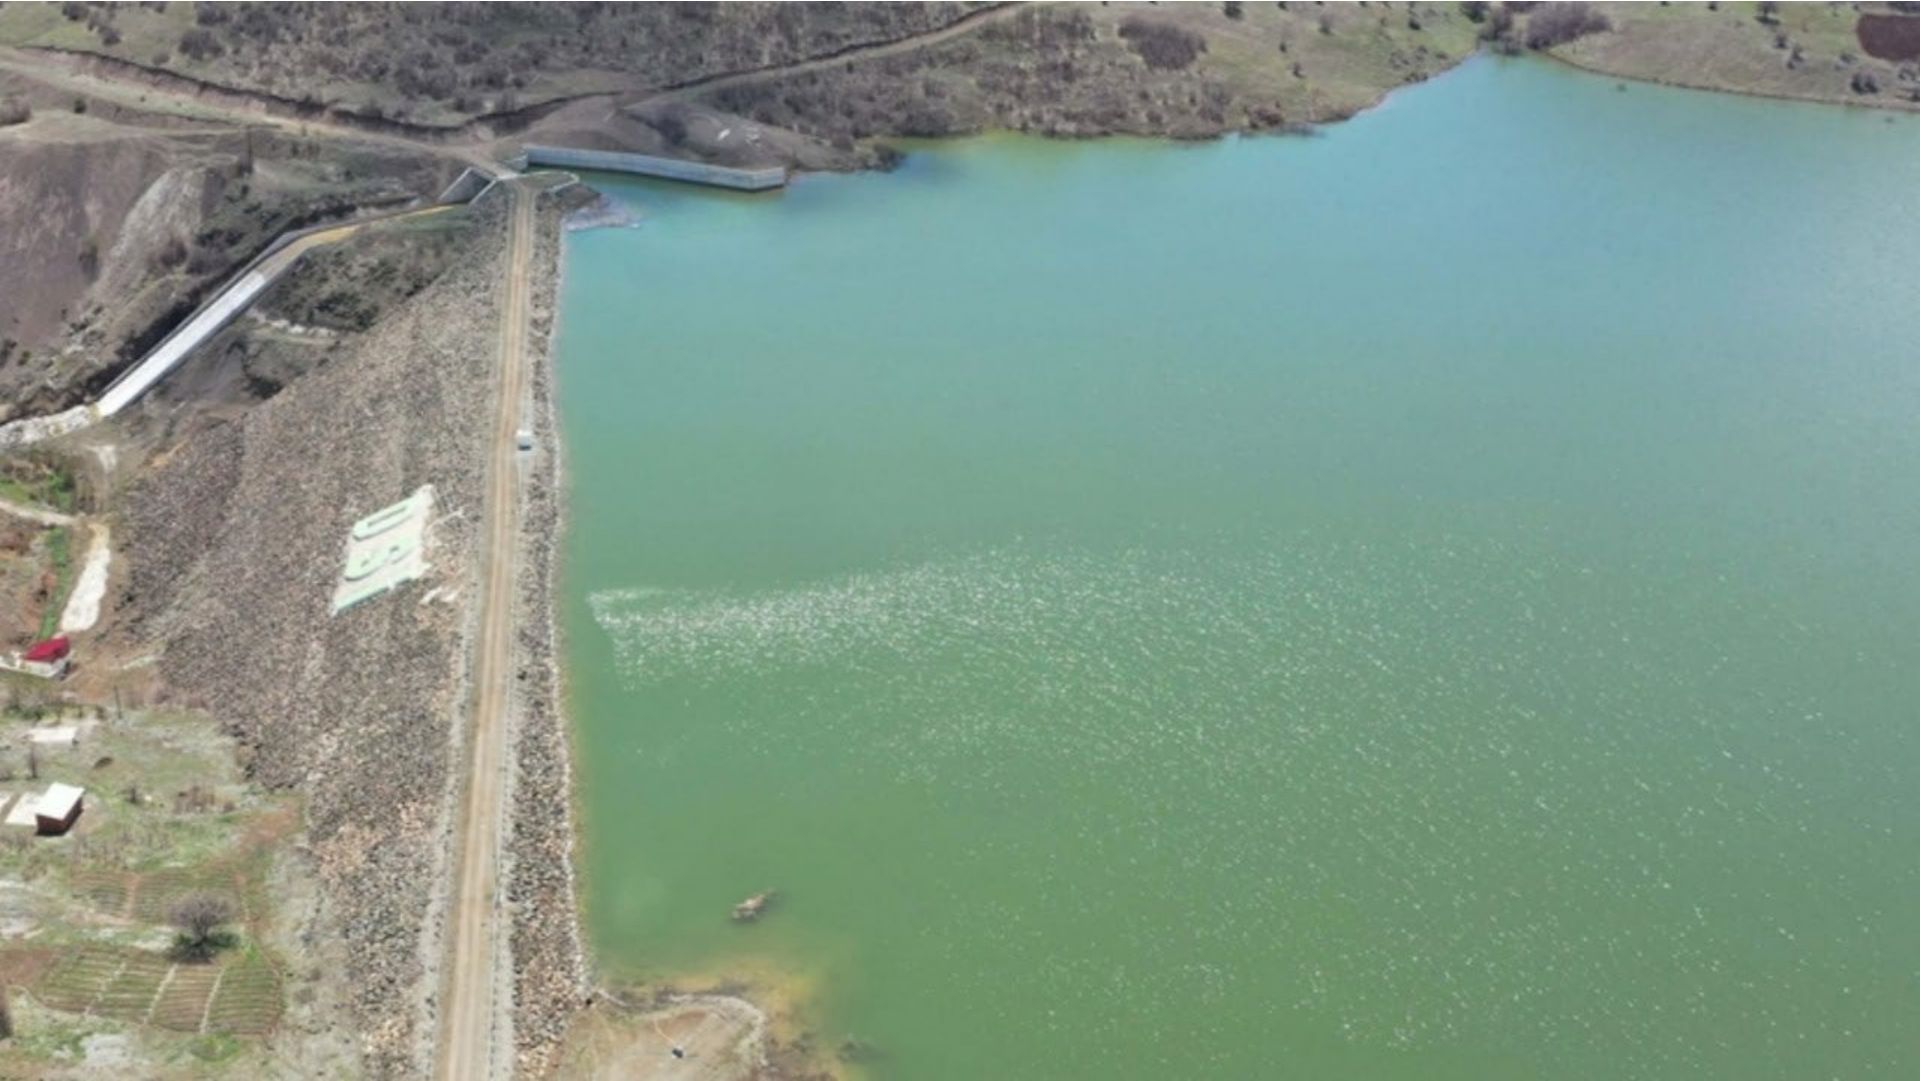
**the Sultansuyu Dam**, which was affected by the 7.7 magnitude earthquake in the Pazarcık district of Kahramanmaraş, **will be evacuated gradually** as a precaution.
