## Residential home in Urayasu, Chiba Prefecture (Tohoku Earthquake, 2011)

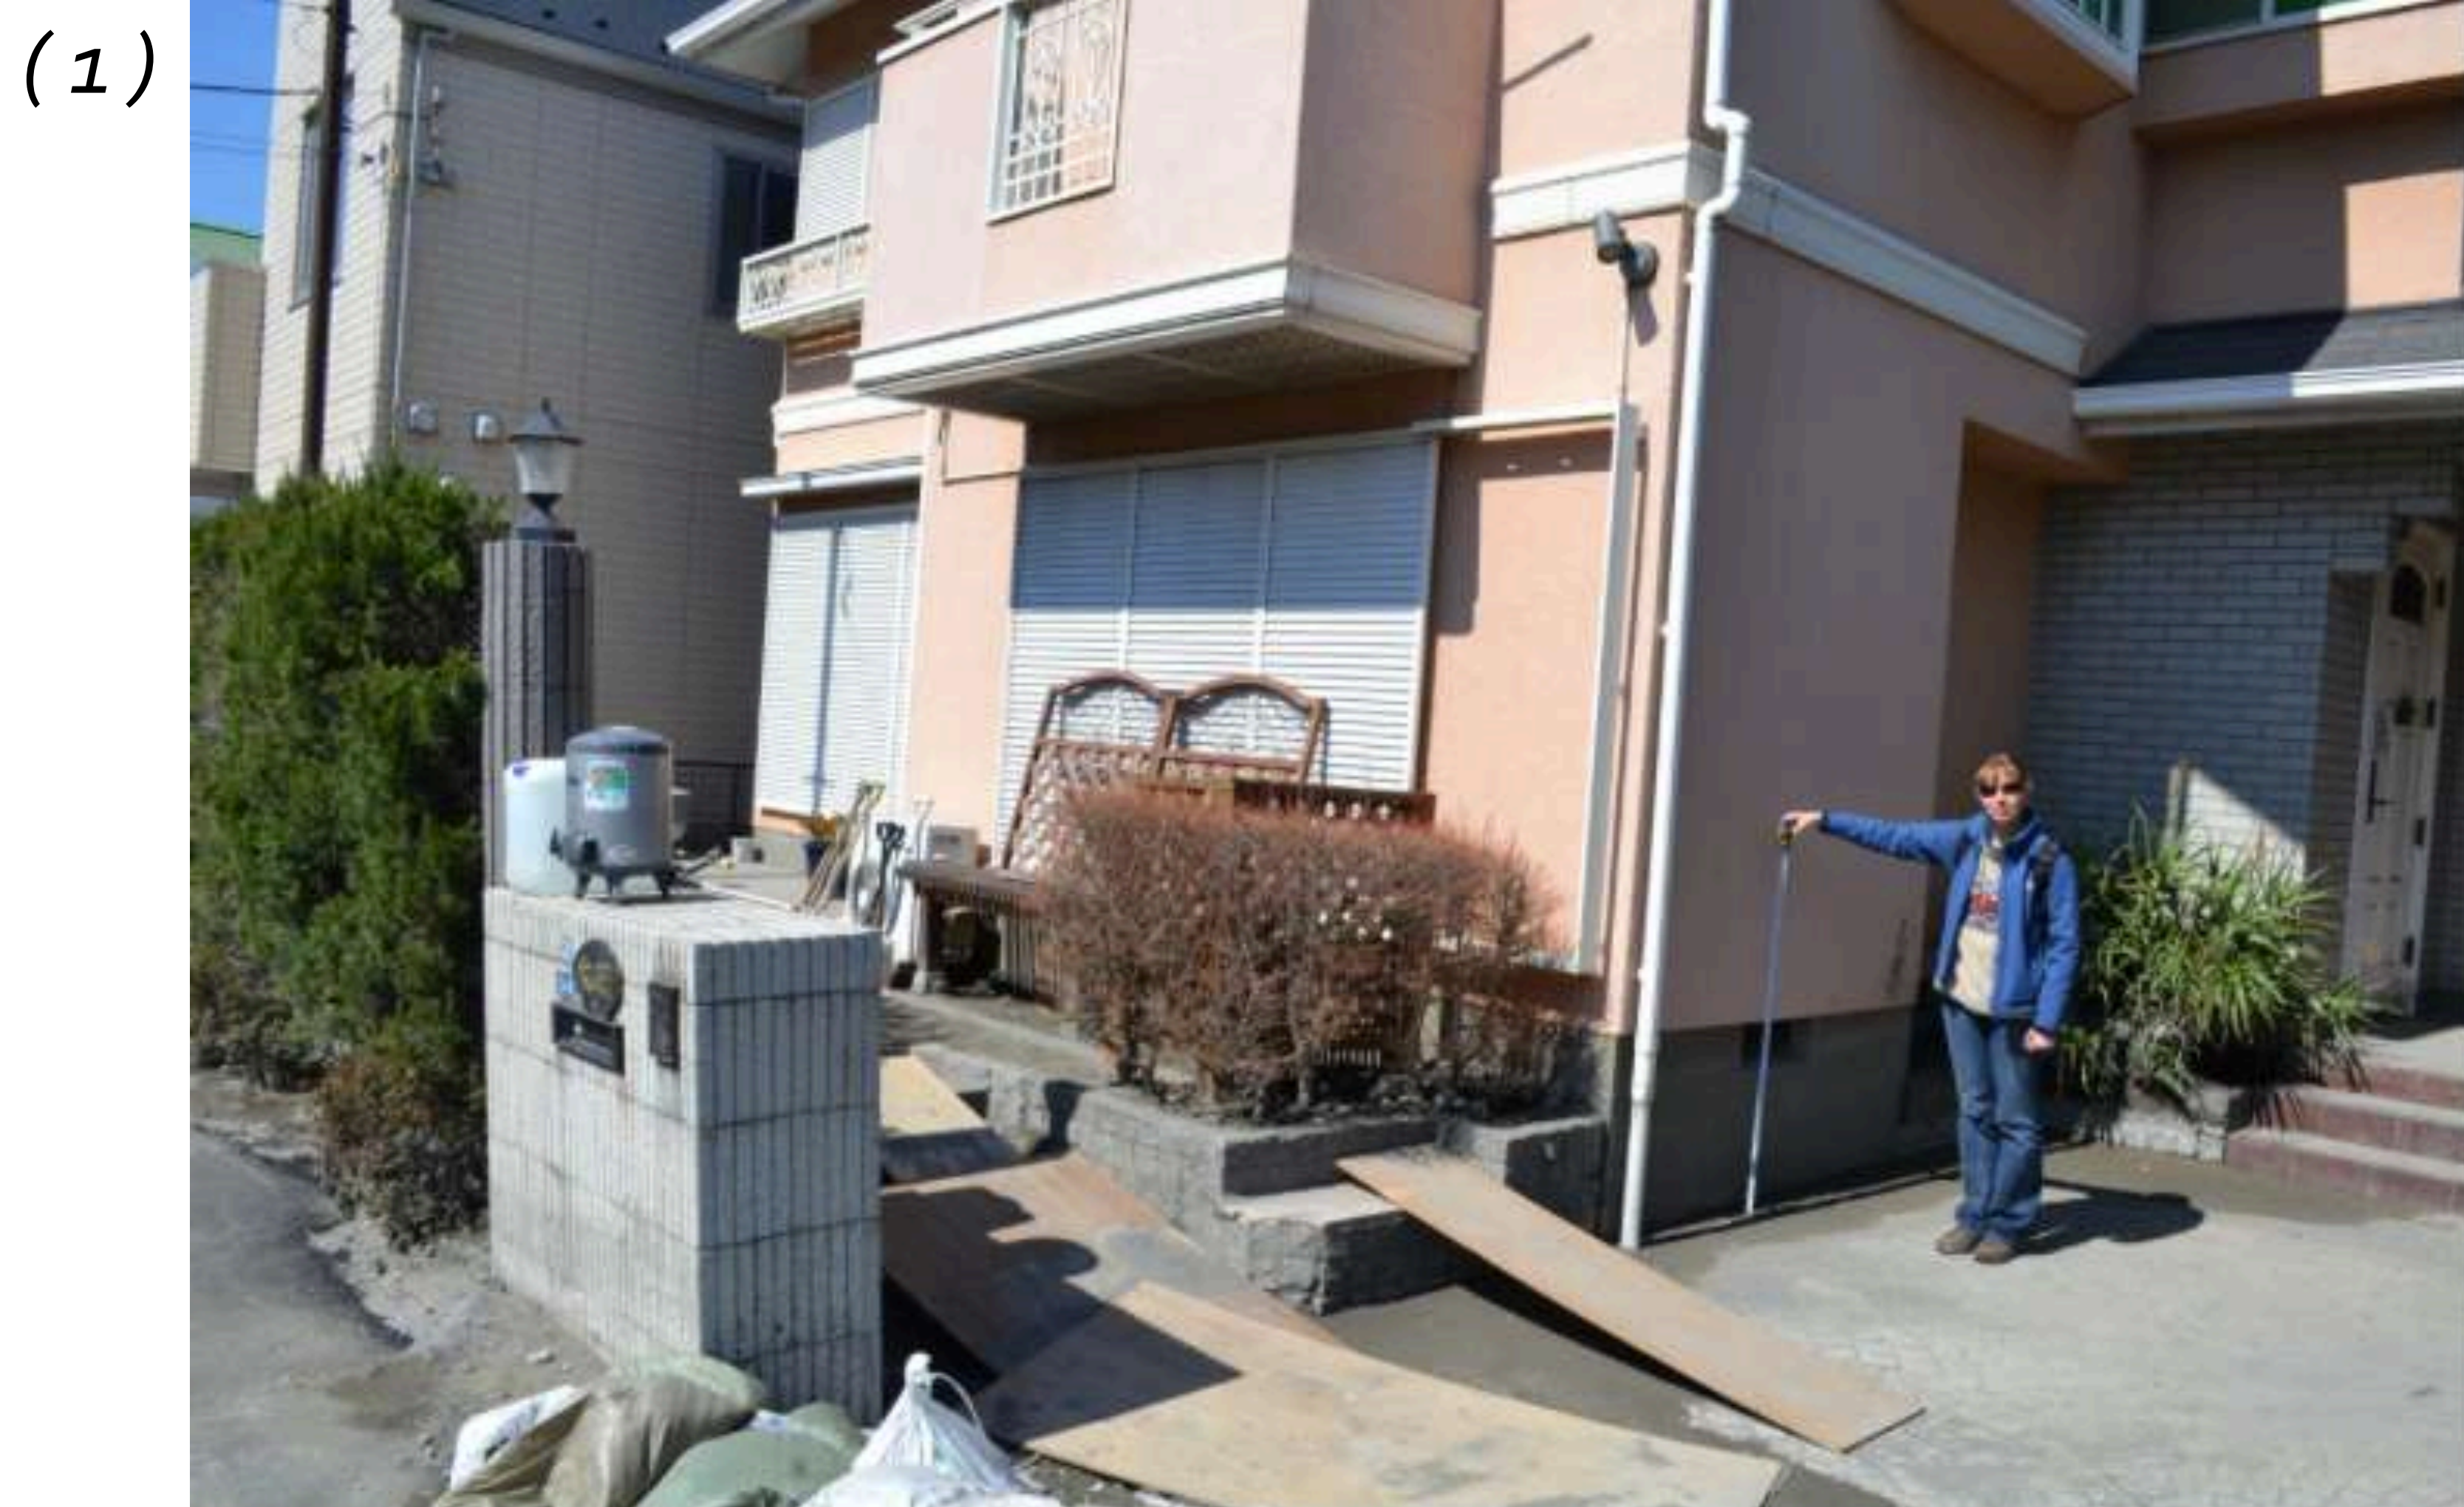
A light frame residential home with an exterior structure finish, built on a typical foundation of deep wall beams over a reinforced concrete mat.

- (1) Residential home
- (2) Neighboring residential foundation (typical of homes in area)
- (3) Land use history in Urayasu
- (4) Soil profile from nearby site

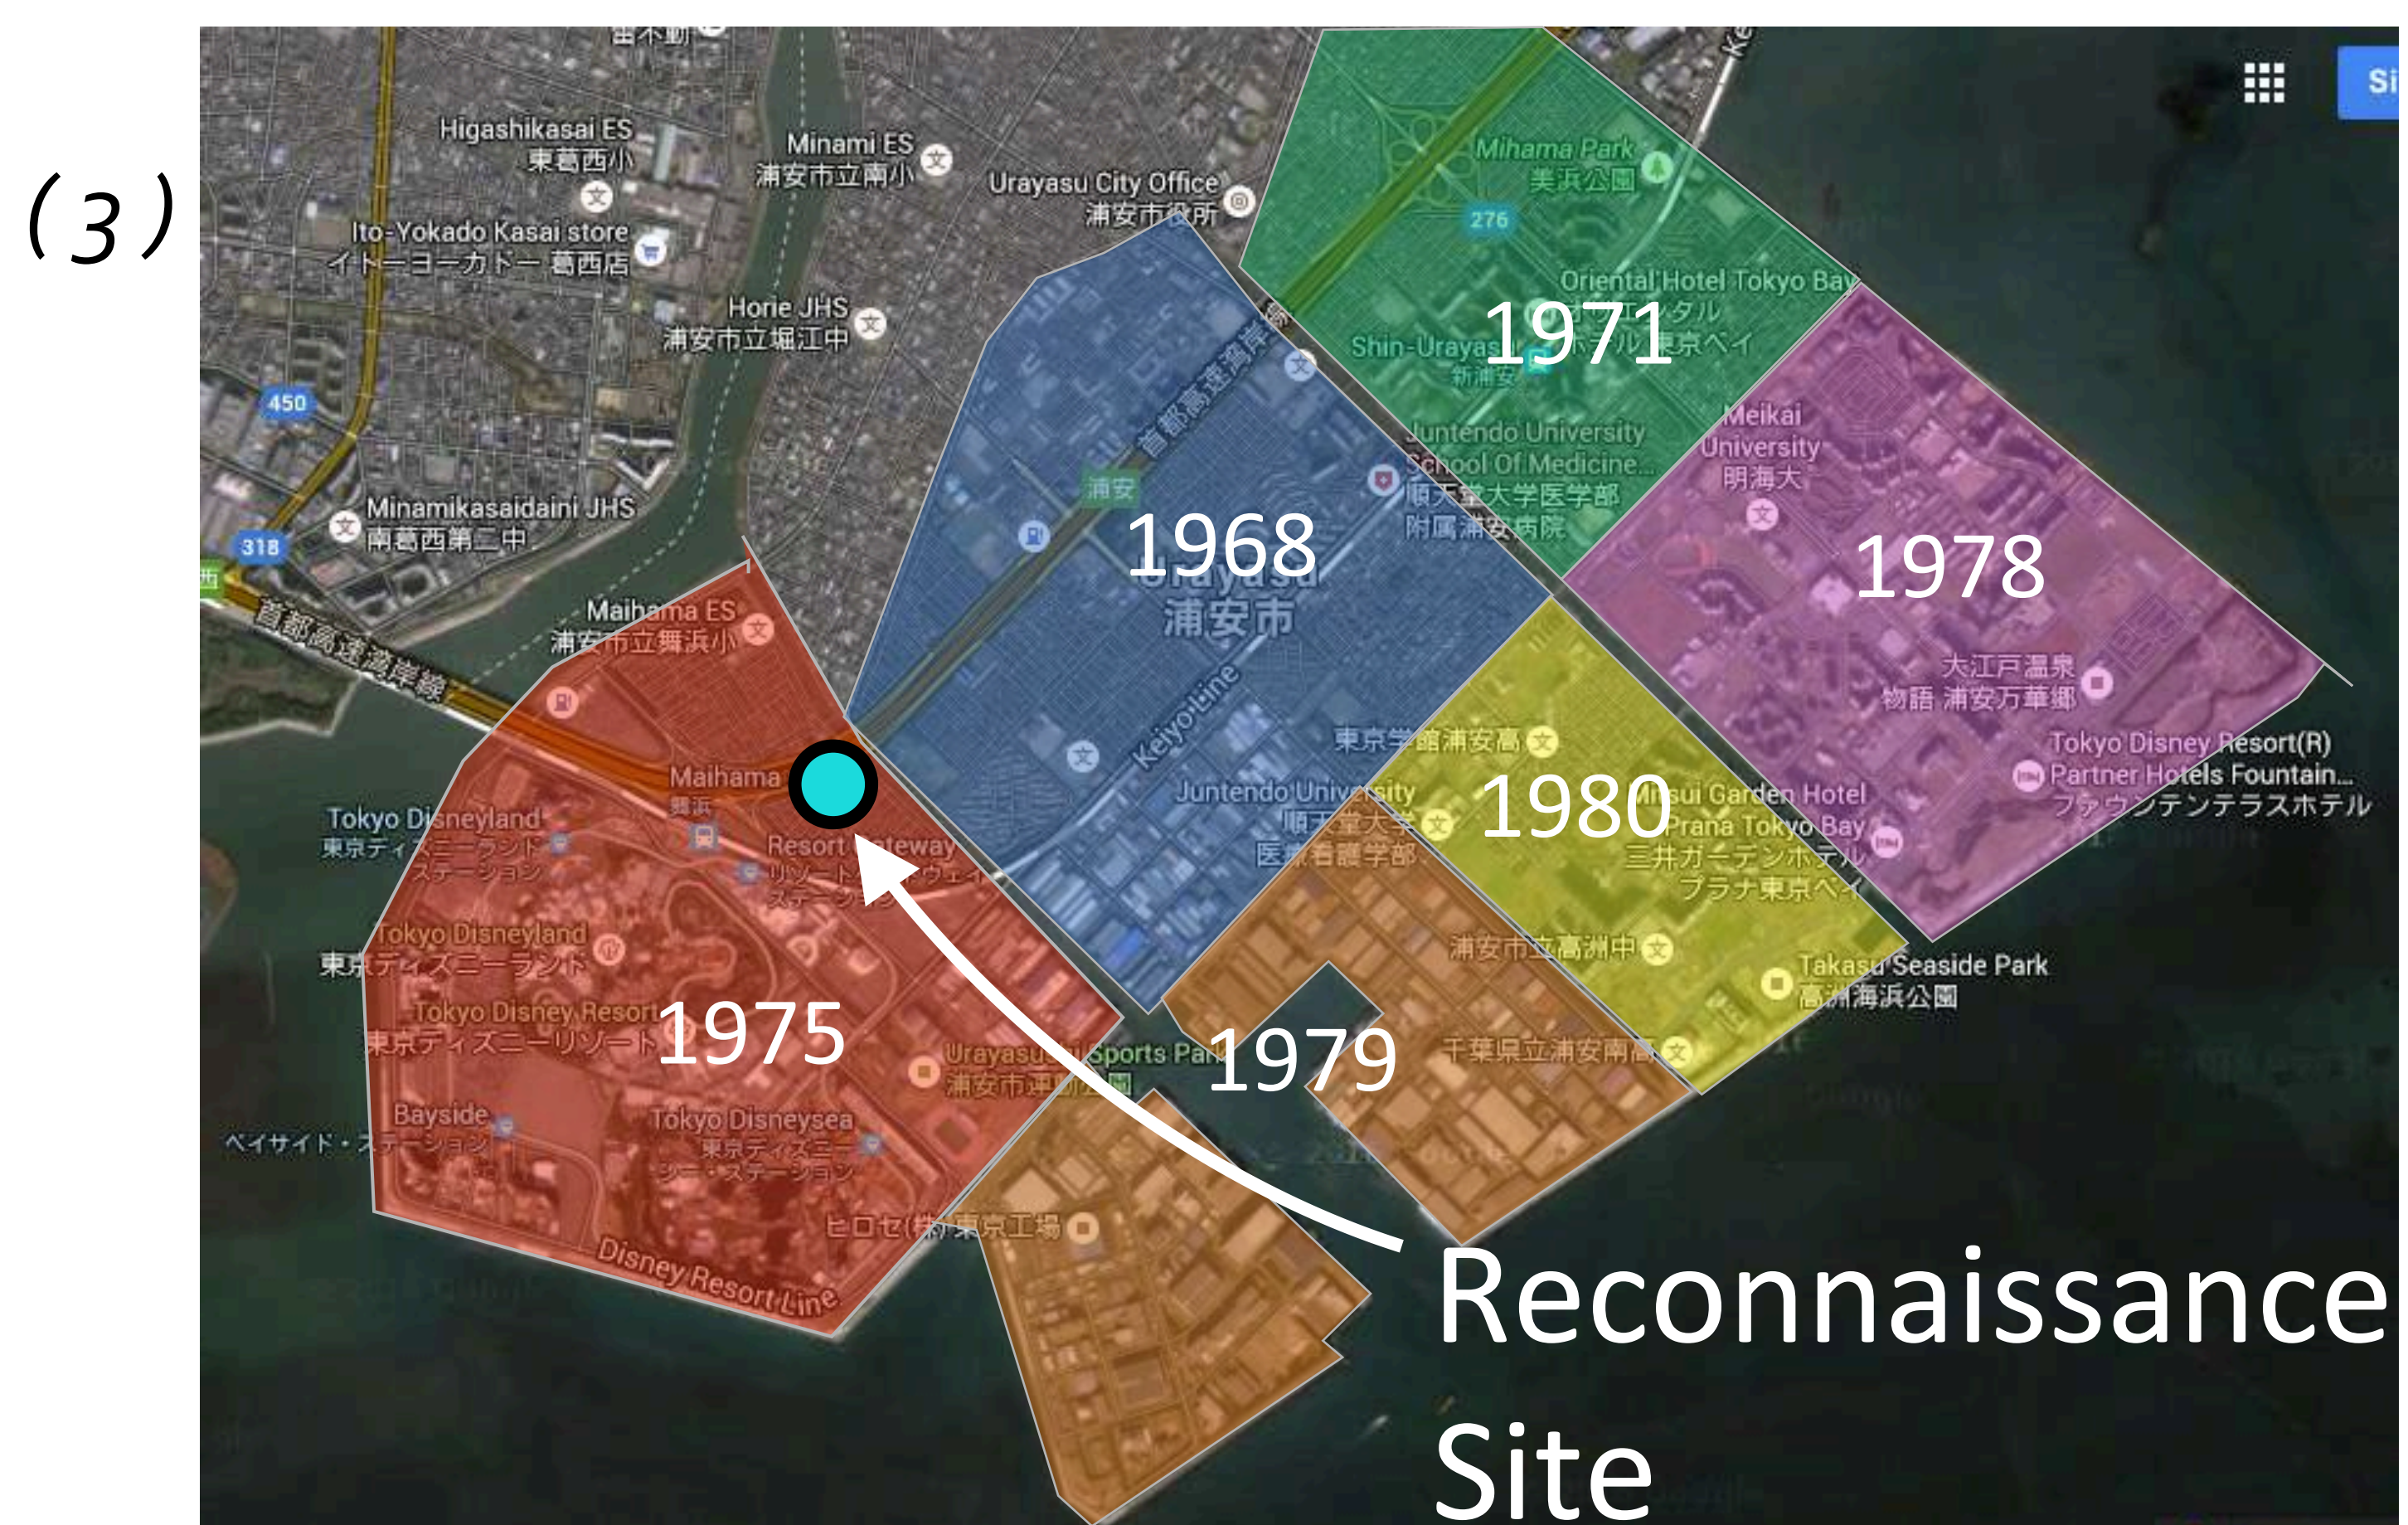
Urayasu City is a residential area located in an area of strong to severe shaking intensity during the Tohoku Earthquake.
