# Preliminary report Mw 7.4, San José del Palmar, Colombia 10-Aug-2026

## Preliminary visual report

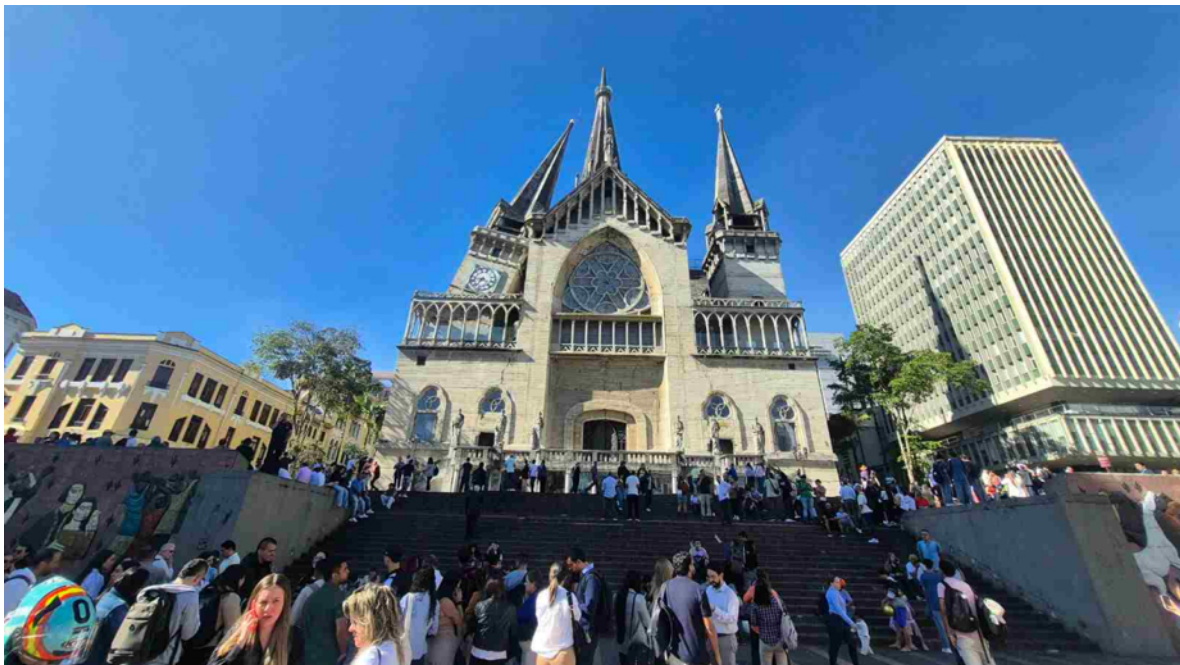
Among the reported cases are damages to unreinforced masonry buildings, including some heritage structures. Notable among these cases is the Basilica of Manizales, which suffered severe damage (See **Figure 3.1**).

**Figure 3.1.** Basílica de Manizales (La Patria, 2026).

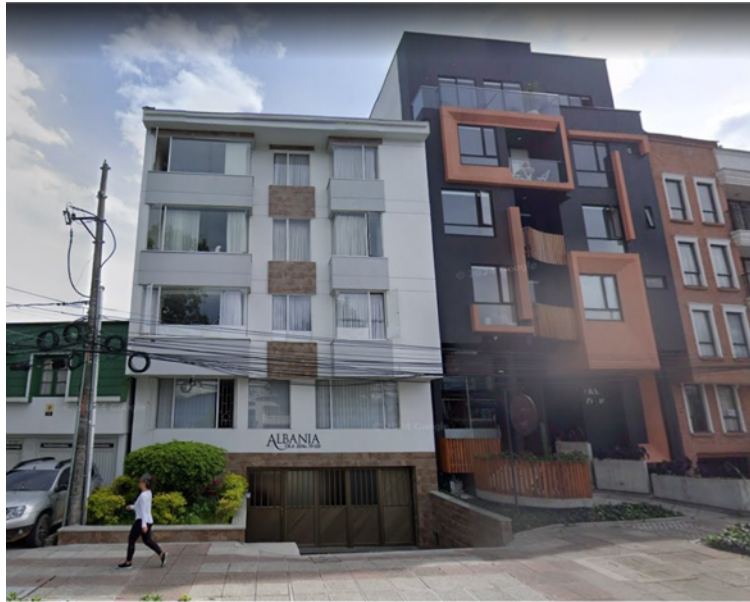
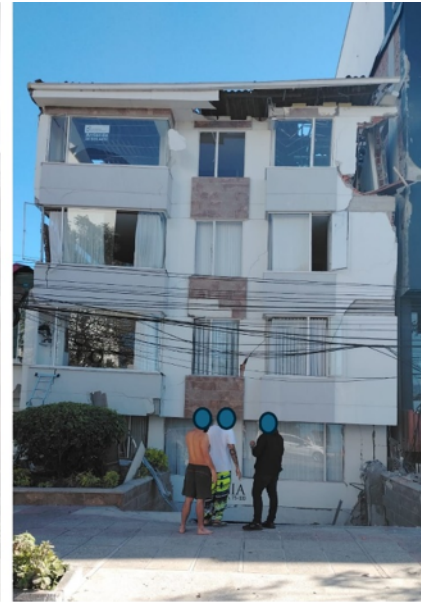
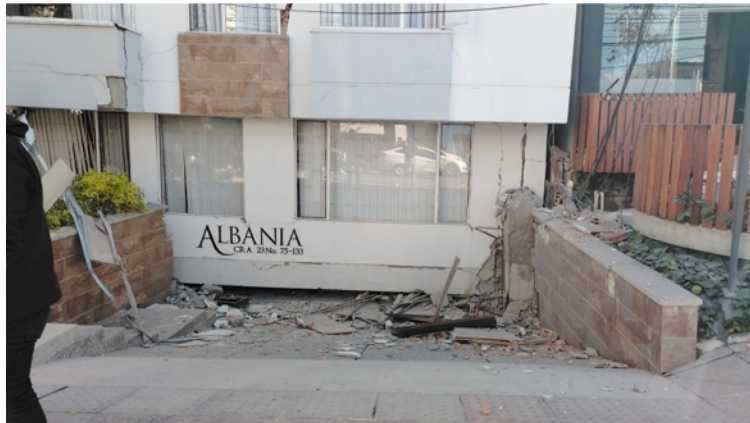
**Figure 3.2** shows a five-story building in Manizales that suffered a collapse concentrated on the first floor. The observed pattern could be consistent with the presence of a soft story, although this hypothesis must be verified through a detailed field inspection. **Figure 3.3** presents an eight-story building with severe damage to the first-story columns. The images show longitudinal reinforcement splices located approximately at mid-height of the columns, a condition that could have contributed to the degradation of the concrete core and the observed damage.

**Figure 3.2.** First-floor collapse in a building in Manizales: (a) Pre-earthquake photo (Google Maps, 2026a); (b) & (c) Post-earthquake photos showing the partial collapse of the structure (Source: Photographs provided by Juan Ocampo via WhatsApp).

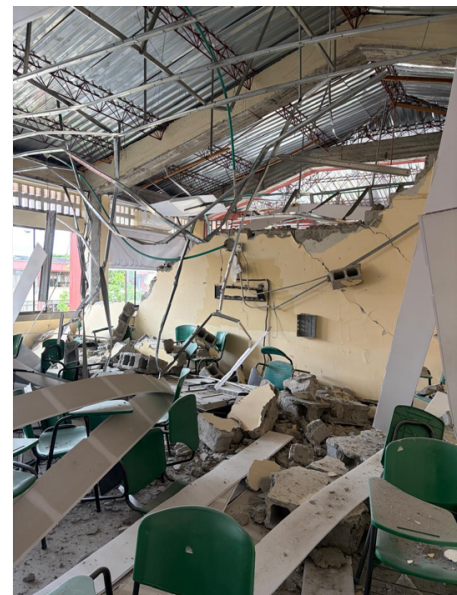
Finally, **Figure 3.4** shows damage to buildings at the Universidad Tecnológica del Chocó, approximately three to four stories high. In this case, damage is observed primarily in masonry partitions and non-structural components, including damage to the roofs.
